### **Meadowbank 2018 TSF As-built report**

**2018 CONSTRUCTION SEASON AS-BUILT REPORT  
TAILINGS STORAGE FACILITY  
MEADOWBANK GOLD PROJECT, NUNAVUT**

1897439-1578-R-Rev0

November 2018

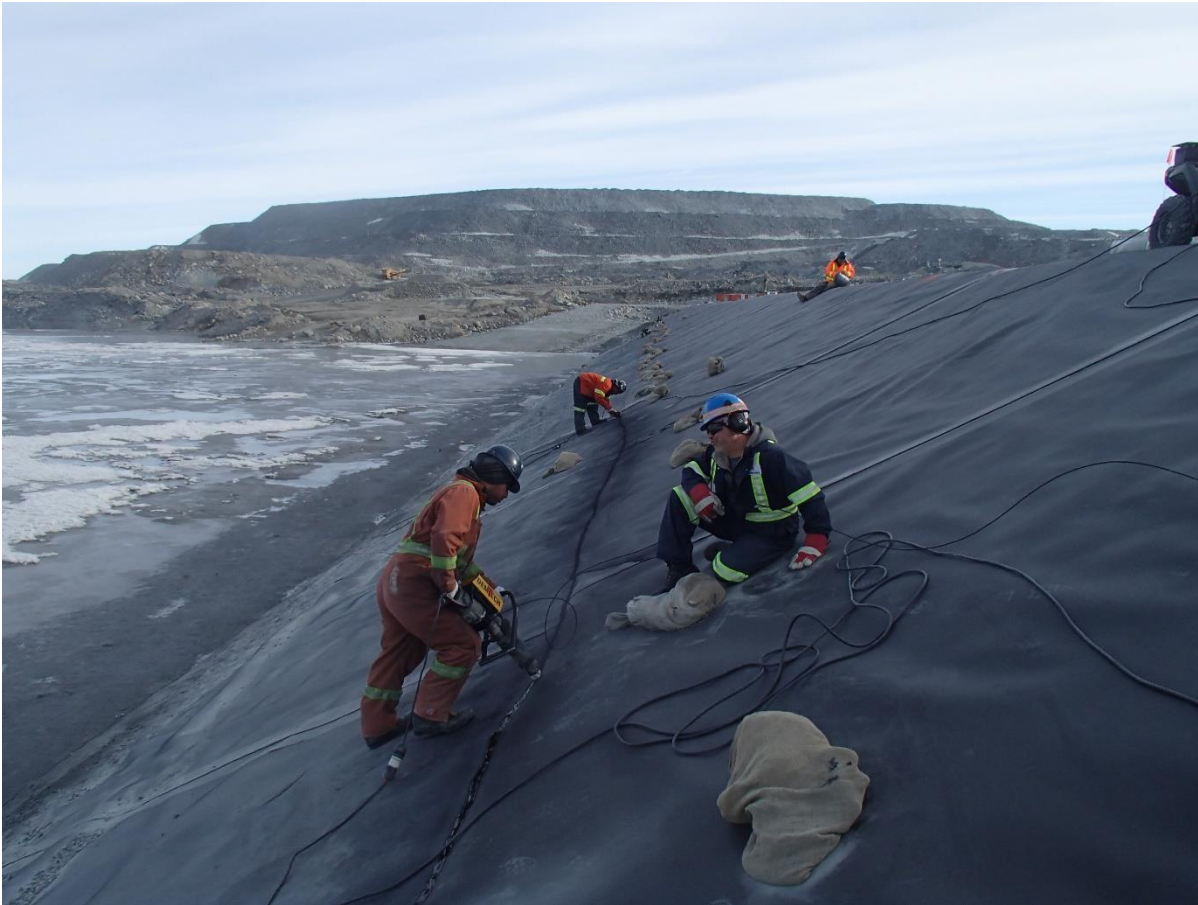
Photograph CD-1890: From Sta. 0+310/-26 m, looking N. View of the extrusion welding.

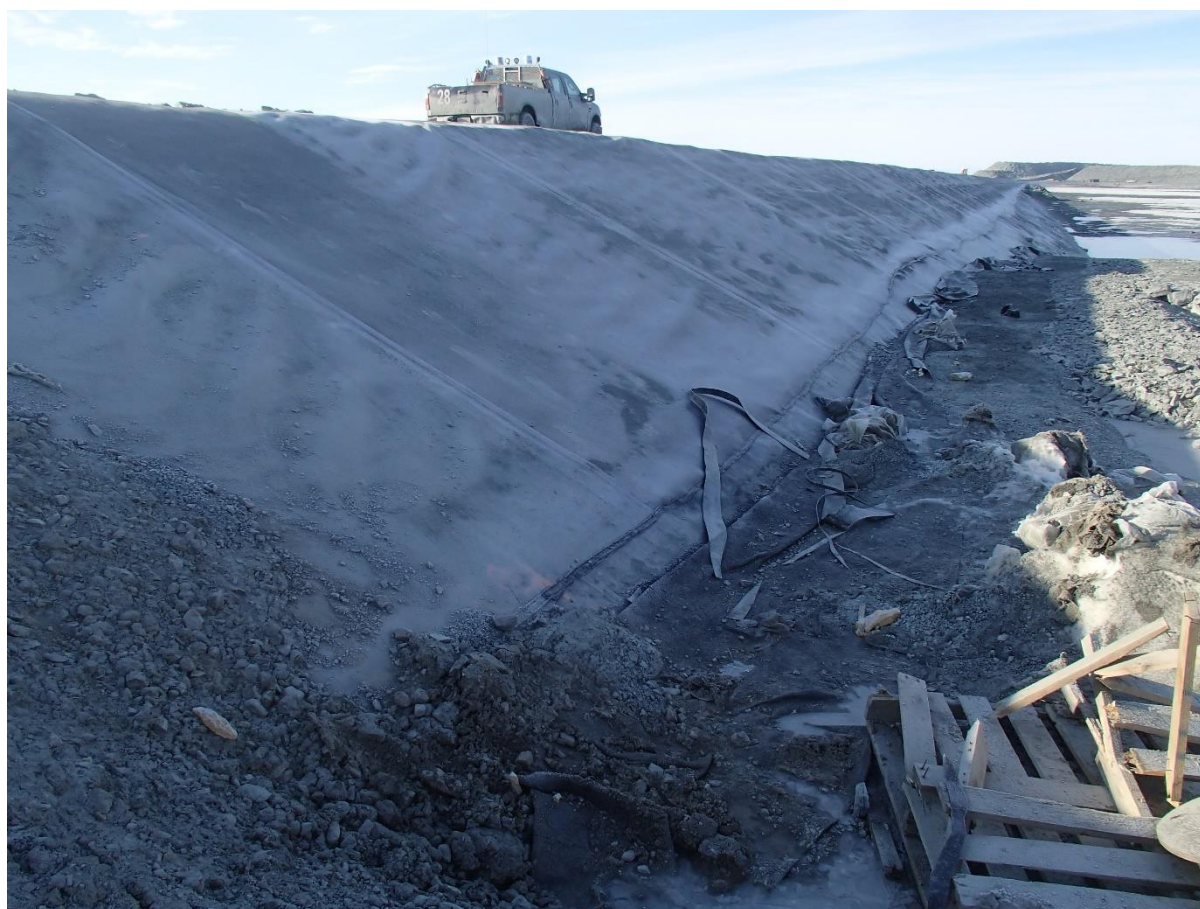
**Photograph CD-1892: From Sta. 0+155/-32 m, looking S. View of the liner panel 933 overlapping the underlying liner that has been cut at around Sta. 0+160 m to drain the water.**

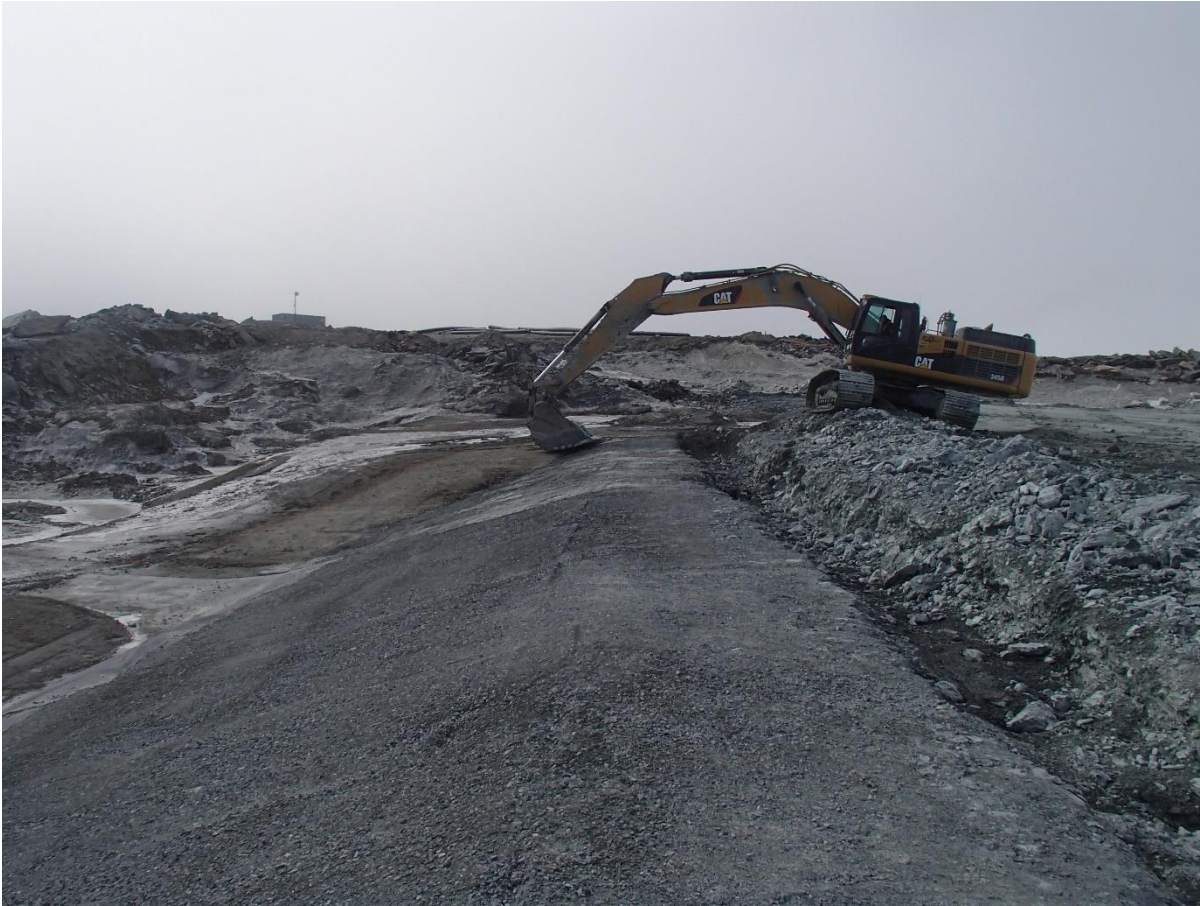
**Photograph SD3-306: From Sta. 20+780/-25 m, looking S. Correction of the surface of the fine filter in the upstream slope and the top of the first class compacted sieved till layer with an excavator from Sta. 20+803 m to 20+793 m.**

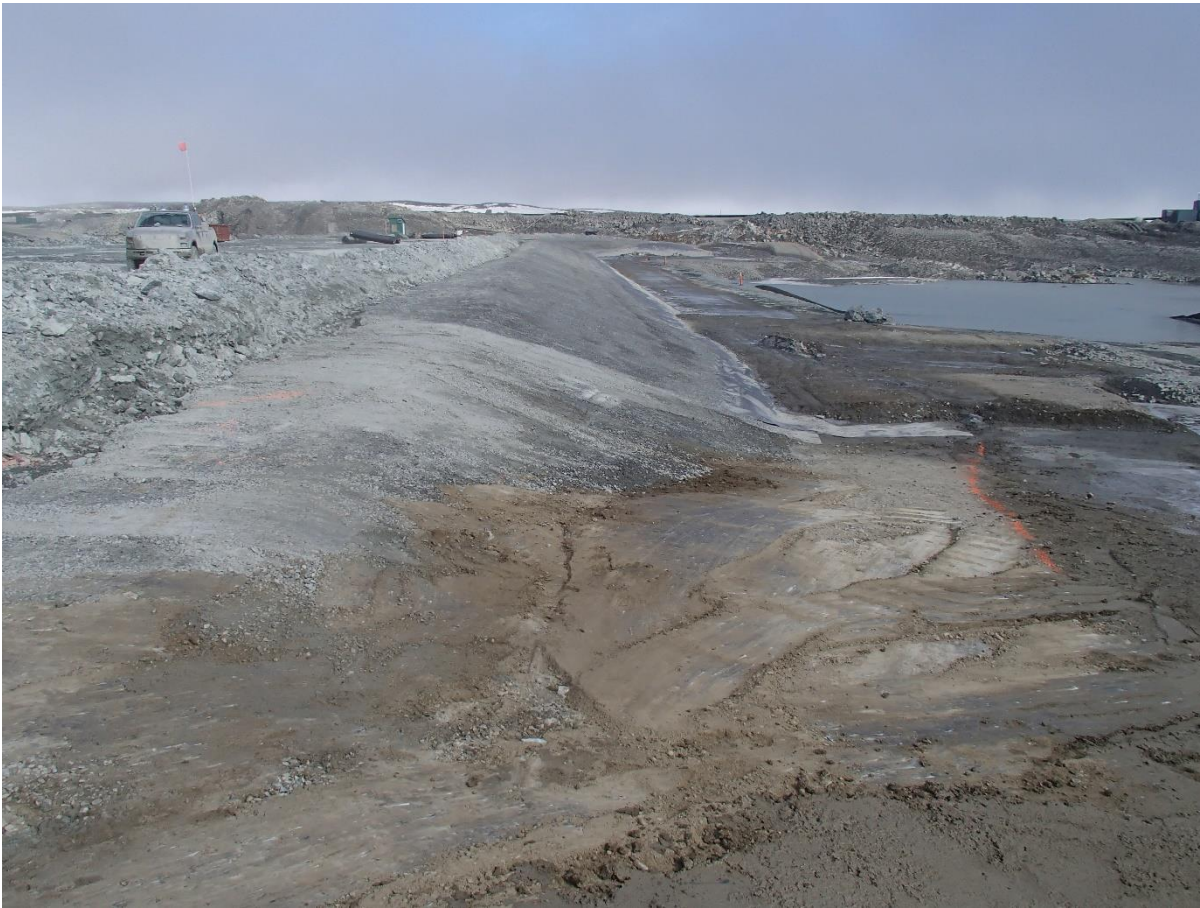
**Photograph SD3-307: From Sta. 20+800/-25 m, looking N. View of the liner bedding ready for geosynthetics installation.**

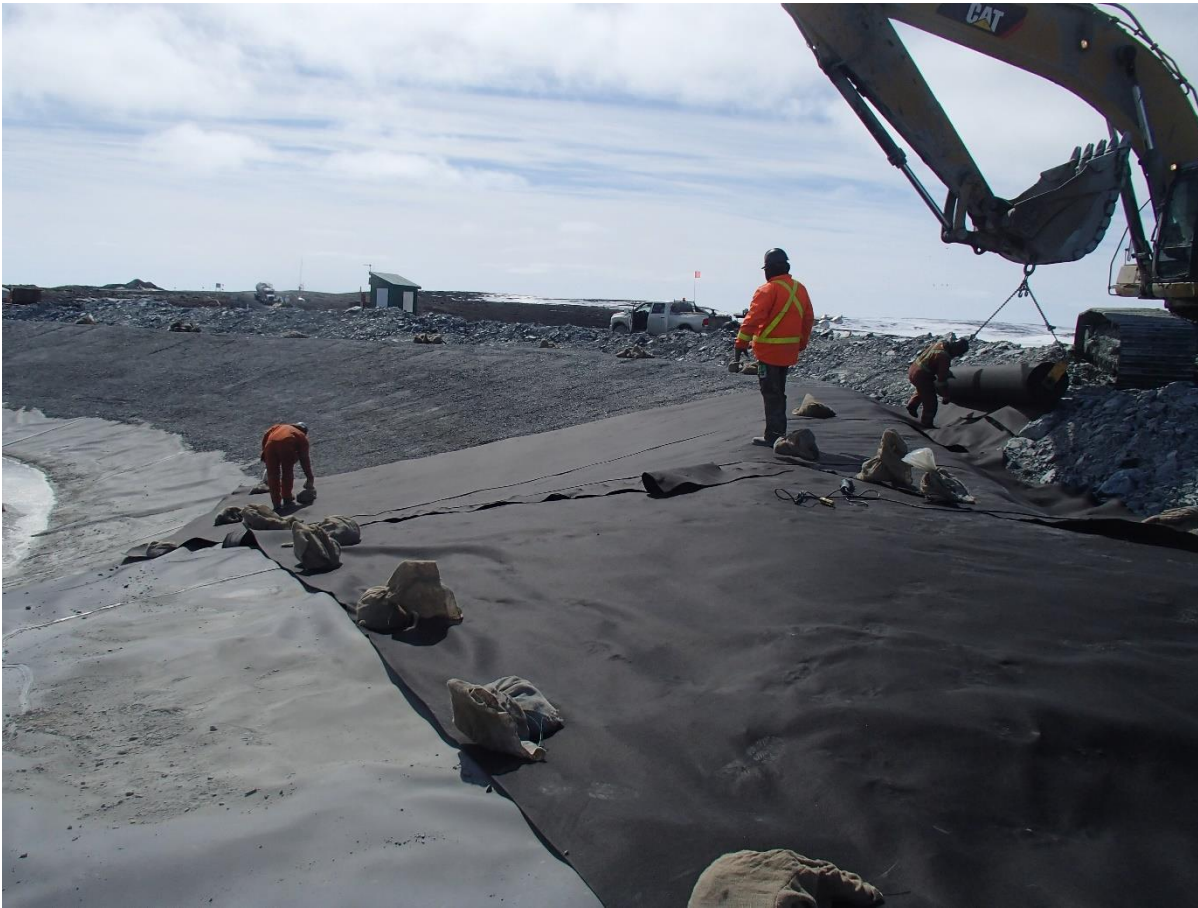
**Photograph SD-308: From Sta. 20+620/-48 m, looking SW. Installation of the geotextile on the upstream slope 2H:1V between El. 143 m and 145 m from Sta. 20+620 m to 20+630 m.**

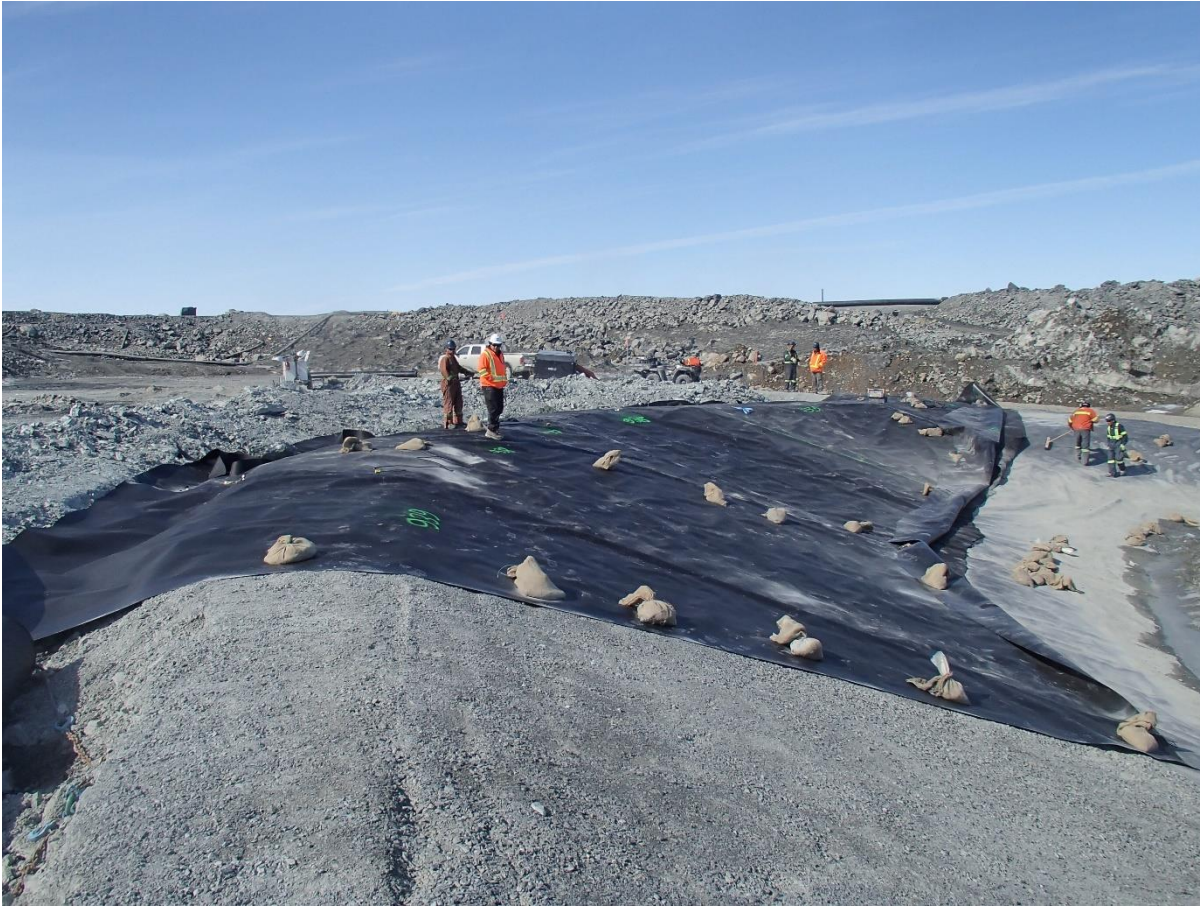
**Photograph SD-309: From Sta. 20+640/-26 m, looking N. Installation of the LLDPE liner on the upstream slope 2H:1V between El. 143 m and 145 m from Sta. 20+620 m to 20+630 m (panel numbers 934 to 939).**

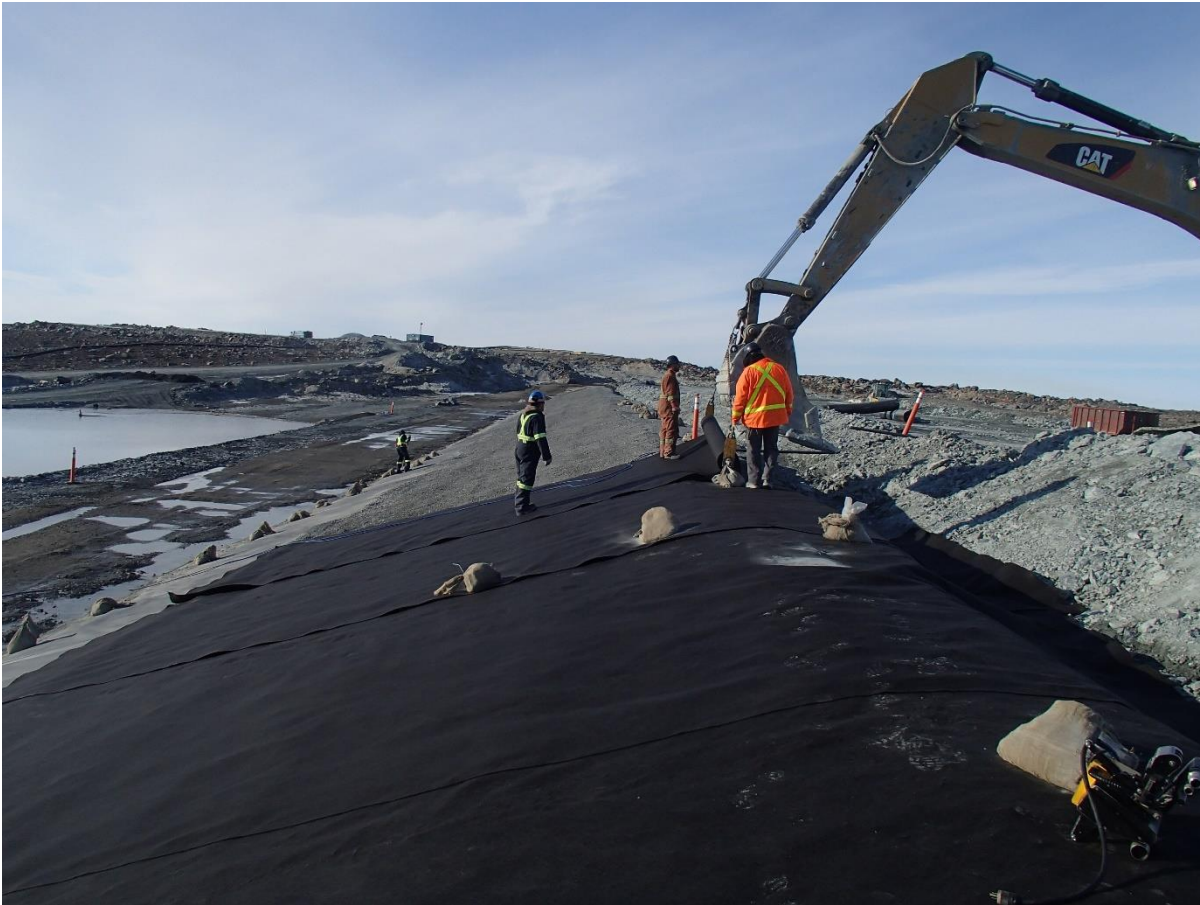
Photograph SD-310: From Sta. 20+635/-24 m, looking S. Installation of the geotextile on the upstream slope 2H:1V between El. 143 m and 145 m from Sta. 20+630 m to 20+800 m.

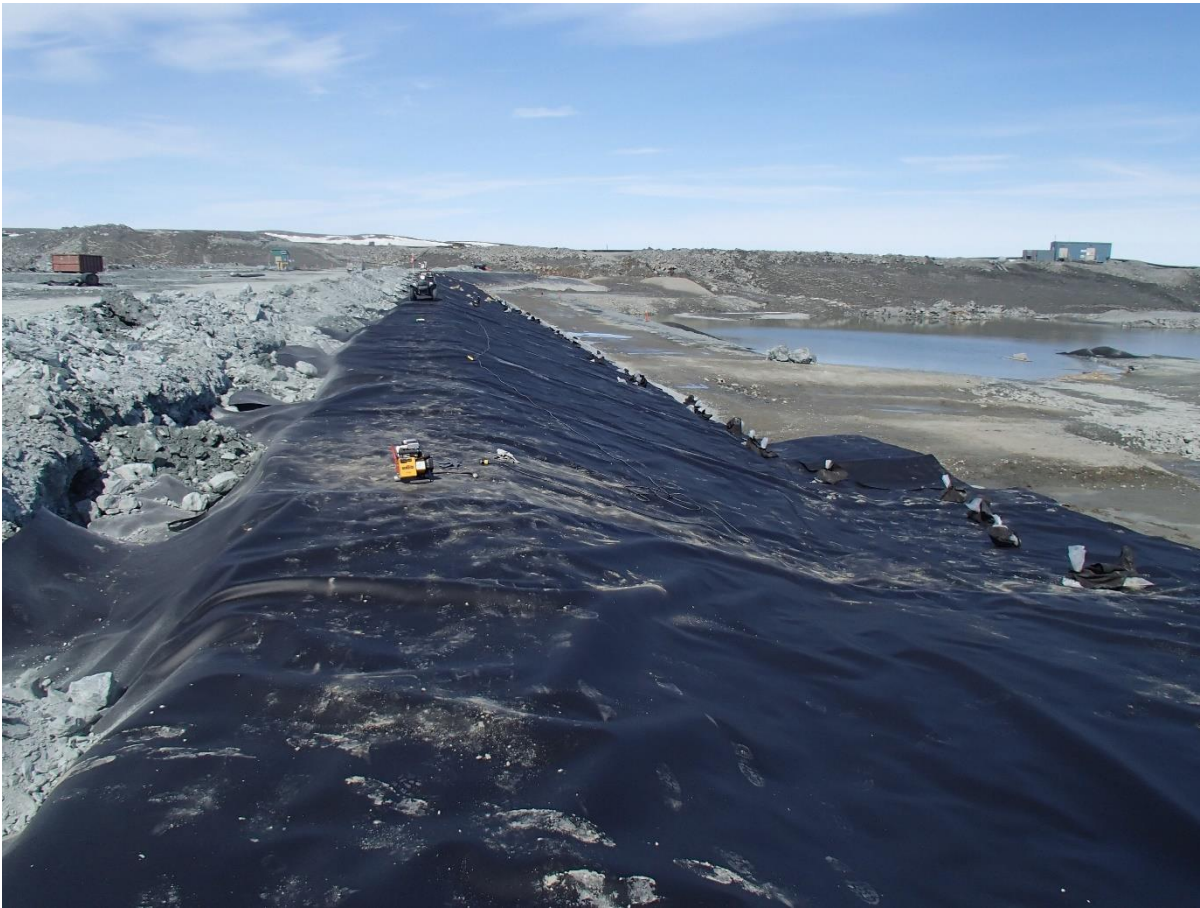
**Photograph SD-311: From Sta. 20+810/-26 m, looking N. Installation of the LLDPE liner on the upstream slope 2H:1V between El. 143 m and 145 m from Sta. 20+630 m to 20+800 m (panel numbers 939 to 964).**

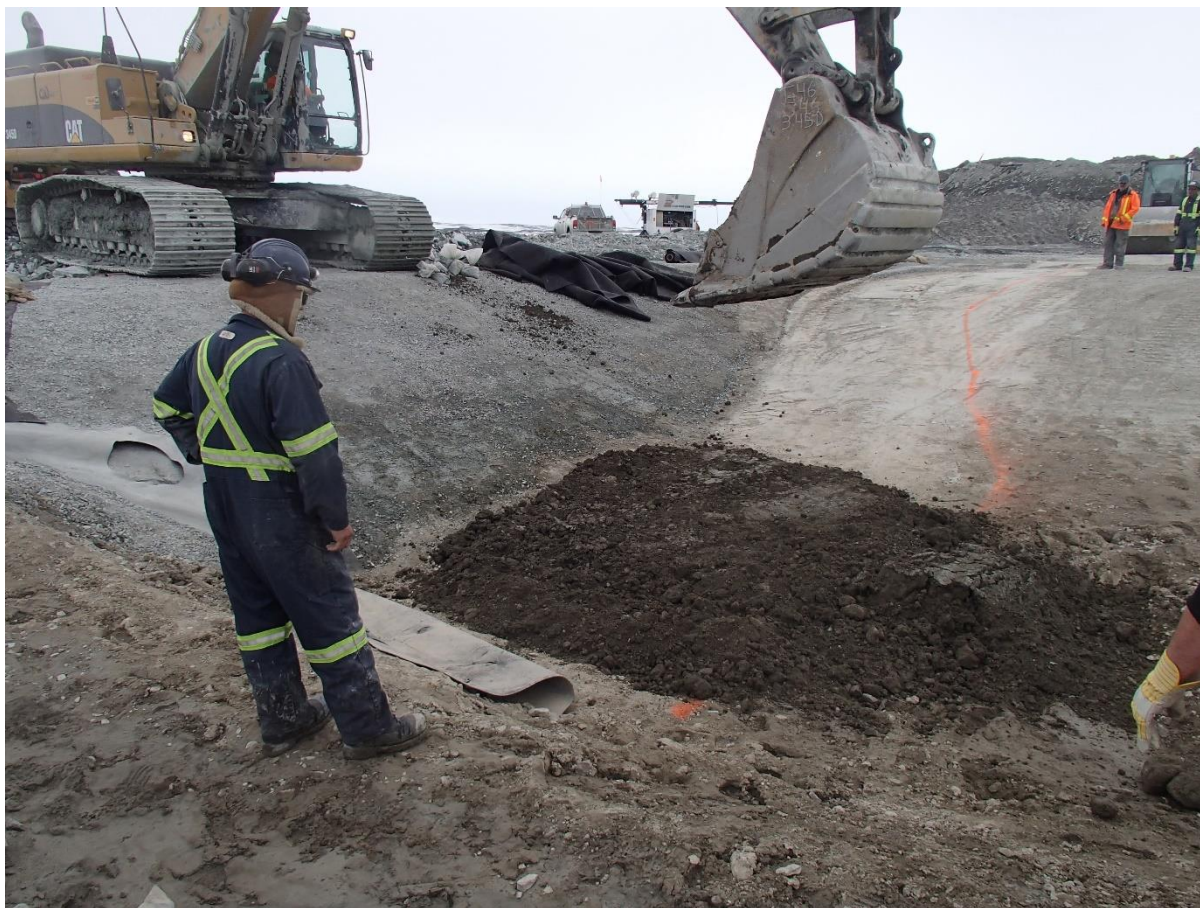
**Photograph SD3-312: From Sta. 20+610/-48 m, looking W. Placement of a 0.15 m thick lift of compacted sieved till from Sta. 20+596.4 m to 20+601.6 m (o.s. -42.6 to -46.3 m) to fill the depression in the compacted sieved till layer.**

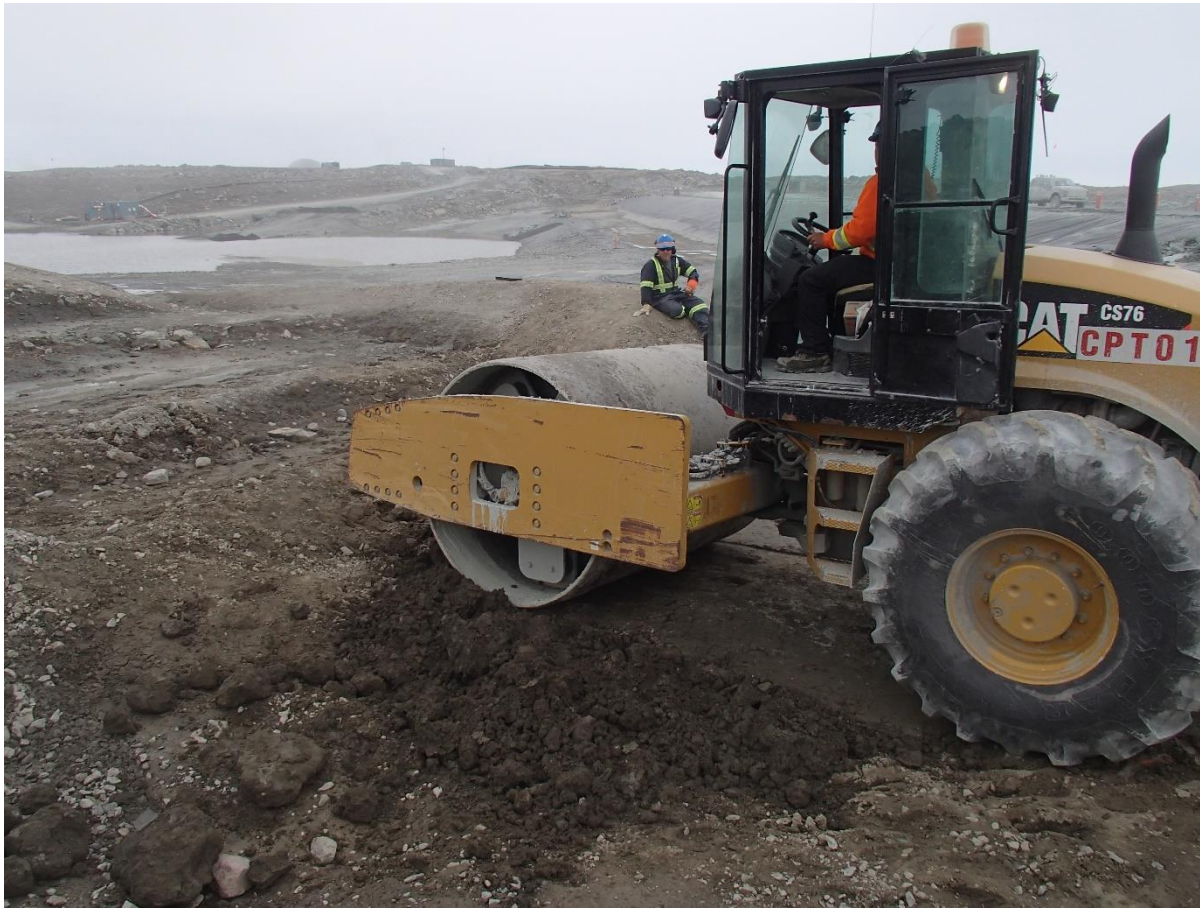
**Photograph SD3-313: From Sta. 20+600/-52 m, looking S. Compaction of the 0.15 m-thick lift of compacted sieved till with a 10-tonne smooth-drum compactor without vibration from Sta. 20+596 m to 20+601 m.**

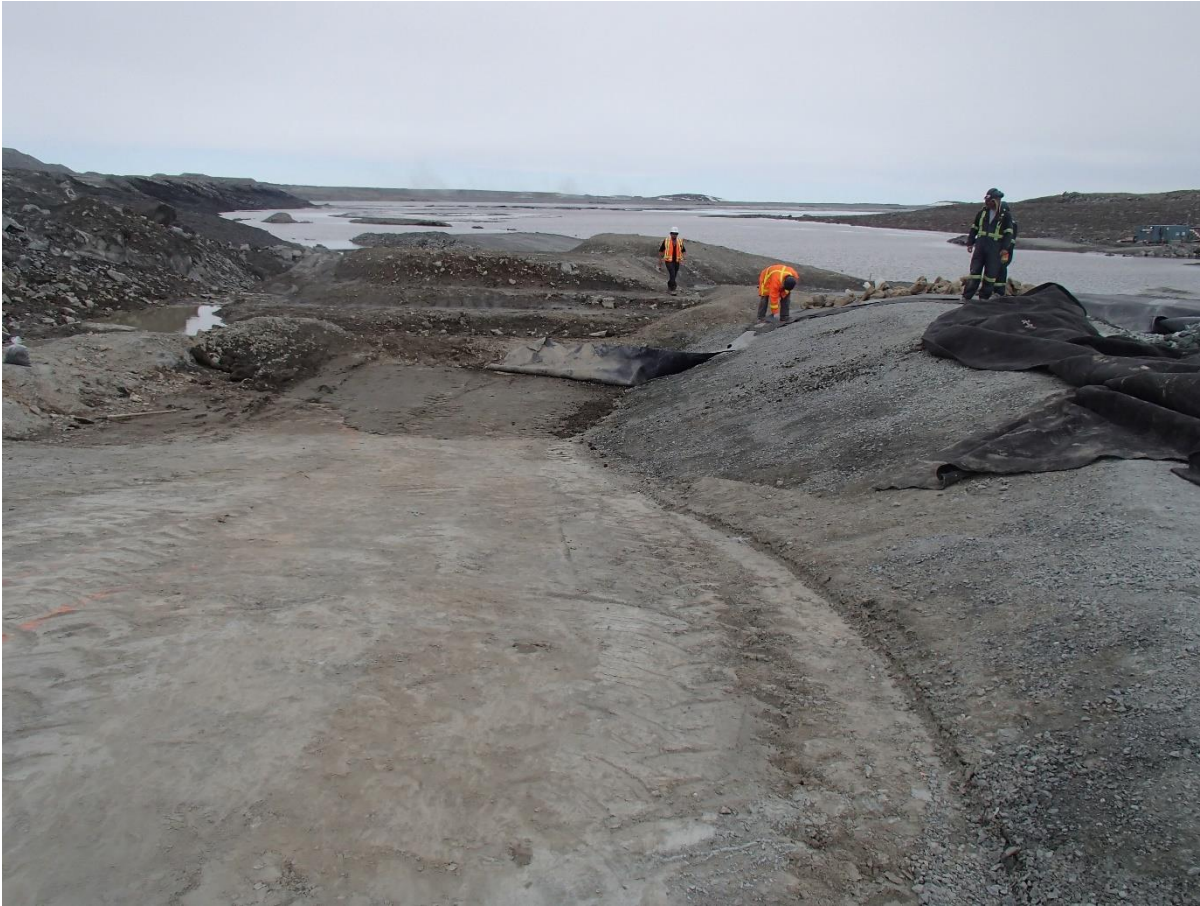
**Photograph SD3-314: From Sta. 20+590/-32 m, looking E. View of the liner bedding ready for geosynthetics installation.**

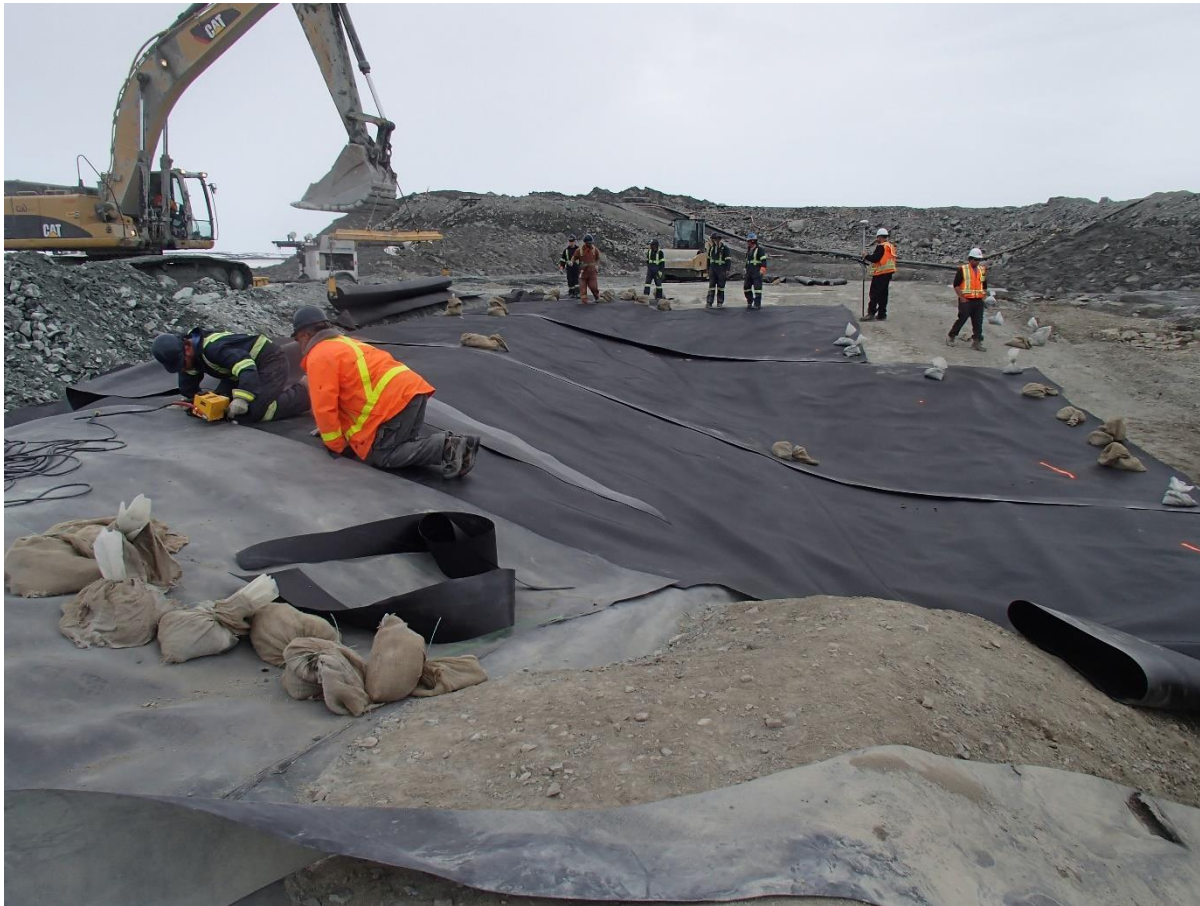
**Photograph SD3-315: From Sta. 20+615/-46 m, looking W. Installation of the geotextile on the upstream slope 3H:1V between El. 143 m and 145 m from Sta. 20+593 m to 20+610 m and installation of the LLDPE liner on the upstream slope 3H:1V between El. 143 m and 145 m from Sta. 20+593 m to 20+610 m (panel numbers 965 to 967).**

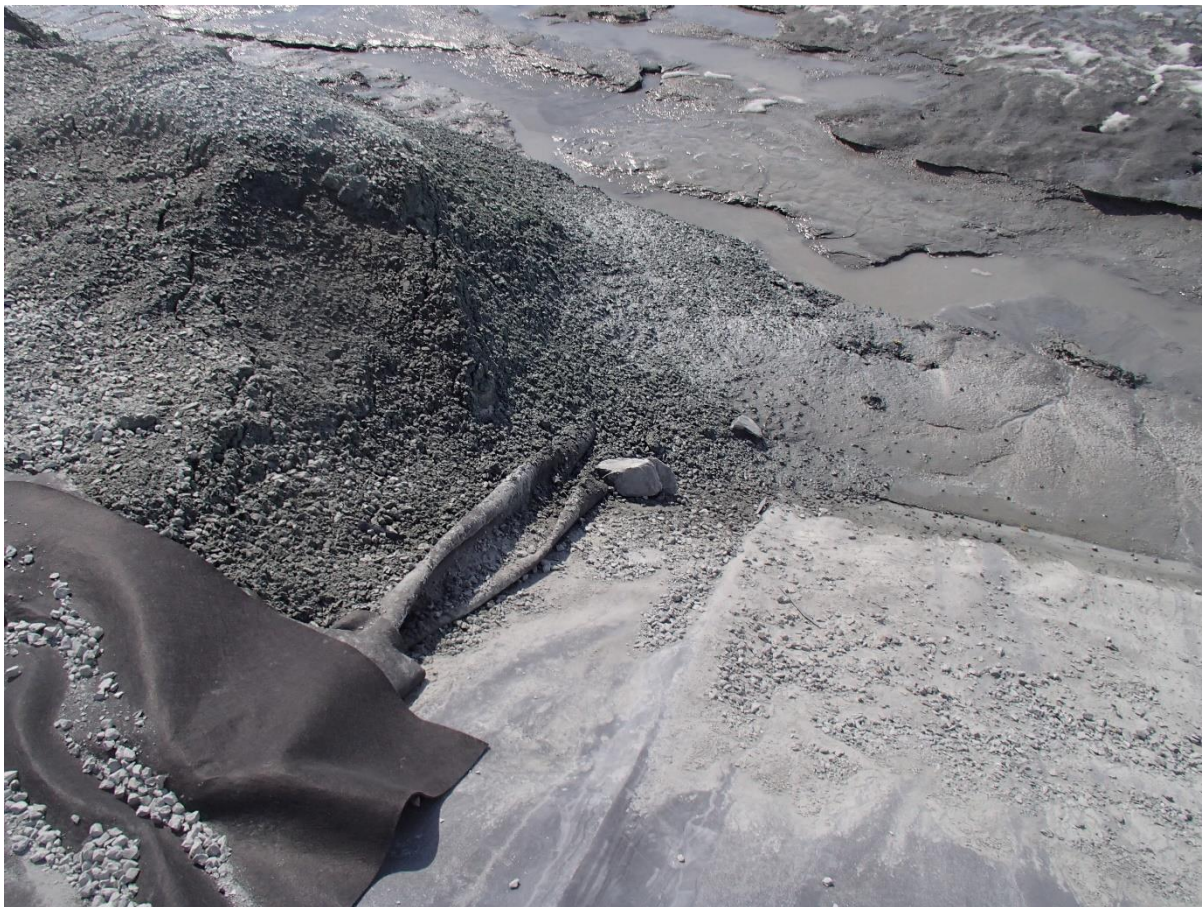
**Photograph CD-1894: From Sta. 0+800/-28 m, looking E. View of a bloc in direct contact with the LLDPE liner following the construction of the deposition fingers on Central Dike.**

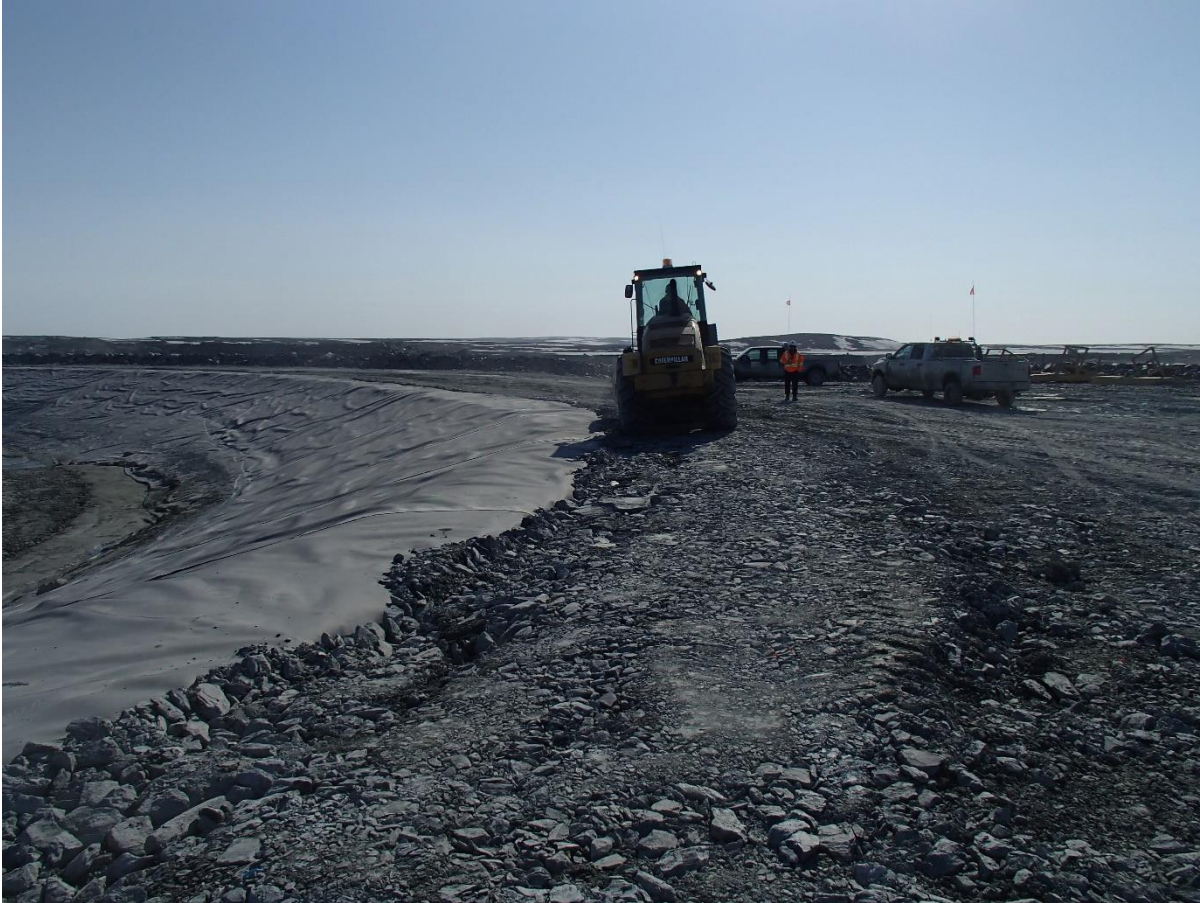
- The QC Personnel observed that the compaction of the backfilling of the geosynthetics tie-in on Central Dike from approx. Sta 0+950 m to 1+050 m was inadequate yesterday. It was recompacted today.
- The QA Manager will leave the site on June 12<sup>th</sup>.

**Photograph CD-1895: From Sta. 40+670/-15 m, looking E. Compaction of the geosynthetics tie-in material at El. 145 m with a 10-tonne smooth-drum compactor with vibration (4 passes) from Sta. 40+670 m to 0+950 m (approx.).**

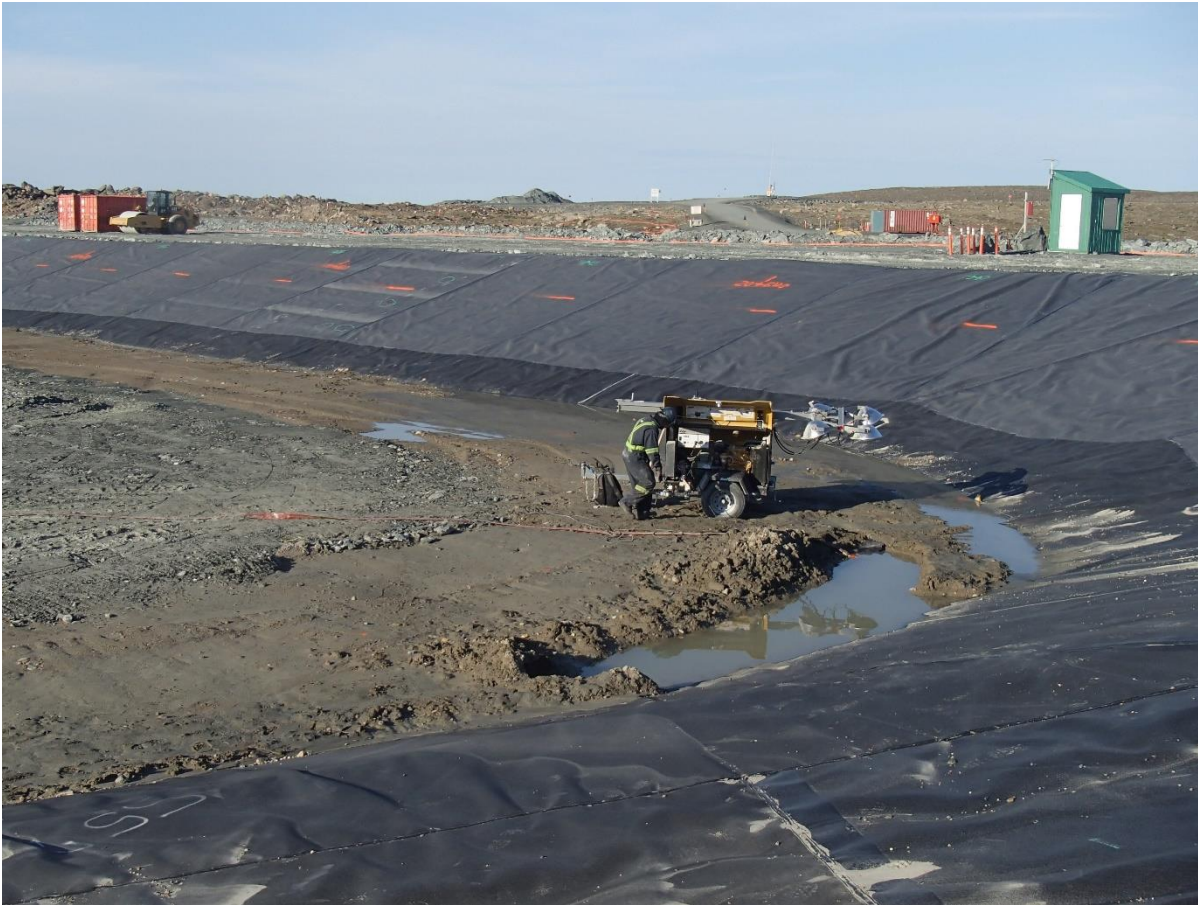
**Photograph SD3-321: From Sta. 20+610/-56 m, looking SW. Water ponding at El. 142m on the compacted sieved till layer of the upstream toe liner tie-in at approx. Sta. 20+620 m to 20+630 m was pumped.**

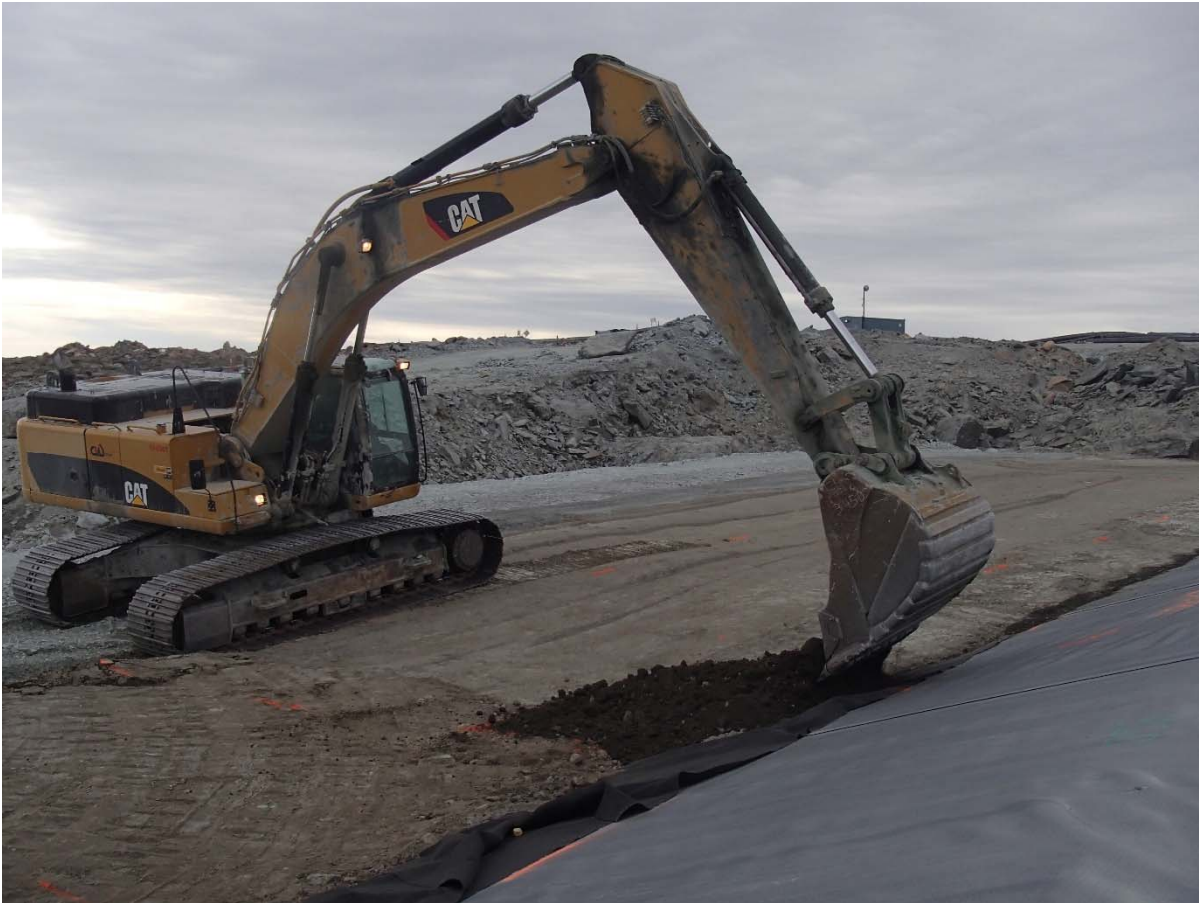
**Photograph SD3-348: From Sta. 20+760/-25 m, looking E. Placement of a 0.5 m thick layer of compacted sieved till on the upstream slope of SD3 with an excavator from Sta. 20+777 m to 20+807 m. No large rock was allowed to be placed against the LLDPE liner.**

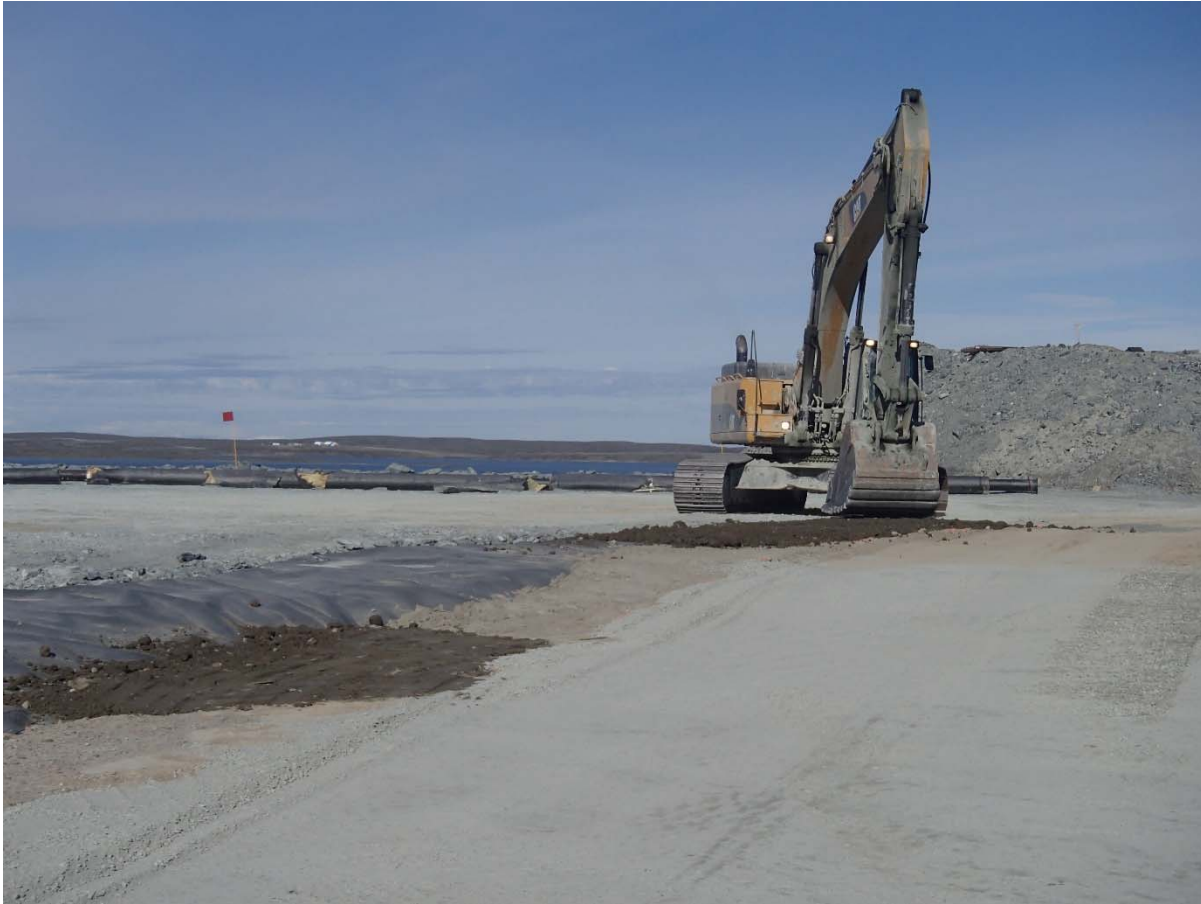
**Photograph SD3-352: From Sta. 20+600/-59 m, looking SW. Corrections to the layer of compacted sieved till placed against the upstream slope from Sta. 20+599 m to 20+613 m.**

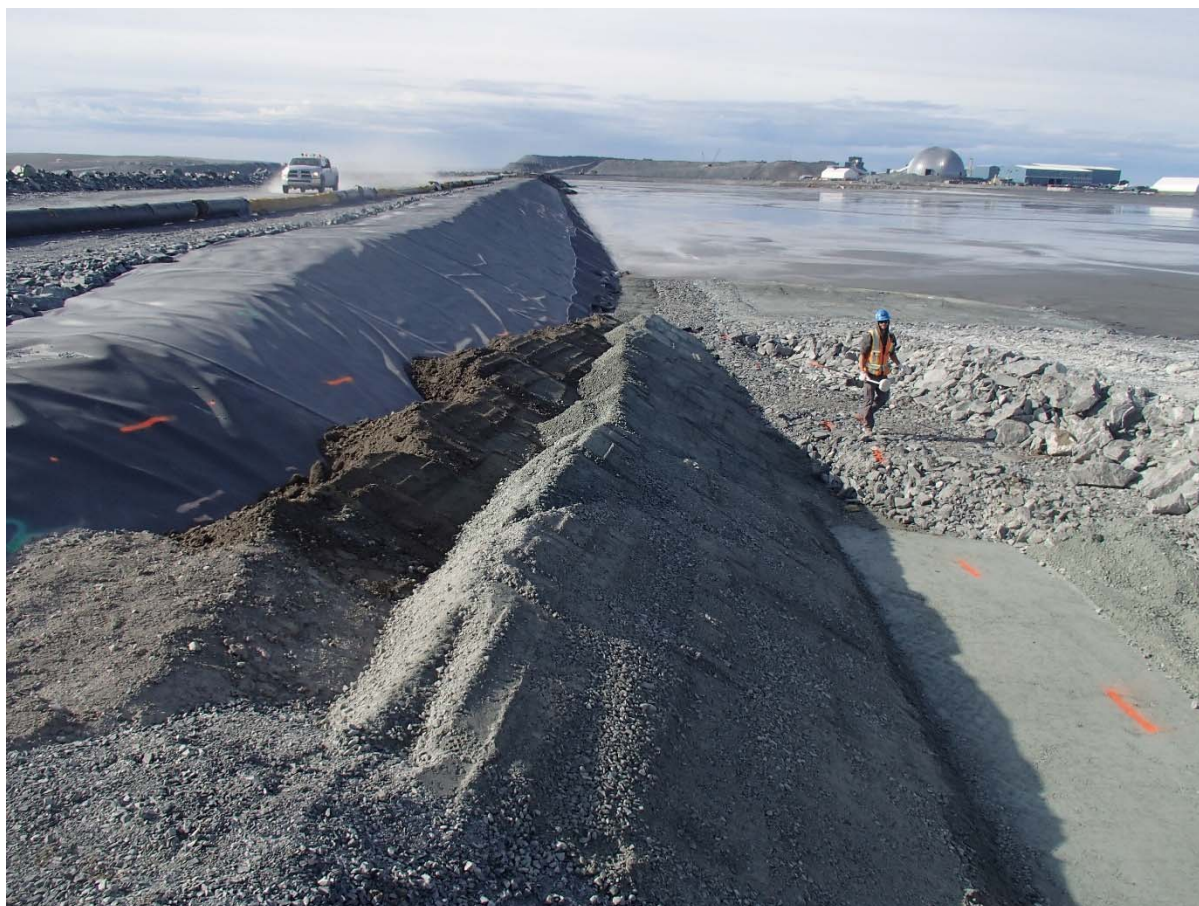
**Photograph CD-1896: From Sta. 0+140/-30 m, looking S. Placement of 0.5 m thick layers of compacted sieved till and fine filter on the upstream slope of Central Dike with an excavator from Sta. 0+147 m to 0+177 m.**

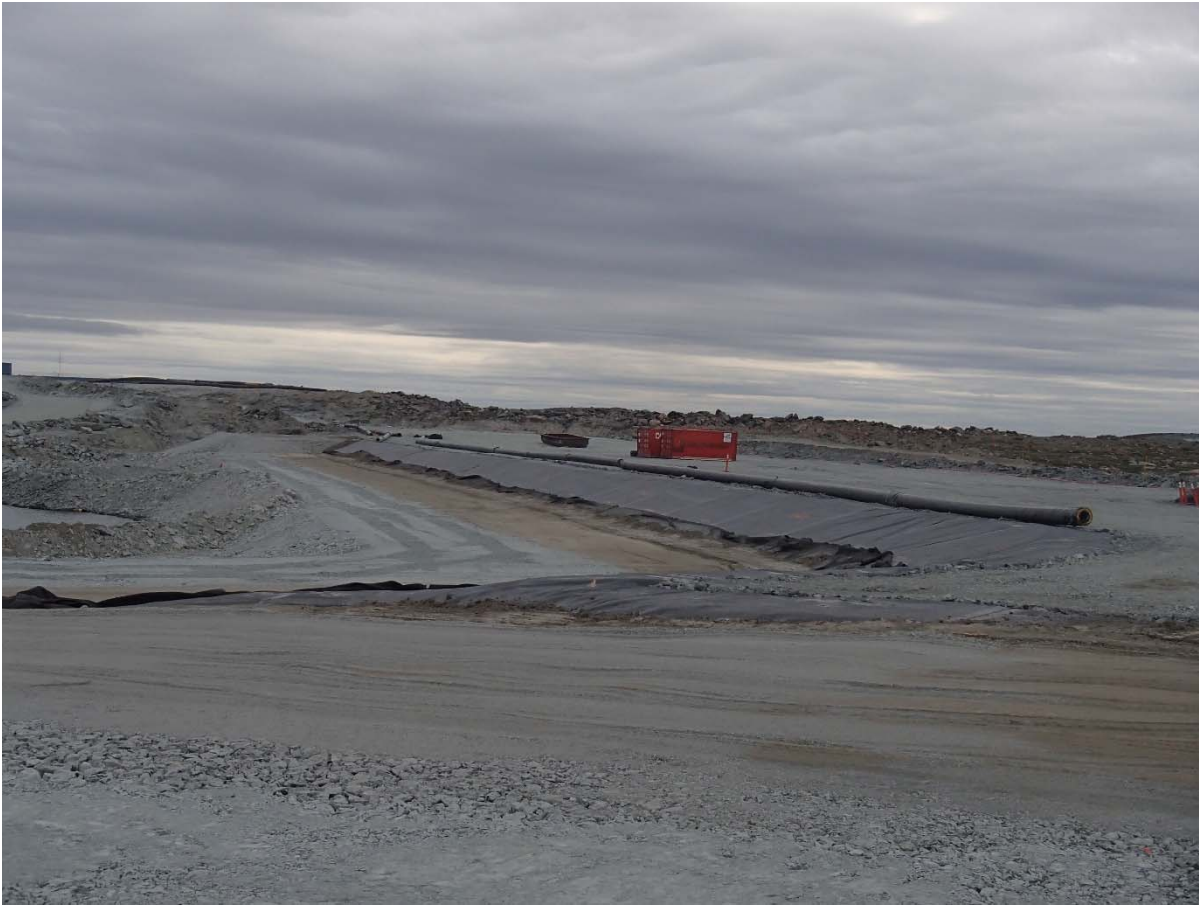
**Photograph SD3-353: From Sta. 20+580/-49 m, looking SW. View of SD3 at the end of the 2018 construction phase.**

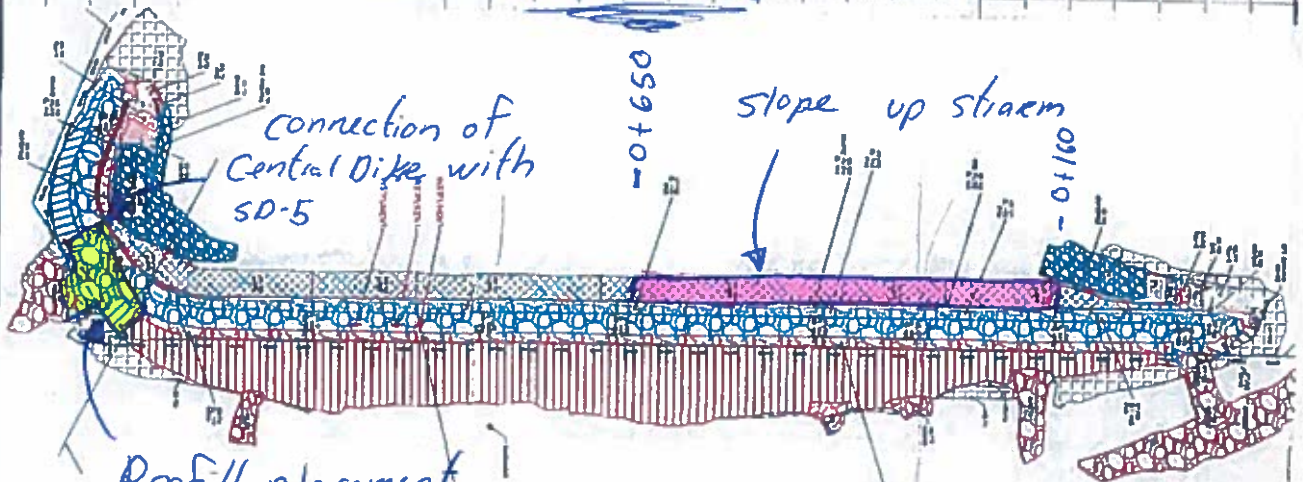
*connection of  
Central Dyke with  
SD-5*

*slope up stream*

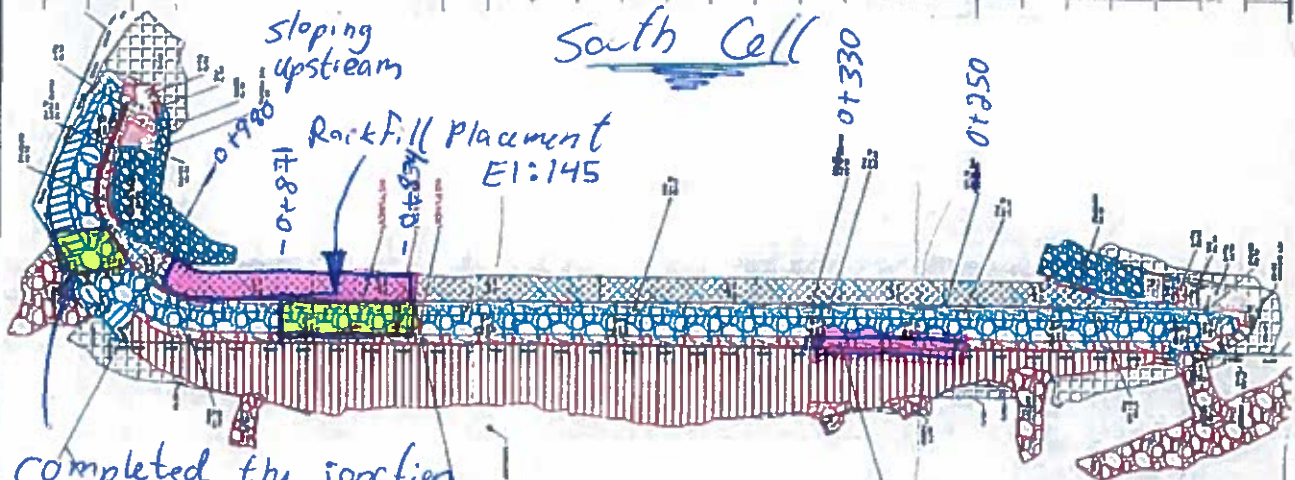
*Completed the junction  
of central dike and saddle dam 5.  
at E1:145*

*The rock fill placement on central dike is  
finish.*
