### **Meadowbank 2018 TSF As-built report**

**2018 CONSTRUCTION SEASON AS-BUILT REPORT  
TAILINGS STORAGE FACILITY  
MEADOWBANK GOLD PROJECT, NUNAVUT**

1897439-1578-R-Rev0

November 2018

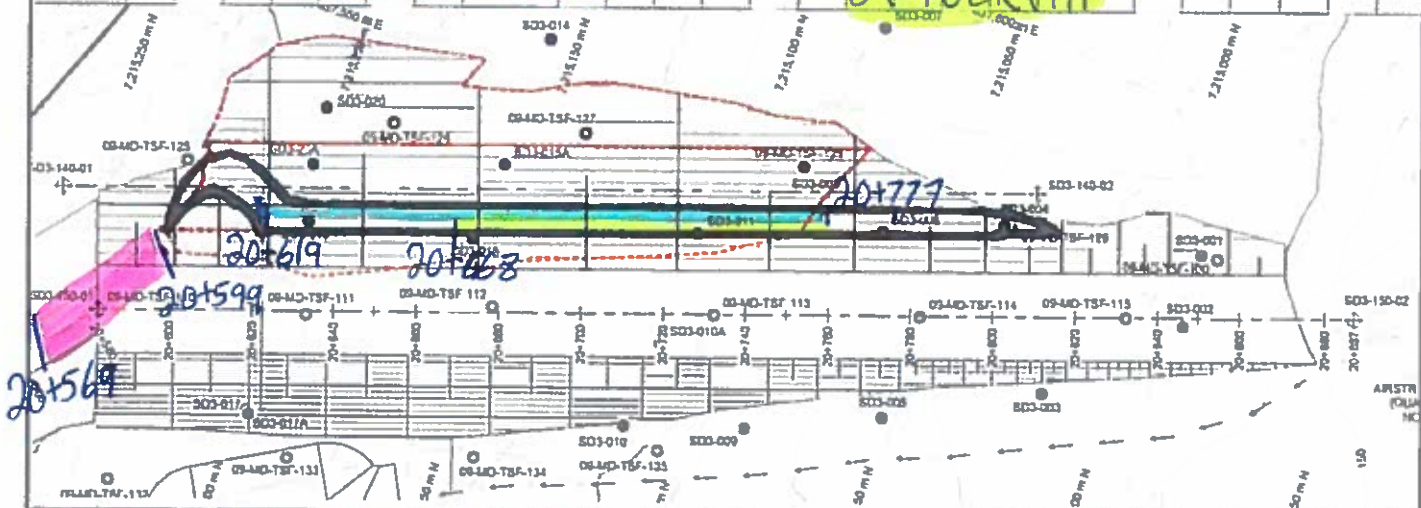
Placement of one lift  
of 2<sup>nd</sup> class Till

Placement of one lift  
of rockfill

Compaction of 2<sup>nd</sup> class  
Till

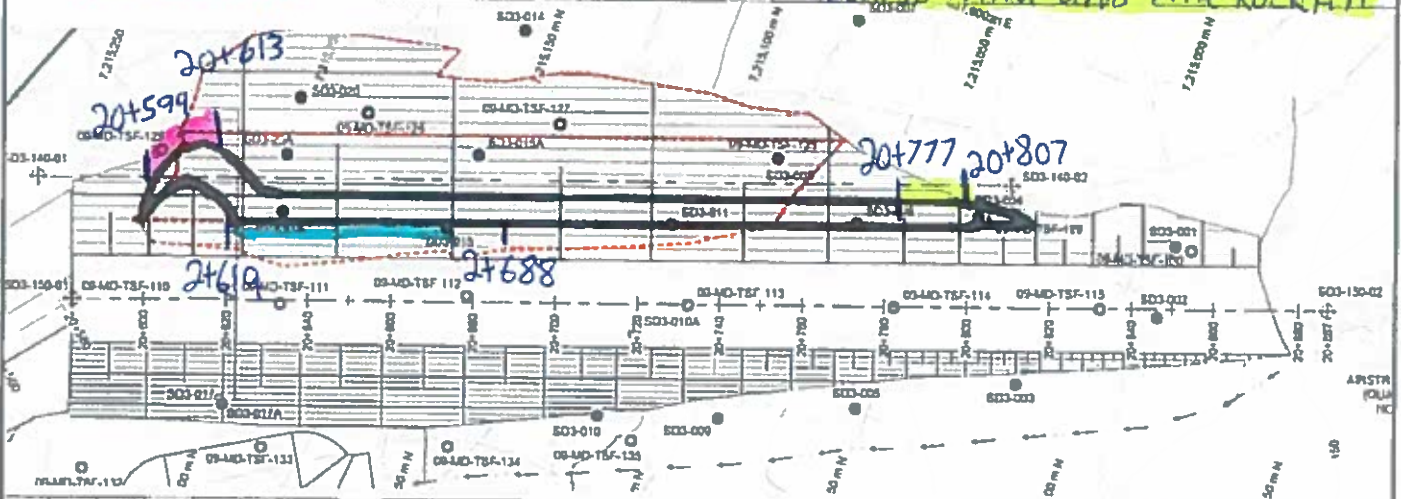
Placement of Fine Rockfill

Placement and compaction of Till 1st class, Fine Filter, Coarse Filter and Fine Rockfill

Compaction test on 2nd class Till under the Fine Filter

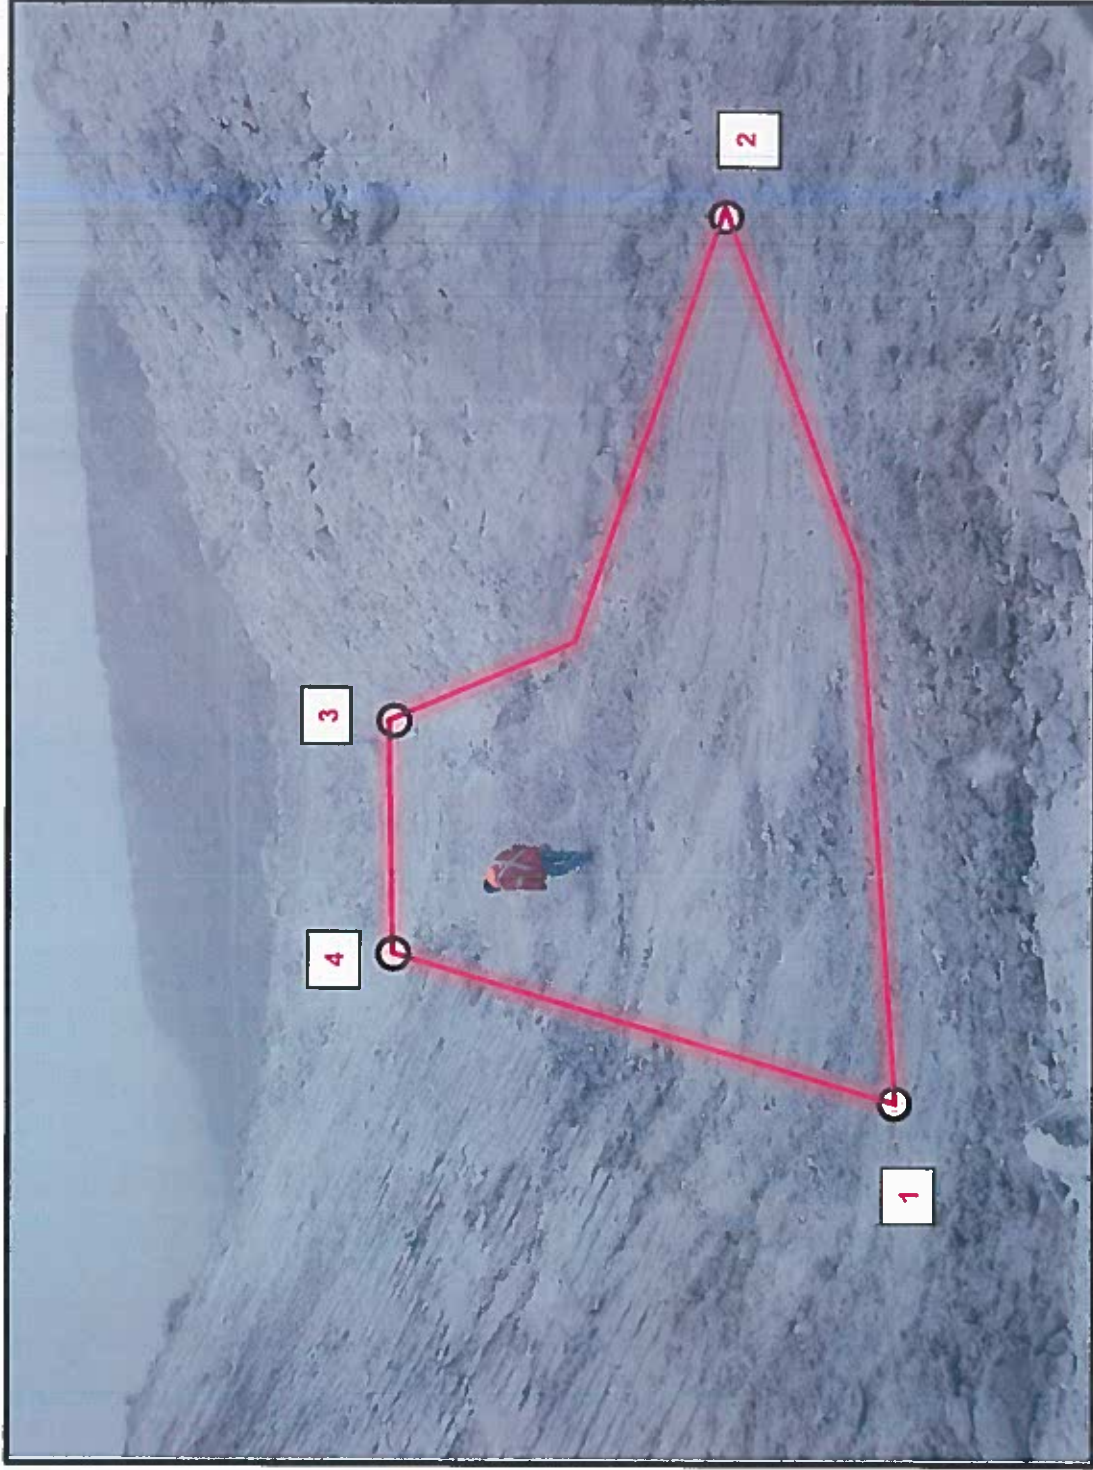
Picture 1- Approximate approved foundation area

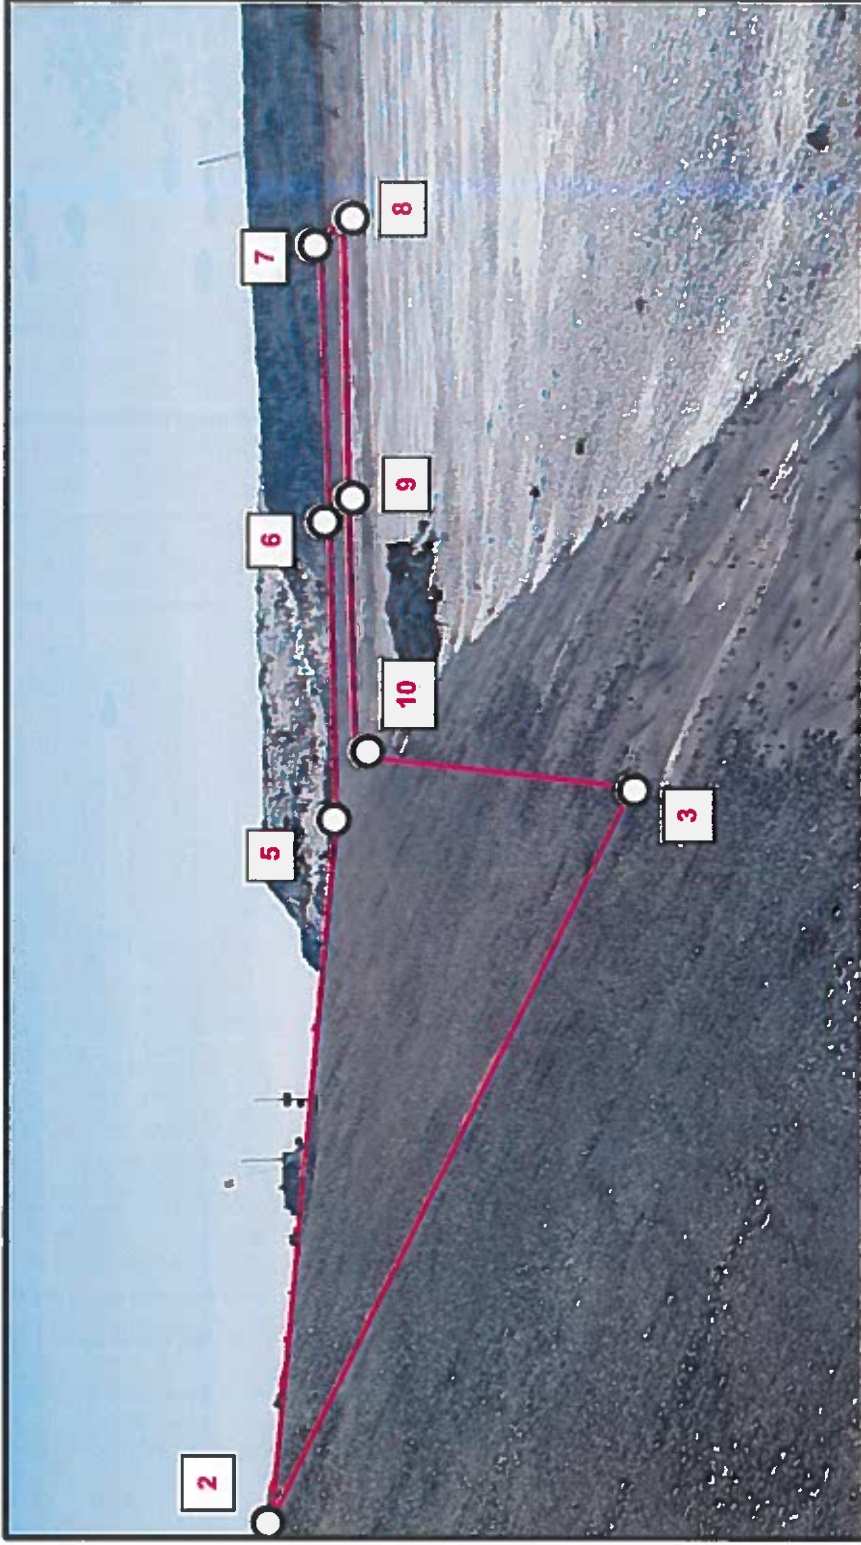
Picture 1 - Approximate approved foundation area

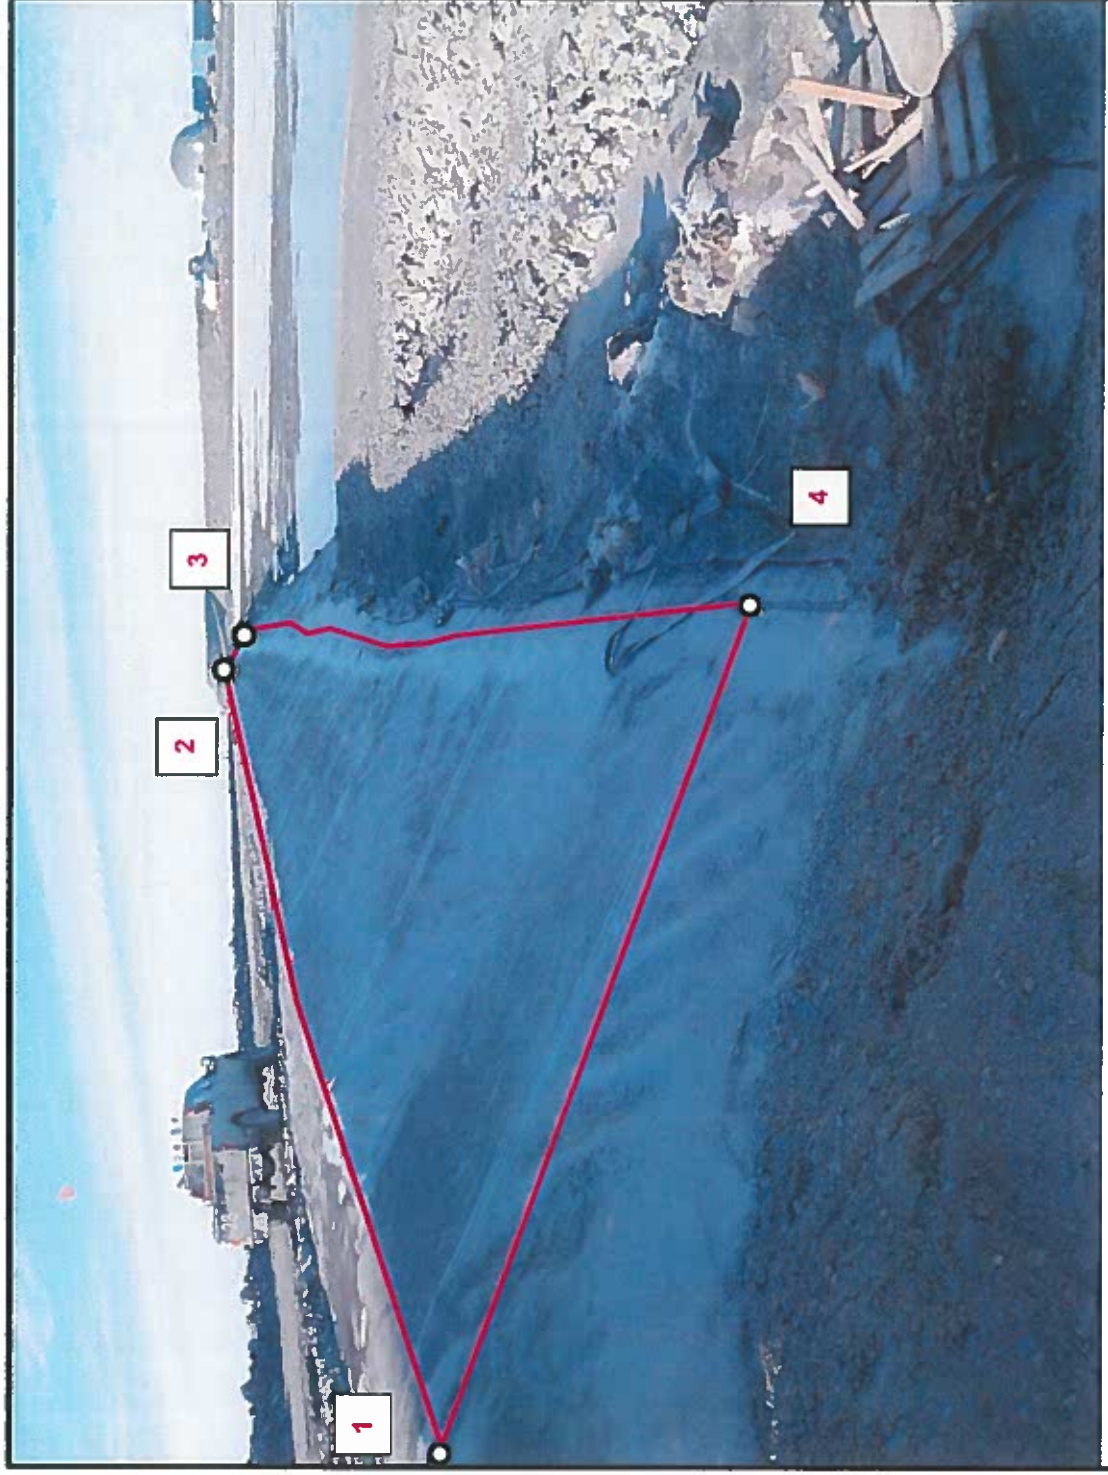
Photo 1- Approximate approved foundation area

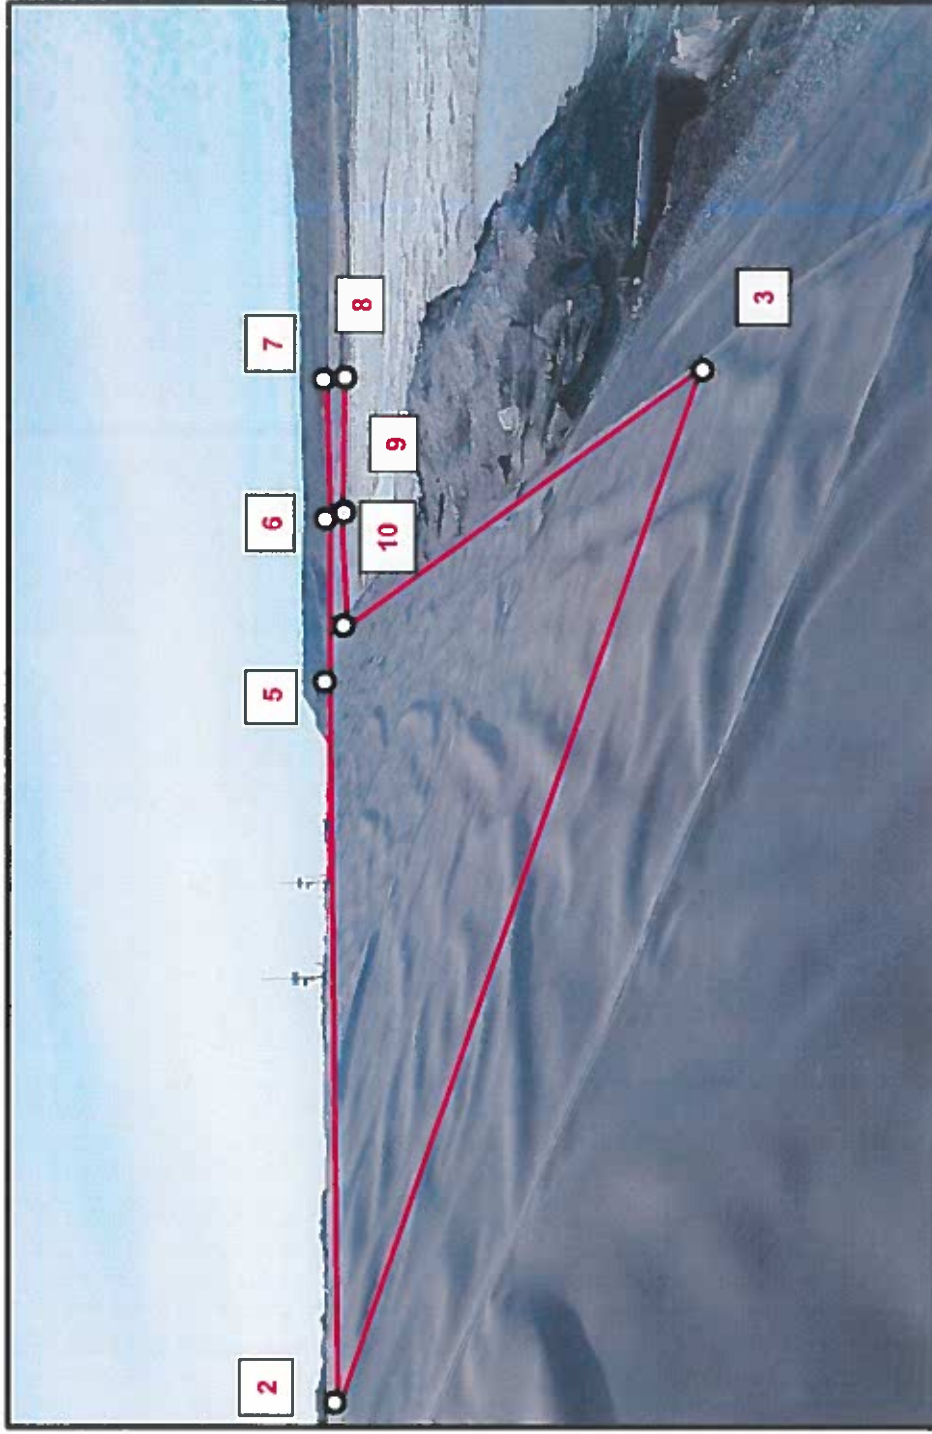
Picture 2- Approximate approved foundation area

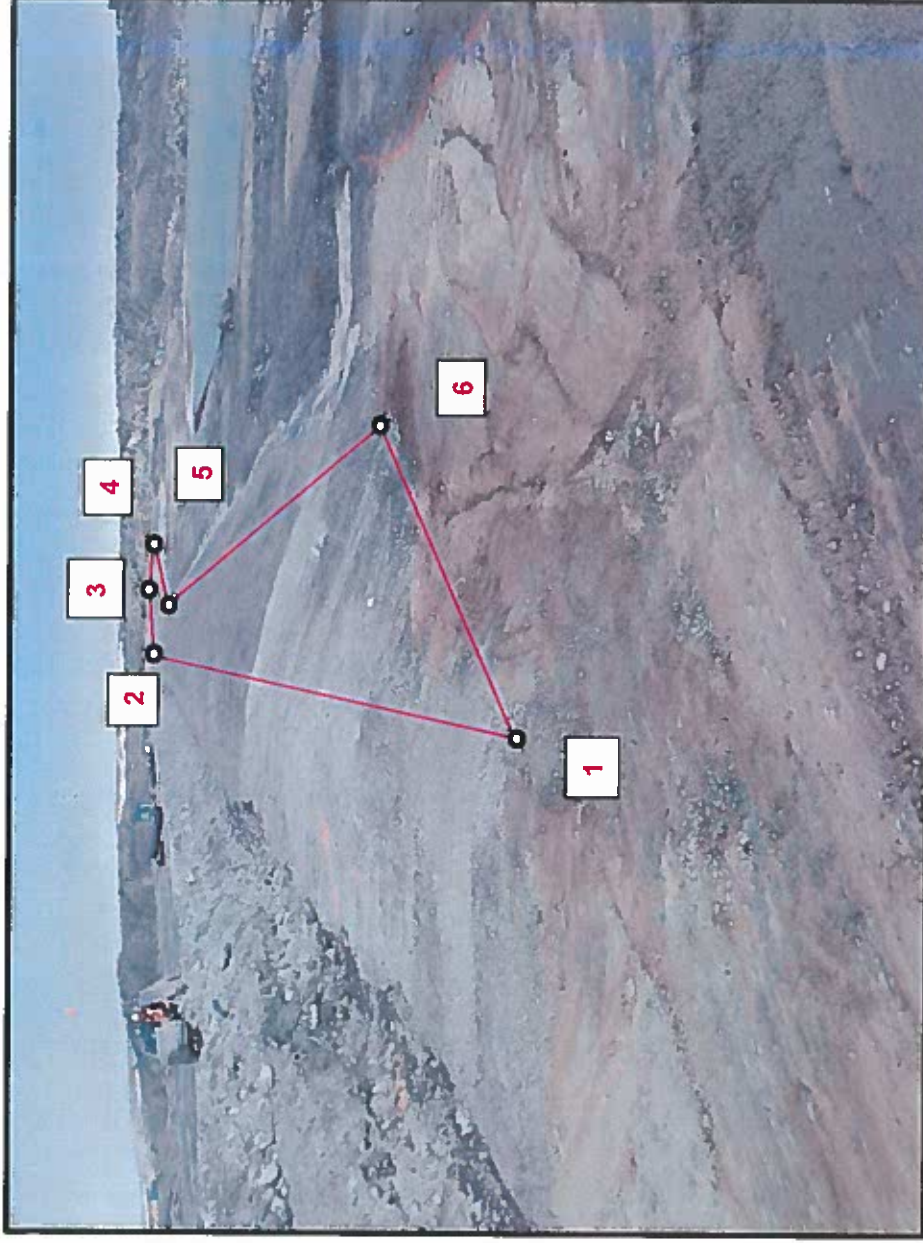
Picture 1- Approximate approved foundation area

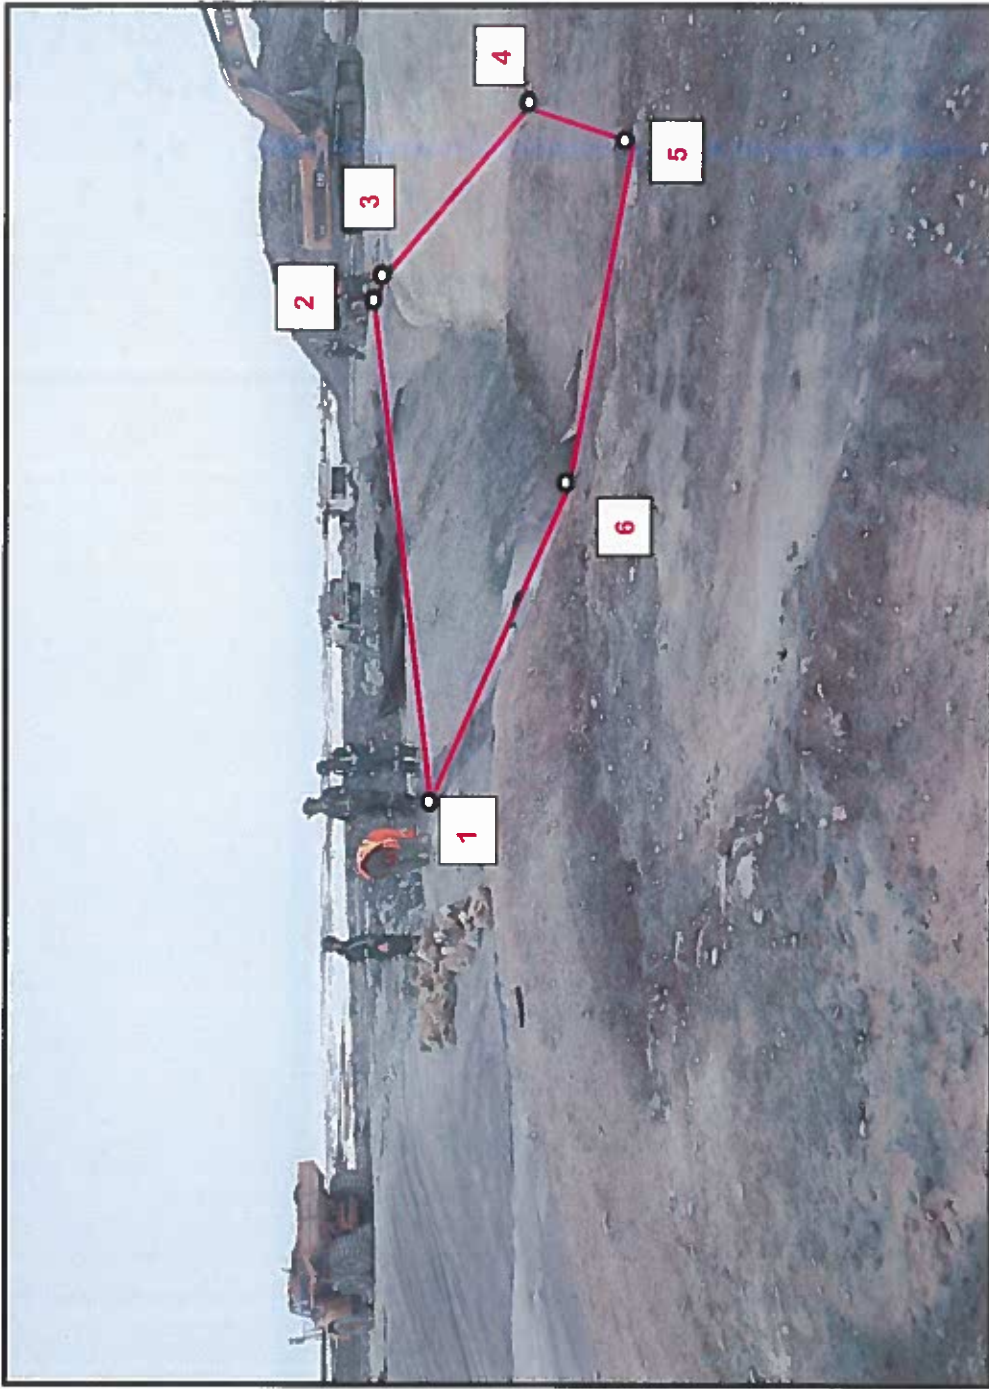
Picture 1- Approximate approved foundation area
