### **Whale Tail MDRB Report No 25B**

Report No 25B, Amaruq  
Meadowbank Mine Dike Review Board  
Meetings September 9-11 and November 27, 2019

## 2.0 WHALE TAIL DIKE

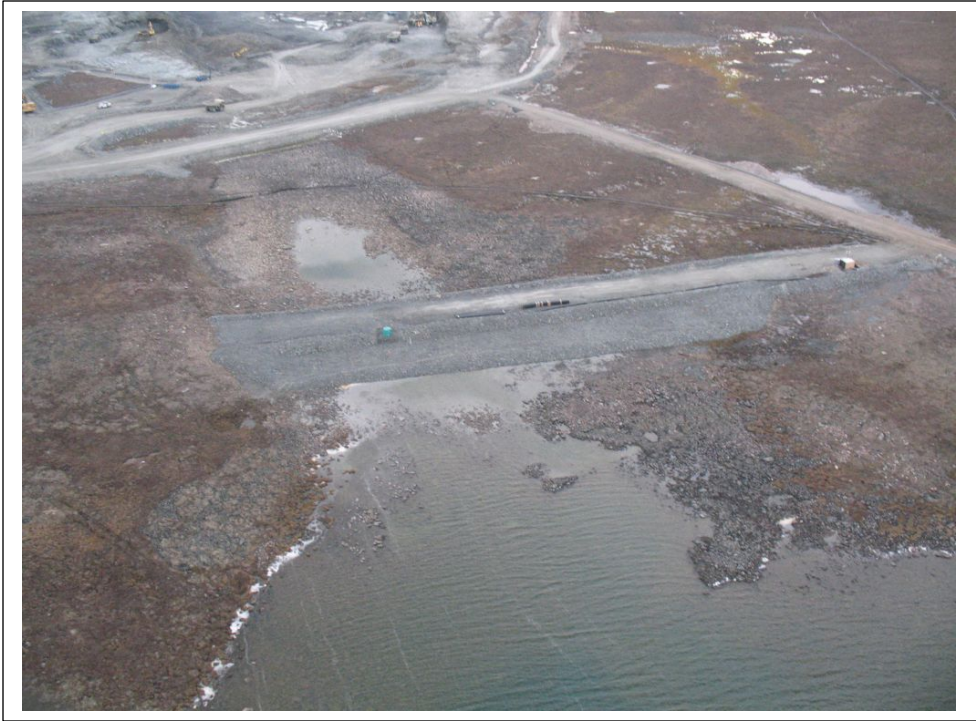
Photo No. 21 Mammoth Dike

The Board recommends that it continue to be advised on performance of the Mammoth Dike and that upgrades recommended for the WRSF Dike be considered for the Mammoth Dike.
