Appendix 25

Meadowbank GN spill reports

January 4th, 2018, Bac 7 Hydraulic Oil spill
(GN Report No 18-005)

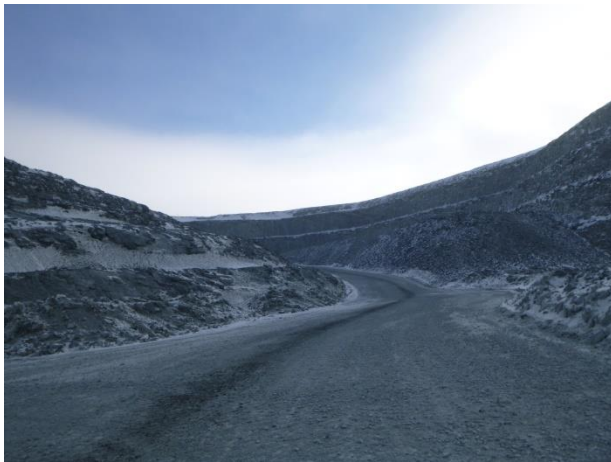
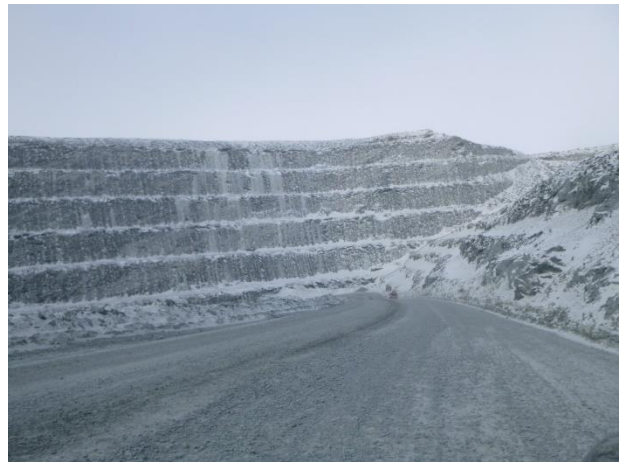
The spill was caused by the hydraulic hose broken causing a spill of hydraulic oil.

The Hydraulic system including hoses on equipment, are inspected as part of the preventive maintenance program done on site. Pre-operation checks also include visual inspection of the coolant system.

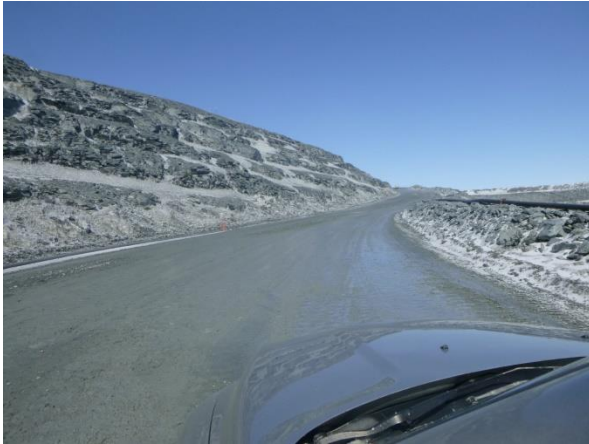
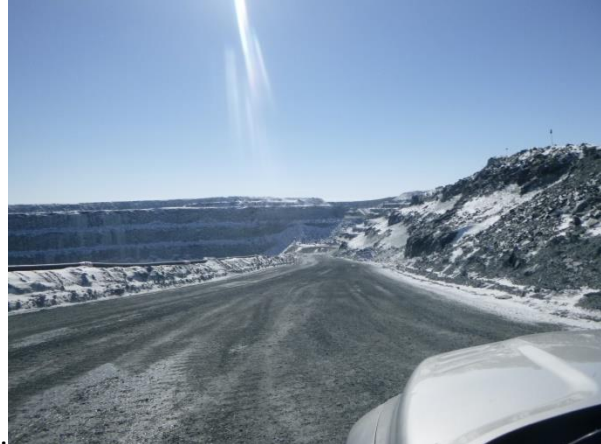
The equipment was stopped and the contaminated material was recovered and brought to the Landfarm

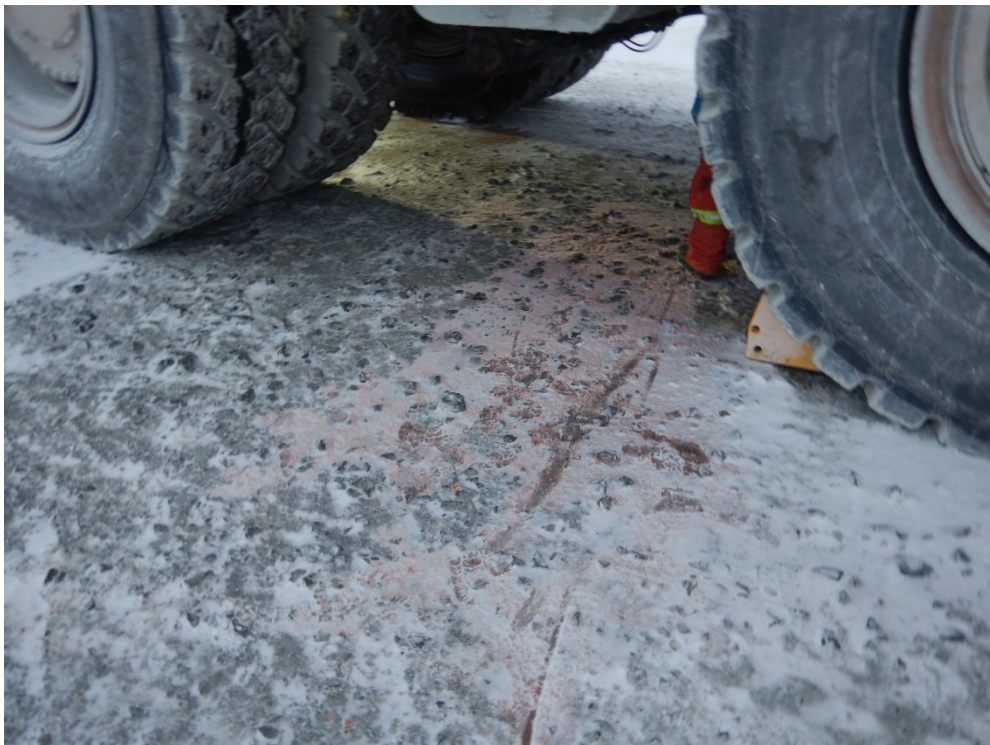
A failure on haul truck brake line caused hydraulic oil to be spilled during loading operations in BB Phaser Pit.

The spill was caused when the main line on the brake system on the hauling equipment failed during operations, causing brake fluid (hydraulic oil) to be spilled on the ground.

Regular pre-operation checks are completed on equipment also including visual inspection of the braking system.

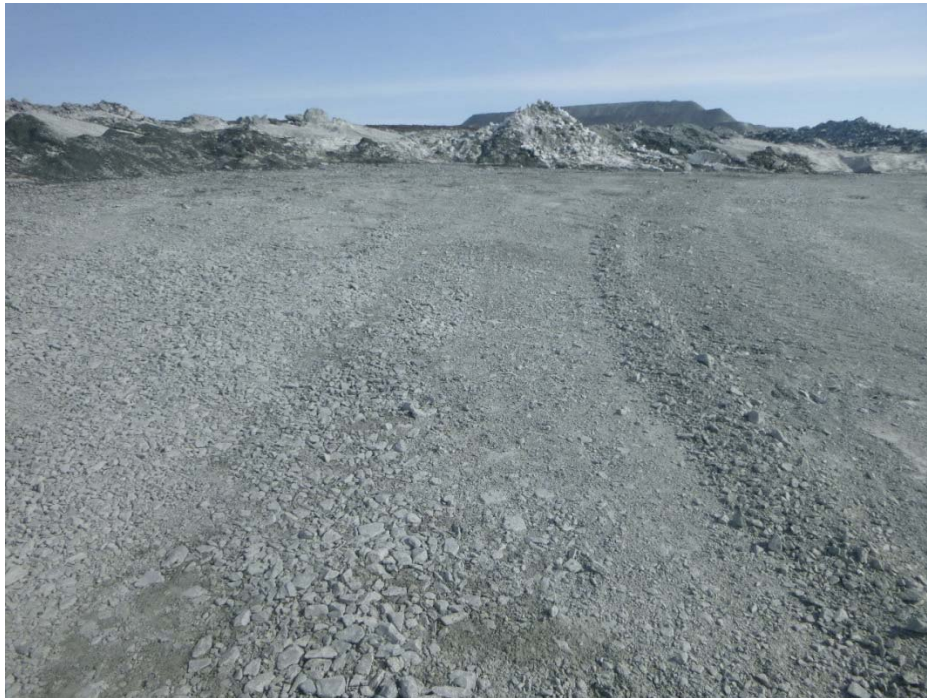
Once the equipment removed out of the area, the contaminated section was scrapped clean and the collected material was brought to the Landfarm area.

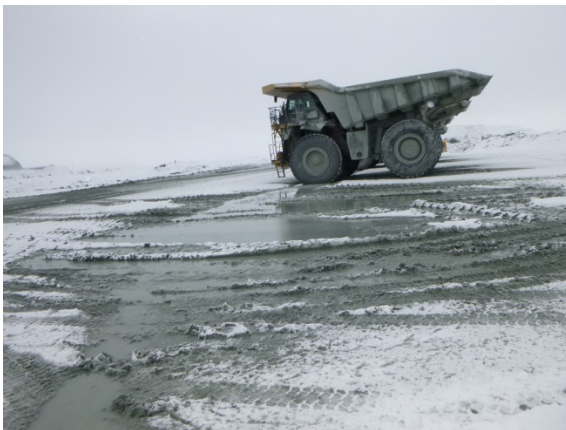
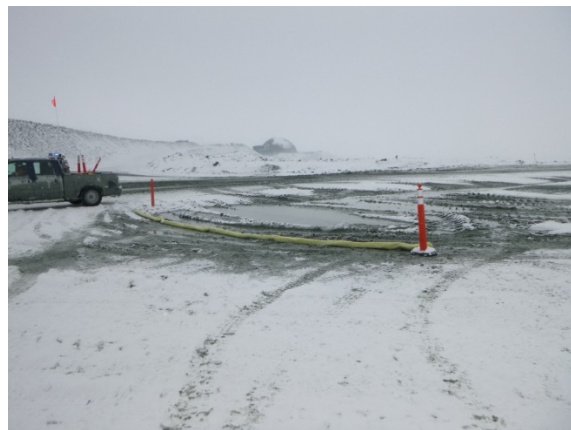
During operations, the Haul Truck 21 operator noticed an engine alarm. He stopped and parked his truck in push back parking to do an inspection and he saw a coolant leak. He shut down the engine and he called a mechanic to fix the problem.

The spill was caused by a failed coolant line.

The Coolant system, including hoses on equipment, is inspected as part of the preventive maintenance program done on site. Pre-operation checks also include visual inspection of the equipment.

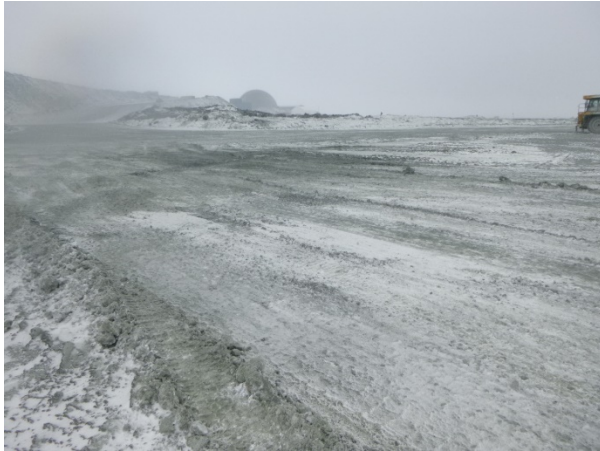
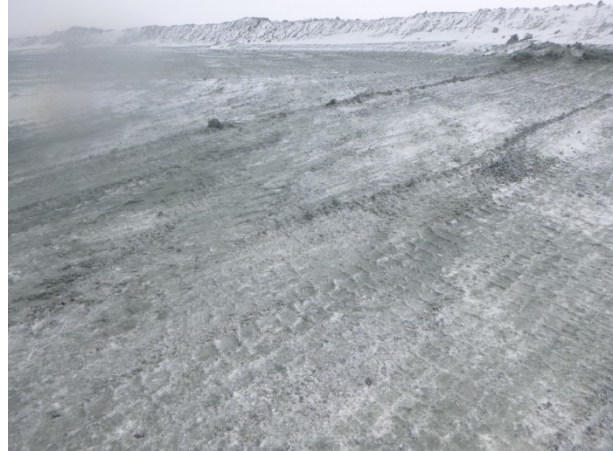
The equipment was stopped and once repaired and moved, the contaminated material was recovered by a loader and brought to the tailing pond.

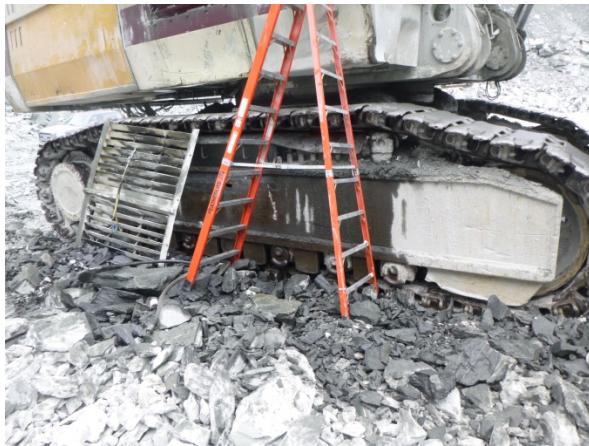
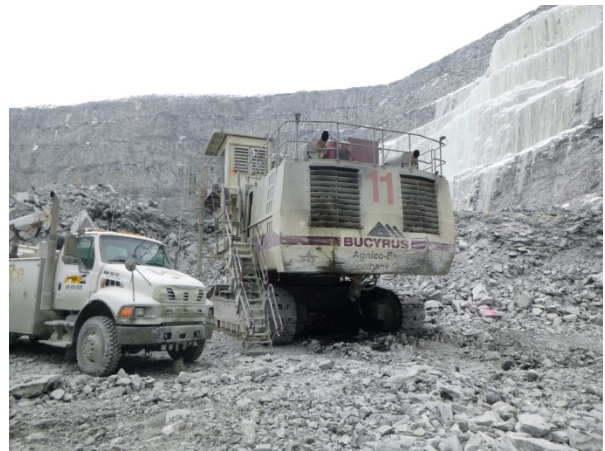
When he operated the excavator (BAC 11) at Vault Pit, a hydraulic hose from the block cooler busted. The operator shut down the equipment and reported it to the maintenance department. After the first inspection of the cause of the spill, they noticed that the block cooler had also a crack.

The spill was caused an hydraulic hose from the block cooler busted.

The hydraulic system, including hoses on equipment, is inspected as part of the preventive maintenance program done on site. Pre-operation checks also include visual inspection of the equipment.

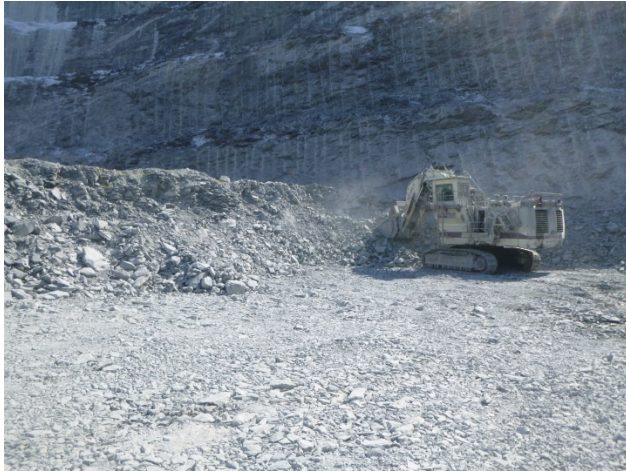
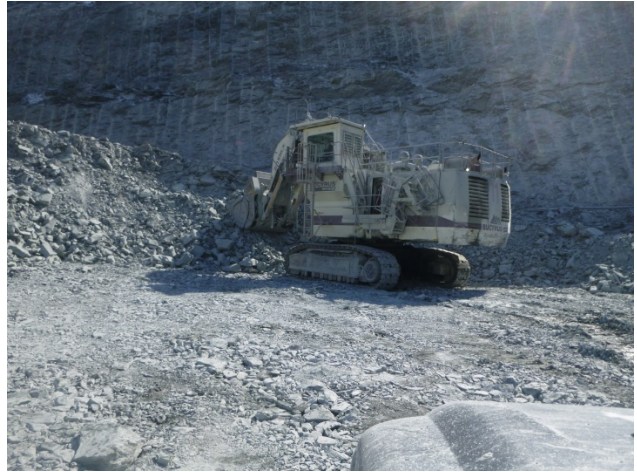
The equipment was stopped immediately and the operator called the maintenance department to fix the problem. After the excavator were moved, the contaminated material was recovered by a loader and brought to the landfarm.

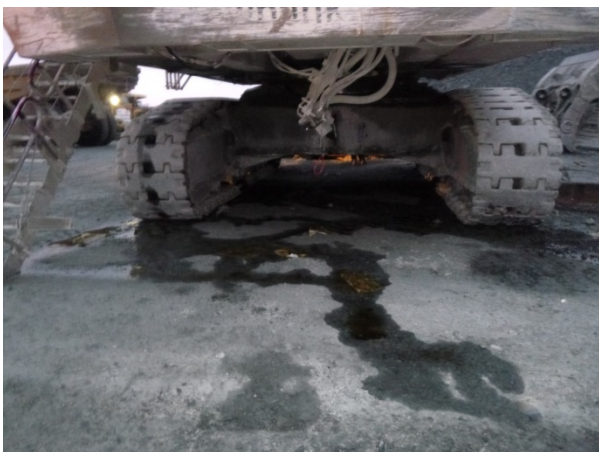
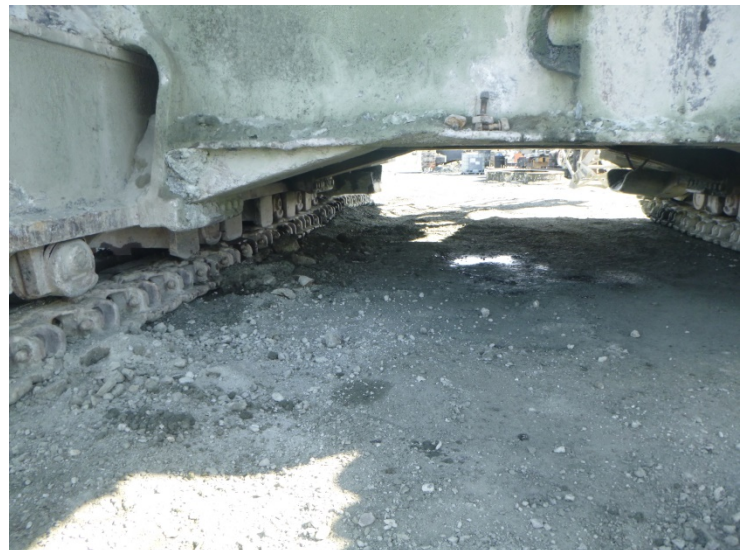
The machine was parked at the winter parking on standby after a bucket swap. During the night, a seal on the track tensioner cylinder has broken and started leaking.

The spill was caused by a failure of a mechanical piece.

The hydraulic system is inspected as part of the preventive maintenance program done on site. Pre-operation checks also include visual inspection of the equipment.

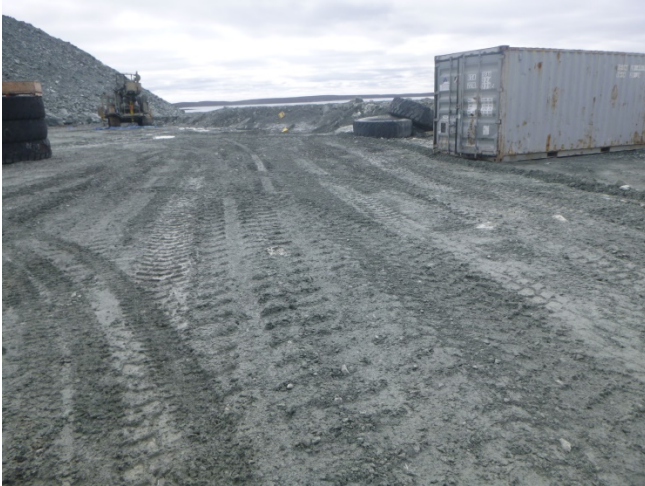
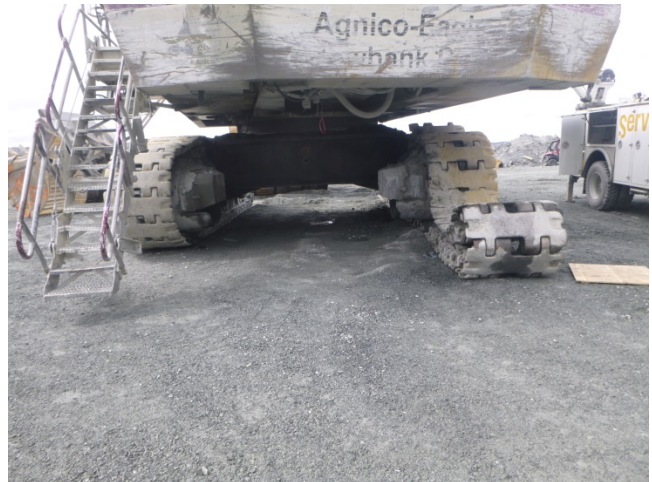
As soon the mechanic saw the leak, he closed the valve to stop the leak and stop the equipment. All contaminated material was recovered by a loader and brought to the landfarm.

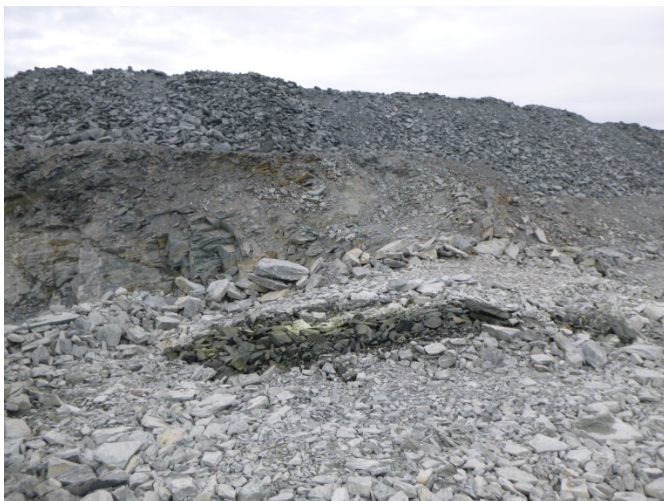
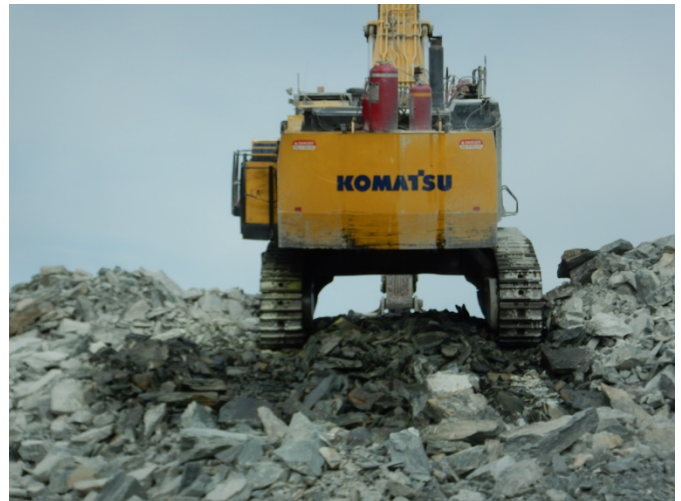
During operation in BB Phaser, an hydraulic hose failed causing the oil to spill. Some oil spread on the motor creating flames which caused the activation of the fire suppression system.

The spill was caused by an hydraulic hose failure.

The hydraulic system is inspected as part of the preventive maintenance program done on site. Pre-operation checks also include visual inspection of the equipment.

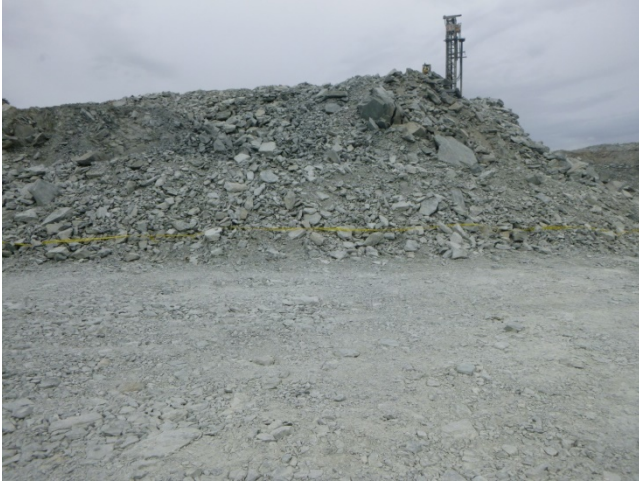
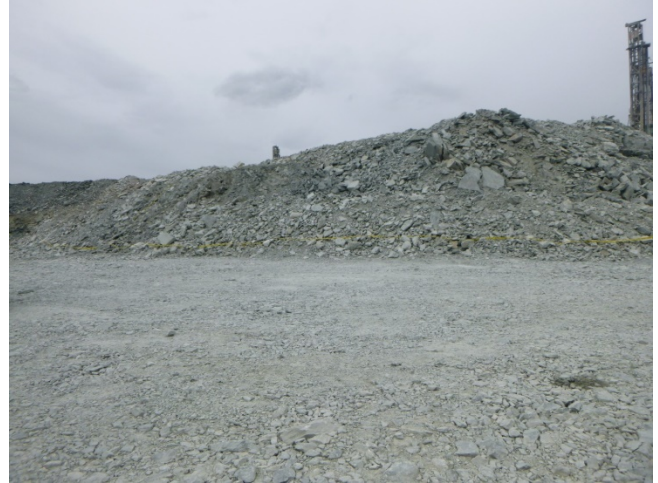
Once the machine has been moved, the area was cleaned. All contaminated material was brought to the landfarm.

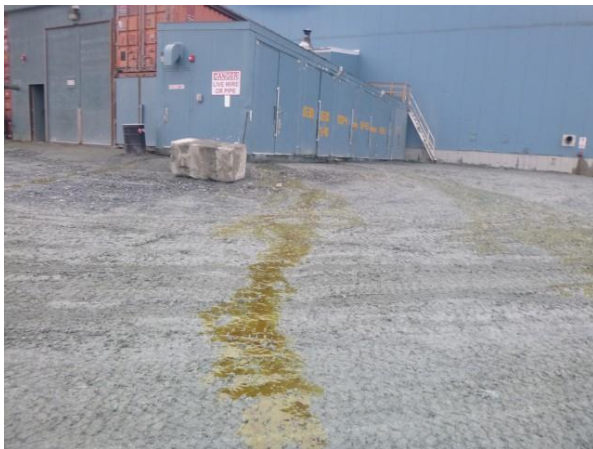
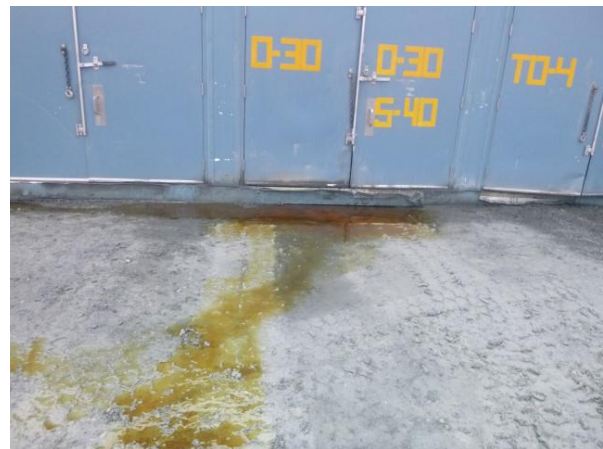
After they have changed one empty tote on the top of the second one, the worker forgot to put back the breather on the new tote. With this piece missing, the oil transferred to the bottom one and overflowing from the tote on the floor of the sea can and then after on the ground.

The spill was caused by a missing piece on the distribution equipment. The employee forgot to put back the breather on the tote.

After this incident it was decided to change the procedure. We stopped to connect the tote together to avoid this type of incident again.

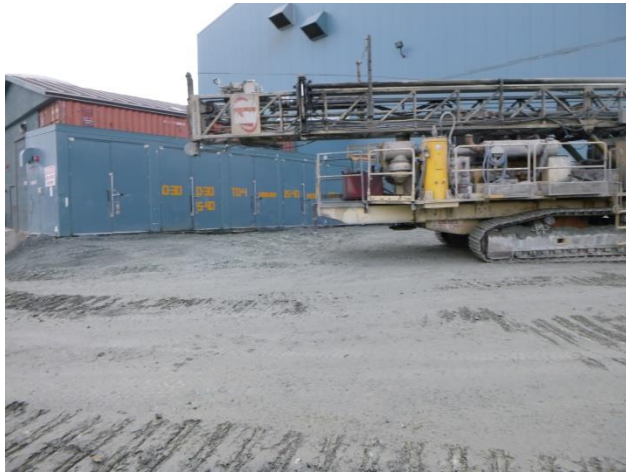
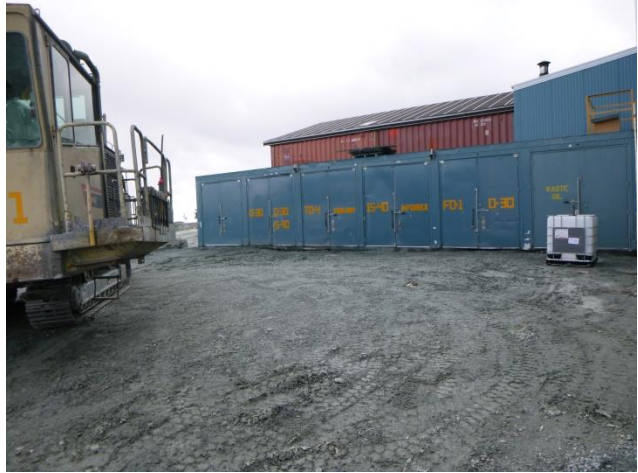
The equipment was stopped immediately and the operator called the maintenance department to fix the problem. After the excavator were moved, the contaminated material was recovered by a loader and brought to the landfarm.

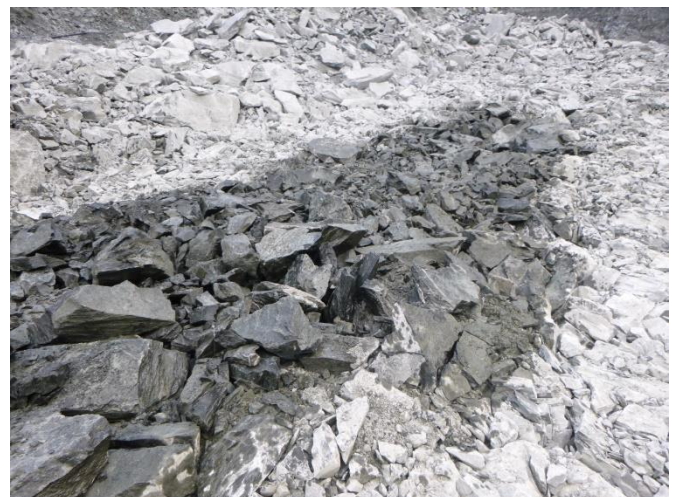
The spill was caused by busted line.

The hydraulic system is inspected as part of the preventive maintenance program done on site. Pre-operation checks also include visual inspection of the equipment.

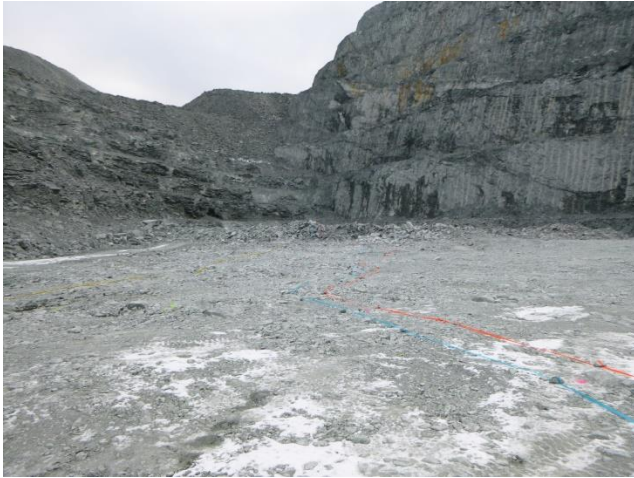
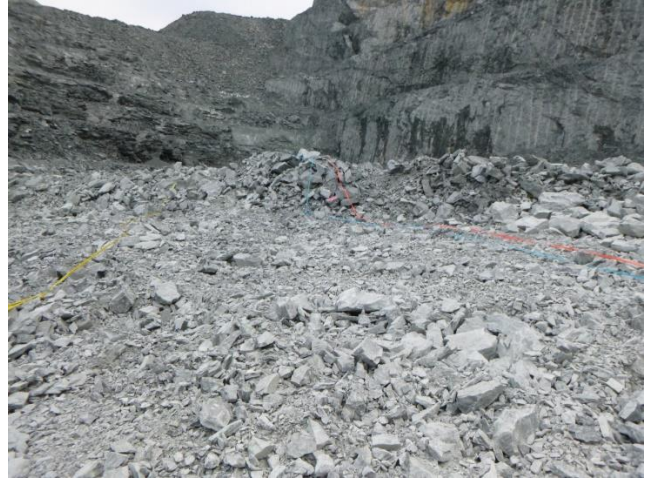
Once the machine has been moved, the area was cleaned. As the contaminated material was ore, it was brought to the process mill.

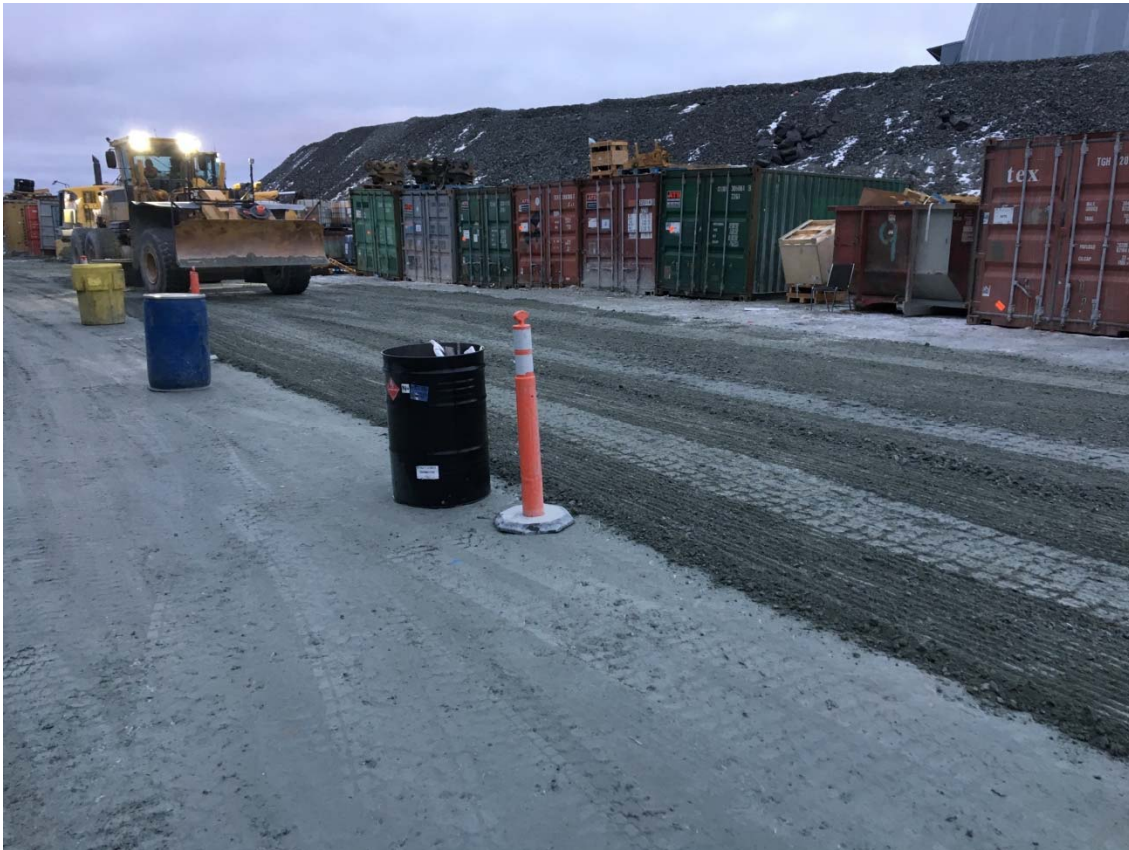
The equipment was immediately stopped and the main valve shut. Absorbent pads were laid out to contain the spill on the ground. The ground was scrapped clean and contaminated material was brought to the Meadowbank Landfarm area.

Regular pre-operation checks are completed on equipment also including visual inspection of the piping of the service truck. It was inspected thoroughly after the incident by the Maintenance department.

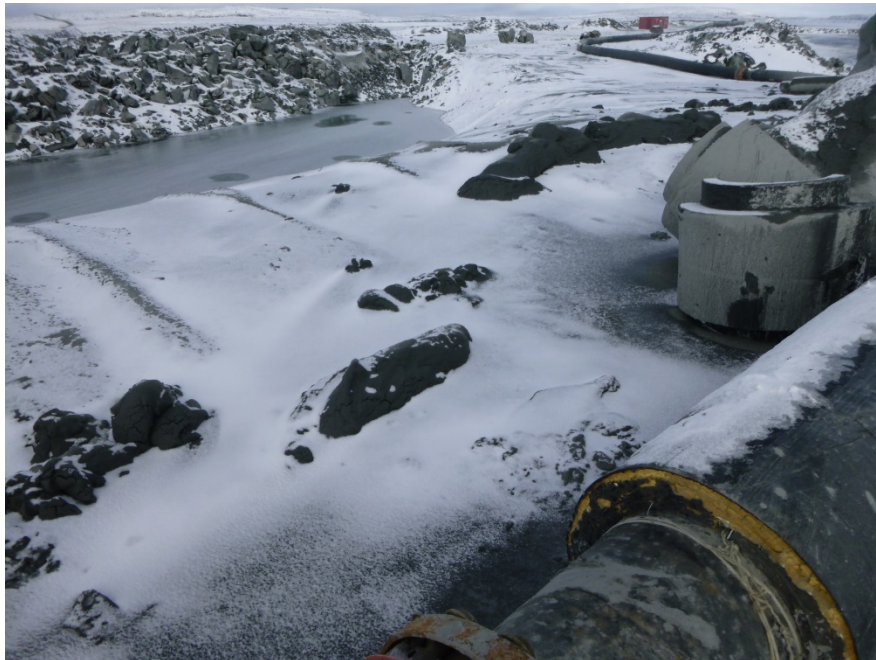
In the process of passing the cleaning “pig” in the tailings line, it got stuck and could not be removed safely by increasing air pressure. The Pipe was cut inside the TSF enclosure and was emptied on location

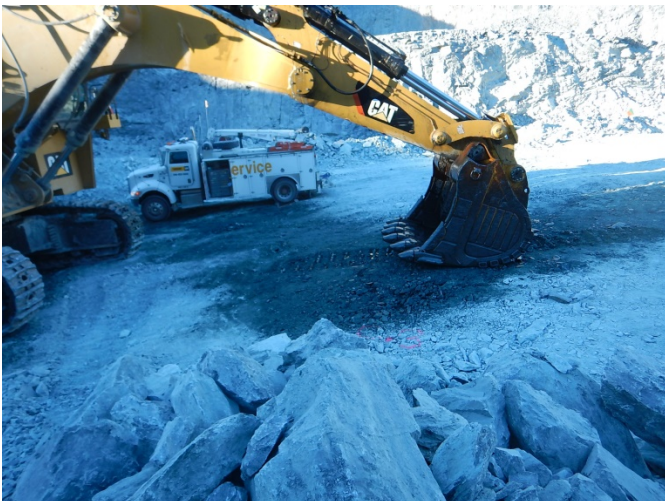
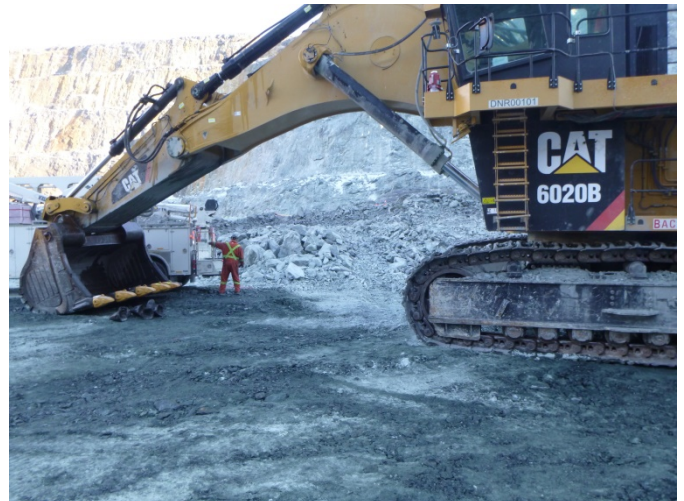
The spill was caused by busted line.

The hydraulic system is inspected as part of the preventive maintenance program done on site. Pre-operation checks also include visual inspection of the equipment.

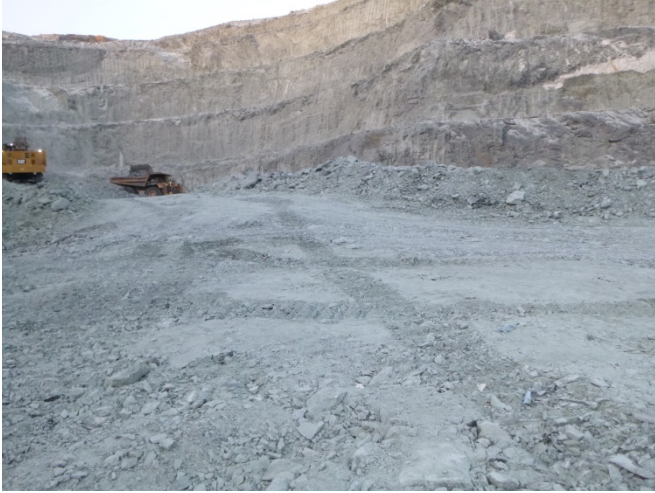
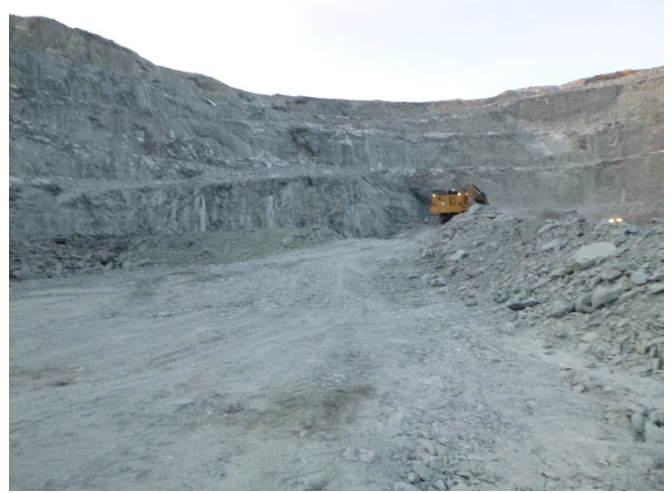
Once the machine has been fixed, the area was cleaned. The contaminated material was brought to the landfarm area.

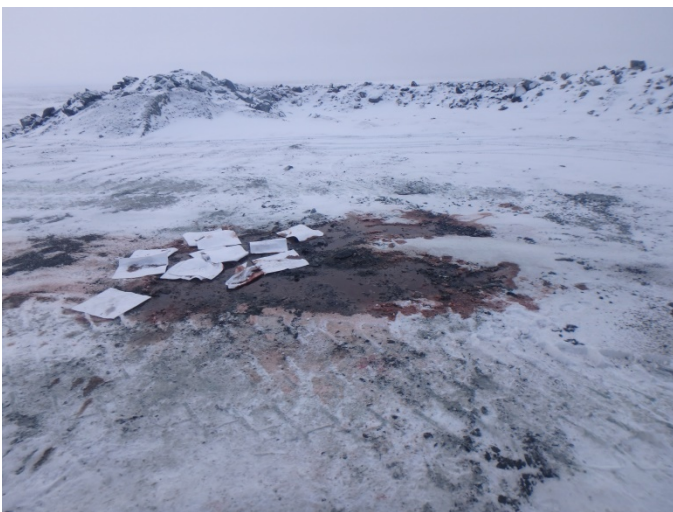
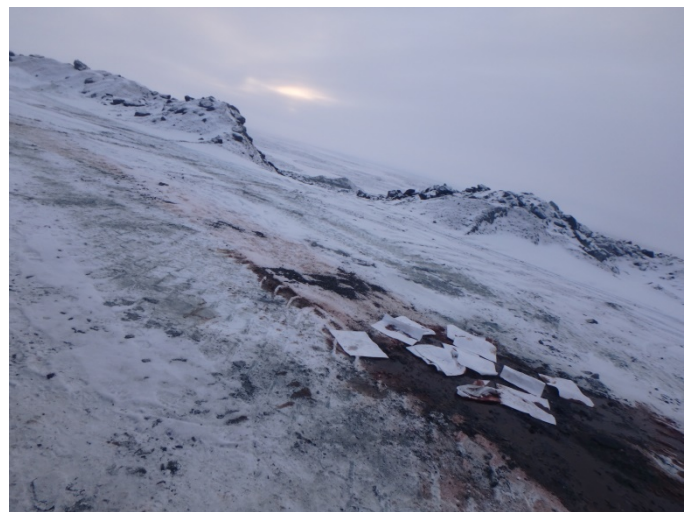
The spill was caused by a ruptured of the main hydraulic line.

The hydraulic system is inspected as part of the preventive maintenance program done on site. Pre-operation checks also include visual inspection of the equipment.

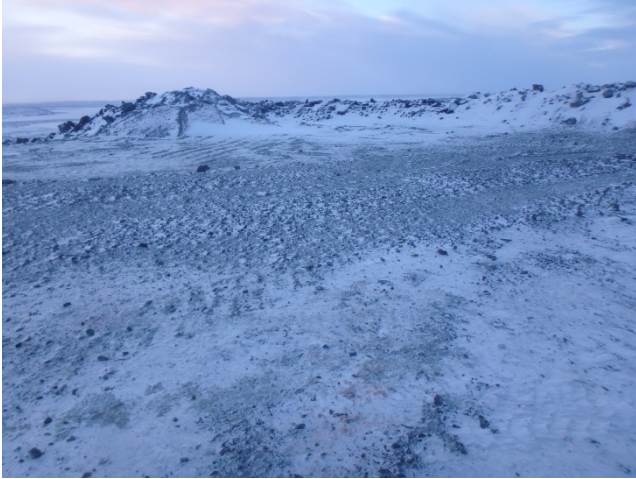
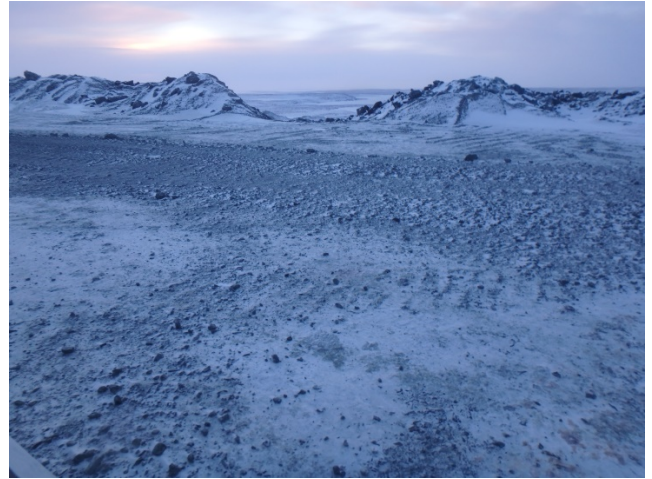
The equipment has been fixed and moved, after the area was cleaned. The contaminated material was brought to the landfarm area.
