Appendix 26

Whale Tail GN spills reports

2018-01-29 AMQ-WWTS Waste water Exceedence

Amaruq, Sewage pipe rupture

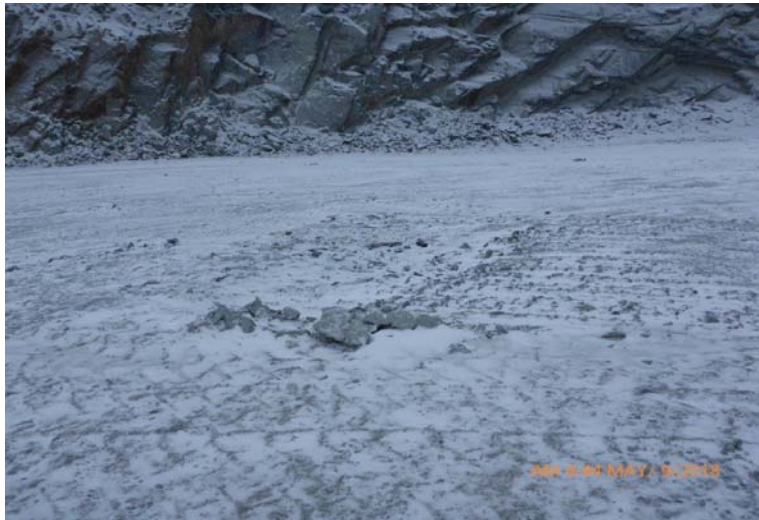
The equipment was stopped and absorbent pads were placed over the affected area. Once the mechanical problem was solved, the equipment was moved and a loader picked up the contaminated soil. The contaminated soil was brought to the Meadowbank mine landfarm.

The Hydraulic system, including hoses on equipment, is inspected as part of the preventive maintenance program done on site. Pre-operation checks also include visual inspection of the hydraulic system.

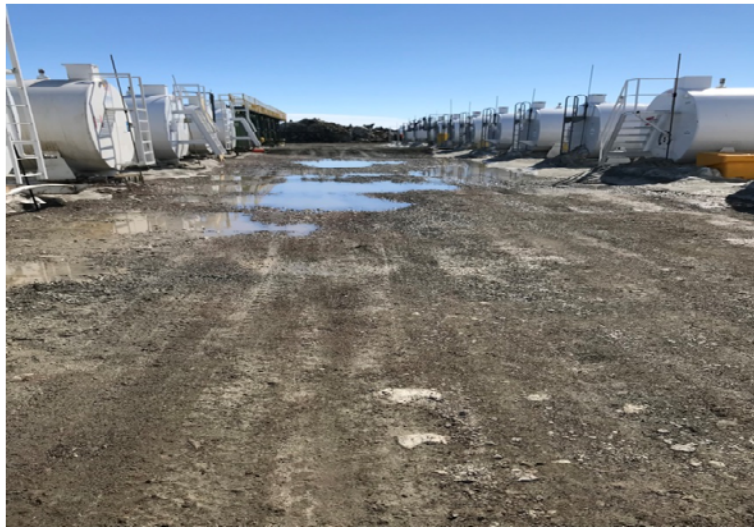
The spill was caused due to workers omitting to open fuel compartment traps to allow proper fuel transfer to the next compartments.

When the spill was noticed, the worker immediately opened the trap. The fuel was recovered using absorbent sheets and the contaminated ground was scrapped using a backhoe. The soil was brought to the Meadowbank mine landfarm.

Workers were reminded to always follow procedures and stay focused while performing a task.

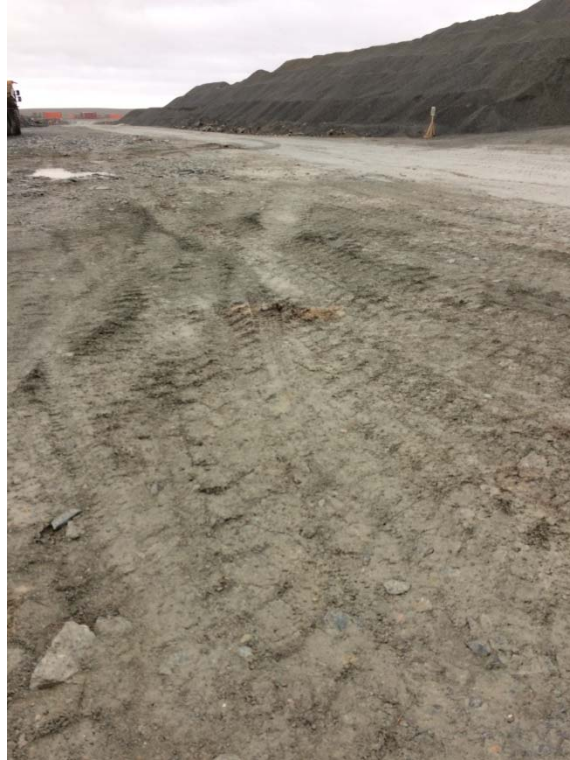
An o-ring failed on the hydraulic hose on a haul truck working at the Whale Tail Pit crusher area, causing hydraulic oil to be spilled on the ground.

The equipment was immediately stopped. Absorbent pads were laid out to contain the spill on the ground. Once the truck was fixed and moved out of the area, the ground was scrapped clean and contaminated material was brought to the Meadowbank Landfarm area.

Regular pre-operation checks are completed on equipment also including visual inspection of the hydraulic hoses.

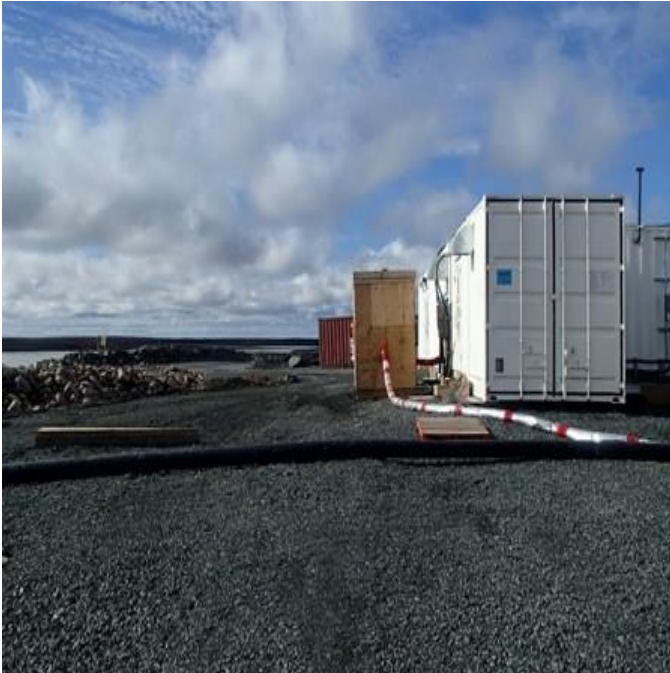
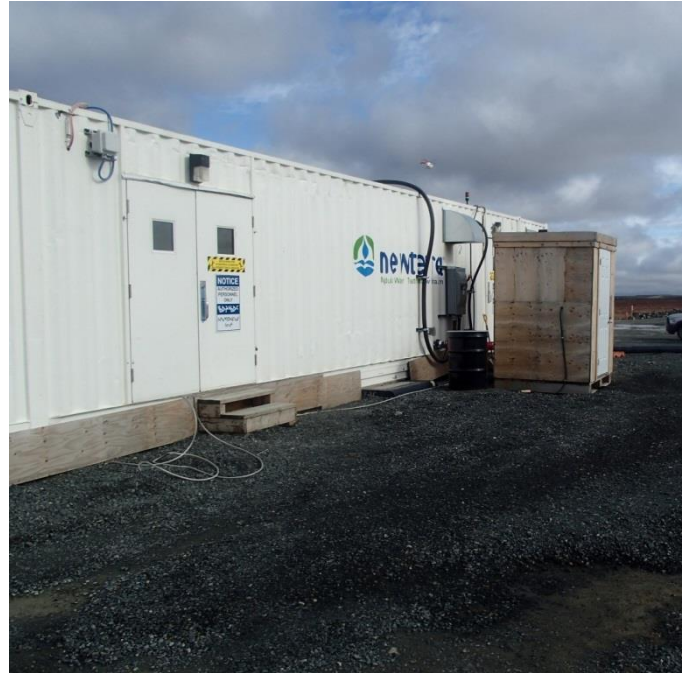
The operator put the pipe back in place and locked the mechanical coupling. A small berm was created around the spill area and a sump was created so the sewage water could be picked up with the vacuum truck. The vacuum truck was also used to collect sewage water that had not seeped out of the 40' sea cans that house the 3 tanks (Pre Annox/Aeration/Post Annox). Once the sewage water was collected, the contaminated material on the ground was collected and brought to the Meadowbank land farm.

Routine inspections on the tanks are completed and supports have been placed under each pipe in the event of a mechanical coupling failure.

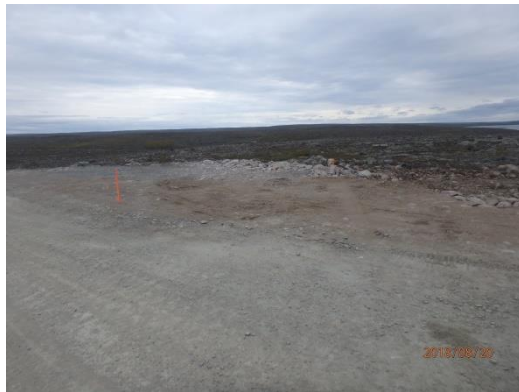
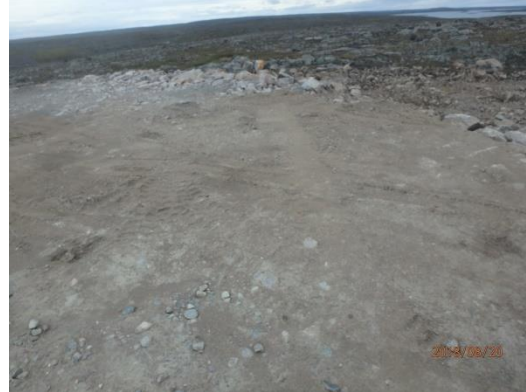
The equipment was immediately stopped and all contaminated soil has been removed and brought in the bin at Amaruq before to be transfer to the landfarm at Meadowbank.

The discussion with the operation was done to make sure that they are aware of the danger to work on the bad conditions. The equipment was repaired.

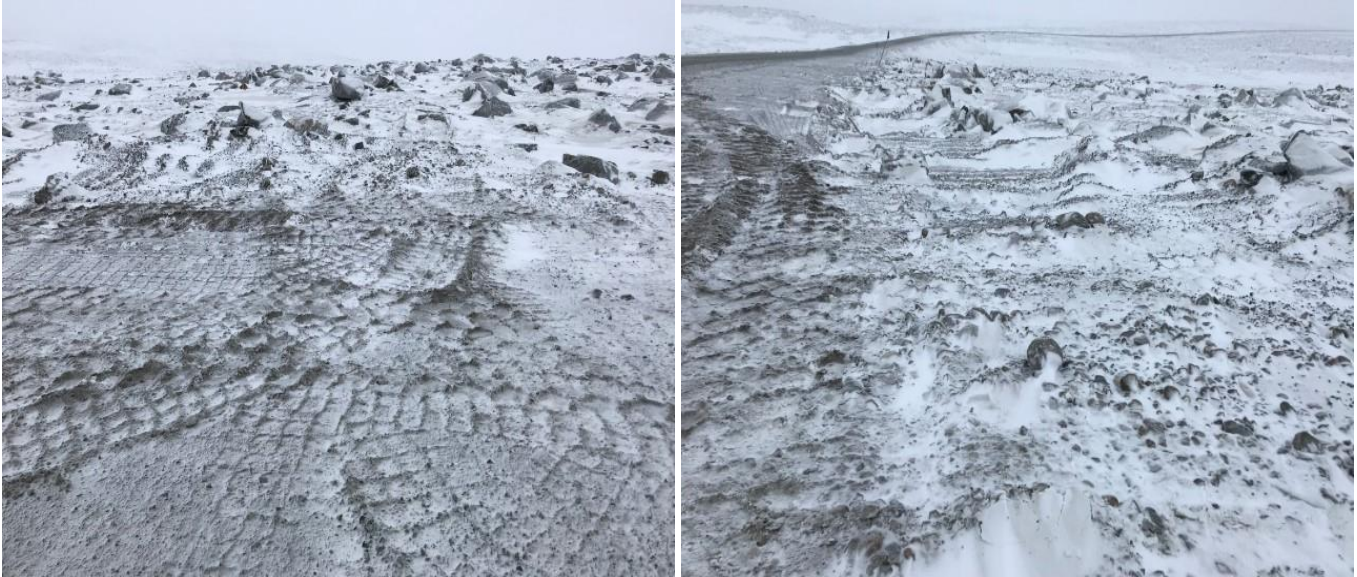
The equipment was immediately stopped. Absorbent pads were laid out to contain the spill on the ground. Once the truck was fixed and moved out of the area, the ground was scrapped clean and contaminated material was brought to the Meadowbank Landfarm area.

Regular pre-operation checks are completed on equipment also including visual inspection of the hydraulic systems.

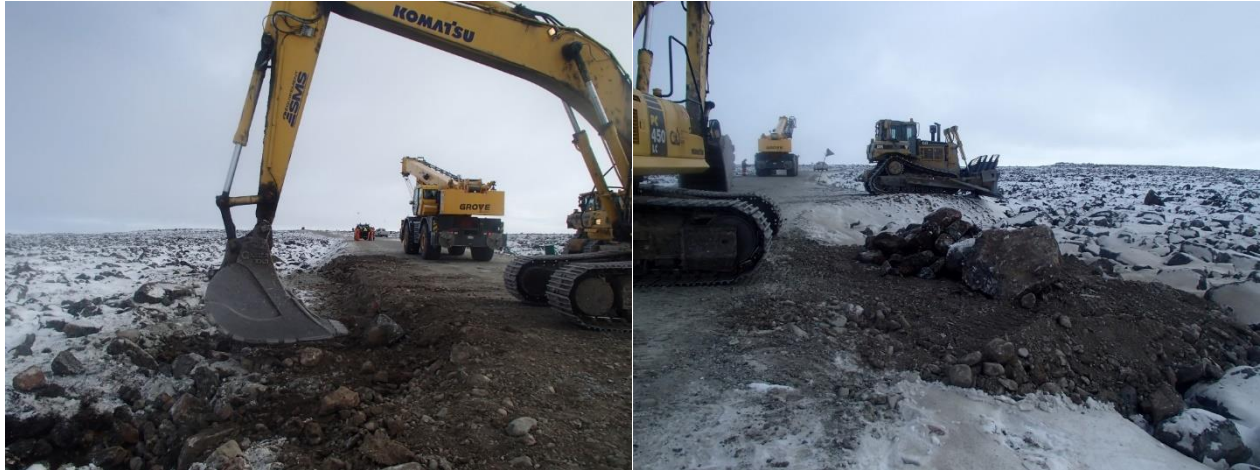
Absorbent pads were laid out to contain the spill on the ground as well as a containment drum. Once the truck was placed back on the road and moved out of the area, the ground was scrapped clean and contaminated material was brought to the Meadowbank Landfarm area.

Investigation on the cause of the incident is ongoing.

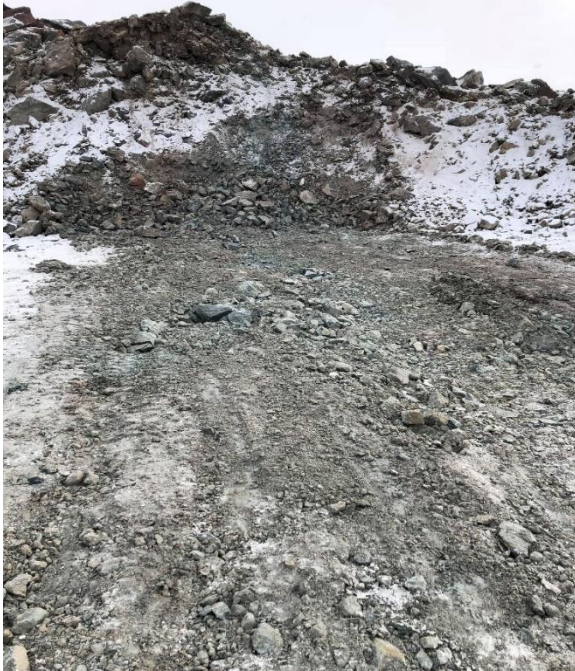
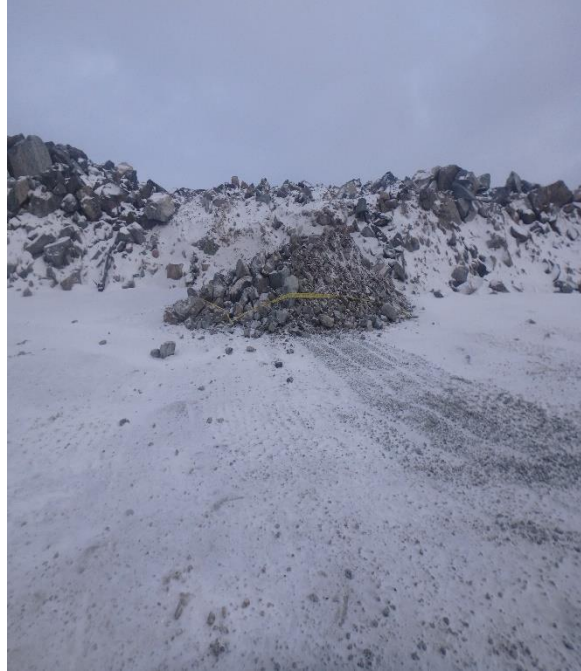
The equipment was immediately stopped. Absorbent pads were laid out to contain the spill on the ground. Once the truck was fixed and moved out of the area, the ground was scrapped clean and contaminated material was brought to the Meadowbank Landfarm area.

Regular pre-operation checks are completed on equipment also including visual inspection of the hydraulic systems.
