Appendix 31

Meadowbank 2019 GN Spill Reports

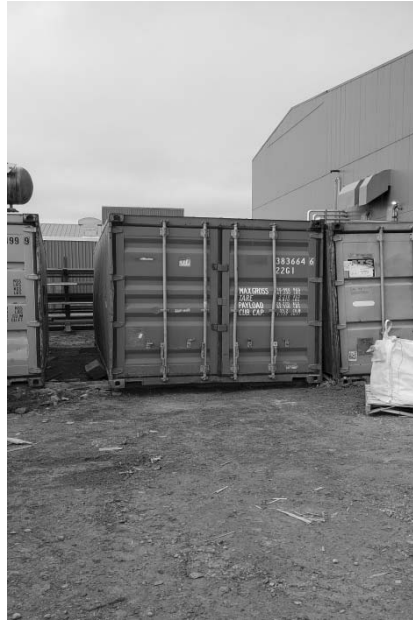
Sea container was delivered with damaged bags of sulphur prills. Workers were trying to salvage bags but as they removed them some pallets and bags scraped some spillage out on the ground at the entrance of the container.

The spill was caused by a human error when the operator during the operation.

The operators are trained for these tasks. They need to follow the procedure.
