Appendix 32

Whale Tail 2019 GN Spill Reports

GN reference #: 2019-001

Please find the following information as a follow up to the spill report submitted January 2, 2019 by Agnico Eagle. This detailed report is submitted to the Inspector in compliance with the conditions under the Nunavut Water Board License NWB-2AM-WTP1826, Part H, Item 8c.

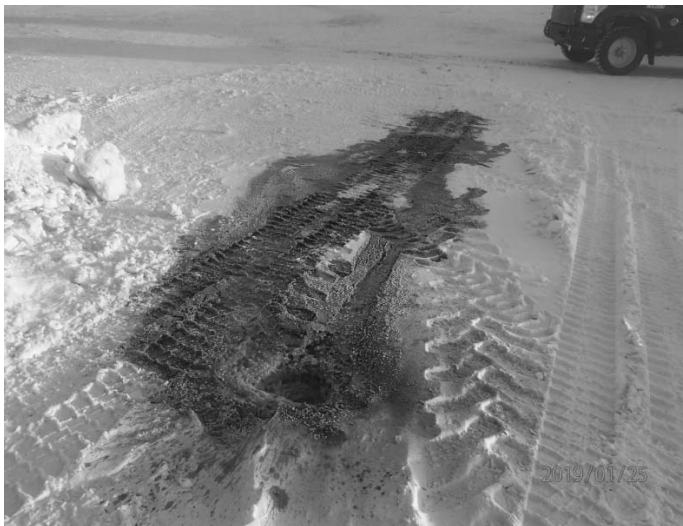
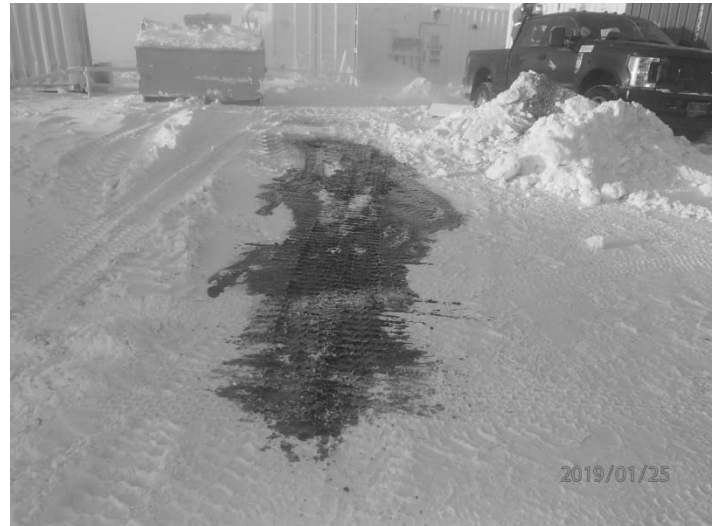
When the operator emptied the sludge from wastewater treatment plant with a vacuum truck, he saw an overflow coming from the tank.

As the operator was close to the vacuum truck he was able to shut down quickly the operation. All contaminated material on the ground was collected and brought to the Meadowbank land farm.

A reminder to all operators was given on the importance to have the good evaluation of the volume available in the tank before starting the operation.

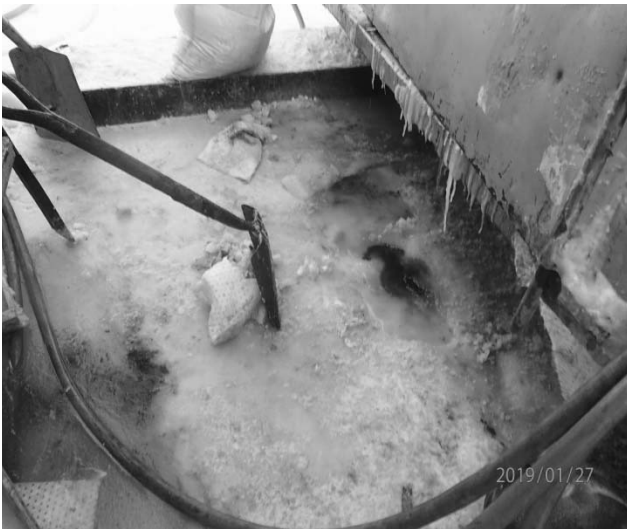
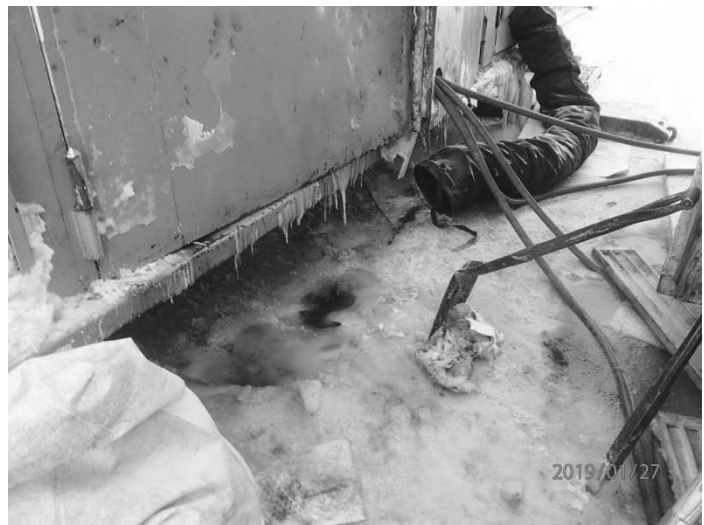
While the drill SH-61 #1 was operating on the Whale Tail North Lake, the hose feeding the cylinder busted causing 30L of engine oil to spill in the secondary containment but an overflow of 5 liters of Engine Oil got in contact with the ice.

The spill has been caused by a mechanical breakage of a hose feeding a hydraulic cylinder.

The drill operators used absorbent pads to clean-up and disposed of the contaminated material at the appropriated facility.

A routine visual inspection of all system is performed during pre-operations checks as a part of the preventive maintenance program.

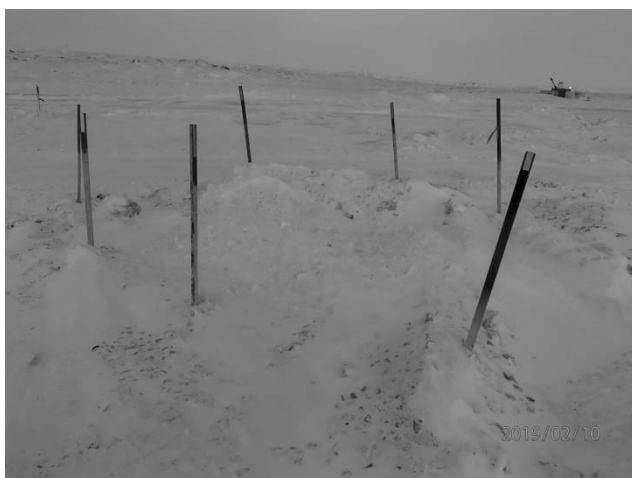
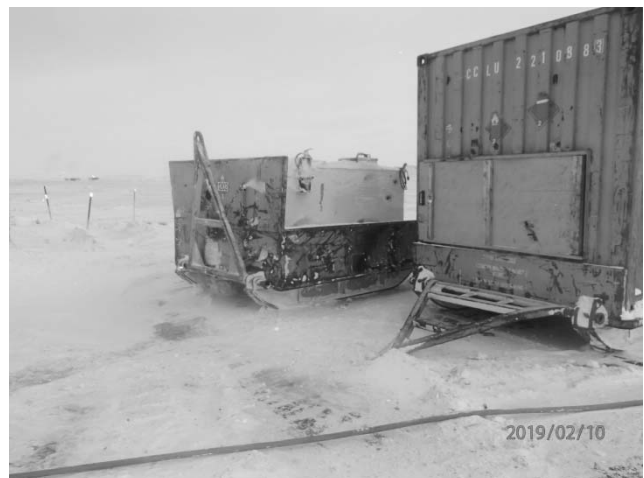
The spill has been caused by a seal popped on hydraulic system.

The drill operators used absorbent pads and shoveled the snow and disposed a contaminated material at the appropriated facility.

A routine visual inspection of all system is performed during pre-operations checks as a part of the preventive maintenance program.

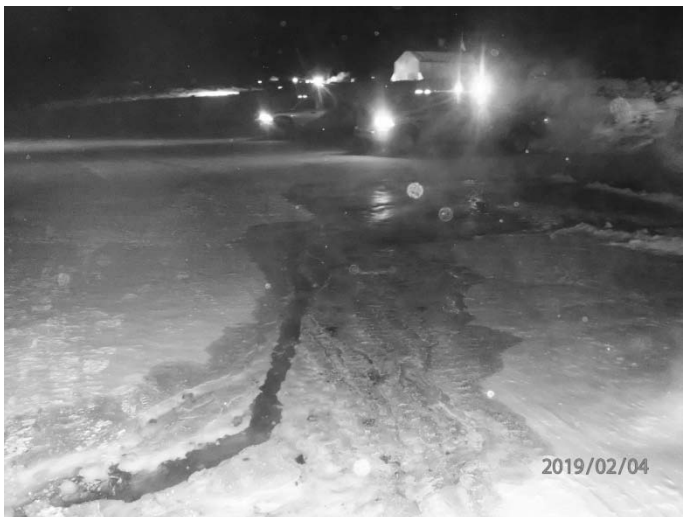
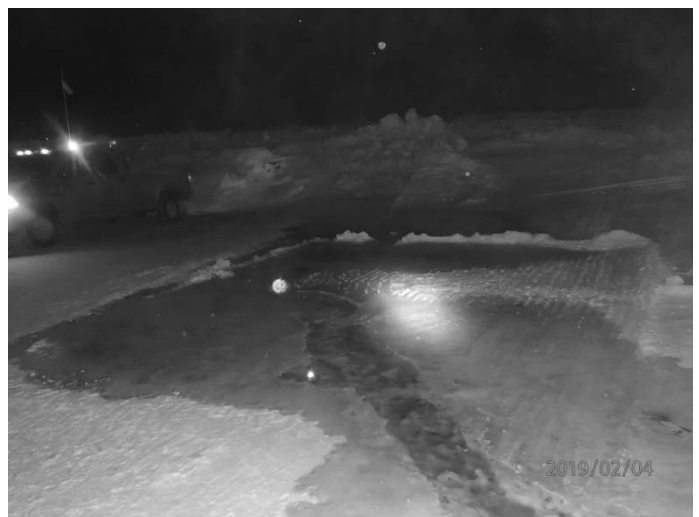
Sewage water accumulated in the EQ tank was pumped in the water treatment system plant and then has overflow inside the building and outside. Approximately 1000 l went on the ground.

The operator stopped the pump as soon that he saw the tank overflowing. All contaminated material on the ground was collected and brought to the Meadowbank land farm.

The procedure for the extended shut down was reviewed and modified to prevent any spill in the future.

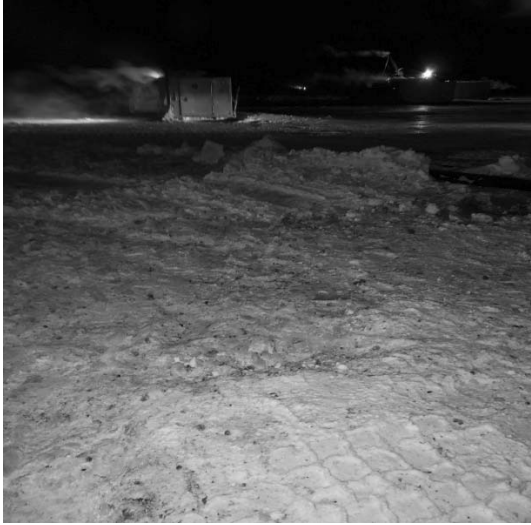
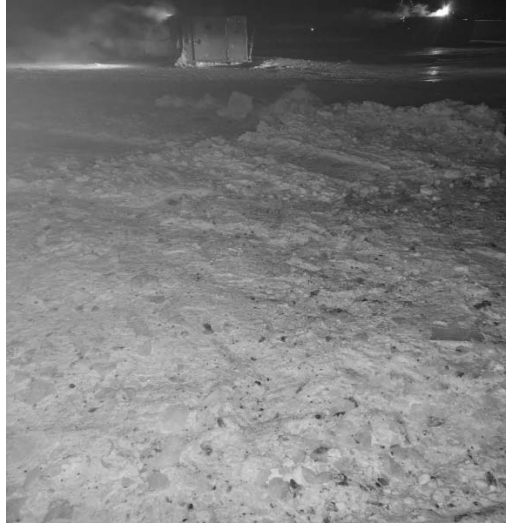
While the drill SH-47 was operating on the Whale Tail North lake, the motor broke down, engine oil leaked from the vent causing a spill in the secondary containment inside the drill but 4 liters of oil has overflowed the containment and goes on snow.

The spill has been caused by mechanical issue with the motor.

The drill operators used absorbent pads and shoveled the snow and disposed a contaminated material at the appropriated facility.

A routine visual inspection of all system is performed during pre-operations checks as a part of the preventive maintenance program.

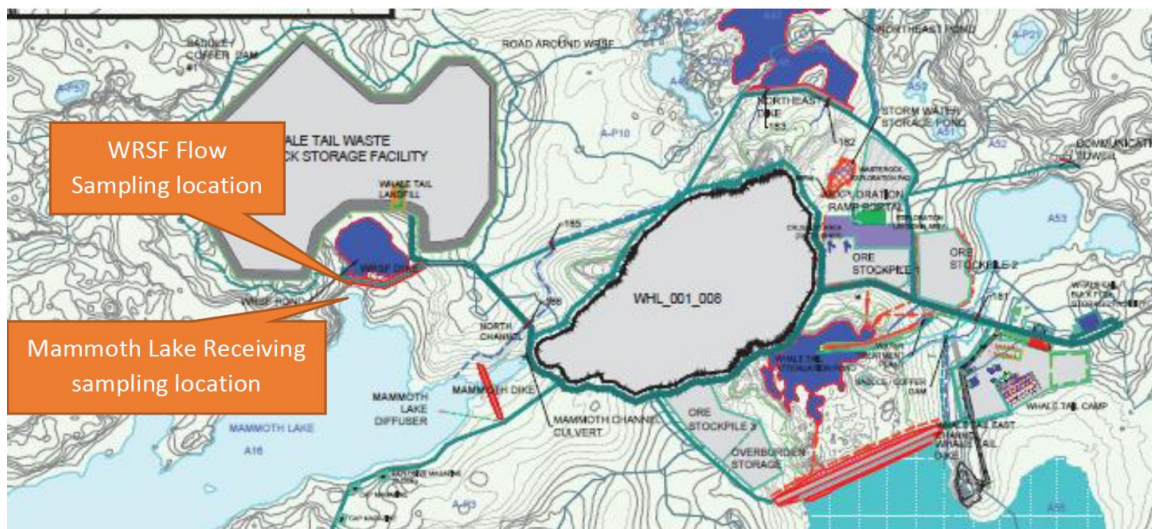
Figure 1: WRSF Flow and Receiving Environment Location

Agnico Eagle Mines Limited – Meadowbank Division (Agnico Eagle) informed you via email on August 25, 2019, that during a routine inspection of the Whale Tail WRSF Dike carried out on August 24, 2019 at 10:30 am, a water flow was observed at the toe of the dike flowing toward Mammoth Lake (UTM 14W 0605380 7255454) (see Figure 1).

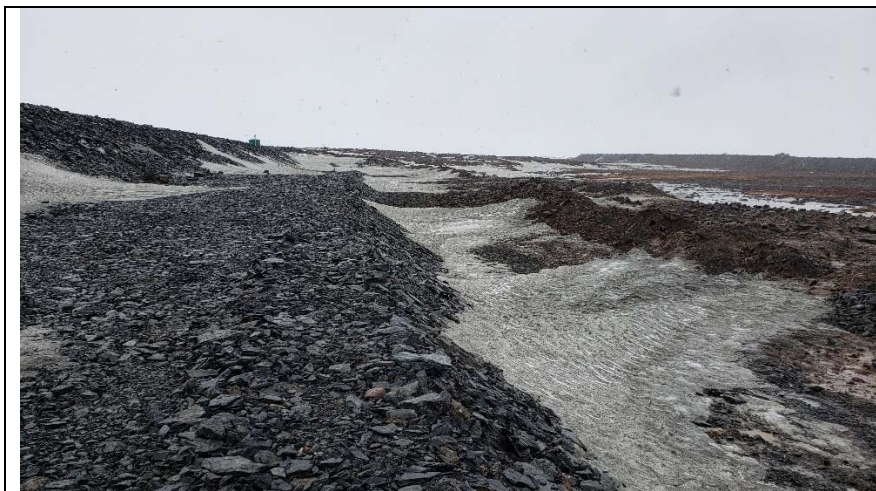
US1: Upstream slope. Water pond far from structure & frozen.

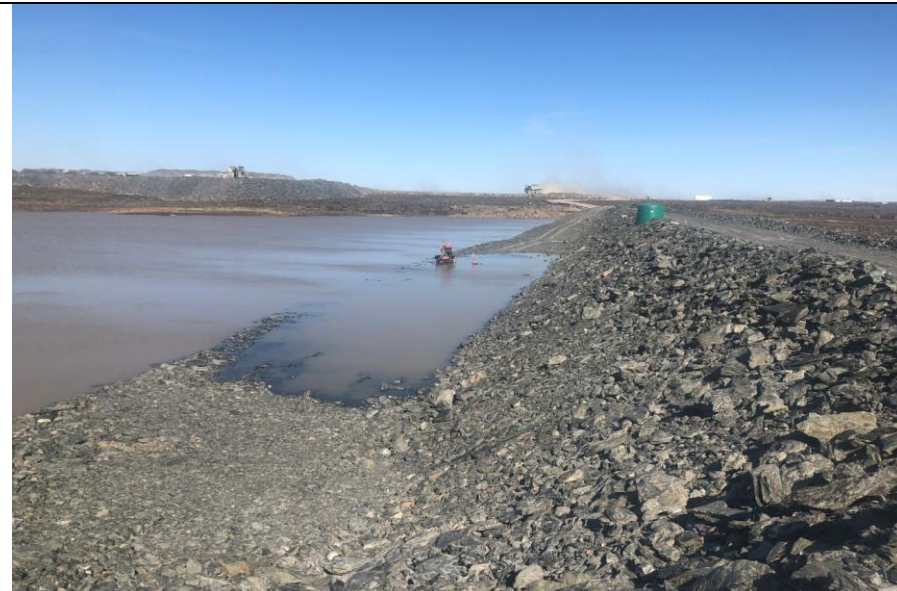
US1: Upstream slope. Water pond far from structure & frozen.

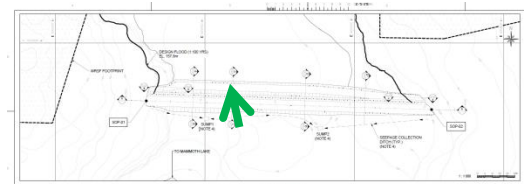
Location and orientation of US2.

US2: Upstream slope.

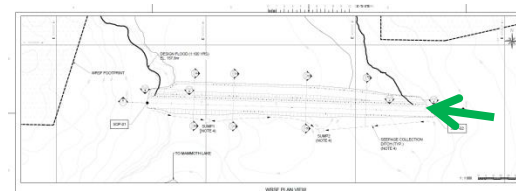
Location and orientation of **CR1**

CR1: Rolling surface. Small puddles at surface, no damages

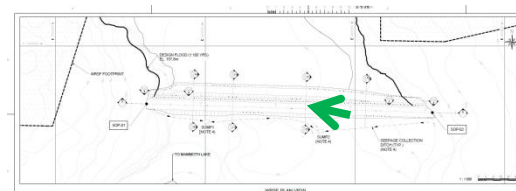
Location and orientation of **CR2**

CR2: Rolling surface. Small puddles at surface, no damages

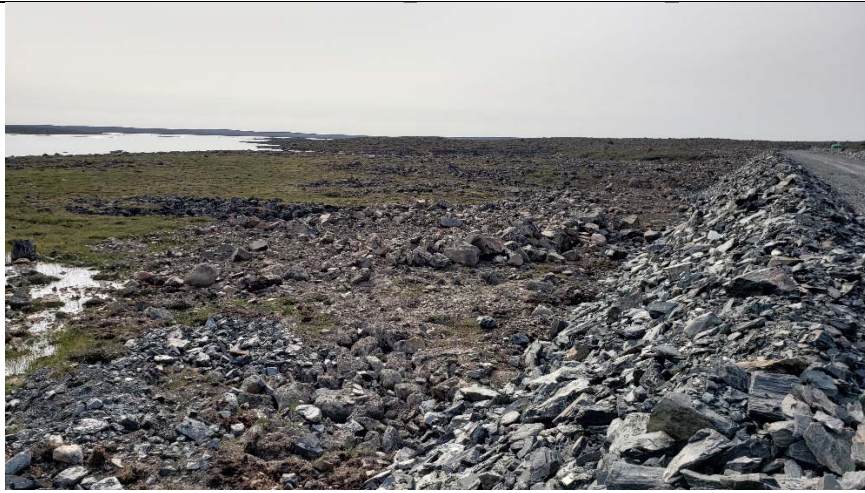
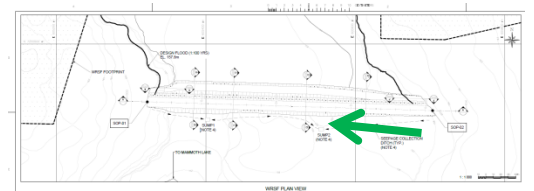
Location and orientation of DS1.

DS1: Downstream slope and berm.

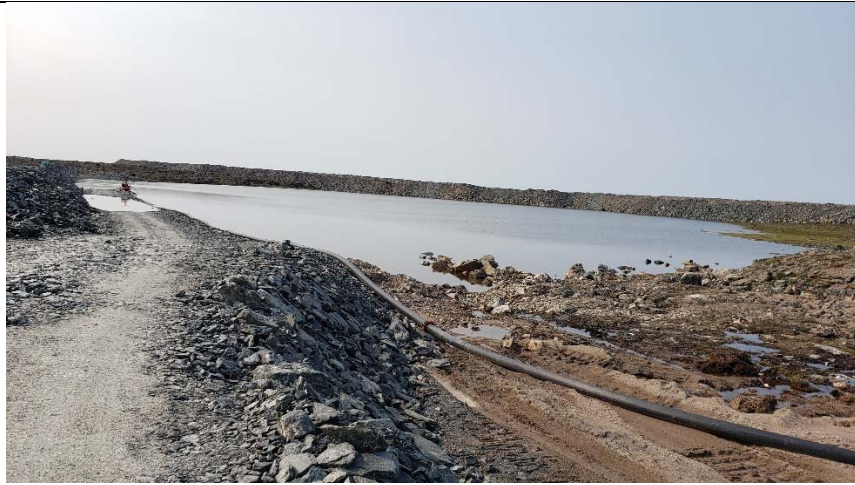
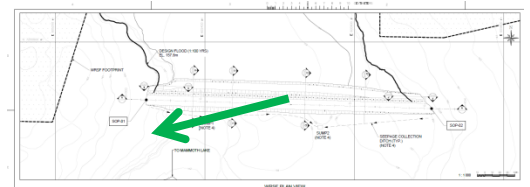
Location and orientation of US1.

US1: Upstream slope. Water elevation at 156.02m.

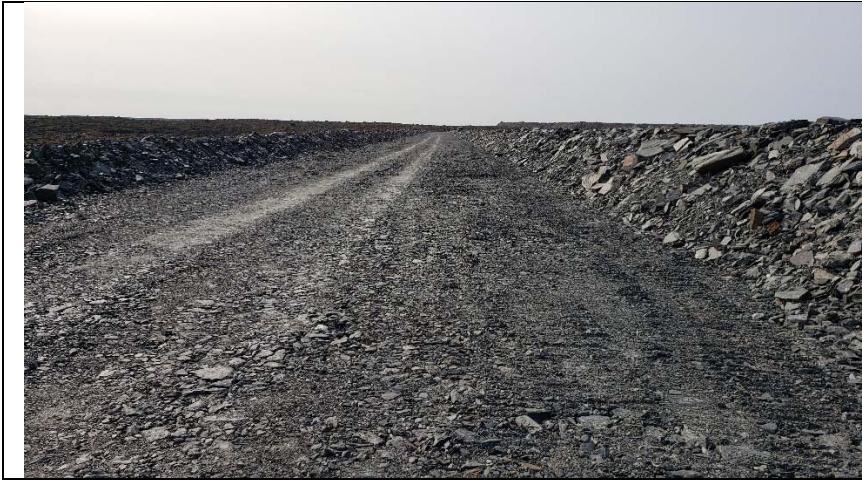
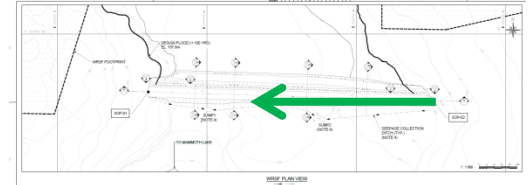
Location and orientation of **CR1**

CR1: Rolling surface.

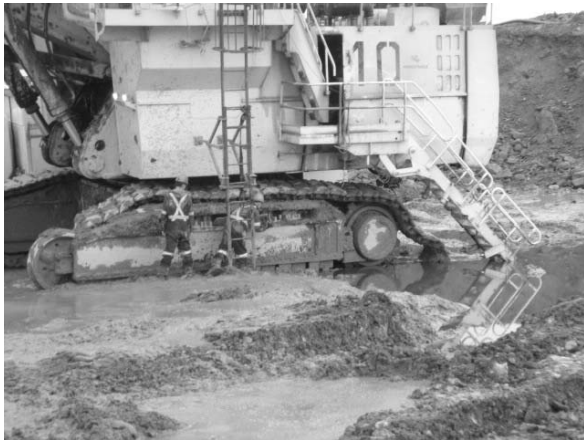
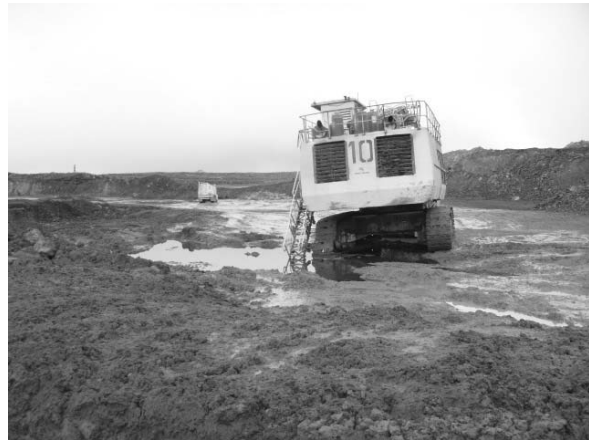
During operations at Whale Tail pit, the left track of BAC10 came off, damaging the tensioner cylinder which fully drained the oil tank of the backhoe. The equipment was shut down immediately.

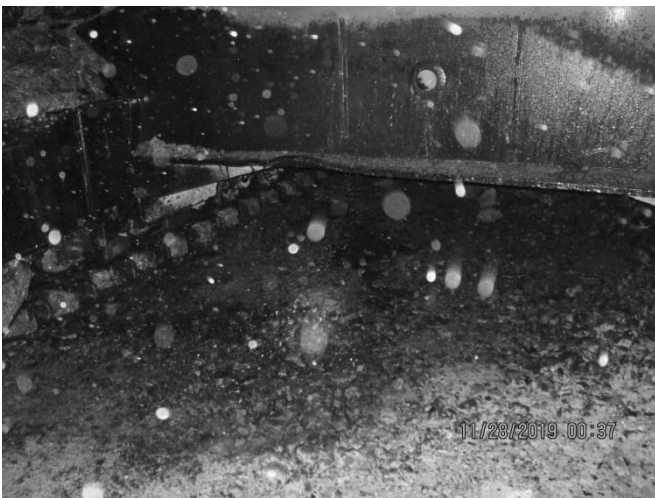
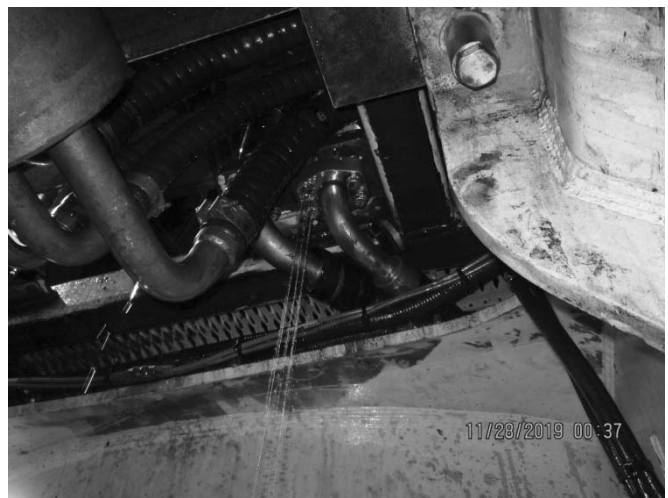
During operations at Whale Tail pit, one of the bolts holding a hydraulic line broke, causing hydraulic oil to spill to the ground.

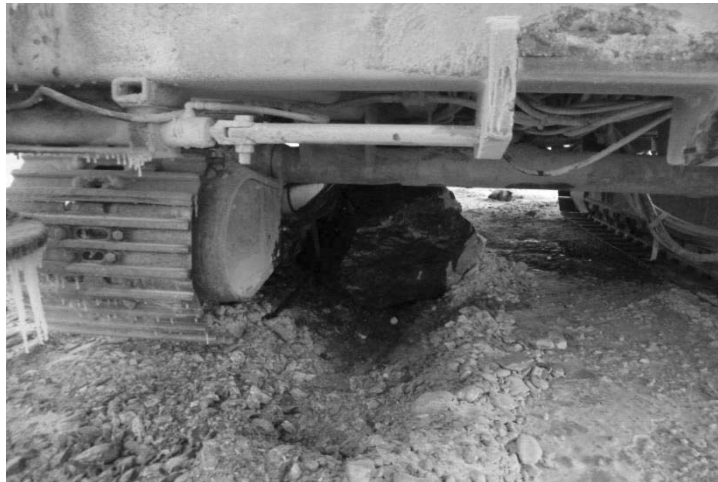
During operations at Whale Tail pit, an operator was moving drill RBD01 to the next pattern and made contact with a spill rock from a haul truck causing oil to spill from the tank.
