Meadowbank 2019 Annual Pit Slope Performance Review

2019 ANNUAL PIT SLOPE PERFORMANCE REVIEW

MEADOWBANK MINE, NUNAVUT

OCTOBER 11, 2019

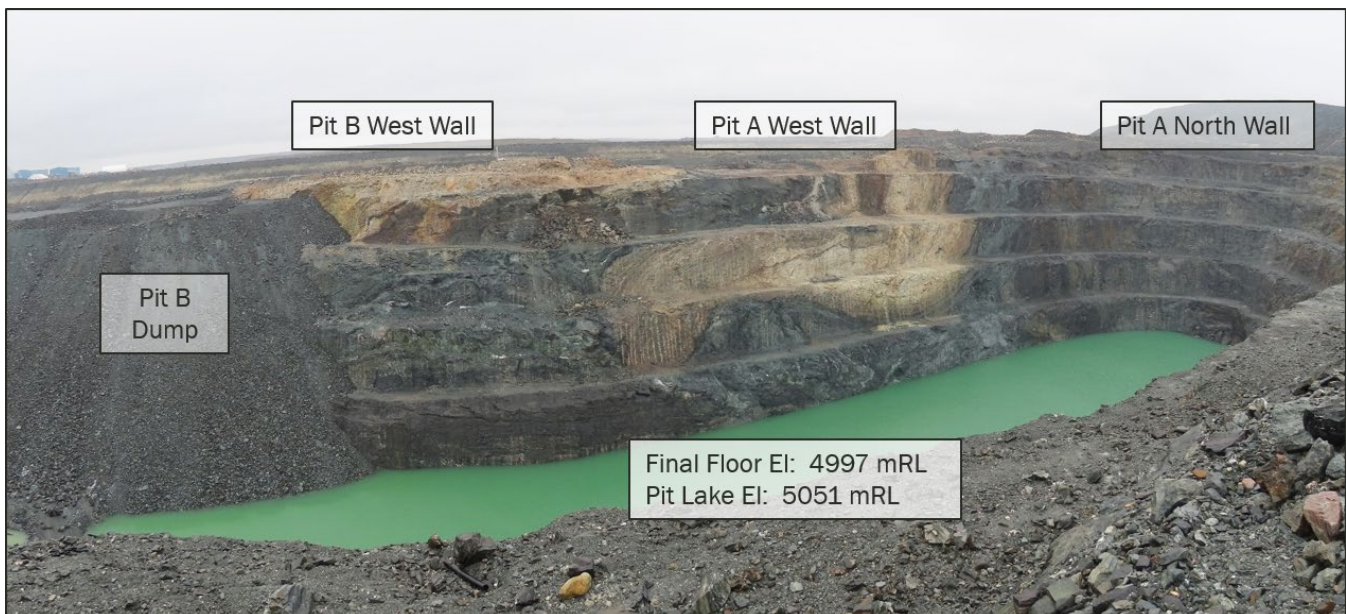
Photograph 4-1: Pits A and B looking west, from east crest (2019)

The inspection consisted primarily of observations made from the crest areas, and from the base of the pit, comparing the current conditions with those previously observed, as well as comparing the current pit usage with risk assessments carried out as part of the assessment of the pits for use as tailings and water management areas (Tetra Tech 2018a and 2018b). Views of Pits A and B at the time of the site visit are shown in the following photographs. For scale, the bench height in the photographs is 21 m.

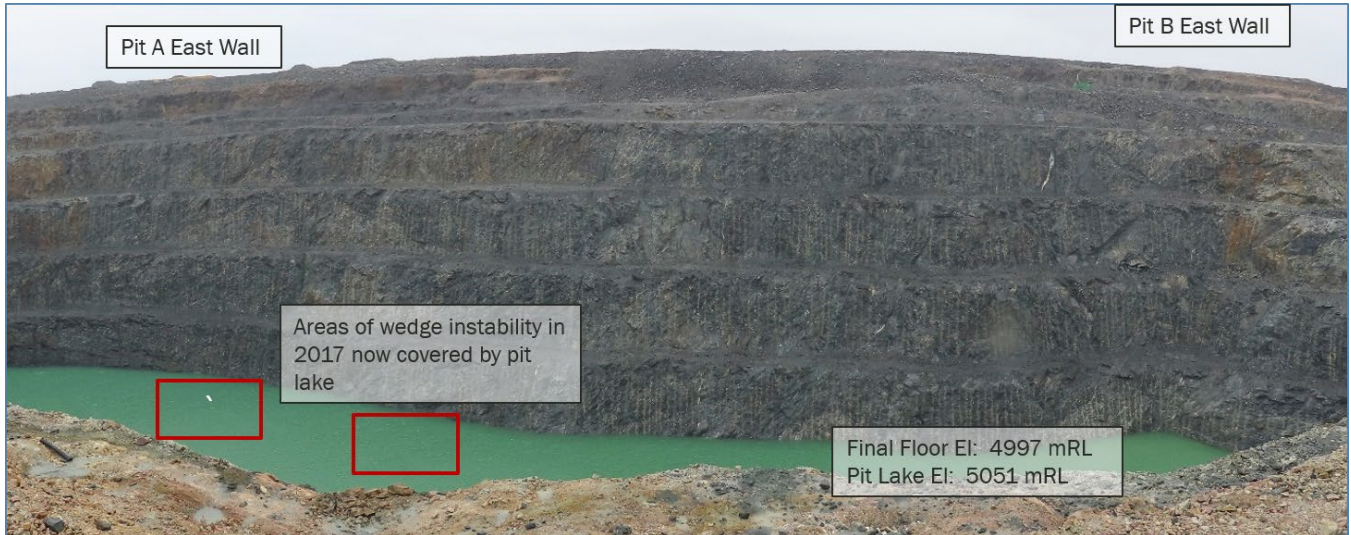
Photograph 4-7: Pit A east wall, north end additional wedges (2019)

The areas of bench scale wedge and planar sliding occurring in 2017 are now covered by the current pit lake.

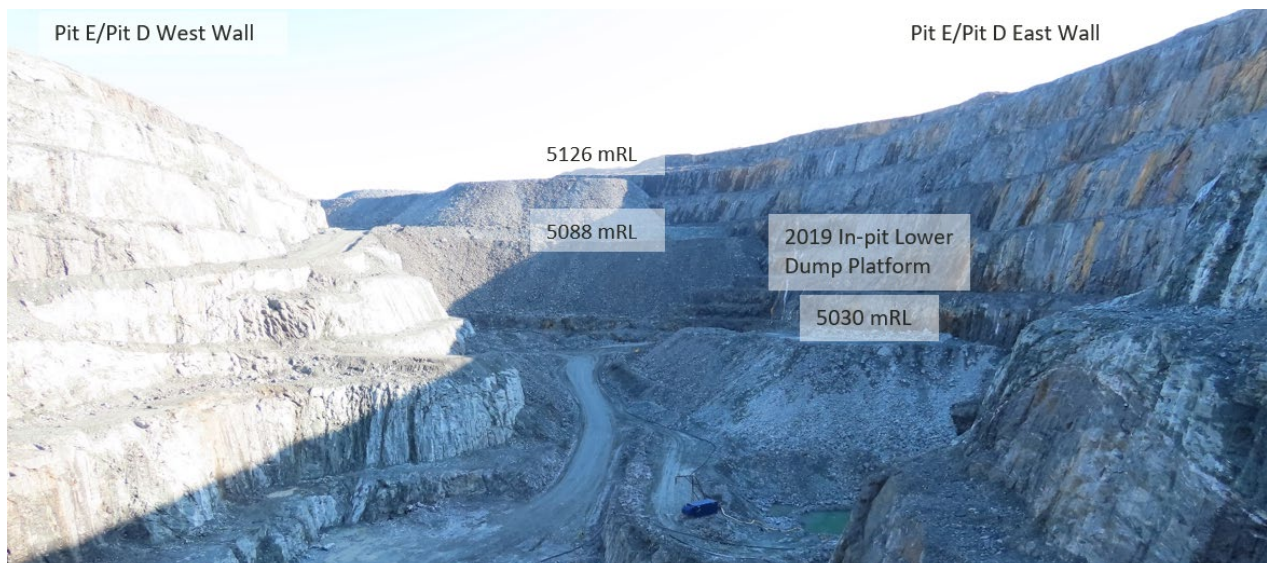
Photograph 5-2: Pit D Dump facing north with in-pit lower dump platform in foreground

The Pit D Dump continues to be actively used. The highest platform remains at approximately 5126 mRL and has not been advanced further to the south along the east wall since 2018. The main dump is inactive, however, an in-pit waste dump in Pit E has been advanced southward in the base of the pit from the south end of Pit D Dump during 2018 and 2019, at an elevation of or approximately 5030 mRL.

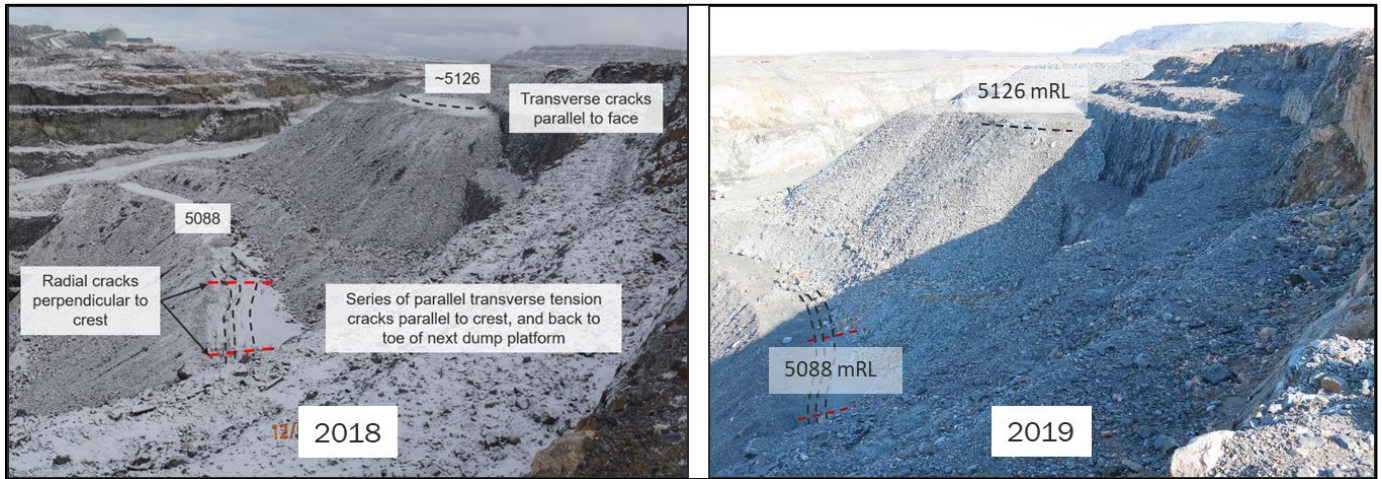
Photograph 5-3: Comparison of Pit D Dump profiles from 2018 and 2019

Areas of tension cracks that were observed on the D Dump 5088 mRL and 5126 platforms during the 2016 and 2017 inspections do not appear to have changed, and no additional tension cracks were observed suggesting that settlement of the platform crests in these areas has stopped. A comparison of the dump profile in 2019 with 2018 is shown in Photograph 5-3. A photograph of radial tension cracks observed on the dump platform with erosional indicators suggesting these are inactive is shown in Photograph 5-4.

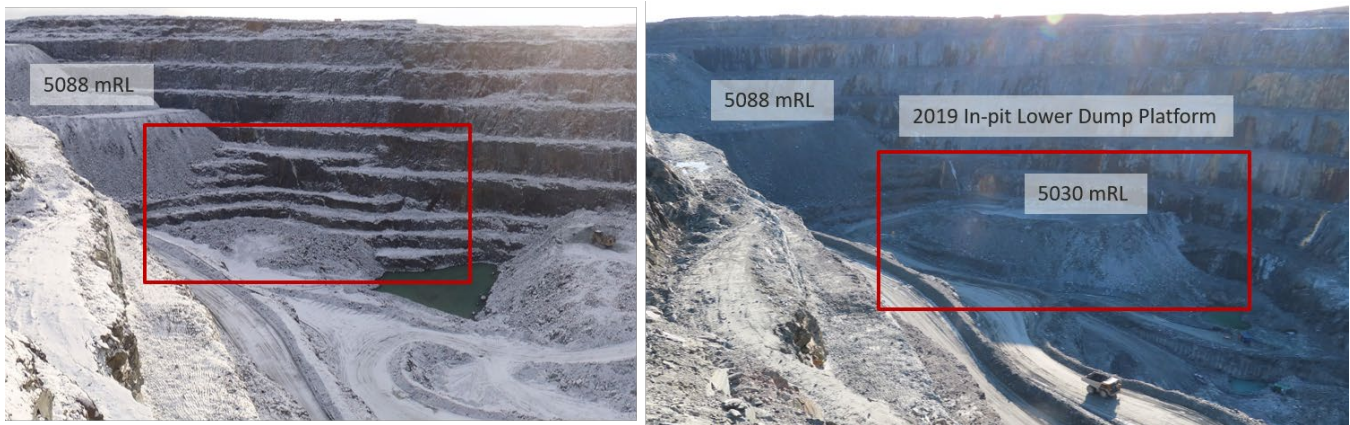
Photograph 5-5: Pit D Dump lower platform

A lower platform was advanced southward from the toe area of the Pit D Dump across the lower benches of the east wall of Pit E to provide short haul to waste material being excavated. The elevation of this lower dump platform at the time of the site visit was approximately 5030 mRL and a sump had been developed at the south end on approximately with a pond elevation of approximately 4995 mRL, shown in Photograph 5-5.

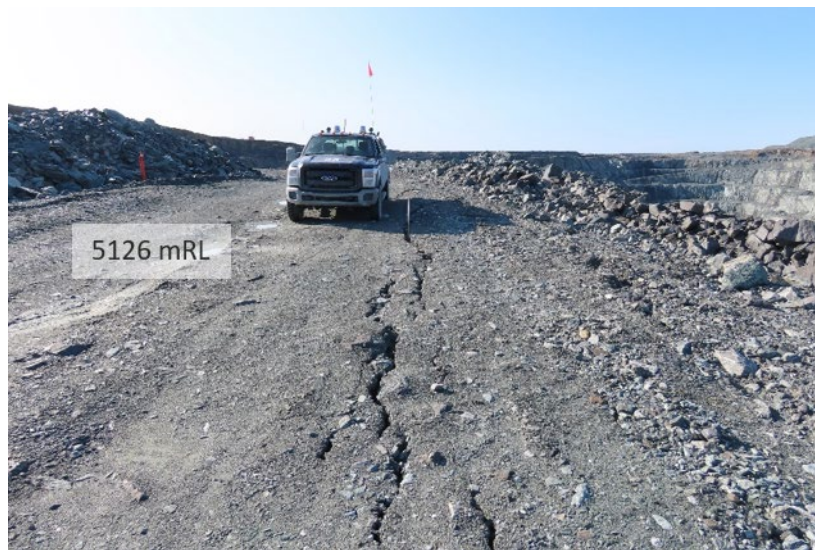
Photograph 5-6: Pit D Dump 5126 platform above haul road

An area of note is along the west crest of the 5126 mRL platform. This area is above the active haul road from Pit E, which will continue to be maintained as access for tailings and water reclaim purposes. Several tension cracks were noted parallel to the crest of the dump above the road. It was recommended during the site visit that a simple wireline extensometer be installed during final mining of Pit E, after which this area should continue to be monitored as part of regular geotechnical inspections.

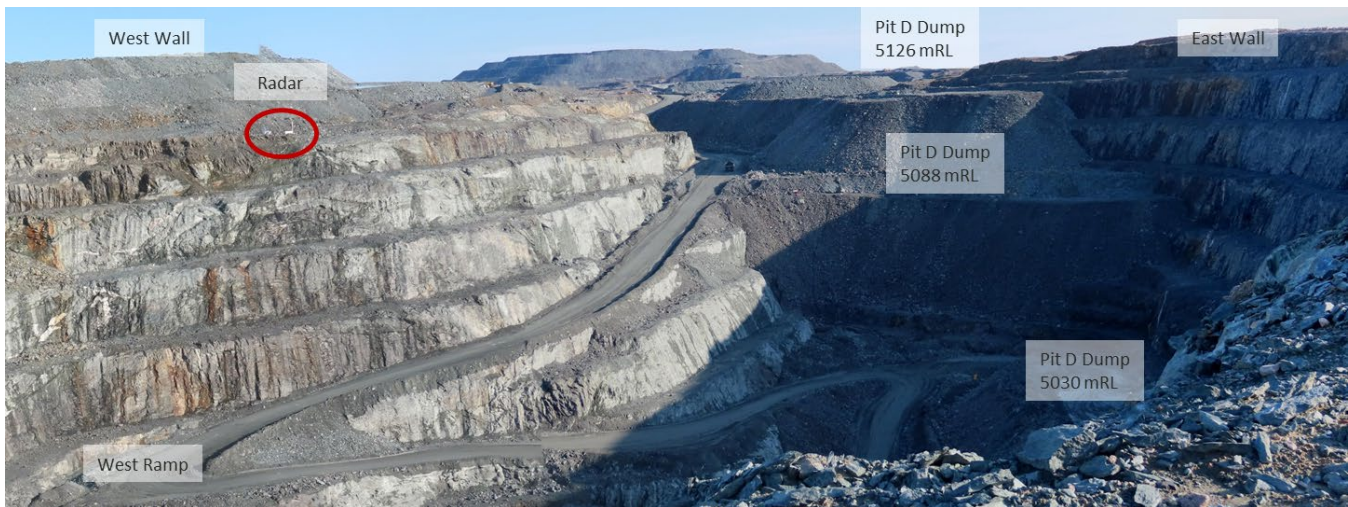
Photograph 6-1: Pit E viewing north (2019)

Based on the most recent pit plan, mining of Pit E is scheduled to be completed near the end of September 2019. The final floor elevation is planned to be 4976 mRL. Access to the pit base was by the west access ramp, in the west wall of the Portage Pit. There is no longer access to the pit base from the south wall access ramp, which is inactive but still accessible by small truck. The pit floor at the time of the site visit was dry, and water was being managed in a small sump at the southeast corner of the floor. The sump water elevation was approximately 4996 mRL. Very little seepage was noted on the pit walls with the exception of the ultramafic rock in the south wall of the pit.

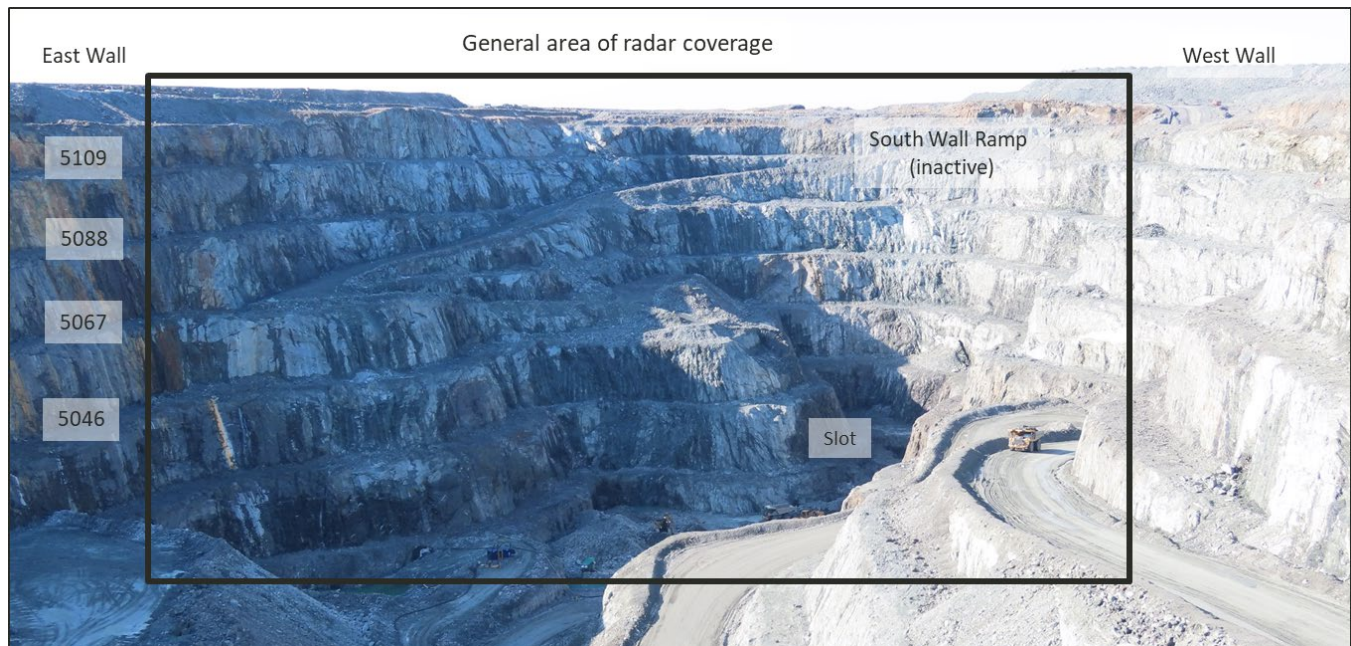
Photograph 6-4: General radar coverage of south wall Pit E5 2019

The wedge and planar instability that have occurred have in many cases been predicted by the radar. AEM have taken proactive steps to buttress areas of instability, to restrict access to others, to sequence mining in higher risk areas during winter months, and to develop a containment platform and berm beneath the broader rockfall zone below the south wall ramp.

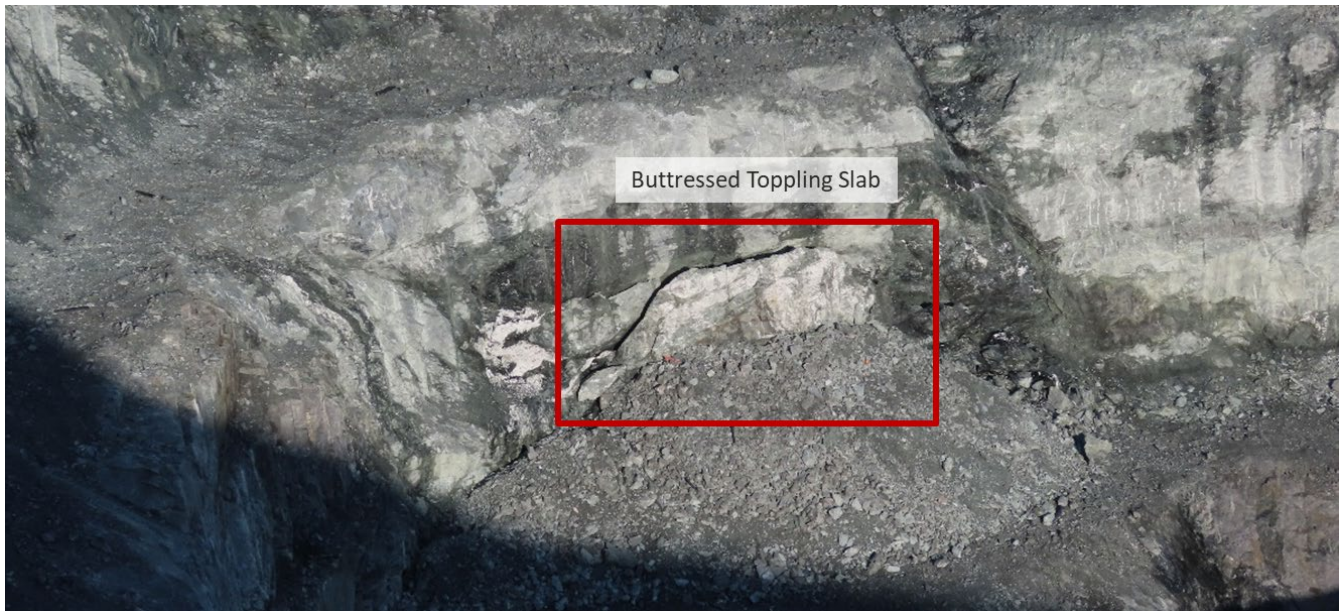
Photograph 6-5: Buttressed toppling slab in the south wall of Pit E

In addition to the rock fall events which occurred, the geotechnical team identified an area of potential toppling during regular inspections of the south wall of the pit. The toppling is associated with the Bay Fault or a splay forming a steeply west dipping back release plane along which toppling is occurring. It is not clear if the mechanism is direct or flexural toppling. Nonetheless, and in response a stabilization berm was constructed, and this has been very effective in buttressing the toppling mechanism.

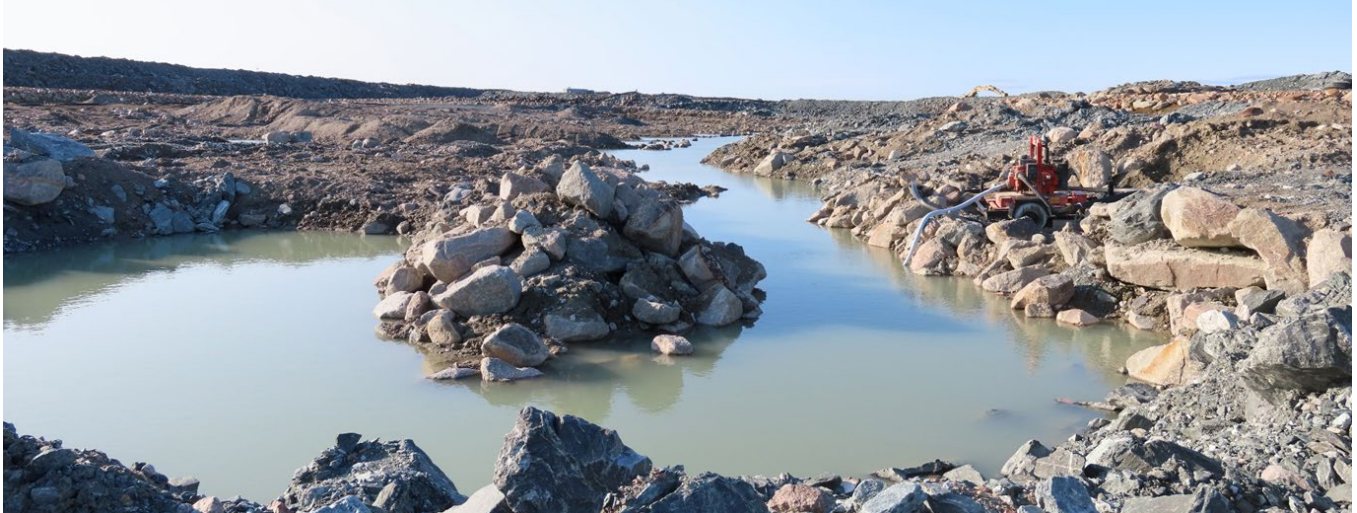
Photograph 6-6: Sump at crest of Pit E south wall

The sump at the crest of south pit wall continues to collect water. A pump has been set up to manage the water that accumulates in the crest area. This is of lesser concern now that the south wall access road is inactive.

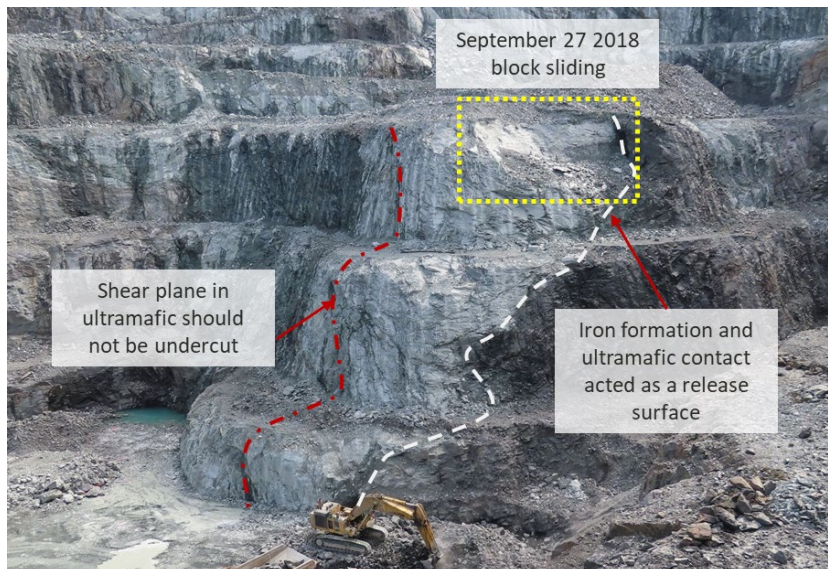
Photograph 6-8: Shear planes in ultramafic rock below September 27 2018 failure

A review of this area during the 2019 inspection indicates subparallel west dipping shear planes exist within the ultramafic rock. The re-orientation of the wall through the ultramafic material reduces the potential for additional sliding on the sheared surfaces by intersecting the west dipping features at an oblique angle, although some additional crest loss can be attributed to these features on subsequent benches. It is essential that these planes are not undercut by the remaining bench faces or inter-ramp angle. This area of the wall is covered by the radar monitoring.

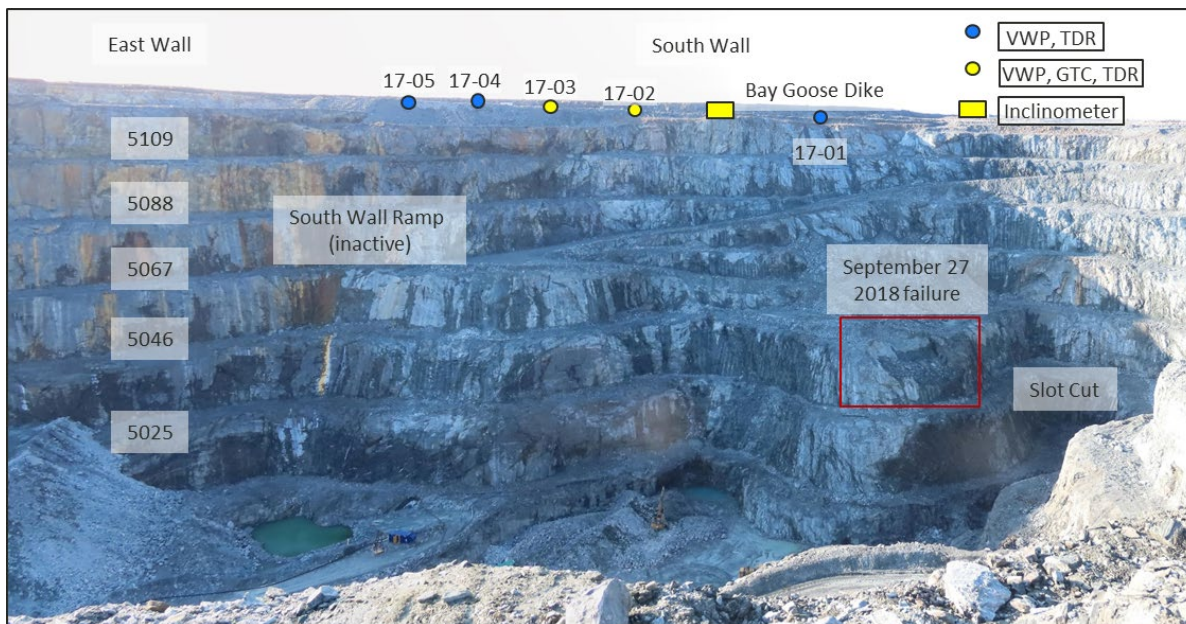
Photograph 6-9: Pit E south wall instrumentation locations (estimated)

The instrumentation consists of vibrating wire piezometers, time-domain reflectometry (TDR) cables, thermistors, and an In Place (IP) inclinometer. The current instrumentation continues to adequately monitor the south wall of Pit E.

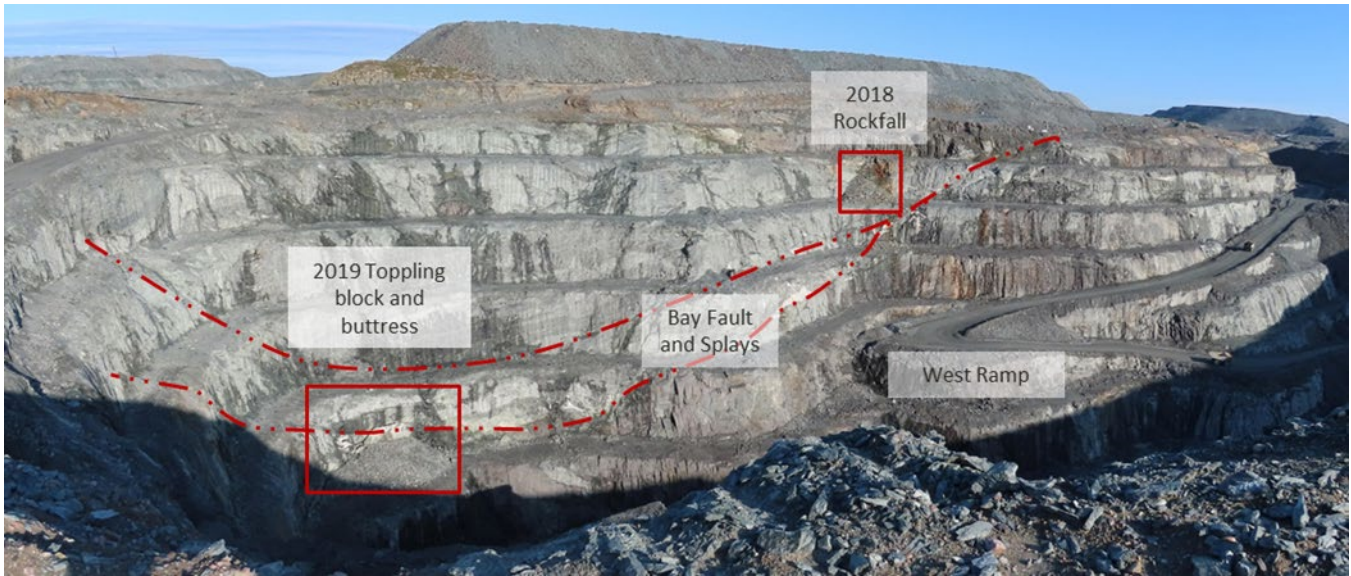
Photograph 6-10: Pit E west wall showing Bay Fault (2019) and toppling

At the south end of the west wall, the contact of the ultramafic rock and overlying intermediate volcanic rock is inclined into the wall, which is generally beneficial for overall slope stability, but can lead to bench-scale instability within the weaker underlying ultramafic rock. The presence of the Bay Fault and associated parallel structures within the ultramafic rock also lead to the potential for toppling, as seen in the transition from the west wall of the pit to the south wall of the pit.

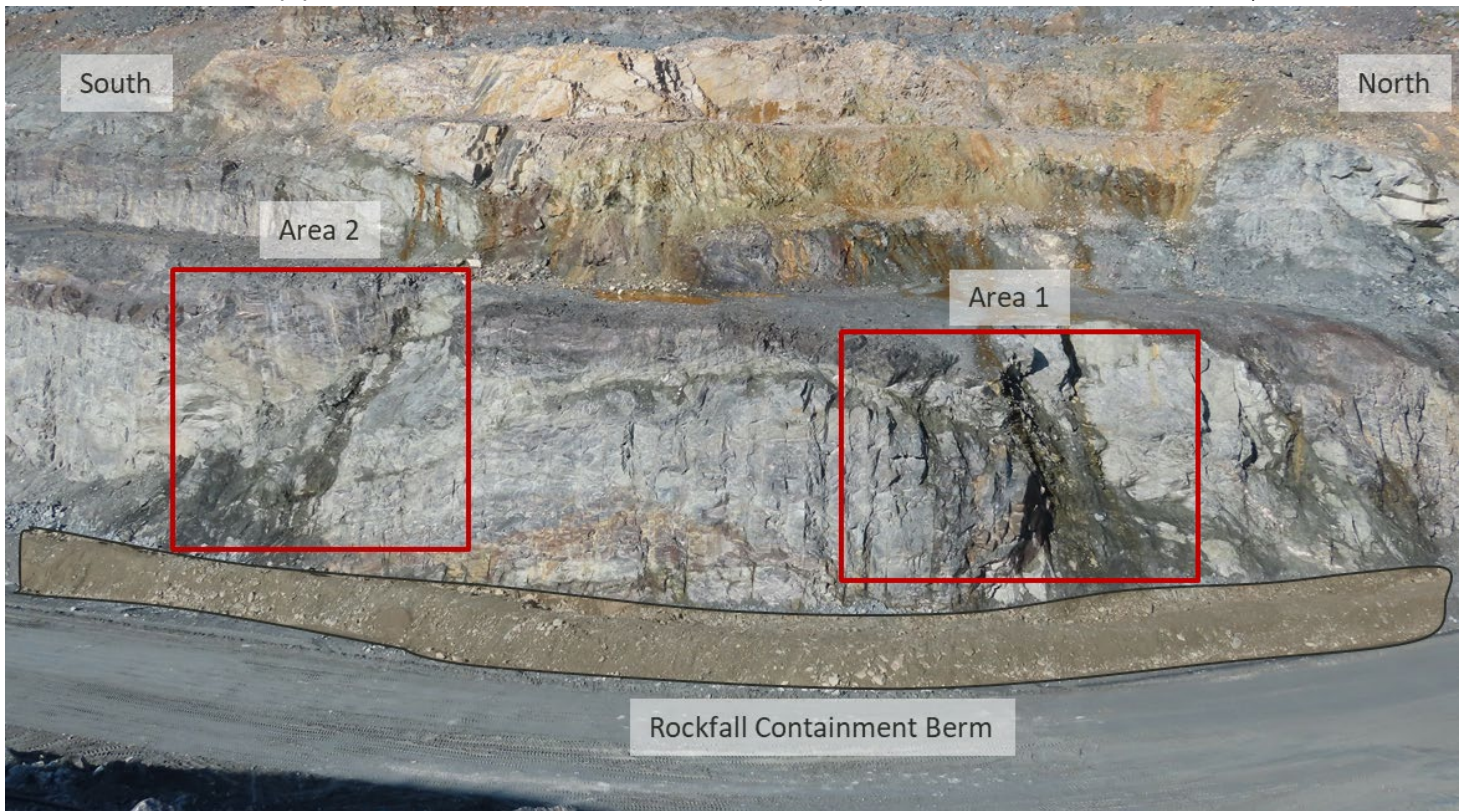
Photograph 6-14: Pit E Ramp Areas 1 and 2 (2019)

The West Wall Ramp enters the Portage Pit along the west side of the pit, and ramps down to the south towards Pit E3/E5. The ramp passes beneath an area of wall that was experienced several rock falls in 2014 (Area 1 and

Area 2). The area of wall is associated with a fault zone – the Bay Fault or a splay off that fault trend - trending along the west wall of the pit. This fault, or shear, is several metres wide, and steeply inclined to the west. The rockfall containment berm along the inside shoulder of the ramp has been re-established to an effective height to contain rockfall runout as recommended following the 2018 site visit.

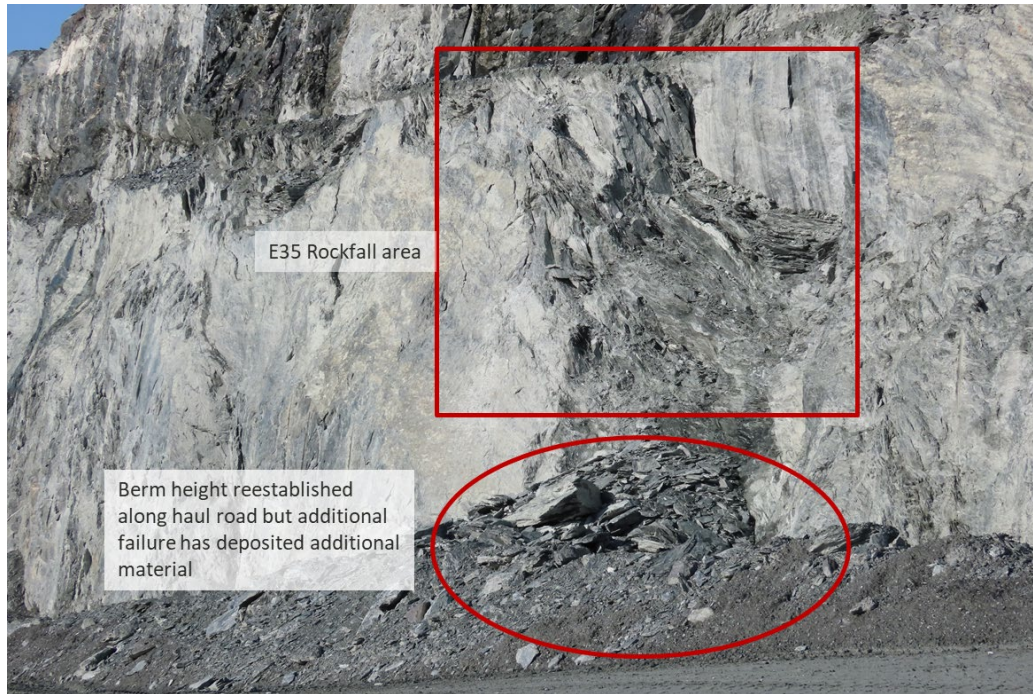
Photograph 6-17: Zone E35 rockfall

In 2018 a rockfall occurred from an area identified as E35. At the time of the 2018 site visit material had spilled over the rockfall containment berm along the edge of the ramp. Furthermore, it was noted that the containment berm in this area had settled. It was recommended that the spill material be cleaned, and that the berm height be restored. Both recommendations were implemented by Agnico. However, some additional material has failed in 2019 and deposited to the crest of the berm but has not over-topped it (see Photograph 6-17). During the site visit it was discussed with AEM to clean this material down using a backhoe to improve catchment at the toe.

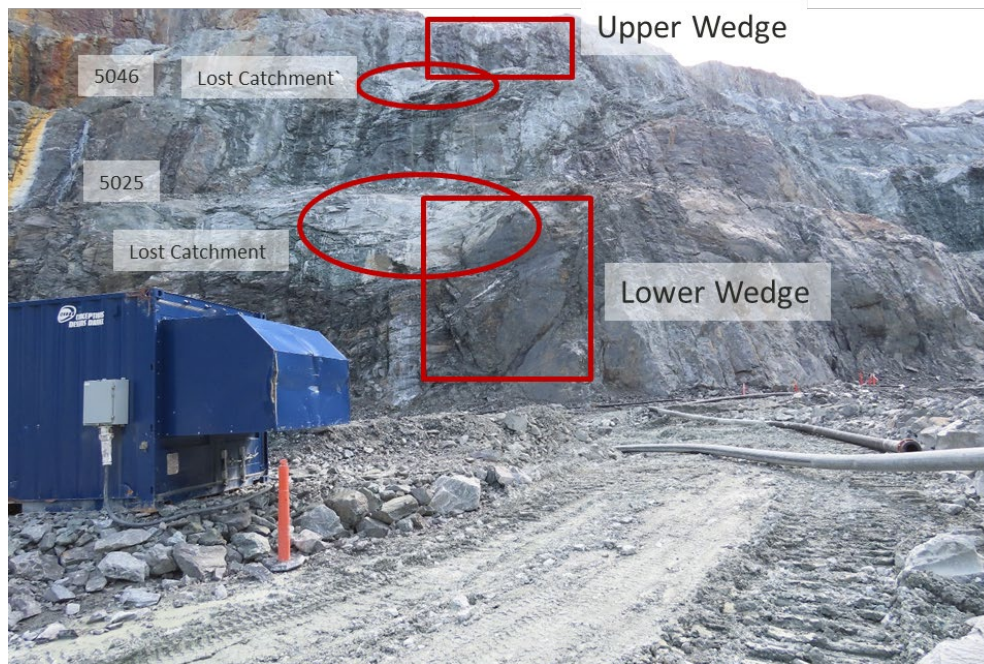
Photograph 6-23: Pit E sump area showing lost catchment

The Pit E sump is in the southeast corner of the pit, directly south of the D Dump 5030 mRL platform and adjacent to the south pit wall, at the contact between ultramafic rock and iron formation. A pump station is located approximately 25 m from the pit wall. AEM geotechnical personnel have noted two potential wedges in the wall above the sump area, one directly in the 5025 mRL bench at the sump level, and one directly above the 5046 mRL bench. The lowest wedge (5025 RL) is within iron formation, while the upper wedge is within ultramafic rock. Attempts to scale out the lowest wedge in the iron formation were not successful, indicating it is currently stable. The ultramafic rock, however has lost catchment on both the 5025 mRL and 5046 mRL benches, below the upper wedge. If the upper wedge in ultramafic rock were to fail, it is likely that some material would spill to the current sump and pump shack platform. Consequently, it was agreed that access to this area would be restricted to no further than the pump station, and that the current pipe location would be moved to the north of the pump station to remove any need for personnel to go beyond the pump station.

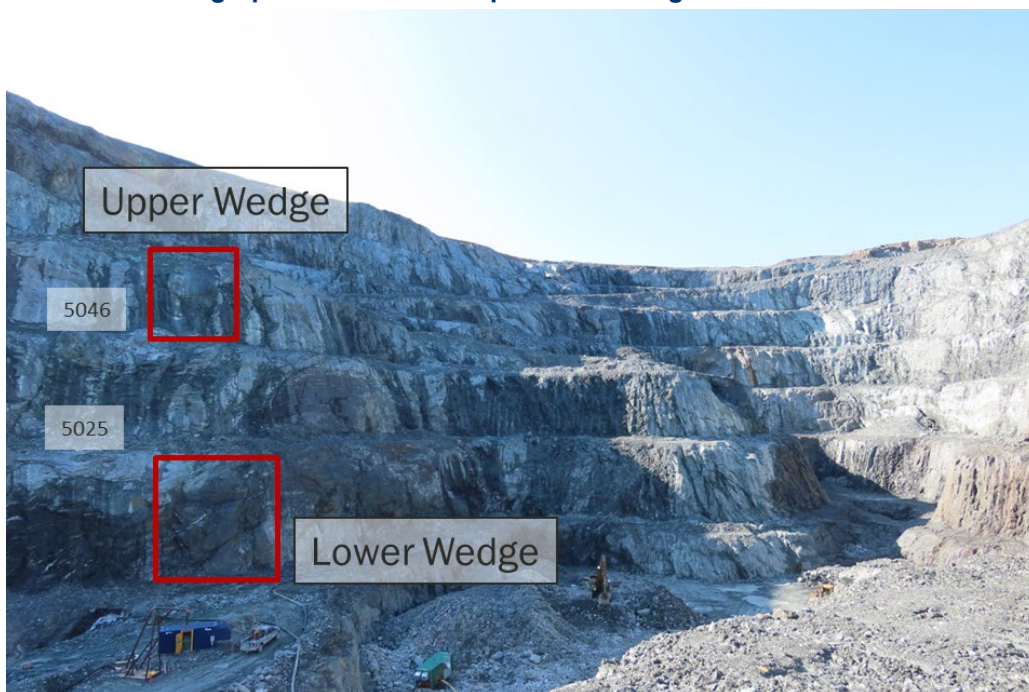
Photograph 6-24: Pit E sump area showing potential wedge instability

- Restrict access no further than pump shack.
- Move current pipe location to north side of pump shack and remove any need to go beyond shack.

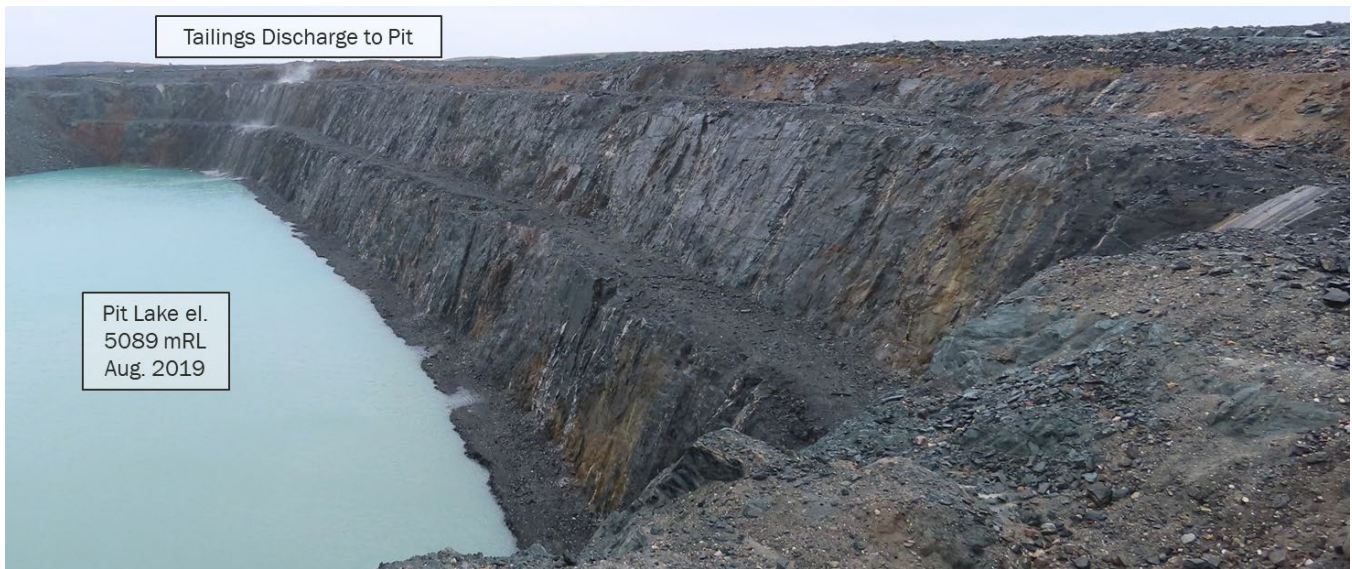
The east wall of the Goose Pit is predominantly intermediate volcanic rock and iron formation. The stratigraphy is inclined steeply at a consistent angle to the west. Steep bench faces were achieved with the use of careful pre-shear blasting, and there was little catchment loss due to overbreak. Tailings are being discharged from a spigot point at the north end of the east wall of the pit and are being discharged over the competent and strong intermediate volcanic rock.

The wall continues to perform well. Currently, there are no geotechnical concerns. The following photograph shows the east pit wall looking north.

Photograph 7-1: Goose Pit east wall looking north (2019)

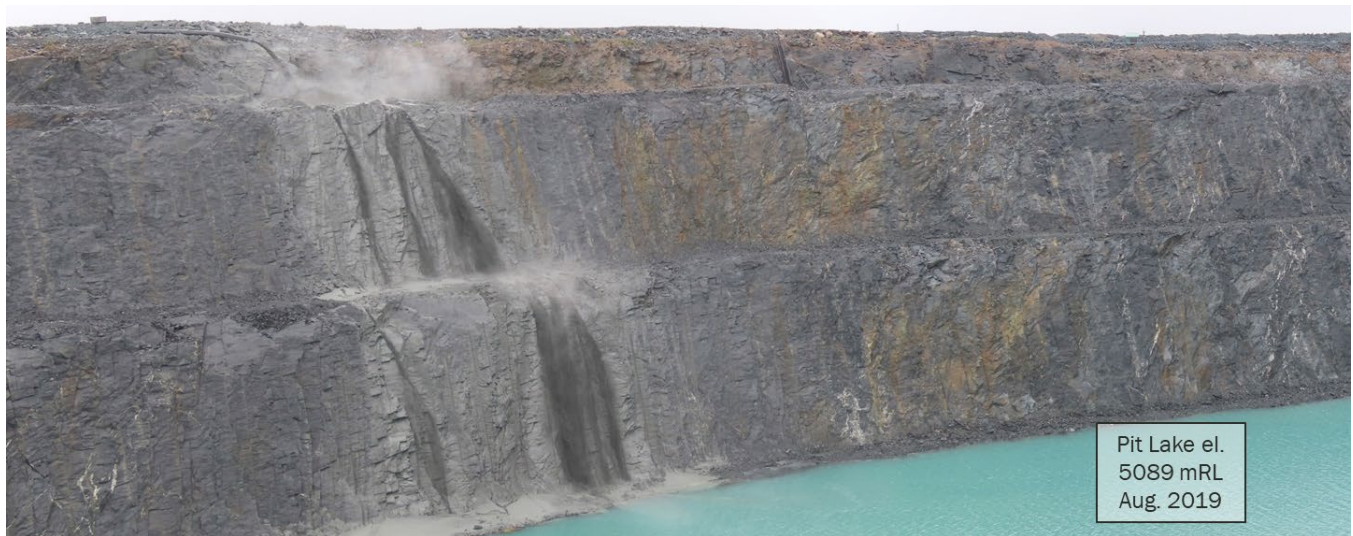
Photograph 7-2: Tailings discharge to Goose Pit from north end of east wall

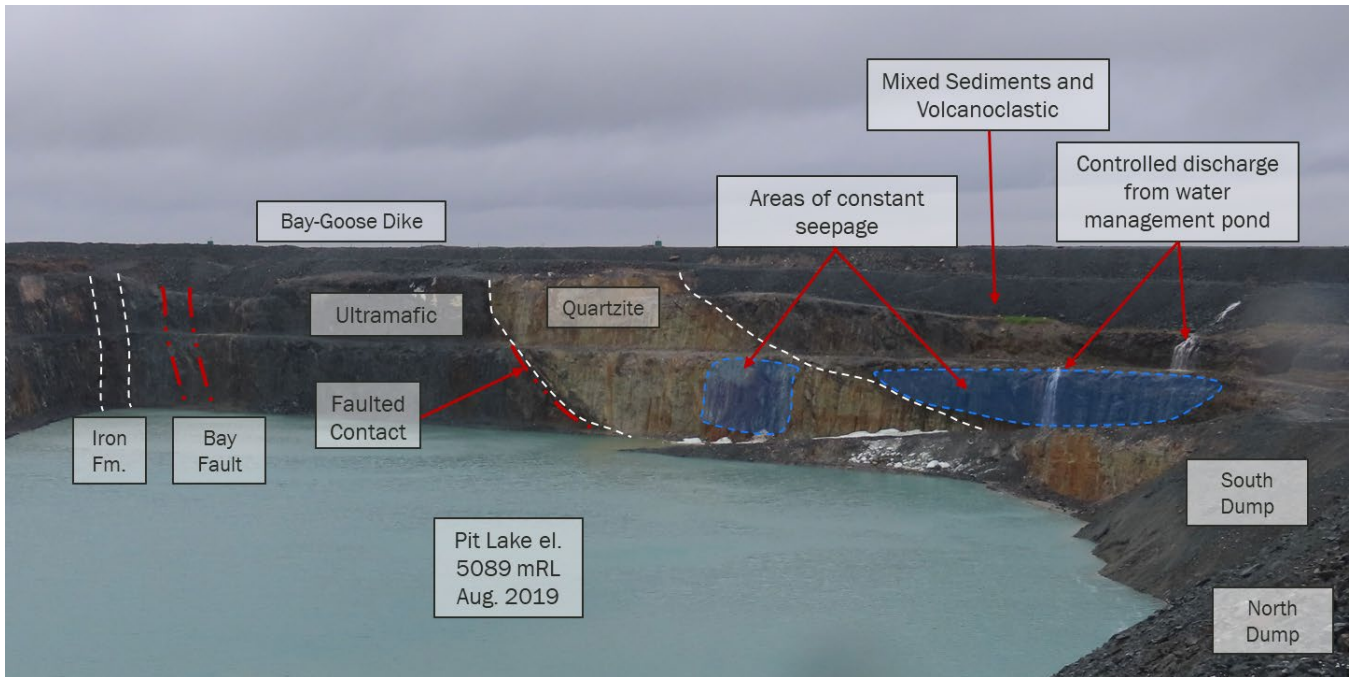
Seepage along the contact of the quartzite and overlying mixed sediments and volcanoclastic rocks continues to flow to the pit along the ditch on the inside edge of the ramp.

Photograph 7-3: Goose Pit south wall (2018)

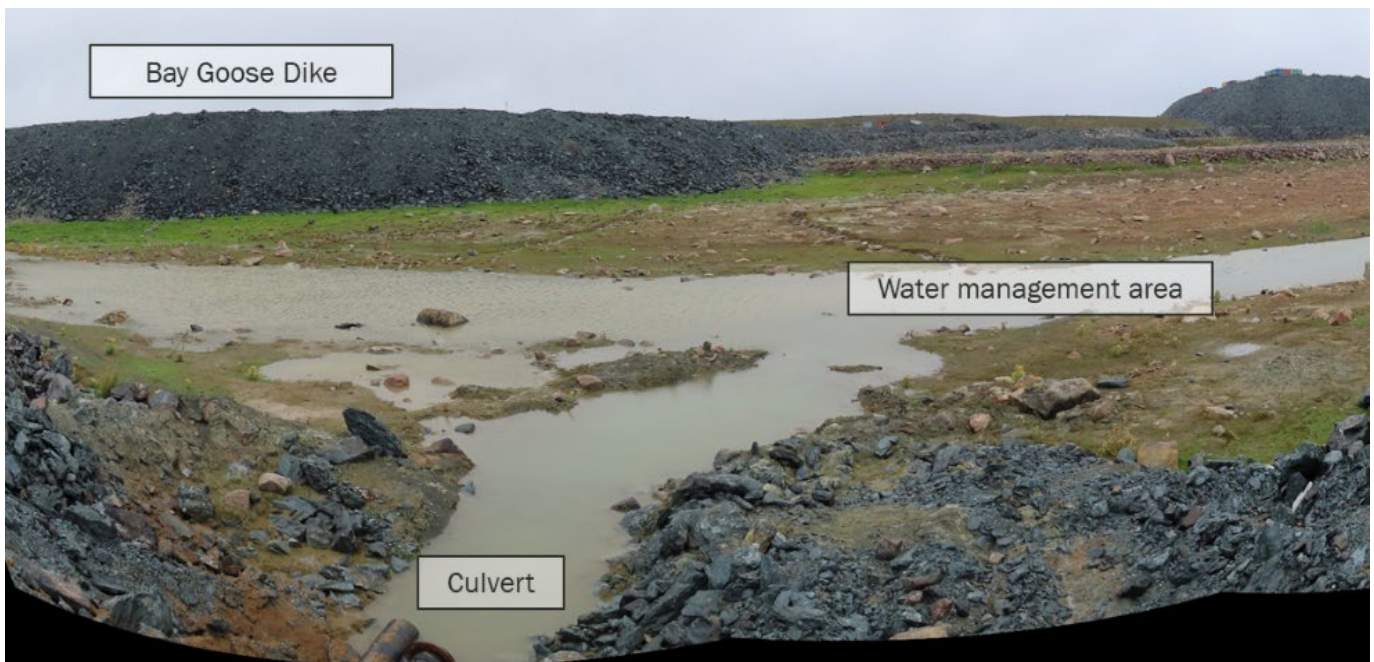
Water is being discharged from the southwest corner of the wall, from a water management and storage pond behind the crest. The crest area where the water is being discharged was reviewed, and no indication of crest erosion was noted. Once reaching the ramp, the water is directed down the inside edge of the ramp to the pit lake.

Photograph 7-5: Water management area between ring road at south crest of Goose Pit

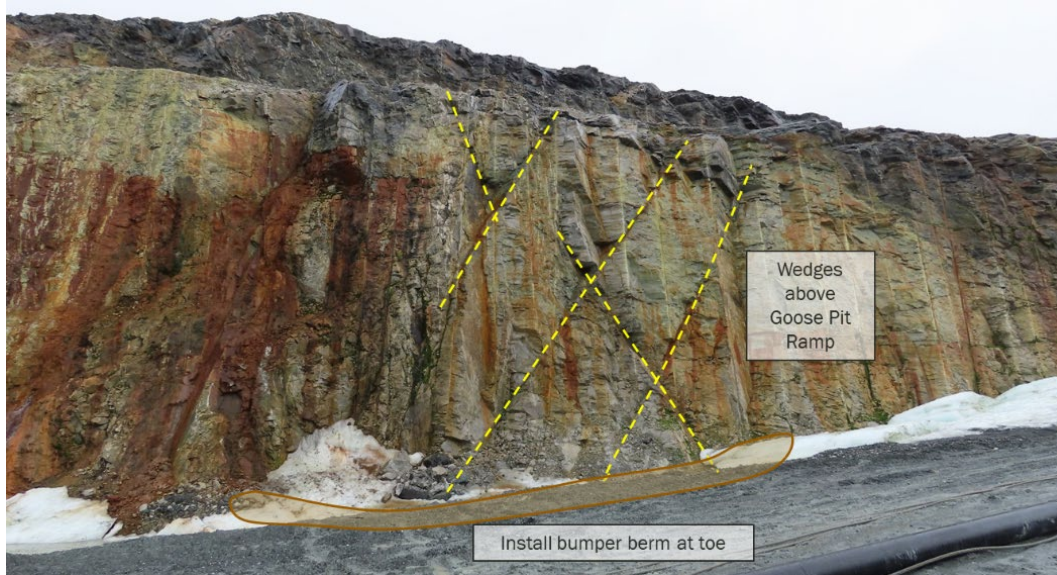
It is understood that the Goose Pit will be operated as a tailings storage facility, and that access to the pit via the ramp will continue for some time. As such, it was noted that a geotechnical risk area that was identified as part of a study by Tetra Tech (2018X) to assess the risks associated with tailings deposition back in the pits remains exposed. Area 21 is comprised of several wedge structures directly above the ramp area. A kinematic assessment

of the wedges suggests these to have a factor of safety of about 1.0. The plunge of the wedges is relatively steep at 46 degrees, and if a failure were to occur it is unlikely it would spill far on to the ramp. It was recommended during the site visit that a bumper berm be constructed to prevent personnel and equipment from stopping directly adjacent to this area.

Photograph 7-6: Wedges above Goose Pit Ramp

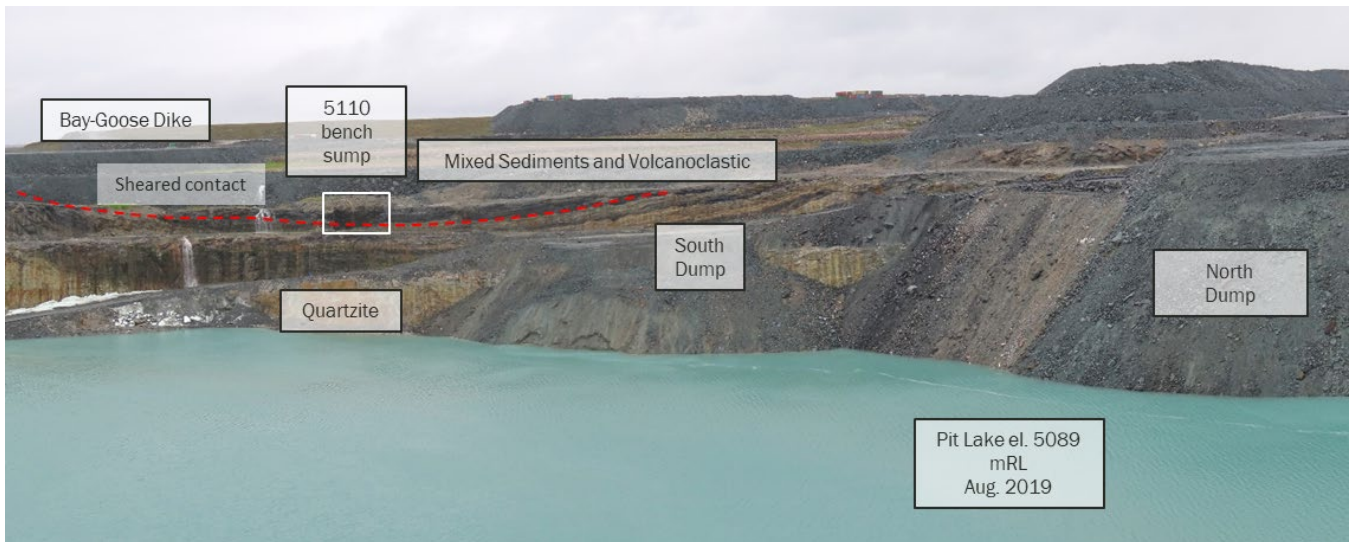
Much of the west wall of the pit is now covered and buttressed by the South and North Waste Rock Dumps. Where not covered by waste rock, only the upper benches of the west wall are visible, exposing quartzite and mixed sedimentary and volcanoclastic units. The poor quality ultramafic rock exposed in the lower west wall is now covered by pit lake and waste rock dumps.

Photograph 7-7: Goose Pit west wall (2019)

There are no significant geotechnical concerns observed with the performance of the west pit wall of the Goose Pit.

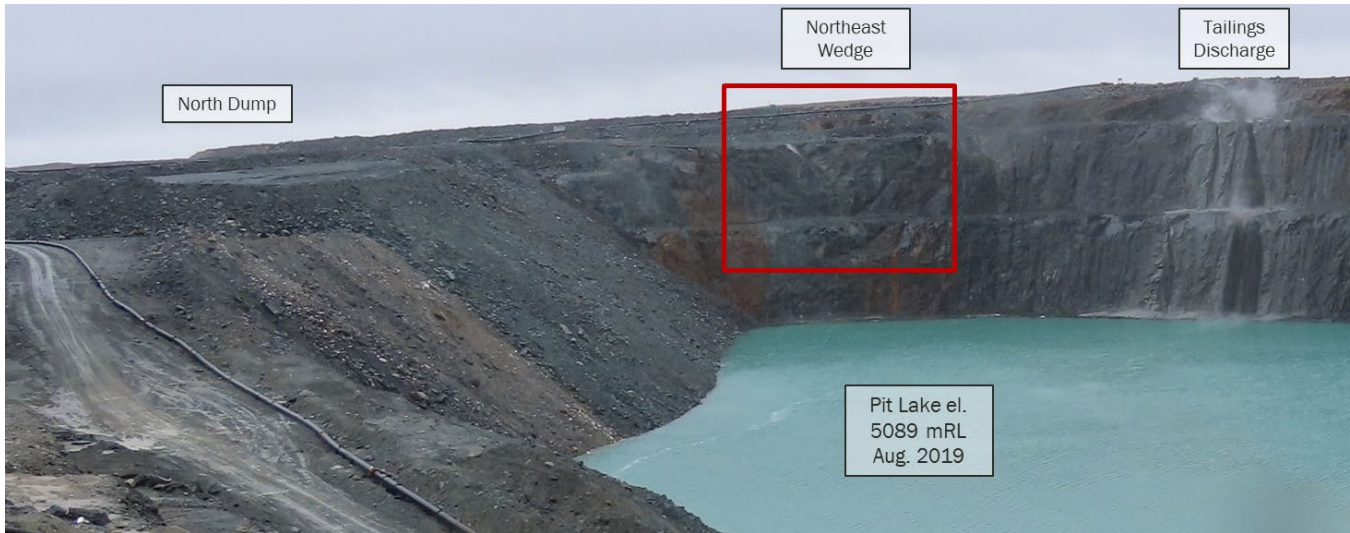
Photograph 7-11: Goose Pit northwest through northeast wall (north end wall 2019)

During the 2018 site inspection, it was noted that water was being discharged on to the ring road and thermal cap at the north pit crest and flowing through the rockfill before spilling on to the rock face. This was inspected in 2019 and noted that water is no longer being discharged in this area.

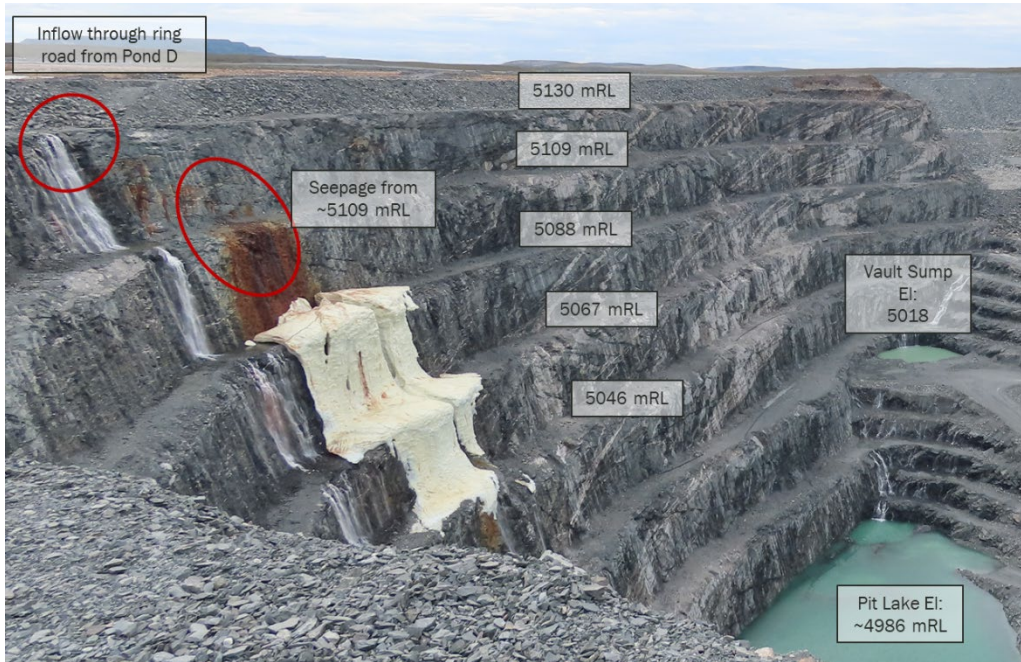
Water from Pond D (the former Vault Lake) located behind the southeast pit wall crest flows freely through the ring road at the crest, and spill over the pit crest. The flow is uncontrolled and is governed by the current elevation of Pond D, which was 5134 mRL at the time of the site visit. During operation of the pit, the water elevation in Pond D was pumped down to control the development of the ice wall from the 5109 mRL. The water currently flowing through the ring road is discharging from the southeast crest and is adjacent to the seepage area responsible for the annual formation of the ice wall.

Photograph 8-2: Vault Pit water inflow from Pond D

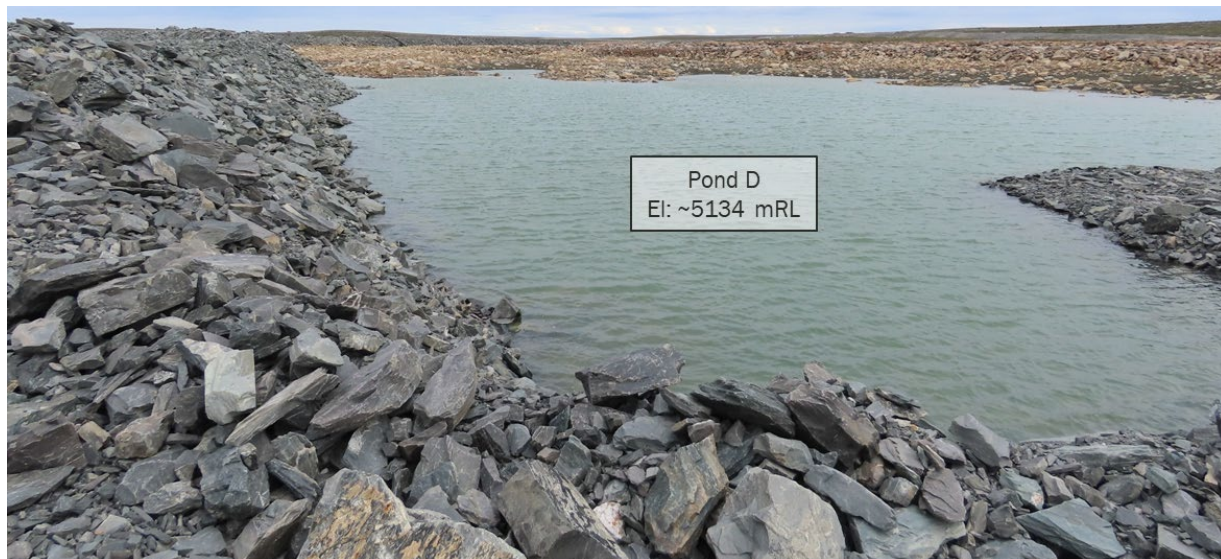
Photograph 8-3: Pond D attenuation storage (2019)

The ring road at the south to southeast pit crest and separating Pond D from its inflow to Vault Pit was inspected during the site visit for signs of settlement or distress and no visible signs were noted. It was discussed that indications of impact to the ring road related to water flow through the road fill material might include settlement of the road surface, the development of tension cracks at the road edge, and potentially sinkholes depending on the materials used to construct the road. The road is constructed with coarse rockfill. Water flows relatively freely through the road. Since the water flow is not through an engineered structure such as a culvert, it was recommended that the road access be bermed off or decommissioned to prevent full use of the road to travel around the pit.
