Meadowbank 2019 Annual Pit Slope Performance Review

2019 ANNUAL PIT SLOPE PERFORMANCE REVIEW

MEADOWBANK MINE, NUNAVUT

OCTOBER 11, 2019

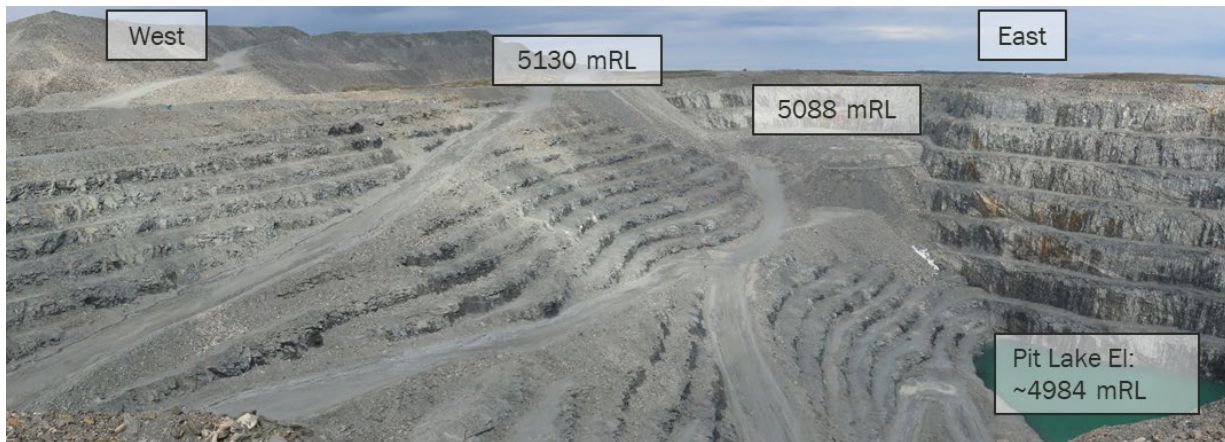
Photograph 8-5: Vault Pit west wall looking north (2019)

There are no significant geotechnical concerns for the footwall slope.

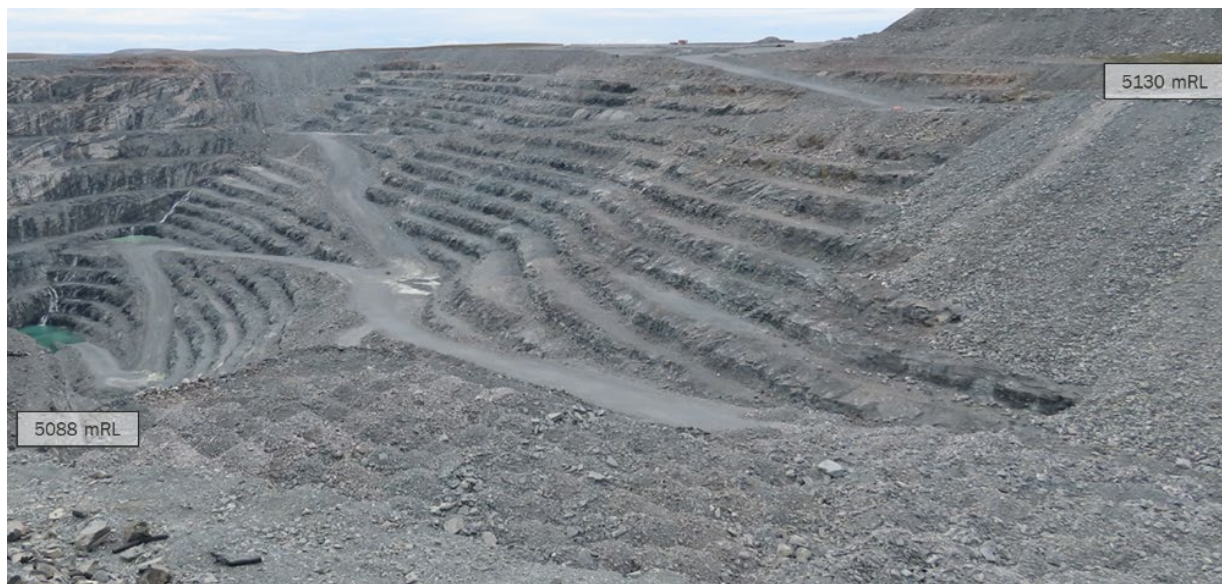
Photograph 8-6: Vault Pit west wall looking south (2019) showing dump advance

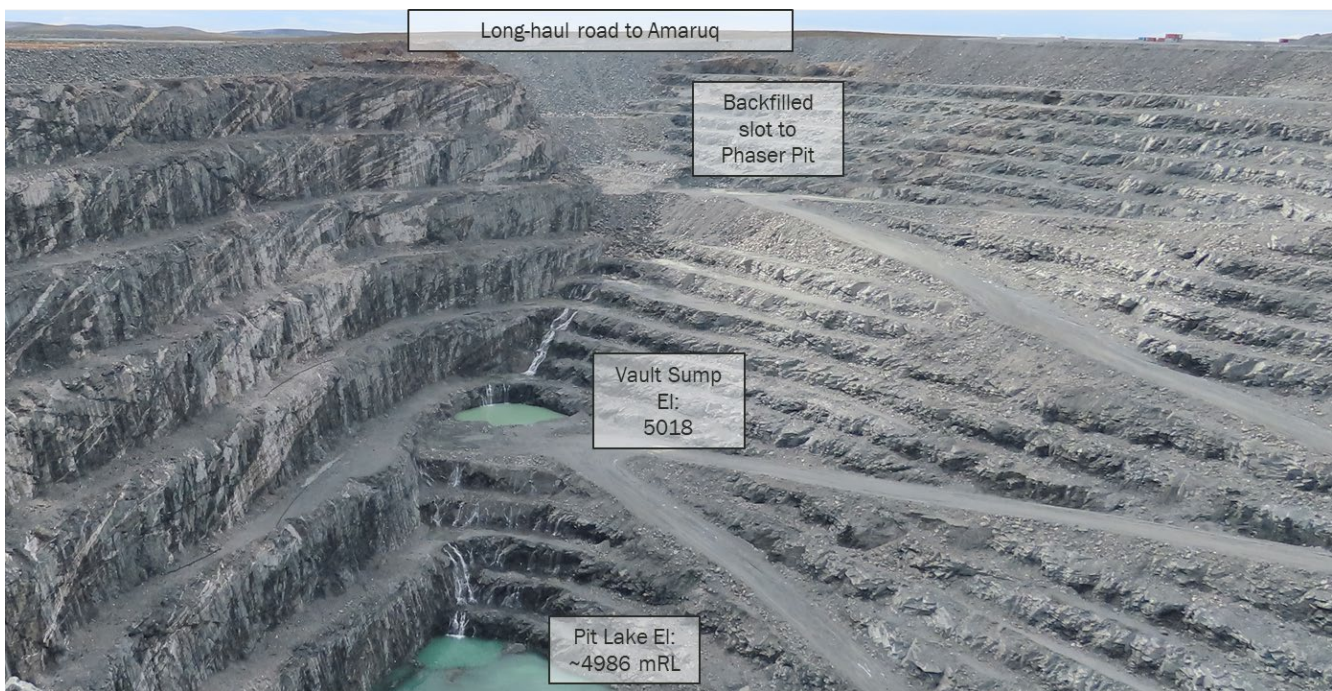
The southwest wall (grid south) intersects the stratigraphy and foliation perpendicular to their trend. The gently east dipping structure is visible in this end wall. The overall wall continues to perform well, with little accumulation of material noted on the benches.

At the west end of the wall, the slot cut joining Vault Pit with Phaser Pit has been backfilled as part of the long-haul road extending north to the Amaruq Project area. Water was also noted to be flowing from the southwest corner of the pit towards the pit sump on the ramp at approximately elevation 5018 mRL. The water is flowing beneath the rock fill material used to backfill the slot between Vault Pit and Phaser Pit as part of the road alignment for the long-haul road to the Amaruq Project. The water elevation in Phaser Pit lake was approximately 5107 mRL at the time of the site visit, and approximately 5018 mRL in the Vault Sump.

Photograph 8-7: Vault Pit grid south wall (2019) and backfilled slot cut to Phaser Pit

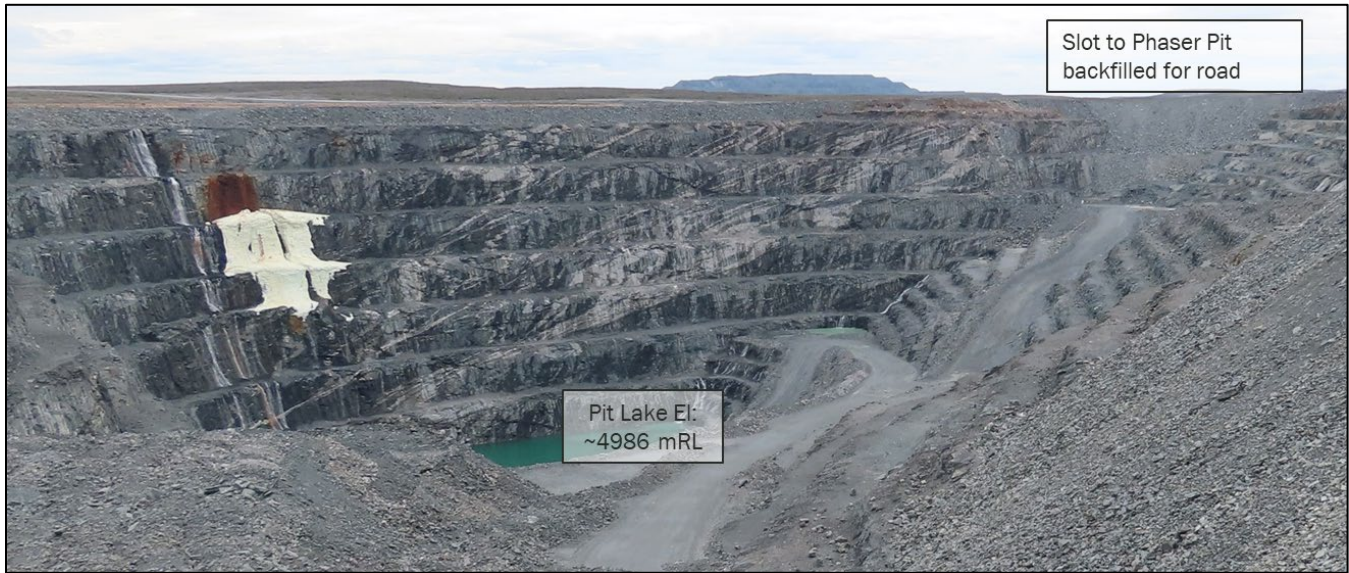
Photograph 8-8: Vault Pit sump and water flow from Phaser Pit

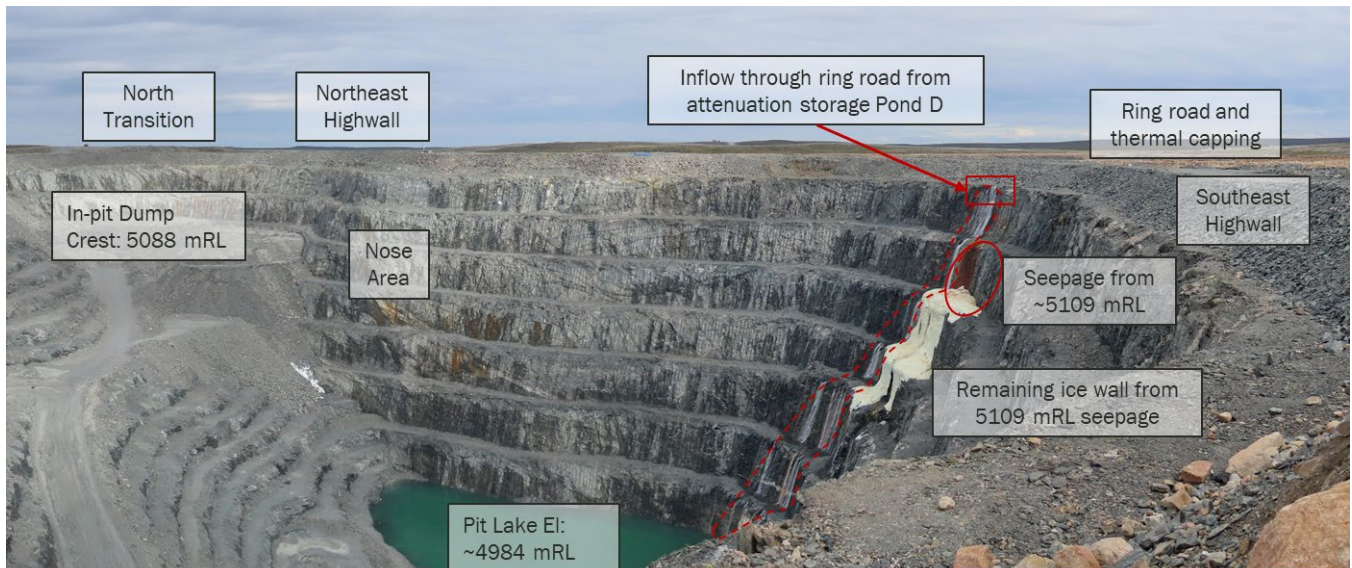
The southeast to northeast highwall (grid east wall) has mined to its final height. The catch benches developed for the highwall continue to perform very well. The pit floor has been deepened since the 2018 site visit by approximately one triple-bench, or approximately 21 metres, to an elevation of 4955 mRL.

Photograph 8-9: Vault Pit east and northeast highwall (2019)

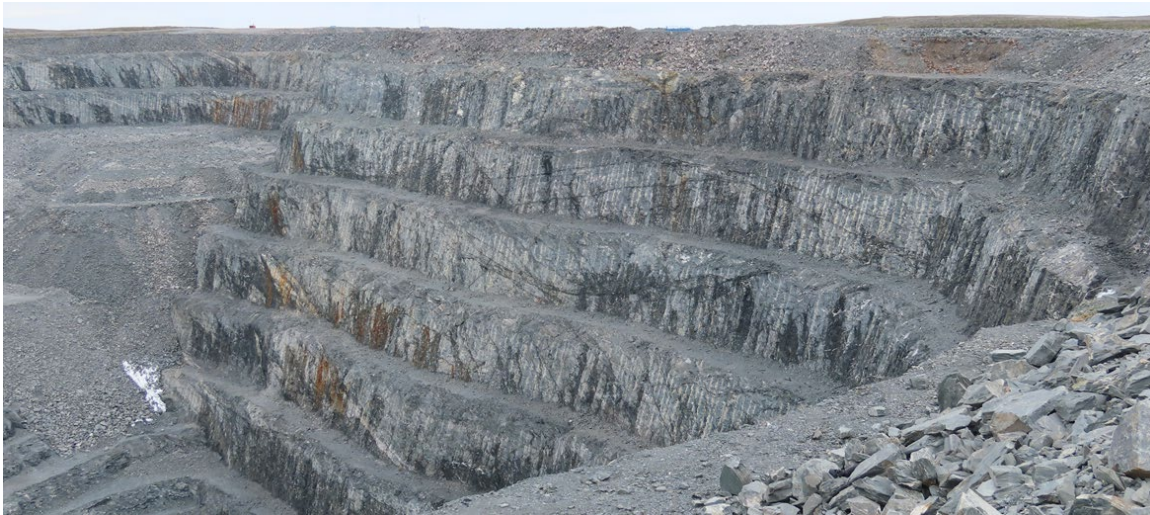
The benches are cleaned well, and there is no indication of significant raveling and no significant accumulation of material on the benches. There is some over break of bench crests due to blasting but this is not significant. In general, the toe of the thermal capping material is greater than 2 m back from the pit crest.

Photograph 8-10: Vault Pit east highwall bench performance, southeast end looking north (2019)

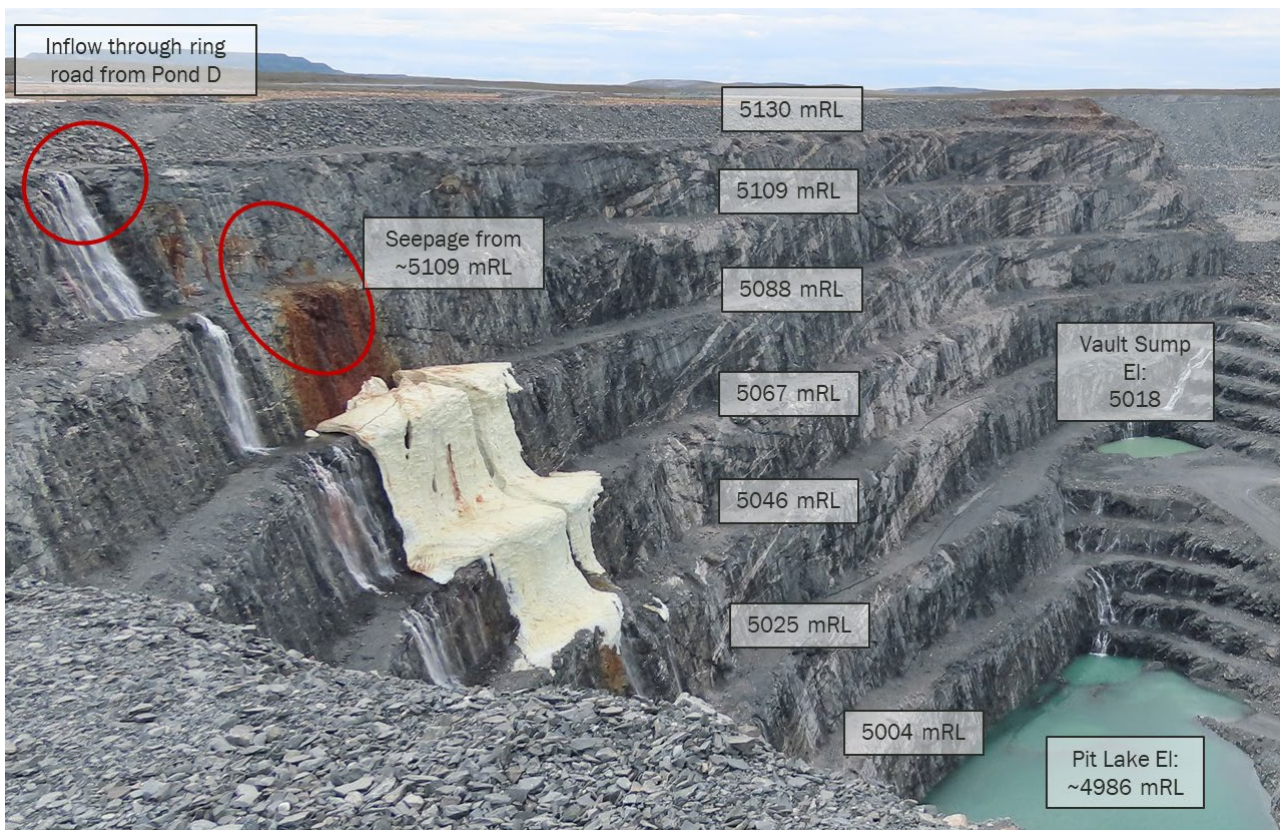
Photograph 8-11: Vault Pit east wall northeast end looking south (2019)

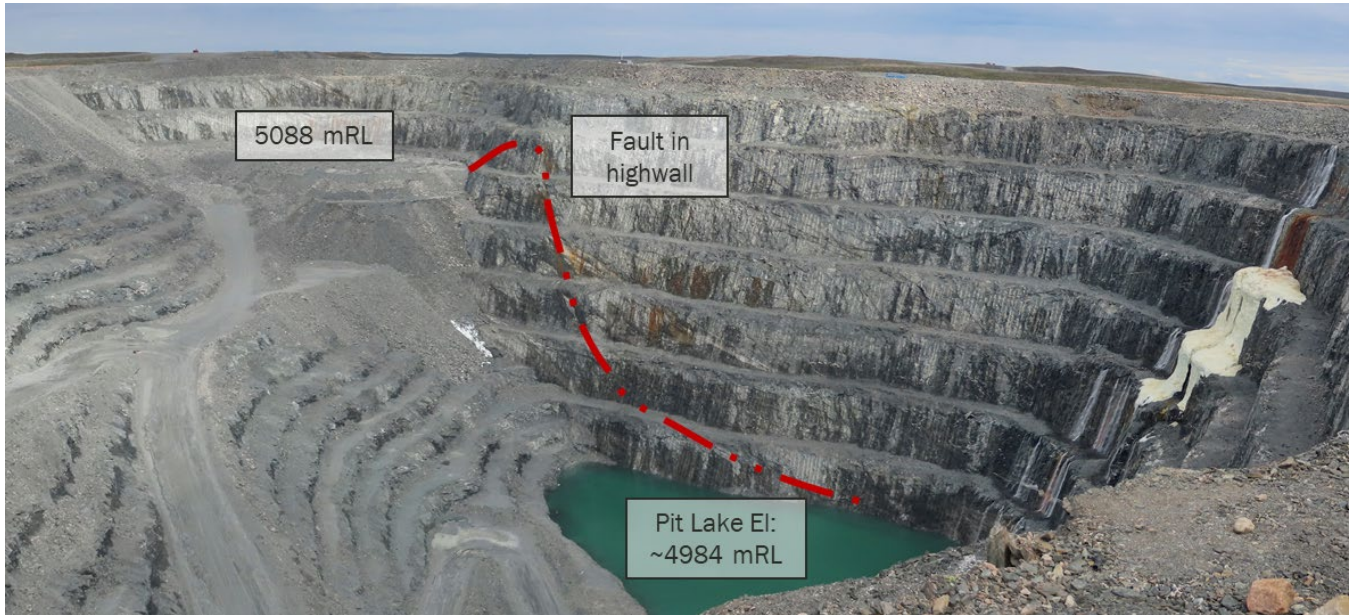
A series of widely spaced faults and open continuous joints dip into an area of the northeast wall. During mining this presented a risk of toppling; this area is now buttressed with waste rock and the risk eliminated.

Photograph 8-14: Vault Pit east highwall nose and fault

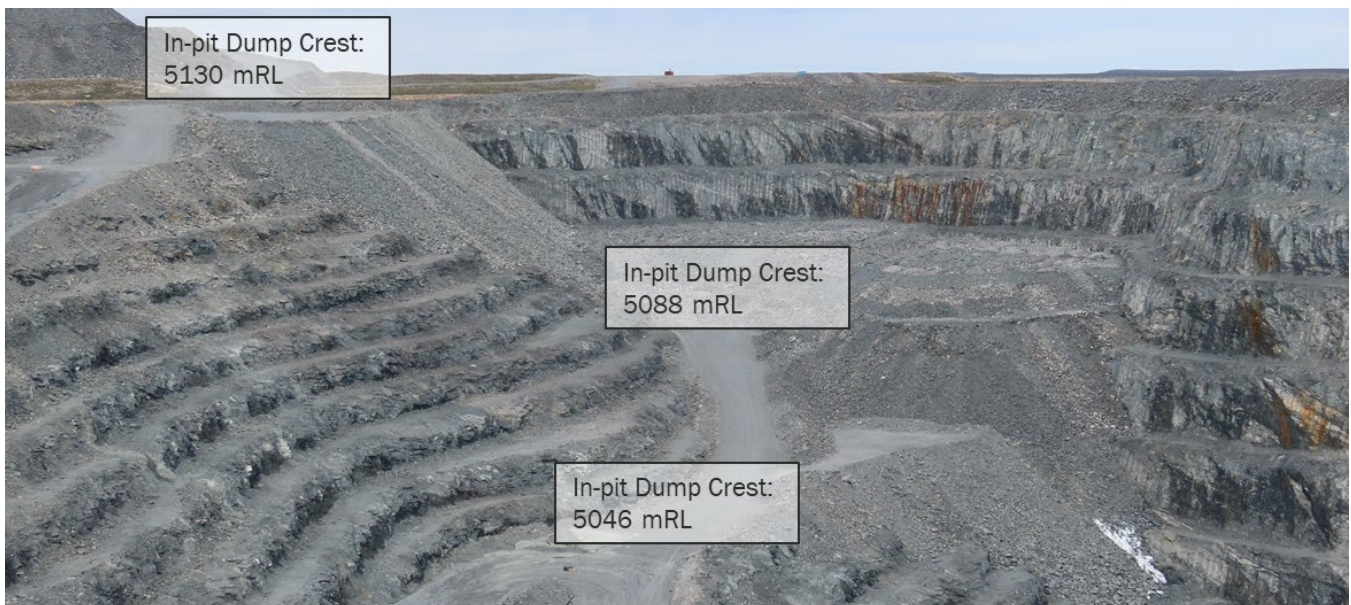
Photograph 8-15: Vault In-Pit dumps

The dump crest areas were reviewed during the site inspection, along with the dump faces, for any indicators of potential instability such as tension cracks, subsidence, or bulging of the dump face. While some minor settlement and tension cracks were noted at the very north end of the westernmost dump platform, these are not considered significant to warrant monitoring other than observation during regular geotechnical inspections. Since the dumps are no longer active, access to the dump crest areas should be bermed off.

There do not appear to be any significant stability concerns with the Vault in-it dumps. Many of the geotechnical hazards identified during previous inspections no longer exist. The following are recommended:

- Continue visual monitoring and recording of observations as part of regular site geotechnical inspections.

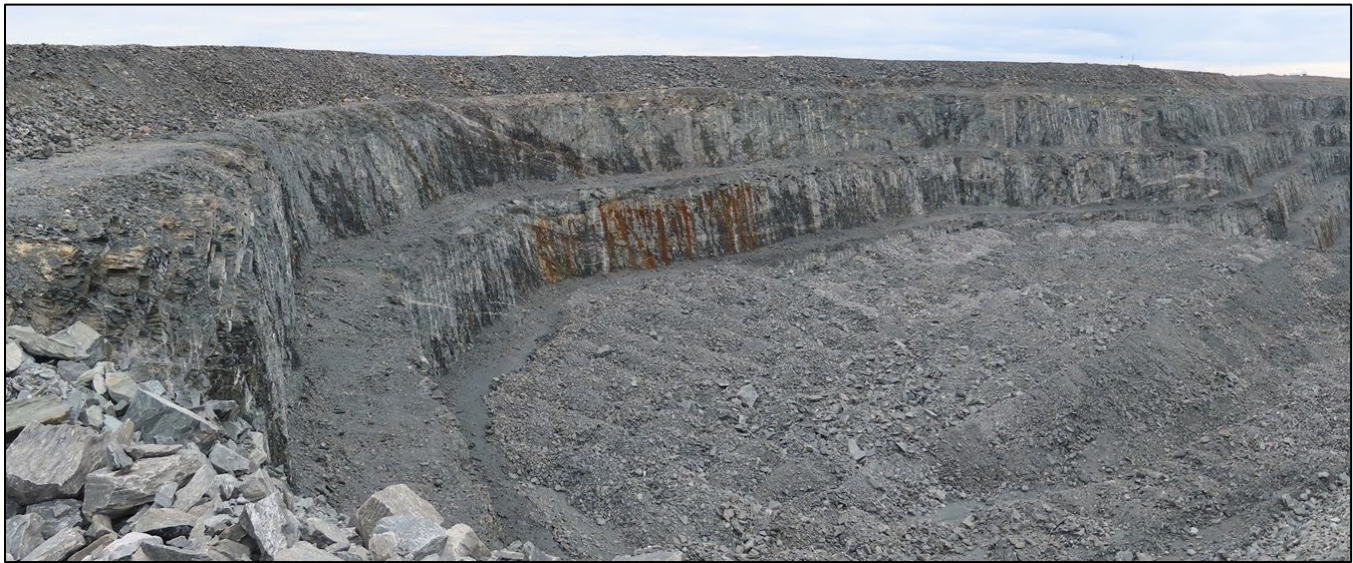
Photograph 8-16: Vault Pit northeast wall bench performance and 5088 mRL dump platform

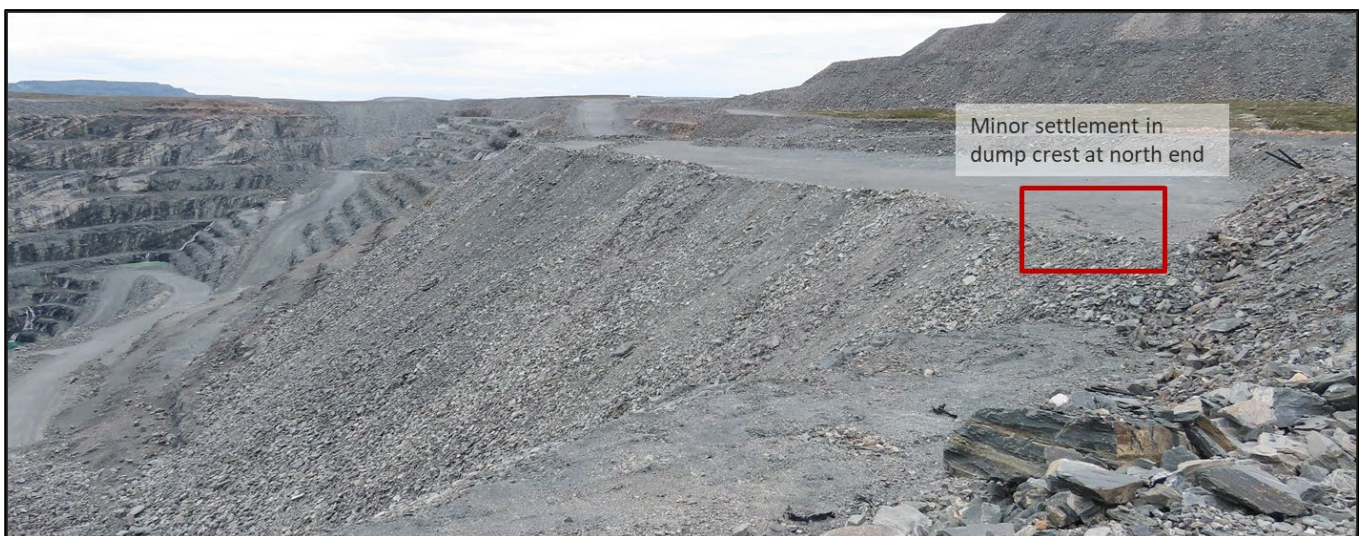
Photograph 8-17: Minor settlement of dump crest at north end

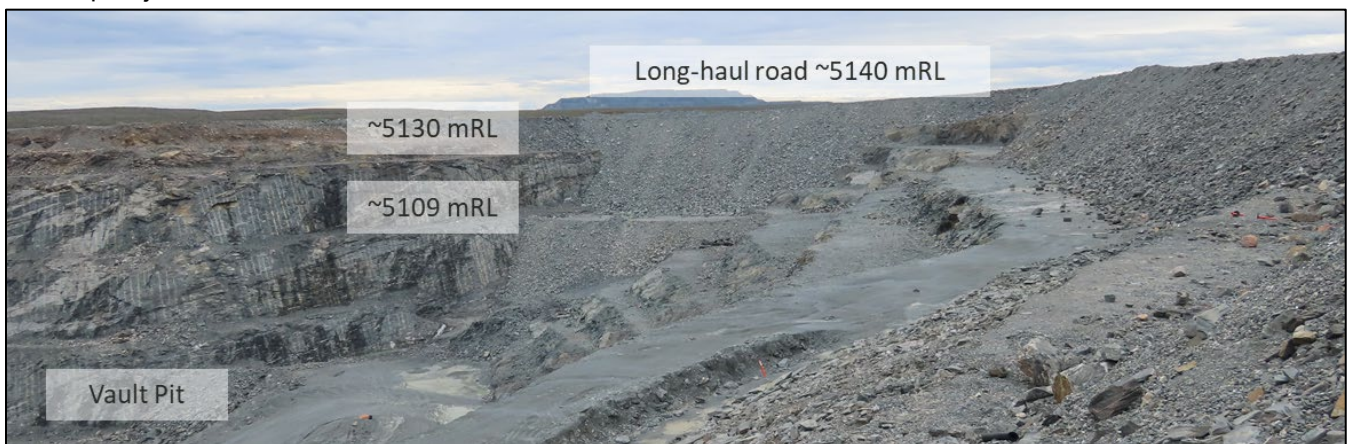
The pit is ovoid in shape with three walls: an east-southeast highwall, a south-southwest endwall, and a west-northwest footwall. There is no north-northeast endwall as this was the transition slot cut to the Vault Pit which has been backfilled. Wedge-forming joints were noted in the wall of the transition slot during the 2018 site visit. These have now been covered as the transition slot to Vault Pit has been backfilled as part of the long-haul road to the Amaruq Project.

Photograph 8-18: Slot from Vault to Phaser Pit backfilled to as part of long-haul road from Amaruq

- Restrict access to the inactive Phaser Pit and to the ring road around the crest.
- Monitor the performance of the long-haul road, specifically for the development of tension cracks and sinkholes which could be indicative of erosion of finer grained material from the rockfill, and particularly during spring freshet when high flows through the rockfill can be expected.
- Continue monitoring as part of regular geotechnical inspections.

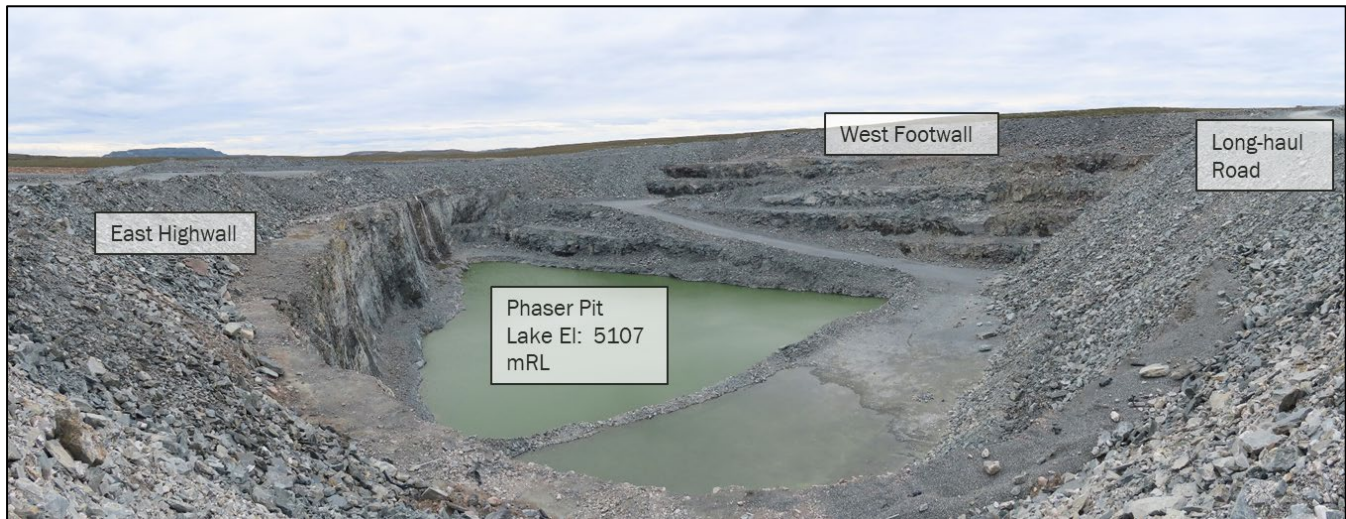
Photograph 8-19: Phaser Pit highwall (east wall) and footwall (west wall) performance (2019)

The west-northwest footwall slope was also reviewed. The excavation of the footwall slope follows similar design to the Vault Pit footwall slope, and experiences similar performance issues relating to undercutting of the bedding by the steep bench face angles. The wall is performing as expected with some accumulation of raveling material on the benches.

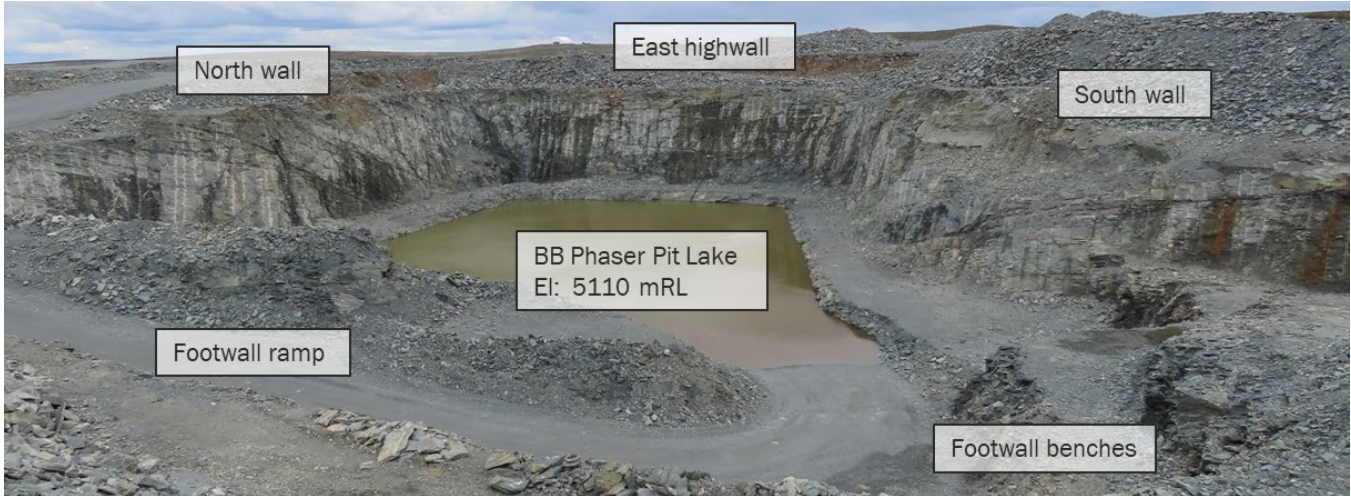
The BB Phaser Pit is relatively small, measuring about 250 m along each wall. The pit shape is generally square, consisting of an east-southeast highwall, a south-southwest endwall, a west-northwest footwall and a north-northeast endwall. Only one bench remains visible due to the pit lake. The pit walls continue to perform well and there are no signs of instability.

Photograph 8-20: BB Phaser Pit east highwall, endwalls and pit lake (2019)

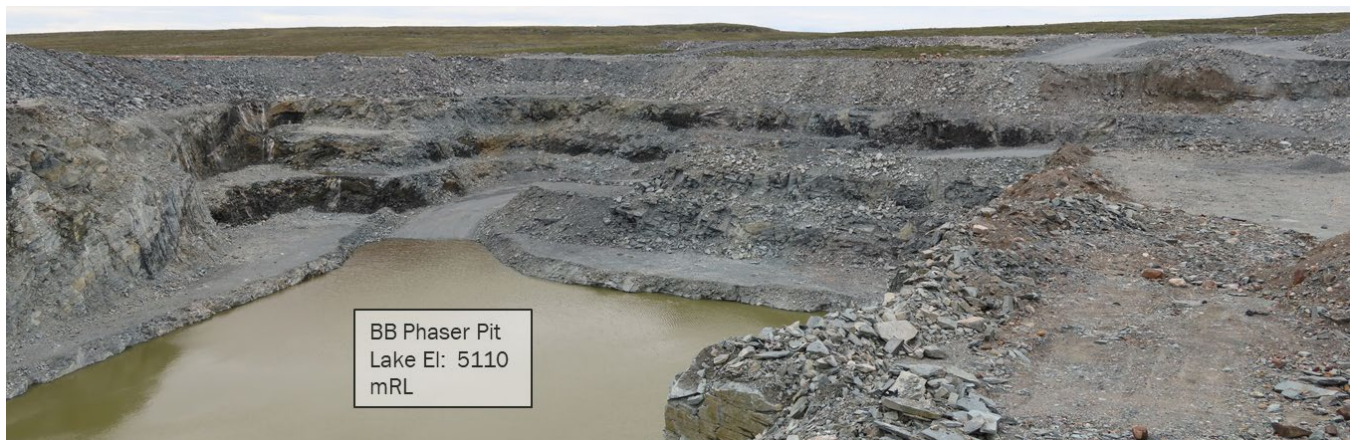
Photograph 8-21: BB Phaser Pit south through east highwall showing south end wall and west footwall slope performance (2019)

The east highwall, north and south endwalls, and west footwall were inspected. In general, all walls are performing well.

An area of the south and west wall of the pit noted during 2018 as displaying poor performance in response to heavy blast damage, local faulting, and continuous open jointing shows no further degradation and is no longer considered a concern for the inactive pit.

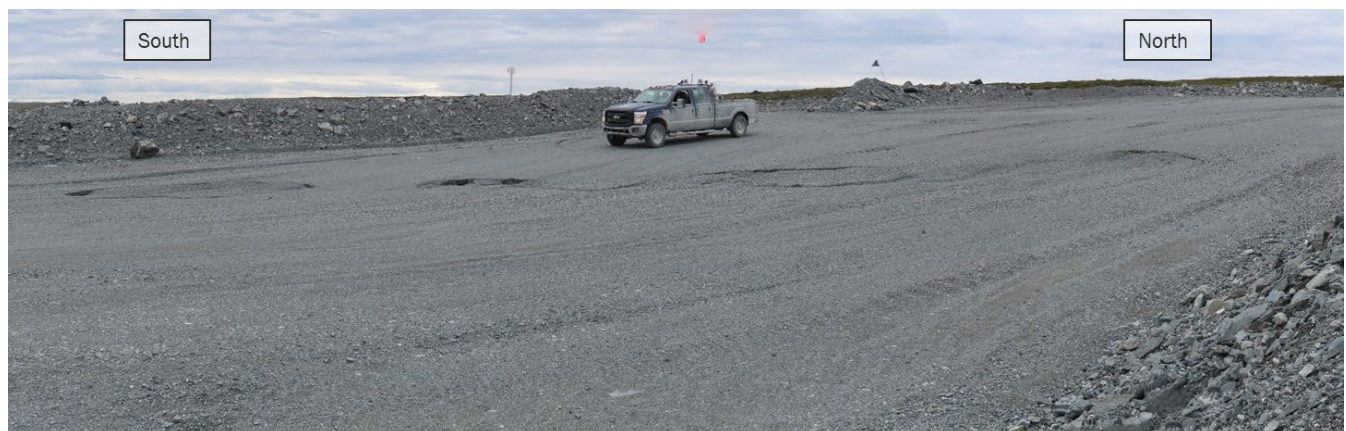
During the inspection of BB Phaser Pit, sinkholes were noted to be developing on the access road that separates the two pits. The general location of the sinkholes is shown on the following figure. The road is no longer considered active but is still accessible. It was discussed with AEM that the road should be deactivated and bermed off to remove it from future use.

Photograph 8-22: Sinkhole development and settlement of road surface between Phaser Pit and BB Phaser Pit

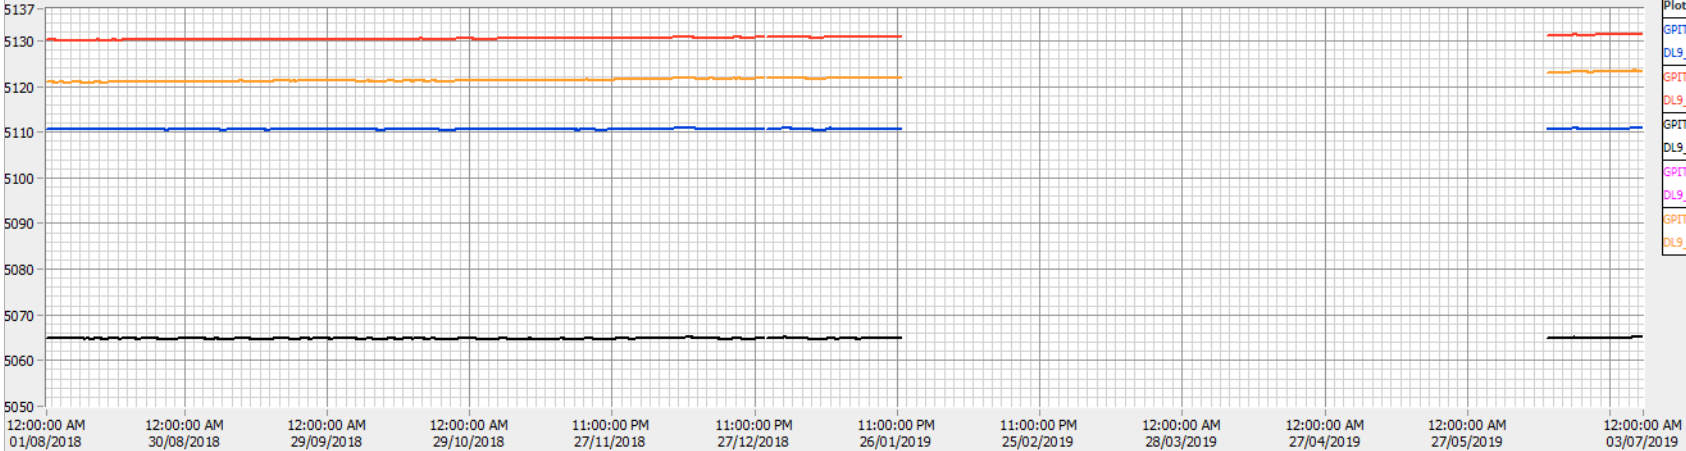
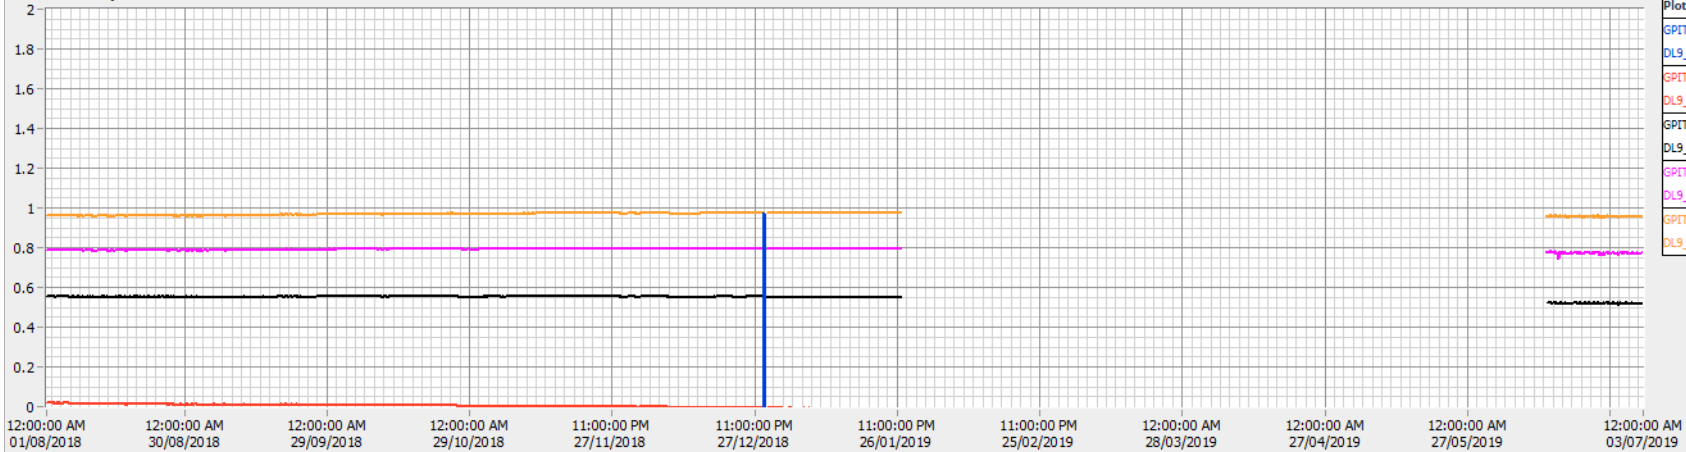
Figure B-13

- All piezometers presents little or no variation during the Q3, 2018. All of them are above freezing point.
- TH-GPIT-13 at masl 5040 has shown a rise in temperature of .409 °C, which could be a capacitance effect, while the first bead temperature change is consistent with the cooling trend during the onset of winter conditions. The rest of the beads are stable.

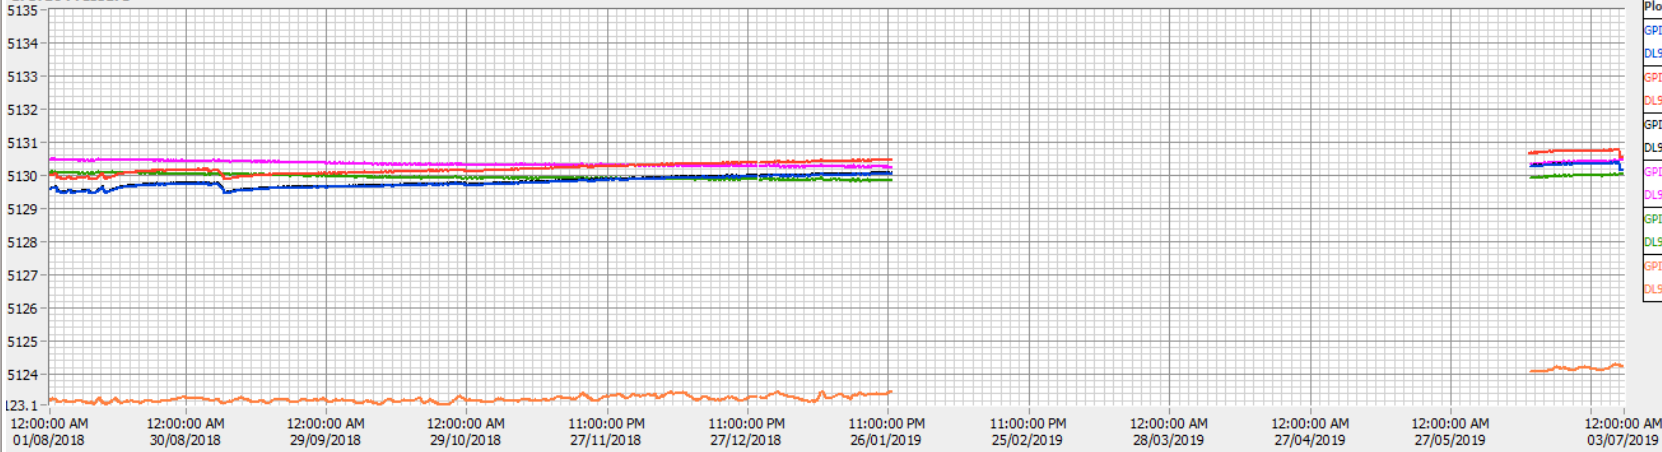
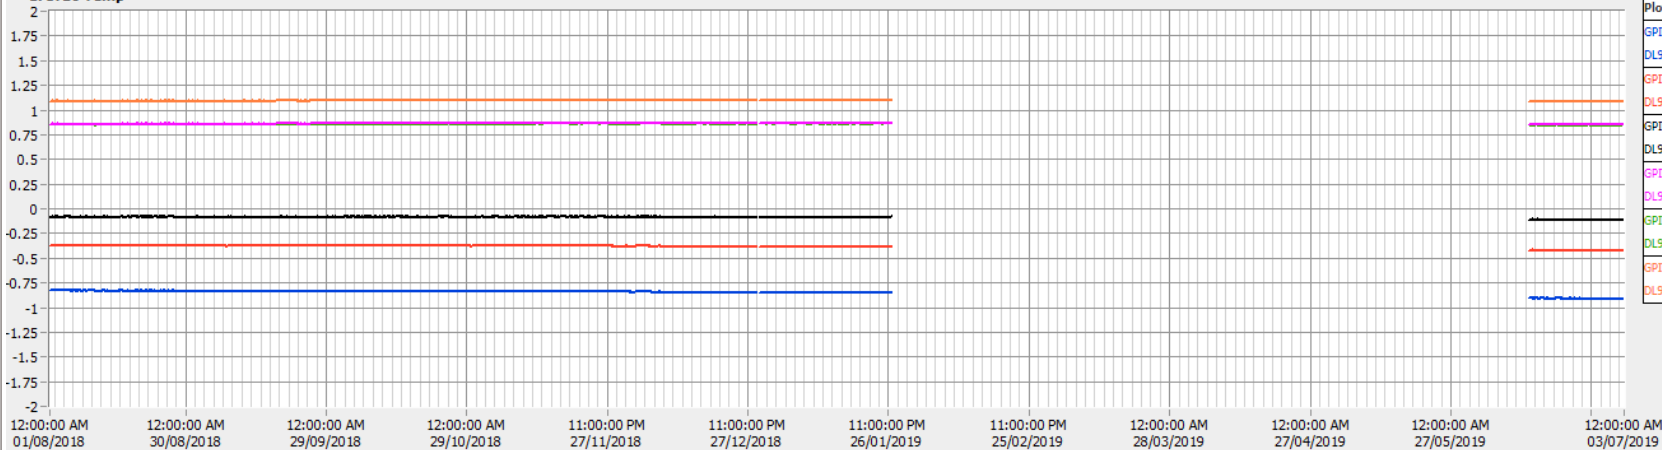
- PZ-7,8,9 are on a very slow rinsing trend.
- PZ-1,2,3 are below the freezing point and can't be considered reliable.
- TH-GPIT-16 is in the permafrost from top at elevation 5124 to 5070. The first bead temperature change is consistent with the cooling trend during the onset of winter conditions.

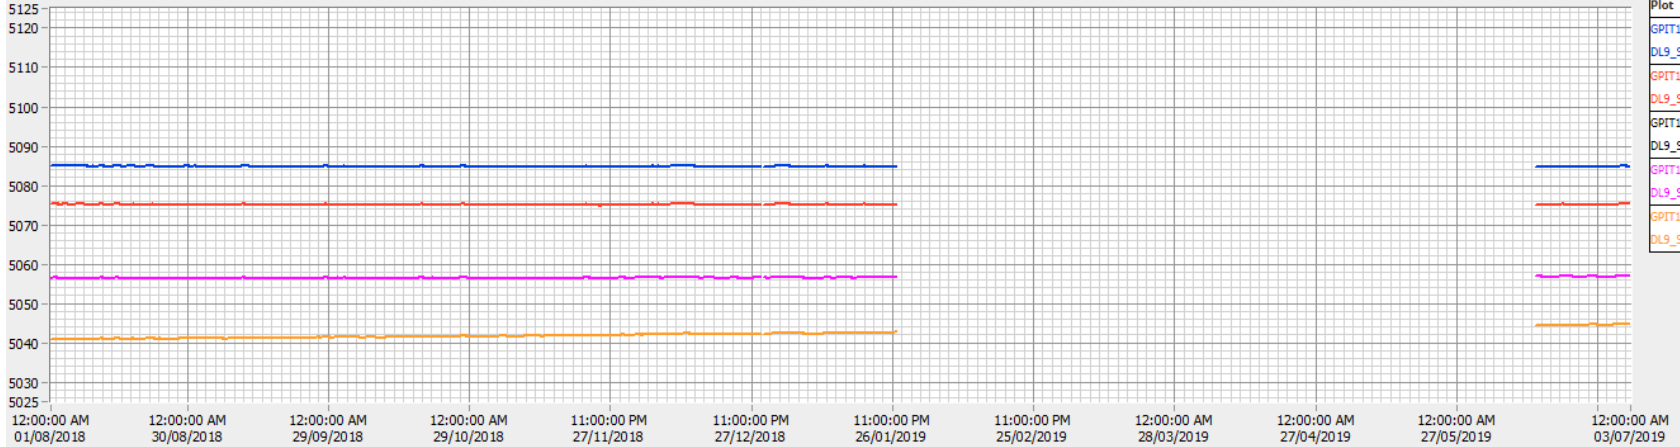
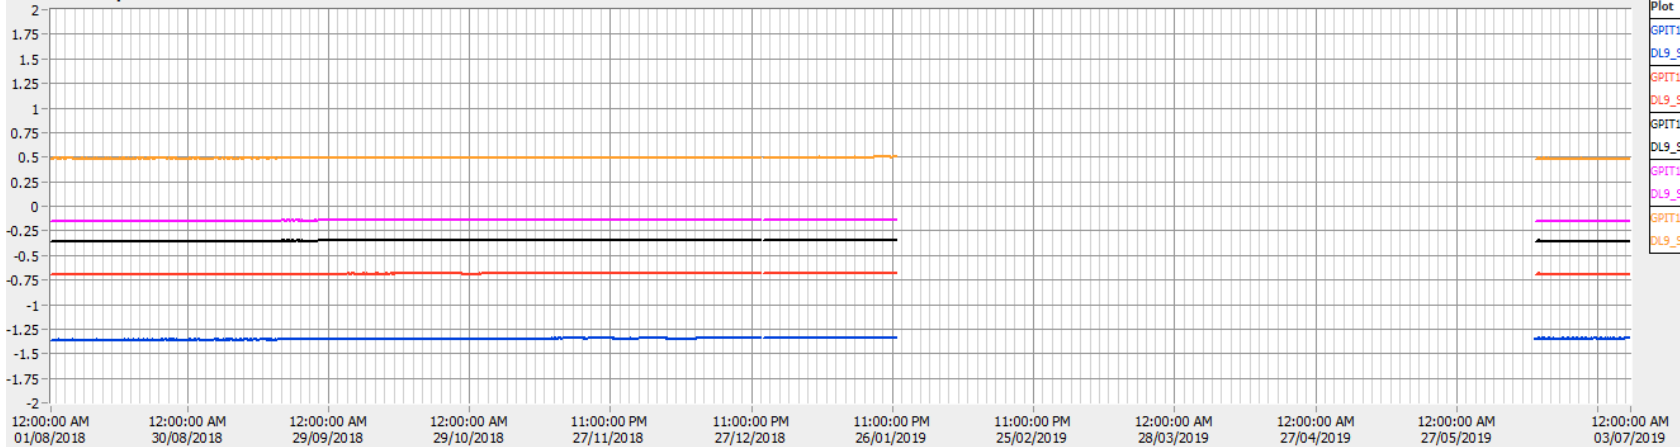
Figure B-17

- PZ-5 is above the freezing line and it shows little or no pore water pressure variations during the Q3, 2018.
- PZ-1,2,3,4 are below the freezing point and can't be considered reliable.
- TH-GPIT-19 is in the permafrost from top at elevation 5126 to 5051. The first bead temperature change is consistent with the cooling trend during the onset of winter conditions.

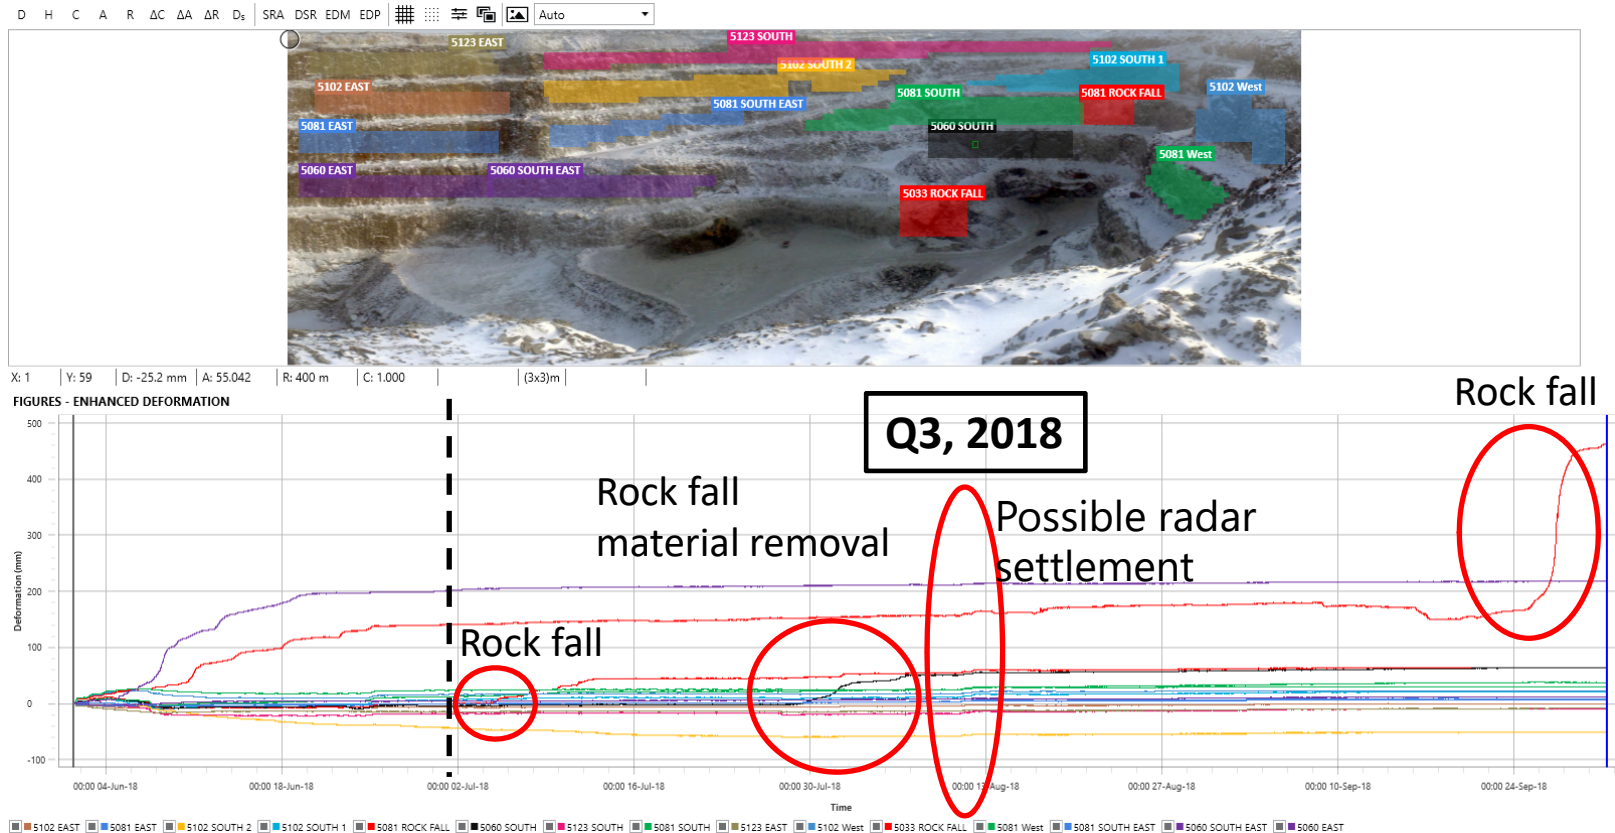
Enhanced deformation per sector (July 1st– Sept. 30th) – Wall folder: SSR253_180601_Meadowbank_E5_South_Wall).

Comments: During the Q3 period, the deformation was relatively stable. There was a consistent deformation trend of 5mm on Aug 11th which could be contributed to the large amount of rain fall and the settling of the material that the radar is placed on. During Q3 there were nine (9) rock falls with the largest being on Sept. 27th, of 10,100T on the 5033 Bench.

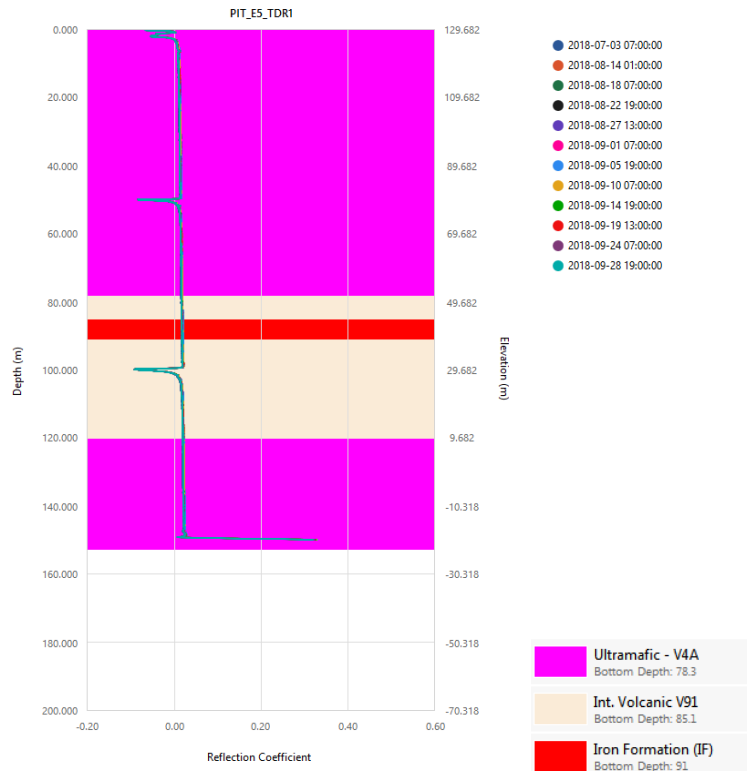
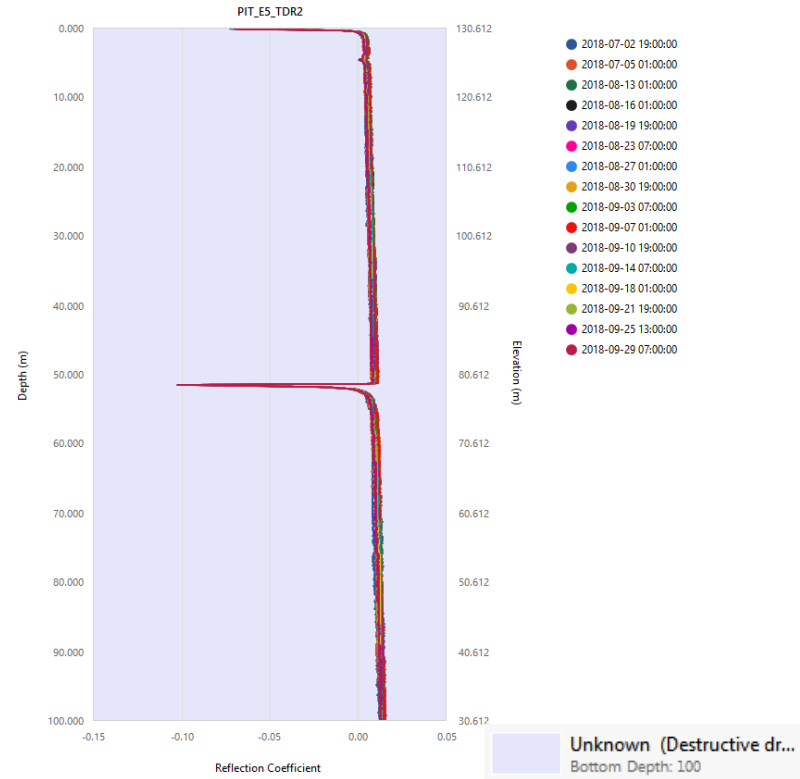
- No sign of deformation observed in TDR1 & TDR2.
- No anomalies from the TDR logger were found in the graphs in Q3.

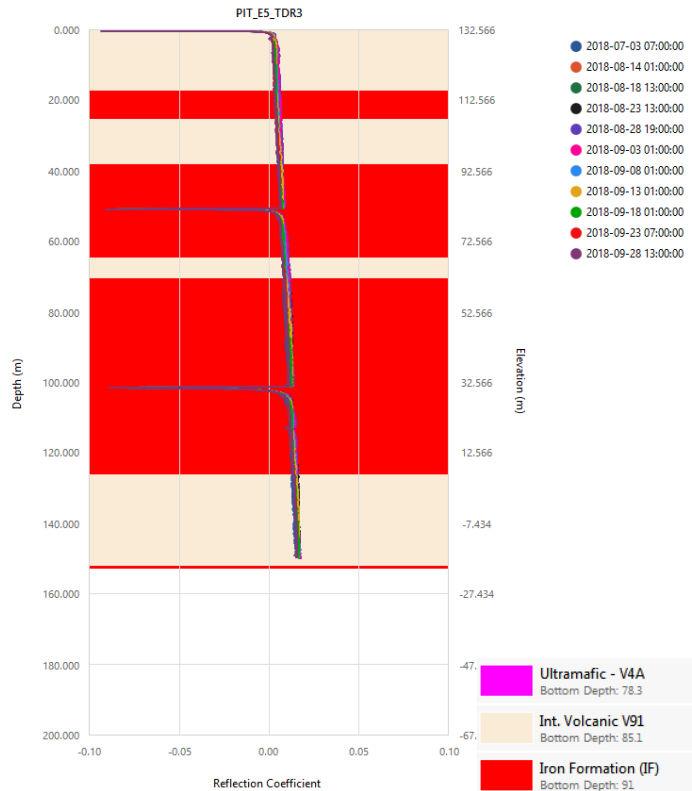
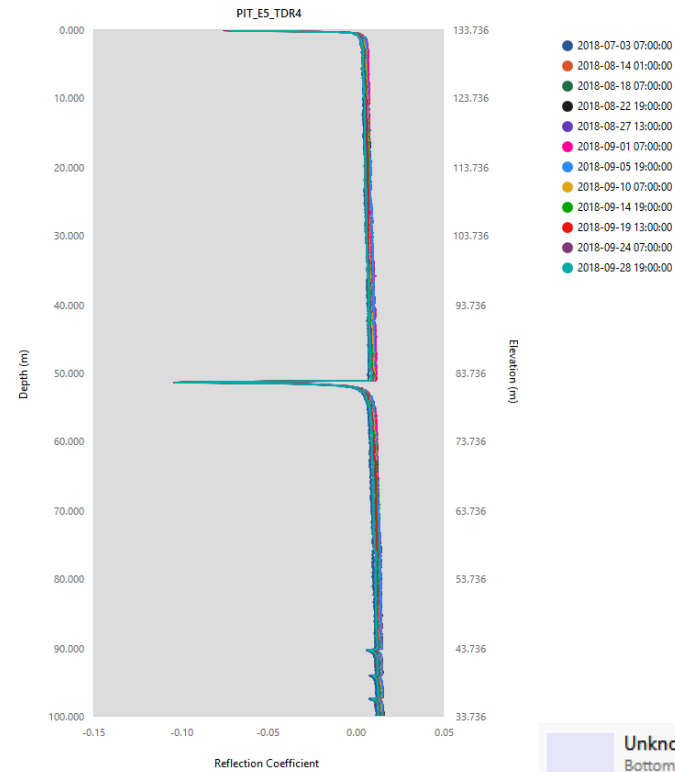
- No sign of deformation observed in TDR3.
- The small reflection coefficient spikes in between elevation 44 and 34 MASL on TDR4 are present since installation.
- No anomalies from the TDR logger were found in the graphs in Q3.

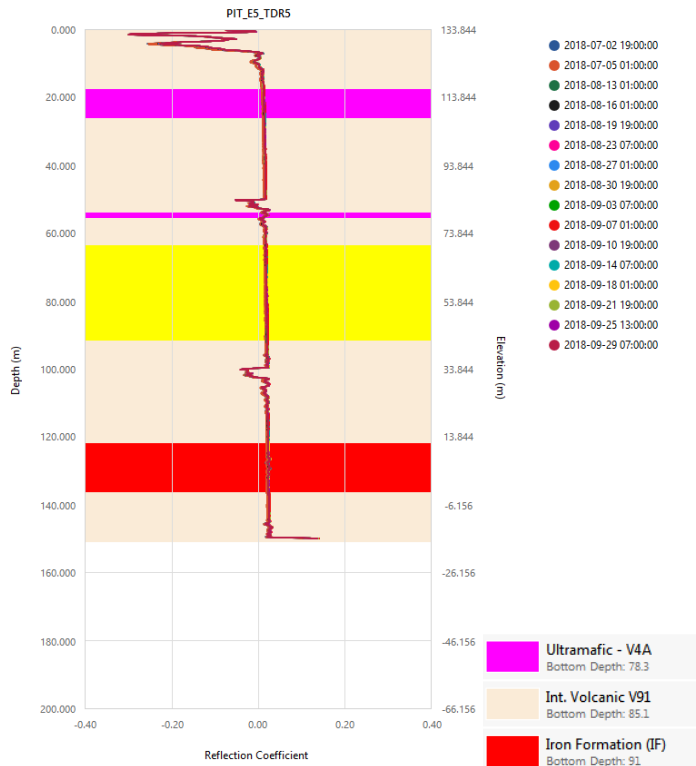
- No sign of deformation observed in TDR5.
- The small reflection coefficient spikes in between elevation 14 and -6 MASL on TDR5 are present since the installation.
- No anomalies from the TDR logger were found in the graphs in Q3.
