Meadowbank 2019 Annual Pit Slope Performance Review

2019 ANNUAL PIT SLOPE PERFORMANCE REVIEW

MEADOWBANK MINE, NUNAVUT

OCTOBER 11, 2019

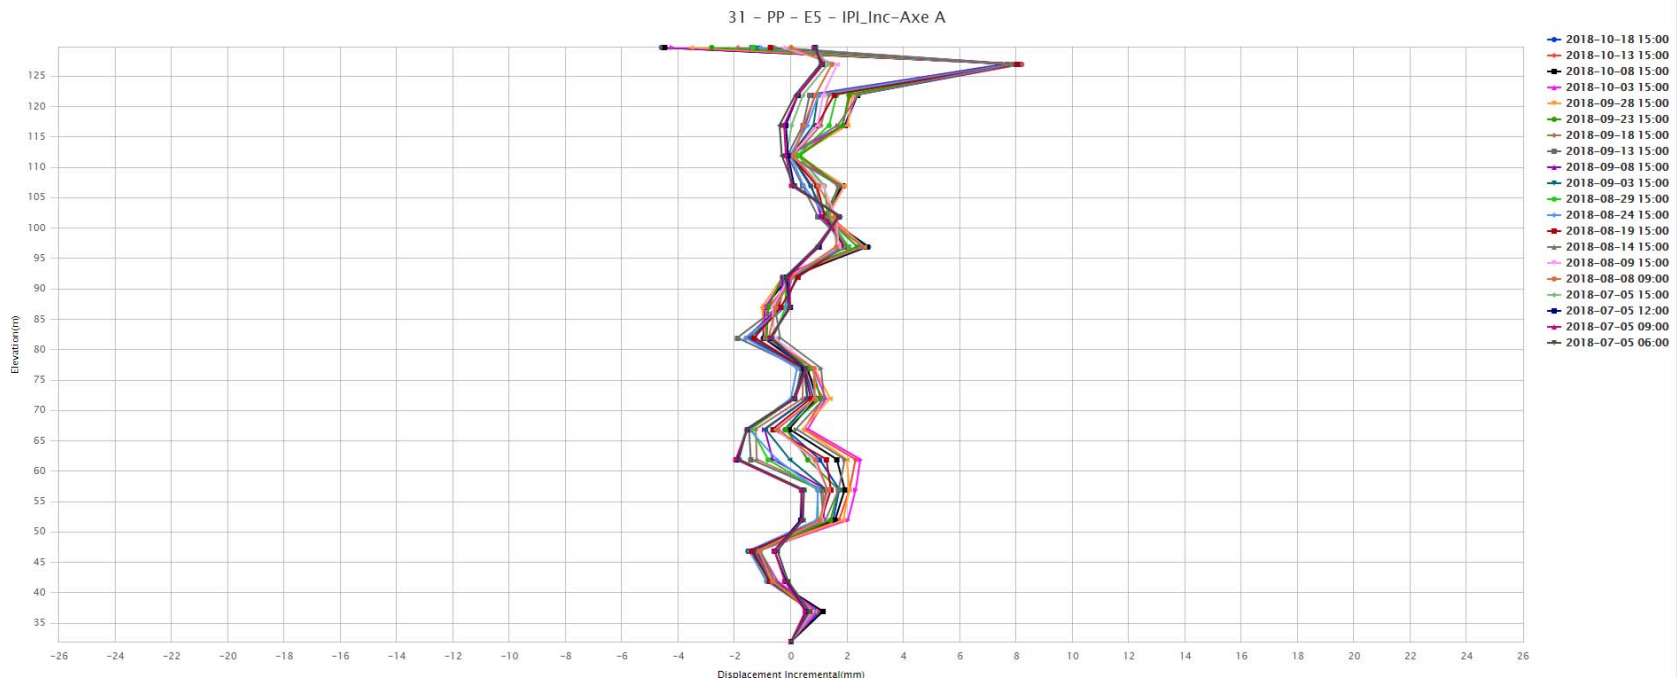
- The results of the IPI are still under investigation to determine whether or not they are reliable.
- The results fall within the Acceptable range for the TARP for Pit E Pushback.

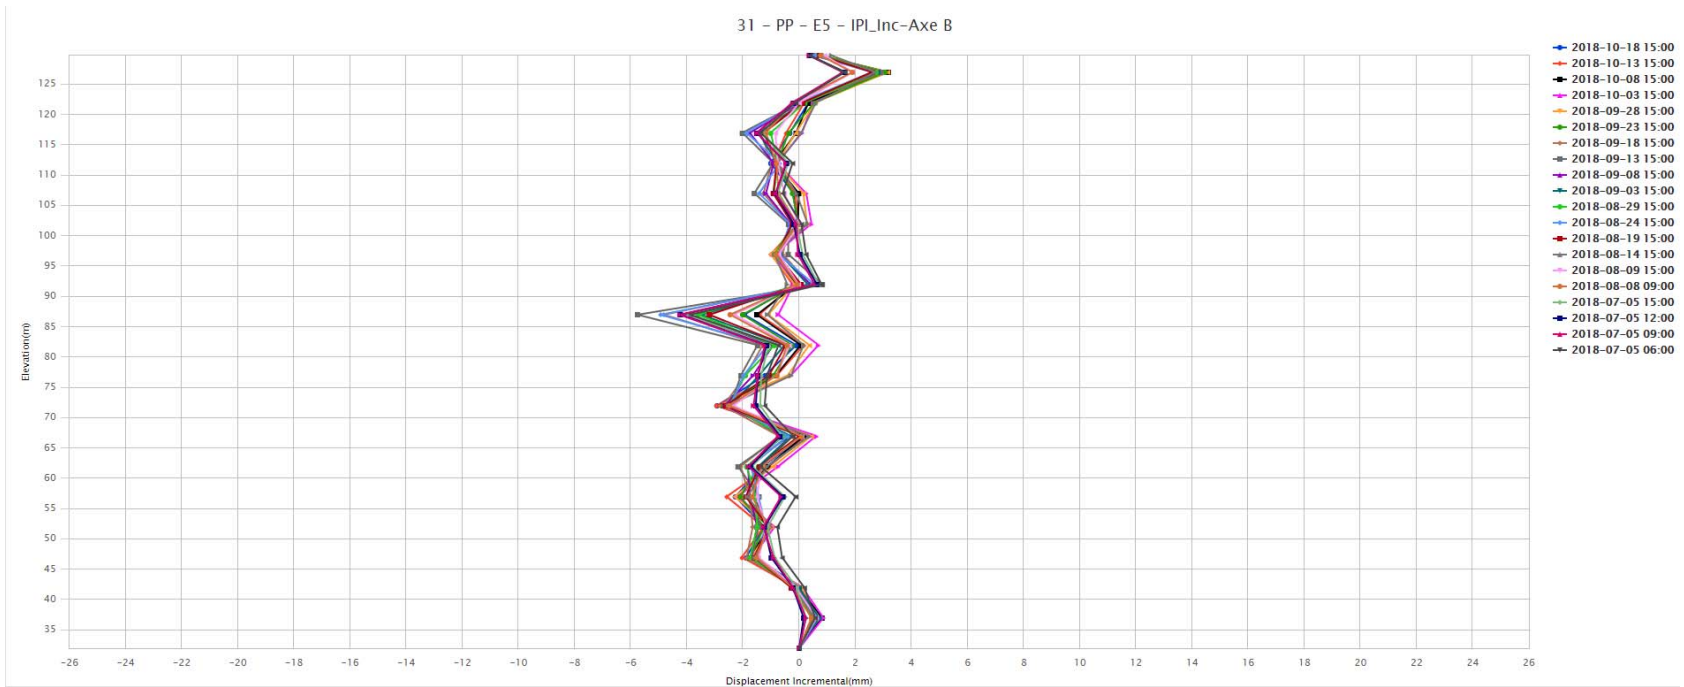
PP-E5-IPI

- The results of the IPI are still under investigation to determine whether or not they are reliable.
- The results fall within the Acceptable range for the TARP for Pit E Pushback.

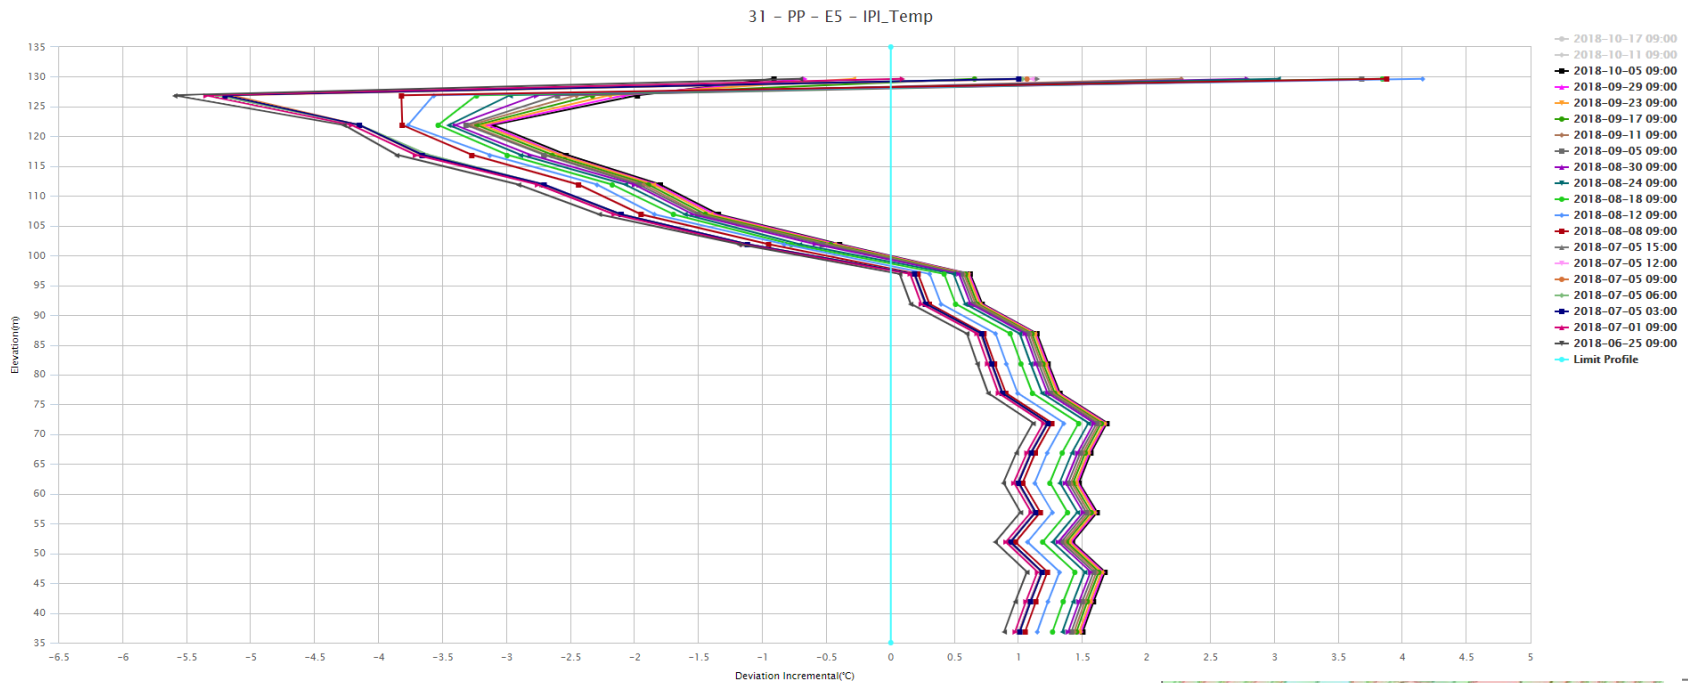
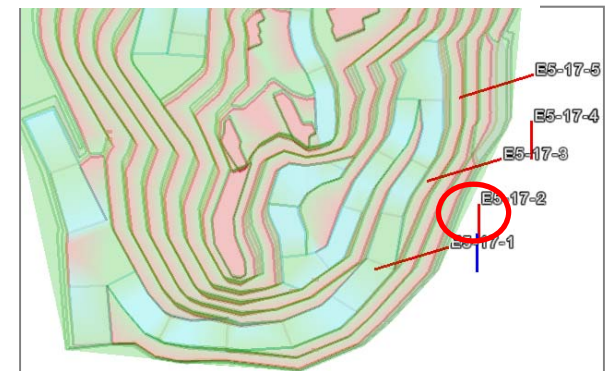
- Unfrozen (Talík) condition under elevation 100 m.a.s.l.
- There is a gradual cooling trend in the talík zone.

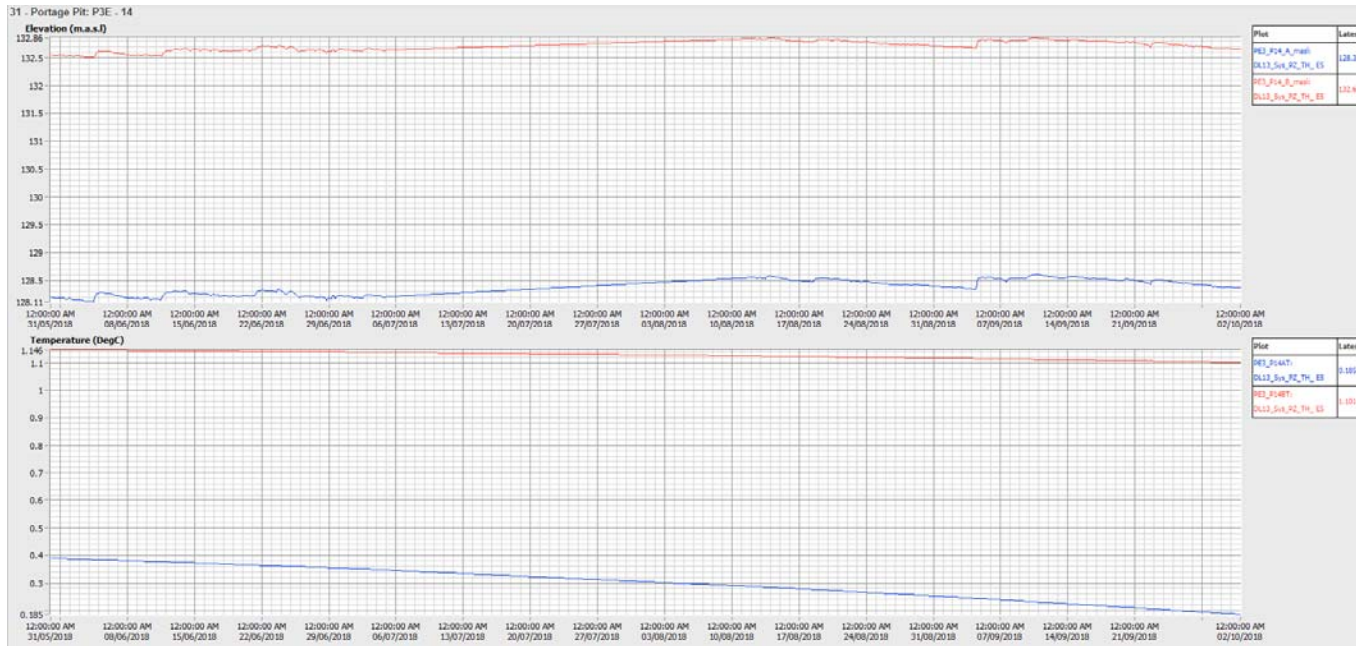
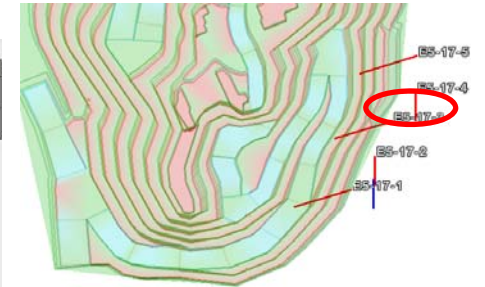
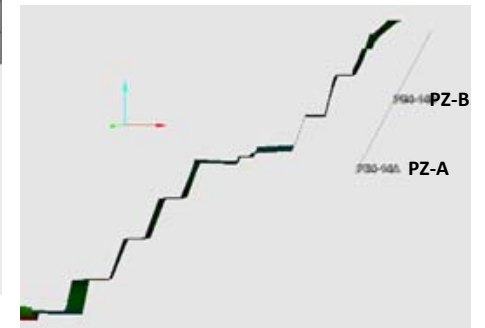
PE3-14 PZ-A,B

- Minor variations in pore water pressure are related to mining activities (drilling/blasting) in Pit E5.
- Overall downward trend for piezometer's temperature.

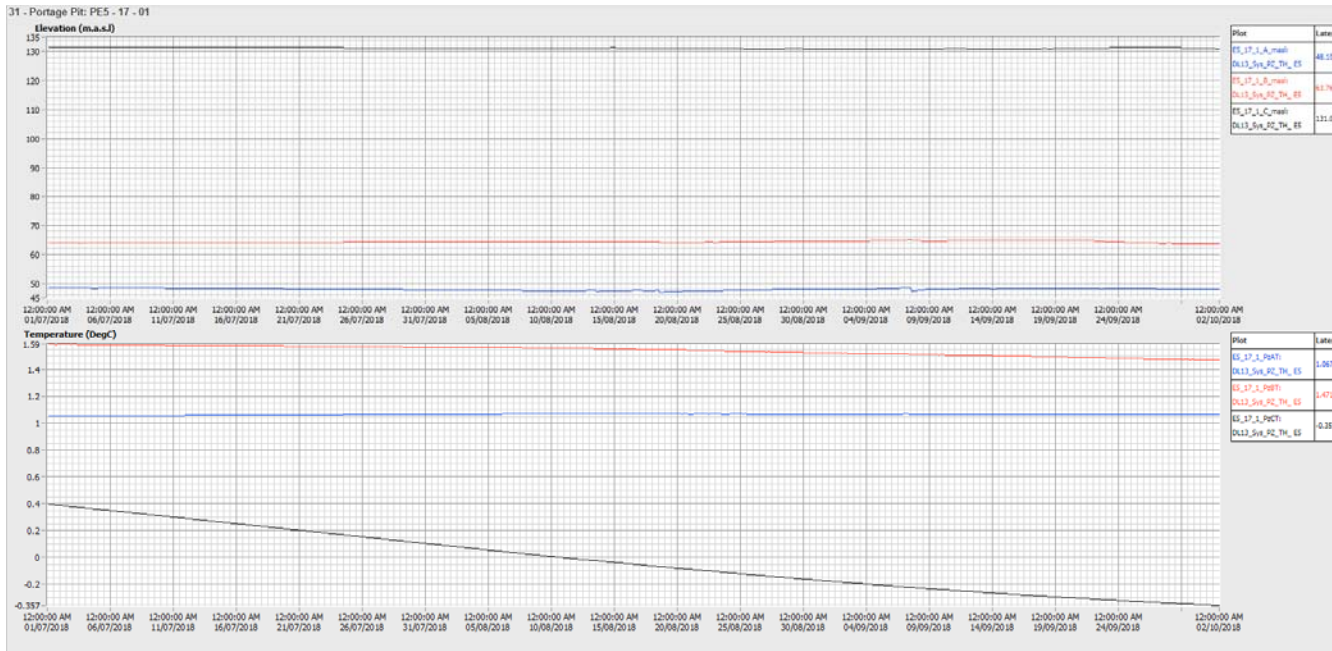
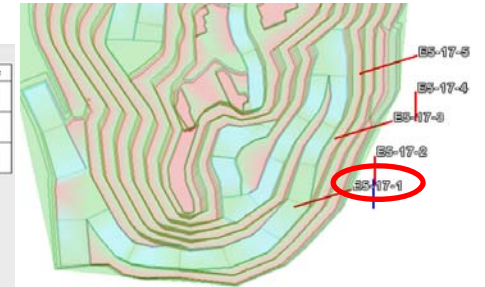
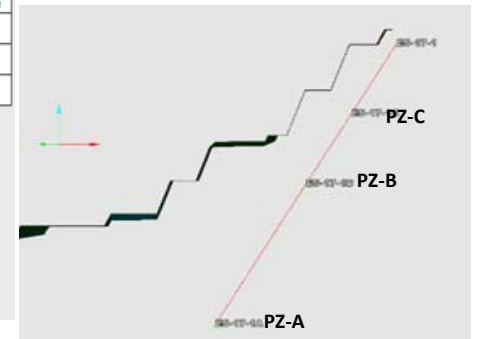
- Minor variations in pressure are related to mining activities (drilling/blasting) in Pit E5. PzB is showing a negative pressure of -1m.
- E5_17_1 PzC is frozen.

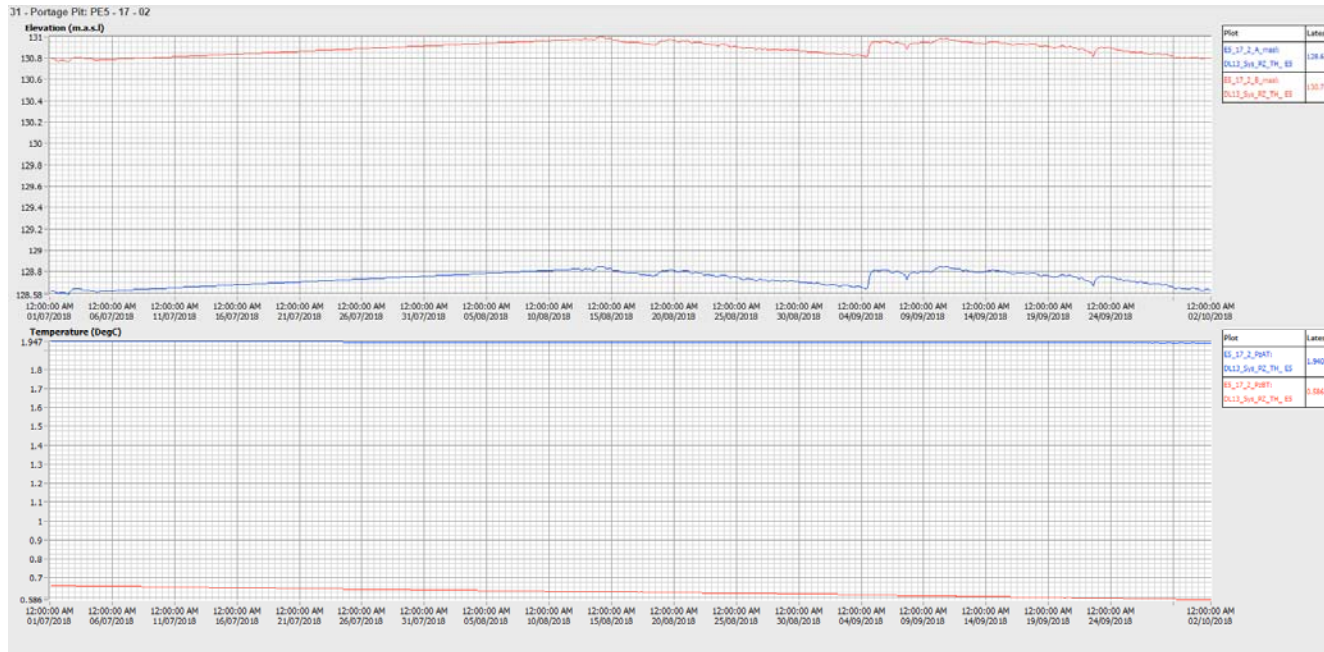
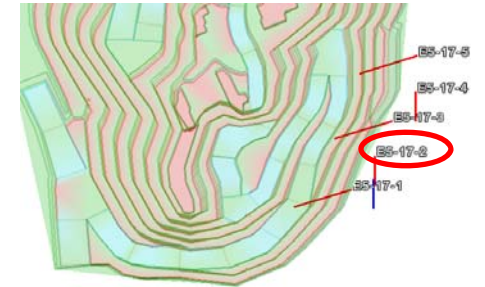
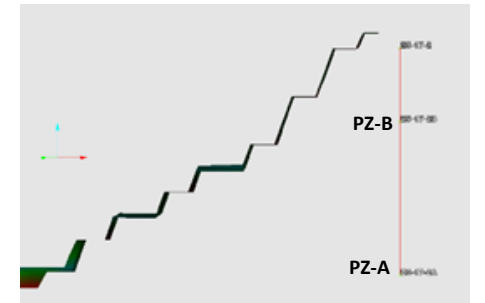
PE5-17-02 PZ-A,B

- Minor variations in pressure are related to mining activities (drilling/blasting) in Pit E5.
- There is slight downward trend in PZ-B temperature's.

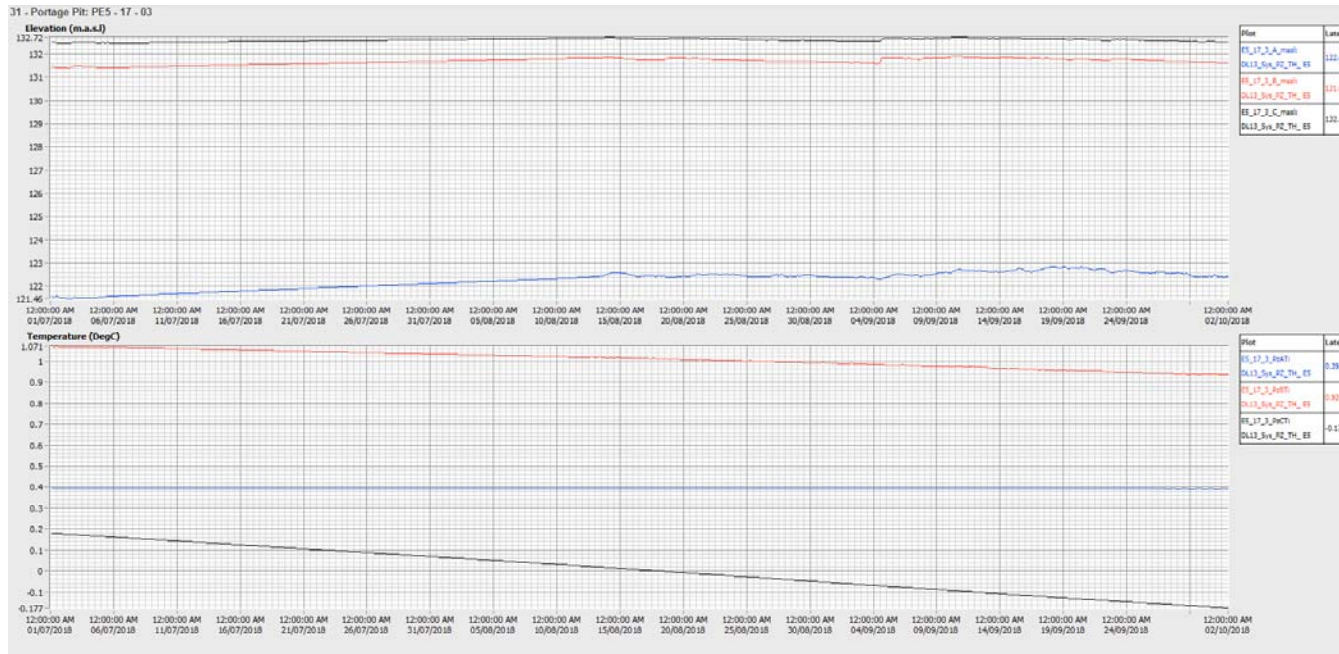
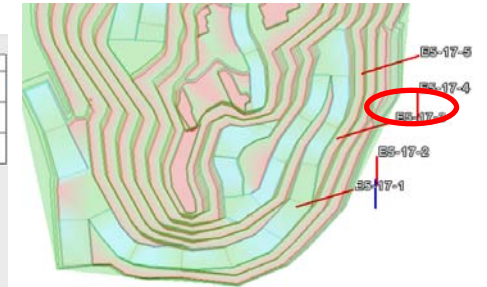
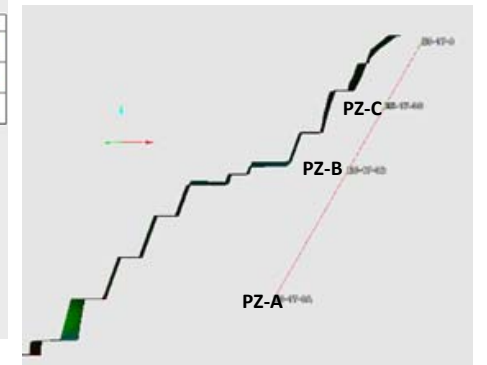
PE5-17-03 PZ-A,B,C

- Minor variations in pressure are related to mining activities (drilling/blasting) in Pit E5
- The temperature for PzA is holding at a steady trend, meanwhile PzB and PzC are showing a cooling trend with PzC now in a negative temperature (-0.18 °C) and considered frozen.

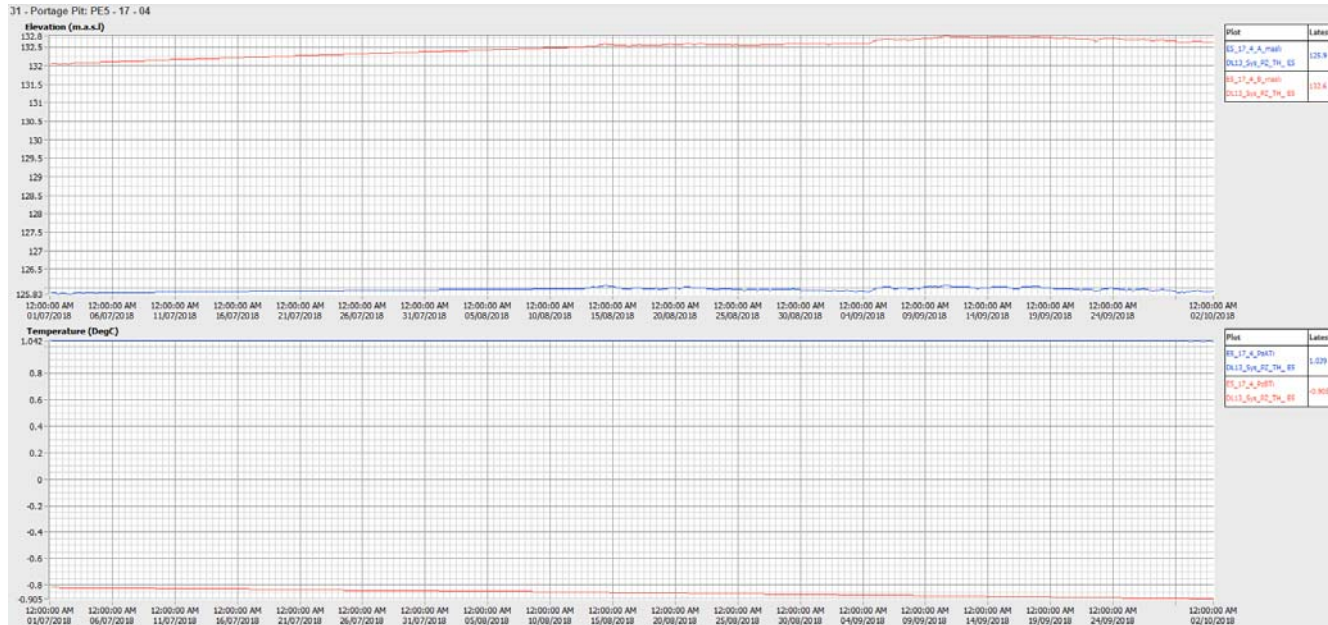
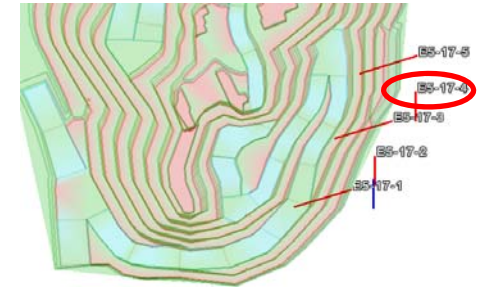
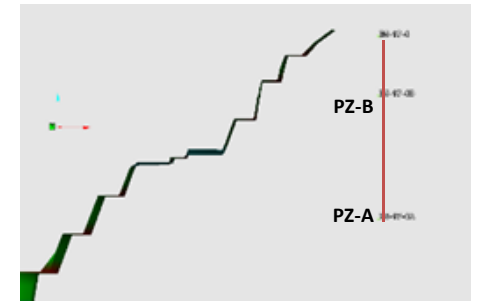
PE5-17-04 PZ-A,B

- Minor variations in pressure are related to mining activities (drilling/blasting) in Pit E5.
- Temperatures for both Pz are in a downward trend with PzB considered to be frozen.

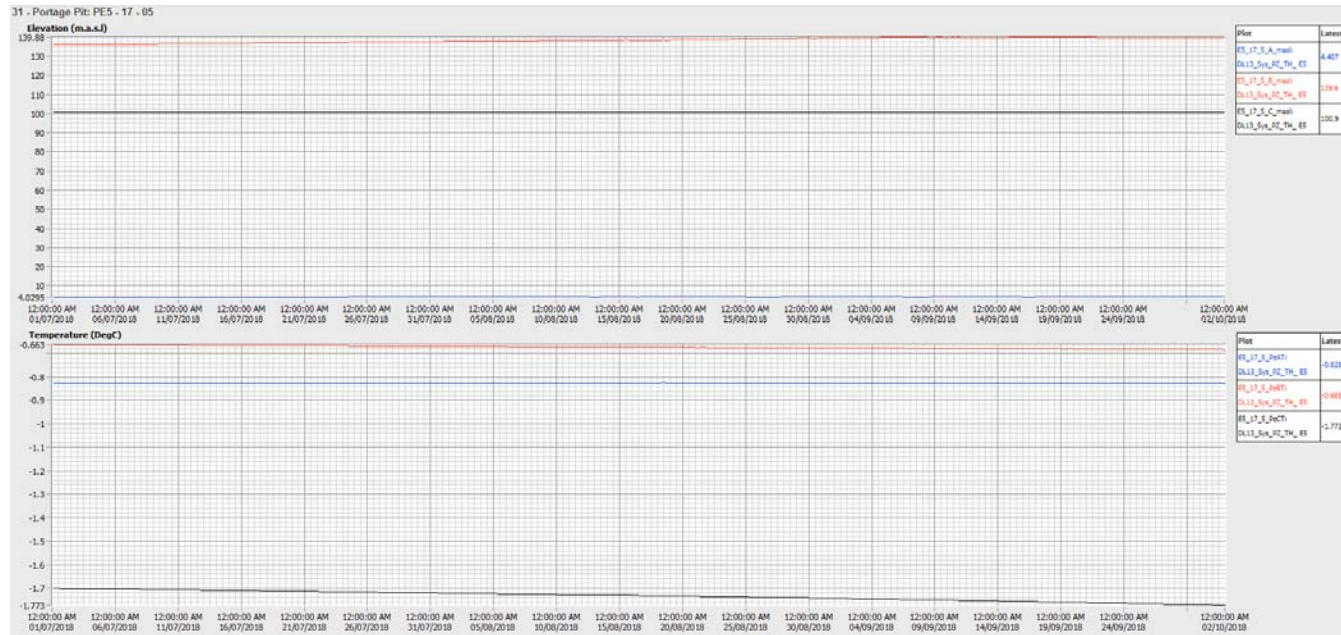
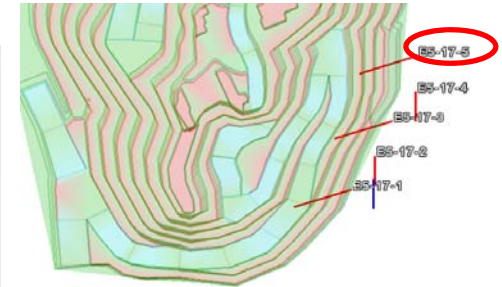
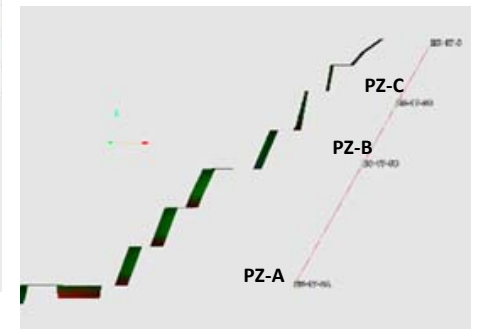
- PZ-A,B and C are frozen. The pressure measurements are considered unreliable.

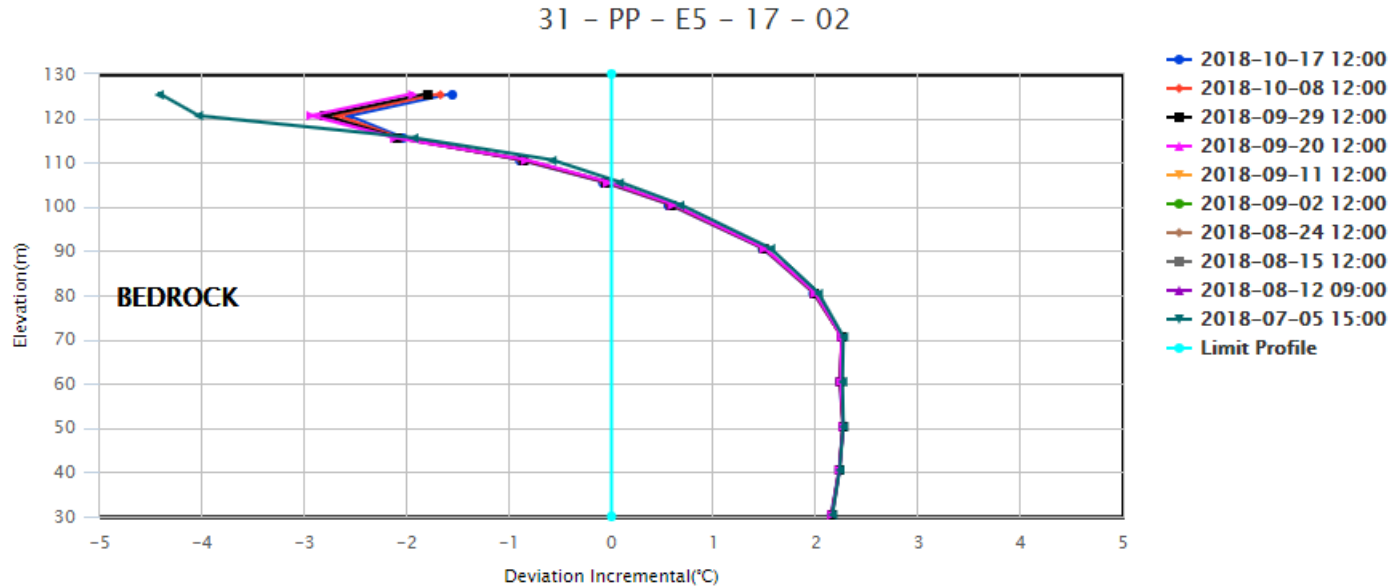
PP-E5-17-02

- There is a permafrost layer from the top of the hole at elev. 125 to the elev. 105 MASL. It suggests an aggradation of the permafrost from the surface since the dewatering of the lake in 2011.
- Apart from the 2 first beads (which are showing a normal cooling trend for onset of winter conditions), only minimal variations were recorded during the period.

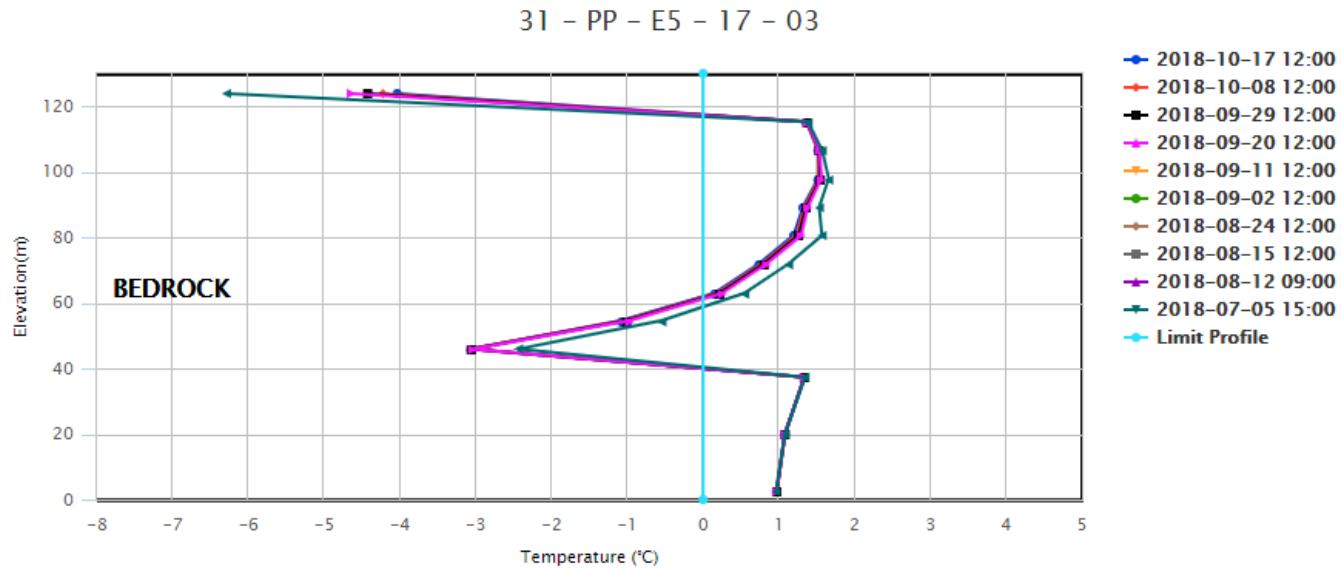
PP-E5-17-03

- Small variations occurred only on the first bead during the Q3 which are consistent with the cooling trend that occurs with the onset of winter conditions. The rest of the thermistor remained consistent with previous data sets.
- There is a unexplained permafrost layer between elevation 40 and 55 m.a.s.l.

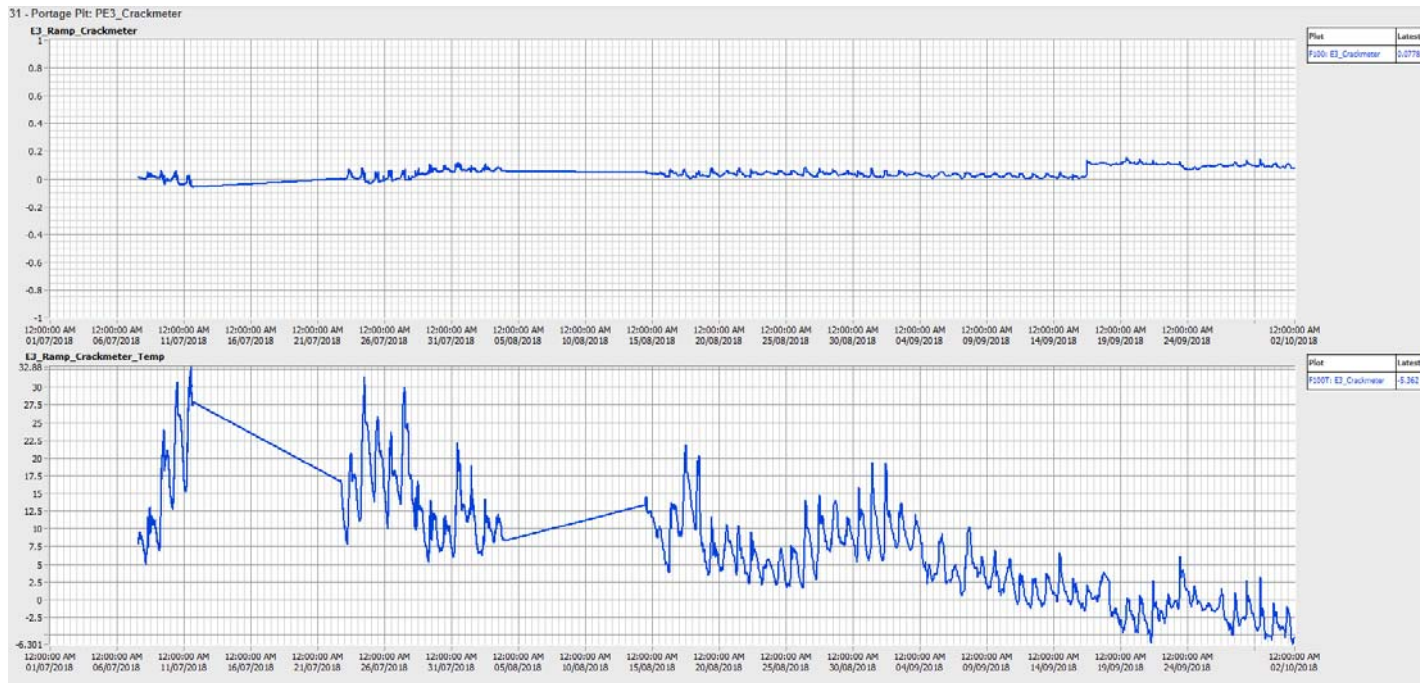
- The large straight lines in data were issues with the DL13 data logger.

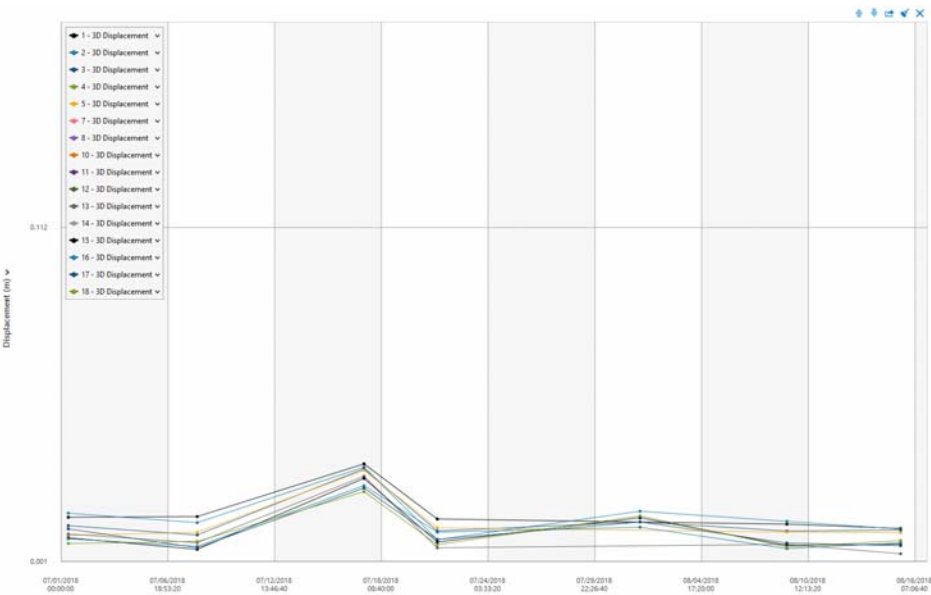
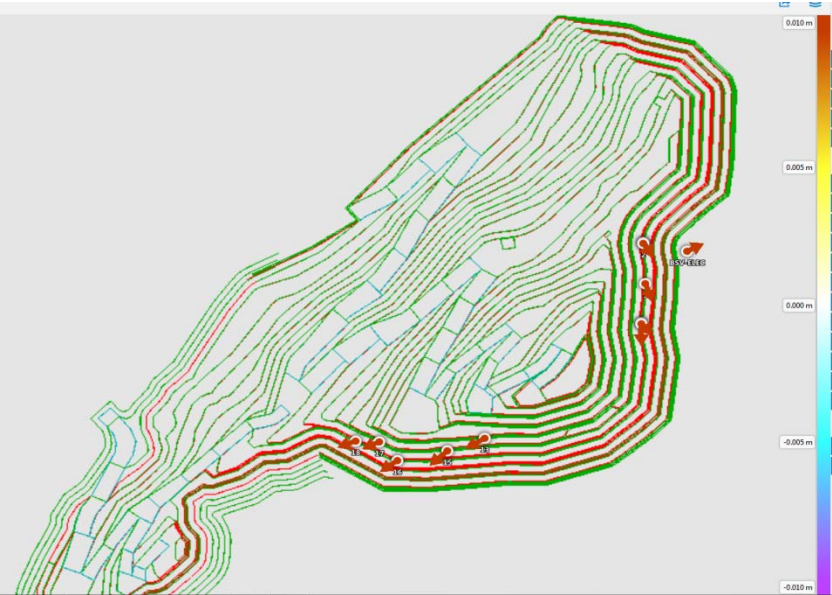
- Six (6) sets of reading were taken for the Q3 Period. No significant movement was detected.
- During the latest survey of the prisms, only 9 were successfully surveyed, the others are either gone or damaged.

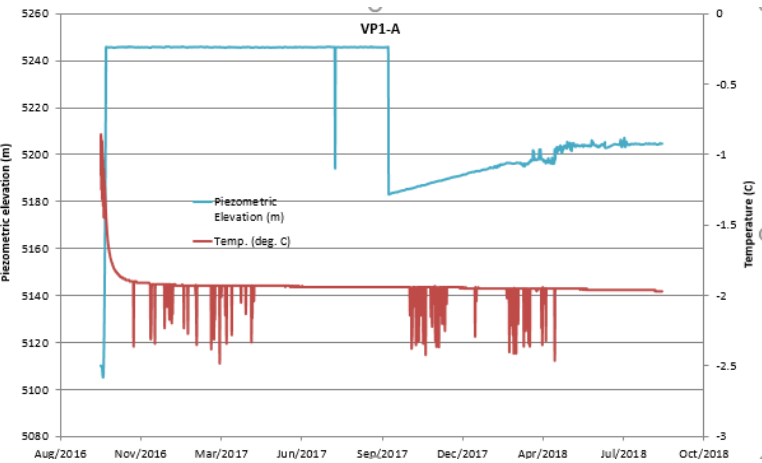
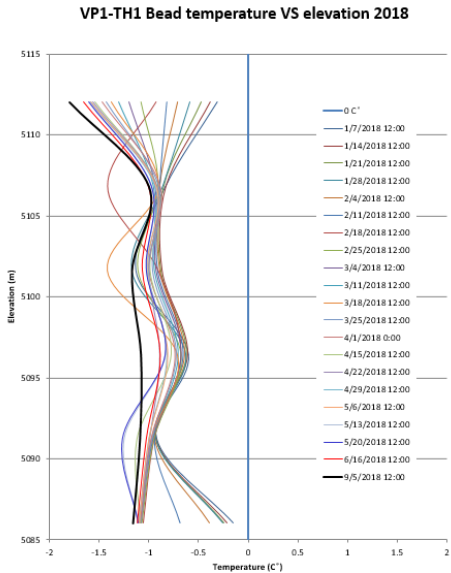
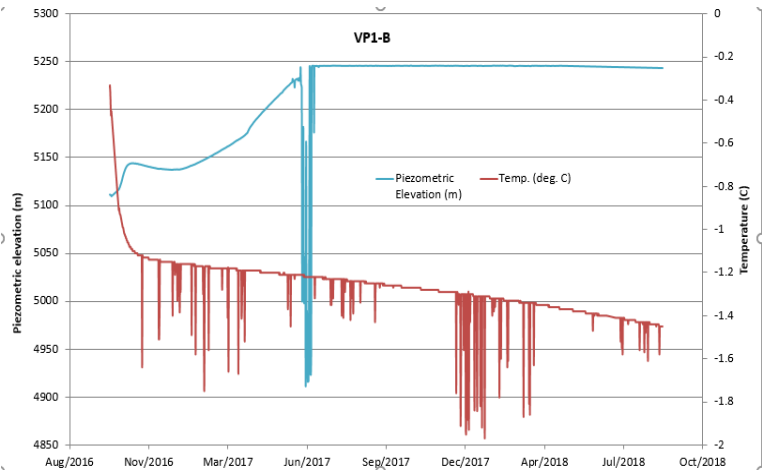
VP1-A, VP1-B, VP1-TH1

- PZ-A&B are below the freezing point. Pressure measurements are therefore considered unreliable and will not be discussed here.
- The thermistor remained frozen during Q3, 2018.

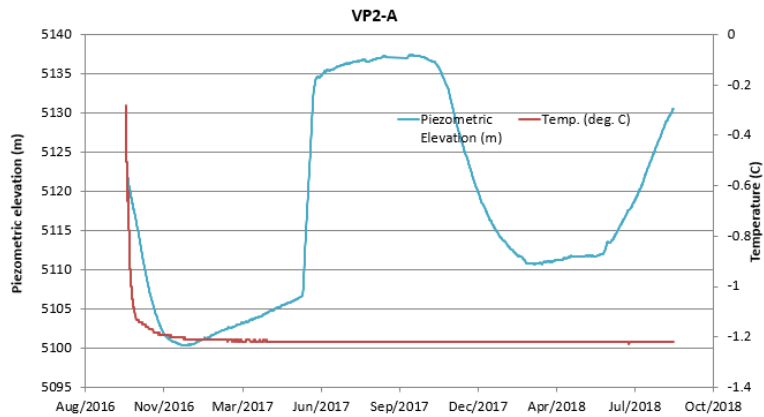
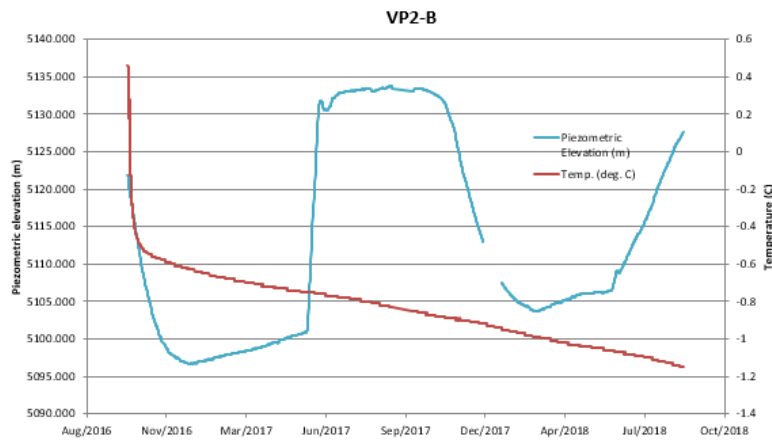
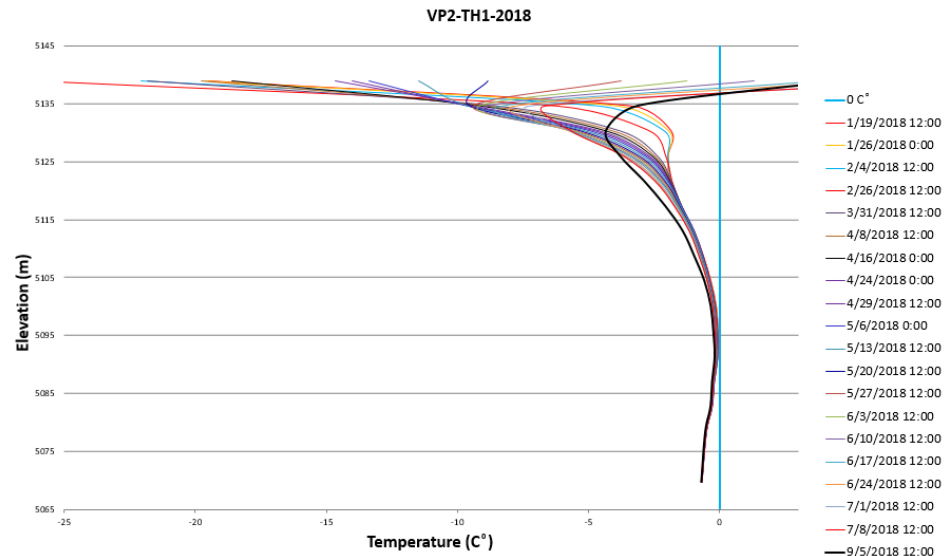
- PZ-A&B are below the freezing point since their installation and their data are considered unreliable.
- The section between 5105 and 5085 is close to the freezing but still below. Apart the top beads, minimal variations were recorded for the rest of the hole.

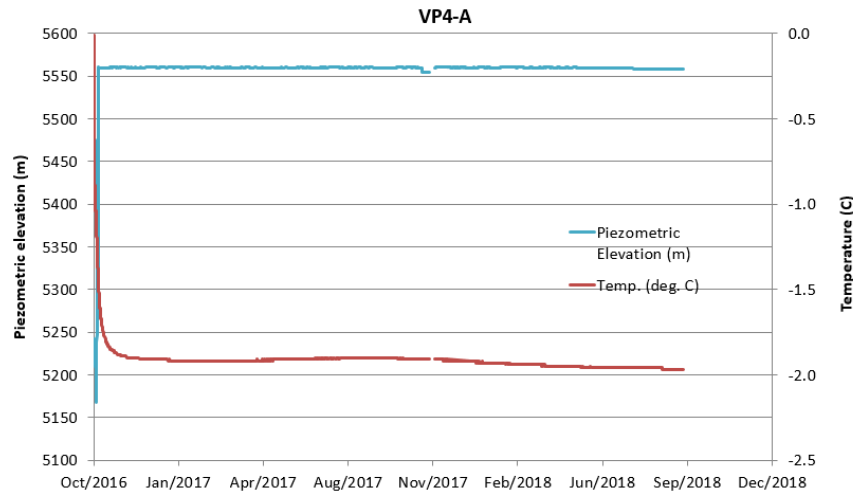
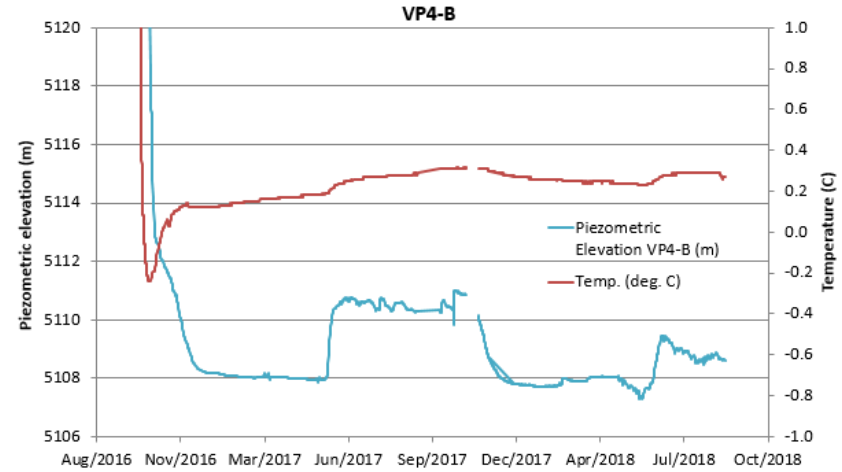
VP4-A, VP4-B

- PZ-A is under the freezing point and considered unreliable.
- PZ-B shows minor variations. The instrument is installed in the confined layer of talik between 5105 and 5095 at the source of the seepage causing the major ice wall in the area.
- The temperature of PZ-B is on a very slight downward trend suggesting a freeze back of the slope and aggradation of permafrost.

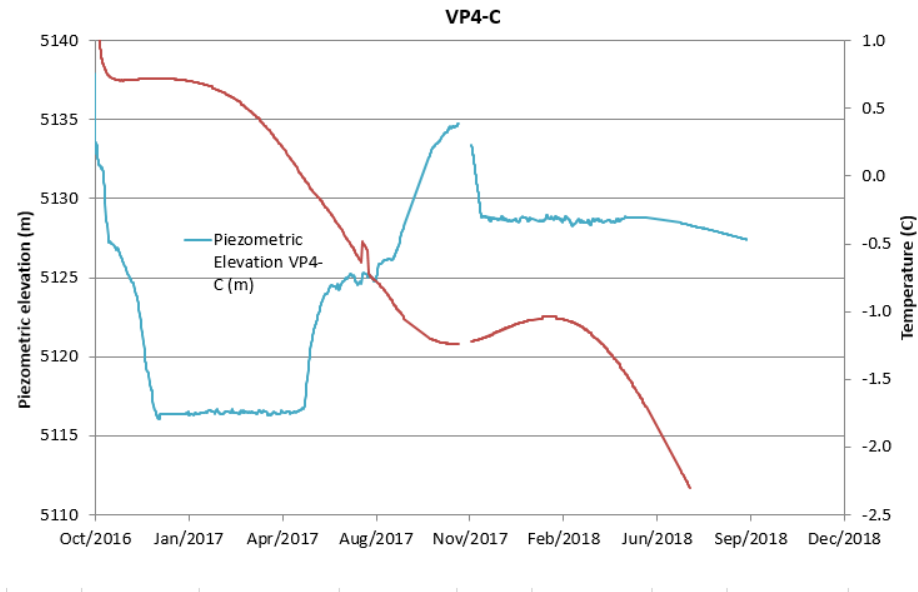
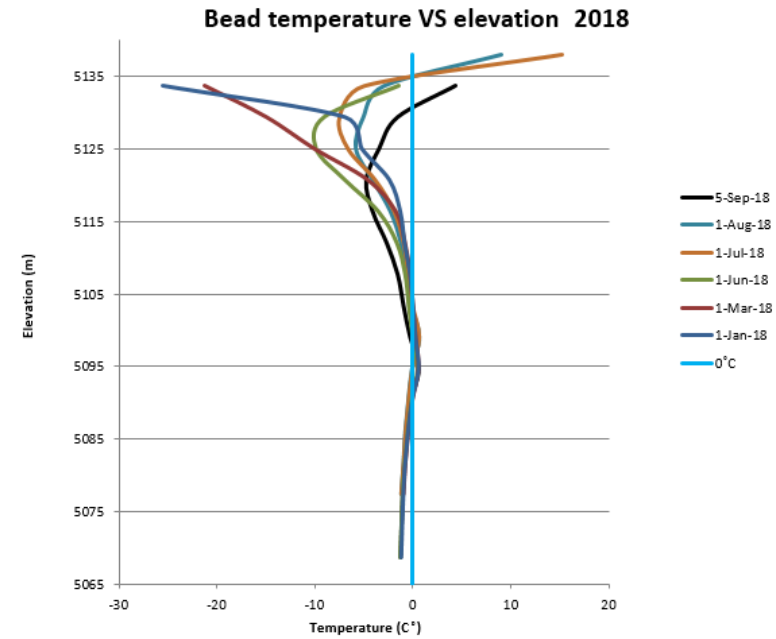
- PZ-C is frozen and data is considered unreliable.
- The thermistor show that the hole is mainly in the permafrost at the exception of the section in between 5100 and 5095 (0.57°C). This zone causes the seepage and therefore the ice wall.

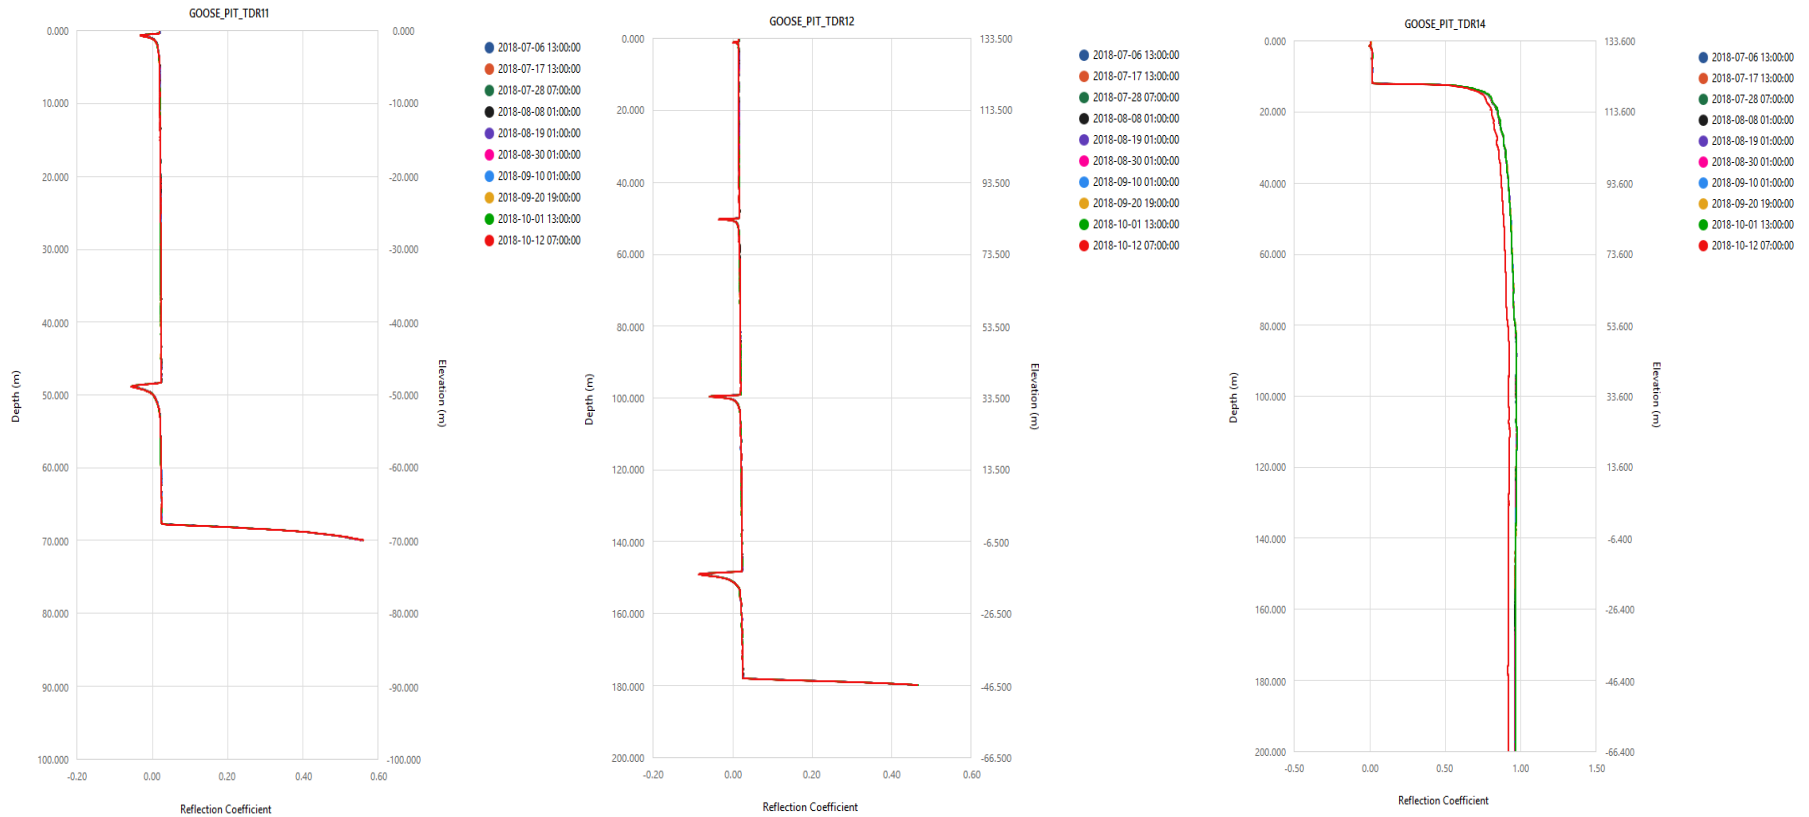
- No sign of deformation was observed in these TDRs.
- Anomalies from the TDR logger are still presents and were disregarded in the presented graphs. We are currently still trying to find a solution for this problem but it does not compromise the data integrity.
- TDR 14 was pinched at installation and therefore result might be compromise in the case of an event raising the reflection coefficient.

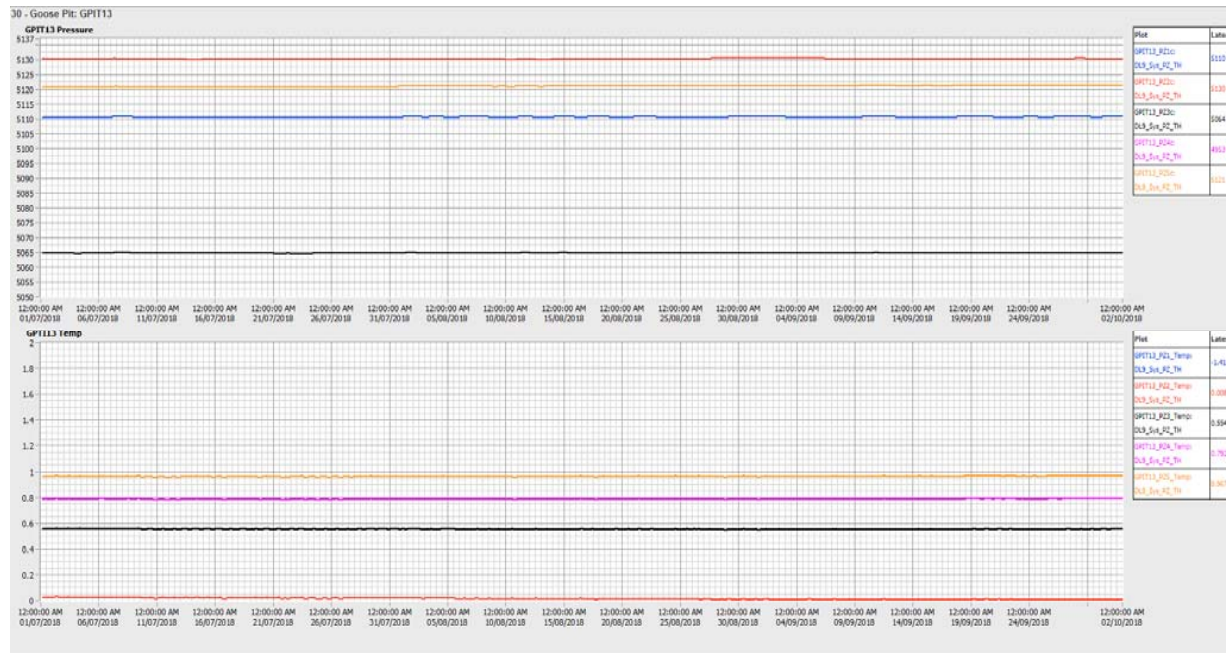
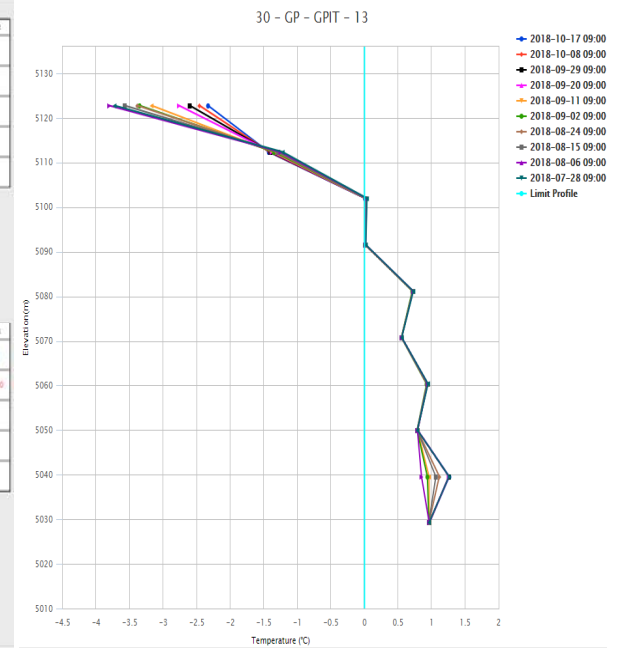
- All piezometers presents little or no variation during the Q3, 2018. All of them are above freezing point.
- TH-GPIT-13 at masl 5040 has shown a rise in temperature of .409 °C, which could be a capacitance effect, while the first bead temperature change is consistent with the cooling trend during the onset of winter conditions. The rest of the beads are stable.
