Meadowbank 2019 Annual Pit Slope Performance Review

2019 ANNUAL PIT SLOPE PERFORMANCE REVIEW

MEADOWBANK MINE, NUNAVUT

OCTOBER 11, 2019

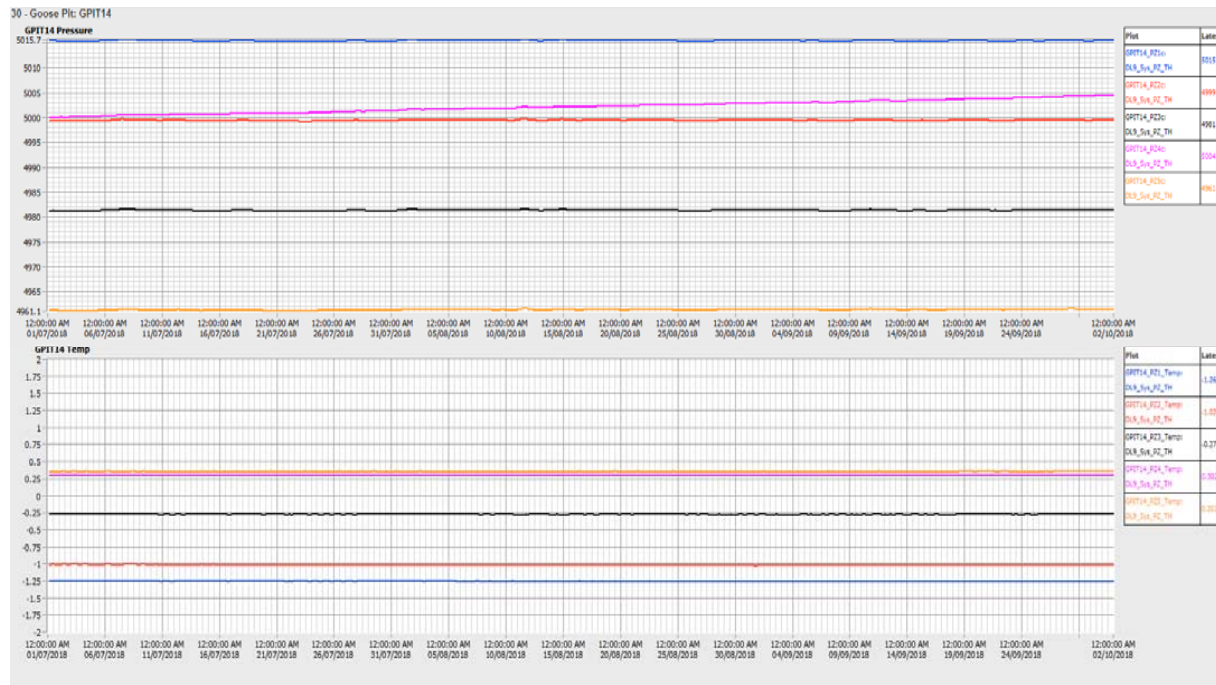
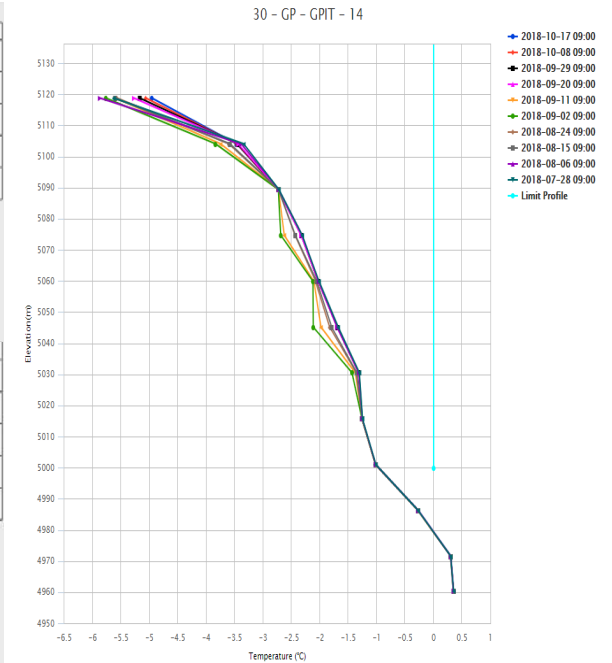
- Pz4 is on a slow rising trend. It rose 4 m of pore water pressure during the third quarter and that could be related to the water level within the Goose pit that is raising (natural flooding).
- PZ-1,2,3 are below the freezing point.
- TH-GPIT-14 is in the permafrost from top at elevation 5120 to 4980. The last 20m of the hole is above the freezing line. The first bead temperature change is consistent with the cooling trend during the onset of winter conditions.

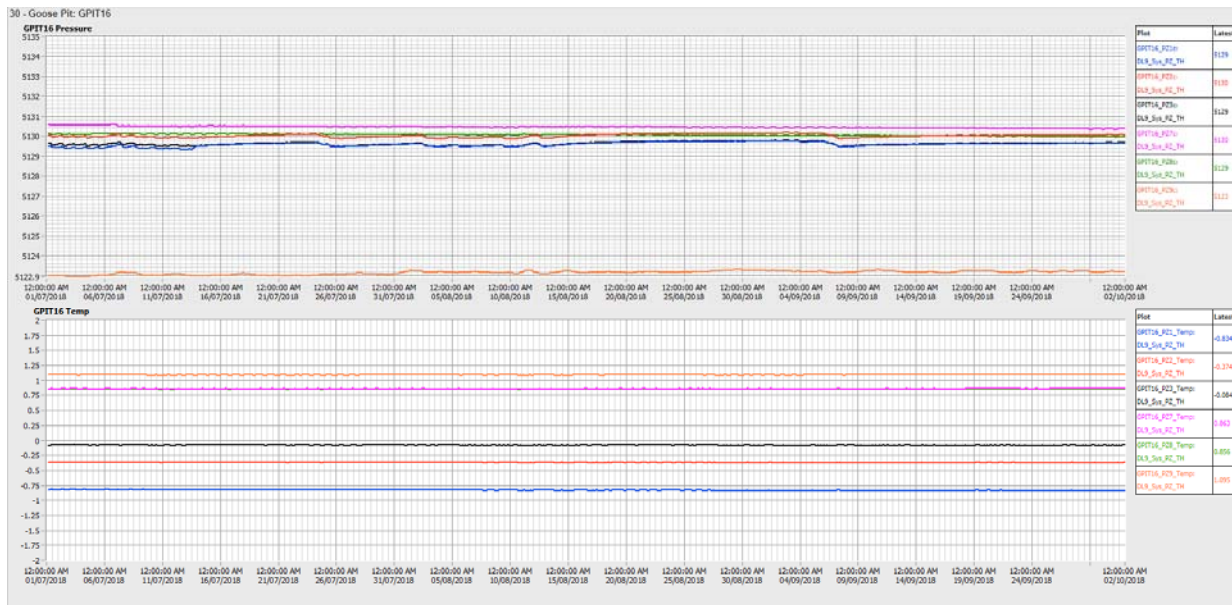
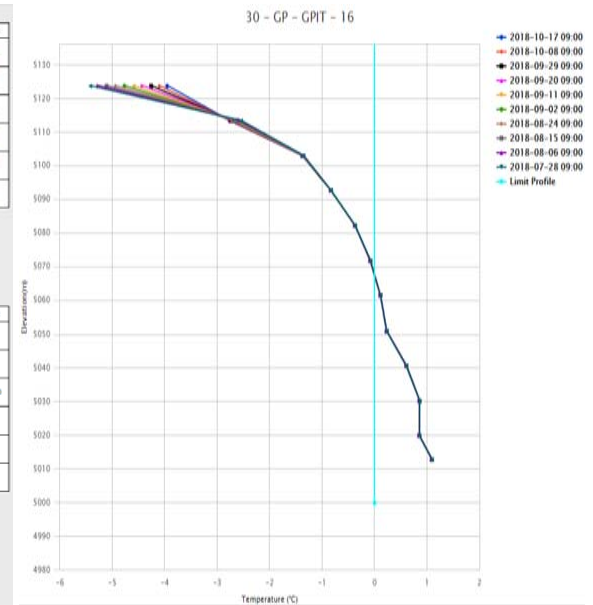
- PZ-7,8,9 are on a very slow rinsing trend.
- PZ-1,2,3 are below the freezing point and can't be considered reliable.
- TH-GPIT-16 is in the permafrost from top at elevation 5124 to 5070. The first bead temperature change is consistent with the cooling trend during the onset of winter conditions.

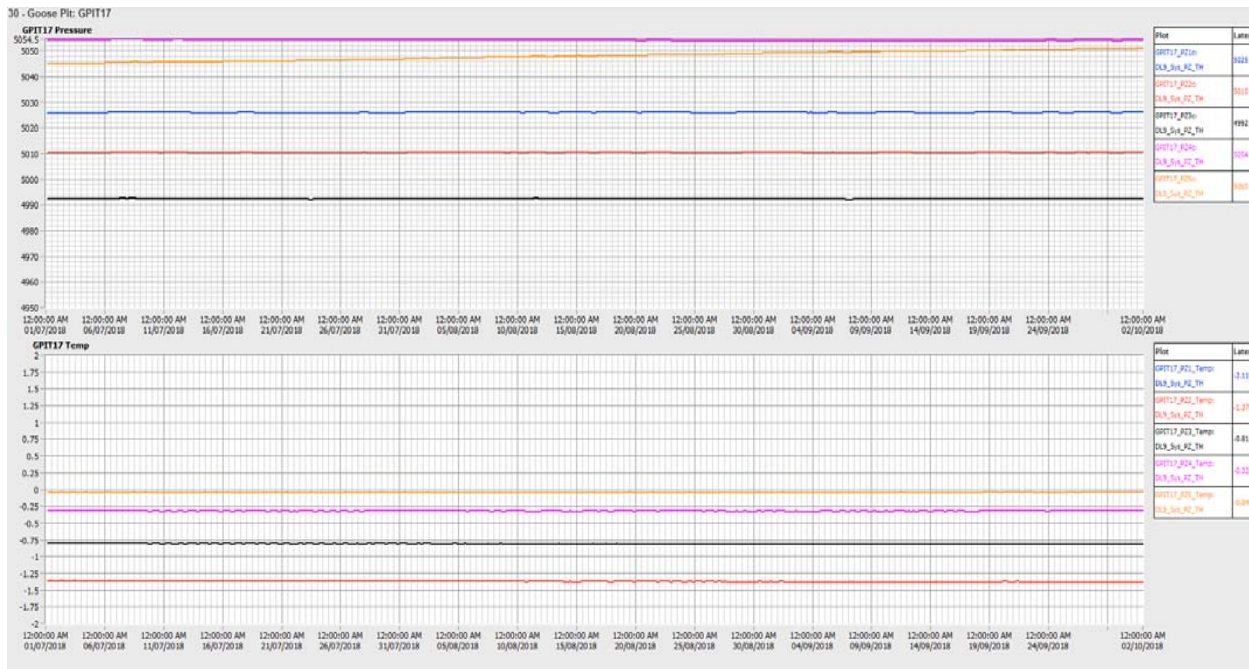
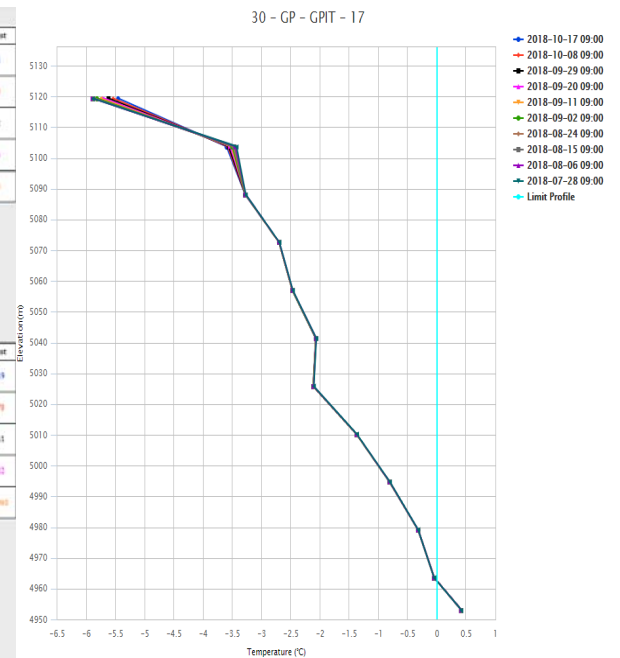
- PZ-1,2,3,4&5 are below the freezing point and can't be considered reliable.
- TH-GPIT-17 is in the permafrost from top at elevation 5119 to 4963. The first bead temperature change is consistent with the cooling trend during the onset of winter conditions.

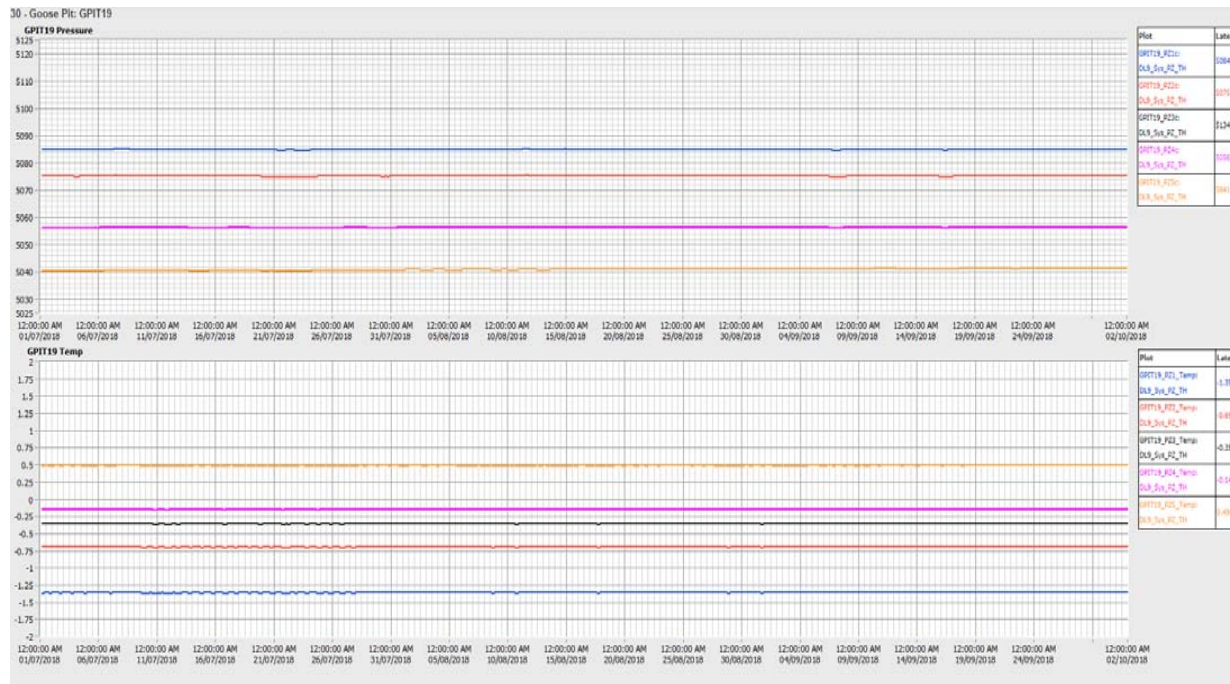
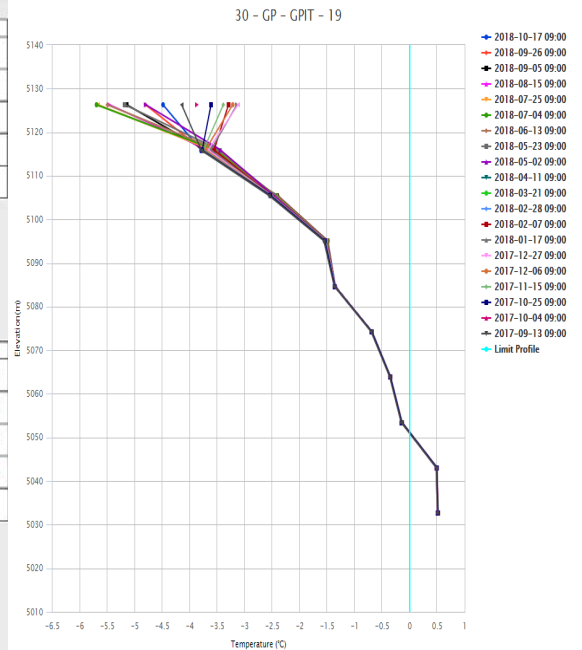
- PZ-5 is above the freezing line and it shows little or no pore water pressure variations during the Q3, 2018.
- PZ-1,2,3,4 are below the freezing point and can't be considered reliable.
- TH-GPIT-19 is in the permafrost from top at elevation 5126 to 5051. The first bead temperature change is consistent with the cooling trend during the onset of winter conditions.

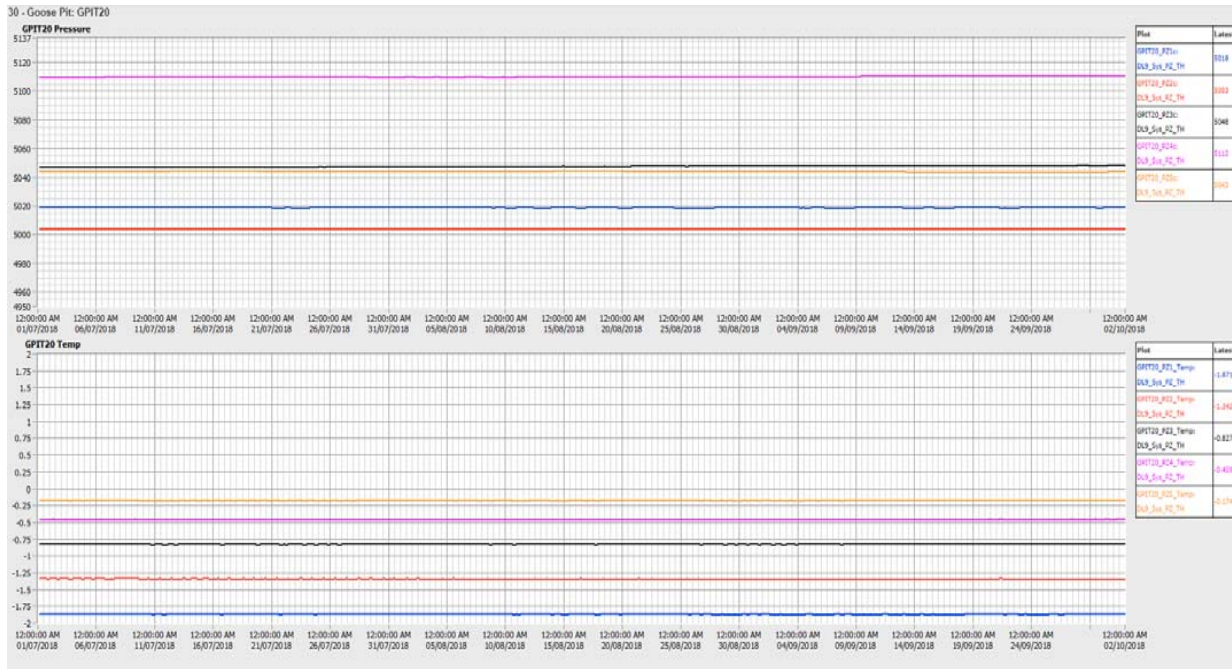
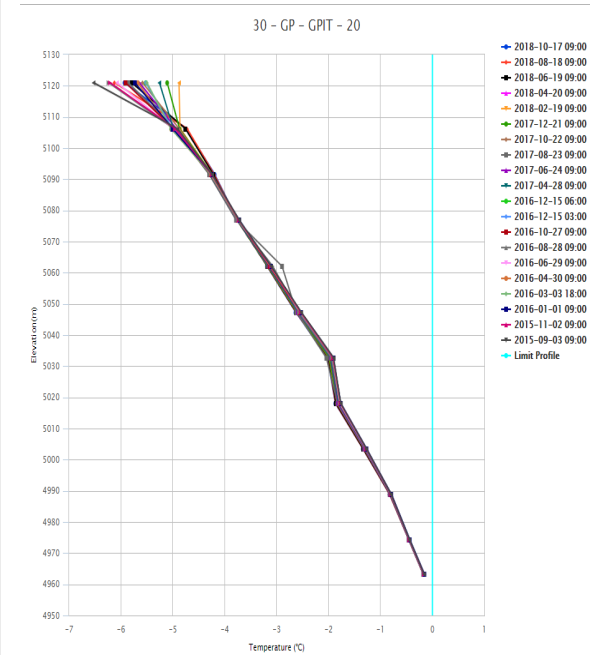
- PZ-1,2,3,4,5 are below the freezing point and can't be considered reliable.
- TH-GPIT-20 is in the permafrost on its entire length from its top at elevation 5121 to the bottom at 4963. The first bead temperature change is consistent with the cooling trend during the onset of winter conditions.

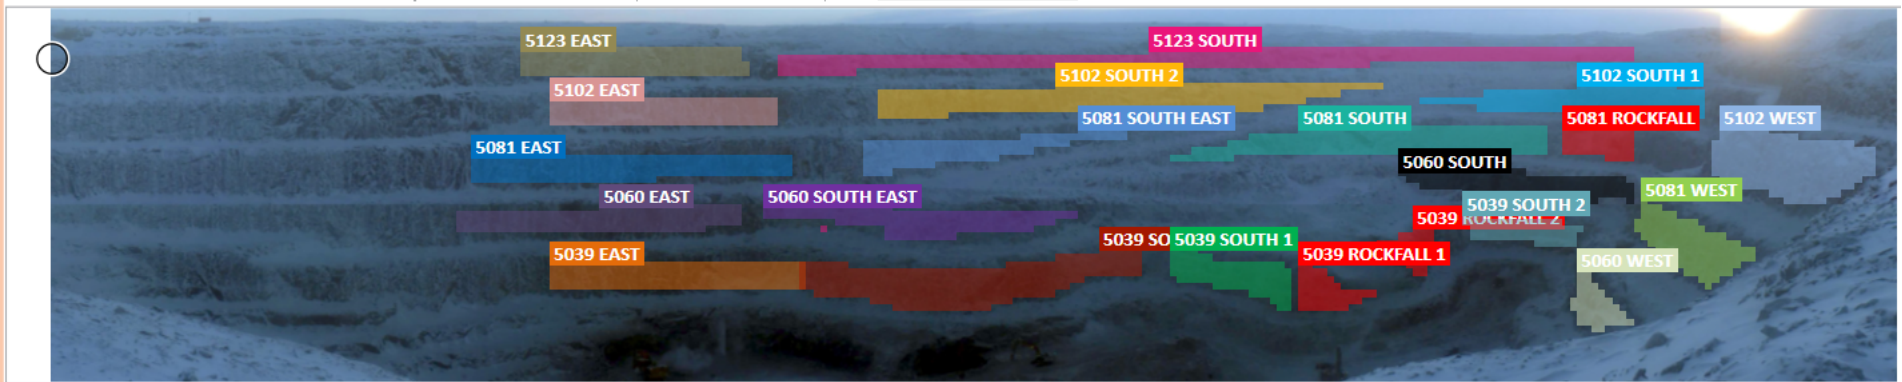
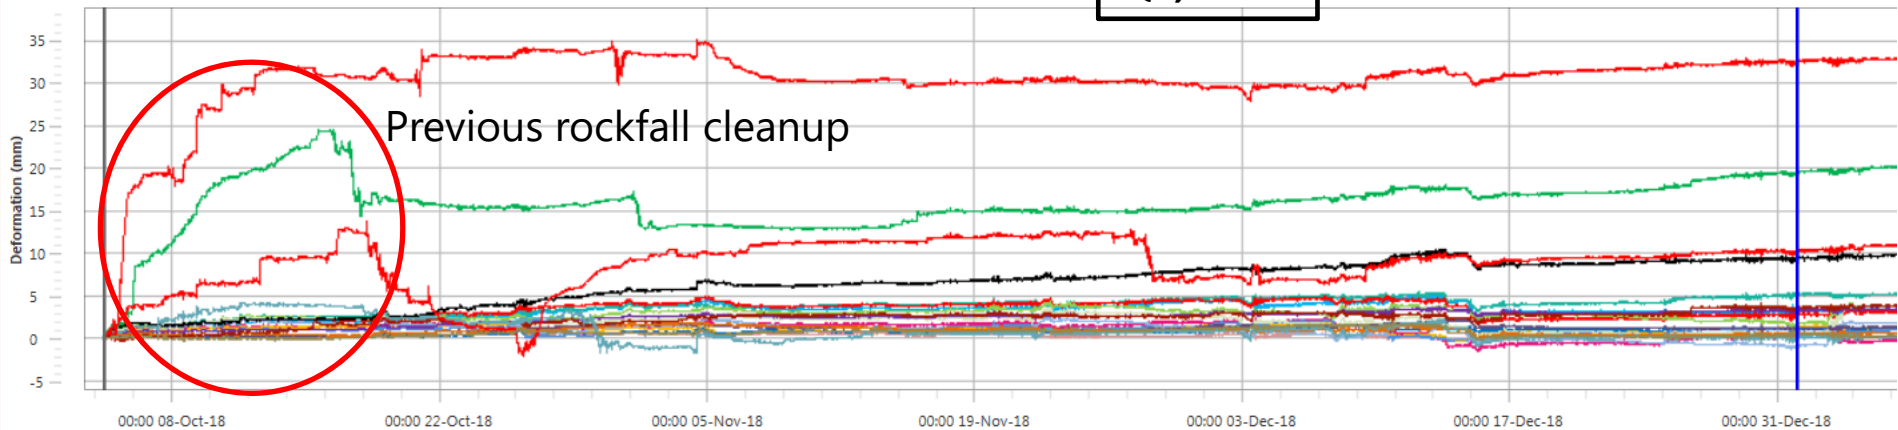
Significant movements observed in the area of the rock fall at level 5039 during the first days of October and then small movement over the period. This can be contributed to Operations clean-up of the Rockfall area which occurred in late Q3.

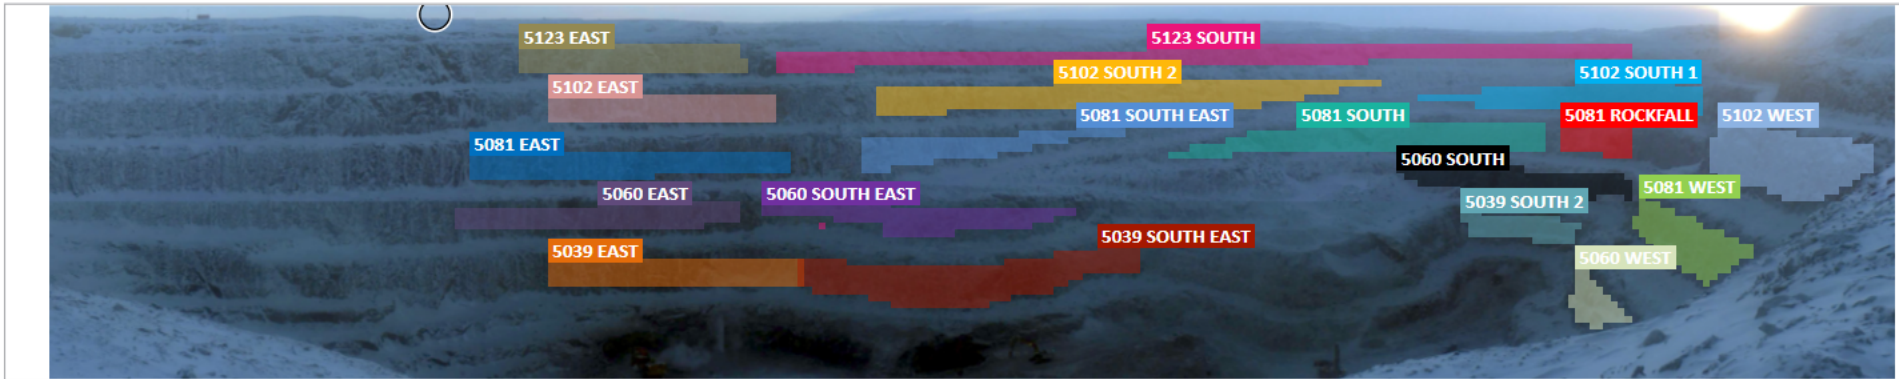
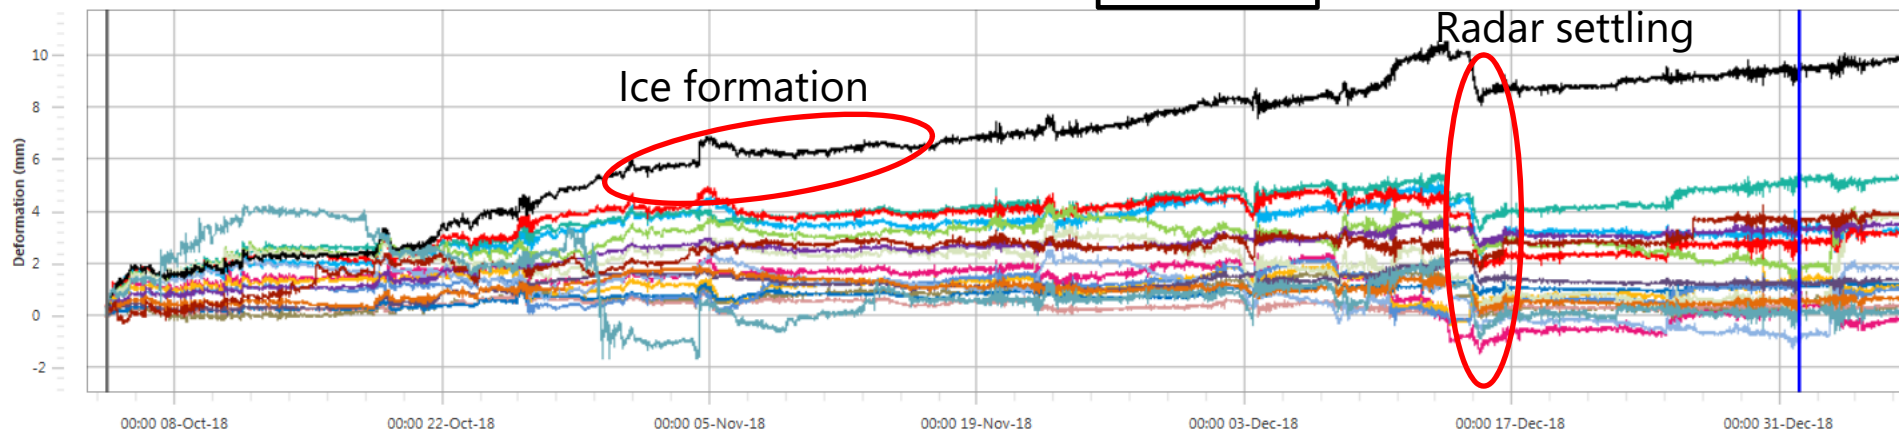
Comments: Image shown without section 5039 South 1 and the Rockfall sections.

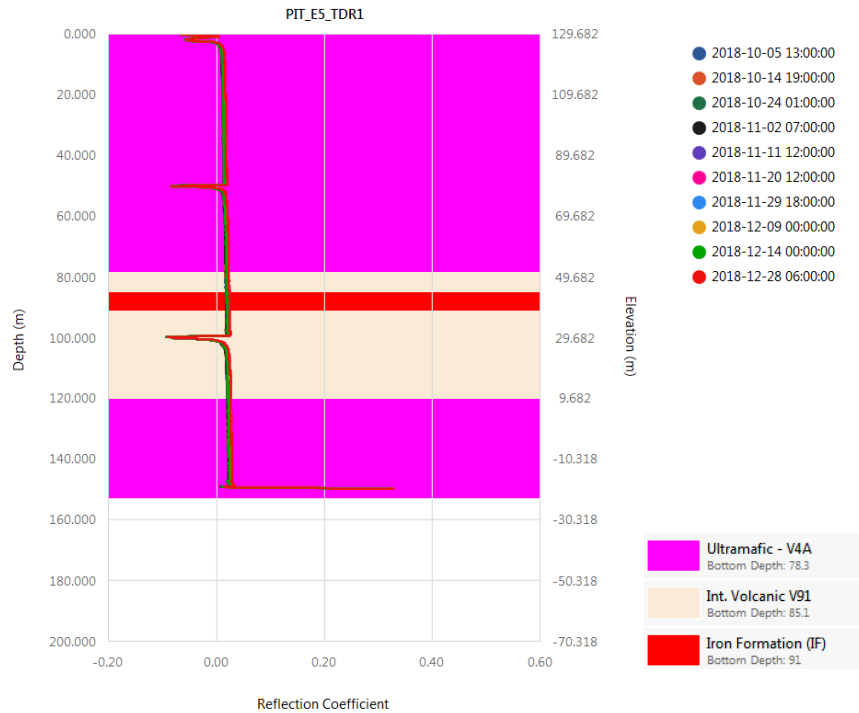
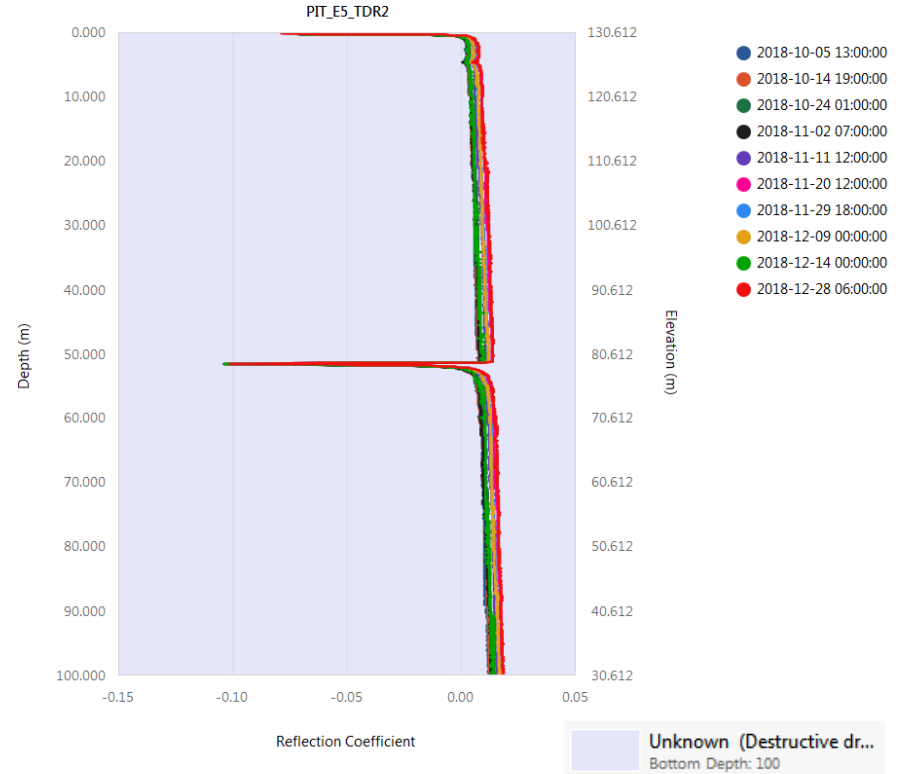
- No sign of deformation observed in TDR1 & TDR2.
- No anomalies from the TDR logger were found in the graphs in Q4.

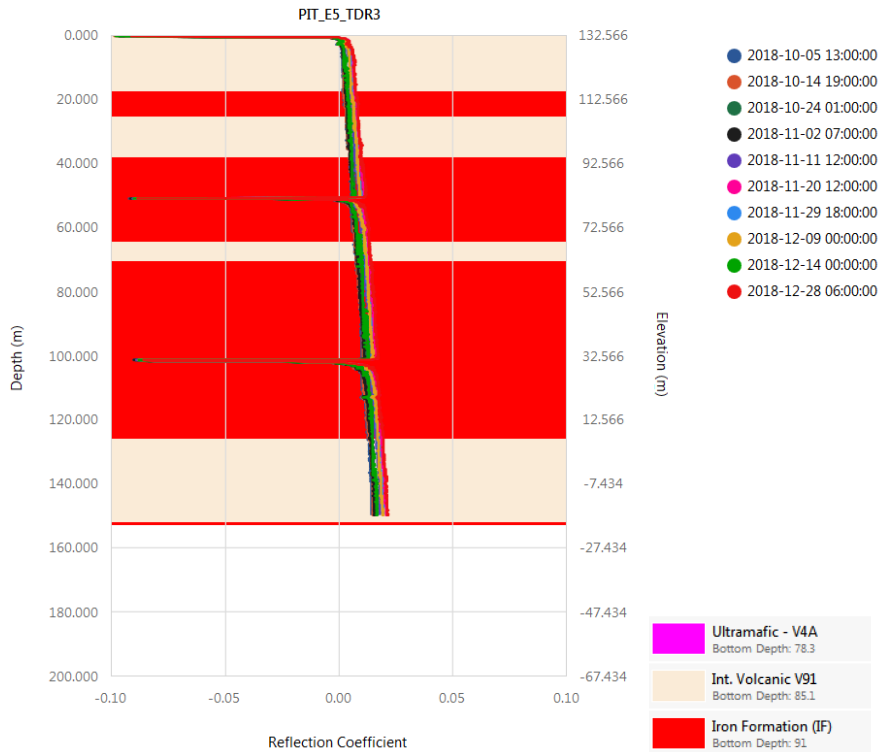
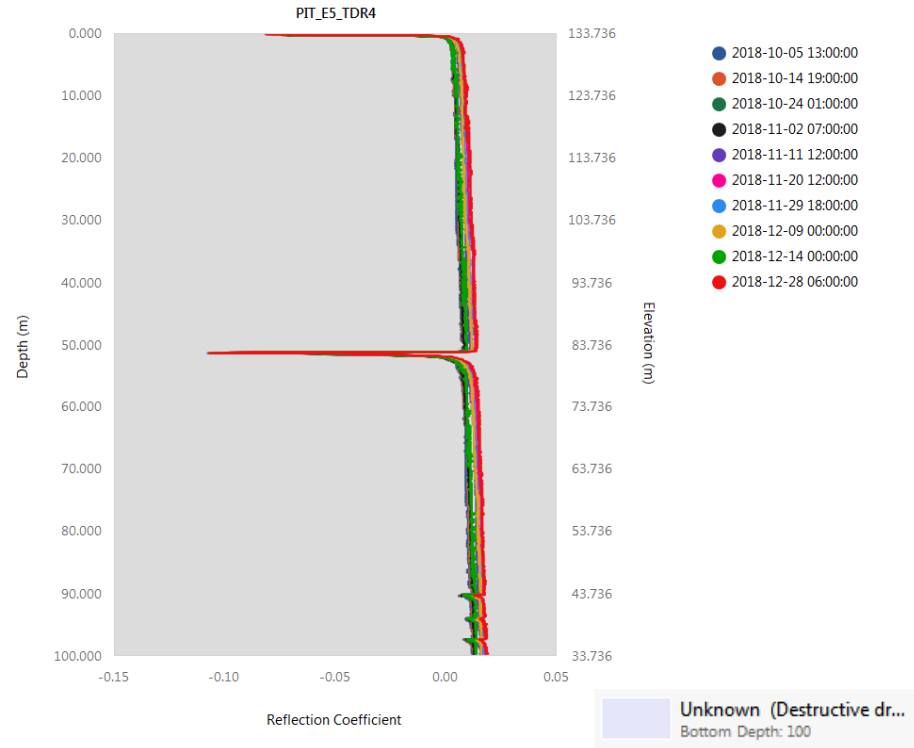
- No sign of deformation observed in TDR3.
- No anomalies from the TDR logger were found in the graphs in Q4.

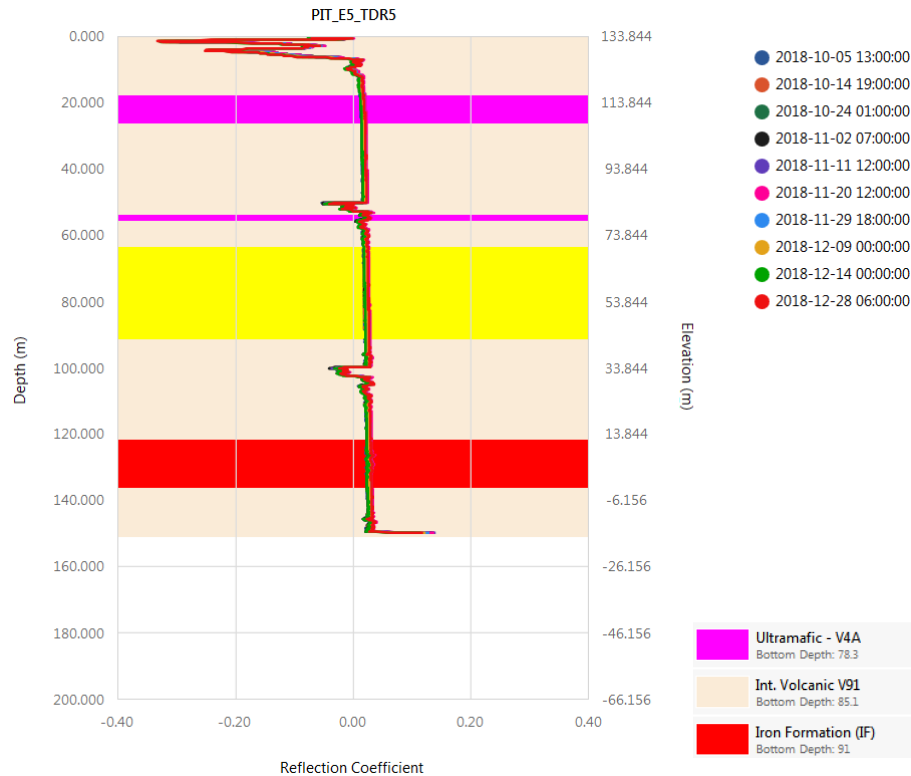
TDR5

- No sign of deformation observed in TDR5.
- No anomalies from the TDR logger were found in the graphs in Q4.

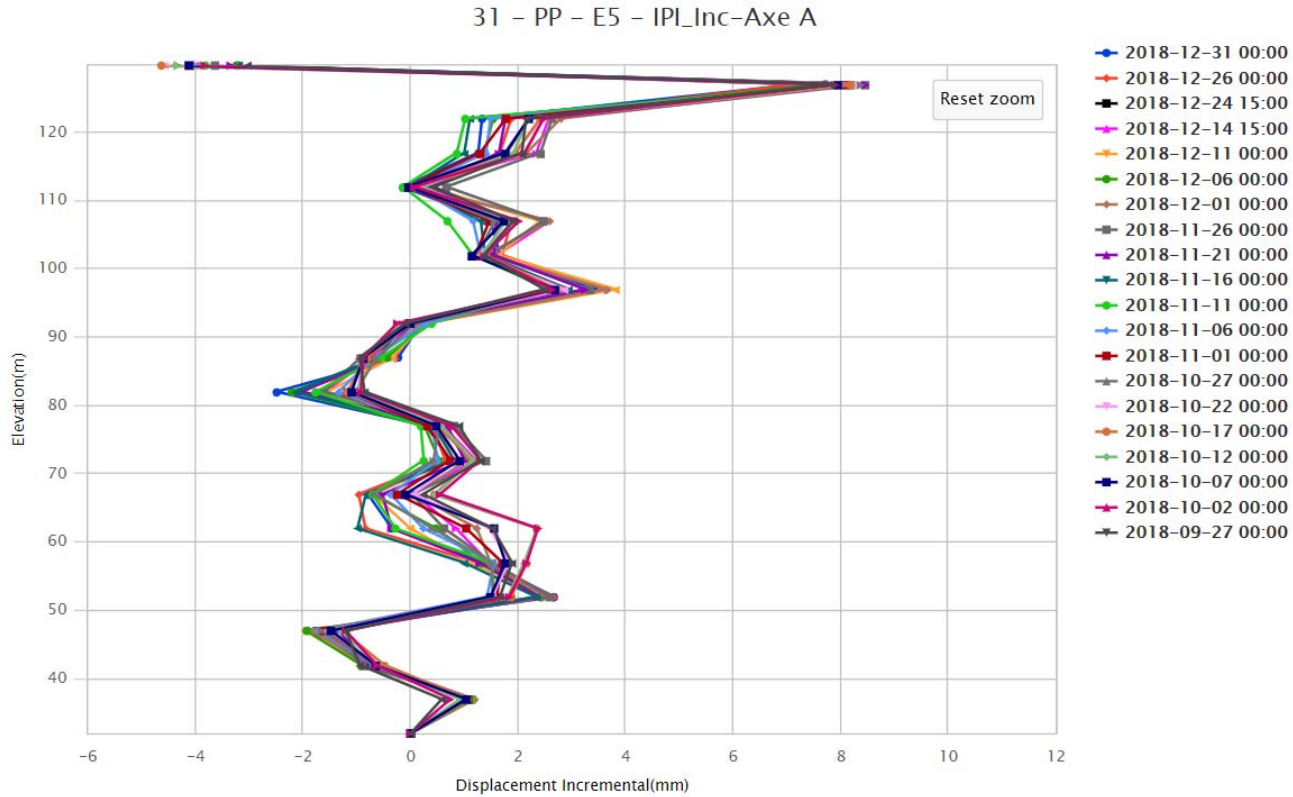
- Erroneous line data between Dec. 14th and Dec, 24th due to low battery voltage.
- Deformation are within the green level for the TARP for Pit E Pushback.

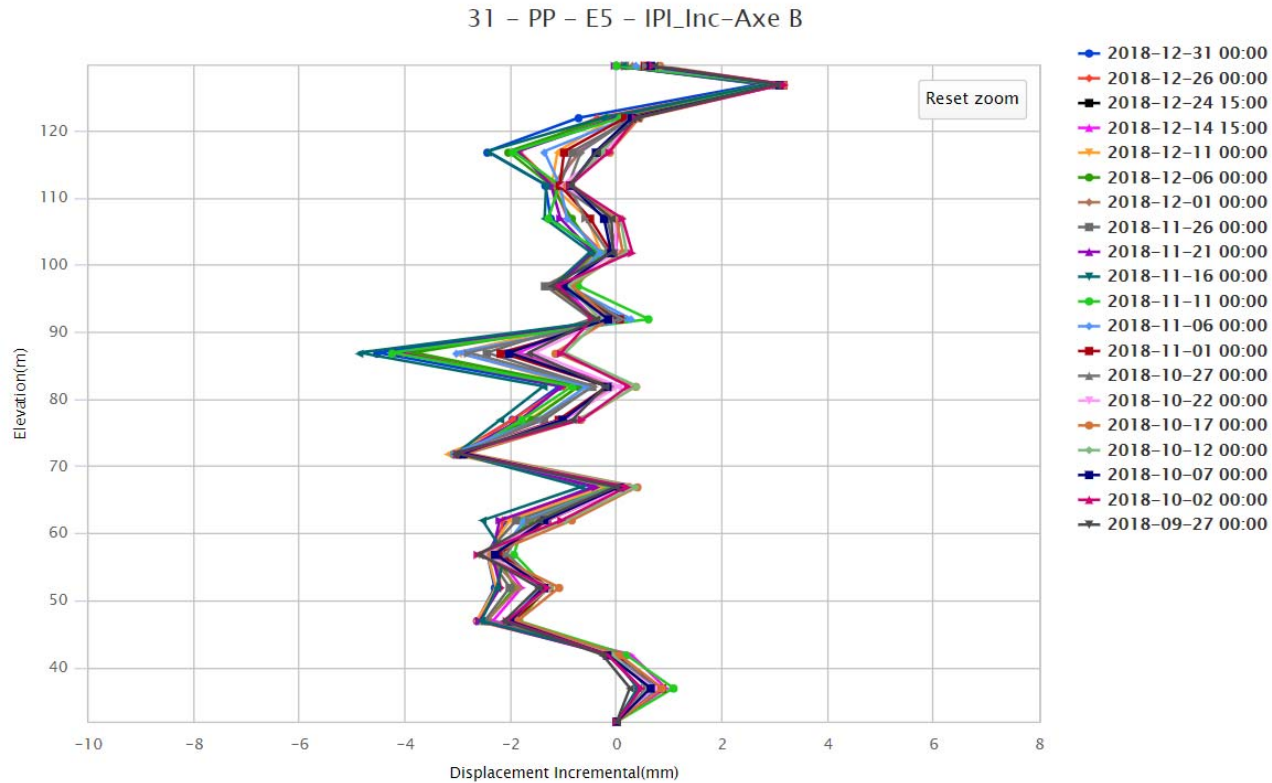
PP-E5-IPI

- With only a bad line data between Dec. 14th and Dec, 24th due to low battery voltage, the results of the data are viable.
- The results fall within the Acceptable range for the TARP for Pit E Pushback.

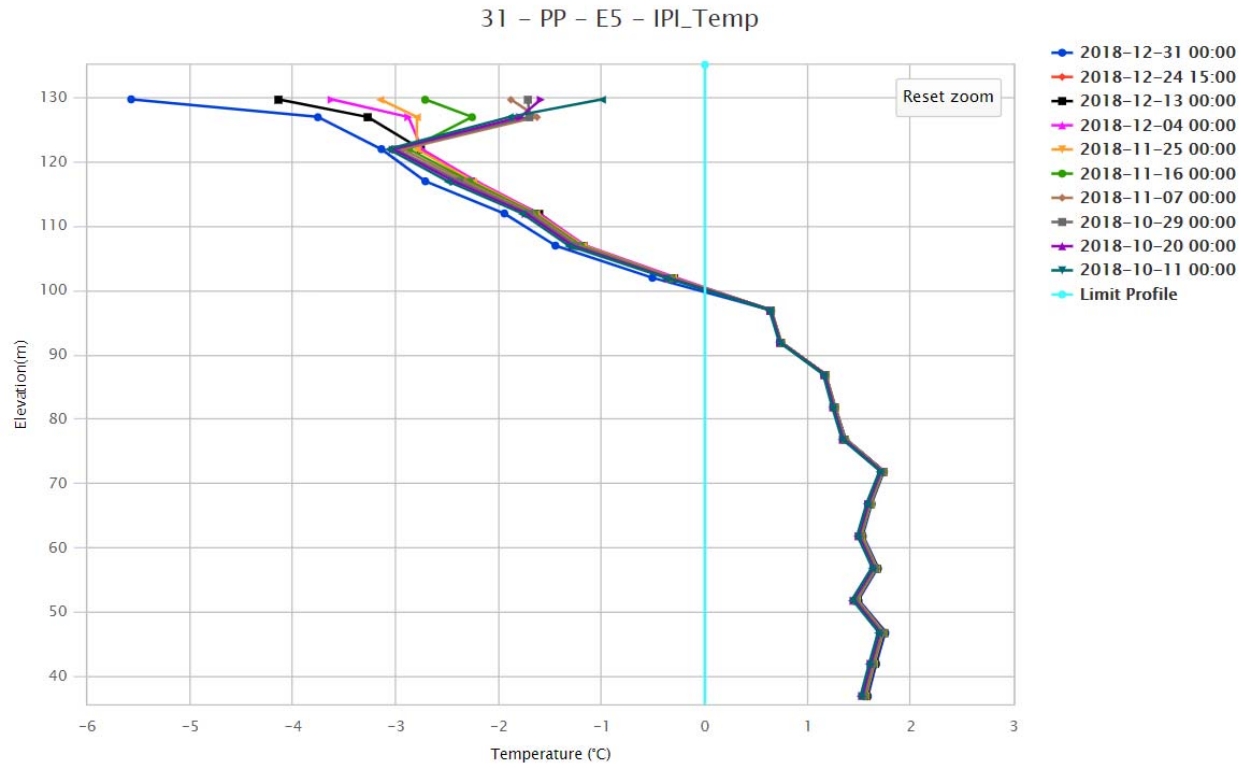
PP-E5-IPI

- Unfrozen (Talík) condition under elevation 100 MASL.
- There is a gradual cooling trend in the talík zone.

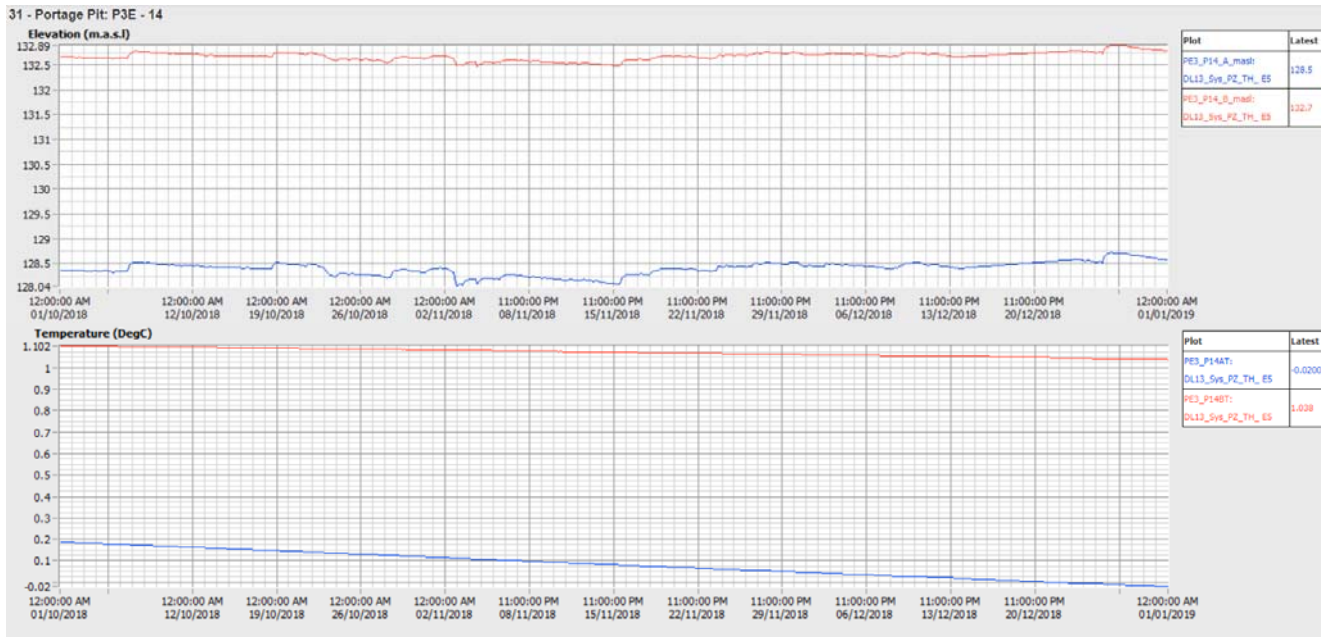
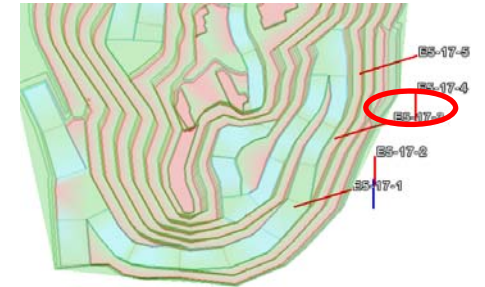
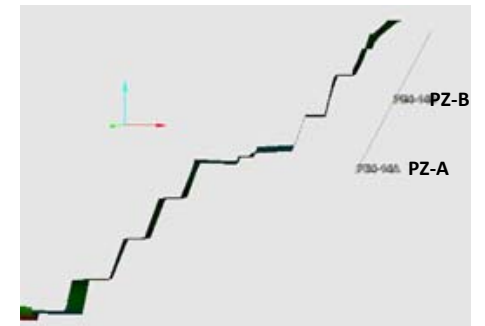
PE3-14 PZ-A,B

- Minor variations in pore water pressure are related to mining activities (drilling/blasting) in Pit E5.
- Overall downward trend for piezometer's temperature.
- PE3-14 PzA is close to be frozen. Latest temperature is -0.02 °C.

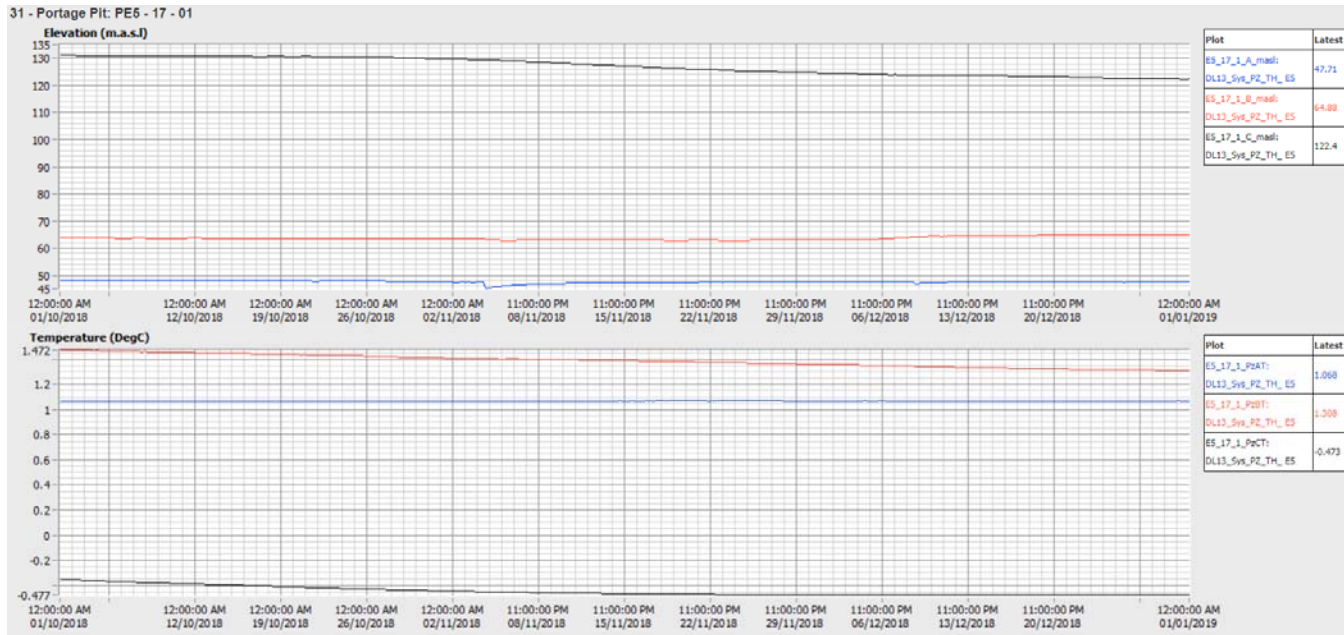
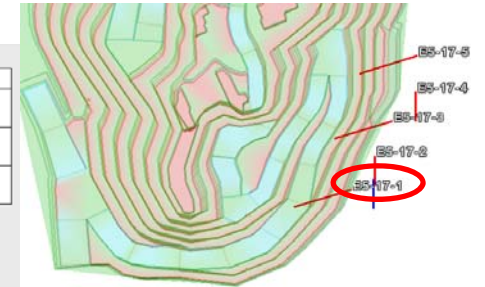
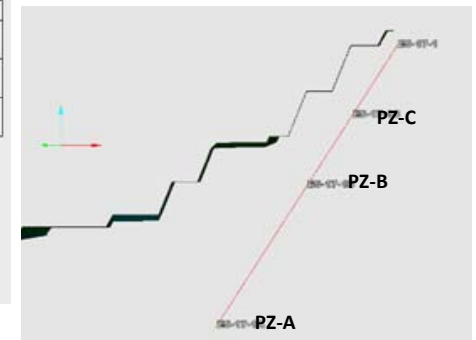
PE5-17-01 PZ-A,B,C

- Minor variations in pressure are related to mining activities (drilling/blasting) in Pit E5.
- PzB has a low PWP of 19 is to be considered to be in a dry area in the wall.
- E5_17_1 PzC is considered to be frozen (-.047 °C).

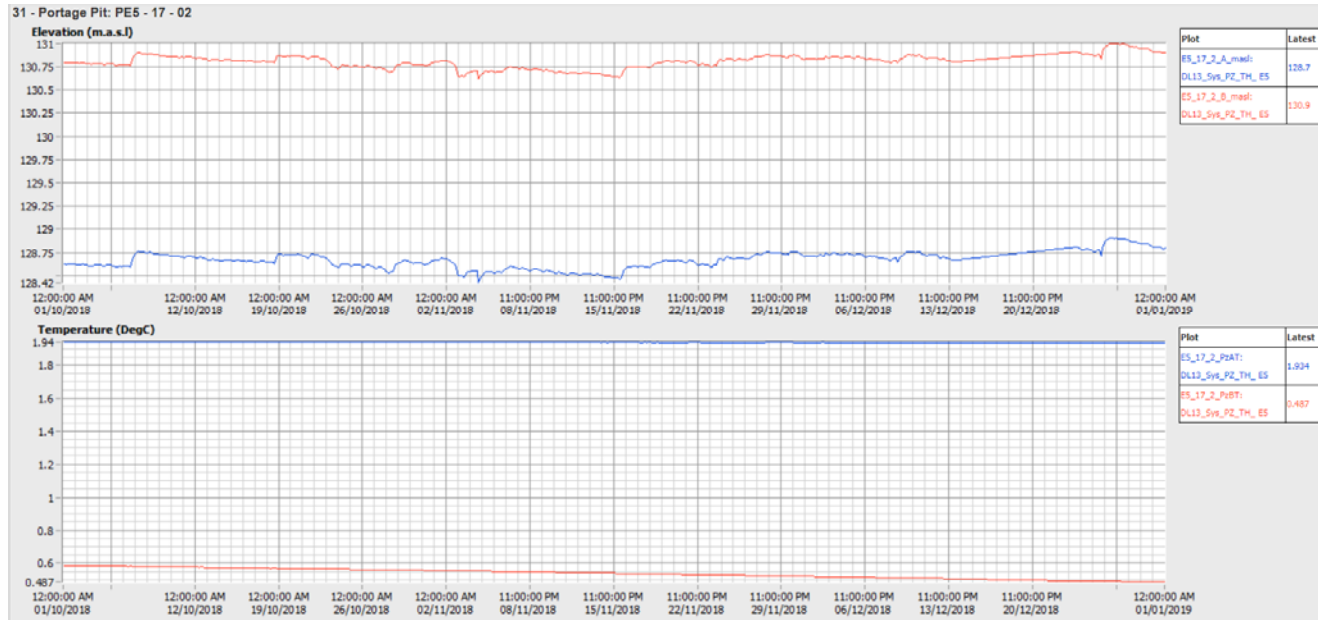
PE5-17-02 PZ-A,B

- Minor variations in pressure are related to mining activities (drilling/blasting) in Pit E5.
- There is slight cooling trend in PzB temperature.

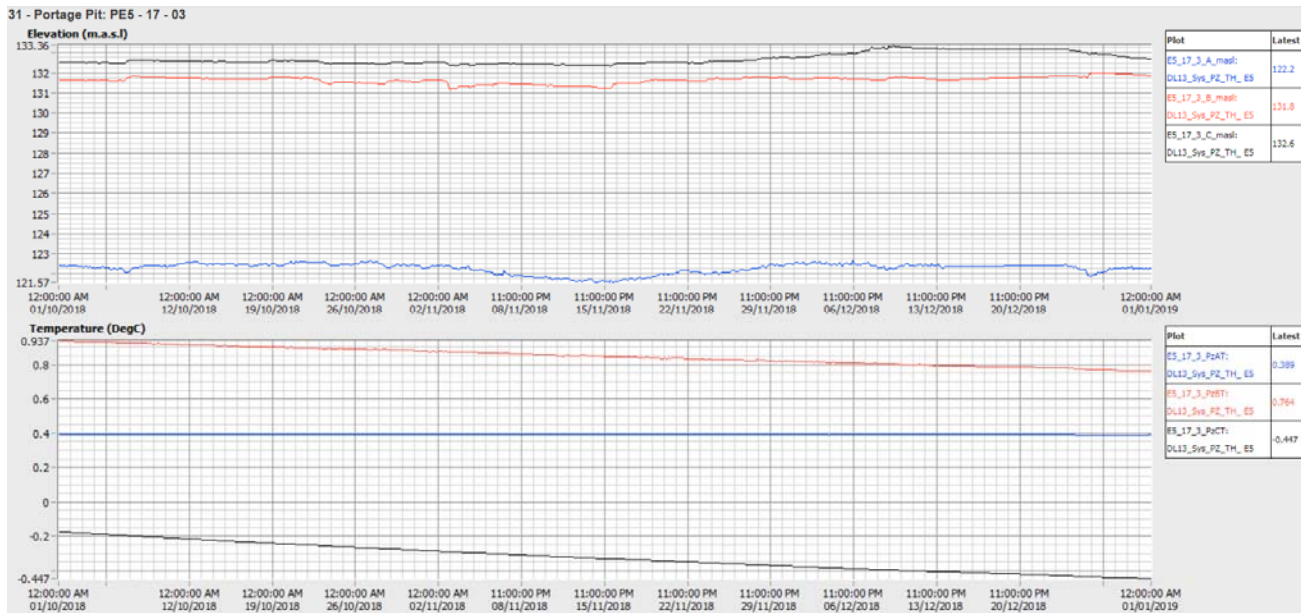
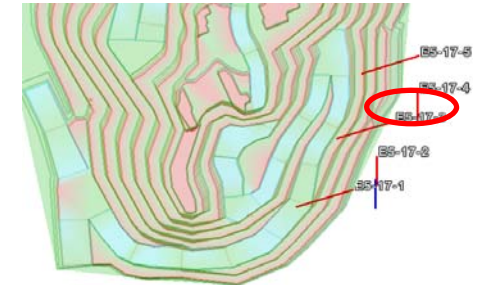
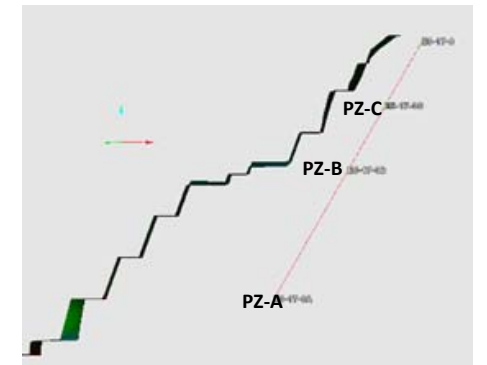
PE5-17-03 PZ-A,B,C

- Minor variations in pressure are related to mining activities (drilling/blasting) in Pit E5
- The temperature for PzA is holding at a steady trend, meanwhile PzB and PzC are showing a cooling trend .
- PzC is considered to be frozen (-0.447°C) . Augmentation of the pressure level is attributed to that.

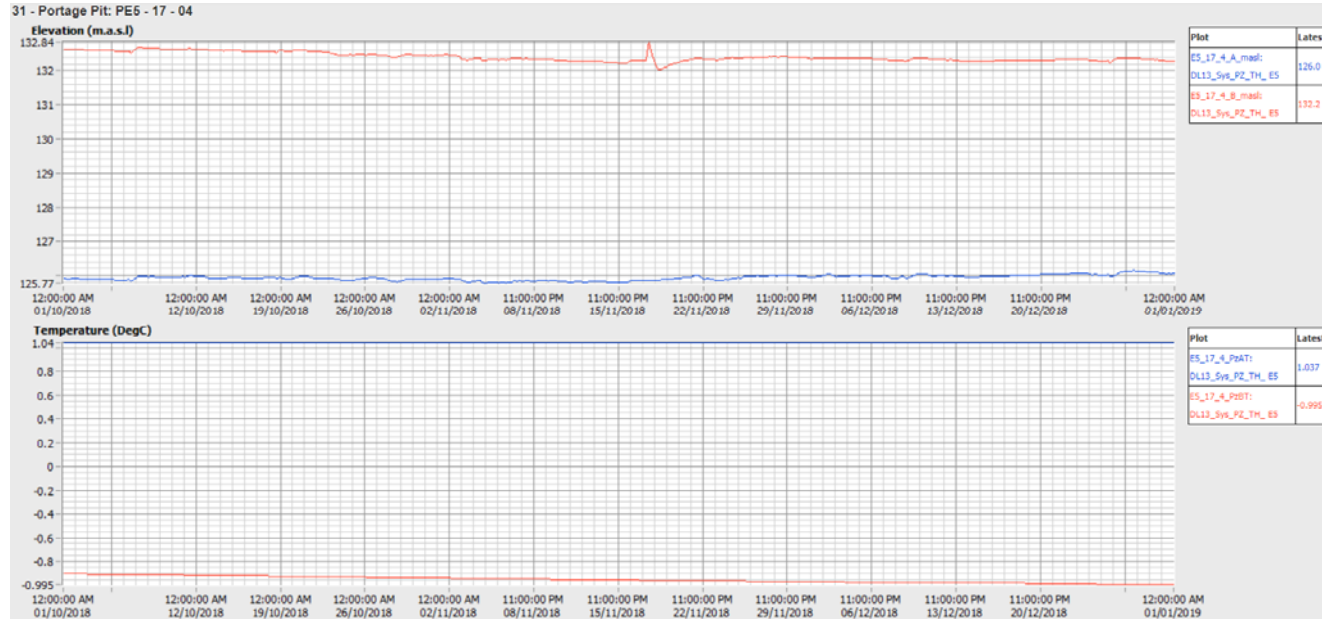
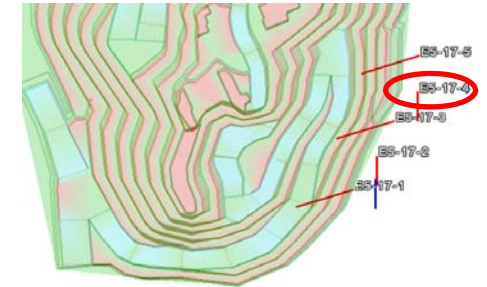
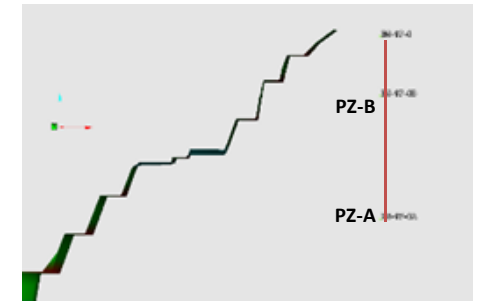
PE5-17-04 PZ-A,B

- Minor variations in pressure are related to mining activities (drilling/blasting) in Pit E5.
- Temperatures in PzA is on a constant trend, whilst temperature in PzB is showing a cooling trend.
- PzB is considered to be frozen (-0.995°C).

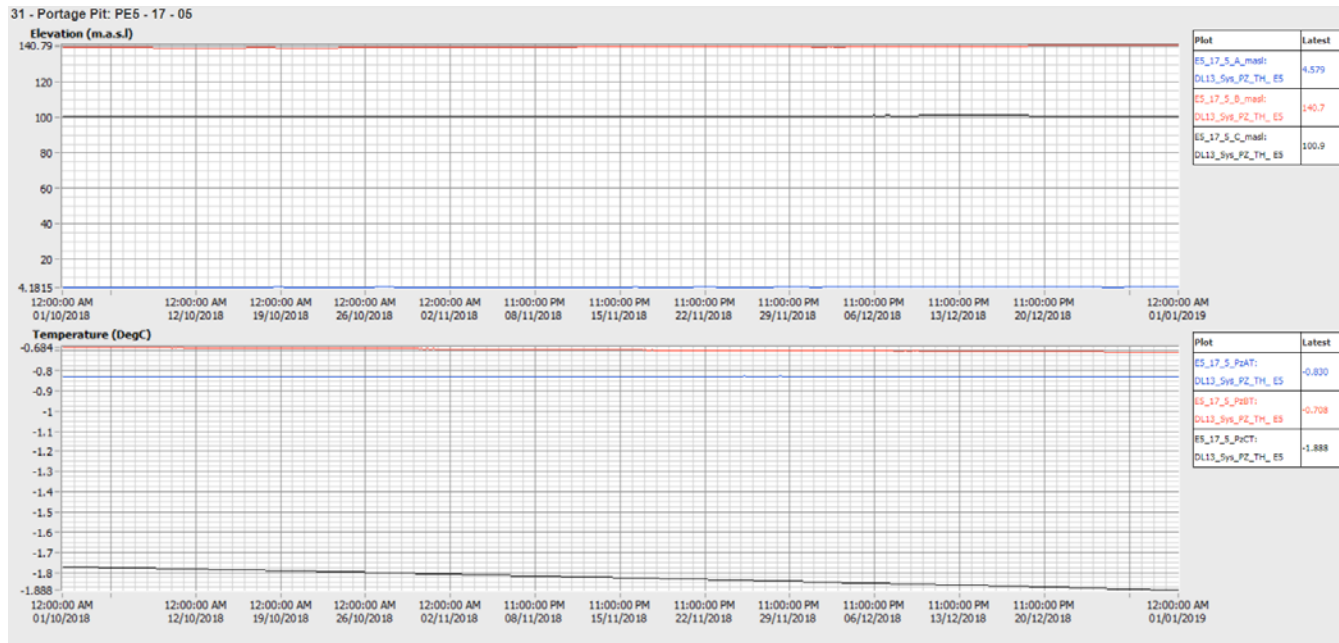
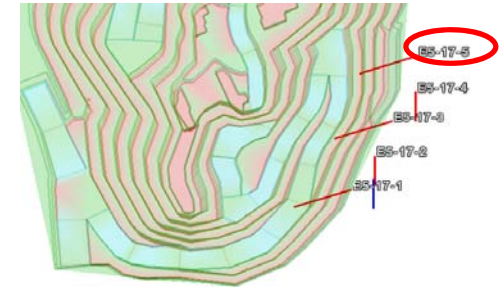
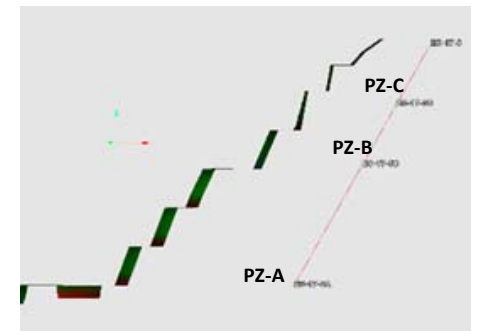
PE5-17-05 PZ-A,B,C

- PZ-A,B and C are considered to be frozen. The pressure measurements are considered unreliable.
