Meadowbank 2019 Annual Pit Slope Performance Review

2019 ANNUAL PIT SLOPE PERFORMANCE REVIEW

MEADOWBANK MINE, NUNAVUT

OCTOBER 11, 2019

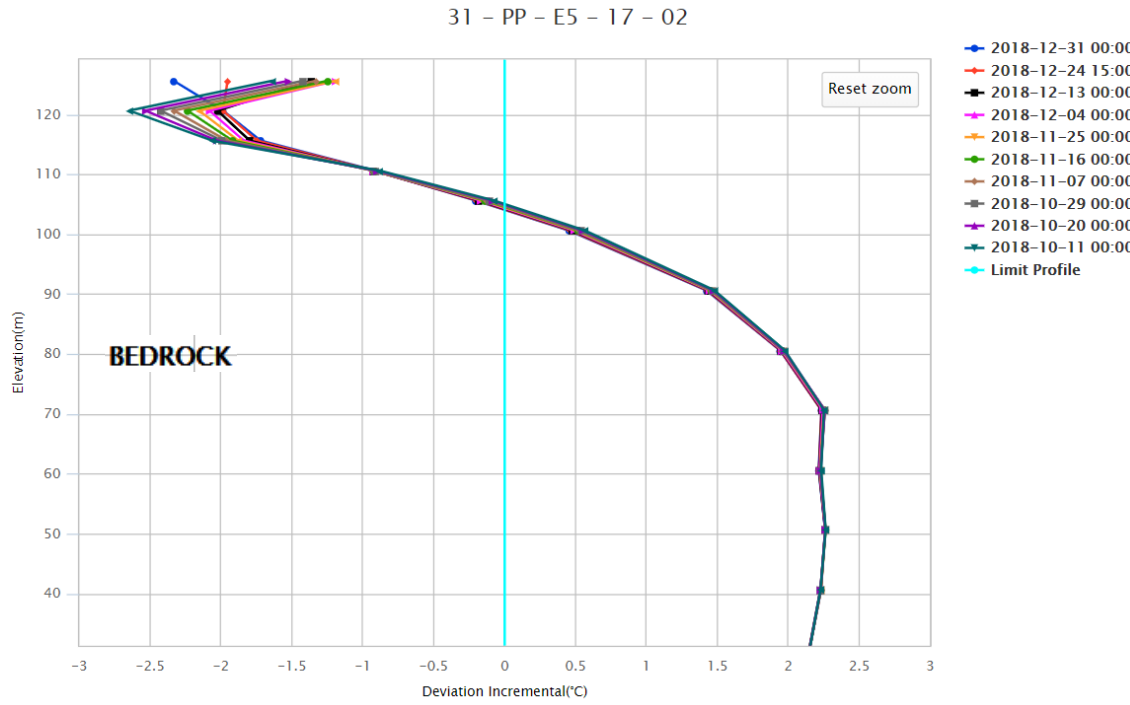
PP-E5-17-02

- There is a permafrost layer from the top of the hole at elev. 125 to the elev. 105 MASL. It suggests an aggradation of the permafrost from the surface since the dewatering of the lake in 2011.
- Apart from the 2 upper beads (which are showing a slight variation in the first 5 meters), only minimal variations were recorded during the period.

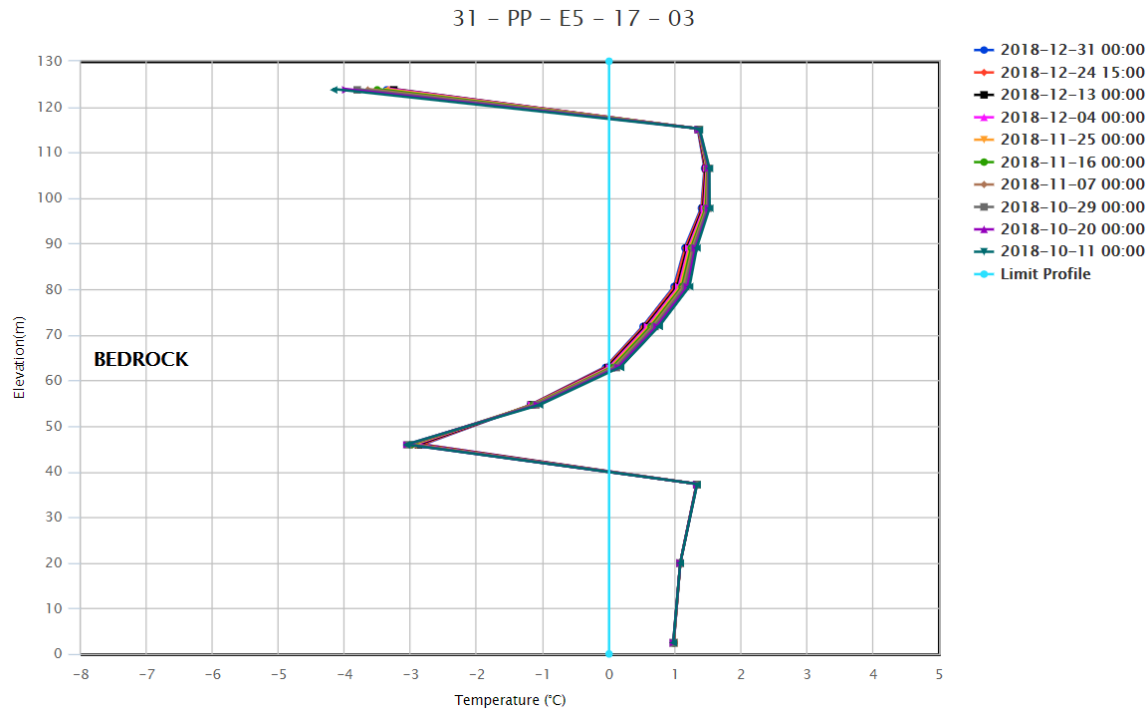
PP-E5-17-03

- Only small variations of the thermistor occurred during Q4.
- There is a unexplained permafrost layer between elevation 40 and 55 m.a.s.l.

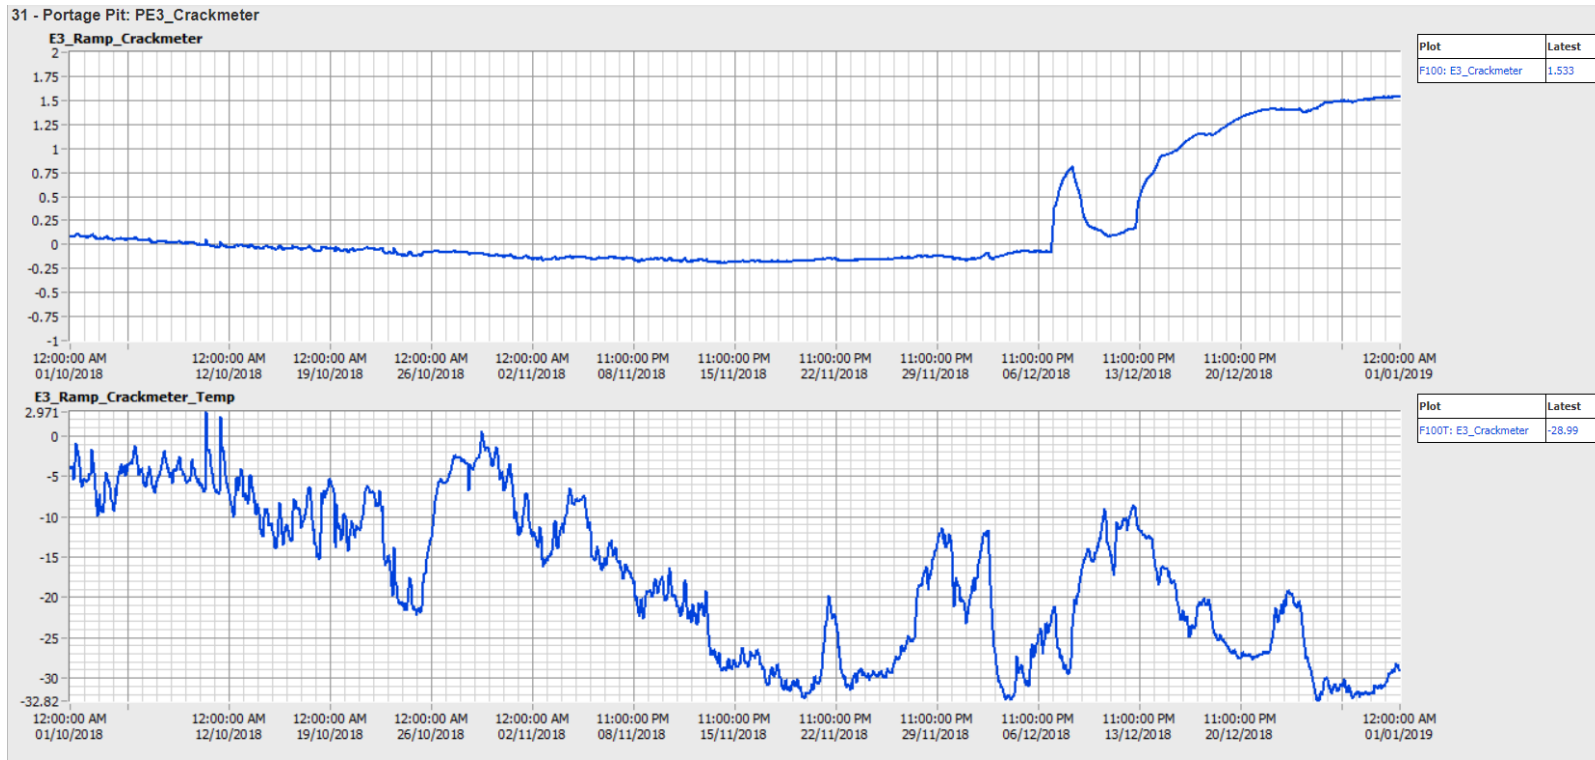
PE3_Crackmeter

- Variation start appearing around December 7th. Ice formation or snow accumulation is a contributing factor in the variations of the deformation

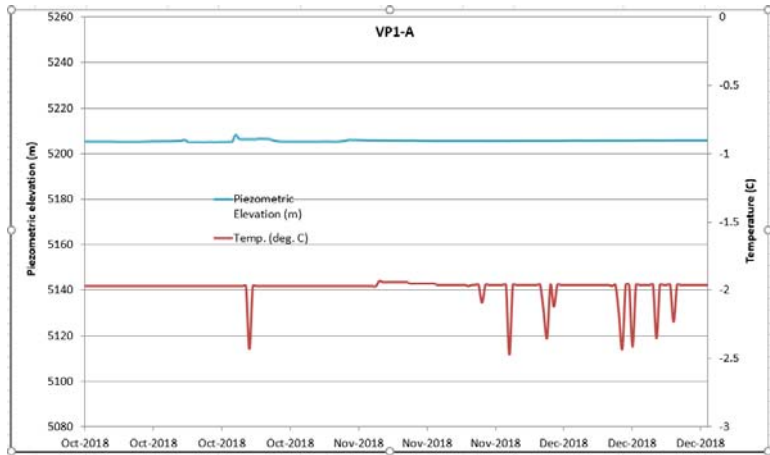
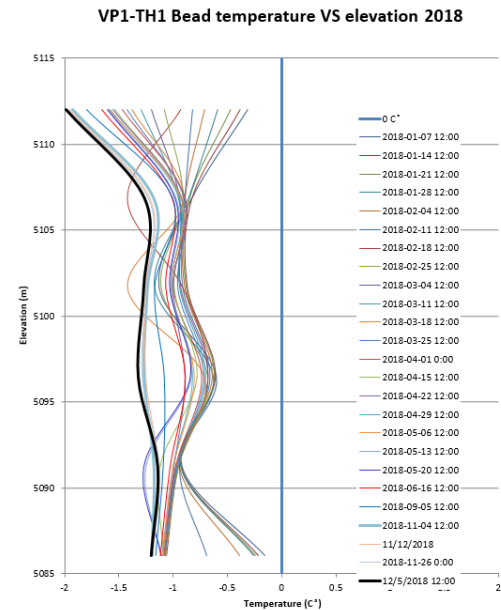
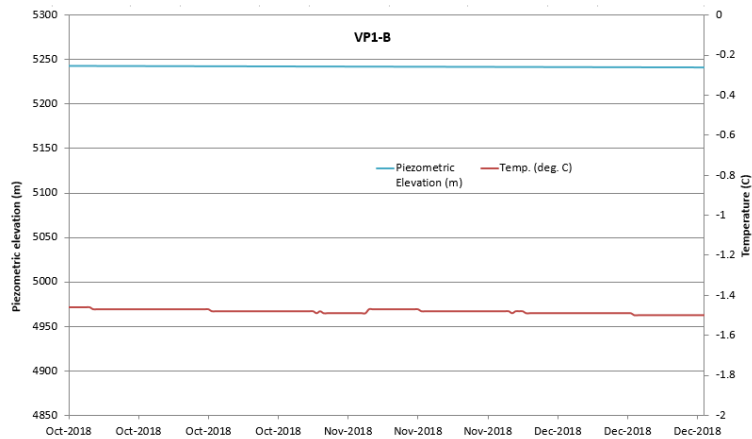
VP1-A, VP1-B, VP1-TH1

- PZ-A&B are below the freezing point. Pressure measurements are therefore considered unreliable.
- The thermistor remained frozen during Q4, 2018.

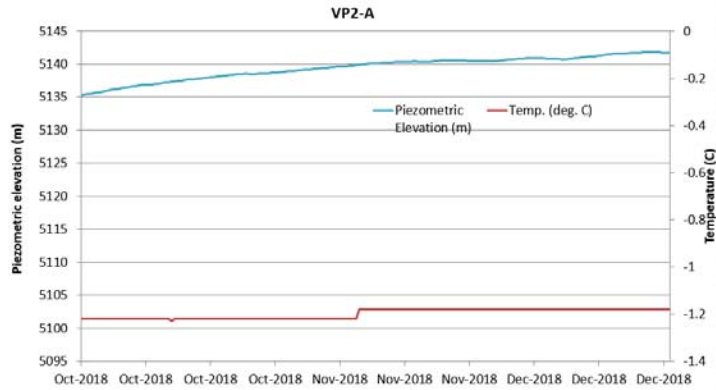
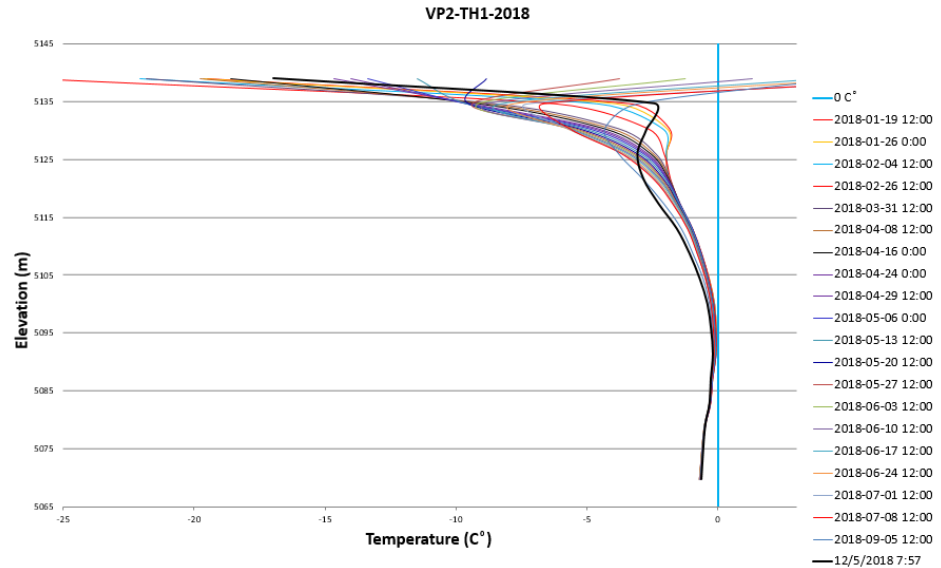
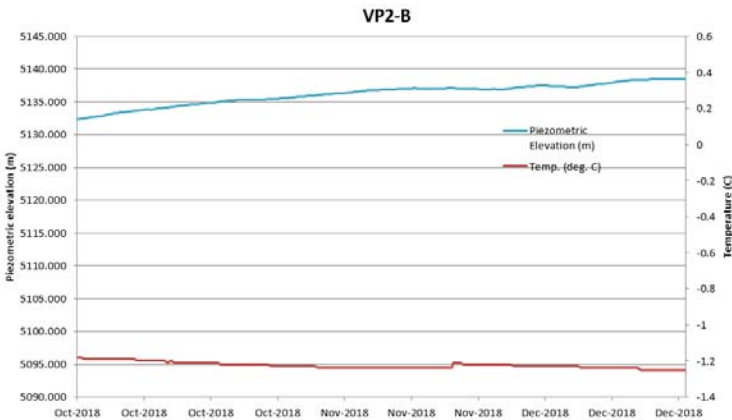
- PZ-A&B are below the freezing point since their installation and their data are considered unreliable.
- The section between 5105 and 5085 is close to the freezing but still below. Apart the top beads, minimal variations were recorded for the rest of the hole.

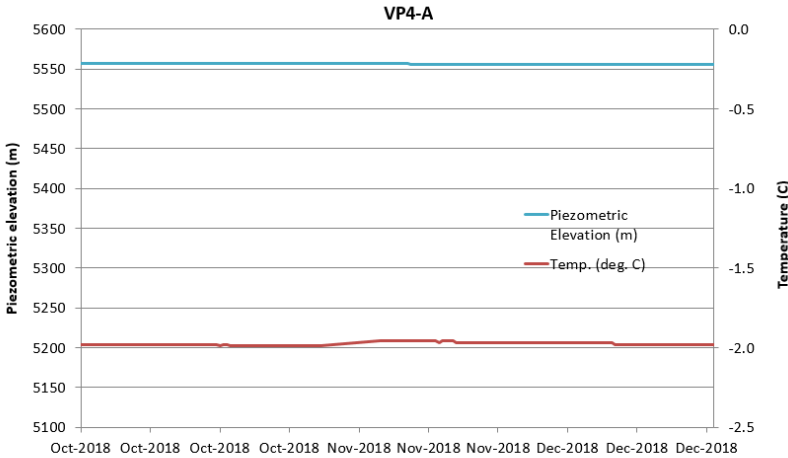
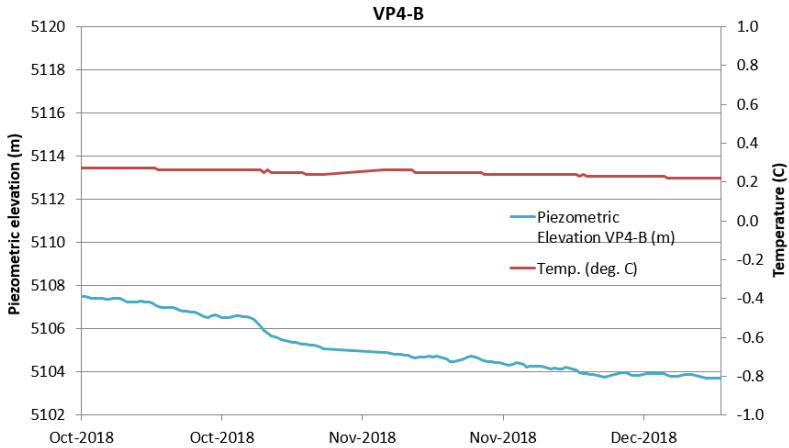
VP4-A, VP4-B

- PZ-A is under the freezing point and considered unreliable.
- PZ-B shows minor variations. The instrument is installed in the confined layer of talik between 5105 and 5095 at the source of the seepage causing the major ice wall in the area.
- The temperature of PZ-B is on a very slight downward trend suggesting a freeze back of the slope and aggradation of permafrost.

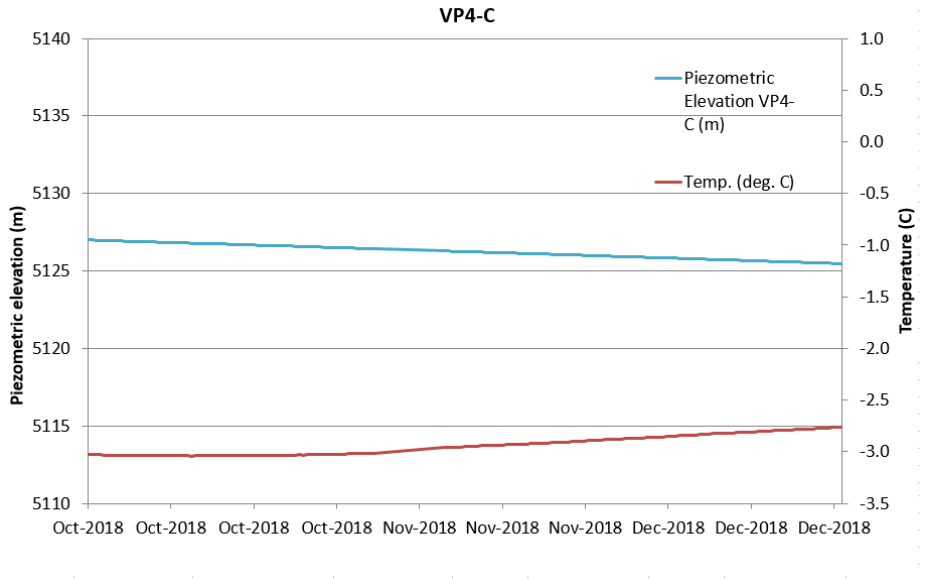
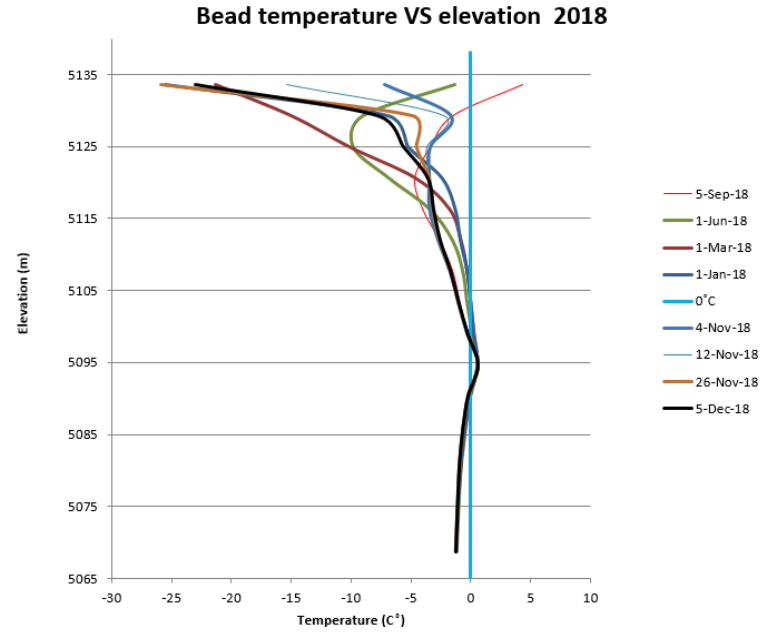
VP4-C, VP4-TH1

- PZ-C is frozen and data is considered unreliable.
- The thermistor show that the hole is mainly in the permafrost at the exception of the section in between 5100 and 5095 (0.57°C). This zone causes the seepage and therefore the ice wall.

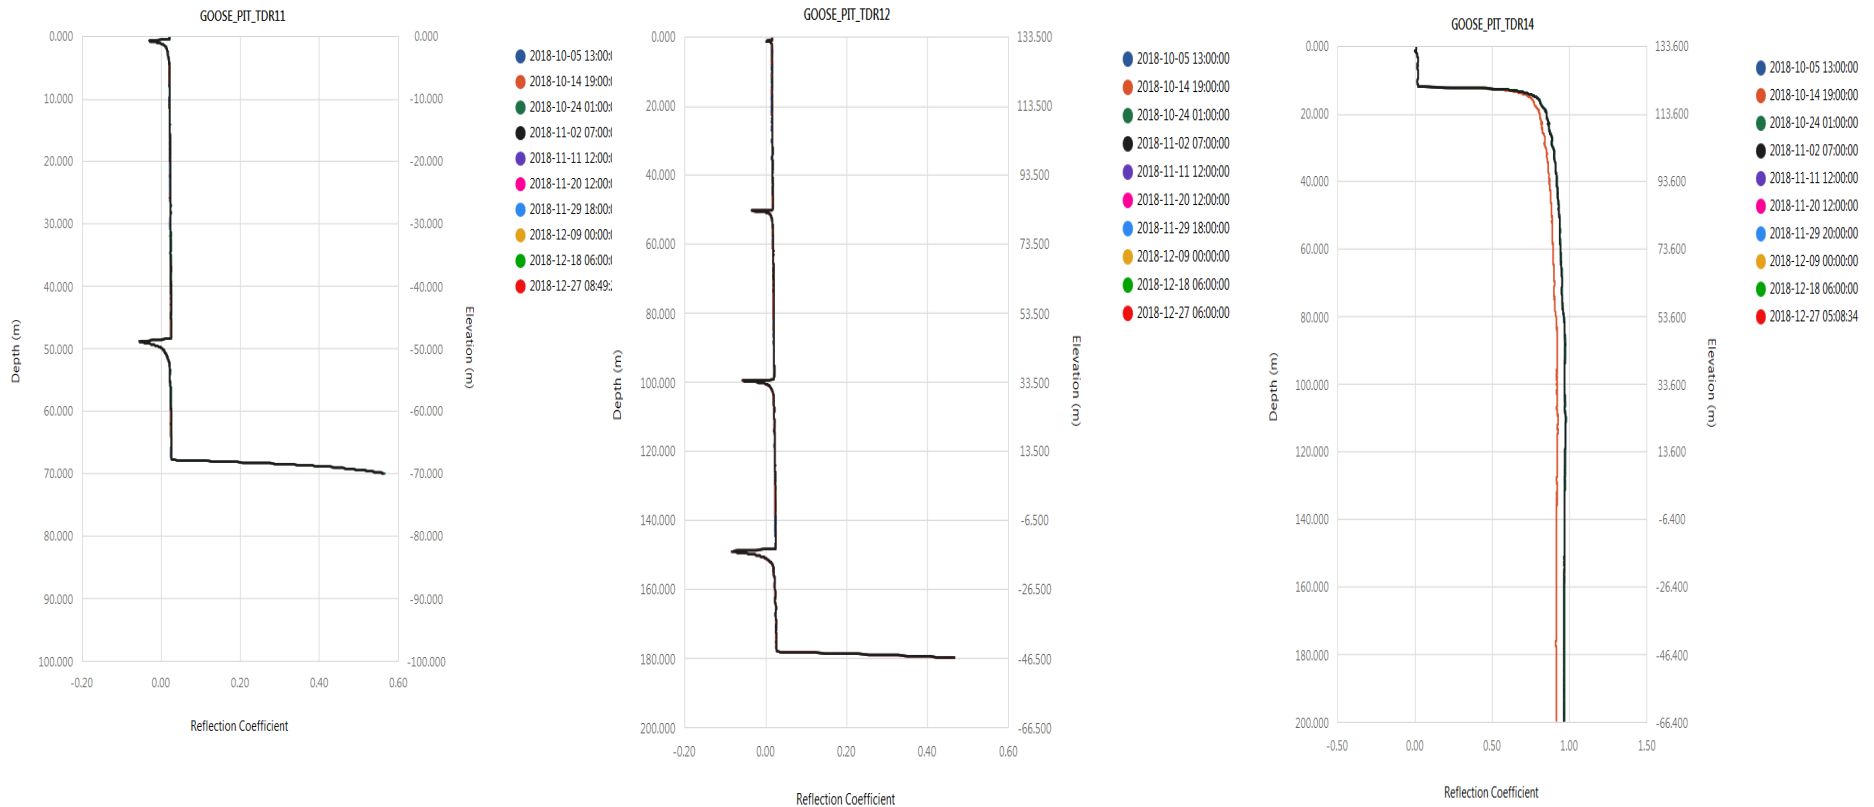
- No sign of deformation was observed in these TDRs.
- Anomalies from the TDR logger are still presents and were disregarded in the presented graphs. We are currently still trying to find a solution for this problem but it does not compromise the data integrity.
- TDR 14 was pinched at installation and therefore result might be compromise in the case of an event raising the reflection coefficient.

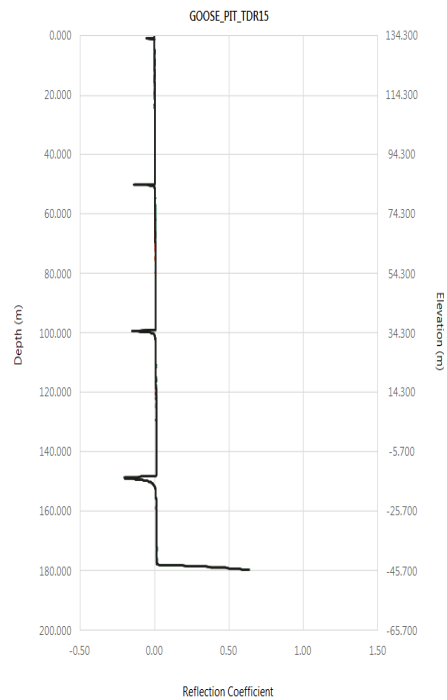
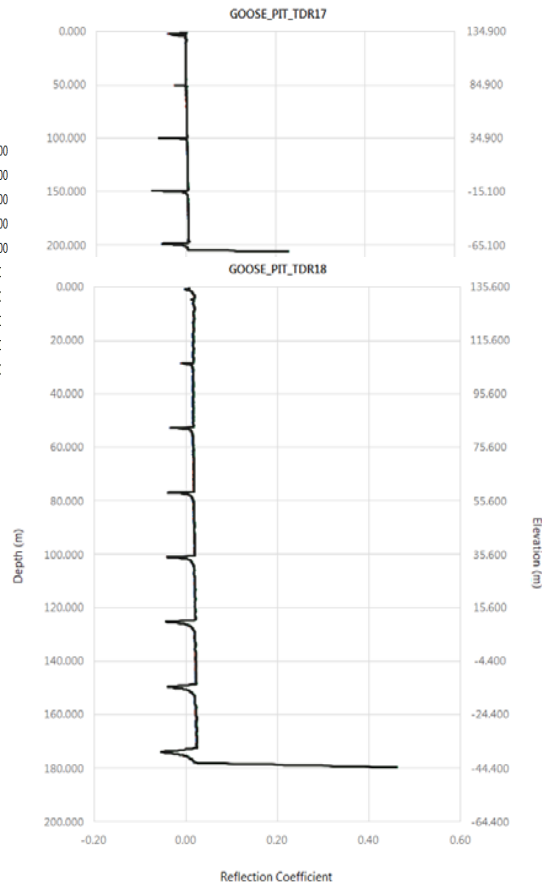
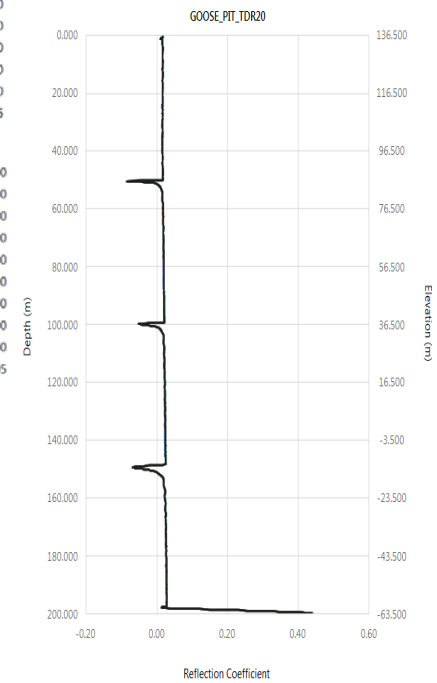
➤ No sign of deformation was observed in these TDRs.

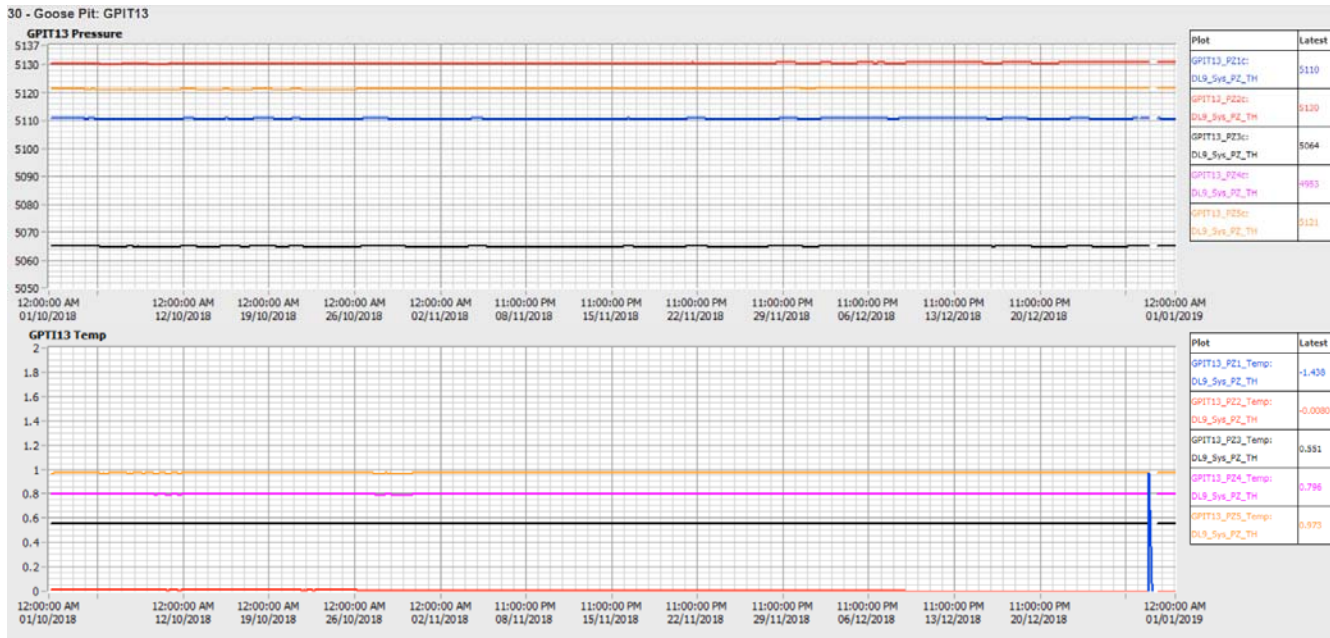
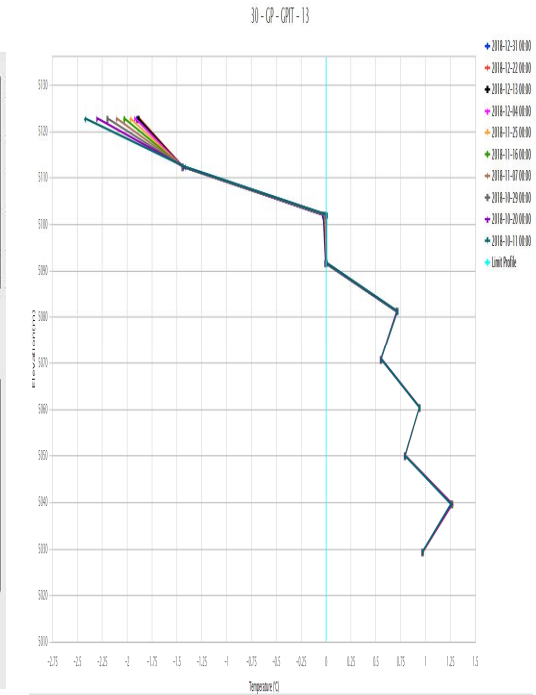
- Piezometer battery went down on December 30th and stop measurements for 24 hours.
- All piezometers presents little or no variation during the Q4, 2018. Piezometer GPIT-13-PZ1 is frozen. GPIT-13-PZ2 is just below 0 °C.
- The beads of thermistor GPIT-13 are stable. The first bead temperature change is consistent with the warming trend during at this time of year. This is consistent with the previous years and with the thermal dynamics of the area.

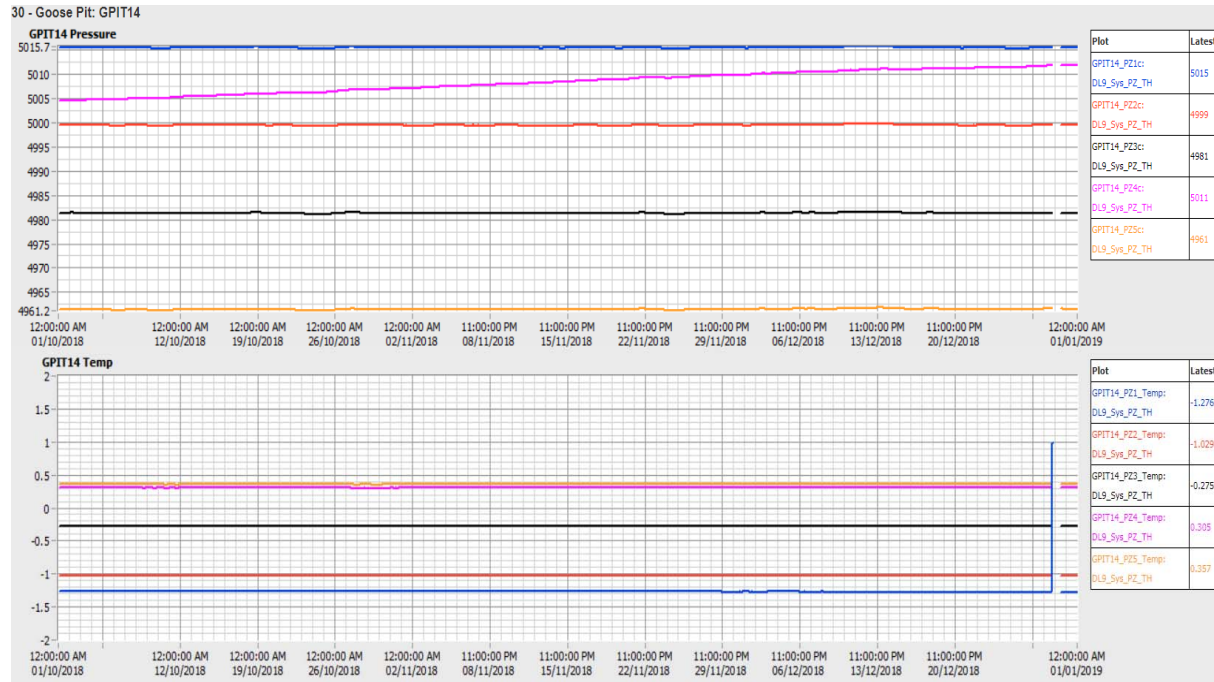
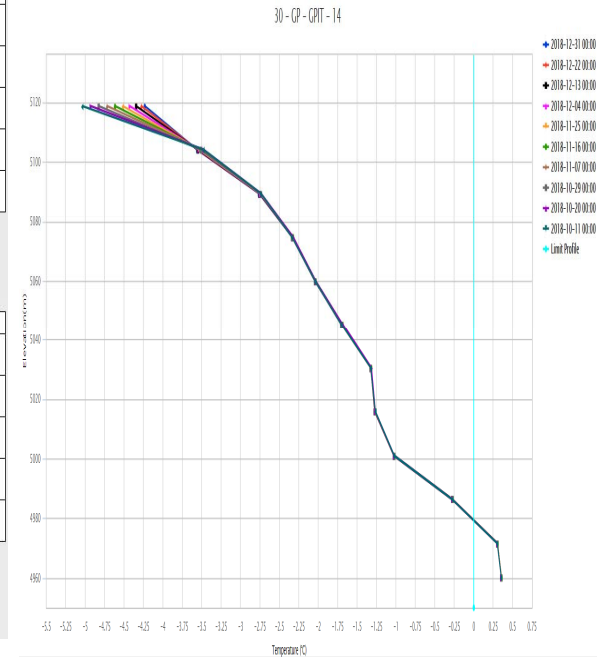
GPIT-14-PZ-1-2-3-4-5, GPIT-14-TH

- Piezometer battery went down on December 30th and stop measurements for 24 hours.
- Pz4 is on a slow rising trend. It rose 4 m of pore water pressure during the fourth quarter and that could be related to the water level within the Goose pit that is raising (natural flooding).
- PZ-1,2,3 are below the freezing point.
- TH-GPIT-14 is in the permafrost from top at elevation 5120 to 4980. The last 20m of the hole is above the freezing line. The first bead temperature change is consistent with the warming trend during at this time of year. This is consistent with the previous years and with the thermal dynamics of the area.

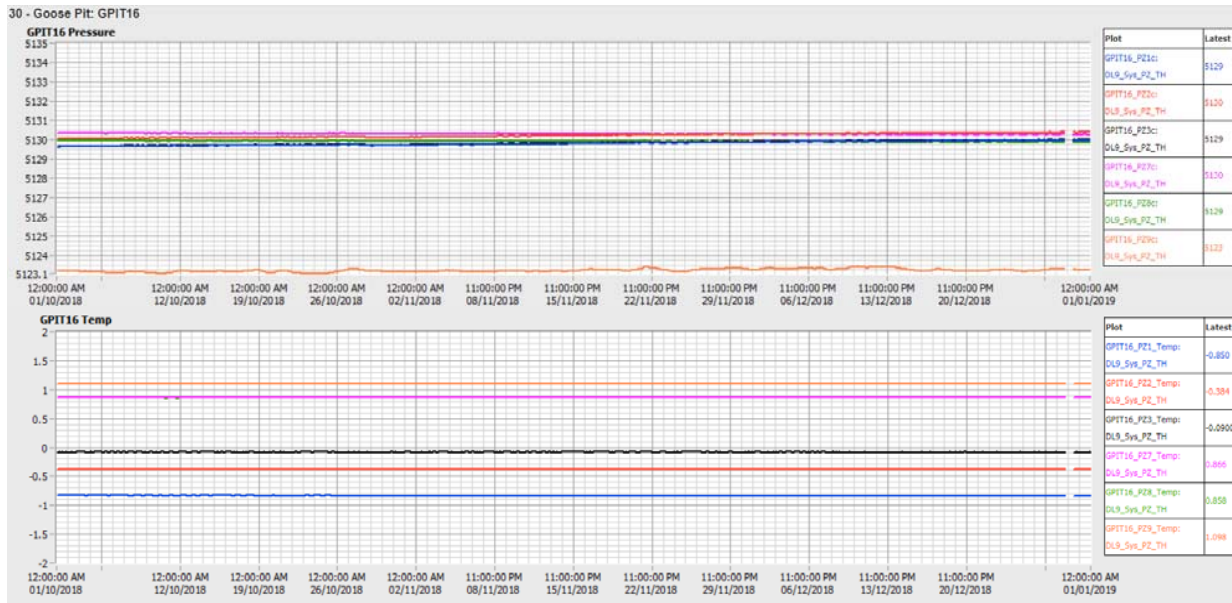
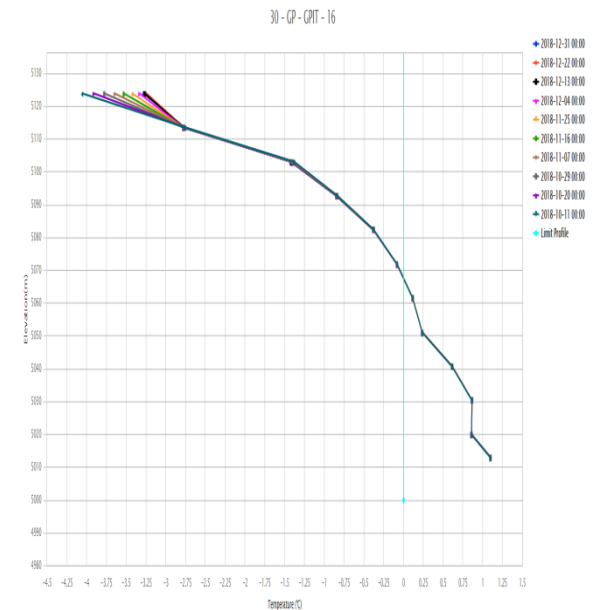
- Piezometer battery went down on December 30th and stop measurements for 24 hours.
- PZ-1,2,3 are below the freezing point and can't be considered reliable.
- TH-GPIT-16 is in the permafrost from top at elevation 5124 to 5068. The first bead temperature change is consistent with the warming trend during at this time of year. This is consistent with the previous years and with the thermal dynamics of the area.

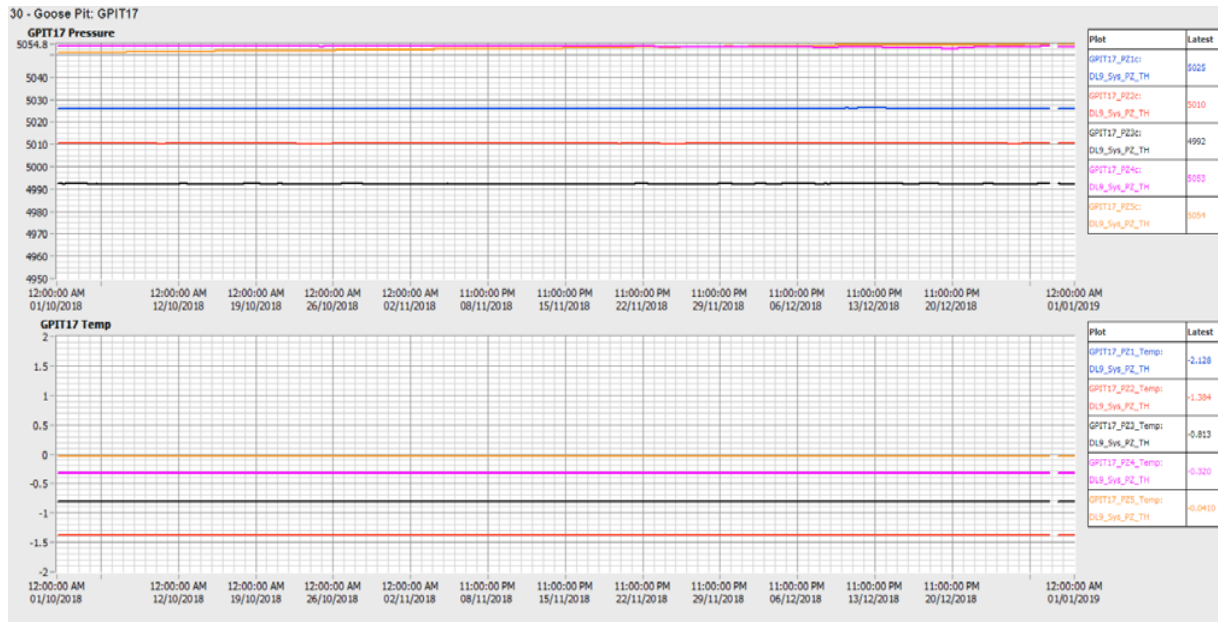
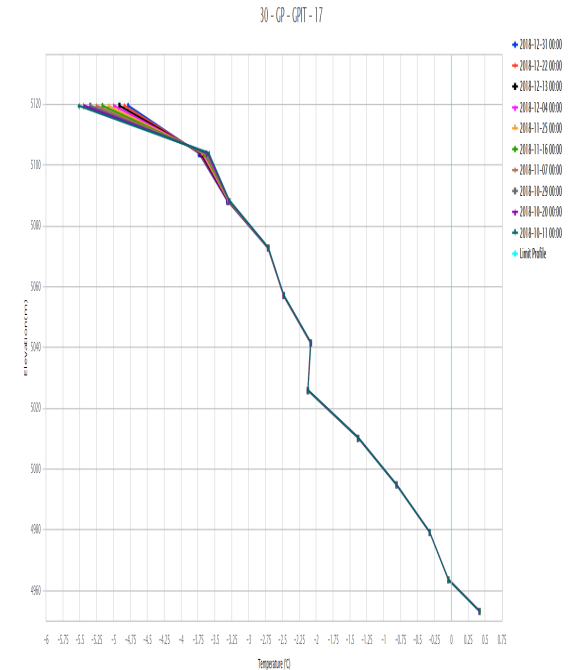
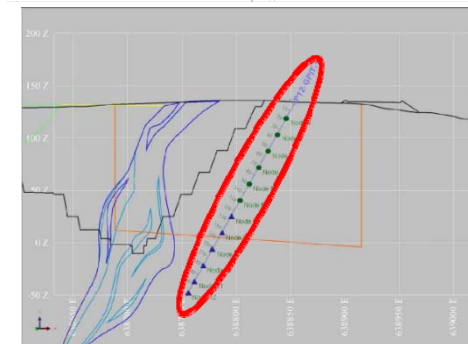
- Piezometer battery went down on December 30th and stop measurements for 24 hours.
- PZ-1,2,3,4&5 are below the freezing point and can't be considered reliable.
- TH-GPIT-17 is in the permafrost from top at elevation 5119 to 4962. The first bead temperature change is consistent with the warming trend during at this time of year. This is consistent with the previous years and with the thermal dynamics of the area.

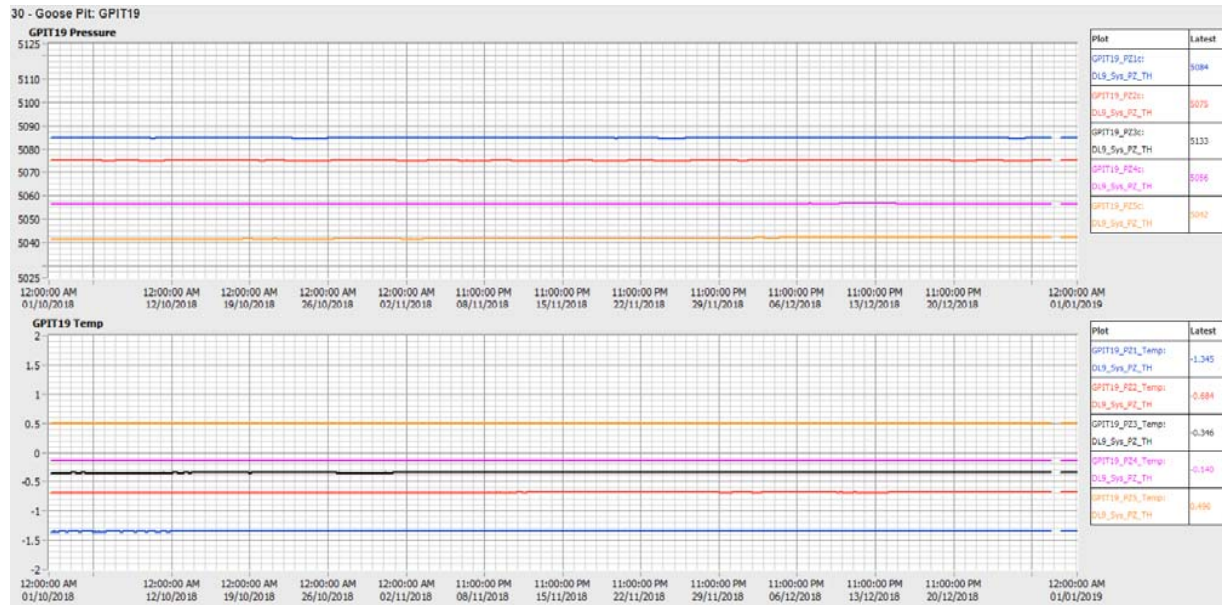
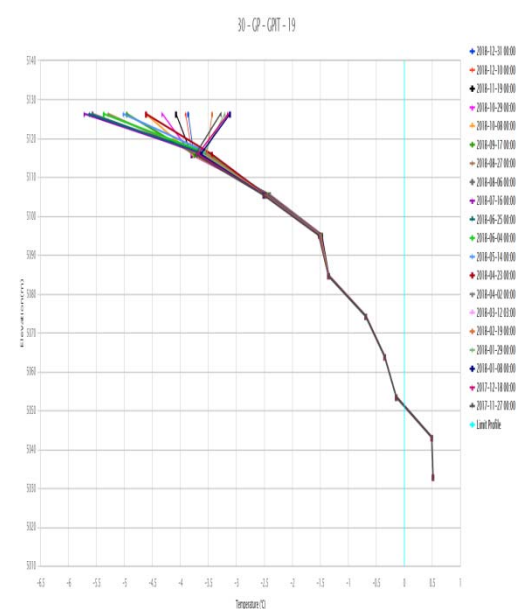
- Piezometer battery went down on December 30th and stop measurements for 24 hours.
- PZ-5 is above the freezing line and it shows little or no pore water pressure variations during the Q4, 2018.
- PZ-1,2,3,4 are below the freezing point and can't be considered reliable.
- TH-GPIT-19 is in the permafrost from top at elevation 5126 to 5051. The first bead temperature change is consistent with the warming trend during at this time of year. This is consistent with the previous years and with the thermal dynamics of the area.

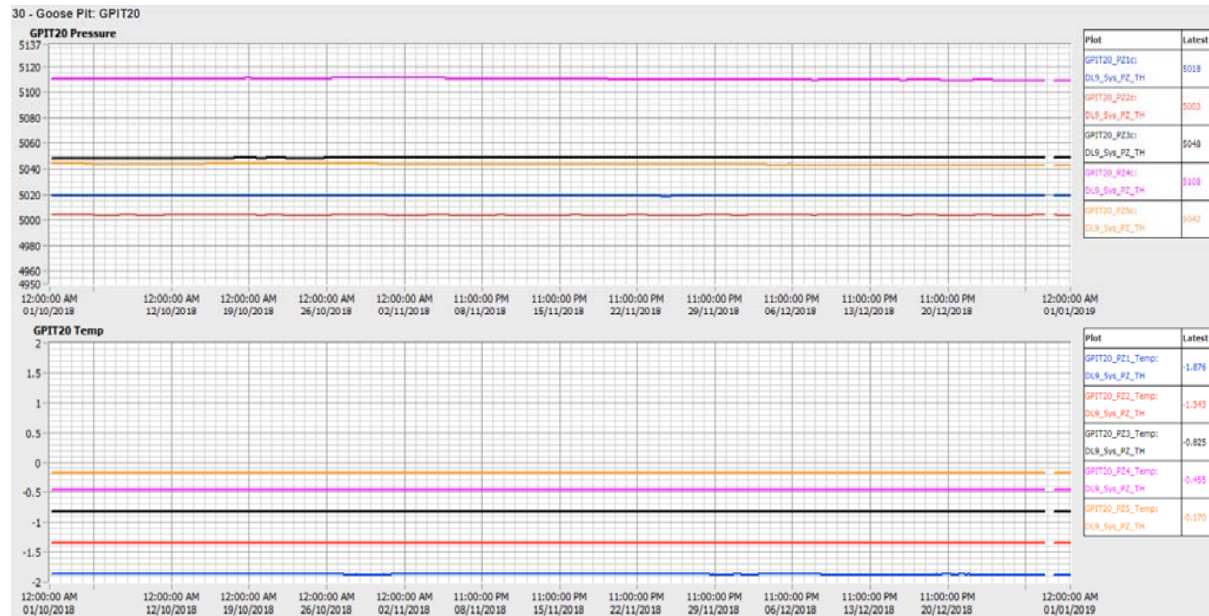
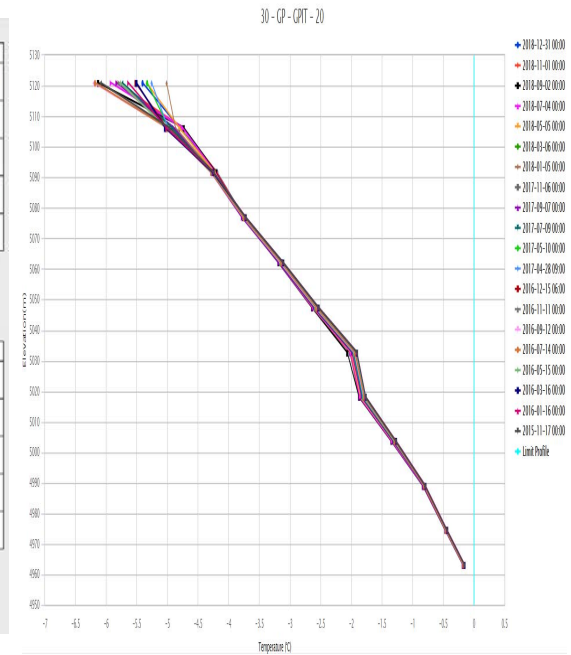
- Piezometer battery went down on December 30th and stop measurements for 24 hours.
- PZ-1,2,3,4,5 are below the freezing point and can't be considered reliable.
- TH-GPIT-20 is in the permafrost on its entire length from is top at elevation 5121 to the bottom at 4963. The first bead temperature change is consistent with the warming trend during at this time of year. This is consistent with the previous years and with the thermal dynamics of the area.

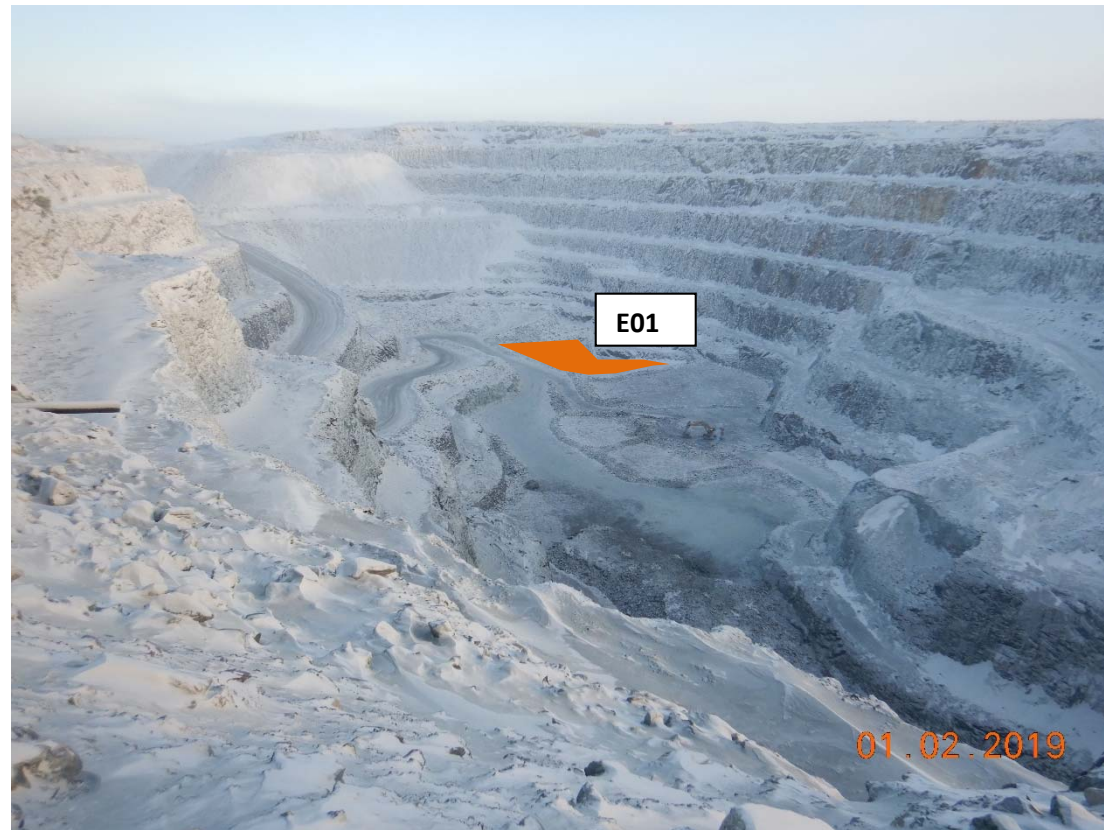
<p>PREVIOUSLY: There are fair size blocks cracked along three planes and part of a partially dislodged wedge and dipping toward the pit right below the crest of the high wall. These are located on the eastern corner at the junction in between the old pit part and the newly mined one.</p> <p>UPDATE: The blocks are still present and for mechanical availability reasons they were not dislodged. However, with the blasting occurring nearby it was judged stable enough to be monitor only, since we got down one bench already.</p>	<p>PREVIOUSLY: Scale and hammer the unstable blocks prior of going further down.</p> <p>UPDATE: Those blocks will be monitored as they may presents risk during freshet.</p>	NA	NA

Zone E01: Pit E3: E01: Restricted access for pumping.

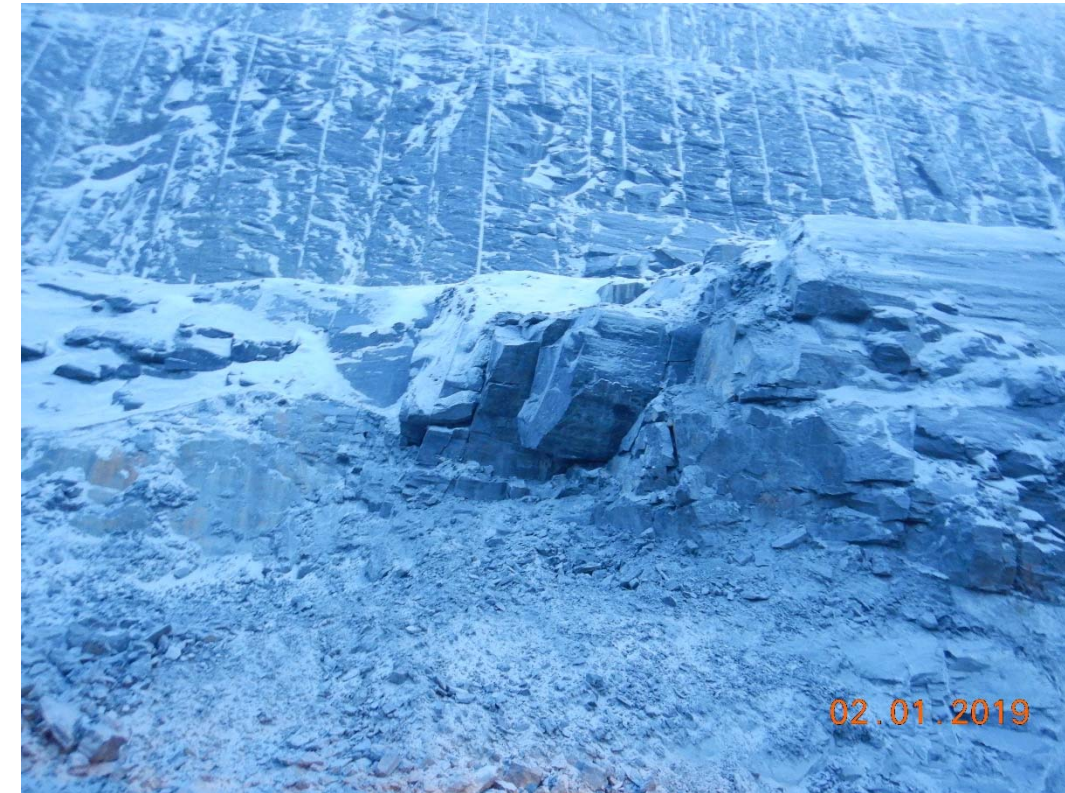
Zone E53: Fair size broken blocks to be monitor with radar.

Zone E53: E5, East Wall: to be monitored with the radar.

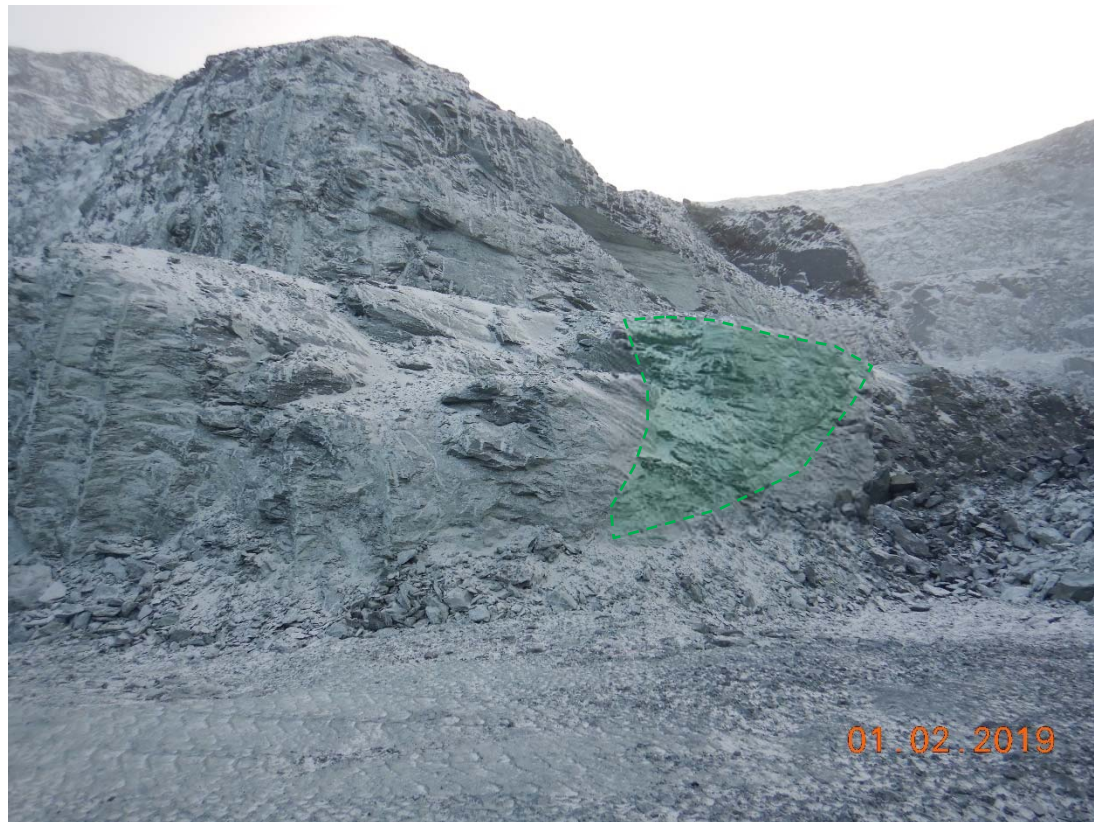
Zone E54: E5, East Wall: Potential wedge was investigated with the shovel and stayed in place.

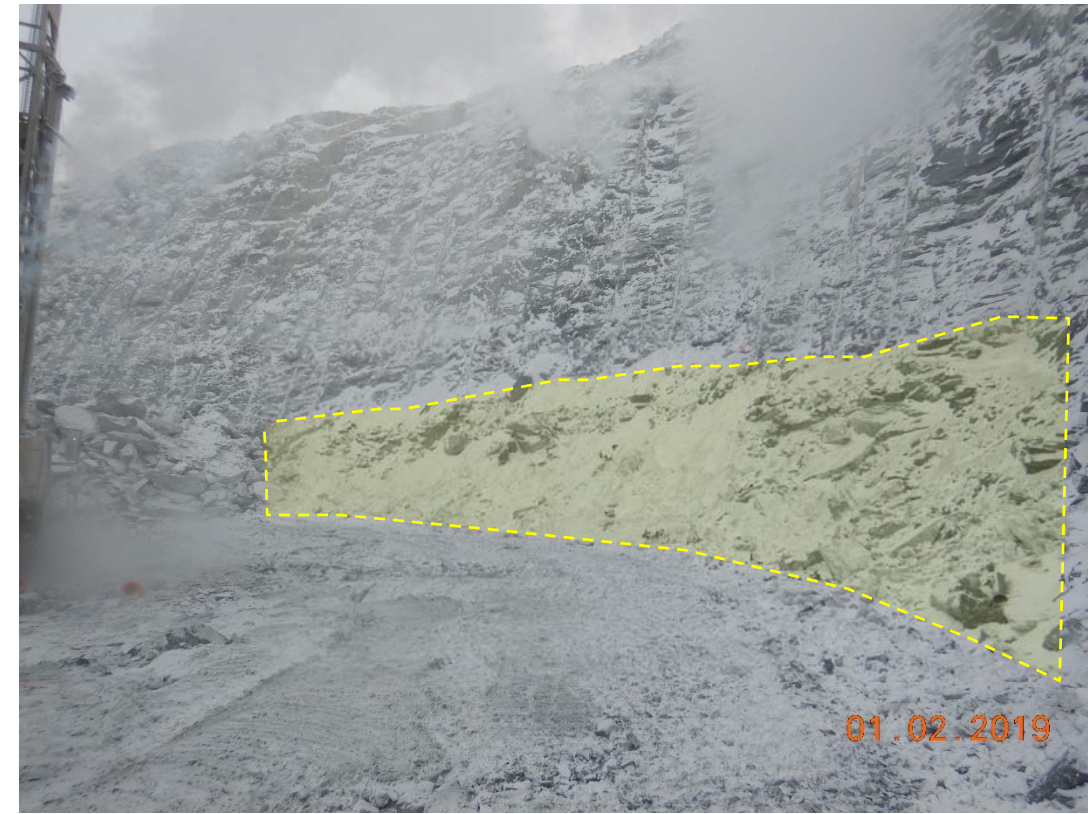
<p>Zone: BB12 Pit: BB Phaser Wall: North Bench: 5109</p> <p>Status: </p>	<p>PREVIOUSLY: The lower section of the high wall was mucked out and presents a rather competent wall with occasional toes and debris at its base.</p> <p>UPDATE: Work haven't been done because of mechanical availability and blasted material in the way. The lower south east corner is having the more debris and loose rocks on its wall.</p>	<p>PREVIOUSLY: Hammer the toes along the wall and clean the debris of this area as it is meant to become a catch bench.</p> <p>UPDATE: A good clean up is mandatory especially on the south east corner.</p>	<p>Mar 1st, 2019</p>	<p>NA</p>
<p>Zone: BB13 Pit: BB Phaser Wall: North East Bench: 5109</p> <p>Status: </p>	<p>PREVIOUSLY: The lower north east corner of the high wall is made of a toe with considerable proportions (10mx20mx2m).</p> <p>UPDATE: Work haven't been done because of mechanical availability and blasted material in the way.</p>	<p>PREVIOUSLY: It is recommended to hammer this toe. However, depending on the hammer availability effort should be concentrated on pit E5 south section for the time being.</p> <p>UPDATE: Hammer the toe whenever possible.</p>	<p>Mar 1st, 2019</p>	<p>NA</p>

Zone BB12: BB Phaser, North Wall: Hammer the toes along the wall and clean the debris of this area as it is meant to become a catch bench.

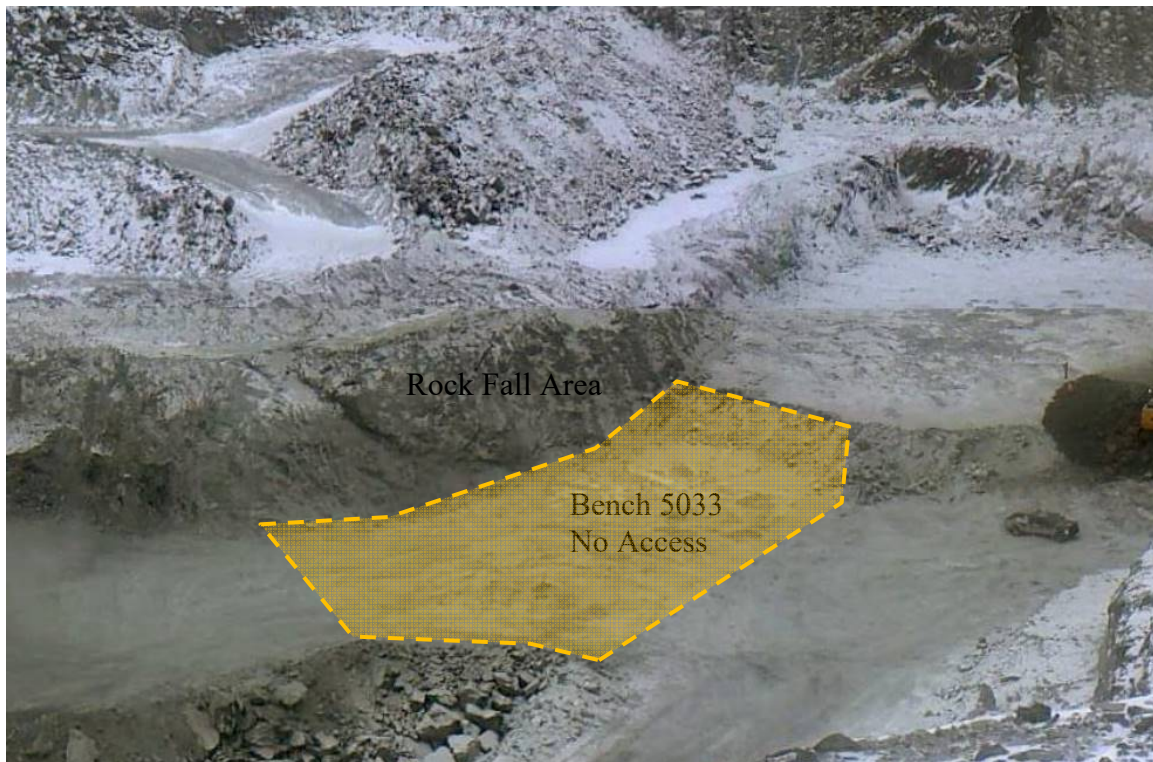
In the morning of September 27th, 2018 a large crack in the wall was observed by pit personnel in the 5033 bench area of Pit E5. Following these events, a back analysis was done on the area using the radar data and it was determined that there was to be a rock fall event. During this time, the area was bermed off and no personnel were to be present in the area.

Fig.1: Photo taken from radar location at 9h30 on Sept. 27th, 2018 prior to rock fall.
