Meadowbank 2019 Annual Pit Slope Performance Review

2019 ANNUAL PIT SLOPE PERFORMANCE REVIEW

MEADOWBANK MINE, NUNAVUT

OCTOBER 11, 2019

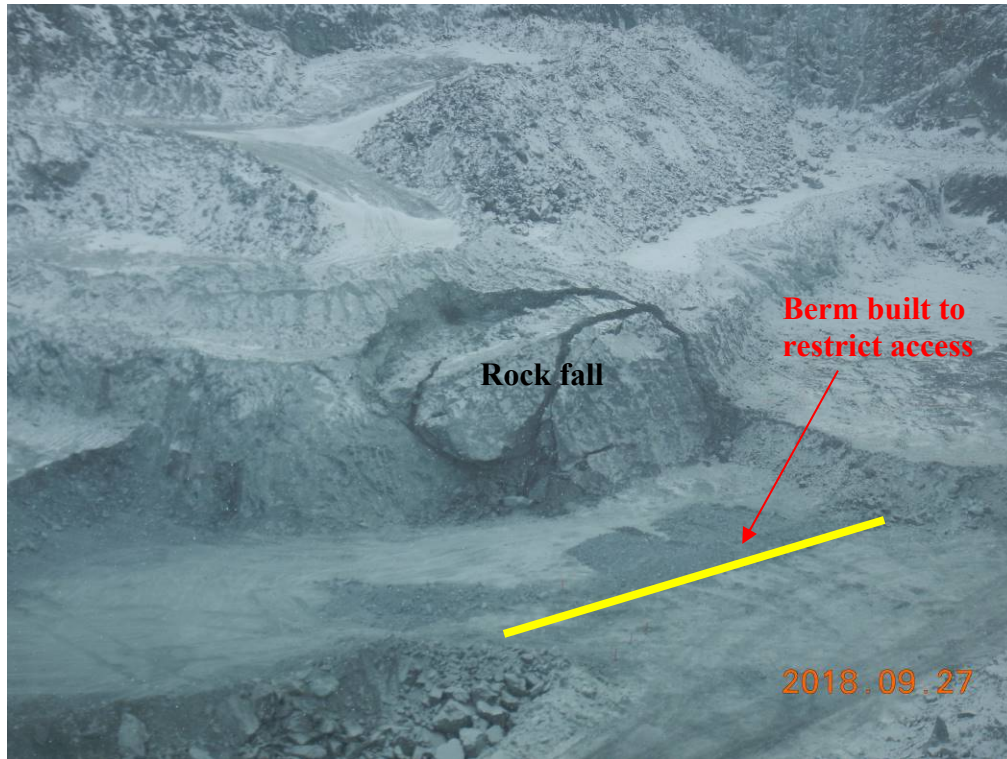
No personnel were injured and no equipment was damaged by the rock fall as the area had already been cleared.

Fig.2: Photo taken from radar location showing the same area after the rock fall occurred. Photo was taken at 11h45 on Sept. 27th, 2018. The rock fall has not stabilized yet and 2 large soapstone blocks will require special care to deal with.

- A monitoring program has been in place since the reopening of E5 and is still active which includes radar monitoring and inspections of the area.
- The area will be continued to be bermed off until a stable trend is observed in the radar monitoring and then the mine will prepare to remove the loose material.
- The plan is to use the RH120 with ramp if needed to be able to take some of the material down safely. If this does not work, then there will be a plan to put a ramp in place to access the area with the drill and blast equipment to try to break the material into smaller pieces for removal. All material will have to be taken back to the smooth stable slip plane visible behind the rock fall. The remediation is planned to begin once the area has stabilized.

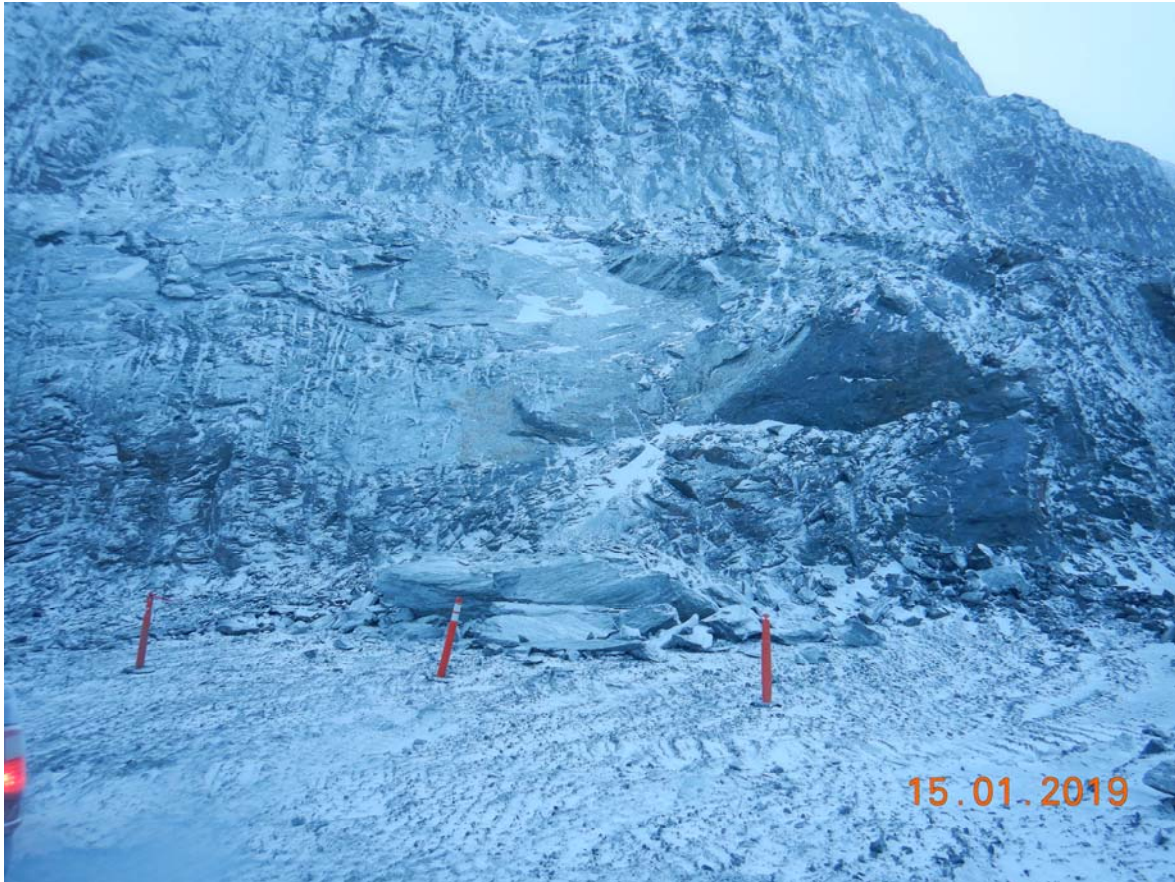
In the afternoon of January 14th, 2019, a rock fall of 127 tonnes occurred around 4h30PM. The loose material on the floor was noticed by pit personnel on the 5011 pit floor. No personnel or equipment were nearby during the event, and no injuries or material damage occurred. Following the event, the area was bermed off, preventing any access to the rockfall zone. Preliminary assessment indicated potential of further rockfall of the same magnitude.

Fig.1: Photo taken in day light at rockfall location at 10:30AM on January 15th, 2019.

- A monitoring program has been in place since the reopening of E5 and is still active which includes radar monitoring and inspections of the area.
- The area will remain bermed off until a stable trend is observed in the radar monitoring, and no field anomalies are observed. Following this, the mine will remove the loose material, and proceed to scale this area.

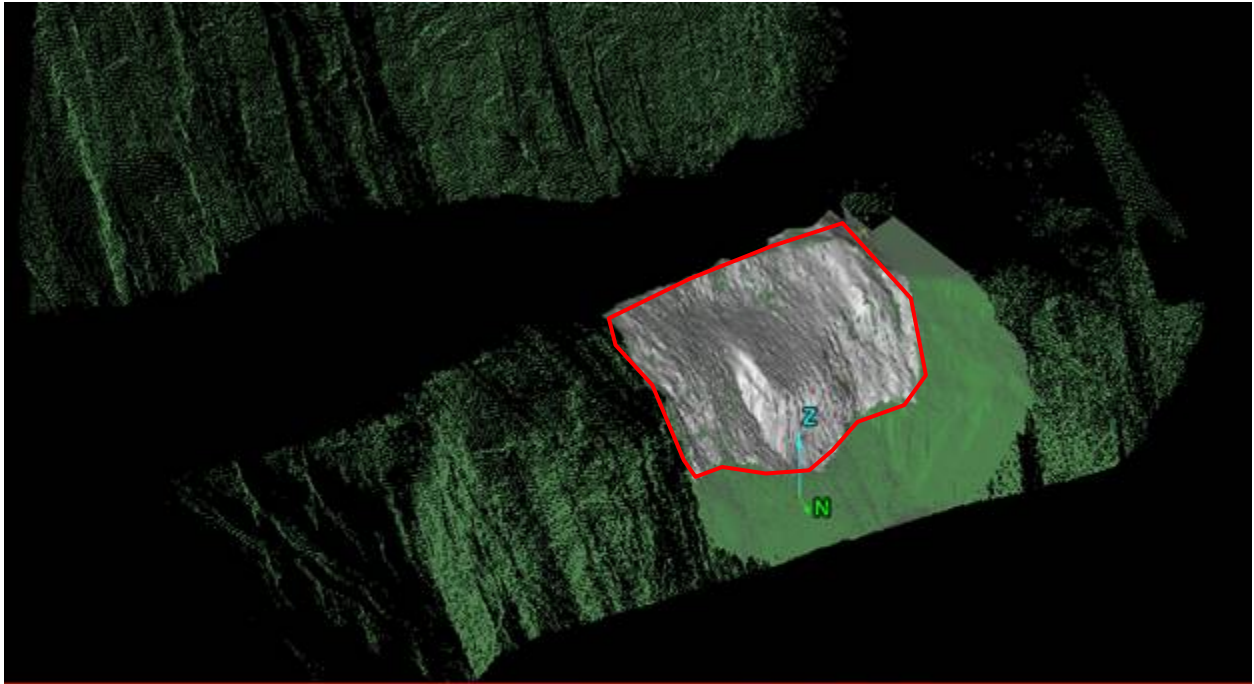
Fig.3: Volumetric Report showing 47.1 m³, or 127 tonnes

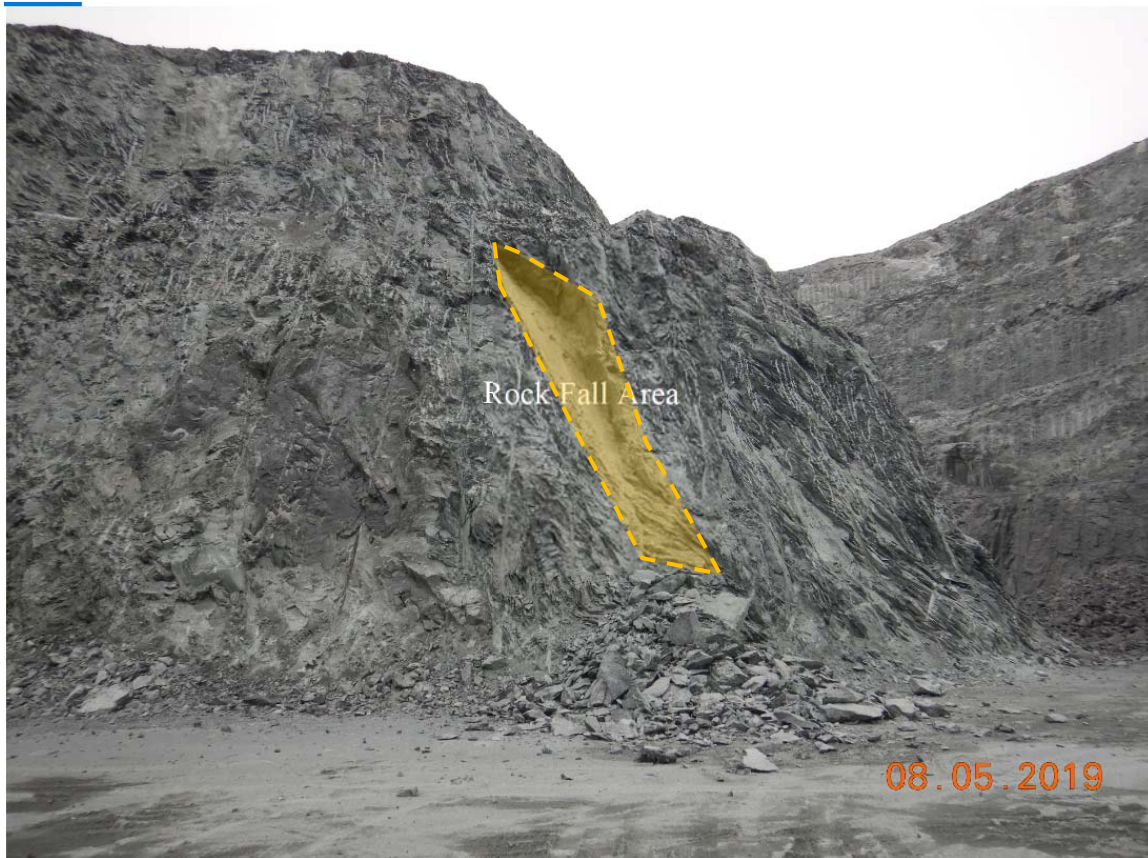
In the afternoon (17h30) of May 8th, 2019 a rock fall of approximately 110 tonnes occurred. Personnel working in the area observed the loose material on the floor of the 5004 area of Pit E5. Following the event, the loose material was cleaned up and a protective berm placed at 10m buffer zone around the area.

Fig.1: Photo taken after rock fall was reported.

- A monitoring program has been in place since the reopening of E5 and is still active which includes radar monitoring and inspections of the area.
- Back analysis on the radar's rockfall signature to target better the lower tonnage rockfalls and improve rockfall detection.
- Re-inforce, to all employee working in the pits, the importance of respecting the procedure "MBK-MINE-OPM-PRO Work close to pit walls". This is especially true with the upcoming freshet season.
- This section of the mining will have an 18m catch bench in place. Keep the berm in place during production to help mitigate any further material that may come off the wall during freshet. Keep area clean of any loose material that may collect within the bermed off area.
