Whale Tail Open Pit 2019 Annual Inspection

RE: Amaruq Mine - Whale Tail Open Pit - 2019 Annual Inspection

Amaruq Project – Whale Tail Open Pit

2019 Annual Inspection

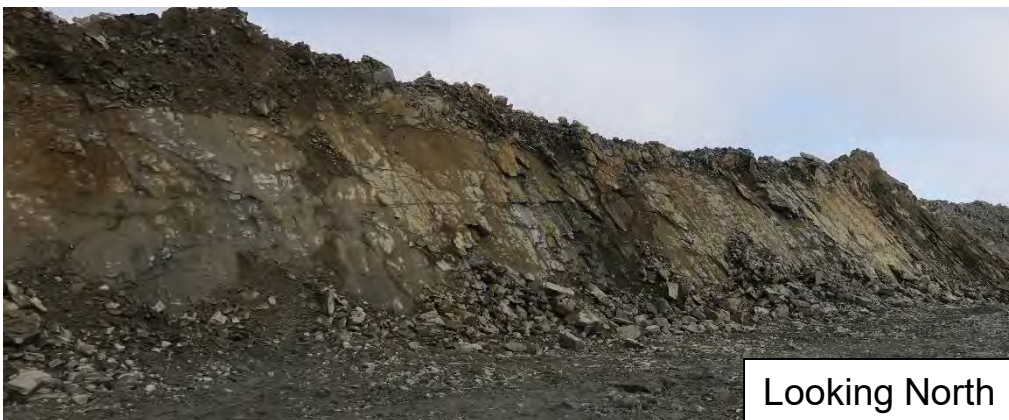
Former Shoreline

Observed Slope Performance

- First bench of the final pit wall in the Greywacke. Design Sector A1.
- The bench performance is controlled by the dip of the foliation, as expected. Bench face angle is approximately 65° , consistent with design.
- Recommend using Maptek Scanner to document bench performance and foliation dip.

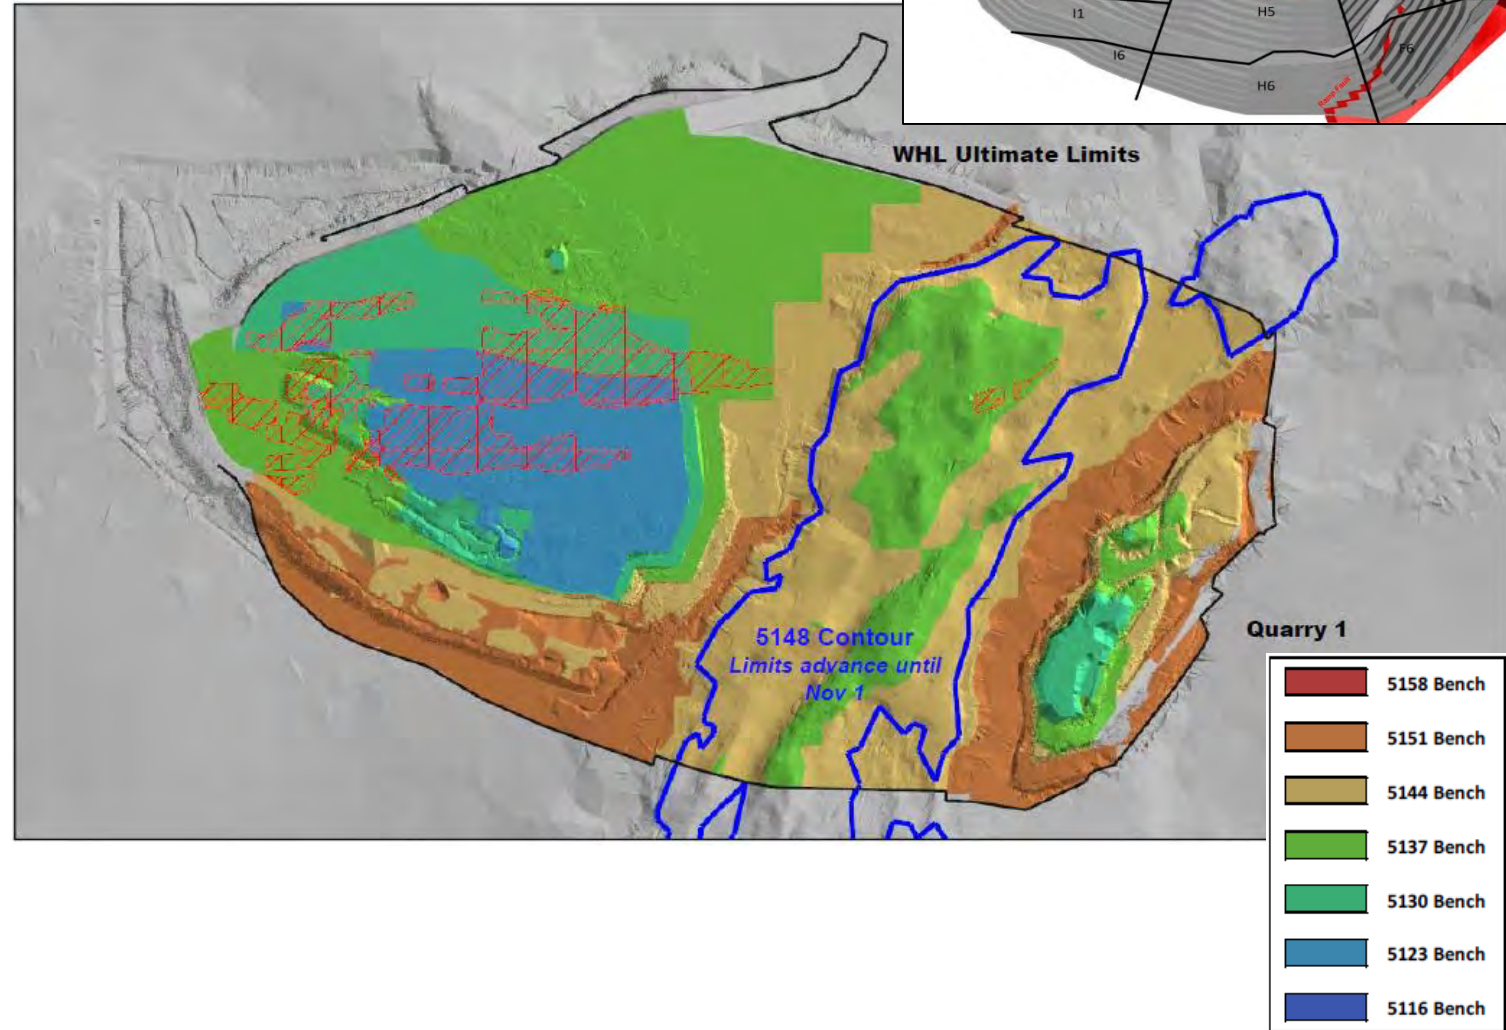
- Starting to establish final walls in Sectors A1 and B1 / B4. Important to start evaluating whether potential for planar failure on these walls is consistent with the FS. Especially since this is one of the last months where we have an opportunity to map / use the Maptek before winter.
- Along the East Wall, managing groundwater inflows and the potential for an inrush of surface water due to the proximity to the remainder of Whale Tail Lake has been an on-going issue. It is understood that conditions have improved significantly, though monitoring will be required until the lake is fully dewatered.

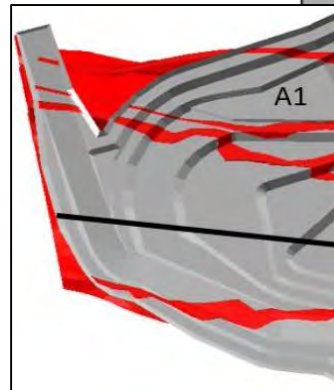
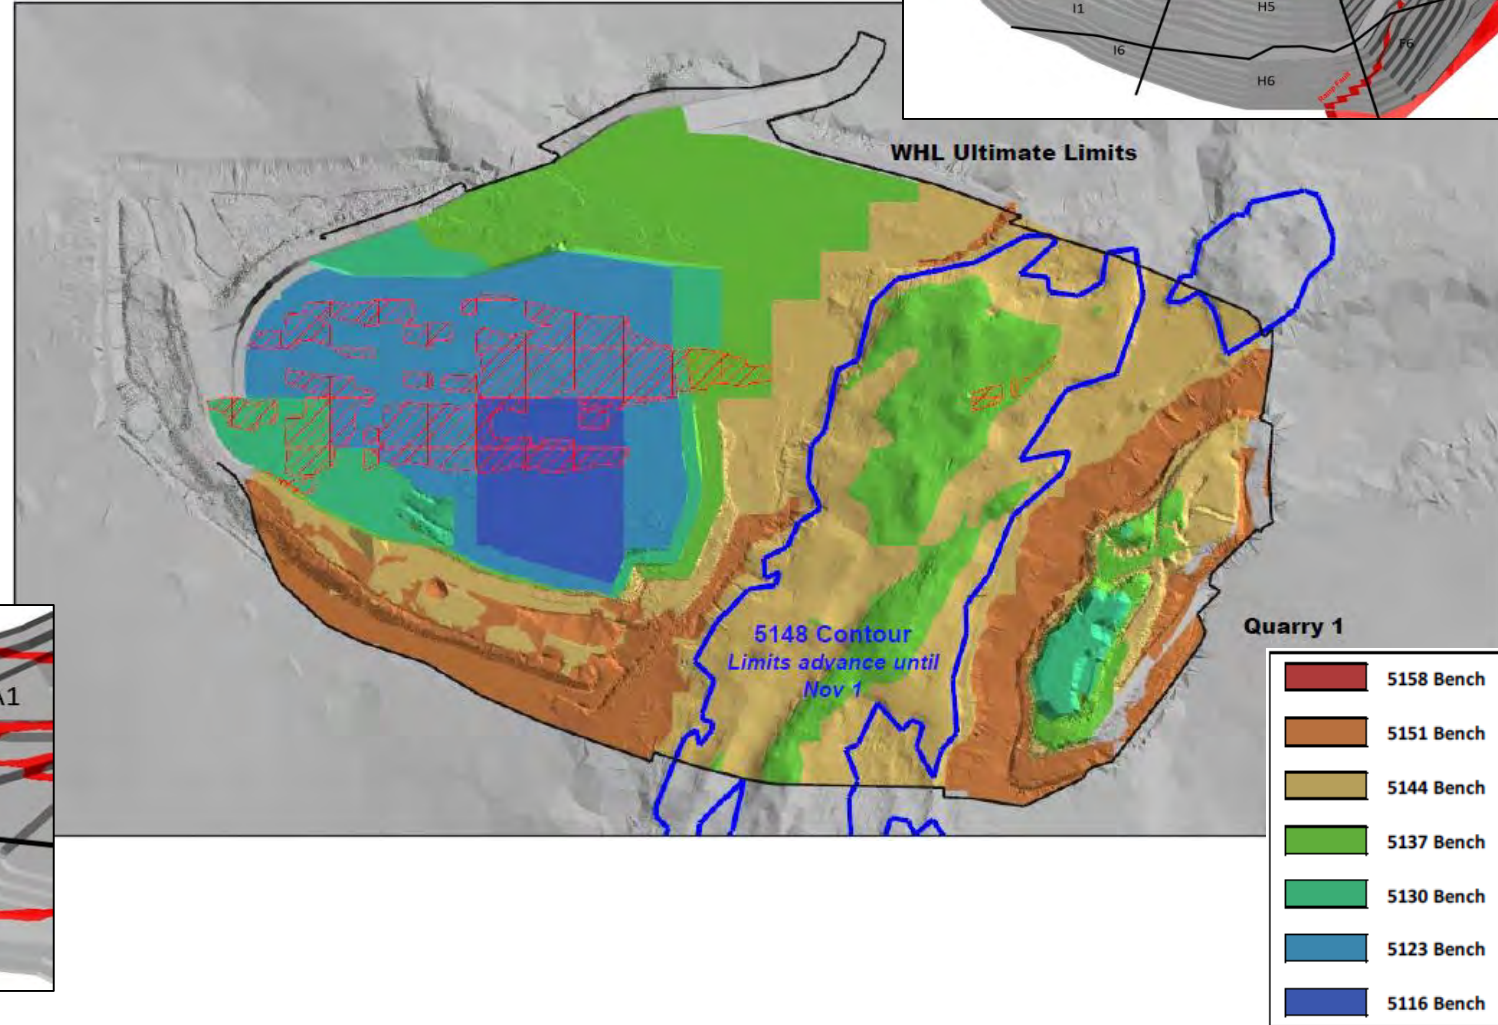
- Look for opportunities to further review bench performance in final walls (planar failure and blasting effects). Are we on the right track?
- Several benches of the final wall established in Sector A1. Brittle structures are predicted to intersect this area (see inset). This presents a good opportunity to assess their characteristics and possible effects. The nose at the ramp could deteriorate.

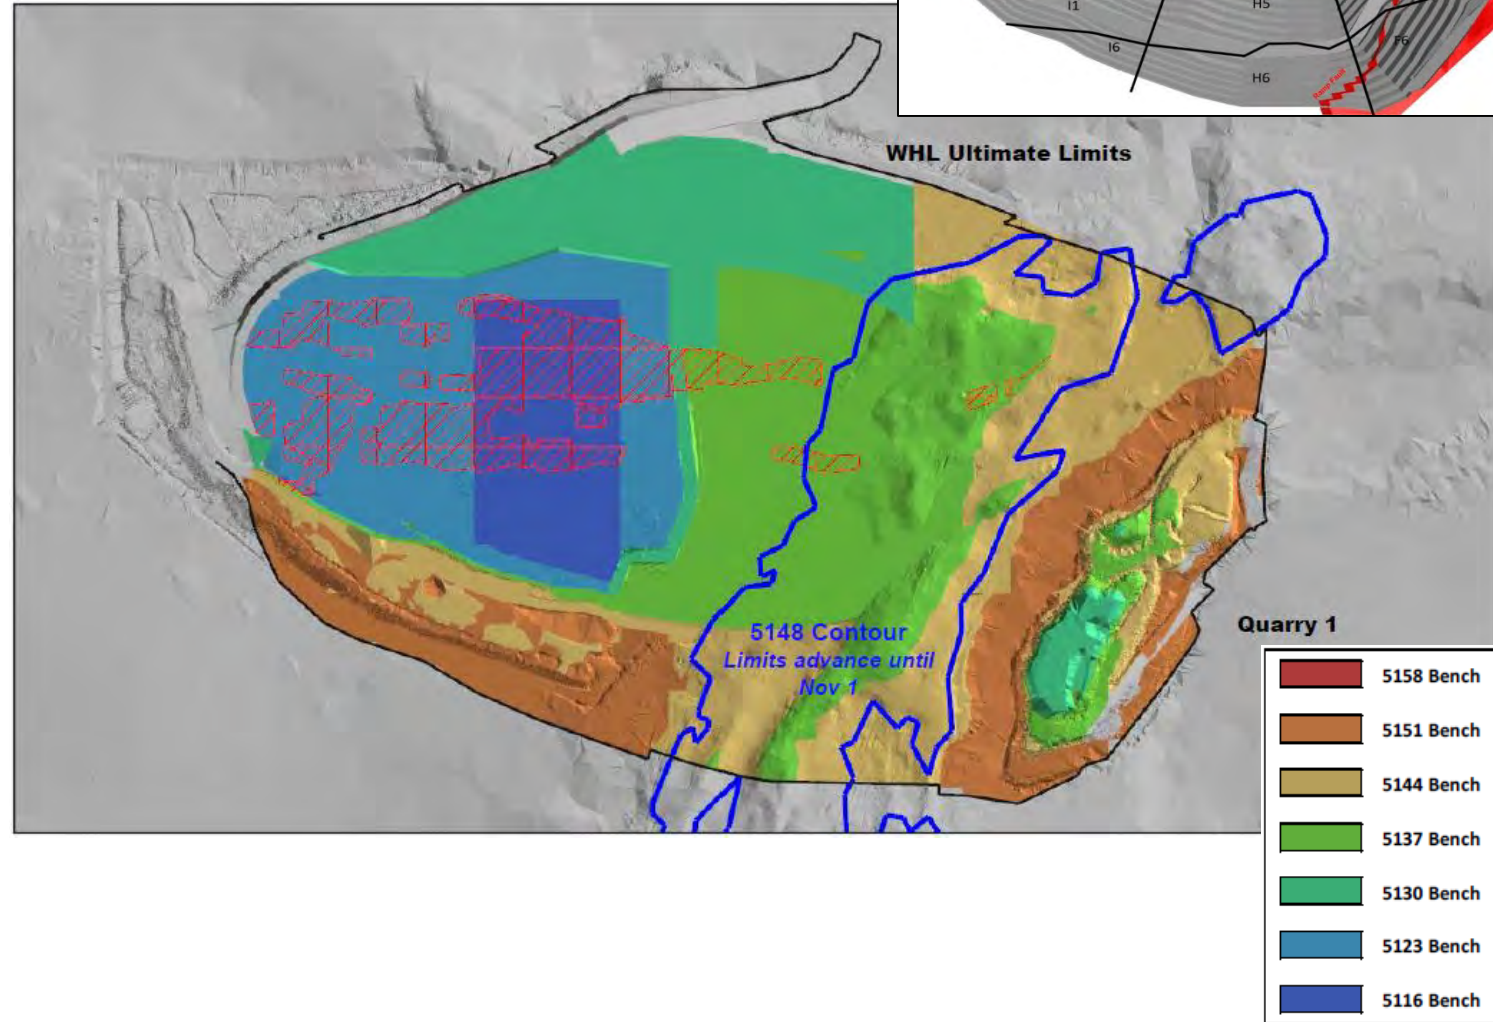
- Lake dewatered. Mining starting to extend into footprint of main portion of Whale Tail Lake. Managing the lake bed sediments will be an important consideration.
- Further establishment of final walls in sectors A, B1 and B4. Note that the structure in B4 is predicted to be more favourable than B1 – it will be important to verify this.
- The Ramp Fault may also be exposed where the northern ramp meets the 5130 bench.

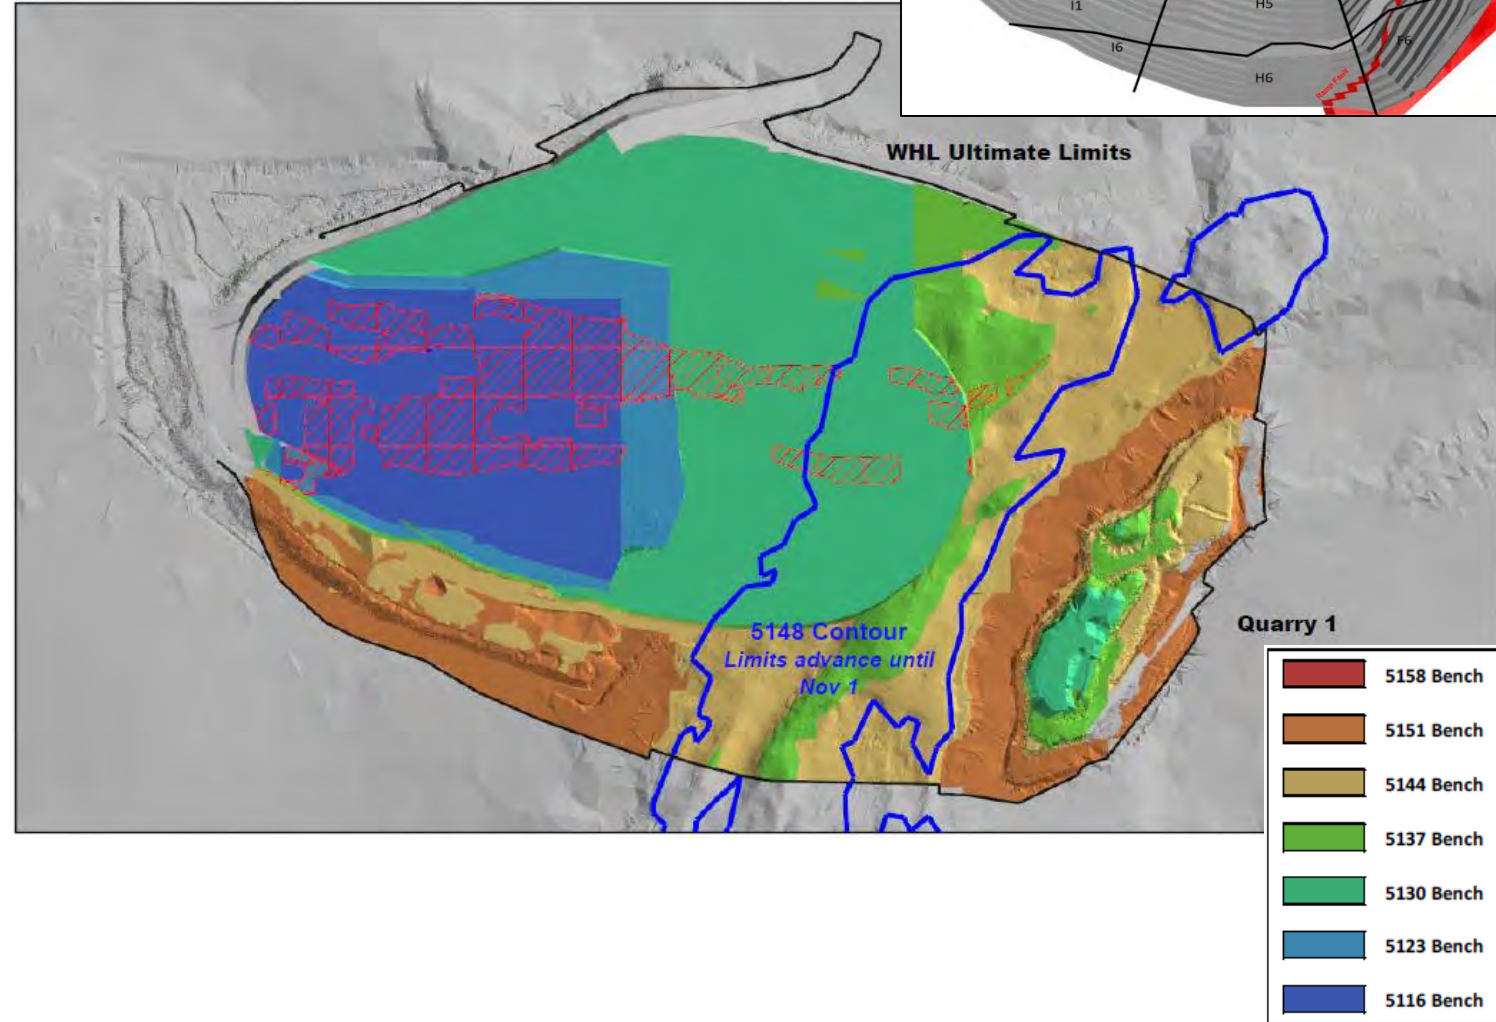
- Establishing first benches within Sector H (south wall of the open pit within Whale Tail Lake footprint). The structure in this sector is unusual, as it is expected to dip to the North. It will be important to verify this.
- Mining continues within footprint of main portion of Whale Tail Lake. Managing the lake bed sediments will continue to be an important consideration. Excavation in winter should help.
- Need to review potential for inflows on south wall. Do we have a plan in place to manage ice walls if they form?
- Will have several benches of the final wall established in Sector A1.

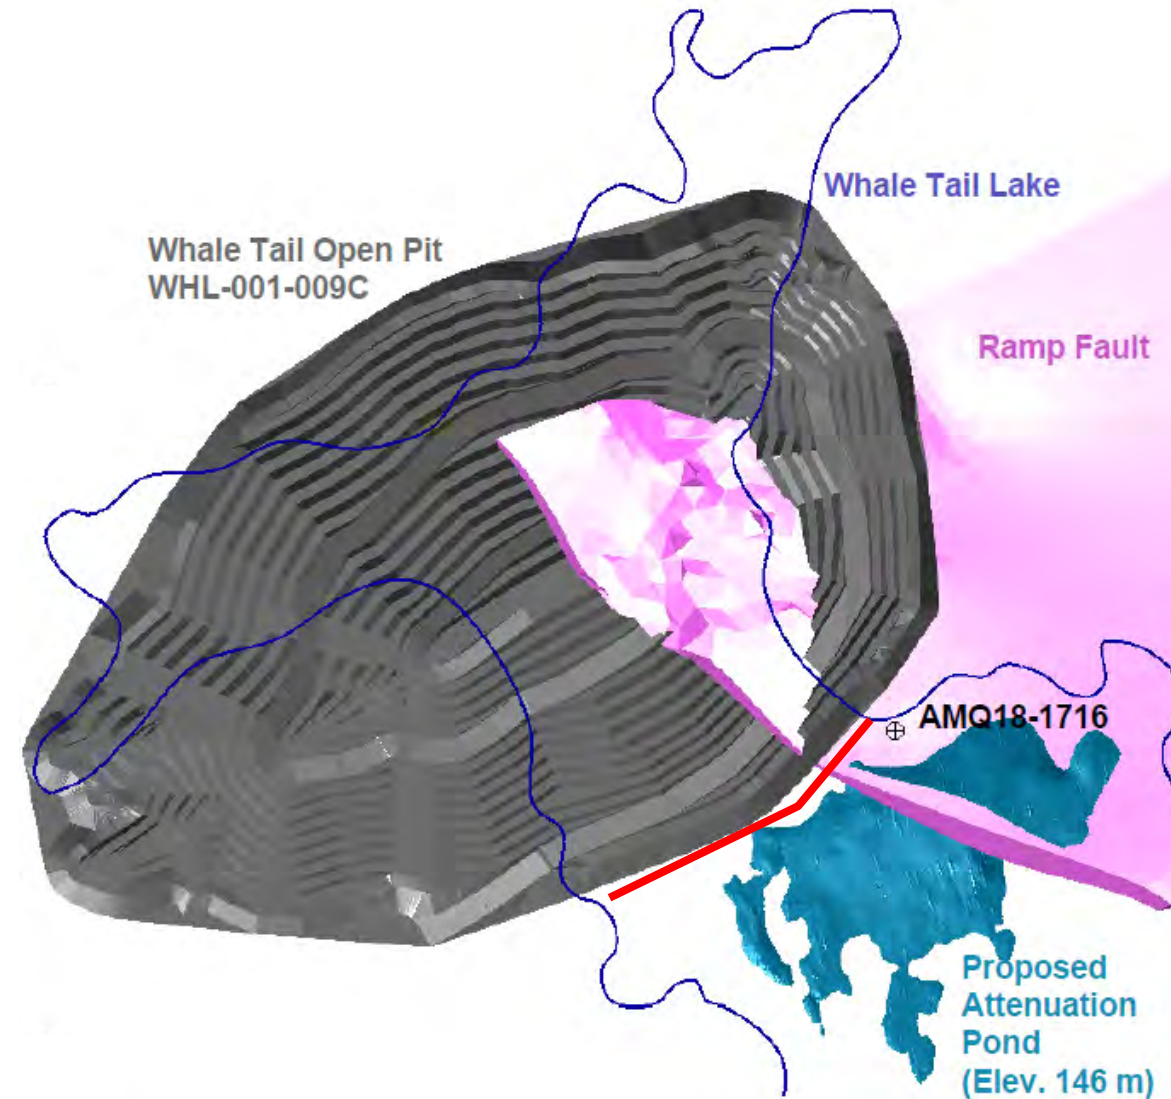
- The following conceptual instrumentation plan was discussed:
 - 3 drillholes along the south wall of the open pit, between the open pit and the attenuation pond (roughly along the red line at right). Approx. 5 piezometers and a thermistor string in each drillhole. The drillholes should extend to the base of the talik zone (approx. 100 m below surface)

- 1 drillhole between the open pit and the Whale Tail Dyke (south of the attenuation pond) with 3 to 5 piezometers. This drillhole is a lower priority than the others.

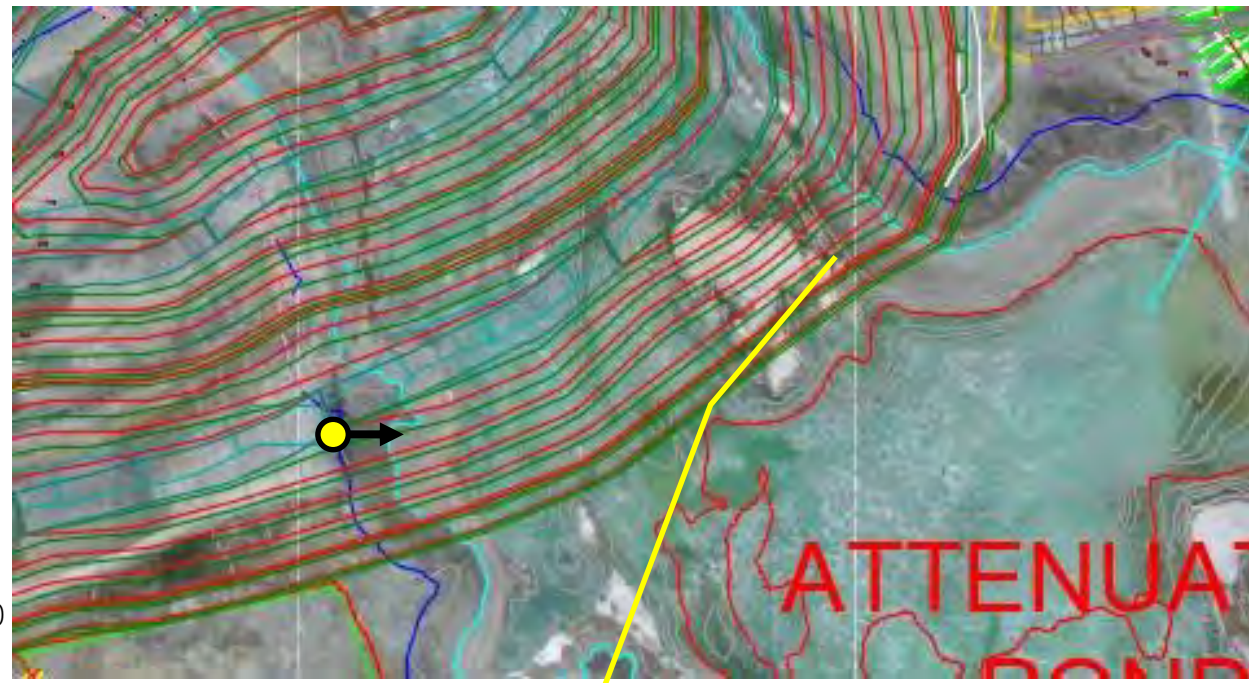
Proximity to Attenuation Pond

- The south wall of the Phase 3 WHL pit is in close proximity to the planned attenuation pond. The likely challenges associated with this (e.g. increased seepage and the formation of ice walls in the pit) have been previously discussed with AEM.
- It is understood that AEM is considering alternatives for the attenuation pond. This is strongly endorsed.
- Silt fence is shown in yellow on both images for reference. Approximate photo location and perspective is shown on the plan at right. Note that the pit limits have not been cut to topography and there will be a larger offset than shown.
