Whale Tail Follow up Letter WRSF

January 27th, 2020

**Re.: Agnico Eagle Whale Tail Project – WRSF Flow Follow up (2019-333) -
Additional Information**

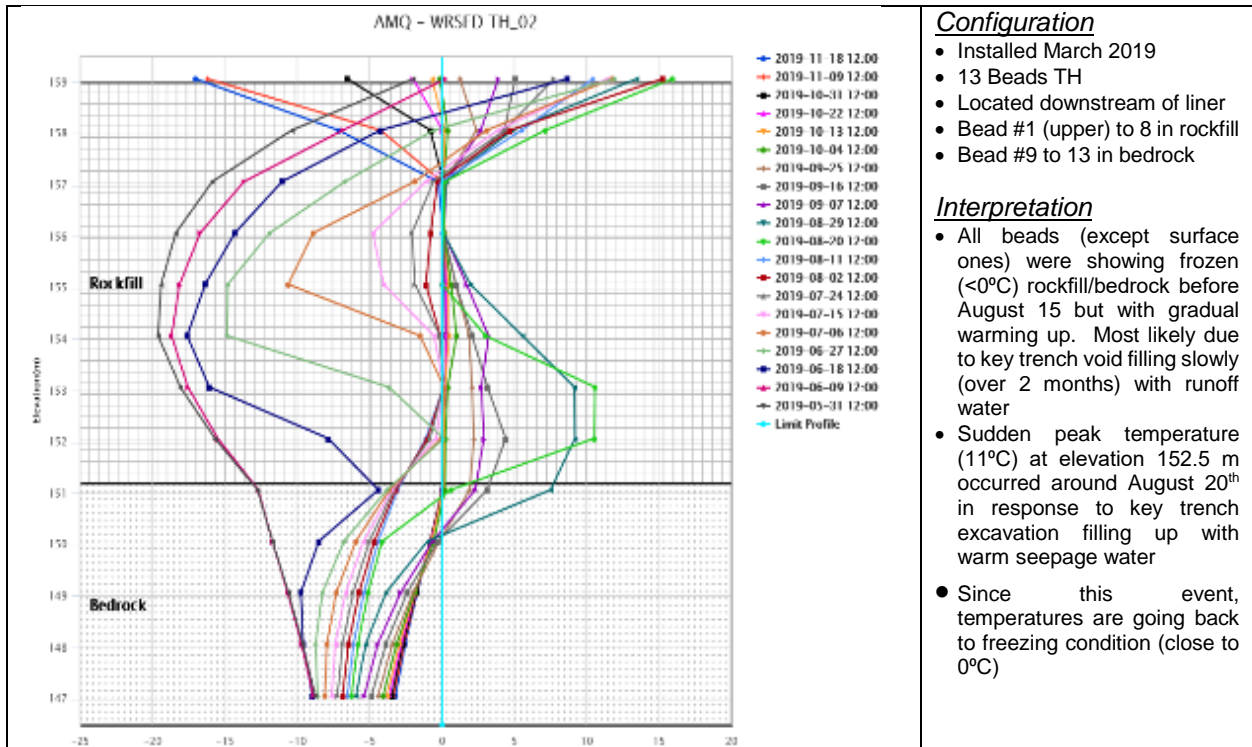
Figure 7: WRSF Temperature profile of thermistor TH-02

- Upstream slope progressively warms as water raise in pond (water in contact with liner & TH)
- Peak temperature (11°C) at elevation 154 occurred around August 20th in response to key trench excavation filling up with warm seepage water
- Beads in FFAB (#9+) show frozen condition until October 2019. Temperature reached slightly above 0°C in FFAB in October
