Meadowbank 2018 Annual Review of Portage and Goose Pit Slope Performance

2018 ANNUAL PIT SLOPE PERFORMANCE REVIEW

MEADOWBANK MINE, NUNAVUT

ISSUED FOR USE
704-ENG. ROCK03053-02

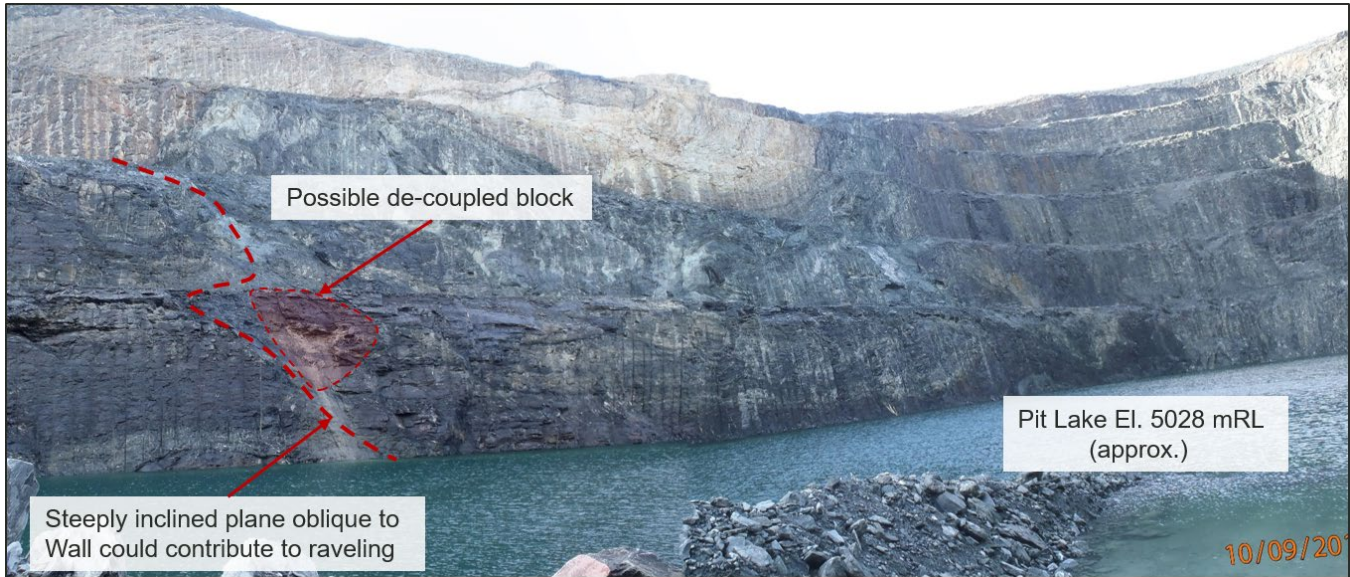
Photograph 4-4: Pit A lower west wall bench performance (2018)

Since the completion of mining in Pit A, the lower benches continue to performing well as shown in Photograph 4-4 below. The de-coupled rock block identified during the 2017 inspection is currently stable.

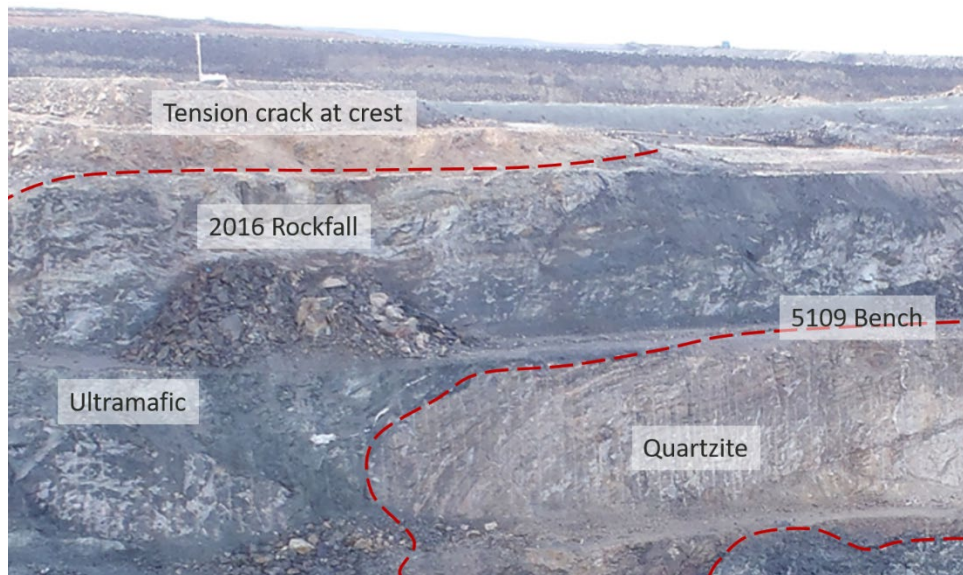
Photograph 4-5: Pit A West Wall 2016 rock fall and tension cracks (2018)

Areas of rock fall events occurring in 2012 and 2016 on the 5109 bench continue to be monitored. As described above, no significant increase in accumulation of material on the benches below these areas was noted during the 2018 site inspection.

The tension crack located at the pit crest and related to the 2016 and 2012 rockfall events continues to be visually monitored and is currently stable. These observations are documented in AEM's Quarterly Ground Control Instrumentation reports.

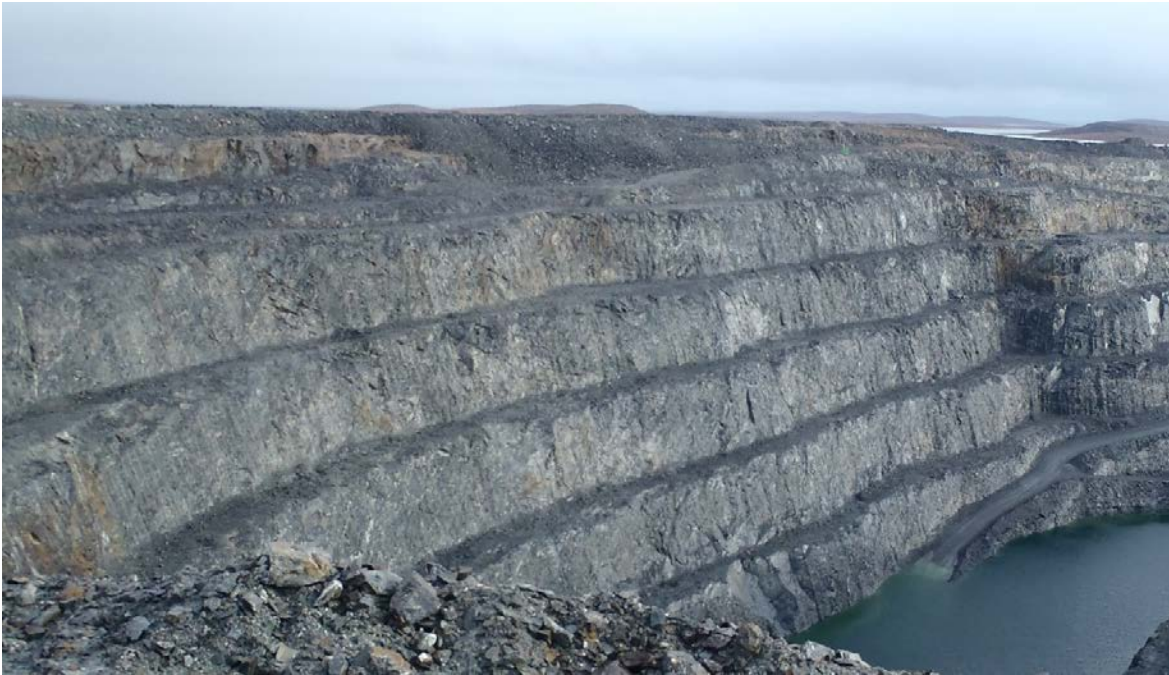
Photograph 4-9: Pit A East wall upper benches (2018)

The benches of the Pit A East Wall continue to perform satisfactorily, as shown in Photographs 4-9 and 4-10.

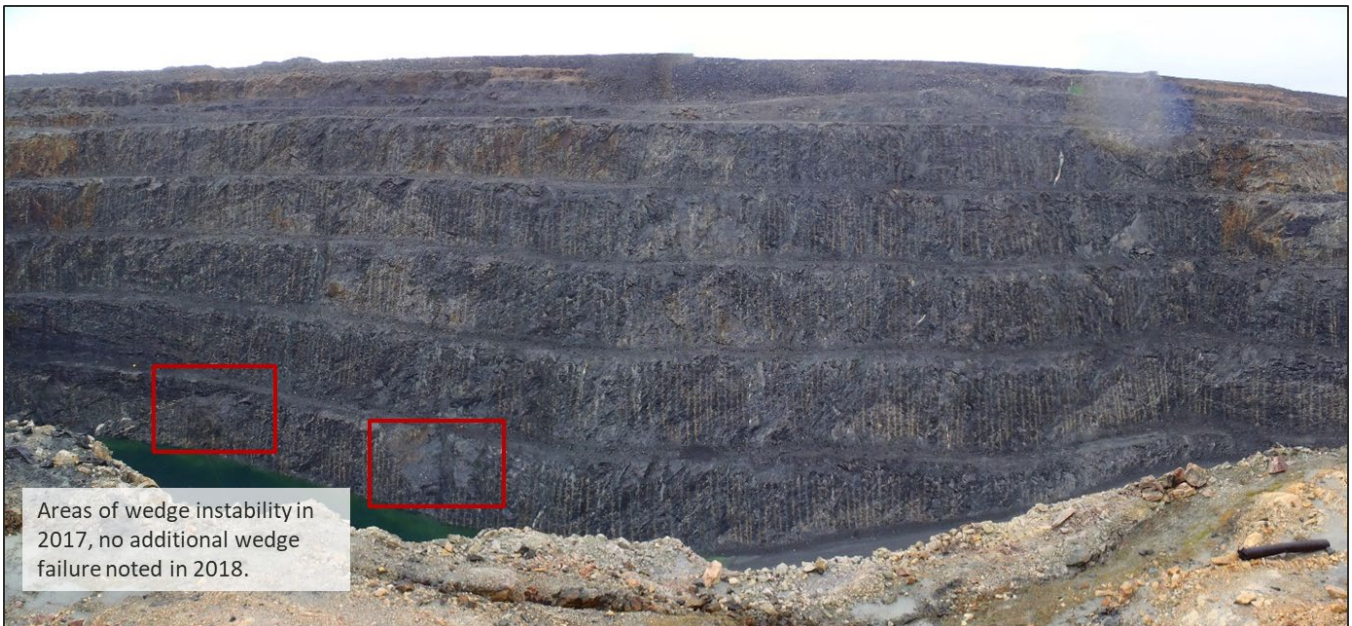
Photograph 4-10: Pit A east wall, north end additional wedges (2018)

No further wedge instability like that encountered during 2017 mining of the lowermost benches of the east wall of the pit was encountered, and the lower benches appear stable.

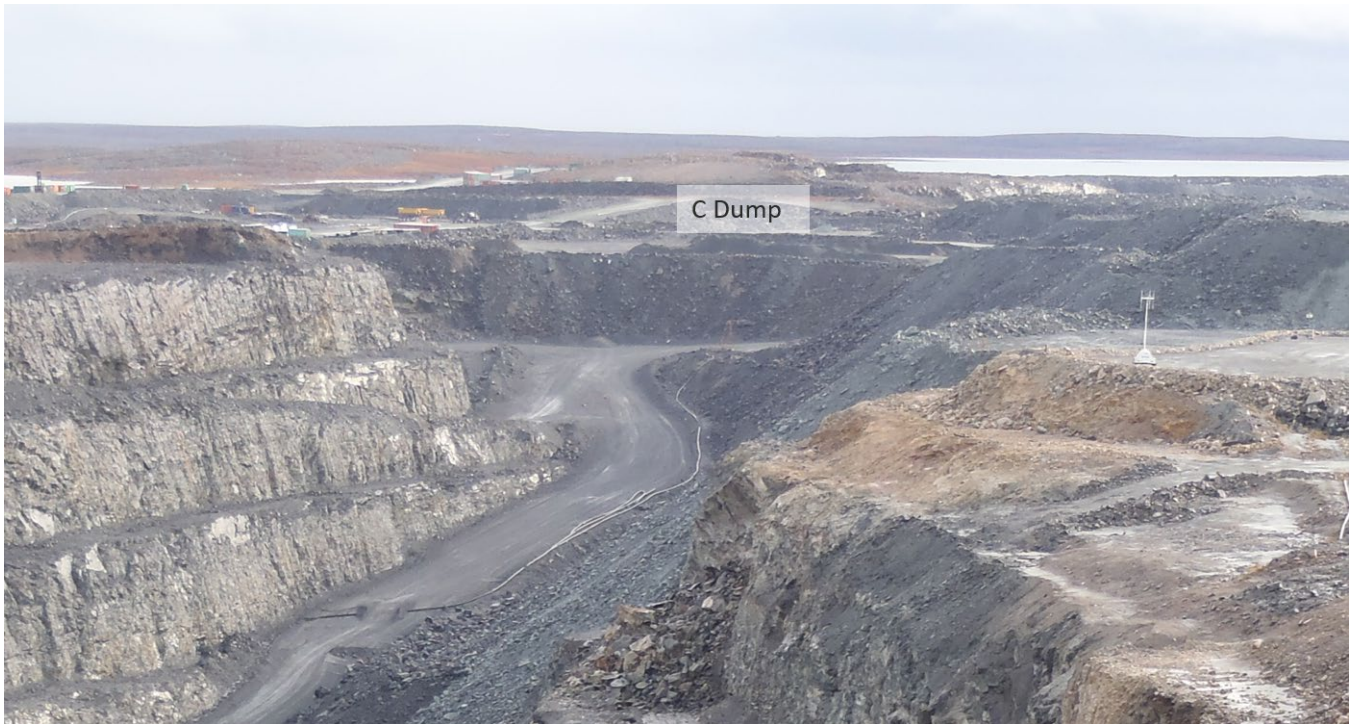
Photograph 5-1: Pit C Dump, viewed looking south (2018)

The west and east pit walls of Pit C are buttressed by waste rock and no longer present any geotechnical hazard. The main dump platform for Pit C is used for storing stockpiles of stemming material. The C Dump platform was visited only briefly and was noted to be performing satisfactorily.

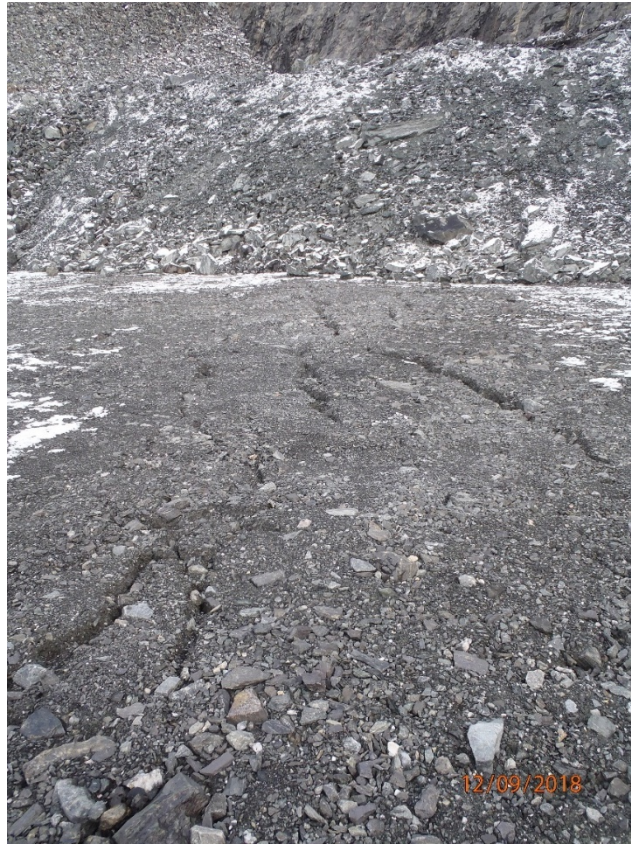
Photograph 5-4: D Dump radial tension cracks

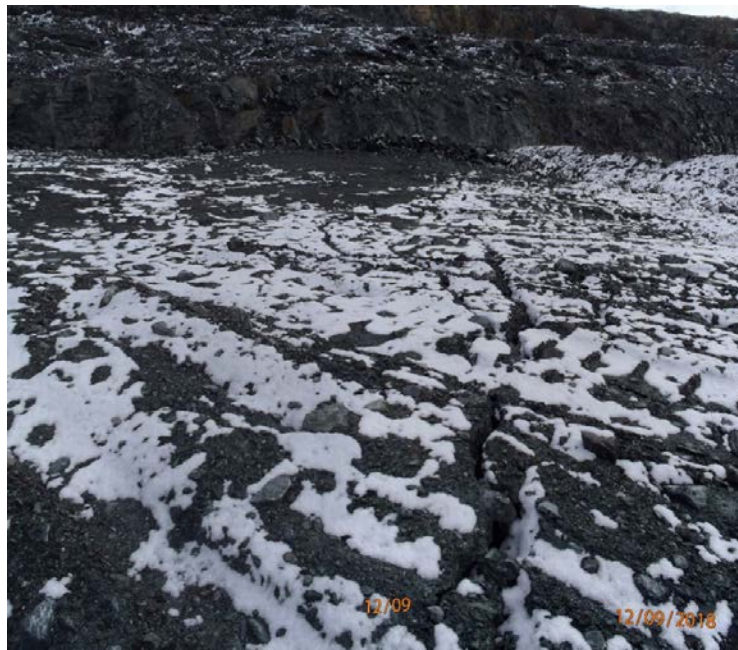
Photograph 5-5: D Dump transverse tension cracks

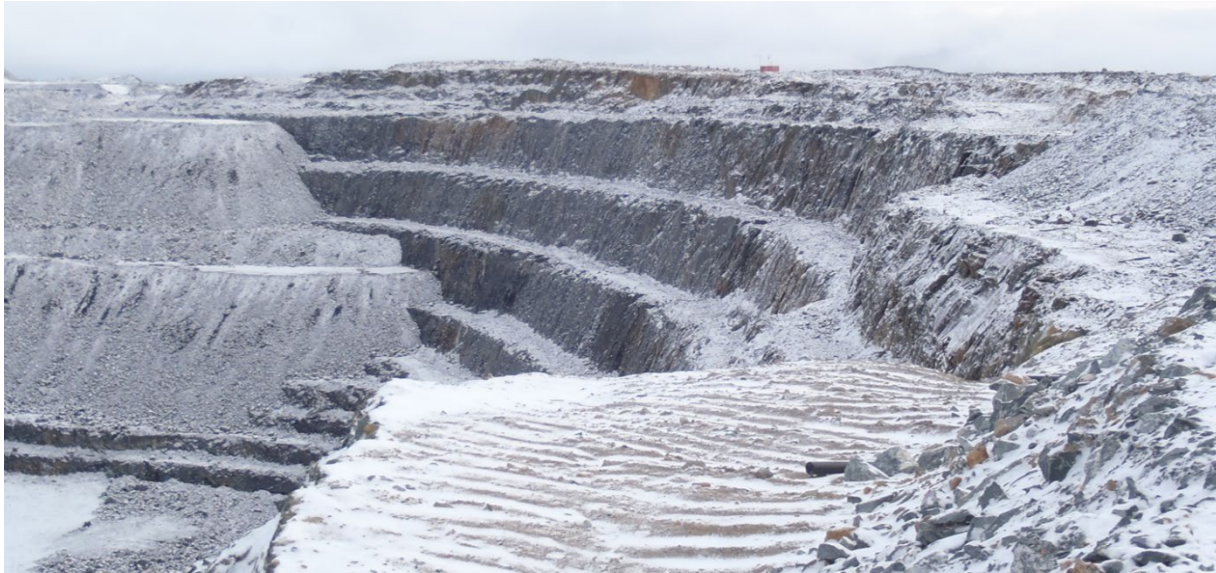
Photograph 6-3: Pit E east wall performance (2018)

The east wall of Pit E continues to perform well, and there is little year-to-year accumulation of material on the benches. The area is underlain by permafrost.

- Continue visual monitoring and recording of observations as part of regular site geotechnical inspections.

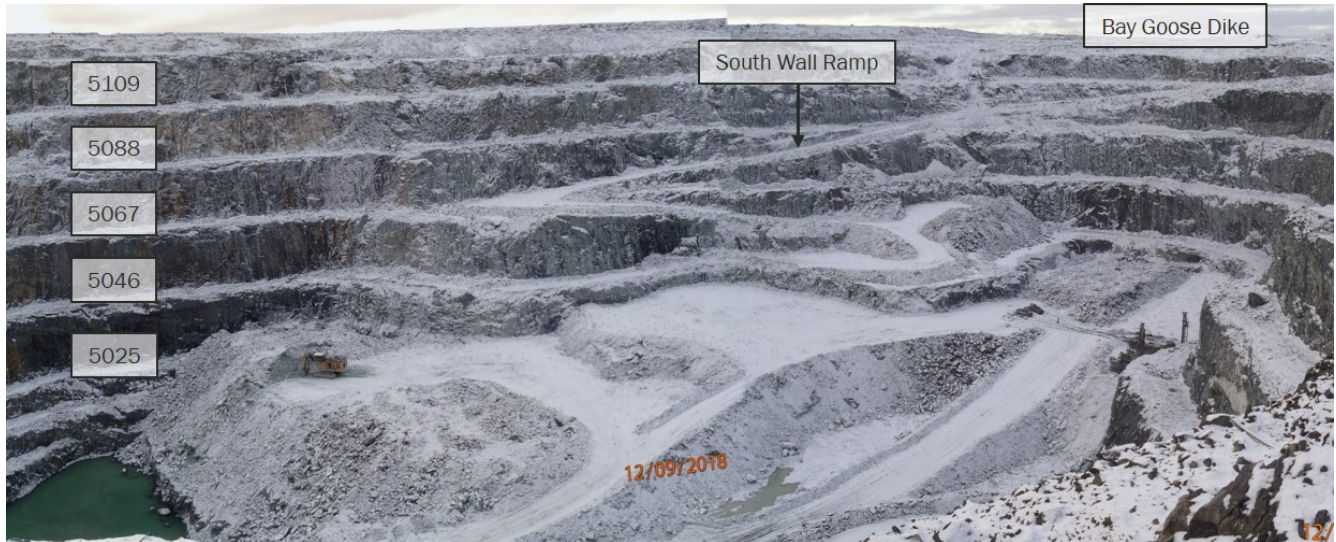
Photograph 6-4: Pit E south wall (2017)

The following photograph shows the south wall at the time of the site visit. The wall has been mined down from the 5088 mRL platform in 2017, to approximately the 5025 mRL platform.

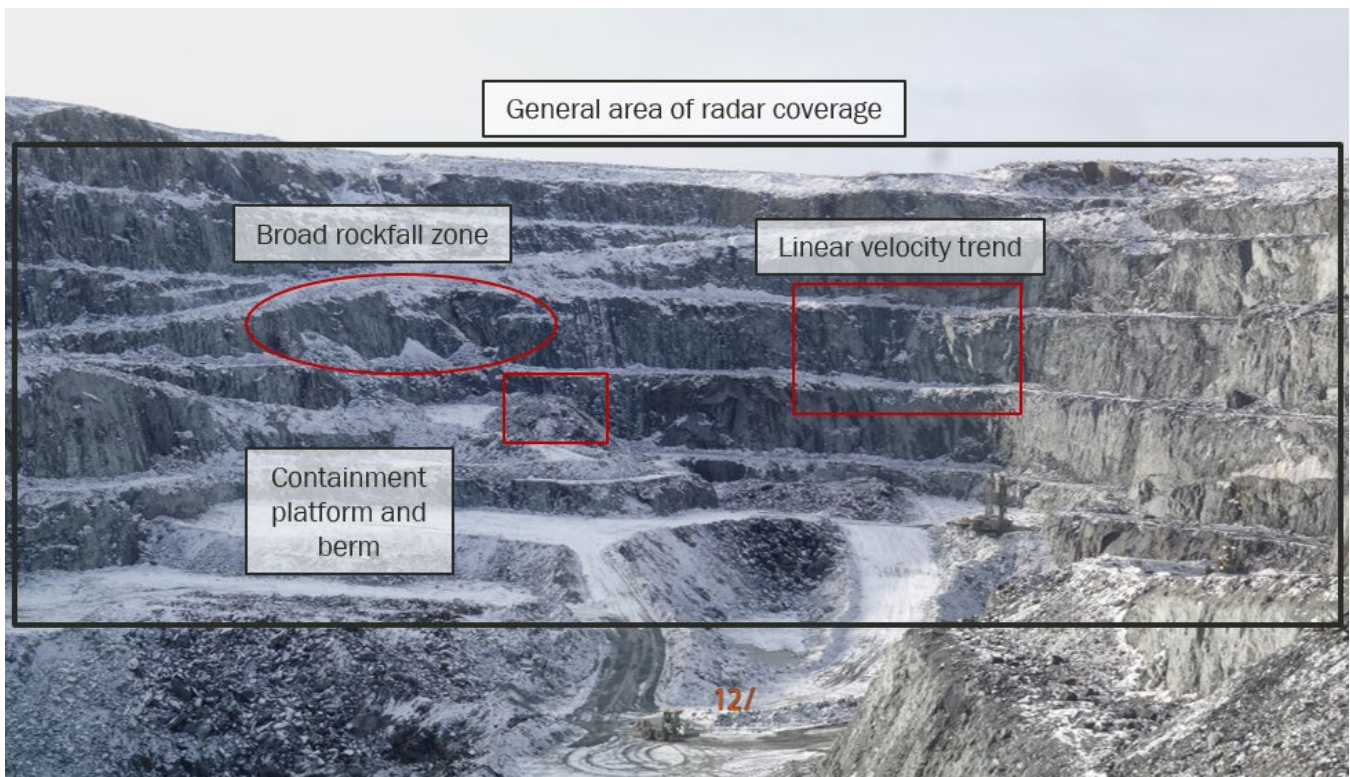
Photograph 6-6: General radar coverage of south wall Pit E5

The south wall of the pit is currently monitored using radar in addition to instrumentation. The following photograph shows the approximate coverage by radar of the south wall of Pit E5. The wedge and planar instability that have occurred have in many cases been predicted by the radar. AEM have taken proactive steps to buttress areas of instability, to restrict access to others, and to develop a containment platform and berm beneath the broader rockfall zone below the south wall ramp. An area of linear velocity trend on the western side of the south wall has been identified on the radar, and is monitored using radar.

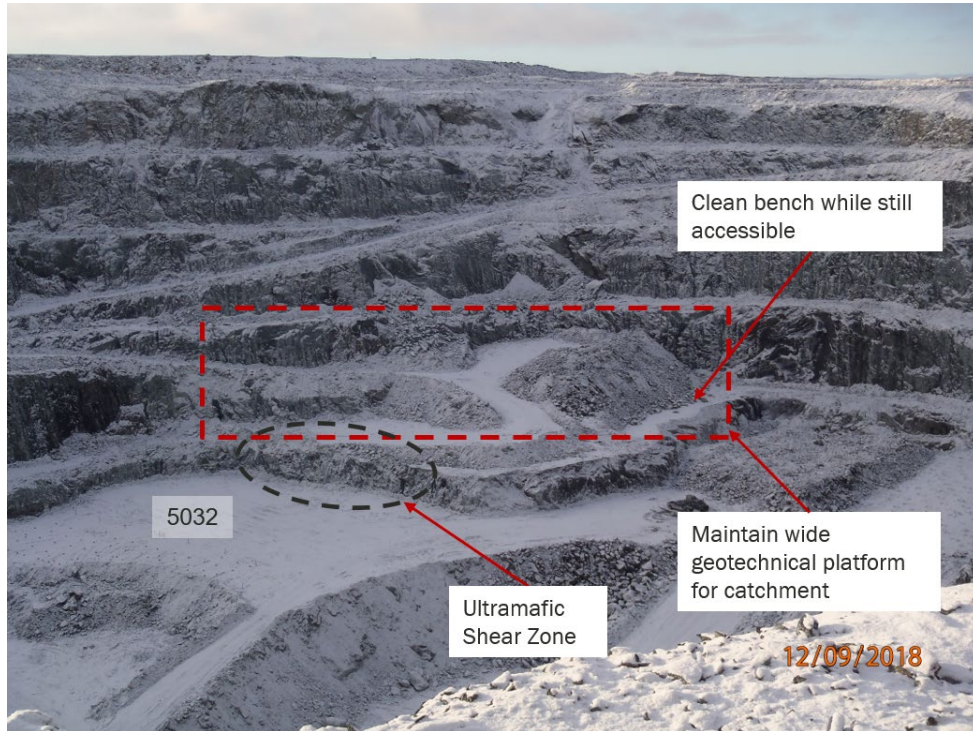
The platform at approximately 5032 mRL was visited during the inspection. Of note is the presence of a zone of strongly sheared ultramafic rock exposed along the bench face directly above the platform. The rock is very poor quality, weak, serpentinized, and wet suggesting a hydraulic conductivity up-slope. The shear zone exposed on 5032 Bench within the ultramafic rock is generally consistent in location, orientation and character with the interpreted shear zone assumed for the stability assessment during design of the pushback wall. The location of the shear zone as exposed on the 5032 mRL platform is shown on Figure 6-8 and Figure 6-9.

Photograph 6-9: Pit E5 5032 mRL platform and ultramafic shear zone

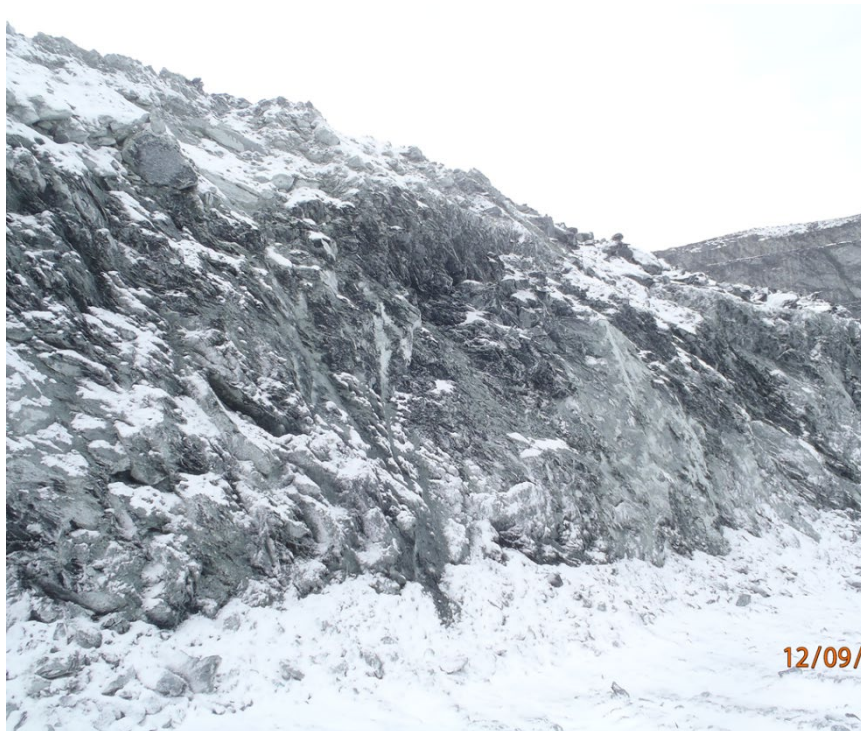
Photograph 6-8: Shear zone in ultramafic rock exposed on the 5032 mRL platform (2018)

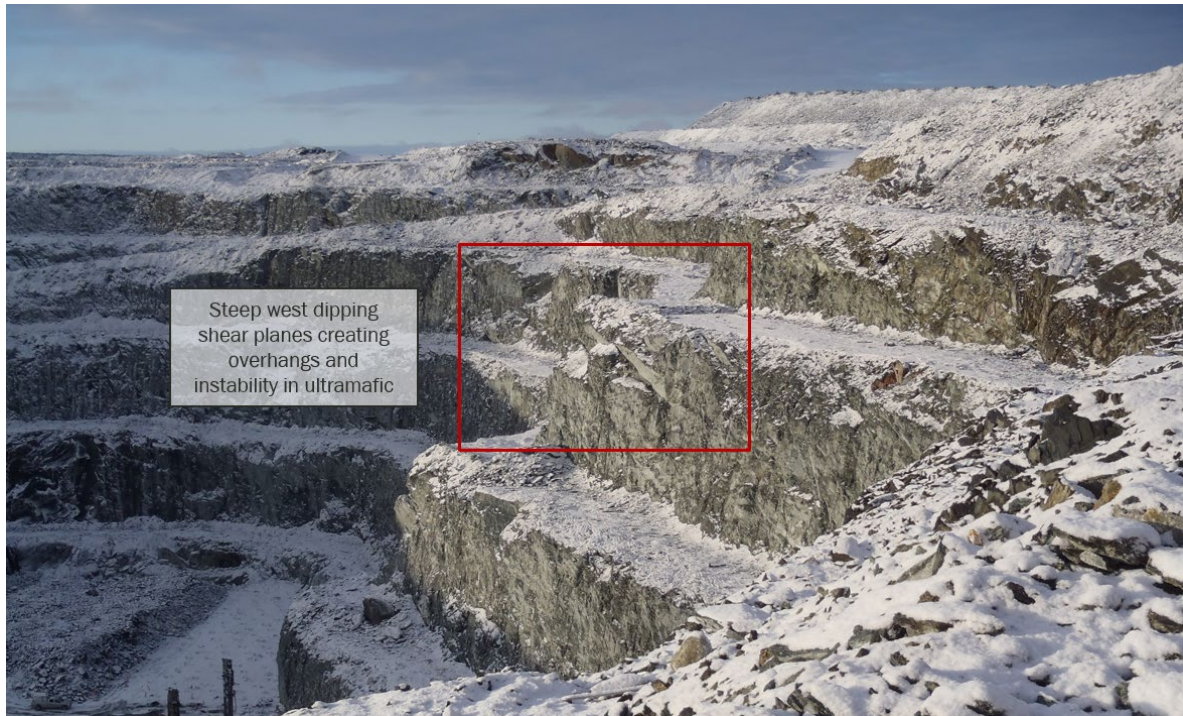
Photograph 6-12: Pit E west wall south end upper benches (2018)

At the south end of the west wall, the contact of the ultramafic rock and overlying intermediate volcanic rock is inclined into the wall, which is beneficial for overall slope stability, but results in bench-scale instability of the underlying ultramafic rock. Local rock falls creating small overhangs have occurred as the ultramafic rock separates from the overlying volcanic contact, followed by sliding along a steeply east dipping orthogonal joint set. This potential instability is contributed to by the presence of the Bay Fault and parallel shear planes within the ultramafic rock, which are also inclined steeply into the west wall. Photograph 6-11 shows the west wall at the time of the 2018 site visit. An area of rockfall events on July 5, 7, and 11 2018, directly above seepage faces and associated with the steeply west dipping Bay Fault and associated shear planes.

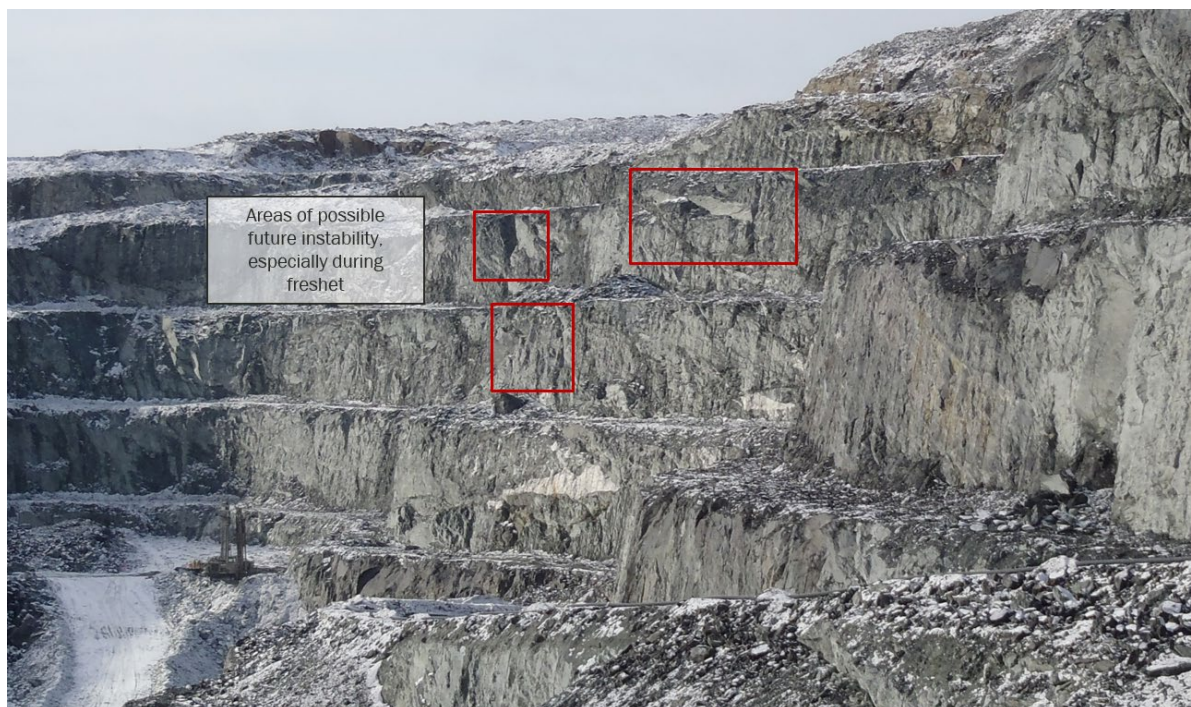
Additional possible areas of instability noted on the upper west wall above the ramp were noted, generally in association with steeply west dipping sheer planes and associated poor rock quality. These should continue to be monitored.

Photograph 6-13: Areas of potential instability along steep west dipping structure

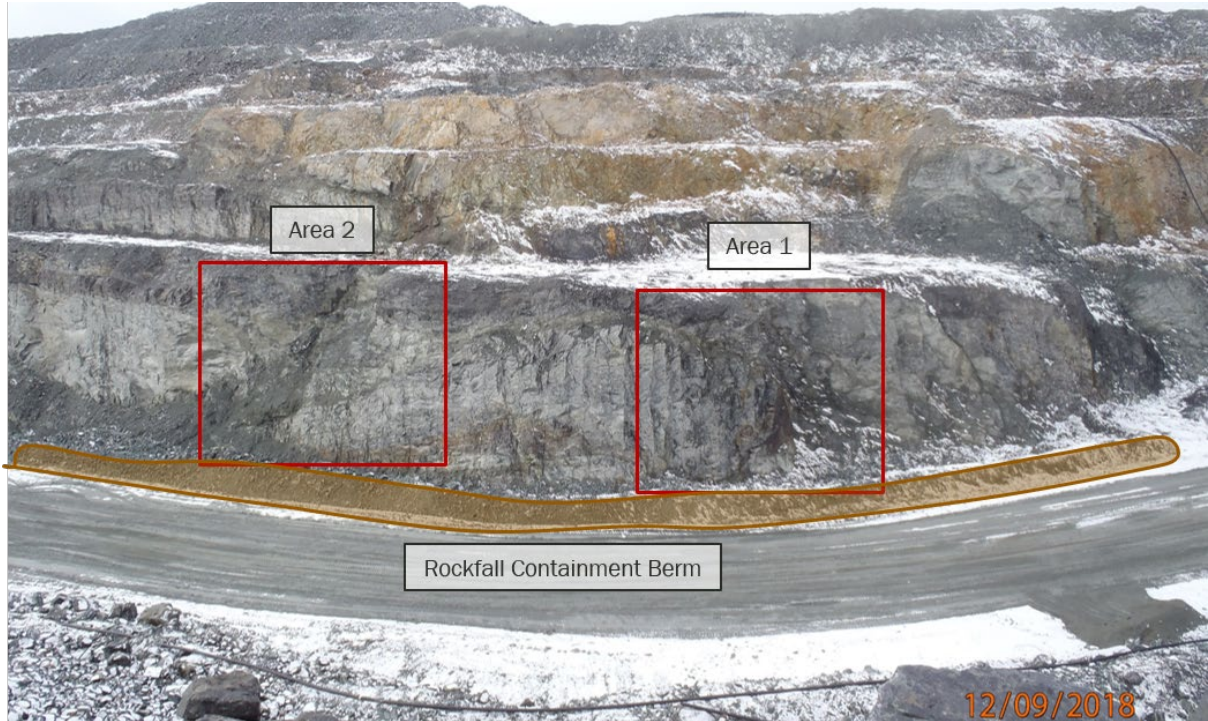
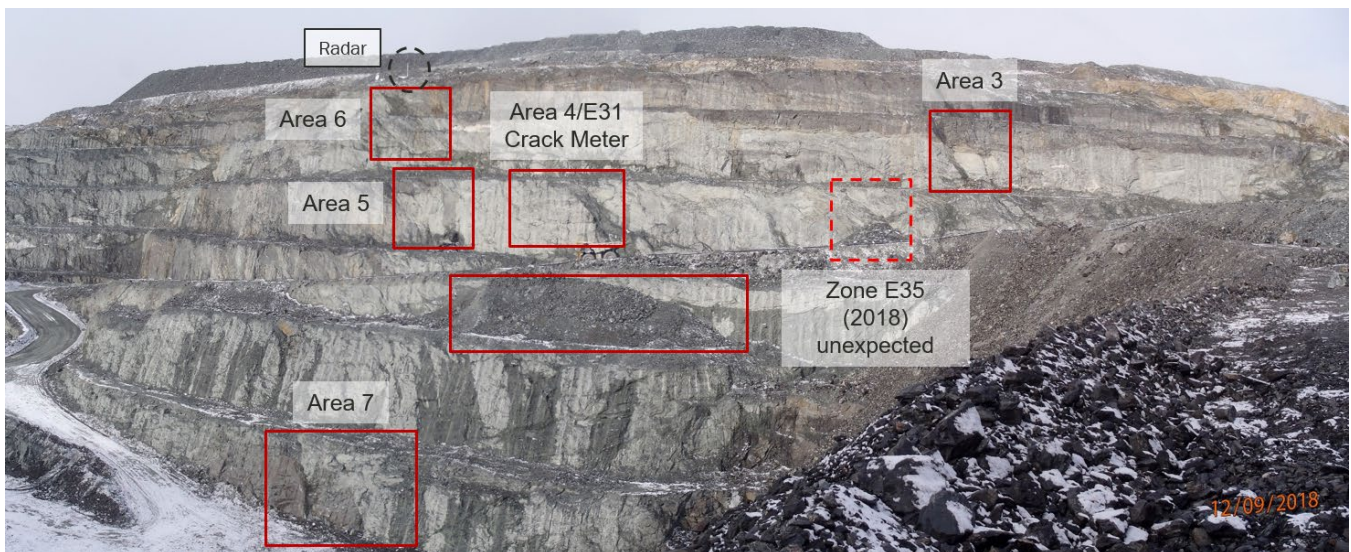
The Pit E ramp descends southward into the pit along the west wall. Seven areas of geotechnical hazards identified during previous inspections continue to be monitored, and are discussed below.

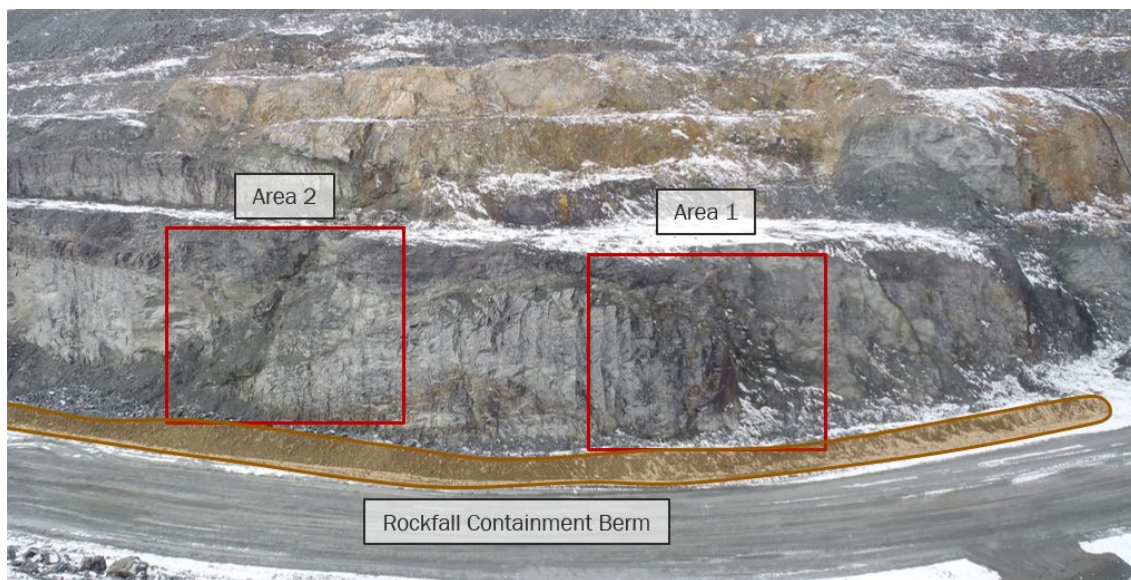
Photograph 6-17: Pit E Ramp Areas 1 and 2 - Bay Fault or splay (2018)

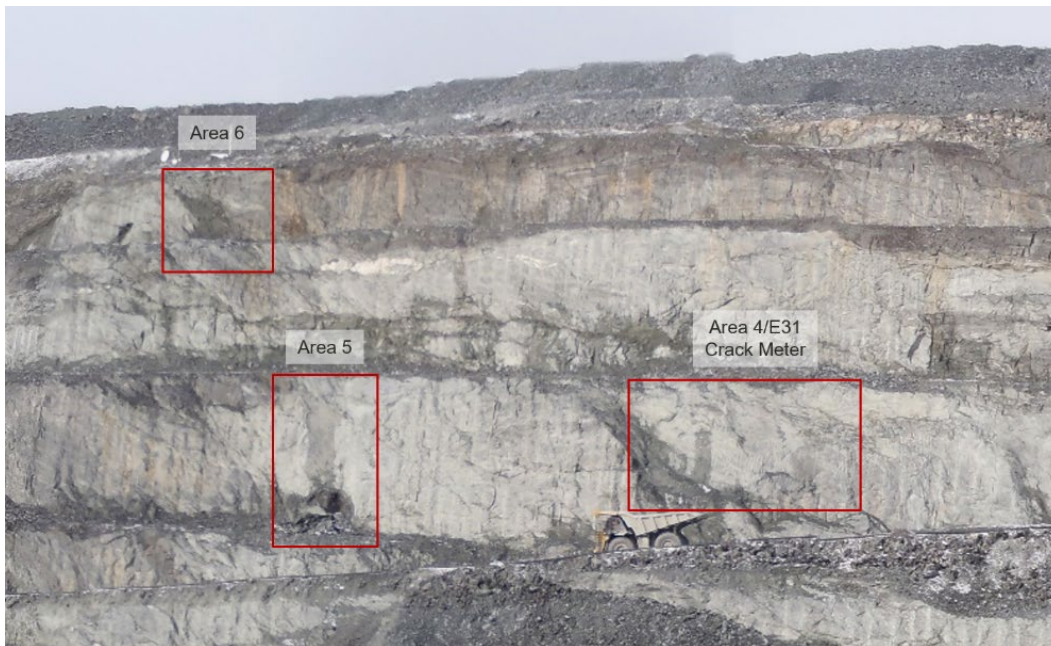
Area 6 is located above the 5088 mRL bench, and is a vertical extension of the closely spaced jointing of Area 5. These are steeply north dipping shear joints, which intersect the volcanic rock. The close spacing and continuous nature of these joints may result in increased raveling of material particularly during freshet and spring thaw.

No new material was observed to have accumulated beneath each of these areas since the 2017 inspection.

Photograph 6-20: Pit E Ramp Areas 4, 5, and 6 (2017)

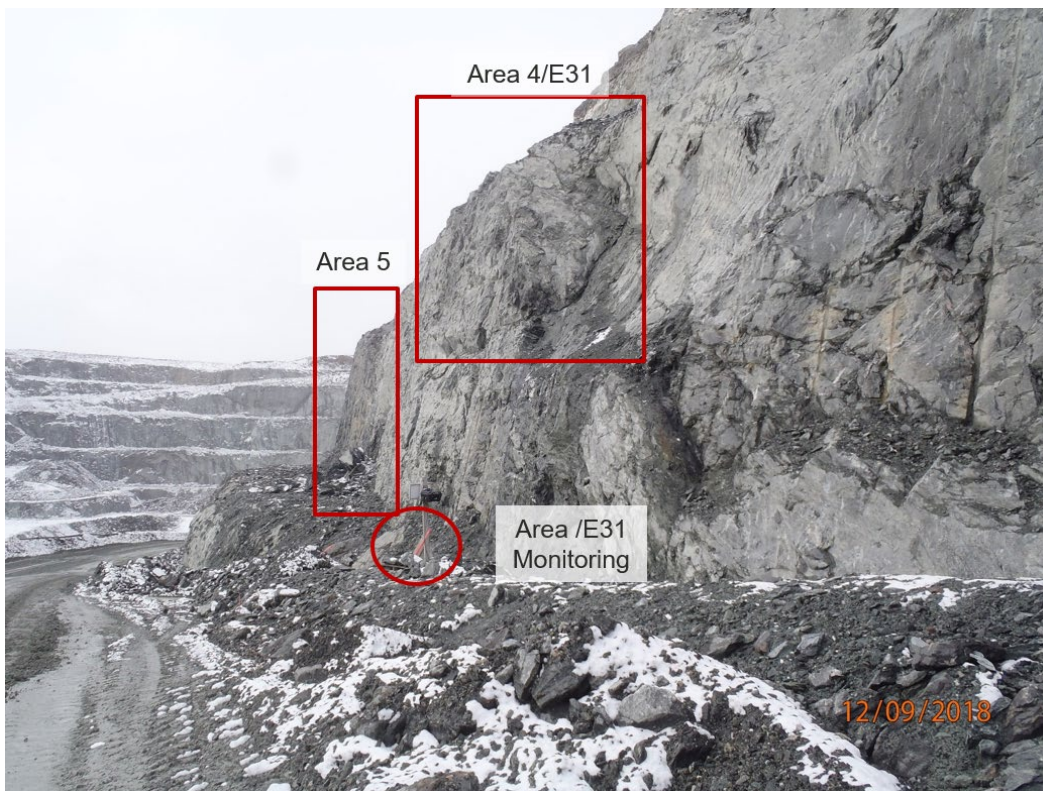
Photograph 6-21: Area 4/Zone E31 crack meter monitoring

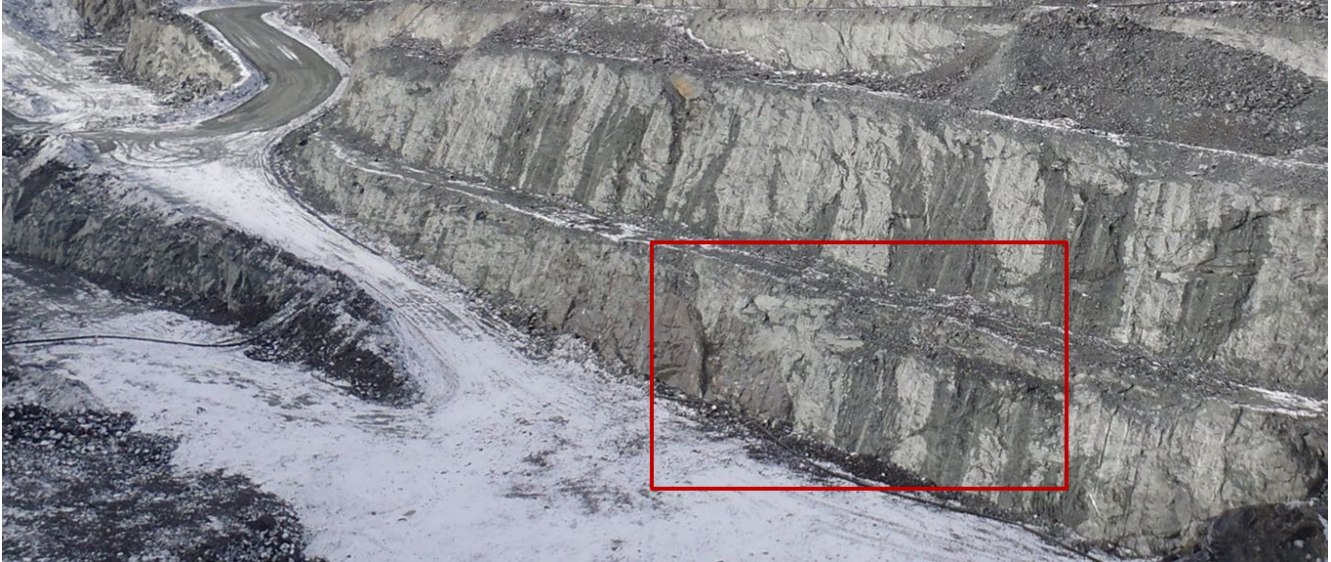
Photograph 6-22: Pit E Ramp Area 7 at bottom of ramp (2018)

Area 7 is at the base of the ramp, at the north end of the pit, and near the contact between iron formation and ultramafic rock.

The potential instability is characterized by strongly sheared ultramafic rock in contact with iron formation, with associated shear planes dipping out of the bench face. Some of the sheared planes are open and appear to form potential wedge and planar mechanisms.

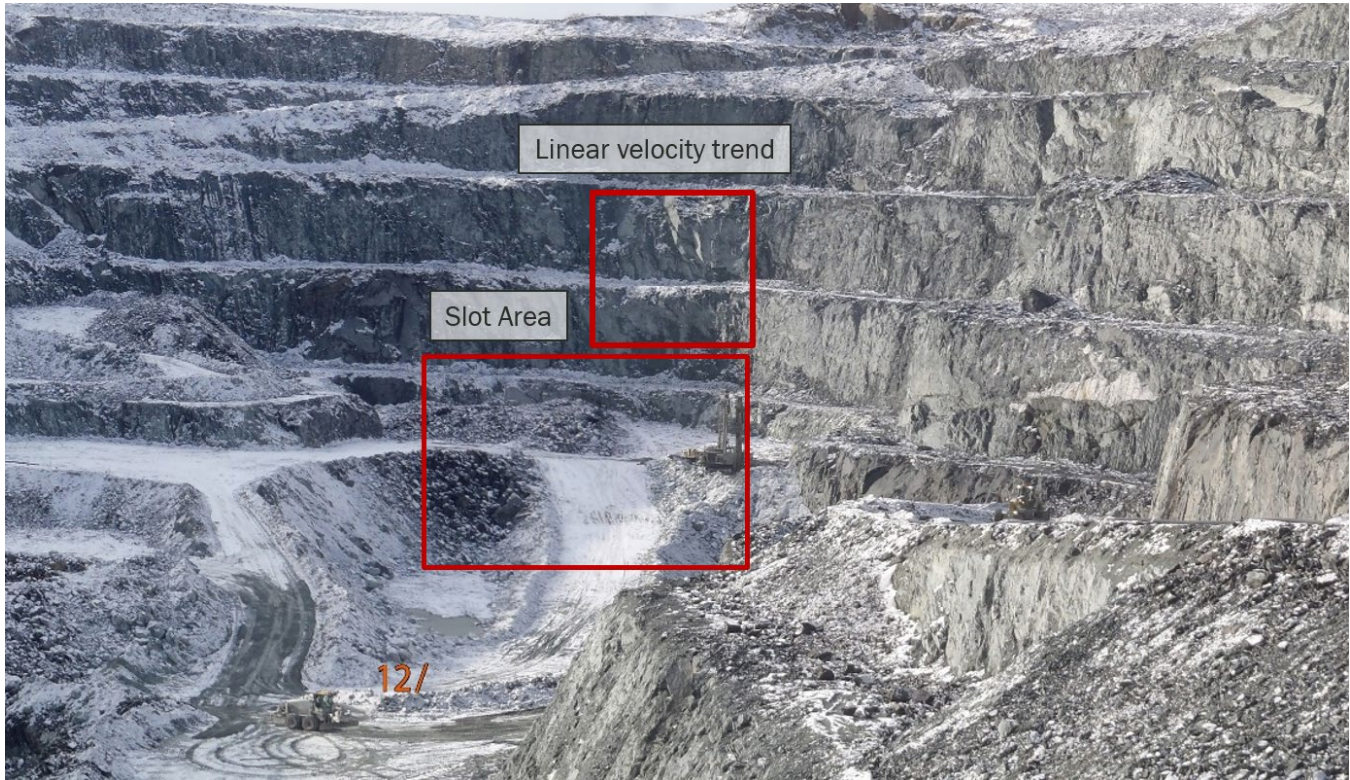
Photograph 6-24: Pit E slot south and east wall

- Mine this area during winter months while ground is frozen.
- Continue monitoring the south wall with the GroundProbe radar, and specifically areas of the south wall above the slot which have demonstrated linear velocity trends, but not acceleration.
- Continue the use of controlled pre-shear blasting methods to minimize damage to the final walls.
- Remind equipment operators to remain within dig-lines, and not to over-excavate or undercut benches.
- Continue careful scaling and bench cleaning as the pushback is deepened.
- Continue visual monitoring and recording observations as part of regular site geotechnical inspections.

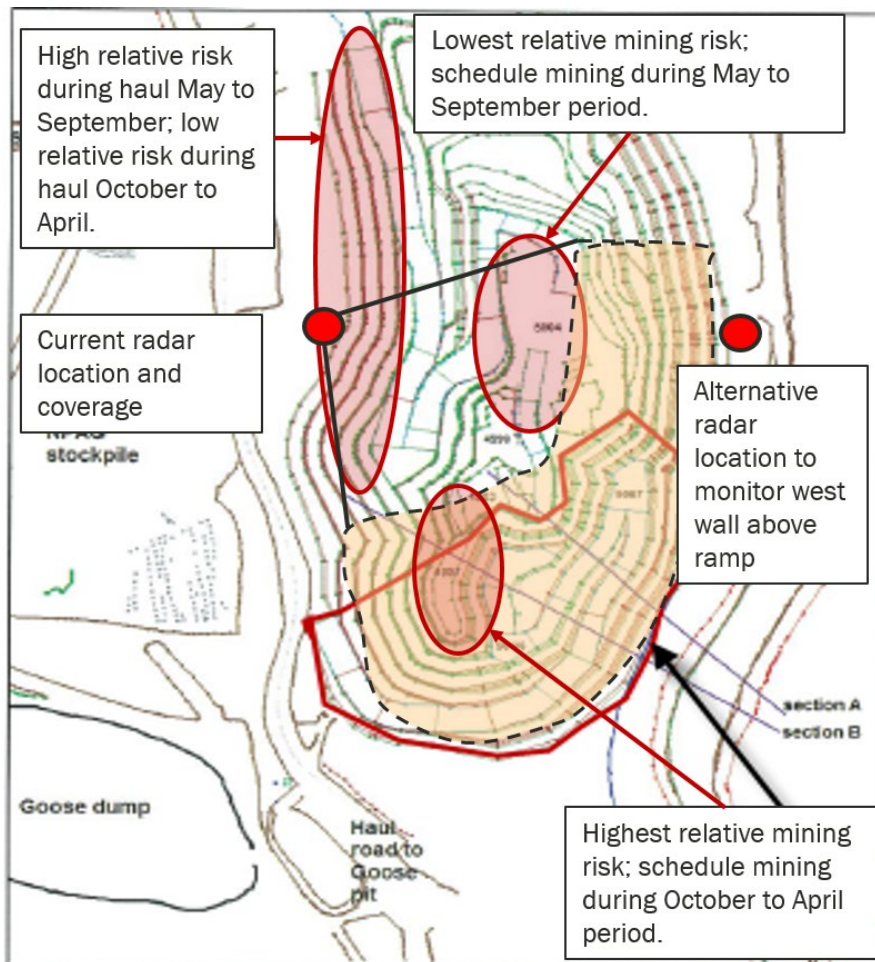
Under this scenario, the slot area at the south of Pit E would be mined during winter, before mining the more central Pit E3 area where the current pit lake is located. The combination of winter mining and active monitoring using radar could be effective in managing risk during mining of the slot. In addition to the benefit that winter mining will provide for stability of the final slopes for the slot, the stability of geotechnical hazards that have been identified along the west ramp haul would also be improved during this period.

Once winter mining of the slot is complete, then this area could be retreated from, and mining of the lower risk central area of Pit E3 would be completed during spring and summer of Q3 2019. During this period, there may be an increased risk associated with the geotechnical hazards identified along the west ramp haul. AEM could consider moving the radar from its current location at the crest of the west wall to a new location at the crest of the east wall. Since the southeast wall is currently monitored by an ADAS which includes piezometer, thermistor, TDR, and inclinometer monitoring combined with a GCMP and appropriate trigger levels, risk associated with the wall is being effectively managed. Consequently, the radar could be moved to the east pit crest to monitor the south through southwest walls of the pit, as well as the west wall above the ramp area. This would provide additional risk management to the west ramp haul during final mining of the pit and hauling along the west wall ramp.

Figure 6-2: Possible mining sequence to complete Pit E3/E5 mining

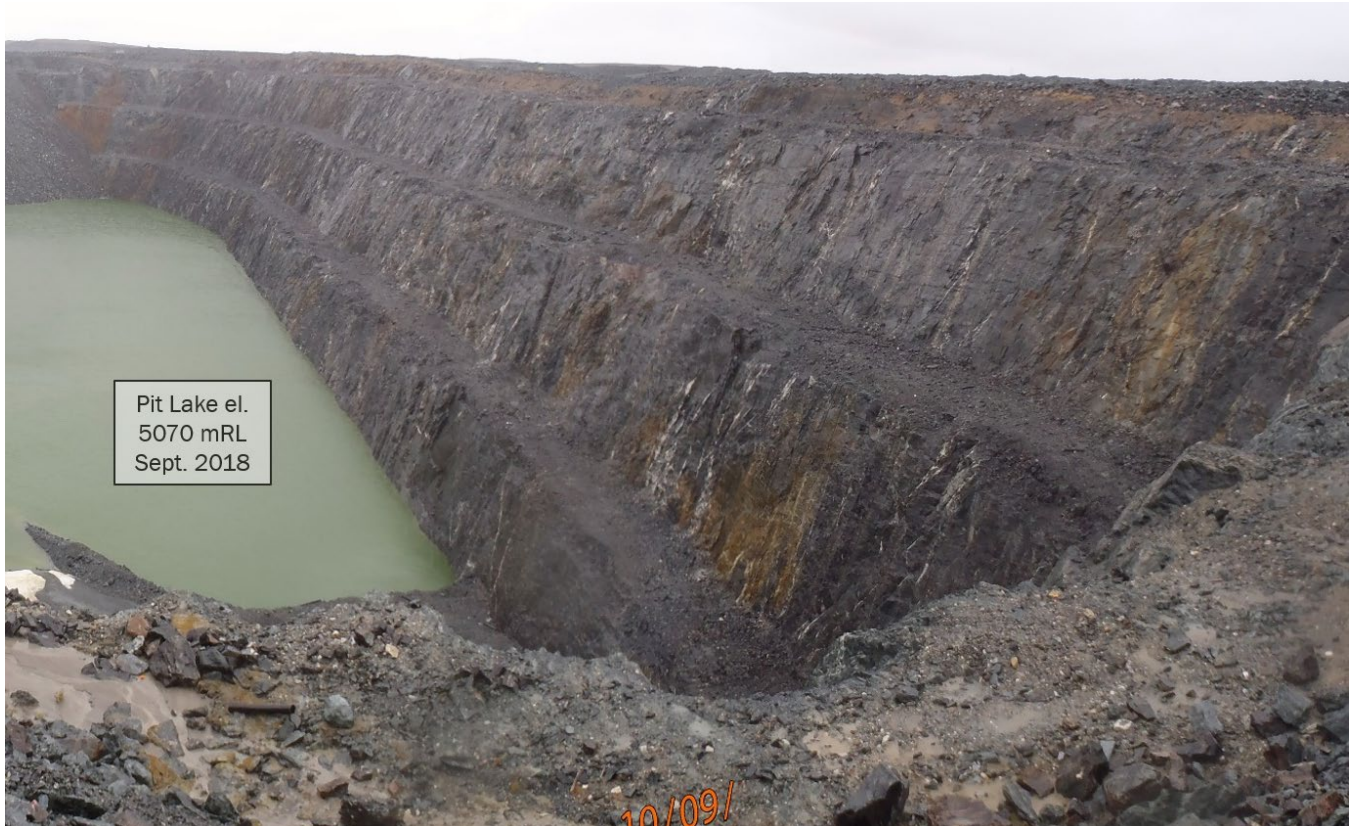
The east wall of the Goose Pit is predominantly intermediate volcanic rock and iron formation. The stratigraphy is inclined steeply at a consistent angle to the west. Steep bench faces were achieved with the use of careful pre-shear blasting. There has been very little loss of catchment, and very little accumulation of material on the benches.

Photograph 7-1: Goose Pit east wall looking north (2018)

The east wall continues to perform satisfactorily and there are no immediate geotechnical concerns.

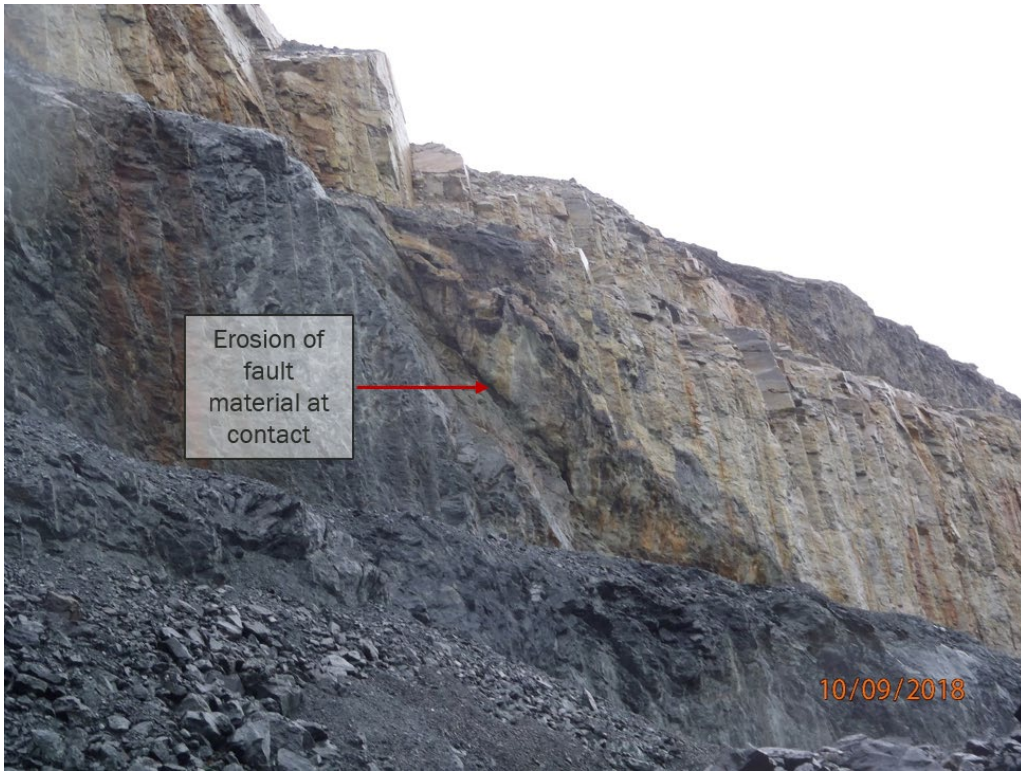
During the 2018 inspection, a fault was identified at the contact between the ultramafic and quartzite, and it was noted that the fault gouge associated with the fault was being eroded, resulting in a widening gap.

Photograph 7-3: Erosion of faulted contact Goose Pit south wall (2018)

While the risk of failure is very low due to the oblique orientation of the fault to the slope face, the potential does exist especially if erosion of the fault material continues. If the Goose Pit remains closed then the consequences of a possible bench scale instability are negligible; however, if the ramp is reactivated for use during tailings deposition, then this should be assessed further. If necessary a buttress could be placed, or the ramp could be bermed off below the fault.

- Continue visual monitoring and recording of observations as part of regular site geotechnical inspections.
- If pit ramp is reactivated, the area below the faulted contact between quartzite and ultramafic rock should be assessed further, and if necessary buttressed or bermed off below the fault. This area should be indicated on a geotechnical hazard map.
- Include the faulted contact between the quartzite and ultramafic rock in the risk register developed as part of the assessment to store tailings in Goose Pit.

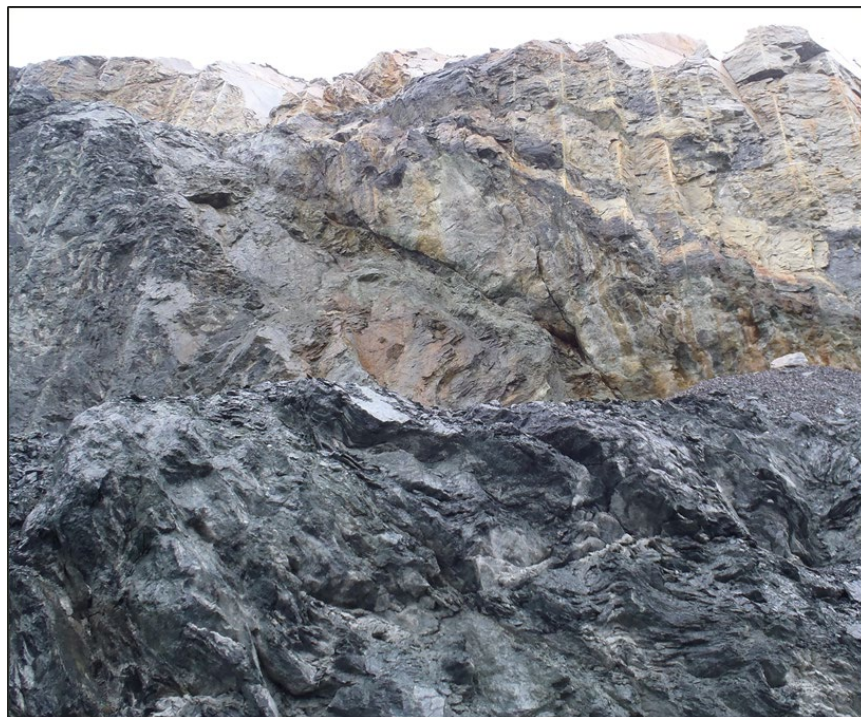
Photograph 7-4: Erosion of material along faulted contact Goose Pit south wall (2018)
