Meadowbank 2018 Annual Review of Portage and Goose Pit Slope Performance

2018 ANNUAL PIT SLOPE PERFORMANCE REVIEW

MEADOWBANK MINE, NUNAVUT

ISSUED FOR USE
704-ENG. ROCK03053-02

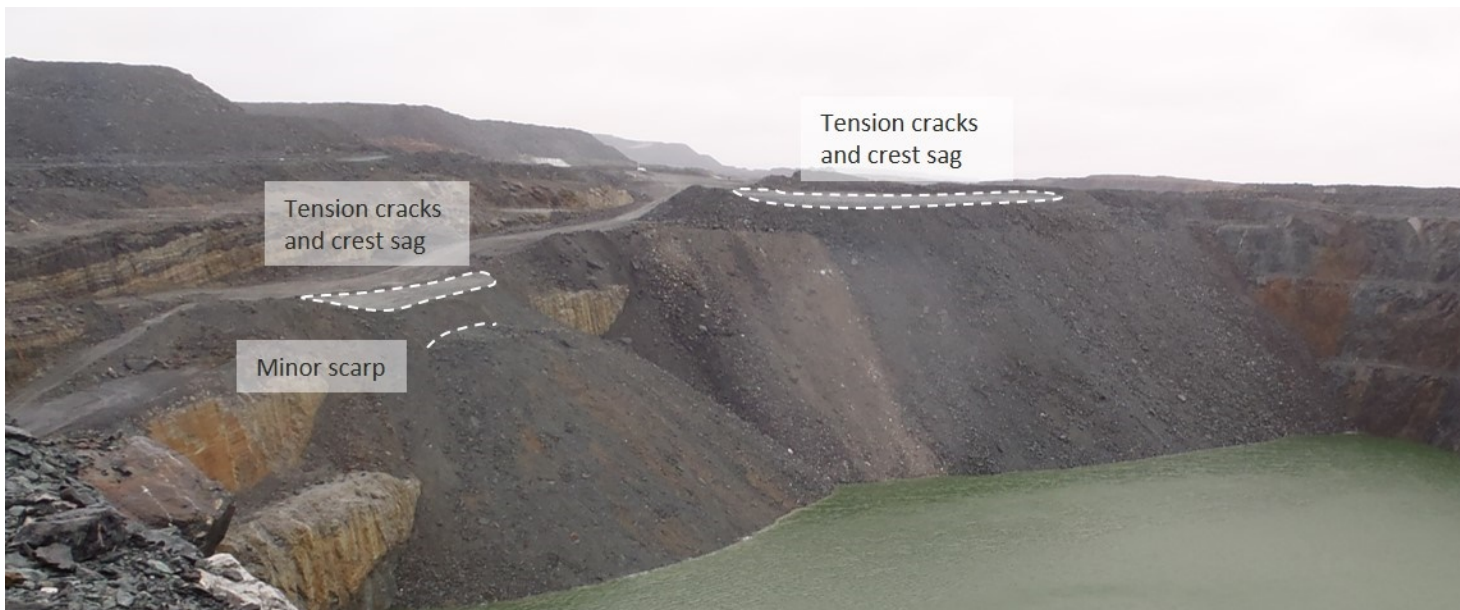
Tension cracks on the North Dump platform were first noted during the 2015 inspection, and these have been monitored regularly since. During the 2017 inspection, tension cracks were also noted on the South Dump platform. During the 2018 inspection additional shallow slumping of the South Dump face was noted, along with significant crest sag. AEM has been monitoring by observation as part of the regular geotechnical inspections. AEM monitoring the dump platform previously using simple wireline extensometers installed across the tension cracks, and established a set of procedures to implement based on relative movement magnitude.

Photograph 7-6: Goose Pit waste rock dumps (2018)

Prior to commencing of active dumping a dump inspection should be carried out, and an action plan developed that might include frequent inspections of the crest area, and the installation of additional instrumentation as required.

- If the dump or the pit are to be reactivated, carry out a dump inspection and develop an action plan for inspections and monitoring. Install wireline extensometers to measure future movement. Continue to limit access to the dump platform areas.
- Mark the position and extents of the existing tension cracks on a dump plan for on-going monitoring purposes.
- Measure the vertical displacement across the tension cracks as a record of settlement.
- Continue visual monitoring and recording of observations as part of regular site geotechnical inspections.

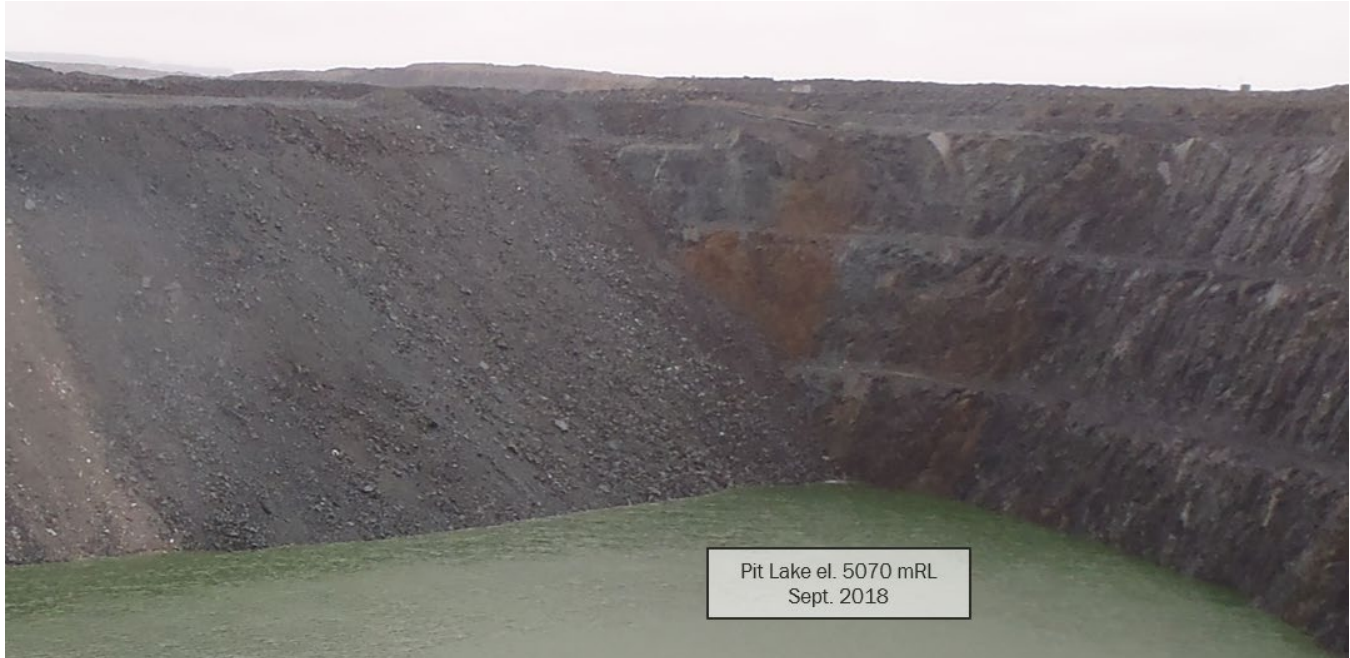
The northwest through northeast (north end-wall) walls of the Goose Pit exposes the stratigraphic sequence of the deposit, from ultramafic rock in the west, through iron formation, and then intermediate volcanic in the east. The stratigraphy and major structural features (faults and dominant foliation) strike approximately perpendicular to the wall. The wall also exposes the Bay Fault, and associated splays.

Photograph 7-9: Goose Pit northwest through northeast wall (north end wall 2018)

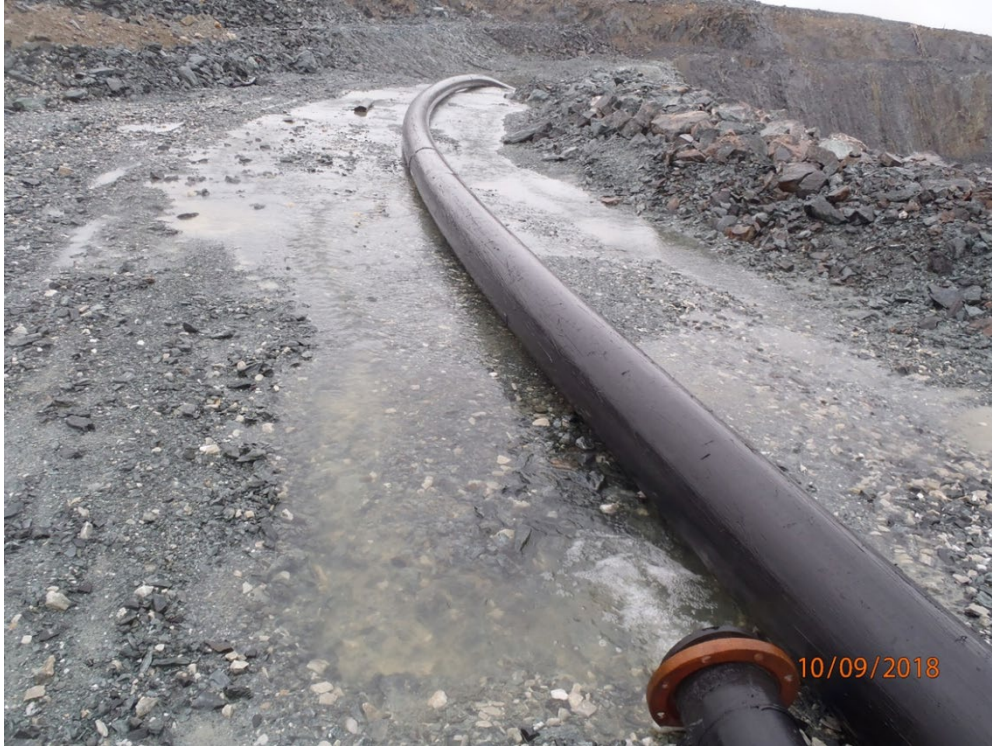
During the site inspection, it was noted that water was being discharged on to the ring road and thermal cap at the north pit crest, and flowing through the rockfill before spilling on to the rock face. Water was also flowing along the ring road to spill over the edge of the pit. The water was being pumped from a sump at the crest of Pit E. It is understood this was only a temporary discharge; however this could still affect the integrity of the ring road and should be avoided. Any water discharge should be directed on to the pit wall face, and not through the rockfill materials at the crest. During the site visit this process was stopped. The location of the water release is shown on the following figure.

Photograph 7-10: Goose Pit uncontrolled water discharge along north crest

- Do not allow uncontrolled discharge of water through fill materials at crest as this may cause unnecessary erosion of the fill materials. Direct water discharges over side on to rock face.
- When moving water discharge line at north end, do not place equipment or personnel near the crest due to potential geotechnical hazard (wedge) in rock bench below.

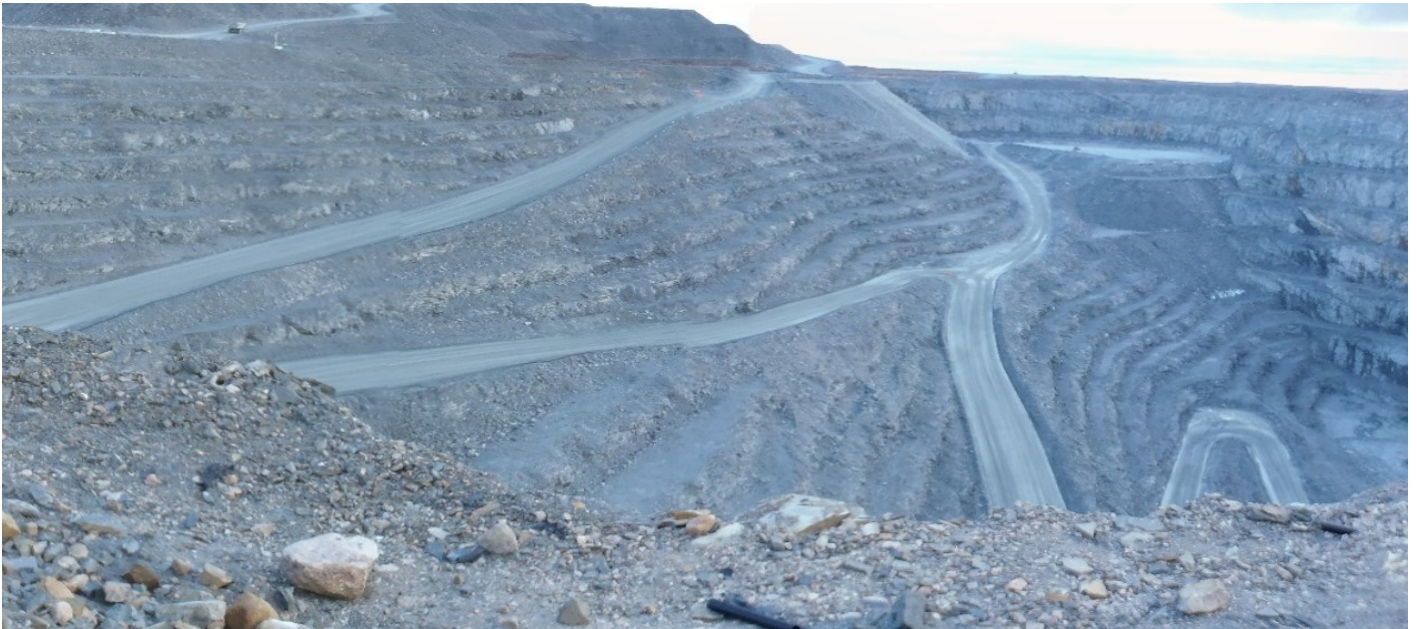
The west wall (grid west) of the Vault is mined as a series of single-benches (7m high) to create a footwall slope. The deposit dips at relatively shallow angles to the east (grid east), parallel to the foliation and stratigraphy. The average inclination is 22 degrees, but ranges from as shallow as 10 degrees to as steep as 40 degrees. Bench faces are not pre-sheared but are bulk blasted at steep angles, and generally break back, or are scaled back, to the orientation of the foliation. Consequently, there are some benches with considerable loss of catchment as was anticipated during the design process. To account for the expected performance, the bench design heights were restricted to single-height to minimize failure volumes. Since the inter-ramp slope angle is shallow at 33 degrees, the likelihood of larger scale multiple bench or overall slope failures of significant volume is low.

Photograph 8-1: Vault Pit west wall looking north (2018)

There are no significant geotechnical concerns noted, and no evidence of large scale (overall slope) instability for the footwall slope.

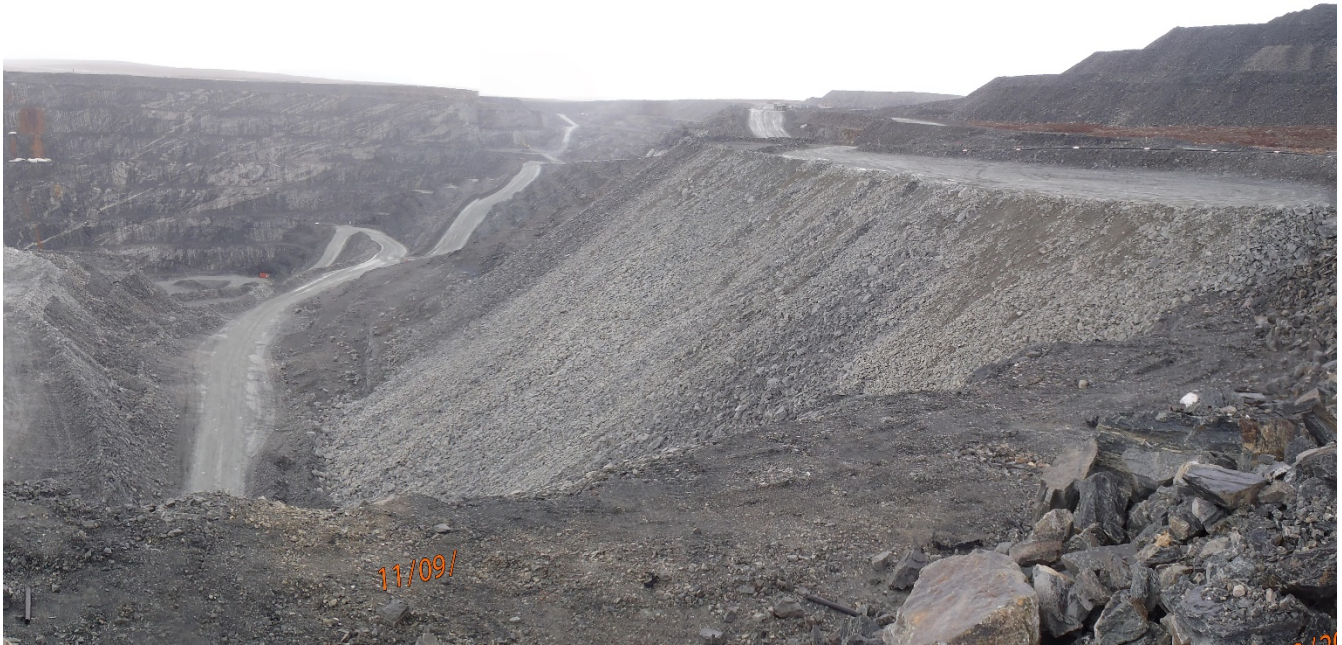
Photograph 8-2: Vault Pit west wall looking south (2018) showing dump advance

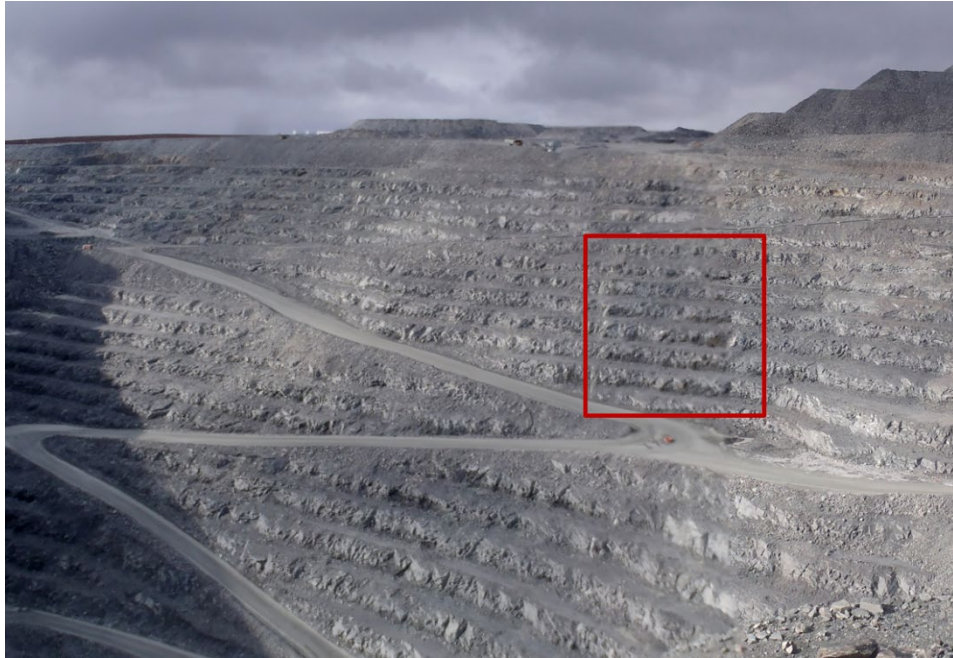
An area of seepage centrally located along the west wall appeared dry at the time of the 2018 site visit. The pit below this area has been deepened by approximately 7 single benches since 2017. Routine maintenance of the drainage ditch should continue, and monitoring of this area as part of regular geotechnical inspections should continue.

Photograph 8-3: Vault Pit west wall seepage (dry in 2018)

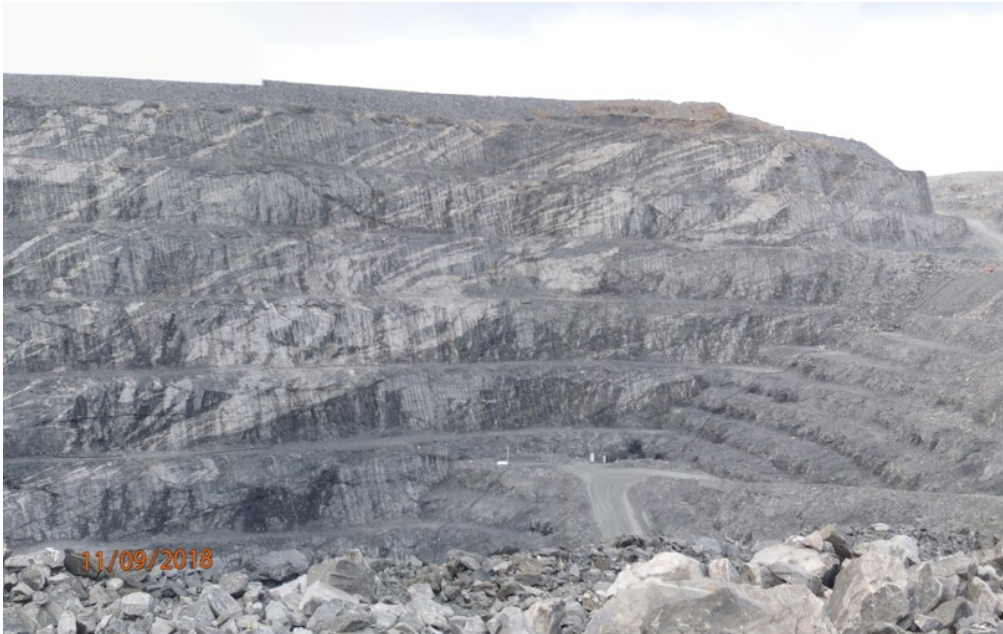
The southwest wall (grid south) intersects the stratigraphy and foliation perpendicular to their trend. The gently east dipping structure can be seen clearly in the wall. The overall wall continues to perform well, with little accumulation of material noted on the benches. The half barrel traces from pre-shear blasting are clearly visible on the wall, even from a distance. There is very little deviation noted for the blast holes.

Photograph 8-4: Vault Pit grid south wall (2018) and slot cut to Phaser Pit

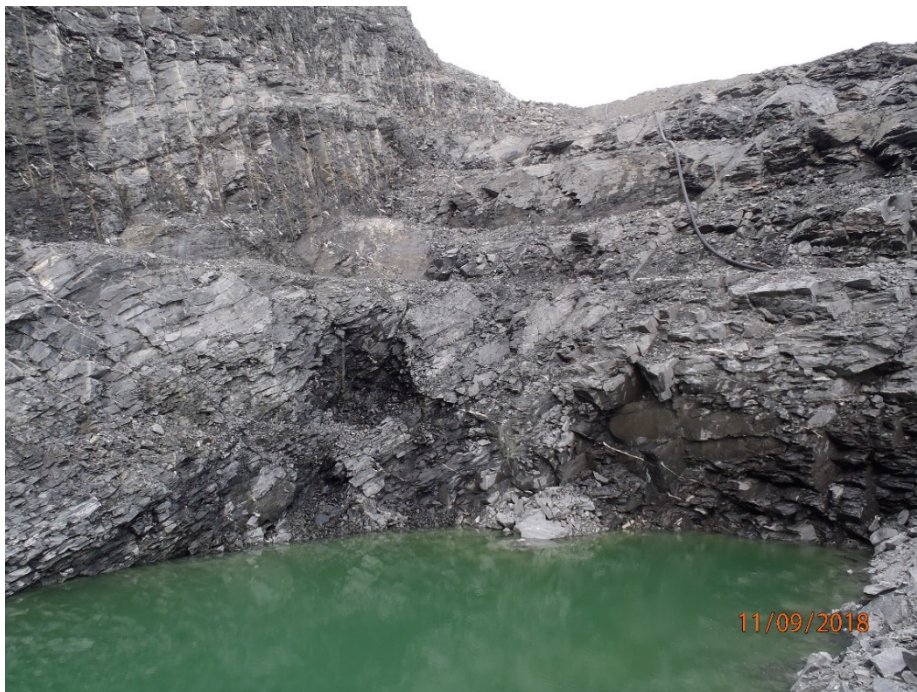
A small sump is in the southwest corner of the pit and manages water in this area. During the 2017 site visit, two outward dipping planes were noted above the sump area, forming shallow slivers of potentially unstable rock. The planes strike slightly obliquely to the wall orientation, and while they are kinematically free on their north extension, they do not appear to have any additional side release planes required for failure to occur. The area was visited again in 2018, and no observable instability associated with these planes was noted. These should continue to be monitored as recommended previously, including reminding personnel of safe work procedures relating to safe distance from rock faces, and for safety should remain to the pit-side of the equipment container.

Photograph 8-5: Vault Pit south ramp sump and out dipping planes

- Communicate the hazards in the sump area to personnel and remain on the pit-side of the equipment container for safety.
- Continue visual monitoring and recording of observations as part of regular site geotechnical inspections.

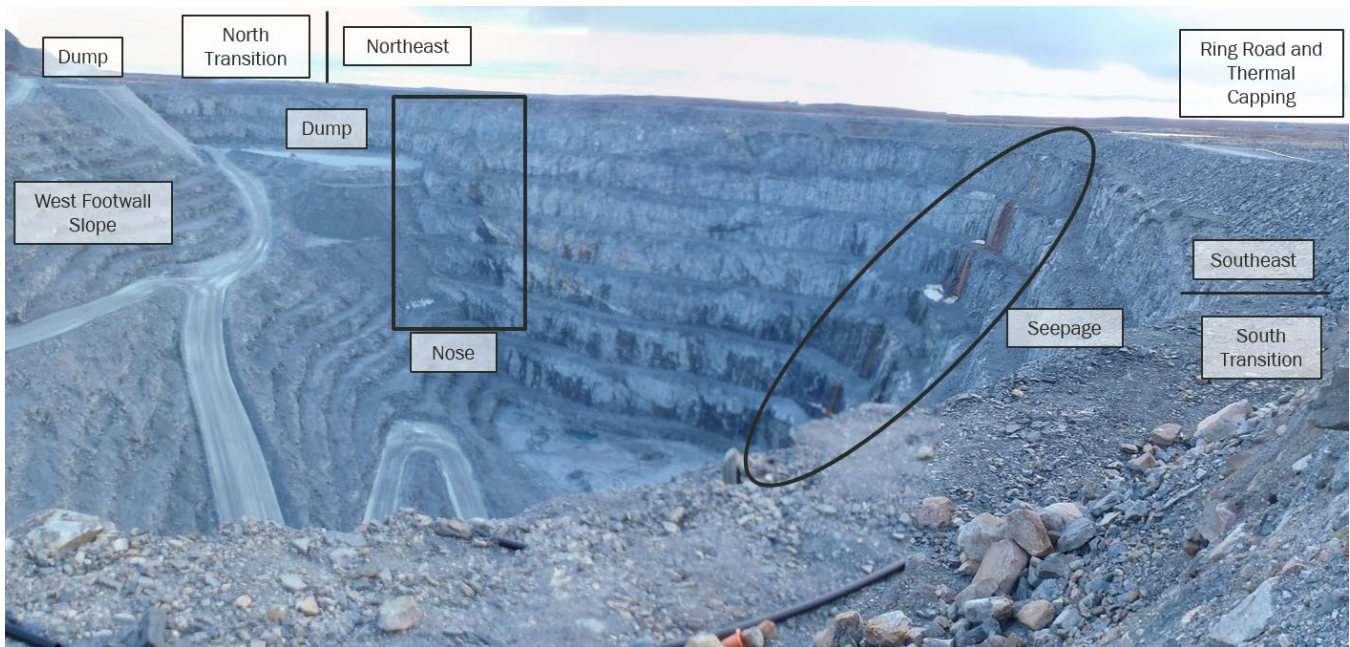
The southeast to northeast highwall (grid east wall) is being mined down to its final height. The catch benches developed for the highwall continue to perform very well. The pit floor has been deepened by approximately two triple-benches, or approximately 42 metres, to an elevation of 4976 mRL. The final benches are being mined using pre-shear blasting methods, and are being excavated to 75-degree bench face angles. Half barrels from the blast holes are clearly visible in the walls and there is very little deviation in the borehole traces.

Photograph 8-6: Vault Pit east highwall (2018)

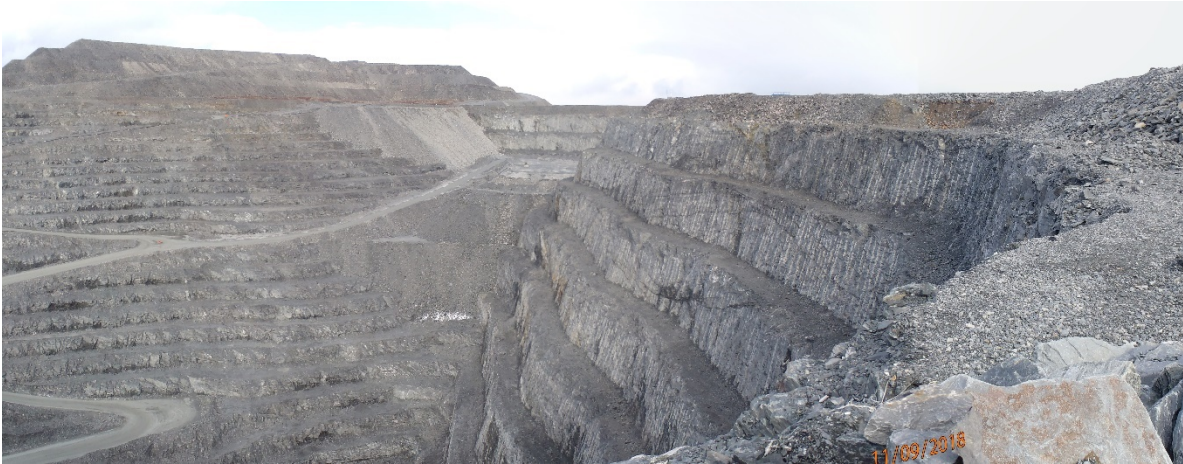
The benches are cleaned well, and there is no indication of significant raveling and no significant accumulation of material on the benches. There is some over break of bench crests due to blasting but this is not significant. In general, the toe of the thermal capping material is greater than 2 m back from the pit crest.

Photograph 8-7: Vault Pit east highwall bench performance, southeast end looking north (2018)

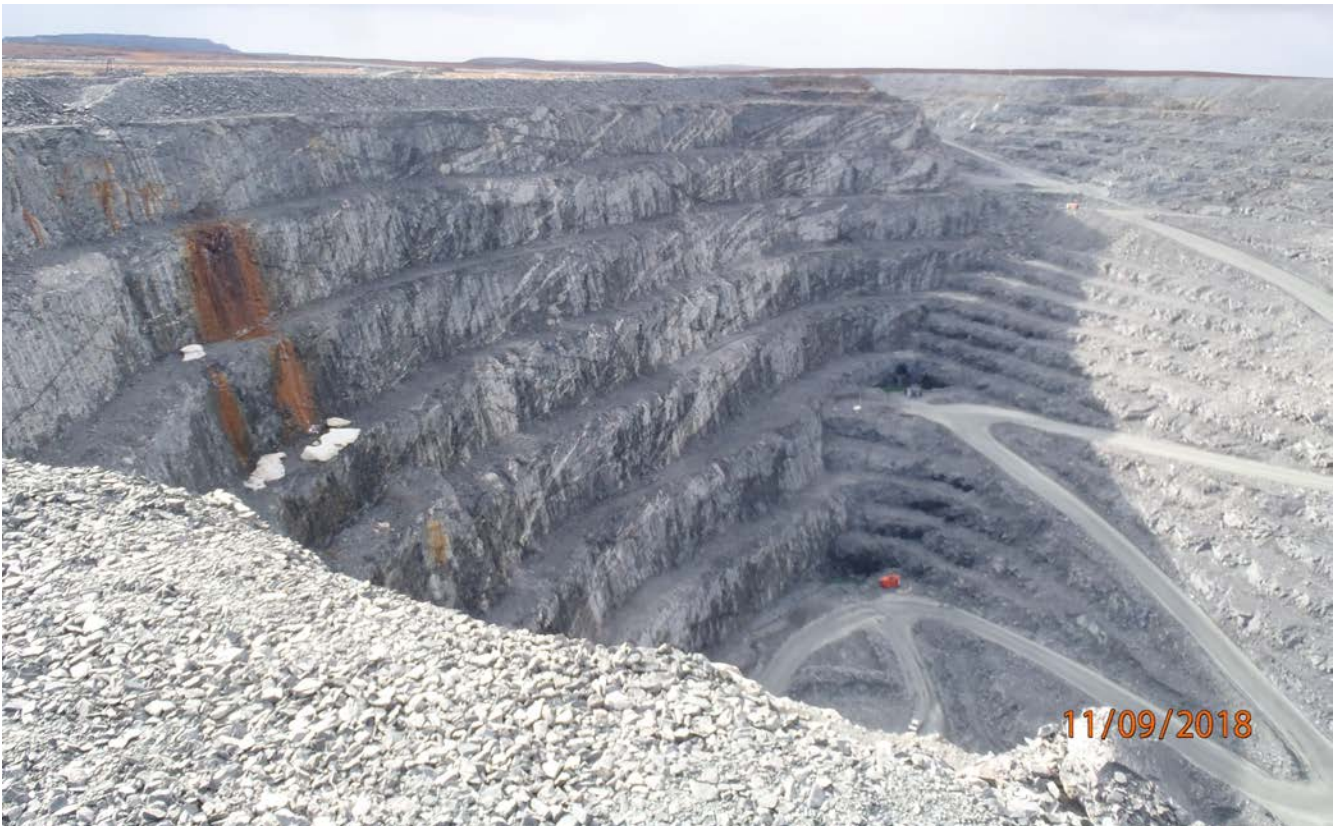
Photograph 8-8: Vault Pit east wall northeast end looking south (2018)

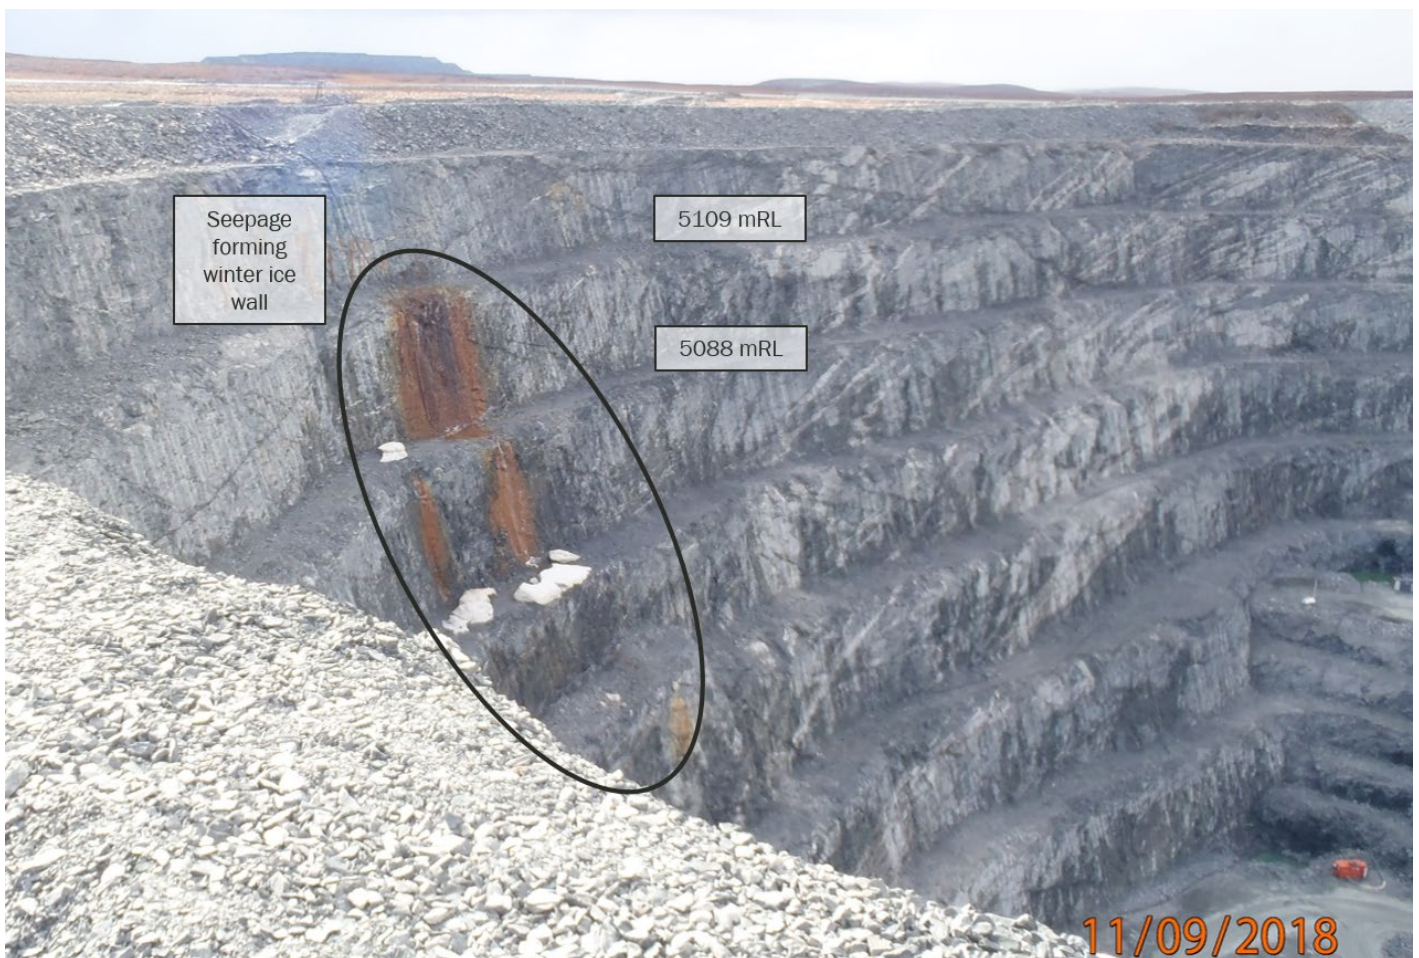
The one area of concern continues to be the south wall where seepage continues to flow from just above the 5109 mRL bench. Thermistor data suggest the area is freezing back but slowly, and there is no significant change to the non-frozen portion of the wall from which seepage flows. The formation of an ice wall can be expected for the remainder of mining in the pit. During winter mining, Agnico carry out bi-weekly inspections of the ice wall, noting any significant changes and communicating this information to operators as part of their standard management procedures. The movement and potential failure of ice is difficult to predict, but the greatest risk associated with mining adjacent to the ice wall occurs during spring freshet when ambient air temperatures are increasing. It is understood that mining of Vault Pit will be complete in January 2019, and so the risk associated with the freshet period will be avoided.

Photograph 8-9: Vault Pit seepage from southeast pit wall 5109 bench (2018)

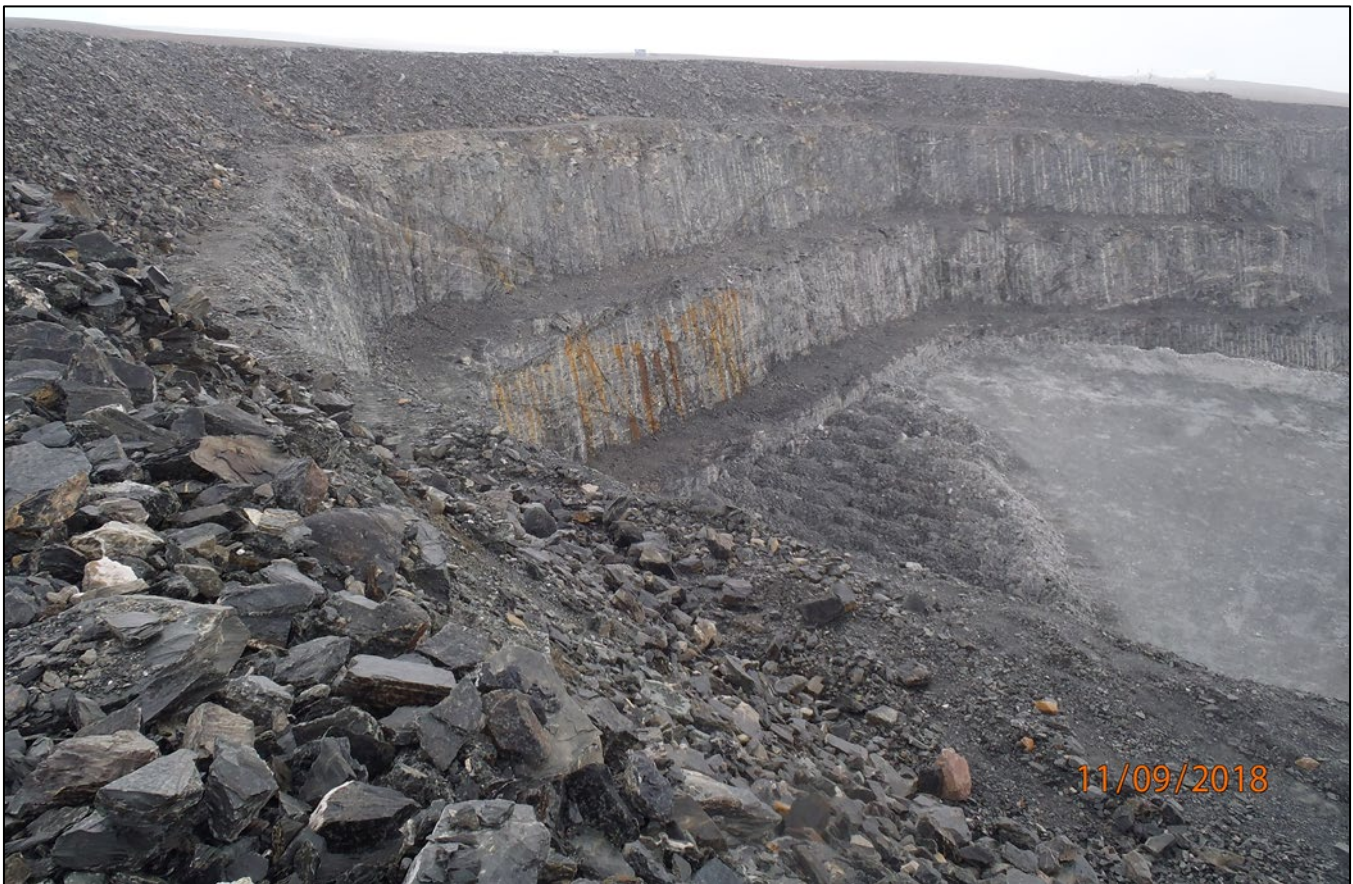
The north through northeast area of the Vault Pit is being backfilled with waste rock material. Waste rock has been backfilled to approximately the 5088 mRL elevation through the north and northeast, and near to ground surface through the northwest. Consequently, many of the geotechnical hazards identified during previous inspections no longer exist.

Photograph 8-11: Vault Pit northeast wall bench performance (2018) and dump platform

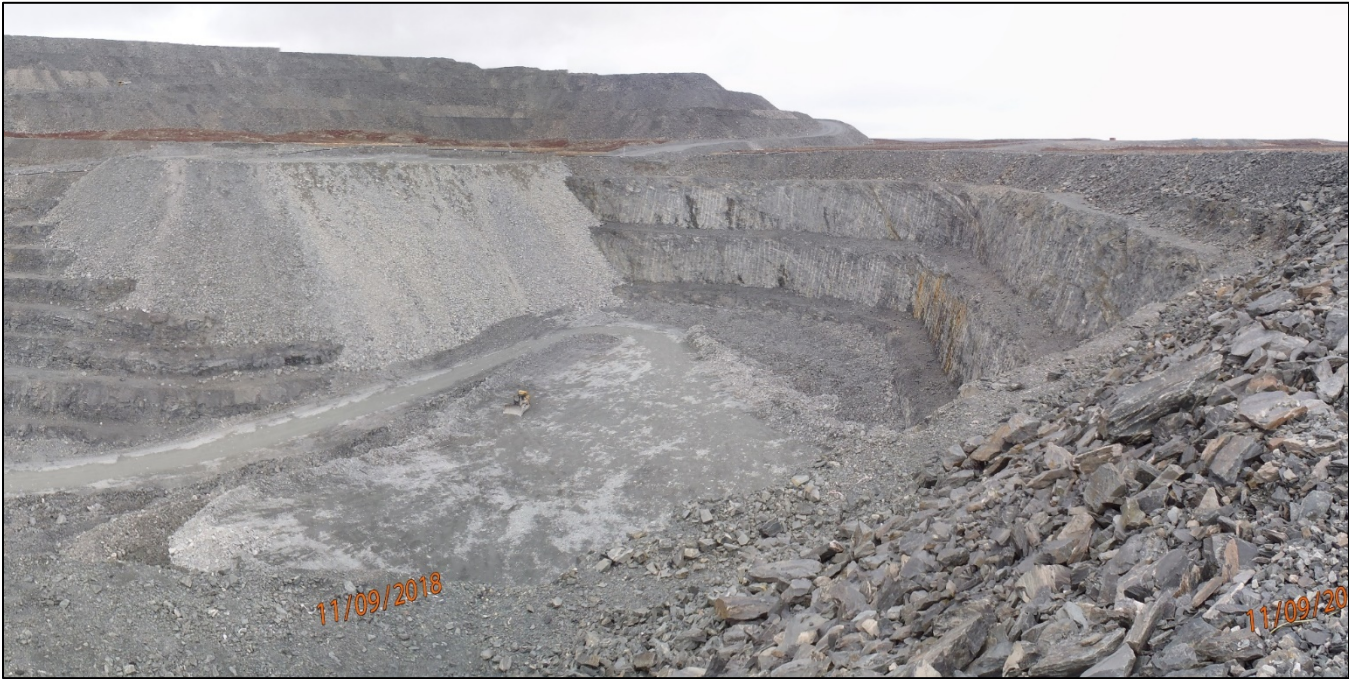
- A series of shear planes, parallel to stratigraphy, in the lower north transition wall. Overhangs identified in the lower northeast wall.
- A potential bench scale wedge was noted at the north end of the east wall, where it intersects the north wall at a right angle.

Photograph 8-12: Northeast through north transition wall (2018) and dump platforms at 5088 mRL and 5130 mRL

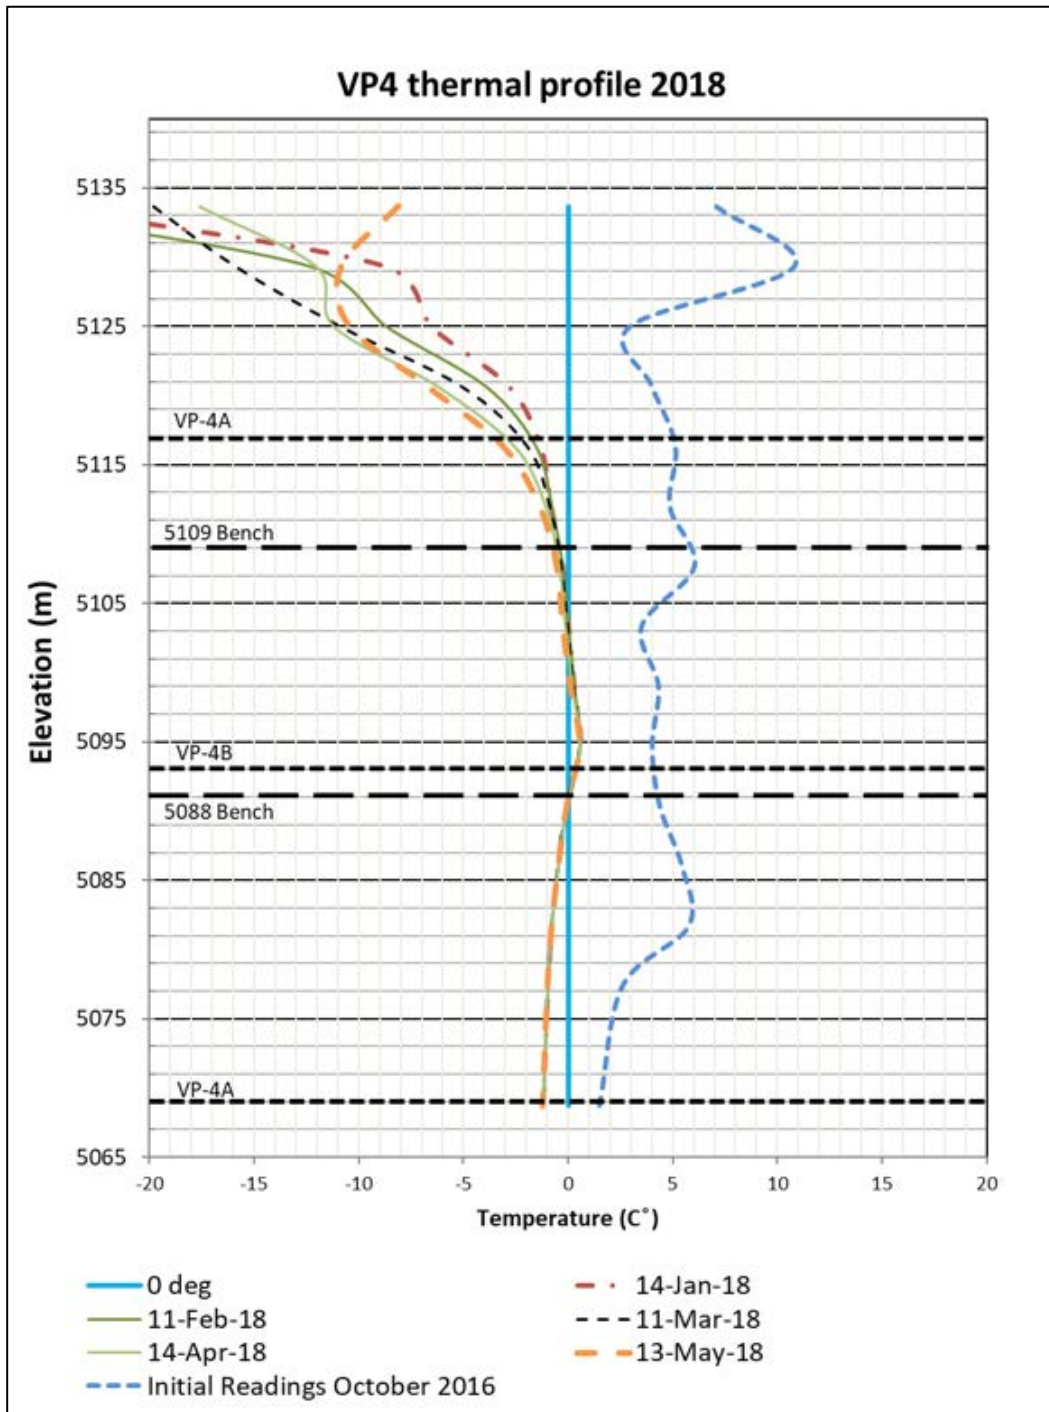
Figure 8-4: Vault Pit VP4 thermal profile

VP4 is installed behind the area of the ice wall on the southeast side of the pit. As with VP2, VP3 displays a typical permafrost 'trumpet' curve. The curve shows that the upper portion of the wall, to an elevation of approximately 5109 mRL, is within permafrost. Between 5109 mRL and 5090 mRL, ground temperatures are approximately 1 degree C in the region that seepage is noted from the wall and where the winter ice wall takes form. There is no noticeable change in the thermal profile in VP4 from 2017.

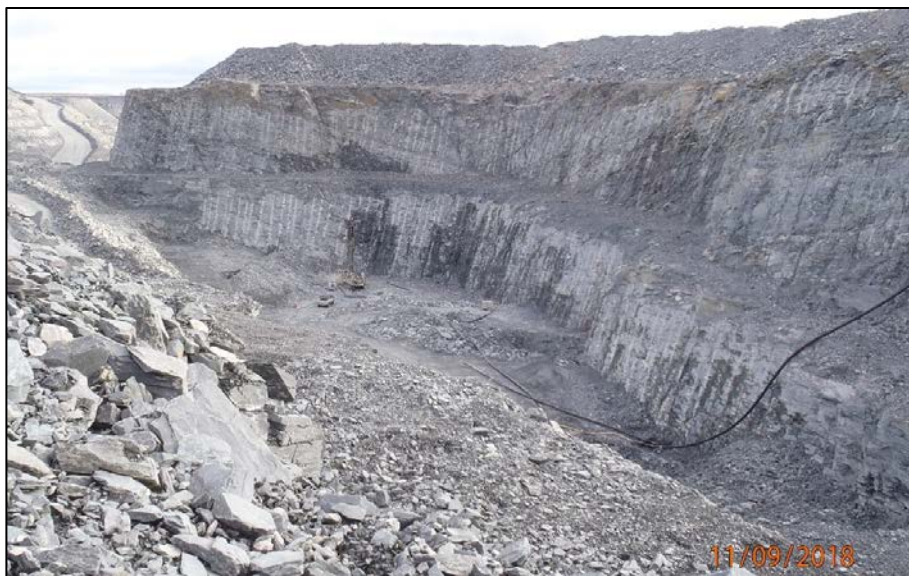
The east-southeast highwall of the pit was reviewed, and is performing well. Half-barrels from pre-shear blast holes are clearly visible, and show little deviation. The upper bench exposed during the site visit is well cleaned and allowed safe access to assess the bench-scale performance. The excavation practices are appropriately following the design criteria for the Vault Pit, and the performance of the highwall is similar to that of the Vault Pit.

Photograph 8-14: Phaser Pit east-southeast highwall performance (2018)

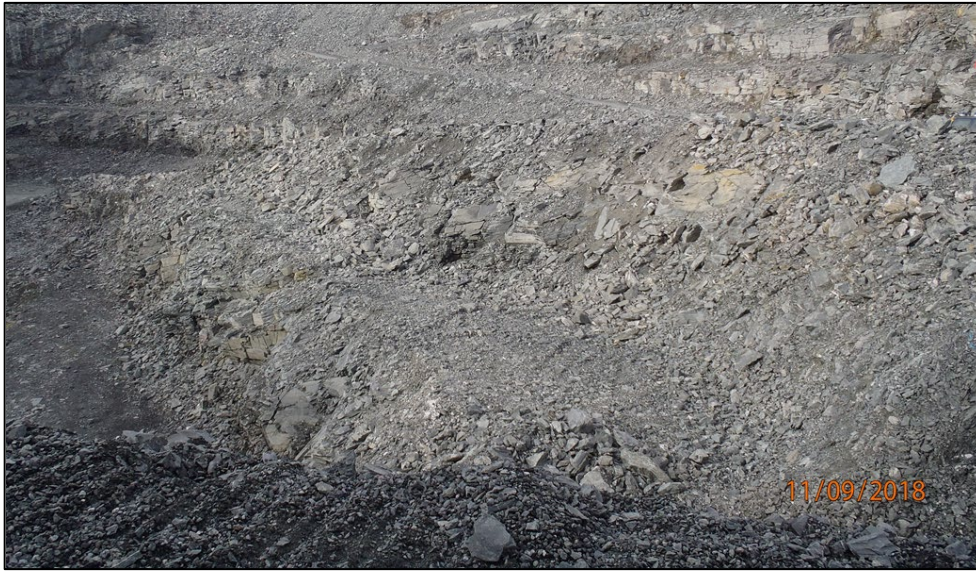
Photograph 8-15: Phaser Pit west-northwest footwall performance (2018)

The west-northwest footwall slope was also reviewed. The excavation of the footwall slope follows similar design to the Vault Pit footwall slope, and experiences similar performance related issues. These relate predominantly to undercutting of the bedding by steep bench faces, and subsequently slabbing along bedding planes resulting in the accumulation of material on the benches. This manner of performance was expected as part of the design of the benches, and the single bench heights of 7 m is to minimize the volume of material that accumulates.

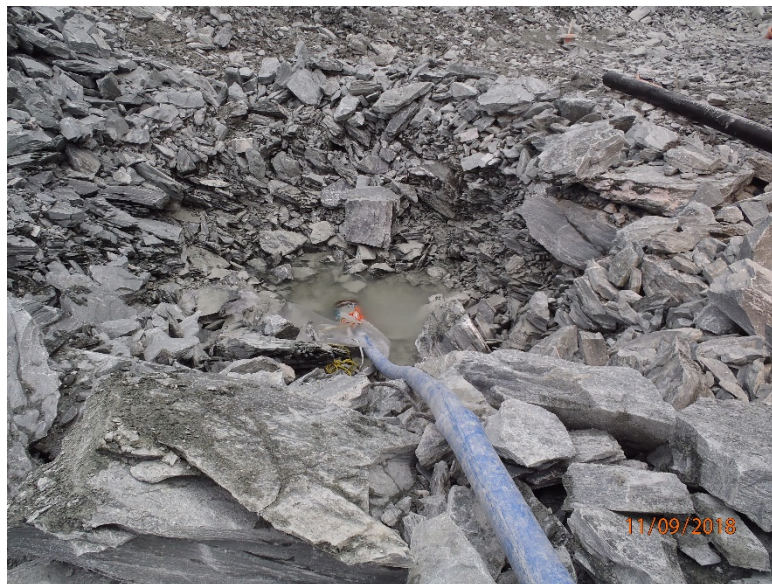
During the inspection it was noted that the pit was relatively dry as expected, with a small sump managing water inflows.

Photograph 8-16: Phaser Pit sump

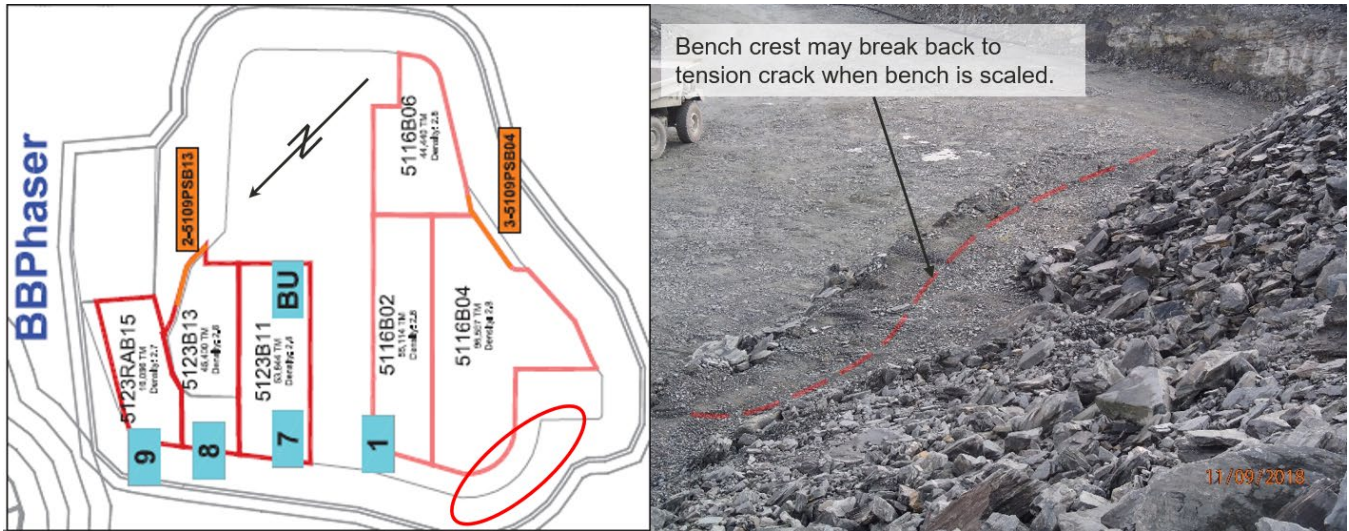
It was noted that in many areas the set back of the thermal cap toe from the crest of the pit was narrow, and less than adequate in some areas that had not yet been scaled. Furthermore, it appeared that the thermal cap was placed predominantly during winter, without proper snow and ice removal before placement. This has resulted in substantial thaw settlement and differential displacement of the thermal capping material and the development of hummocky ground, sinkholes, and tension cracks. The presence of voids may allow for water infiltration into the thermal cap, which could result in erosion. The lack of sufficient catchment at the toe of thermal cap, and above the pit, may result in spill over on to the ramp and benches.

Photograph 8-17: Tension crack at crest of first bench below thermal capping toe

- Improve bench cleaning and wall scaling practices in BB Phaser Pit.
- Monitor ring road in BB Phaser Pit, and manage water accordingly. The current differential settlement is most likely due to the time of year the fill was placed, and so is not unexpected. However, the proximity of the ring road and thermal cap to the pit crests presents some potentially unsafe conditions because of this.
- Consider re-grading of the ring road/thermal cap to remove hummocky ground and promote drainage away from the crest areas.
- Consider developing a small windrow of material at the toe of the first bench to catch any material that may spill over from the thermal cap above.
- Continue visual monitoring and recording of observations as part of regular site geotechnical inspections.
- Continue mapping to confirm the orientation of stratigraphy and other important structures.

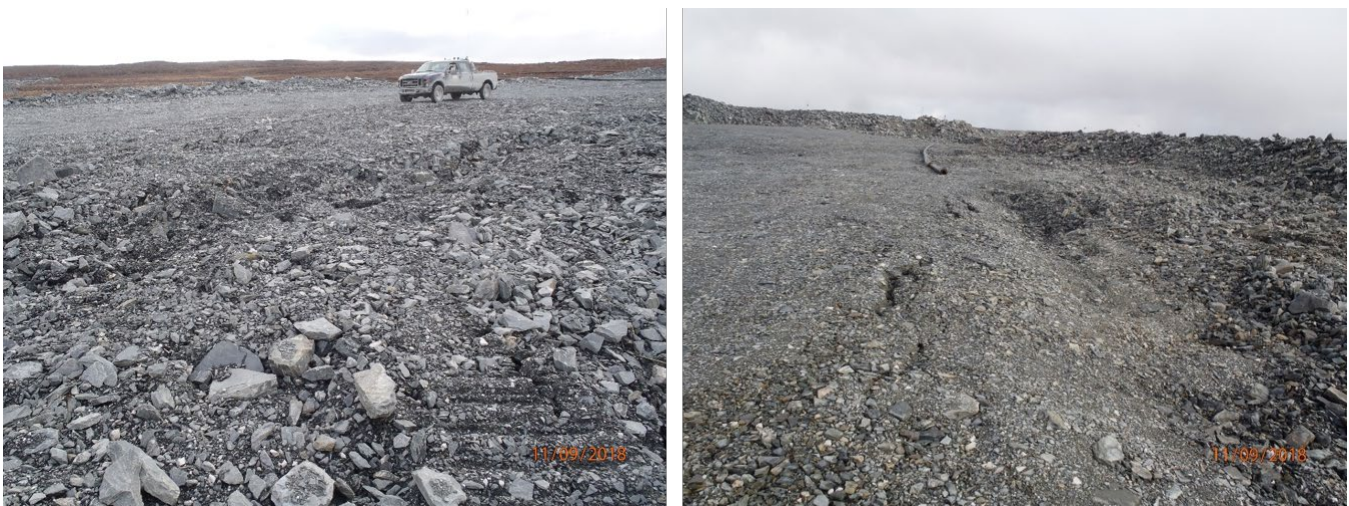
Photograph 8-18: Thermal cap showing hummocky ground, differential settlement, and voids

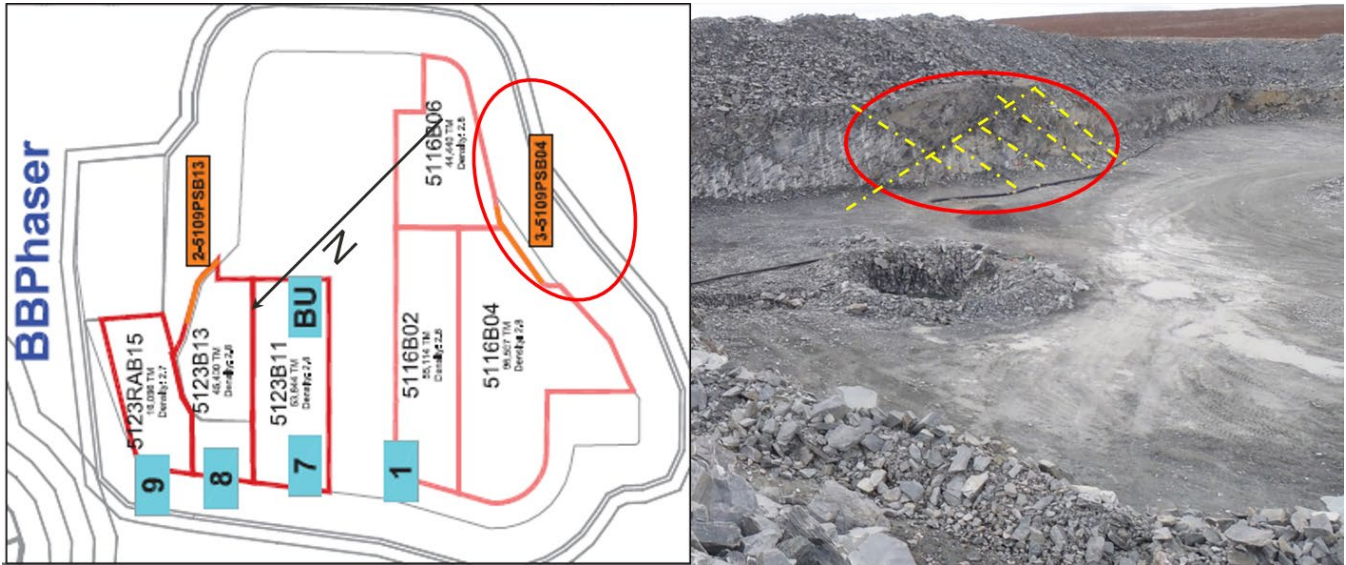
An area of the south and west wall of the pit was noted to display significant blast damage to the rock. This blast damage, combined with local faulting and continuous open jointing, has resulted in a rock mass that may be difficult to effectively scale. Over excavation during scaling could result in undercutting of the thermal cap. Consequently, it may be more effective to leave this specific area unscaled to avoid over digging of the rock mass and undercutting of the overlying materials. An alternative might be to construct a low buttress against the face if the current platform elevation is the final platform for this area. This was discussed with AEM during the site visit, and it was recommended that as a minimum, candles should be placed to restrict entry to the area until appropriately cleaned.

Photograph 8-19: BB Phaser Pit south wall blast damaged rock

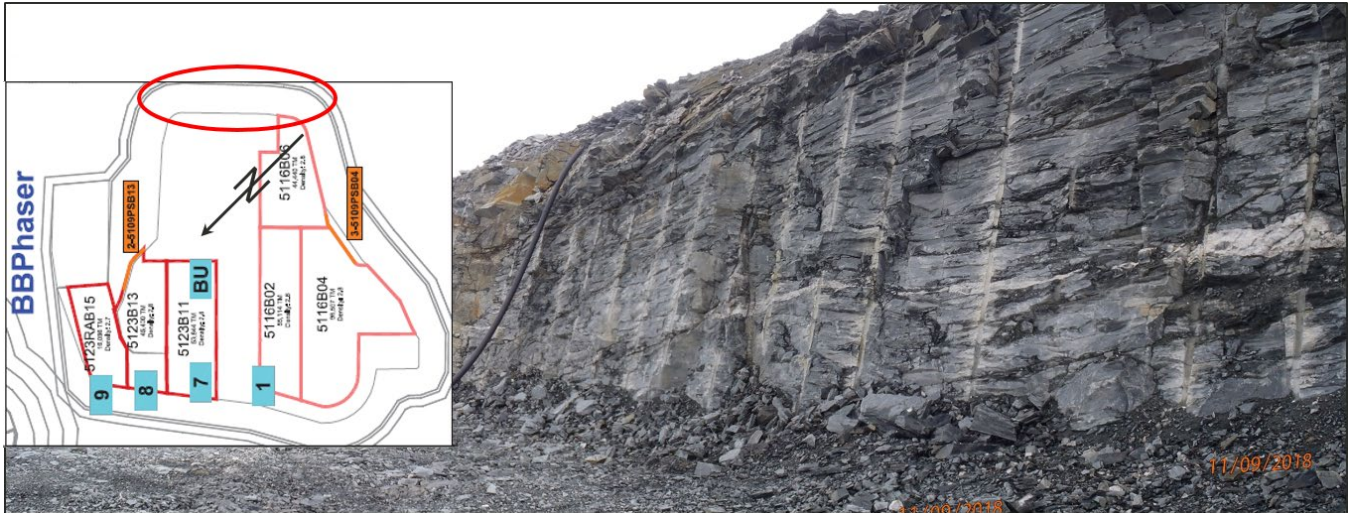
The south through east highwall of the BB Phaser Pit was inspected. This area of the pit has responded well to pre-shear blasting with half-barrels visible in the wall, and good wall performance.

Photograph 8-20: BB Phaser Pit south through east highwall showing good performance

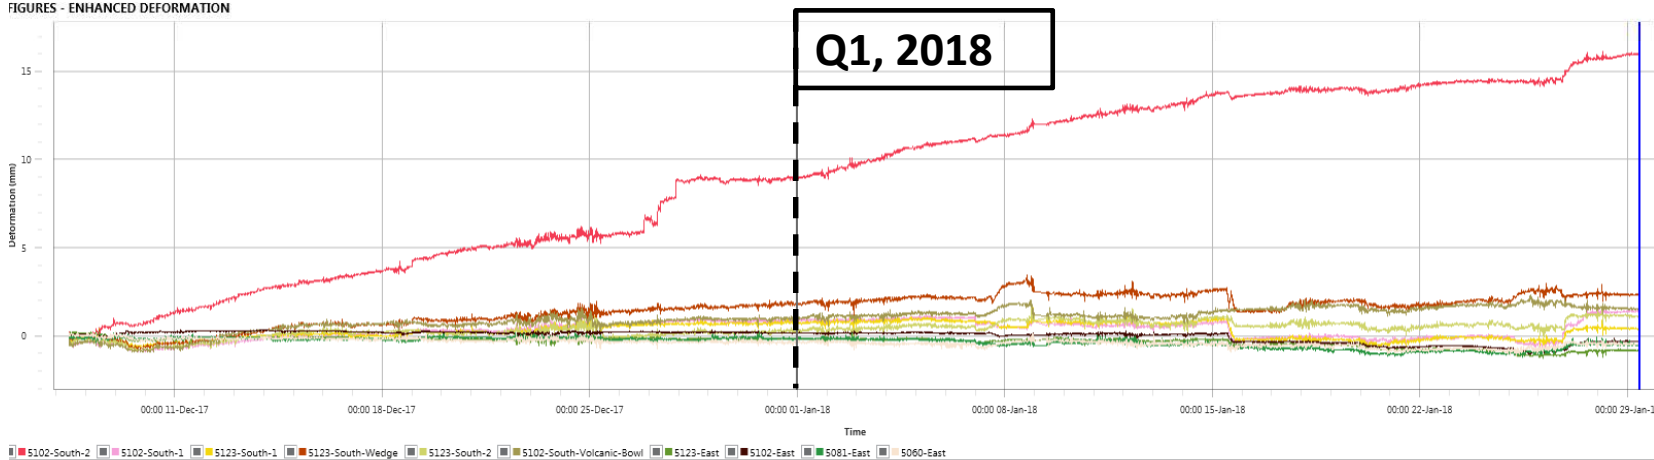
Comments: Most of the sectors were showing stable wall condition. The sector identify as 5102-South-2 presents a linear progression in deformation during that period(+7mm during January). The primary interpretation of this linear trend is the build-up of ice within joints behind the wall. It is assumed that this ice formation could (or not) lead to a detachment of a large block. A specific alarm setup has been implemented for this area to quickly catch any acceleration of the deformation. Usual TARP is applicable with the dispatch office for the night shift.
