Meadowbank 2018 Annual Review of Portage and Goose Pit Slope Performance

2018 ANNUAL PIT SLOPE PERFORMANCE REVIEW

MEADOWBANK MINE, NUNAVUT

ISSUED FOR USE
704-ENG. ROCK03053-02

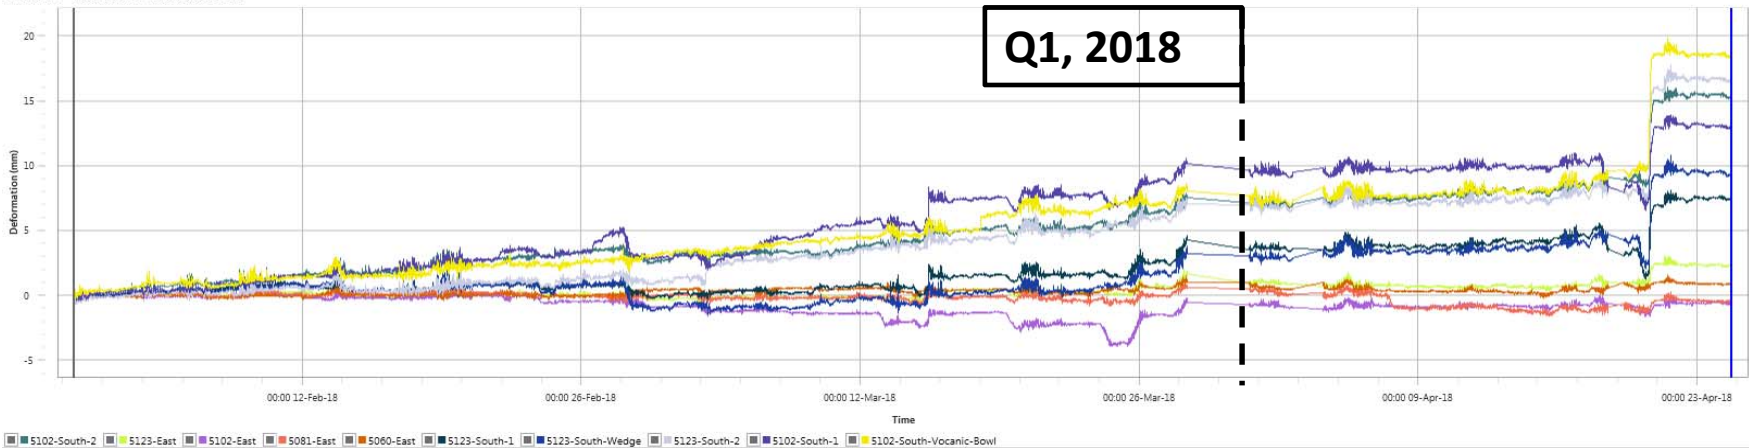
Comments: During the second monitoring period, the section mentioned previously (5102-South-2) gained 10mm over a 2 months period. On this second monitoring period, it is interesting to point out that out that the section does not stand out from the others like before, and it is now his close neighbour (5102-South-1) that has the strongest deformation trend. The probable cause of the small fluctuation (spikes) recorded on all the trend is the monitoring condition the Radar has to performed in.

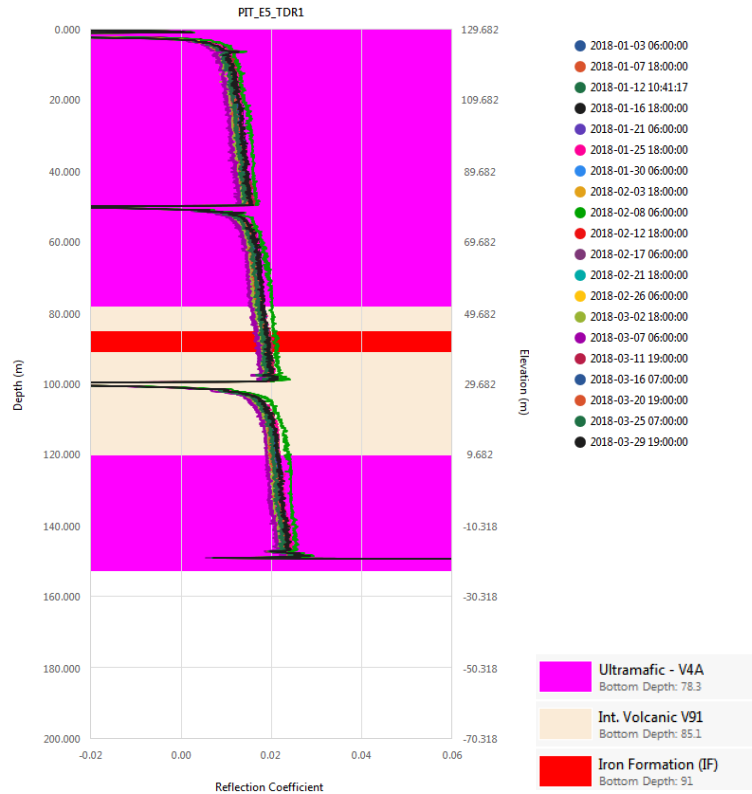
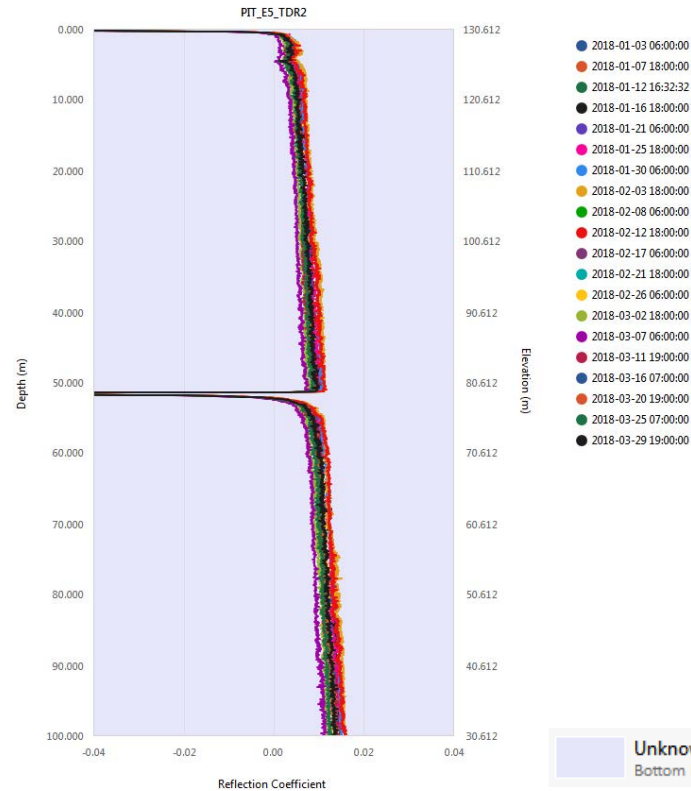
- No sign of deformation observed in TDR1 & TDR2.
- Anomalies from the TDR logger are still presents and were disregarded in the presented graphs.

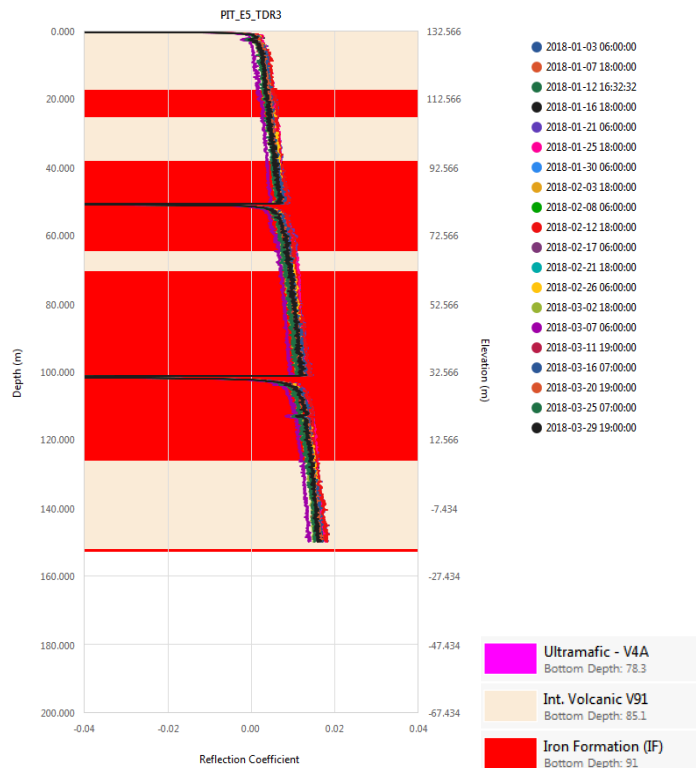
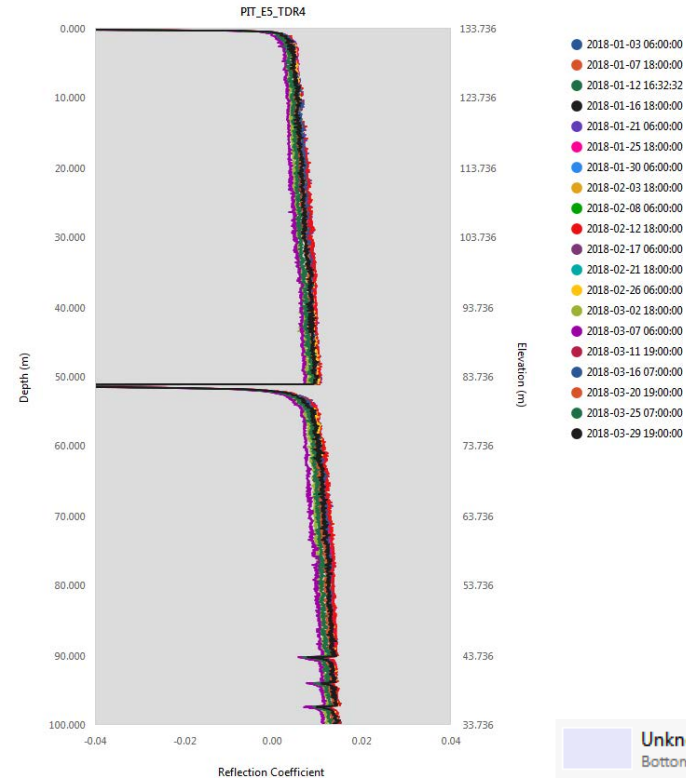
- No sign of deformation observed in TDR3.
- The small reflection coefficient spikes in between elevation 44 and 34 MASL on TDR4 are present since installation.
- Anomalies from the TDR logger are still presents and were disregarded in the presented graphs.

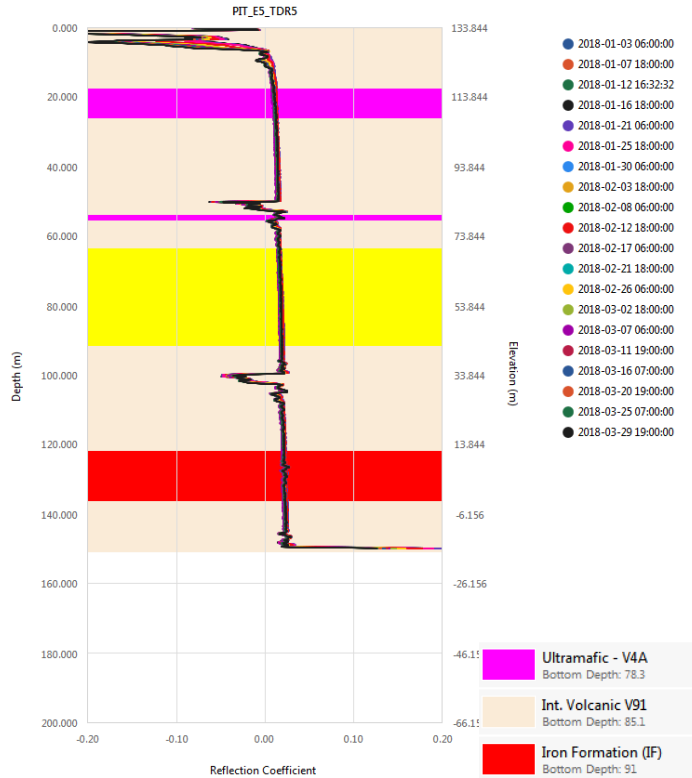
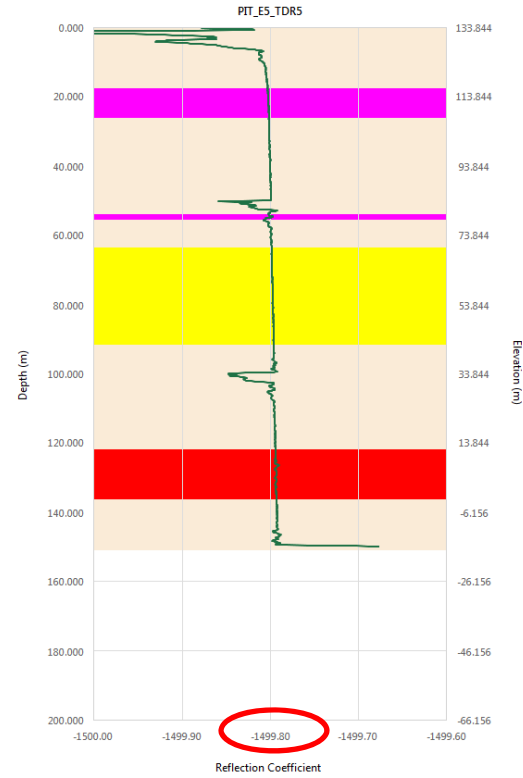
The anomalies quoted in the previous TDR results are under investigation. Basically, the defect causes the data set to be translated into the graph ($x \approx -1,500$) in the example. Even though the general aspect of the graph seems to be preserved, the Reflection Coefficient is well below the expectations.

- No sign of deformation observed in TDR5.
- The small reflection coefficient spikes in between elevation 14 and -6 MASL on TDR5 are present since the installation.
- Anomalies from the TDR logger are still presents and were disregarded in the presented graphs.

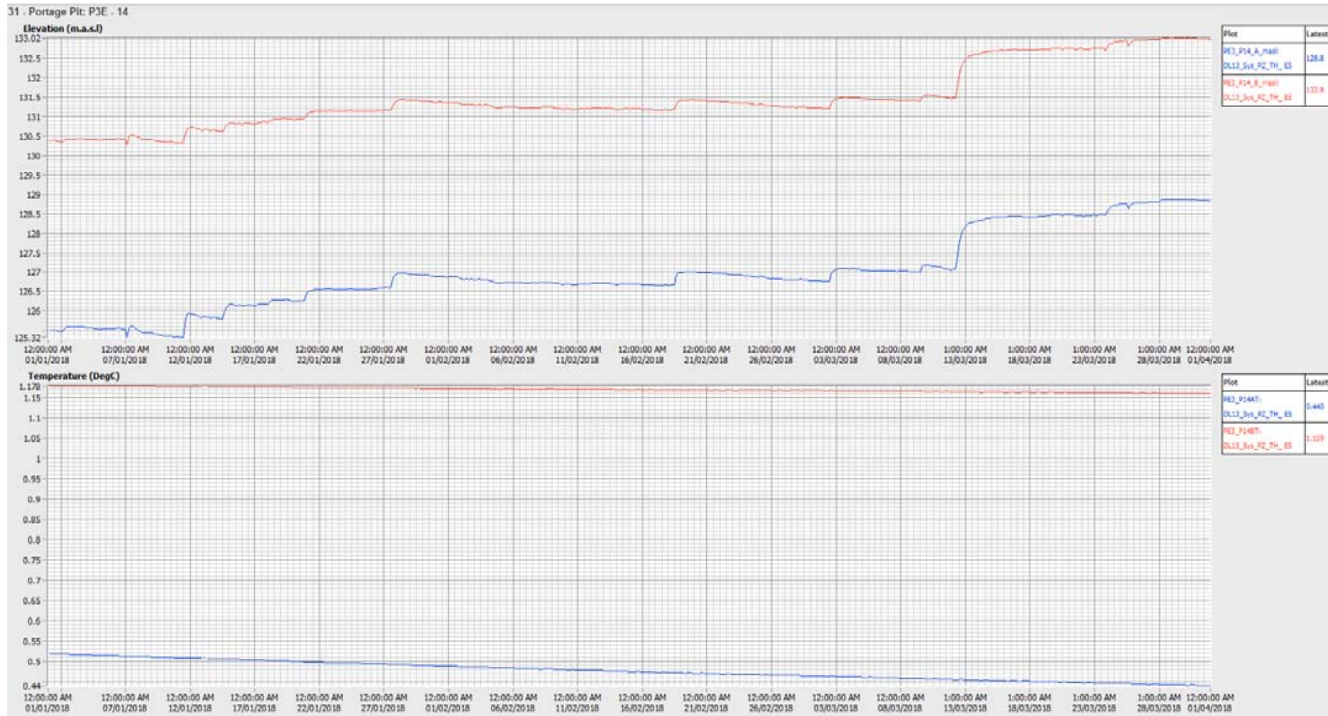
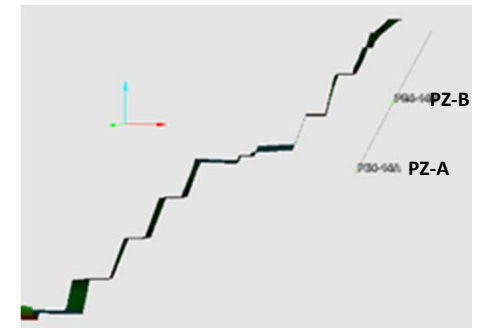
- Overall increase in pressure of +2.6m in the Q1, 2018. This is assumed to be related to freeze back of seepage faces.
- Smaller increase and decrease in pressure are related to mining activities (drilling/blasting).
- Overall downward trend for piezometer's temperature.

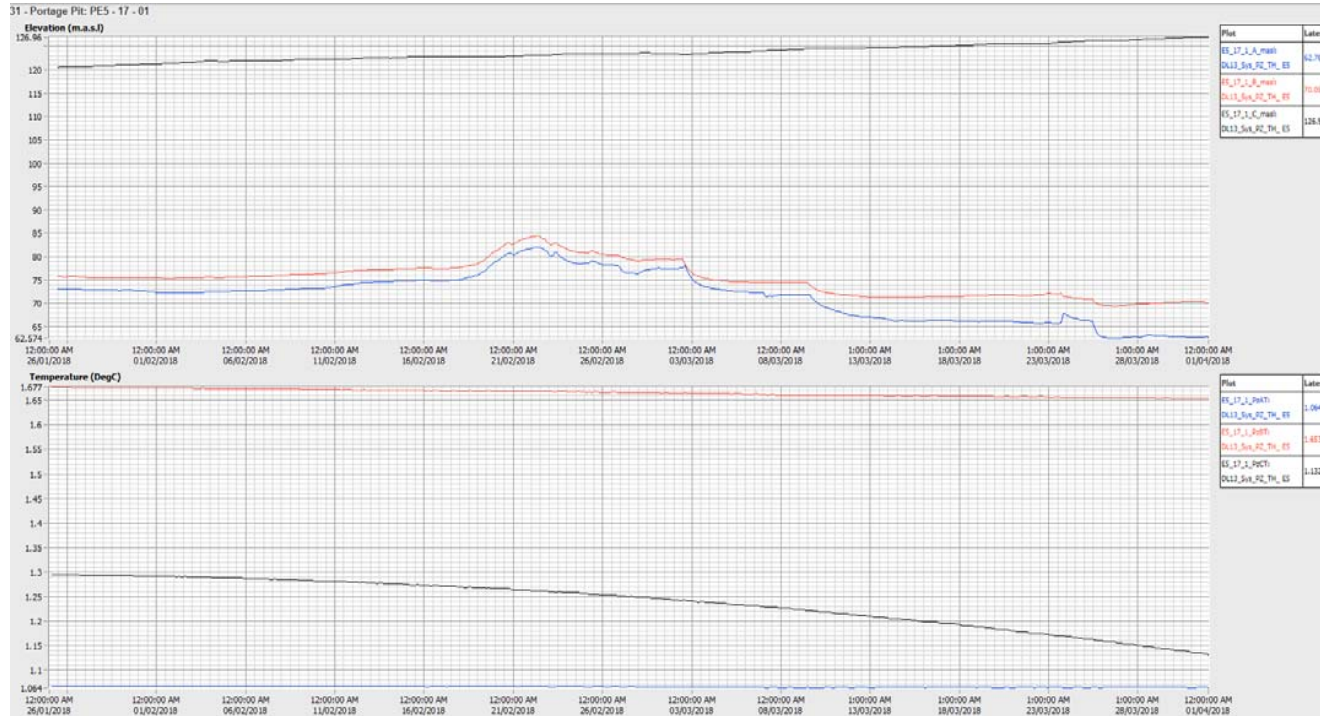
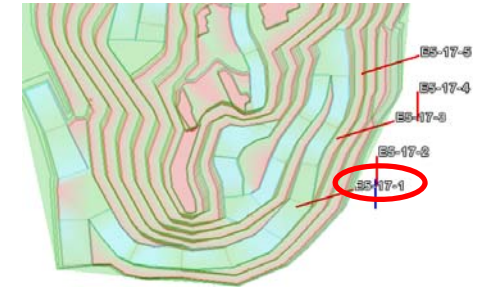
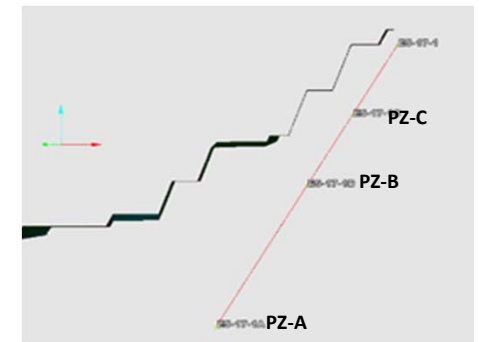
PE5-17-01 PZ-A,B,C

- PZ-A&B sharply rose 7m PWP before dropping 15m PWP from the end of February to the end of the Q1. The increasing section could be attributed to freeze back of the seepage faces while the decreasing trend could be the result of a pressure release due to the mining activities close by the hole. PZ-C has a consistent pressure increase and gained 8.7 m PWP during the Q1, 2018.
- Smaller increase and decrease in pressure are related to mining activities (drilling/blasting).
- None of the piezometers are under the freezing point.

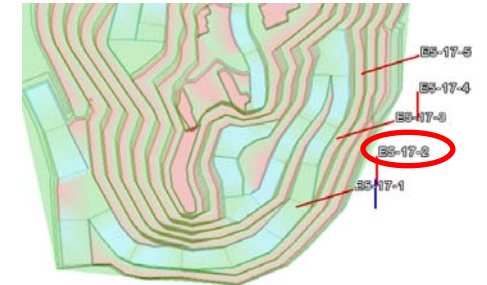
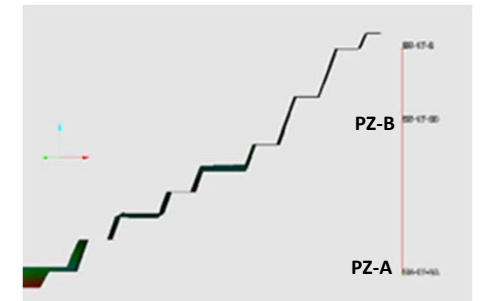
PE5-17-02 PZ-A,B

- PZ-A sharply rose 3m PWP around mid-February, while PZ-B acted the same way but on a smaller scale. This could be attributed to freeze back of the seepage faces. Indeed, PZ-A appeared to be more sensitive than PZ-B and that may be attributed to its proximity with the talik.
- None of the piezometers are under the freezing point. There is slight downward trend in PZ-B temperature's.

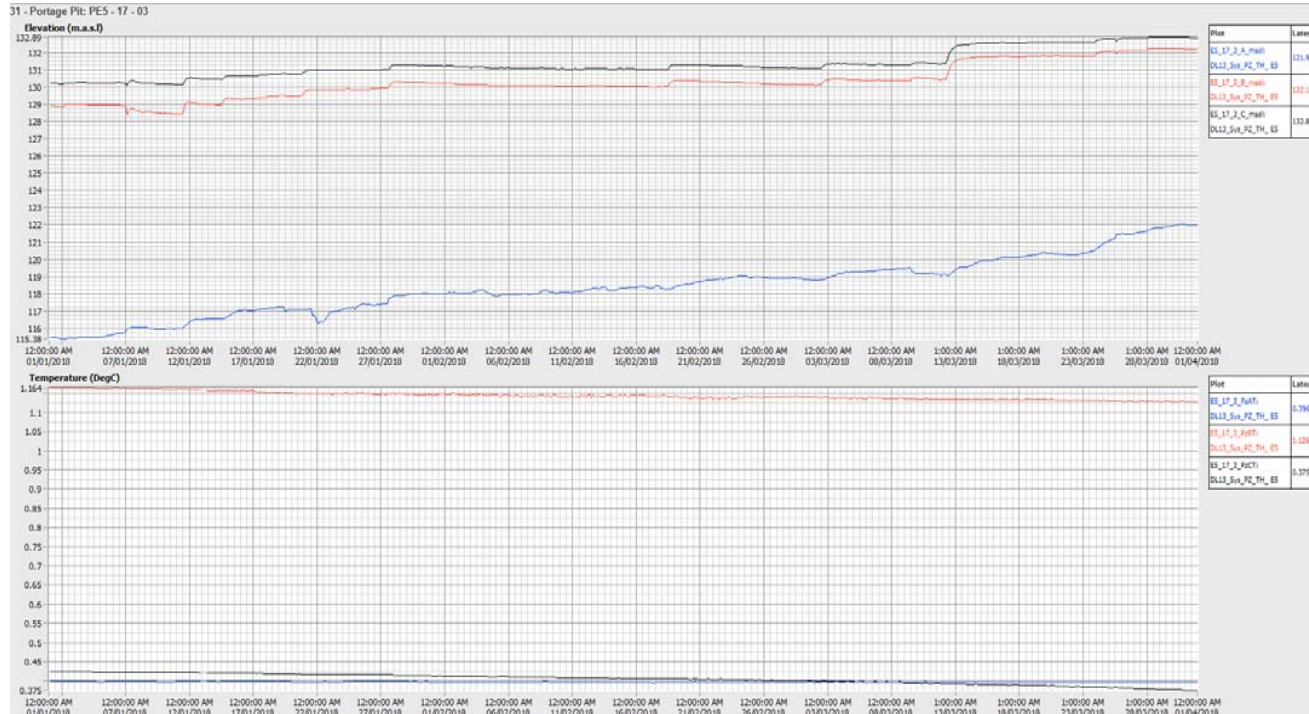
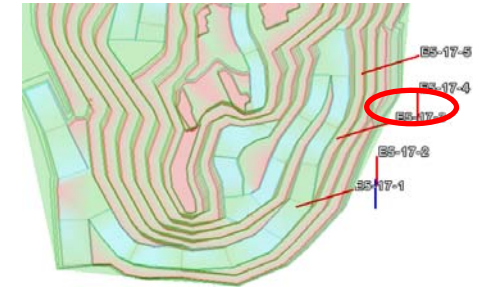
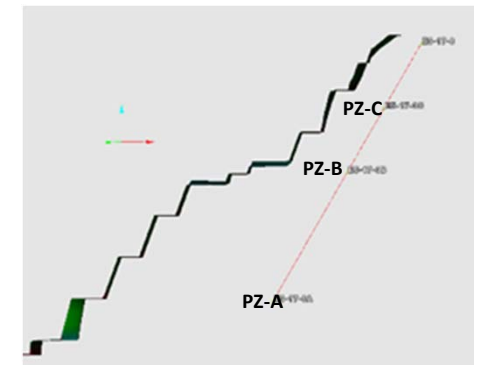
PE5-17-03 PZ-A,B,C

- PZ-A rose steadily during the Quarter Period totaling 9 m of pore water pressure.
- PZ-B & C rose 5.3 m PWP and were subject to small sudden variations cause by the mining activities.
- All the PZs are above the freezing point and PZ-B (0.8°C) is warmer than the others.
- PZ-C is on a cooling trend and might become frozen and unreliable in the upcoming months.

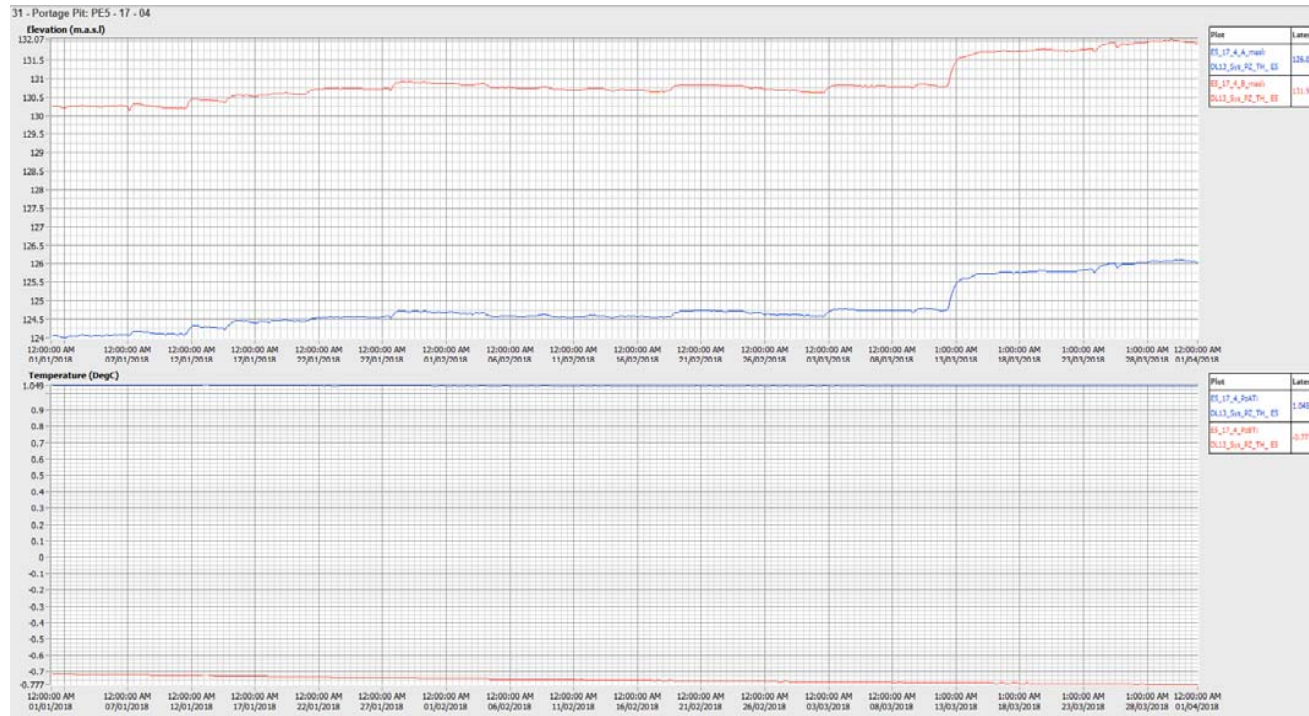
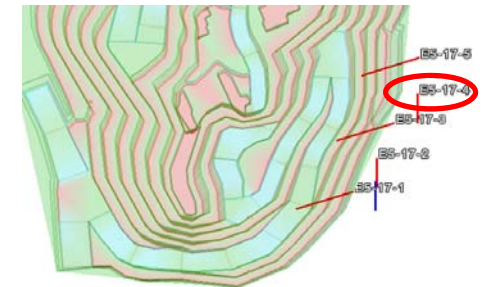
- PZ-A is on a slow increasing trend.
- PZ-B is frozen while PZ-A is at around 1°C.
- Smaller increase and decrease in pressure are related to mining activities (drilling/blasting).

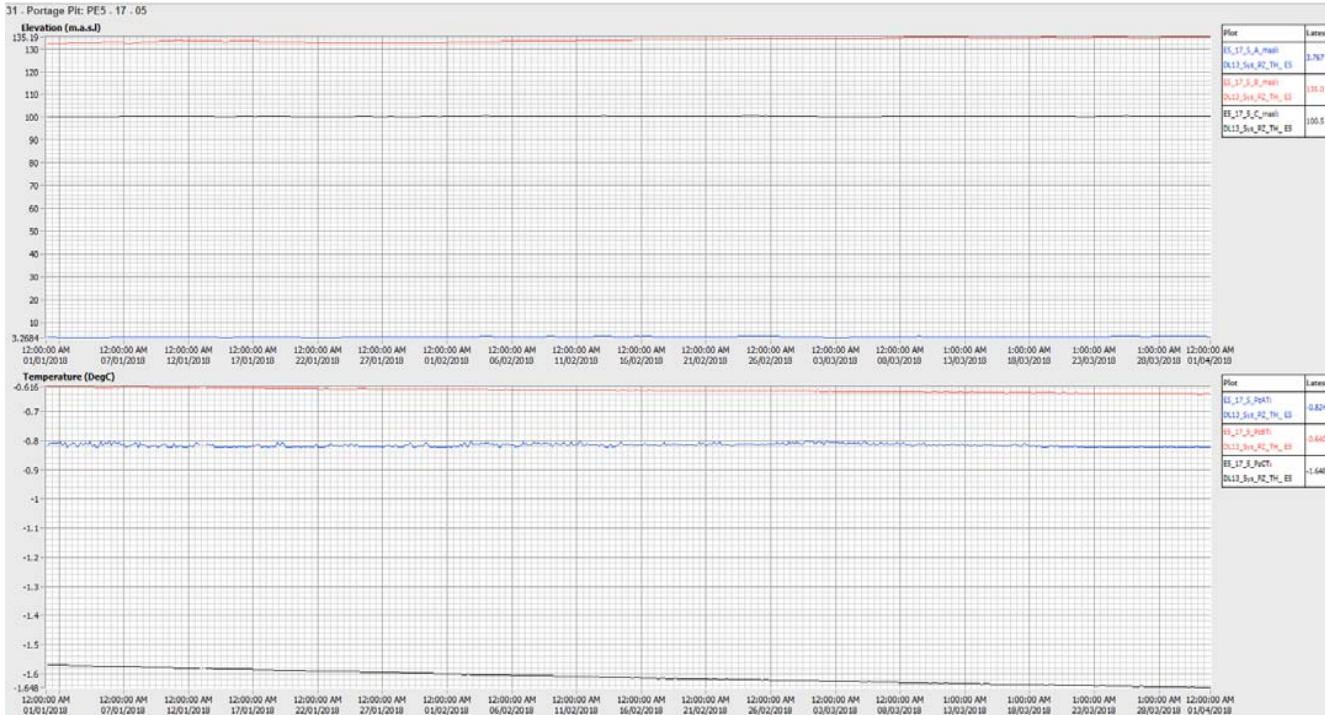
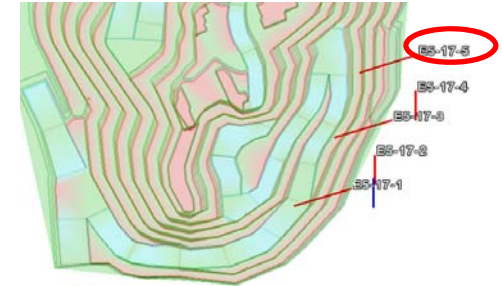
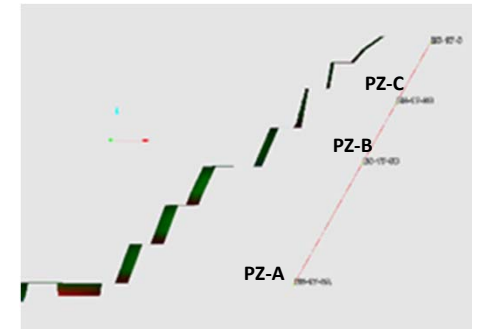
- PZ-A,B and C are frozen. The pressure measurements are considered unreliable.
- Temperature of PZ-C is still on a downward trend.

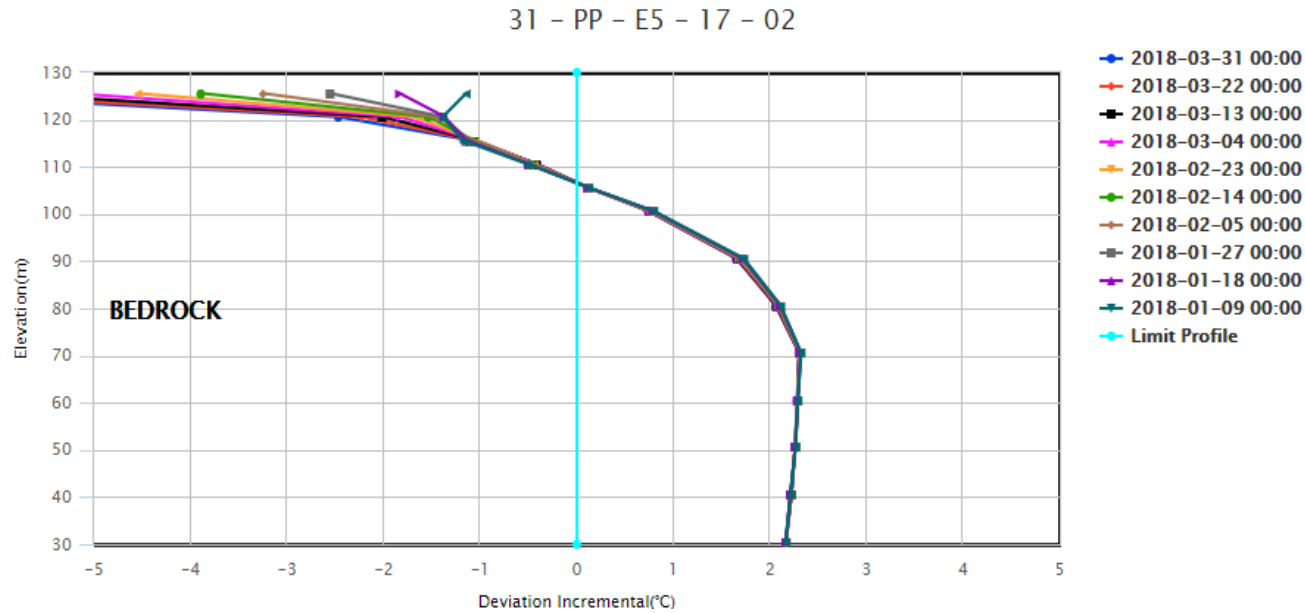
PP-E5-17-02

- There is a permafrost layer from the top of the hole at elev. 125 to the elev. 105 MASL. It suggests an aggradation of the permafrost from the surface since the dewatering of the lake in 2011.
- Apart from the 2 first beads, only minimal variations were recorded during the period.

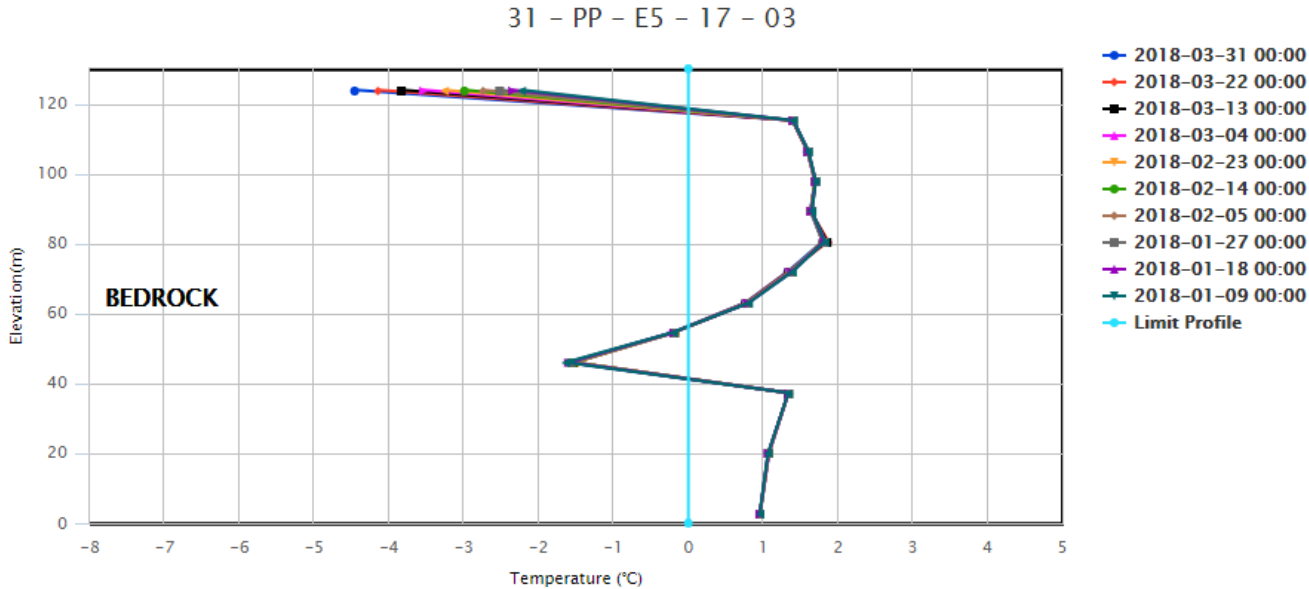
PP-E5-17-03

- Small variations occurred only on the first bead during the Q1, 2018. The rest of the thermistor remained consistent with previous data sets.
- There is a permafrost layer between elevation 40 and 55 MASL.

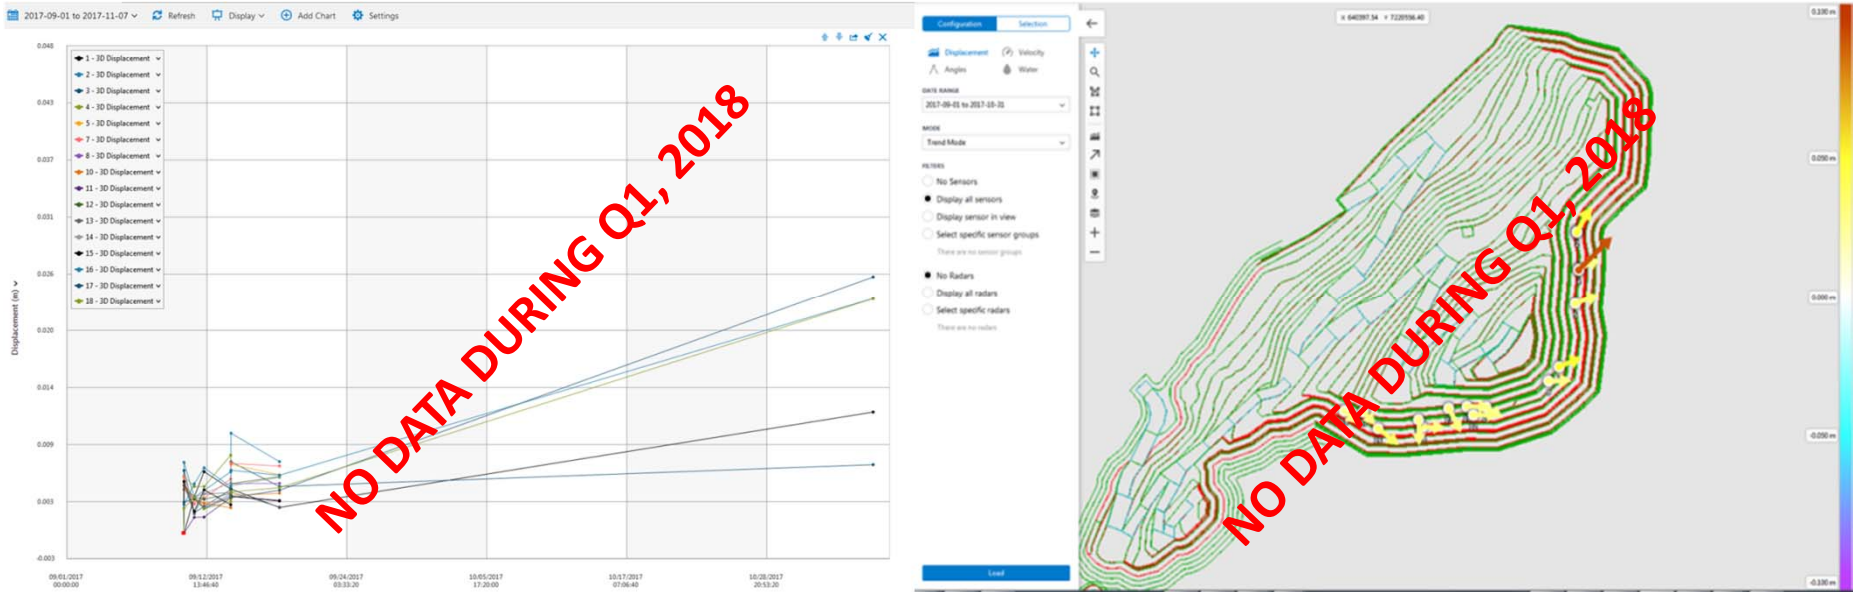
- The latest reading was taken in November.
- During the latest survey of the prisms, only few were successfully surveyed due to cold weather (frost in the lens, snow, ice wall etc.).
- The monitoring will be restarted when weather conditions will allow it (May).

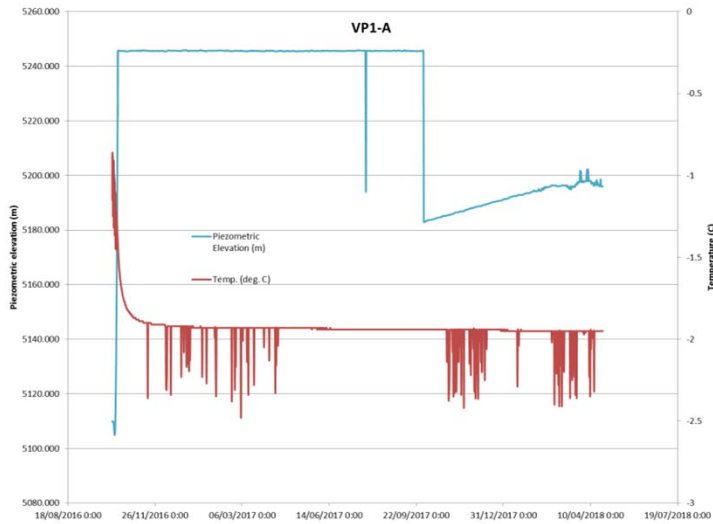
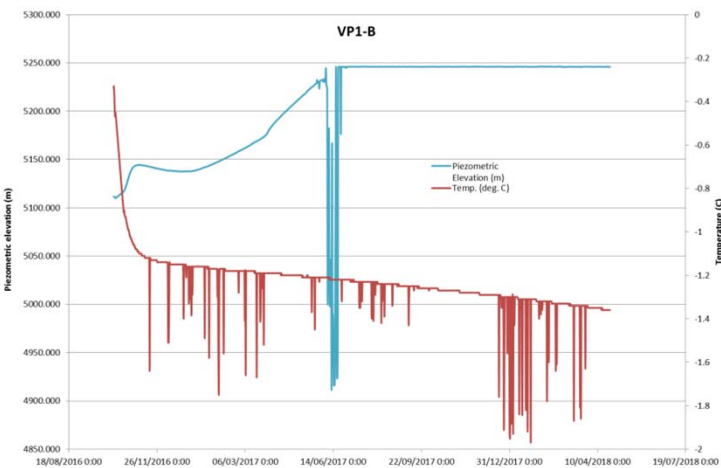
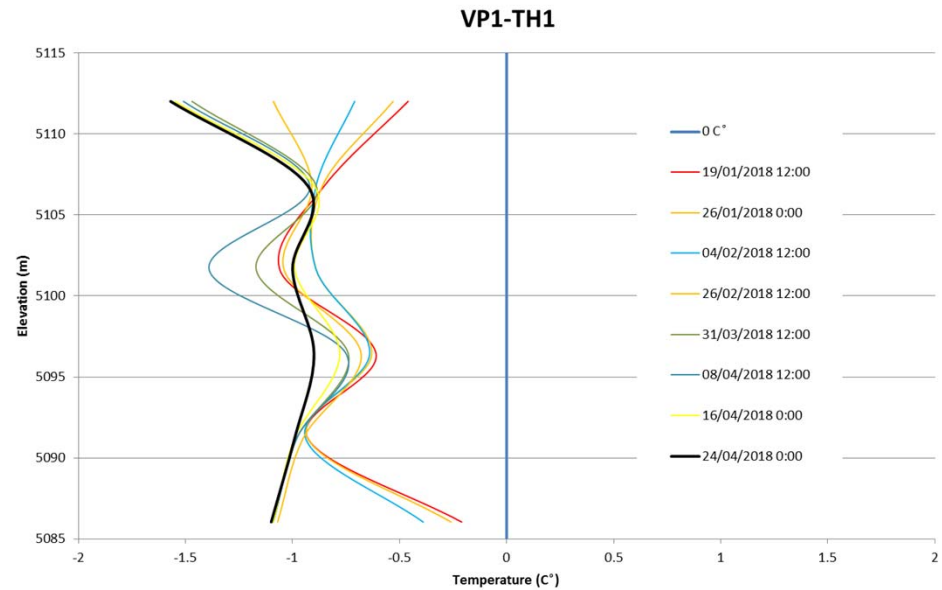
VP1-A, VP1-B, VP1-TH1

- PZ-A&B are below the freezing point. Pressure measurements are therefore considered unreliable and will not be discussed here.
- The thermistor remained frozen during Q1, 2018.

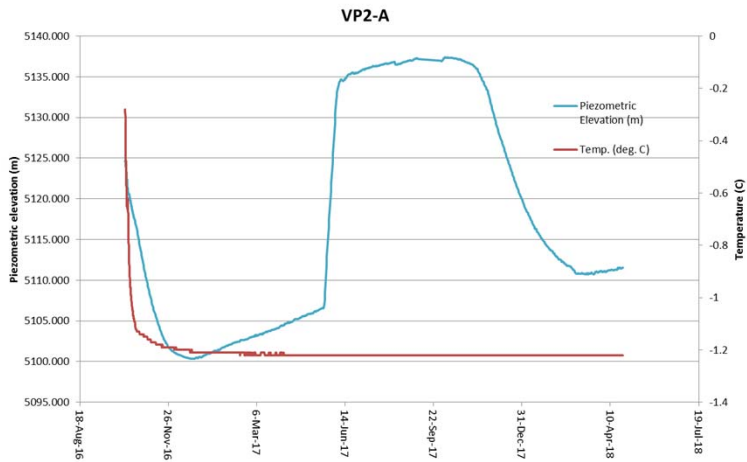
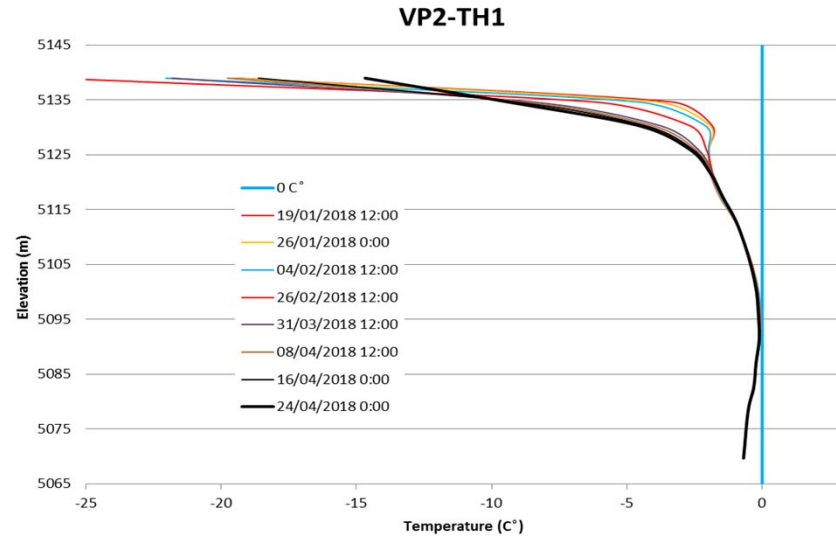
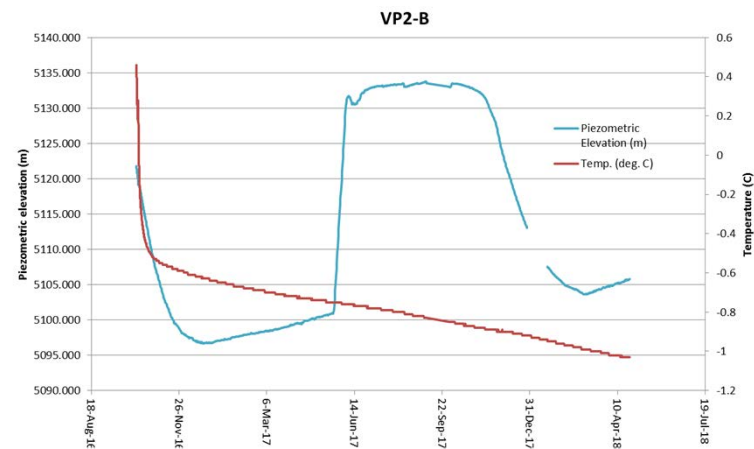
VP2-A, VP2-B, VP2-TH1

- PZ-A&B are below the freezing point since their installation and their data are considered unreliable.
- The section between 5105 and 5085 is close to the freezing but still below. Apart the top beads, minimal variations were recorded for the rest of the hole.

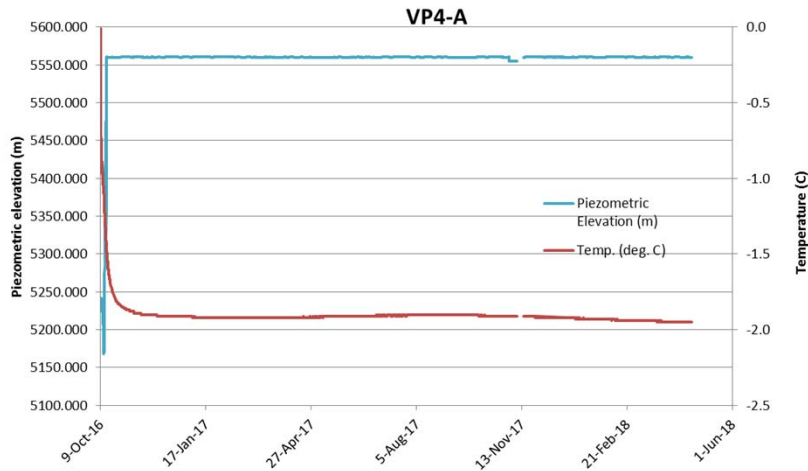
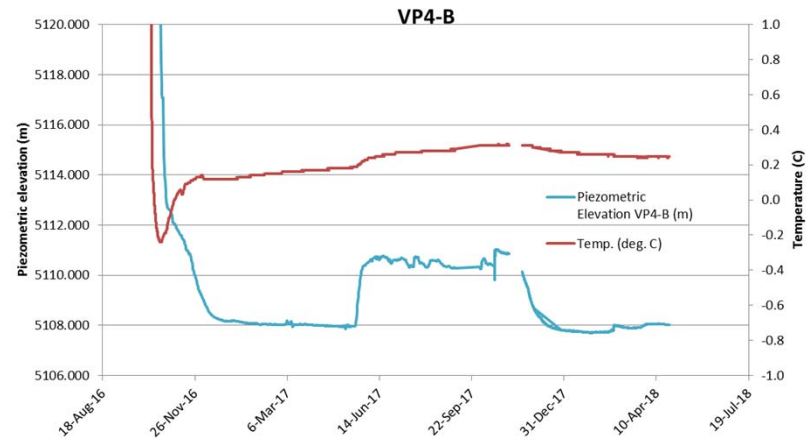
VP4-A, VP4-B

- PZ-A is under the freezing point and considered unreliable.
- PZ-B is unfrozen and since is significant pressure drop, it remained stable during Q1 ,2018. The instrument is installed in the confined layer of talik in between 5105 and 5095 at the source of the seepage causing the major ice wall in the area.
- The temperature of PZ-B is on a very slight downward trend suggesting a freeze back of the slope and aggradation of permafrost.

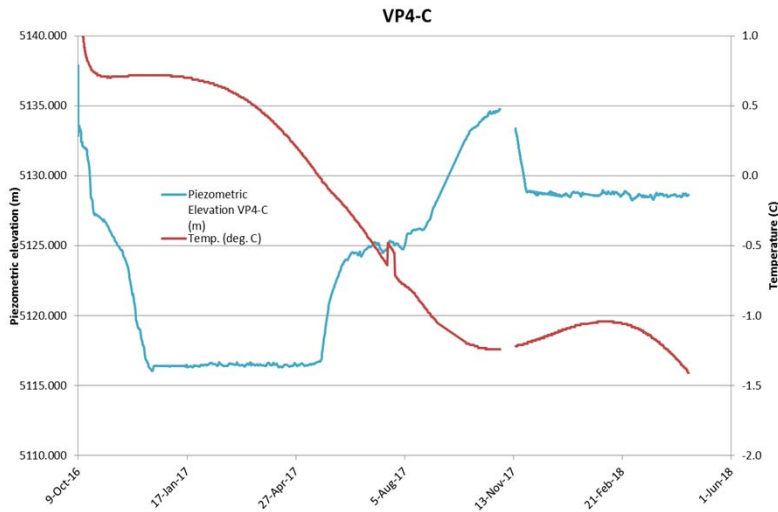
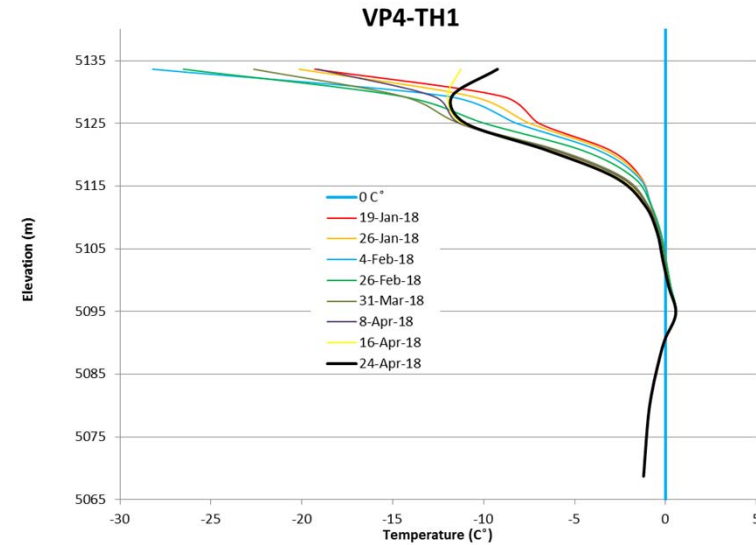
VP4-C, VP4-TH1

- PZ-C is frozen and data is considered unreliable.
- The thermistor show that the hole is mainly in the permafrost at the exception of the section in between 5100 and 5095 (0.56°C). This zone causes the seepage and therefore the ice wall.

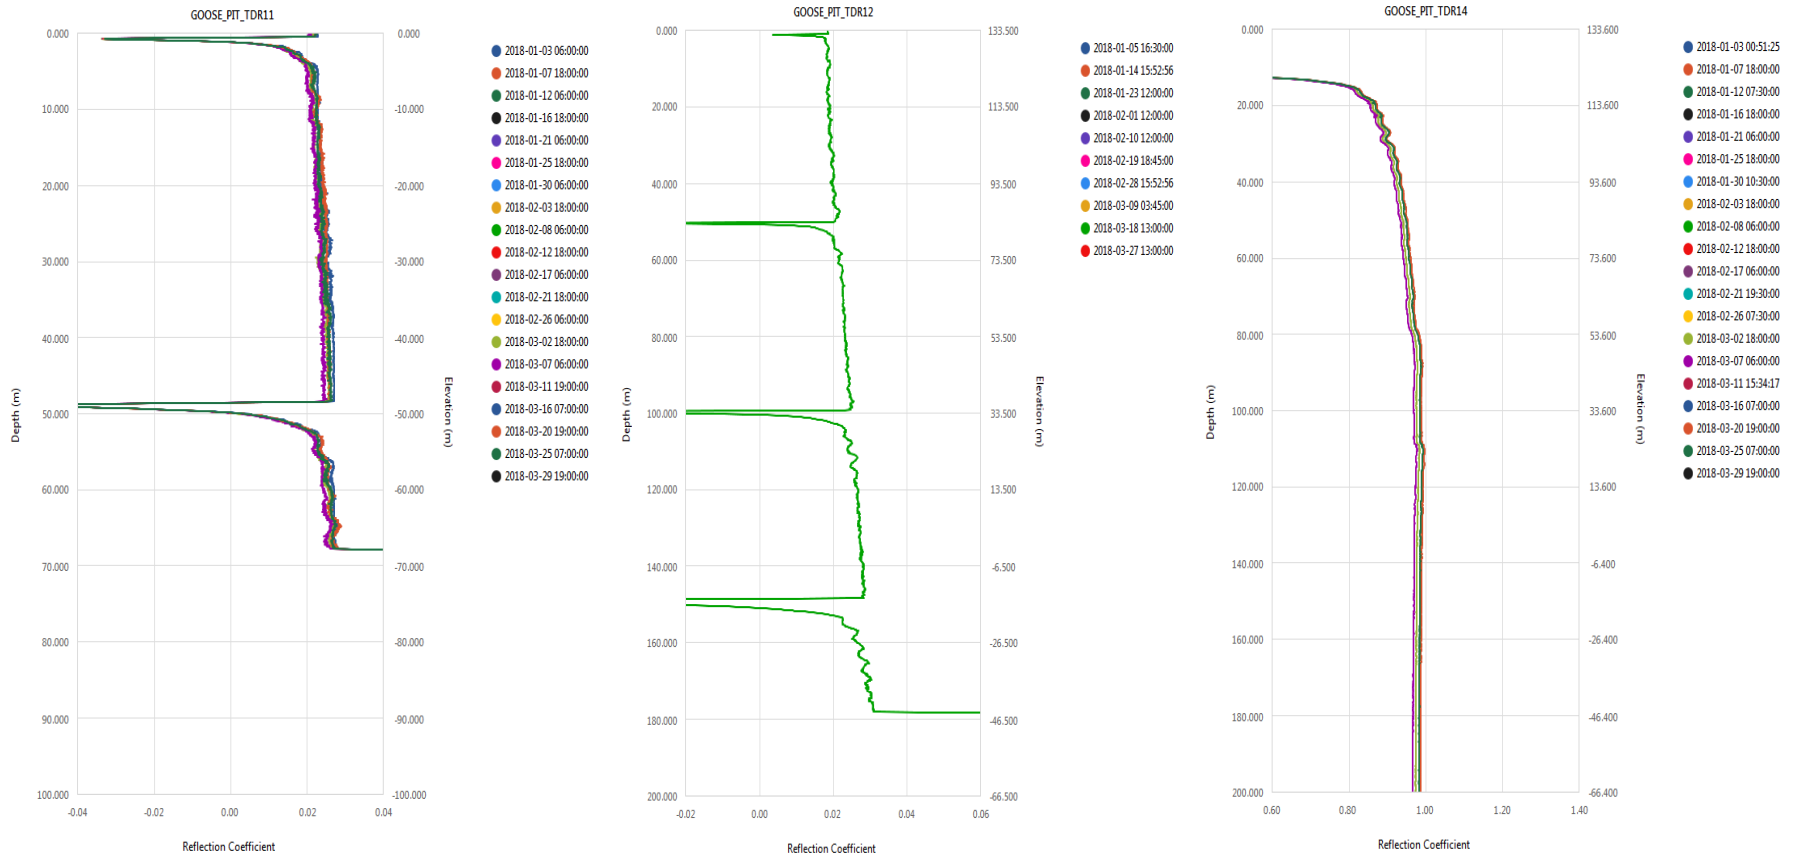
- No sign of deformation was observed in these TDRs.
- Anomalies from the TDR logger are still presents and were disregarded in the presented graphs. The issue will be addressed shortly by reprogramming the logger.

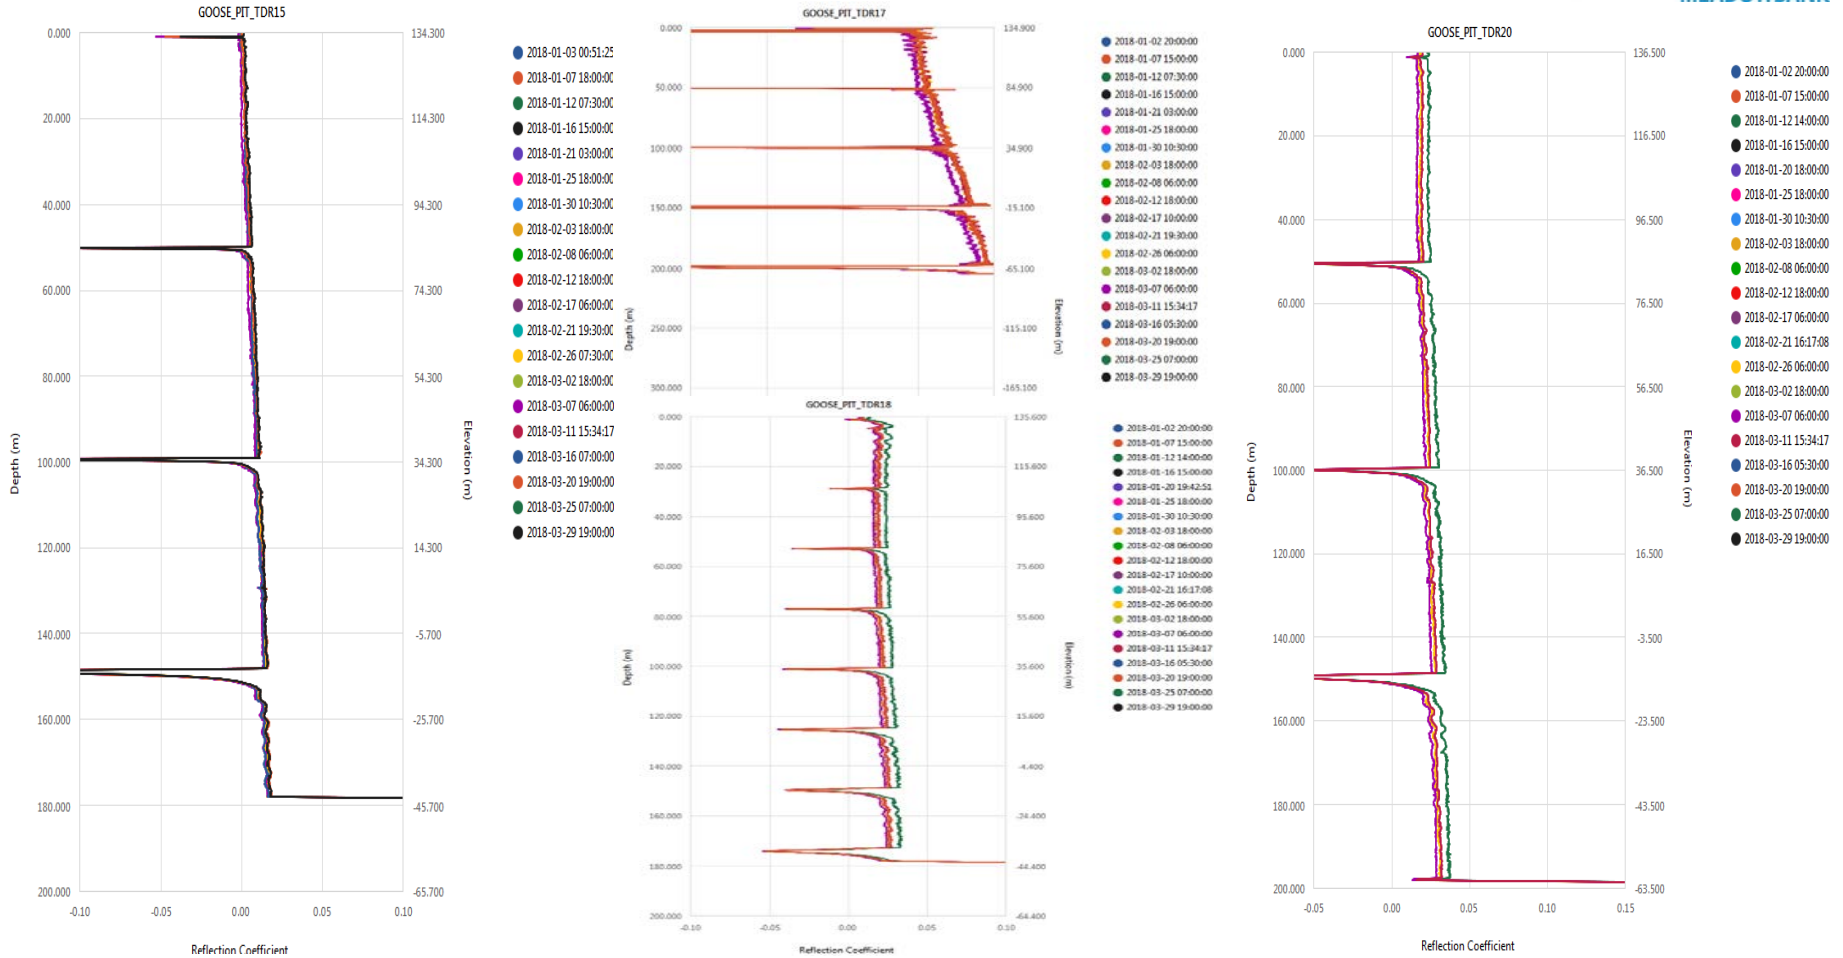
➤ No sign of deformation was observed in these TDRs.

➤ Anomalies from the TDR logger are still presents and were disregarded in the presented graphs. The issue will be addressed shortly by reprogramming the logger.

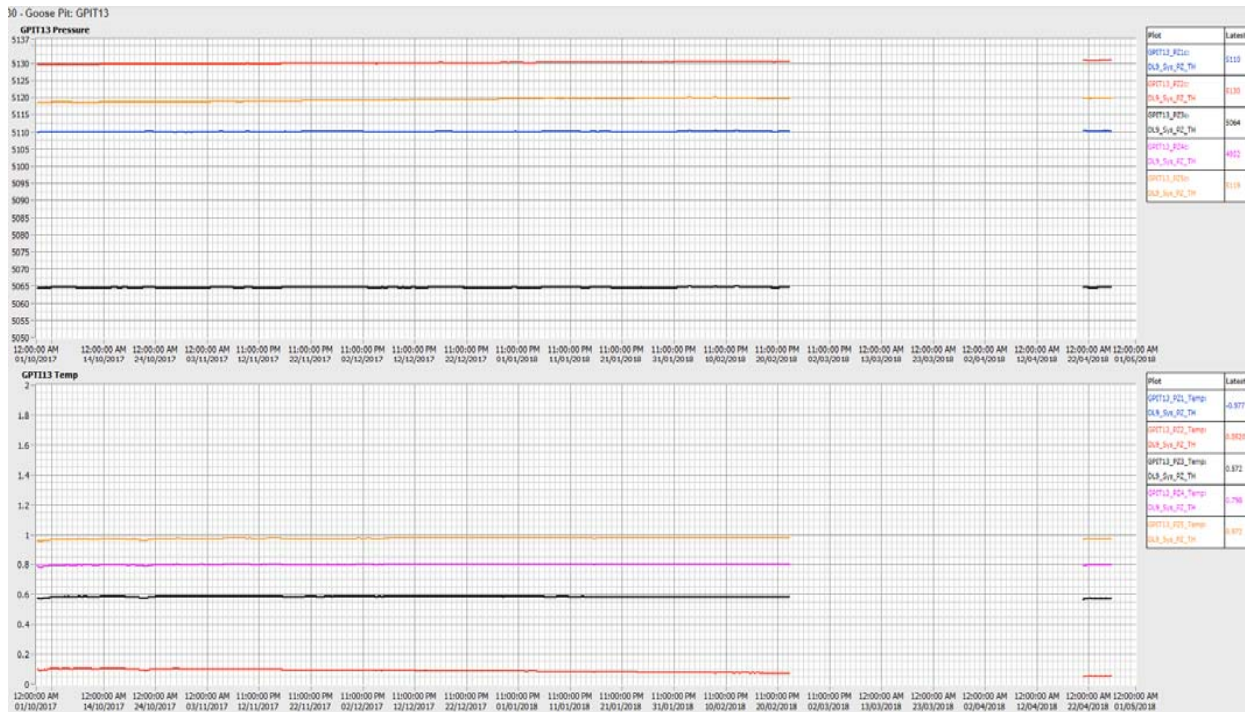
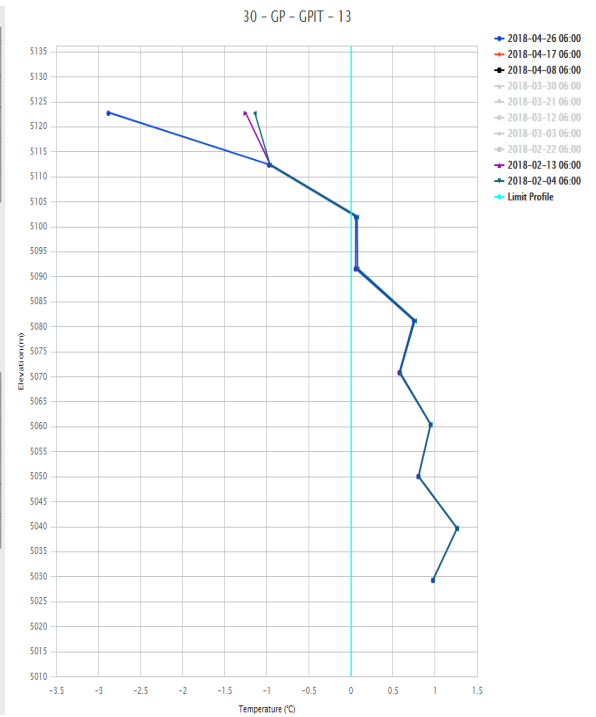
- All piezometers presents little or no variation during the Q1, 2018. All of them are above freezing point.
- A part of the data logger (DL9) was used on DL13 and no record were taken in between Feb. 23, 2018 to the end of the Quarter.
- TH-GPIT-13 was stable during Q1 compared to previous data sets. It is in the permafrost from top to elev. 5102.
