Meadowbank 2018 Annual Review of Portage and Goose Pit Slope Performance

2018 ANNUAL PIT SLOPE PERFORMANCE REVIEW

MEADOWBANK MINE, NUNAVUT

ISSUED FOR USE
704-ENG. ROCK03053-02

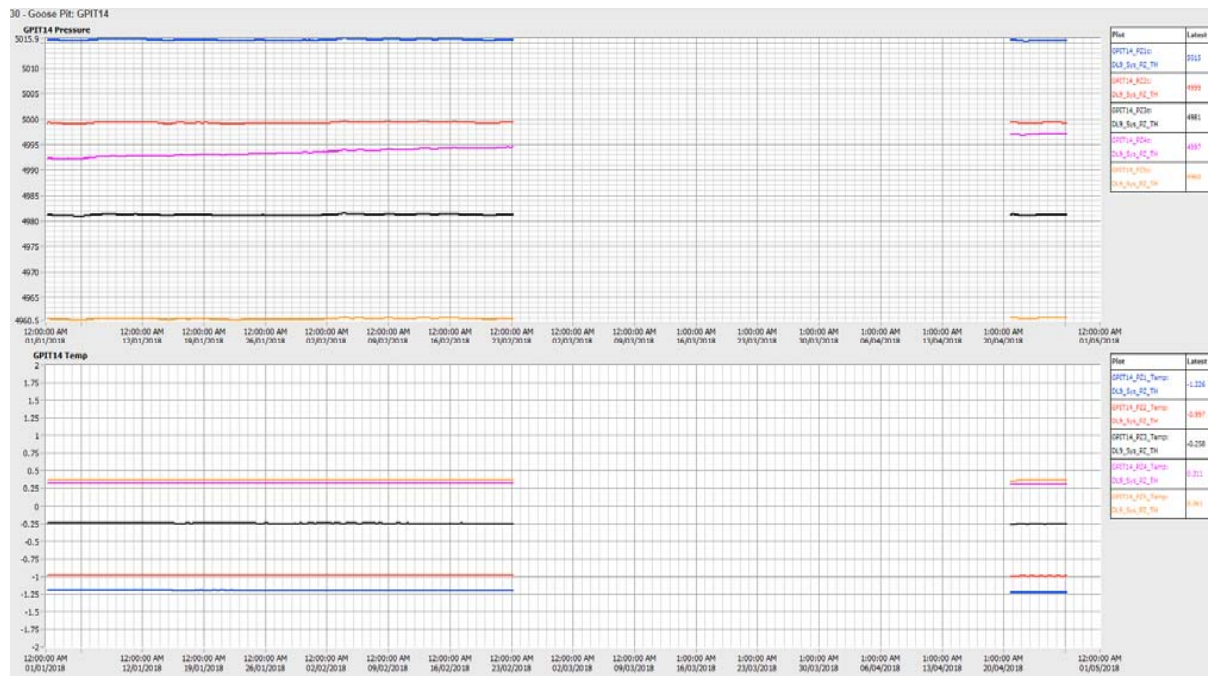
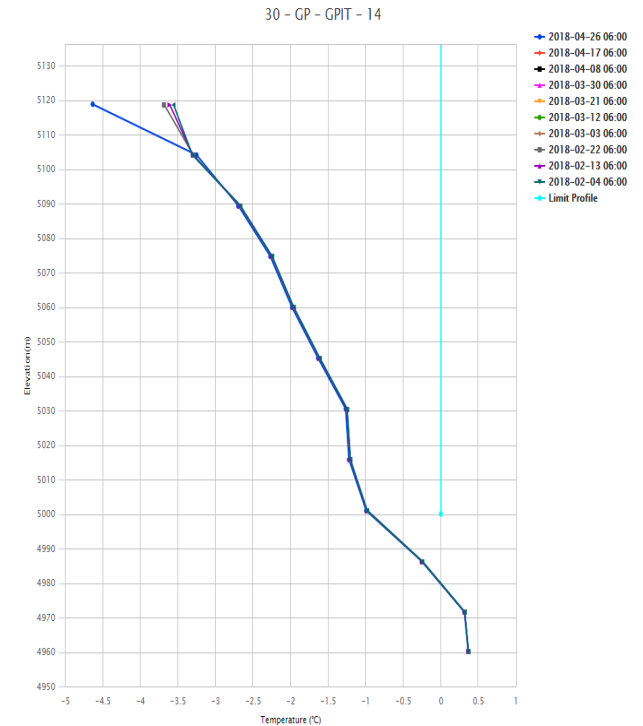
- PZ-4 is on a slow rising trend. It rose 1 m pore water pressure during the first quarter and that could be related to the water level within the Goose pit that is raising (natural flooding).
- PZ-1,2,3 are below the freezing point.
- TH-GPIT-14 is in the permafrost from top at elevation 5120 to 4980. The last 20m of the hole is above the freezing line.

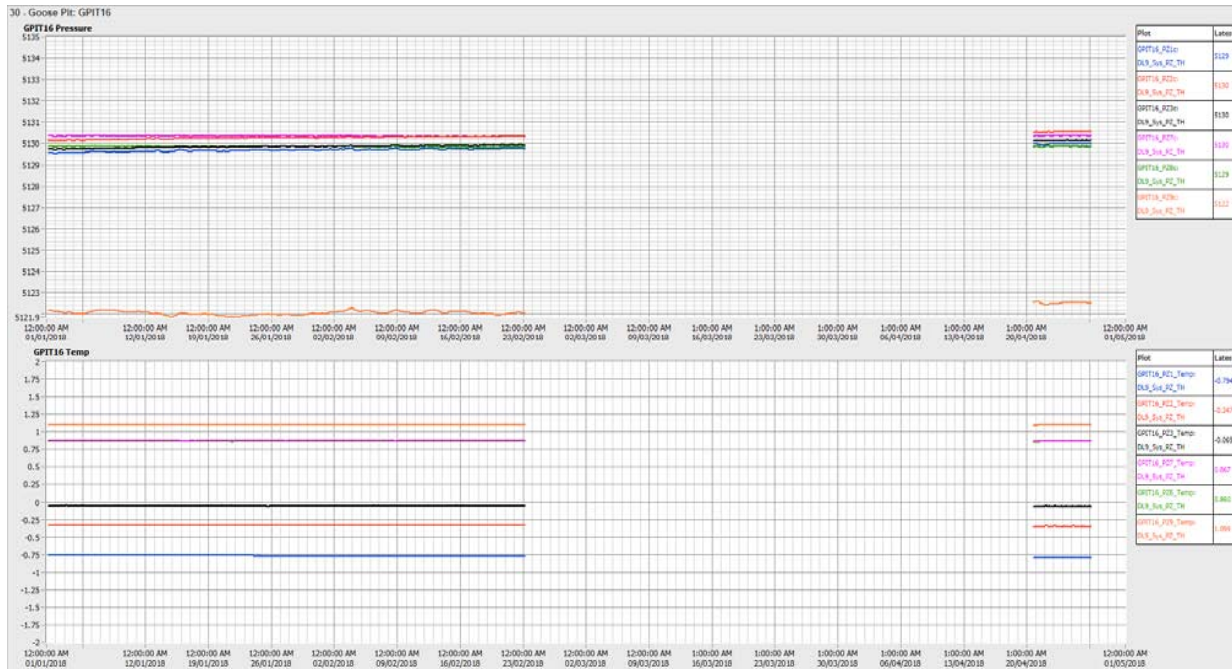
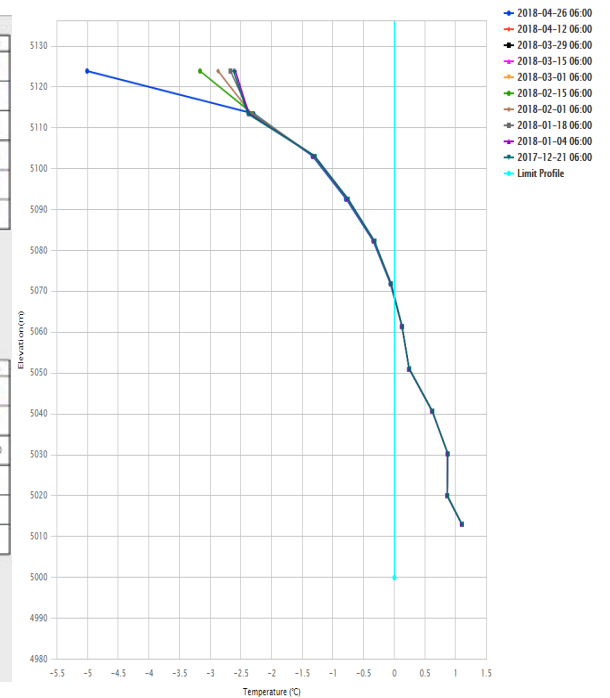
30 - GP - GPIT - 16

- All of the piezometers are on a very slow rising trend. However PZ-1,2,3 are under the freezing line and can not be considered as reliable.
- PZ-1,2,3 are below the freezing point.
- TH-GPIT-16 is in the permafrost from top at elevation 5124 to 5070. The last 57m of the hole is above the freezing line.

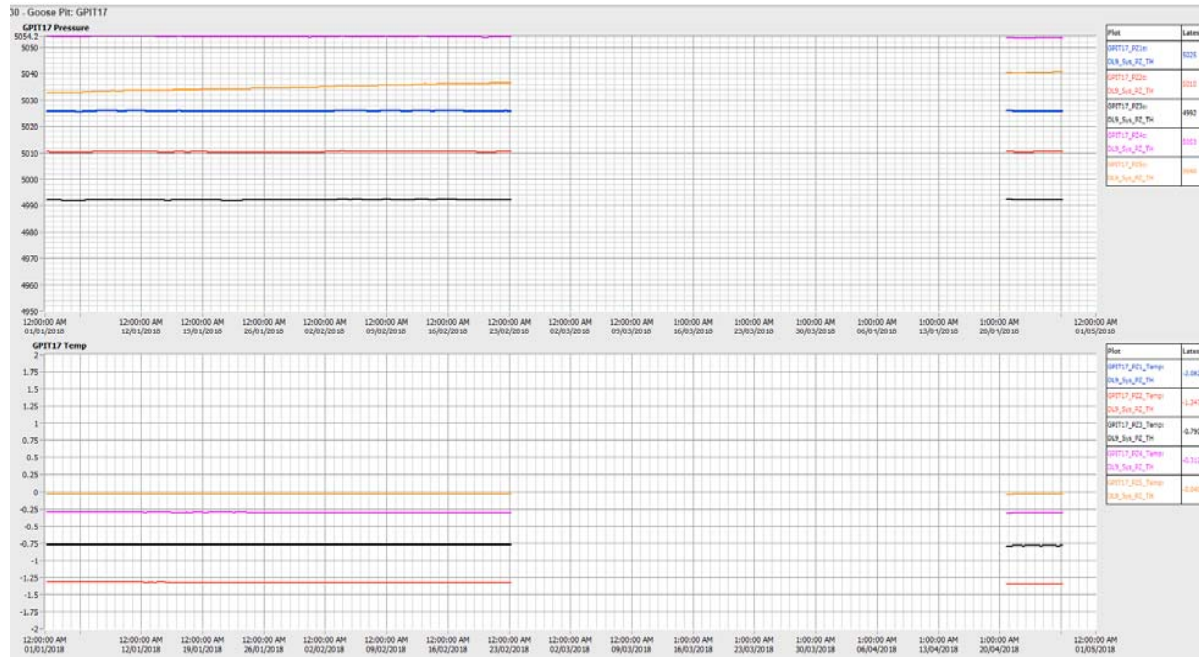
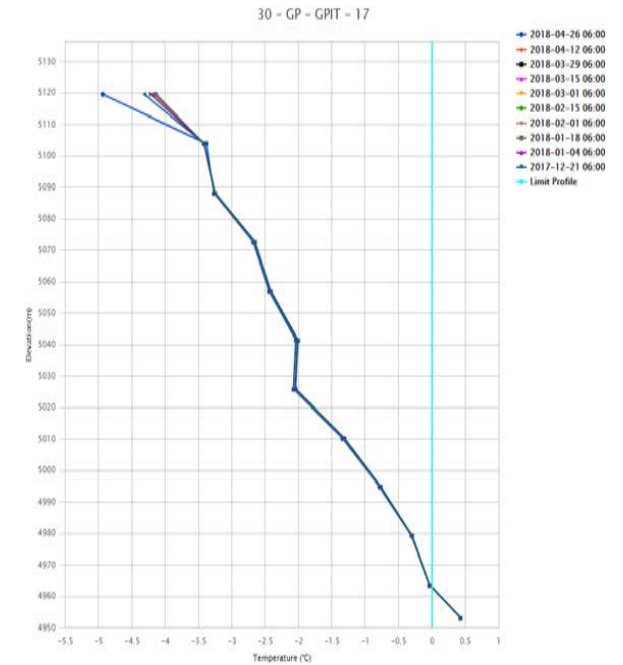
- PZ-5 has risen 6 m of pore water pressure. However, this PZ is just under the freezing line.
- PZ-1,2,3,4 are below the freezing point and can't be considered reliable.
- TH-GPIT-17 is in the permafrost from top at elevation 5119 to 4963. The last 10m of the hole is above the freezing line.

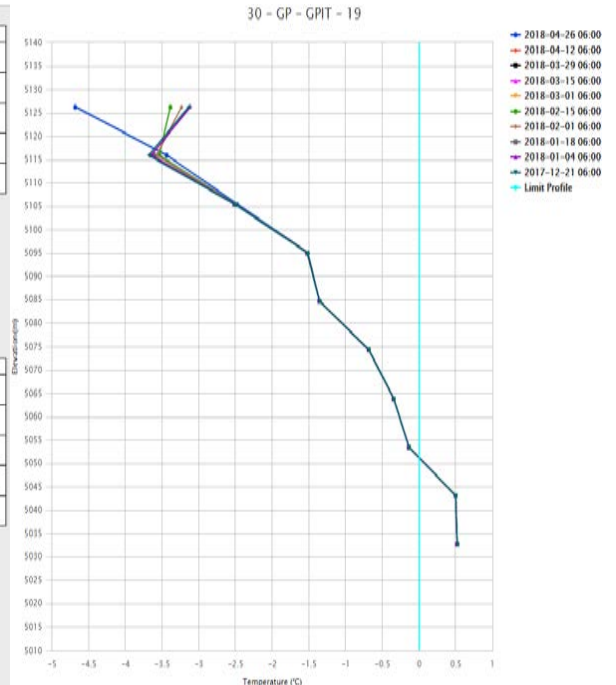
- PZ-5 is above the freezing line and it shows little or no pore water pressure variations during the quarter 1, 2018.
- PZ-1,2,3,4 are below the freezing point and can't be considered reliable.
- TH-GPIT-19 is in the permafrost from top at elevation 5126 to 5051. The first couple beads varied decimals of a degree. The last 19m of the hole is above the freezing line.

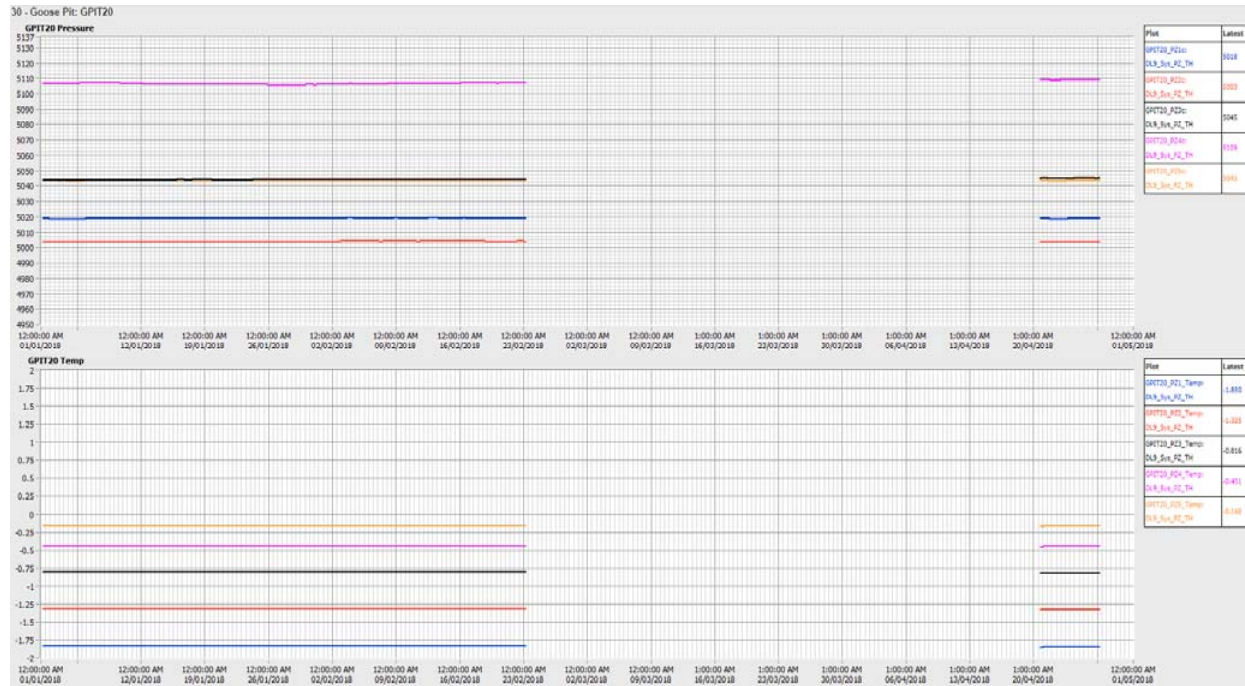
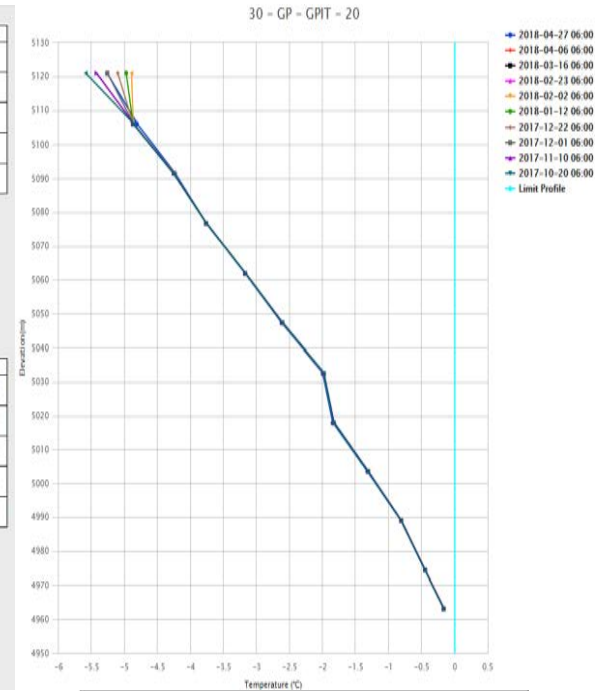
- PZ-1,2,3,4,5 are below the freezing point and can't be considered reliable.
- TH-GPIT-20 is in the permafrost on its entire length from its top at elevation 5121 to the bottom at 4963.

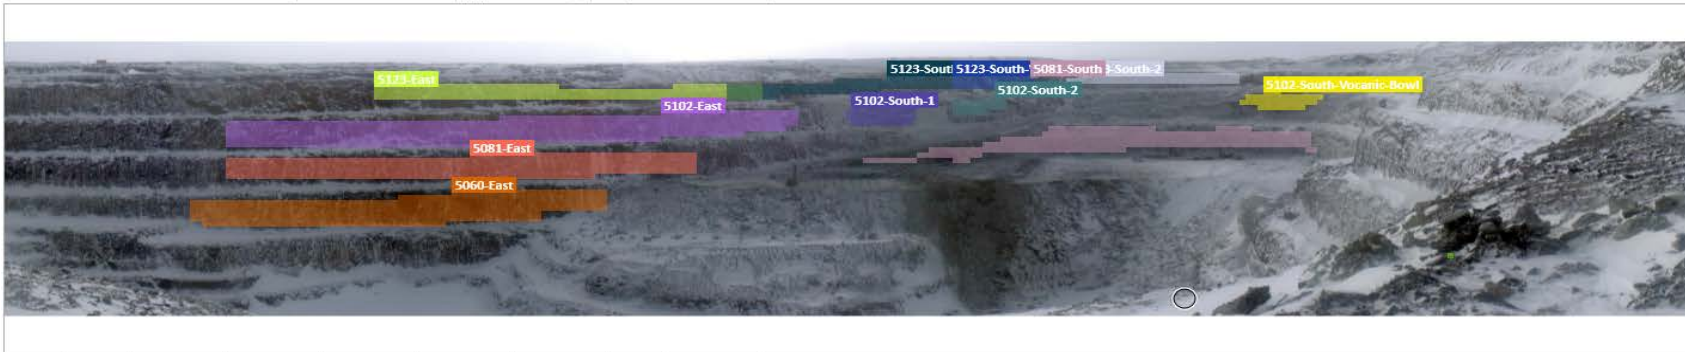
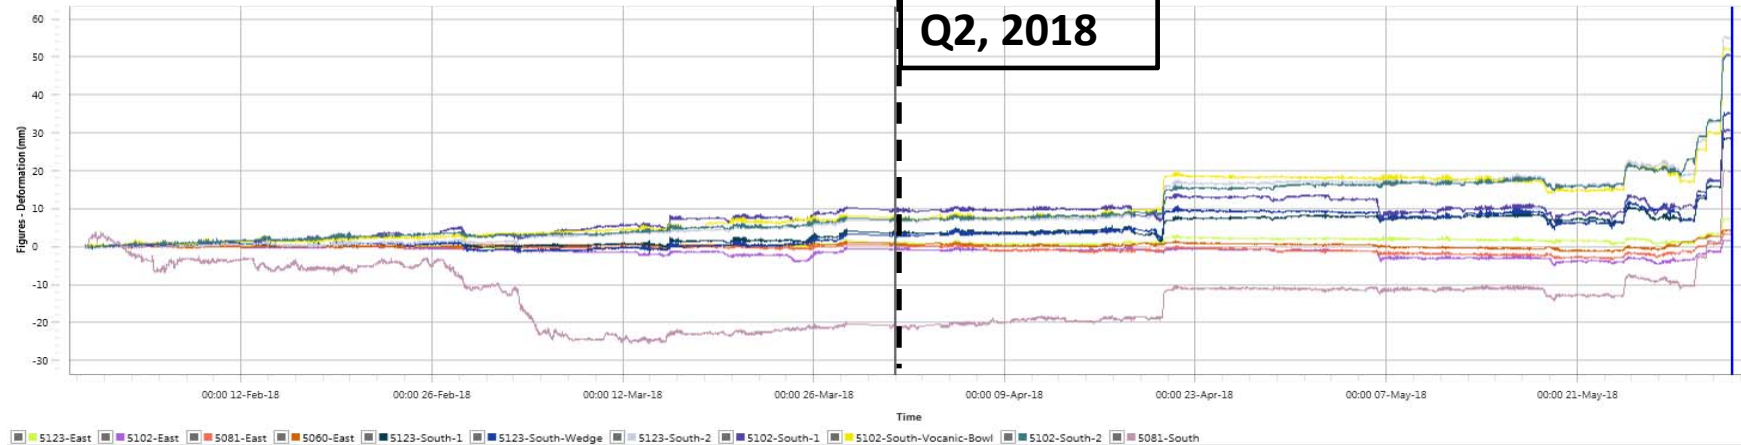
Enhanced deformation per sector (April 1st to June 1st) – Wall folder: SSR253_18031_Meadowbank_E5_SouthWall_Archive).

Comments: Most of the sectors were showing stable wall condition. A disturbance occurred on the radar around April 20 during an unknown event (wind, ice etc.), creating noise in the data. It is reflecting on every section of the wall monitored. Prior to that period the section identify as 5081 South as a small rising trend and gained 2 millimetres. Another rising trend is showed on every sections starting on May 27. This major rising trend correlates with the temperature augmentation and the possible melting at the base of the radar.

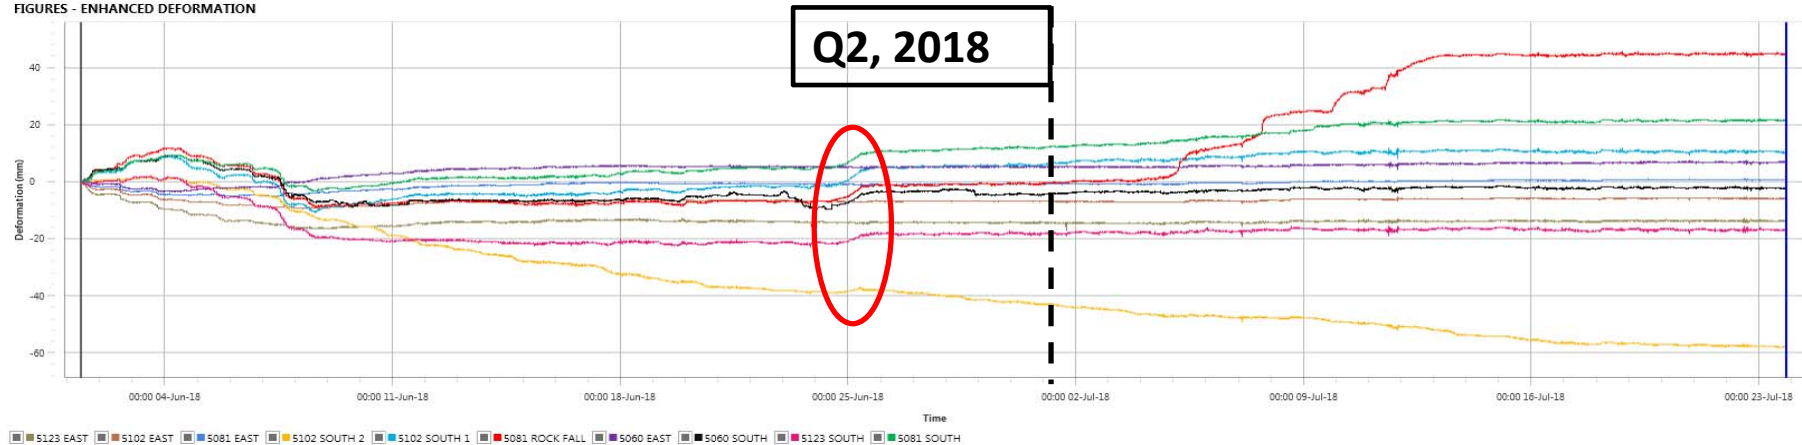
Enhanced deformation per sector (June 1st to June 30) – Wall folder: SSR253_180601_Meadowbank_E5_South_Wall).

Comments: During the second monitoring period, the section identified as 5102-SOUTH 2 lost 45mm on average over the month. The melting of the snow and ice accumulation could be an hypothesis for this downward trend. It is also interesting to point out that on June 24 and 25 it was raining. This situation was reflected on the graph on all the sections of the south west wall, by a raise of 5-6 mm. Those sections are mostly in the ultramafic formation and rain really does affect the wall performance .

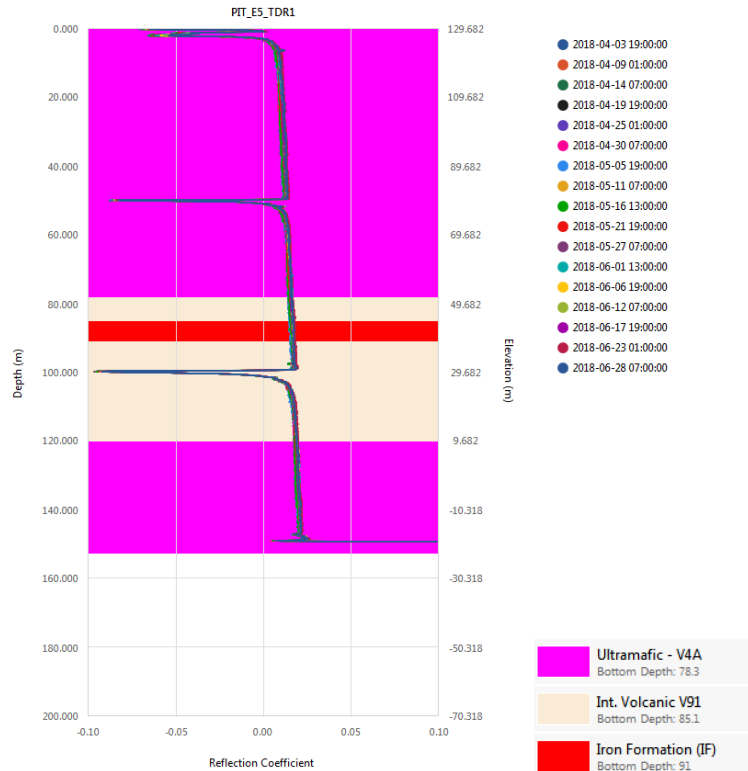
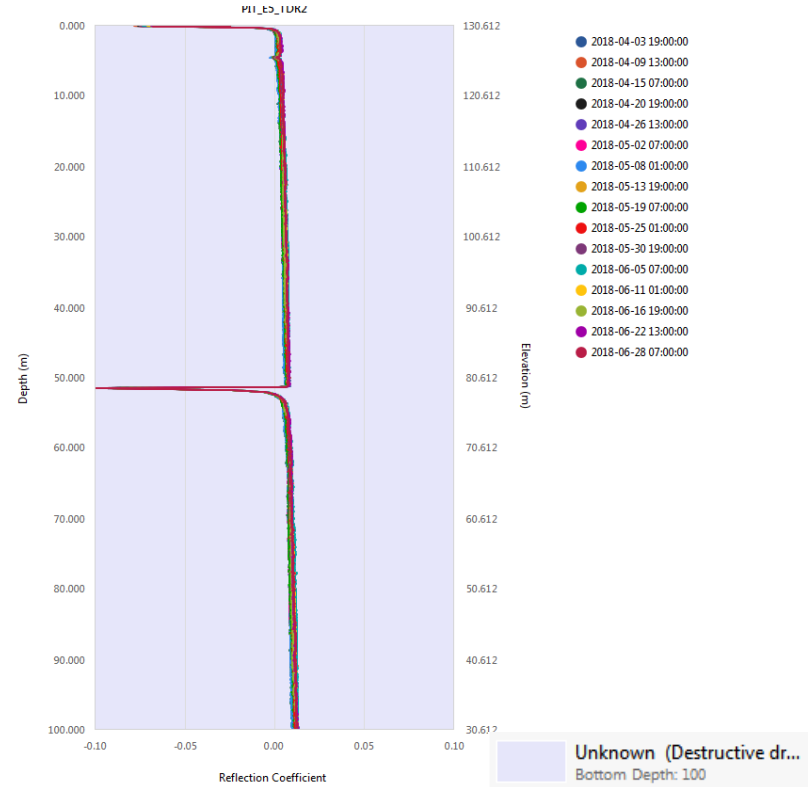
- No sign of deformation observed in TDR1 & TDR2.
- Unlike the previous period, no anomalies from the TDR logger were found in the present graphs.

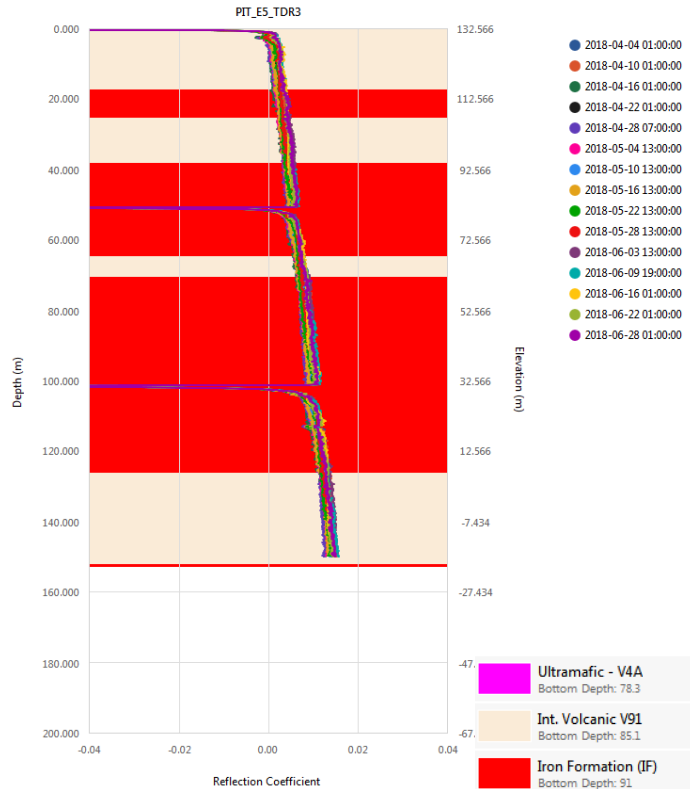
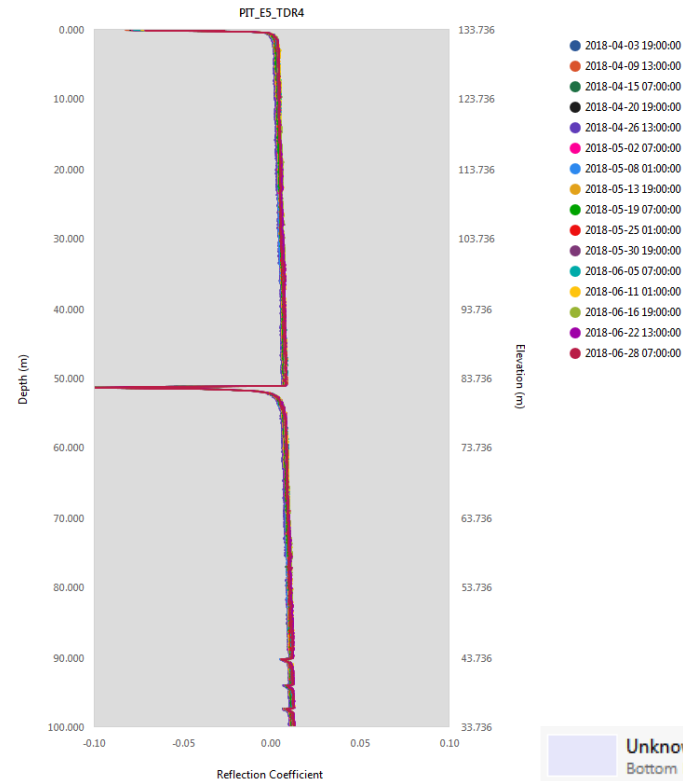
- No sign of deformation observed in TDR3.
- The small reflection coefficient spikes in between elevation 44 and 34 MASL on TDR4 are present since installation.
- No anomalies from the TDR logger were found in the presented graphs unlike the previous covered period (Q1).

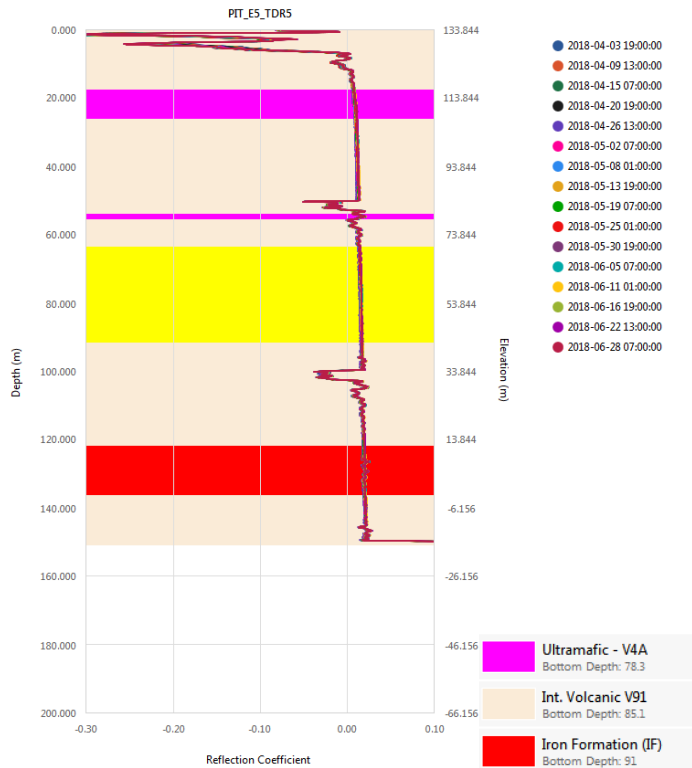
- No sign of deformation observed in TDR5.
- The small reflection coefficient spikes in between elevation 14 and -6 MASL on TDR5 are present since the installation.
- No anomalies from the TDR logger were found in the presented graphs unlike the previous covered period (Q1).

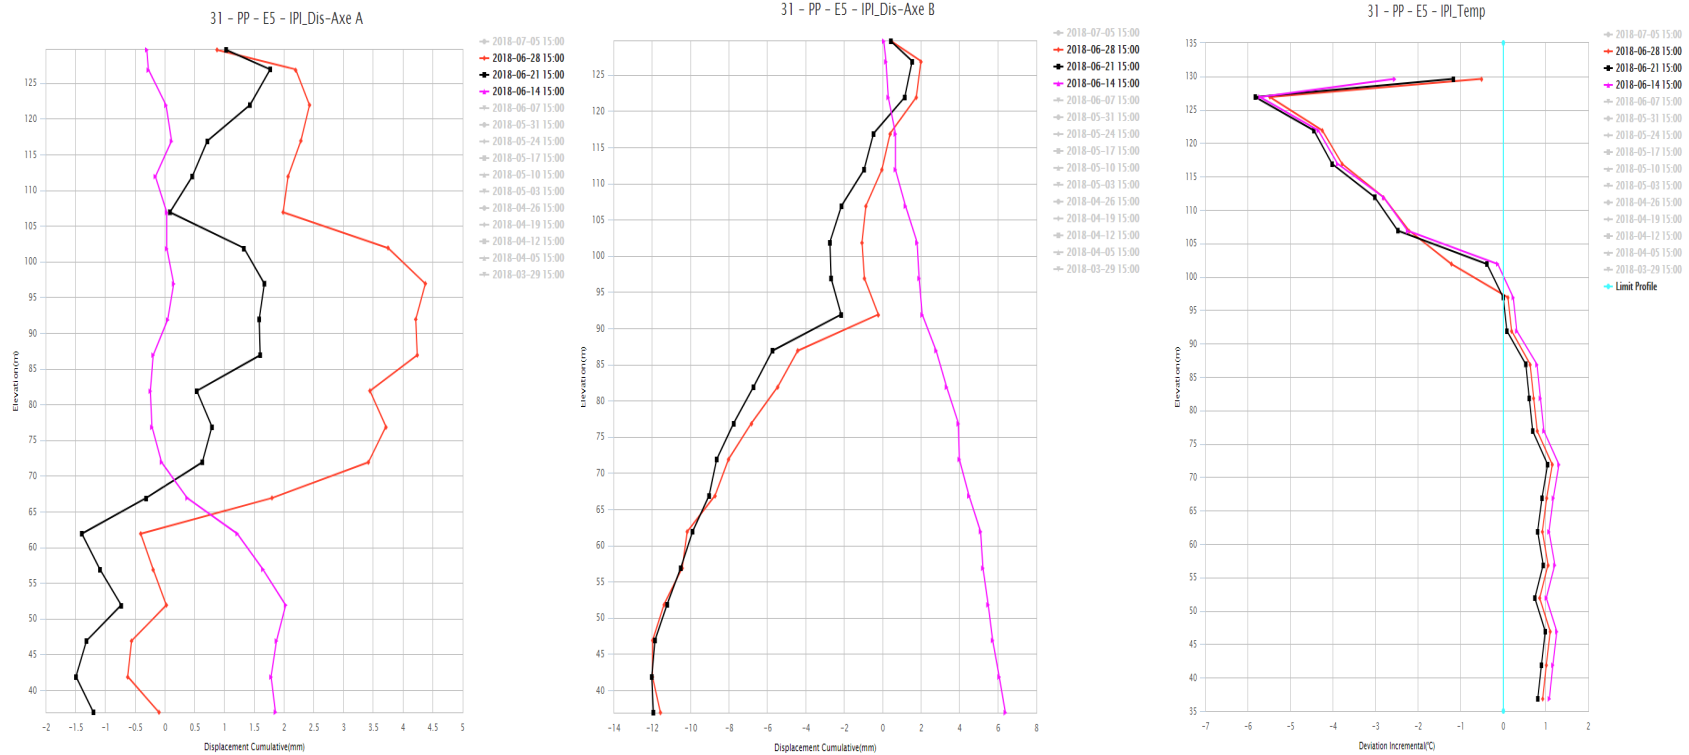
PP-E5-IPI

- The inclinometer was reinstalled on June 13, 2018.
- The two data sets after June 14, 2018 are more consistent. A cumulative displacement of -12mm is observe on the B axis.
- It is unfroze from elevation 96 MASL to 36 MASL.

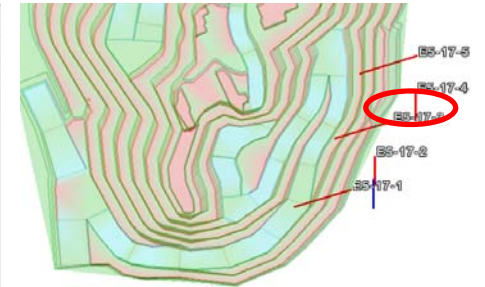
- Overall decrease in pressure of -0.7m during the Q2, 2018 after the rapid increase in the middle of March 2108.
- Smaller increase and decrease in pressure are related to mining activities (drilling/blasting).
- Overall downward trend for piezometer's temperature.

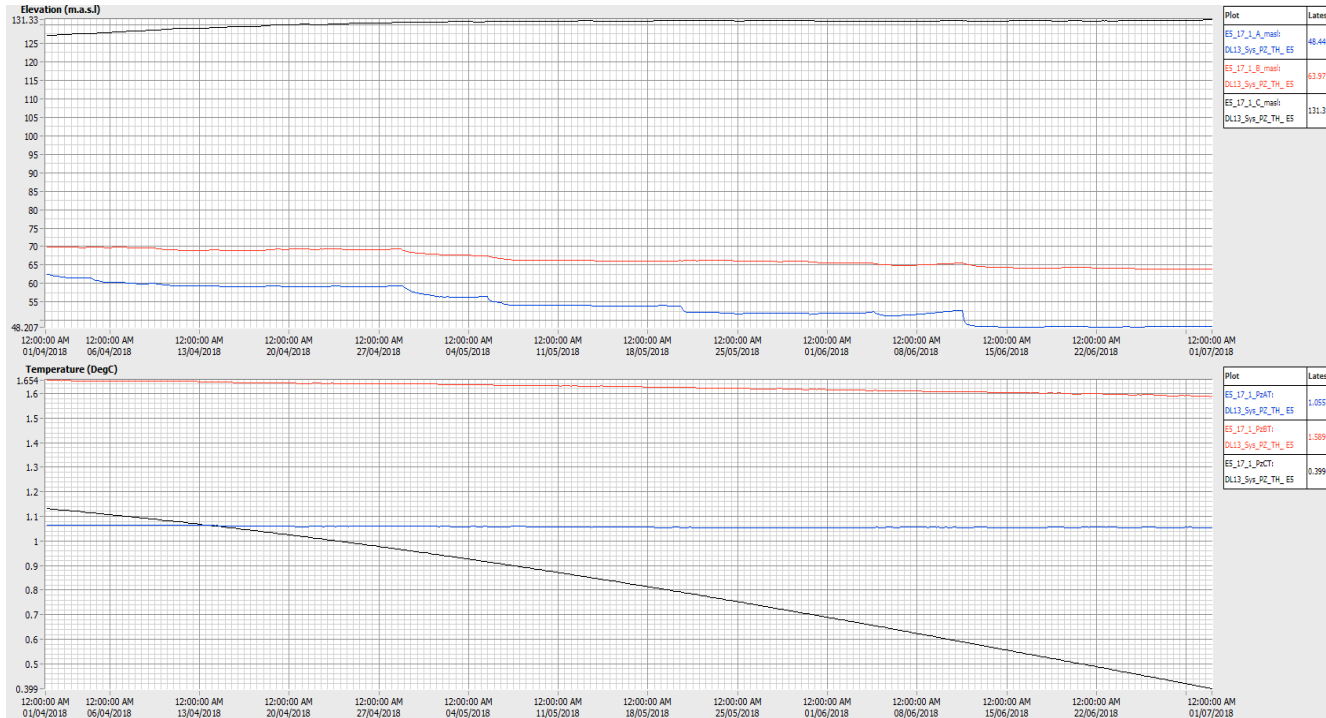
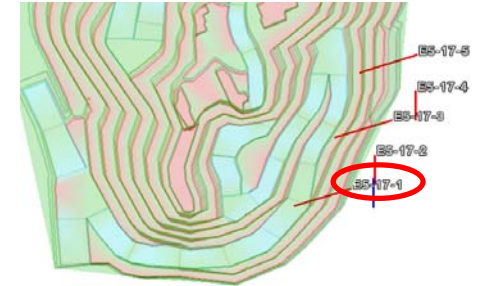
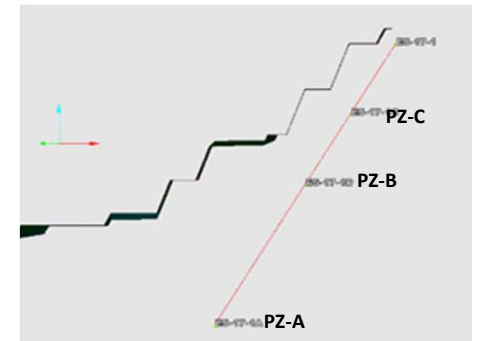
PE5-17-01 PZ-A,B,C

- PZ-A continued is downward trend during Q2, dropping another 15m PWP during the period. As for PZ-B, it dropped 6m PWP during the period. PZ-C has a consistent pressure increase and gained 8.7 m PWP during the Q1, while in Q2, it increase of 6m PWP. Instruments in this hole are very responsive and will be closely monitored.
- Smaller increase and decrease in pressure are related to mining activities (drilling/blasting).
- None of the piezometers are under the freezing point.

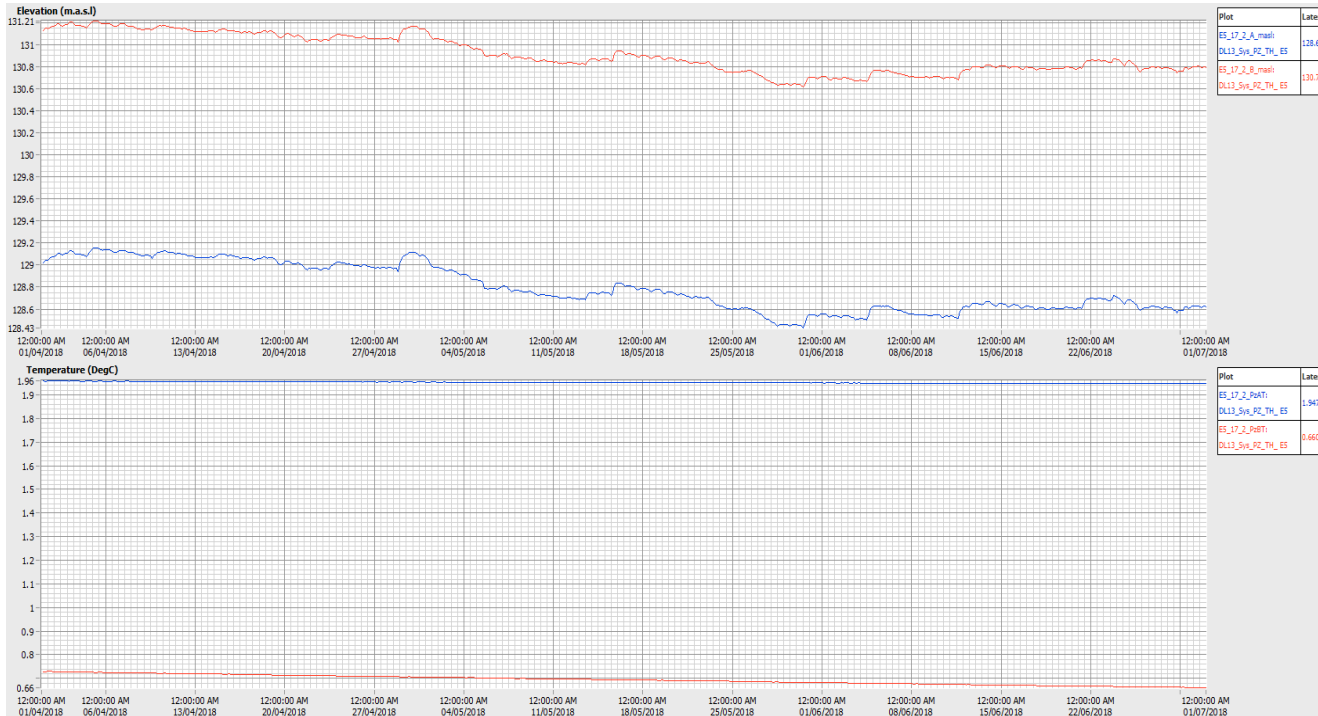
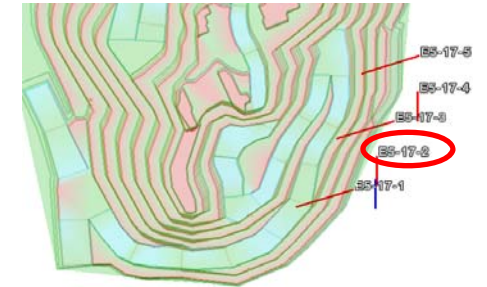
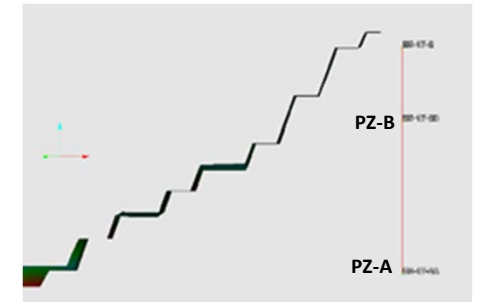
PE5-17-02 PZ-A,B

- Both piezometers are following the same kind of downward trend. A slight decrease of around 1m PWP until what appear to be a slight increase concordant with the beginning of the freshet season.
- None of the piezometers are under the freezing point. There is slight downward trend in PZ-B temperature's.

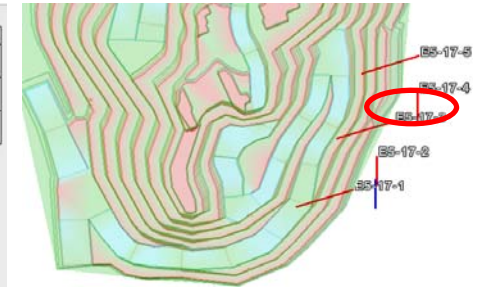
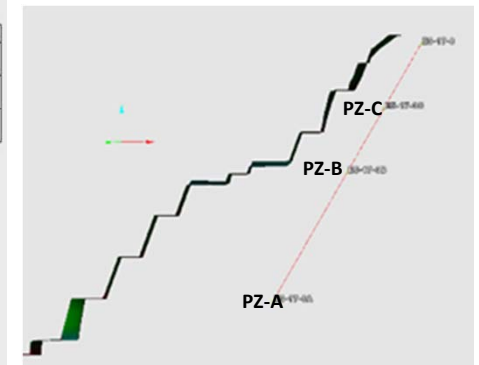
- PZ-A remain stable during the Q2 period with fluctuations around +/- 0.5m PWP, unlike the previous Quarter Period (Q1), where it's water pressure rose of 9m.
- PZ-B & C experienced a small decrease of -0.5m PWP and were subject to small sudden variations cause by the mining activities. Both piezometers are following the same trend with 1m PWP difference.
- All the PZs are above the freezing point and PZ-B is 0.6°C warmer than PZ-A.
- PZ-C is on a cooling trend and might become frozen and unreliable in the upcoming months (0.2°C).

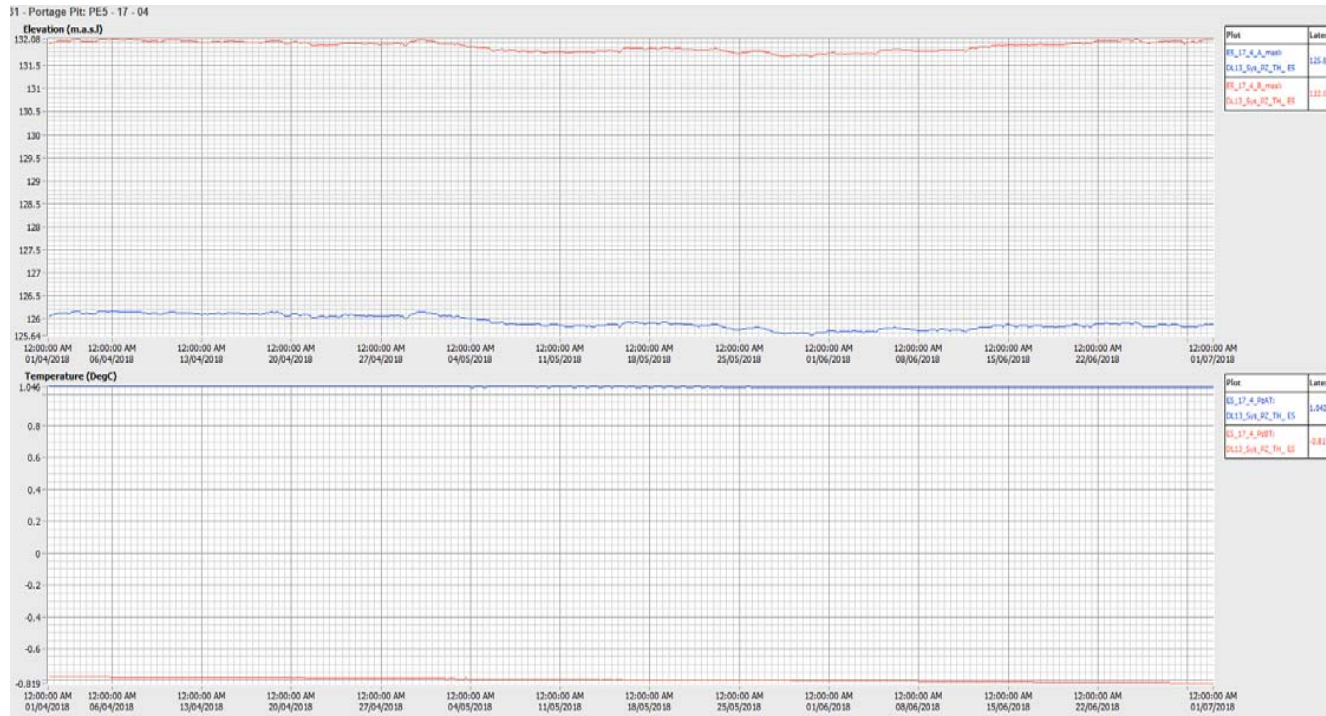
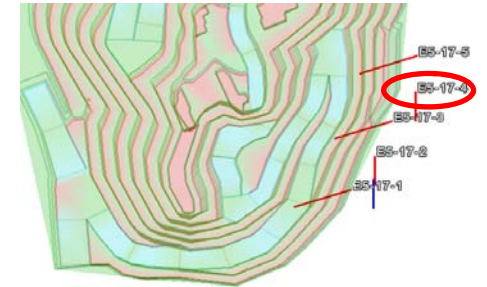
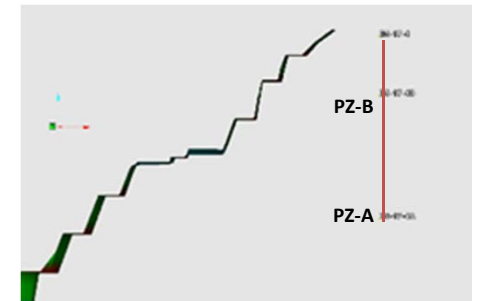
- Both piezometers remained stable during Q2 and experienced the same kind of fluctuations.
- PZ-B is frozen while PZ-A is at around 1°C.
- Smaller increase and decrease in pressure are related to mining activities (drilling/blasting).

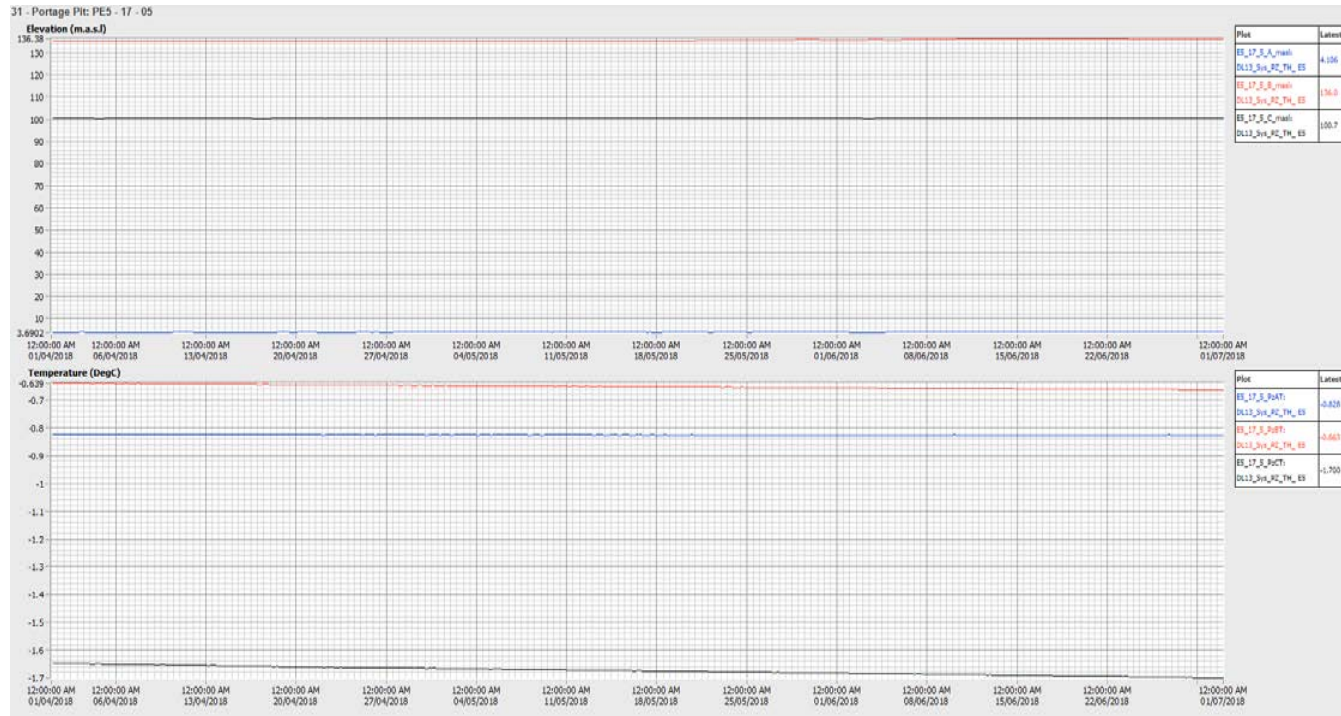
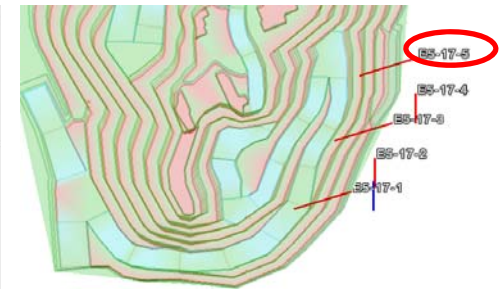
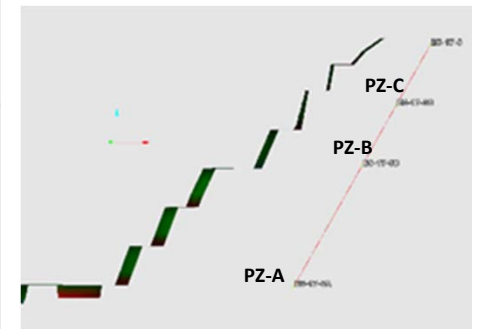
- PZ-A,B and C are frozen. The pressure measurements are considered unreliable.

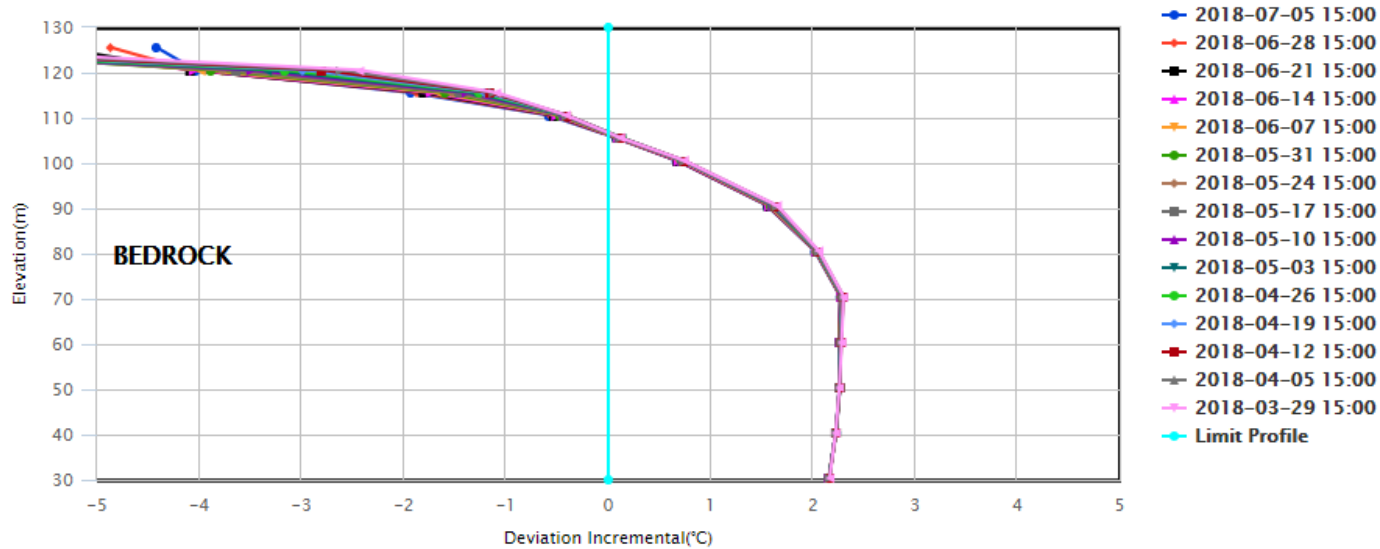
31 - PP - E5 - 17 - 02

- There is a permafrost layer from the top of the hole at elev. 125 to the elev. 105 MASL. It suggests an aggradation of the permafrost from the surface since the dewatering of the lake in 2011.
- Apart from the 2 first beads, only minimal variations were recorded during the period.

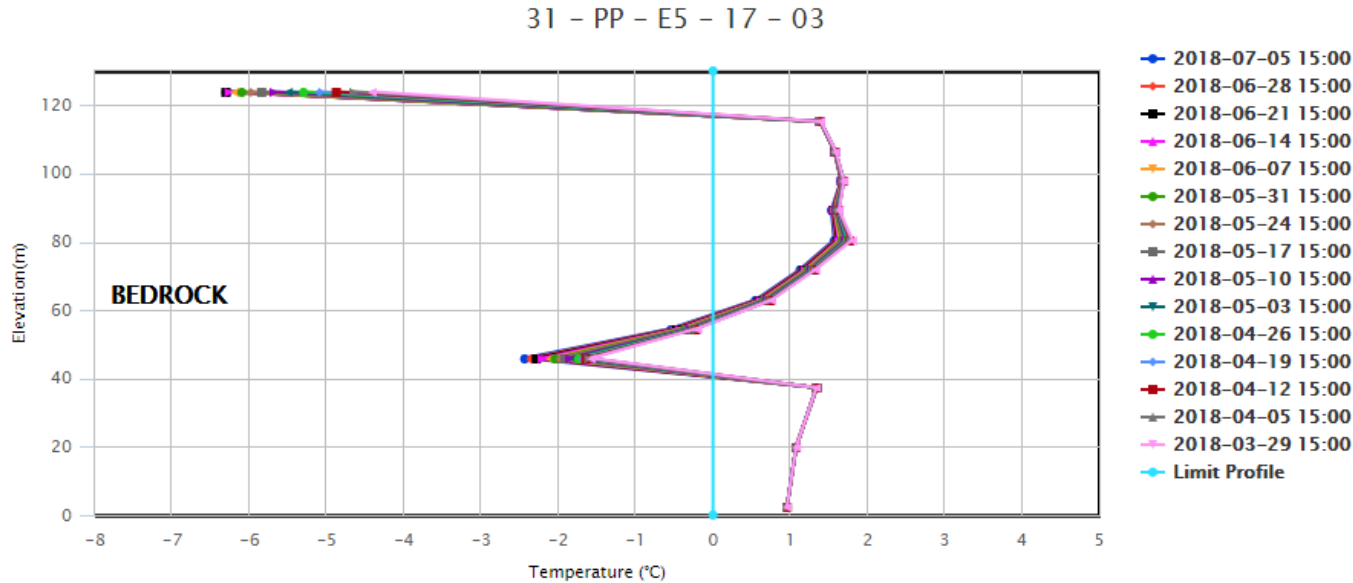
PP-E5-17-03

- Small variations occurred only on the first bead during the Q2, 2018. The rest of the thermistor remained consistent with previous data sets.
- There is a permafrost layer between elevation 40 and 55 MASL.

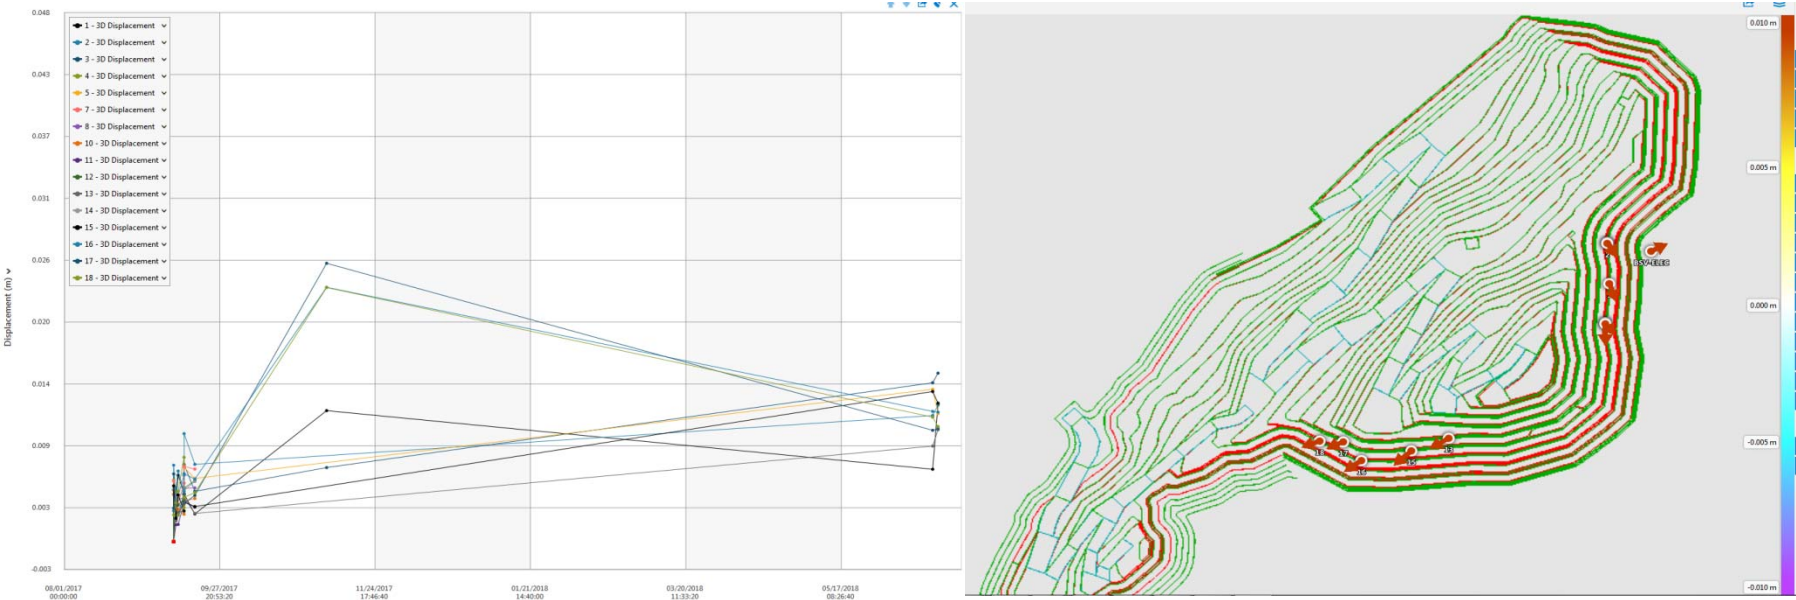
- Two sets of reading were taken in June for the Q2 Period. Prior to this period, the inside of the survey shack was not accessible due to ice accumulation.
- During the latest survey of the prisms, only 9 were successfully surveyed, the others are either gone or damage.
- More data needs to be collected to extract a trend.

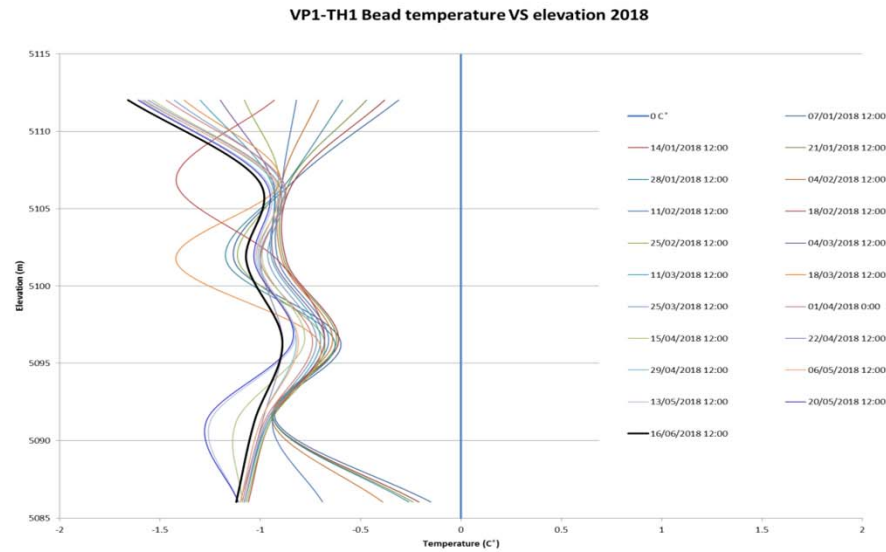
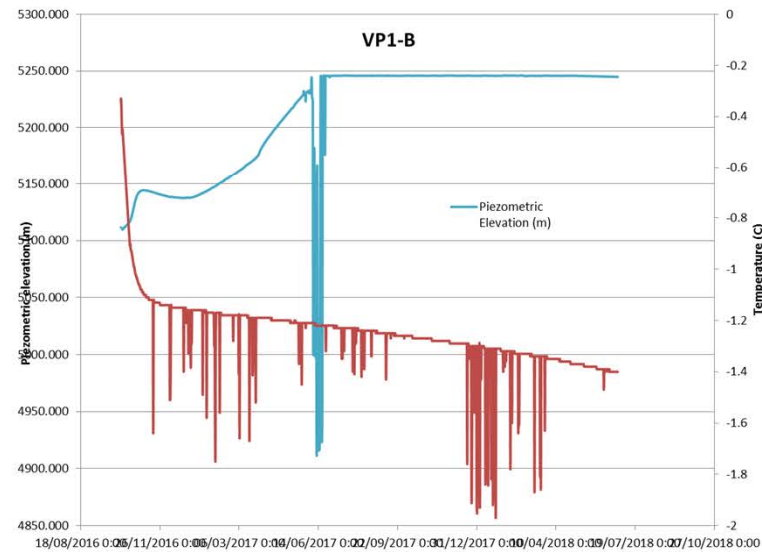
VP1-A, VP1-B, VP1-TH1

- PZ-A&B are below the freezing point. Pressure measurements are therefore considered unreliable and will not be discussed here.
- The thermistor remained frozen during Q2, 2018.
