Meadowbank 2018 Annual Review of Portage and Goose Pit Slope Performance

2018 ANNUAL PIT SLOPE PERFORMANCE REVIEW

MEADOWBANK MINE, NUNAVUT

ISSUED FOR USE
704-ENG. ROCK03053-02

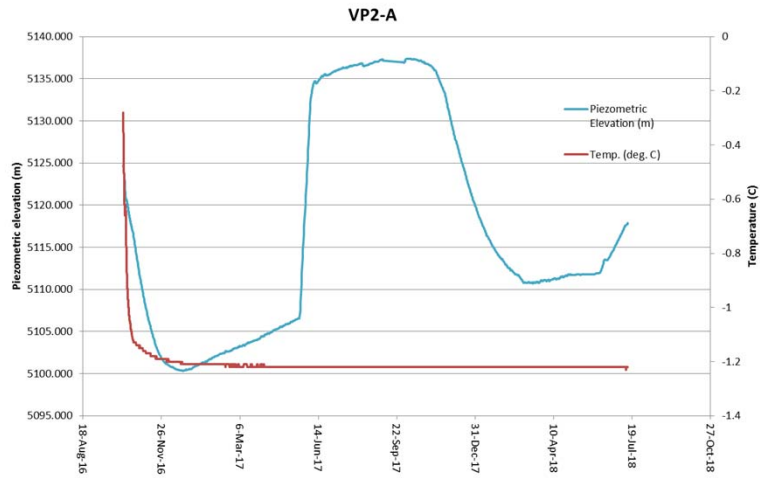
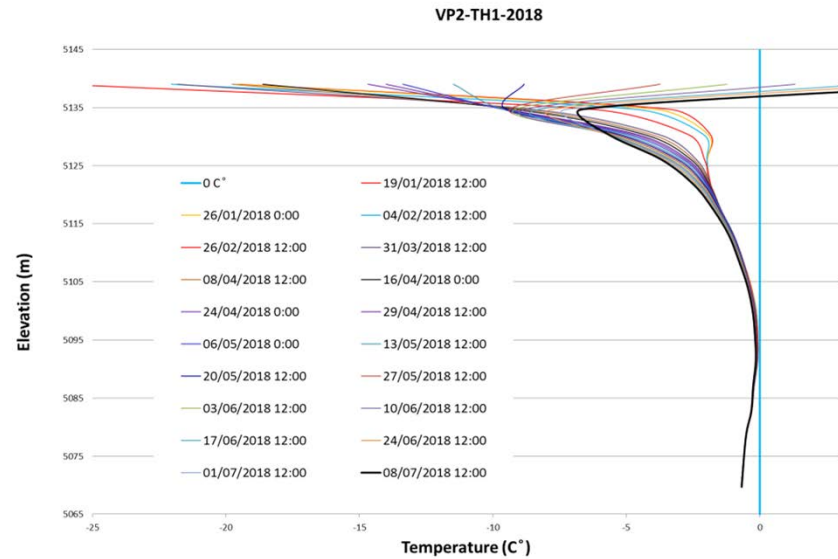
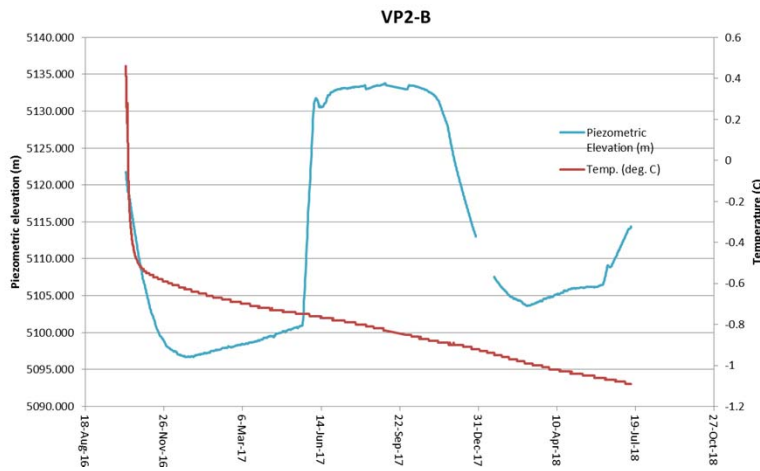
VP2-A, VP2-B, VP2-TH1

- PZ-A&B are below the freezing point since their installation and their data are considered unreliable.
- The section between 5105 and 5085 is close to the freezing but still below. Apart the top beads, minimal variations were recorded for the rest of the hole.

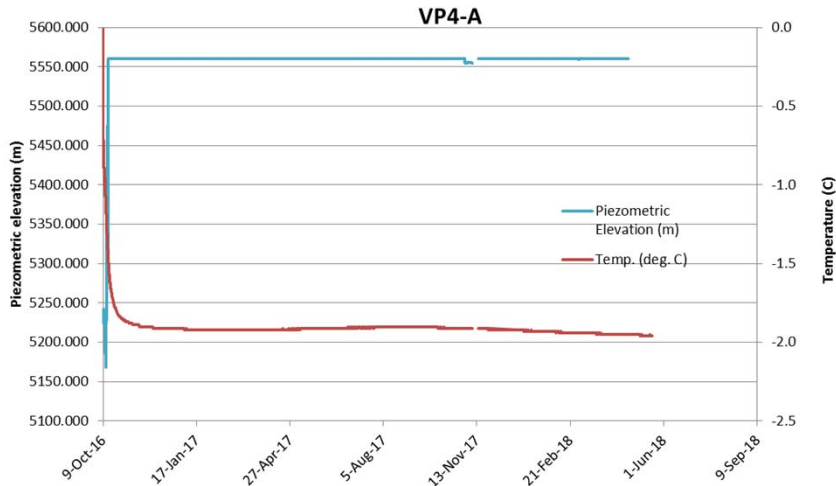
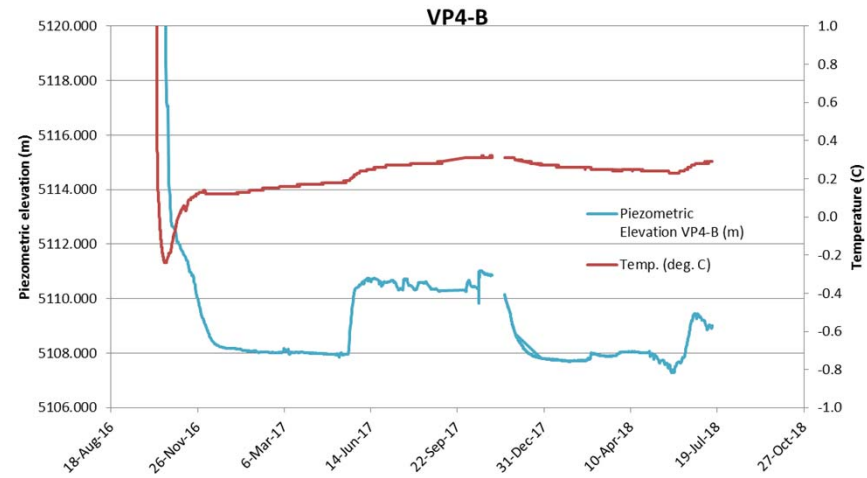
VP4-A, VP4-B

- PZ-A is under the freezing point and considered unreliable.
- PZ-B is unfrozen and since is significant pressure drop, it remained stable during Q1 ,2018. The instrument is installed in the confined layer of talik in between 5105 and 5095 at the source of the seepage causing the major ice wall in the area.
- The temperature of PZ-B is on a very slight downward trend suggesting a freeze back of the slope and aggradation of permafrost.

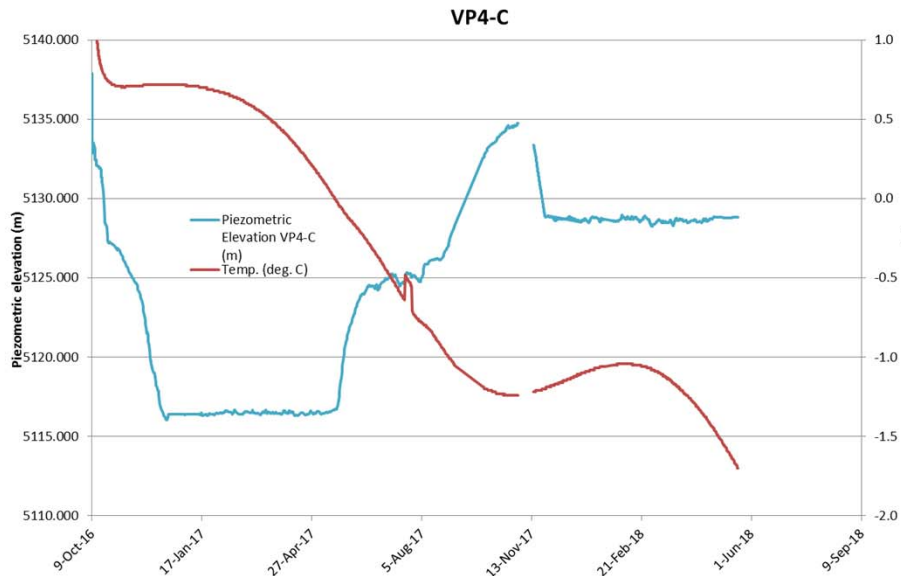
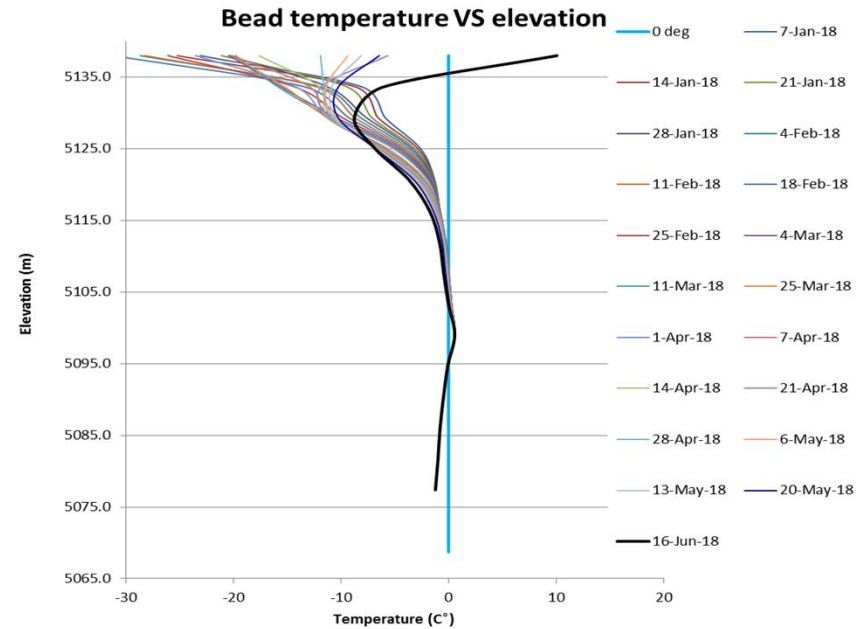
VP4-C, VP4-TH1

- PZ-C is frozen and data is considered unreliable.
- The thermistor show that the hole is mainly in the permafrost at the exception of the section in between 5100 and 5095 (0.57°C). This zone causes the seepage and therefore the ice wall.

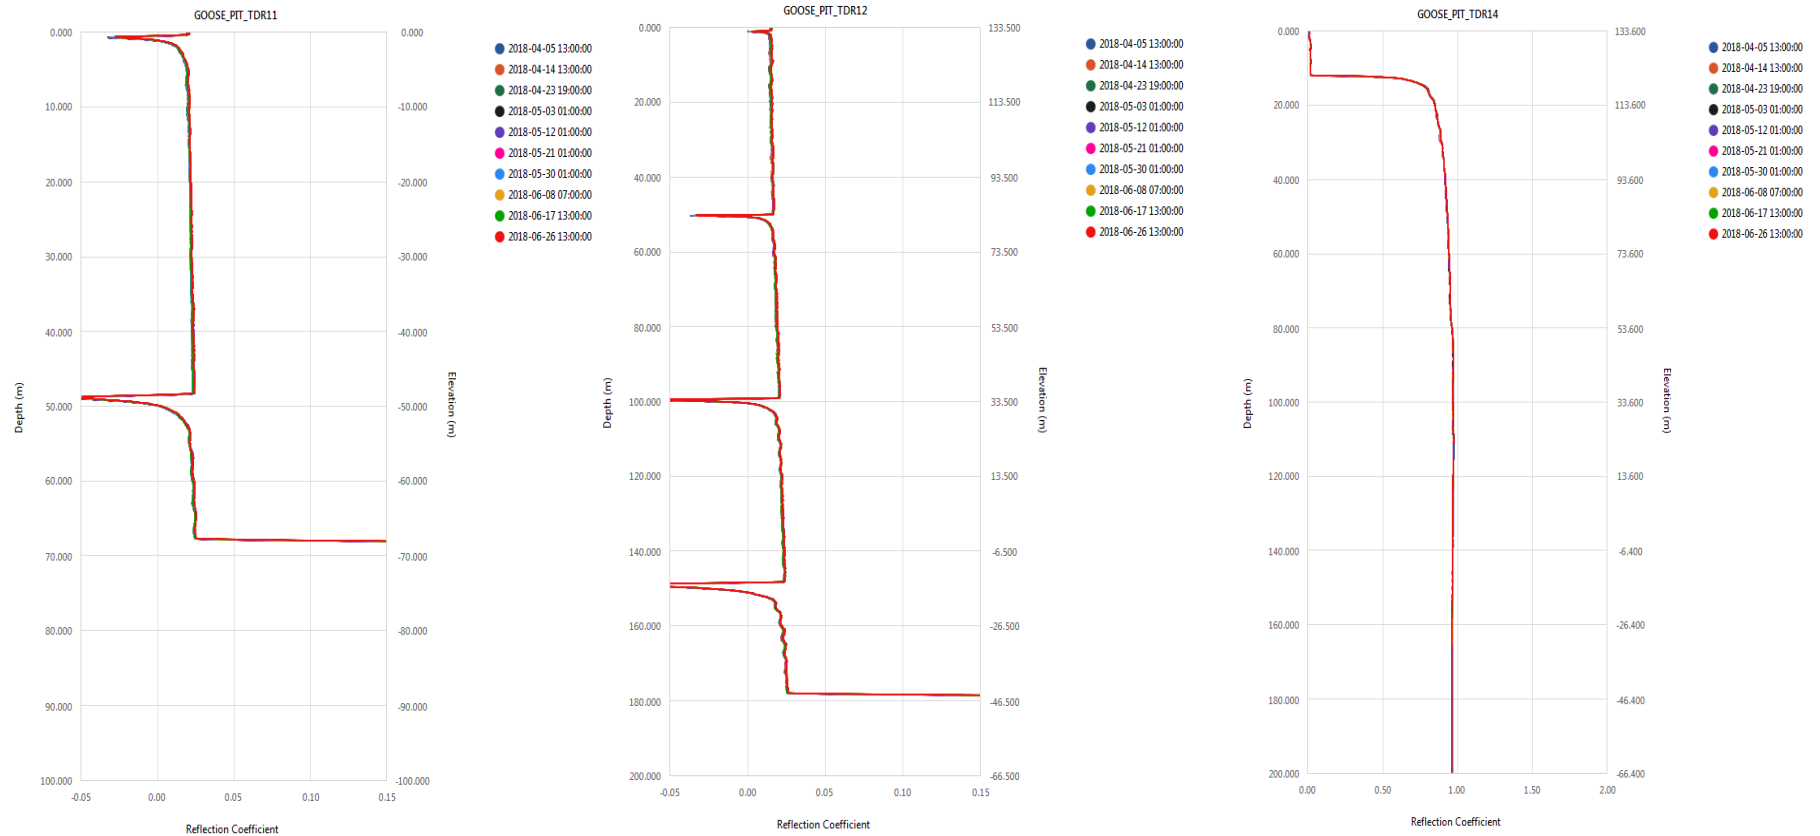
- No sign of deformation was observed in these TDRs.
- Anomalies from the TDR logger are still presents and were disregarded in the presented graphs. We are currently still trying to find a solution for this problem but it does not compromise the data integrity.
- TDR 14 was pinched at installation and therefore result might be compromise in the case of an event raising the reflection coefficient.

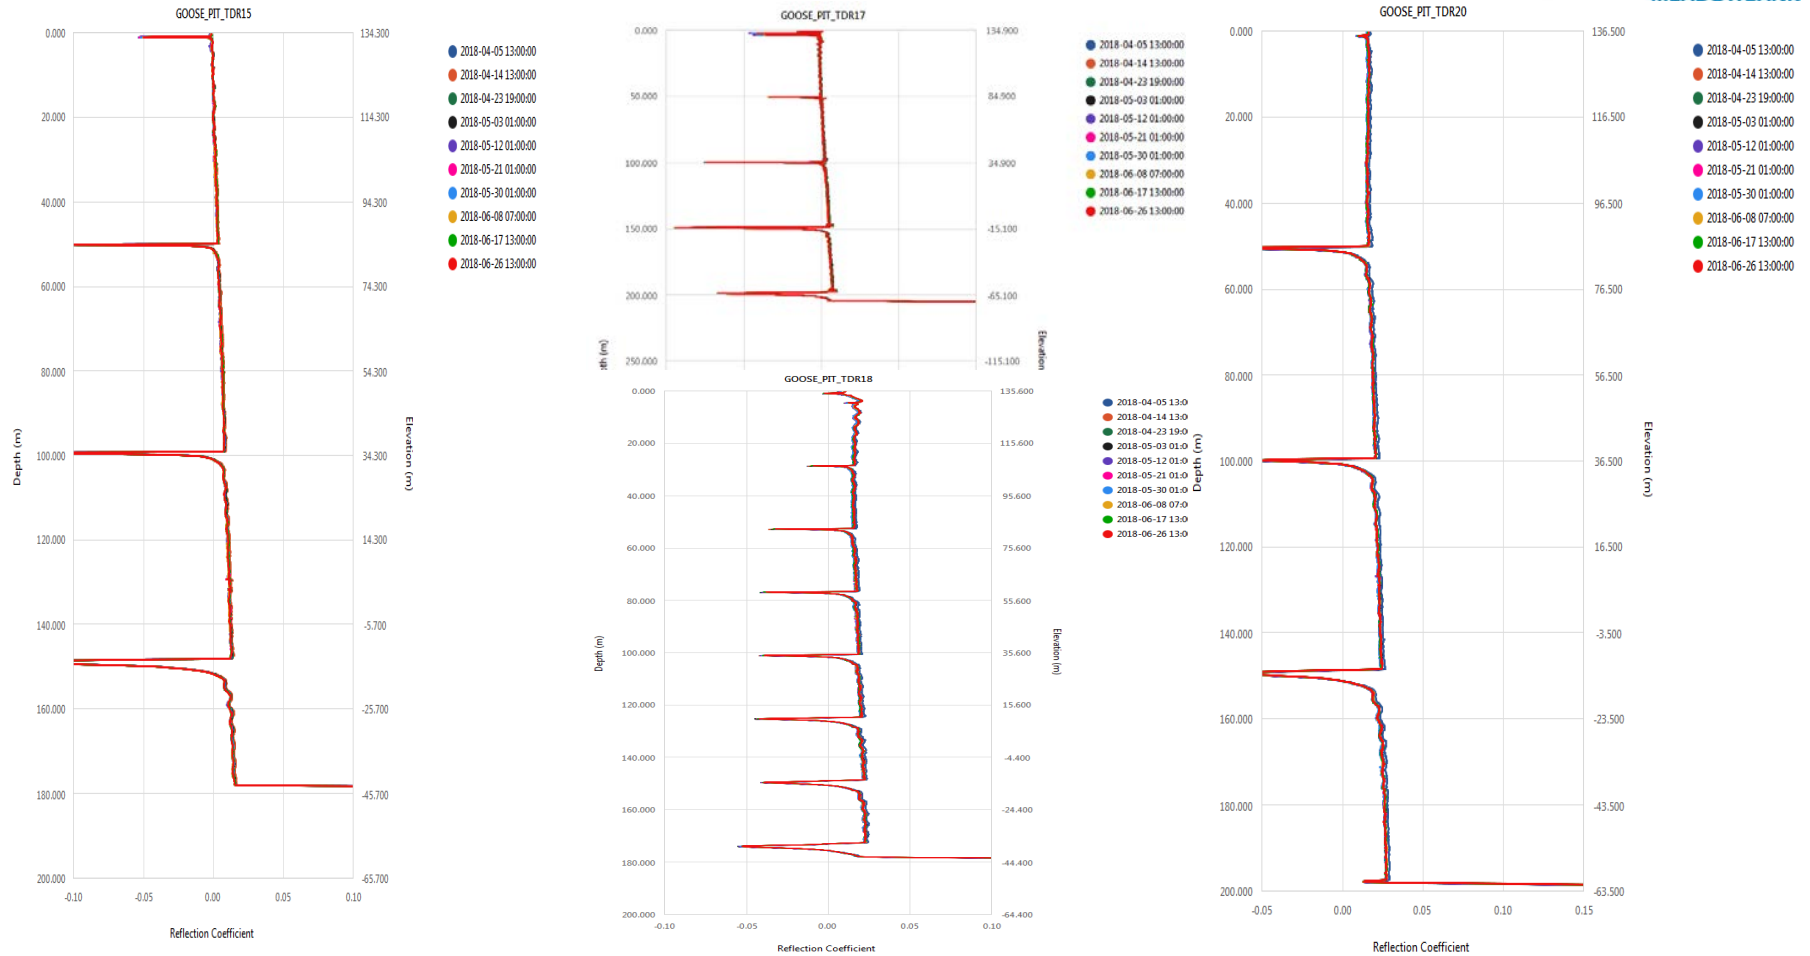
- No sign of deformation was observed in these TDRs.
- Anomalies from the TDR logger are still presents and were disregarded in the presented graphs. We are currently still trying to find a solution for this problem but it does not compromise the data integrity.

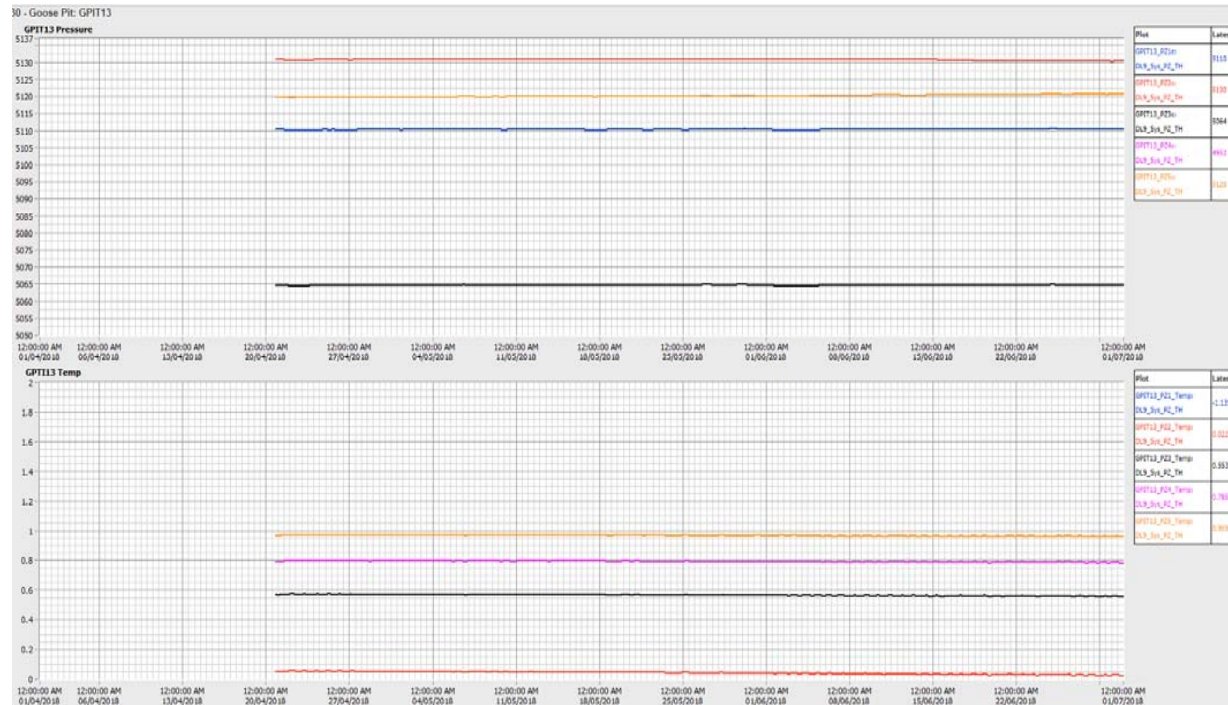
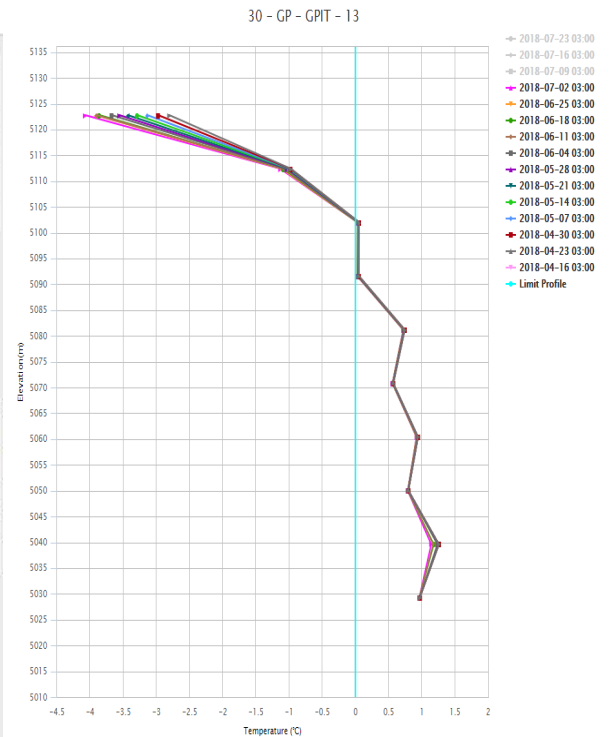
- All piezometers presents little or no variation during the Q2, 2018. All of them are above freezing point.
- A part of the data logger (DL9) was used on DL13 and no record were taken in between Feb. 23 to April 20, 2018.
- TH-GPIT-13 was stable during Q2 compared to previous data sets. It is in the permafrost from top to elev. 5102. First bead at elevation 5123 lose 1.2°C and a decimal of a degree at elevation 5039 during the Q2.

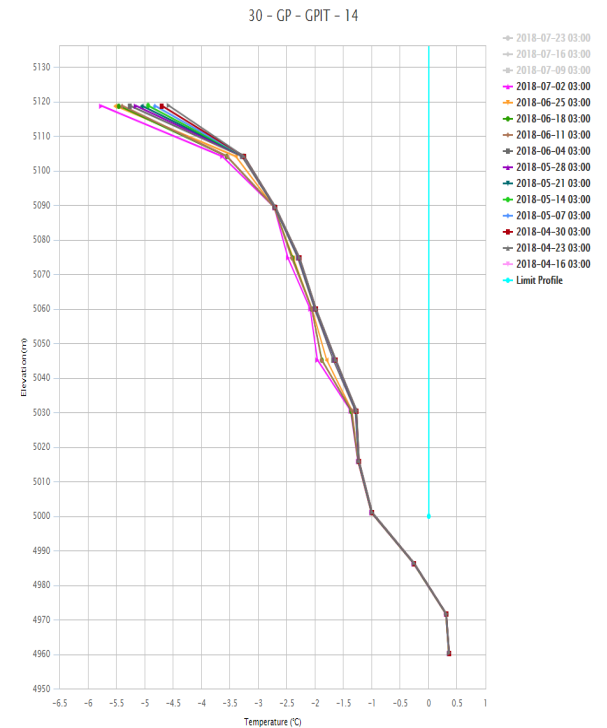
- PZ-4 is on a slow rising trend. It rose 3.12 m pore water pressure during the second quarter and that could be related to the water level within the Goose pit that is raising (natural flooding).
- PZ-5 stayed constant with very few variations (0.17m).
- PZ-1,2,3 are below the freezing point.
- TH-GPIT-14 is in the permafrost from top at elevation 5120 to 4980. The last 20m of the hole is above the freezing line. From elev. 5120 to 5030, temperatures generally went down decimals of a degree. The remaining of the hole stayed the same from 5015 to 4960.

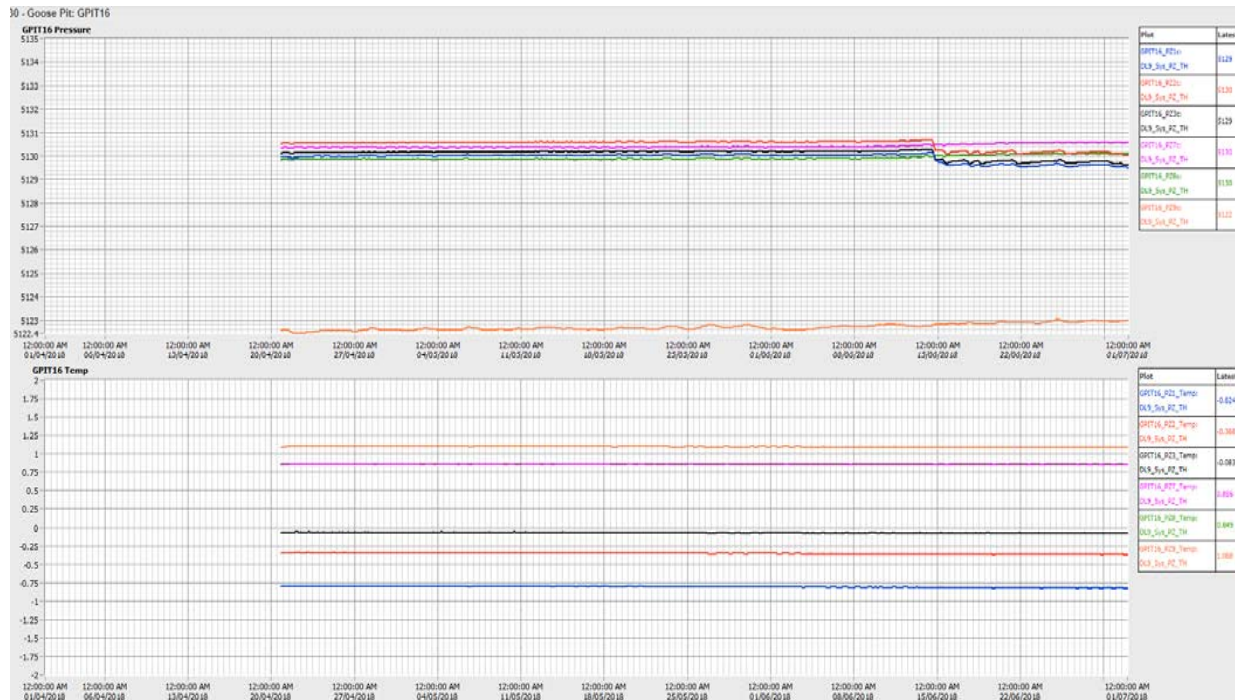
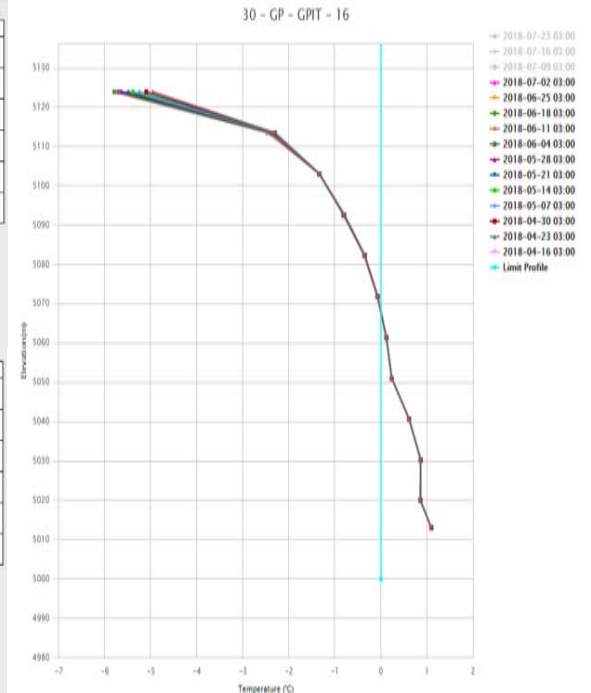
- PZ-7,8,9 are on a very slow rinsing trend.
- PZ-1,2,3 are below the freezing point and can't be considered reliable.
- TH-GPIT-16 is in the permafrost from top at elevation 5124 to 5070. The last 57m of the hole is above the freezing line. The first couple of beads loose decimals of a degree during the Q2.

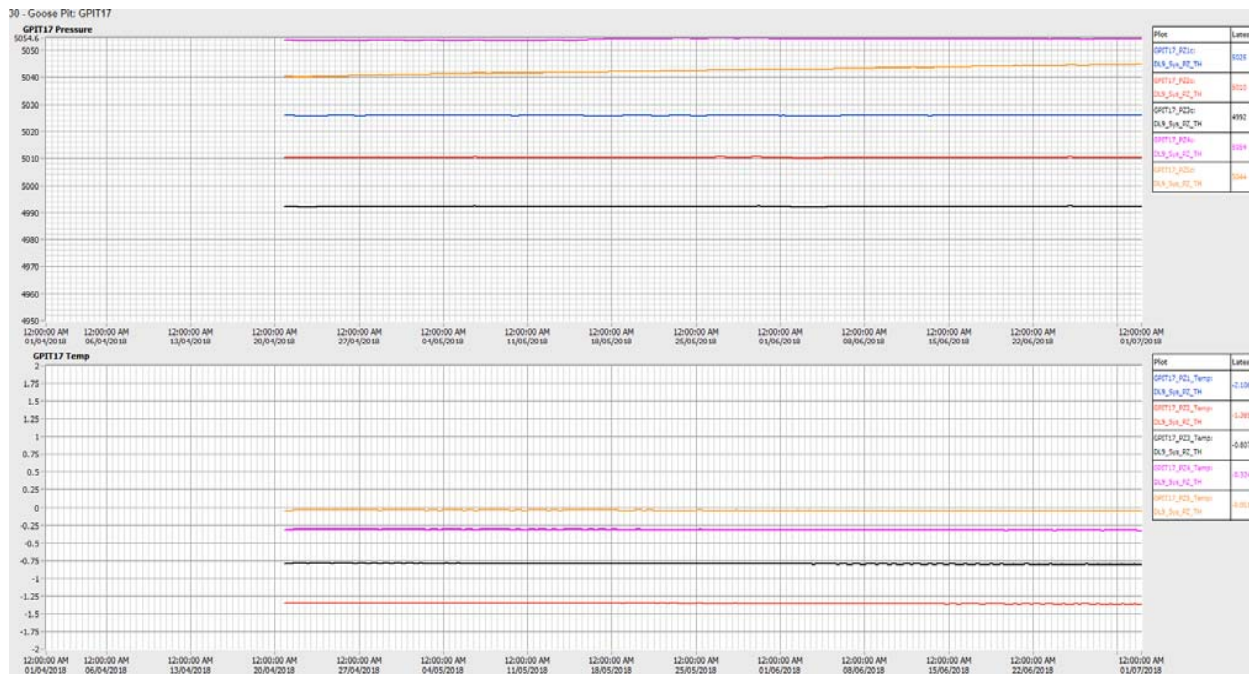
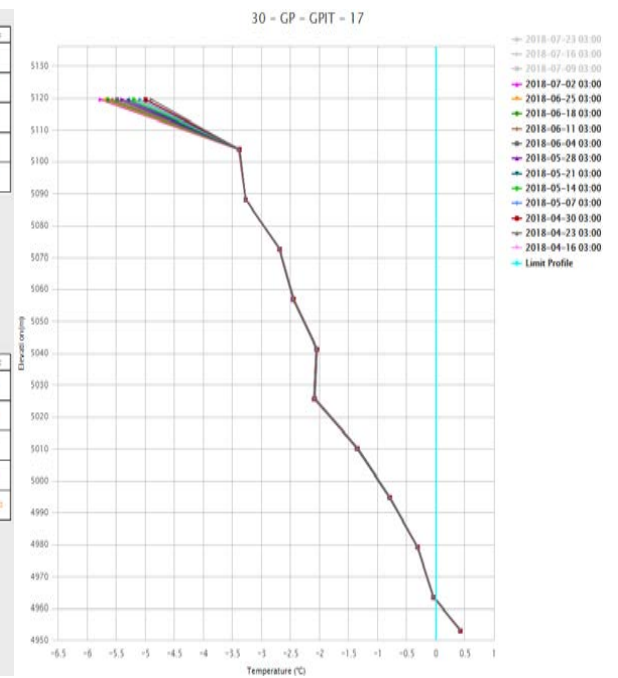
- PZ-1,2,3,4&5 are below the freezing point and can't be considered reliable.
- TH-GPIT-17 is in the permafrost from top at elevation 5119 to 4963. The first bead lost 0.7°C. The last 10m of the hole is above the freezing line.

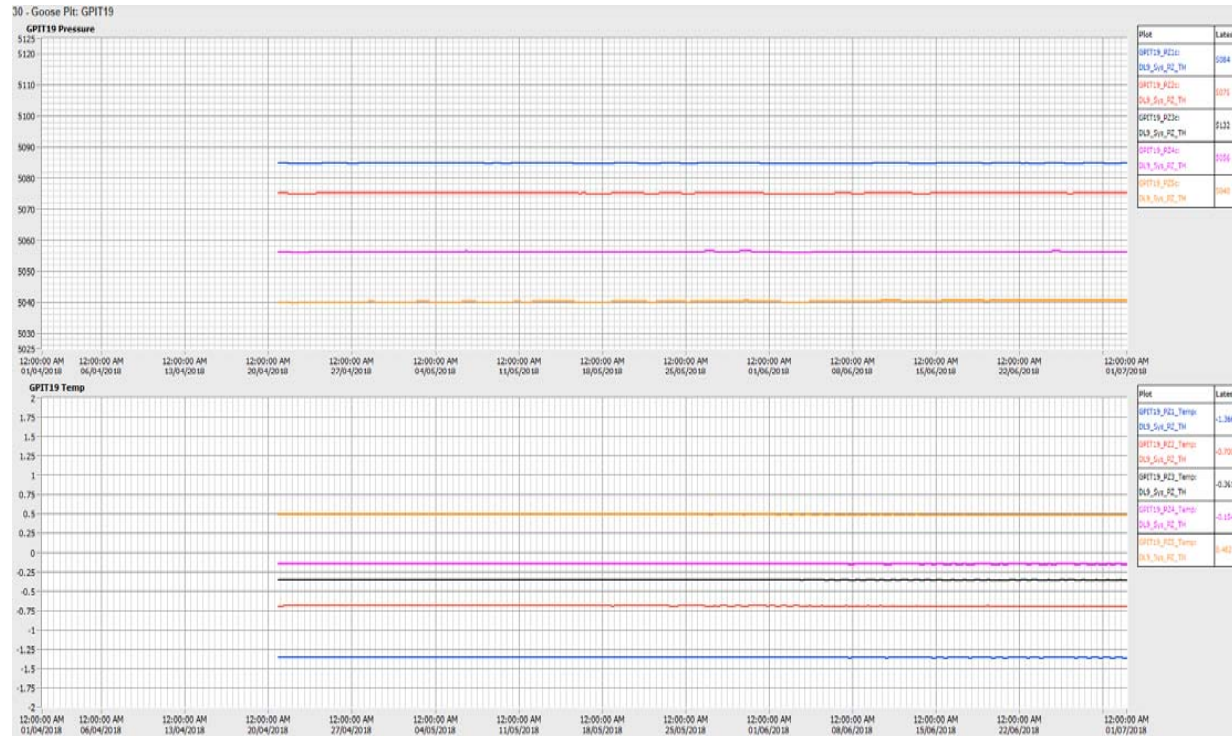
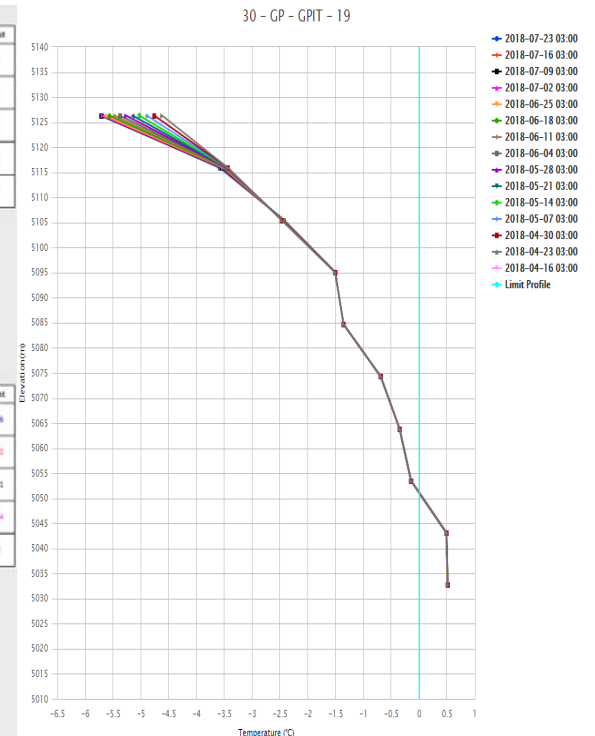
- PZ-5 is above the freezing line and it shows little or no pore water pressure variations during the Q2, 2018.
- PZ-1,2,3,4 are below the freezing point and can't be considered reliable.
- TH-GPIT-19 is in the permafrost from top at elevation 5126 to 5051. The first bead lost 1°C. The last 19m of the hole is above the freezing line and didn't varied during the Q2.

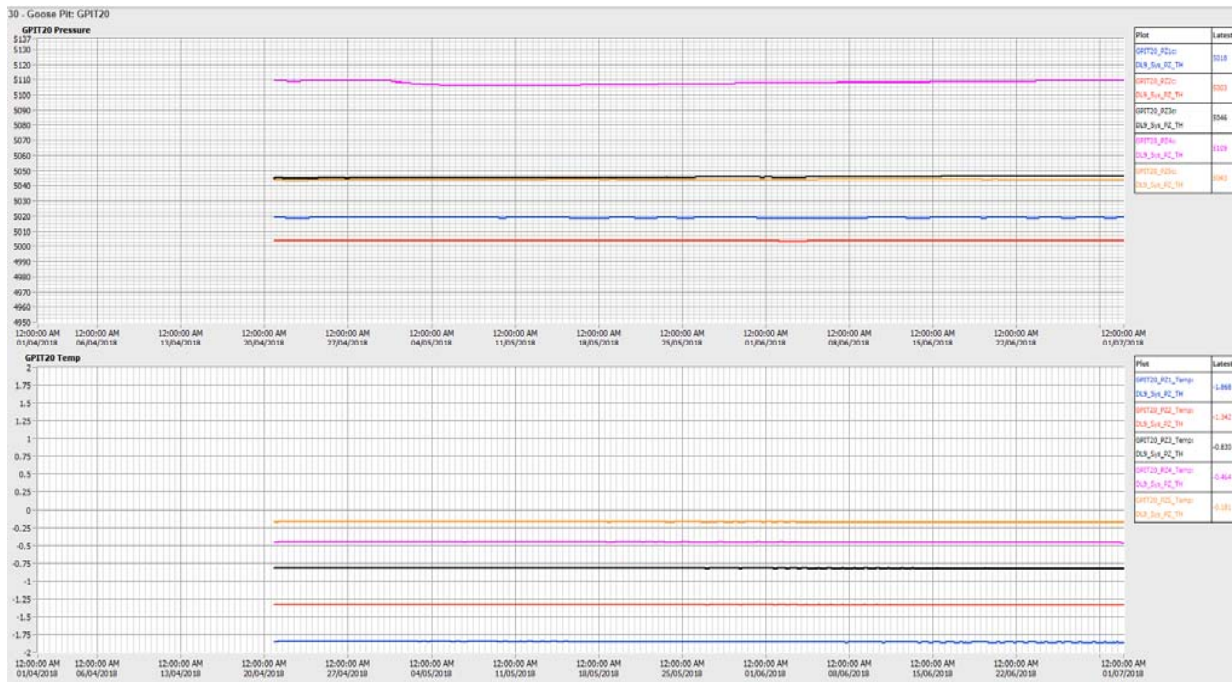
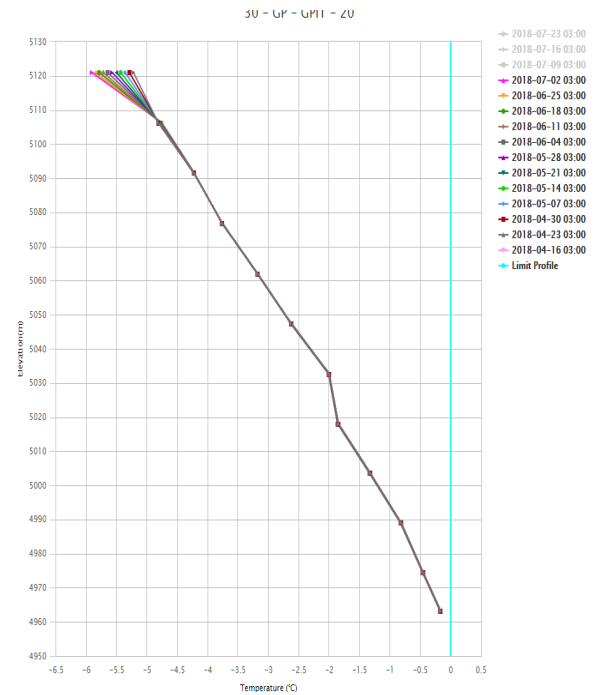
- PZ-1,2,3,4,5 are below the freezing point and can't be considered reliable.
- TH-GPIT-20 is in the permafrost on its entire length from its top at elevation 5121 to the bottom at 4963. The first bead at elevation lost 0.6°C during the Q2, 2018.

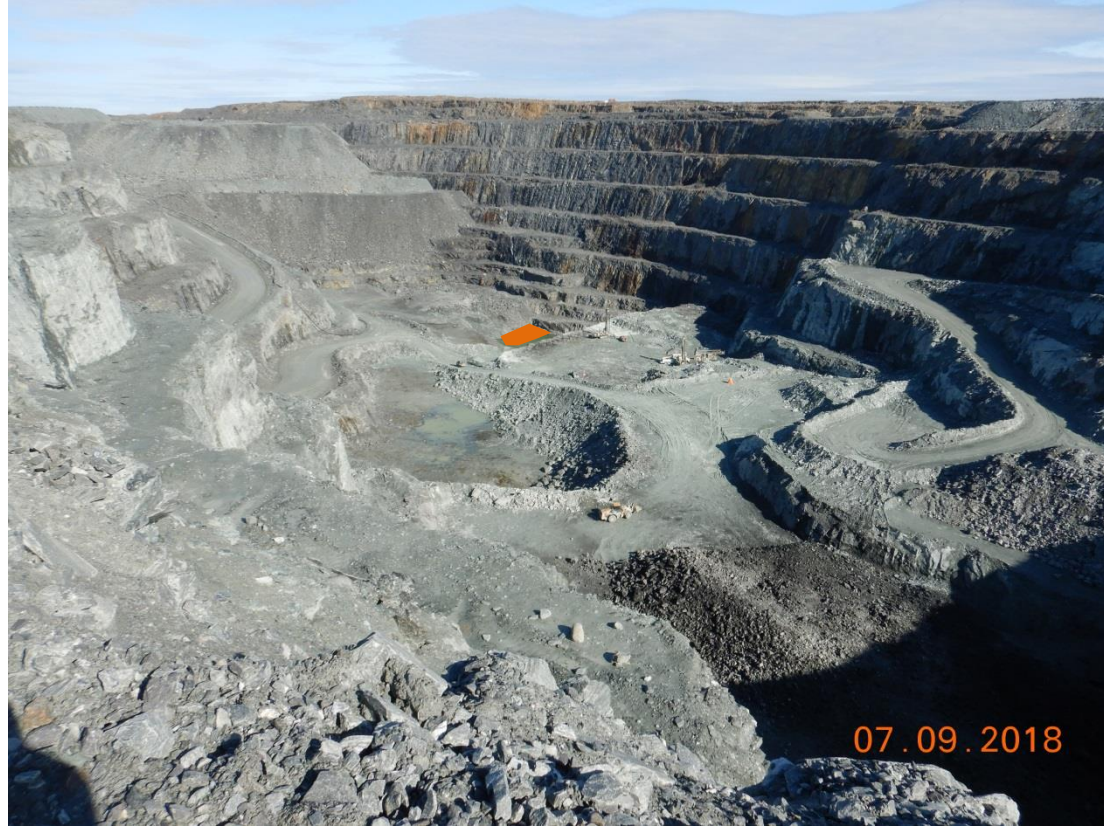
Zone E01: Pit E3: No Access Zone while in dewatering process.

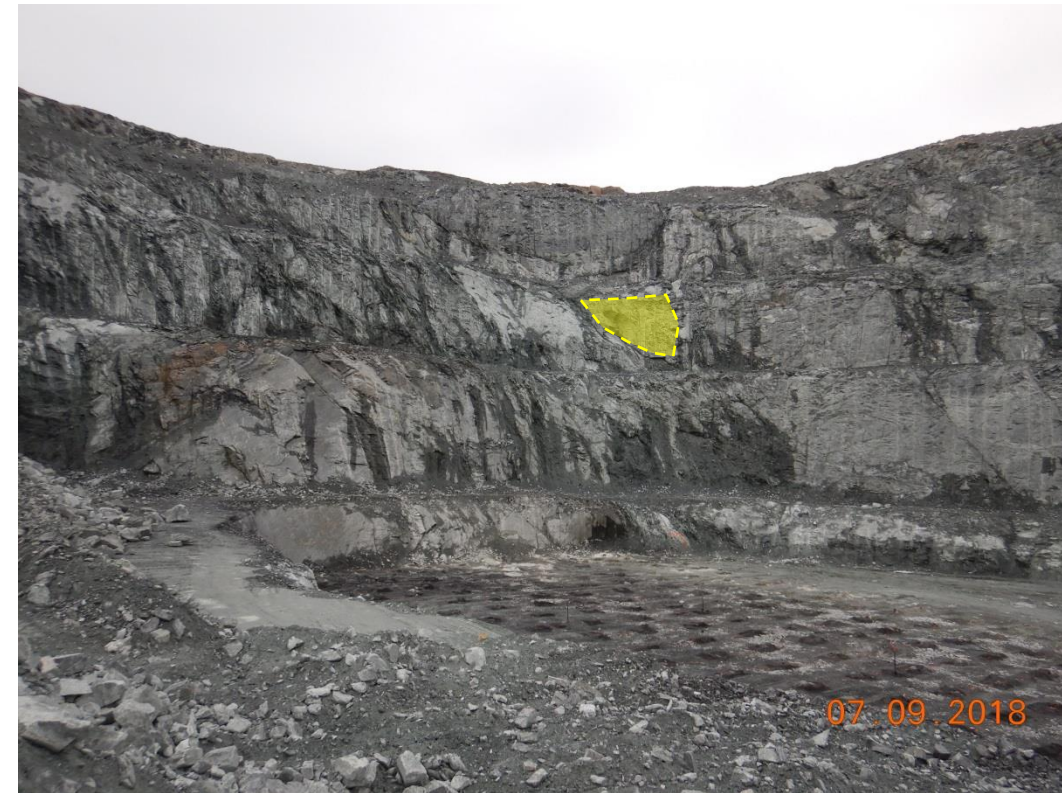
Zone E29: Pit E5, South Wall: Slab with linear progression to be monitored.

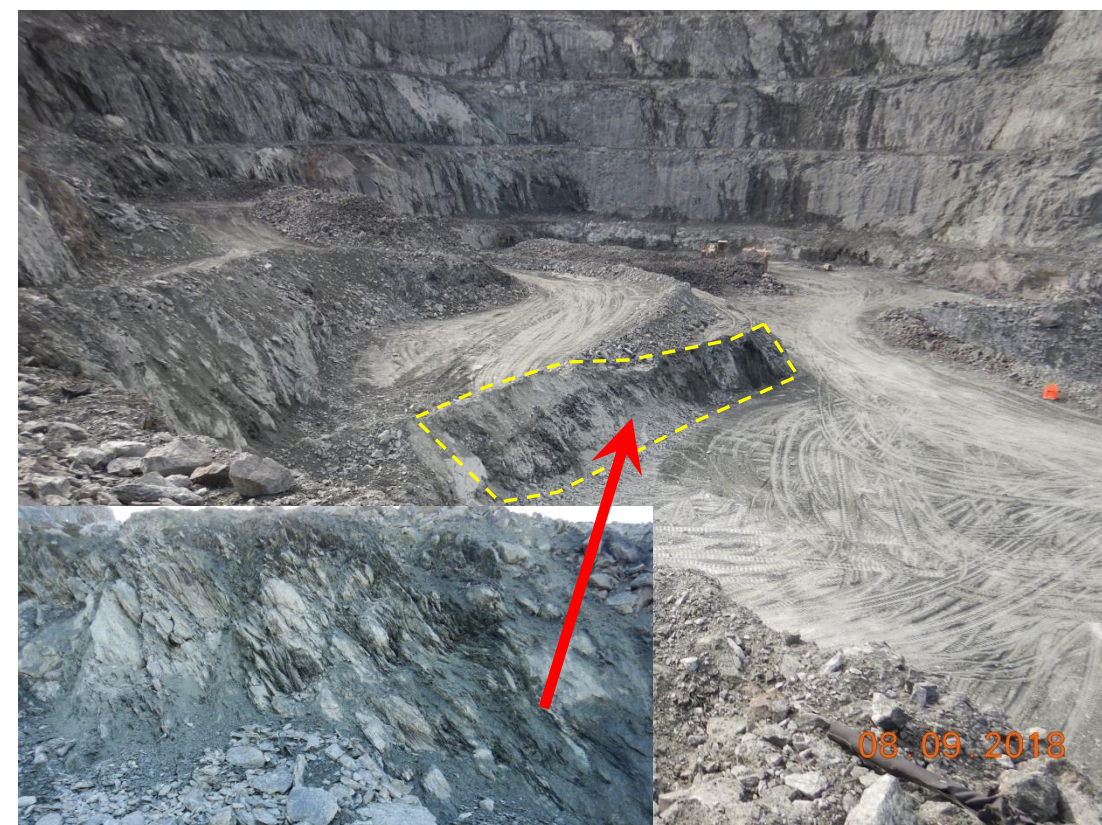
</p>	<p>NEW: This wall section is made of heavily foliated ultramafic rock. In addition to that, bumpers from above are too close crest. The wall is the top section of a 21 meters wall and could become a problem as we go down.</p>	<p>NEW: Scale and remove all loose material from the wall. Because of the large section above open space), there is a possibility to use a backhoe and slope the crest if needed. Pull back the bumpers away from the crest.</p>	<p>Sept. 14, 2018</p>	<p>NA</p>

Zone E37: E5, South Wall: Scale and slope the wall. Pull back the bumpers away from the crest.

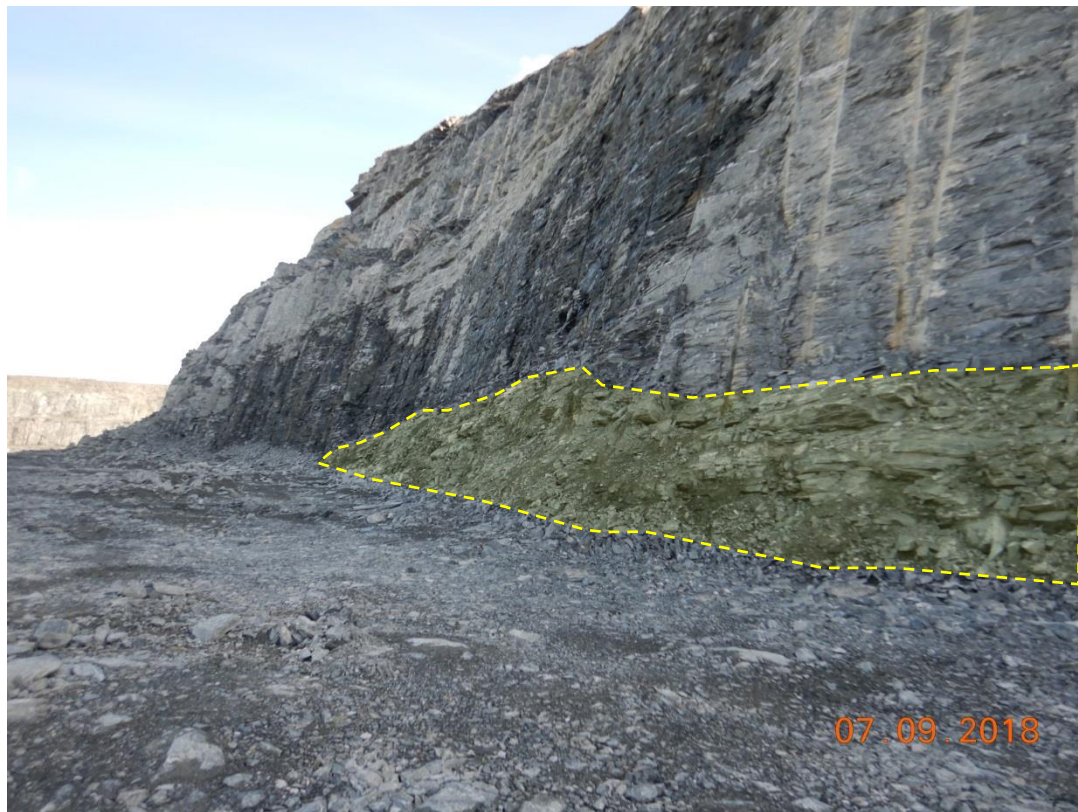
</p>	<p>NEW: A new section of the wall was exposed and presents mostly toes and loose material on its bottom despite being in general good condition.</p>	<p>NEW: Scale the wall and hammer the toes when required.</p>	<p>Sept. 21, 2018</p>	<p>NA</p>

Zone P31: Phaser, East Wall: Scale the wall and hammer the toes when required.
