# **Meadowbank and Whale Tail 2018 Annual Geotechnical Inspection**

# 2018 Annual Geotechnical Inspection

*Meadowbank Gold Mine, Nunavut*

18101627-1583-R-Rev0

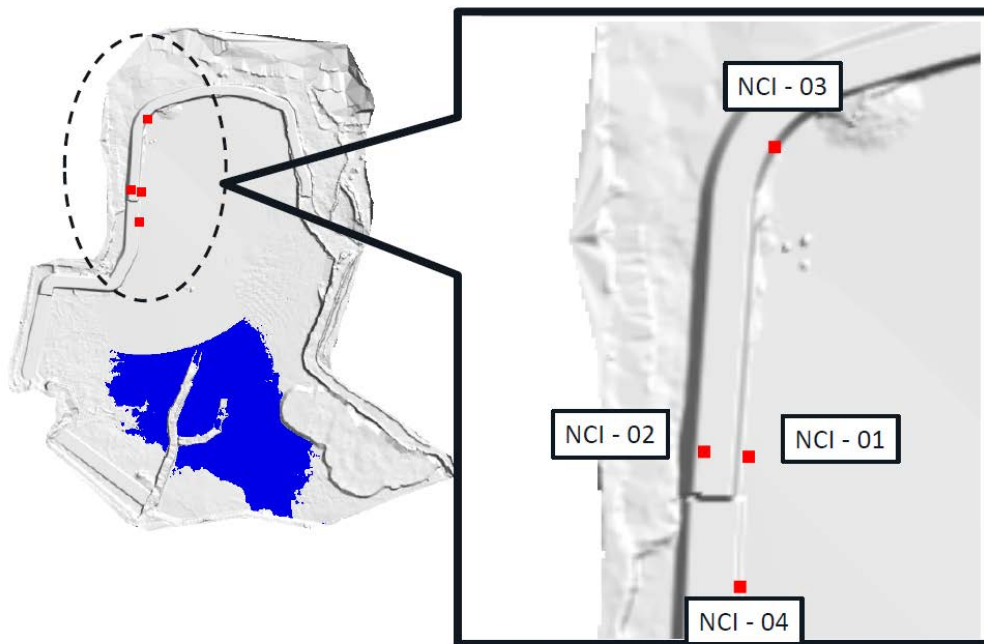
Figure 2: Locations of the thermistors installed in the North Cell Internal Structure (source: AEM)

Four vertical thermistor strings (NCIS-01 to NCIS-04) are installed in the North Cell Internal Structure to monitor the thermal condition within the structure and its foundation constituted of rockfill capping and/or tailings depending on the sections. Three instruments are located around a deposition point in the section where the structure is built at the El. 154 m entirely on exposed tailings, while the fourth instrument is located further north where the structure is built at the El. 154 m over the rockfill capping (see Figure 2 below).

Four vertical thermistor strings were installed on the crest of the North Cell Internal Structure in August 2018 (NCIS-01, NCIS-02, NCIS-03 and NCIS-04), as detailed in Figure 2 in Section 4.4. NCIS-01, NCIS-02 and NCIS-04 are installed on the upstream side of the dike whereas NCIS-03 is installed on the downstream side. At the time of the inspection, the instruments had just been installed and the data reviewed by Golder included early August to the end of September 2018. NCIS-01, NCIS-02 and NCIS-03 show frozen tailings and an active layer within the entire layer of rockfill, while NCIS-04 indicates that the active layer extends into the first 0.5 m of the tailings. It will be important to continue following the performance of the structure as the North Cell Internal Structure is now operational and retaining tailings and has only been recently built.

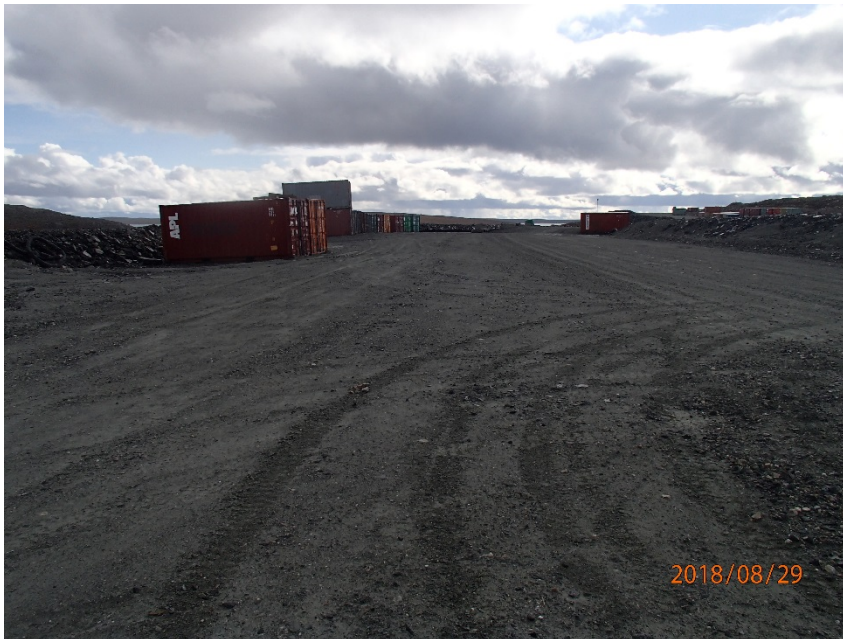
**Photograph A1-1 East Dike**

**Description:** From approximately Sta. 60+375, looking south at the crest.

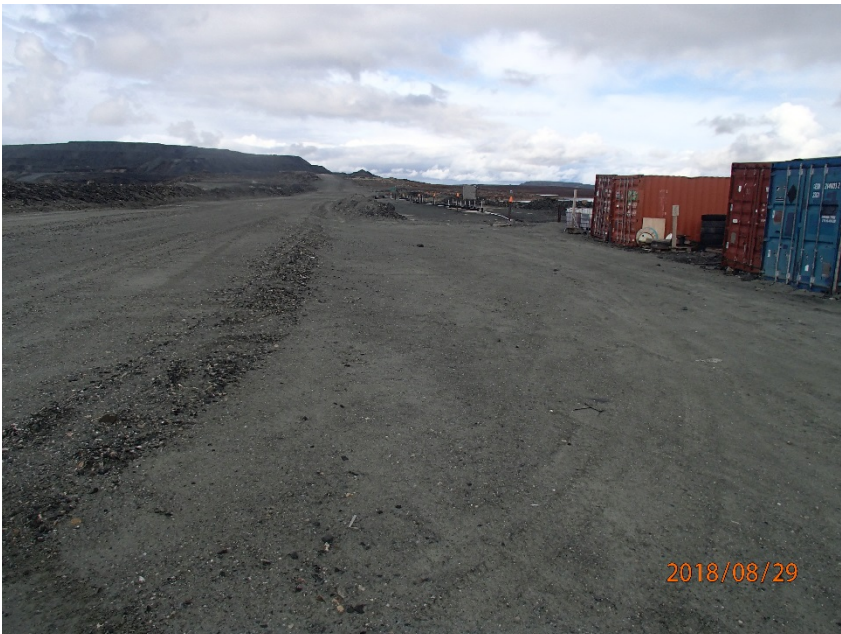
**Photograph A1-2 East Dike**

**Description:** From approximately Sta. 60+410, looking north at the crest.

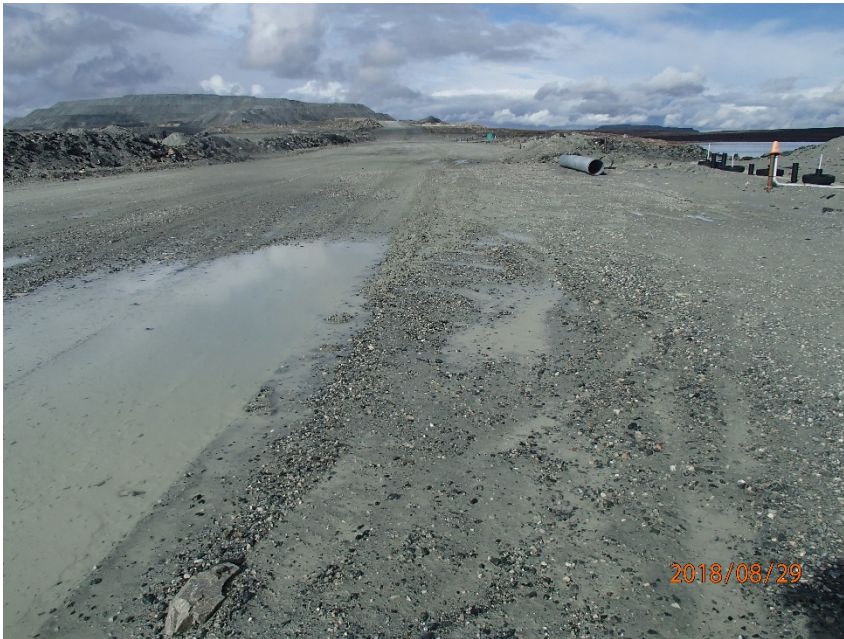
**Photograph A1-3 East Dike**

**Description:** From approximately Sta. 60+560, looking north at the crest.

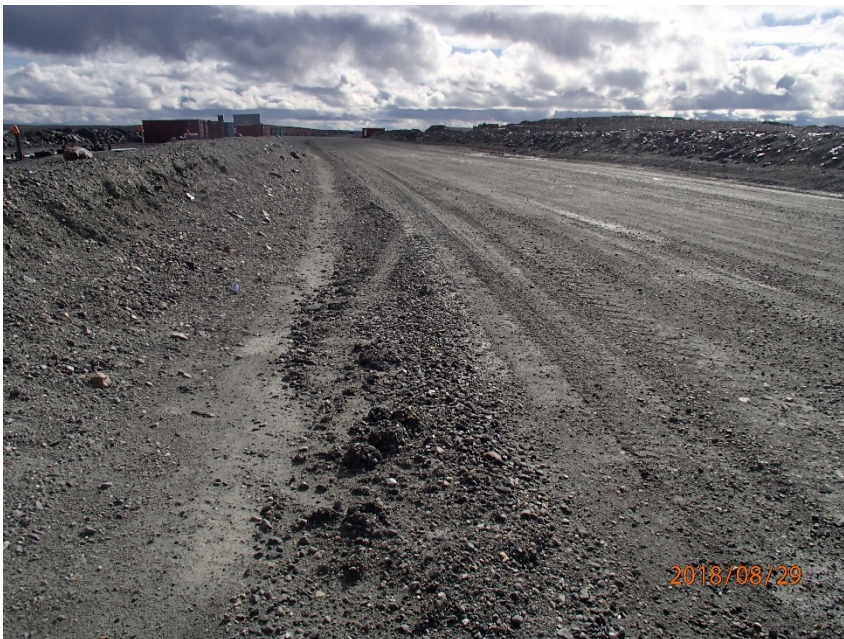
**Photograph A1-4 East Dike**

**Description:** From approximately Sta. 60+540, looking south at the crest.

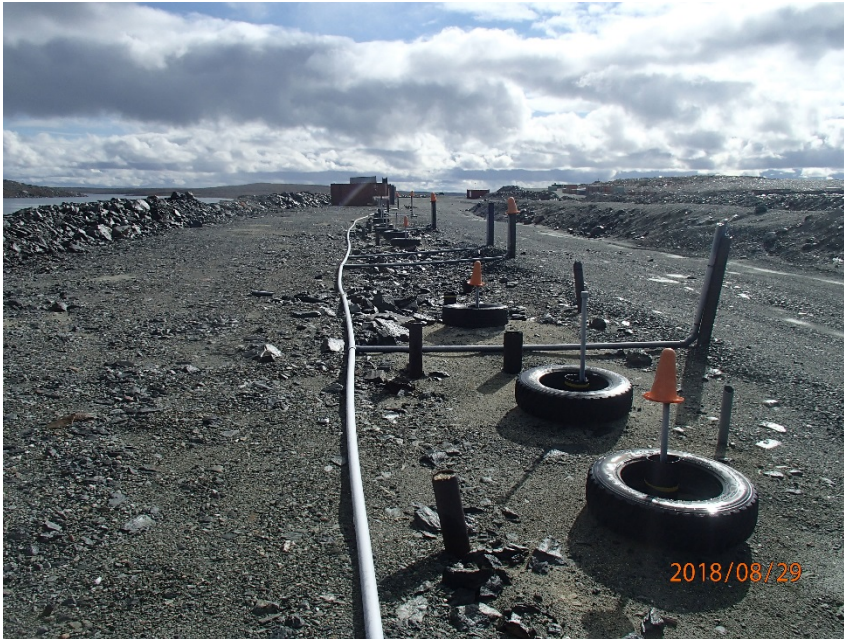
**Photograph A1-5 East Dike**

**Description:** From approximately Sta. 60+540 upstream, looking south at the crest and the upstream slope.

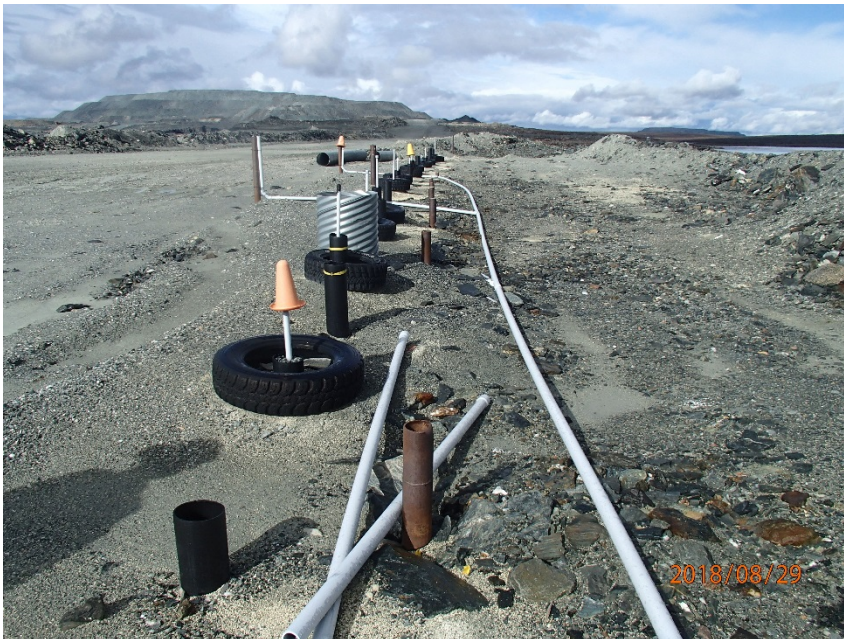
**Photograph A1-6 East Dike**

**Description:** From approximately Sta. 60+560 upstream, looking north at the crest and the upstream slope.

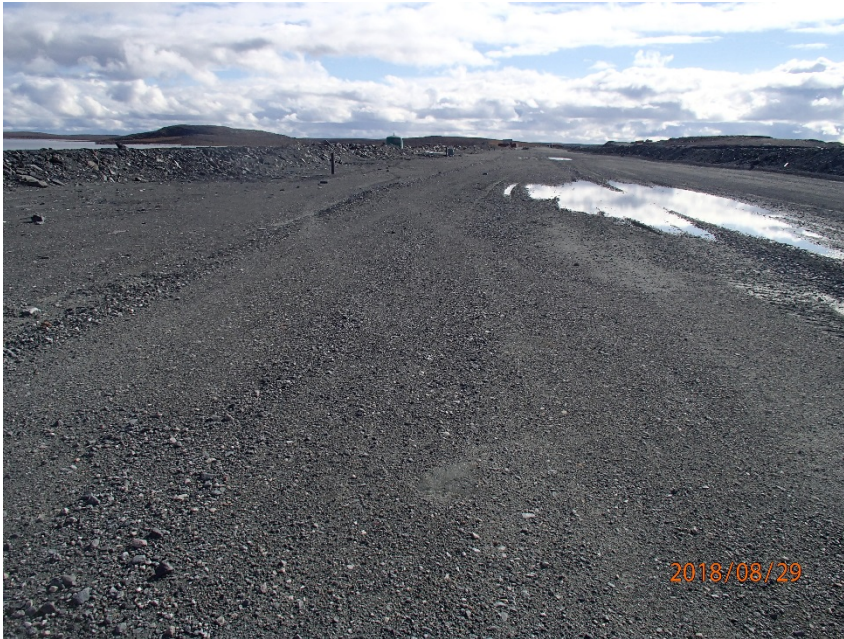
**Photograph A1-7 East Dike**

**Description:** From approximately Sta. 60+810, looking south at the crest.

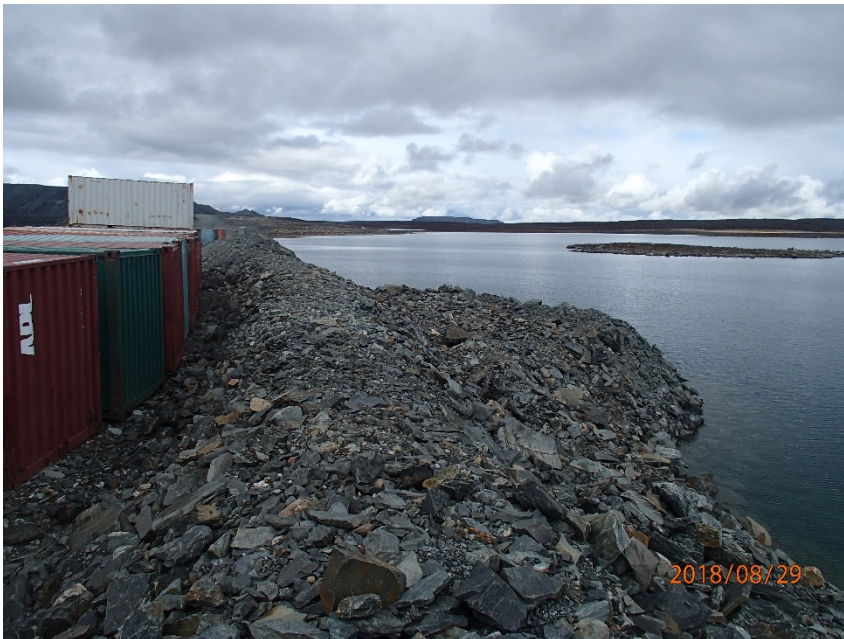
**Photograph A1-8 East Dike**

**Description:** From Sta. 60+300 upstream, looking north along the upstream slope.

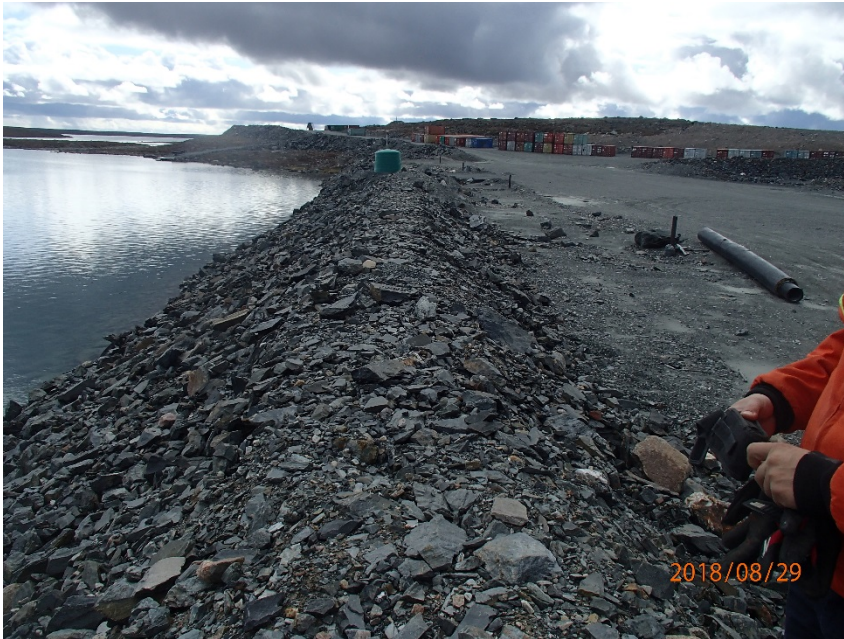
**Photograph A1-9 East Dike**

**Description:** From approximately Sta. 60+250 upstream, looking south at the crest and the upstream slope.

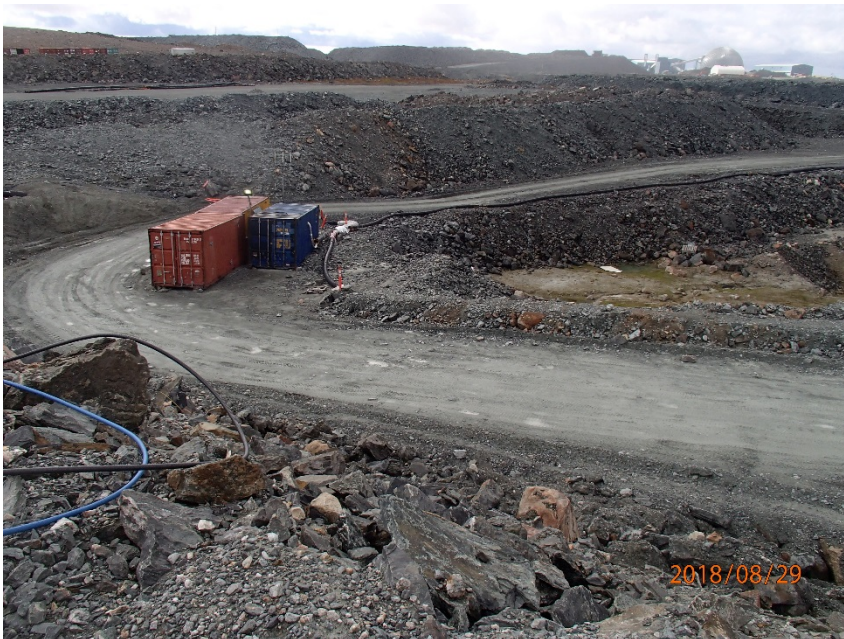
**Photograph A1-10 East Dike**

**Description:** From approximately Sta. 60+250, looking west at the downstream side and toe.

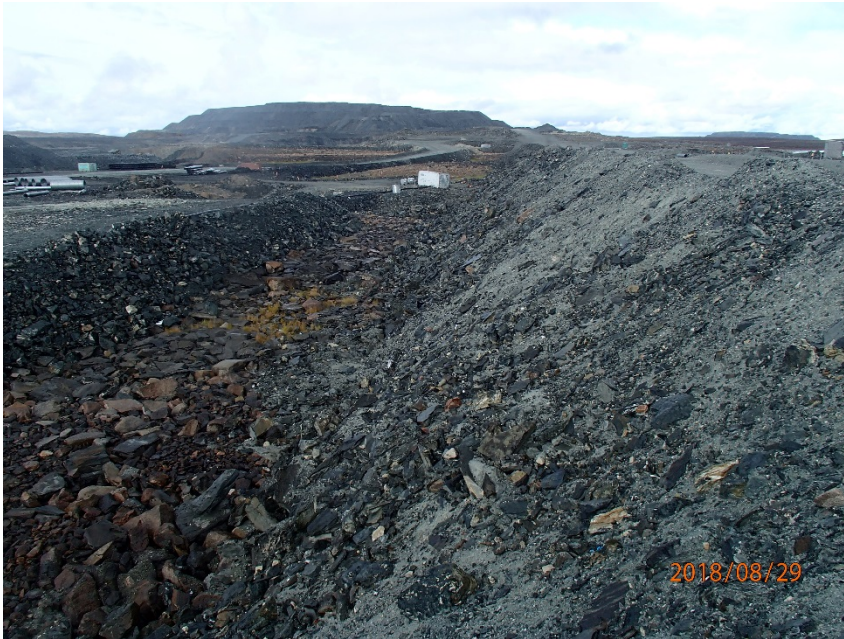
**Photograph A1-11 East Dike**

**Description:** From approximately Sta. 60+380, looking north at the downstream side.

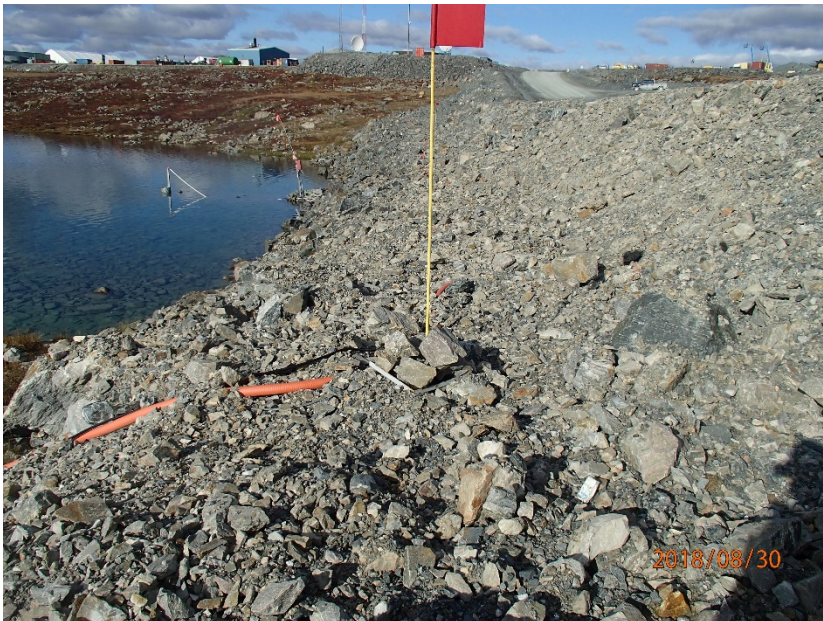
**Photograph A2-1 South Camp Dike**

**Description:** From the south abutment, looking north at the upstream slope and the thermistors instrumentation set-up.

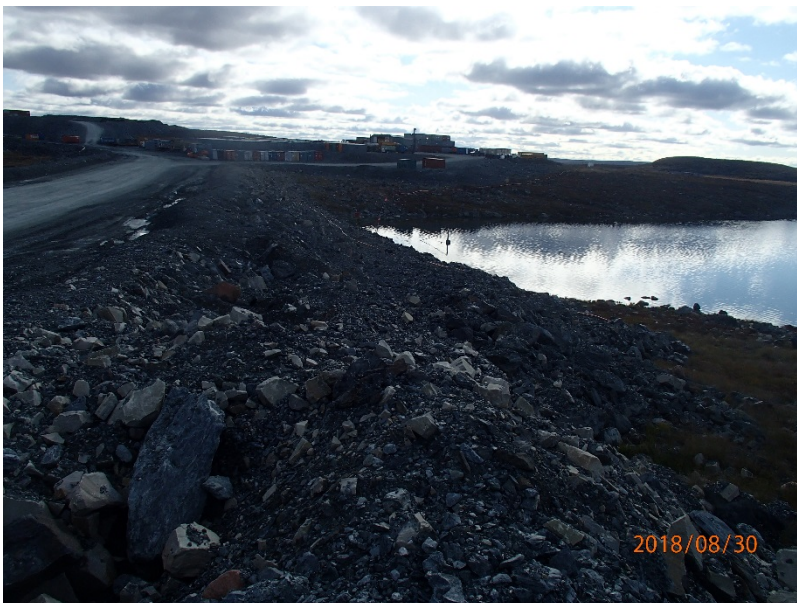
**Photograph A2-2 South Camp Dike**

**Description:** From the north abutment, looking south at the upstream slope and thermistors instrumentation set-up.

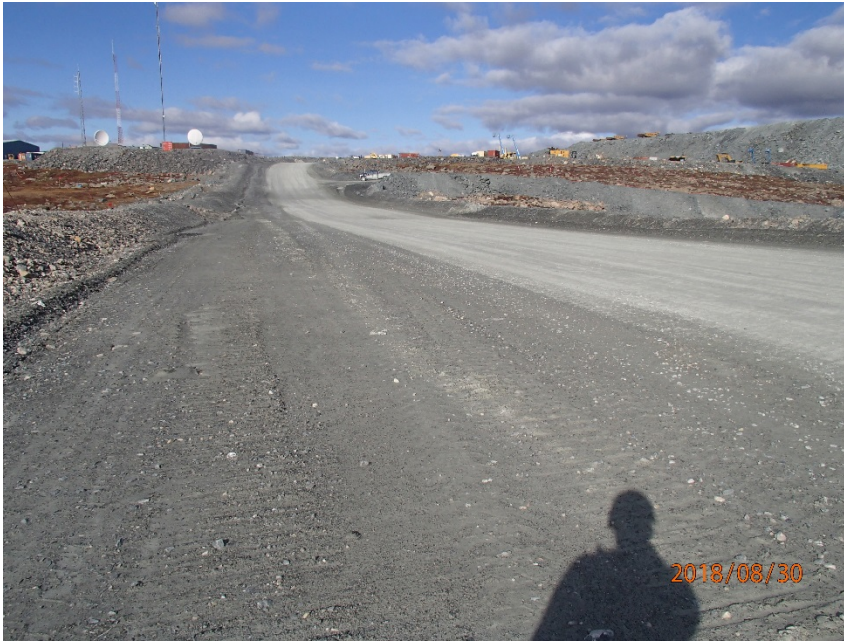
**Photograph A2-3 South Camp Dike**

**Description:** From the south abutment, looking north at the crest.

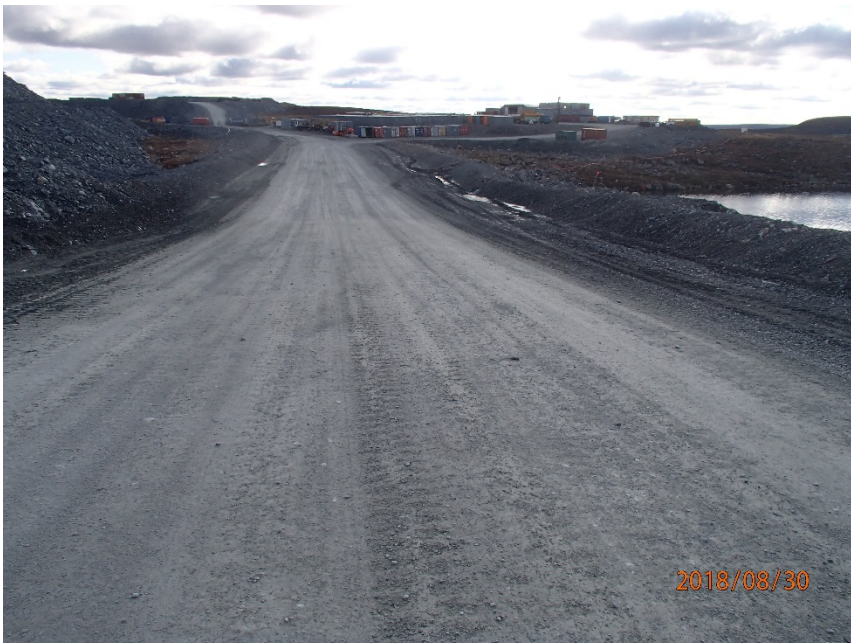
**Photograph A2-4 South Camp Dike**

**Description:** From the north abutment, looking south at the crest.

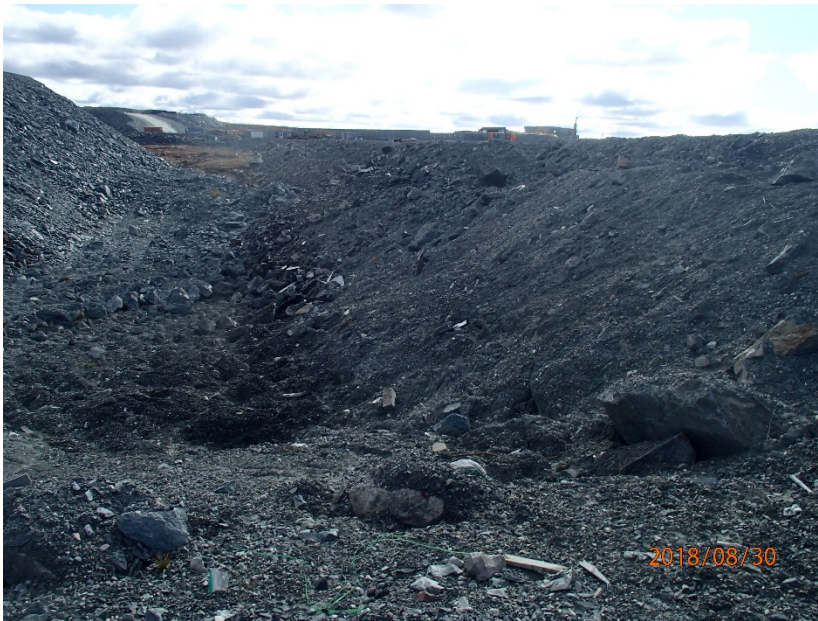
**Photograph A2-5 South Camp Dike**

**Description:** From the north abutment, looking south at the downstream slope.

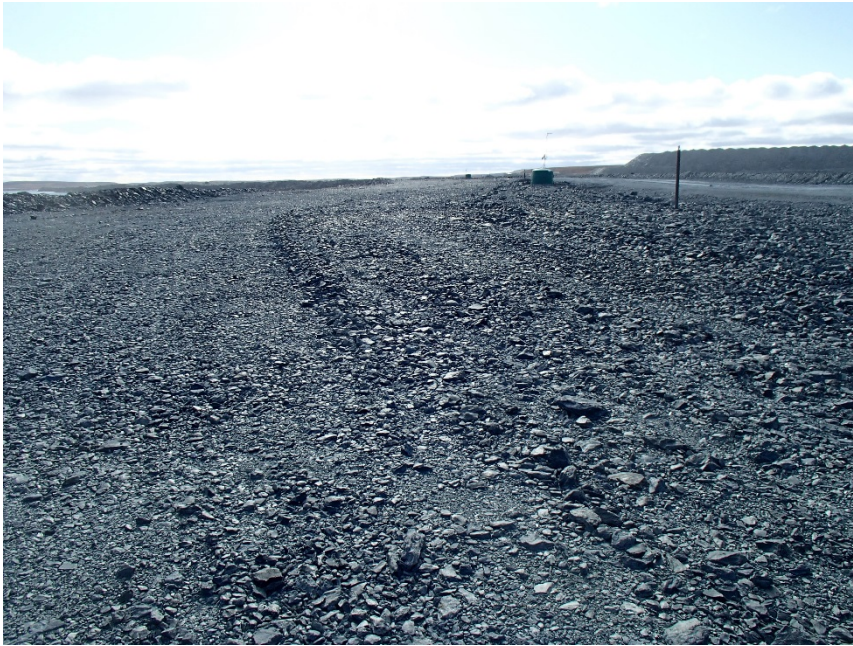
**Photograph A3-1 Bay Goose Dike**

**Description:** From approximately Sta. 30+142 (north abutment) looking southwest at the crest.

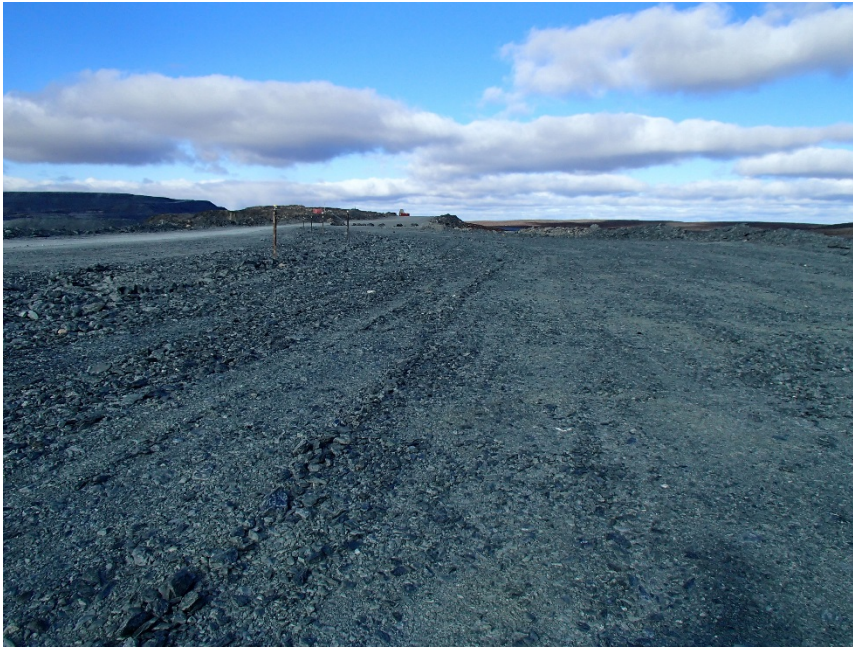
**Photograph A3-3 Bay Goose Dike**

**Description:** From approximately Sta. 30+075 (north abutment), looking north at the downstream toe.

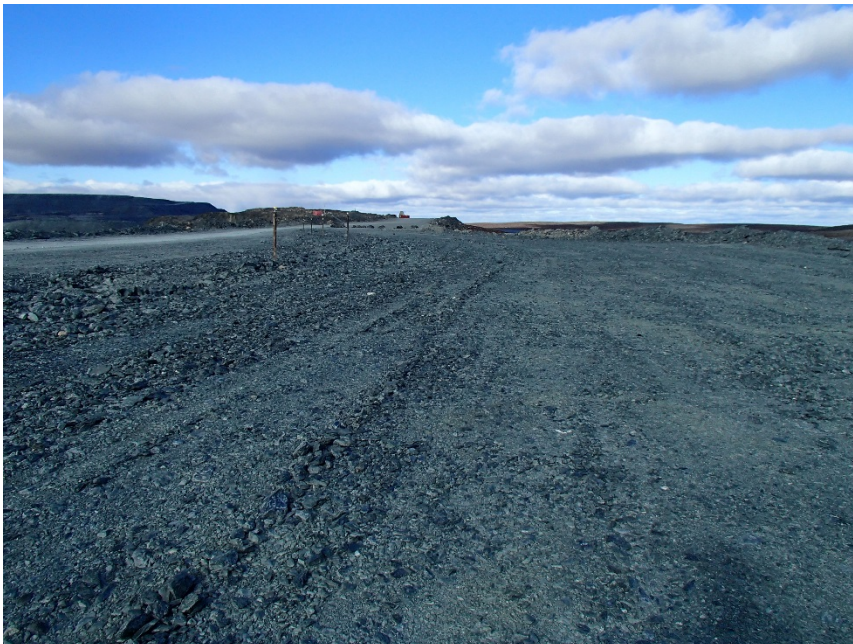
**Photograph A3-4 Bay Goose Dike**

**Description:** From approximately Sta. 30+075 (north abutment), looking south at the downstream toe.

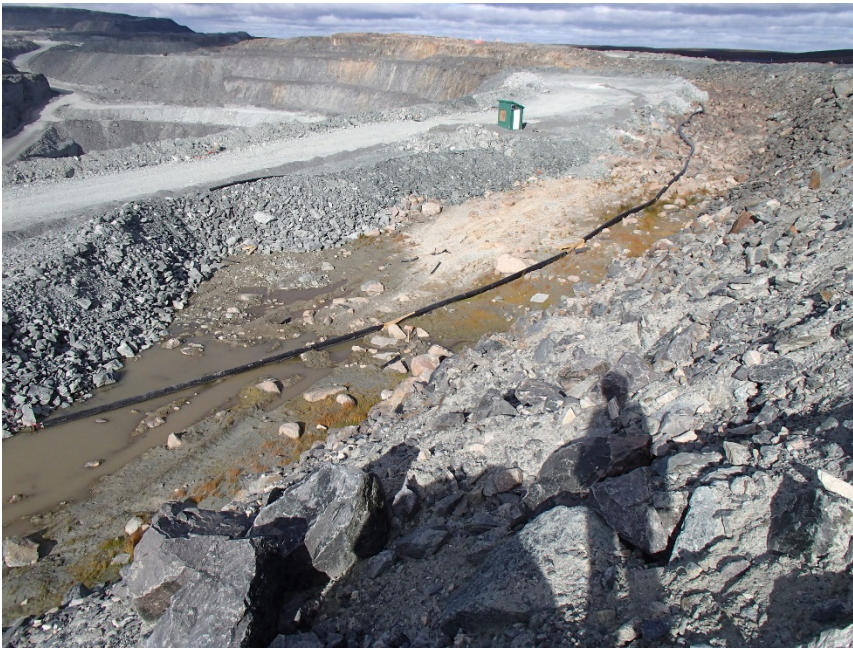
**Photograph A3-6 Bay Goose Dike**

**Description:** From approximately Sta. 30+340, looking northwest at the north seepage channel.

| INSPECTION ITEM | OBSERVATIONS DATA | PHOTO | COMMENTS & OTHER DATA |
|---|---|---|--|
| | North Channel | 225, 219 | Monitored by stations 8 (30+420) and 9 (30+380). Water flowing was observed during the inspection. |

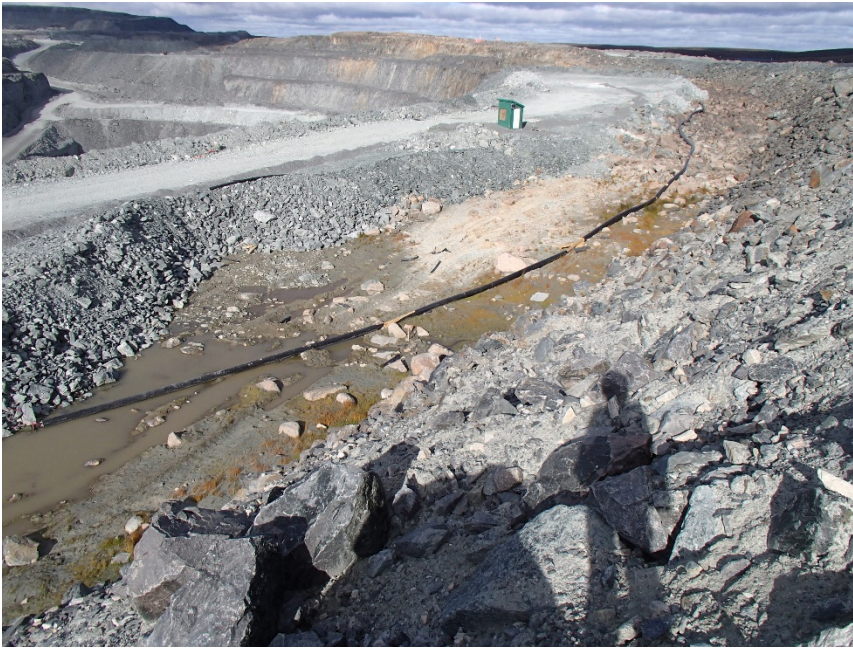
**Photograph A3-7 Bay Goose Dike**

**Description:** From approximately Sta. 30+350 downstream, looking south at the north seepage channel.

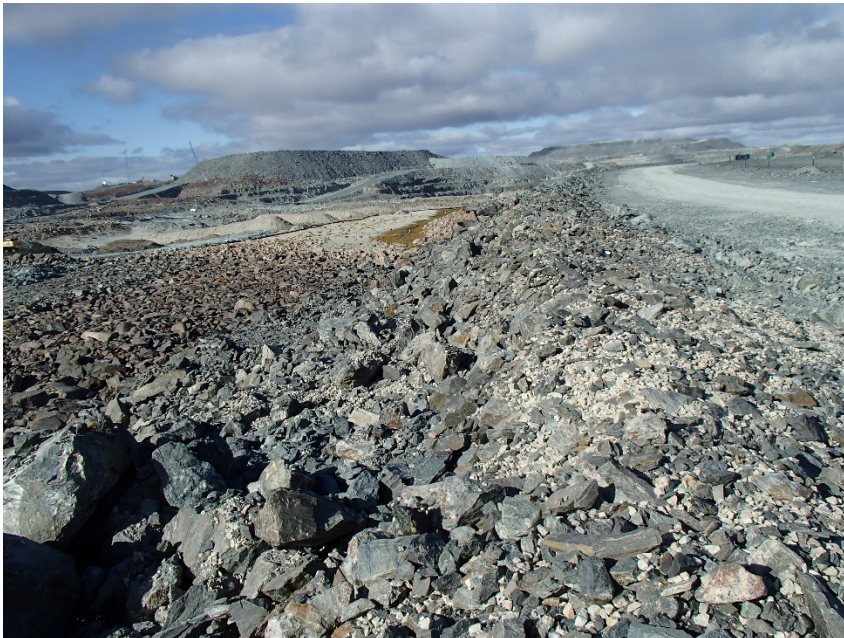
**Photograph A3-15 Bay Goose Dike**

**Description:** From approximately Sta. 30+680 on the crest, looking north at the downstream slope and toe.

| INSPECTION ITEM | OBSERVATIONS DATA | PHOTO | COMMENTS & OTHER DATA |
|---|---|---|--|
| | Central Shallow | 230 | Presence of 2 seepage channels at 30+650 and 30+625. Flow was observed during inspection at 30+650. Monitored by station 7. |

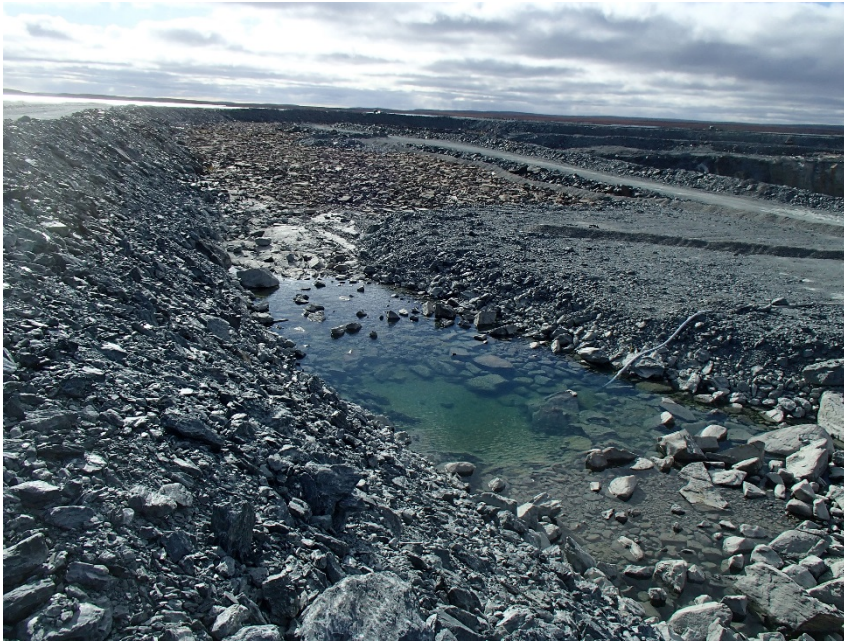
**Photograph A3-20 Bay Goose Dike**

**Description:** From approximately Sta. 31+080 on the crest, looking southwest at the pond of water at Central Channel seepage at Sta. 31+165.

| INSPECTION ITEM | OBSERVATIONS DATA | PHOTO | COMMENTS & OTHER DATA |
|---|---|---|--|
| | Central Channel | 265 | Presence of a seepage channel at Sta. 31+165. Water ponding was observed at the time of the inspection. It was pumped once after freshet only. |

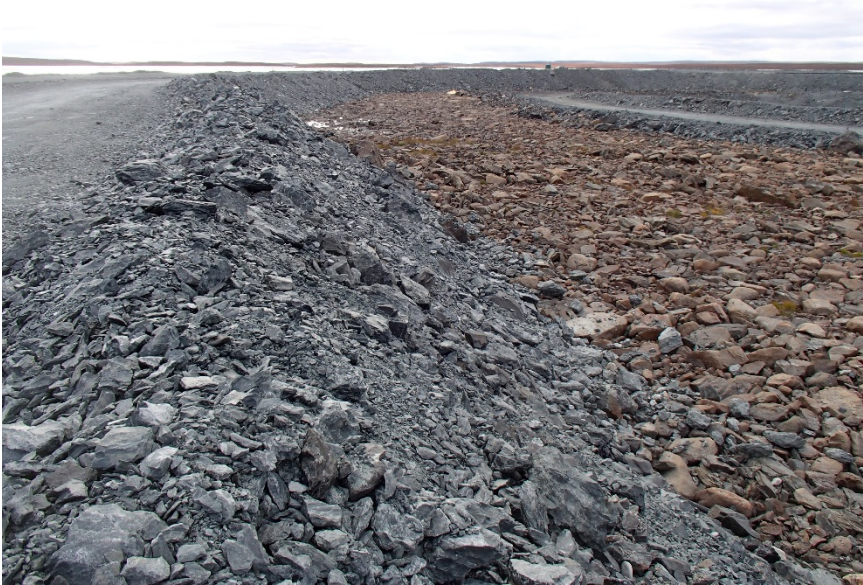
**Photograph A3-24 Bay Goose Dike**

**Description:** From approximately Sta. 31+280 on the crest, looking southwest at the downstream slope and the water pond at the downstream toe at Sta. 31+350.

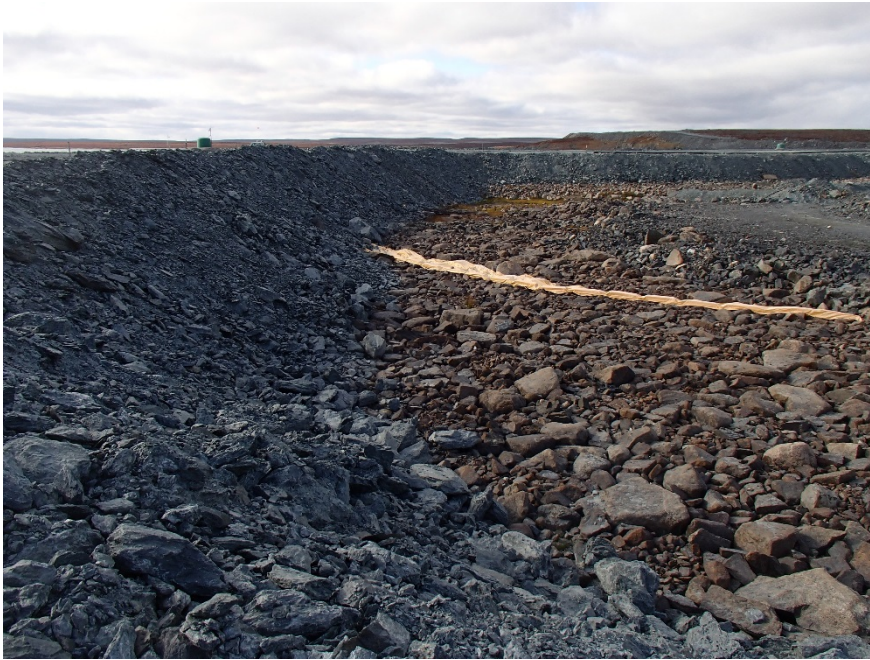
**Photograph A3-28 Bay Goose Dike**

**Description:** From approximately Sta. 31+490, looking west toward Channel 3.

| INSPECTION ITEM | OBSERVATIONS DATA | PHOTO | COMMENTS & OTHER DATA |
|--|---|---|---|
| | Channel 3 | 246, 251, 255 | Light flow observed during inspection. Monitored by station 6. |

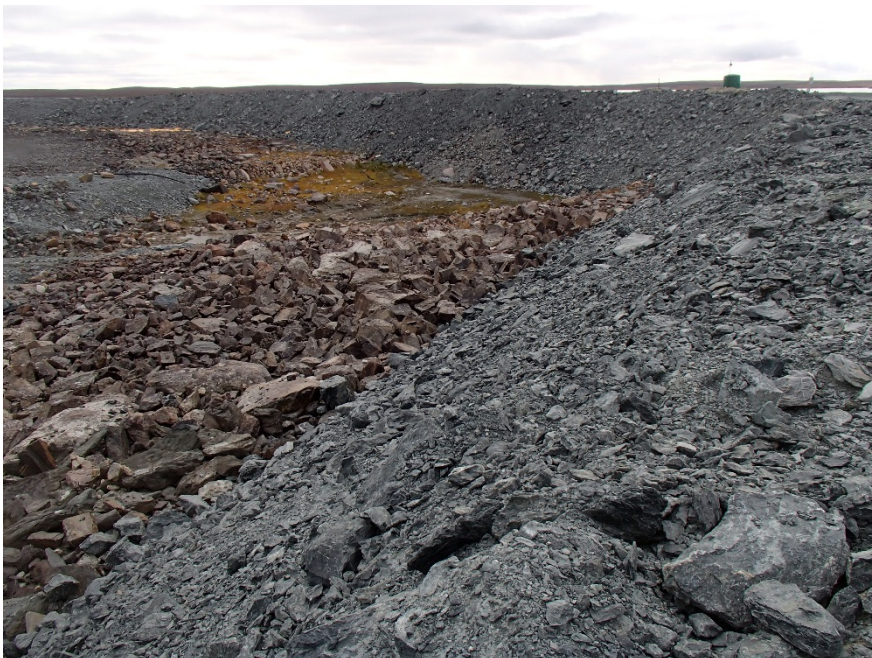
**Photograph A3-35 Bay Goose Dike**

**Description:** From the crest at approximately Sta. 31+740. Looking southeast downstream toward Channel 3.

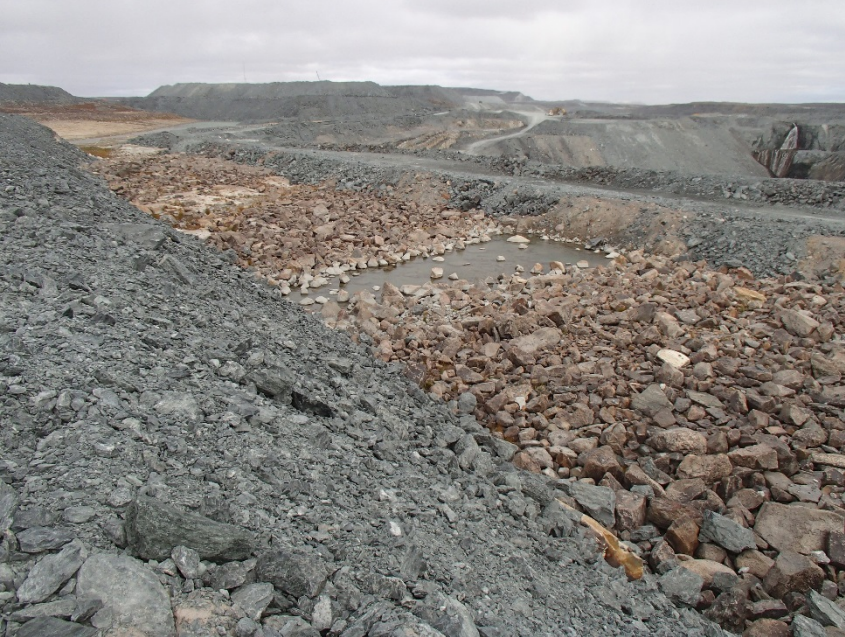
**Photograph A3-36 Bay Goose Dike**

**Description:** From the crest at approximately Sta. 31+740, looking north downstream at the water pond at Sta. 31+750.

| INSPECTION ITEM | OBSERVATIONS DATA | PHOTO | COMMENTS & OTHER DATA |
|--|---|---|---|
| | Water Ponds | 247 | Presence of water pond with no sign of seepage. Located at 31+750. Water was observed downstream of Channel 1 ponding against the ring road of Goose Pit. |

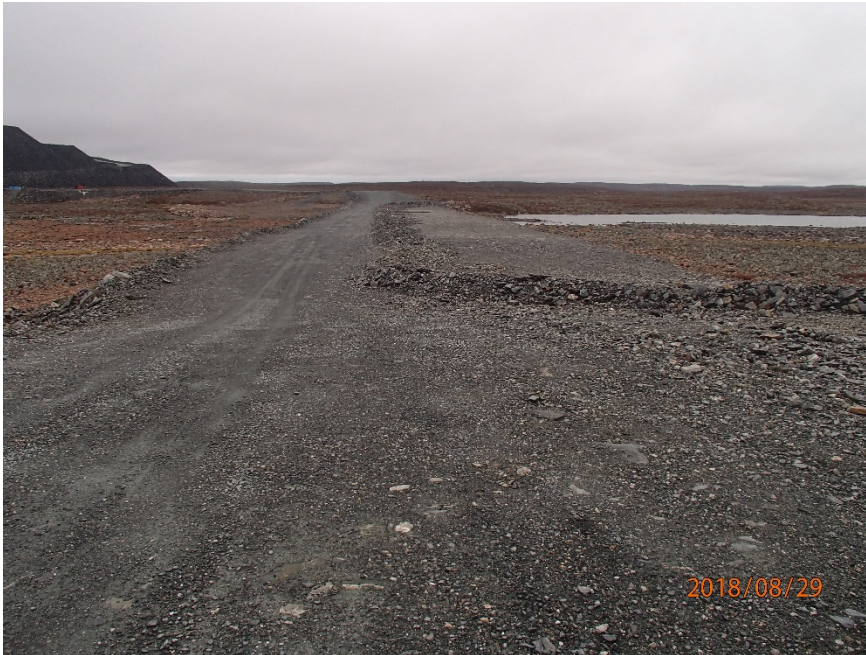
**Photograph A4-1 Vault Dike**

**Description:** From the east abutment, looking northwest at the crest.

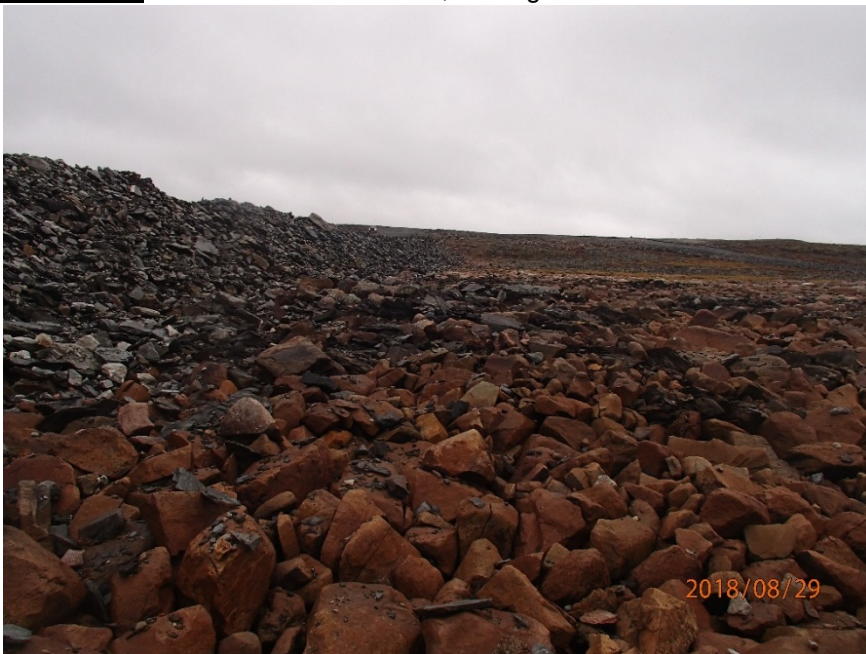
**Photograph A4-2 Vault Dike**

**Description:** From downstream, looking southeast at the downstream toe.

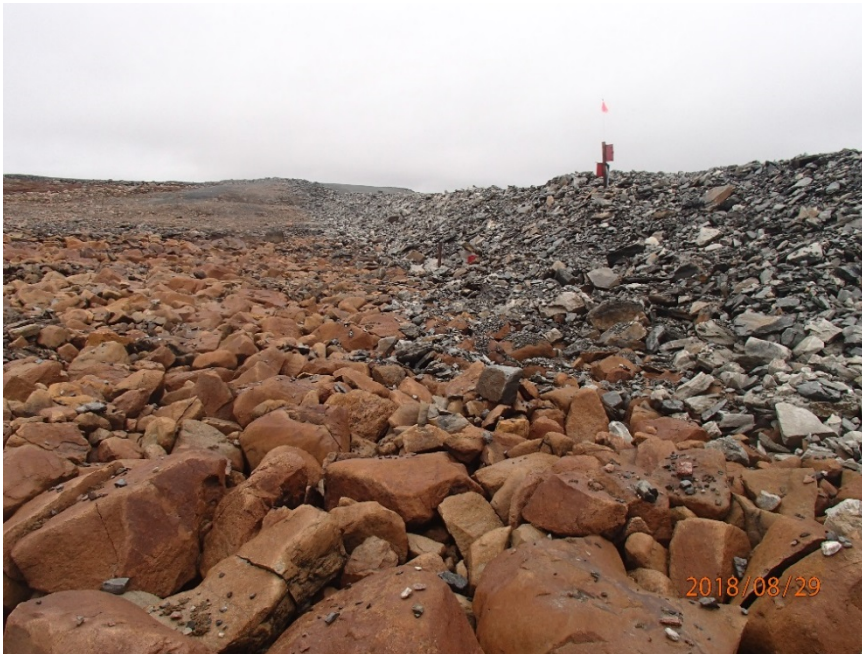
**Photograph A4-3 Vault Dike**

**Description:** From downstream, looking northwest at the downstream toe.

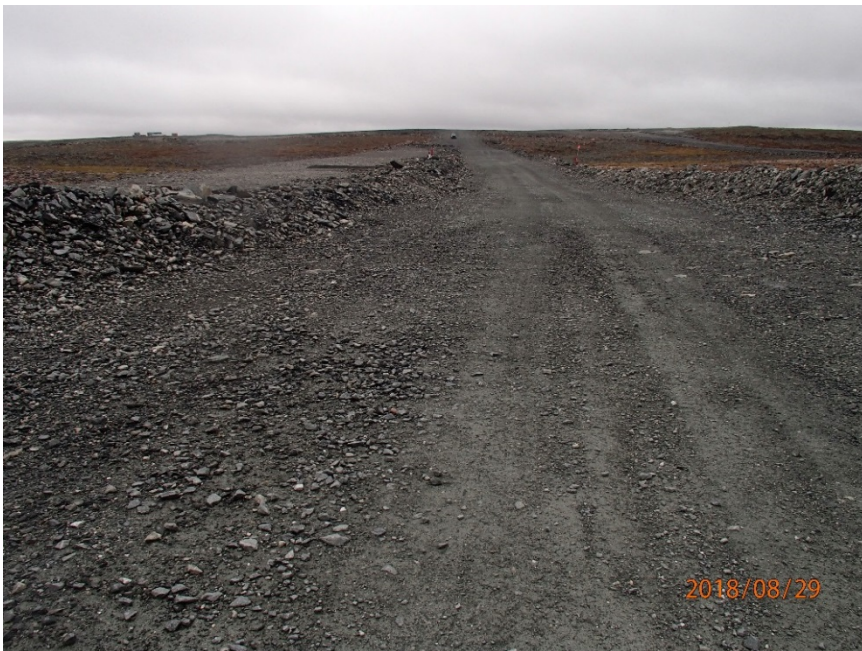
**Photograph A4-4 Vault Dike**

**Description:** From the west abutment, looking southeast at the crest.

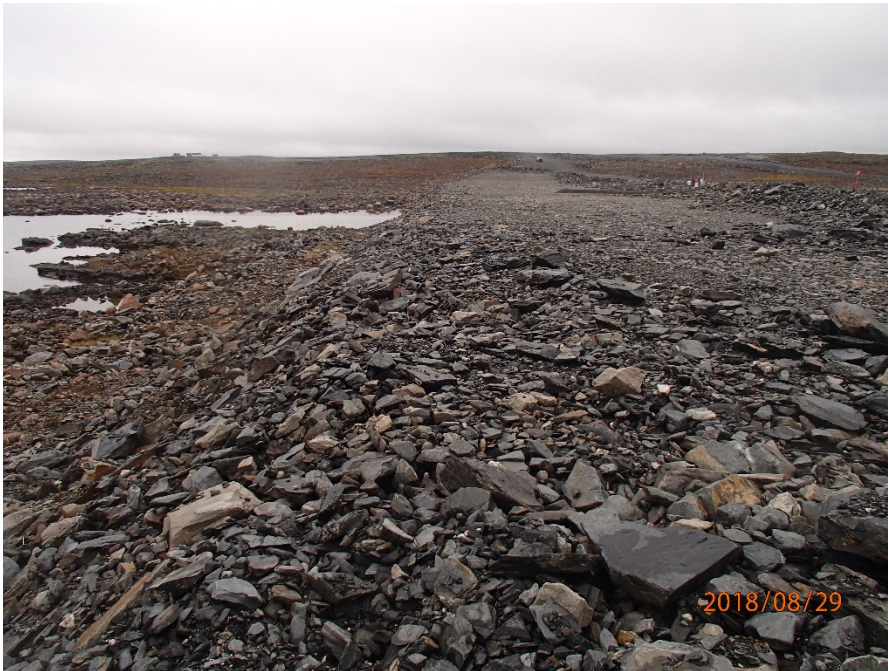
**Photograph A4-5 Vault Dike**

**Description:** From the upstream side, looking southeast at the upstream slope.

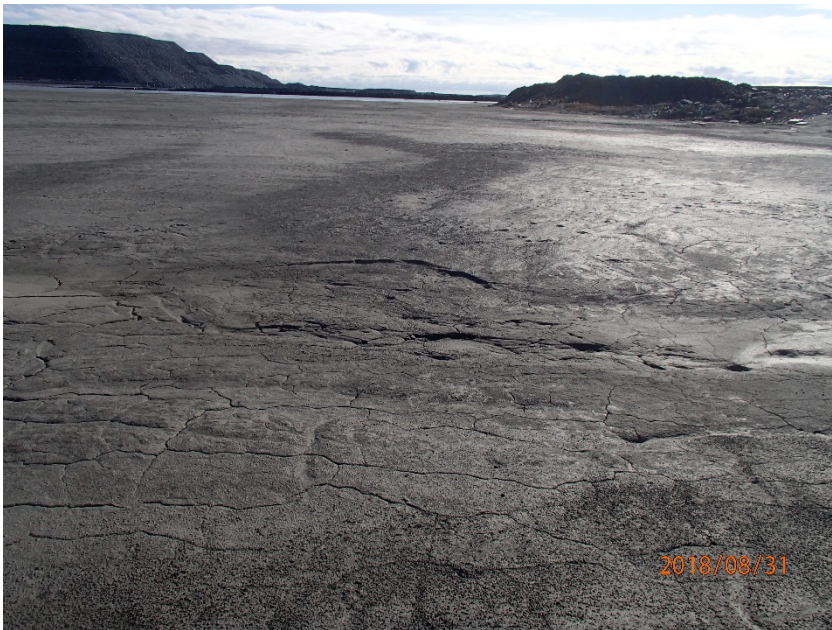
**Photograph B1-1 Tailings Storage Facility**

**Description:** From Saddle Dam 1 (approximately Sta. 0+410) looking northeast at the North Cell tailings pond. Adequate tailings beach against SD1.

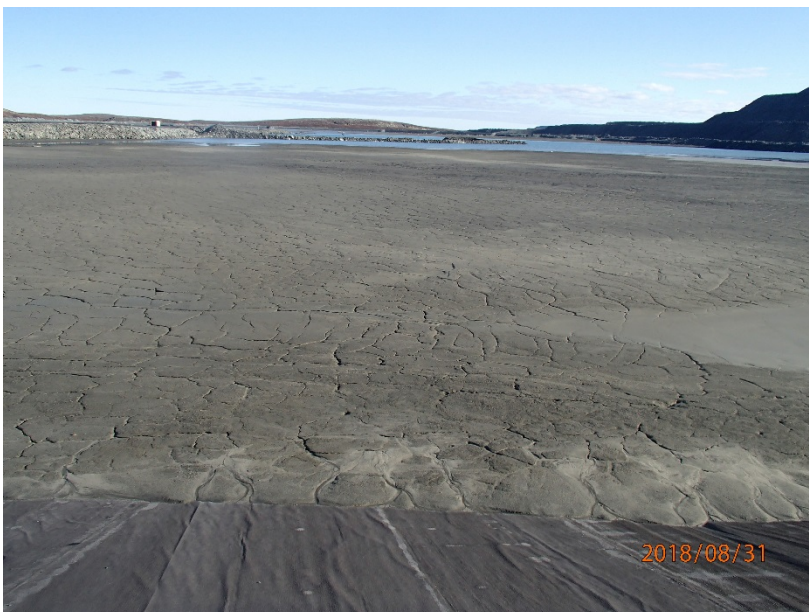
**Photograph B1-4 Tailings Storage Facility**

**Description:** From Stormwater Dike, looking north at the North Cell tailings pond. Adequate tailings beach against Stormwater Dike.

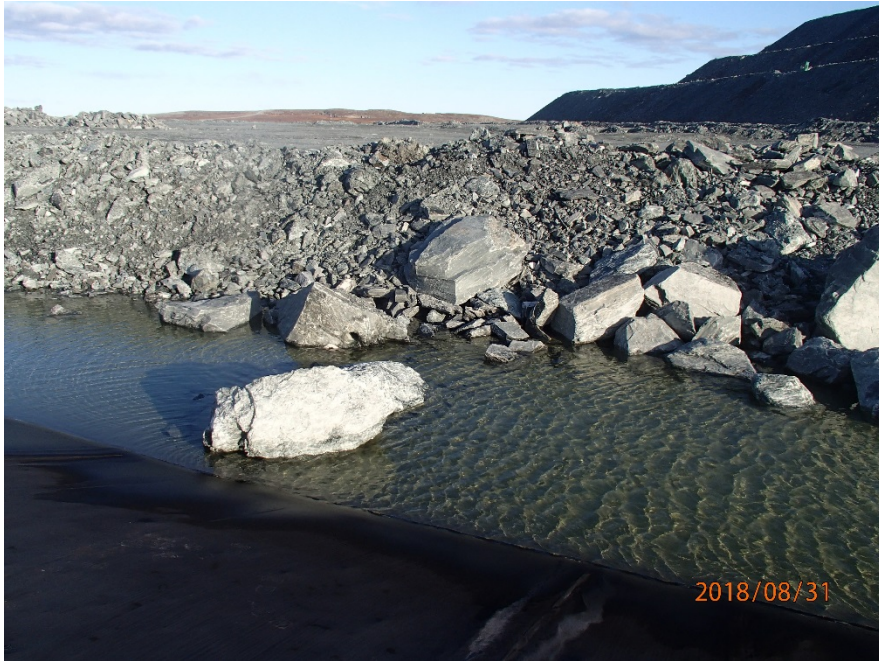
**Photograph B1-16 Tailings Storage Facility**

**Description:** From Stormwater Dike, looking Northwest at the upstream slope and the 2018 capping. Large rocks are present near the liner.

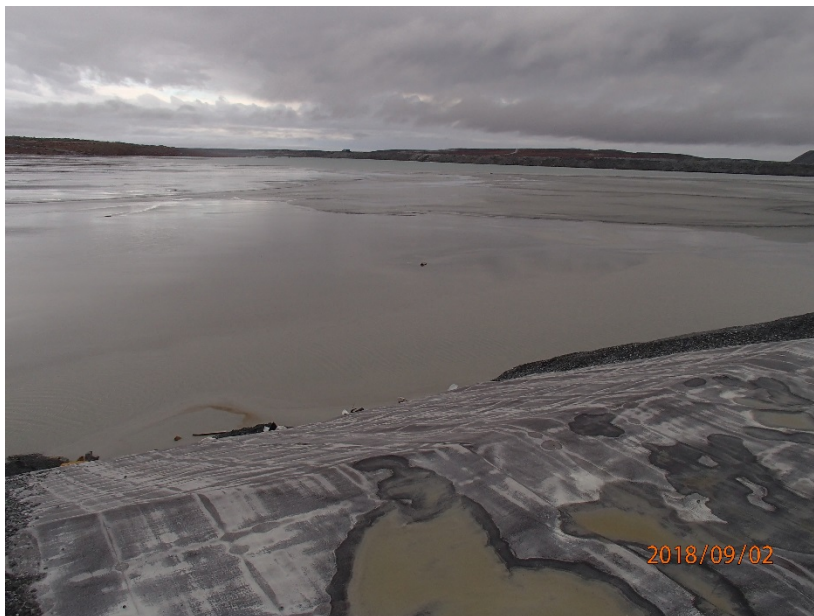
**Photograph B1-21 Tailings Storage Facility**

**Description:** From Central Dike looking west at the South Cell. A shallow pond is present in the tailings against the dike.

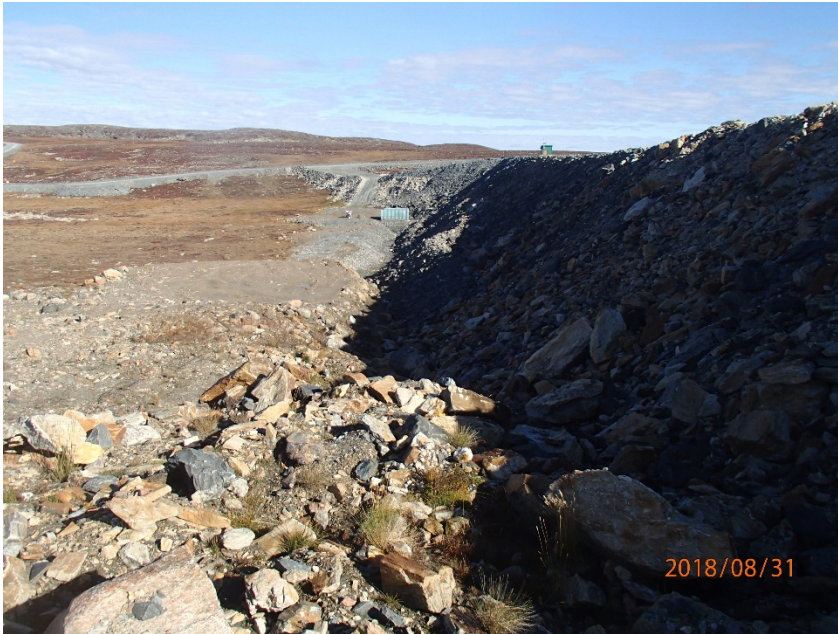
**Photograph B2-1 Saddle Dam 1**

**Description:** From the south abutment (Sta. 0+350) looking north at the downstream face. Notice the sea-can container where a sump is installed.

| INSPECTION ITEM | OBSERVATIONS DATA | PHOTO | COMMENTS & OTHER DATA |
|--|---|---|---|
| 4.1 Seepage from dam | Uncertain | | A dewatering sump is installed downstream. Water was observed ponding in that area. |
