# **Meadowbank and Whale Tail 2018 Annual Geotechnical Inspection**

# 2018 Annual Geotechnical Inspection

*Meadowbank Gold Mine, Nunavut*

18101627-1583-R-Rev0

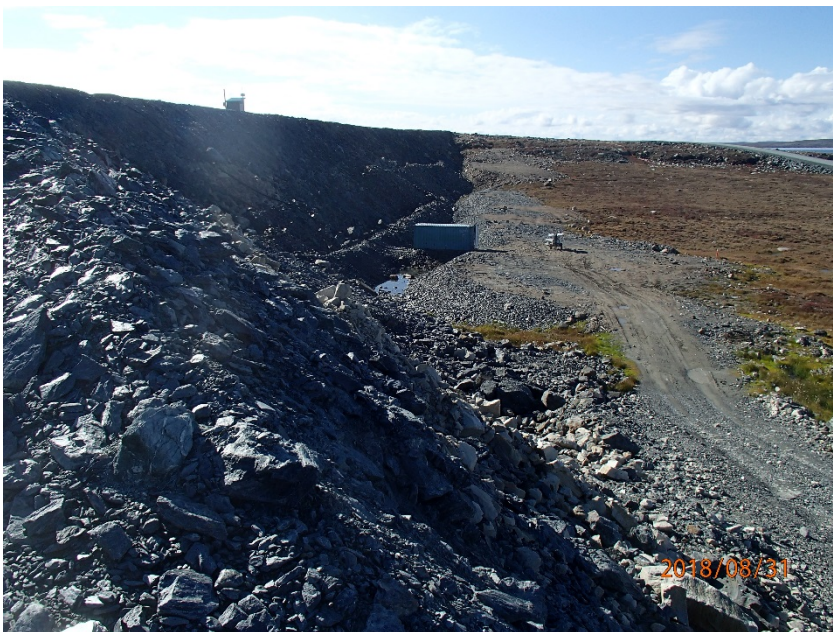
**Photograph B2-2 Saddle Dam 1**

**Description:** From Sta. 0+150 looking south at the downstream face. Notice the sea-can container where a sump is installed.

| INSPECTION ITEM | OBSERVATIONS DATA | PHOTO | COMMENTS & OTHER DATA |
|--|---|---|---|
| 4.1 Seepage from dam | Uncertain | | A dewatering sump is installed downstream. Water was observed ponding in that area. |

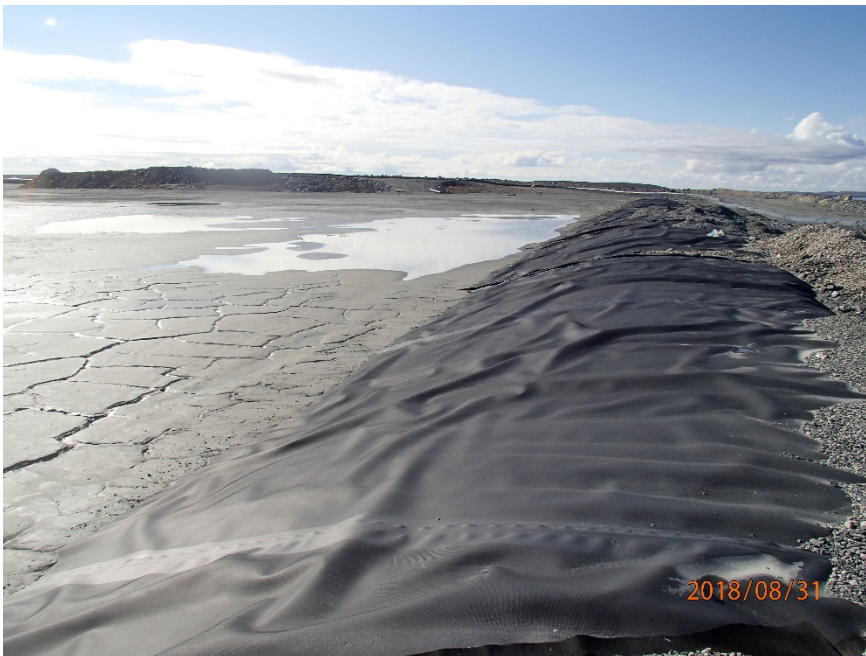
**Photograph B2-6 Saddle Dam 1**

**Description:** From approximately Sta. 0+195 upstream, looking south at the upstream slope. Adequate tailings beach against SD1. A small pond of water is present at the surface of the tailings and is not a concern.

| INSPECTION ITEM | OBSERVATIONS DATA | PHOTO | COMMENTS & OTHER DATA |
|--|---|---|--|
| 6.5 Other unusual conditions | No | | A small pond of water was observed in the tailings and is not a concern. |

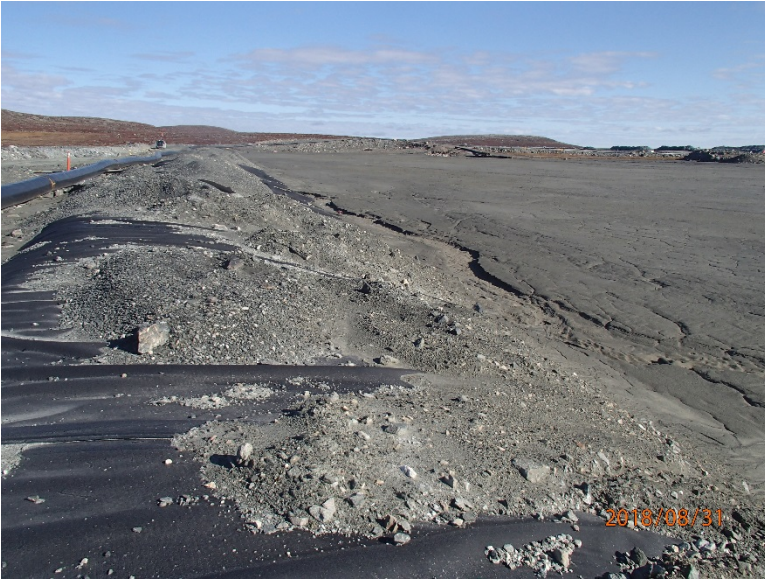
**Photograph B2-7 Saddle Dam 1**

**Description:** From approximately Sta. 0+195 upstream, looking north at the upstream slope. Adequate tailings beach against SD1.

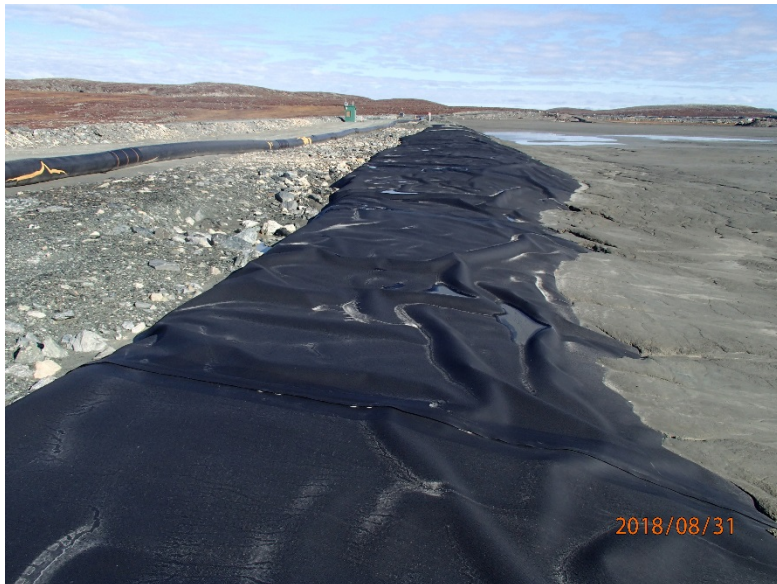
**Photograph B2-8 Saddle Dam 1**

**Description:** From the south abutment looking north at the upstream slope. Adequate tailings beach against SD1.

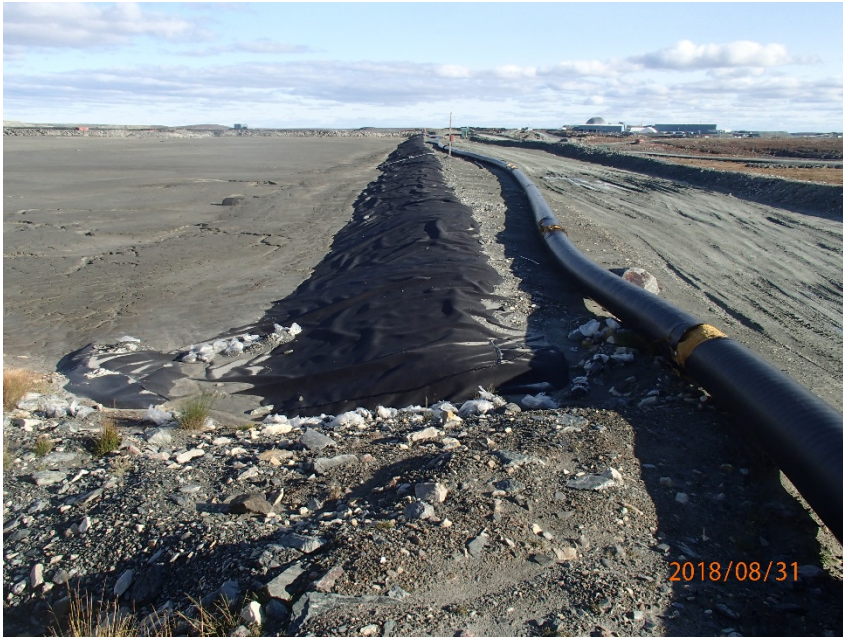
**Photograph B3-1 Saddle Dam 2**

**Description:** From Saddle Dam 2 (approximately Sta. 20+110) looking southeast at the crest and upstream slope of Saddle Dam 2. The tailings beach against SD2 is adequate.

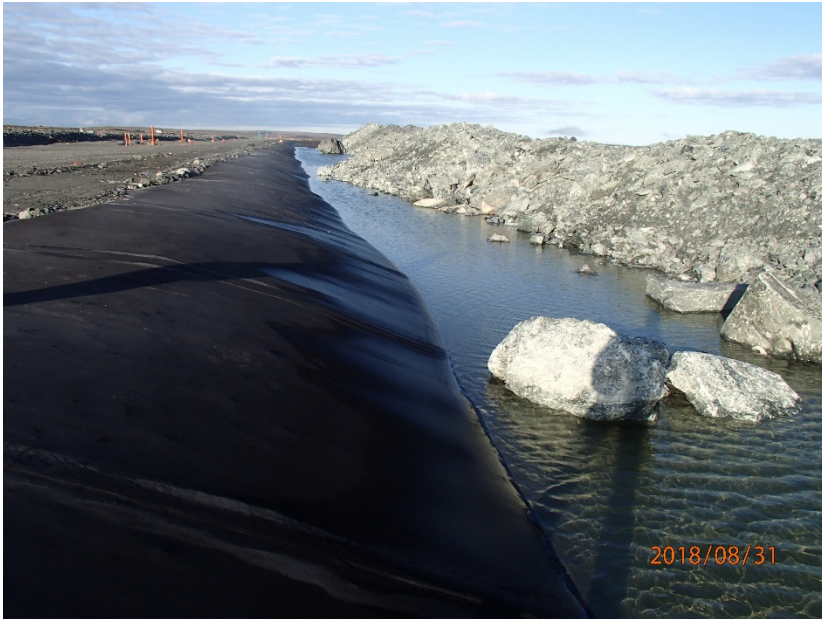
**Photograph B4-1 Stormwater Dike**

**Description:** From the east abutment (11+100 approximately), looking west at the upstream face and the rockfill cover of the North Cell. Shallow water ponding against portion of the dike (less than 30 cm deep). Large rocks are present near the liner.

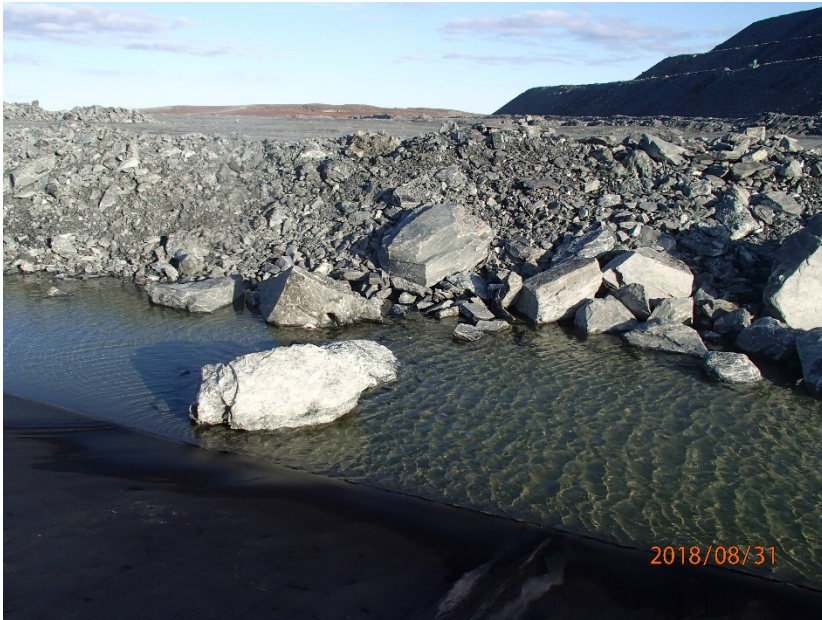
**Photograph B4-2 Stormwater Dike**

**Description:** From the east abutment (11+100 approximately), looking northwest at the North Cell and the rockfill cover. Large rocks are present near the liner.

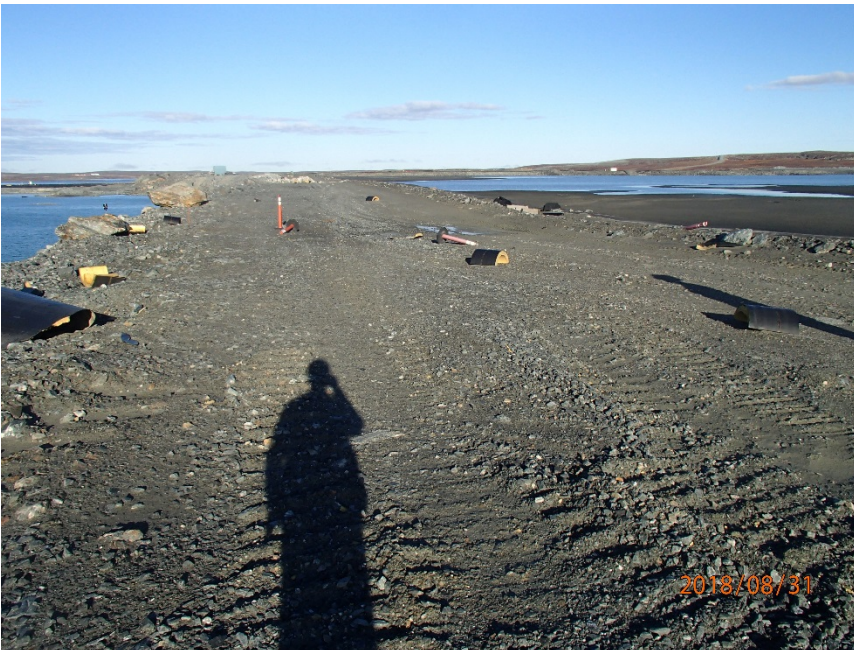
**Photograph B4-4 Stormwater Dike**

**Description:** From Sta. 10+650 looking west at the crest. Shallow water against portion of Stormwater Dike.

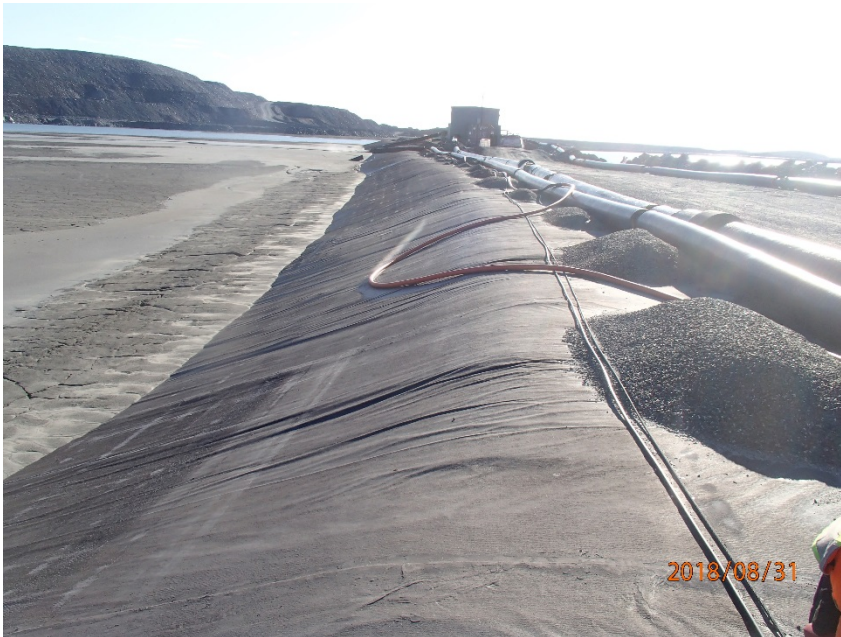
**Photograph B4-11 Stormwater Dike**

**Description:** From Sta.10+175, looking east at the upstream slope. The tailings beach is adequate.

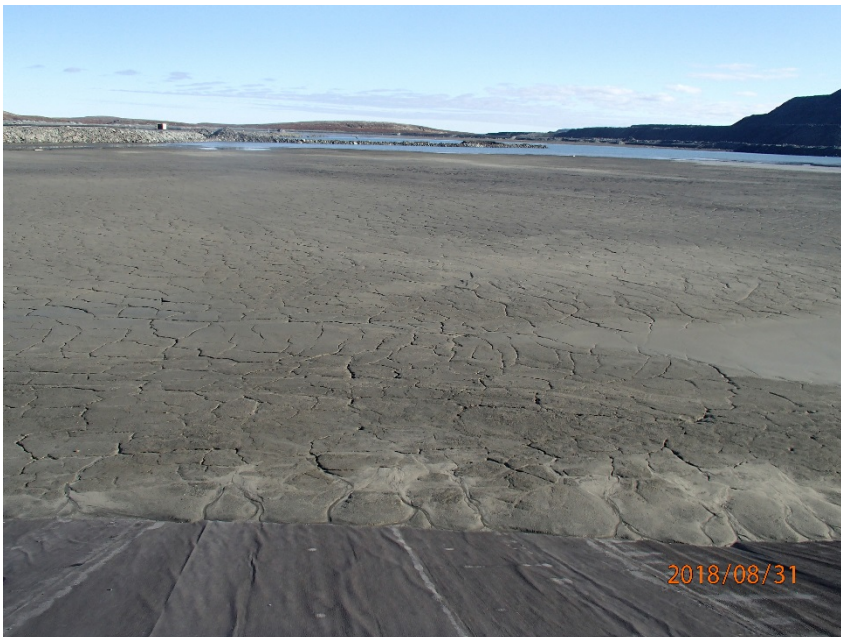
**Photograph B4-12 Stormwater Dike**

**Description:** From Sta.10+175, looking north at the upstream slope and the North Cell. The tailings beach is adequate.

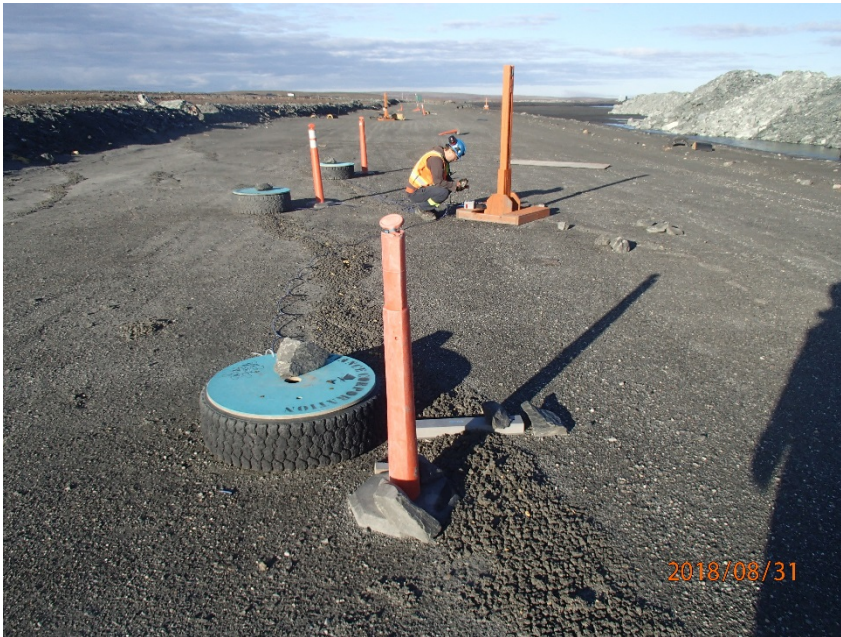
**Photograph B4-17 Stormwater Dike**

**Description:** From Sta.10+975, looking southwest at the crest. View of the crackmeters and wire extensometers installed in the previous settlement zone active in the spring.

| INSPECTION ITEM | OBSERVATIONS DATA | PHOTO | COMMENTS & OTHER DATA |
|--|---|--|---|
| 1.5 Unexpected settlement | No | | Tension cracks and unexpected movement were observed (oblique tension cracks extending side to side). They are concentrated from 10+700 to 11+000 and appeared in May before the freshet. They have since been filled with bentonite. No movement has been observed in the zone where a buttress was constructed at the toe in the South Cell. The buttress is covered by the pond. |

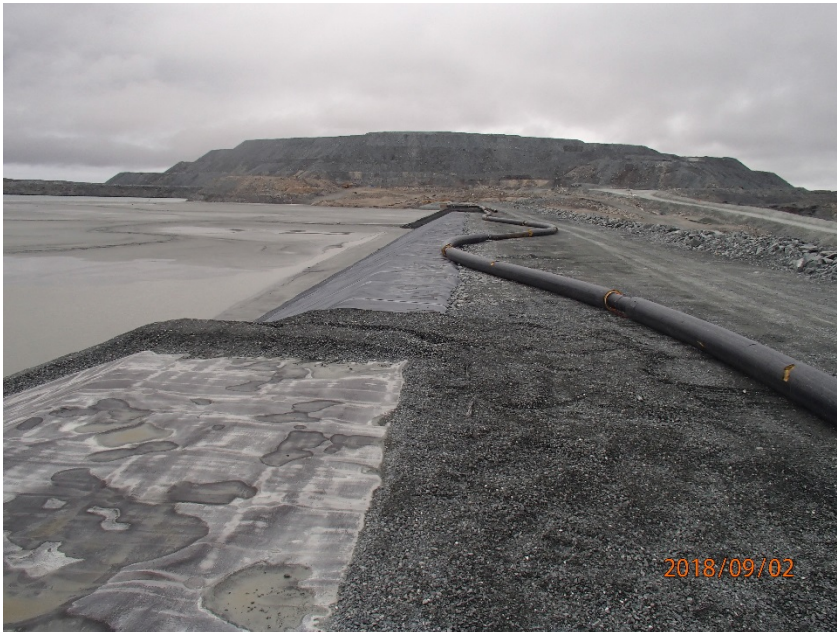
**Photograph B7-2 Central Dike and Saddle Dam 5**

**Description:** From approximately Sta. 0+525 looking northwest at the upstream slope. Adequate tailings beach against the south section of the structure.

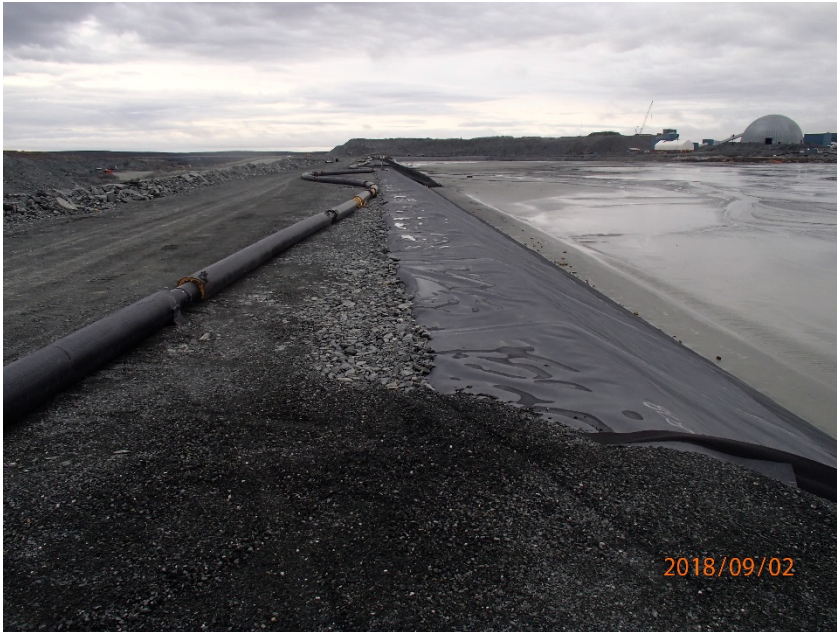
**Photograph B7-3 Central Dike and Saddle Dam 5**

**Description:** From approximately Sta. 0+525 looking southwest at the upstream slope. Adequate tailings beach against the south section of the structure.

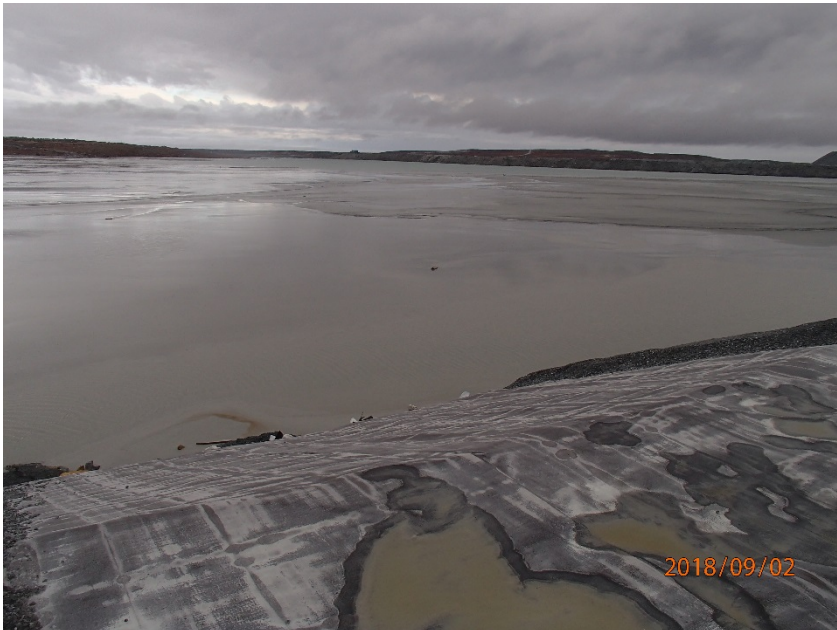
**Photograph B7-4 Central Dike and Saddle Dam 5**

**Description:** From approximately Sta. 0+525 looking at the deposition finger. The LLDPE liner is well protected and the tailing beach against the structure is adequate.

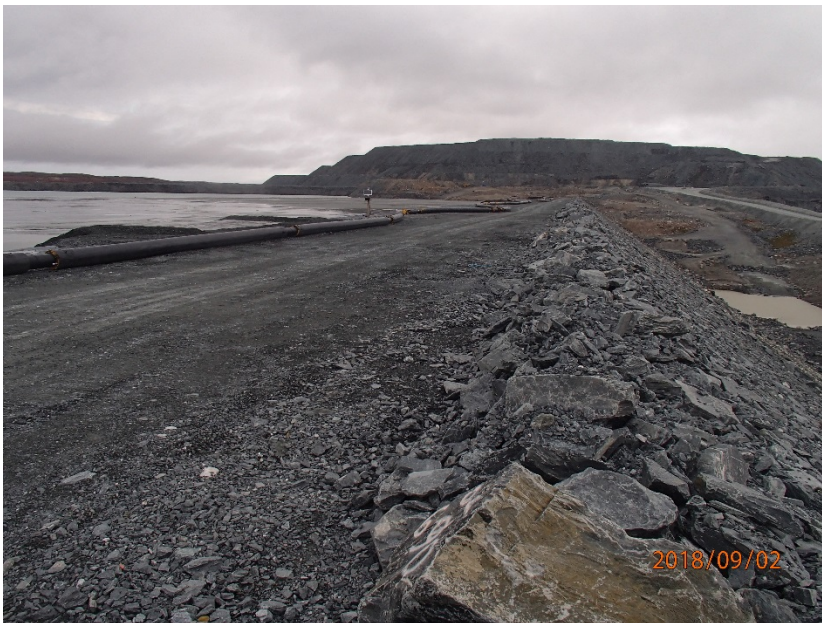
**Photograph B7-8 Central Dike and Saddle Dam 5**

**Description:** From approximately Sta. 0+720 looking south at the crest.

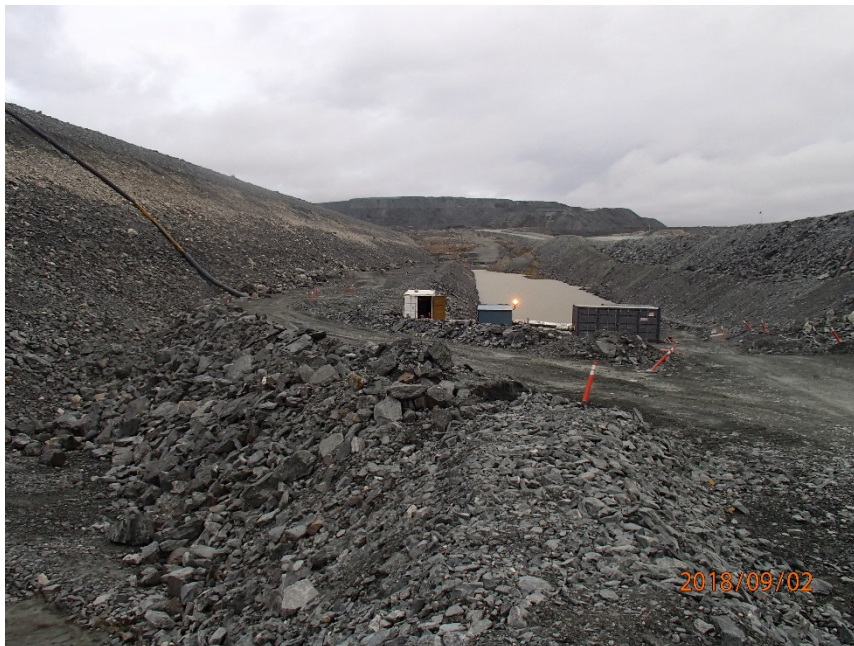
**Photograph B7-12 Central Dike and Saddle Dam 5**

**Description:** From approximately Sta. 1+075 upstream. Presence of gravel on the LLDPE liner.

| INSPECTION ITEM | OBSERVATIONS DATA | PHOTO | COMMENTS & OTHER DATA |
|---|---|--|--|
| 2.5 Face liner condition<br>(if applicable) | | 382 | Liner covered by a granular<br>protection layer up to El. 128 m and<br>well protected underneath deposition<br>fingers.<br>Presence of gravel on the liner on<br>the sides of the deposition points. |

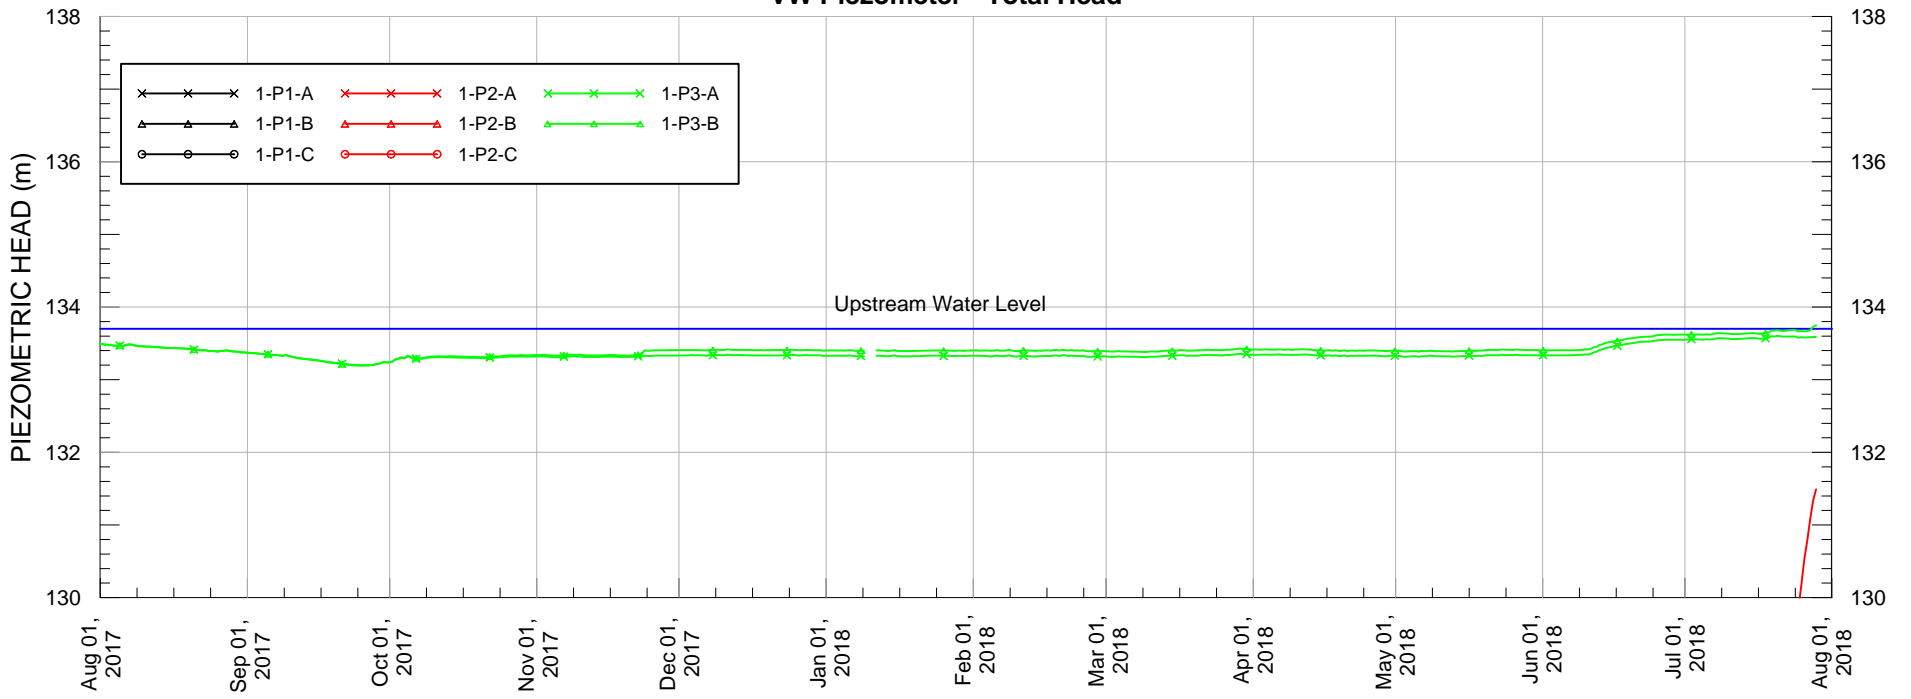
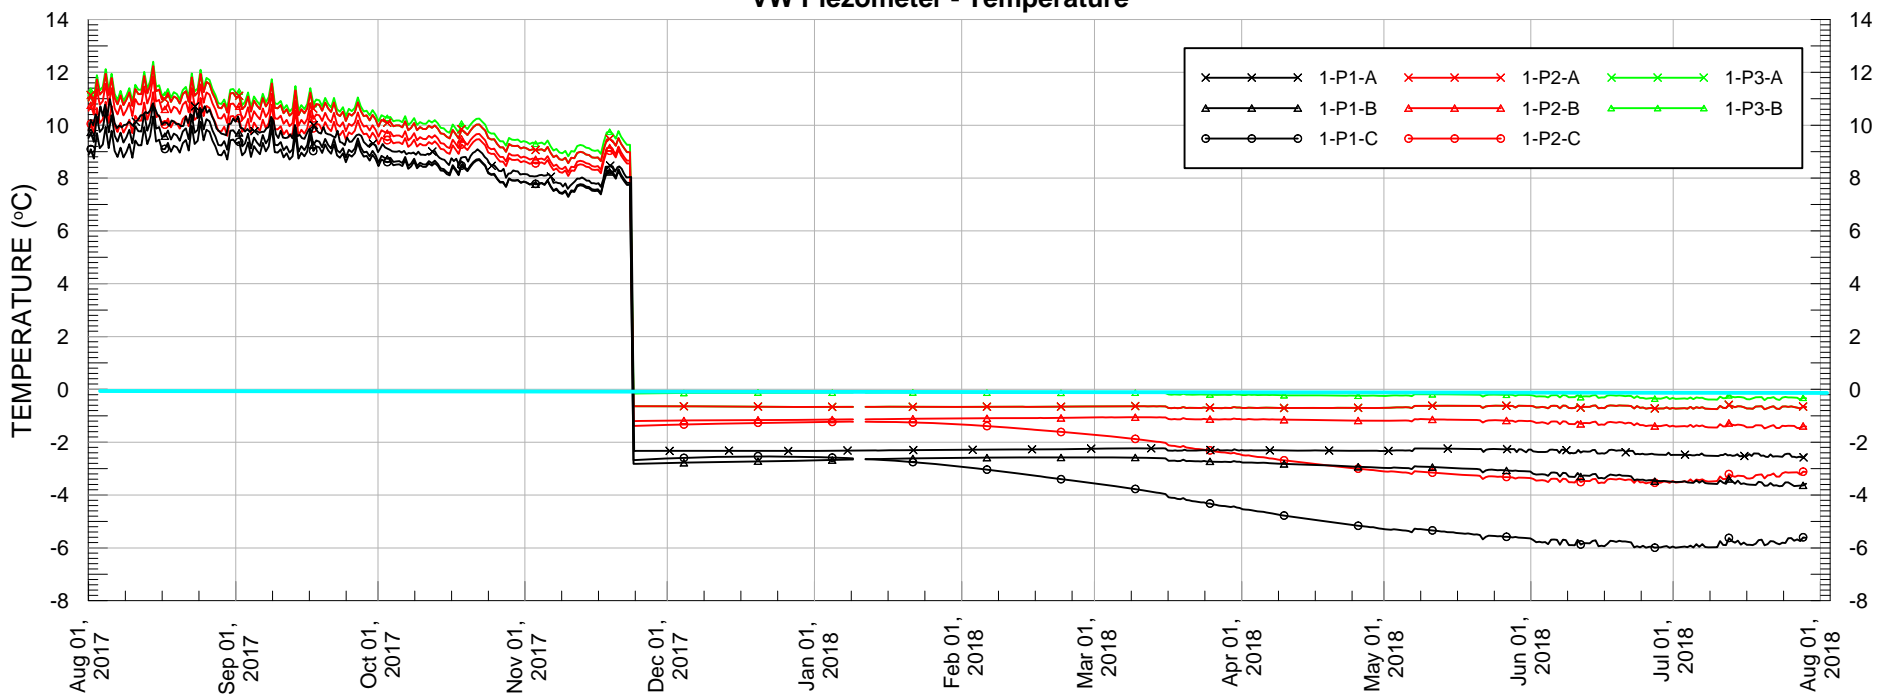
**BAY-GOOSE DIKE  
NORTH SECTION  
30+000 TO 31+000**

1. 1-P1-A, 1-P2-B, 1-P1-C, 1-P2-A and 6P2 are assumed to be frozen and not giving good data. The PWP not reliable.
2. GKM investigated the large jump in the temperature and changed the multiplexer as this turned out to be the issue. Old one is being fixed to have spare. Readings have since stabilized.
3. Gap in data in January is due to low battery. Battery was changed the following day.

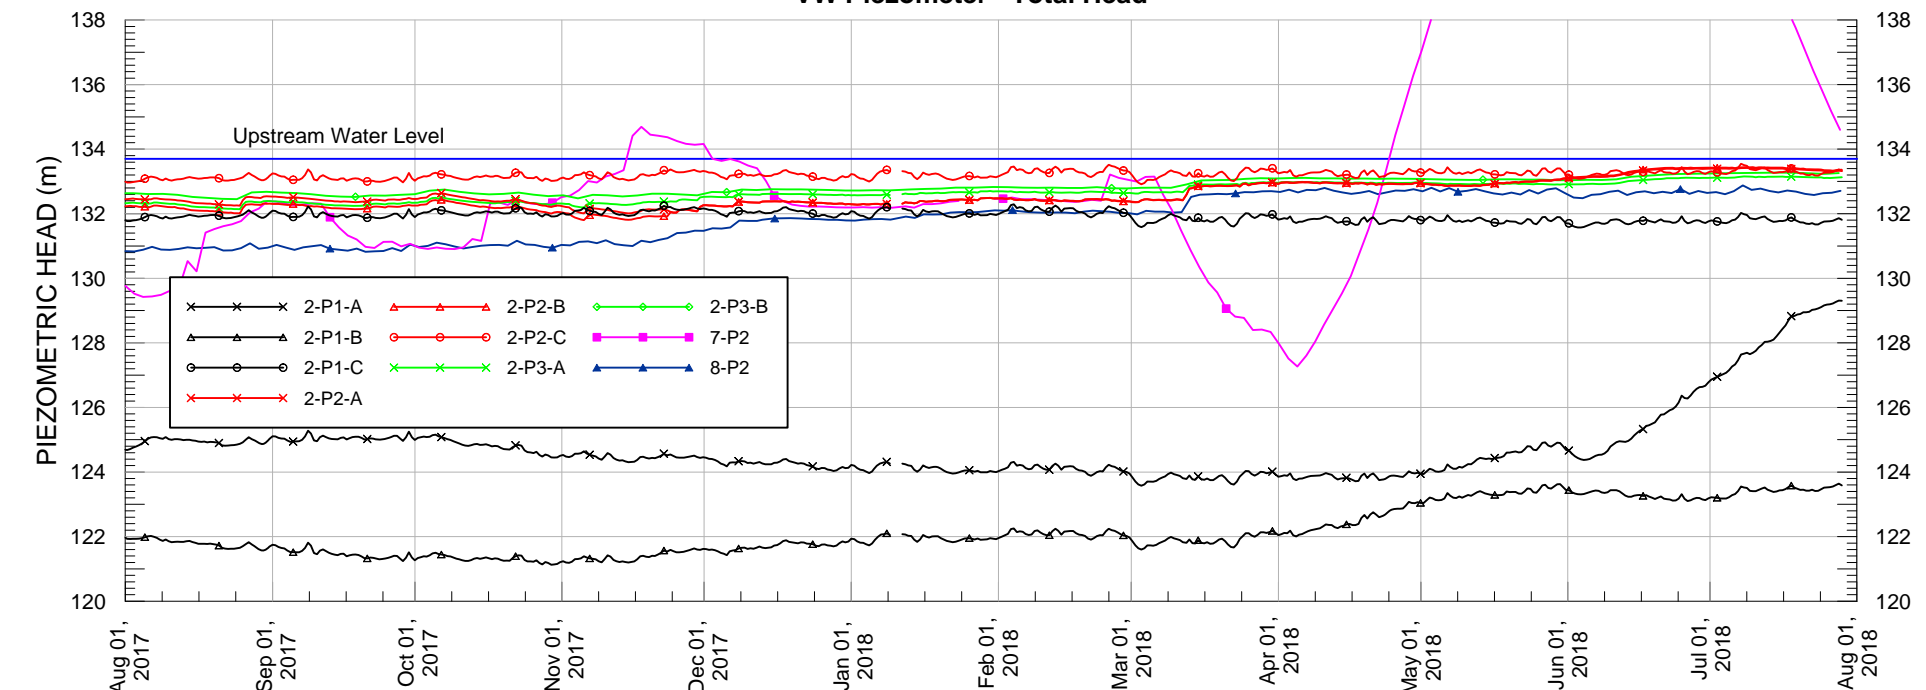
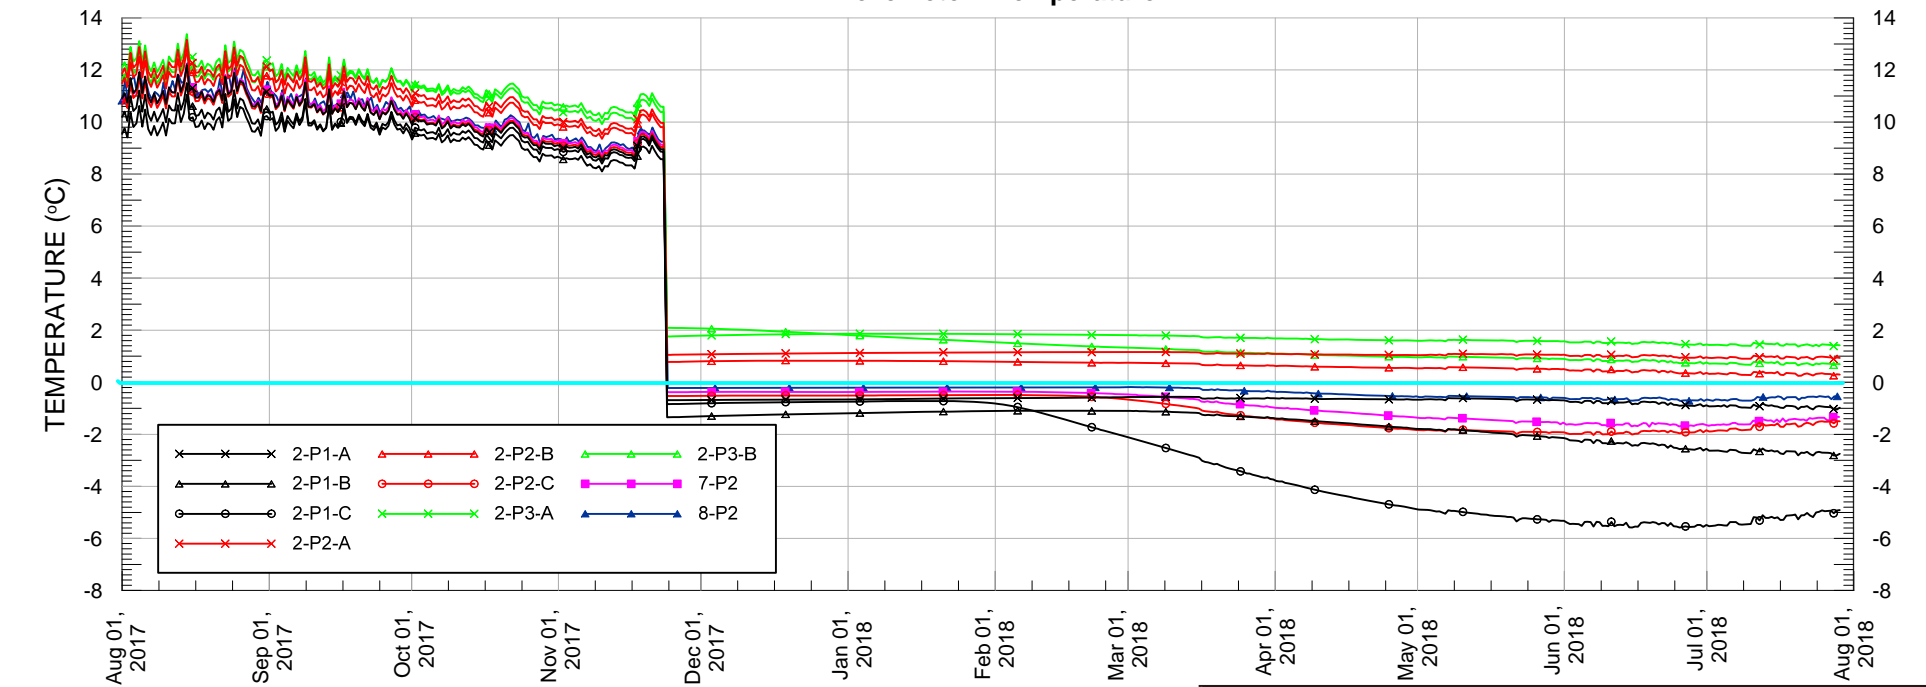
**"North Channel" Bay-Goose Dike - Section 30+276.5 (DL1)**

- 2P1A, 2P1B and 2P2C are assumed to be frozen. 7P2 is also frozen therefore the data is considered not feasible as the previous trend shows.
- GKM investigated the large jump in the temperature and changed the multiplexer as this turned out to be the issue. Readings have since stabilized.

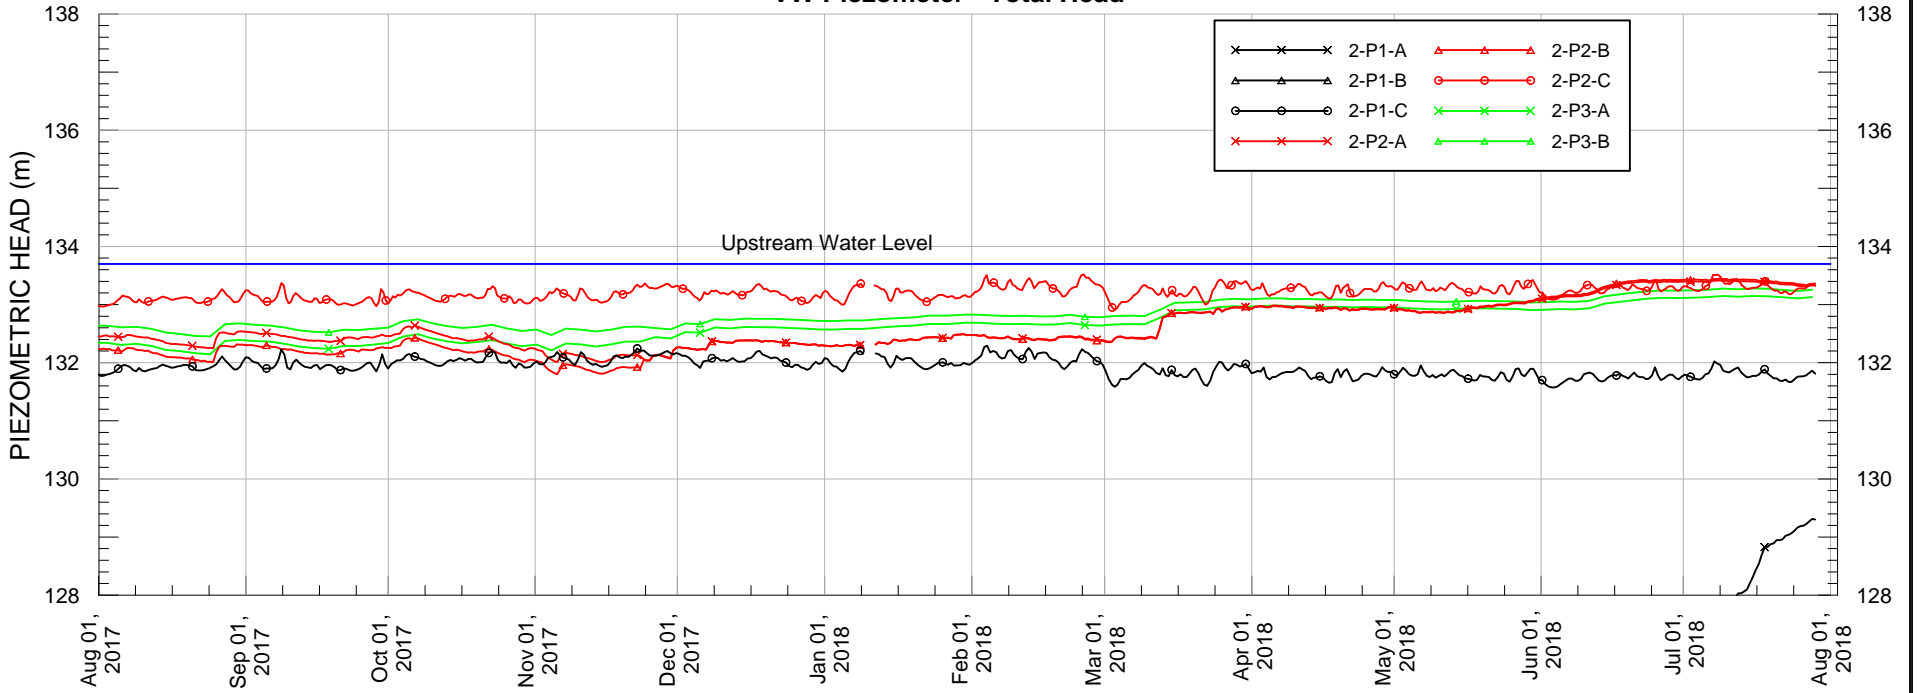
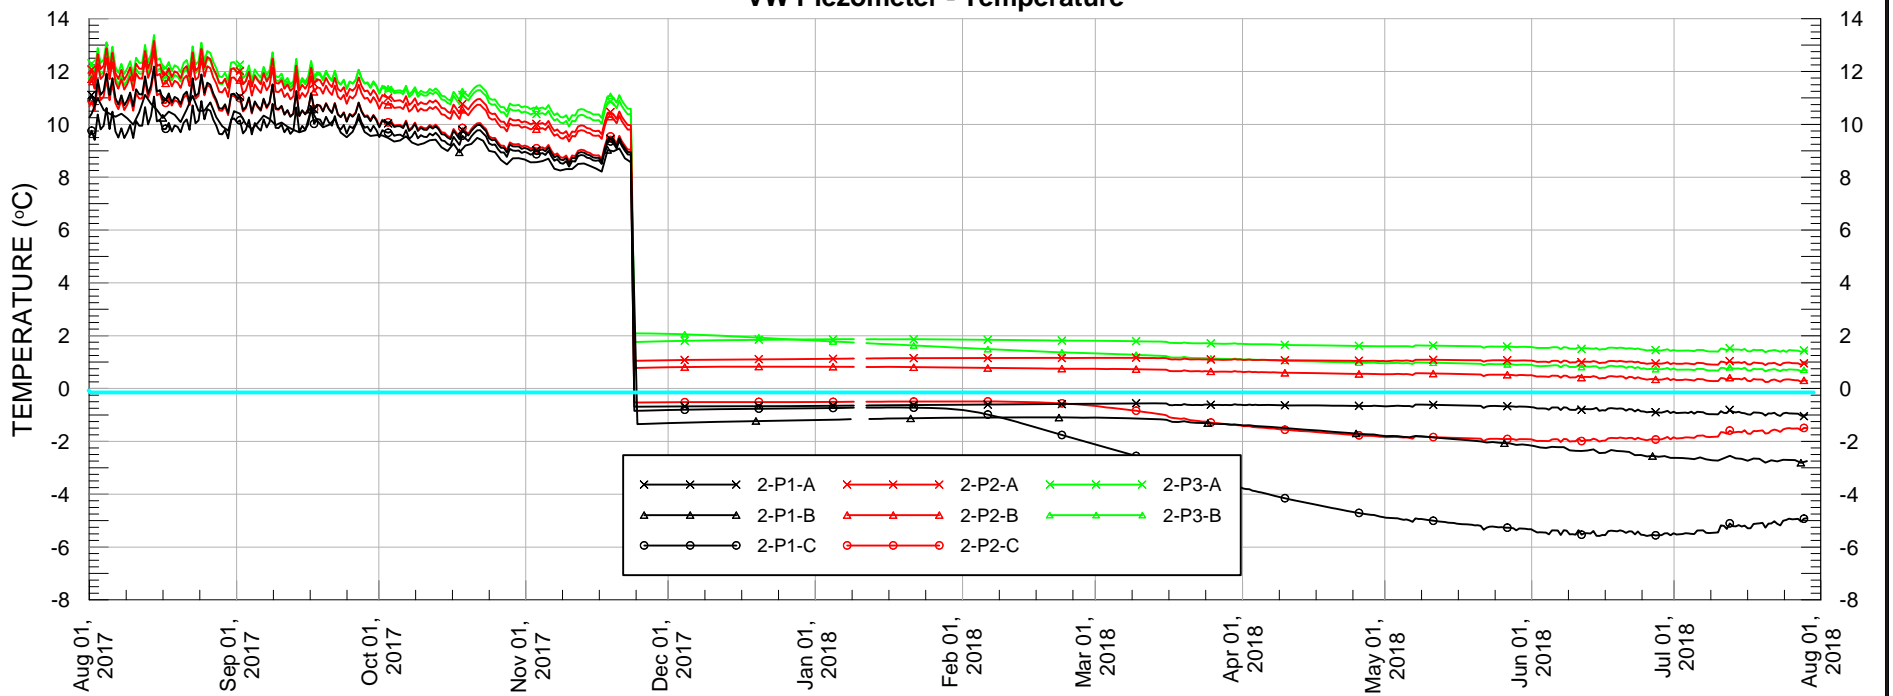
**BAY-GOOSE DIKE  
NORTH SECTION  
30+000 TO 31+000**

1. 2P1A, 2P1B and 2P2C are assumed to be frozen. 7P2 is also frozen therefore the data is considered not feasible as the previous trend shows.
2. GKM investigated the large jump in the temperature and changed the multiplexer as this turned out to be the issue. Readings have since stabilized.
3. Gap in data in January is due to low battery. Battery was changed the following day.

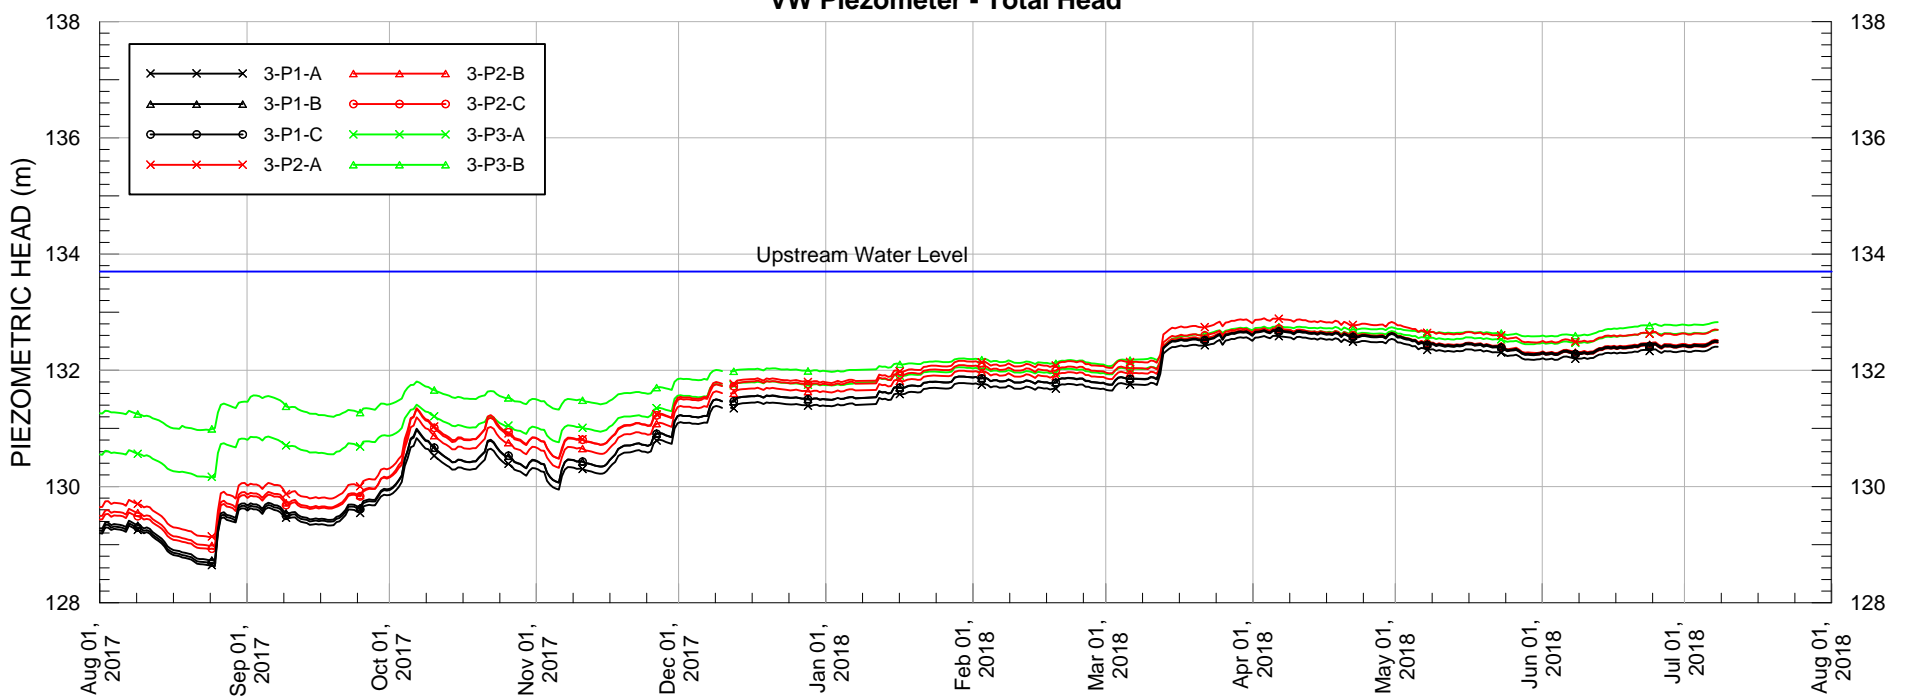
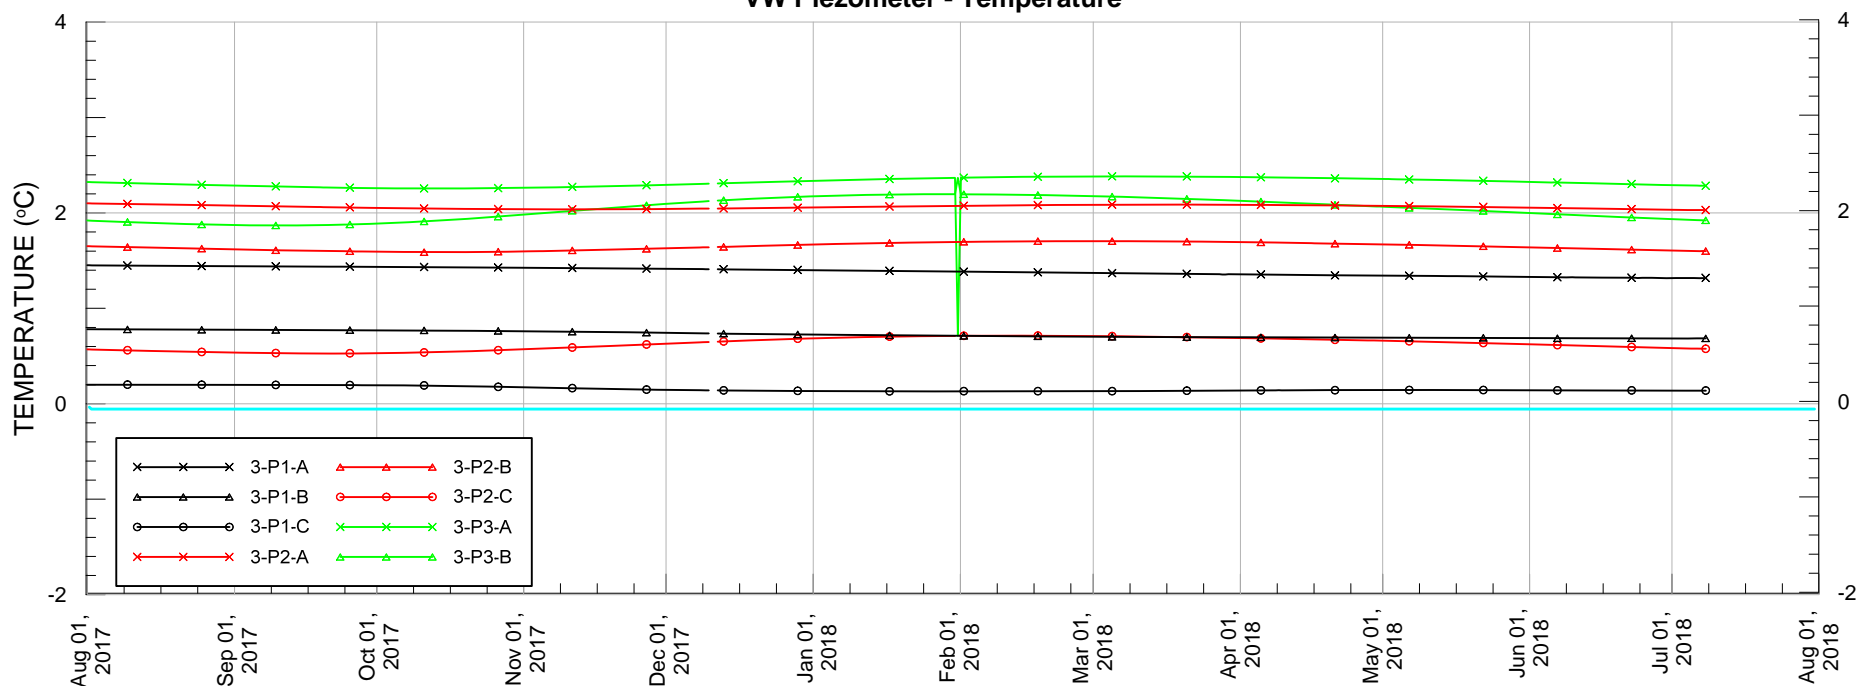
### "North Channel" Bay-Goose Dike - Section 30+378.5 (DL2)

- The gap in data from Dec. 10 to Dec. 11 was due to low battery. Battery was changed the following day.
- Changes in PWP pressure are directly related to the drill and blasting that is currently ongoing in Portage Pit E5. Ice buildup is also a factor.

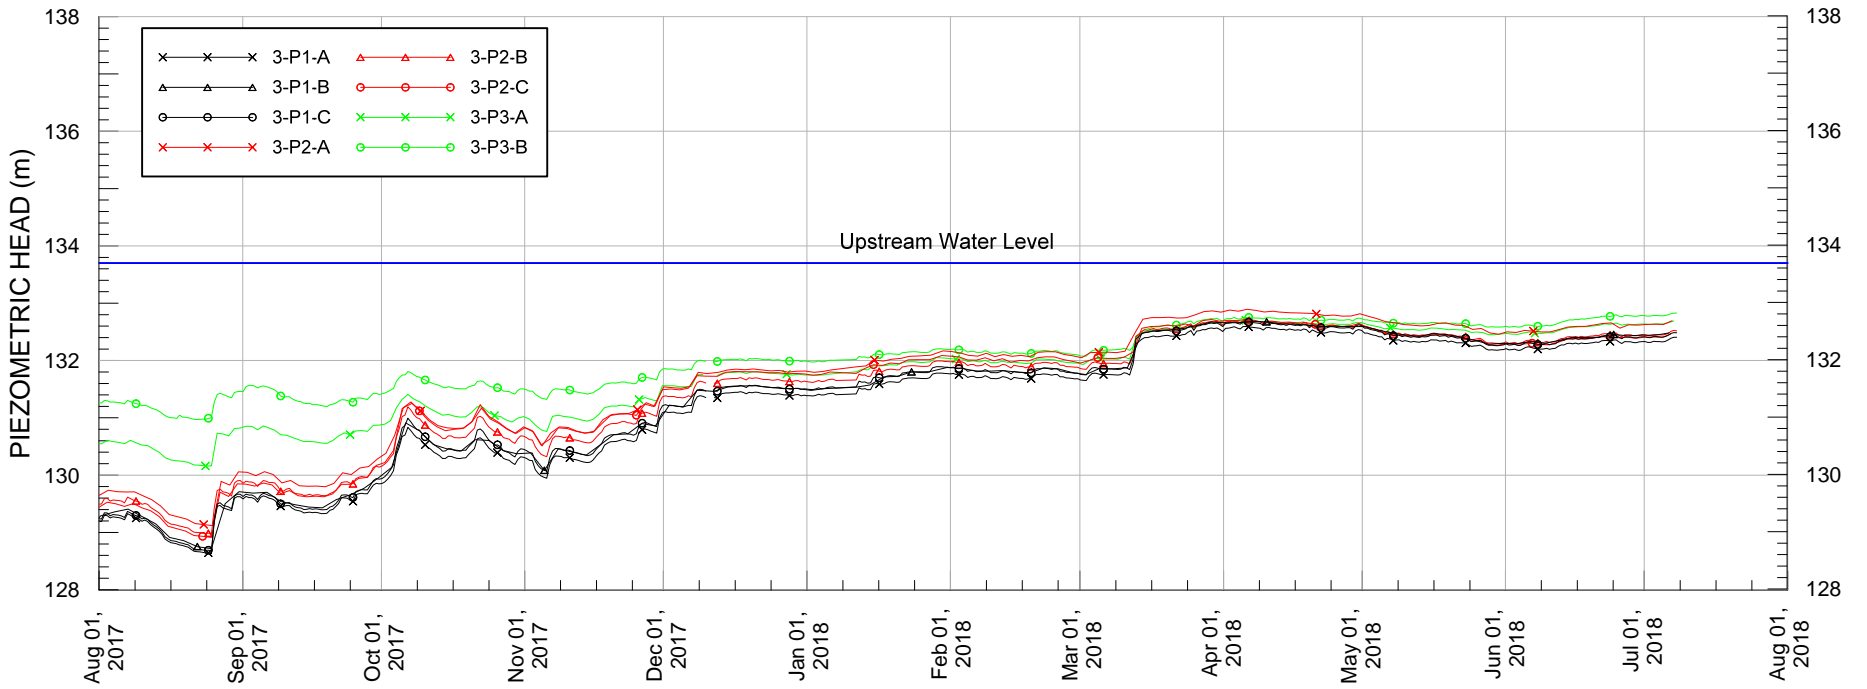
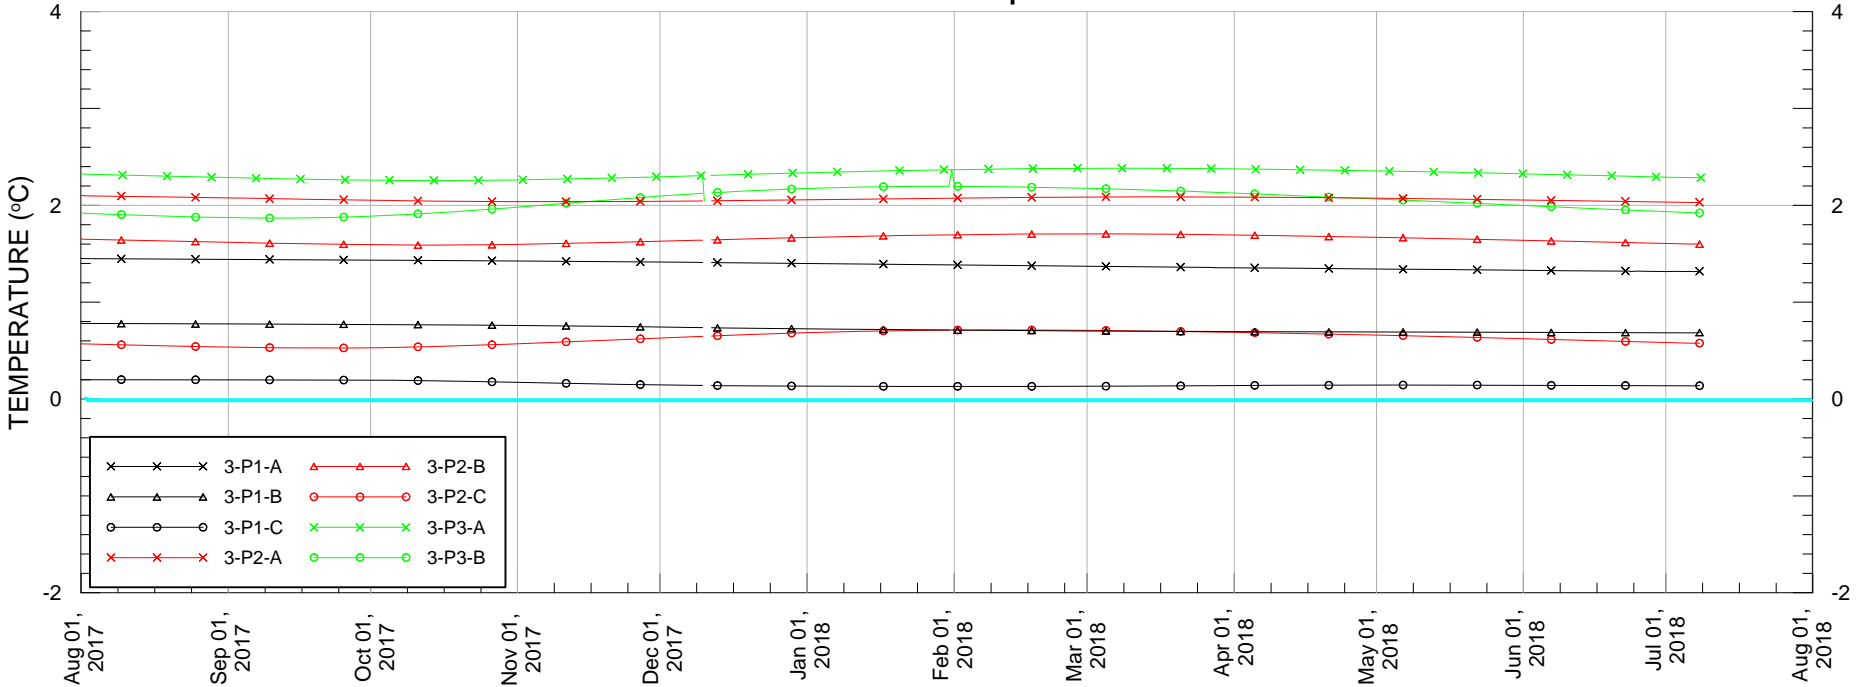
**BAY-GOOSE DIKE  
NORTH SECTION  
30+000 TO 31+000**

1. The gap in data from Dec. 10 to Dec. 11 was due to low battery. Battery was changed the following day.
2. Changes in PWP pressure are directly related to the drill and blasting that is currently ongoing in Portage Pit E5. Ice buildup is also a factor.
