# **Meadowbank and Whale Tail 2018 Annual Geotechnical Inspection**

# 2018 Annual Geotechnical Inspection

*Meadowbank Gold Mine, Nunavut*

18101627-1583-R-Rev0

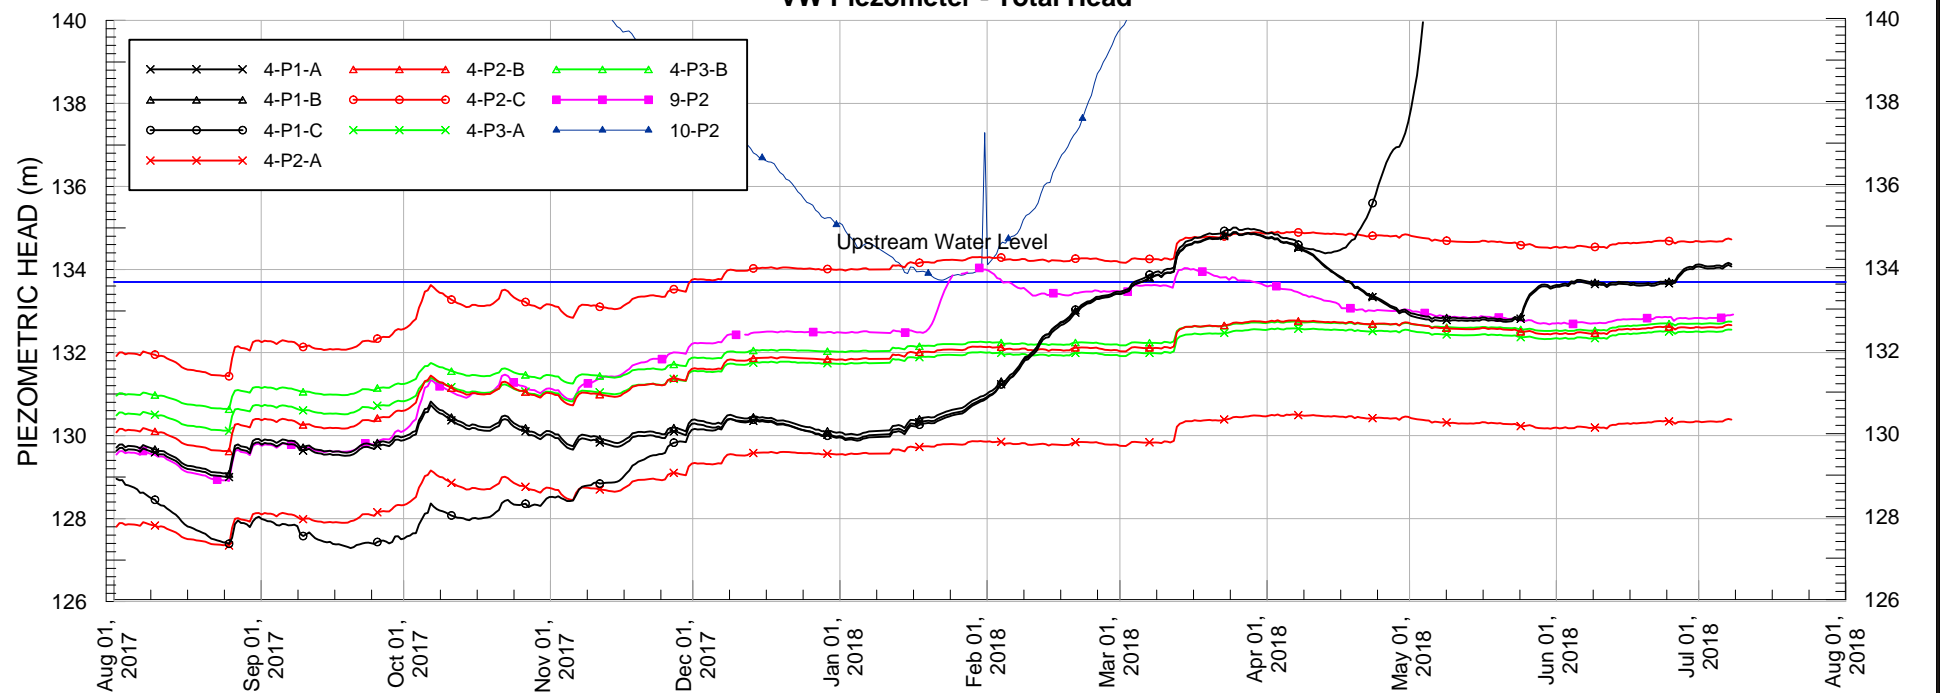
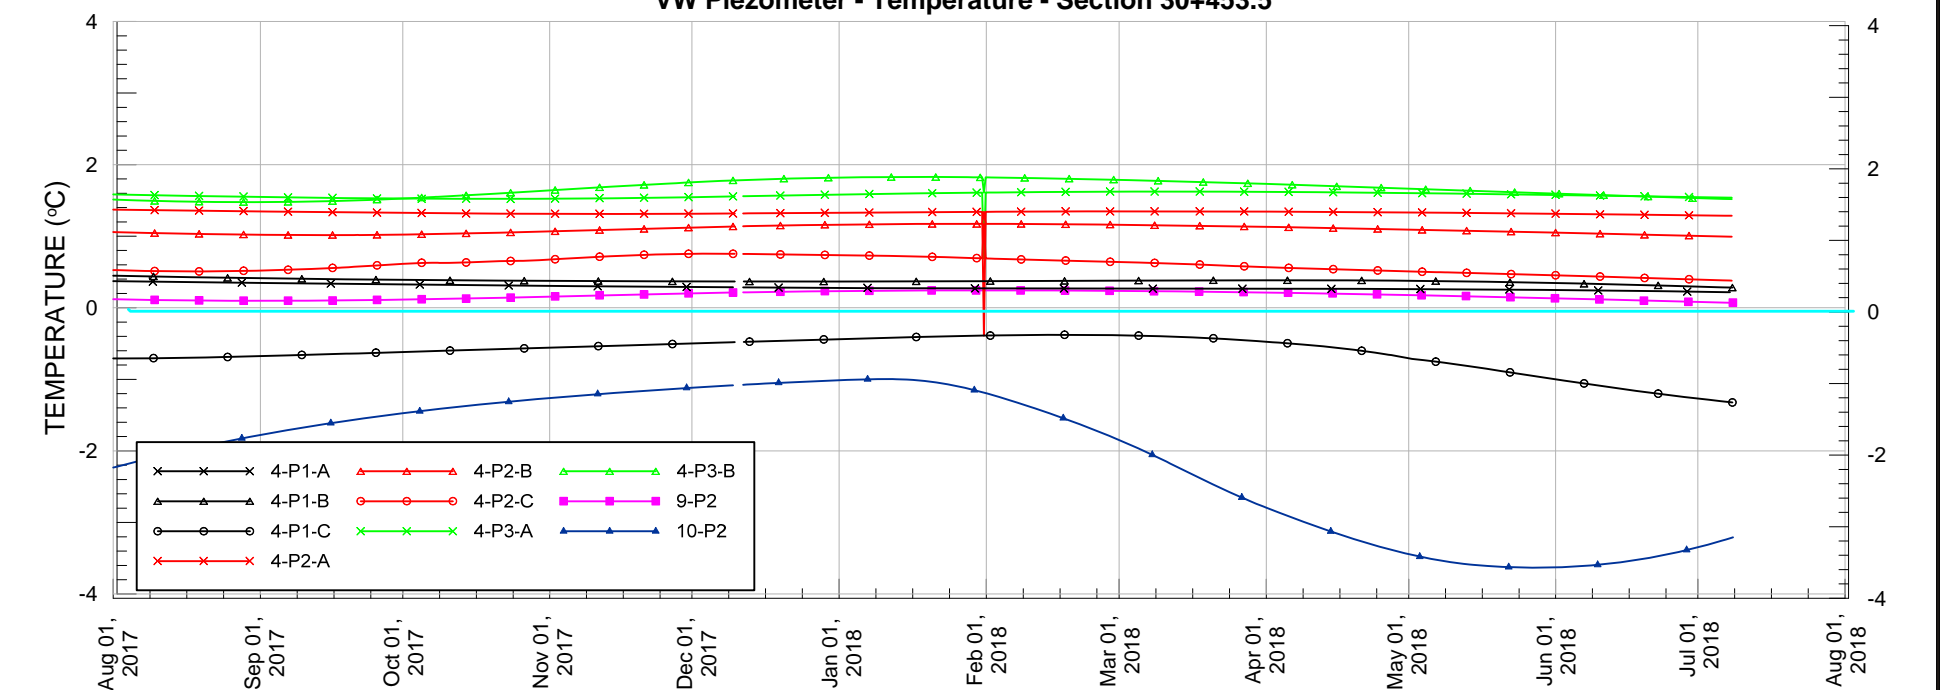
**"North Channel" Bay-Goose Dike - Section 30+453.5 (DL2)**

- All 4P1, 4P2C and 10P2 is given unstable readings and since the temperature either shows a negative reading or is close to a negative reading it is assumed to be frozen.
- Pressure changes are attributed to the drill and blast in Portage Pit E5 along with ice buildup that occurs.
- Some of the PWP that are over the Upstream Water Level can be attributed to having a negative temperature and assumed frozen.
- Gap in data in December is due to a low battery. Battery was changed the following day.

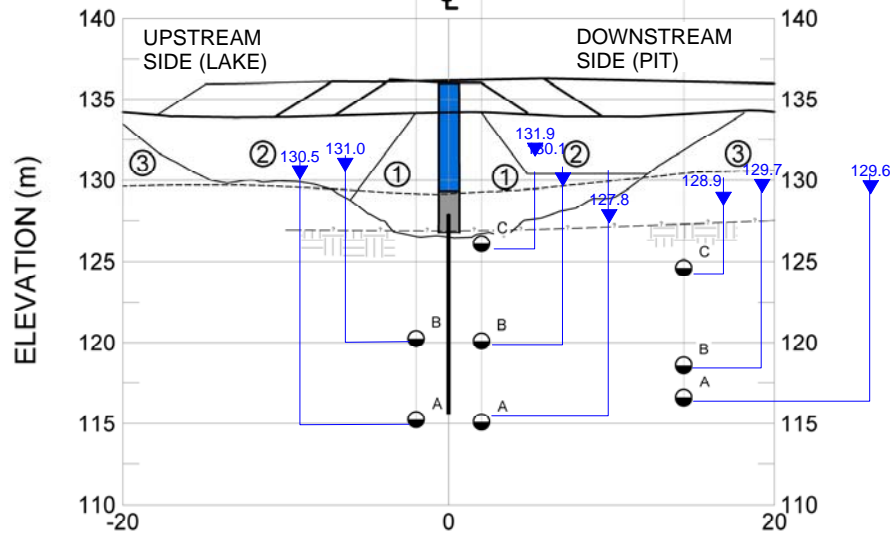
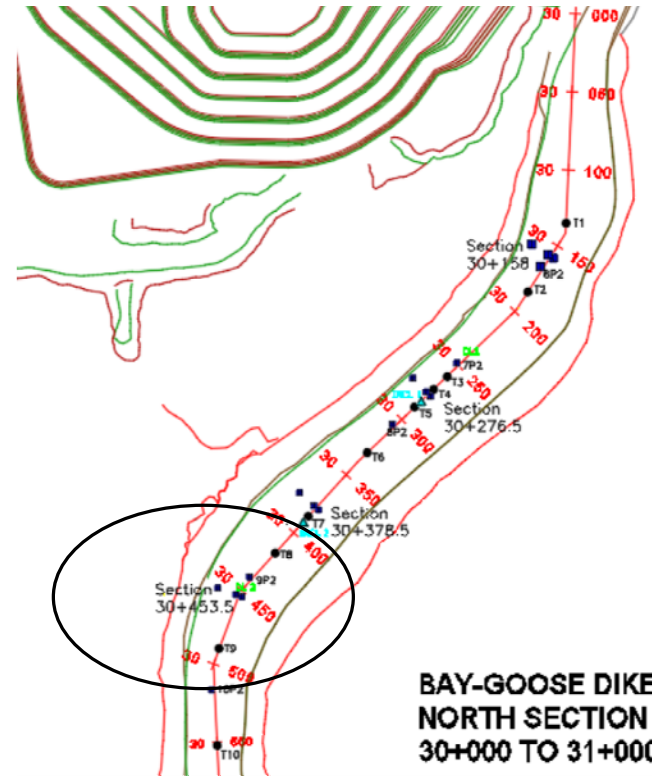
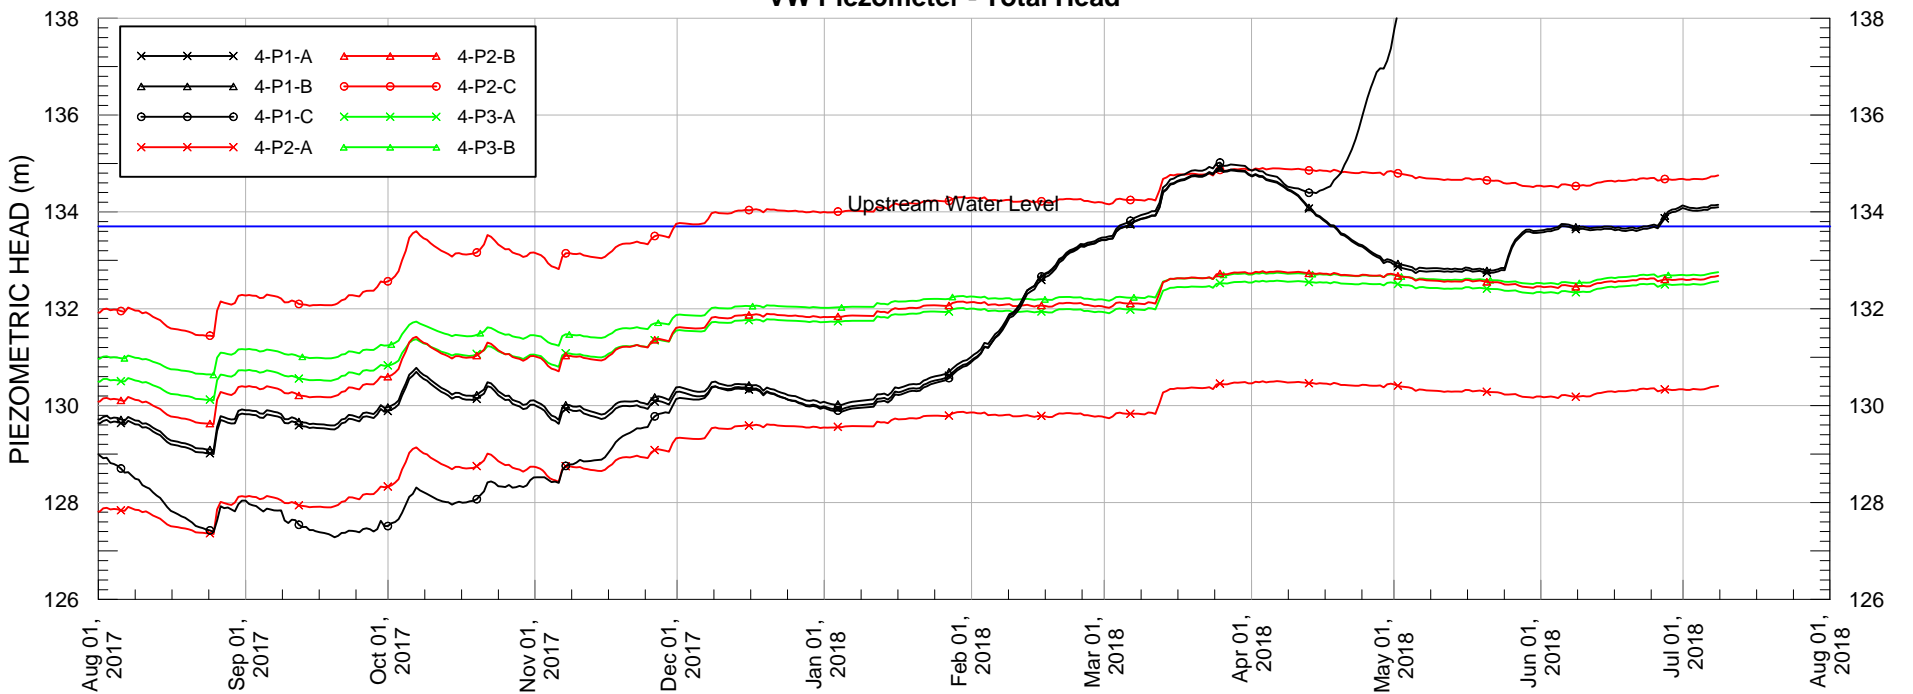
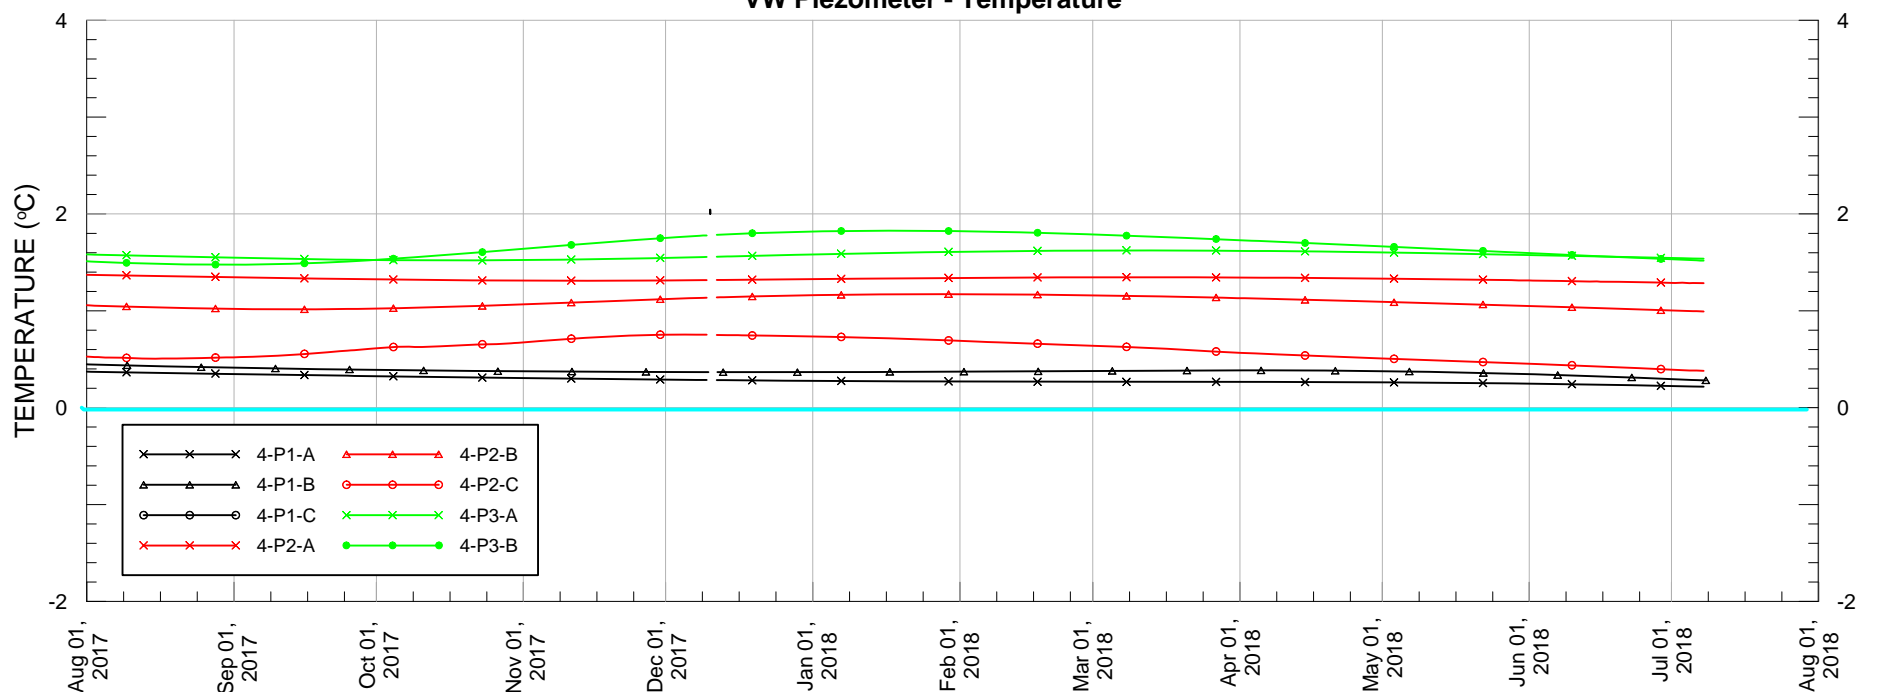
**STATION 30+453.5**

1. 4P1 and 4P2CPWP is given unstable readings and since the temperature is close to a freezing temperature it is assumed to be frozen.
2. Pressure changes are attributed to the drill and blast in Portage Pit E5 along with ice buildup that occurs.
3. Some of the PWP that are over the Upstream Water Level can be attributed to having a negative temperature and assumed frozen.
4. Data gap in December is due to low battery. Battery was changed the following day.

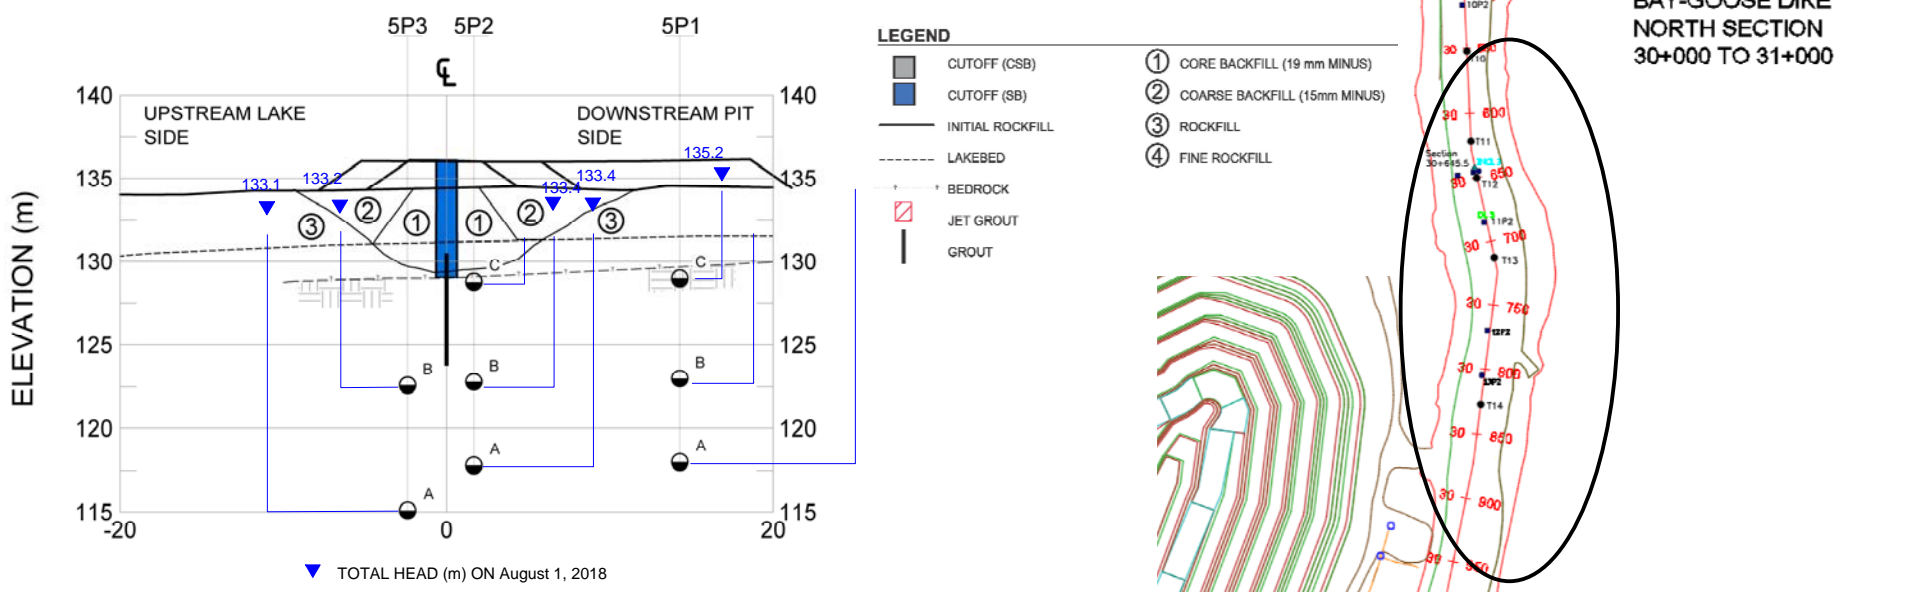
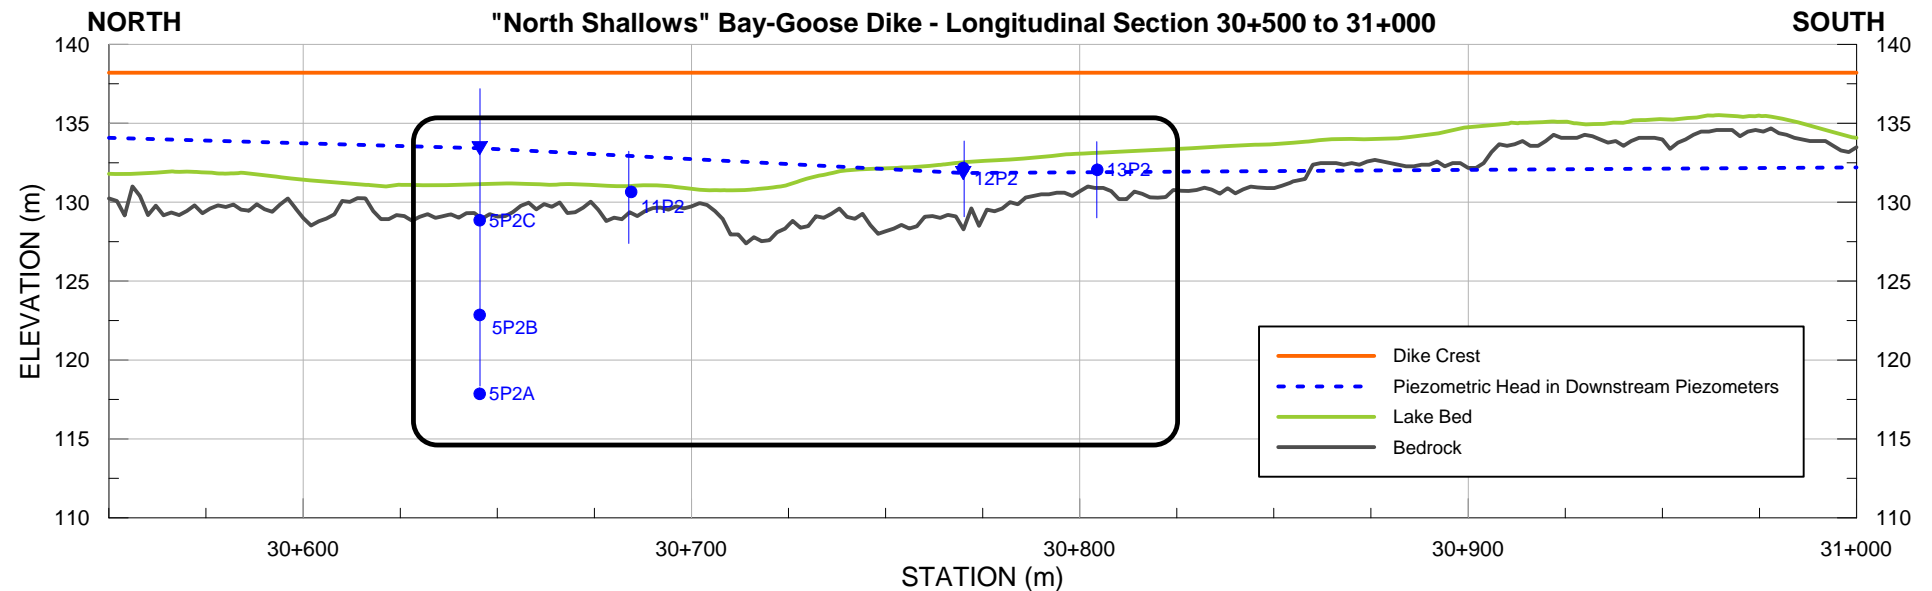
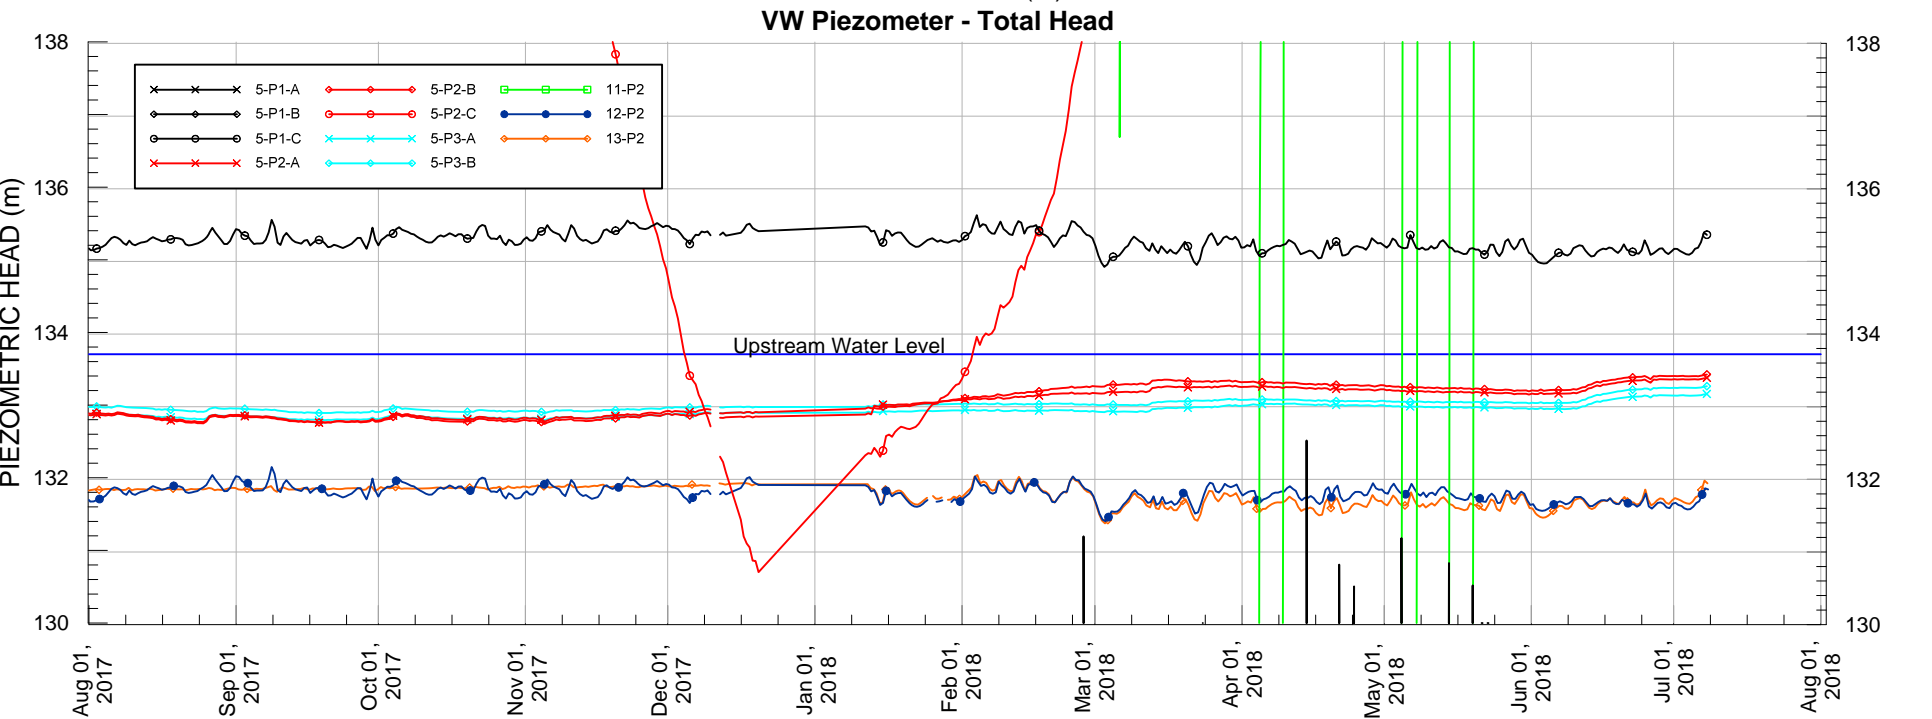
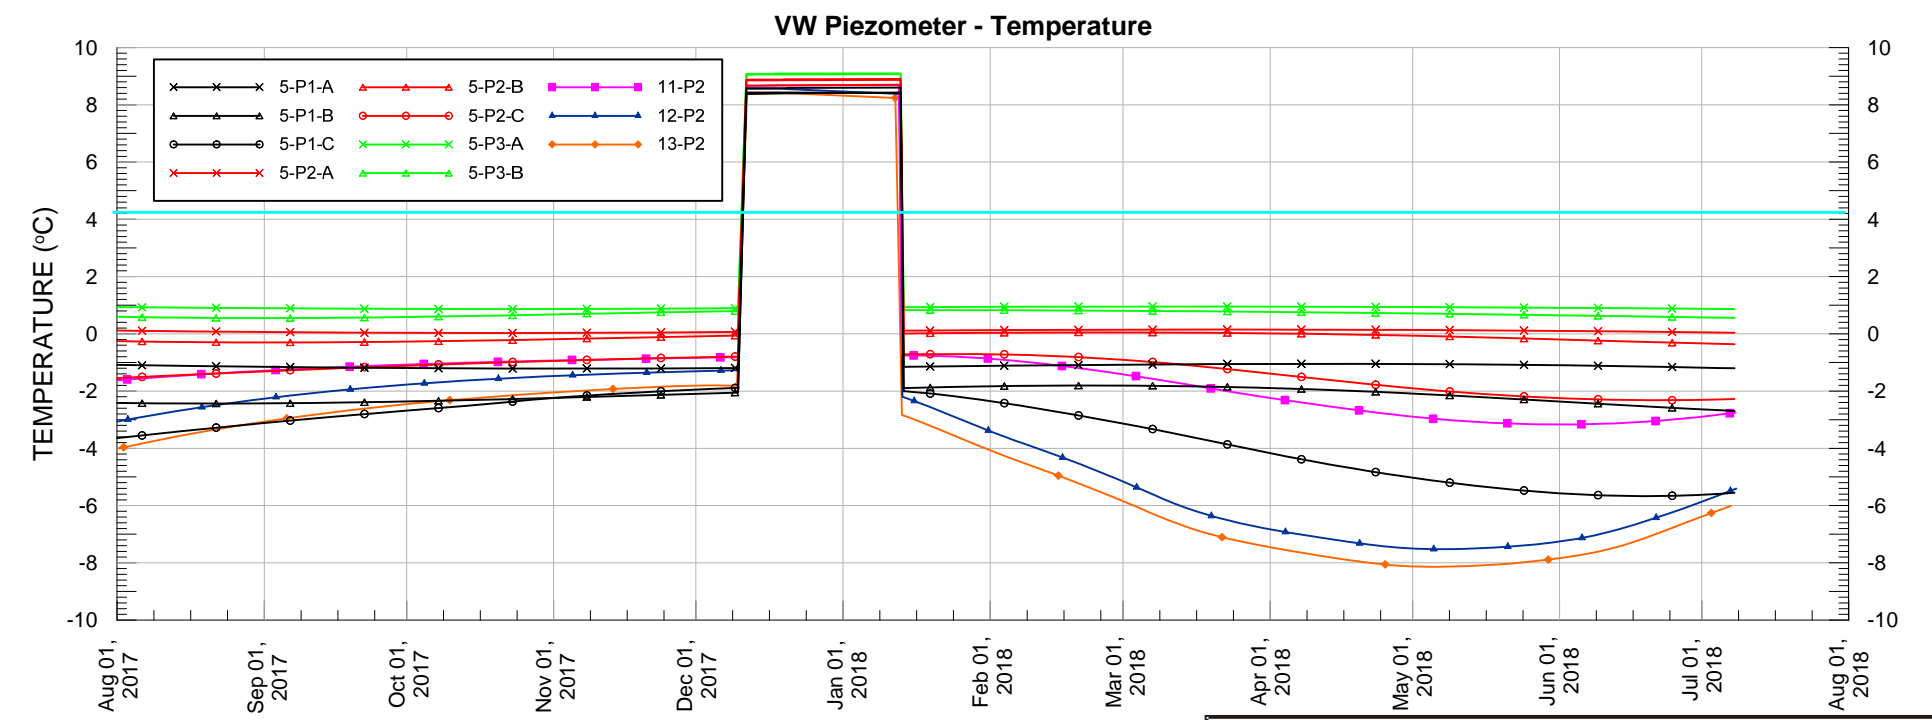
**"North Shallows" Bay-Goose Dike - 30+500 to 31+000 (DL3)**

**NOTES:**  
 1. 5P1A, 5P1B, 5P1C, 5P2C and 11P2 are giving unstable readings and since the temperature shows a negative reading it is assumed to be frozen.  
 2. A spike in temperature also has been corrected and stabilized due to a faulty MUX board.  
 3. Gap in data in December was due to a low battery. Battery was changed the following day.

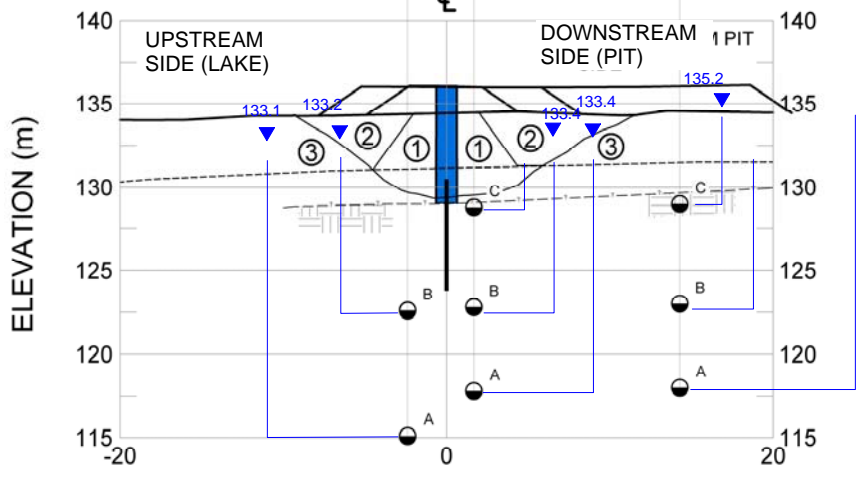
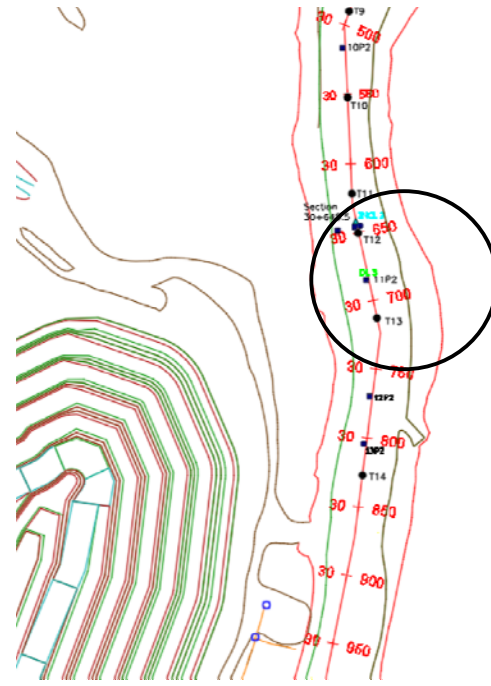
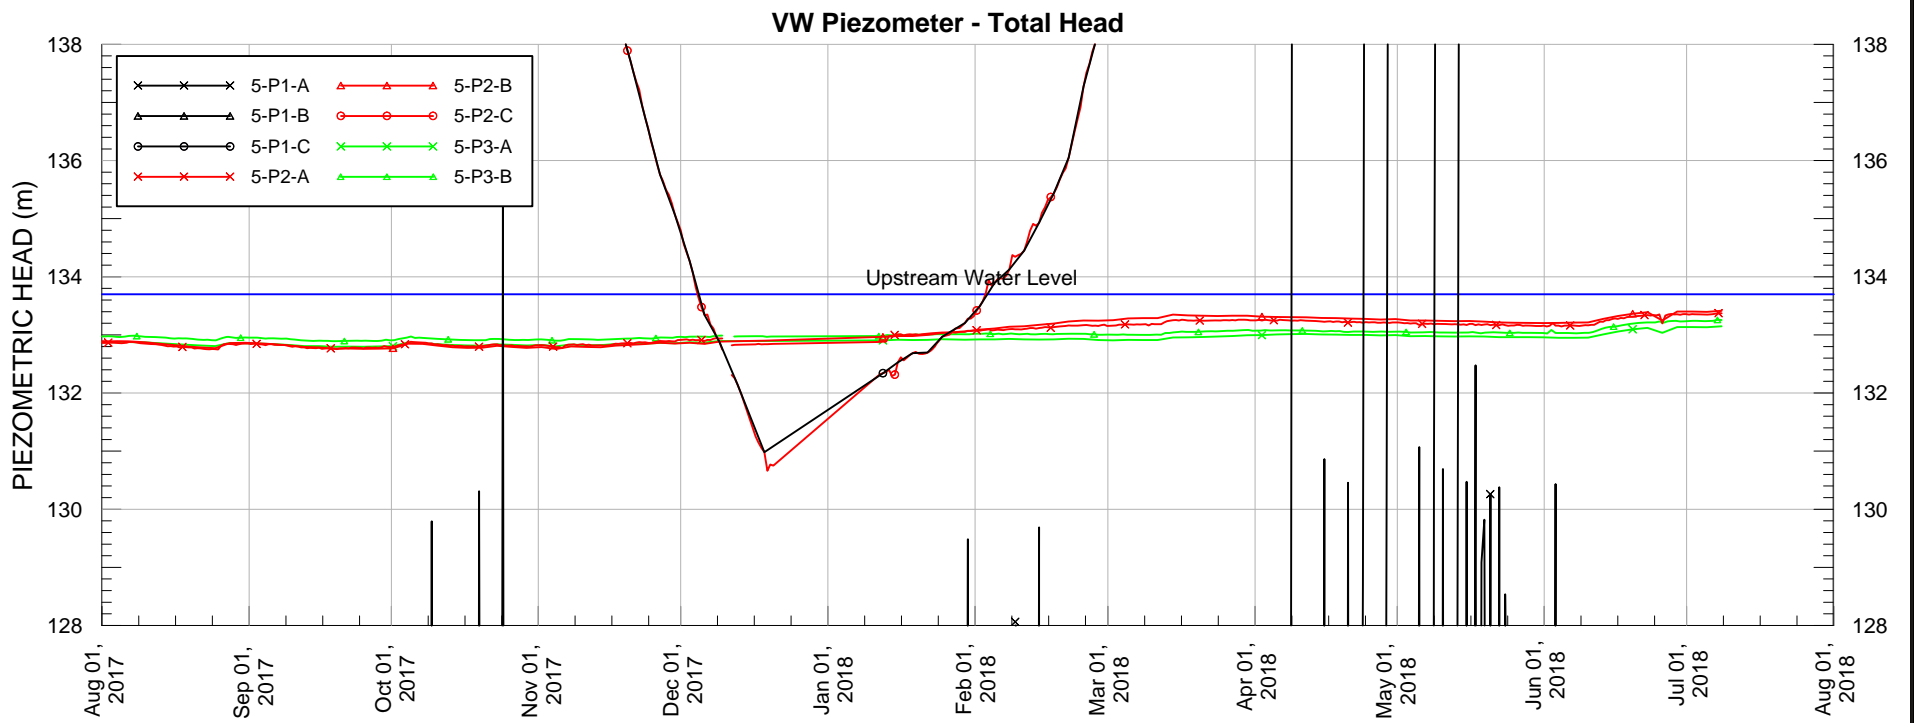
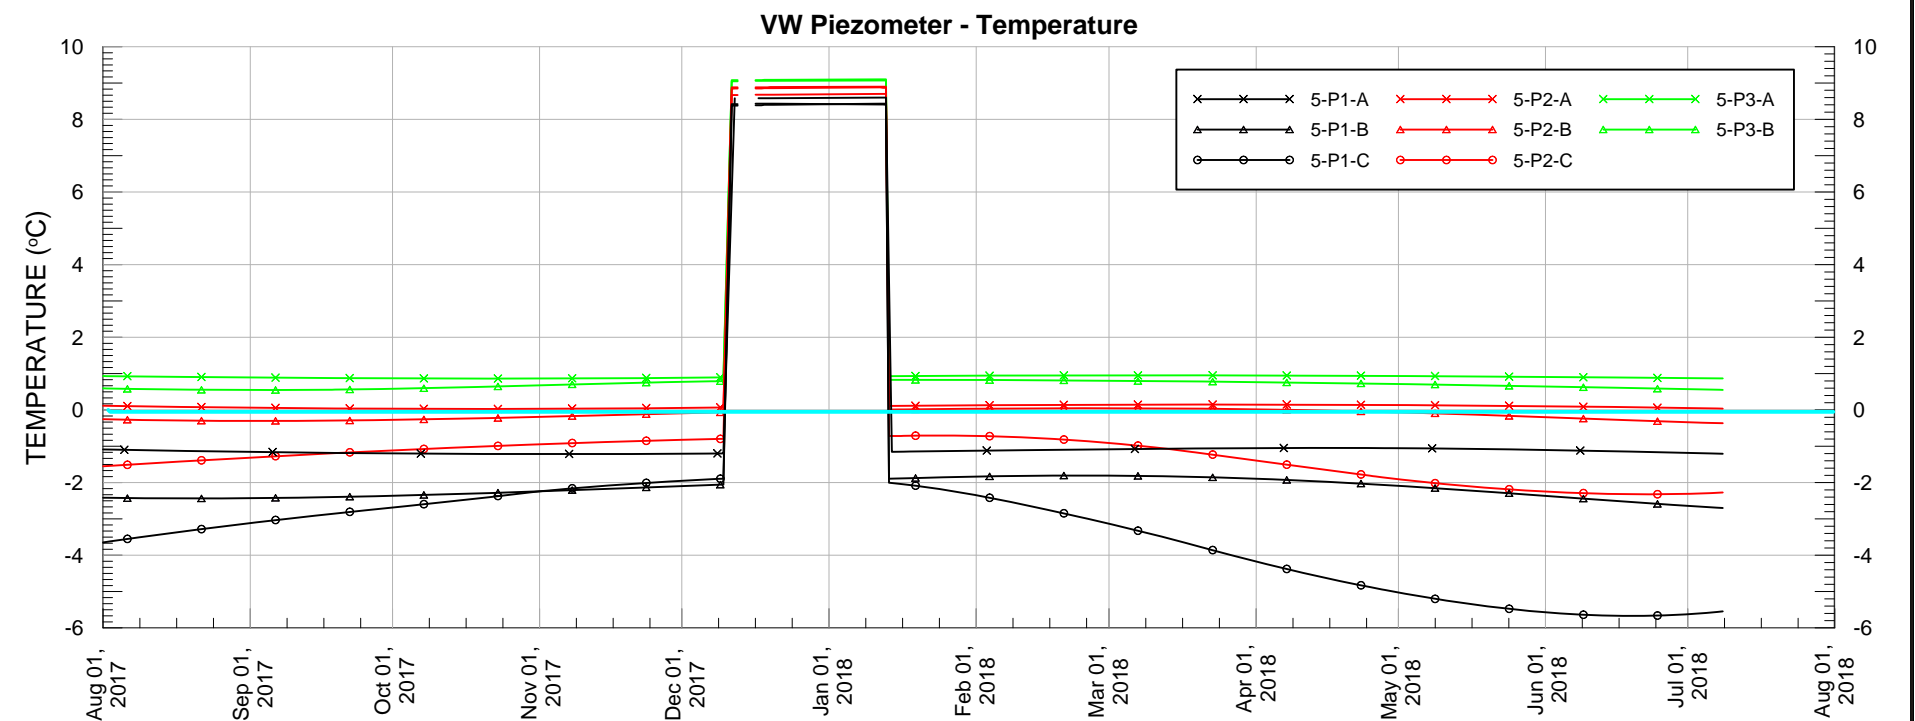
**STATION 30+645.5**

1. 5P1A, 5P1B, 5P1C, 5P2C are giving unstable readings and since the temperature shows a negative reading it is assumed to be frozen.
2. A spike in temperature also has been corrected and stabilized due to a faulty MUX board.
3. Gap in data in December was due to a low battery. Battery was changed the following day.

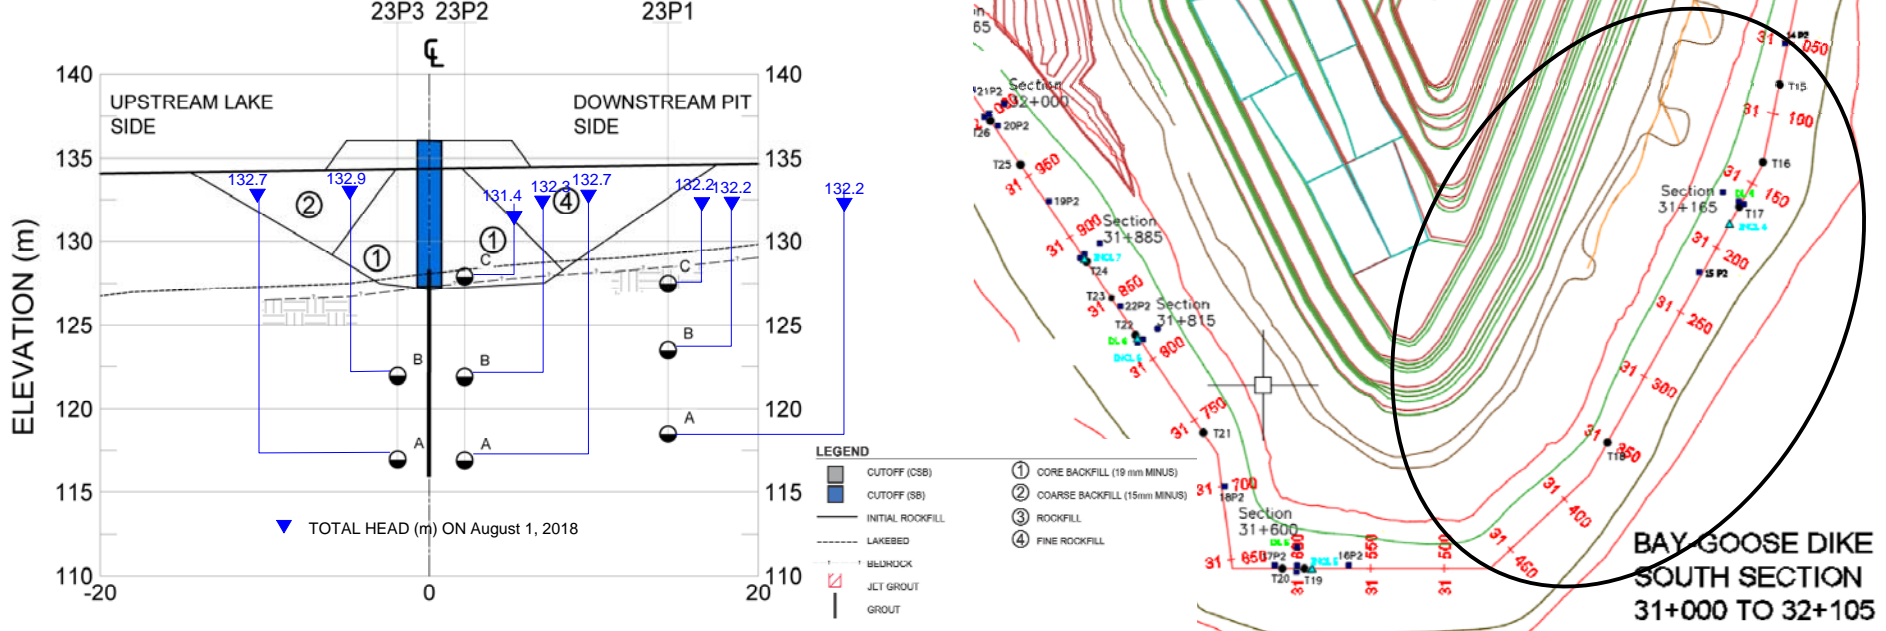
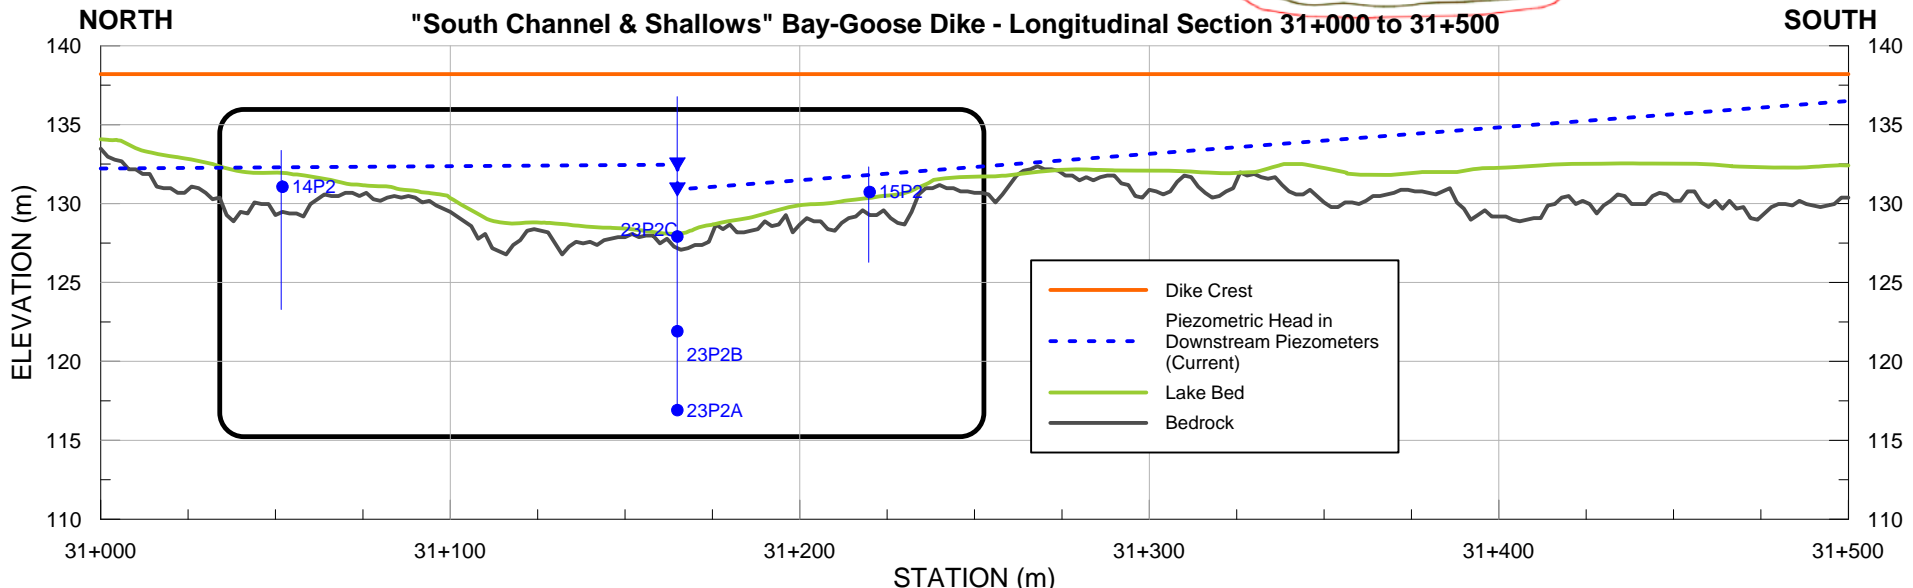
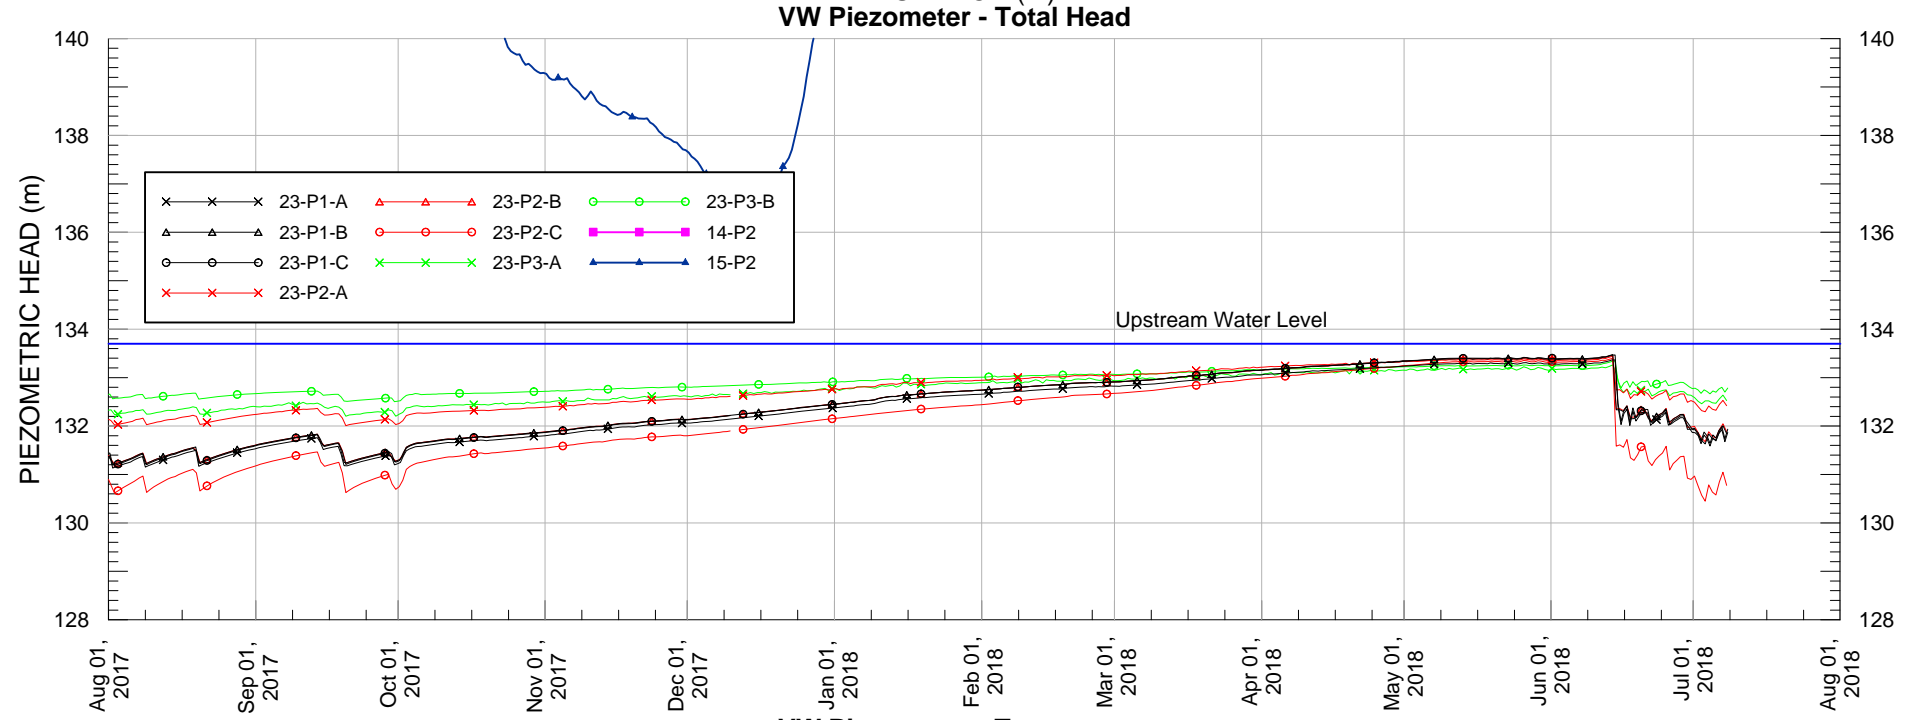
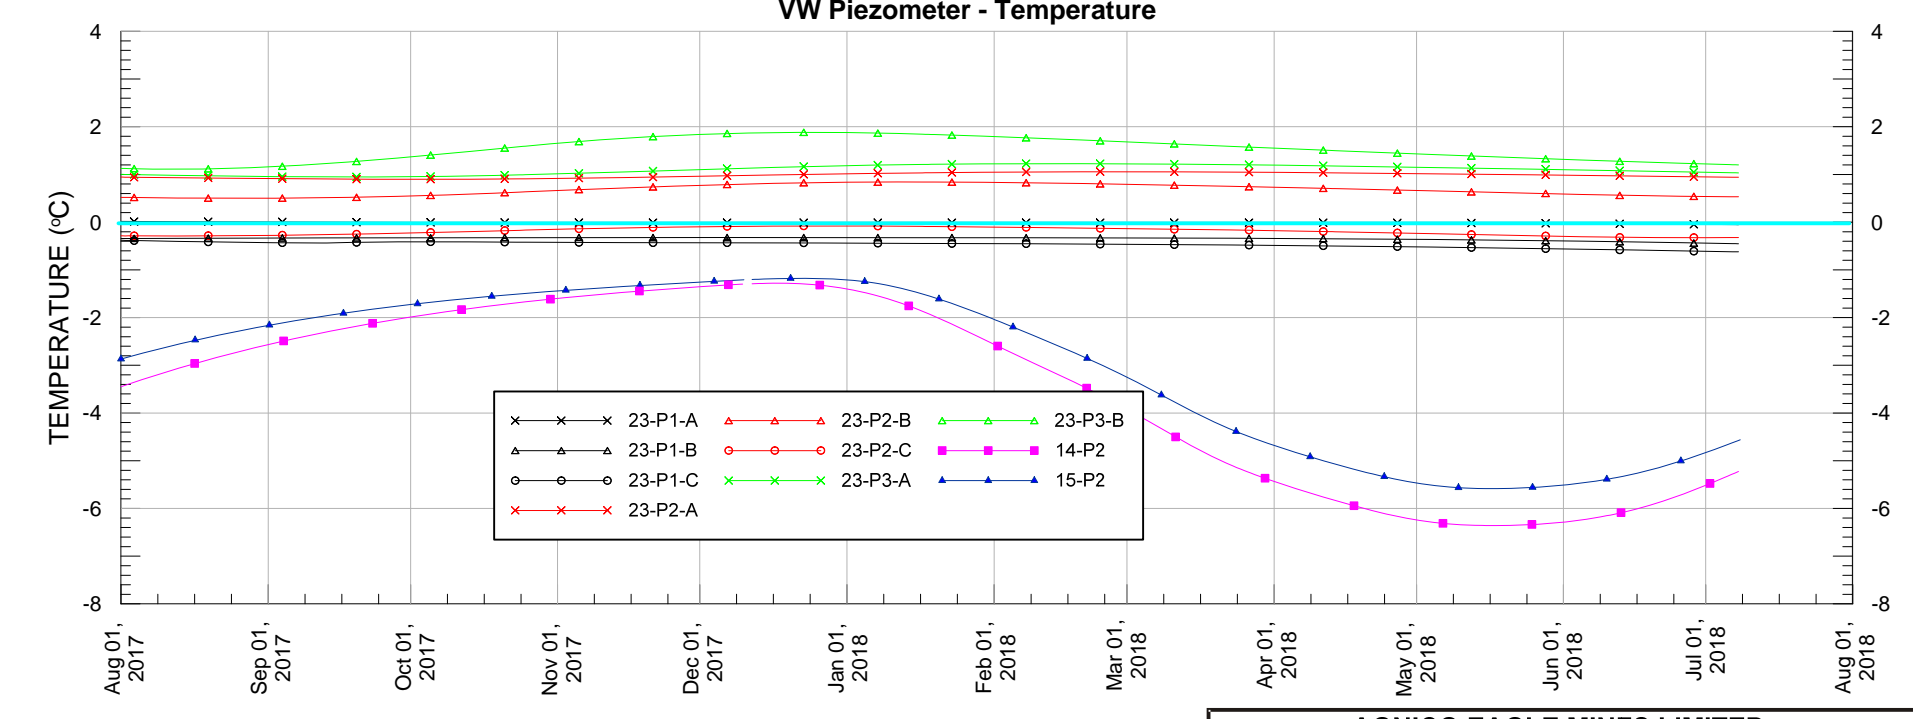
**"South Channel & Shallows" Bay-Goose Dike - Section 31+000 to 31+500 (DL4)**

**NOTES:**  
 1. 14P2 and 15P2 are given unstable readings and since the temperature shows a negative reading it is assumed to be frozen.  
 2. PWP rises and falls due to ponding in the area and continuous pumping, and allowing the ponding to raise. The steady increase is when the ponding area freezes, and no pumping is done till the thawing of the area.  
 3. Gap in data in December is due to low battery. Battery was changed the following day.
