# **Meadowbank and Whale Tail 2018 Annual Geotechnical Inspection**

# 2018 Annual Geotechnical Inspection

*Meadowbank Gold Mine, Nunavut*

18101627-1583-R-Rev0

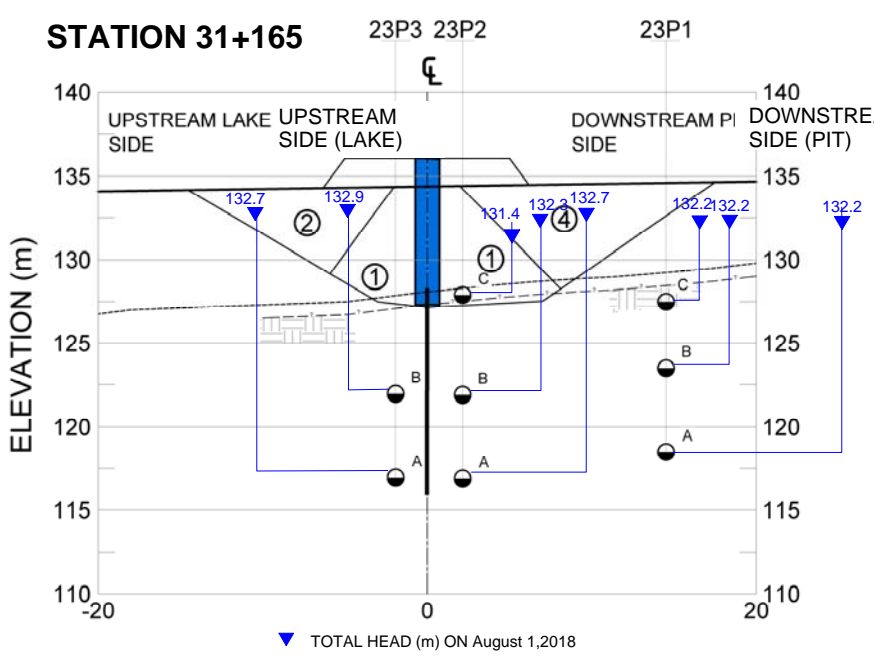
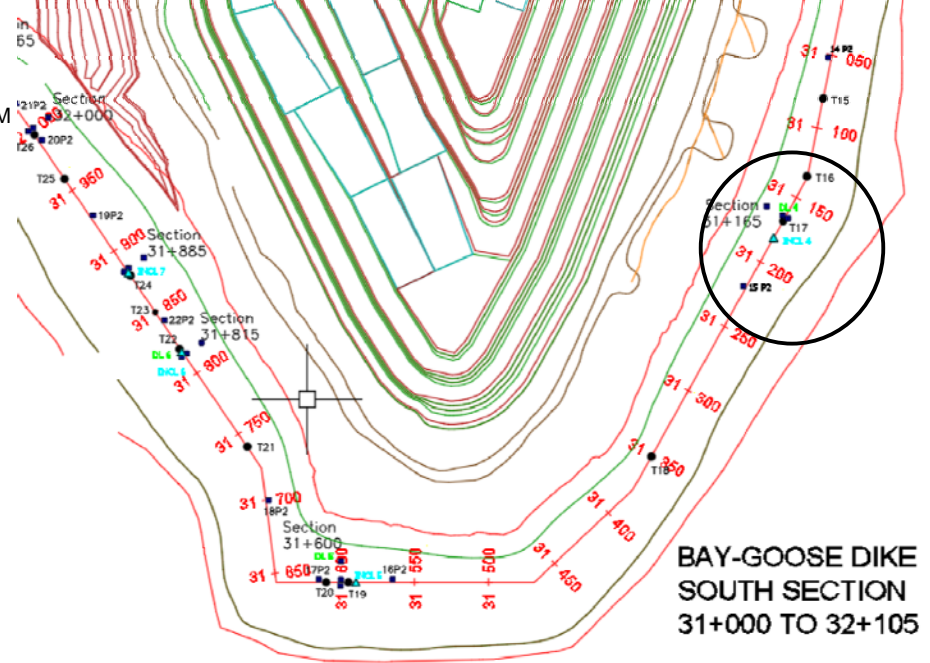
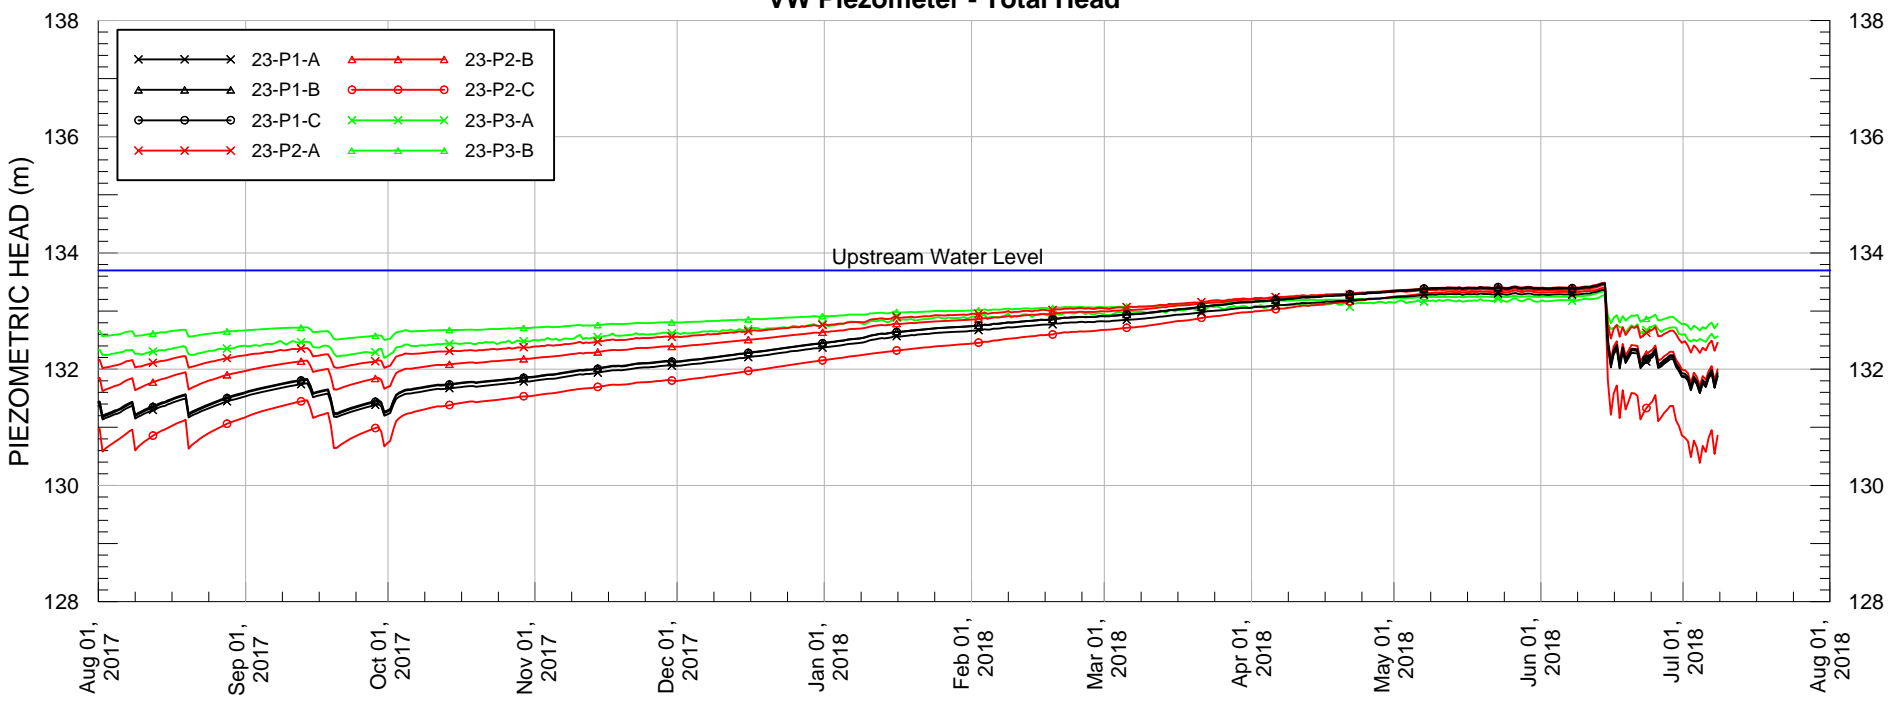
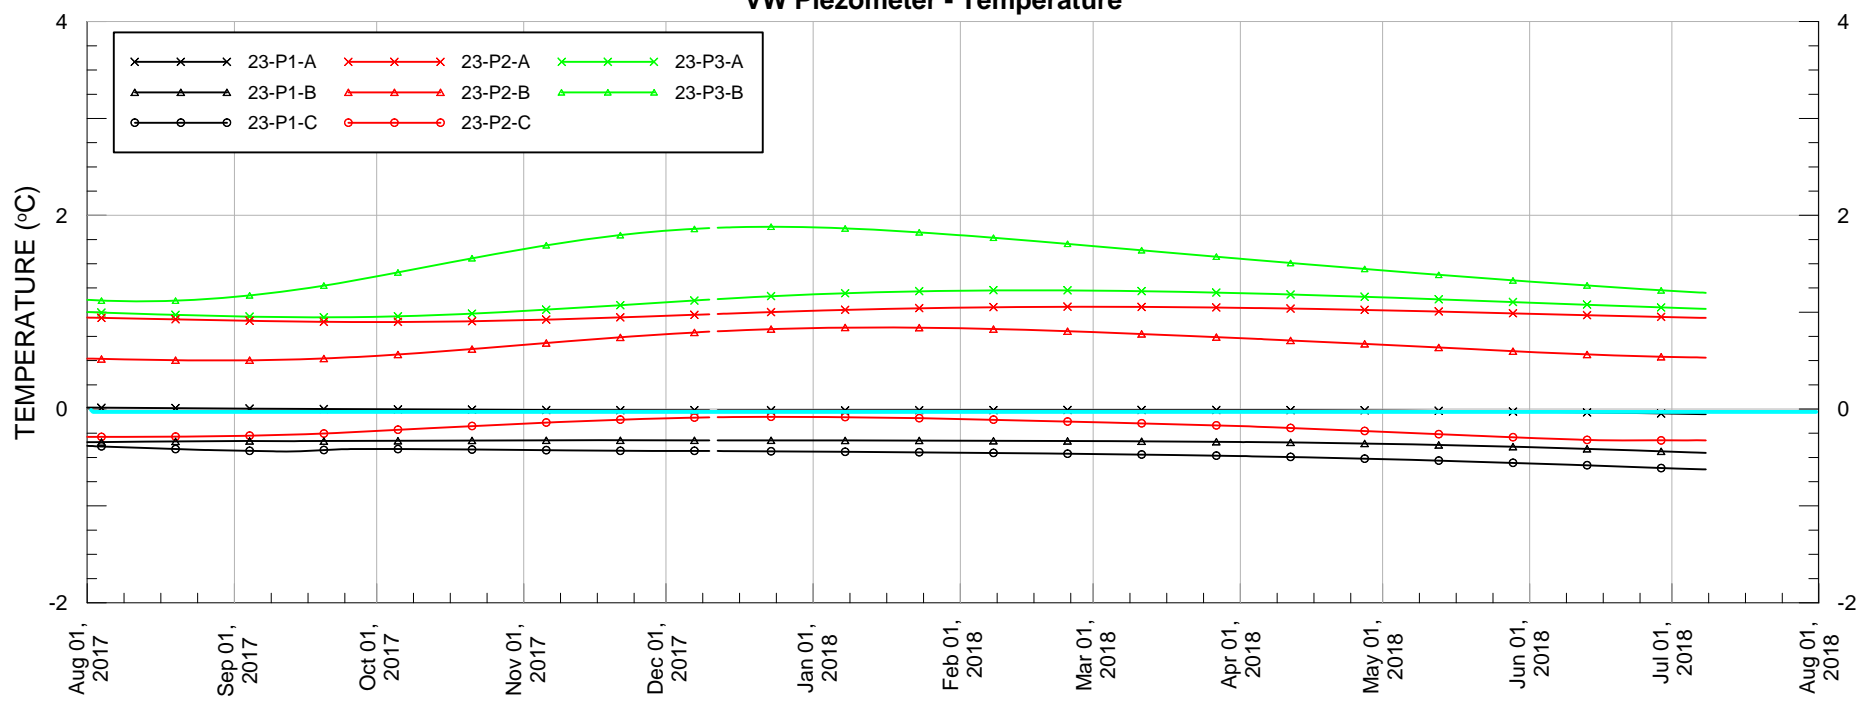
| REVIEW | | | <b>FIGURE 11</b> |

- PWP rises and falls due to ponding in the area and continuous pumping, and allowing the ponding to raise. The steady increase is when the ponding area freezes, and no pumping is done till the thawing of the area.
- Gap in data in December is due to low battery. Battery was changed the following day.

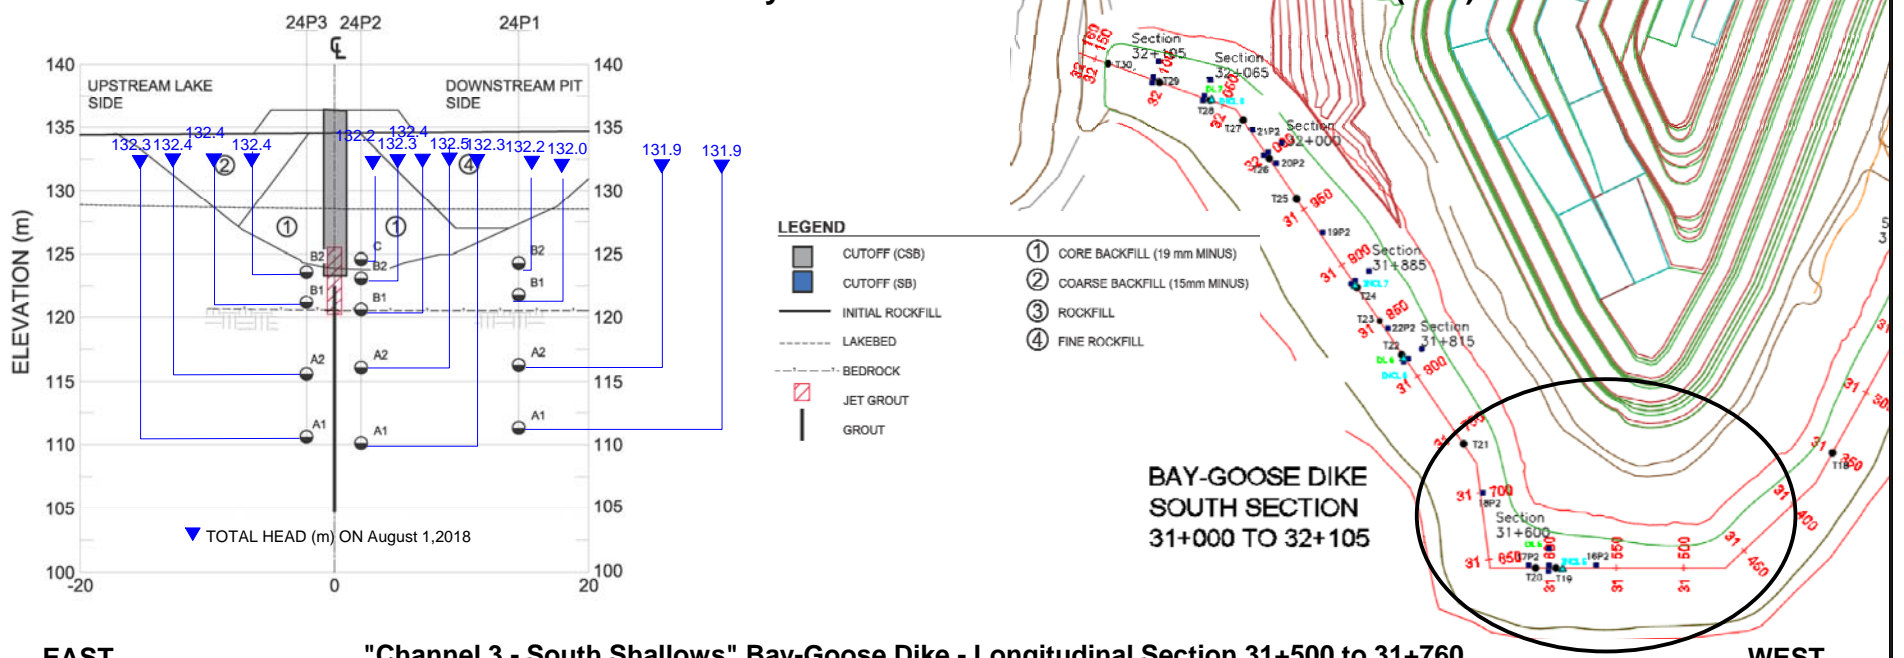
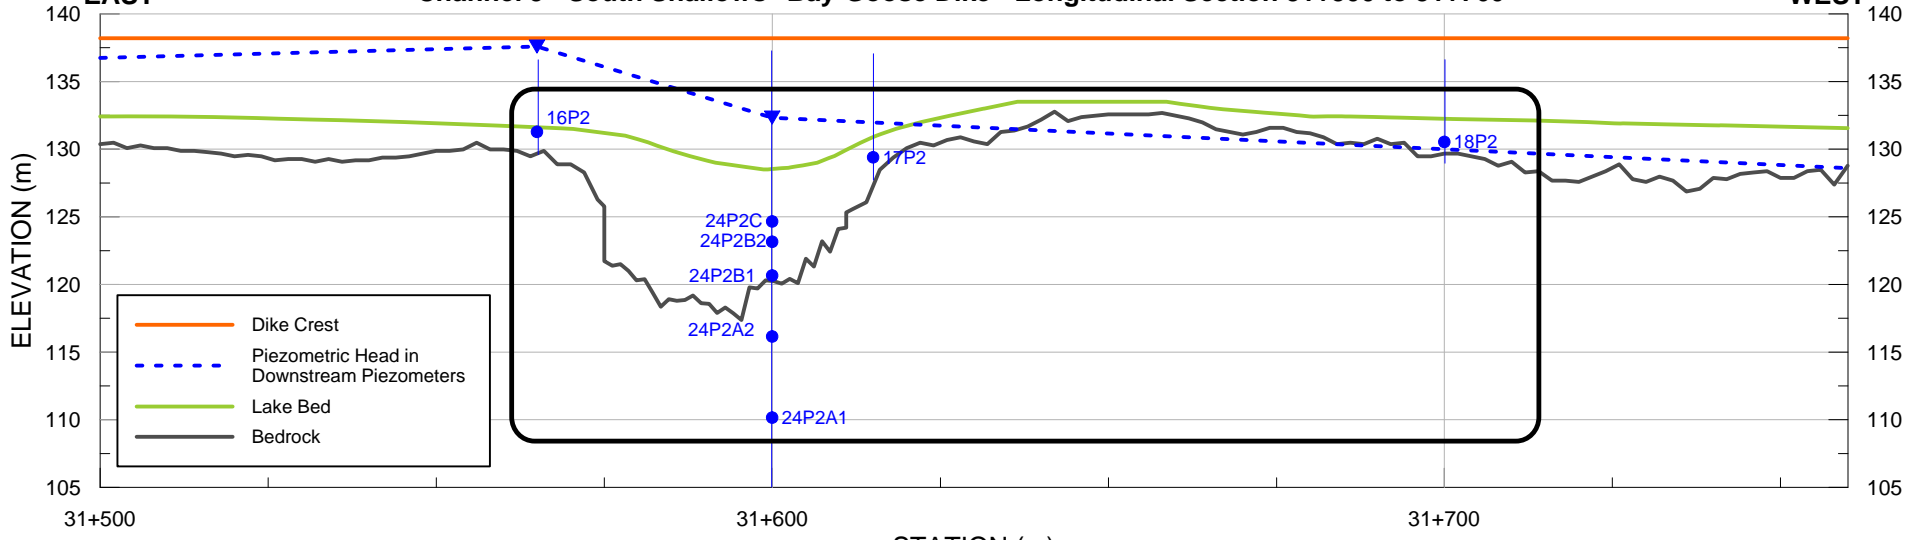
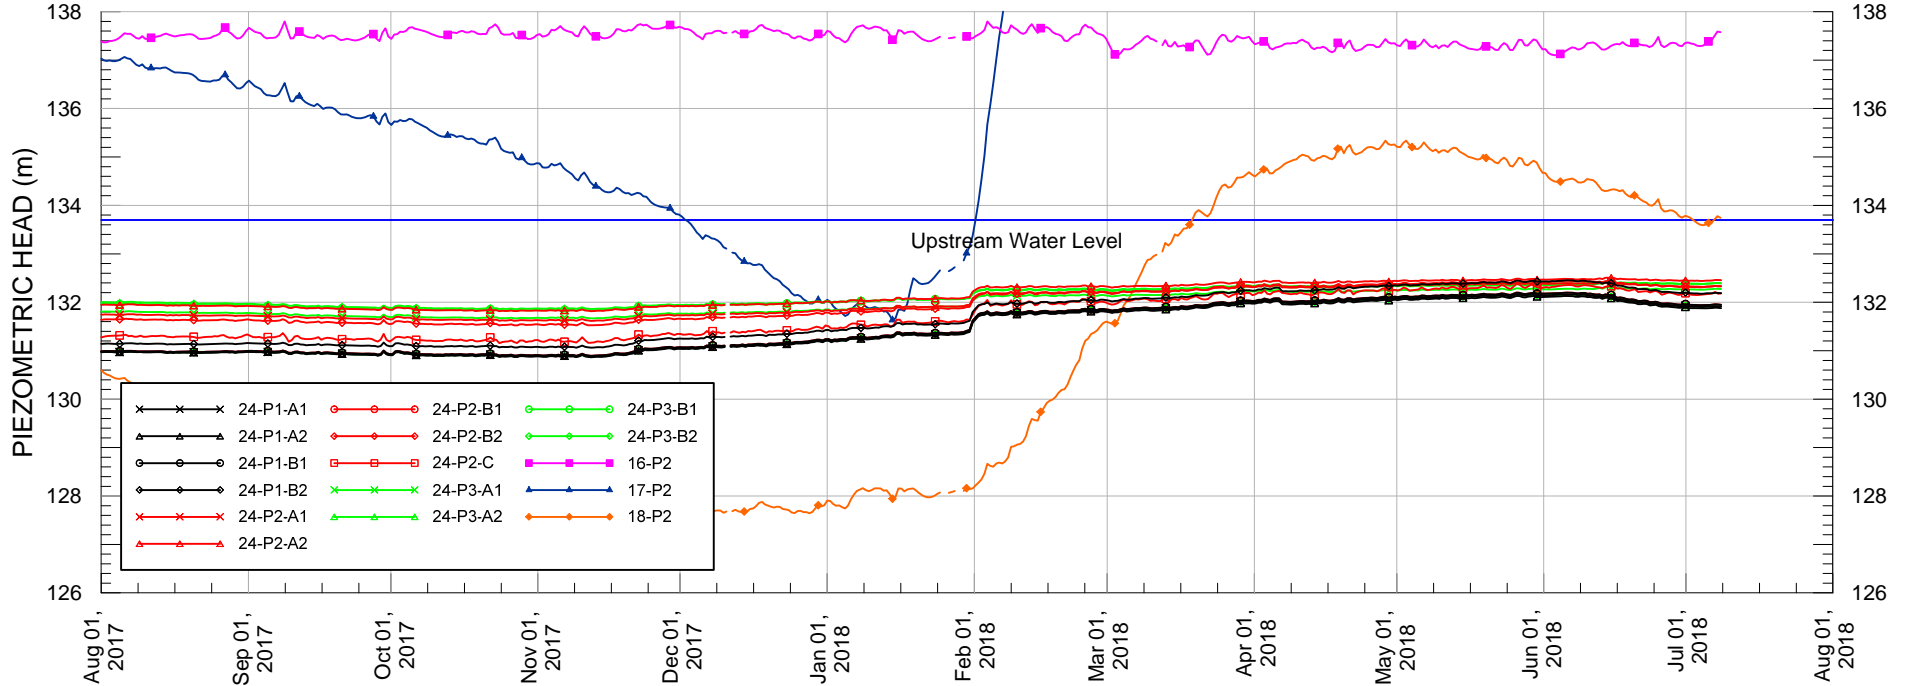
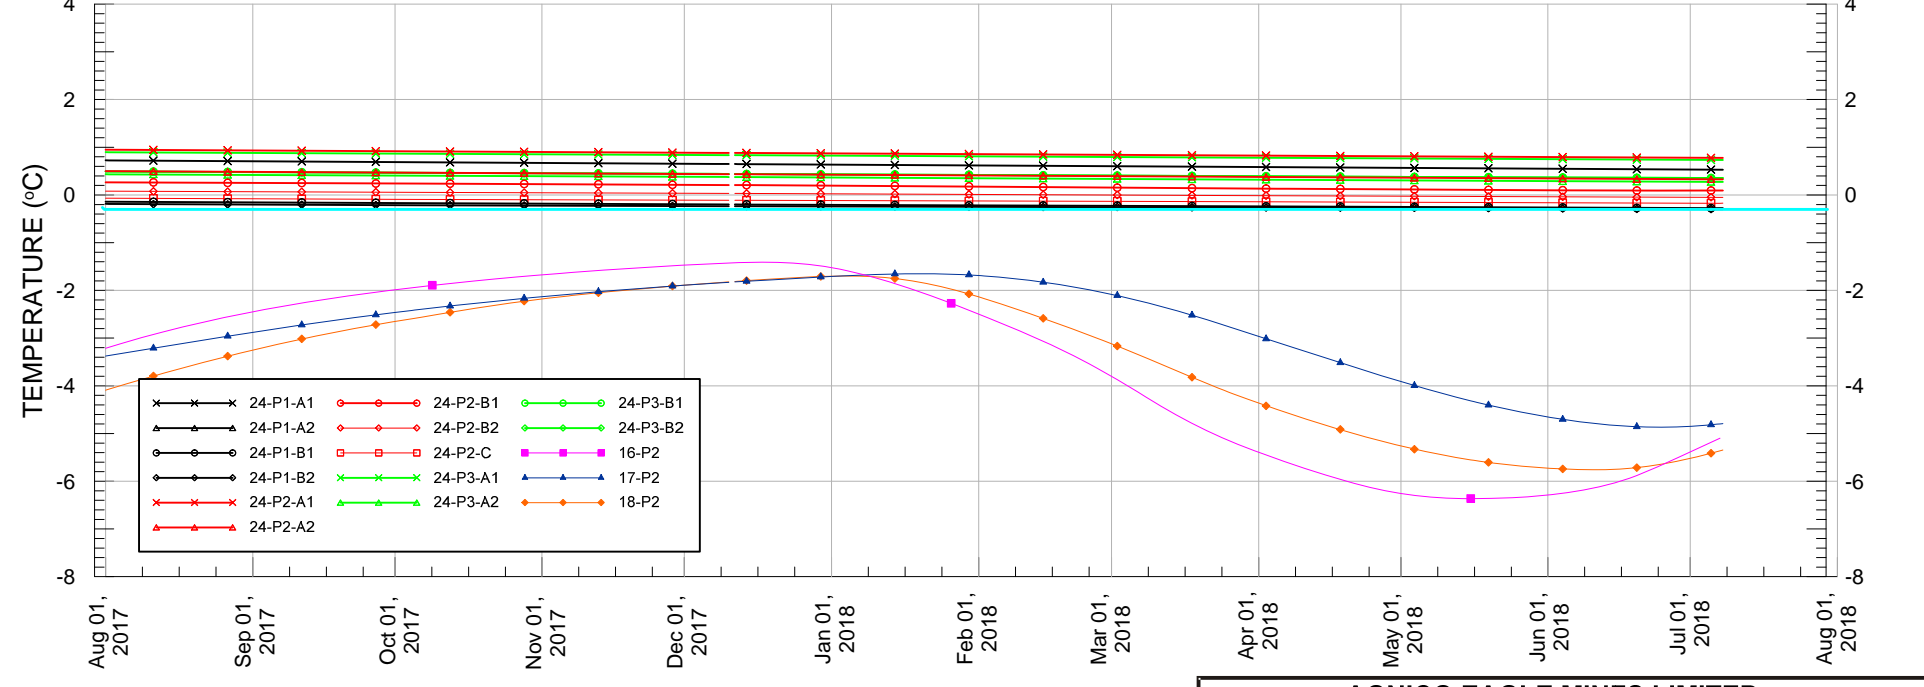
**"Channel 3 - South Shallows" Bay-Goose Dike - Section 31+500 to 31+760 (DL5)**

- 16P2, 17P2 and 18P2 are given unstable readings and since the temperature shows a negative reading it is assumed to be frozen.
- PWP is following same trend as previous years. When ice builds the pressure increases and when it melts in summer the pressure decreases
- Gap in data in December is due to low battery. Battery was changed the following day.

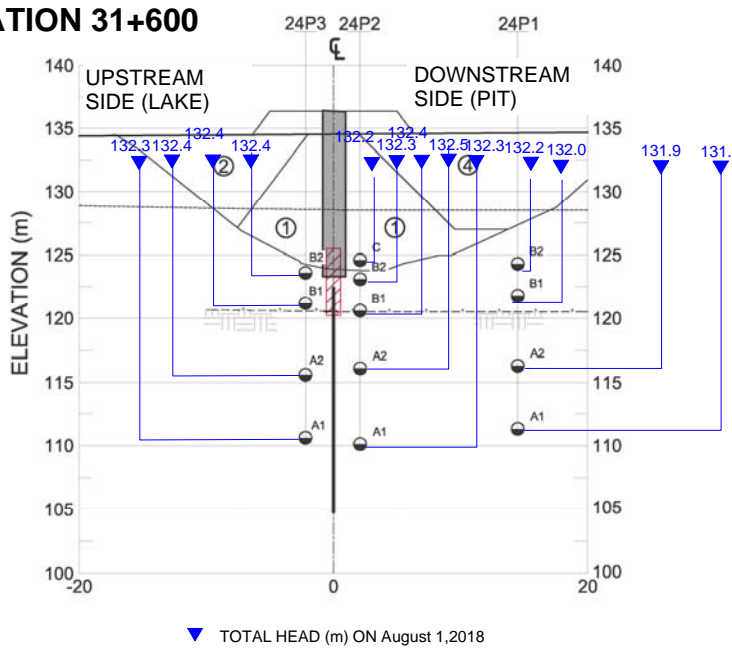
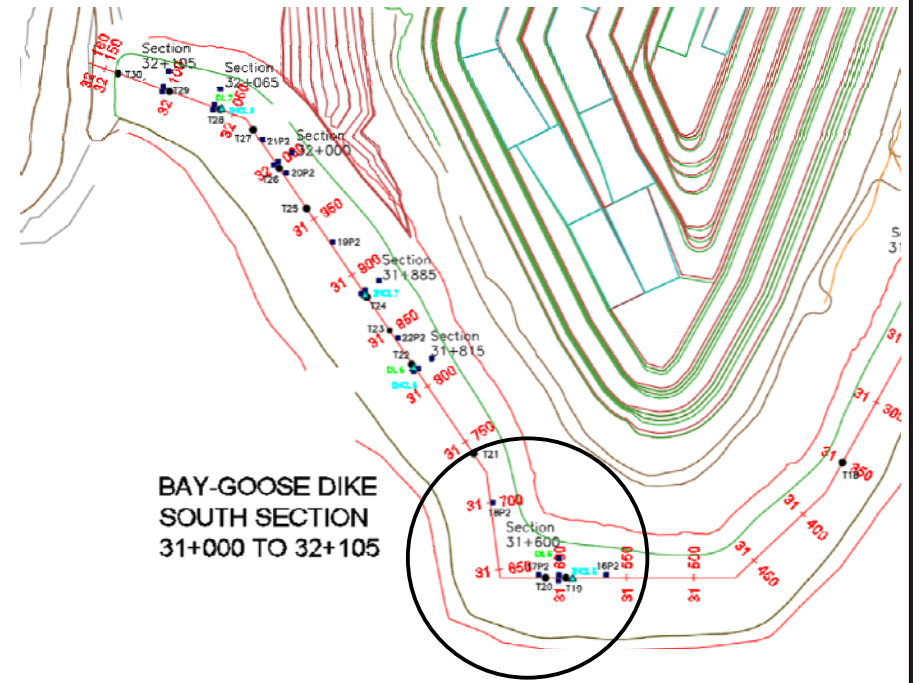
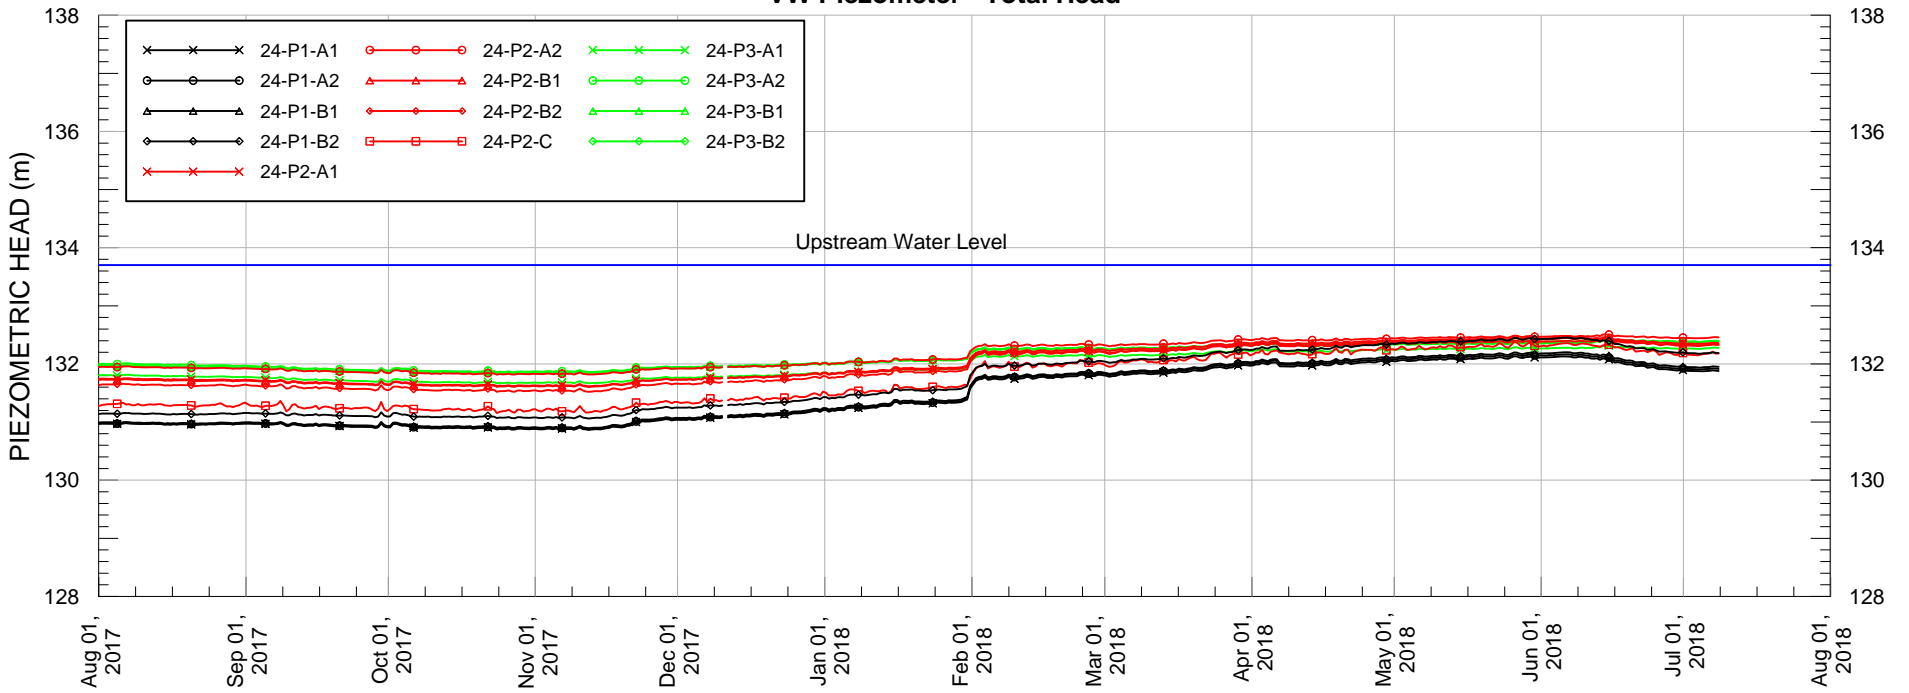
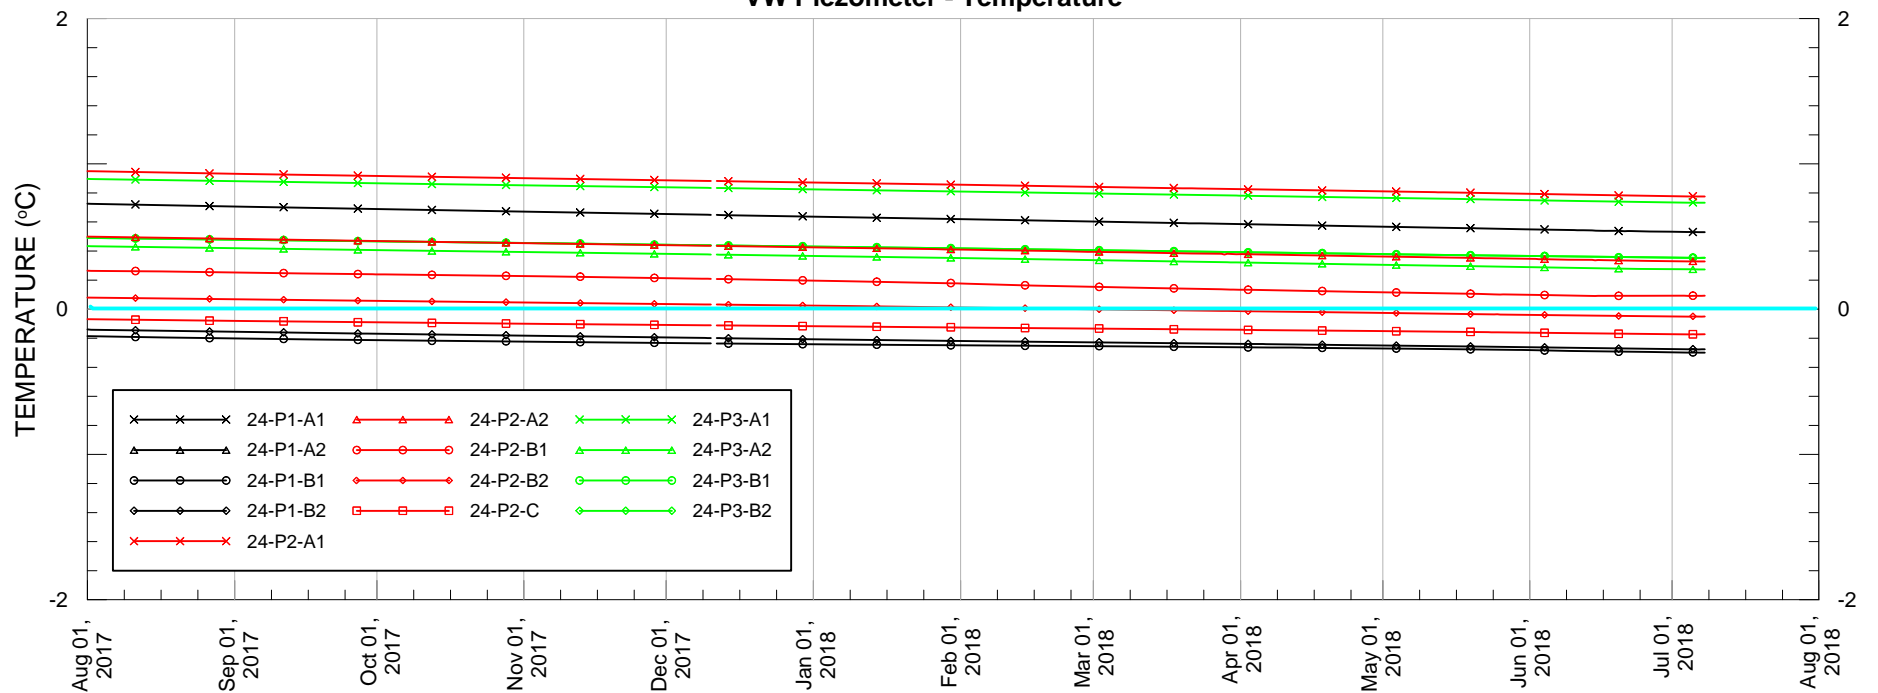
**STATION 31+600**

1. PWP is following same trend as previous years. When ice builds the pressure increases and when it melts in summer the pressure decreases
2. Gap in data in December was due to a low battery. Battery was changed the following day.

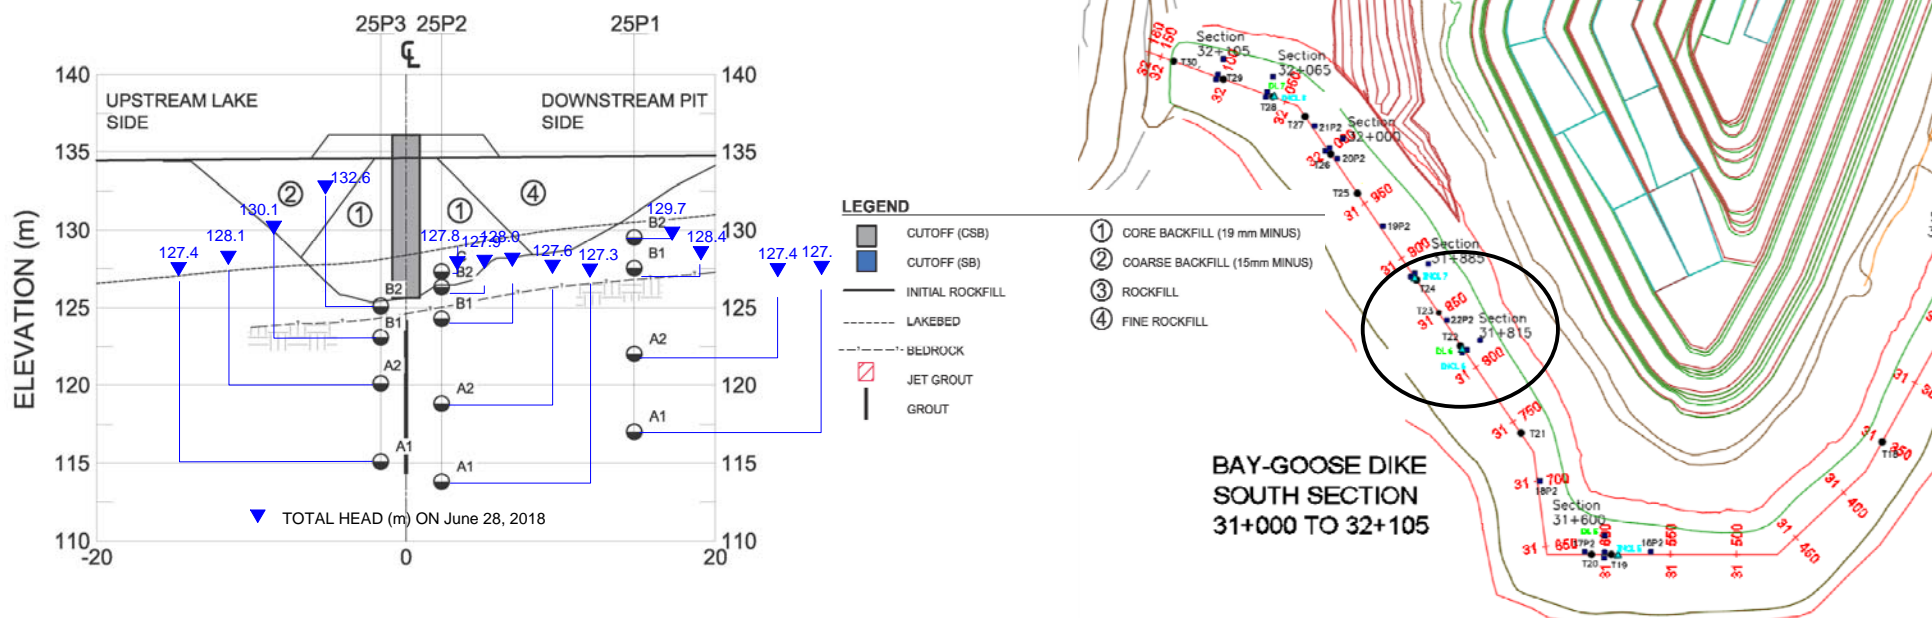
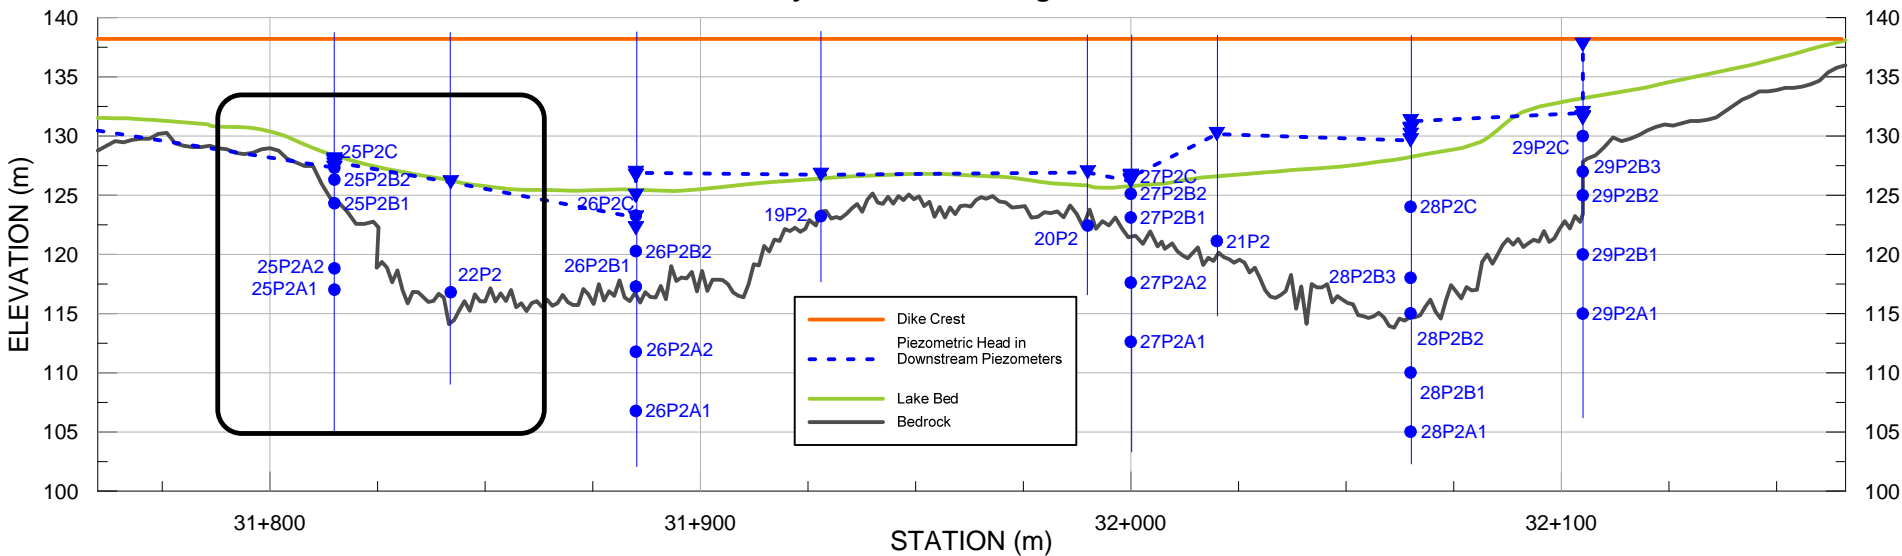
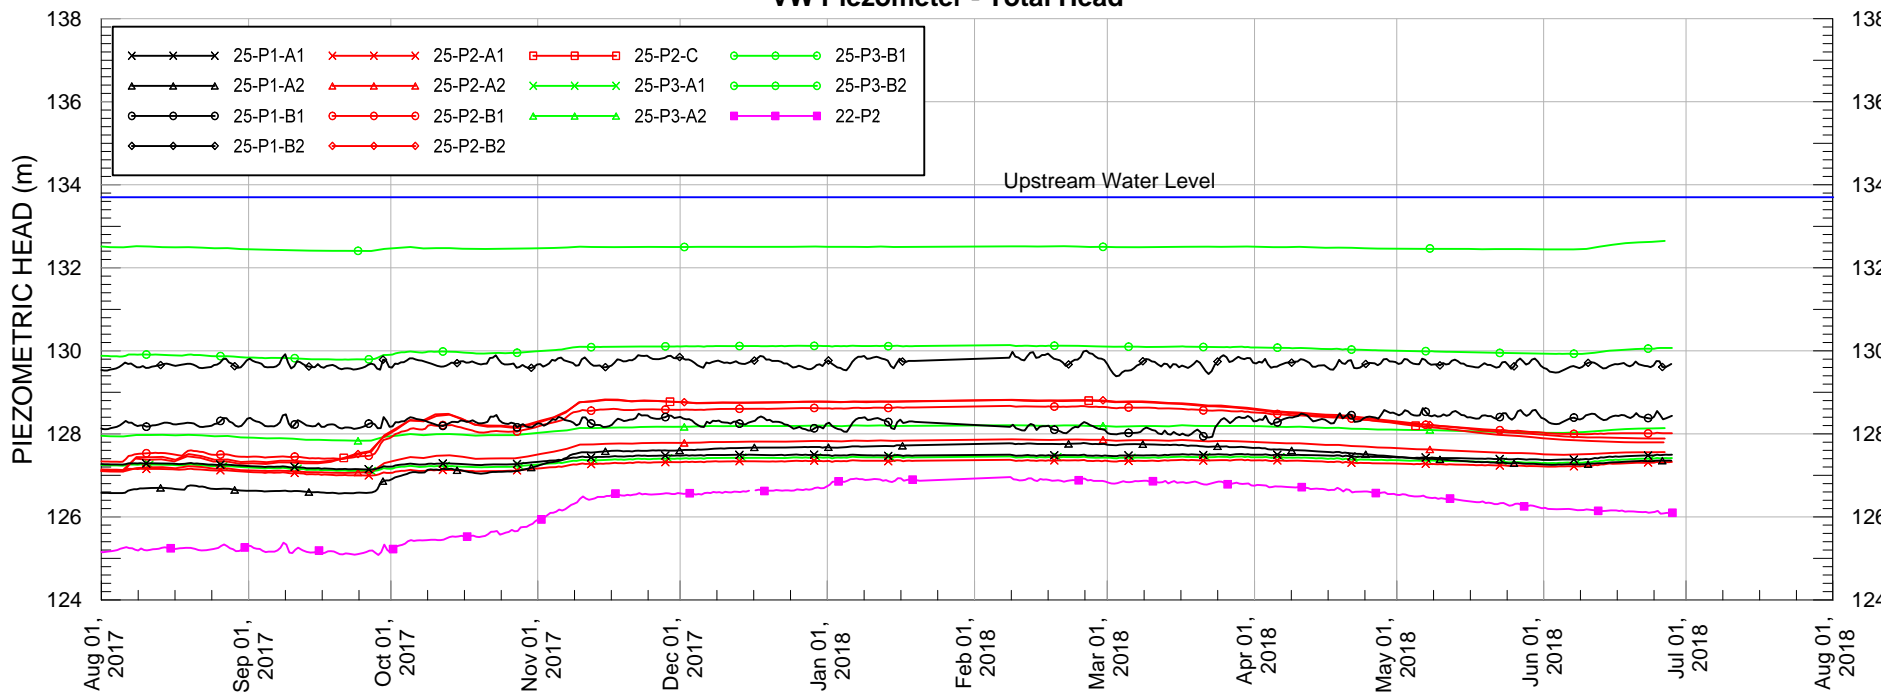
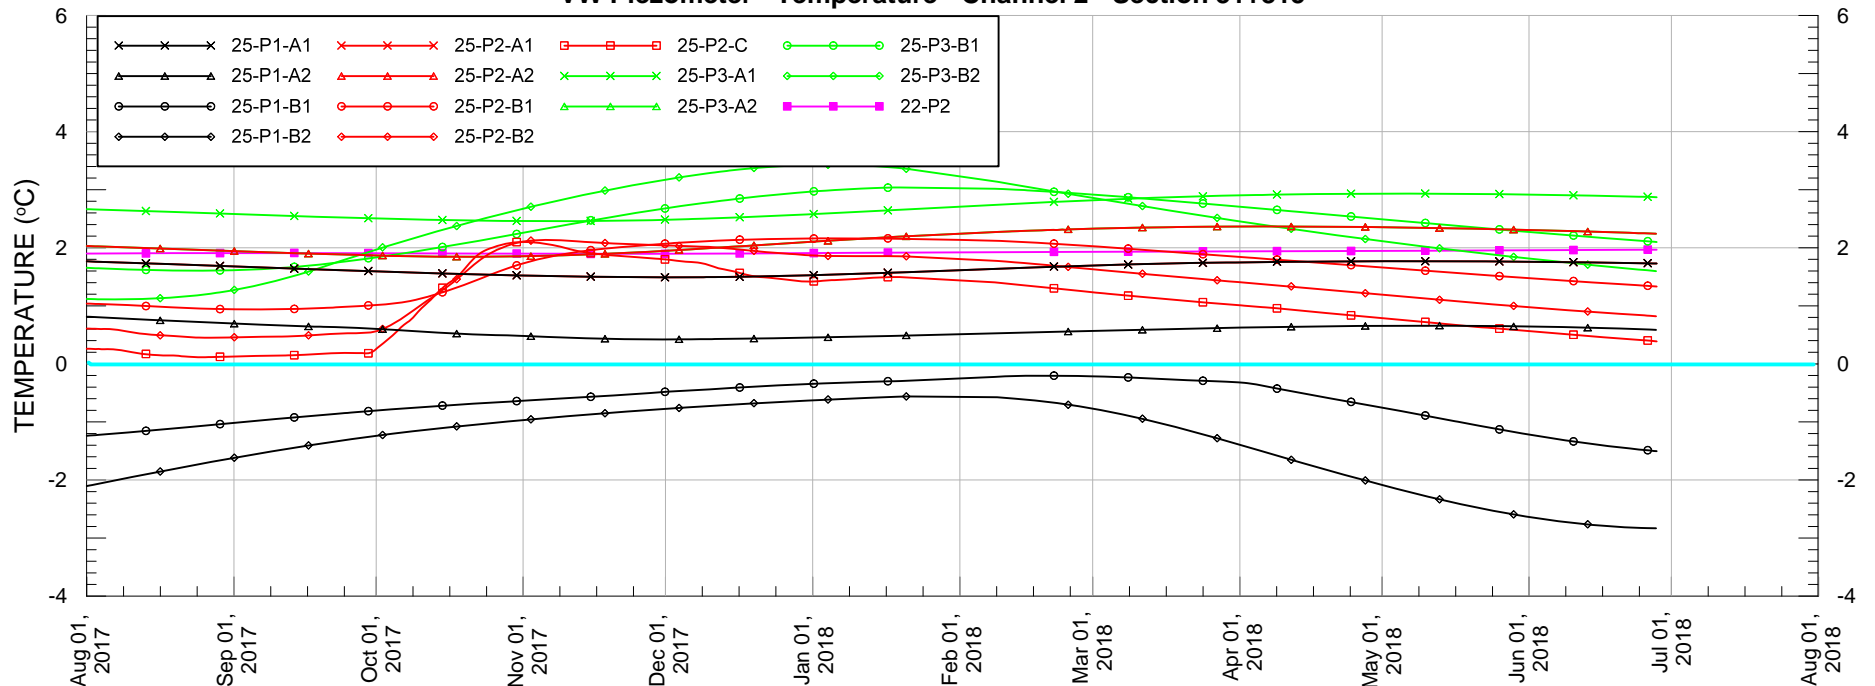
"Channel 2 & Channel 1" Bay-Goose Dike - Section 31+815 (DL6)

1. The rise in temperature and PWP was interpreted as the permafrost at the toe of the dike blocking the seepage path which led to this events. Will continue to monitor in the field and the instruments. Since the snow melt the blockage is not longer there and the PWP is on a downtrend.
2. There is a signal loss since March 7/18 which is due to the snow accumulating on the Goose Waste Dump pile. Since the snow melt signal is back.

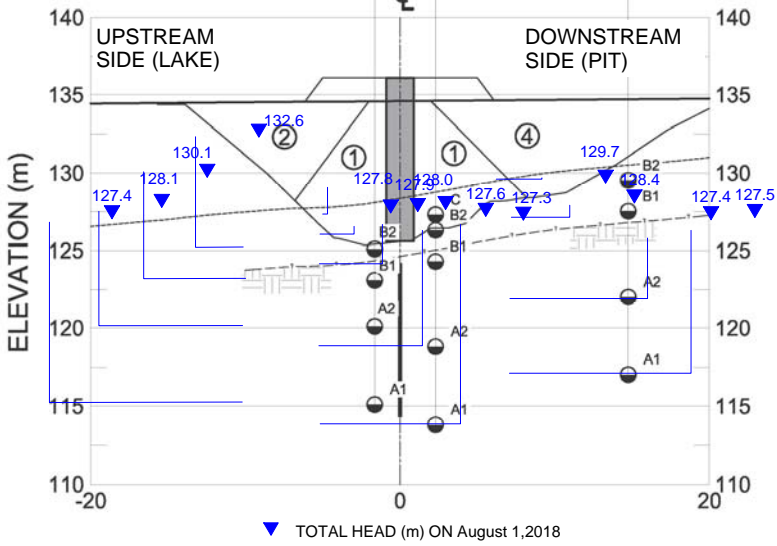
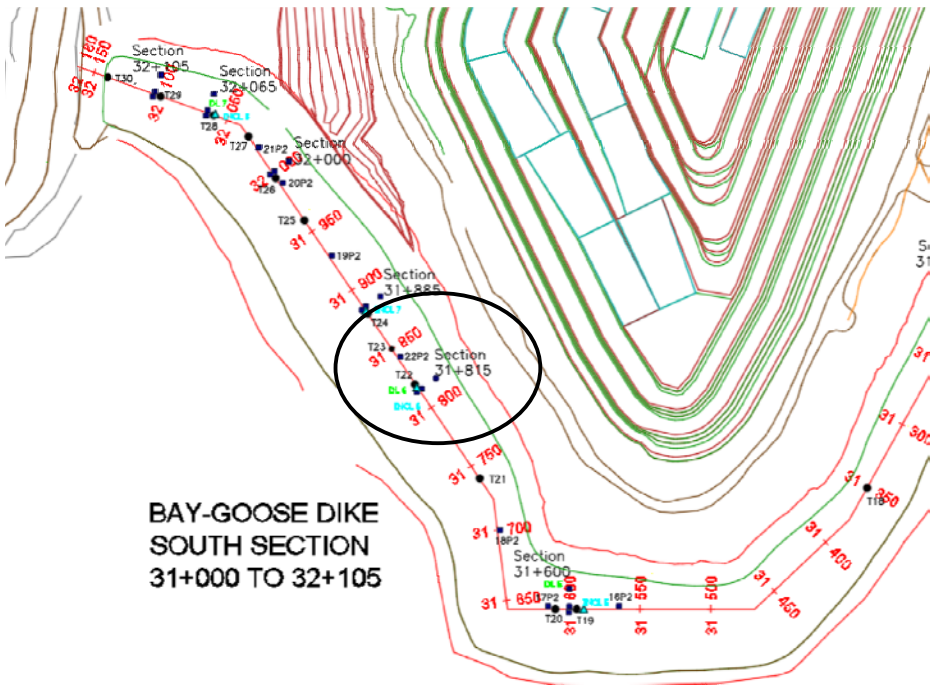
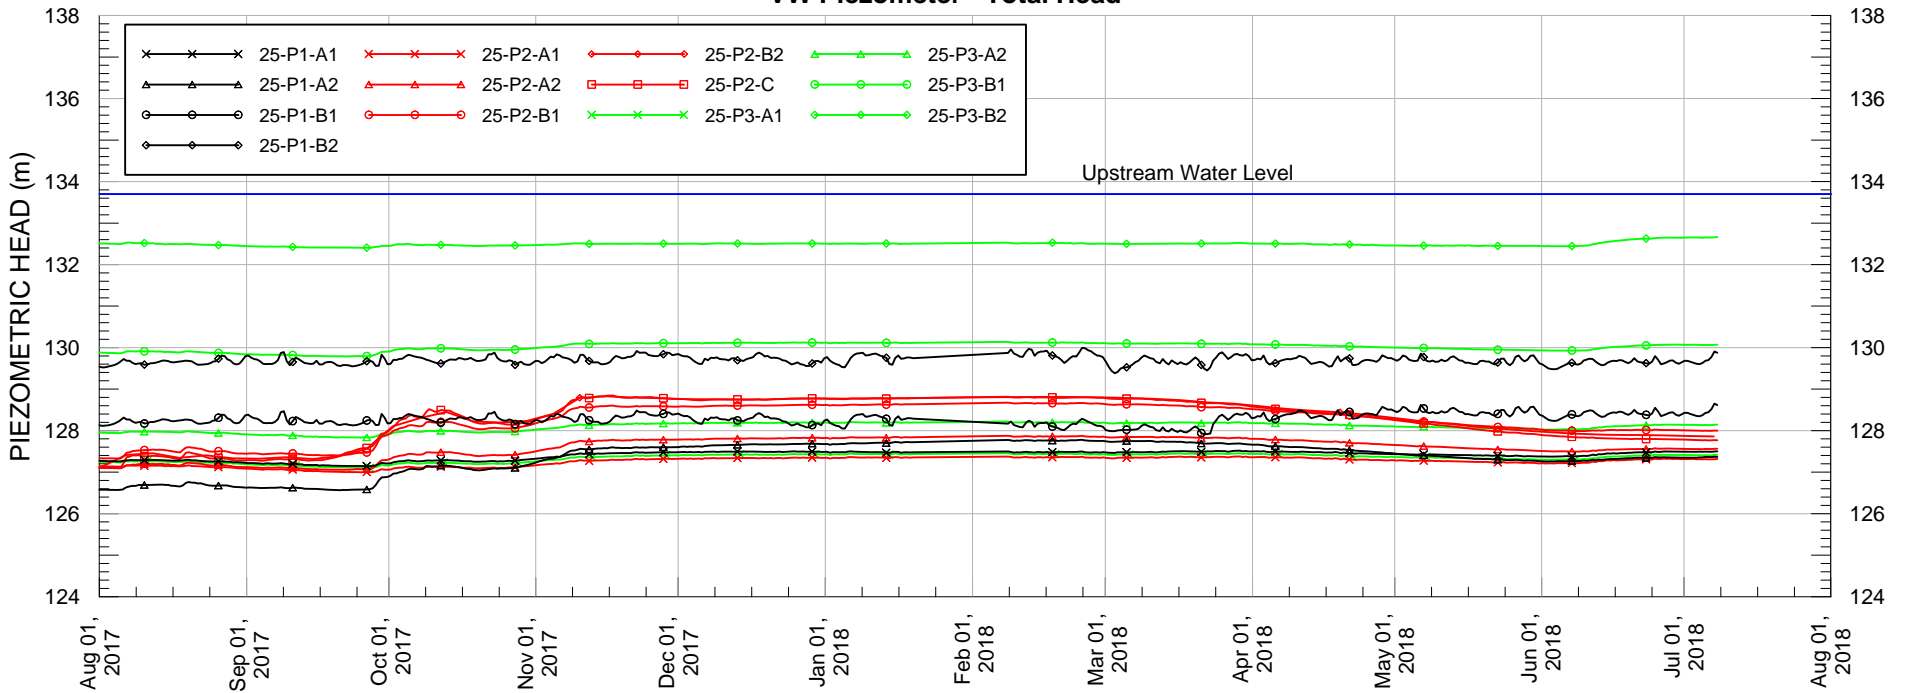
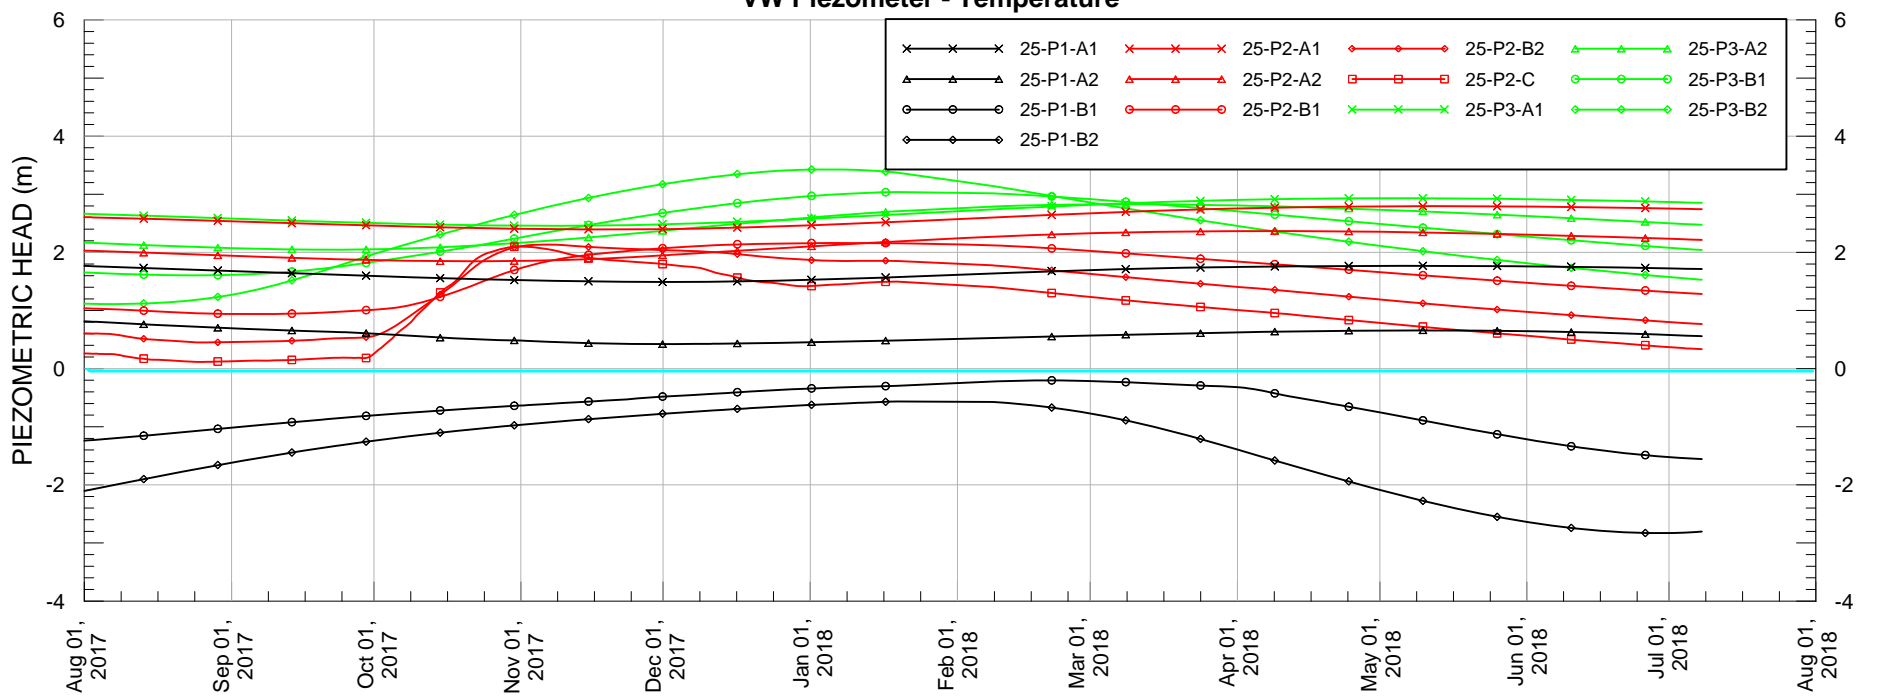
**STATION 31+815**

1. The rise in temperature and PWP was interpreted as the permafrost at the toe of the dike blocking the seepage path which led to this events. Will continue to monitor in the field and the instruments. Since the snow melt the blockage is no longer there and the PWP is on a downtrend.
2. There is a signal loss since March 7/18 which is due to the snow accumulating on the Goose Waste Dump pile. Since the snow melt signal is back.
