# **Meadowbank and Whale Tail 2018 Annual Geotechnical Inspection**

# 2018 Annual Geotechnical Inspection

*Meadowbank Gold Mine, Nunavut*

18101627-1583-R-Rev0

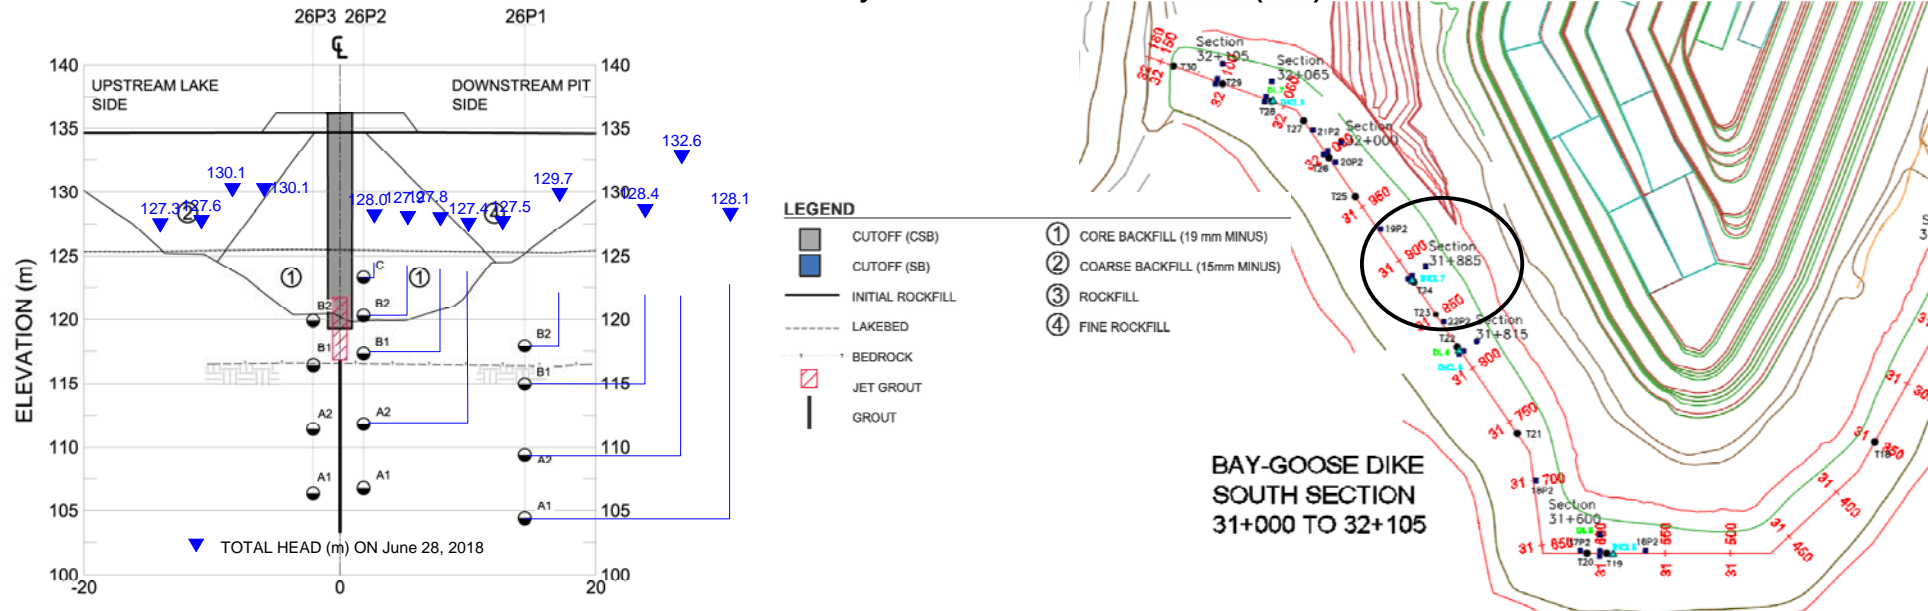
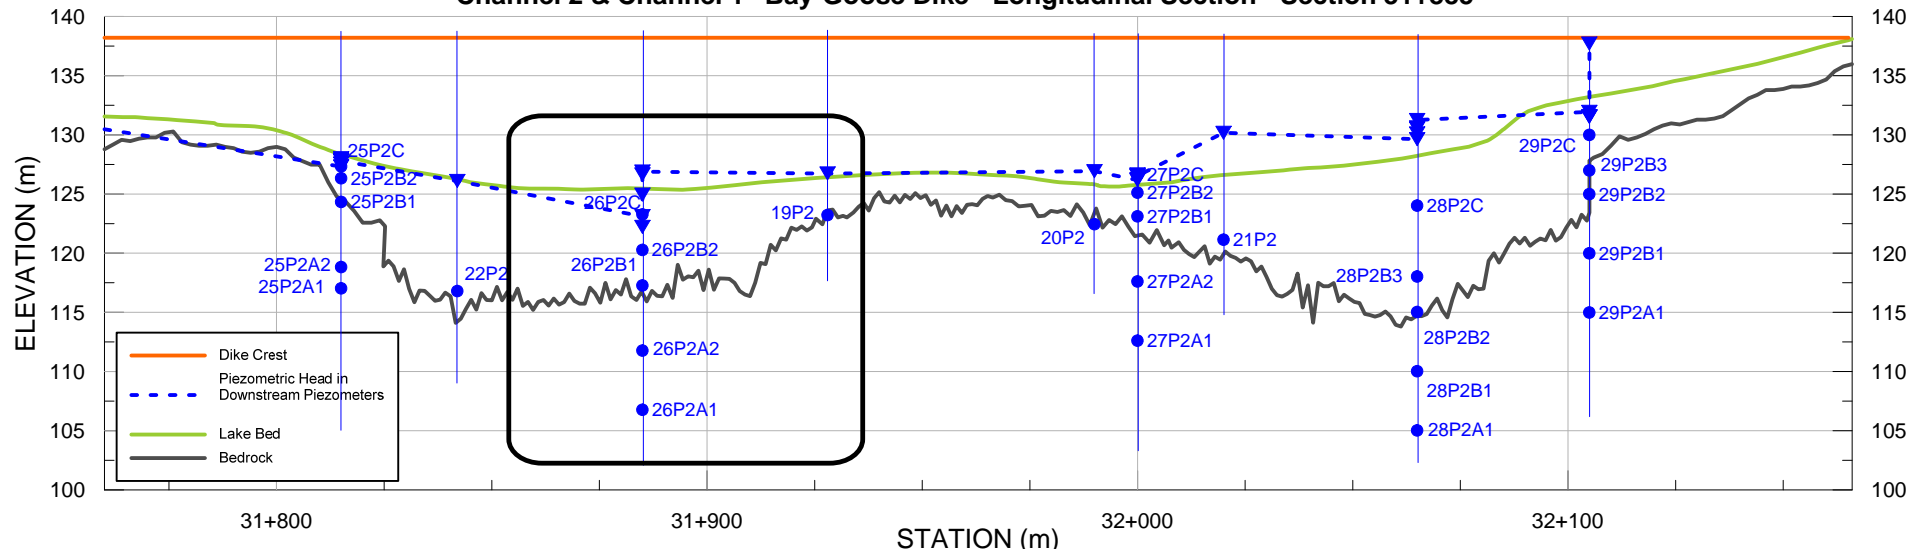
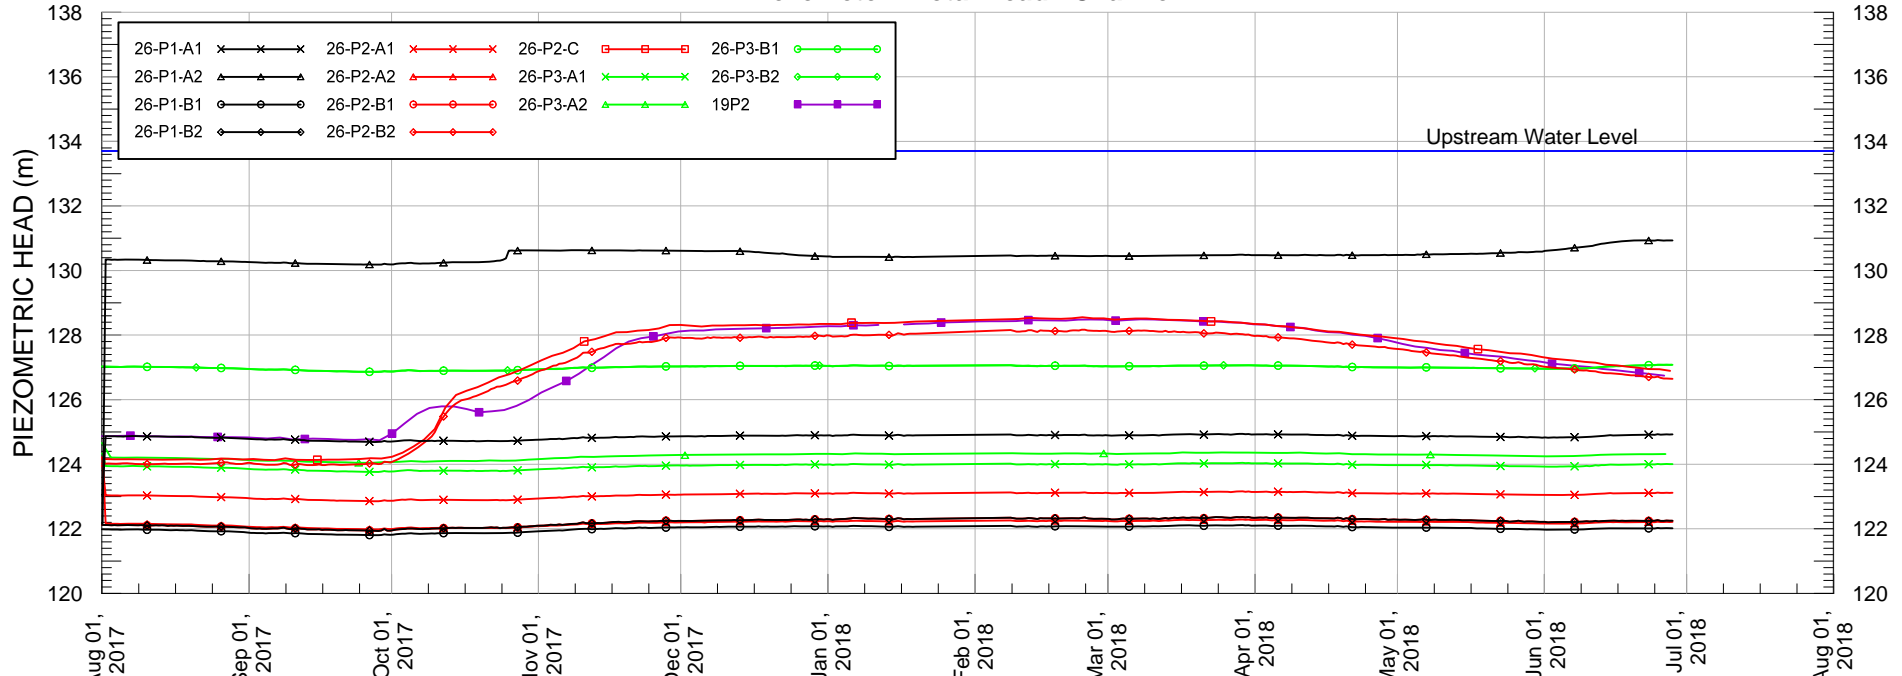
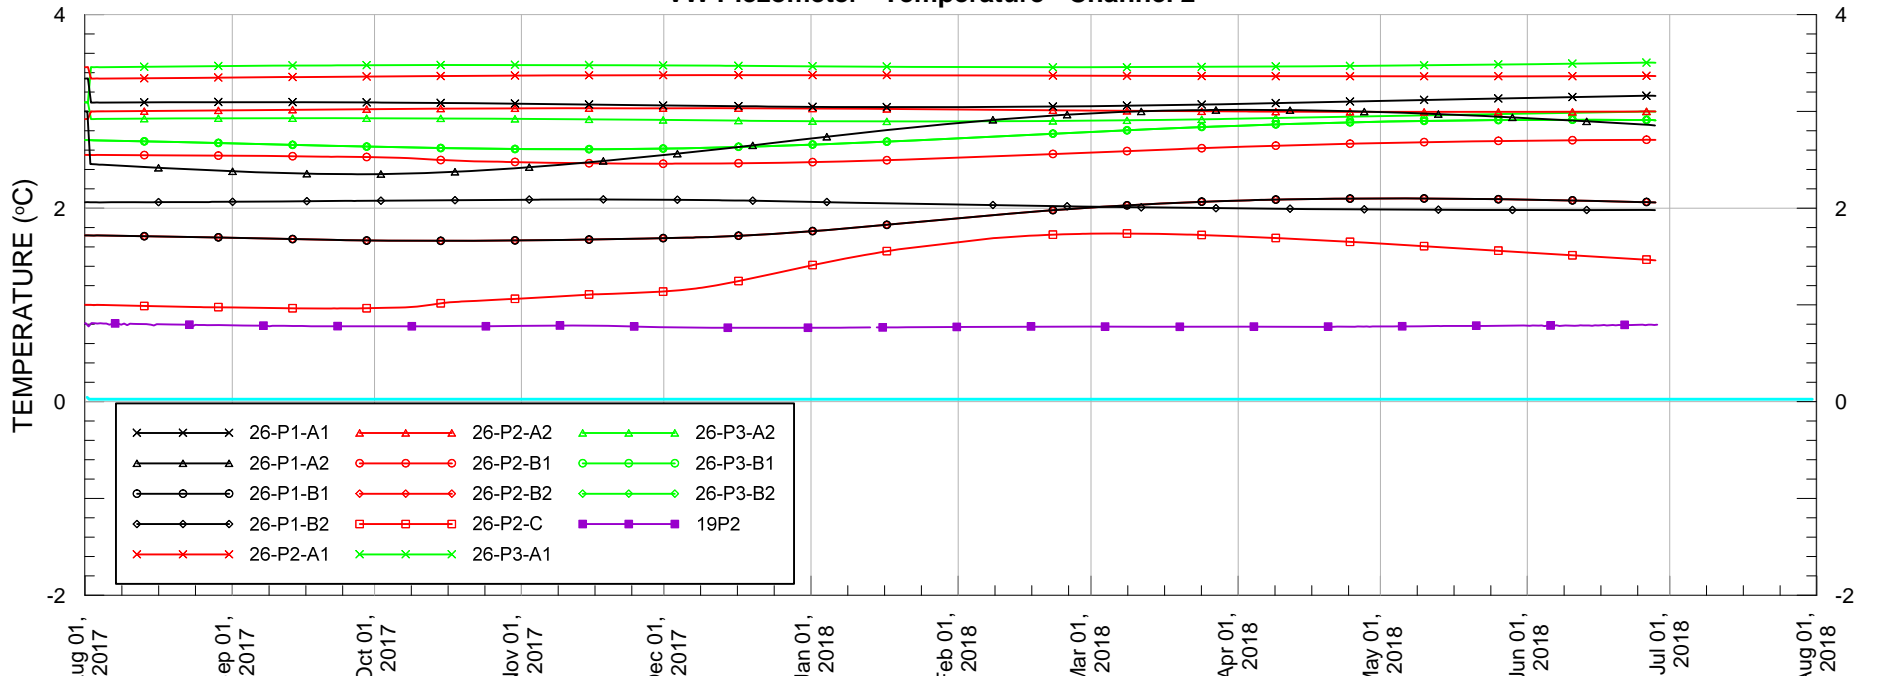
"Channel 2 & Channel 1" Bay-Goose Dike - Section 31+885 (DL6)

- The rise in temperature and PWP was interpreted as the permafrost at the toe of the dike blocking the seepage path which led to this events. Will continue to monitor in the field and the instruments. Now that ice has melted the PWP has decreased as the seepage path is no longer blocked.
- There is a signal loss since March 7/18 which is due to the snow accumulating on the Goose Waste Dump pile. Signal since snow melt has resumed.

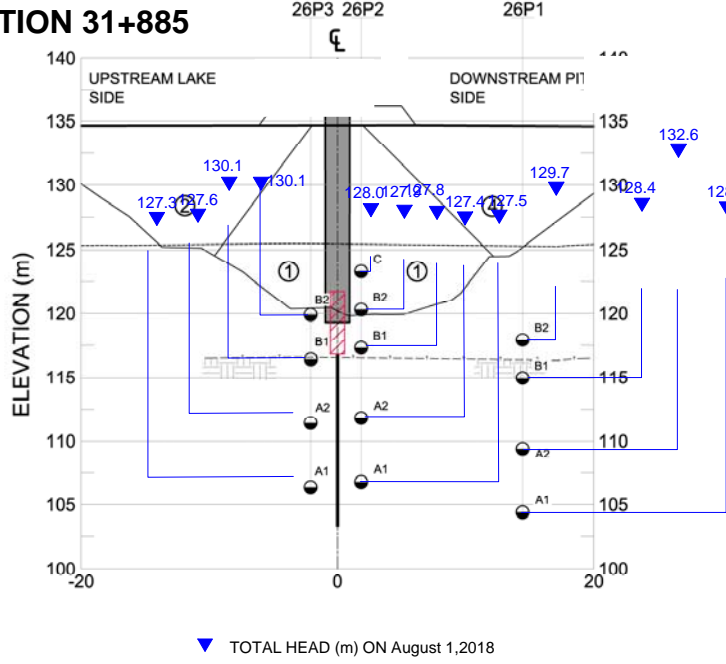
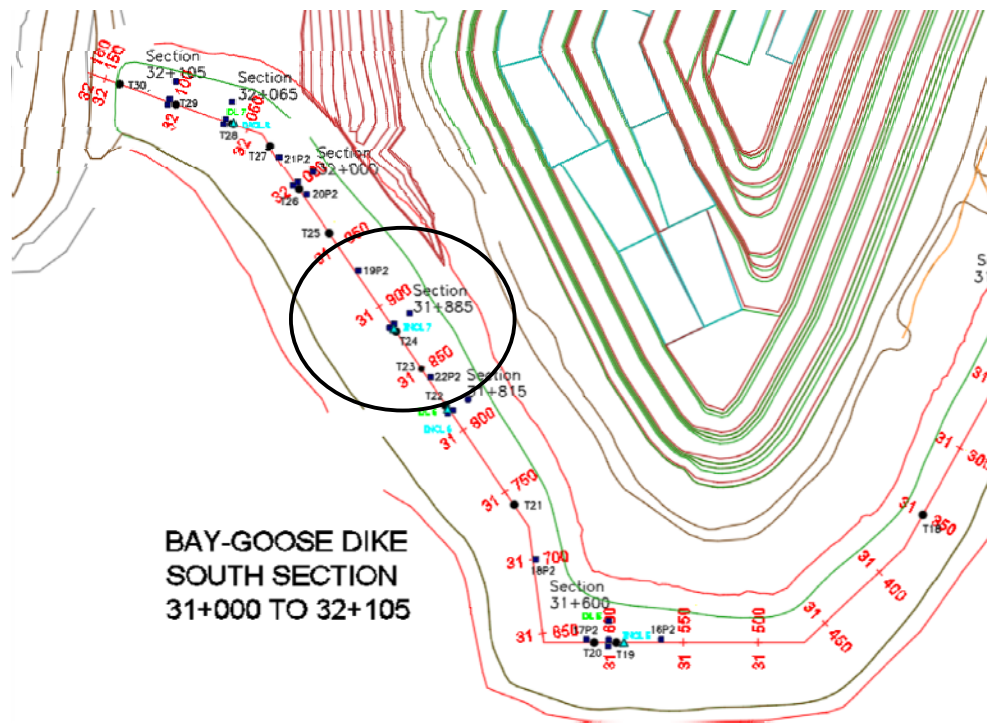
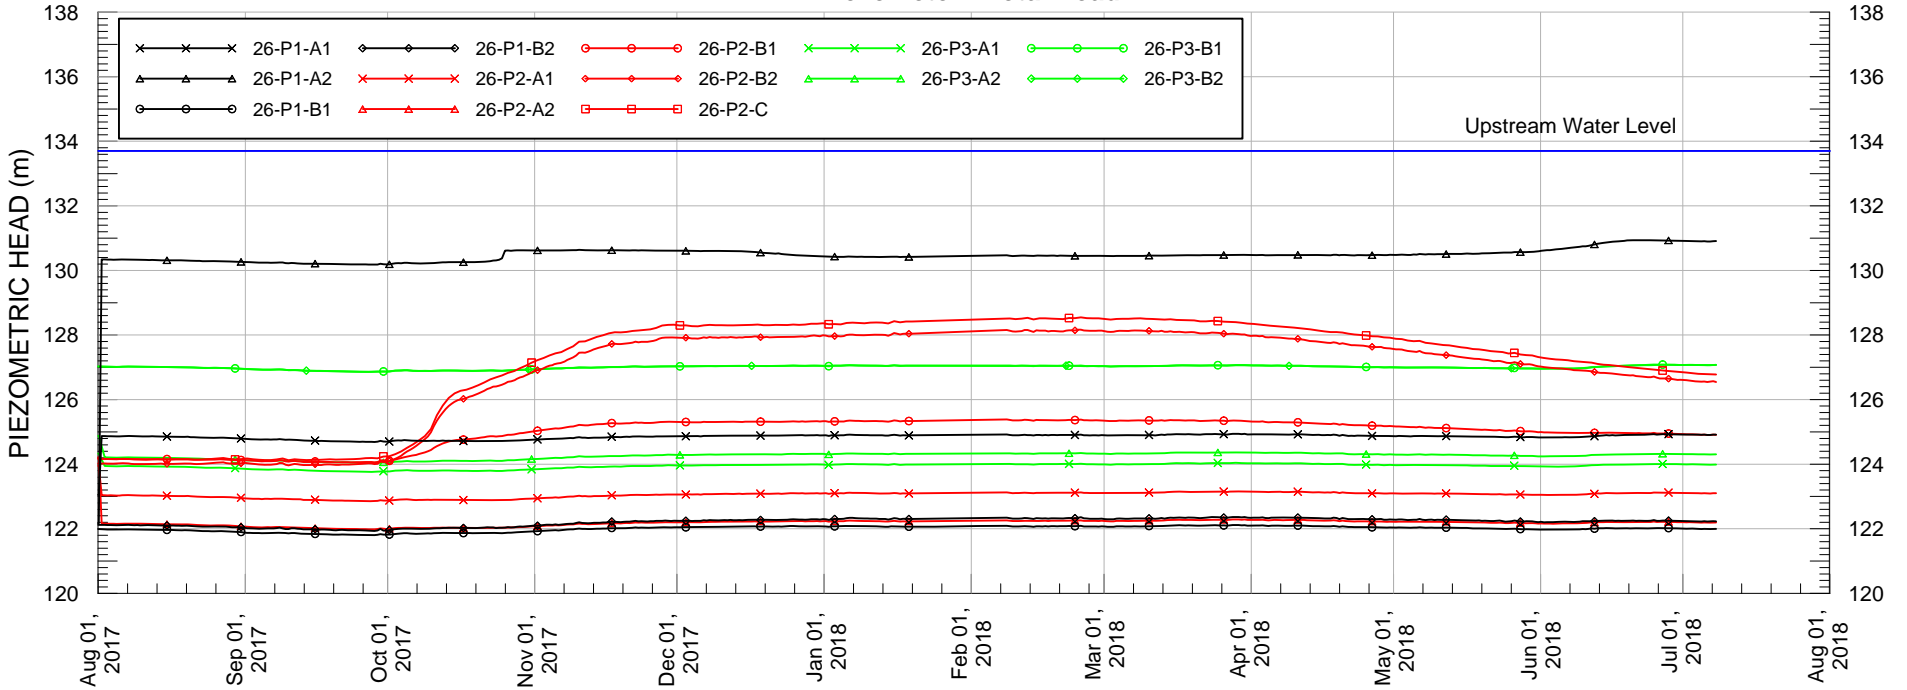
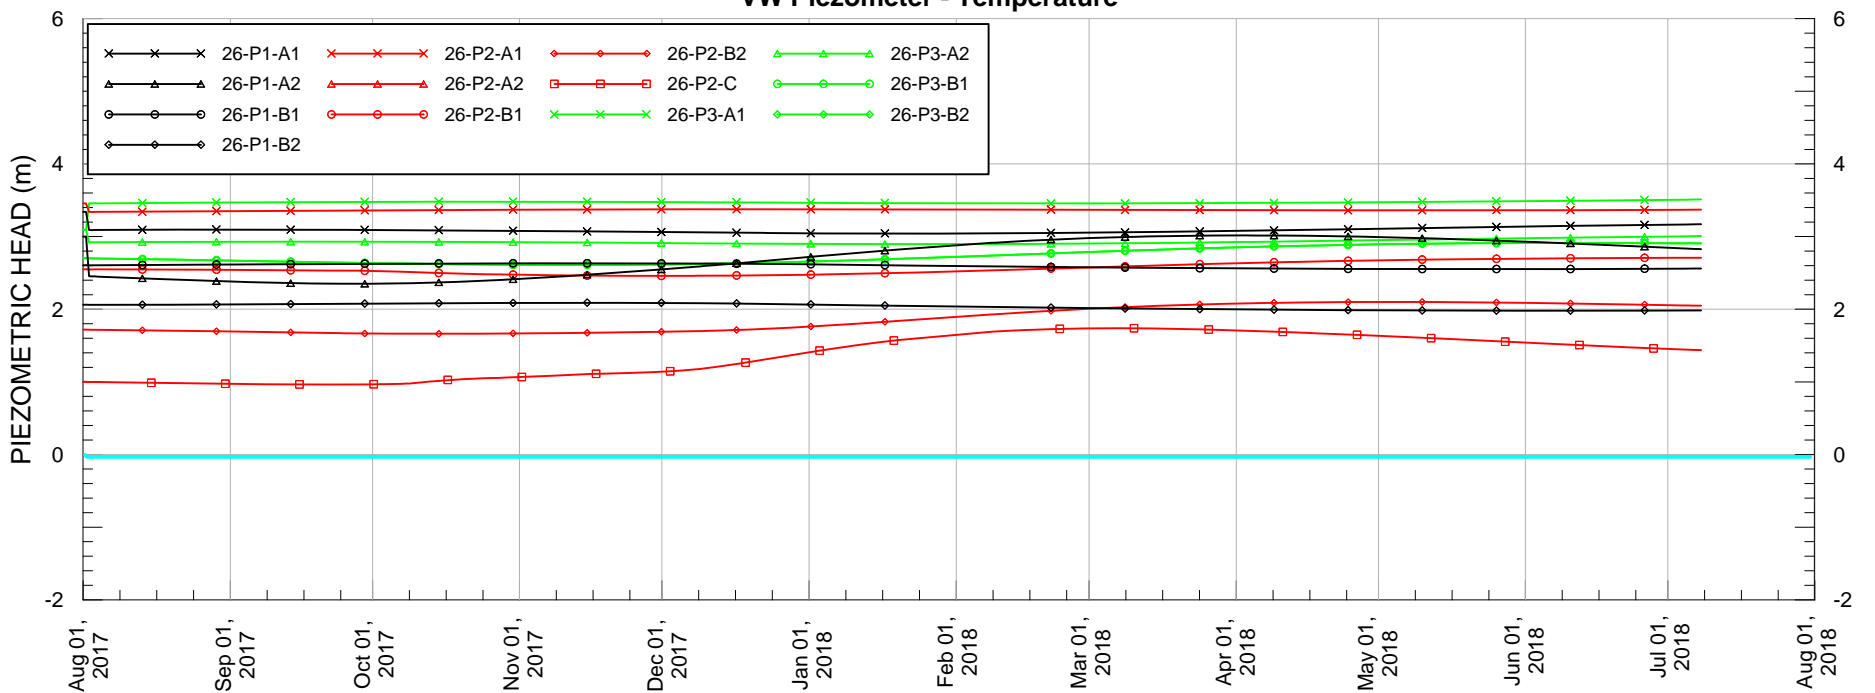
| REVIEW | | | <b>FIGURE 17</b> |

1. The rise in temperature and PWP was interpreted as the permafrost at the toe of the dike blocking the seepage path which led to this events. Will continue to monitor in the field and the instruments. Now that ice has melted the PWP has decreased as the seepage path is no longer blocked.
2. There is a signal loss since March 7/18 which is due to the snow accumulating on the Goose Waste Dump pile. Signal since snow melt has resumed.

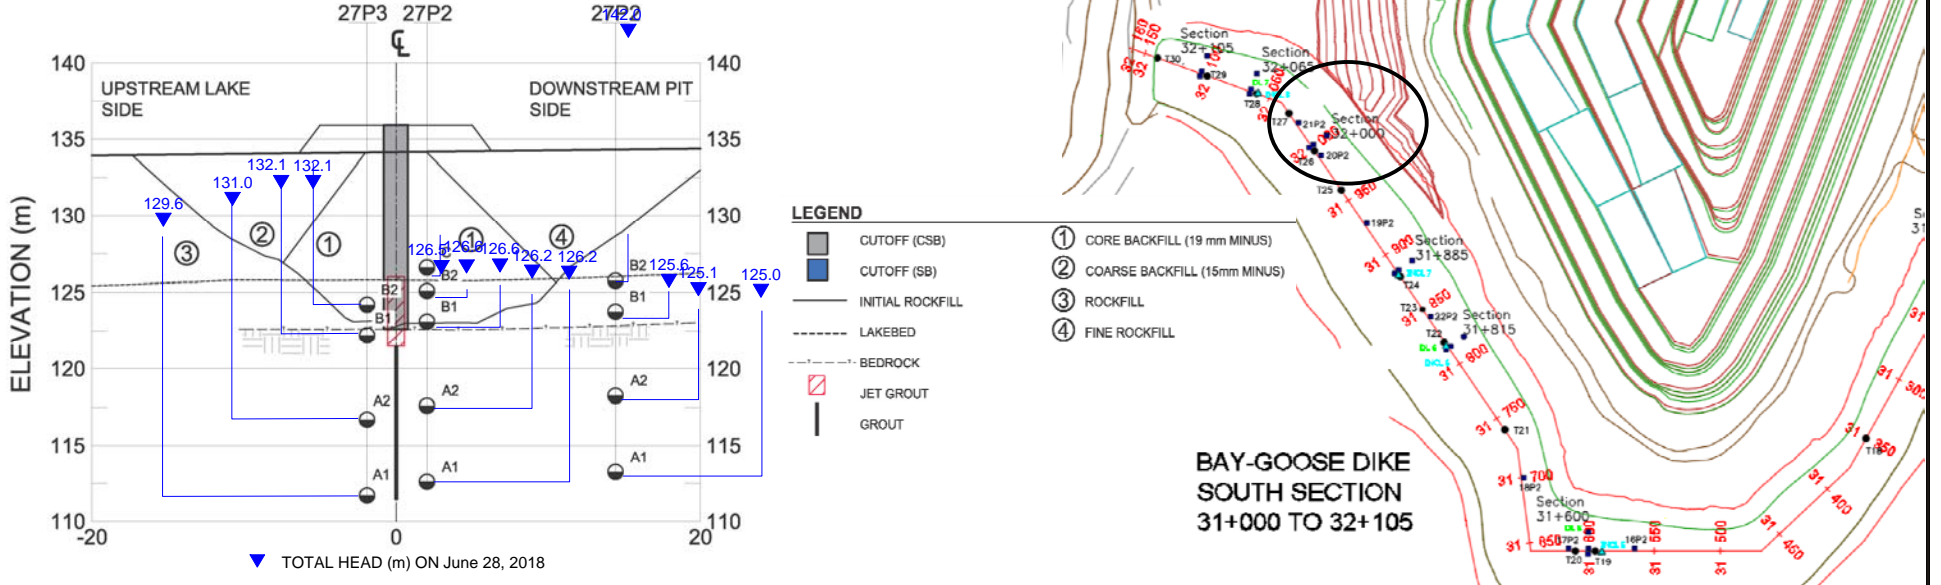
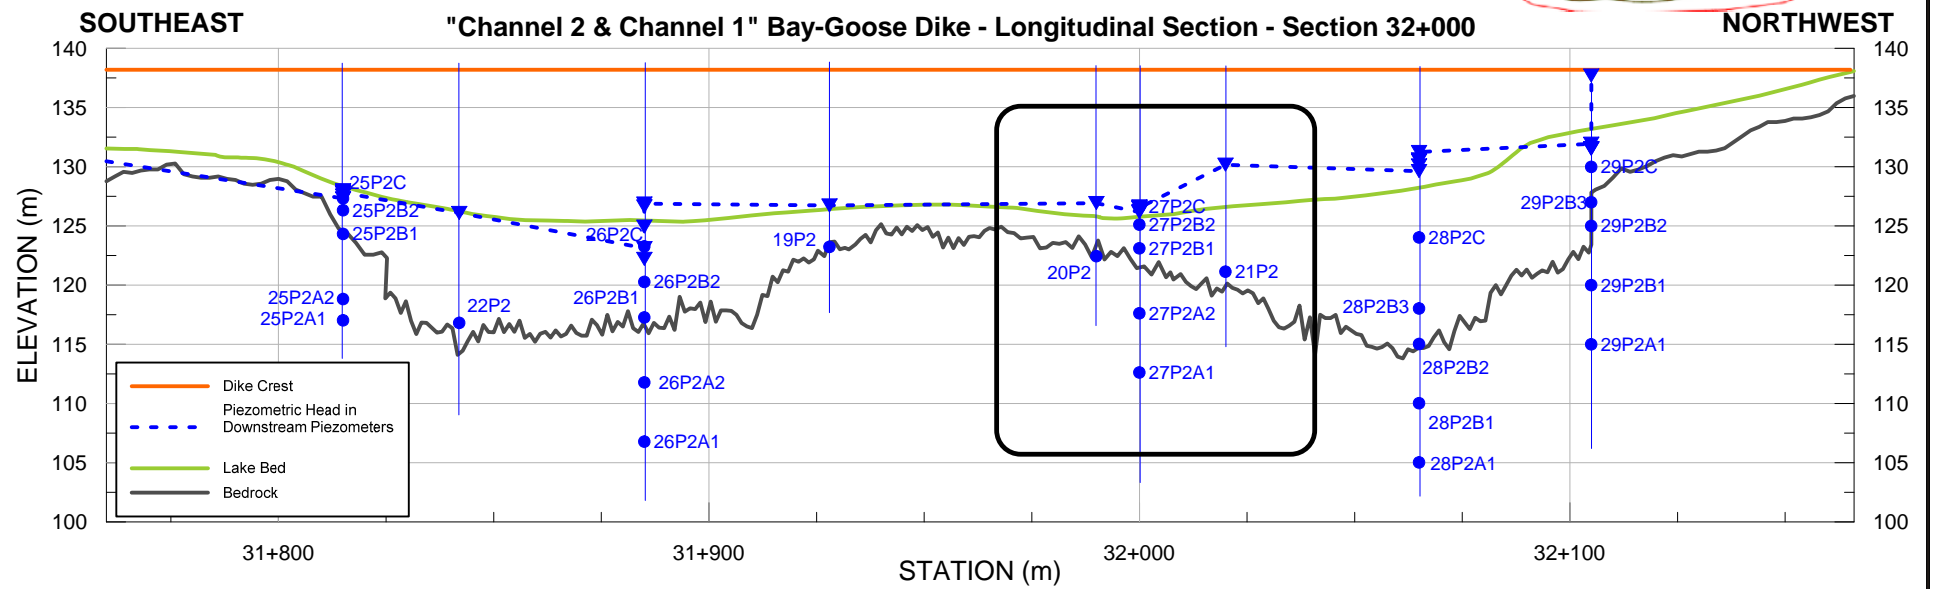
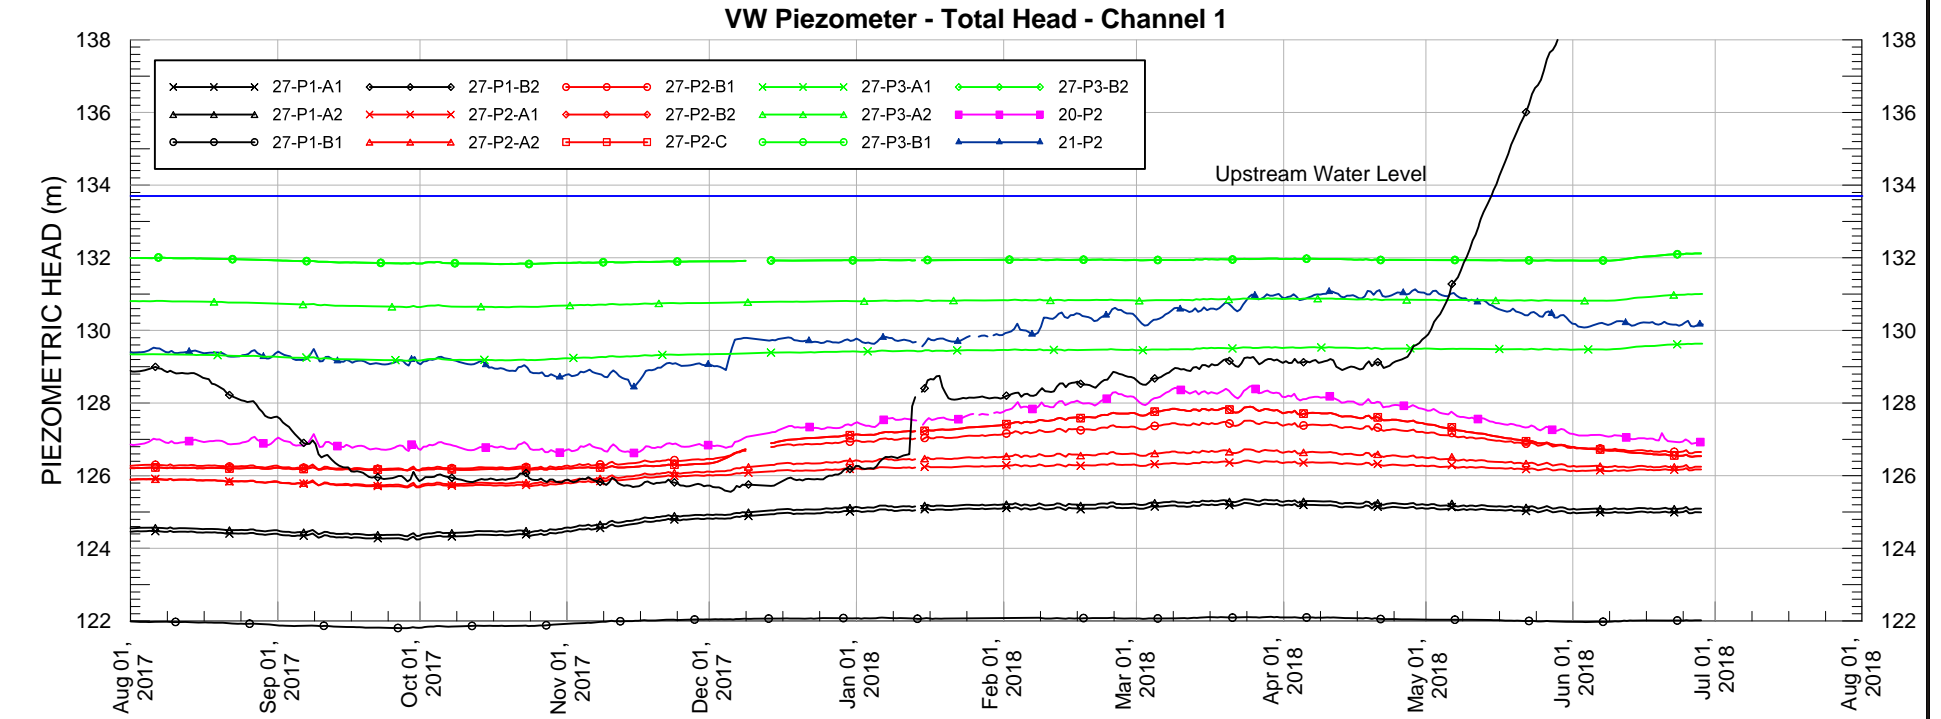
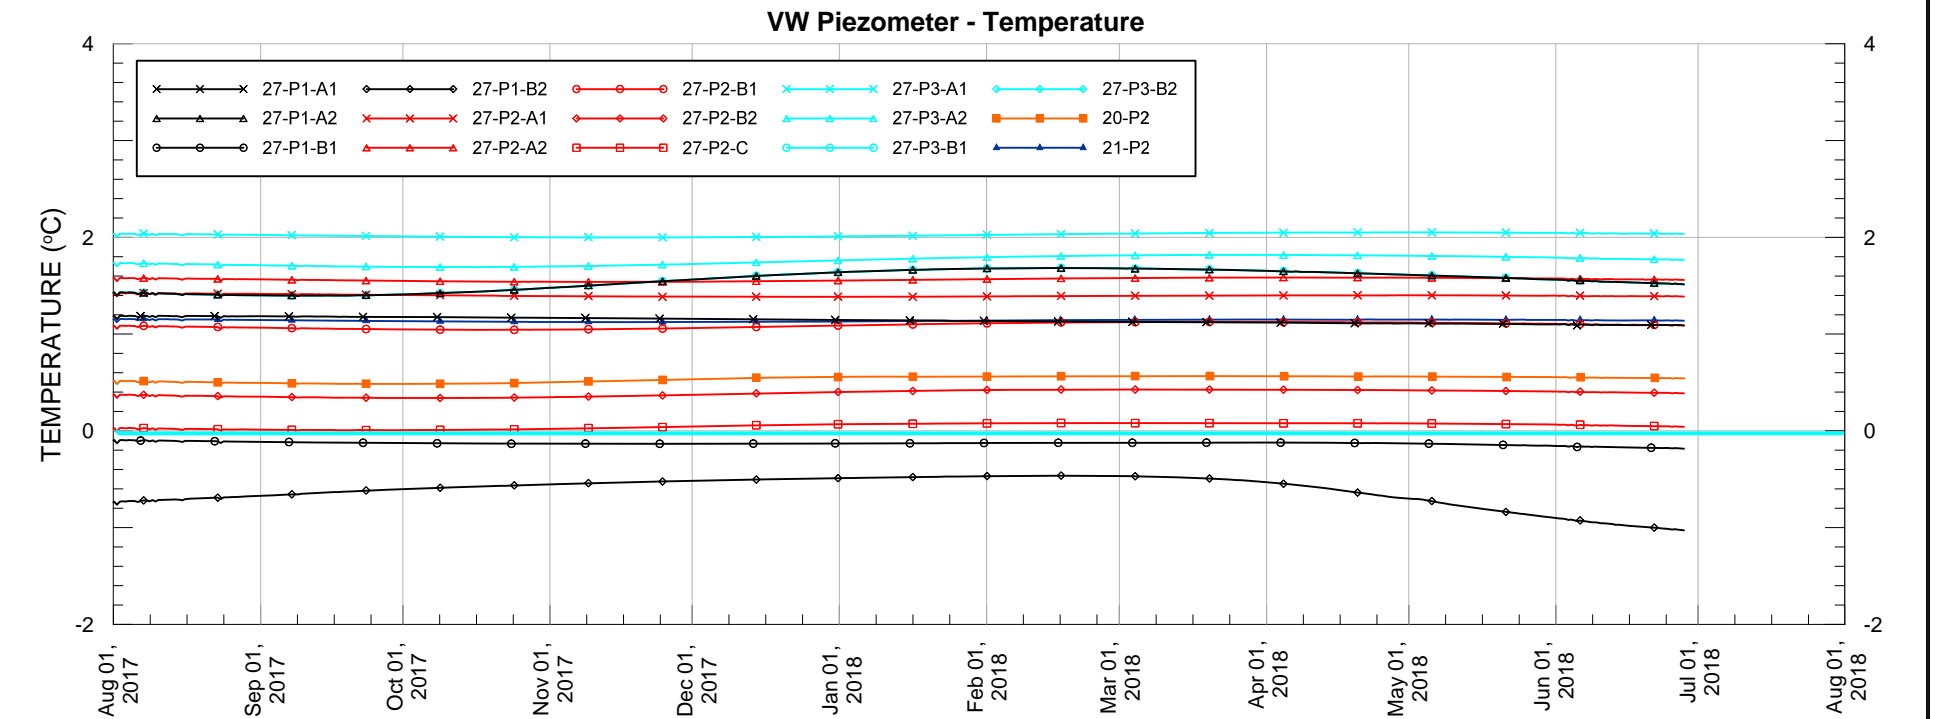
**"Channel 2 & Channel 1" Bay-Goose Dike - Section 32+000 (DL7)**

**NOTES:**  
 1. There is a signal loss since March 7/18 which is due to the snow accumulating on the Goose Waste Dump pile. Since the snow melt the signal has returned. Data is still collected in the instrument.  
 2. With the spike PWP pressure in 27-P1-B2 it is assumed that this instrument is not functioning anymore as the PWP pressure is higher than the lake elevation.

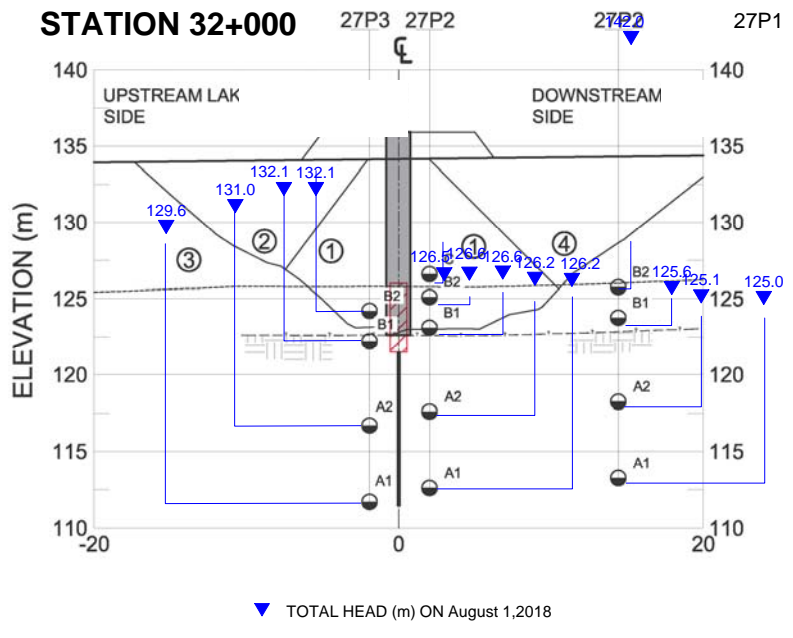
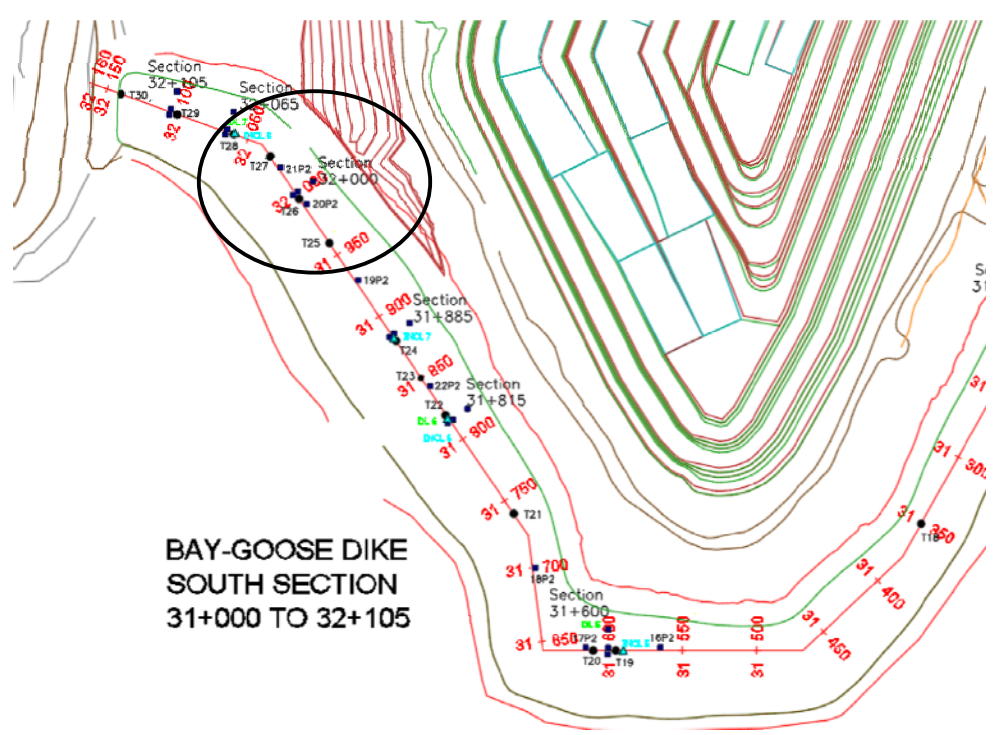
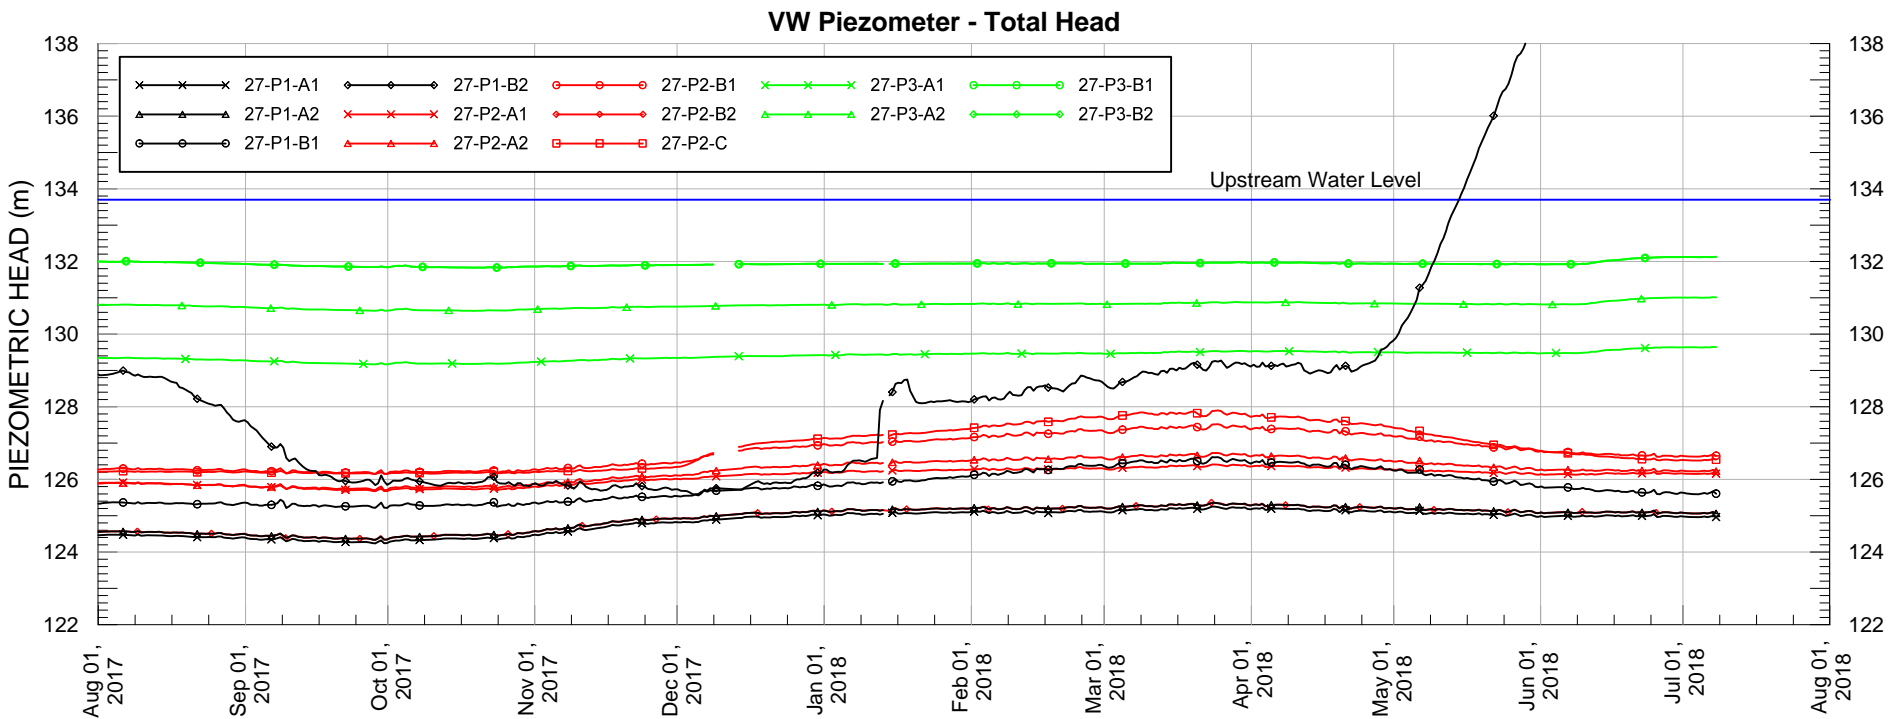
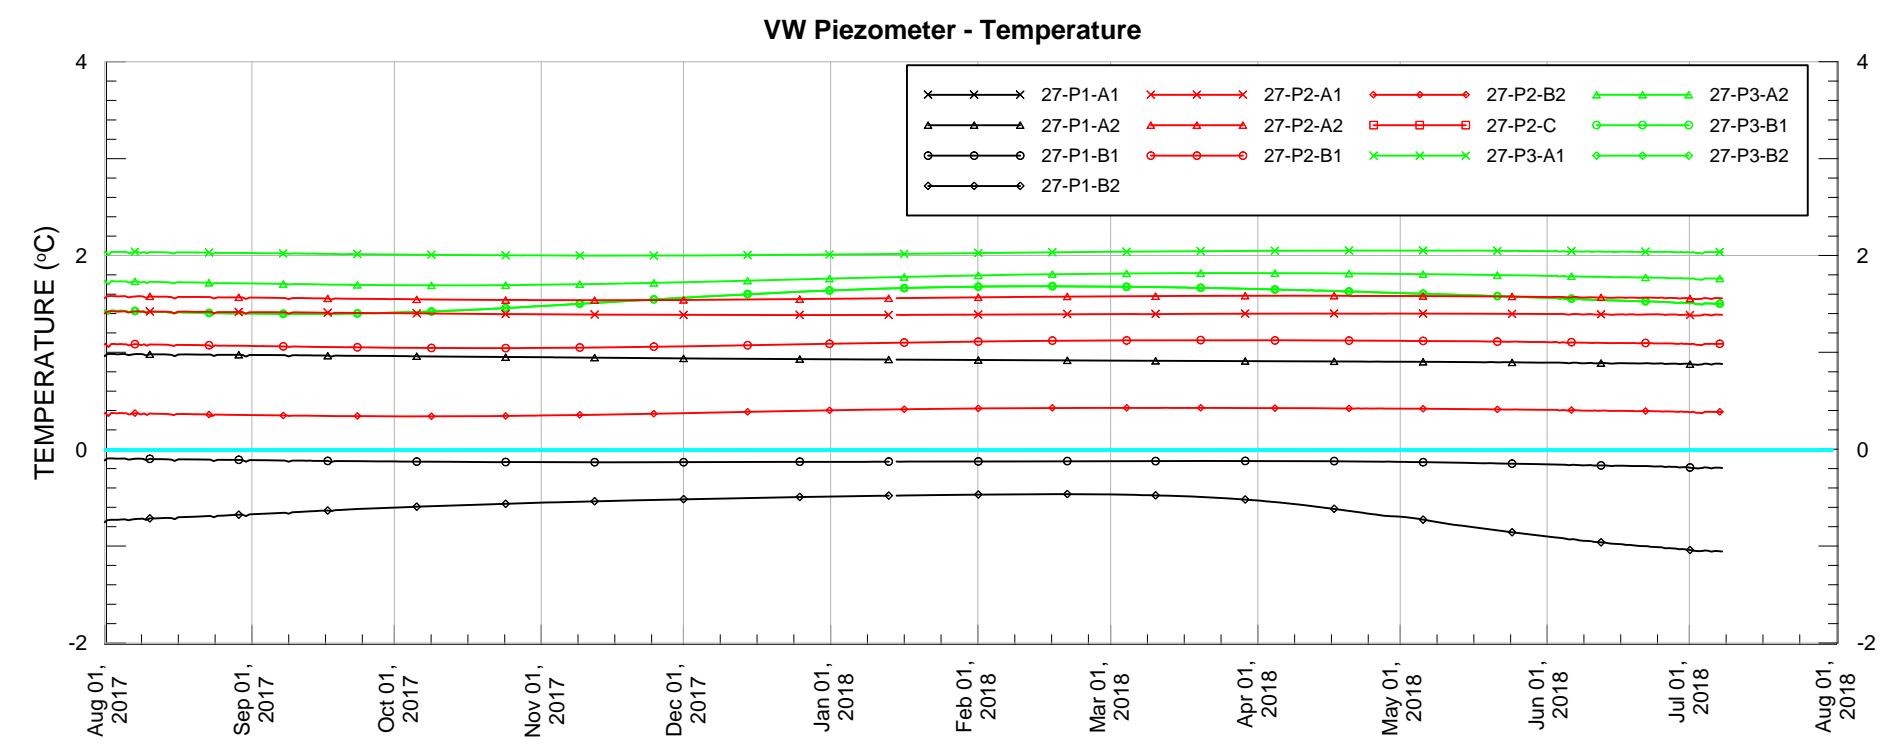
| REVIEW | | | | <b>FIGURE 19</b> |

1. There is a signal loss since March 7/18 which is due to the snow accumulating on the Goose Waste Dump pile. Since the snow melt the signal has returned.
2. With the spike PWP pressure in 27-P1-B2 it is assumed that this instrument is not functioning anymore as the PWP pressure is higher than the lake elevation.

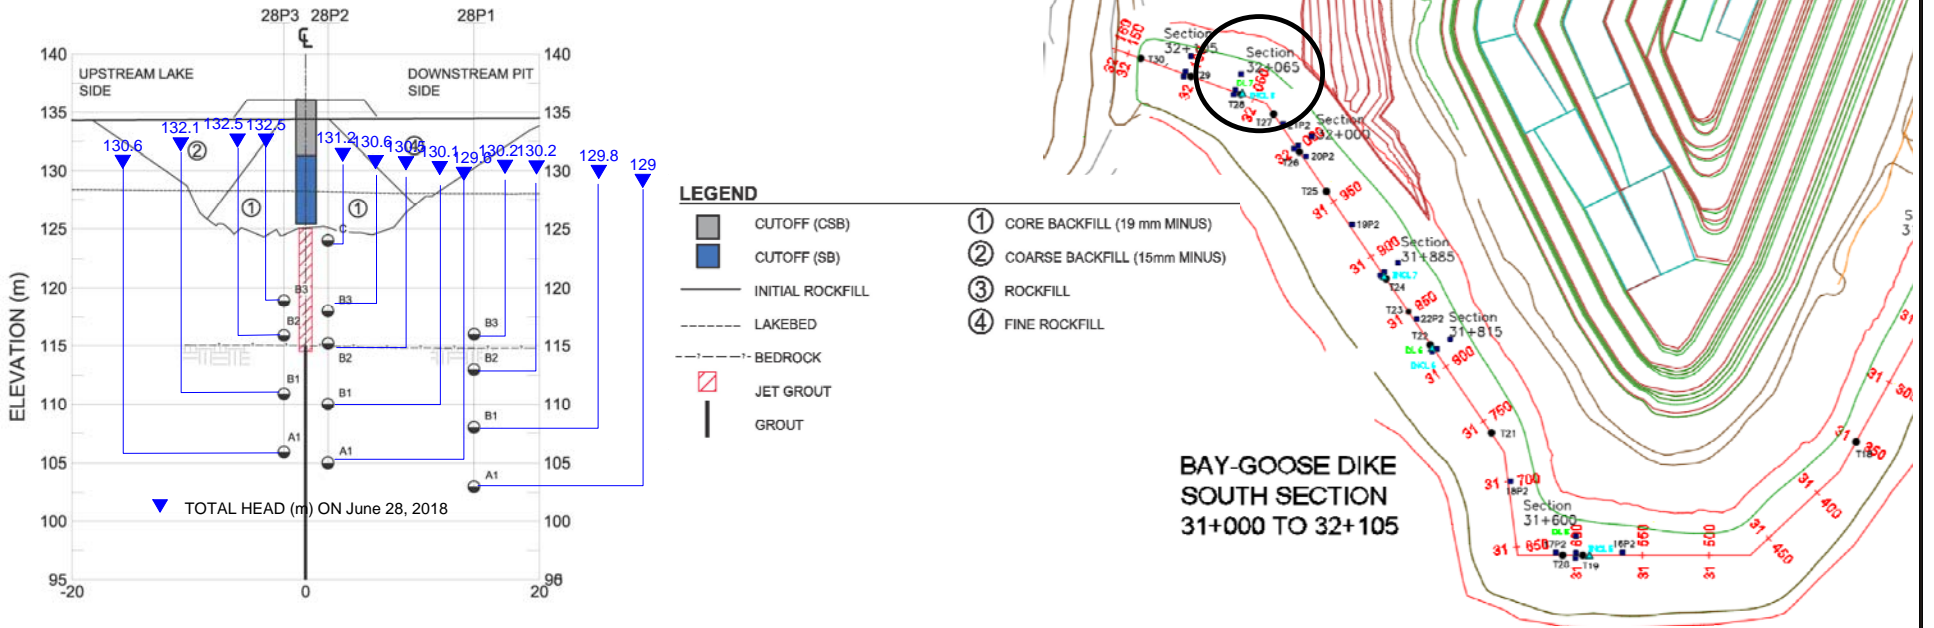
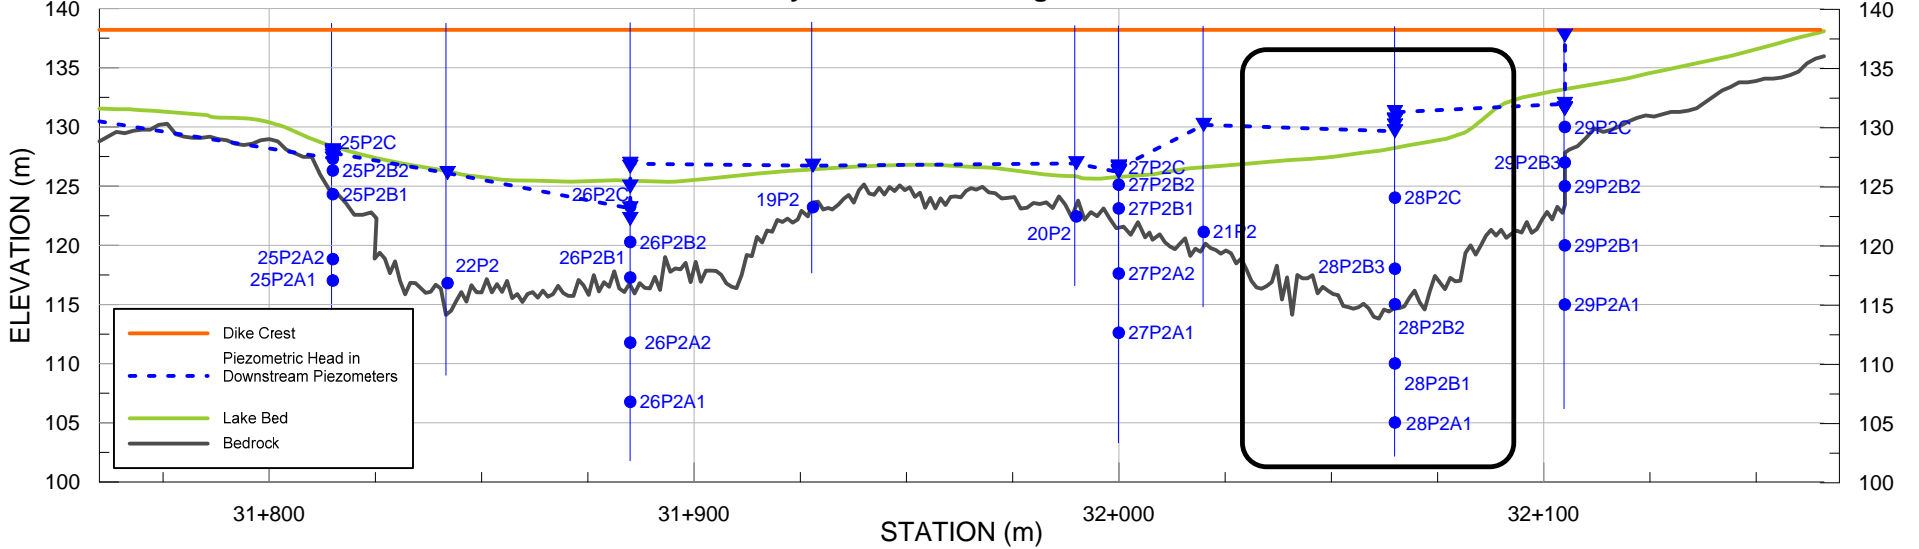
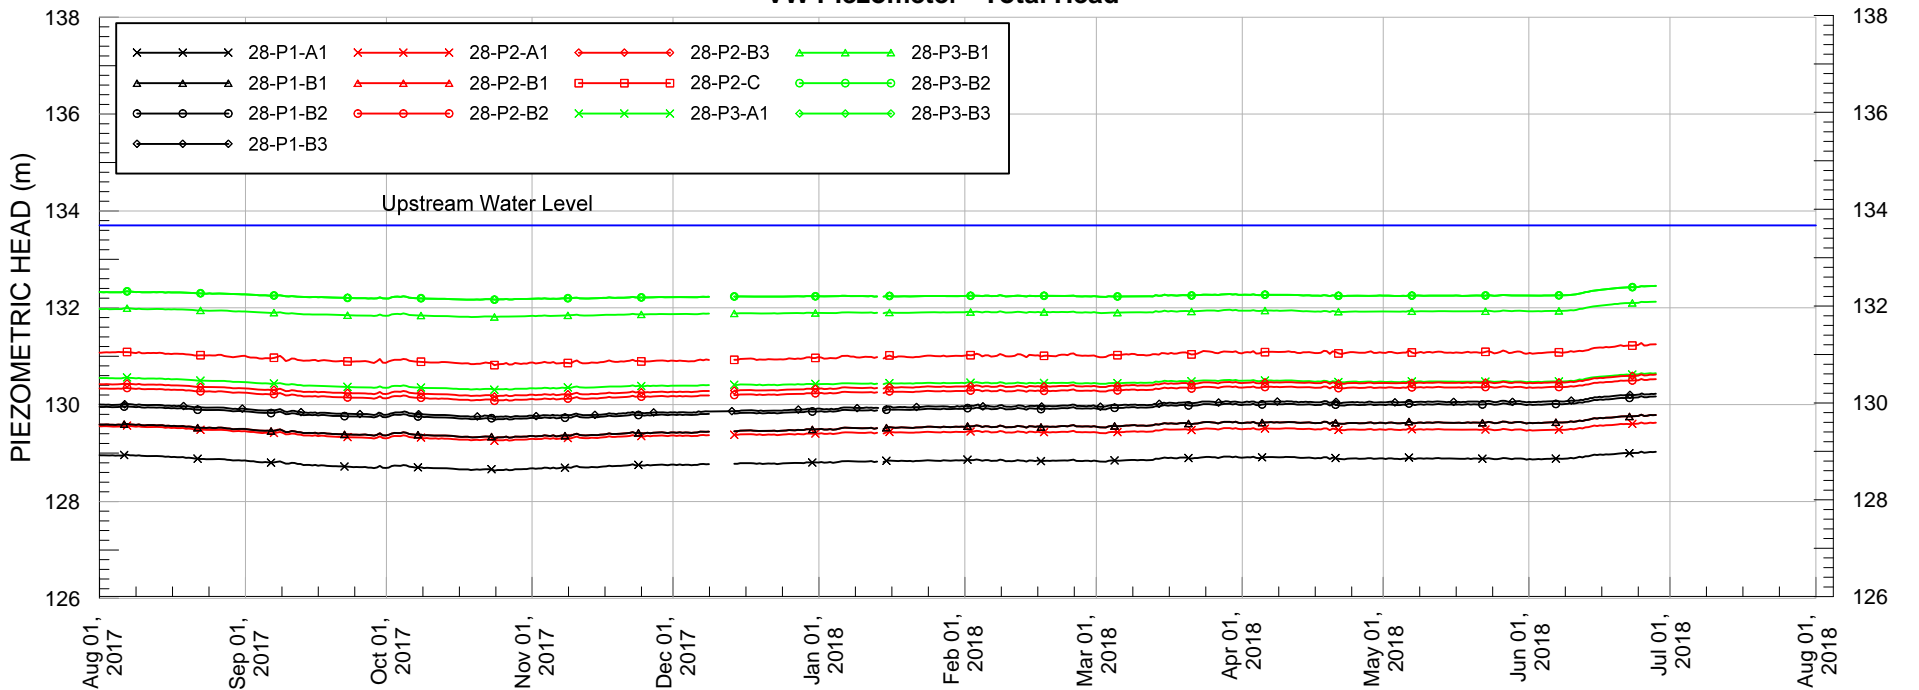
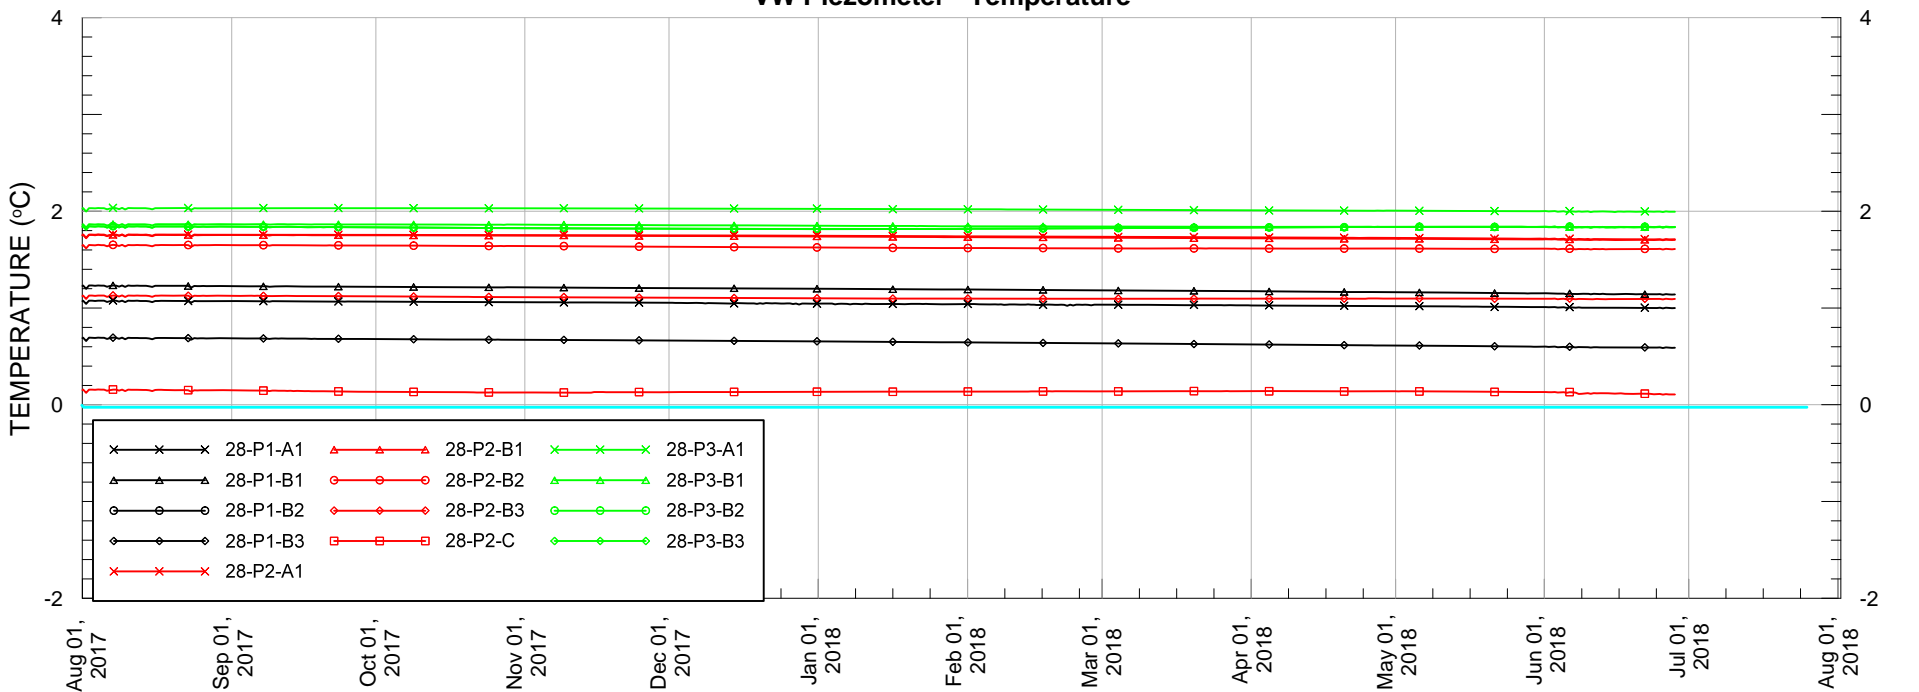
| REVIEW | | <b>FIGURE 20</b> | |

1. There are some anomaly readings from Dec. 10 to Dec. 11 which is due to low battery, which was changed.
2. There is a signal loss since March 7/18 which is due to the snow accumulating on the Goose Waste Dump pile. Since the snow melt the signal has returned.
3. Gap in data in December and January is due to low battery. Battery was changed the following day after.
