# **Meadowbank and Whale Tail 2018 Annual Geotechnical Inspection**

# 2018 Annual Geotechnical Inspection

*Meadowbank Gold Mine, Nunavut*

18101627-1583-R-Rev0

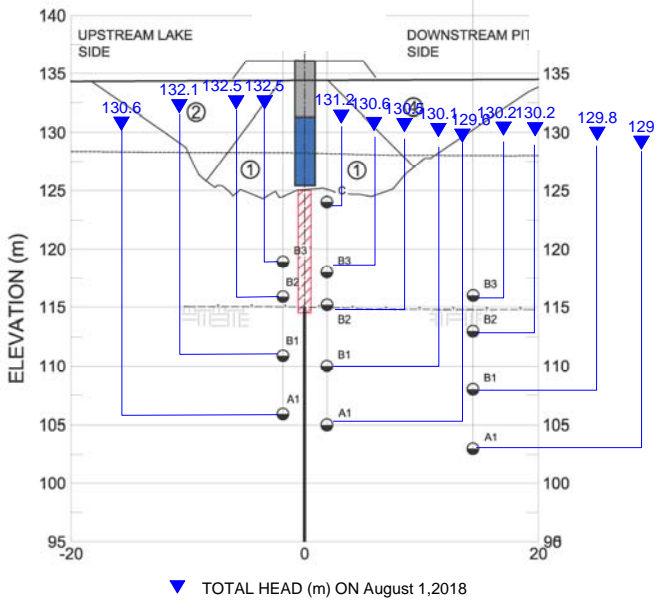
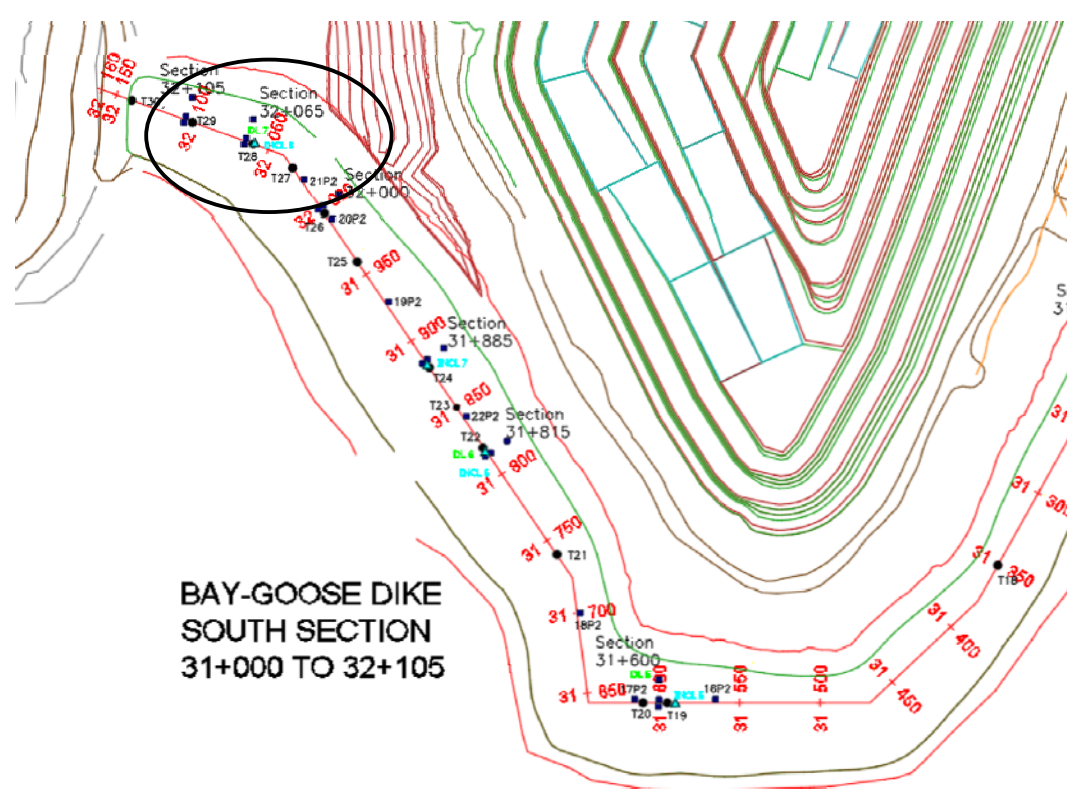
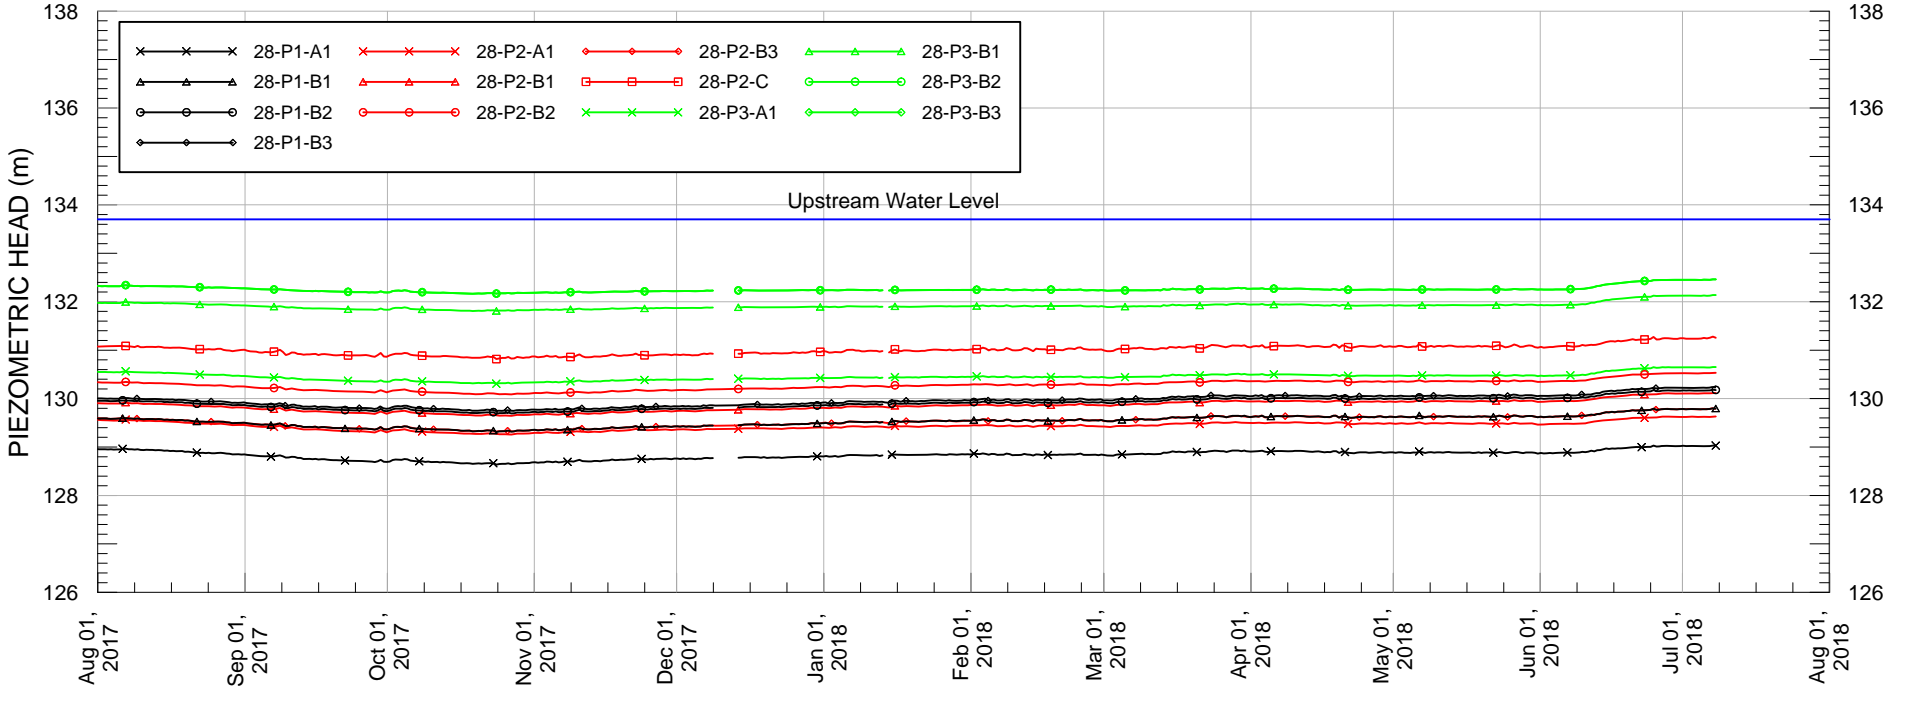
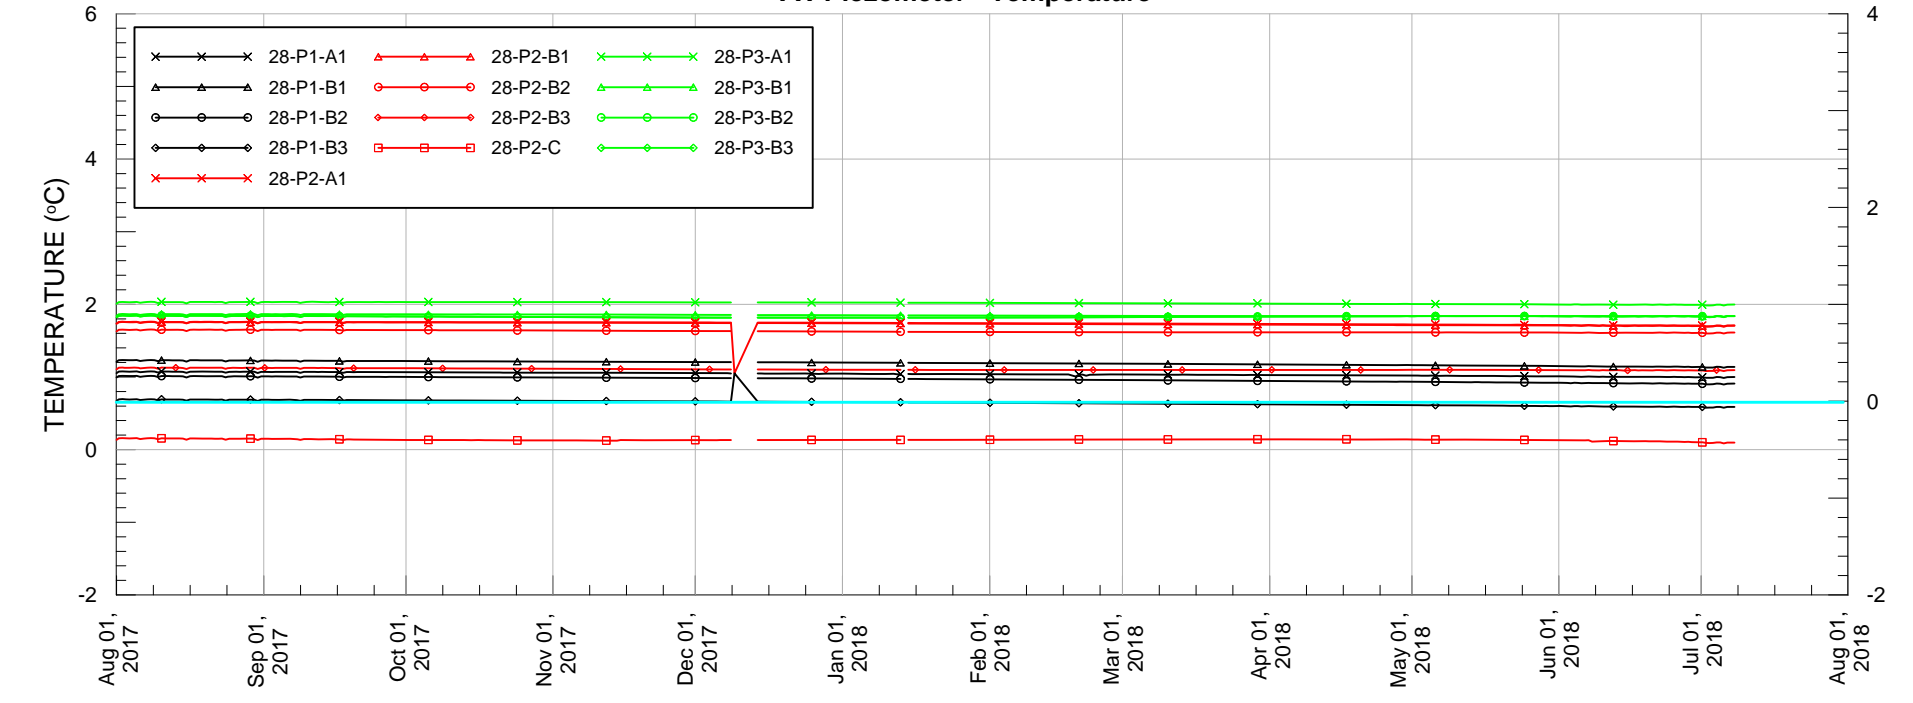
**FIGURE 21**

- NOTES:**
- There is a signal loss since March 7/18 which is due to the snow accumulating on the Goose Waste Dump pile. Since the snow melt the signal has returned.
  - With the spike PWP pressure in 27-P3-A2 it is assumed that this instrument is not functioning anymore as the PWP pressure is higher than the lake elevation.
  - Gap in data in December and January is due to low battery. Battery was changed the following day after.

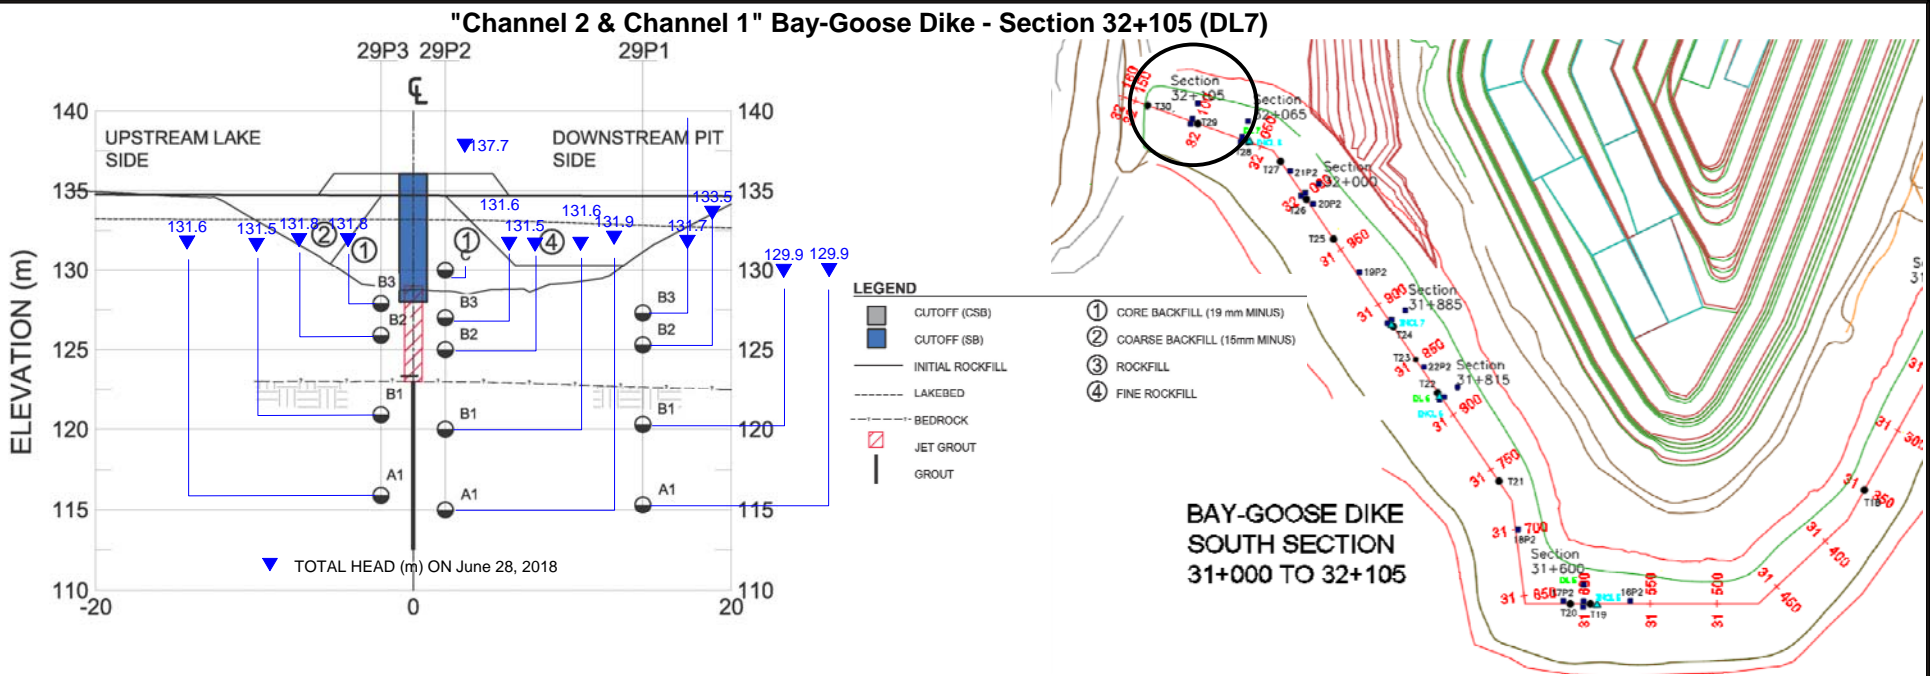
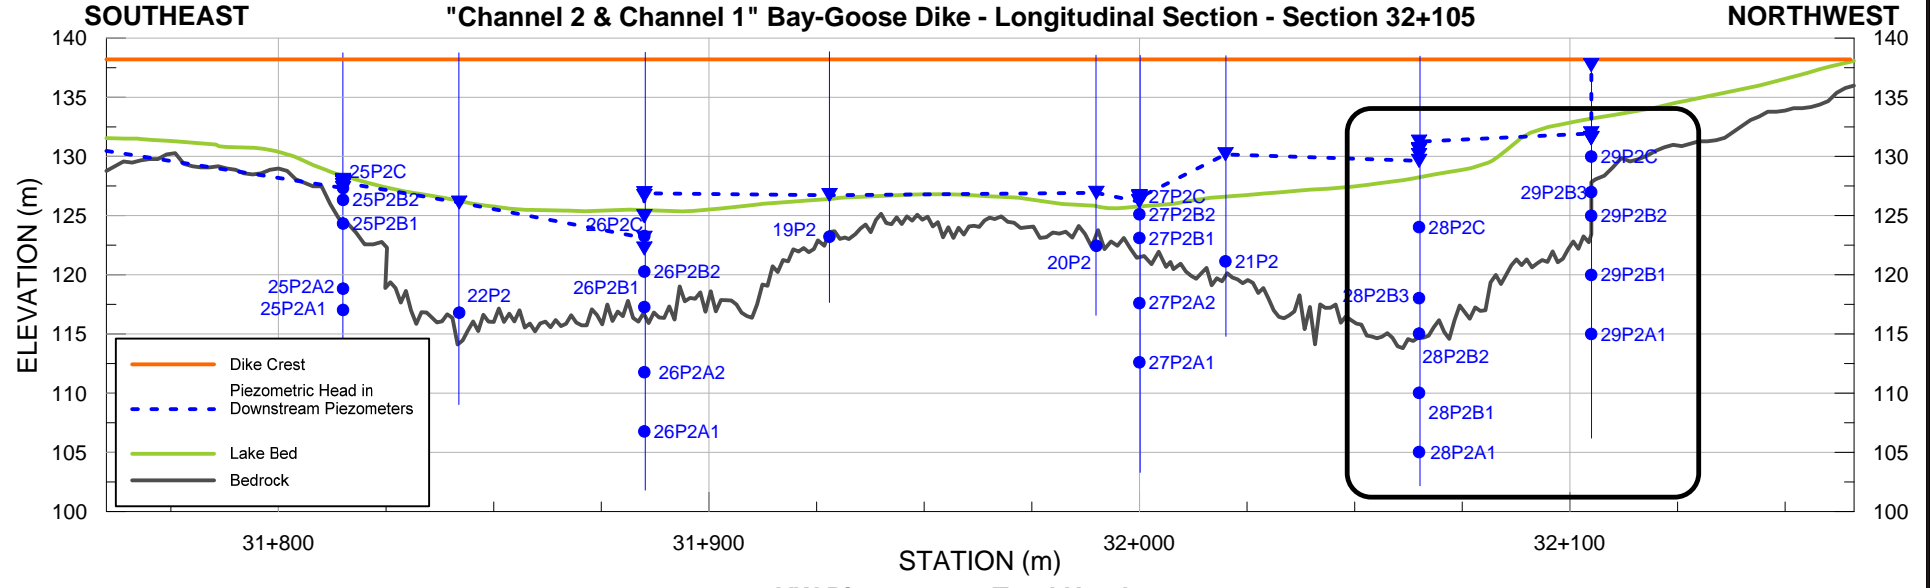
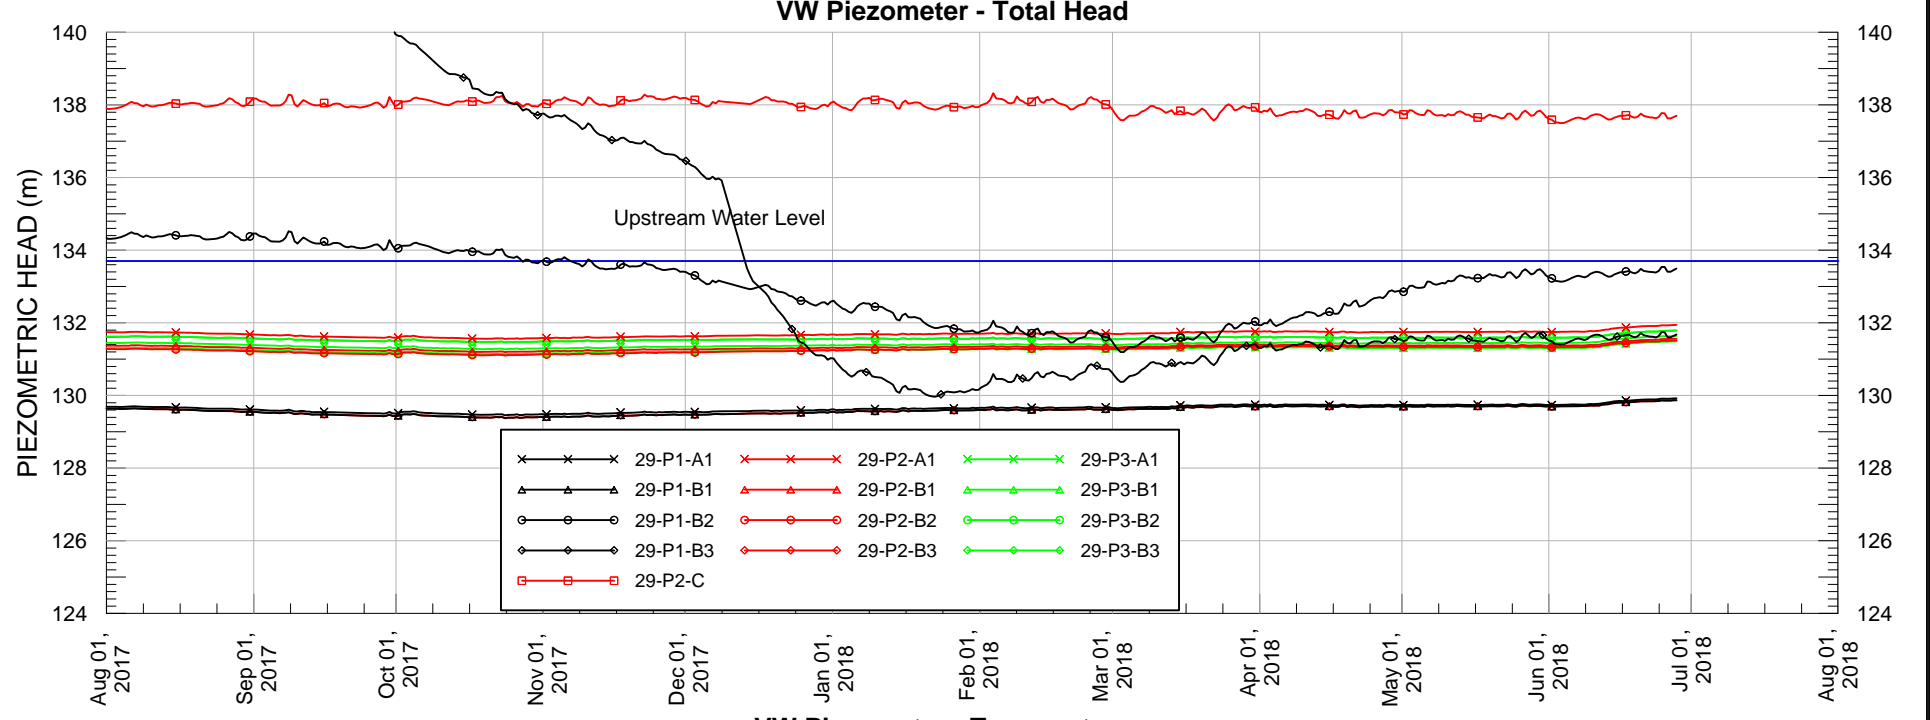
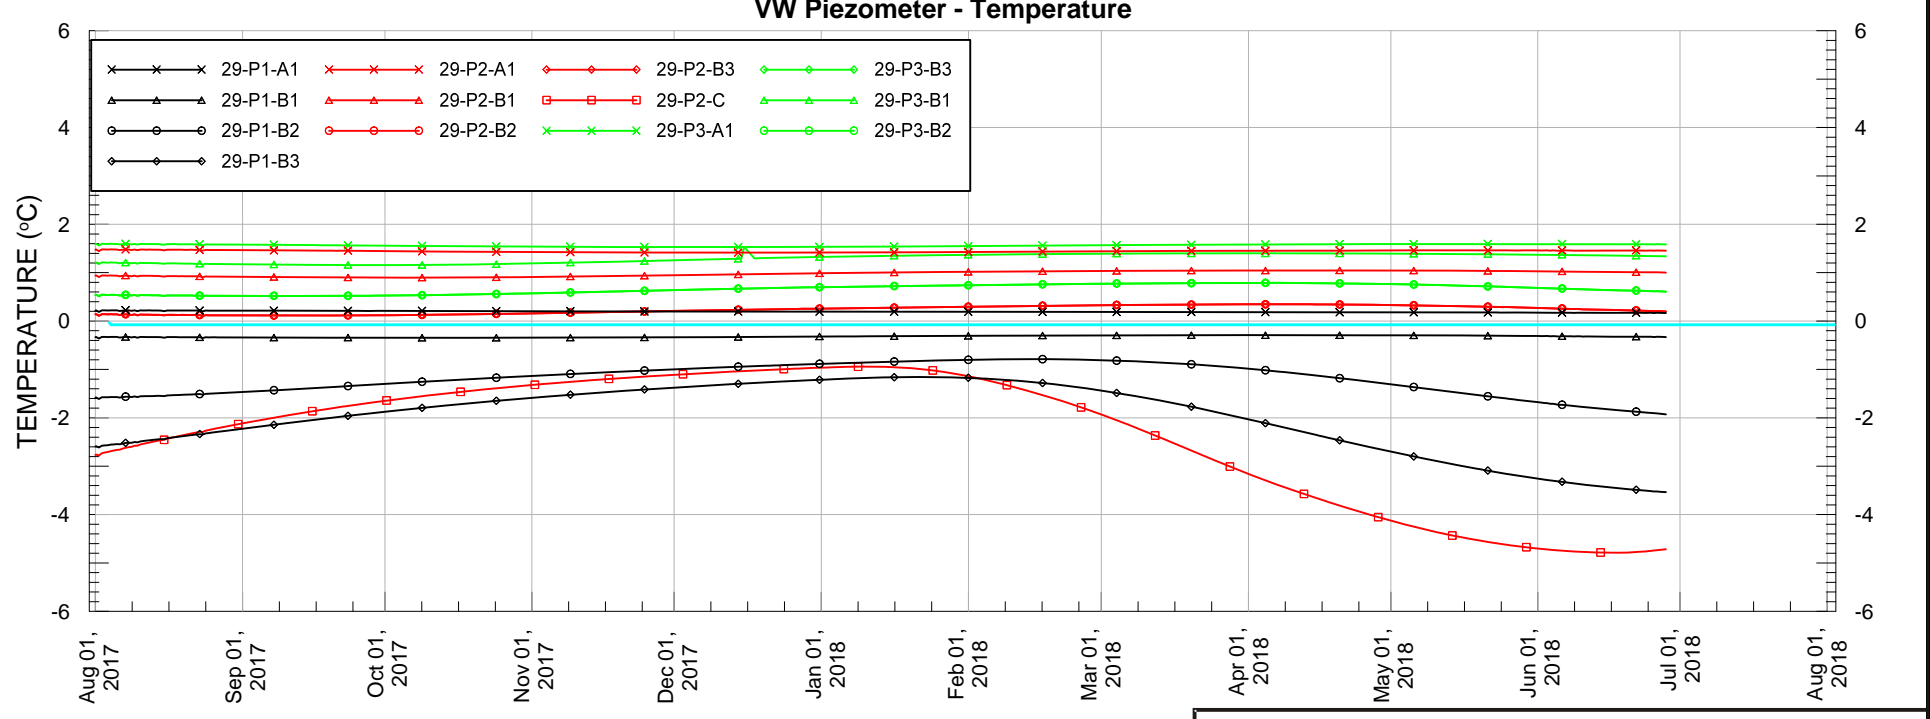
| | CHECK | PG 28AUG14 | <b>FIGURE 22</b> |

- 29P1B2, 29P1B3, 29P2B3, 29P3B3 and 29P2C are given unstable readings and since the temperature shows a negative reading it is assumed to be frozen.
- There is a signal loss since March 7/18 which is due to the snow accumulating on the Goose Waste Dump pile. Since the snow melt the signal has returned.
- Gap in data in December is due to low battery. Battery was changed the following day after.

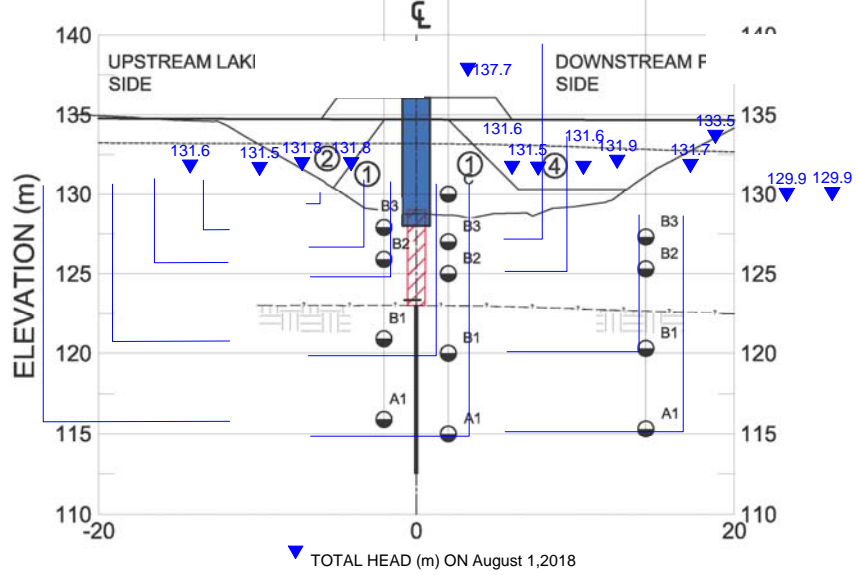
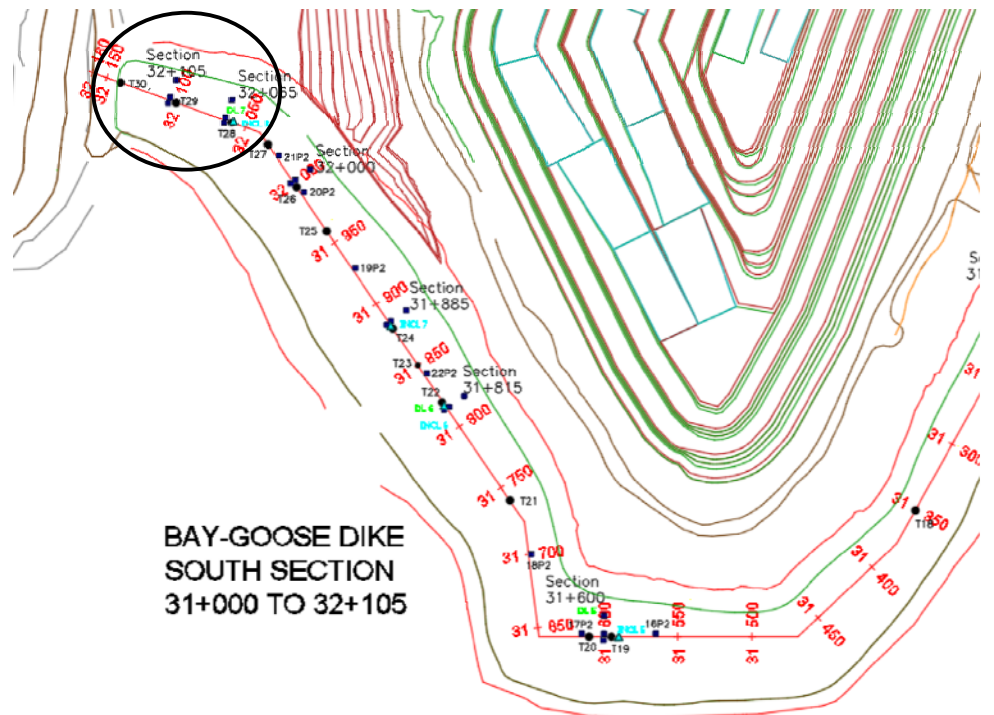
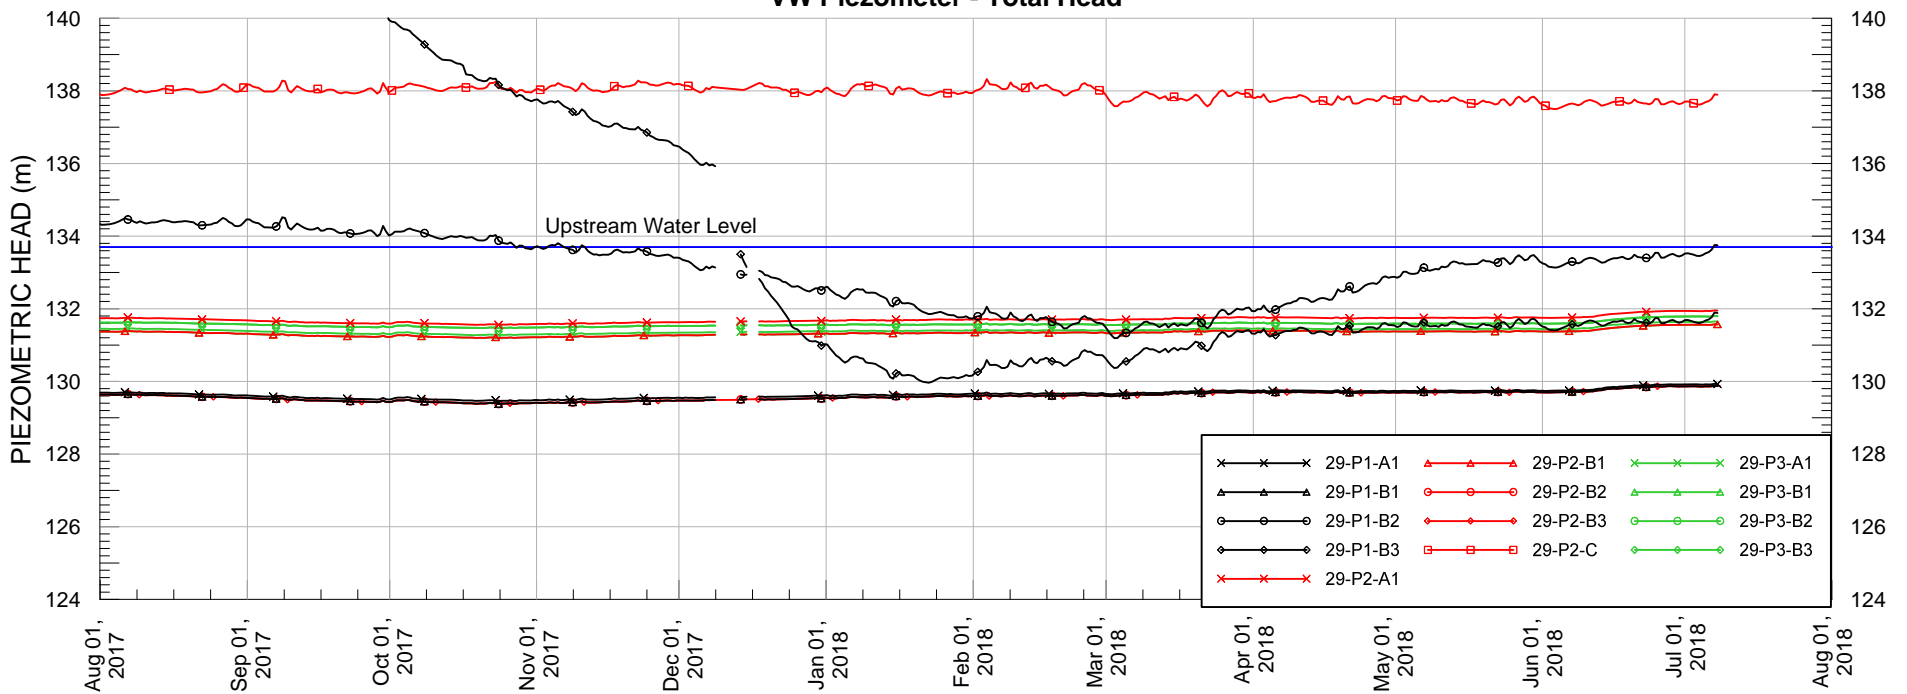
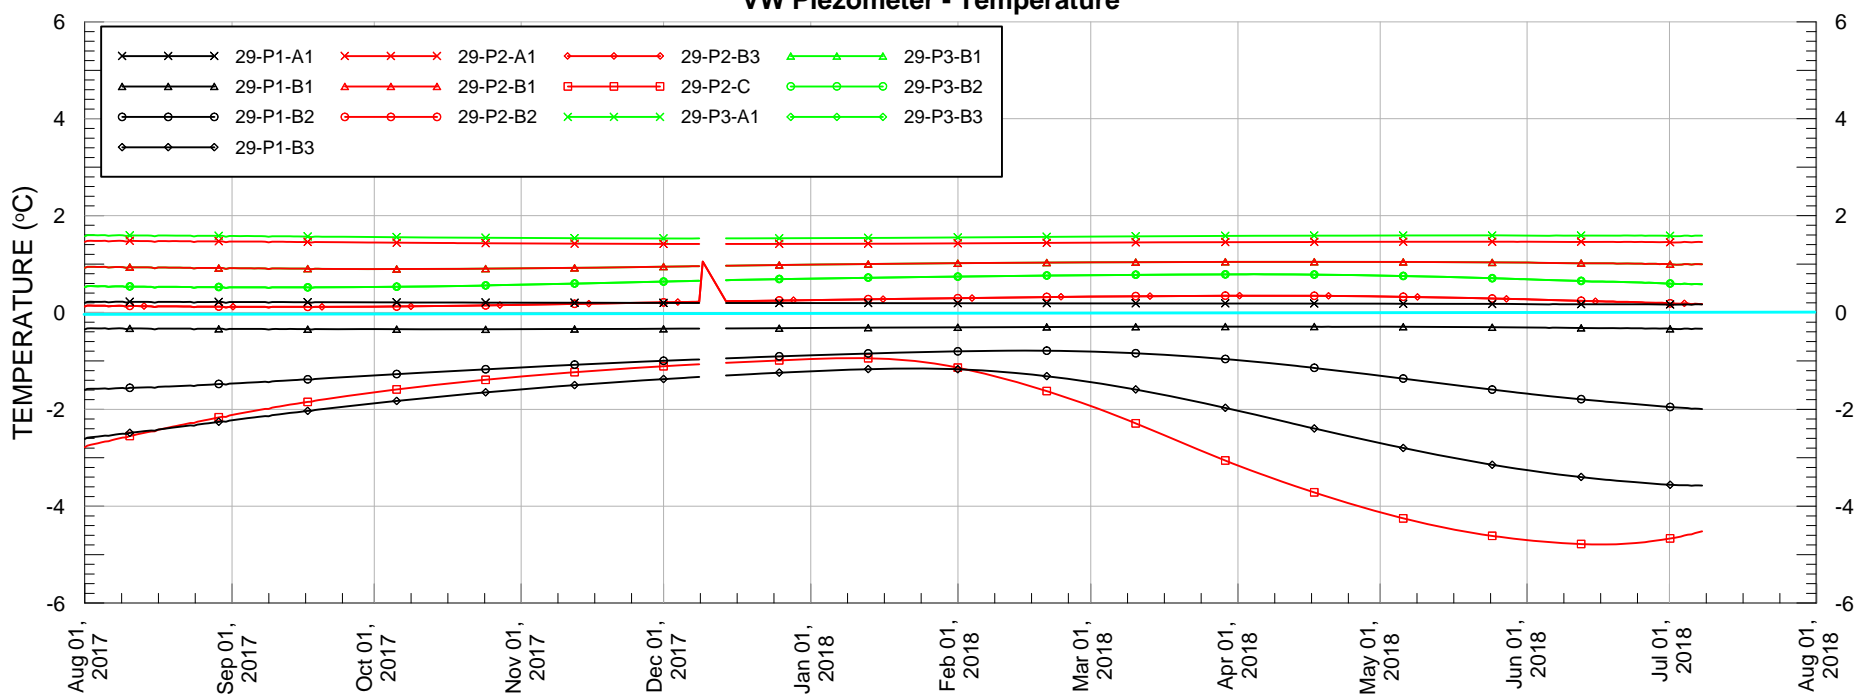
**FIGURE 23**

1. 29P1B2, 29P1B3, 29P2B3, 29P3B3 and 29P2C are given unstable readings and since the temperature shows a negative reading it is assumed to be frozen.
2. There is a signal loss since March 7/18 which is due to the snow accumulating on the Goose Waste Dump pile. Since the snow melt the signal has returned.
3. Gap in data in December is due to low battery. Battery was changed the following day after.

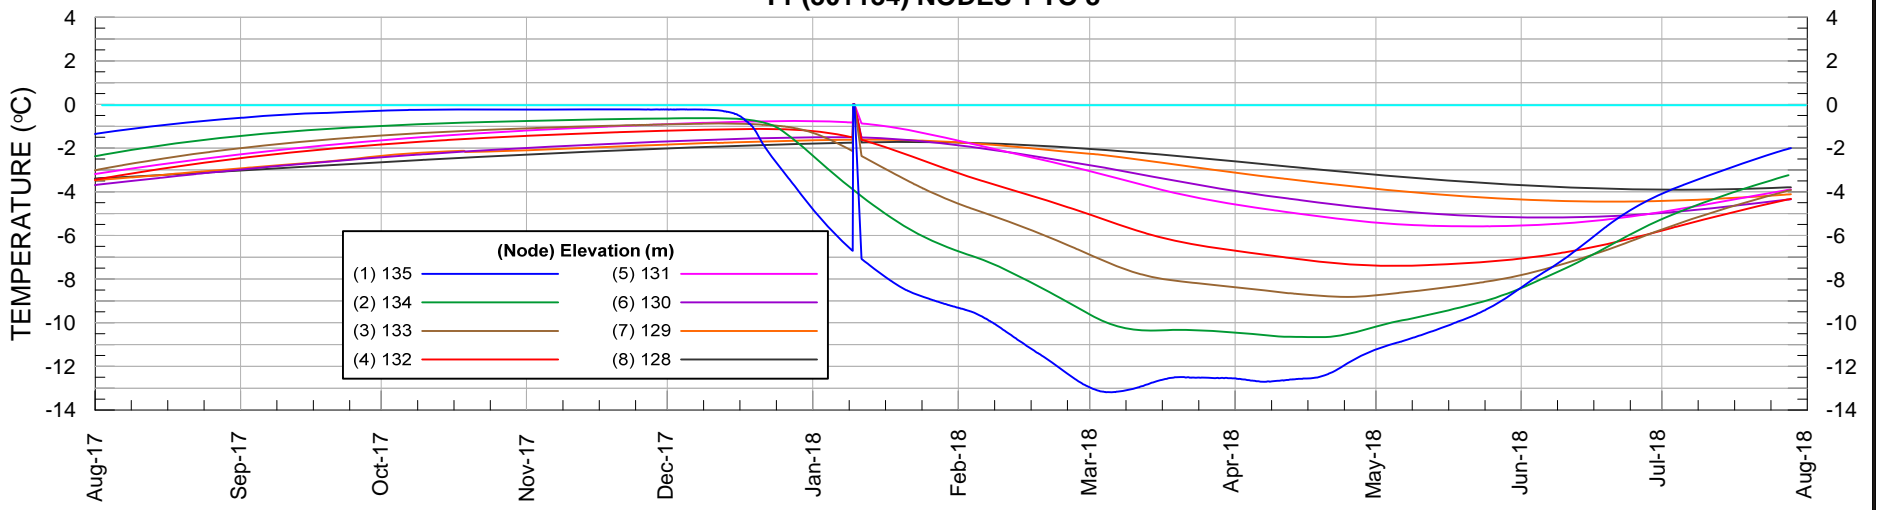
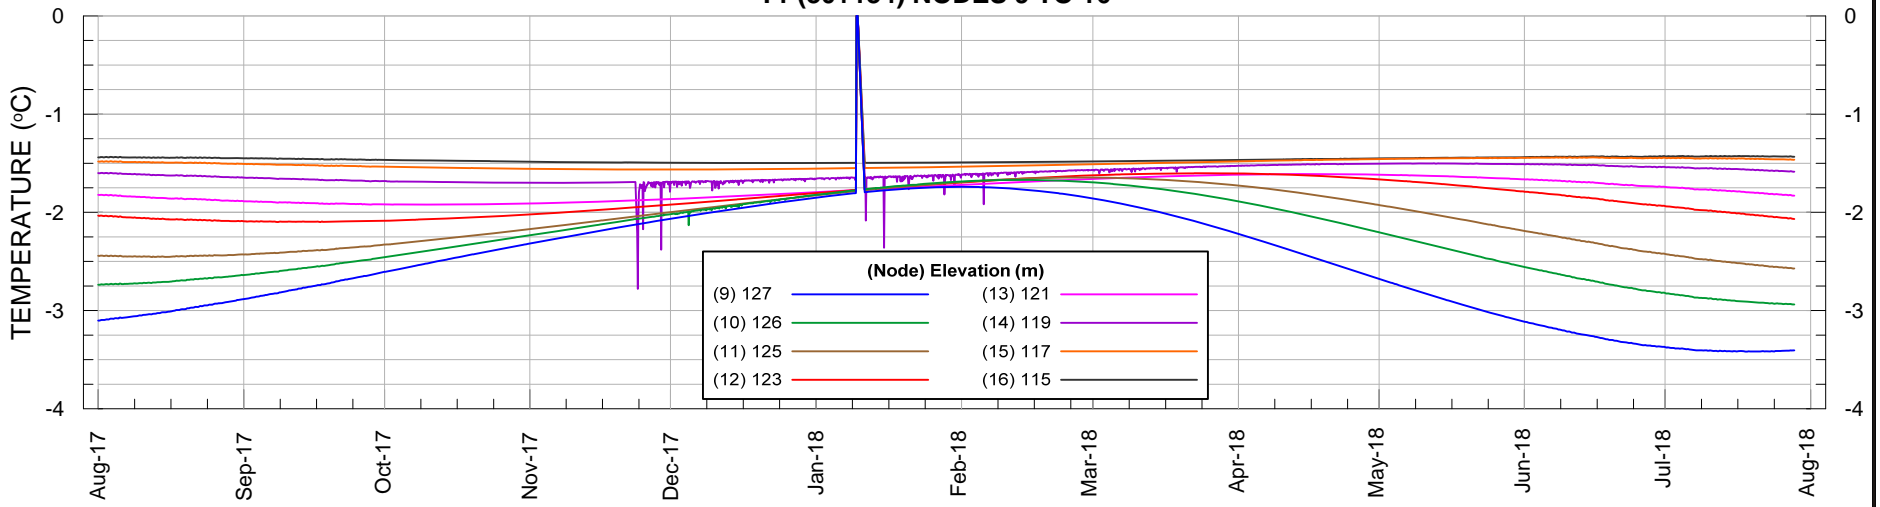
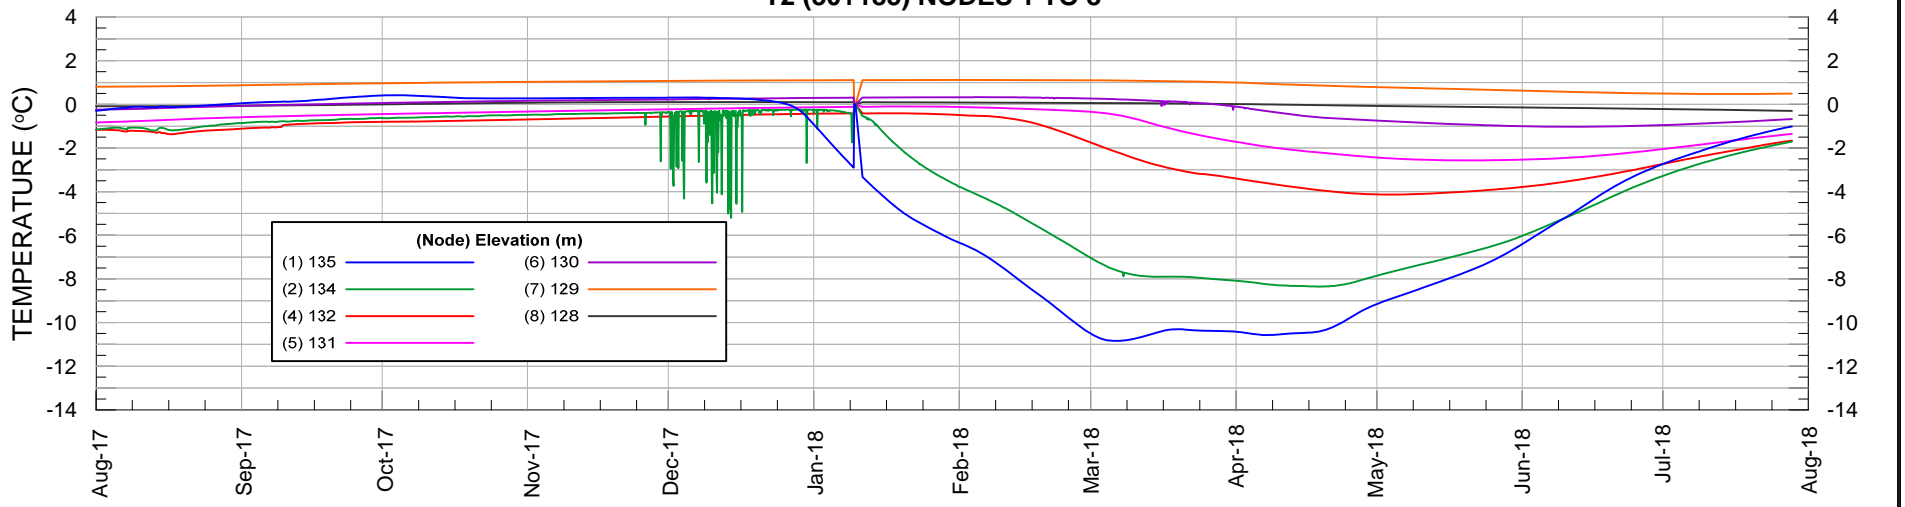
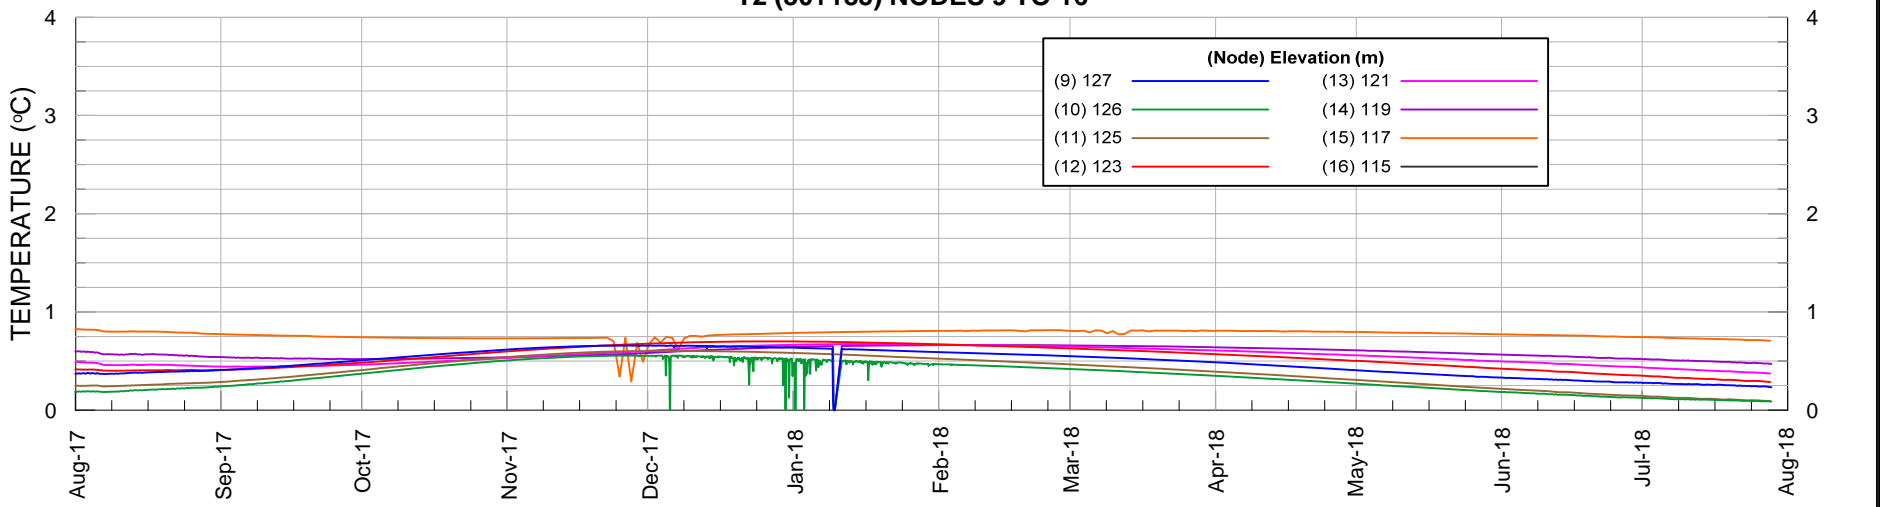
1. T1 (30+134) - values less than -0.5°C are not shown for Node 8 at elevation 128 m from June 24, 2011 to June 30, 2011 as these values are believed to be inaccurate.
2. Third node of thermistor T2 (elevation 135 m) is not functional.
3. T1 and T2 thermistors stopped transmitting data on June 10, 2015. Inspecting areas to determine a cause.

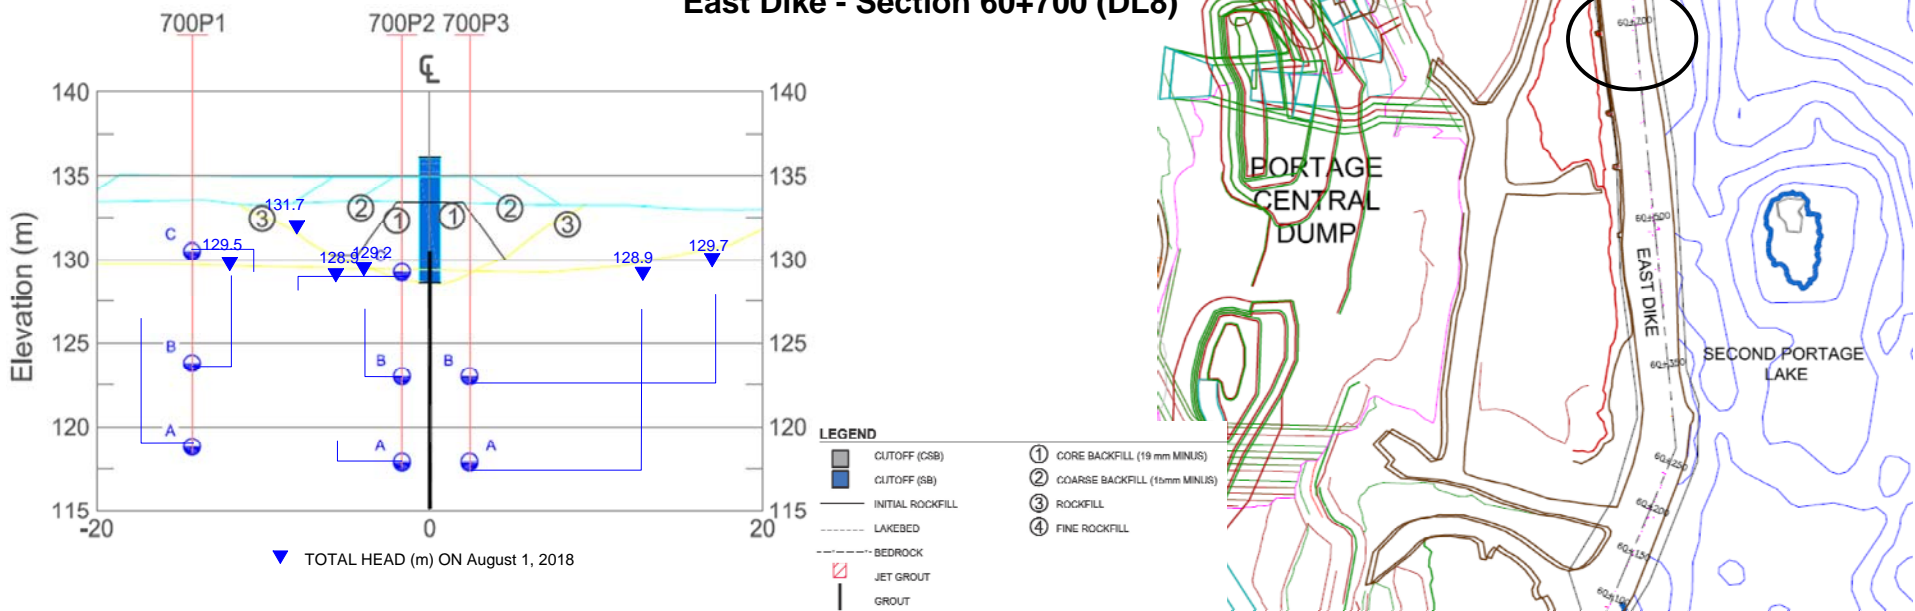
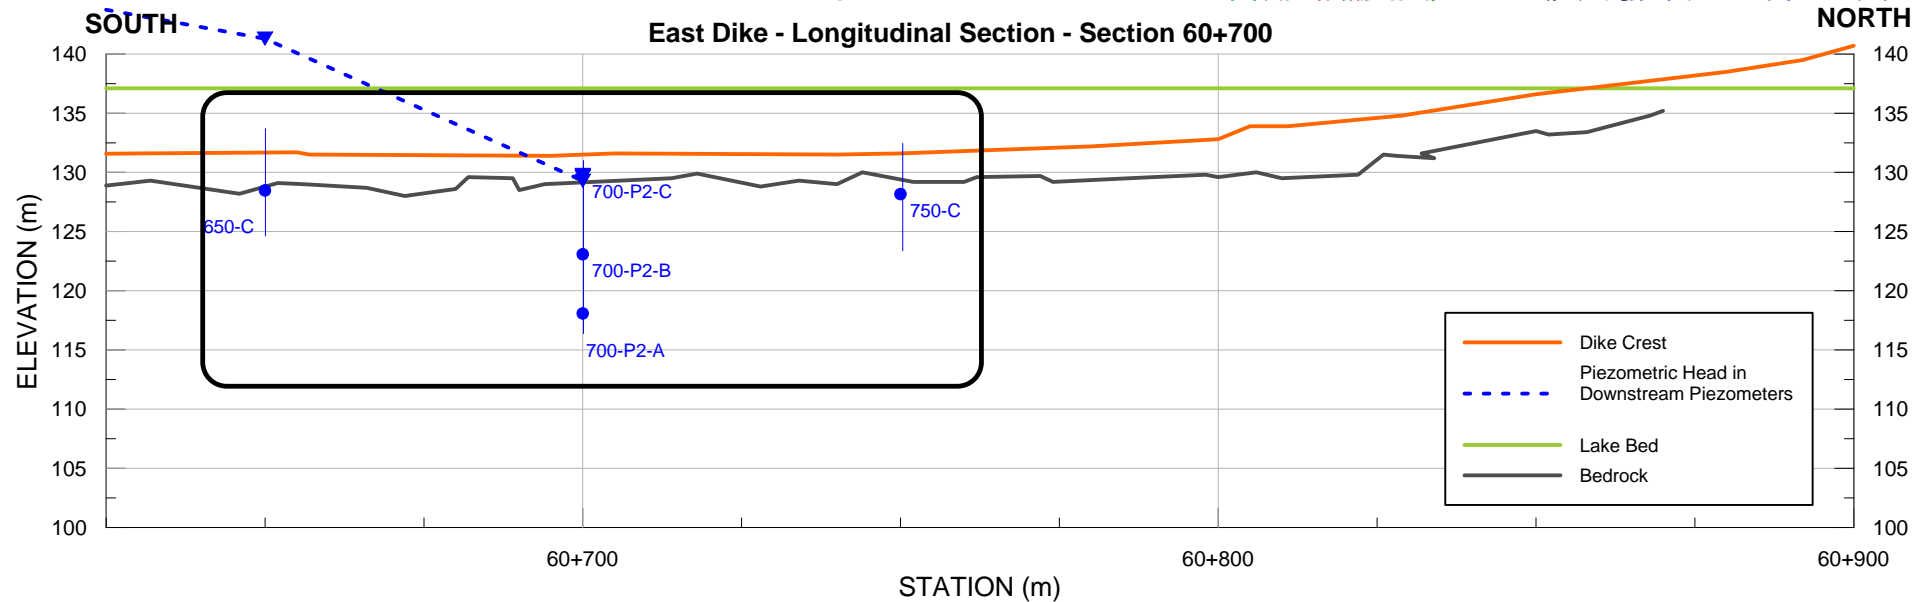
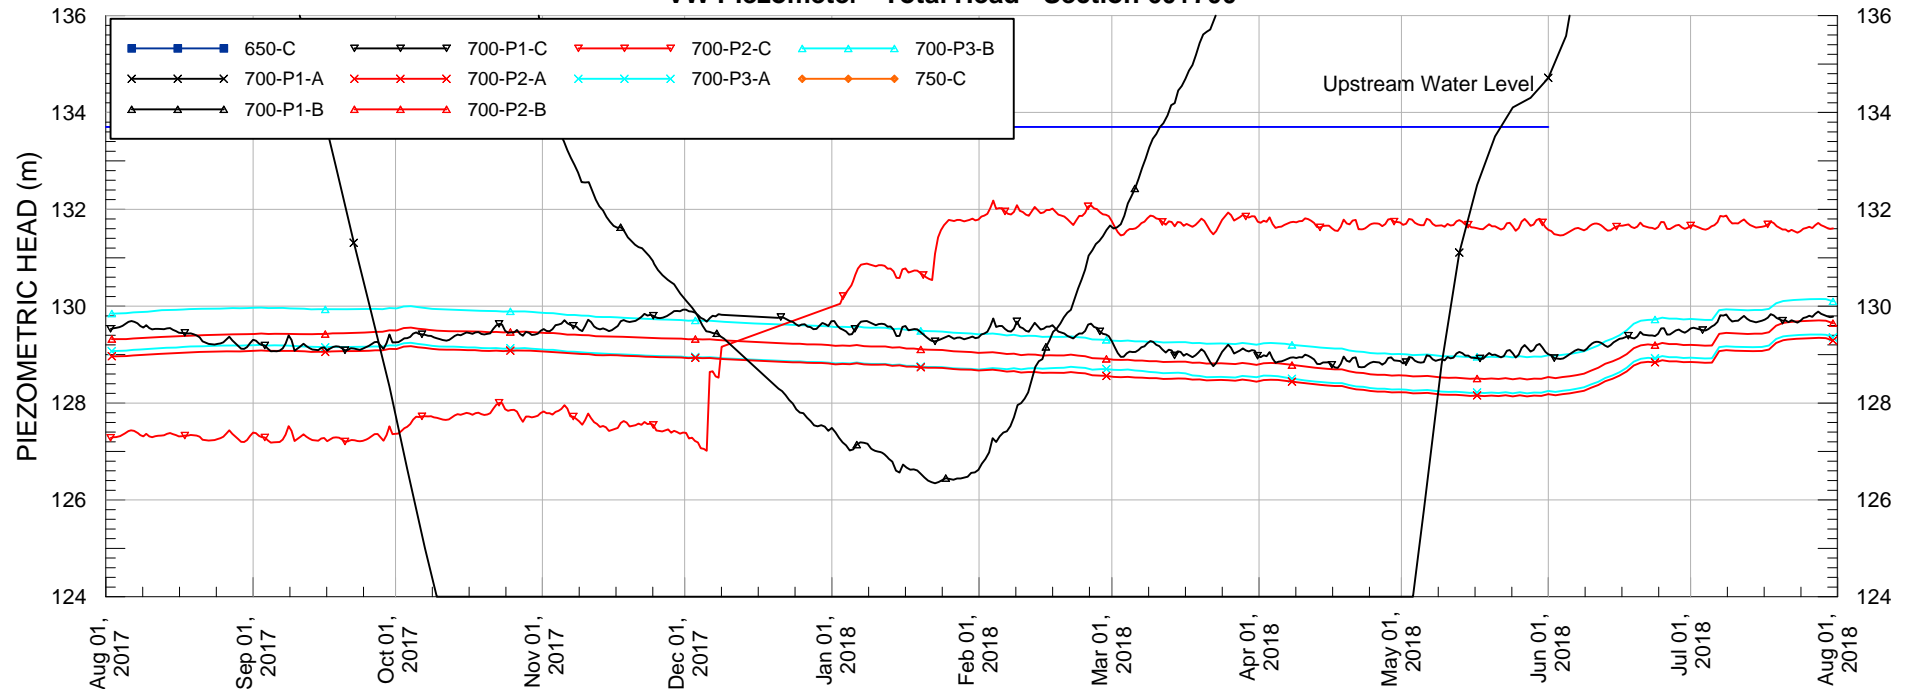
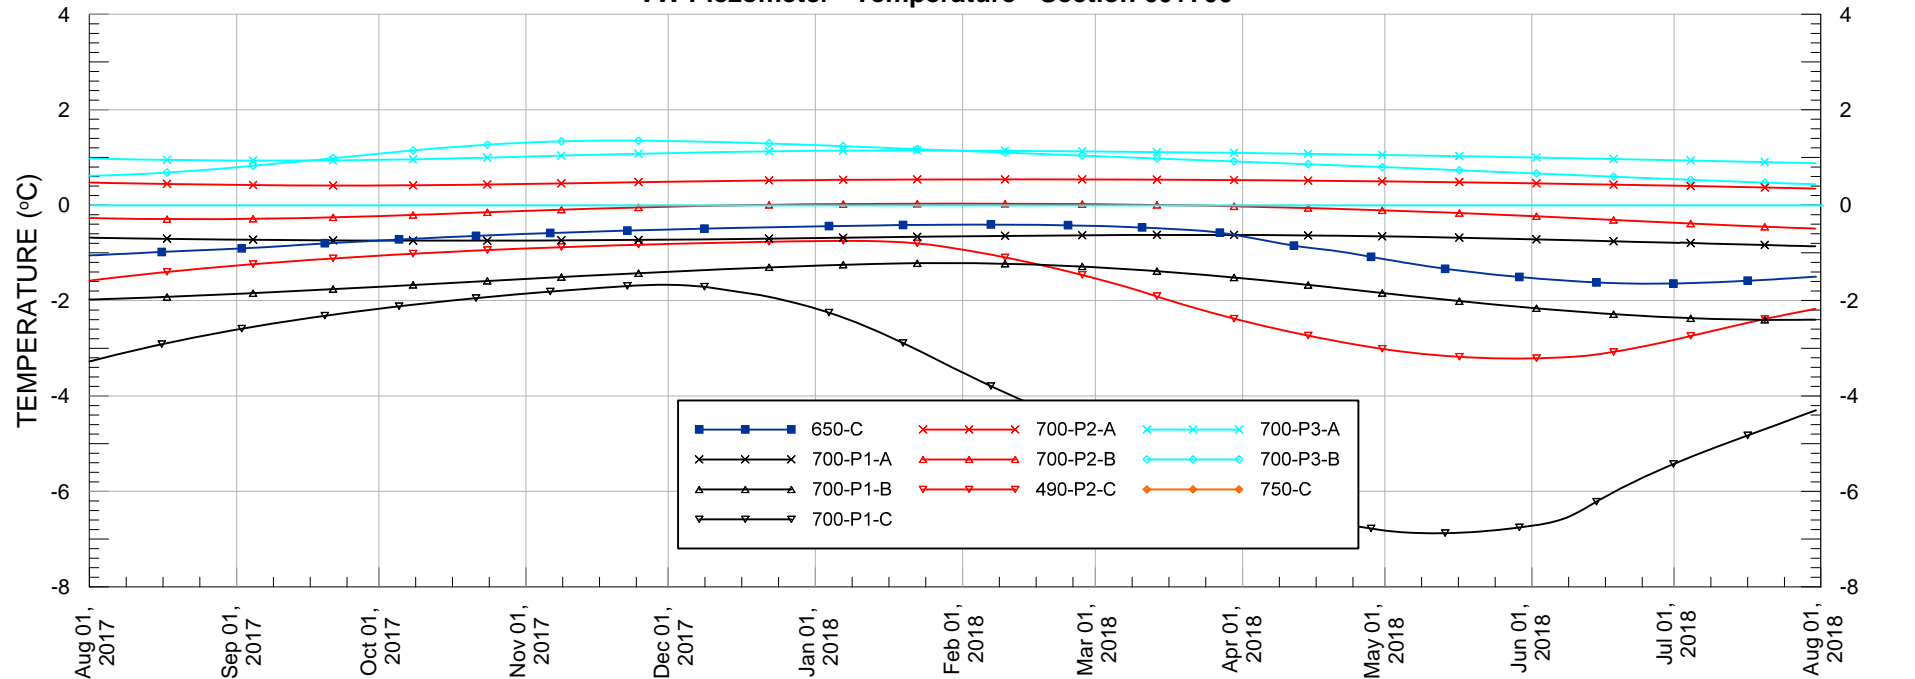
### East Dike - Section 60+700 (DL8)

- 1: 700-P1-B and 750-C are giving anomaly readings and with a negative temperature are assumed to be frozen.
2. There was a rise in PWP in June. This was an unknown reason as there were no indications in the field.
