# **Meadowbank and Whale Tail 2018 Annual Geotechnical Inspection**

# 2018 Annual Geotechnical Inspection

*Meadowbank Gold Mine, Nunavut*

18101627-1583-R-Rev0

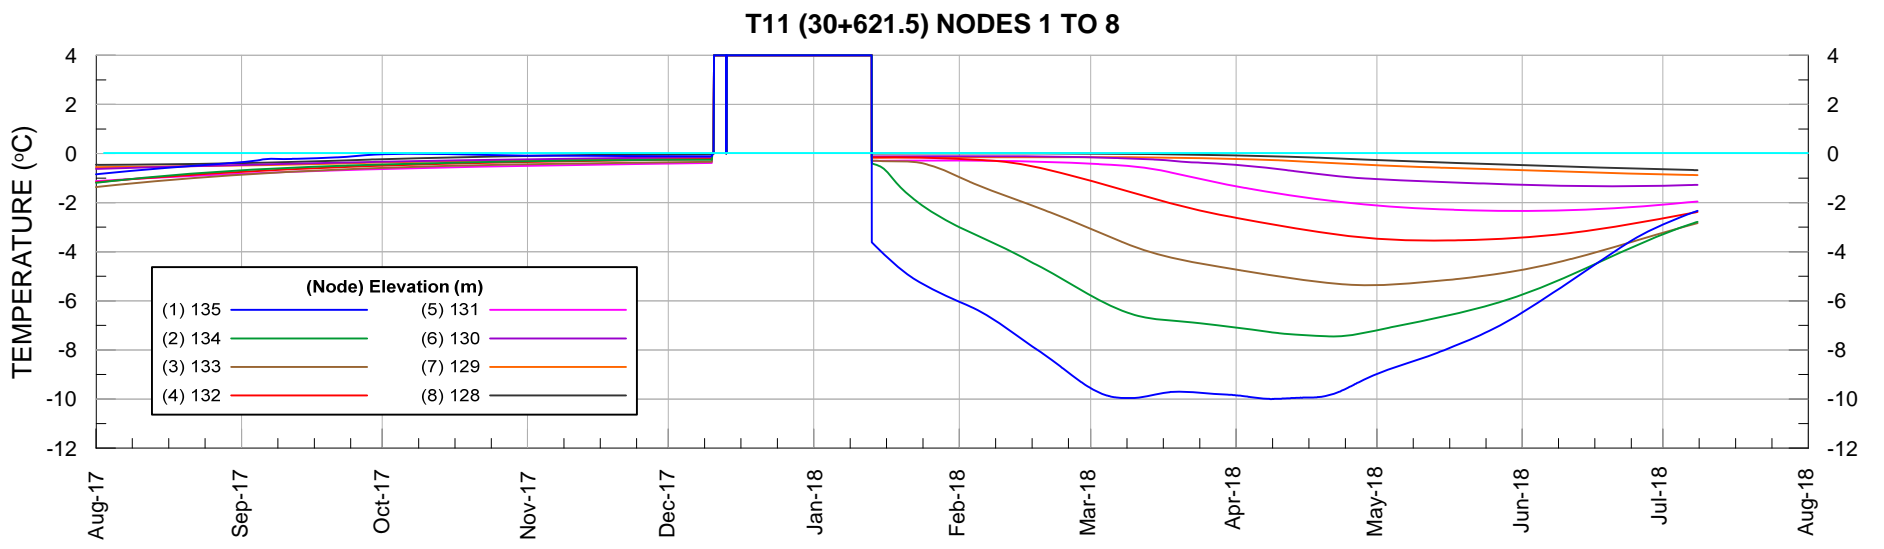
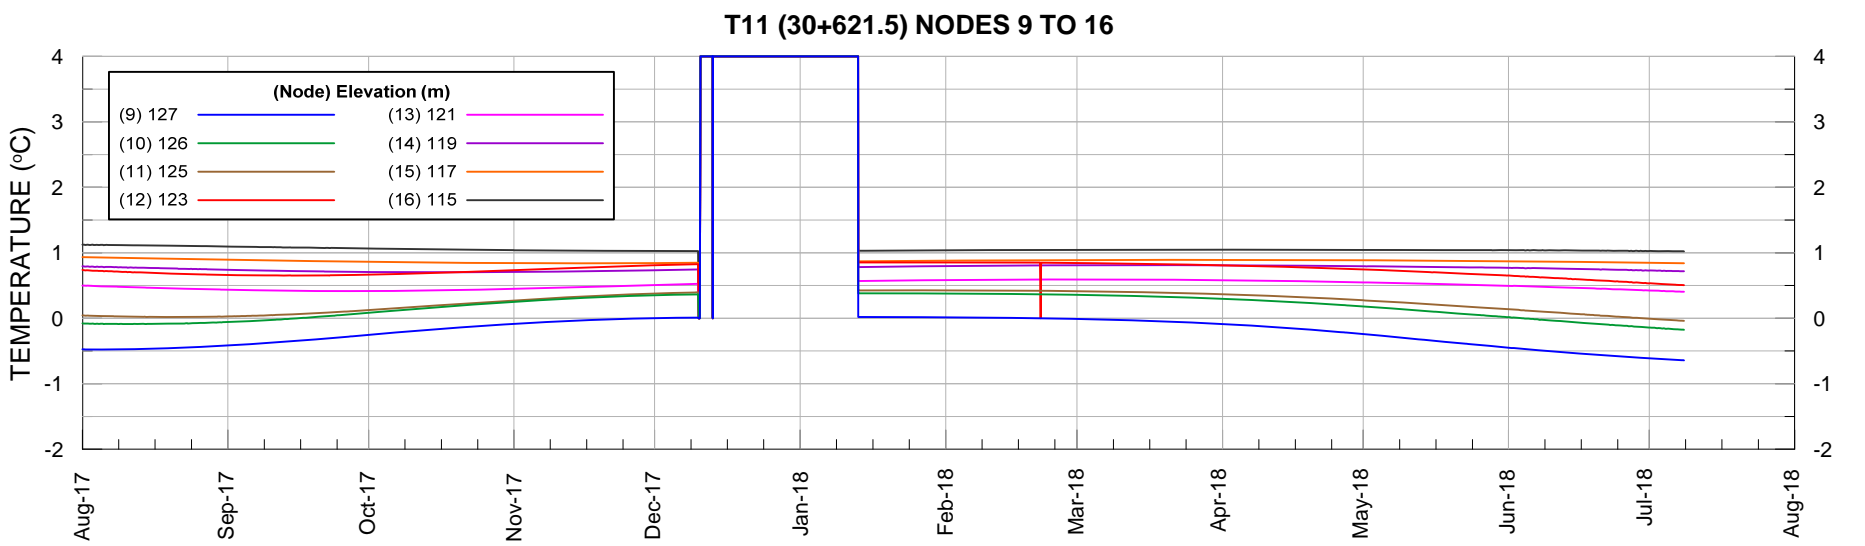
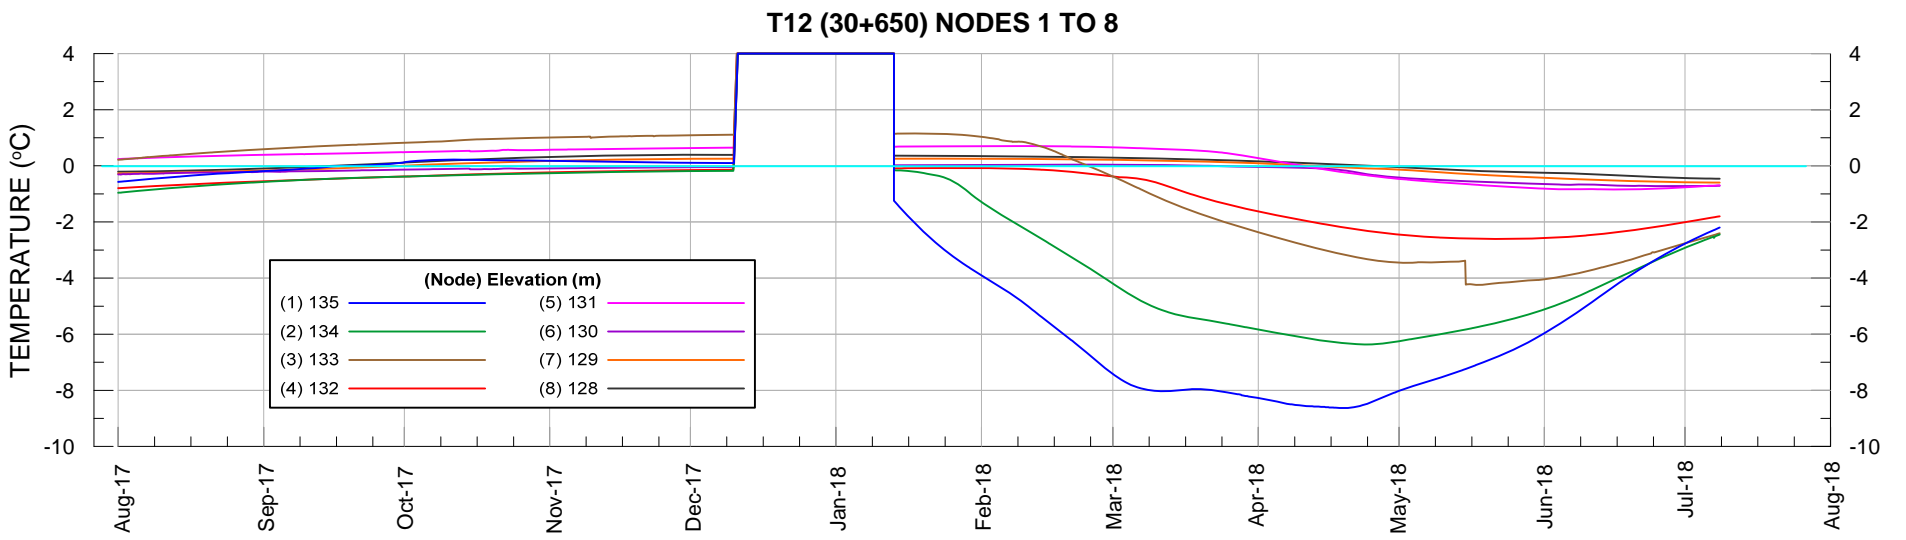
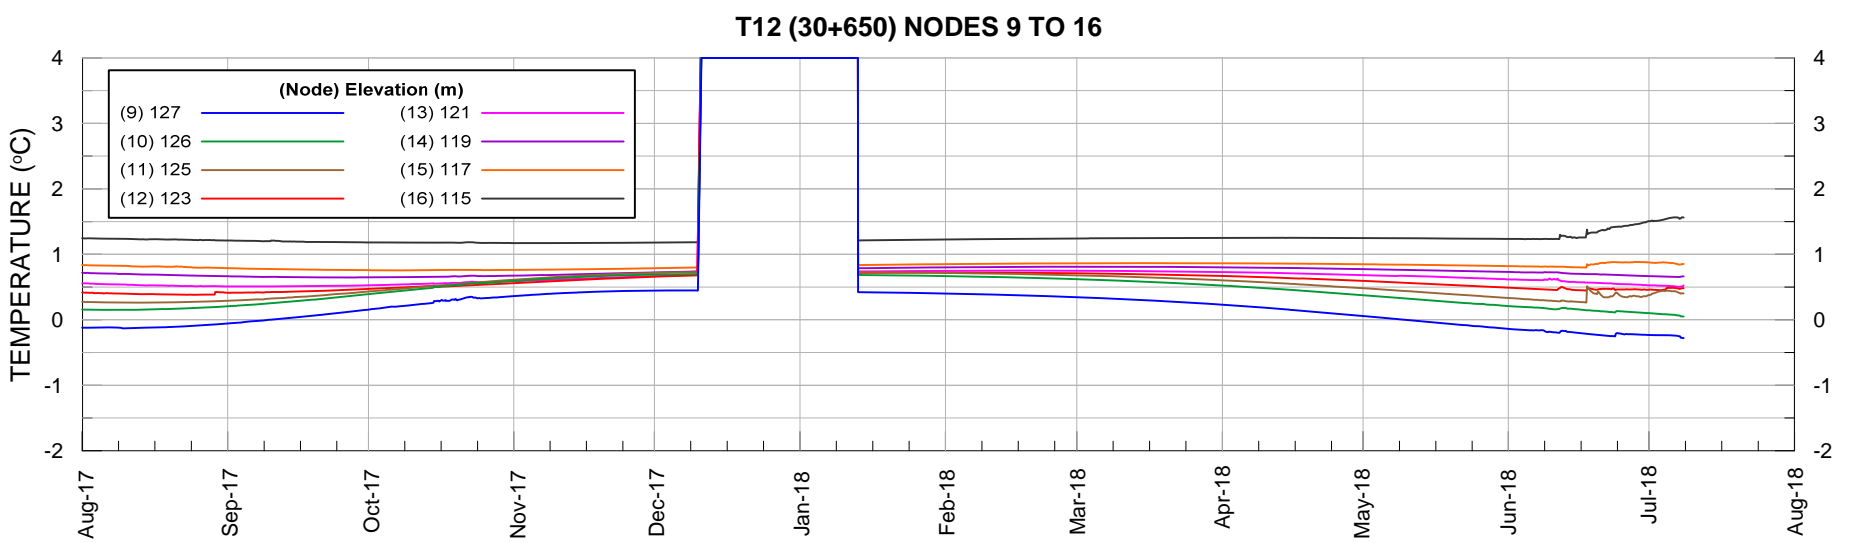
Note: The jump in temperature is an error with the MUX board in the data logger. Board was replaced.

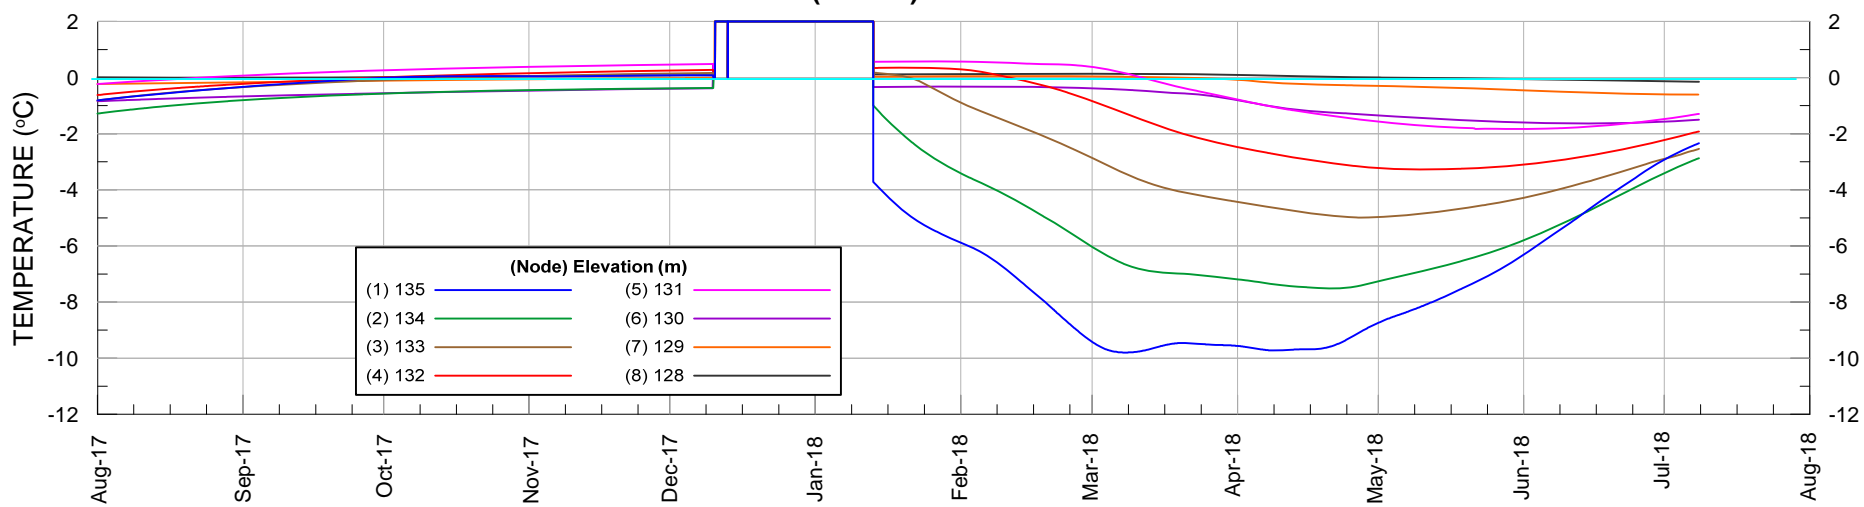
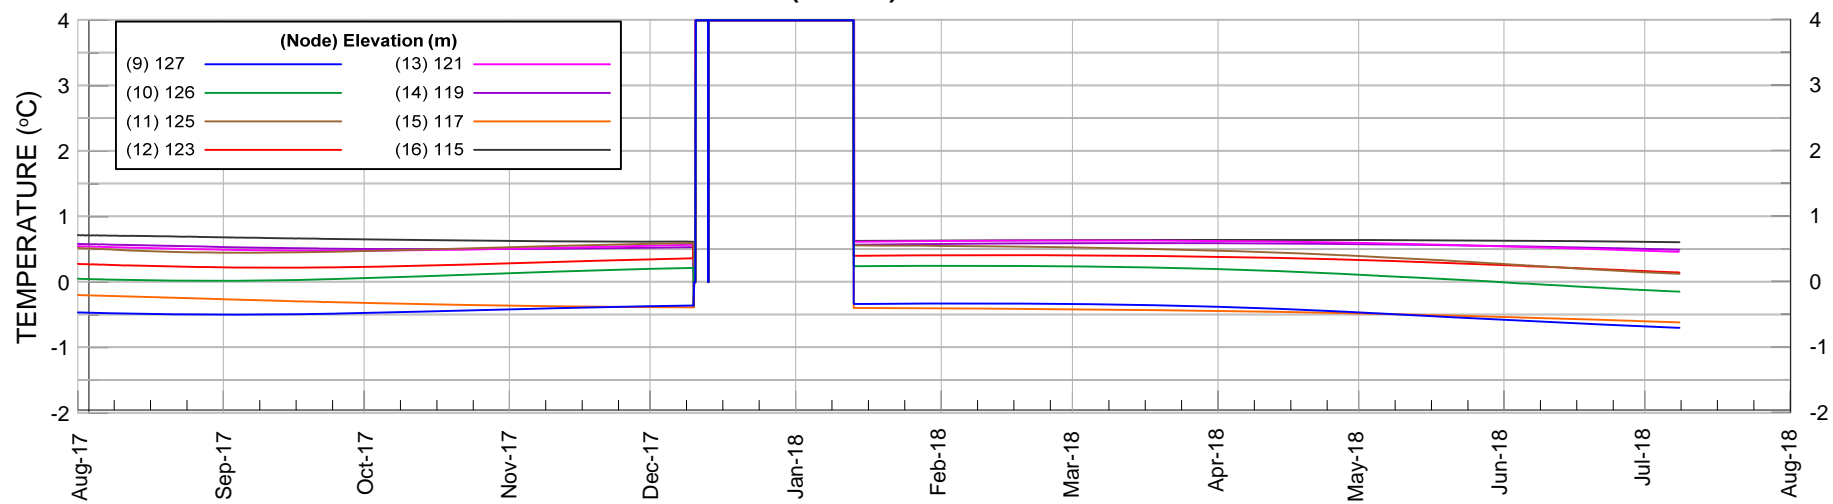
Note: The jump in temperature is an error with the MUX board in the data logger. Board was replaced.

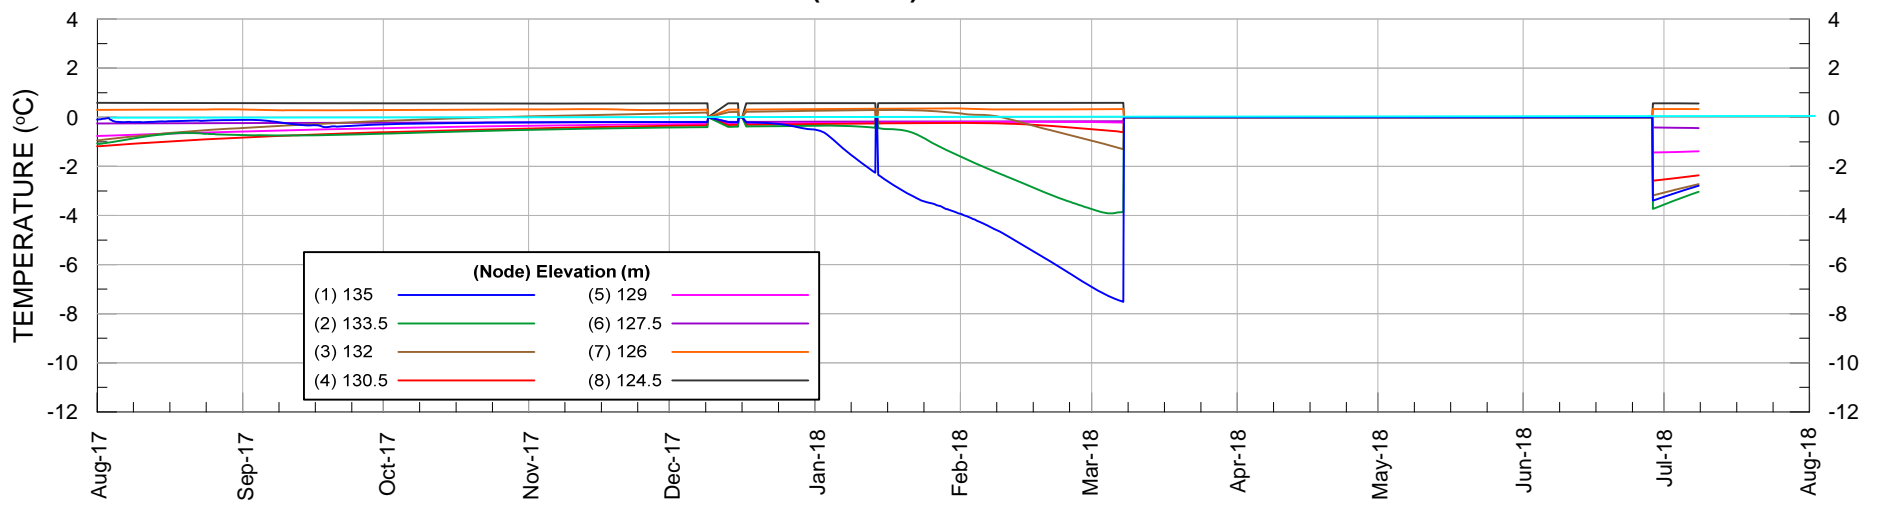
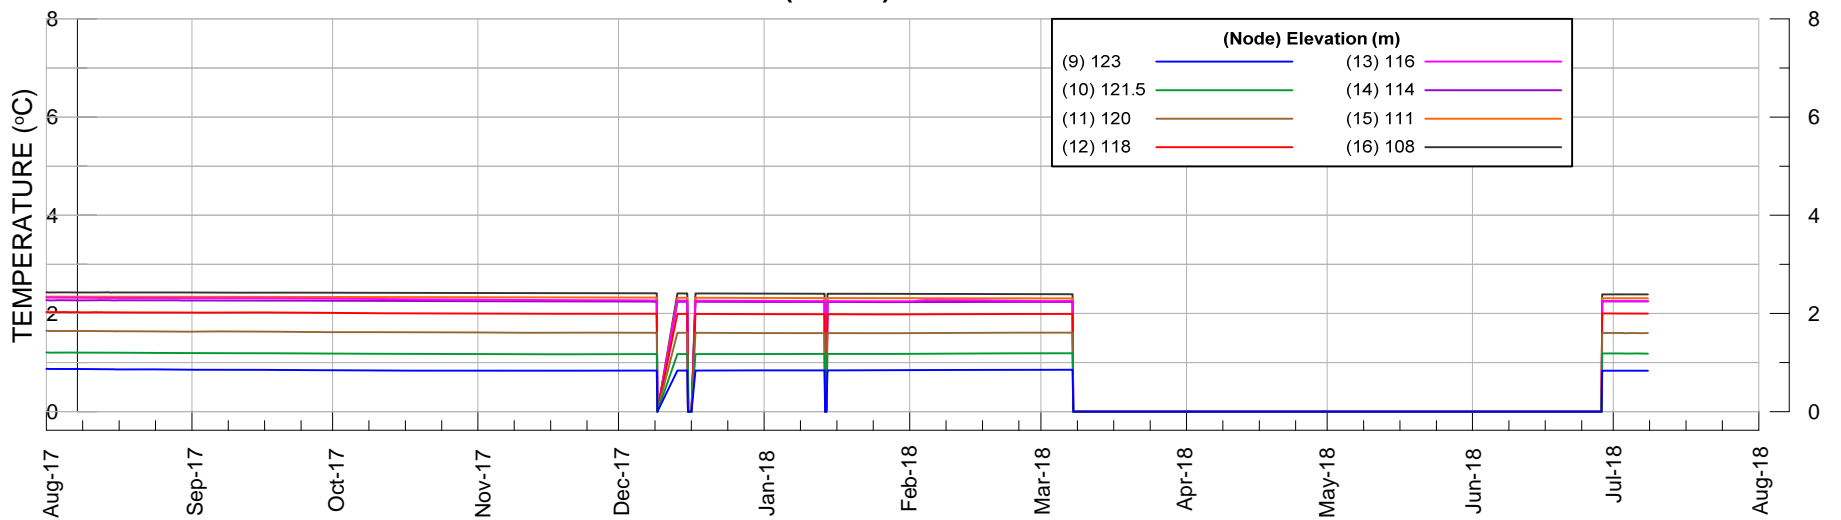
T28 (32+060) NODES 1 TO 8

Note: The jump in temperature is an error with the instrument. Inspections in the field yielded no results.

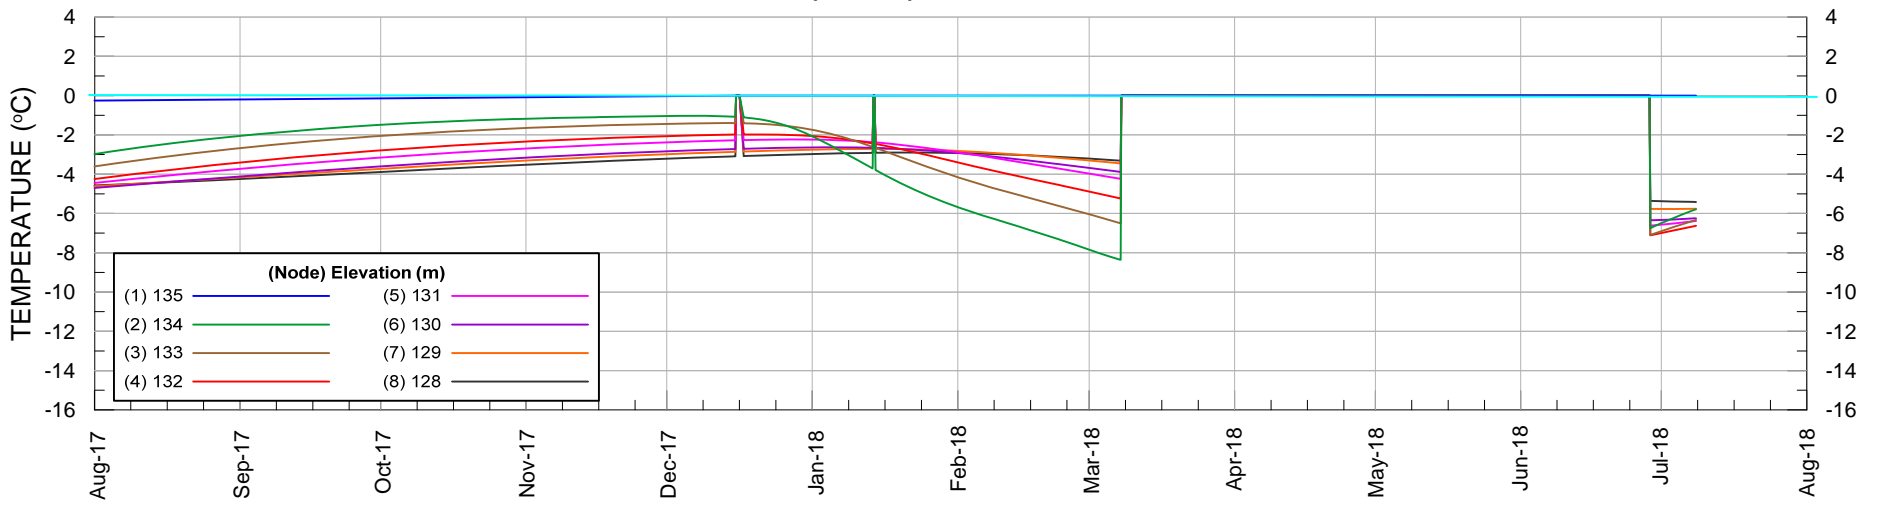
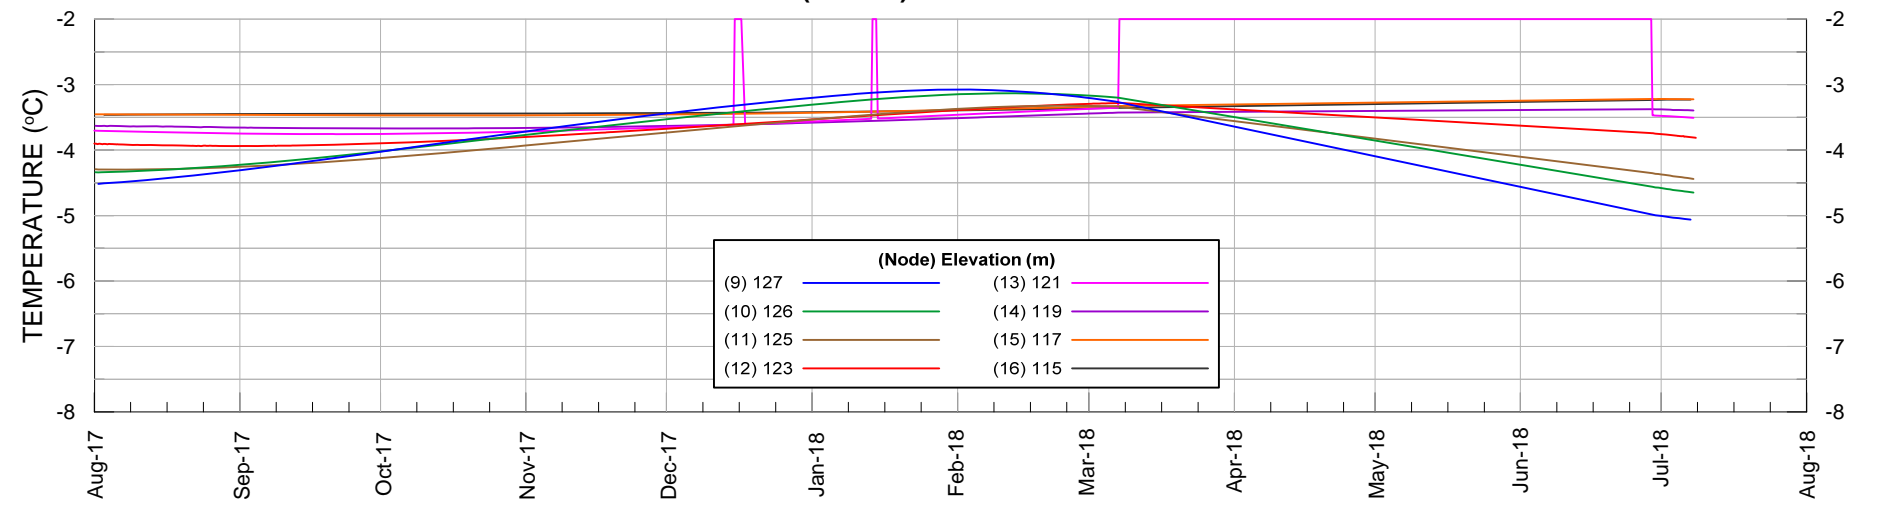
T30 (32+140) NODES 1 TO 8

Note: The jump in temperature is an error with the instrument. Inspections in the field yielded no results.

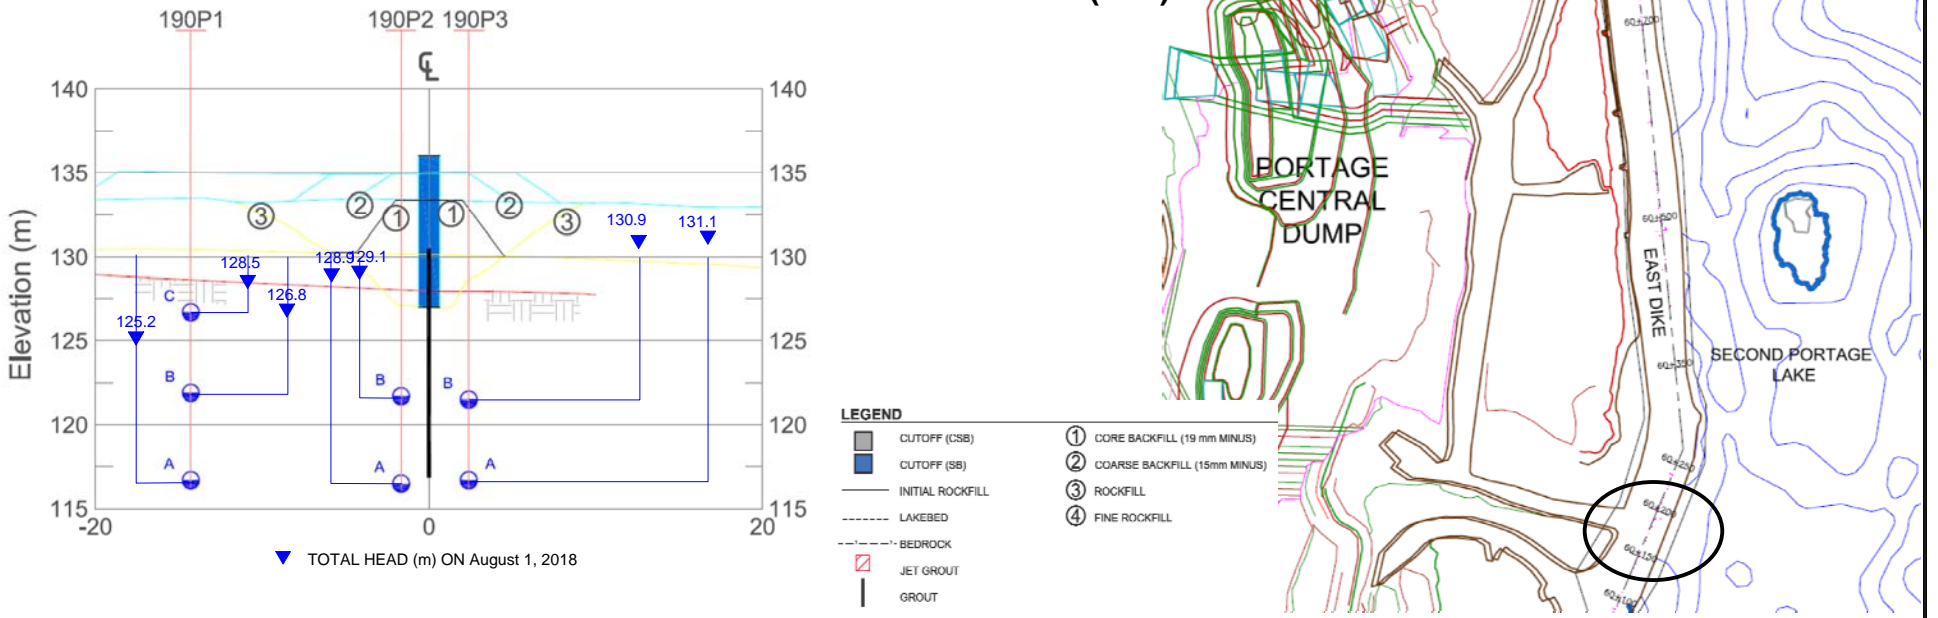
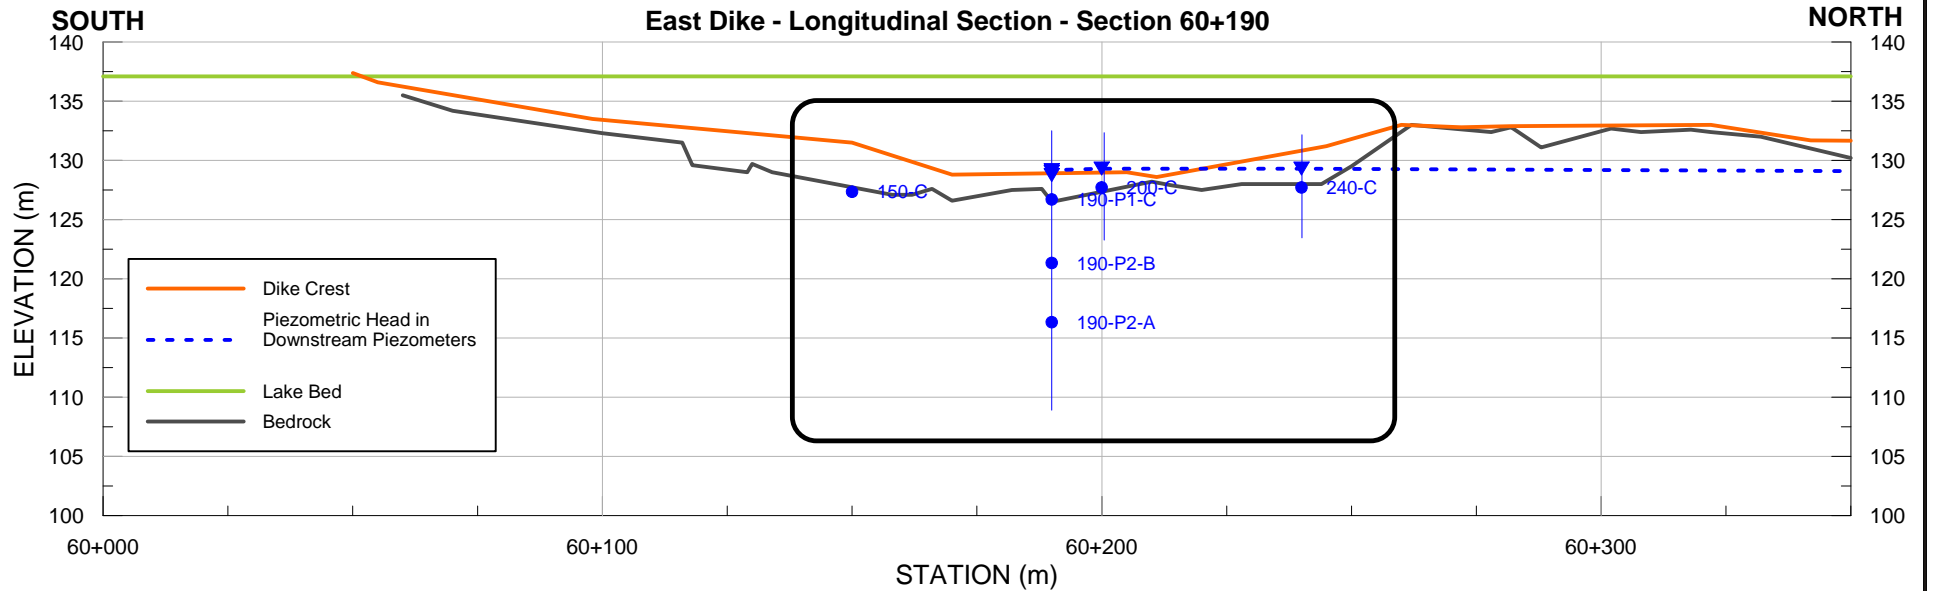
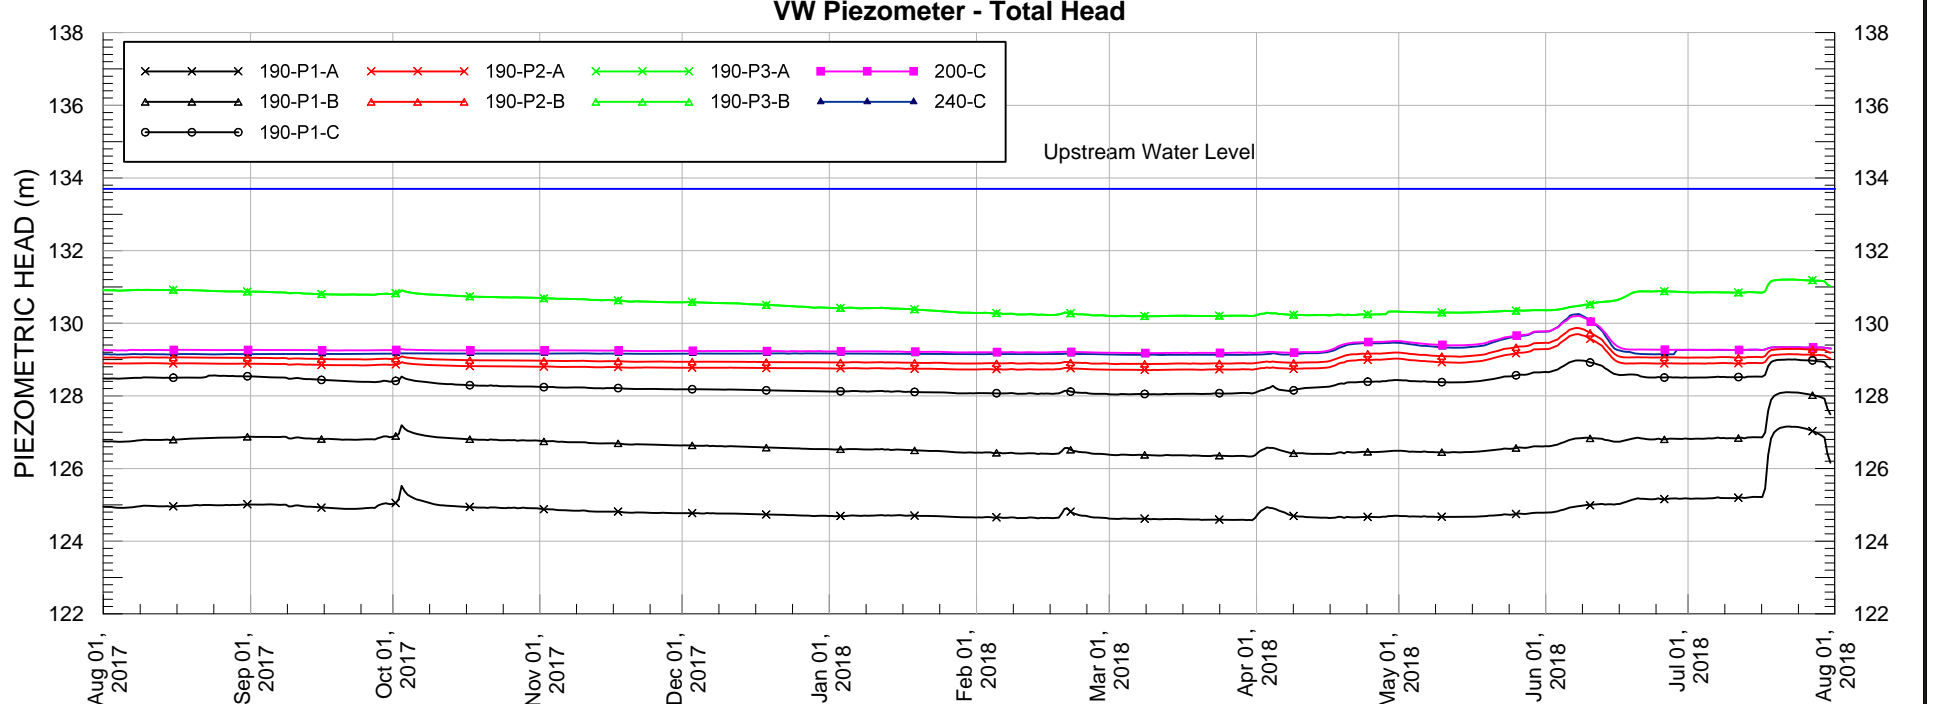
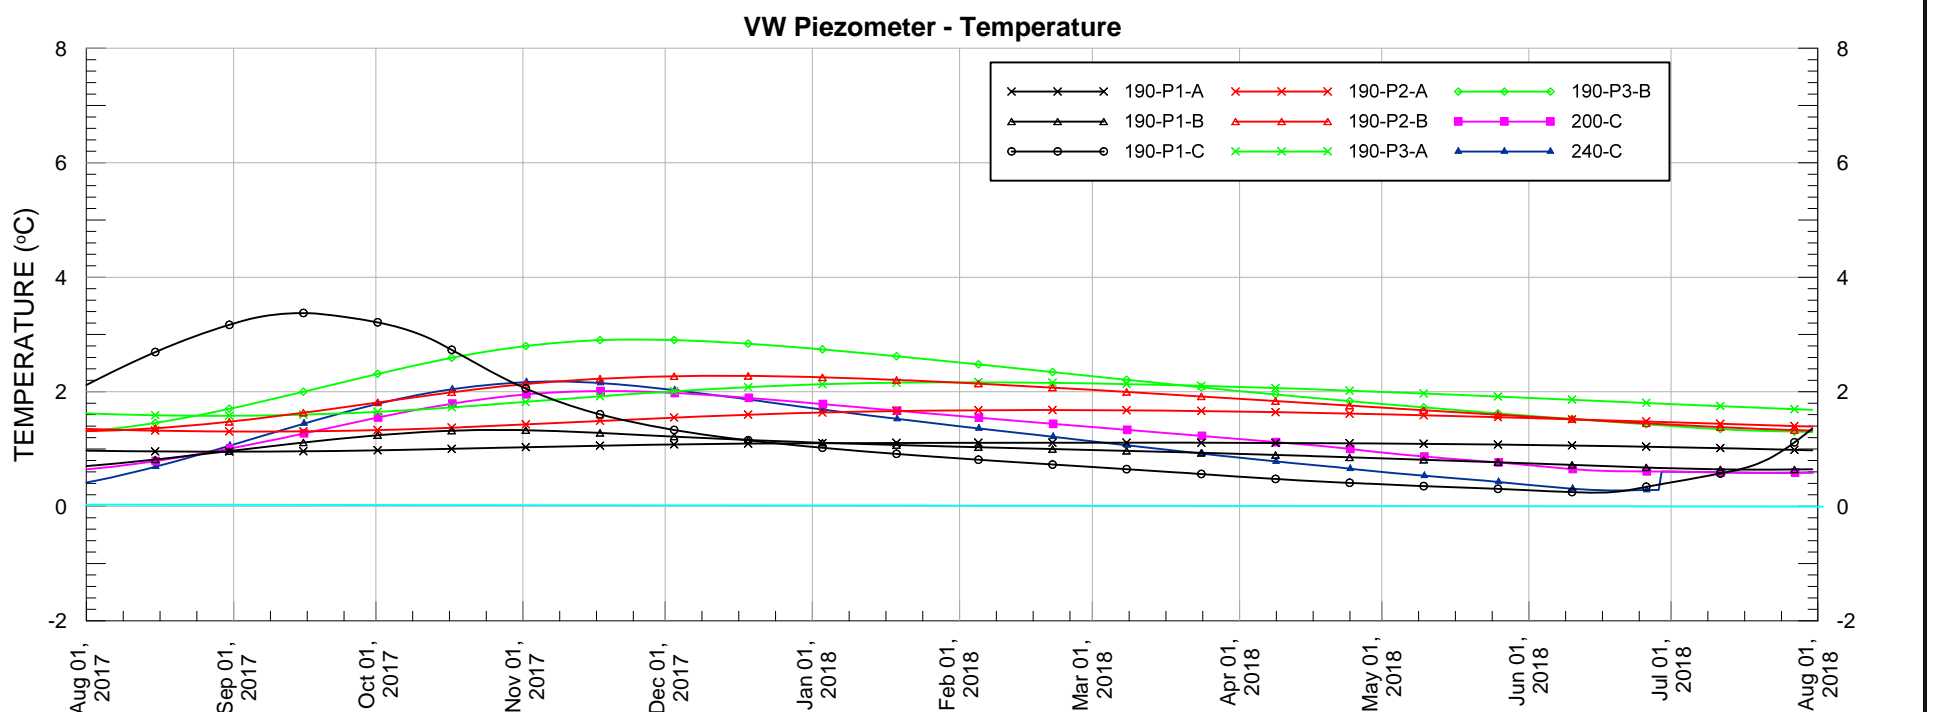
### East Dike - Station 60+190 (DL8)

- NOTES:**
- 1: 150-C stopped working in Nov 2012
  2. Change in PWP and temperature are related to the discharge pipe changed from pit to lake.
  3. There was a rise in PWP in June. Inspections of the area noted no changes.

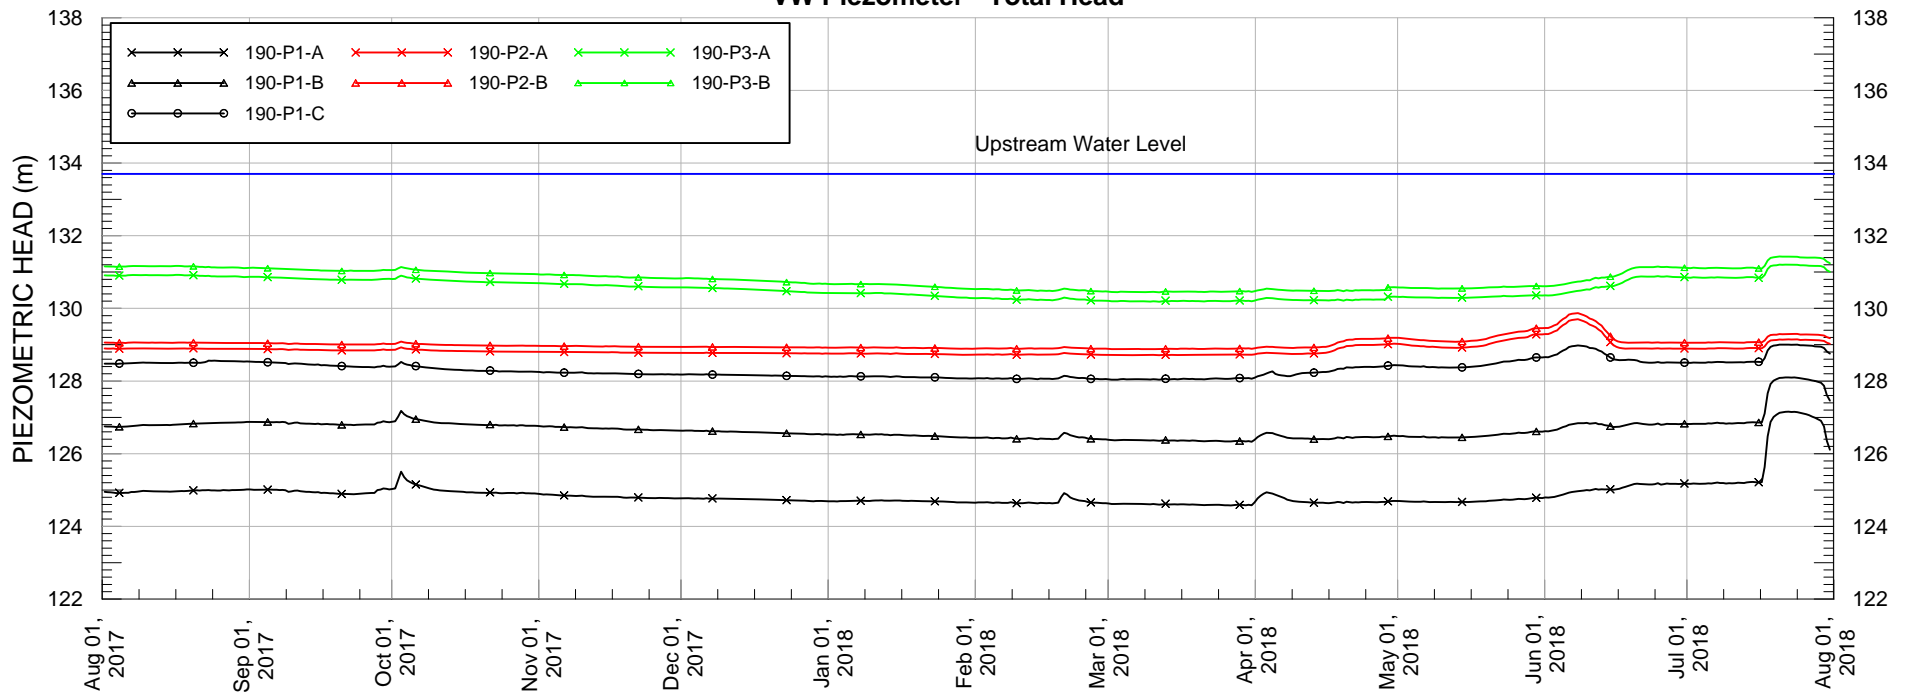
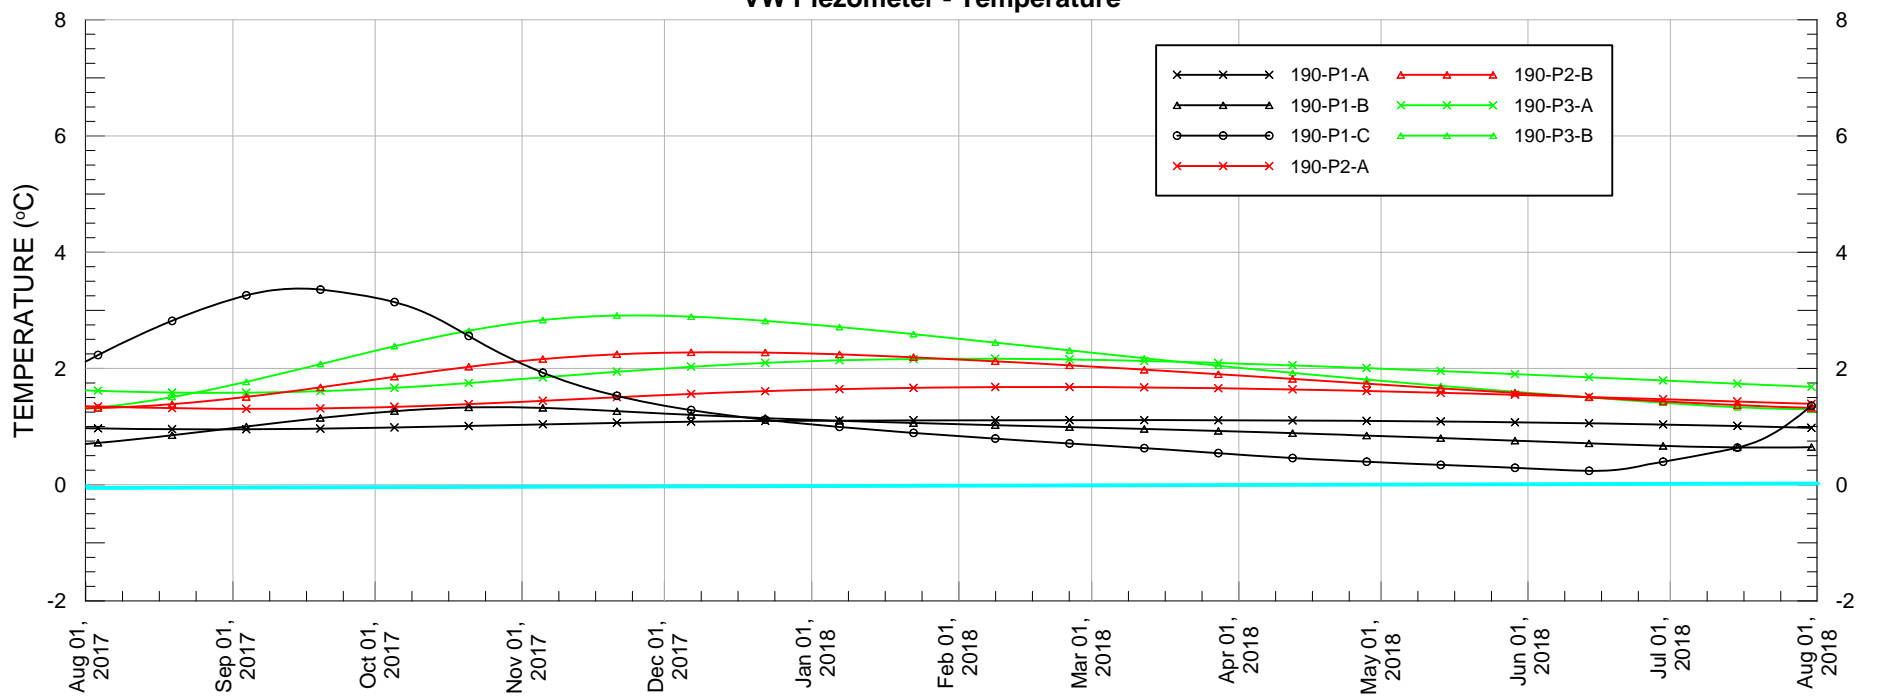
1. Change in PWP and temperature are related to the discharge pipe changed from pit to lake and lake to pit.

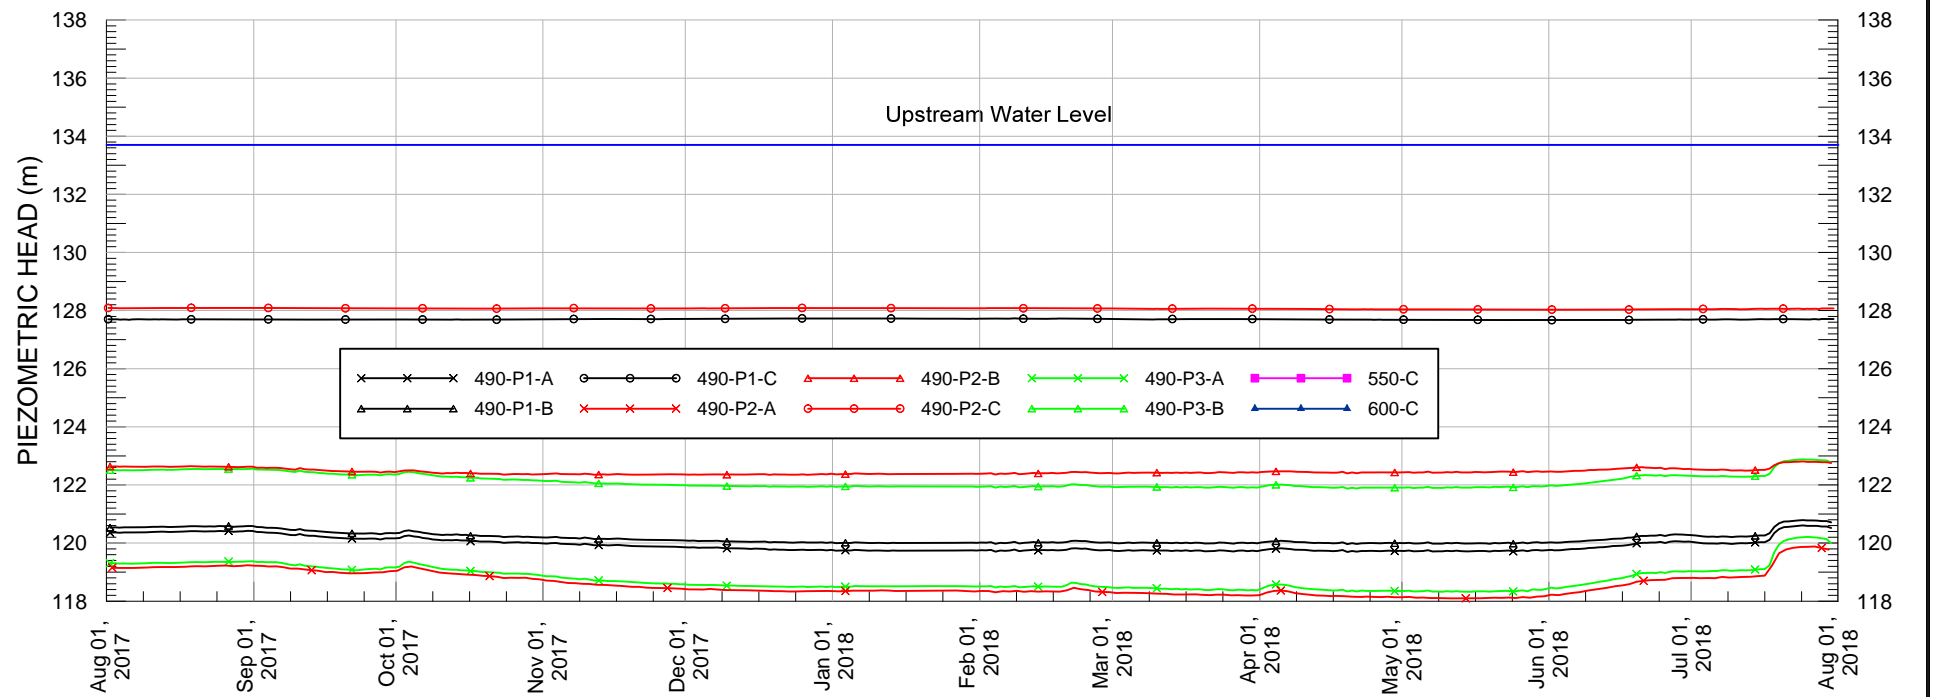
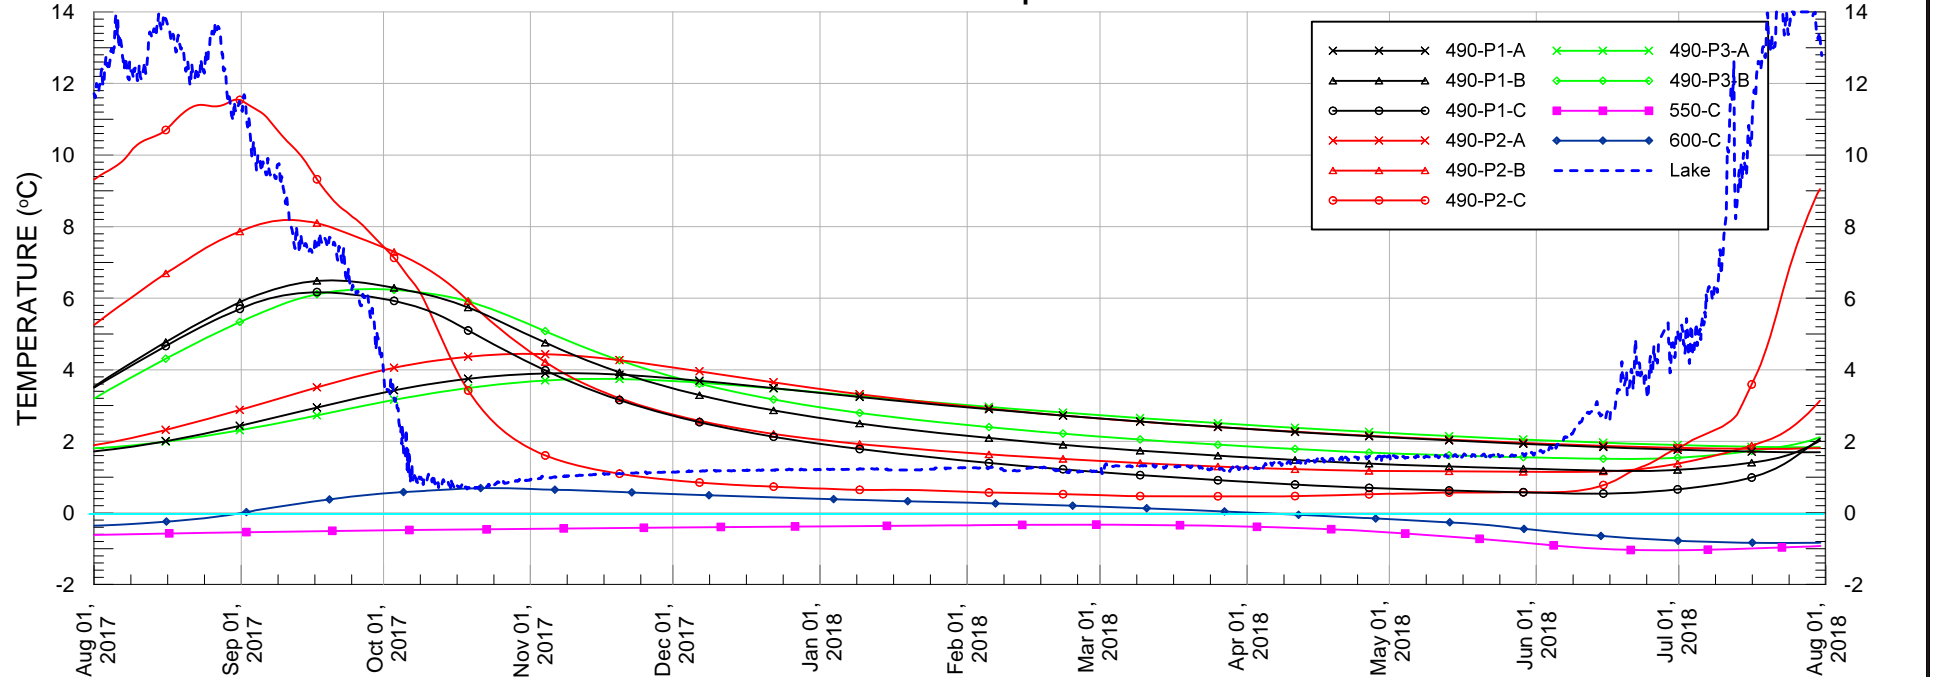
**East Dike - Station 60+490 (DL8)**

- 1: 550-C and 600-C are giving anomaly readings and with a negative temperature are assumed to be frozen.
2. As seen in the graph on the side, the progression of the temperature in the Pz follows the lake temperature closely. Usually it takes approximately one to two weeks to see the trend following the lake temperature.
