# **Meadowbank and Whale Tail 2018 Annual Geotechnical Inspection**

# 2018 Annual Geotechnical Inspection

*Meadowbank Gold Mine, Nunavut*

18101627-1583-R-Rev0

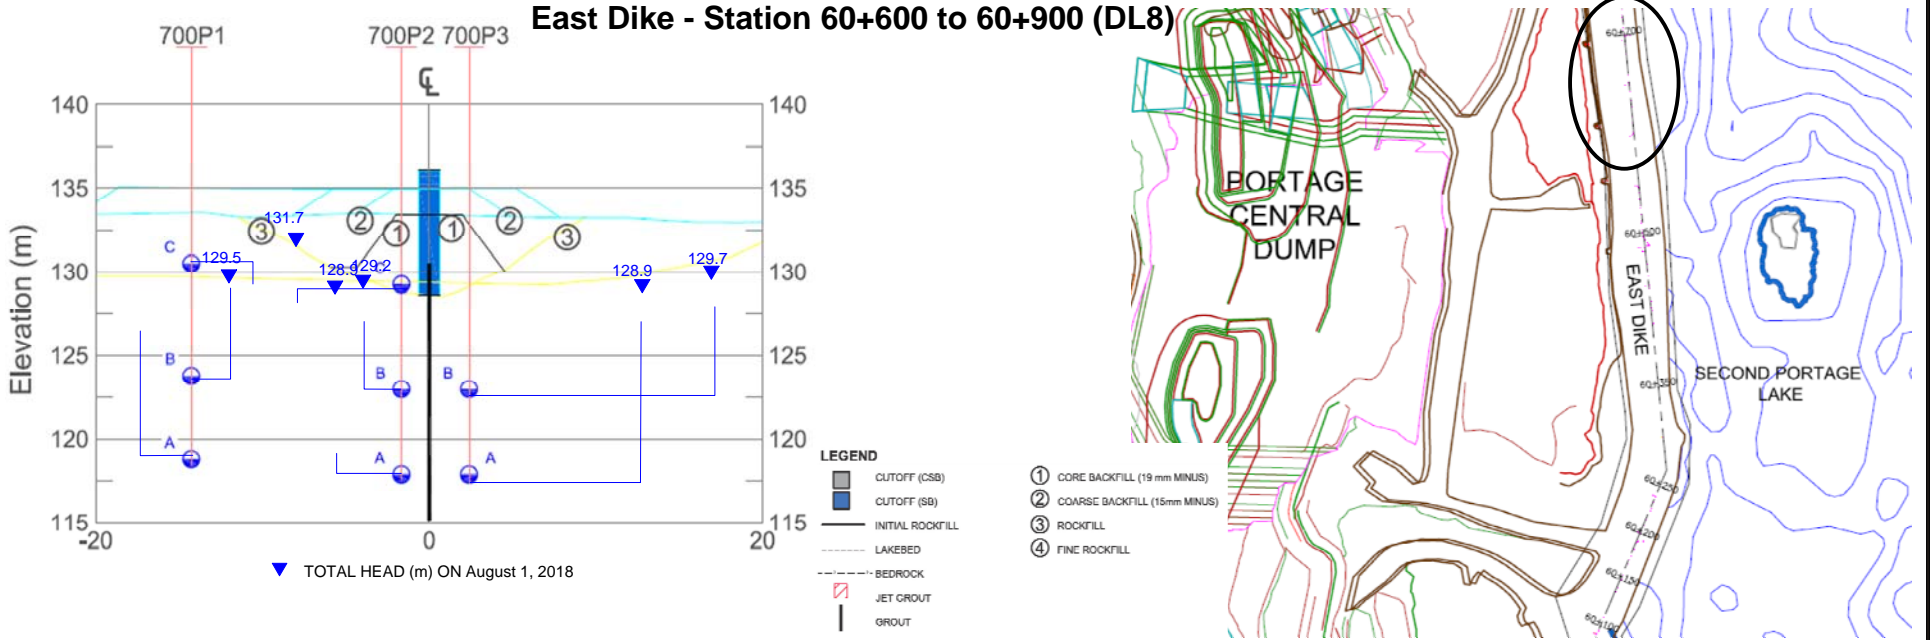
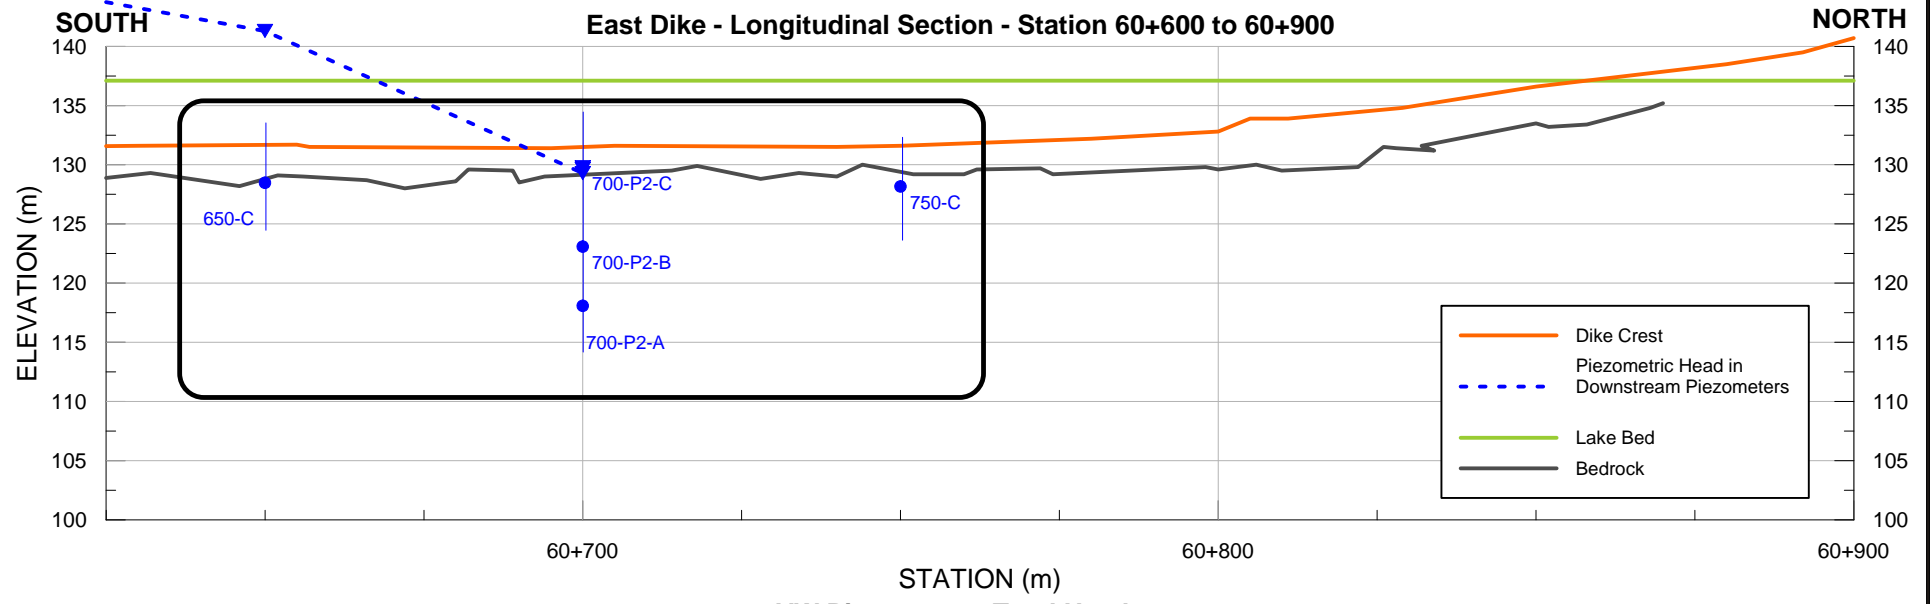
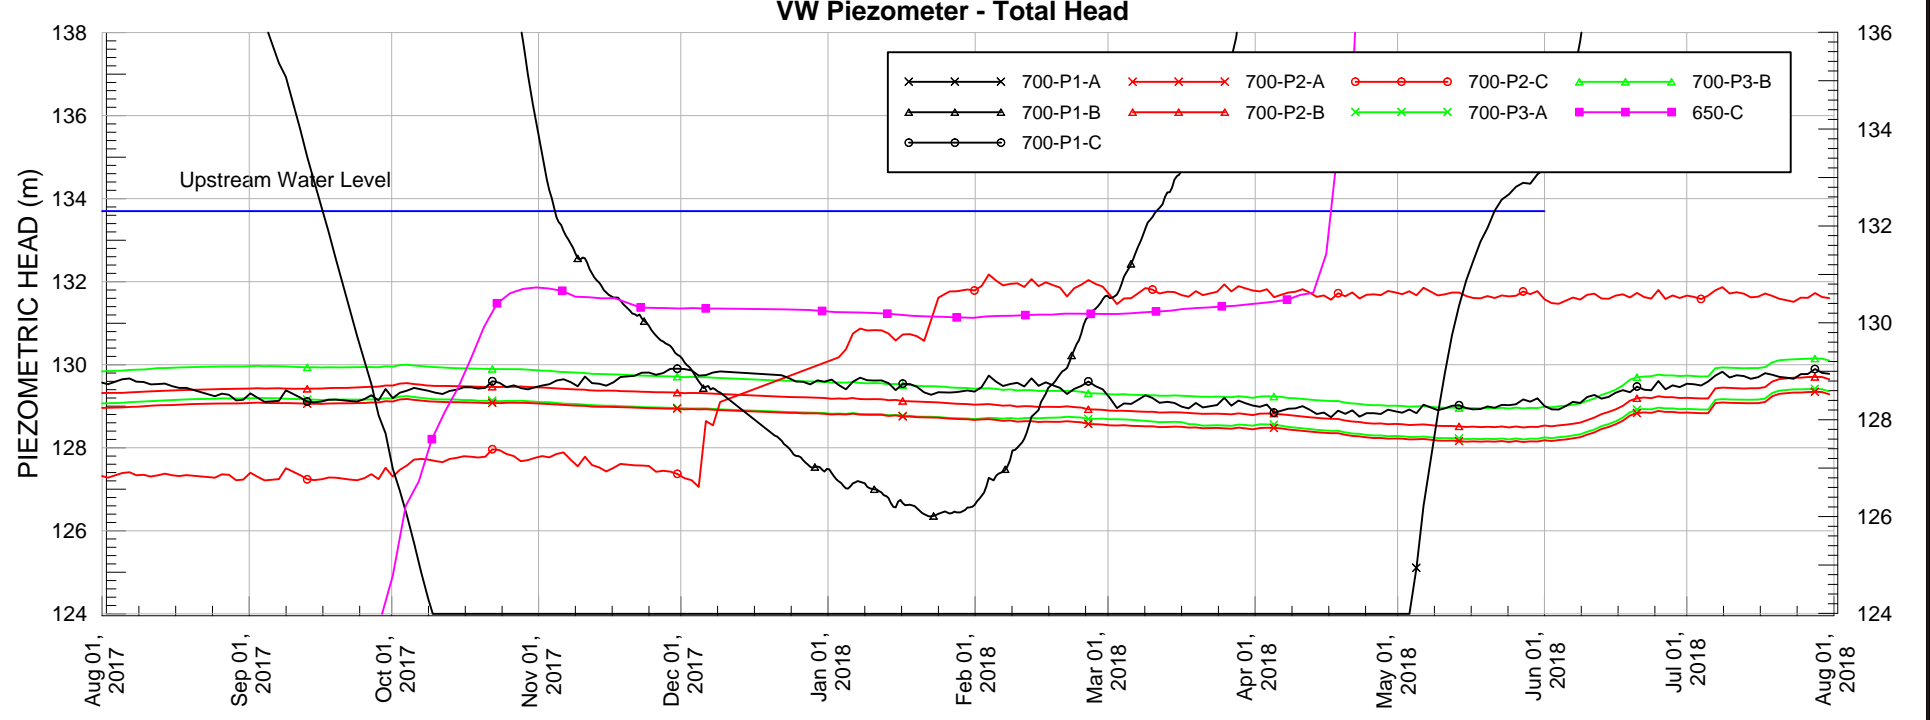
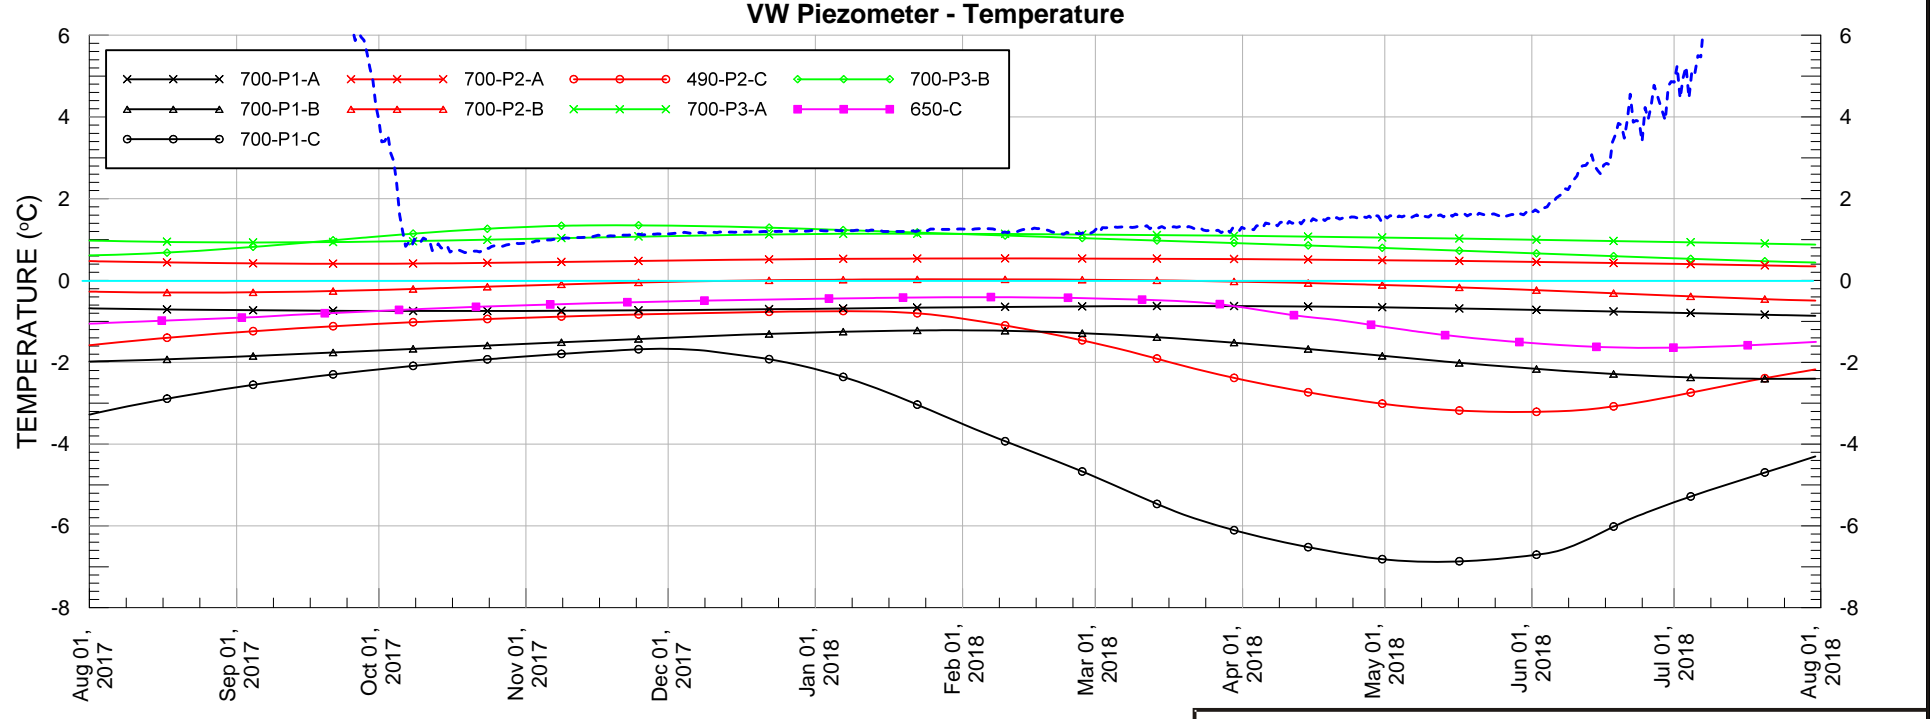
- 1: 700-P1-B and 750-C are giving anomaly readings and with a negative temperature are assumed to be frozen.
2. There was no data from Dec 10 on as the battery had lost charge. The battery was changed on Dec 20.
3. PWP follows same trends as previous years.
4. There was a rise in PWP in June. Inspections found no correlation.

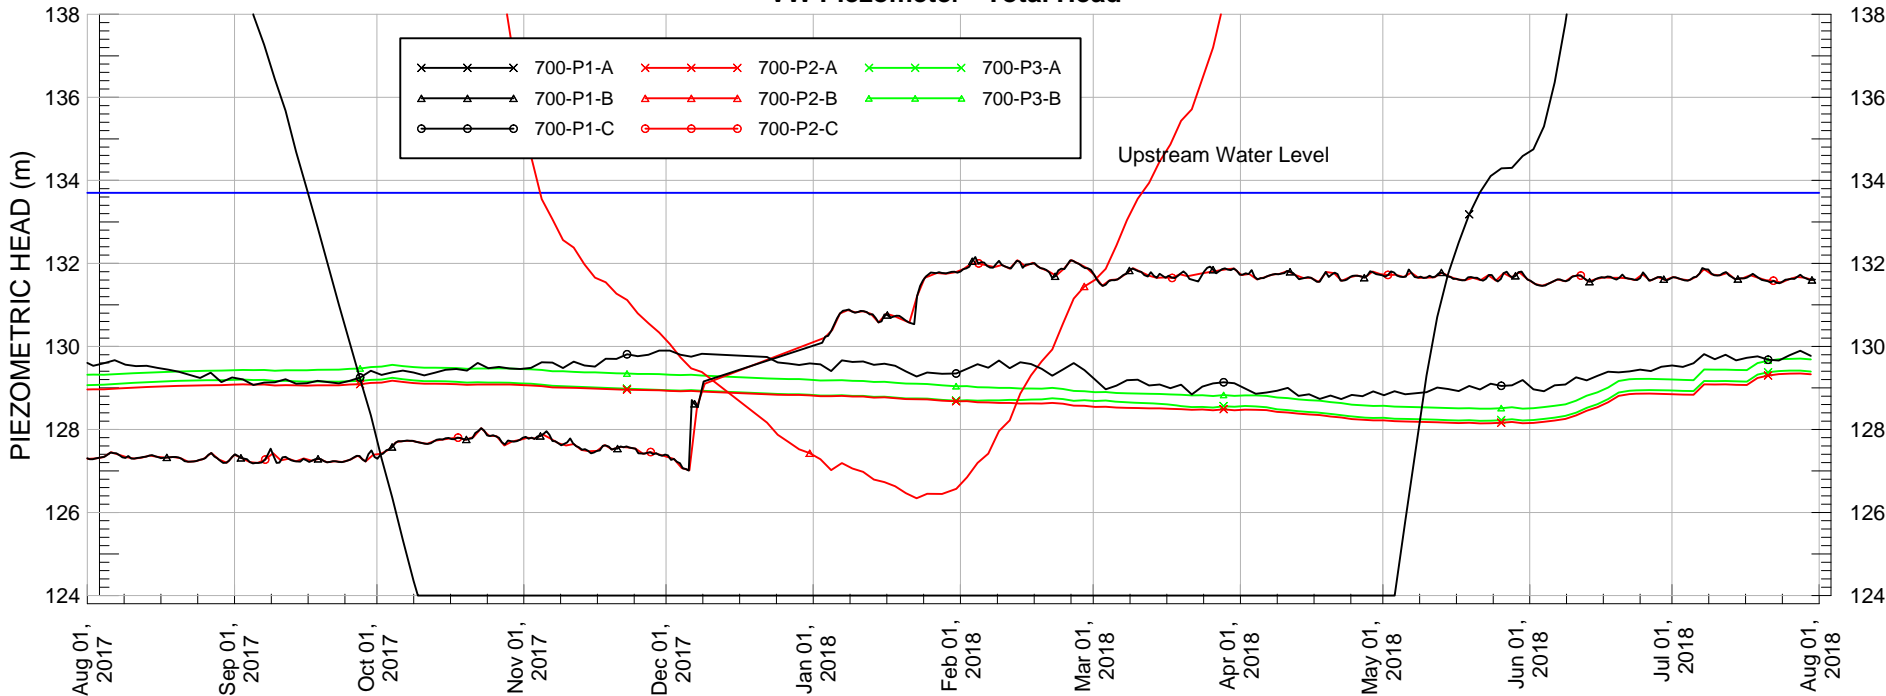
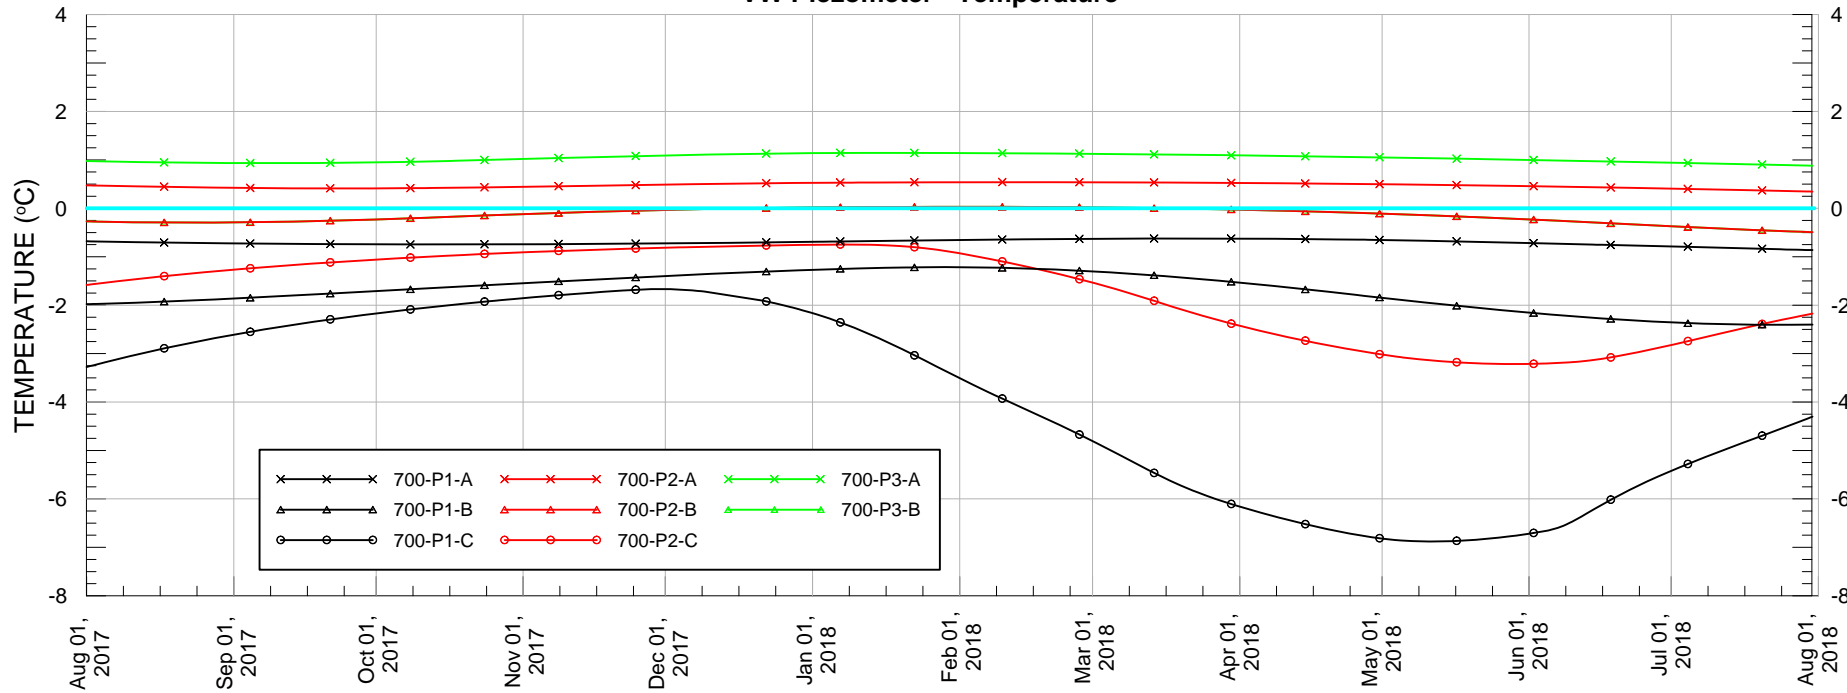
**STATION 60+700**

1: 700-P1-B and 750-C are giving anomaly readings and with a negative temperature are assumed to be frozen.

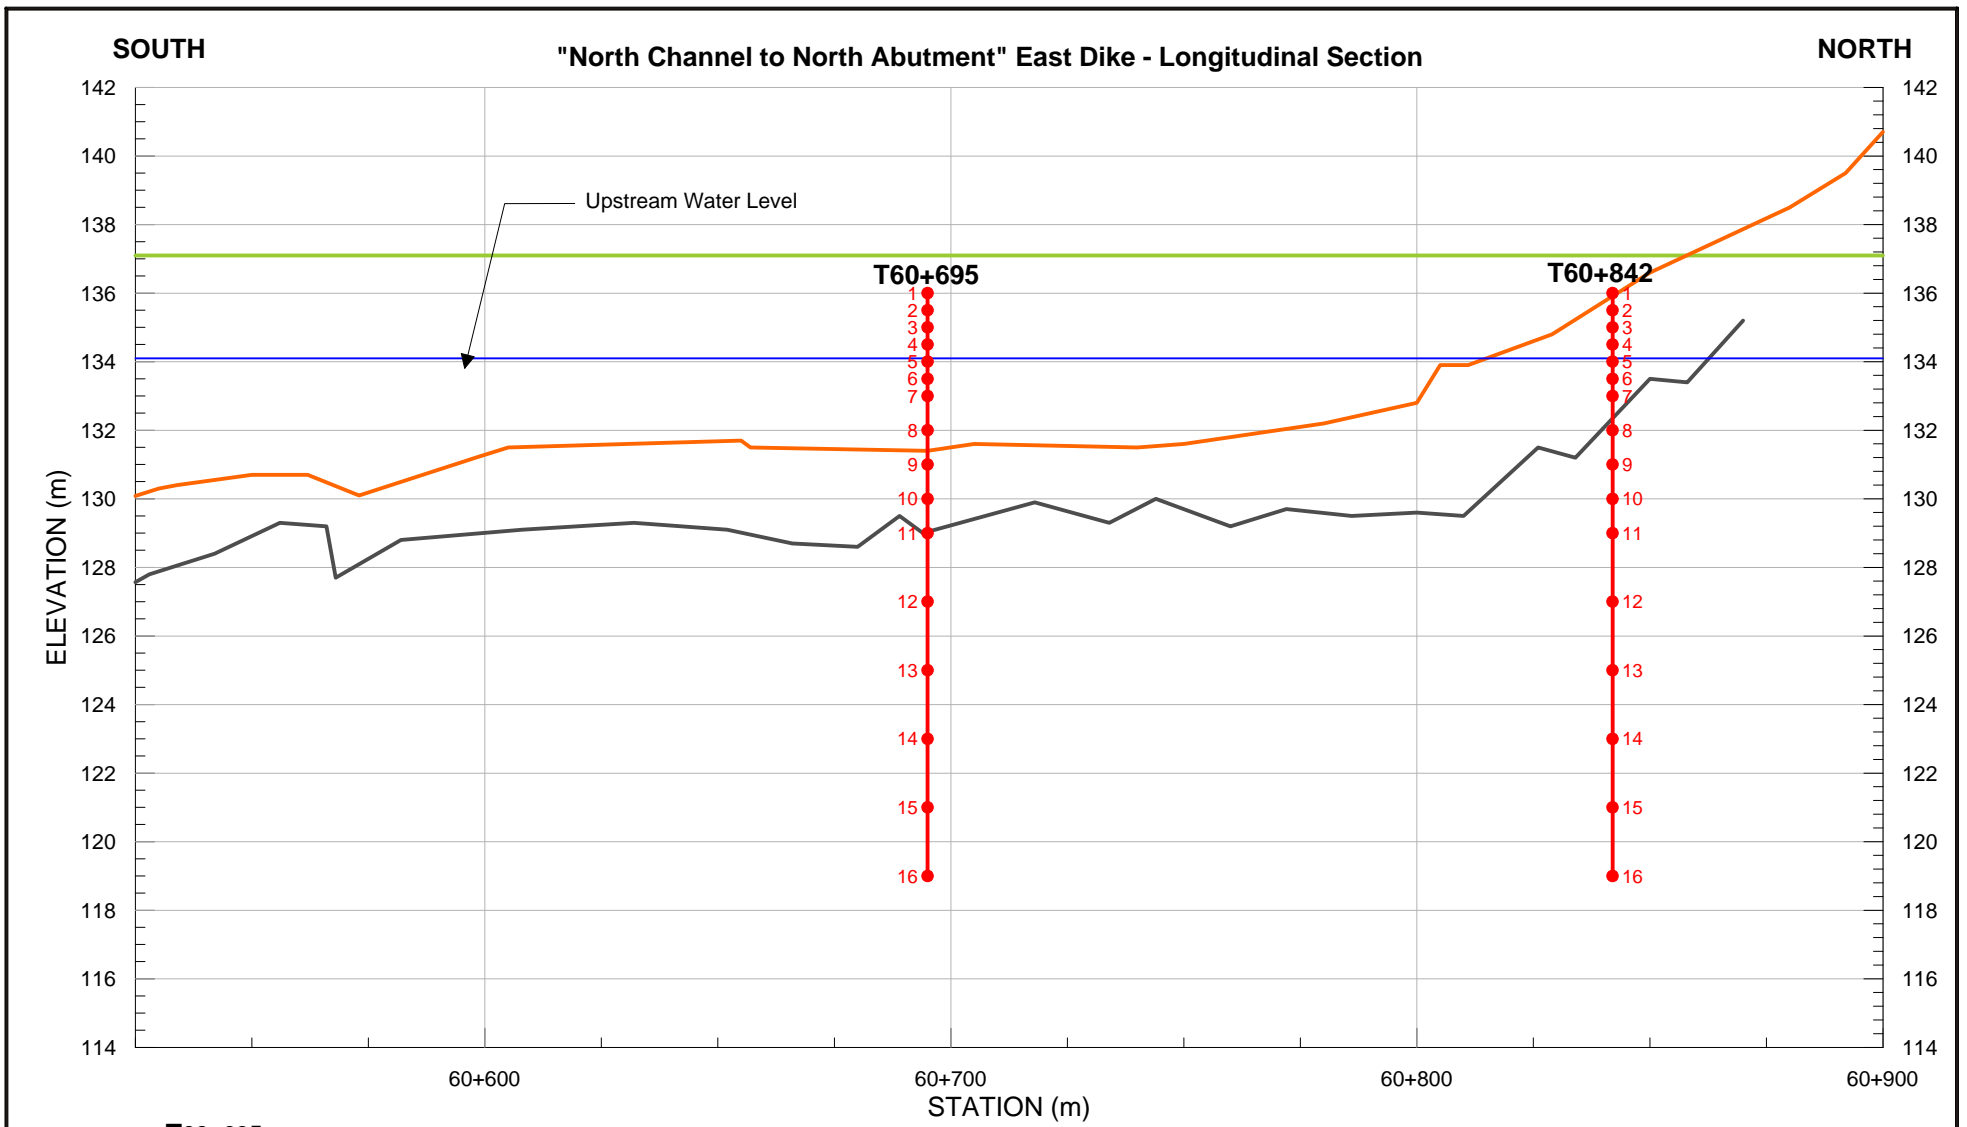
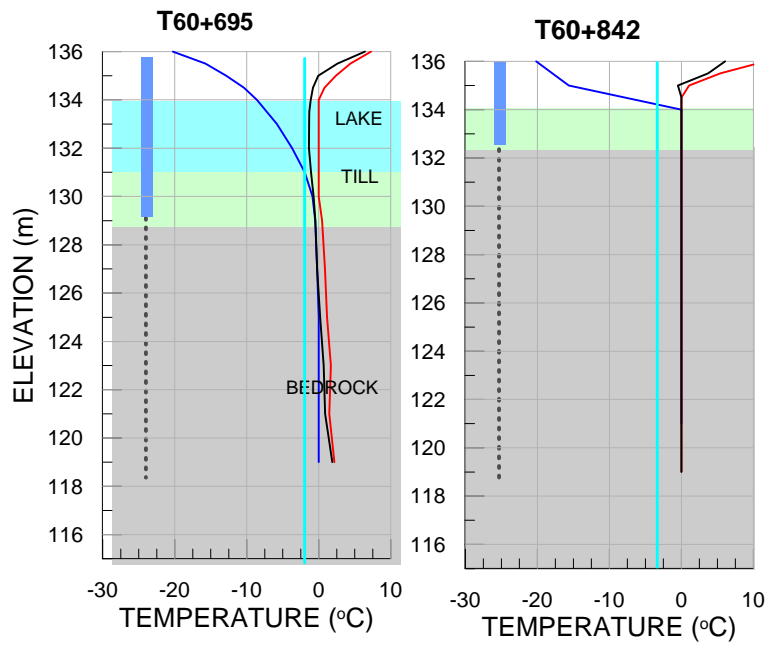
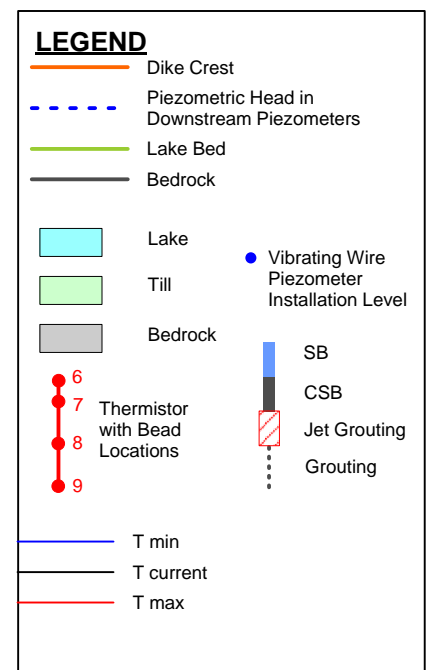
**NOTES:**  
1. Beads on T60+842 do not seem to be working properly.

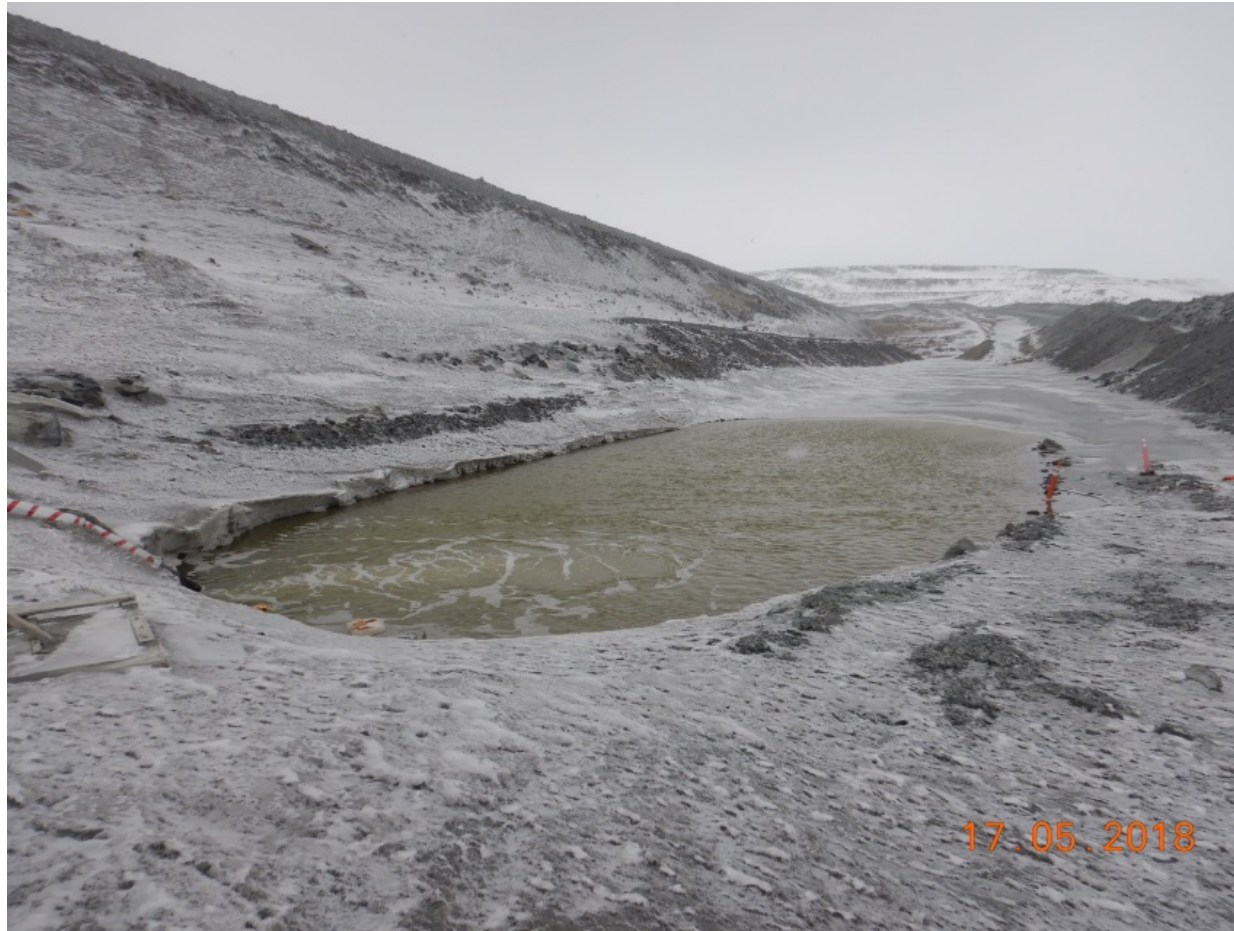
**May 17<sup>th</sup>, 2018**

### Monthly Photo of D/S Pond Coloration

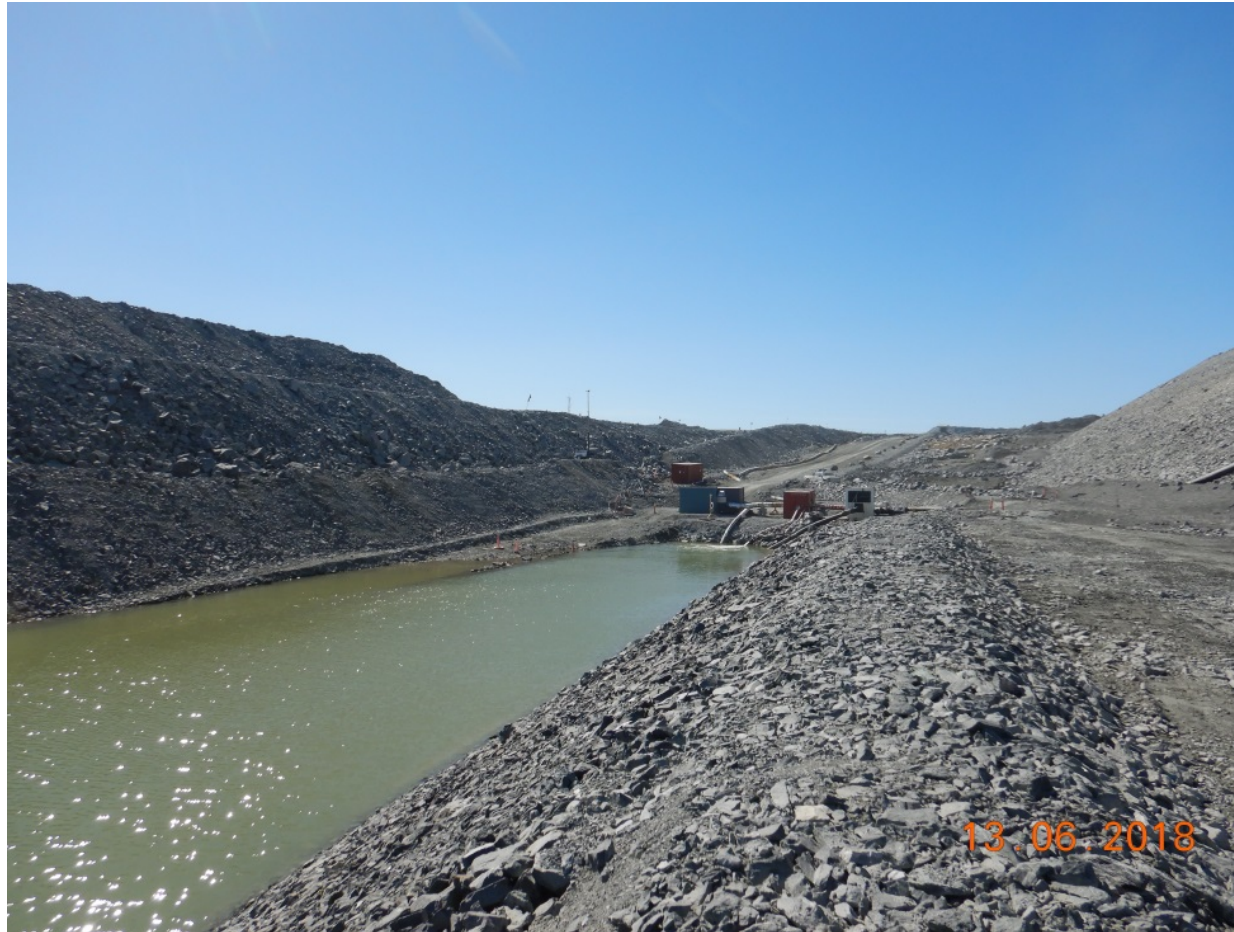
**June 13<sup>th</sup>, 2018**

### Monthly Photo of D/S Pond Coloration

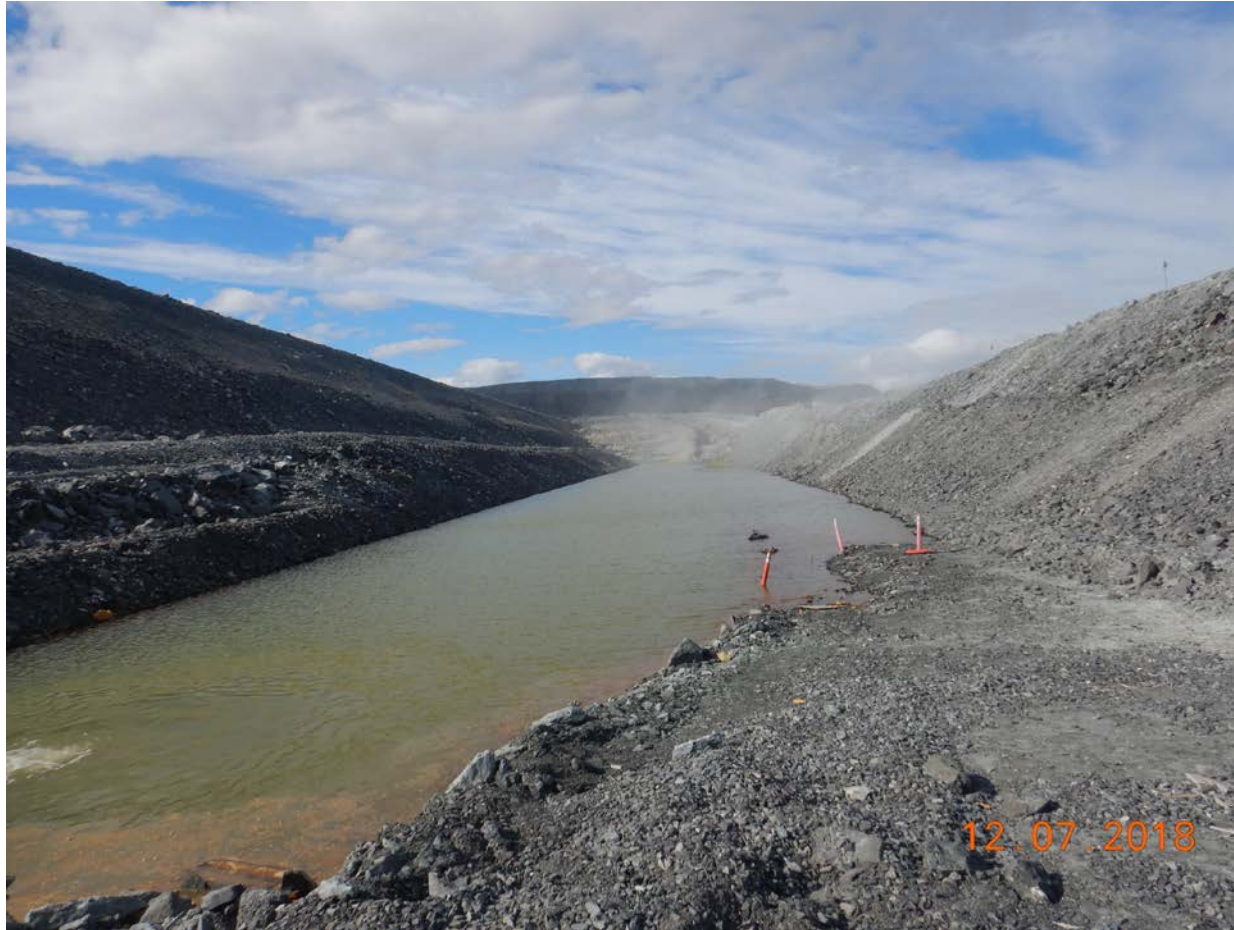
**July 12<sup>th</sup>, 2018**

### Monthly Photo of D/S Pond Coloration

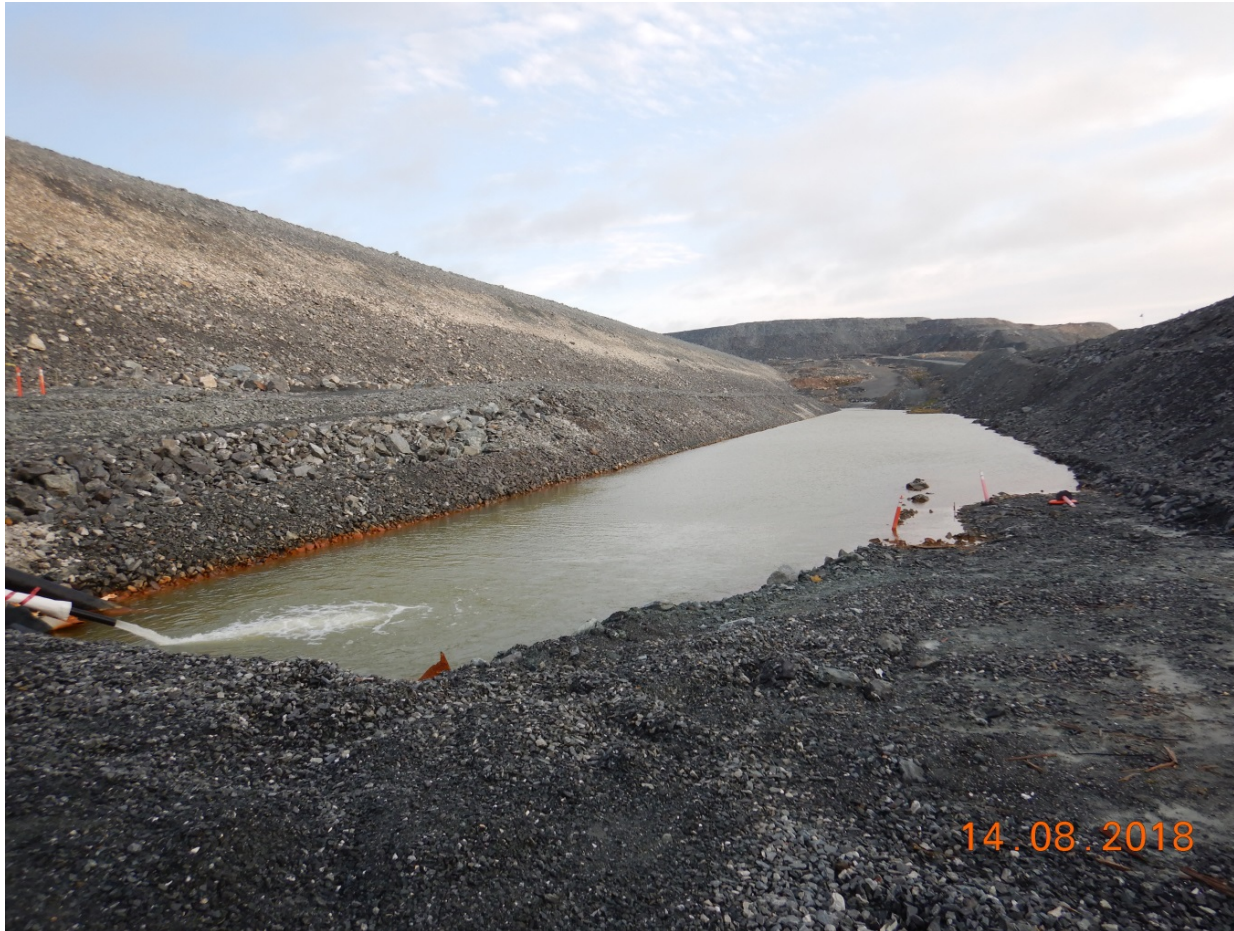
**August 14<sup>th</sup>, 2018**

### Monthly Photo of D/S Pond Coloration

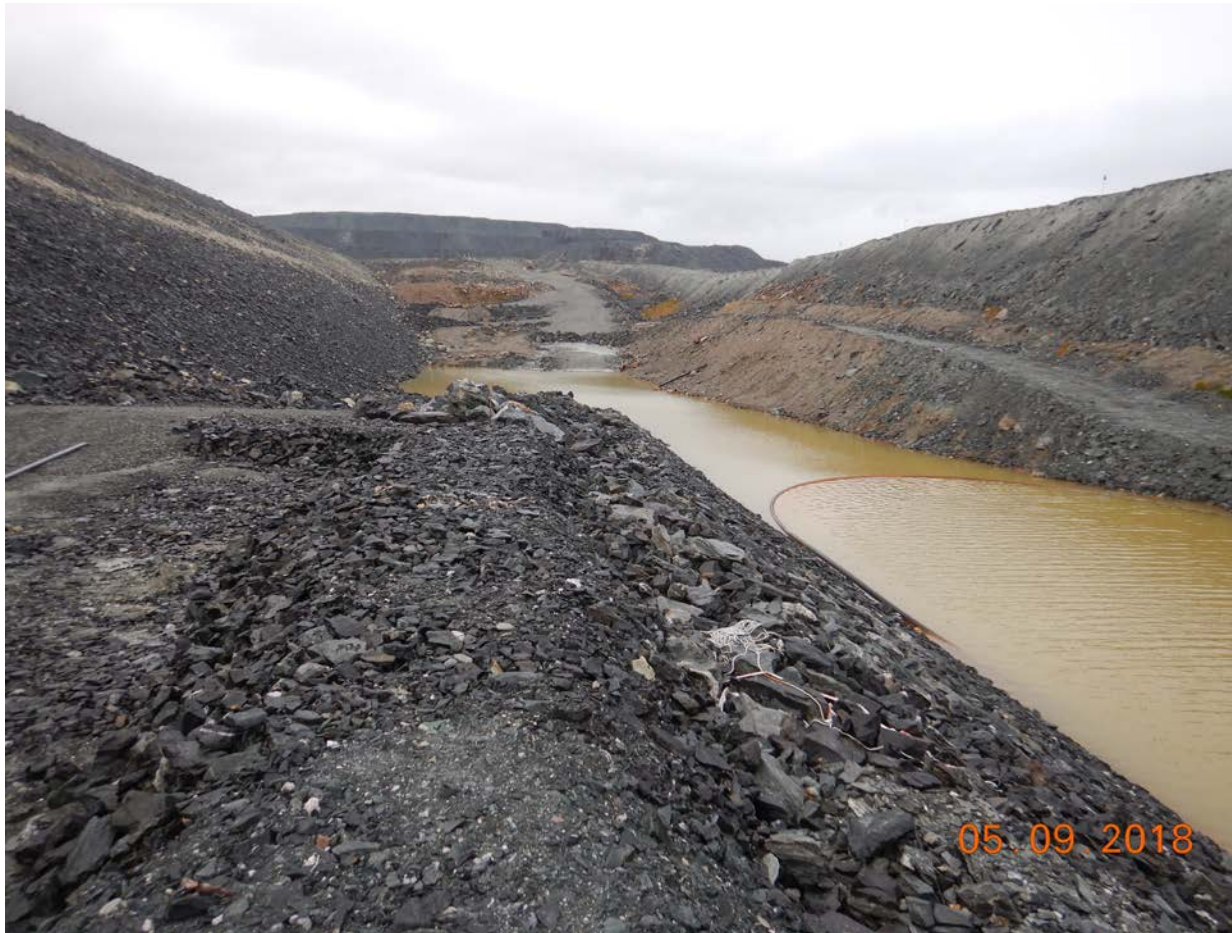
**September 5<sup>th</sup>, 2018**

### Monthly Photo of D/S Pond Coloration

- Water sample analysis parameter are reviewed on a monthly basis by an AEM geochemist
- Expected trend ongoing and support the hypothesis of coloration change due to microbial metabolism resulting in a reduction of ferric iron
- The process will likely happen every year, but is not expected to worsen
- Water sampling will stop once the pond freeze and will resume in 2019

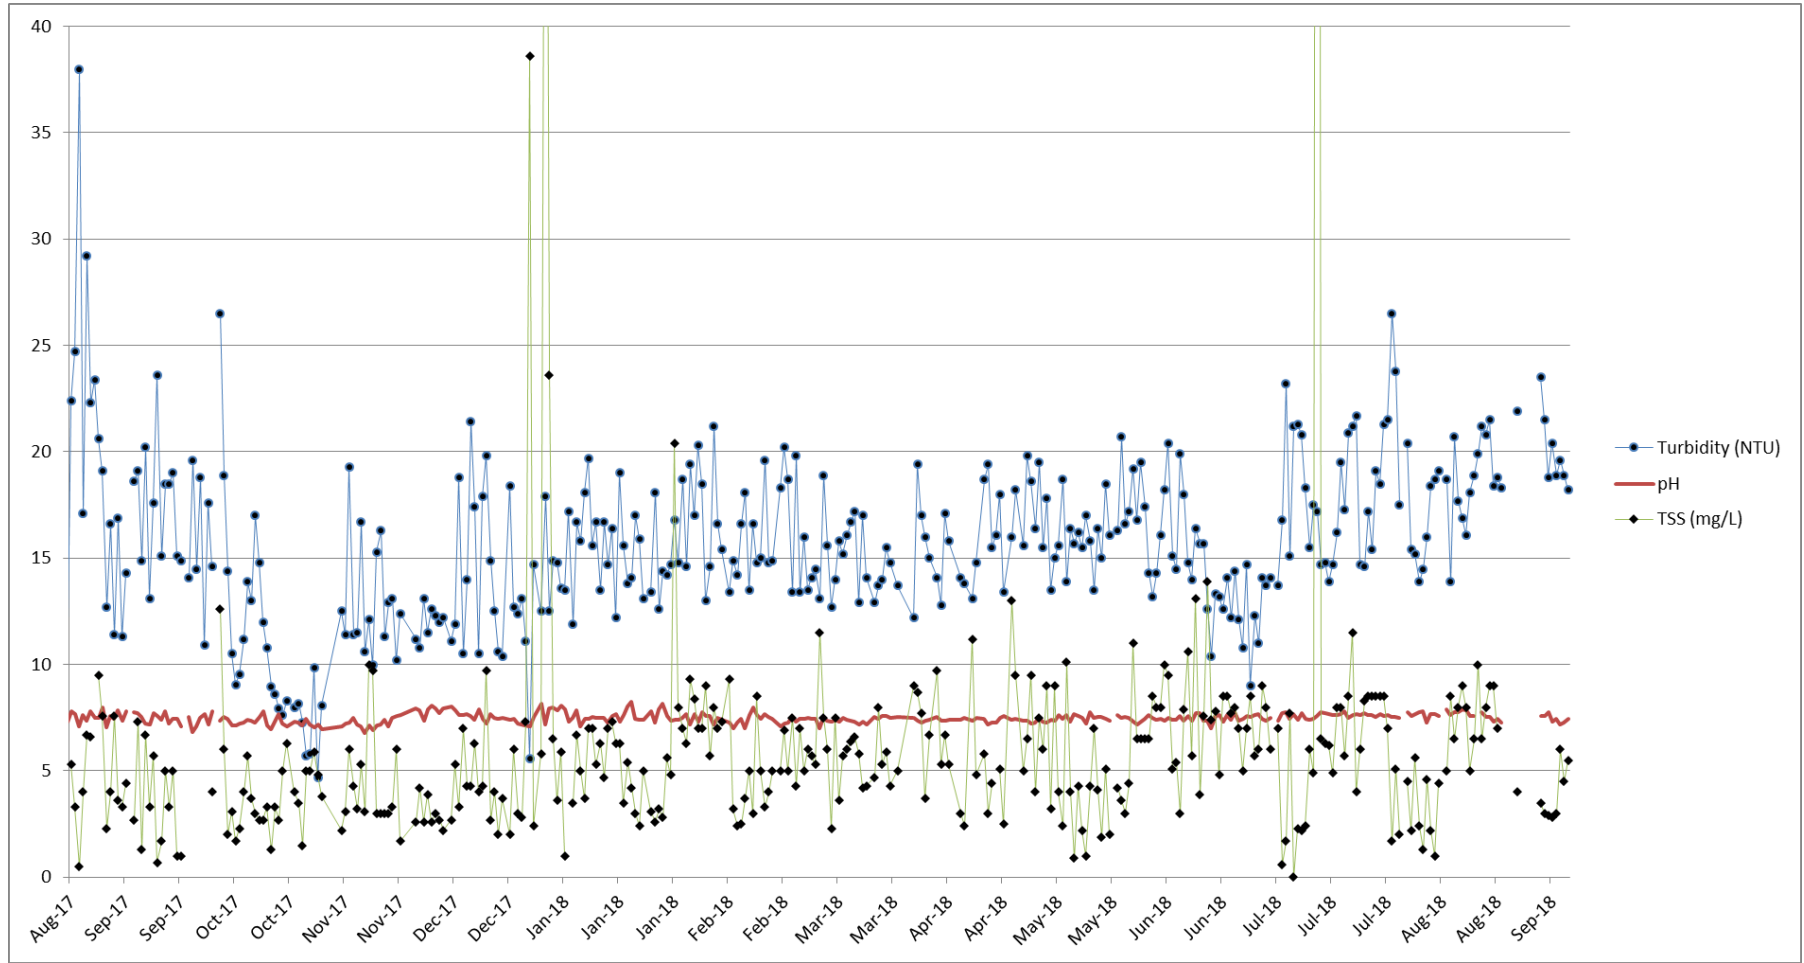
# D/S POND TSS, PH, TURBIDITY

TSS = 70.4 mg/L

TSS = 144 mg/L

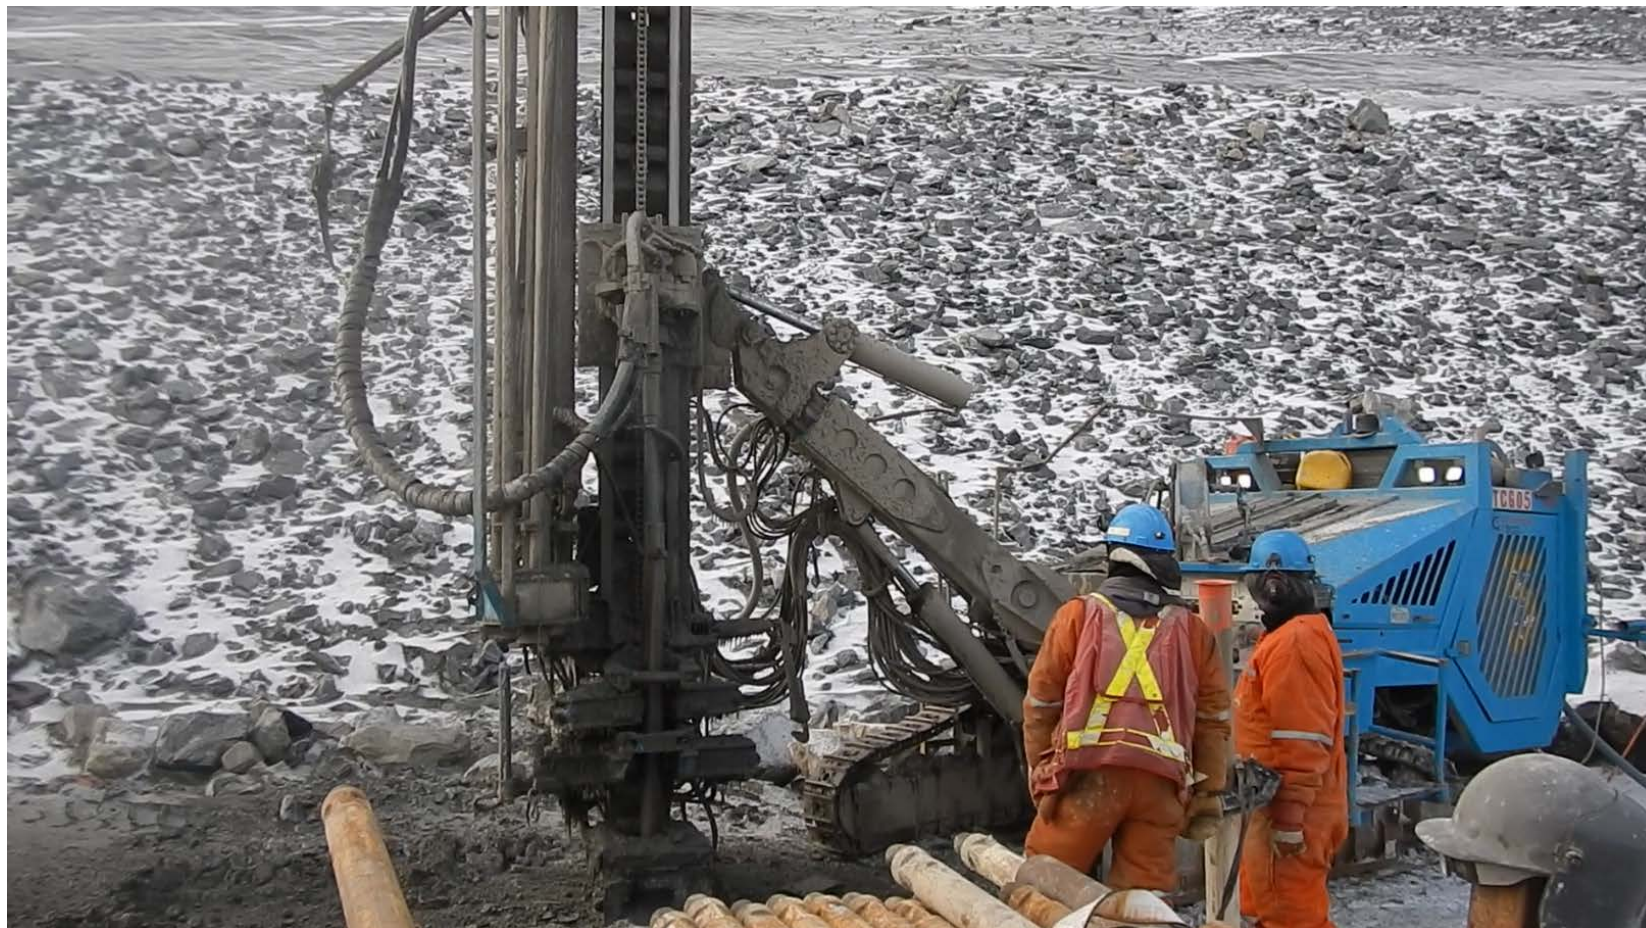
## 2.2 700P1 Area (October 2017)

- During the Central Dike investigation campaign performed in June 2017, an anomaly was detected during the drilling of the hole 700P1.
- An hypothesis for this anomalie was the presence of a void in the till layer.
- To investigate this hypothesis, AEM decided to perform additional drilling in the vicinity of the 700P1.

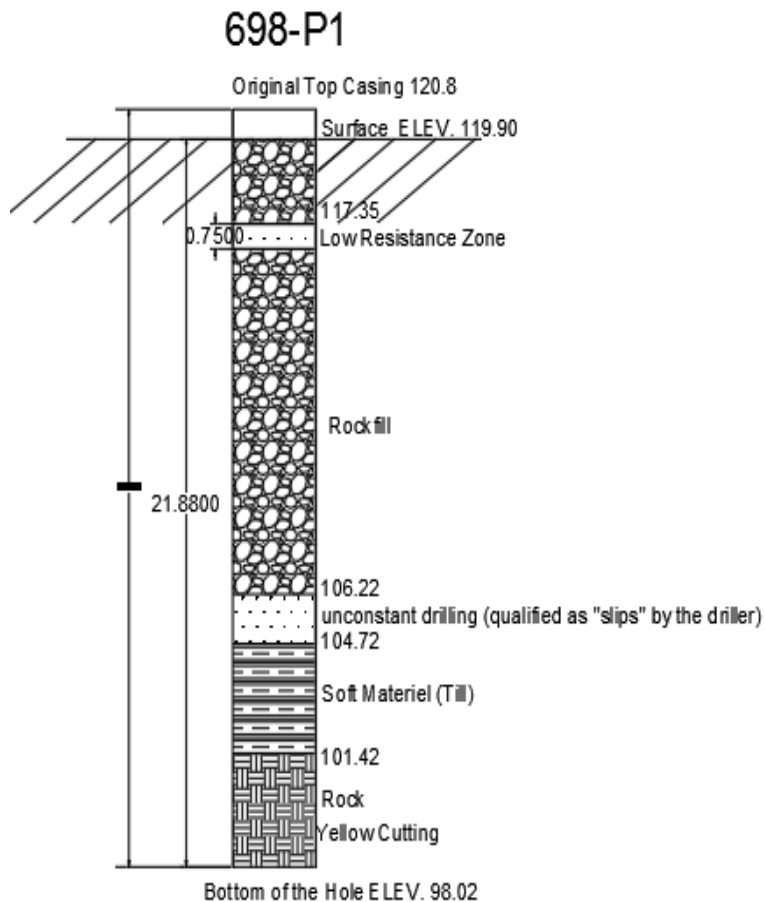
#### Hole 698-P1

- Started to be drilled at around 1:30 PM October 5, 2017.
- Starting at elevation 117.35, a small zone in the rockfill (0.75m) was encountered where there was not much resistance on the drill. It went back to the rockfill after that.
- The water started pouring out of the hole at elevation 115.
- At elevation 106.22, the driller mentioned that he was feeling some kind of slips in the material
- No void was encountered around the till zone.

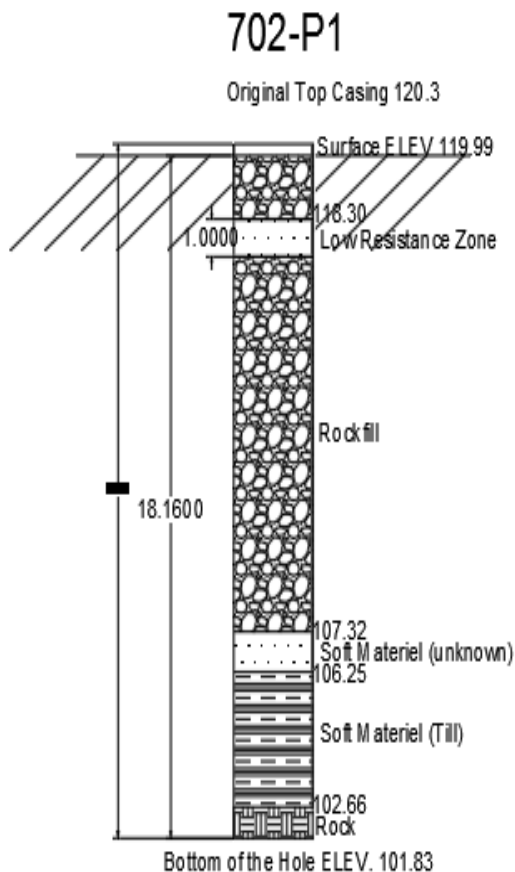
#### Hole 698-P1

- The hole 702-P1 started to be drilled at around 7:30 AM October 6, 2017.
- Starting at elevation 118.30, a small zone in the rockfill was encountered (1.0m) where there was not much resistance on the drill.
- The water started pouring out of the hole at elevation 115.
- At elevation 107.32, the driller mentioned that the material was very soft and shortly after that, the till zone was confirmed.
- No void was encountered around the till zone.

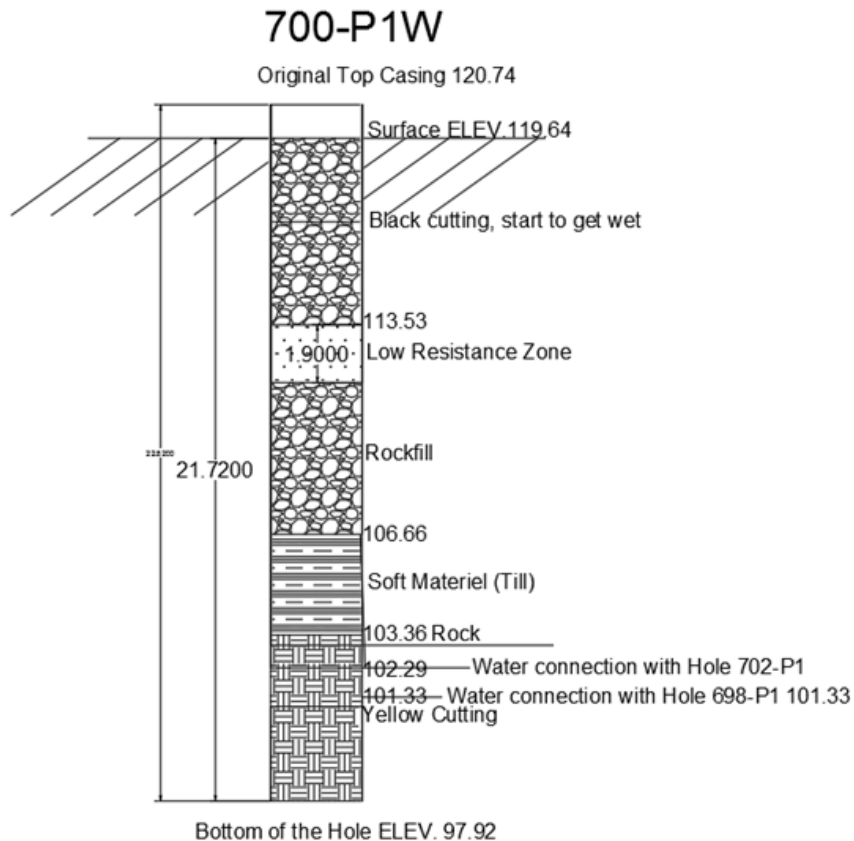
### Hole 698-P1

- The hole 700-PW started to be drilled at around 1:30 PM October 6, 2017.
- Starting at elevation 113.53, a zone in the rockfill (1.9m) was encountered where there was not much resistance on the drill. It went back to the rockfill after that.
- The water started pouring out of the hole at elevation 115. At elevation 106.66 the drill encountered the till. Around the same time and elevation, the water started to poured out of the second hole that was drilled (702-P1). No void was encountered around the till zone. At elevation 101.33 the water started pouring out of the first hole that was drilled (698-P1). Water resurgence was observed in nearby holes while drilling in the bedrock.
