# **Meadowbank and Whale Tail 2018 Annual Geotechnical Inspection**

# 2018 Annual Geotechnical Inspection

*Meadowbank Gold Mine, Nunavut*

18101627-1583-R-Rev0

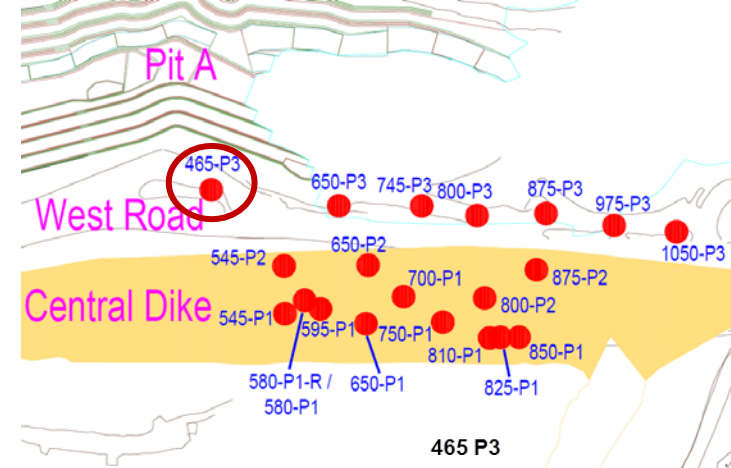
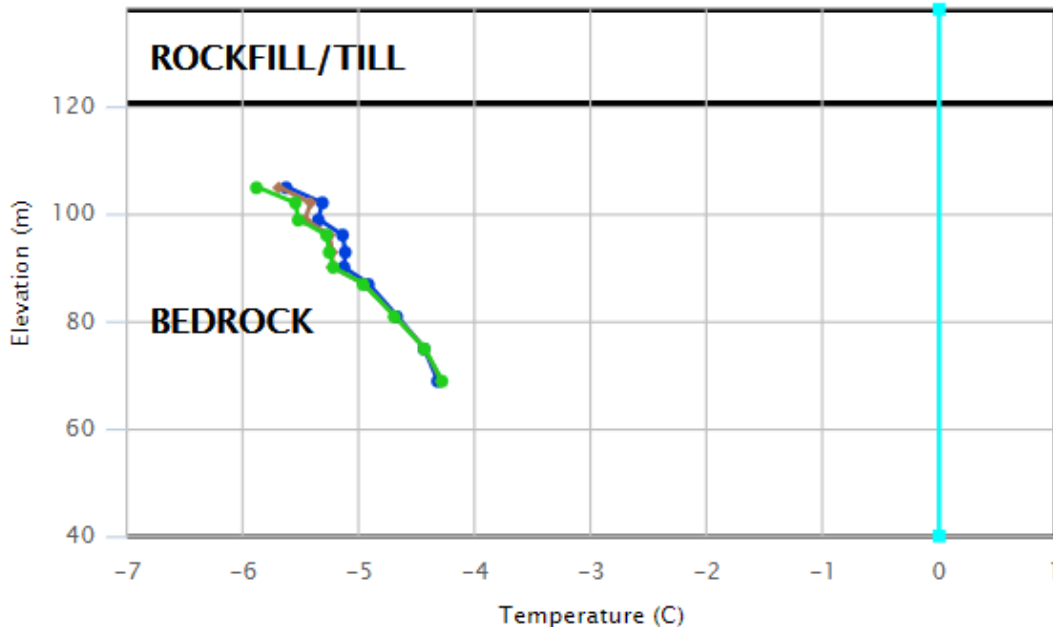
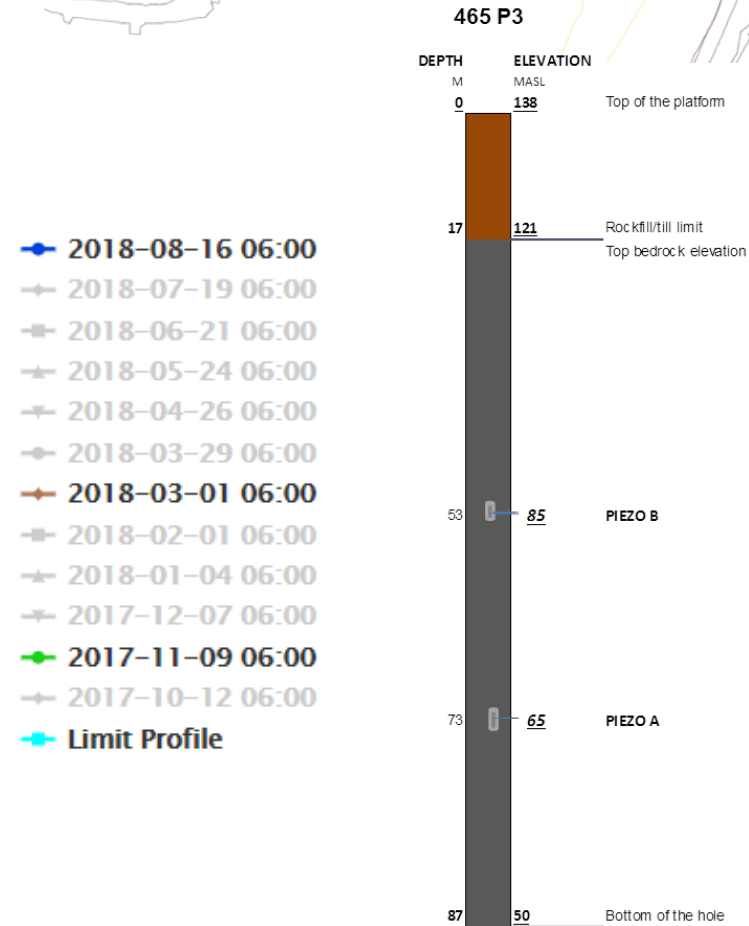
# THERMISTOR 465 P3

➔ Bedrock Below 0° C at 465-P3 [-5.6 ° C to -4.3° C]

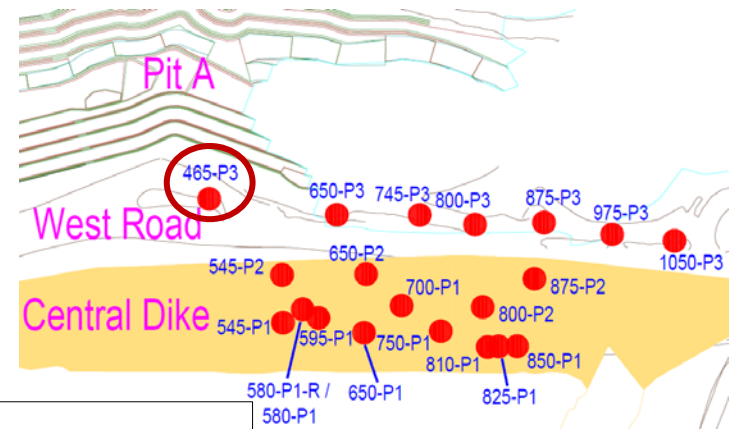
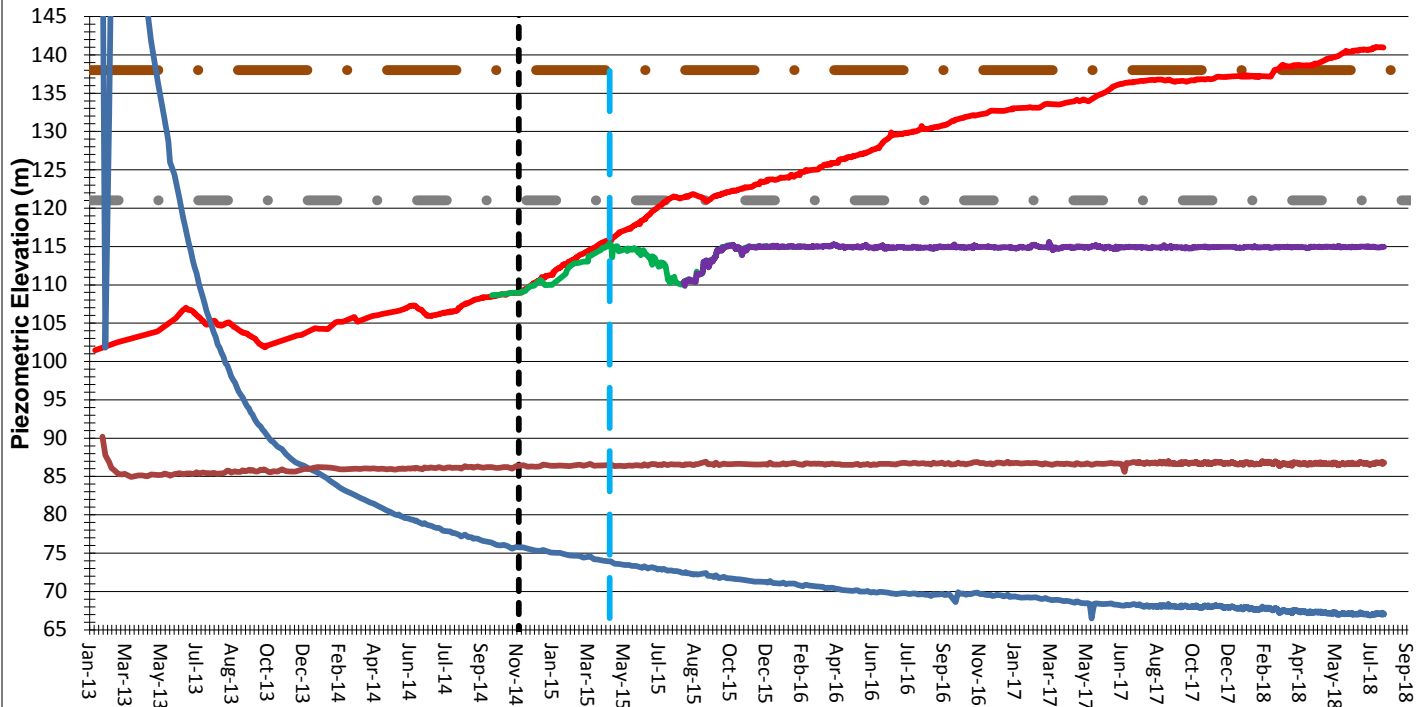
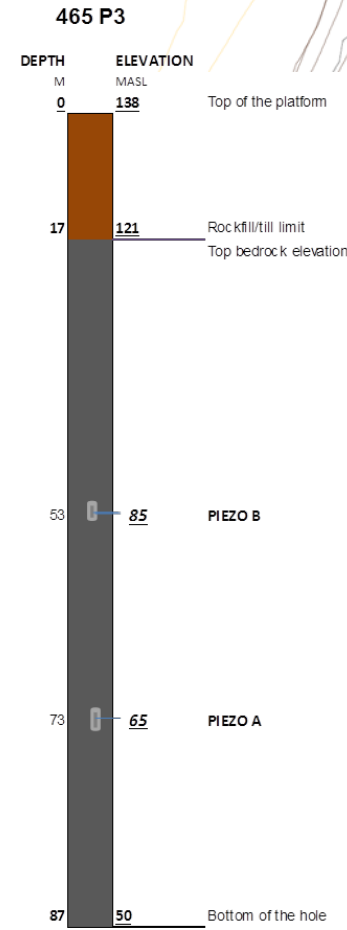
# PIEZOMETERS 465-P3

➔ Both Piezo are showing temperature values under the freezing point

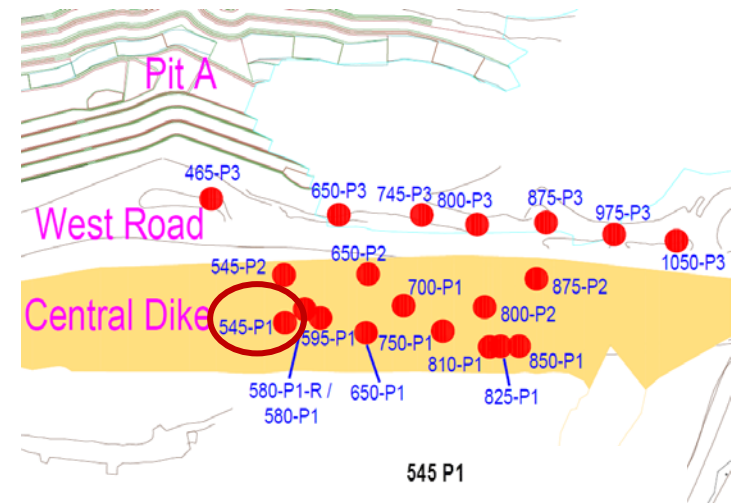
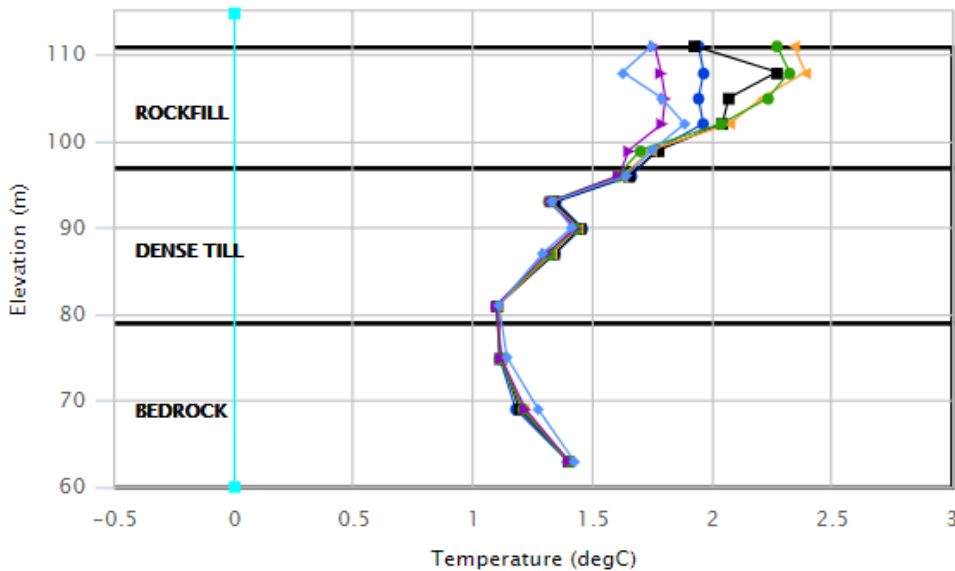
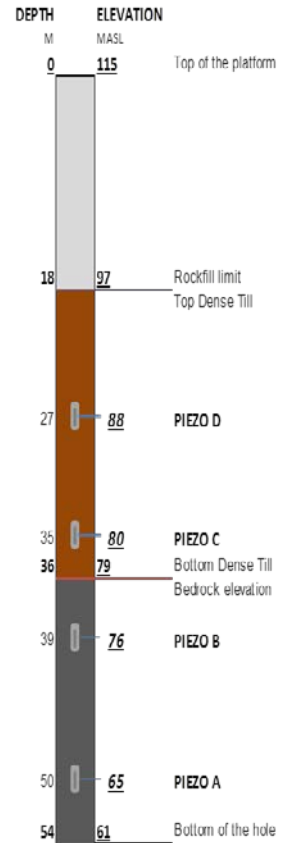
# THERMISTOR 545-P1

- 545-P1 thermistor is showing the same temperature profile than last year. Warmer peak observed at elevation 81.
- Temperature in the bedrock/till unit is in between 1.1°C and 1.4°C.

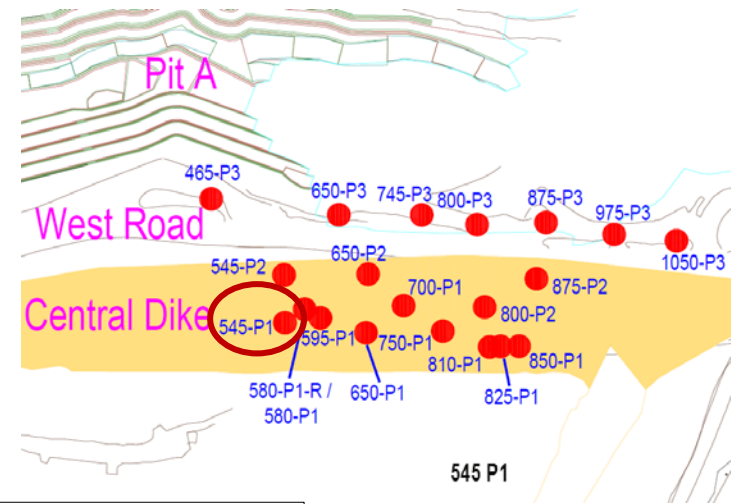
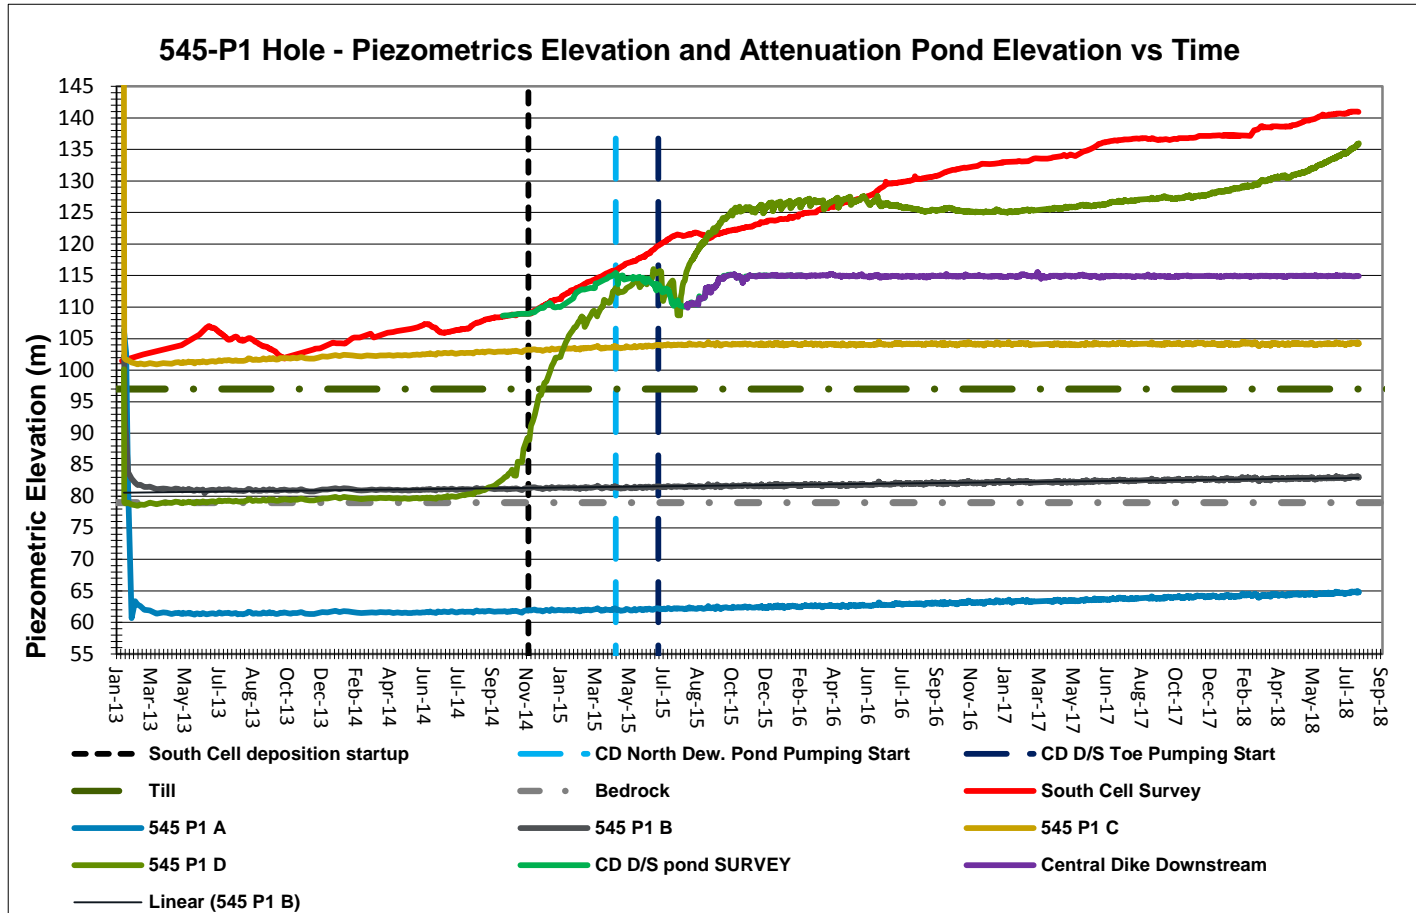
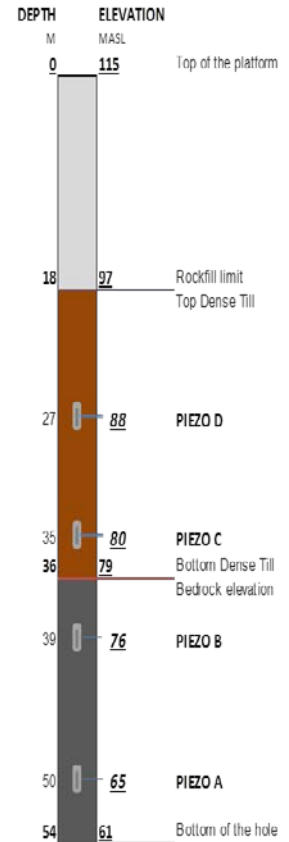
# PIEZOMETER 545-P1

- Piezometer D is on a rising trend (approximately the same rate than SC)
- Piezometer A, B & C are increasing at a very slow rate
- Piezometer A is recording suction since its installation

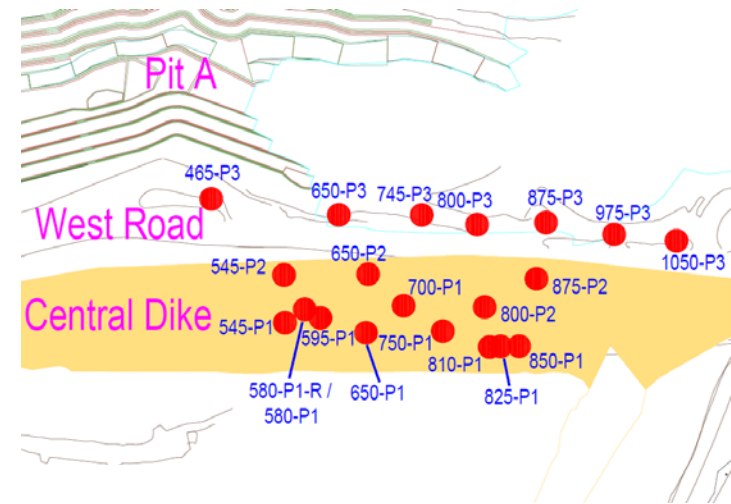
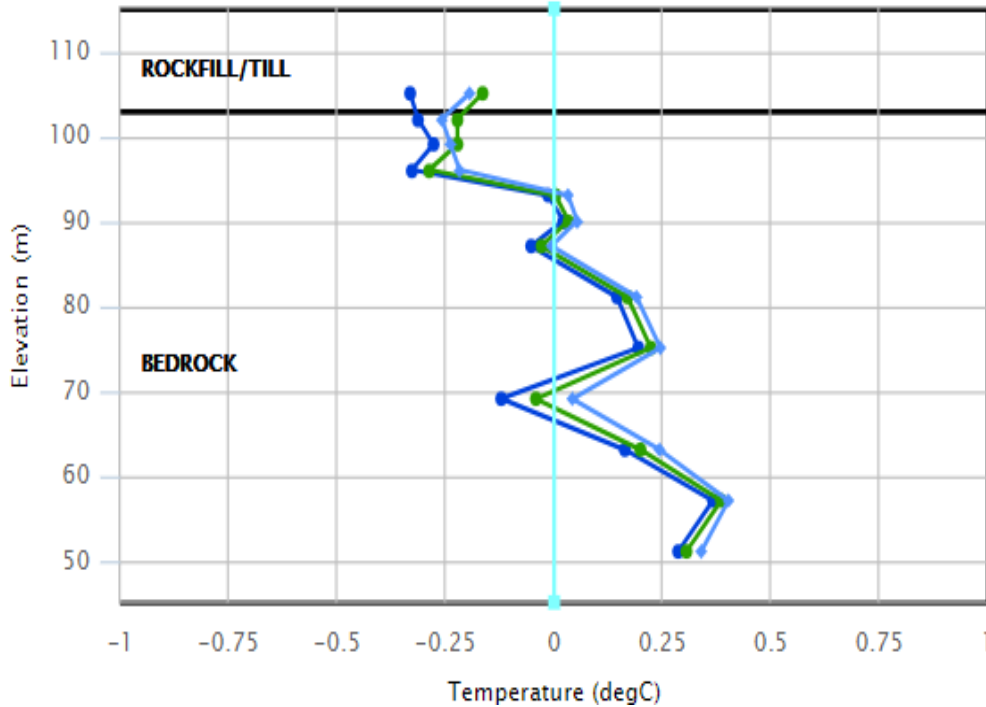
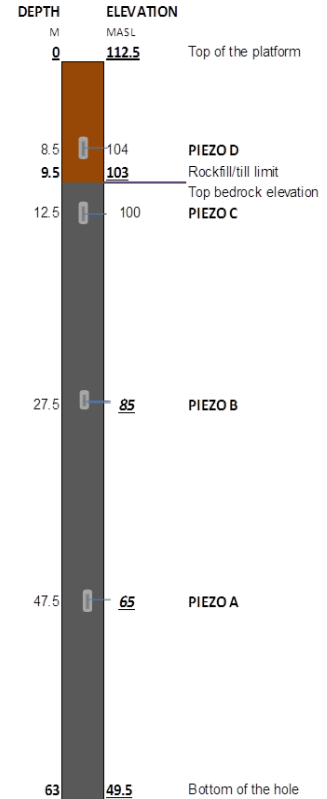
# THERMISTOR 545-P2

- All data set are following the same trend
- Temperature at El.69 is slowly decreasing since the end of 2017

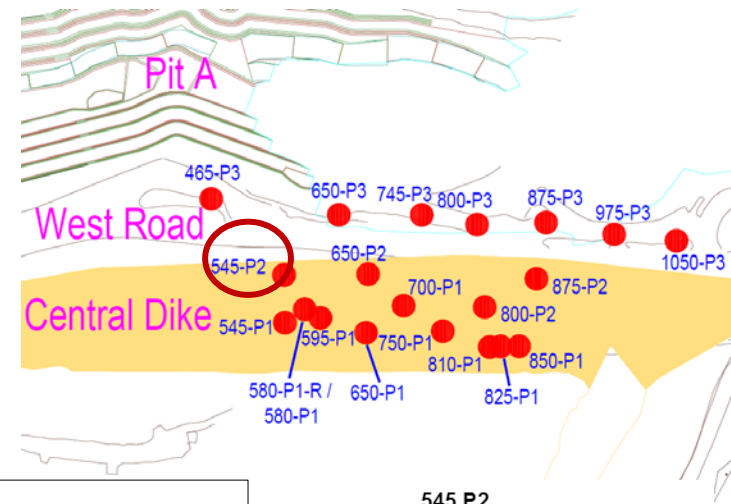
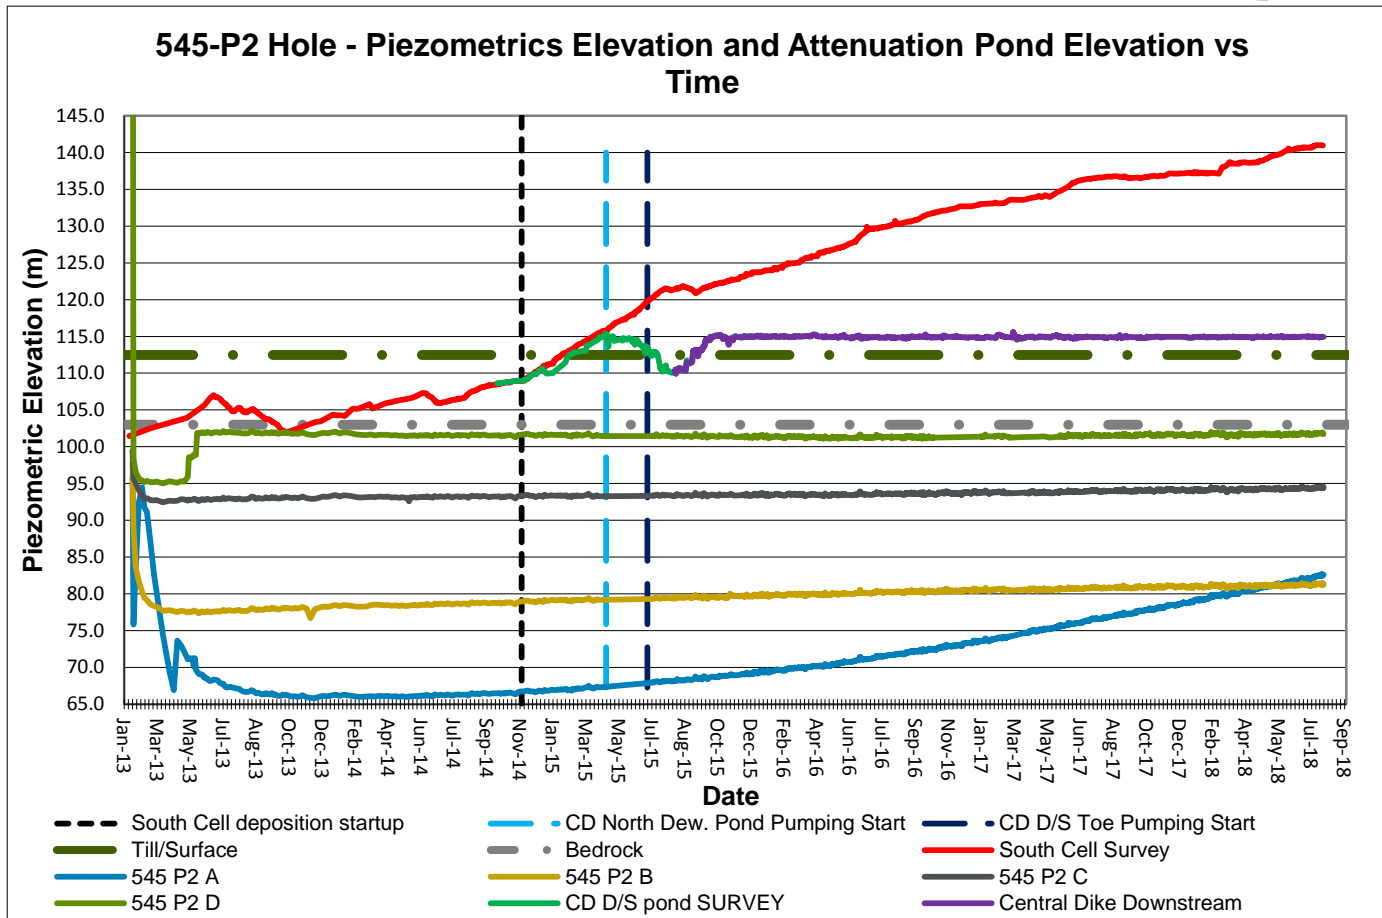
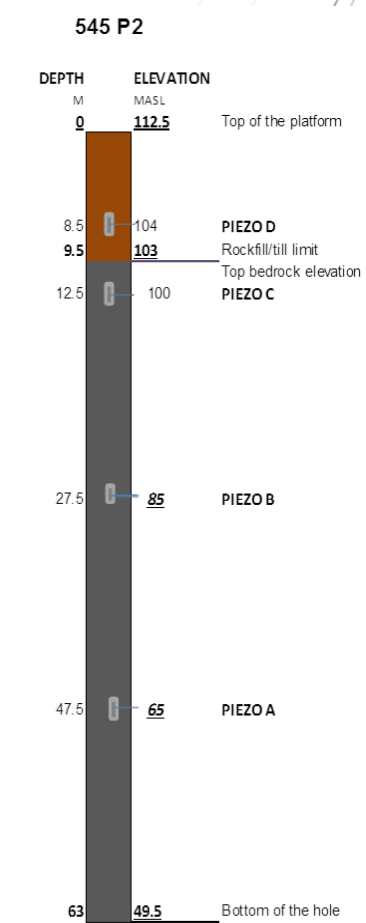
# PIEZOMETER 545-P2

- Piezometer A reading is increasing with South Cell level
- Other piezometers are recording suction

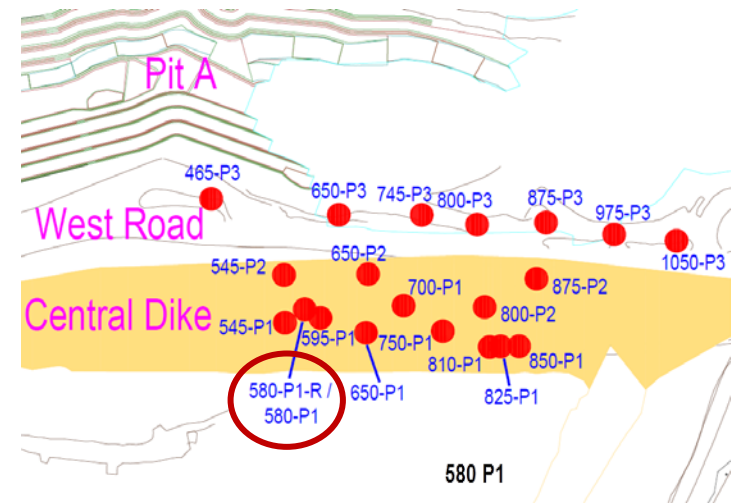
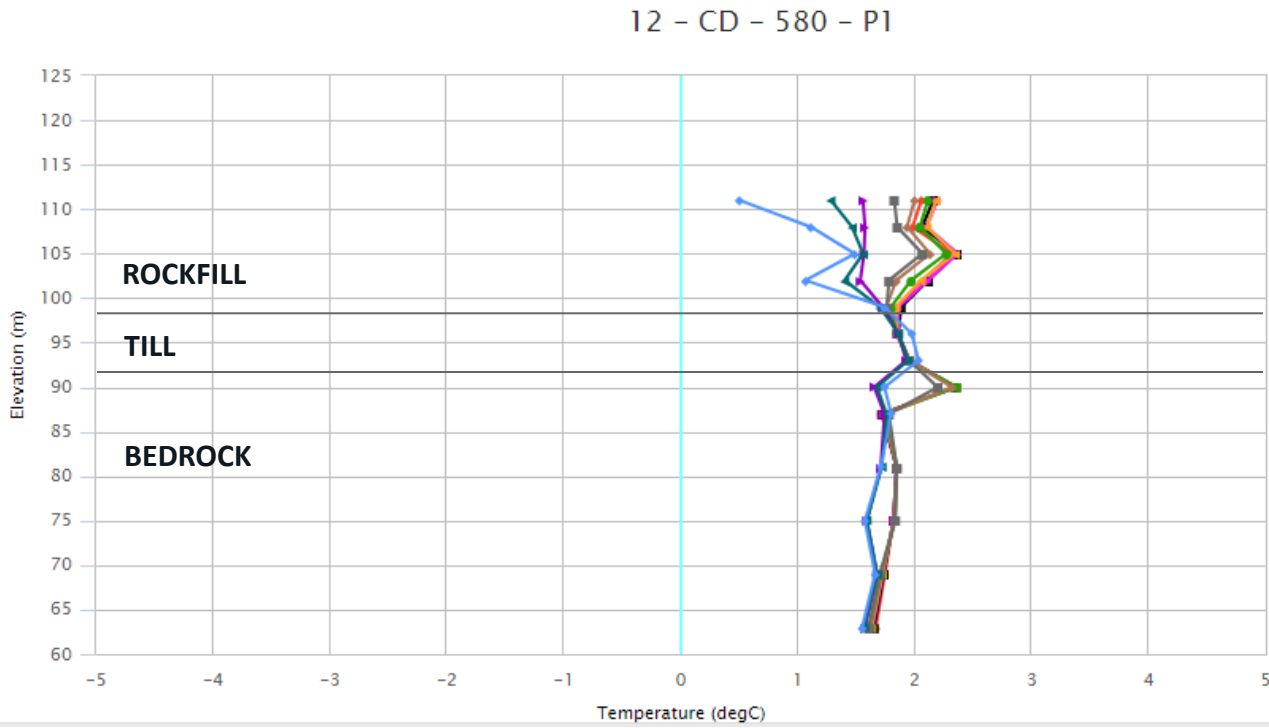
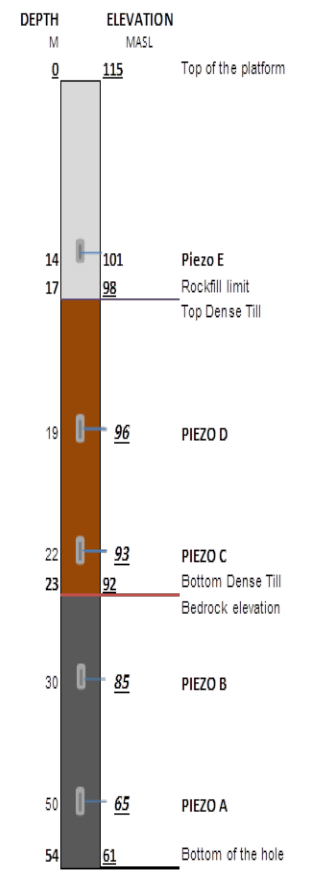
# 580-P1

- Piezometer and thermistance readings are not functional since July 2016
- Replacement hole 580-P1R drilled during 2017 campaign

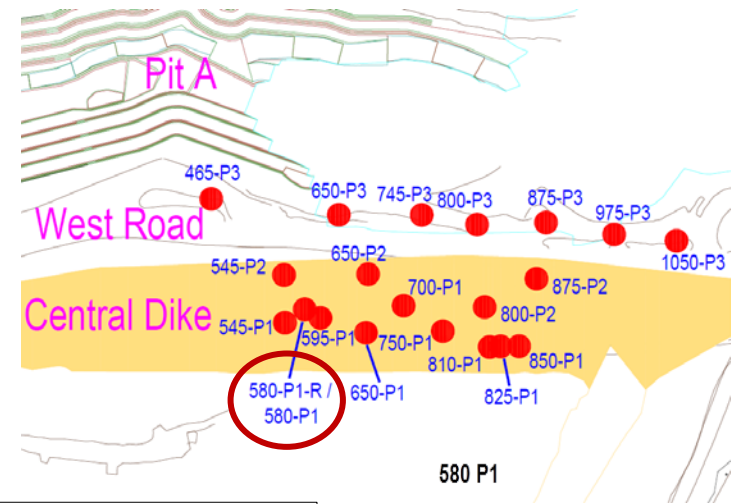
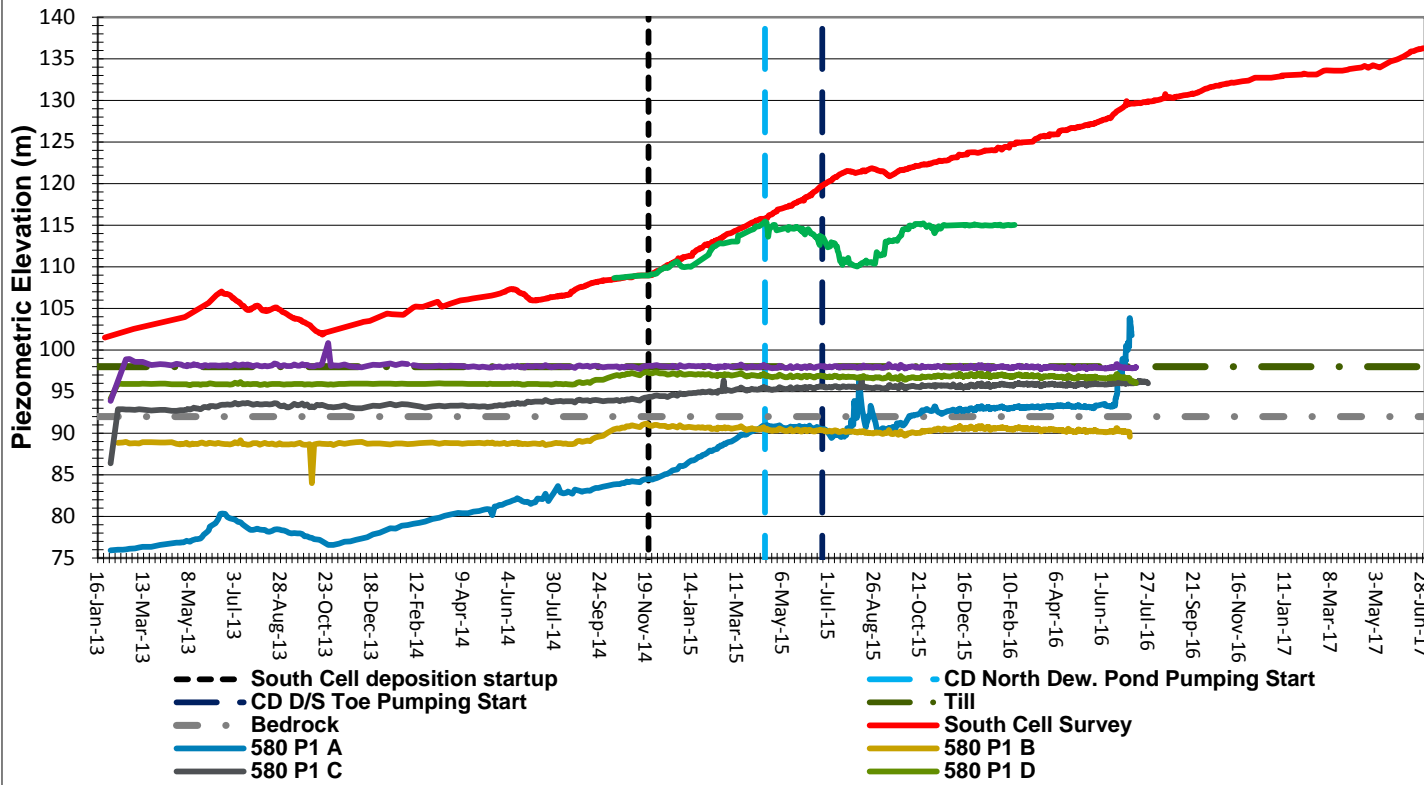
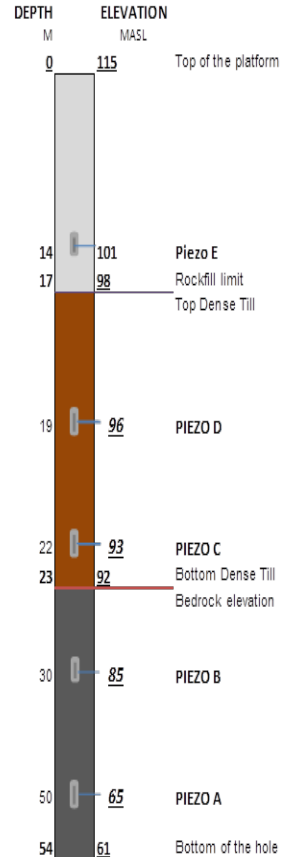
# 580-P1

- ➔ Piezometer and thermistor readings are not functional since July 2016
- ➔ Replacement hole 580-P1R drilled during 2017 campaign

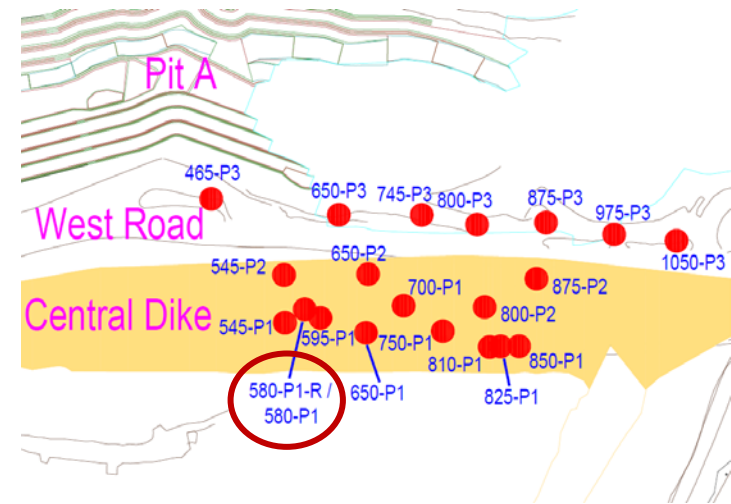
# THERMISTOR 580-P1R

➔ Unfrozen thermal situation from elevation 110 MASL to the bottom of the hole at elevation 65 MASL

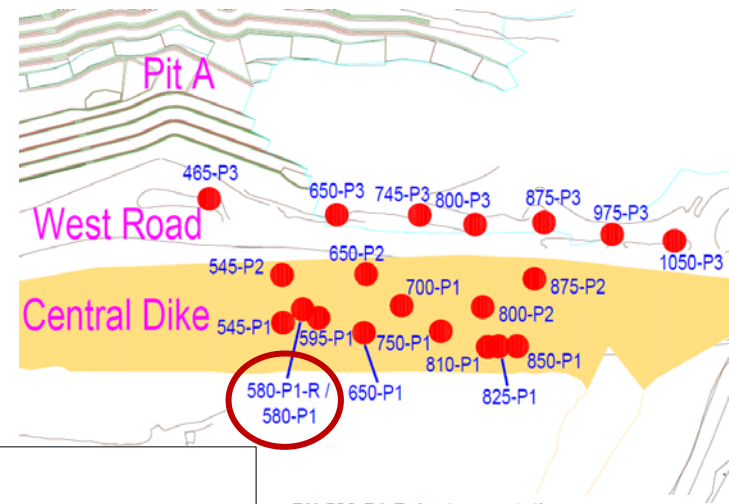
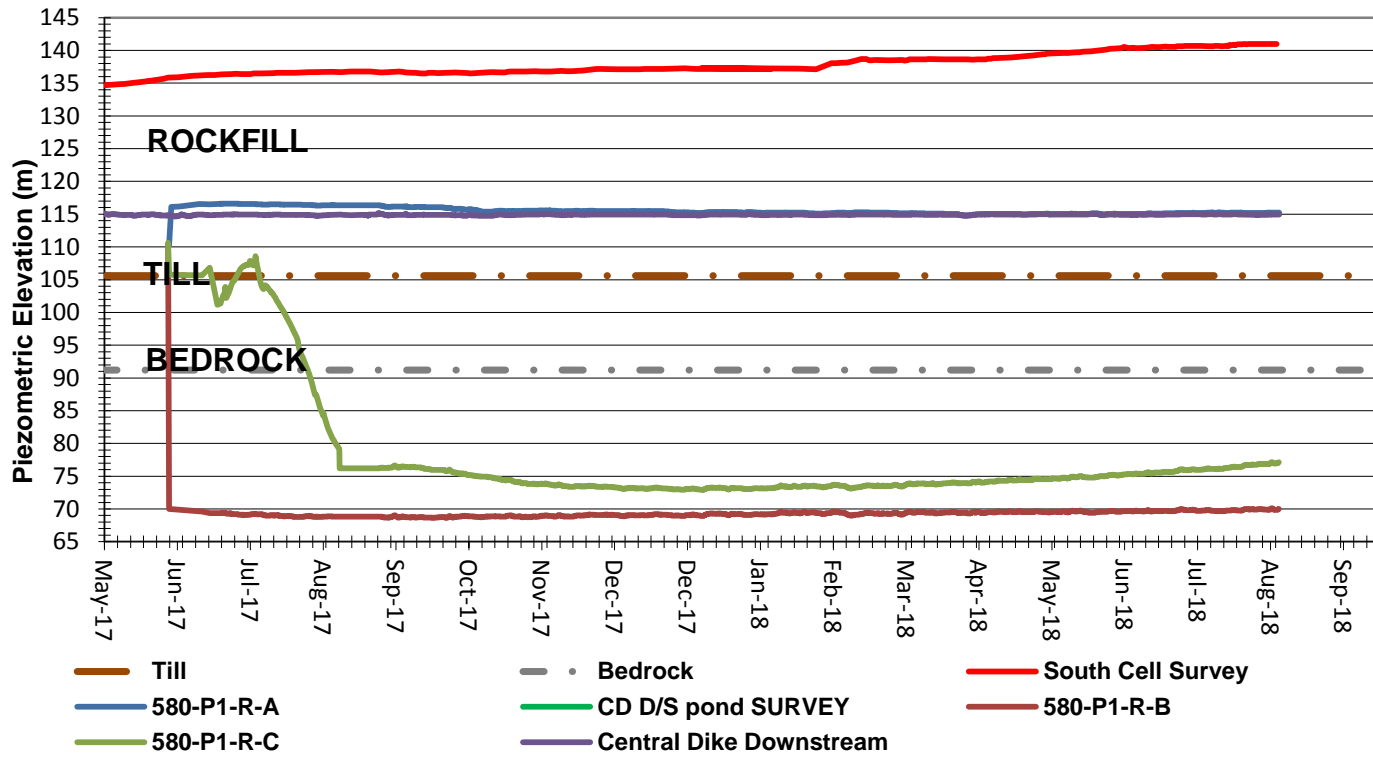
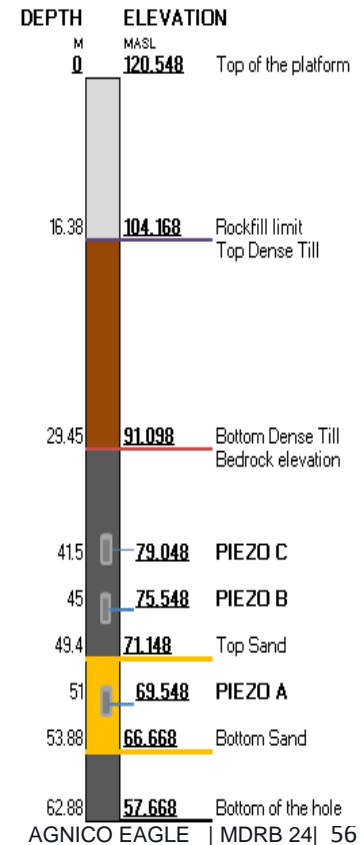
# PIEZOMETER 580-P1R

- ➔ Piezo A is located in a sand layer and pressure readings are following the D/S pond regime
- ➔ Piezo A & C are increasing following a similar trend to the SC Survey

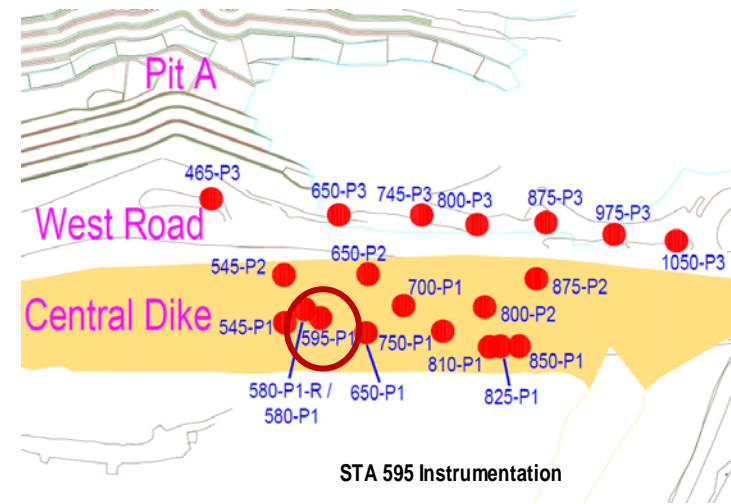
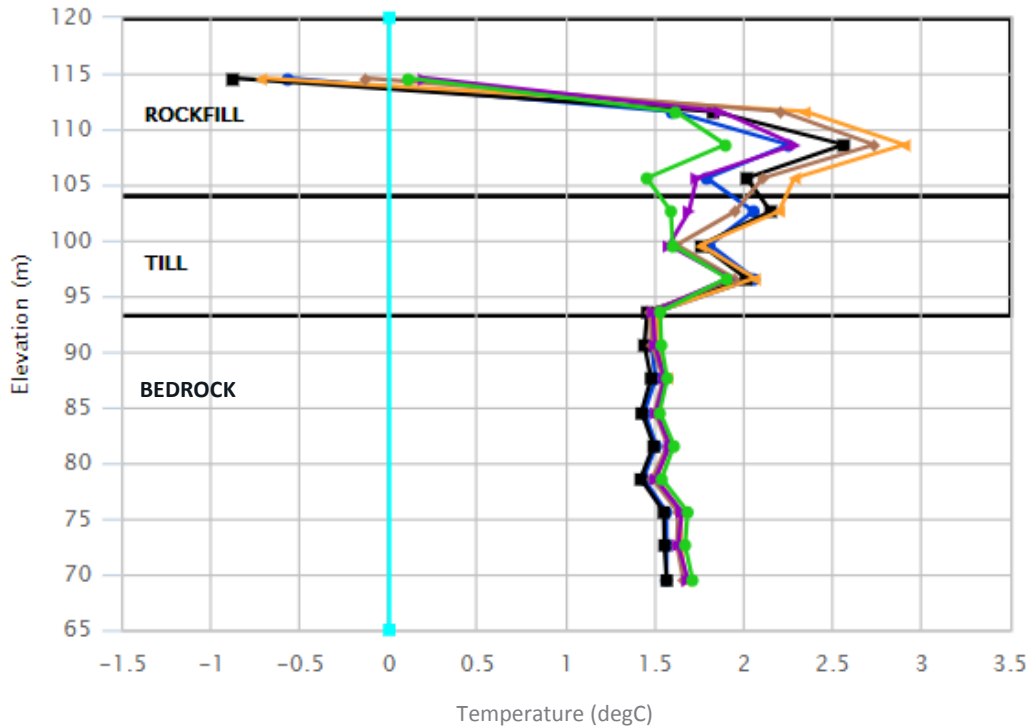
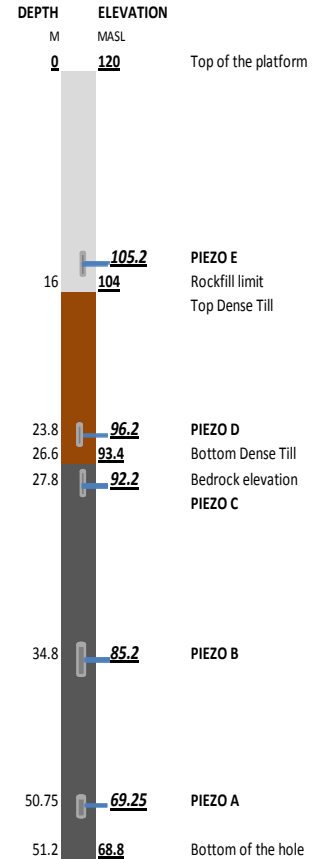
# THERMISTOR 595-P1

- Temperature in the bedrock/till unit is in between 1.5° C and 2.0° C.
- Glitch of 0.25° C could be caused by the automatization works done in August 2017.

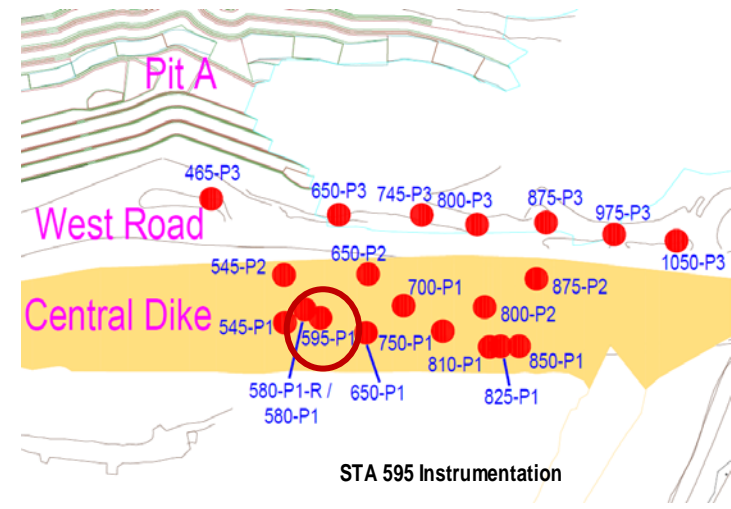
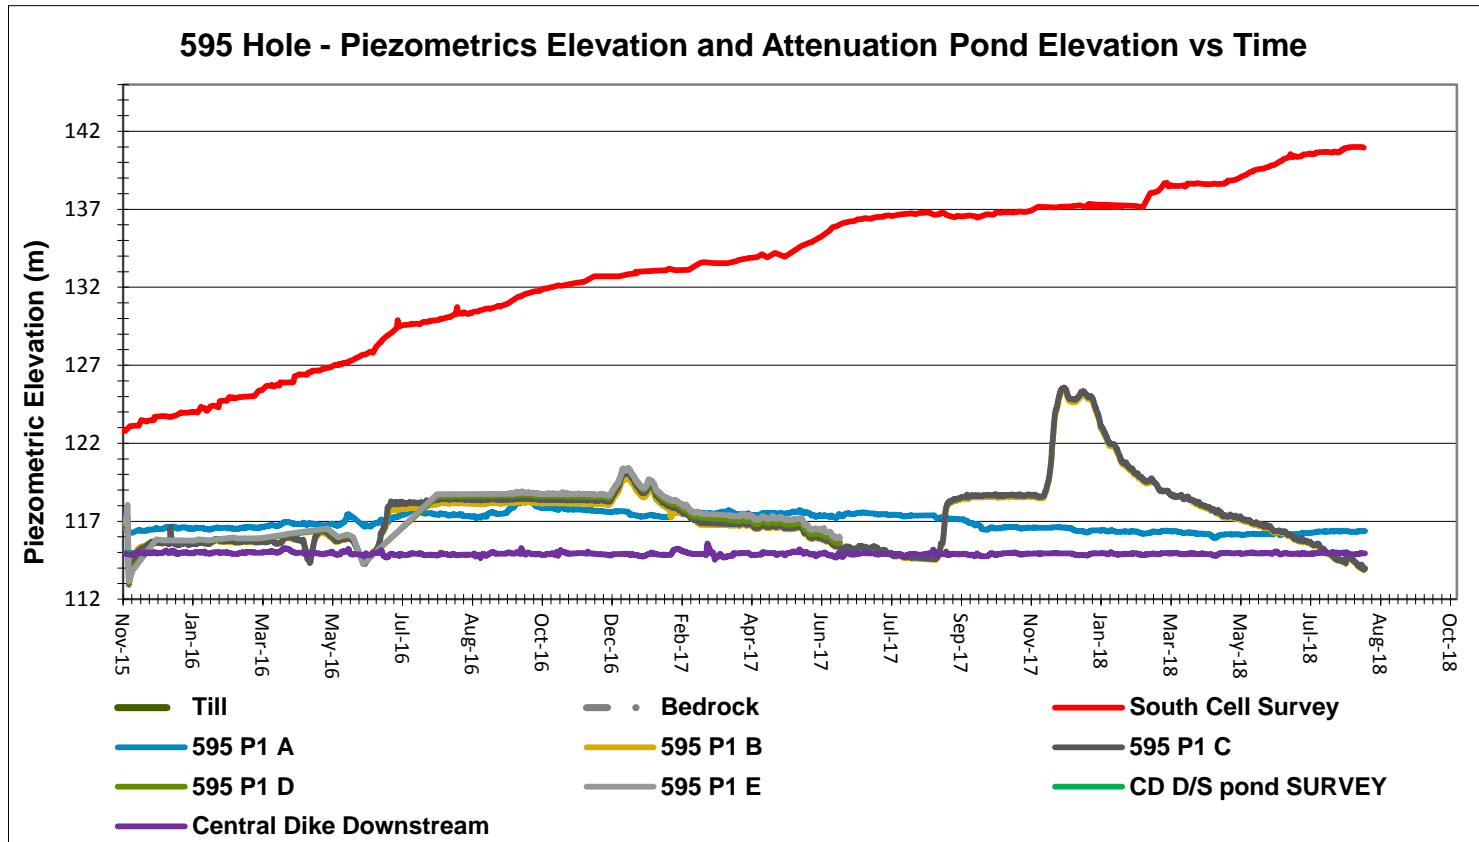
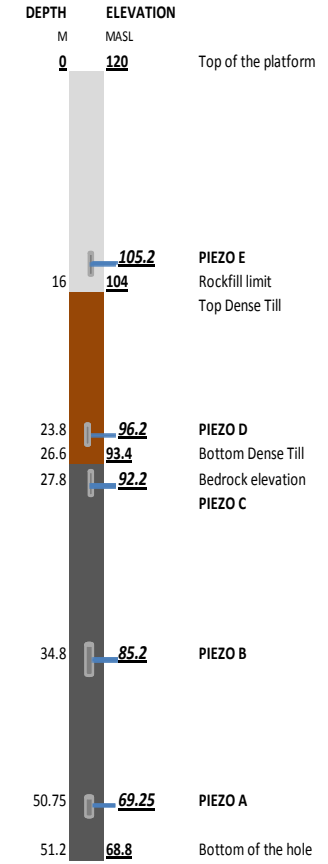
# PIEZOMETER 595-P1

- Piezometric readings are fluctuating around D/S pond elevation since the installation.
- The drop trend adopted in the last couple months has softened lately for piezometer 595-P1 B & C. Piezo C to E was installed in casing
- Piezo D & E were removed from VDV in June 2017 since they are broken

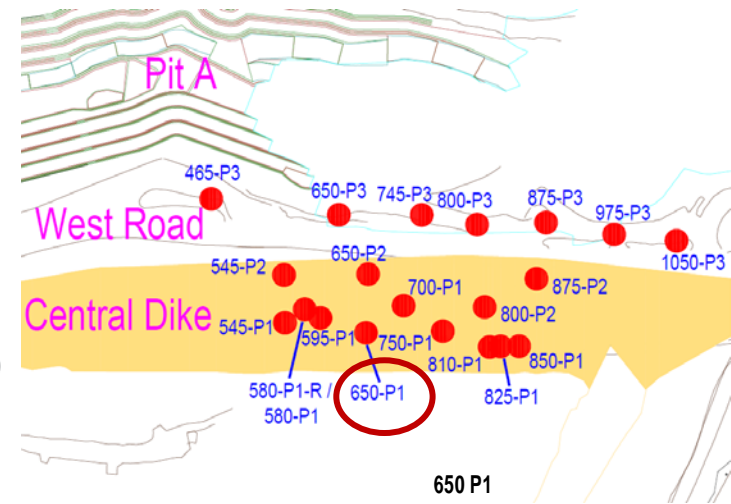
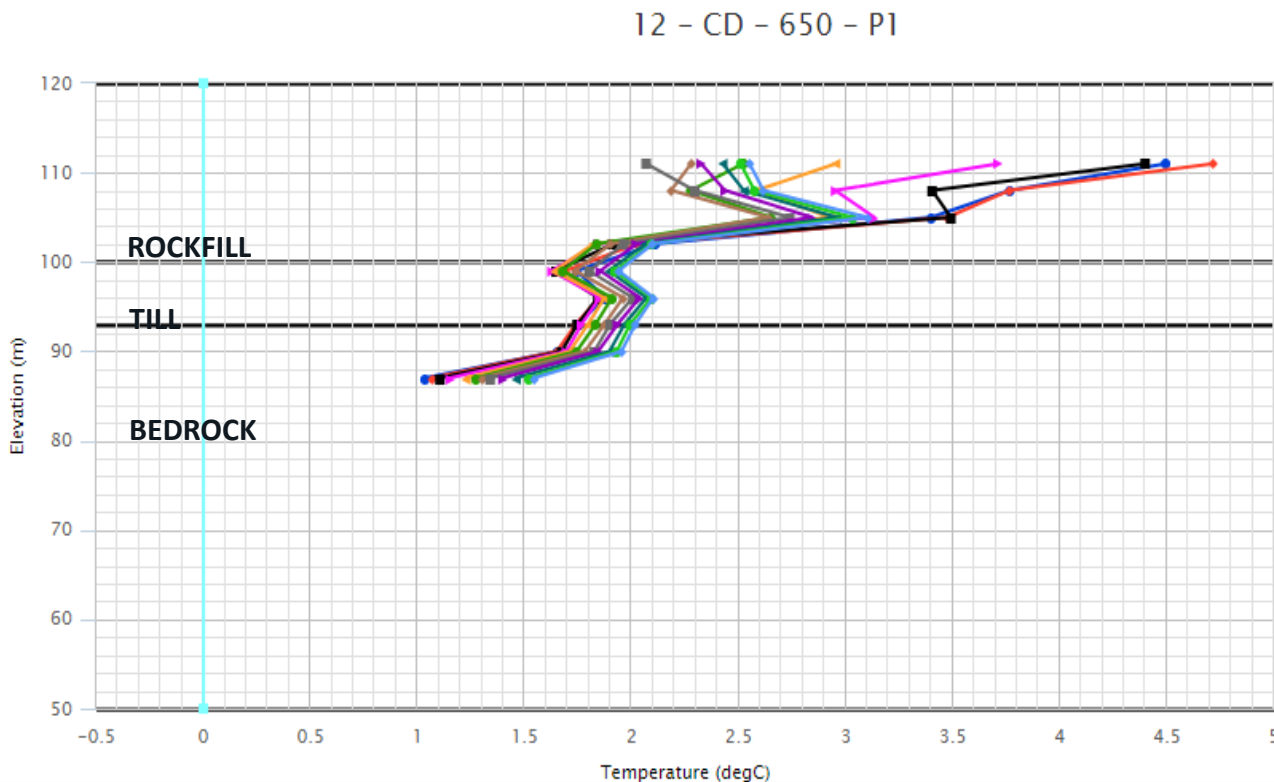
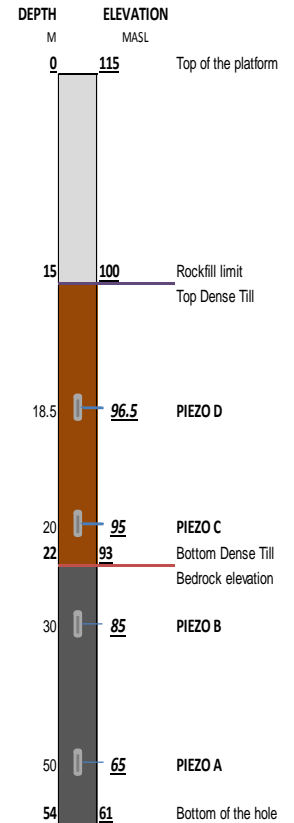
# THERMISTOR 650-P1

- Thermistance reading not functional since January 2017
- Beads 10 to 12 are not functioning since August 2016
- Temperature of the bedrock/till units were in between 1.0 and 2.1°C.

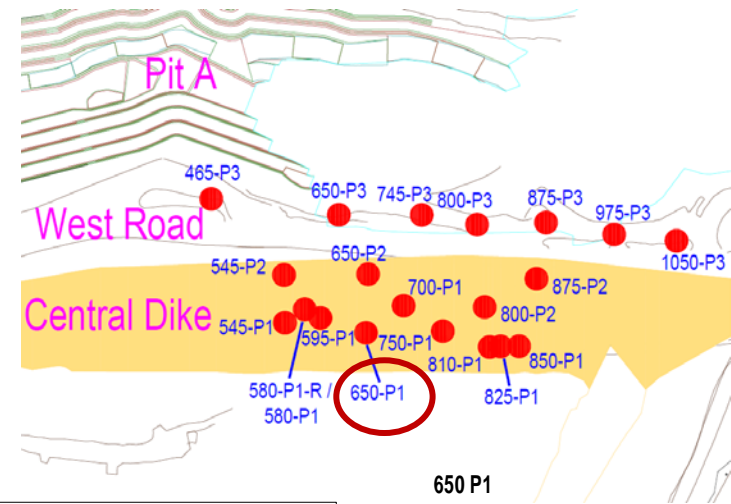
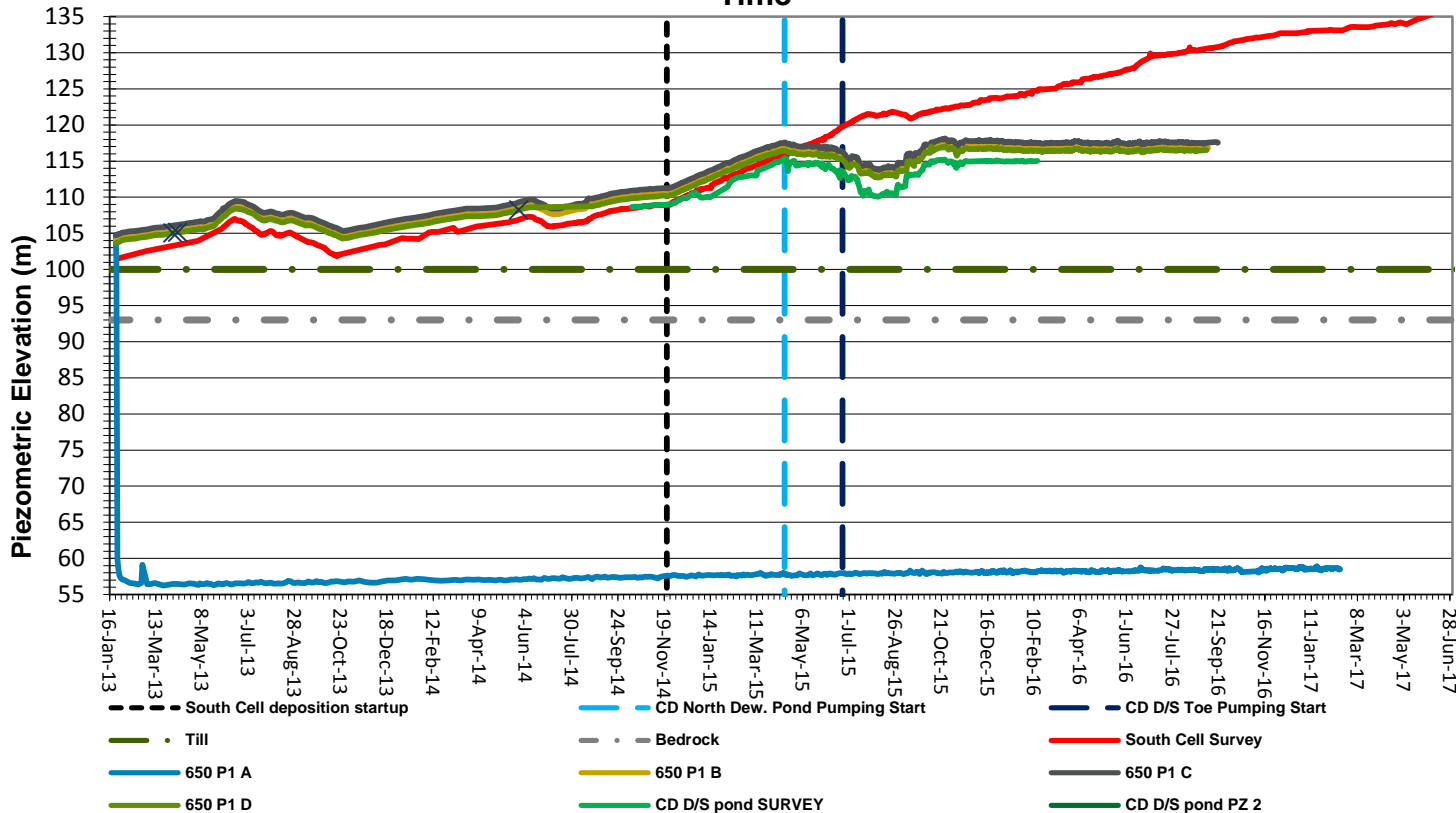
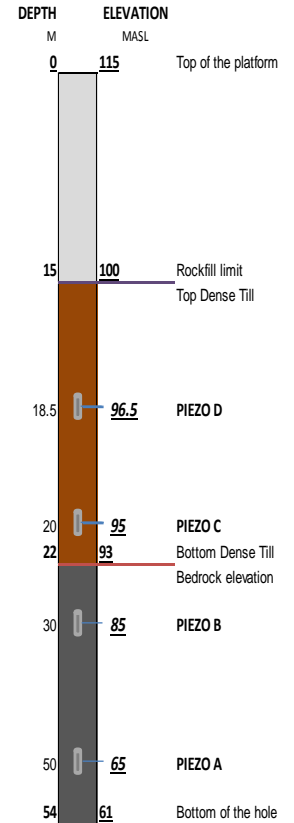
# 650-P1

- ➔ Piezometer reading not functional since February 2017
- ➔ Piezo A was in suction and piezo B to D were following D/S pond regime with readings around 117m.
