# **Meadowbank and Whale Tail 2018 Annual Geotechnical Inspection**

# 2018 Annual Geotechnical Inspection

*Meadowbank Gold Mine, Nunavut*

18101627-1583-R-Rev0

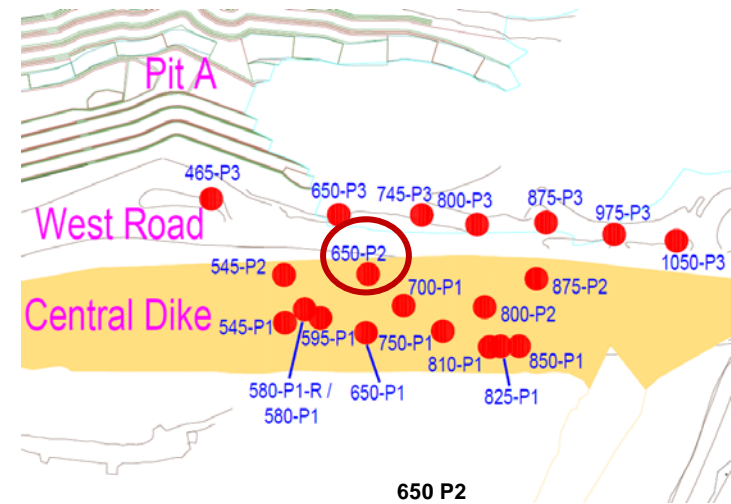
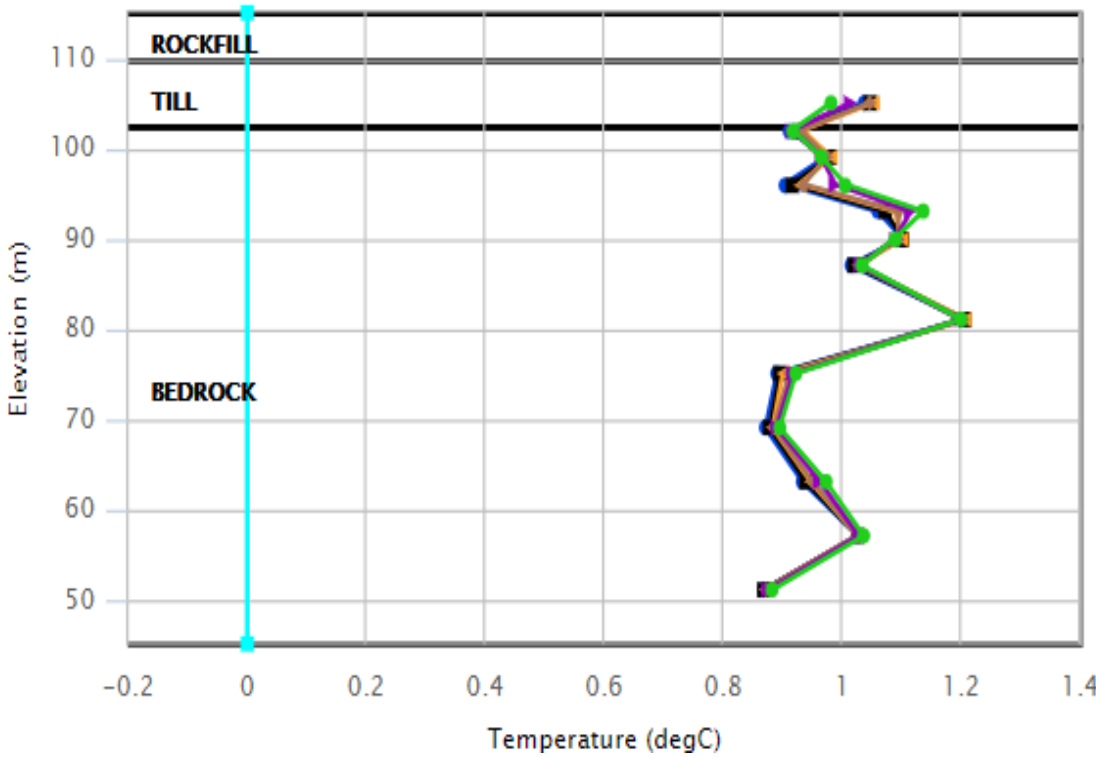
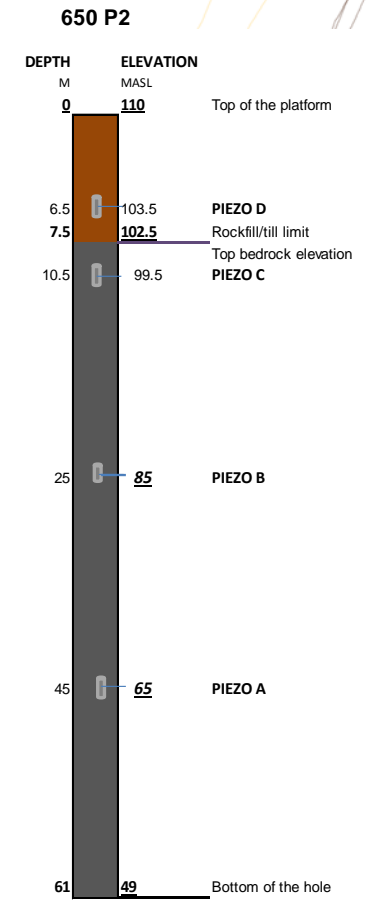
# THERMISTOR 650-P2

- Cooling trend observed below El. 80 similar to 2016-2017 readings.
- Temperature peak of 1.2° C at El.81 MASL.

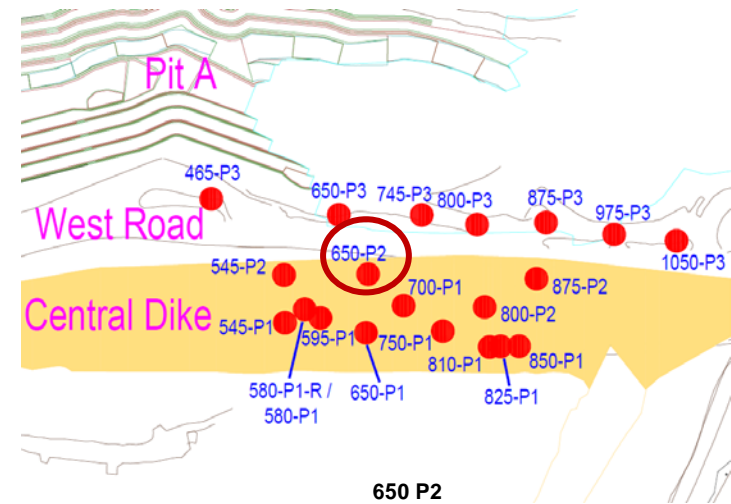
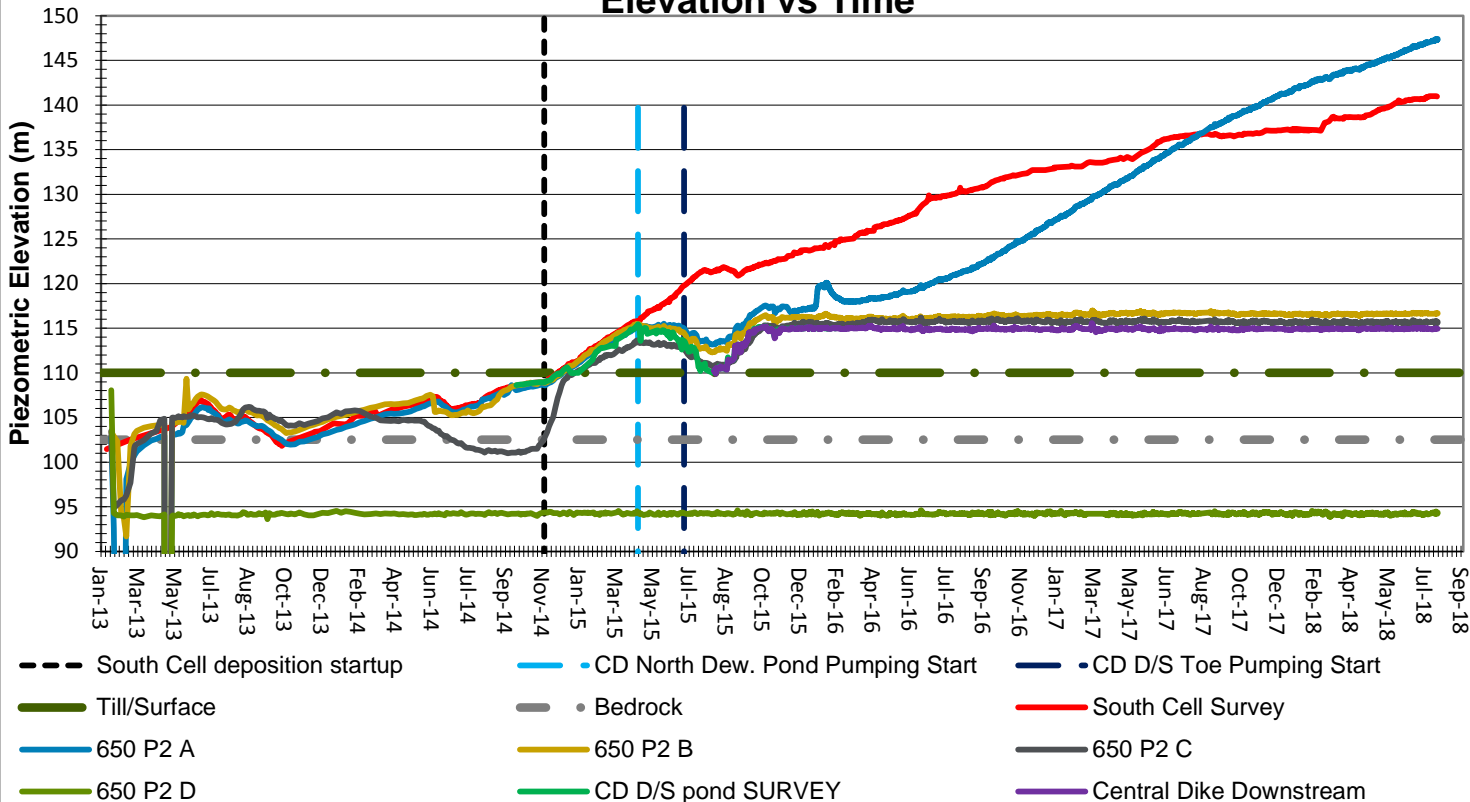
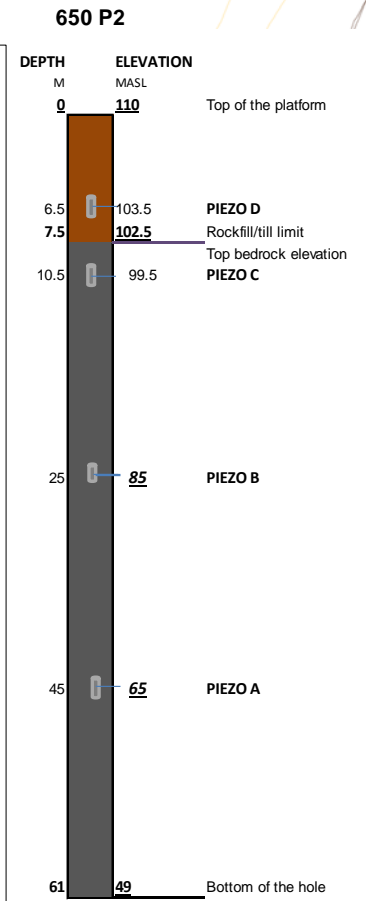
# PIEZOMETER 650-P2

- Piezometer A in bedrock continue its rise and is now over the elevation of the South Cell
- Piezo B-C are following the piezometric regime of the D/S pond
- Piezo D is in suction

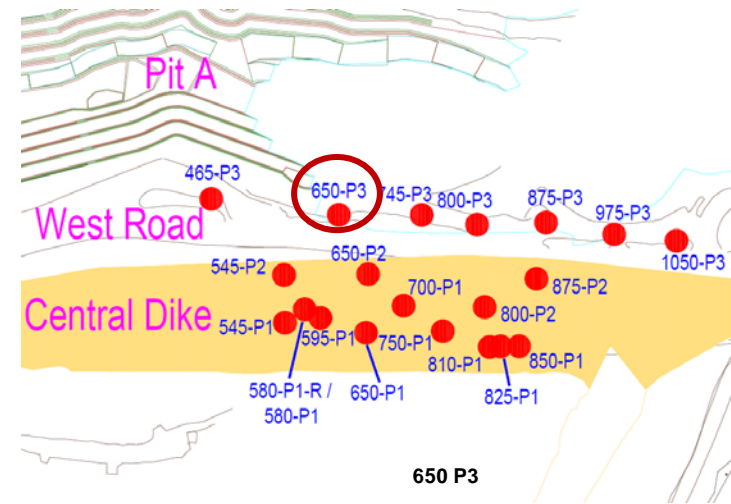
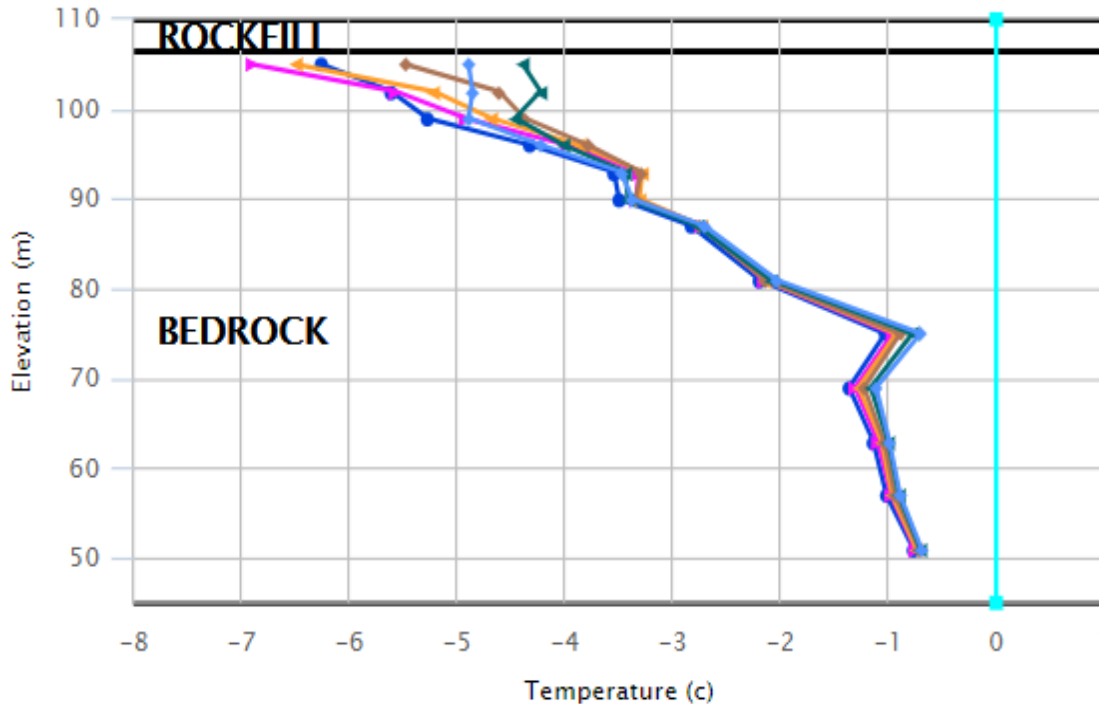
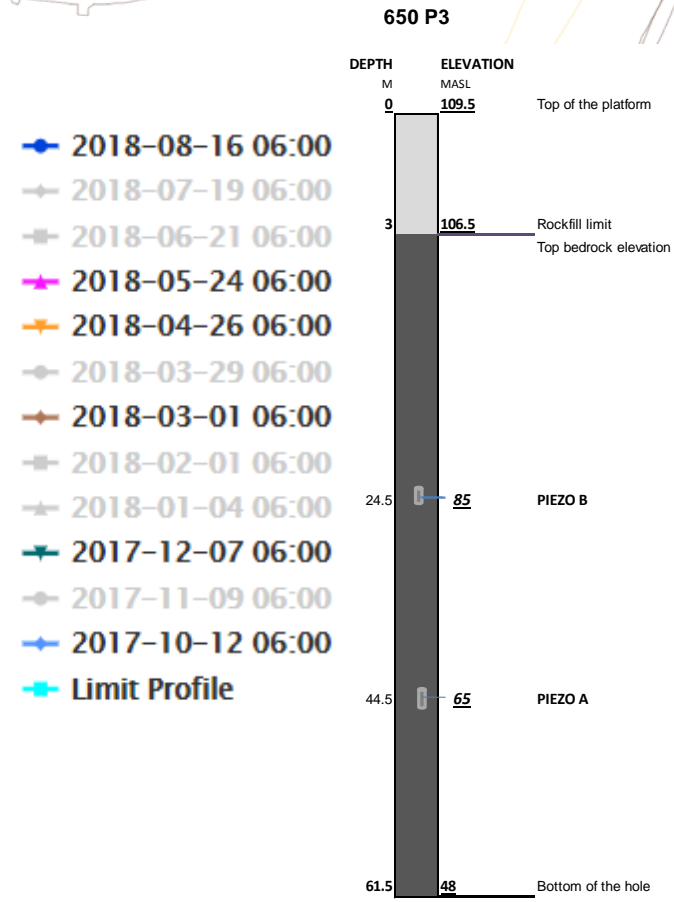
# THERMISTOR 650-P3

- Bedrock Below 0° C at 650-P3
- Temperature spike at El. 75 m is related to capacitance effect on this specific bead.

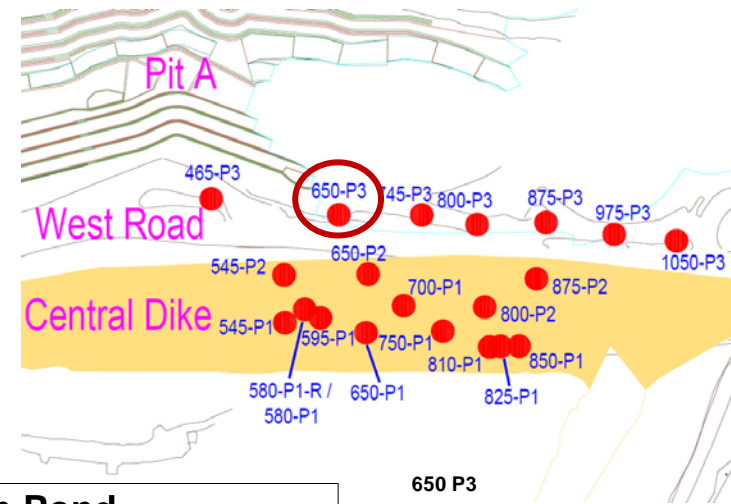
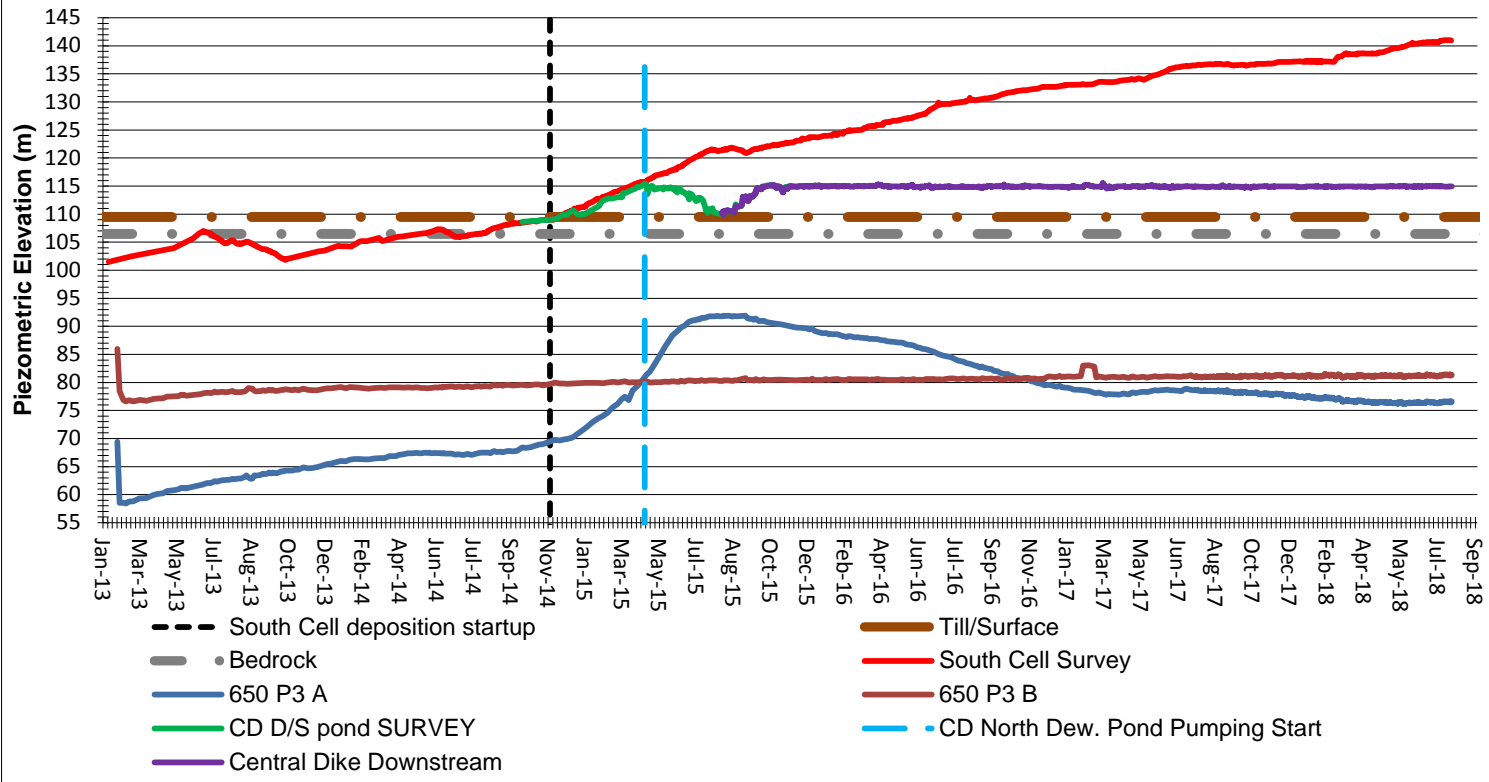
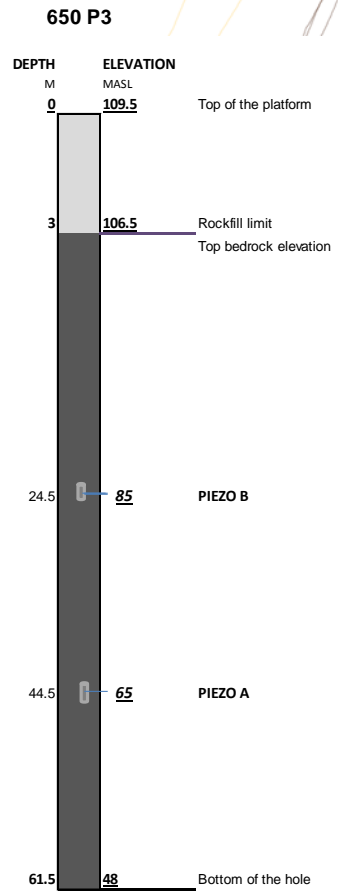
# PIEZOMETERS 650-P3

➔ Frozen Piezometers

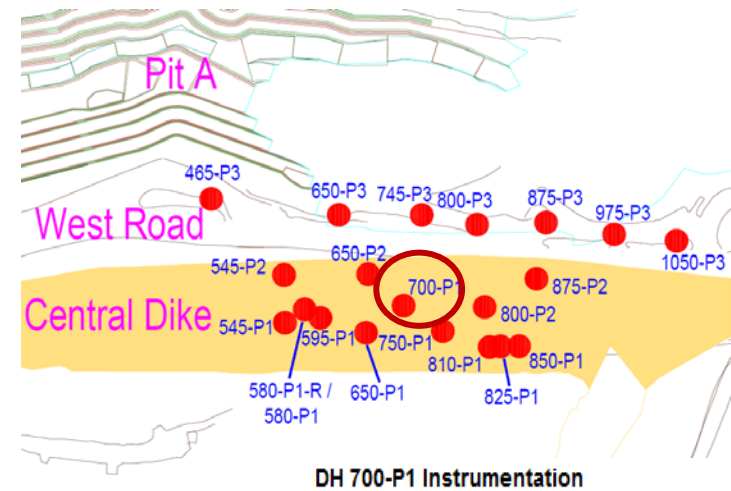
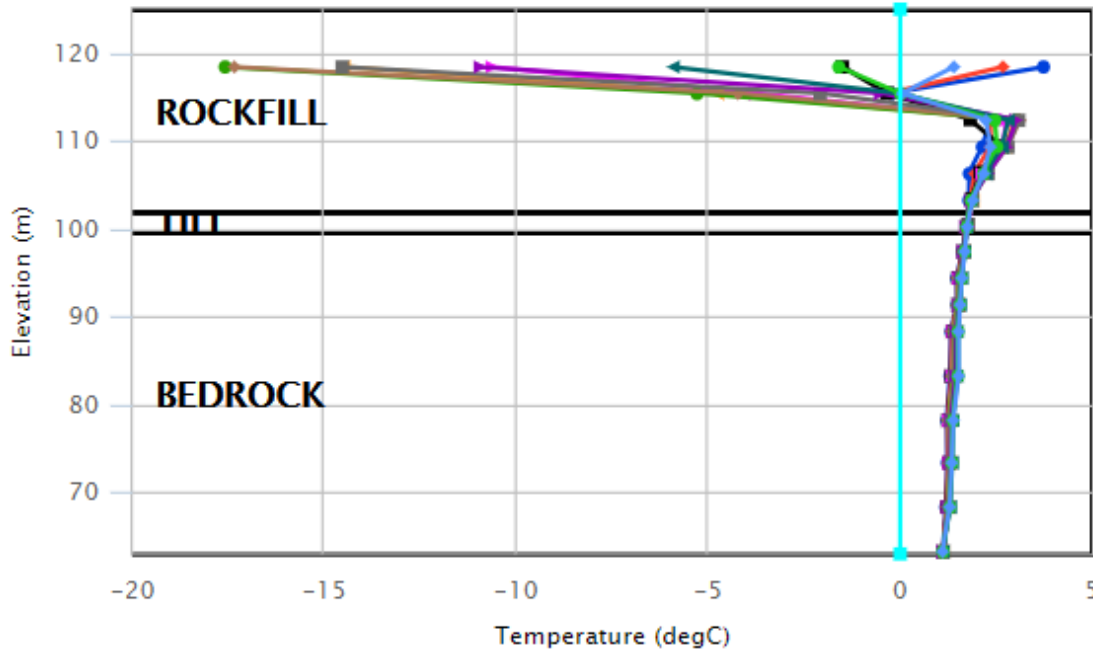
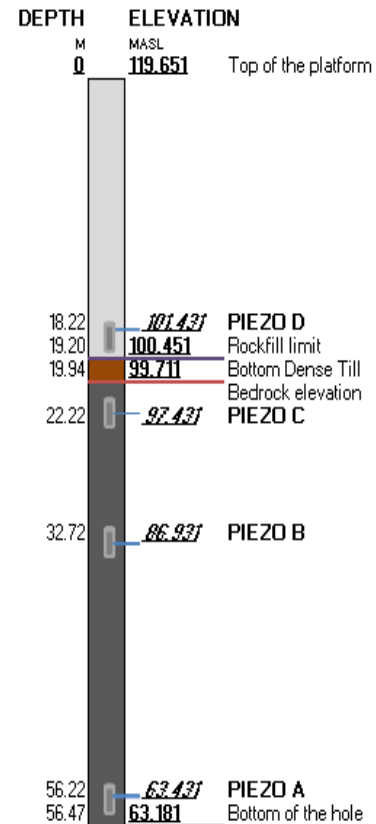
# THERMISTOR 700-P1

- New instrument installed in 2017
- Till and bedrock temperature readings above 0° C

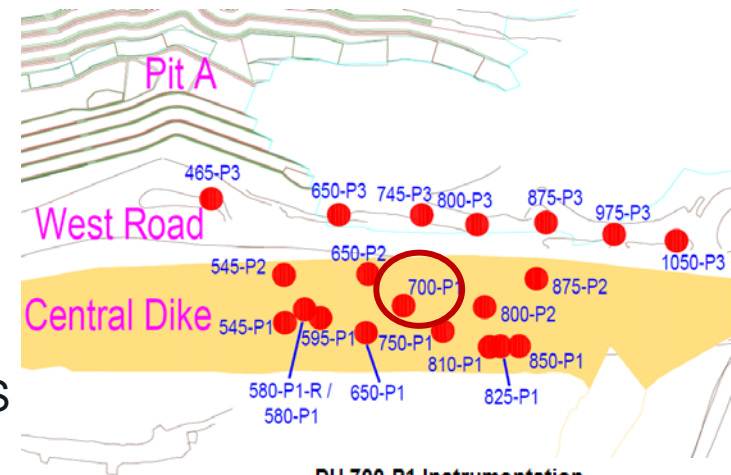
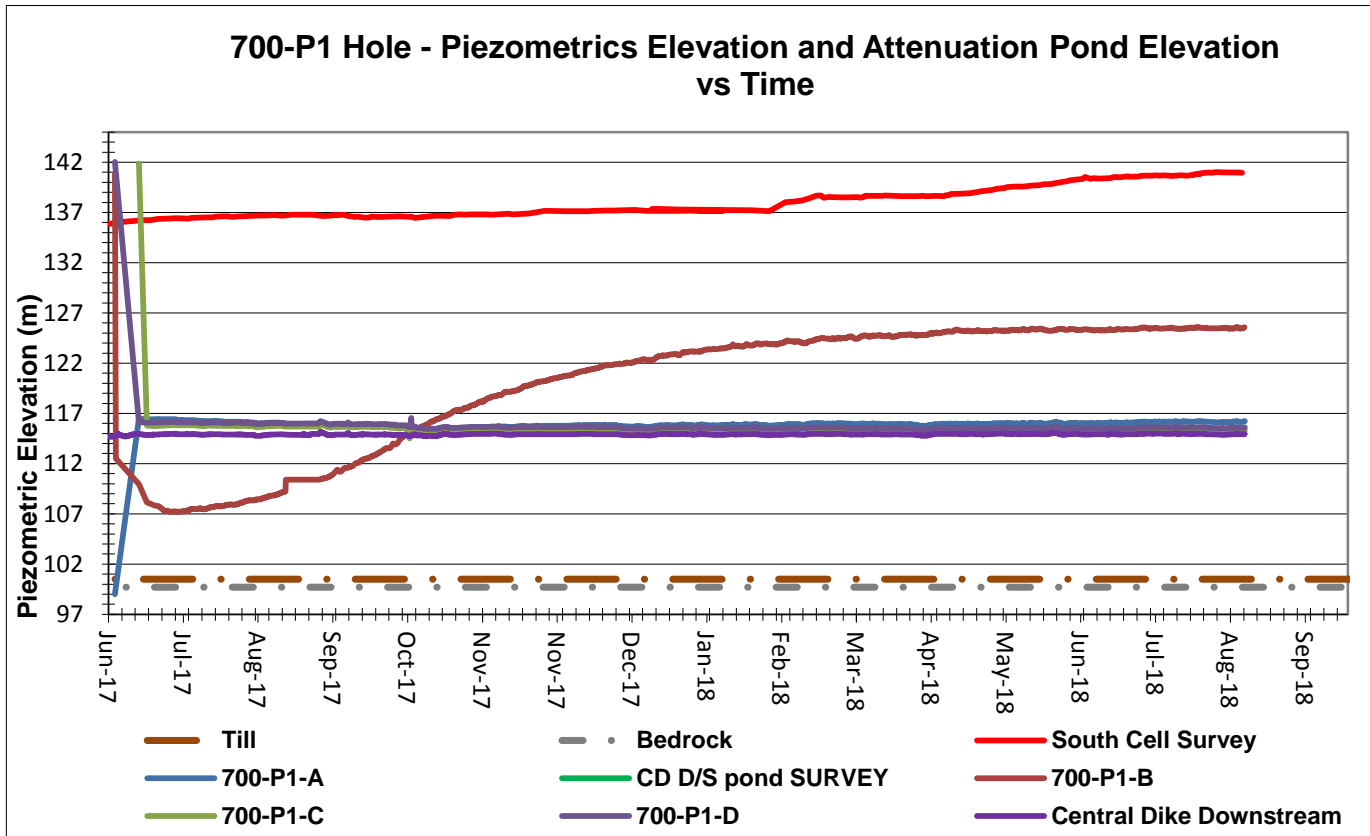
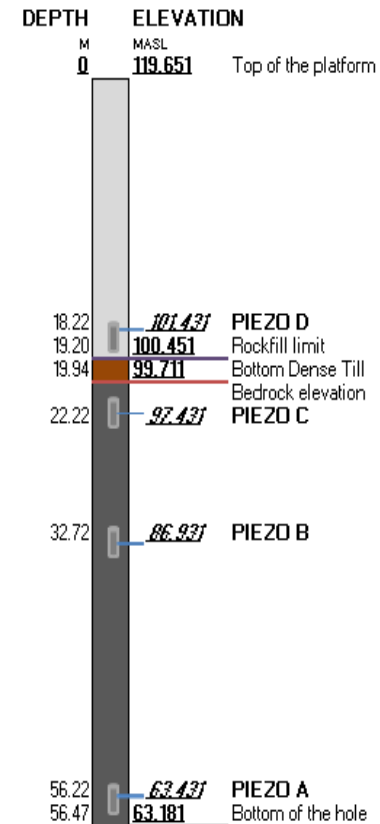
# PIEZOMETER 700-P1

- New instrument installed in 2017
- Piezo B was on a rising trend but has stabilized
- Piezo A, C and D are showing reading similar to the D/S pond.

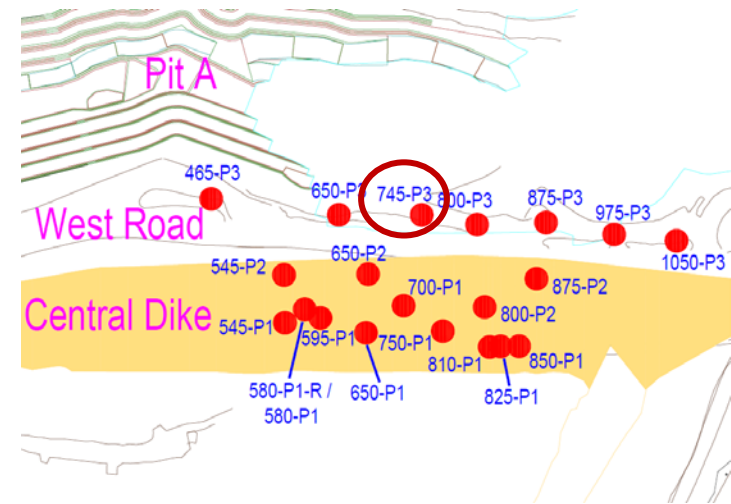
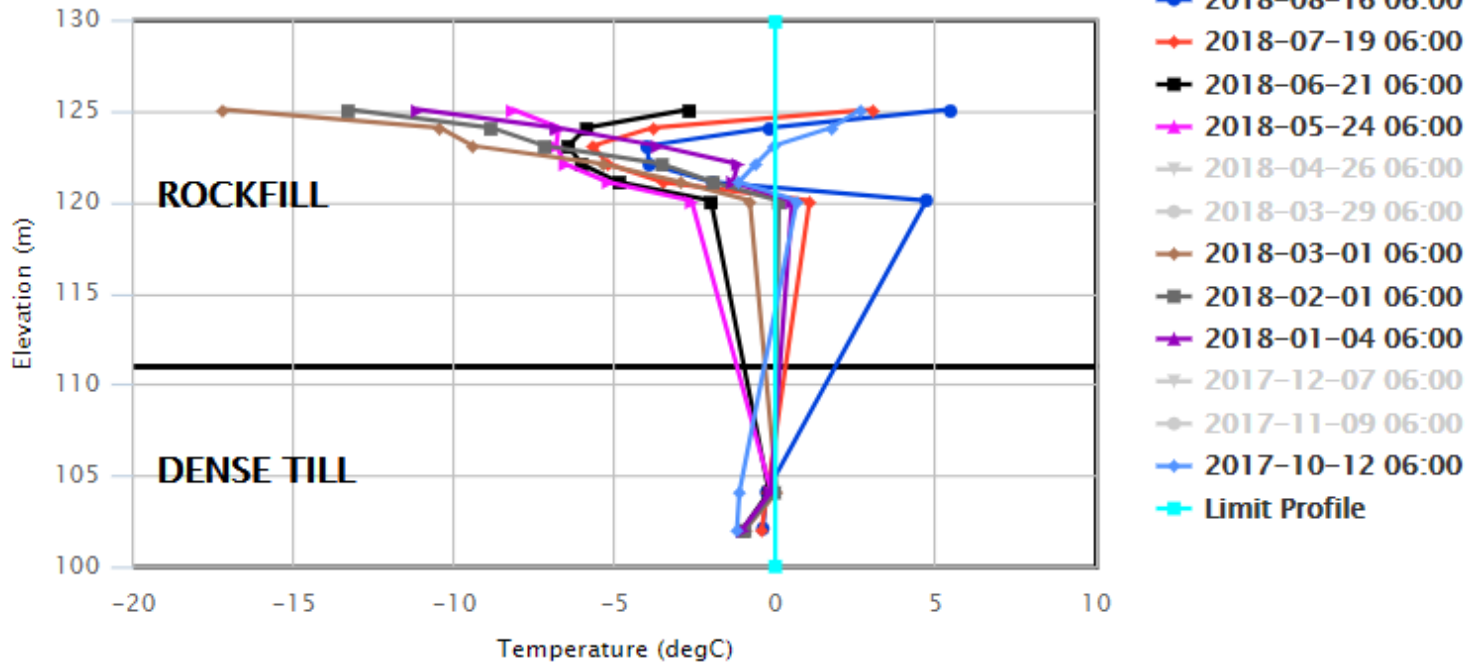
# THERMISTOR 745-P3

- Thermistor installed to monitor freeze back of the West Road. This thermistor do not reach bedrock
- Temperatures are above the freezing point for July & August, 2018
- Frozen limit of the northern section of the P3 line

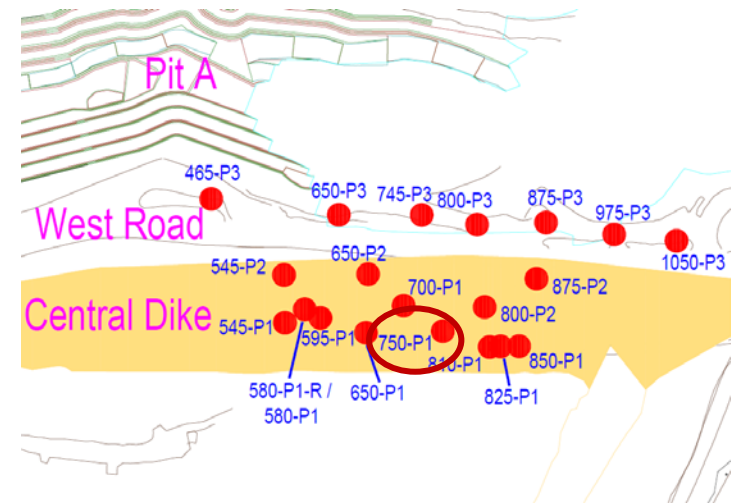
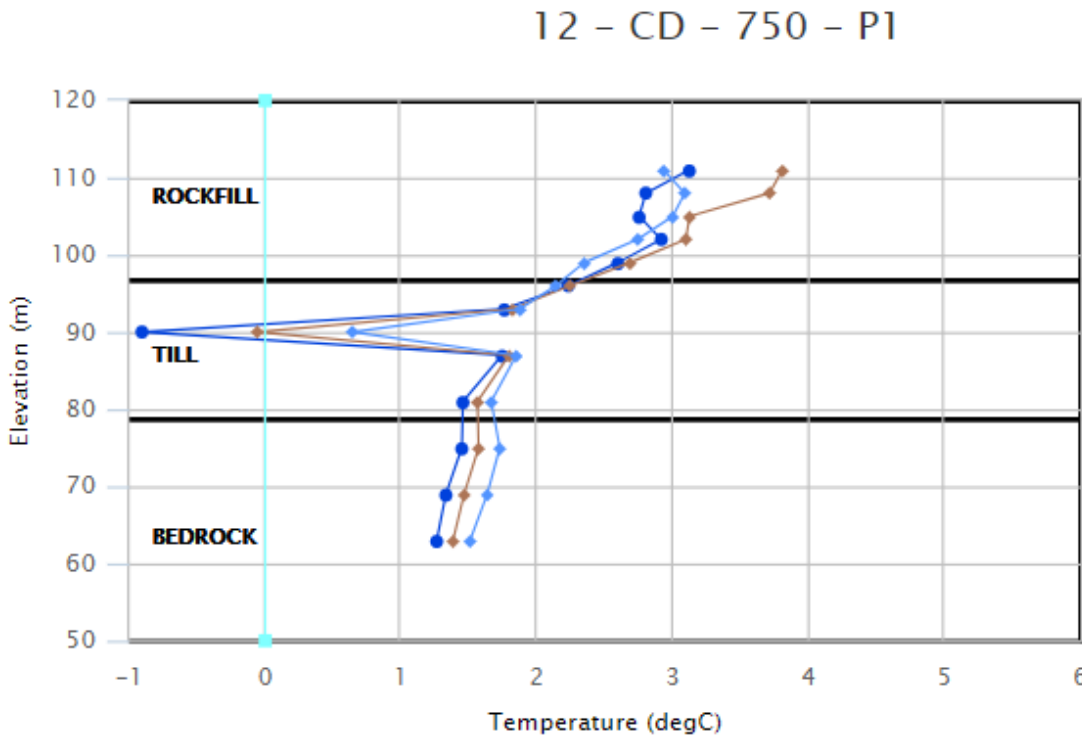
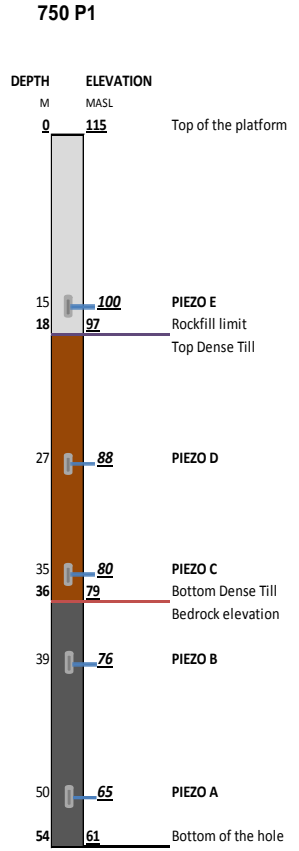
# THERMISTOR 750-P1

➔ Cooling trend in till layer. The bead located at elevation 90m is approximately 1°C cooler than in 2017.

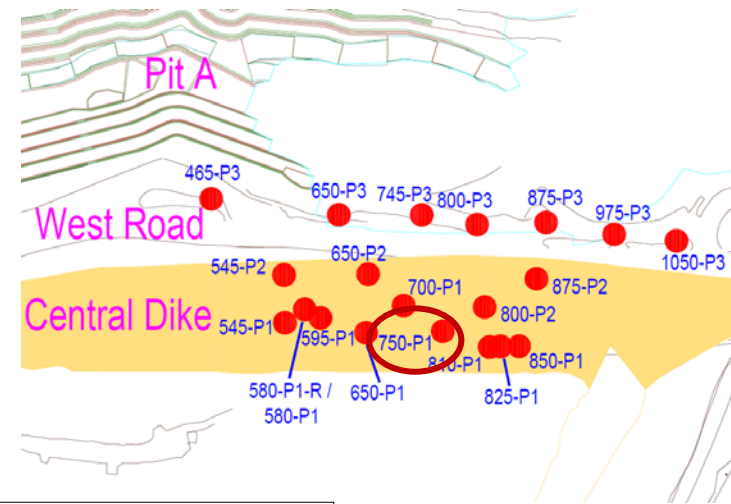
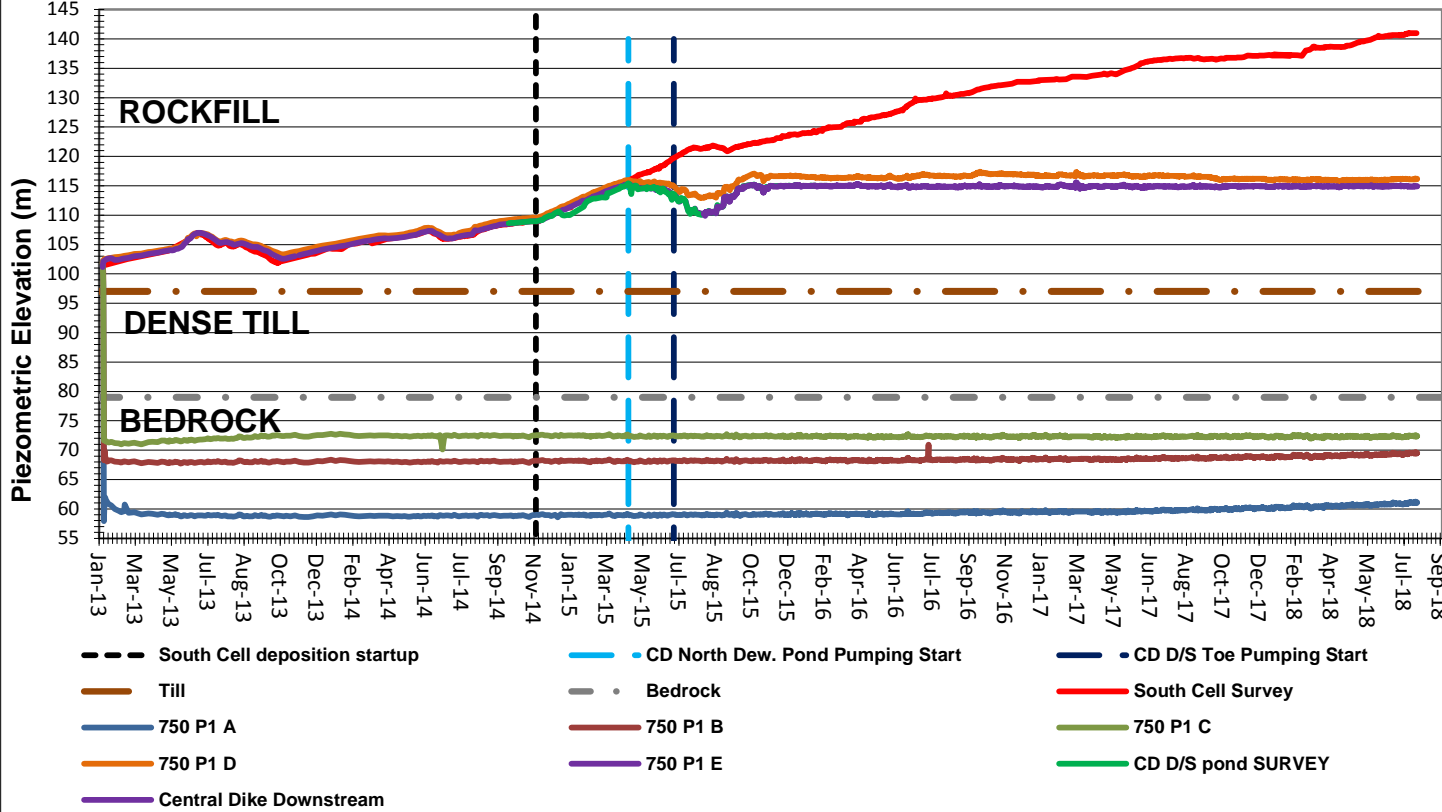
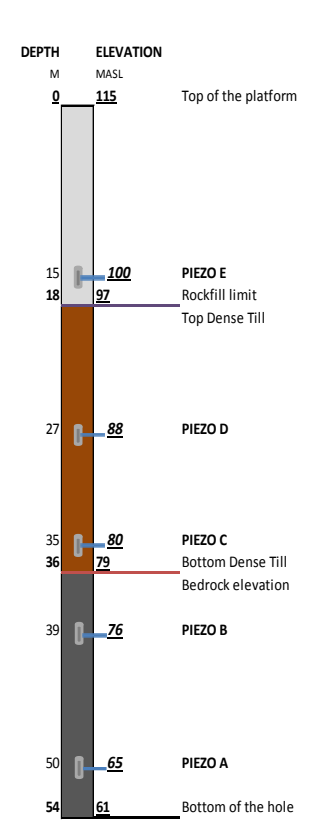
# PIEZOMETER 750-P1

- ➔ Piezo A, B and C are in suction
- ➔ Piezo D is have a direct reaction to any variation in elevation observe in the D/S pond.

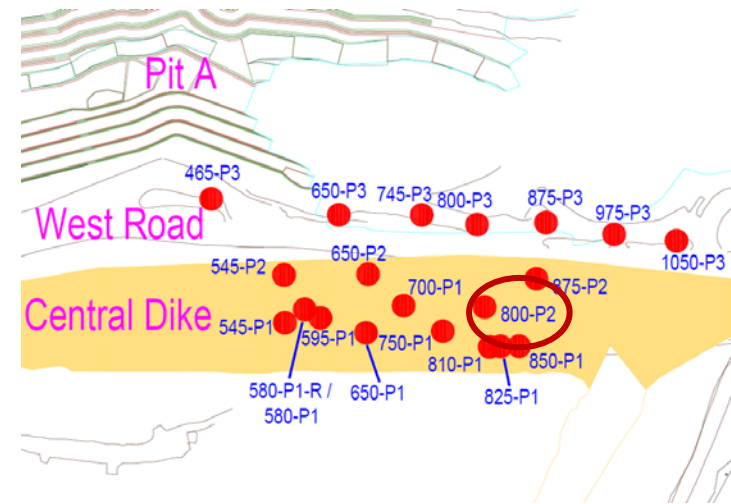
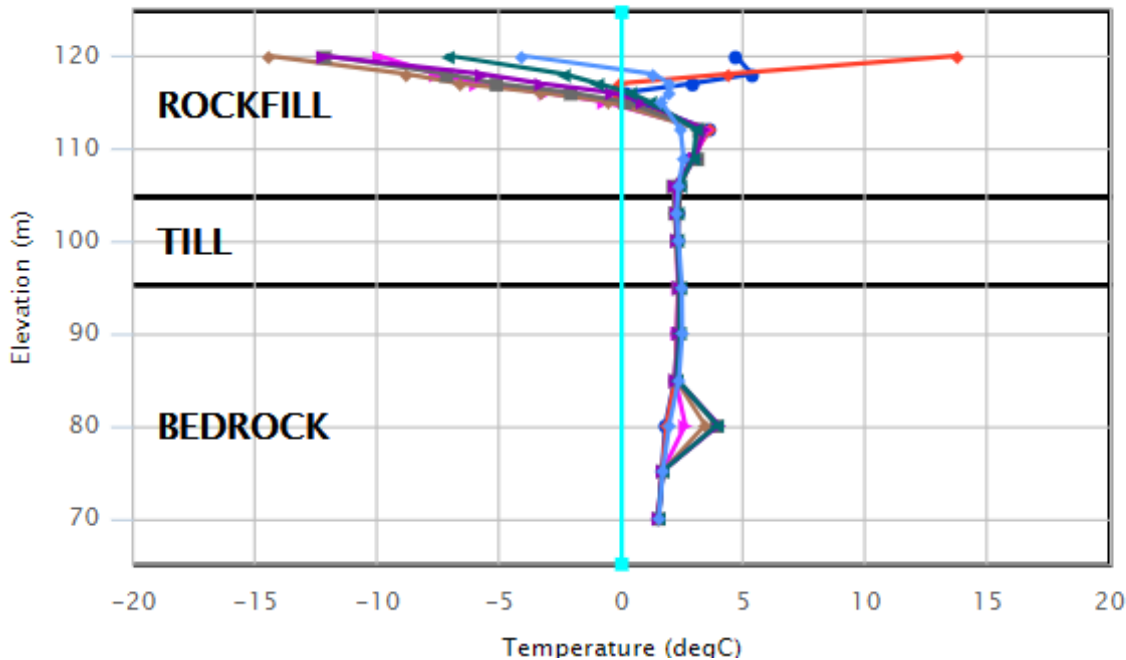
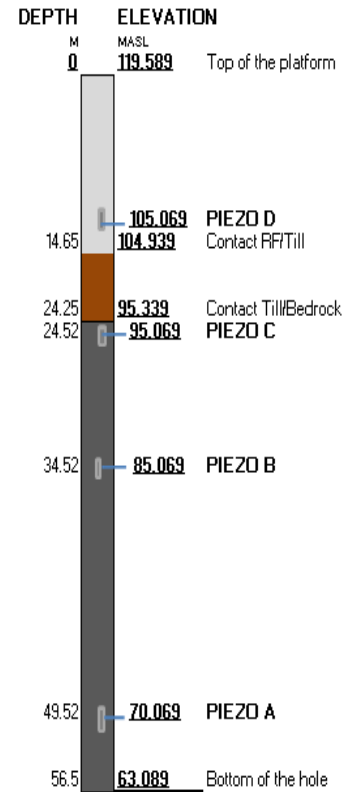
# THERMISTOR 800-P2

- New instrument installed in 2017
- Capacitance effect was observed at the end of 2017/beginning 2018. Stabilized since June 2018.
- Temperature above 0°C

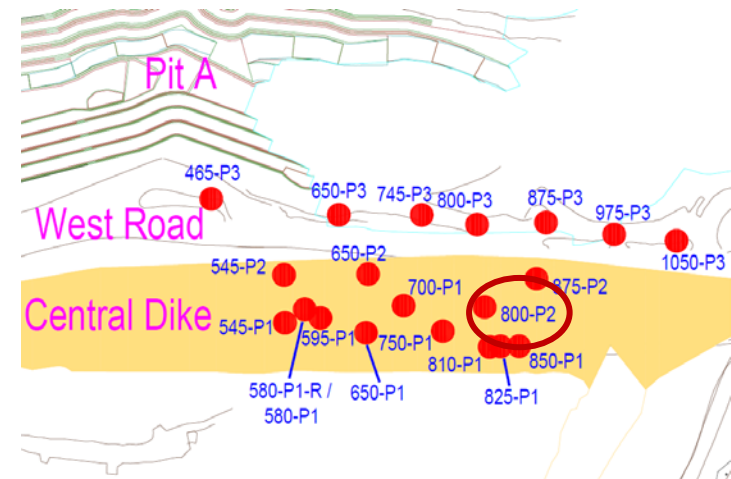
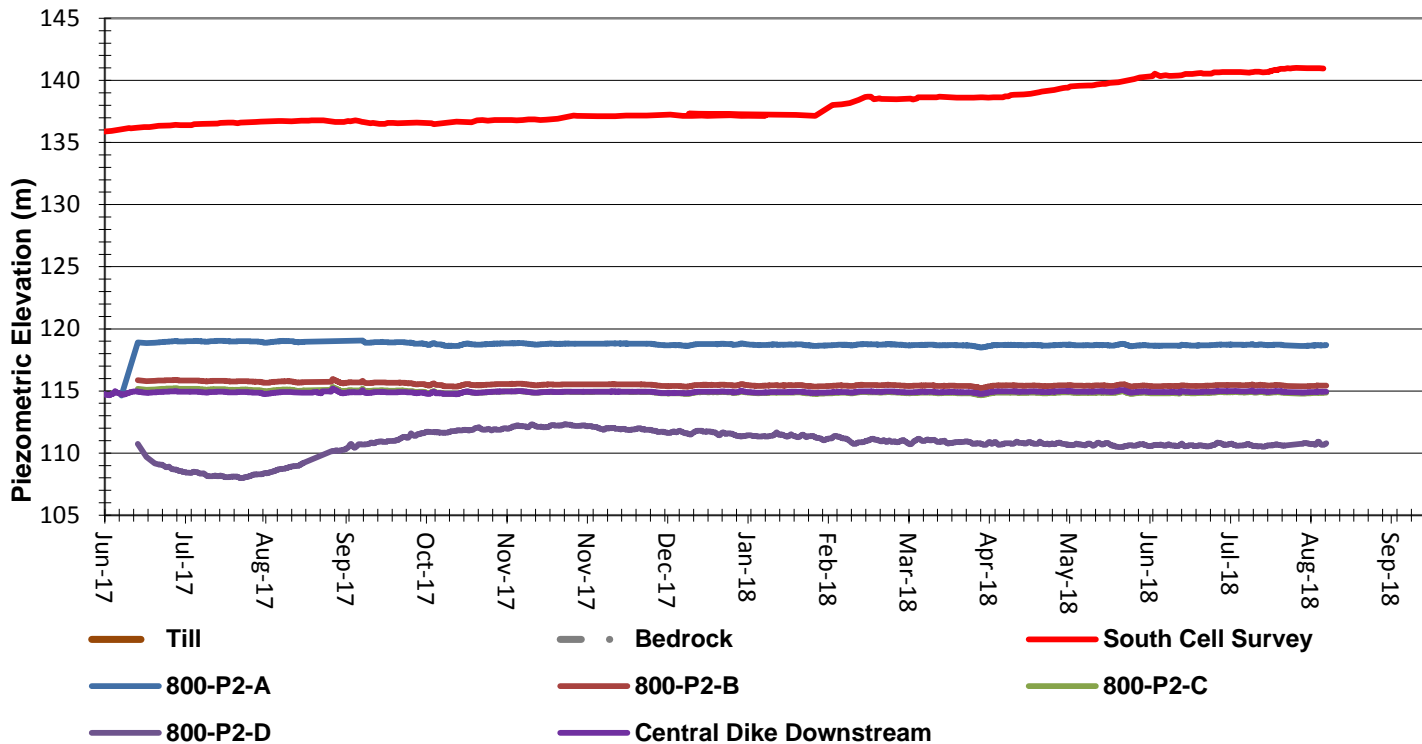
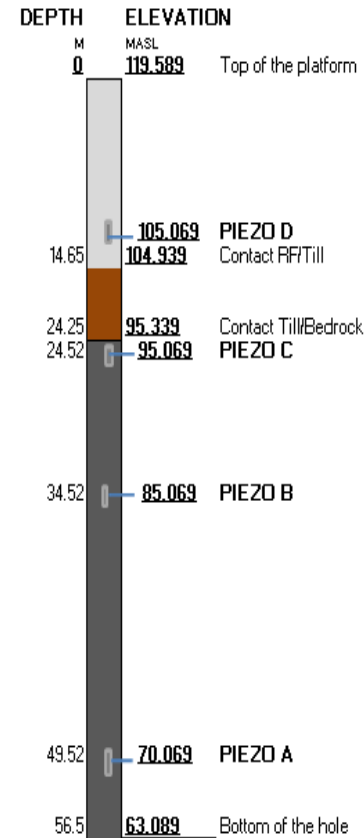
# PIEZOMETER 800-P2

- New instrument installed in 2017
- All Piezo are stable
- Piezo A,B and C are showing pressure readings similar to the elevation of the D/S pond.

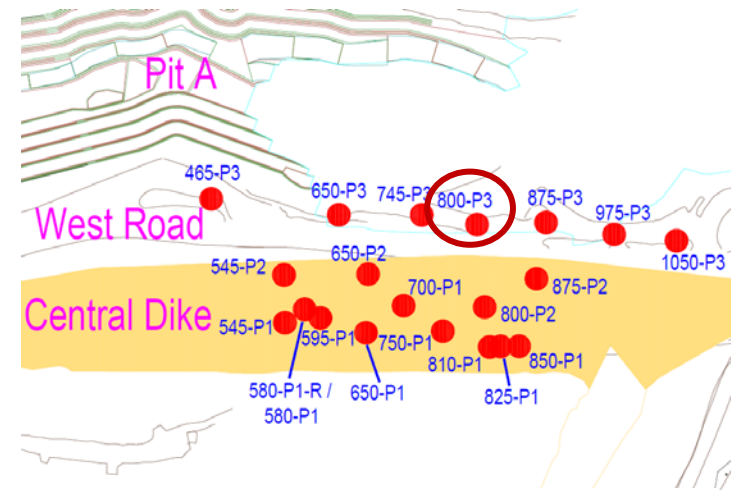
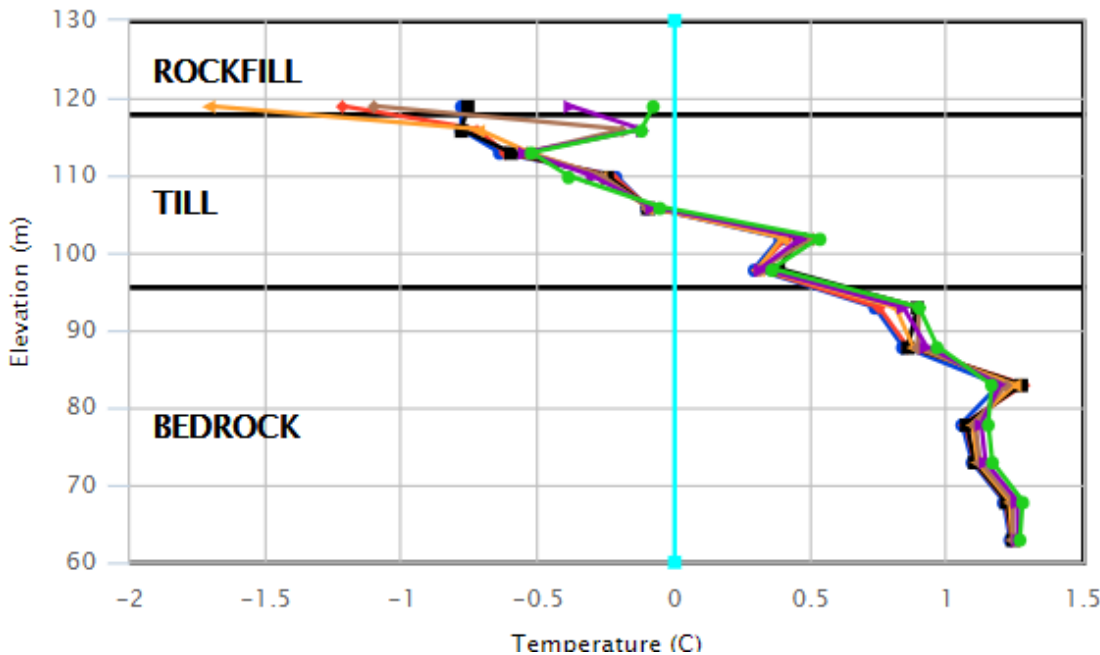
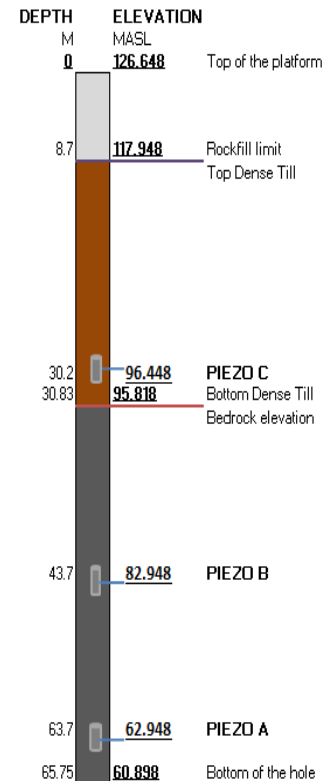
# THERMISTOR 800-P3

- New instrument installed in 2017
- The unfreezing point occurs around elevation 103 MASL.
- From elevation 78 to the bottom of the hole, temperatures are stable at approximately 1.2 °C.

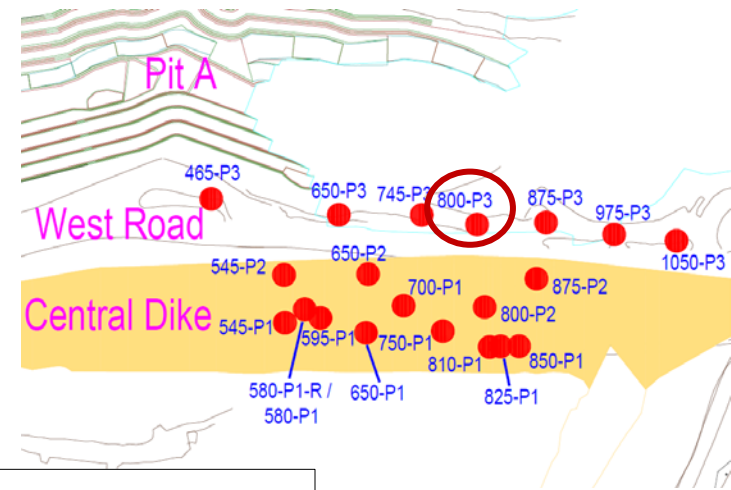
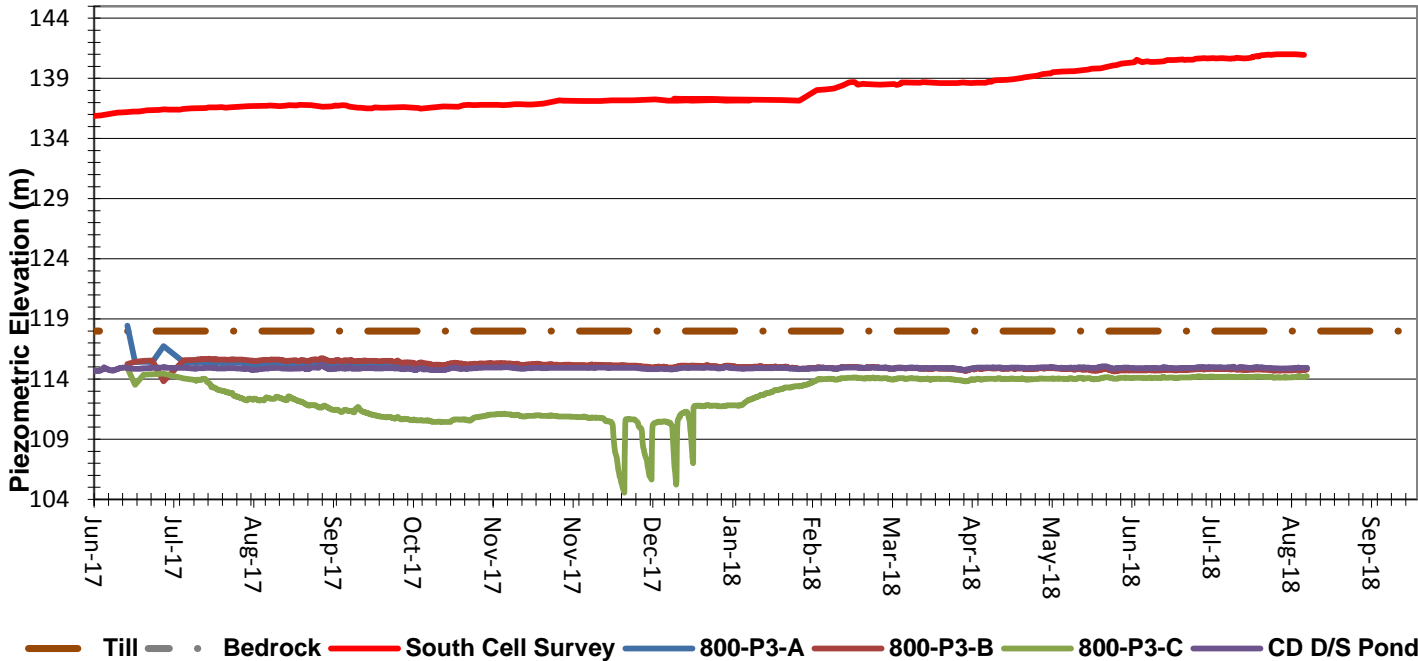
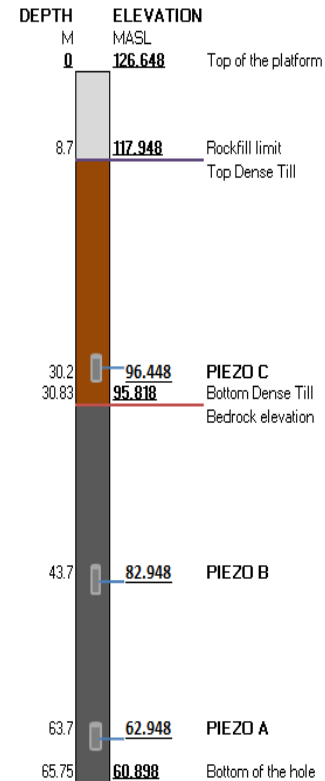
# PIEZOMETERS 800-P3

- New instrument installed in 2017
- Piezo are stable
- Piezo A, B & C readings are similar to the D/S pond elevation readings

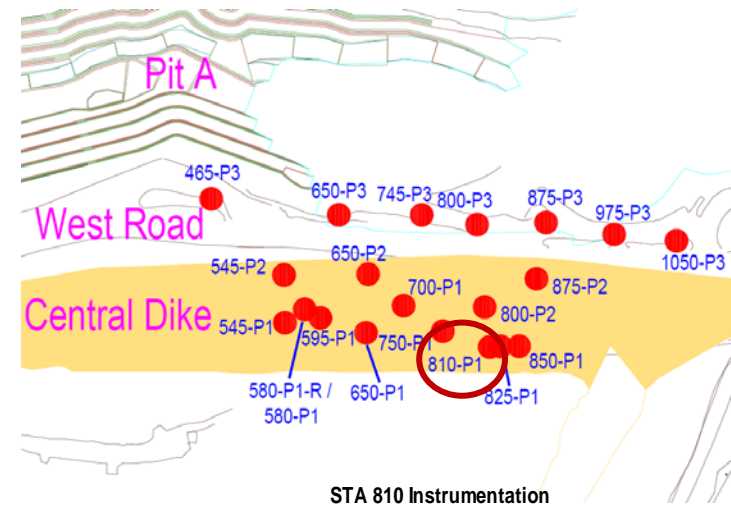
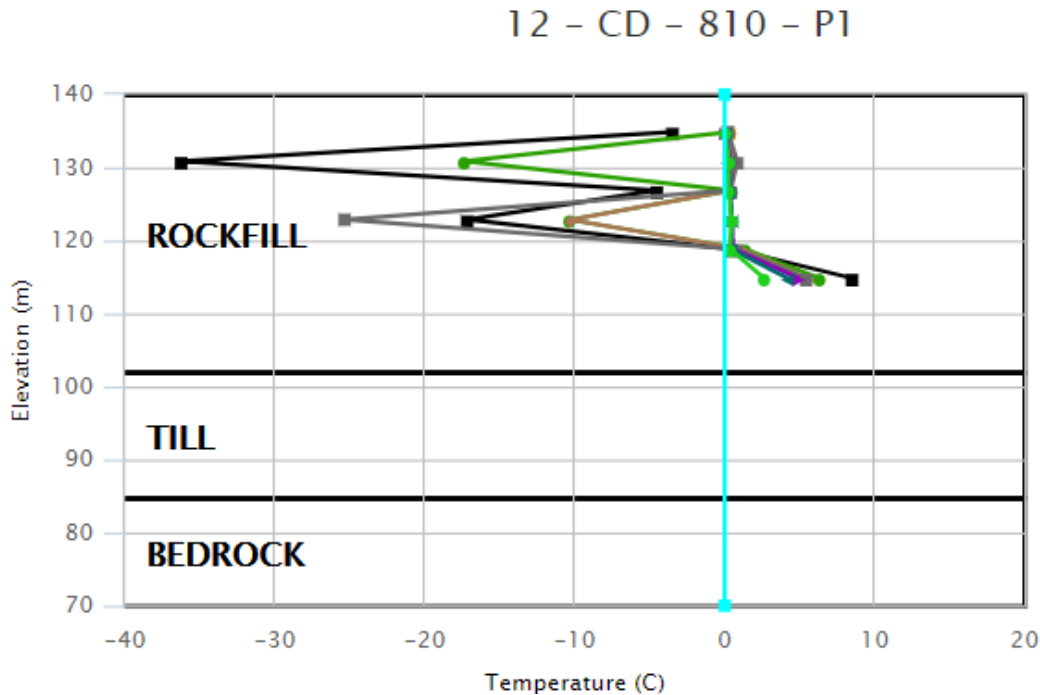
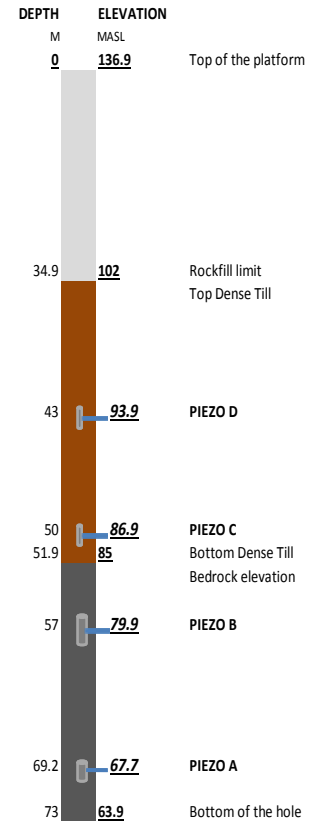
# THERMISTOR 810-P1

- Bead below El. 114.84 m stop working in February 2017
- Higher temperature observed in this hole (might be the instrument progressively failing)
