# **Meadowbank and Whale Tail 2018 Annual Geotechnical Inspection**

# 2018 Annual Geotechnical Inspection

*Meadowbank Gold Mine, Nunavut*

18101627-1583-R-Rev0

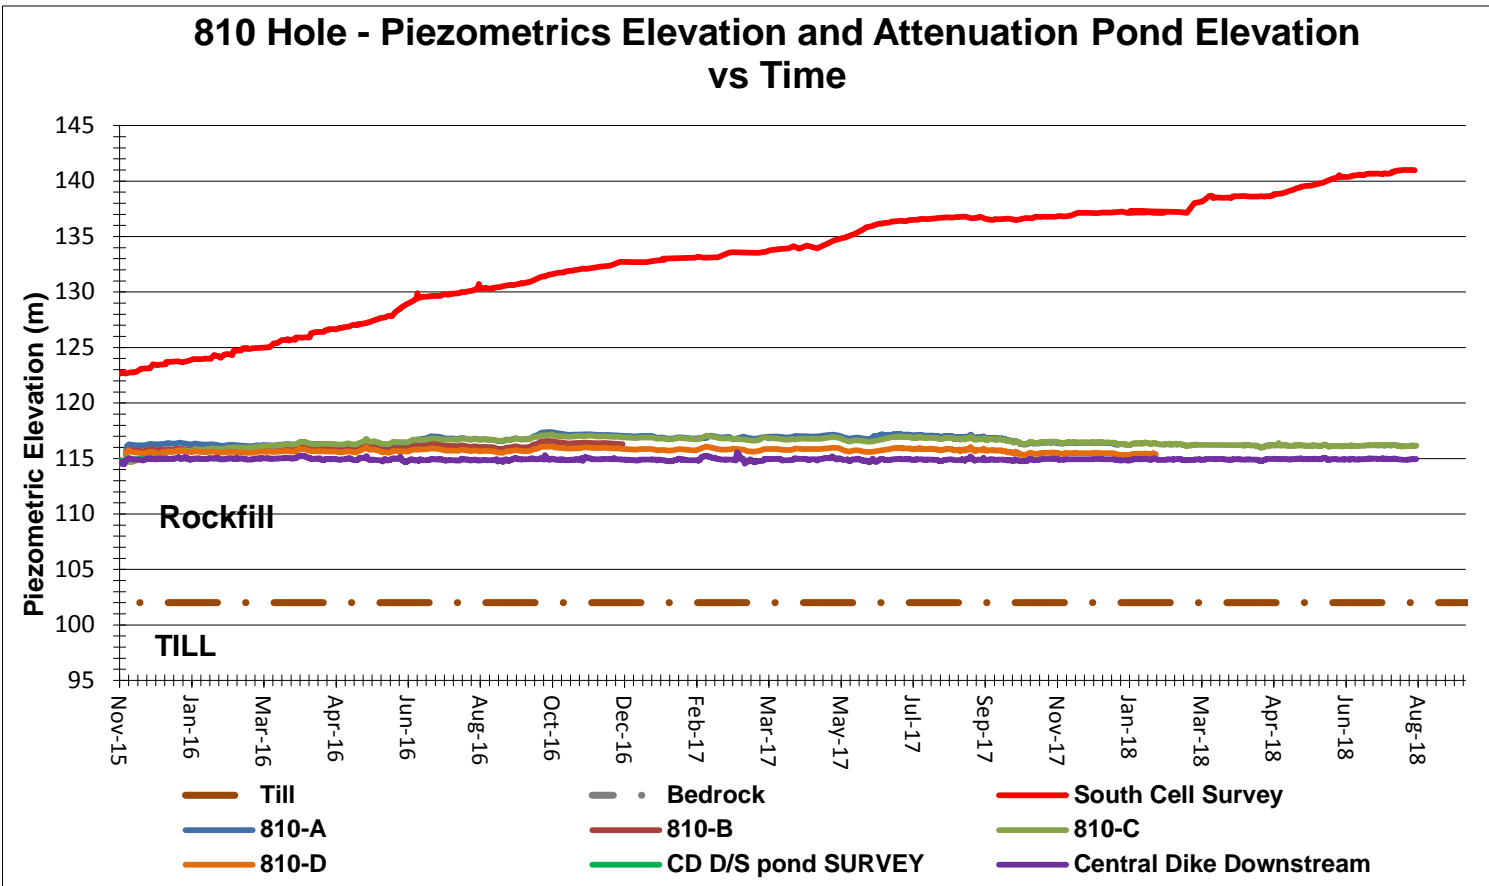
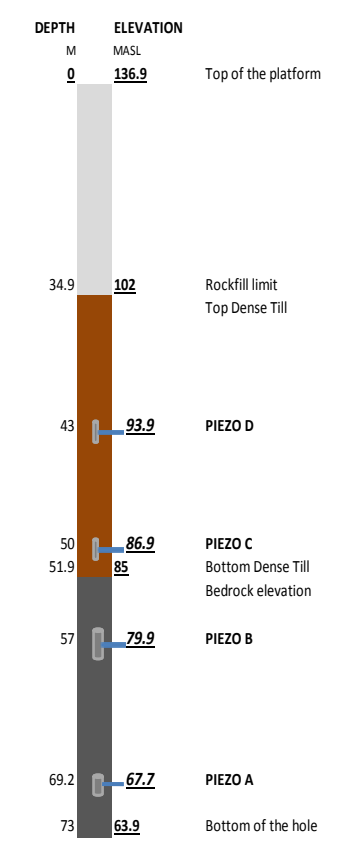
# PIEZOMETER 810-P1

- Piezo B stop working in December 2016
- Piezo A stop working in December 2017
- Piezo D stop working in May 2018
- Piezo C is following the elevation change of the D/S pond

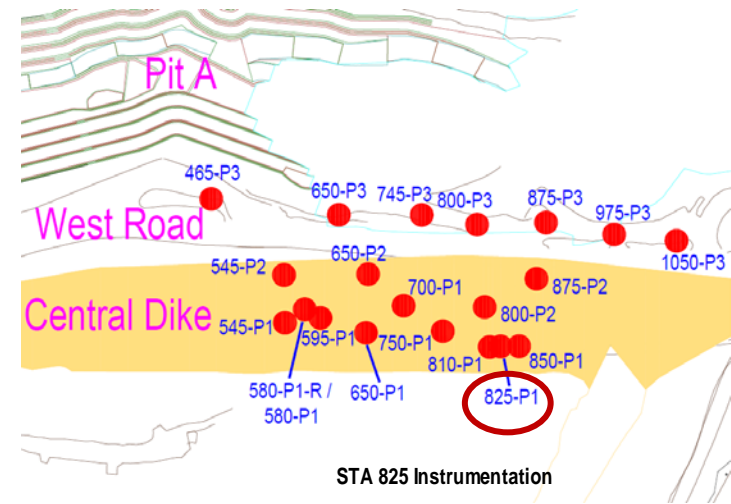
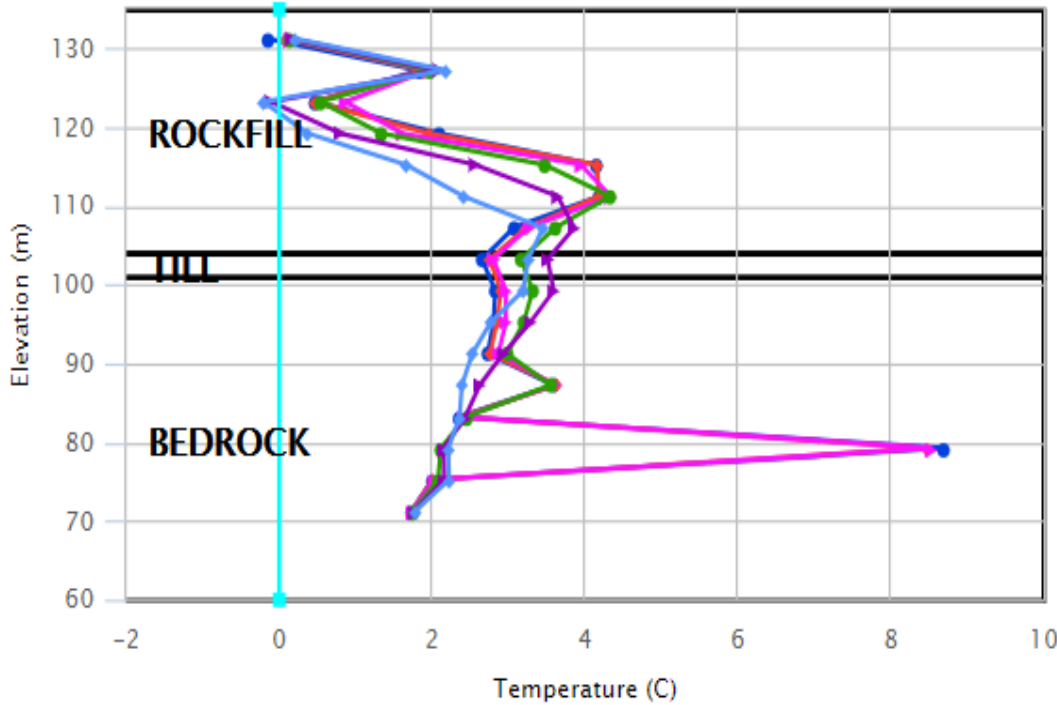
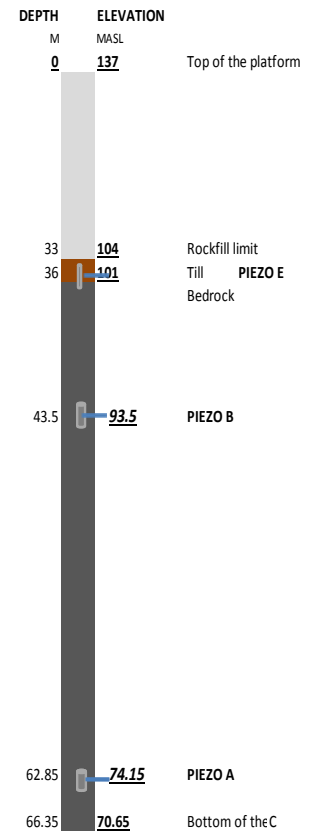
# THERMISTOR 825-P1

- Capacitance effect at elevation 79.25 MASL and 87.5 MASL.
- Peak of temperature at El.111 MASL (4.1 °C)

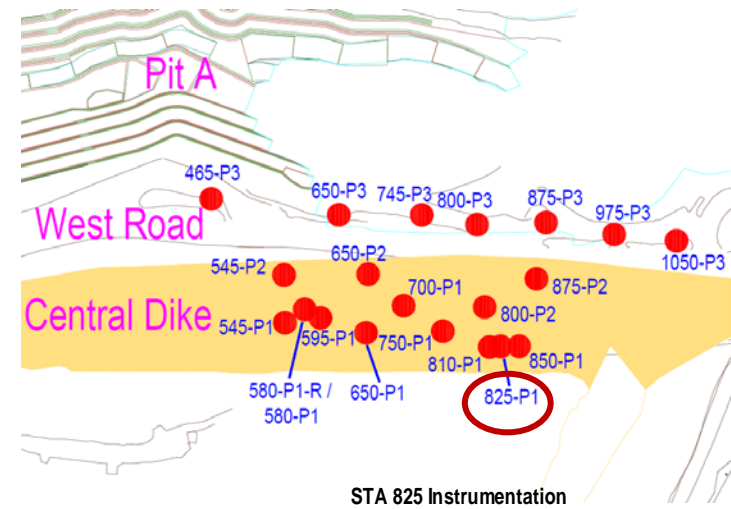
# PIEZOMETER 825-P1

- ➔ Increased in piezometric elevation of Piezo E since April 2017. Seem to be connected now with South Cell.
- ➔ Piezo A and B showing readings similar to the D/S pond and are reacting directly with elevation change.

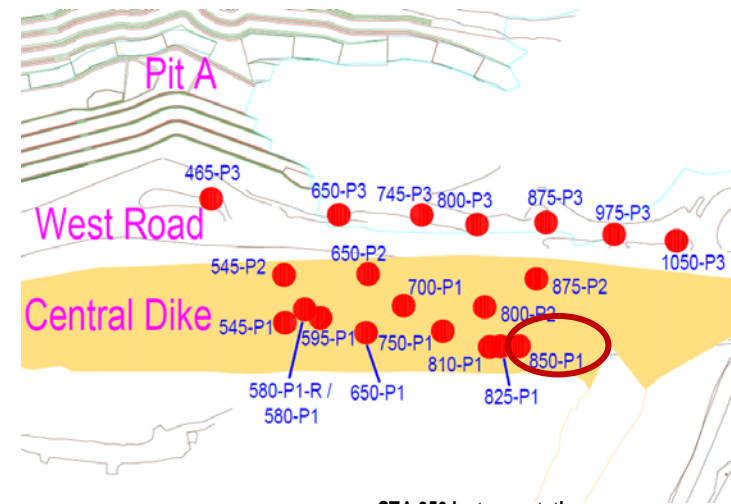
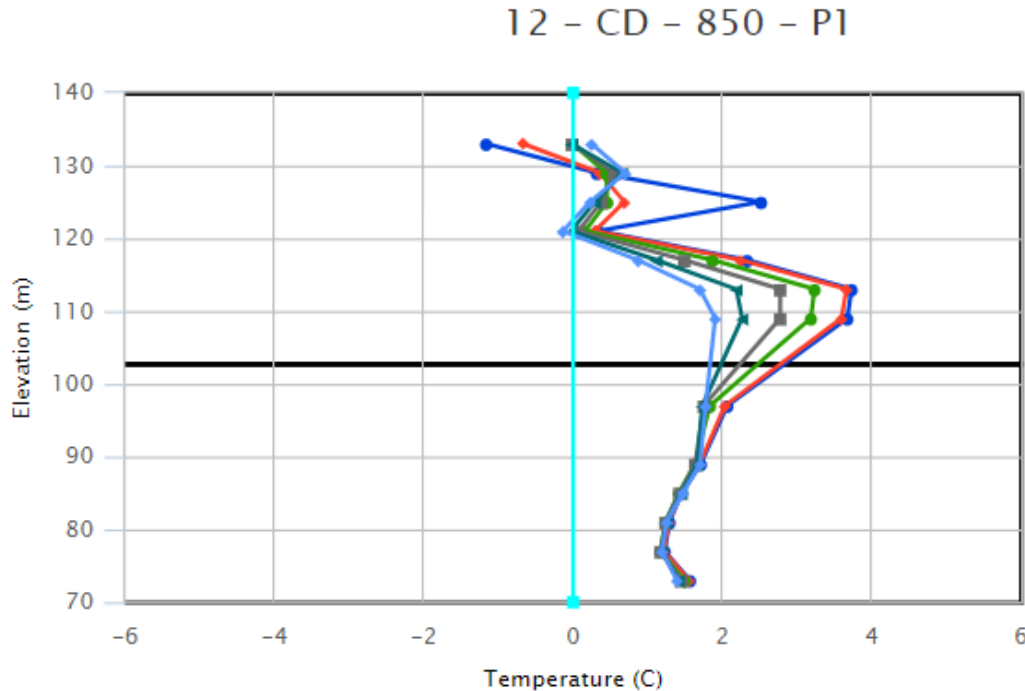
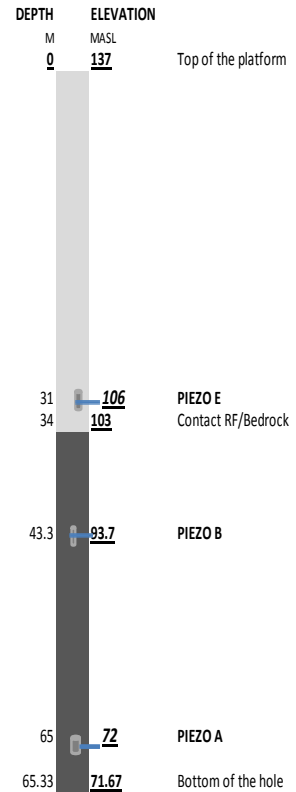
# THERMISTOR 850-P1

- Temperature above 0° C in bedrock at 850-P1
- General temperature rising since the end of 2017
- Peak of temperature at El.125 MASL

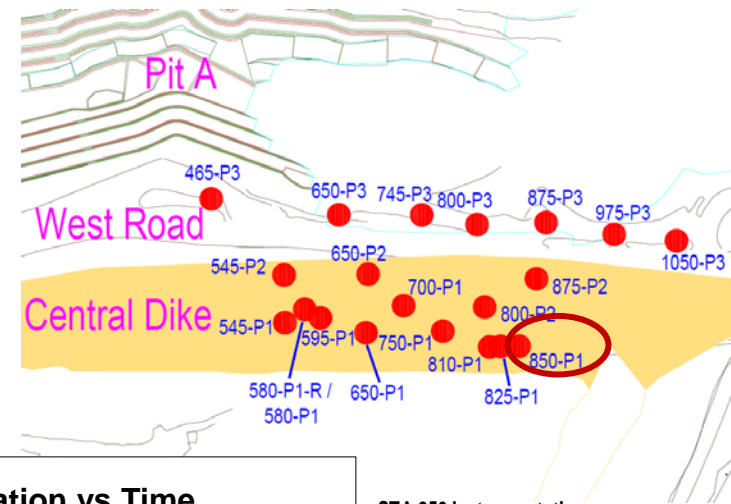
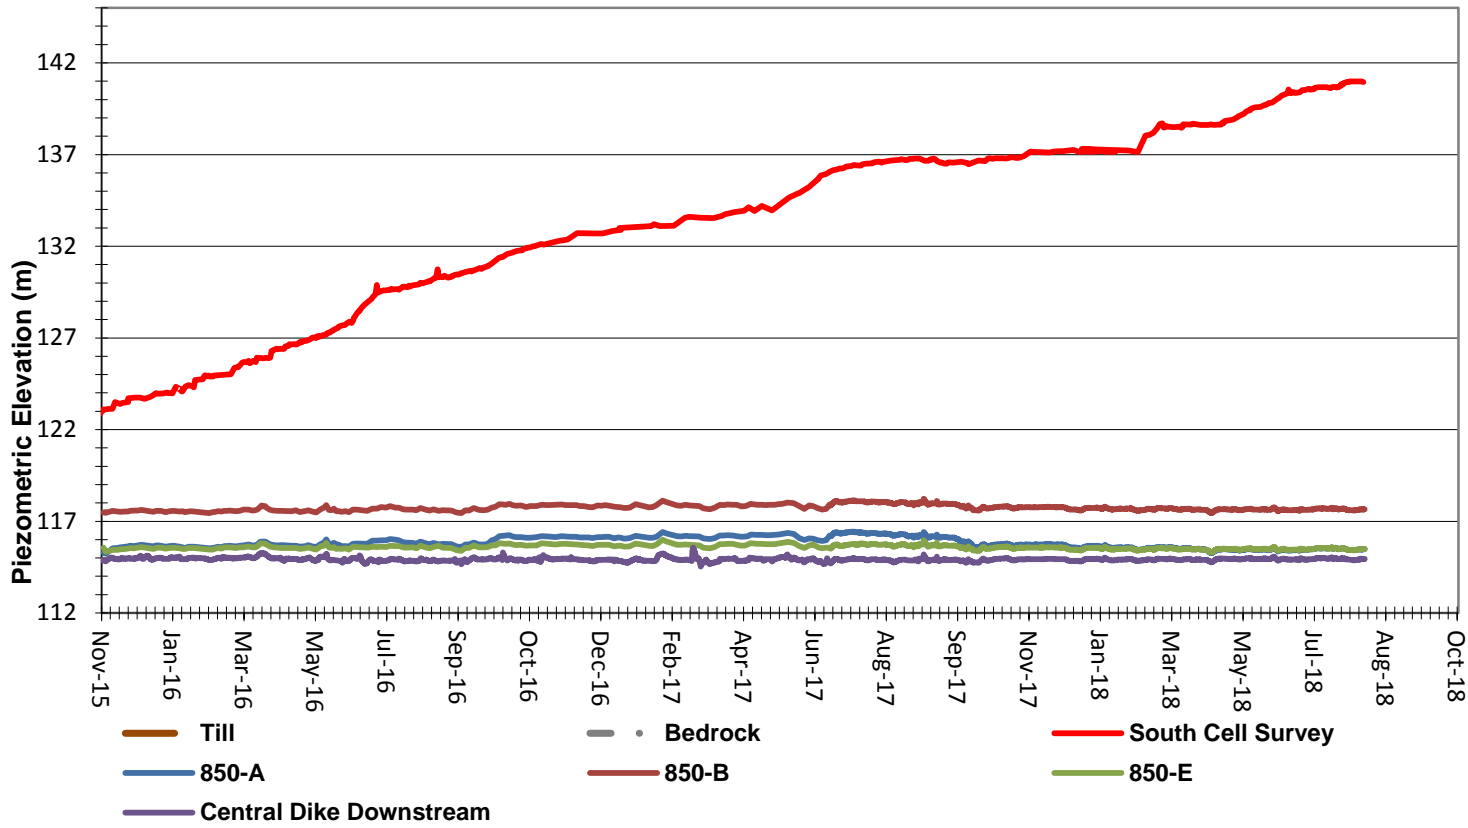
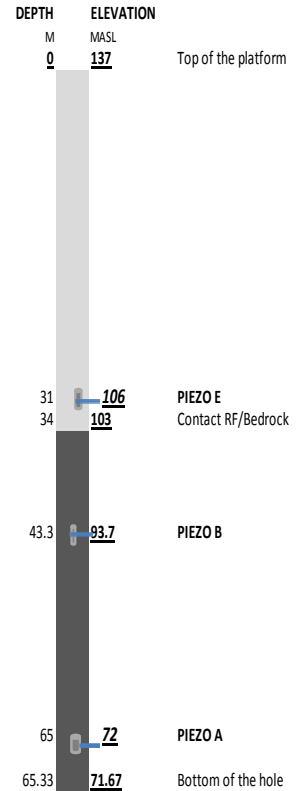
# PIEZOMETER 850-P1

- ➔ All piezometer are following the trend of the D/S pond regime
- ➔ However piezo B is one of the highest in the piezometer readings that have stable reading (117.7m)

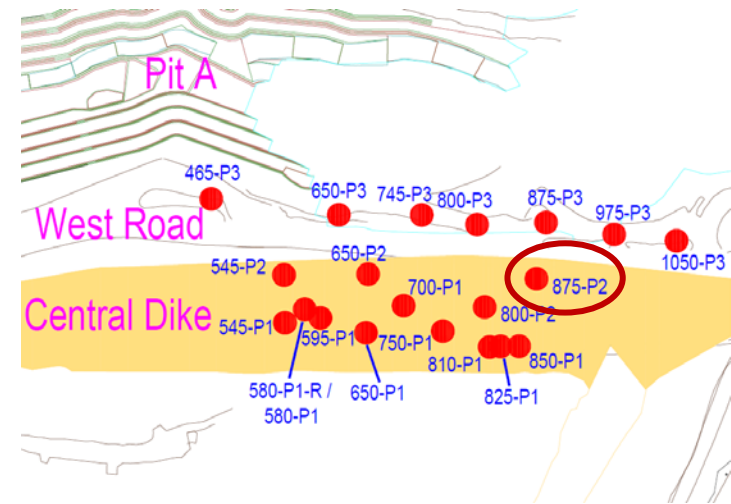
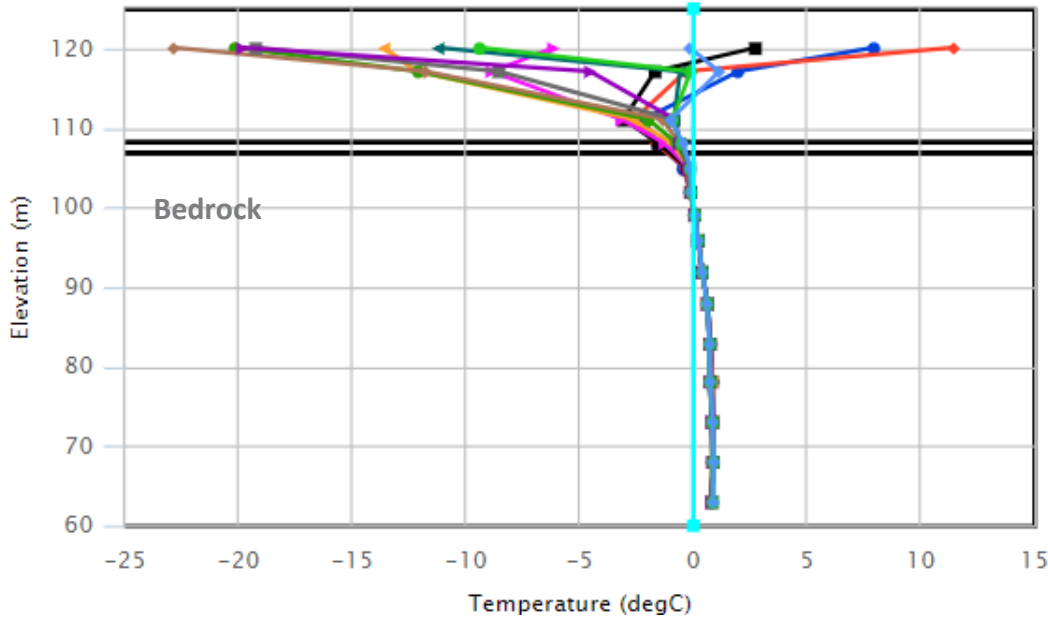
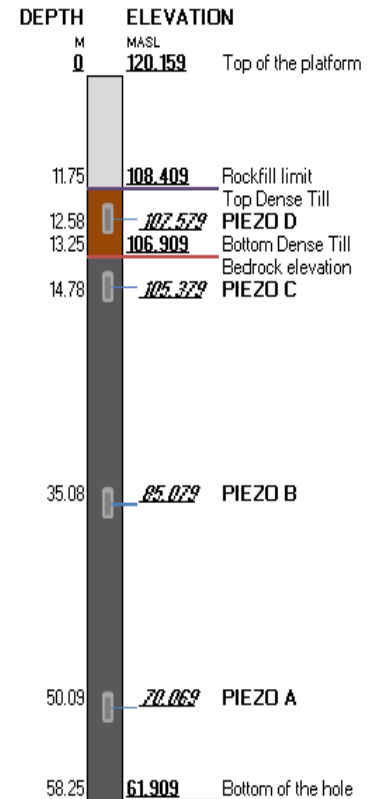
# THERMISTOR 875-P2

- ➔ New thermistor installed in 2017
- ➔ Bedrock temperature above 0°C

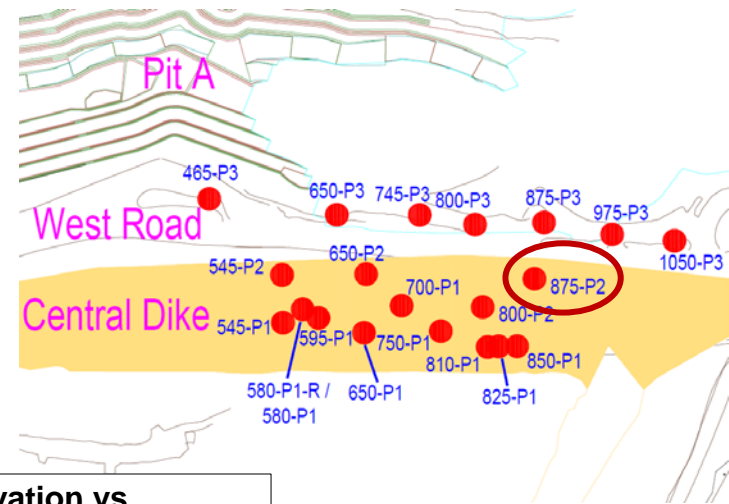
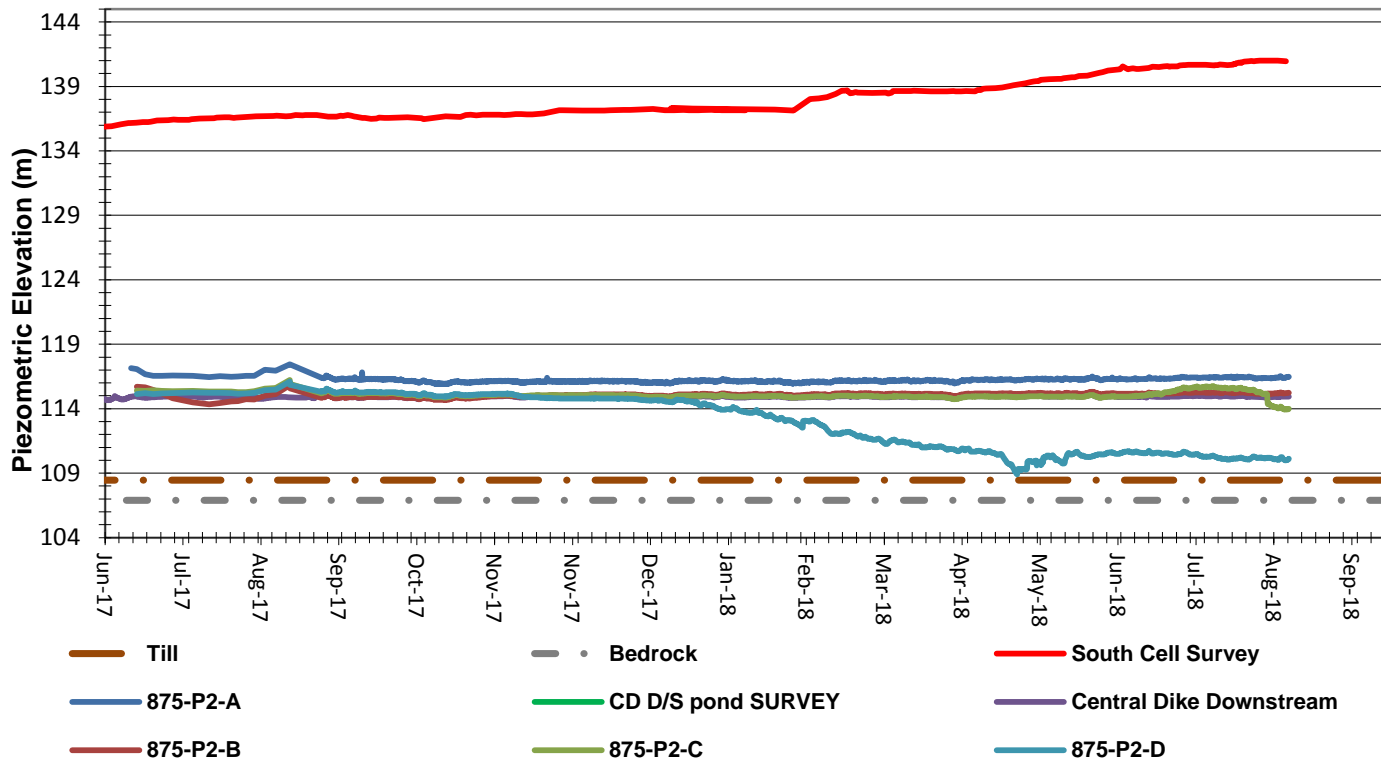
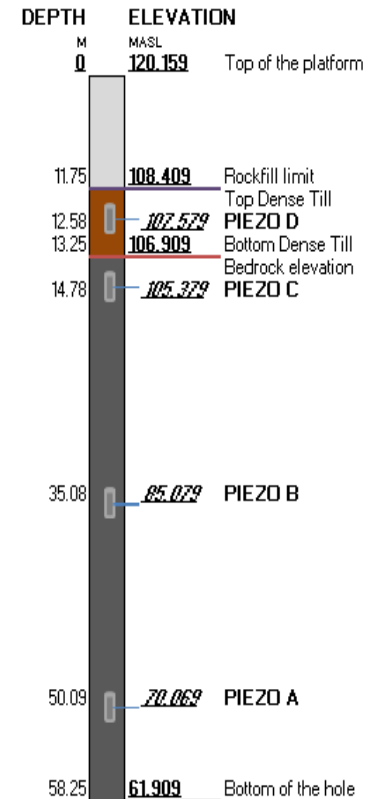
# PIEZOMETER 875-P2

- ➔ All piezometer are following the trend of the D/S pond regime
- ➔ PZ-D show temperatures under the freezing point

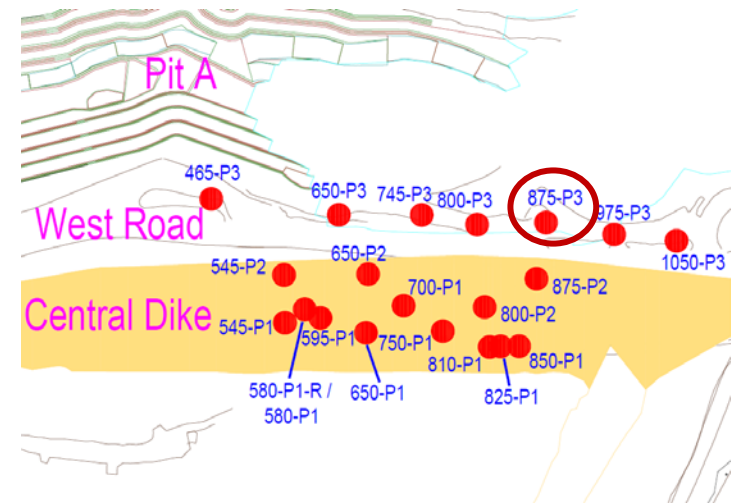
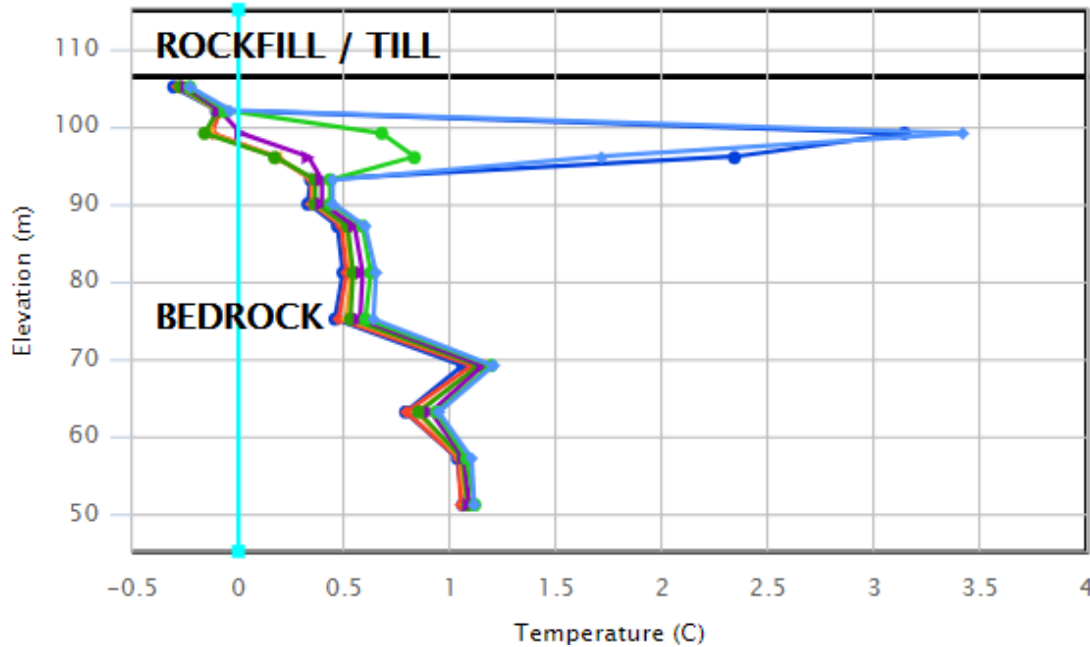
# THERMISTOR 875-P3

- Temperature above 0° C in bedrock at 875-P3
- Temperature spike at El.96 m and 99 m are related to capacitance effect.

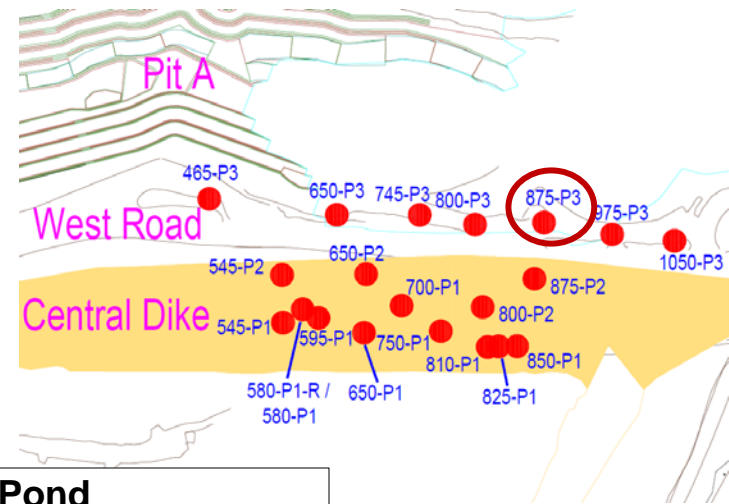
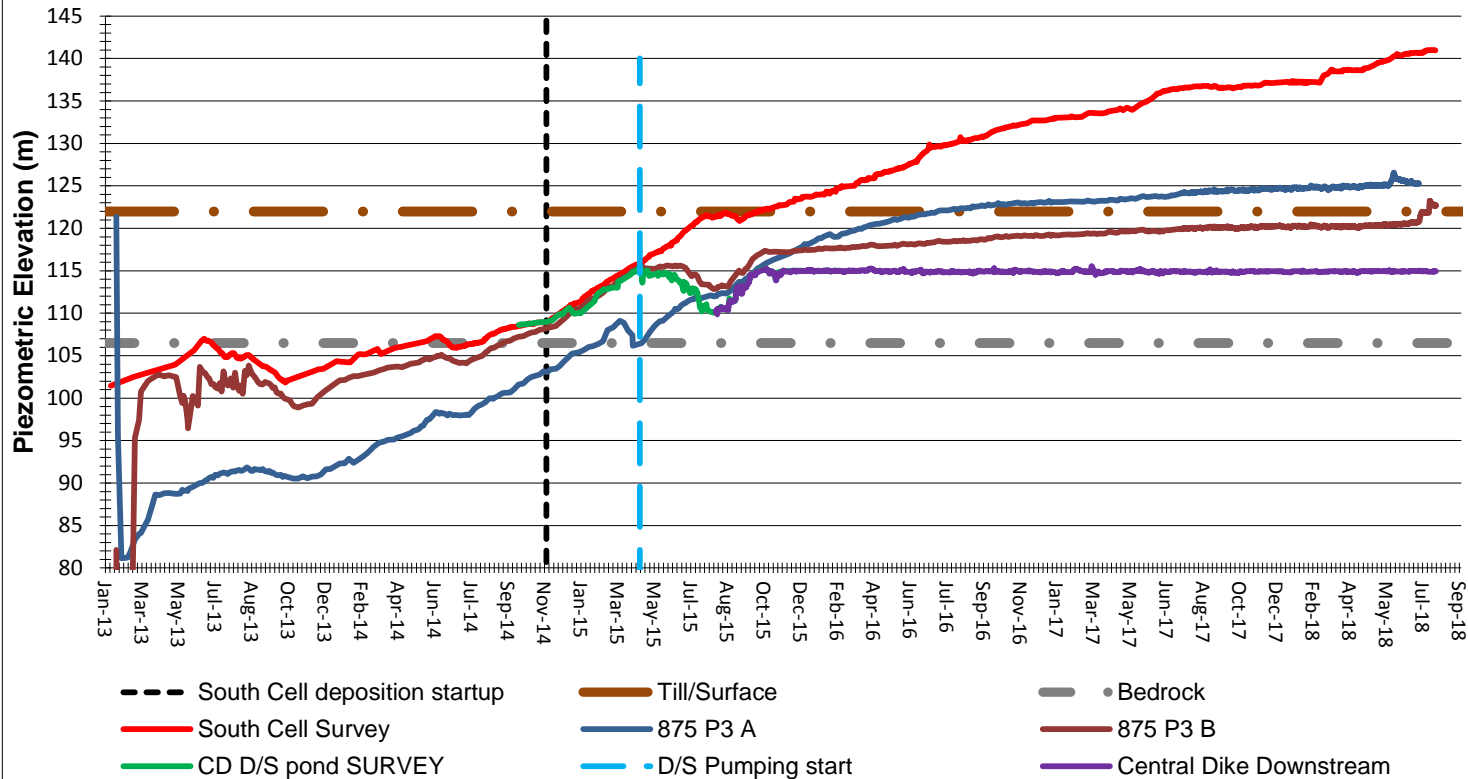
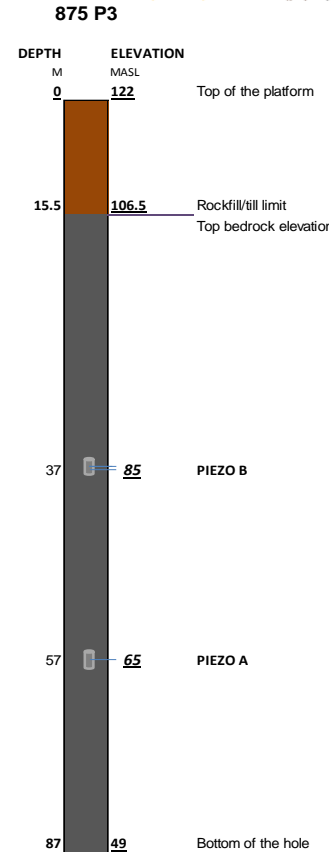
# PIEZOMETER 875-P3

➔ Piezometer at 875-P3 are in bedrock and are impacted by increase in South Cell head

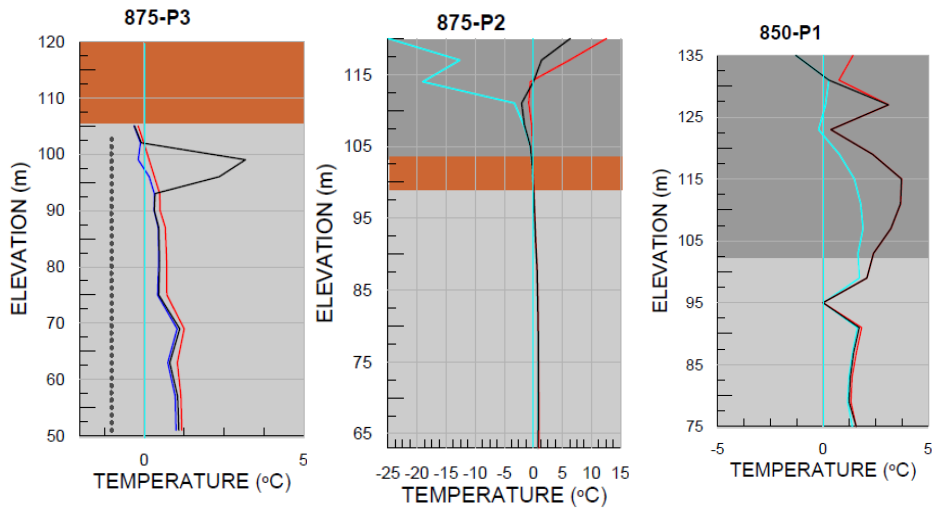
## THERMISTOR READINGS AUGUST 2017-2018

2018 graph are showing the good representation of the bedrock/till/rockfill units

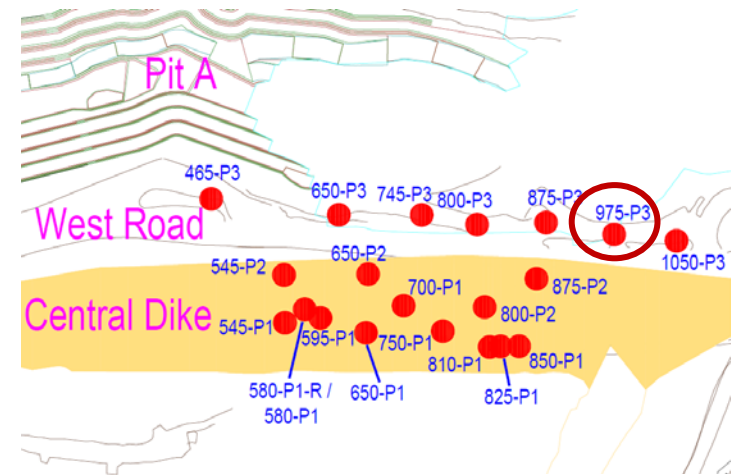
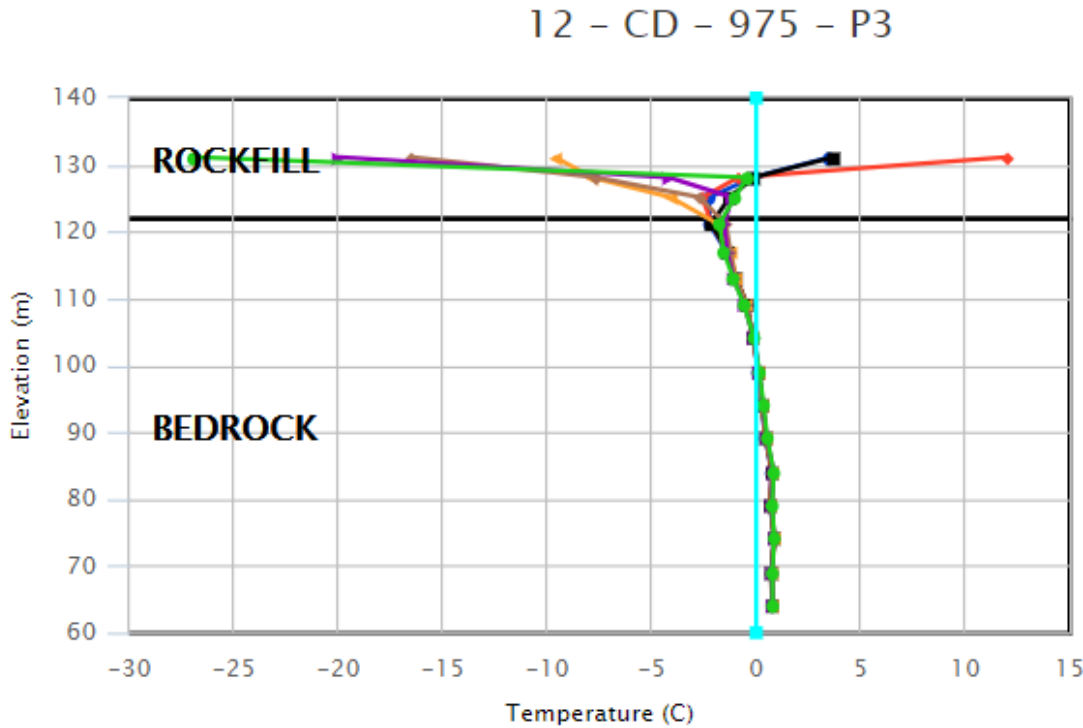
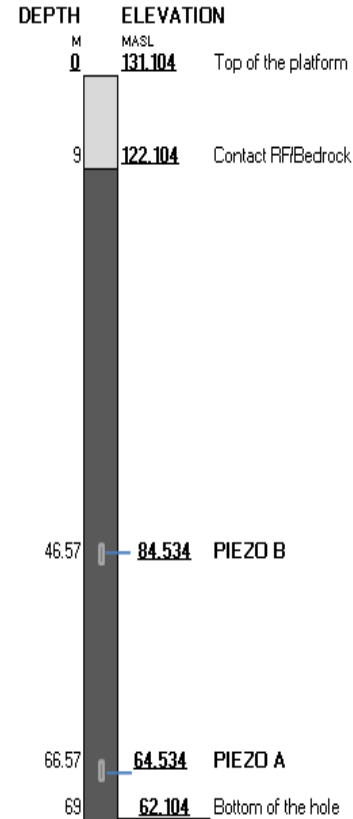
# THERMISTOR 975-P3

- New instrument installed in 2017
- Temperature above 0° C in bedrock below El. 105 m

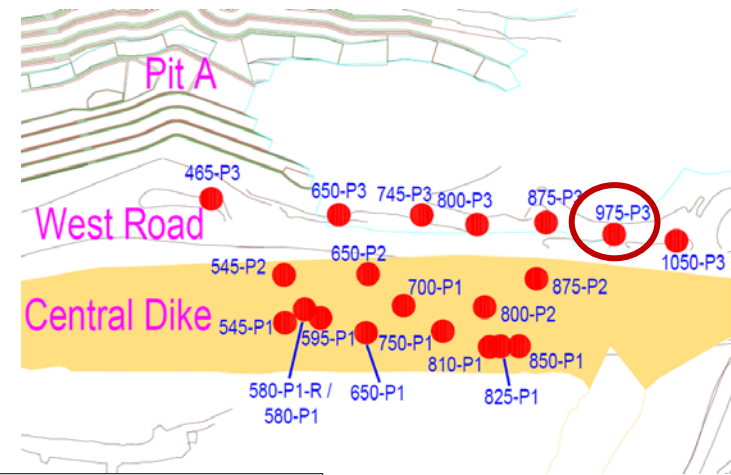
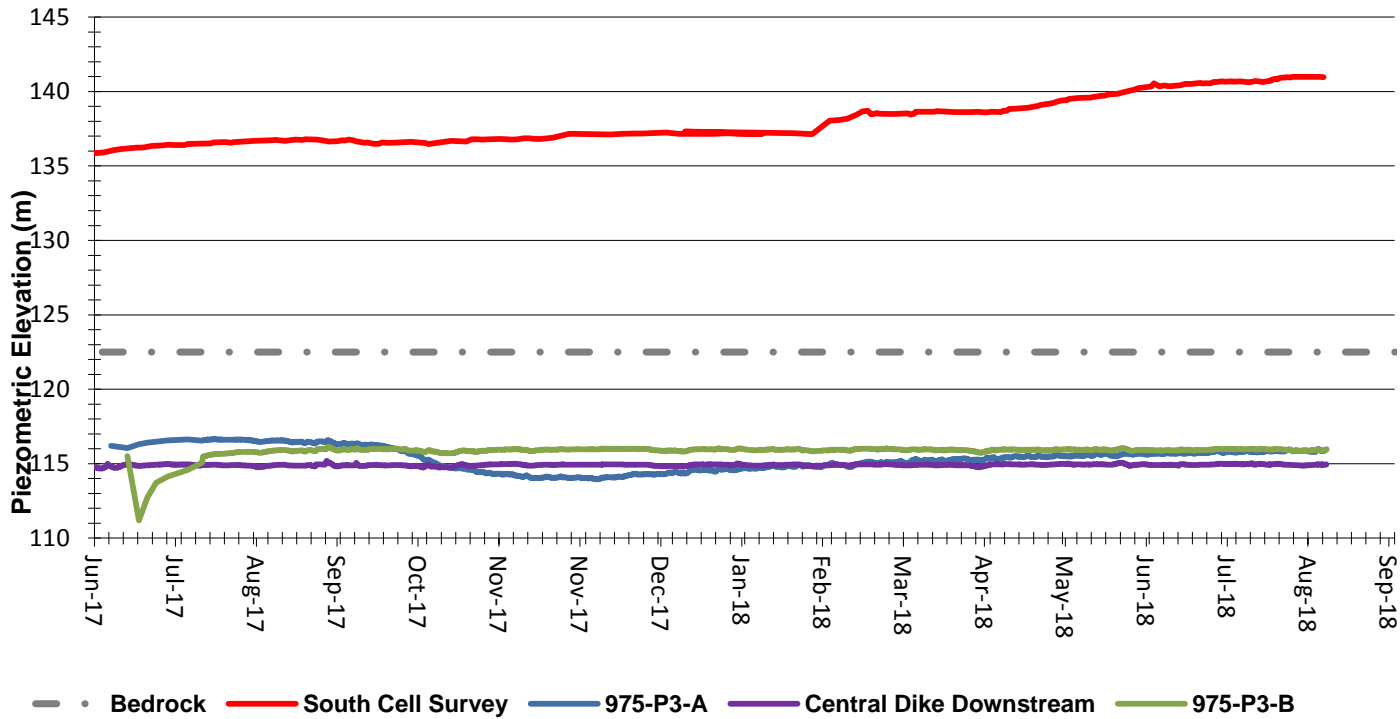
# PIEZOMETER 975-P3

- ➔ New instrument installed in 2017
- ➔ Both piezometers are following the trend of the D/S pond regime

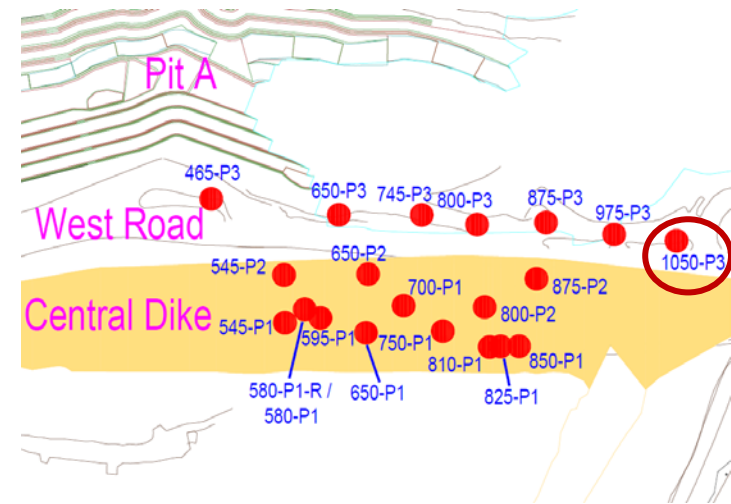
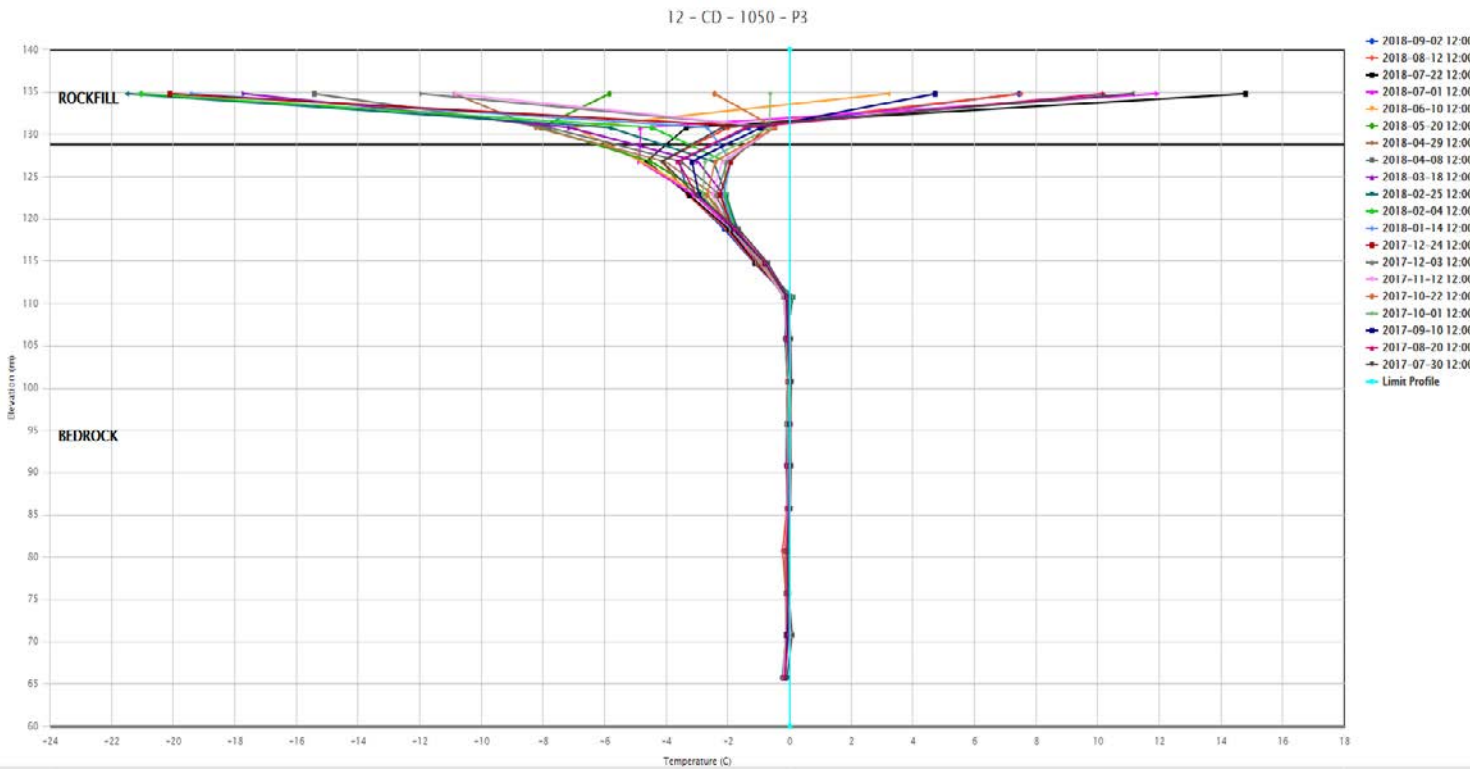
# THERMISTOR 1050-P3

➡ Temperature at 0° C in bedrock

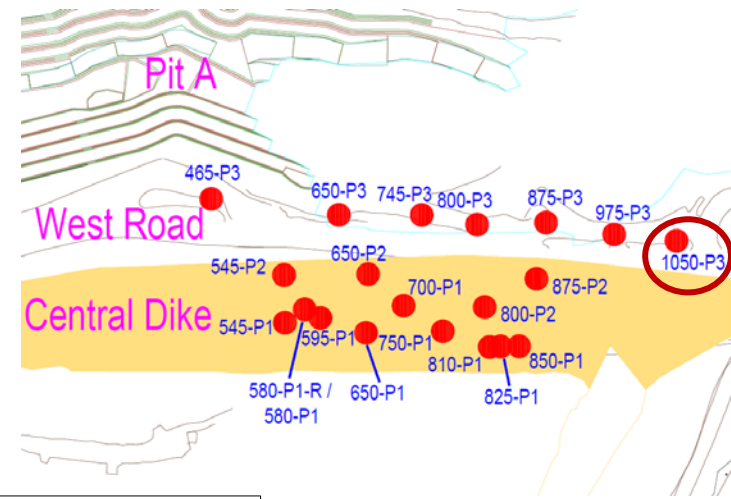
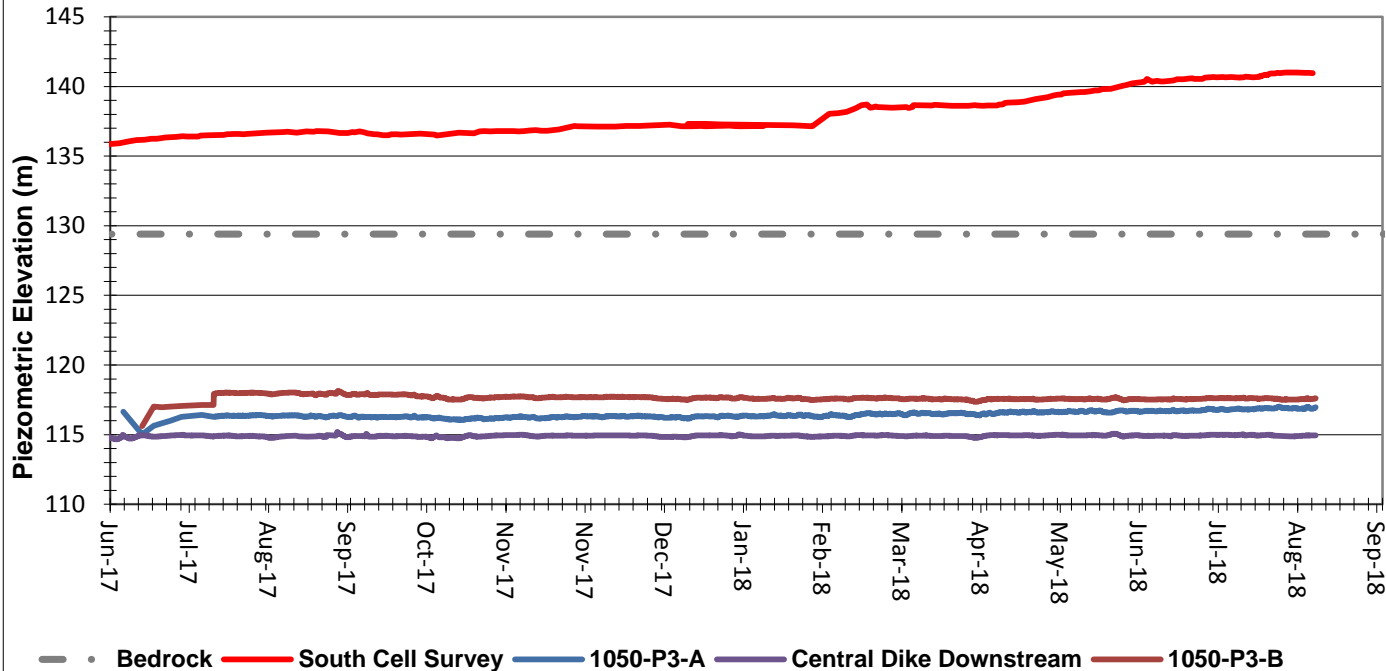
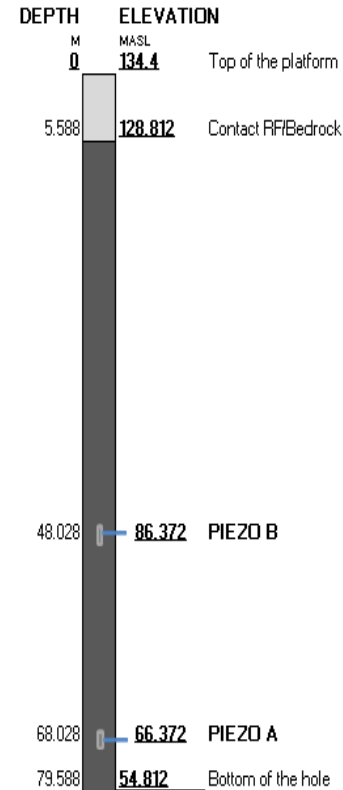
# PIEZOMETER 1050-P3

- ➔ Piezometers temperature just below the freezing point
- ➔ Piezometers are following the trend of the D/S pond elevation.

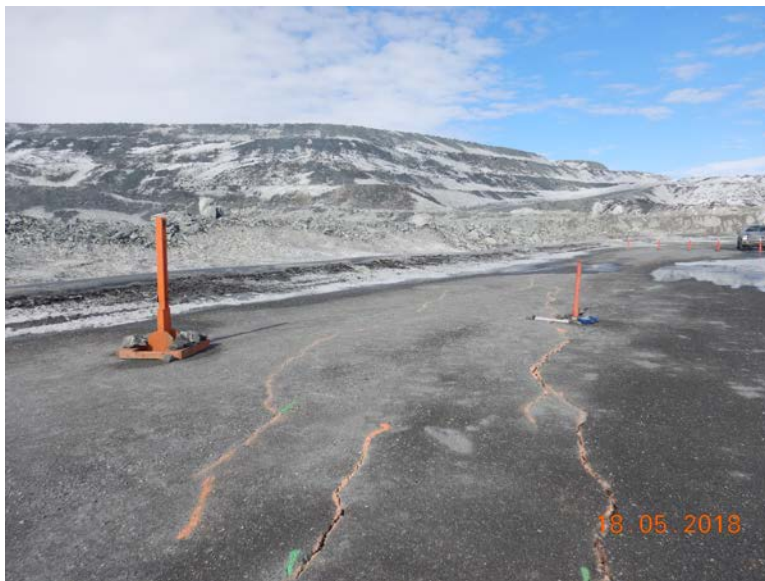
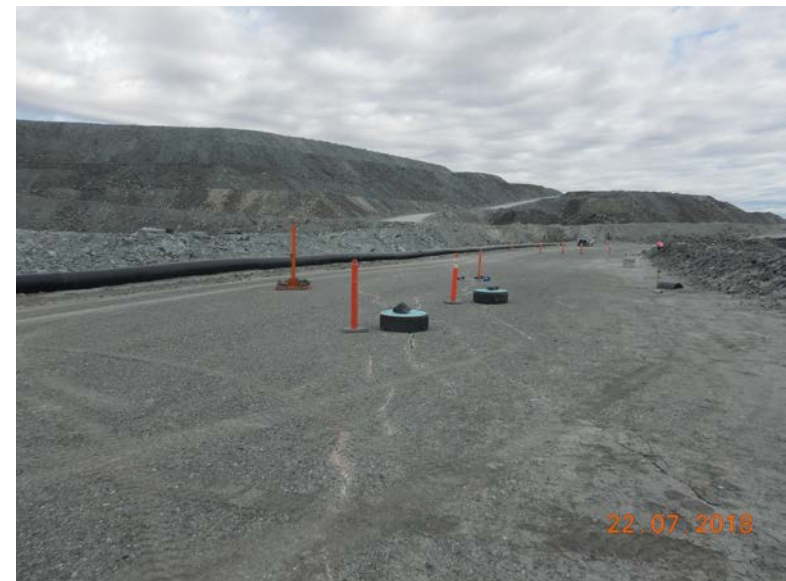
### Description of the new cracks area

- Observed initially on April 27th 2018
- Appeared at the end of the winter with warmer temperature
- Cracks width varying approximately from 1cm to 4 cm
- No significant visual changes since April 27th 2018

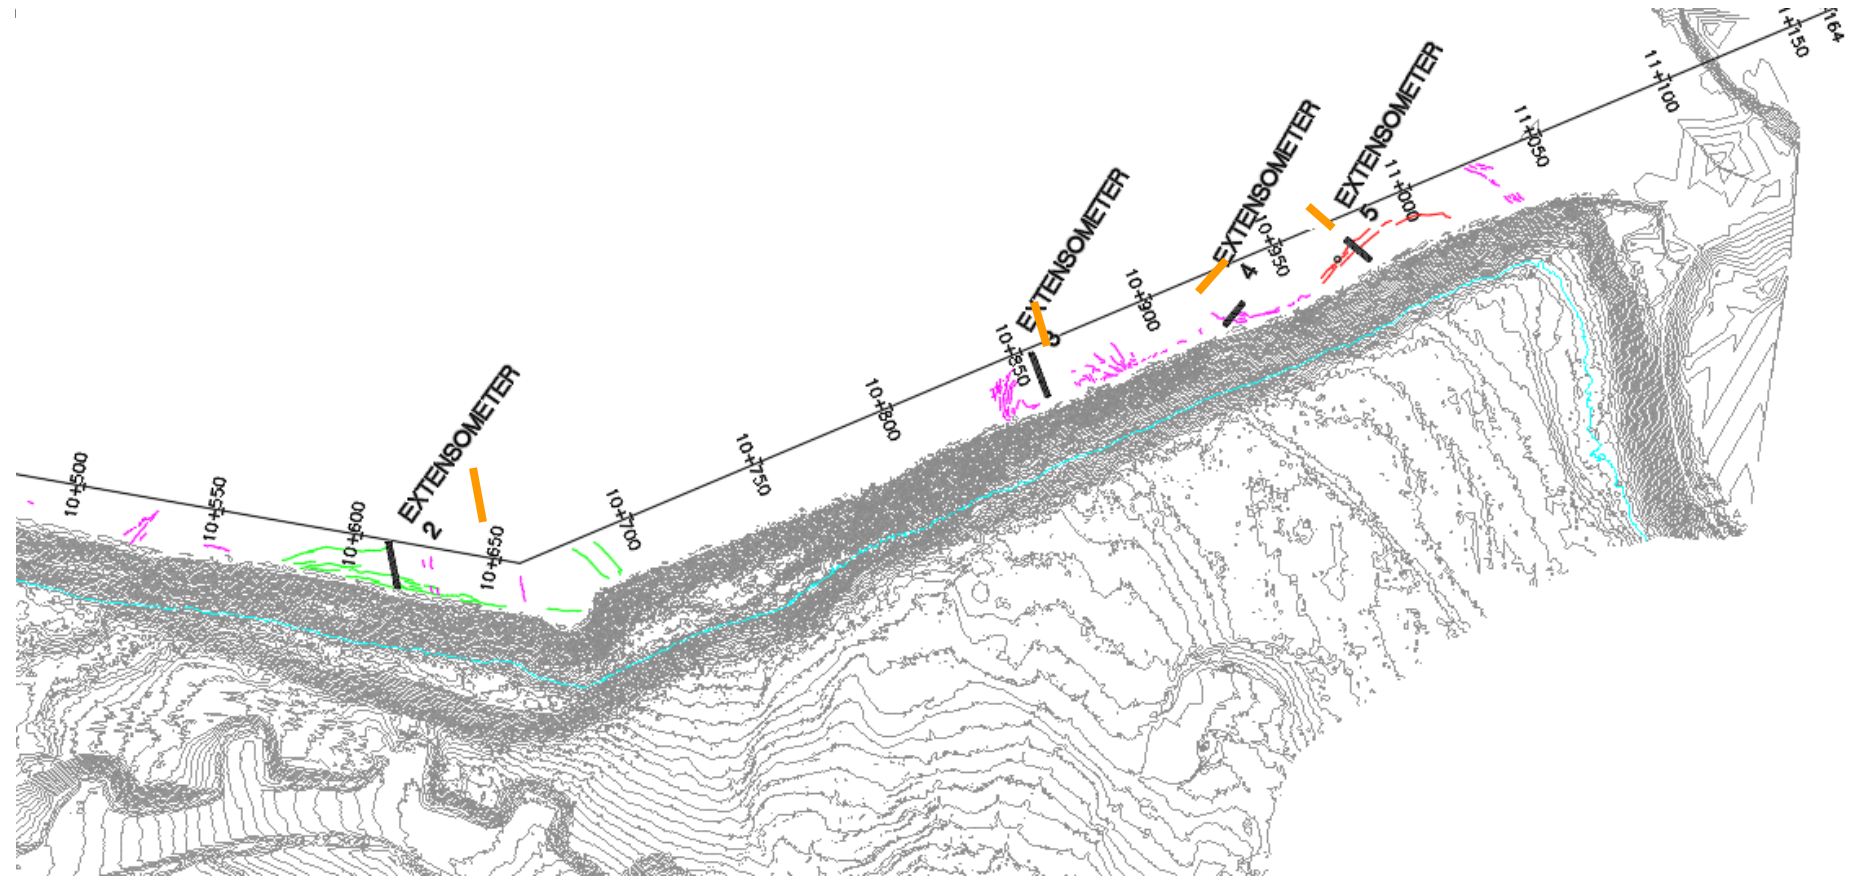
### Location of extensometers 2, 3, 4 & 5

- Four wireline extensometers are installed on Stormwater Dike.
- Located at stations 10 + 620, 10+850, 10+925 and 10+975.
- Monitored every three days.
- The four extensometers have shown none or very little variations.
