# **Meadowbank and Whale Tail 2018 Annual Geotechnical Inspection**

# 2018 Annual Geotechnical Inspection

*Meadowbank Gold Mine, Nunavut*

18101627-1583-R-Rev0

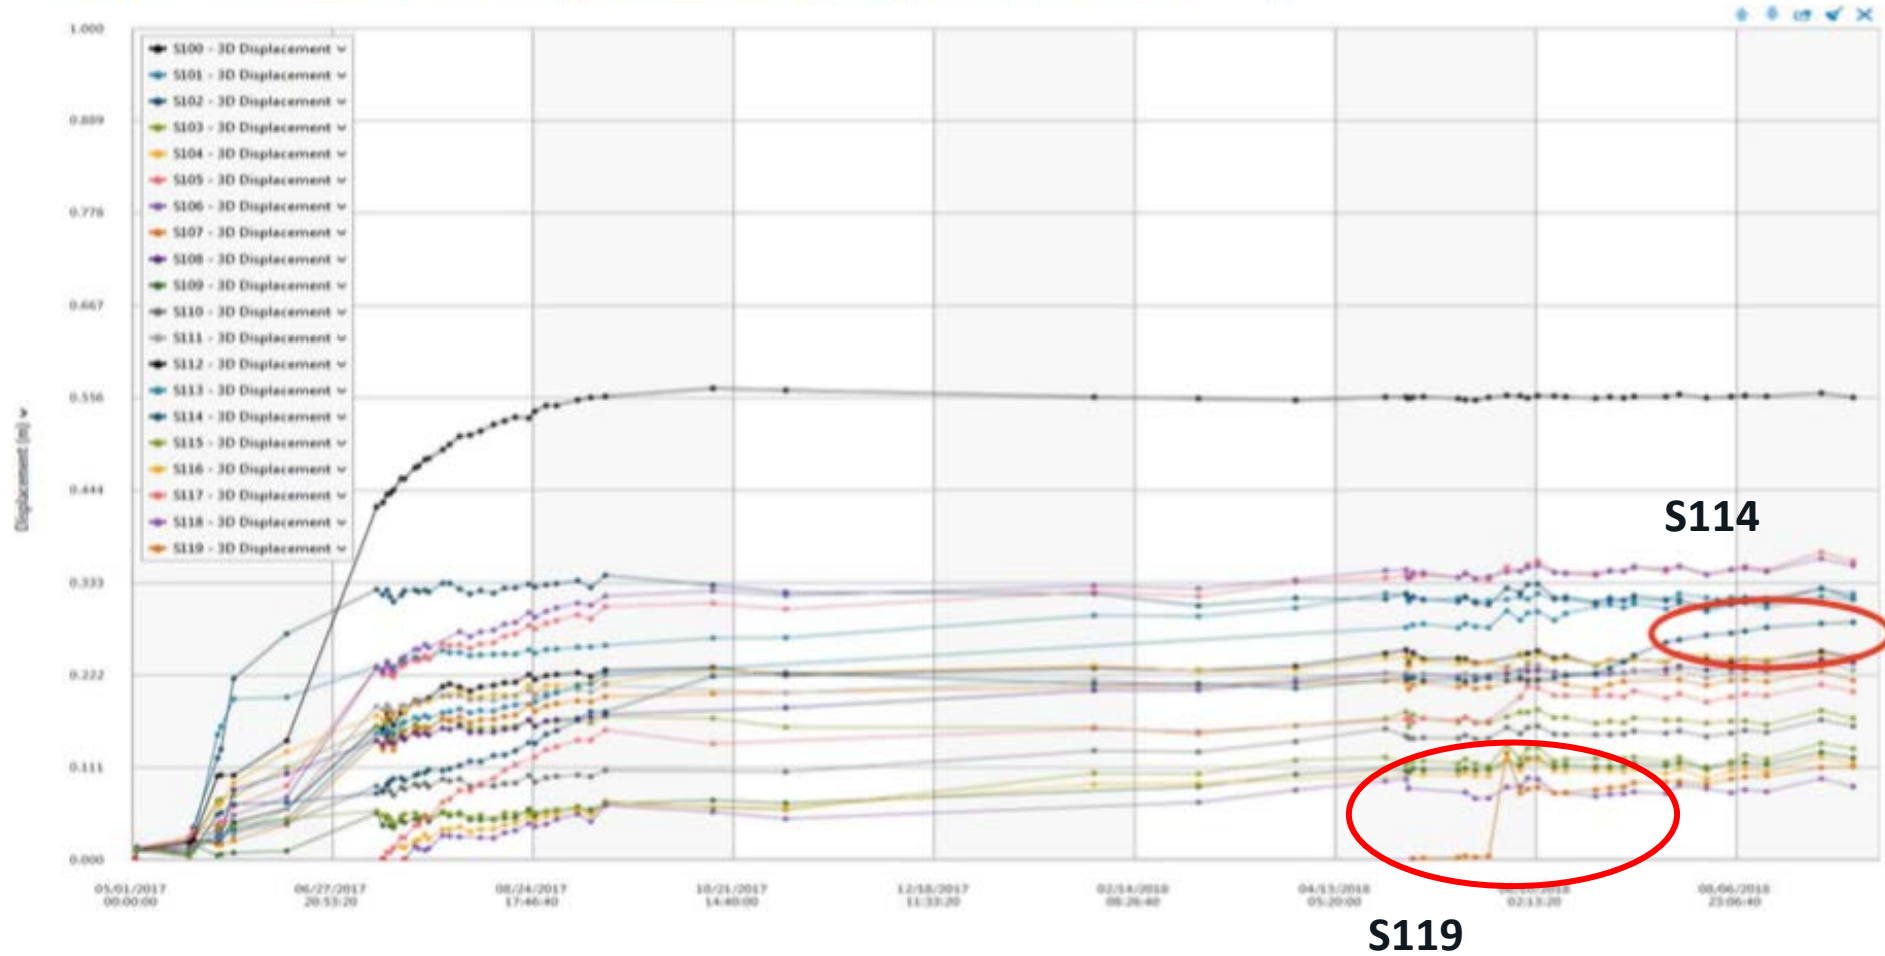
### Prisms cumulative 3D displacement (May 2017-June 2018)

- The prisms S119 is located in the 2018 new crack area
- The prisms analysis shows that the prisms movement was fairly constant throughout season
- 3D displacement is in majority due to the vertical displacement
- Significant variations of velocity and vertical displacement recorded at S119 between June 1<sup>st</sup> and 5<sup>th</sup>. These displacements were probably due to the settling of the boulder installed during the winter.

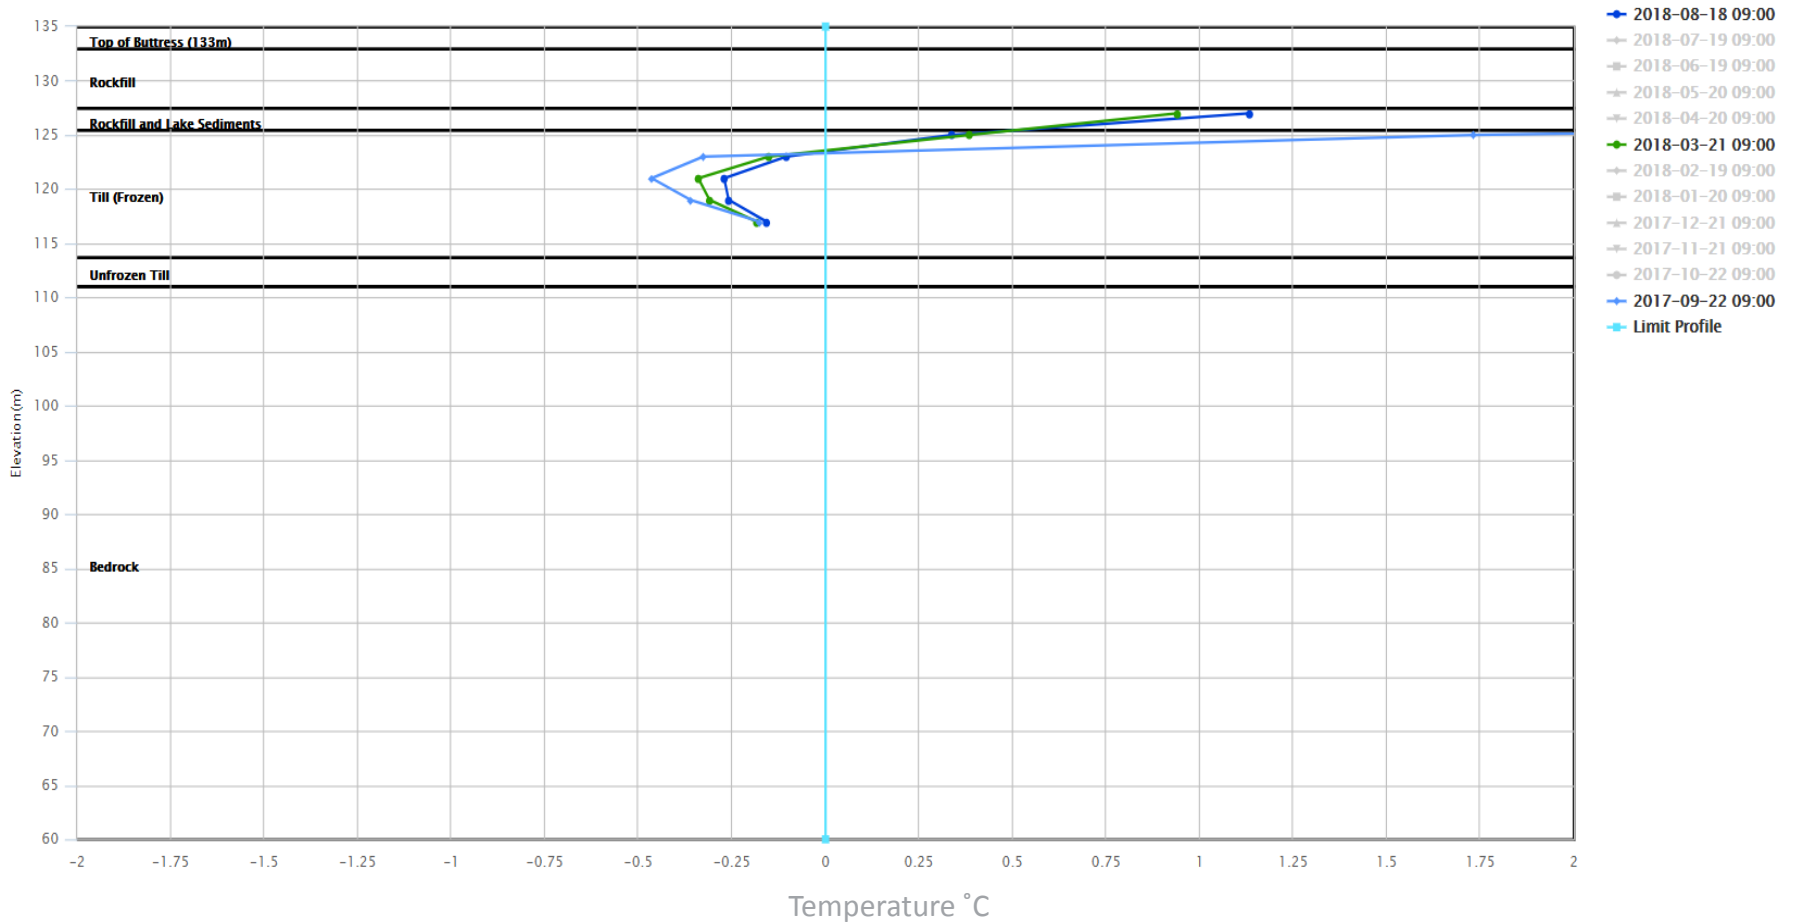
13 - SWD - 02

### SWD-02-16 Temperature Monitoring:

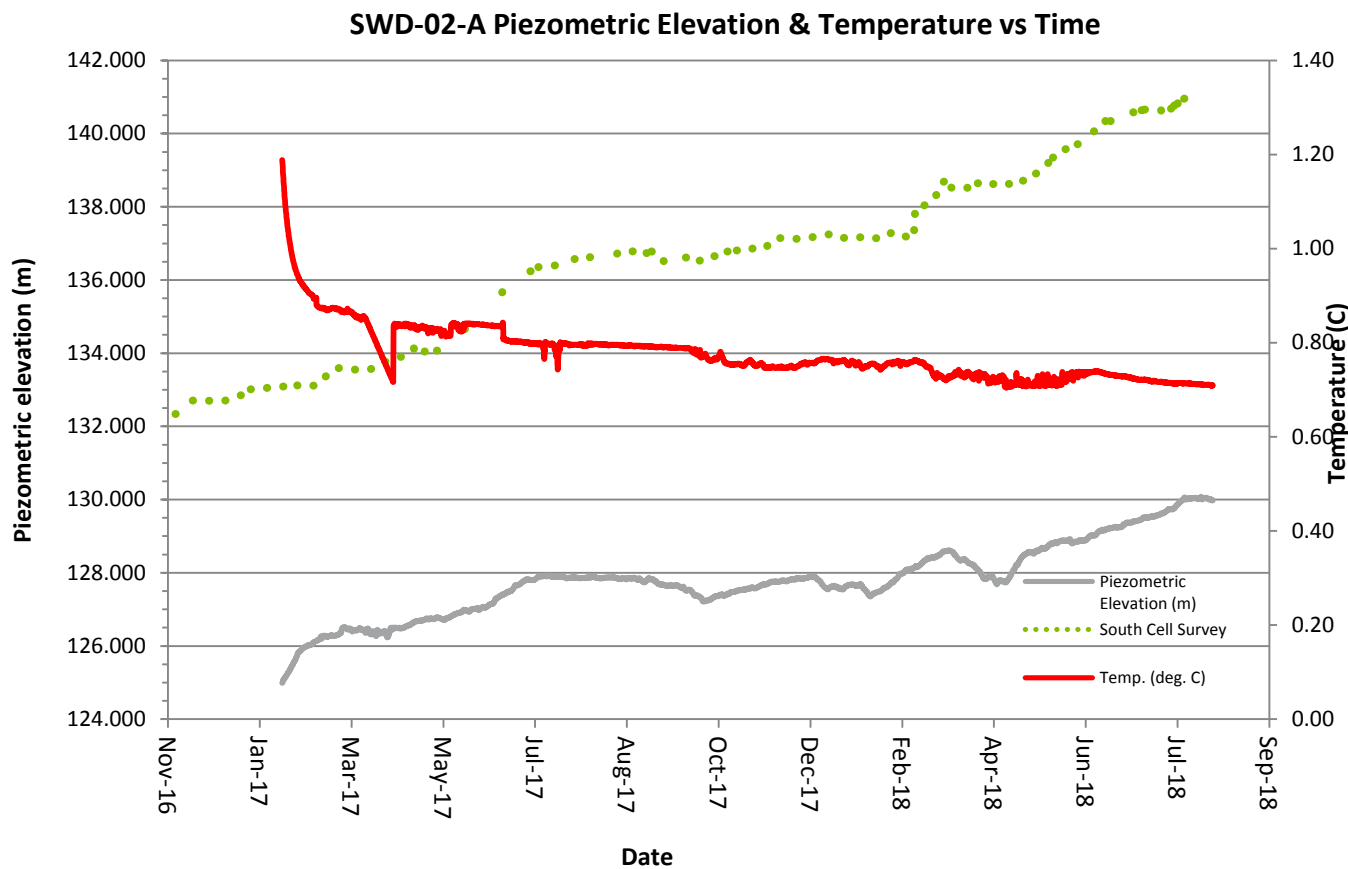
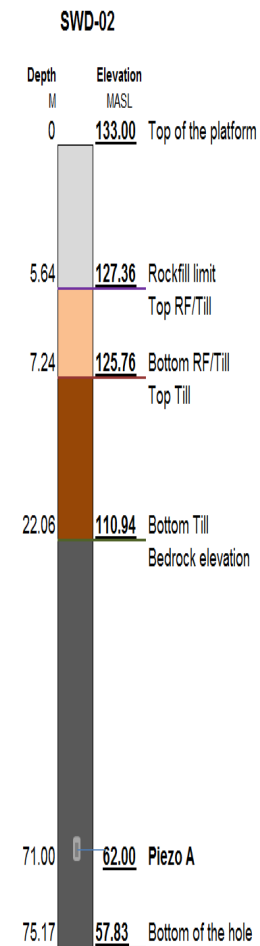
### SWD-02-16 PZ Head Monitoring:

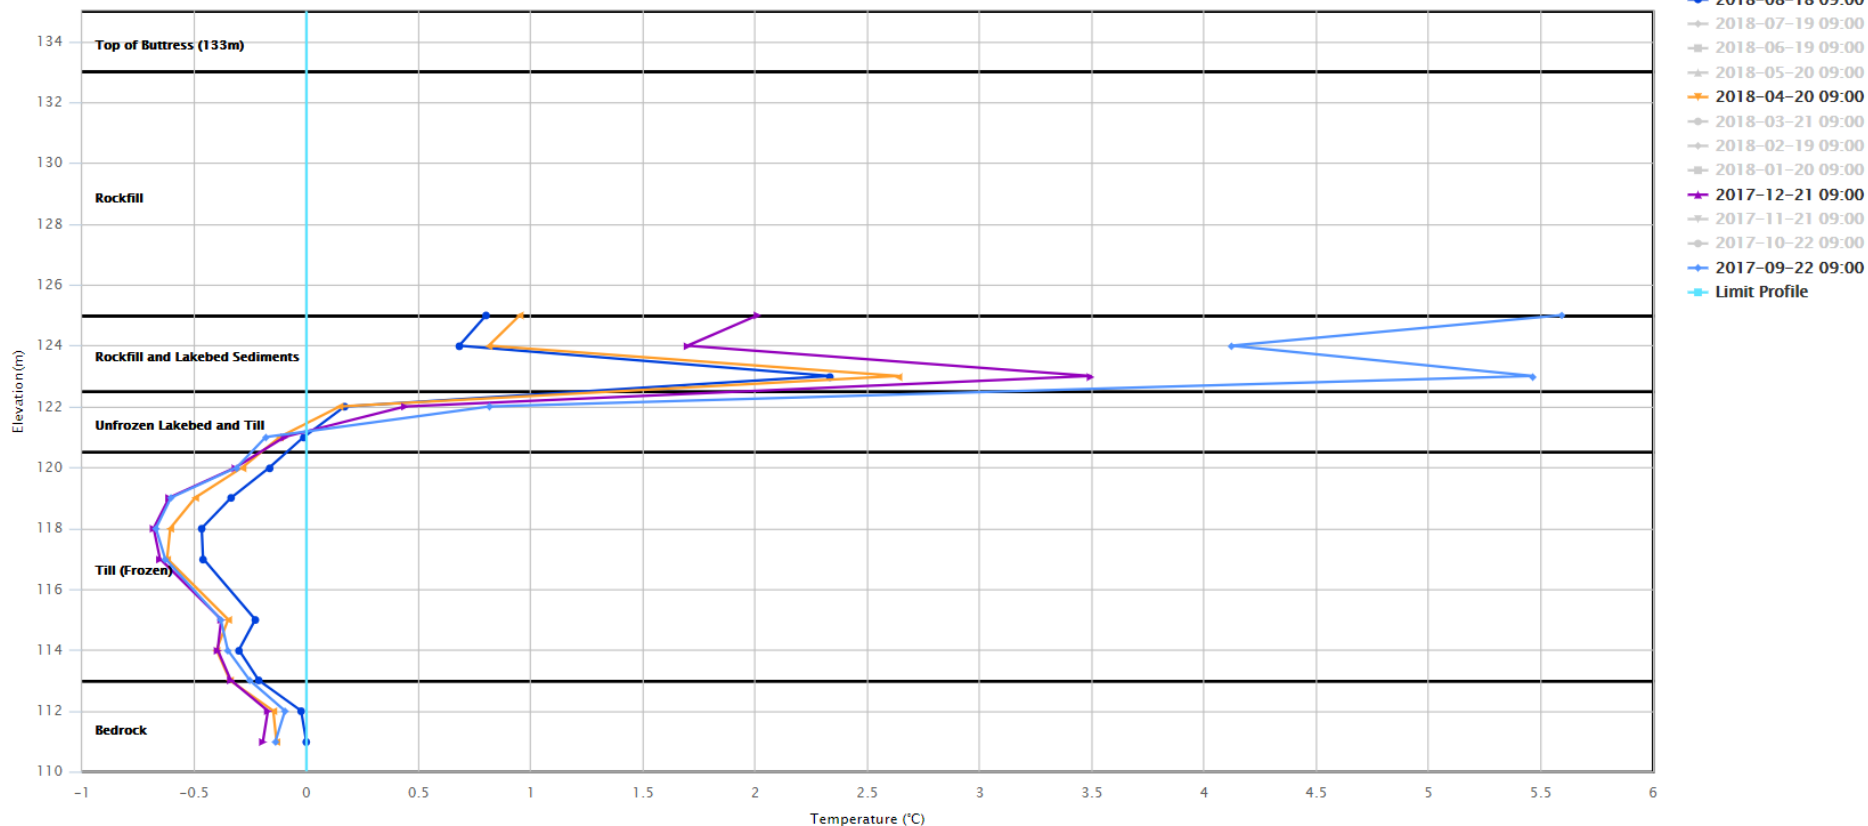
13 – SWD – 03

### SWD-03-16 Temperature Monitoring:

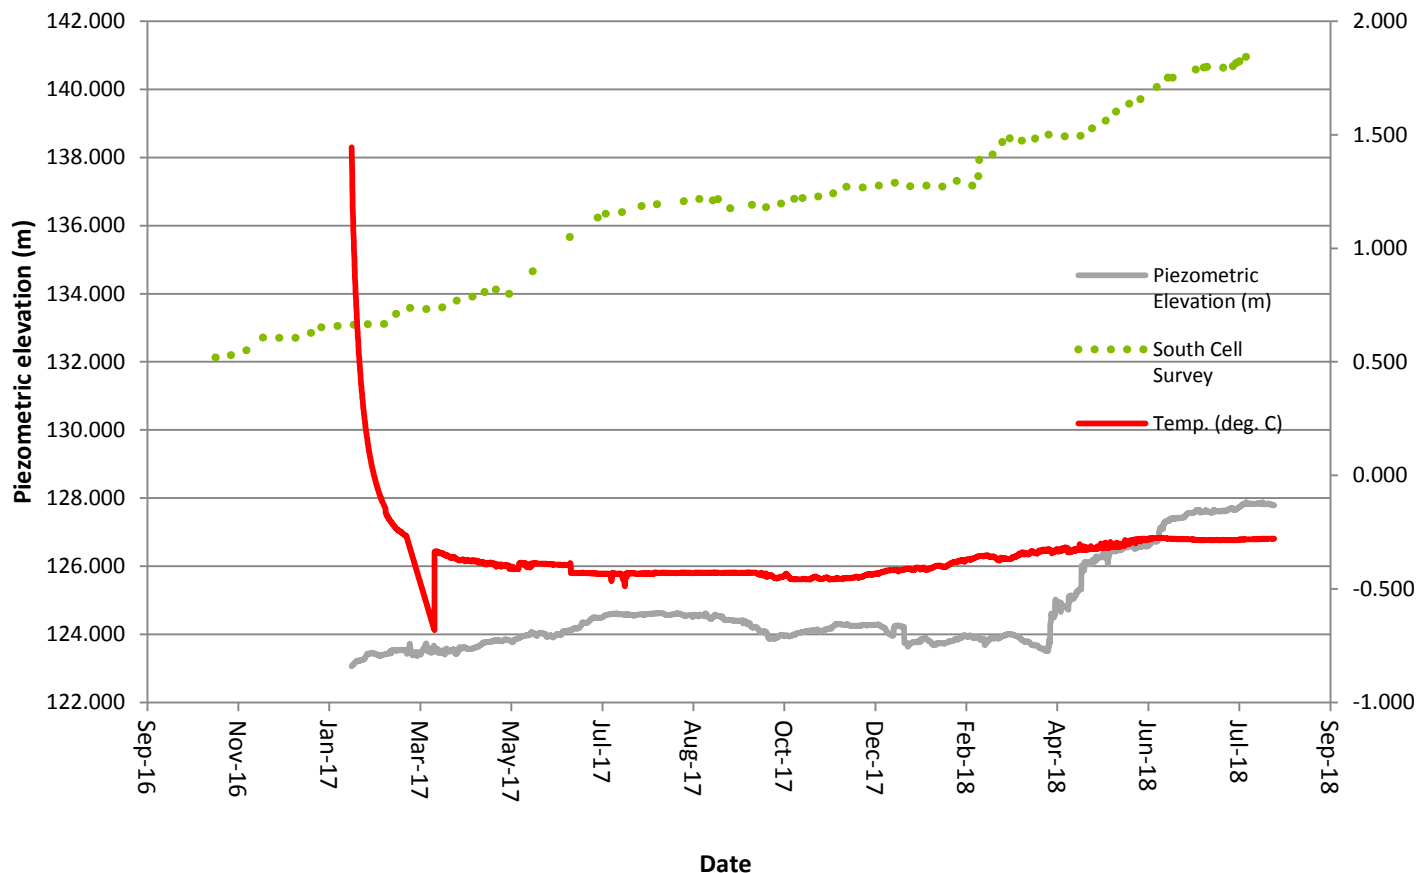
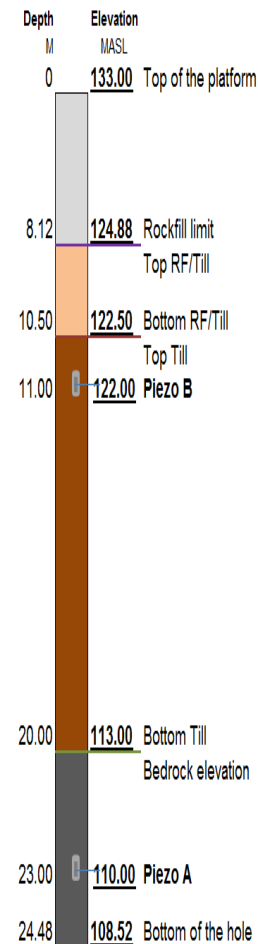
SWD-03

SWD-03-A Piezometric Elevation vs Temperature vs Time

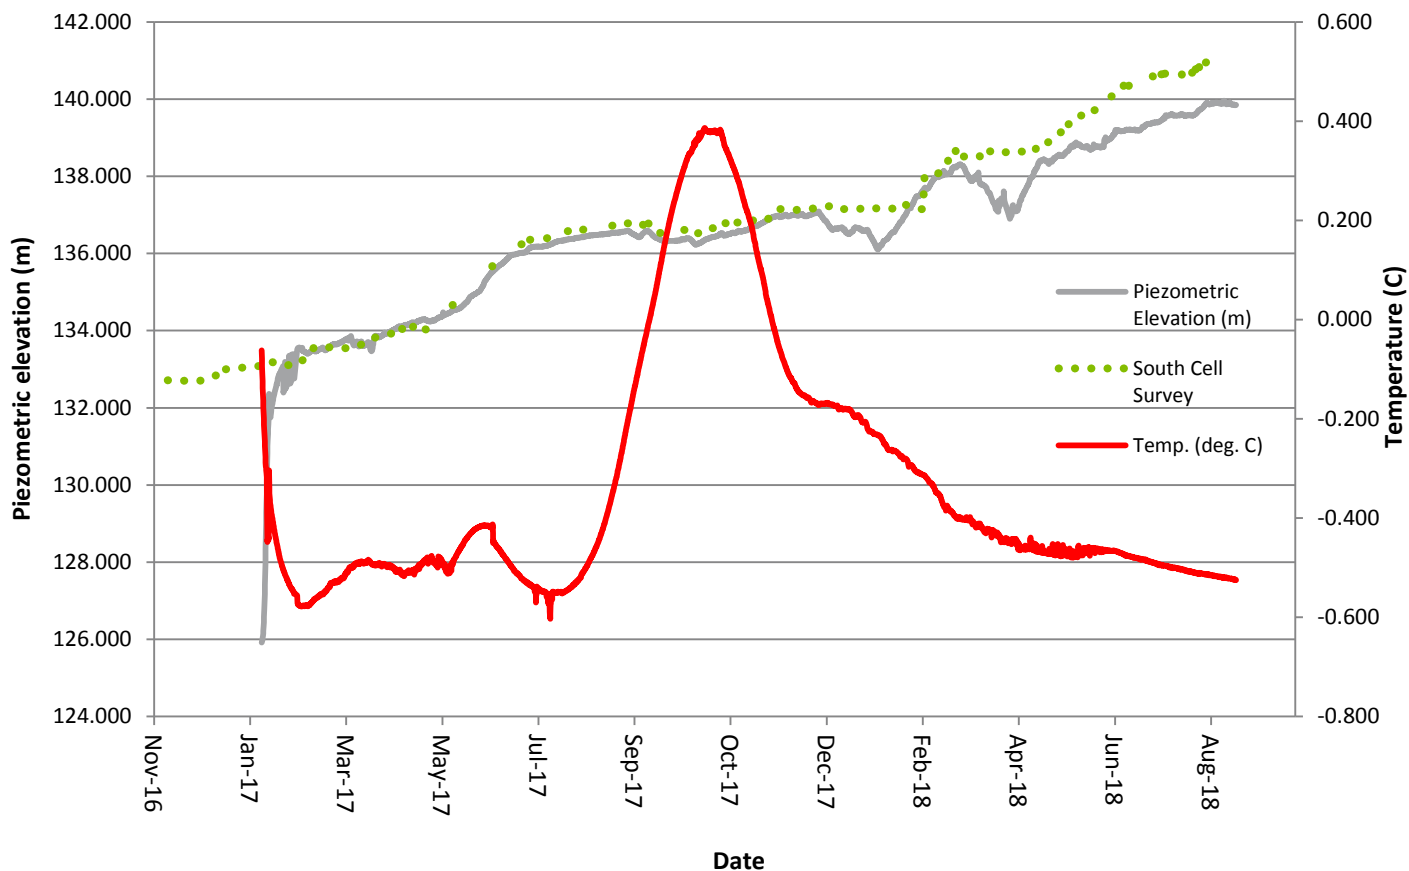
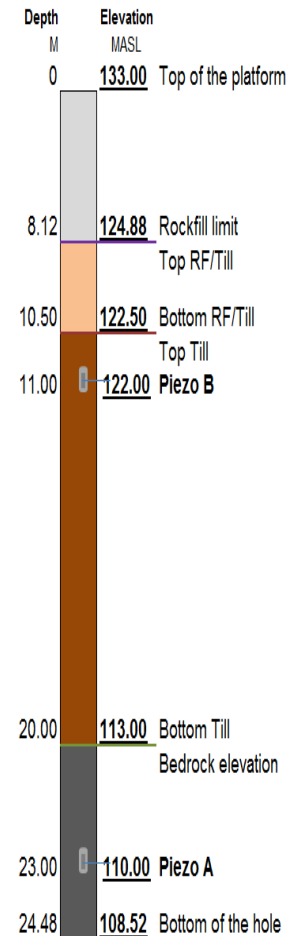
SWD-03

Piezometric Elevation vs Temperature vs Time  
**SWD-03-B Piezometric Elevation vs Temperature vs Time**

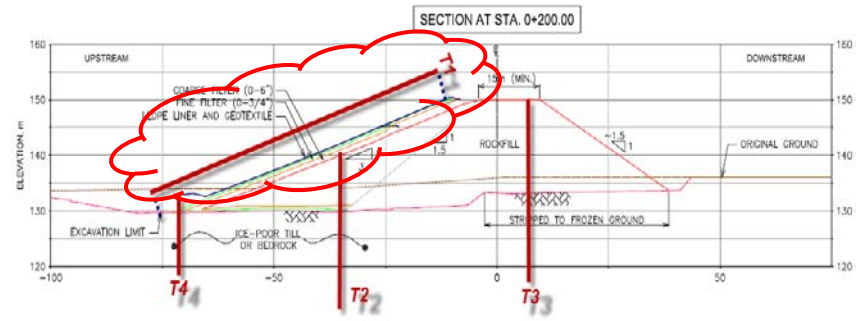
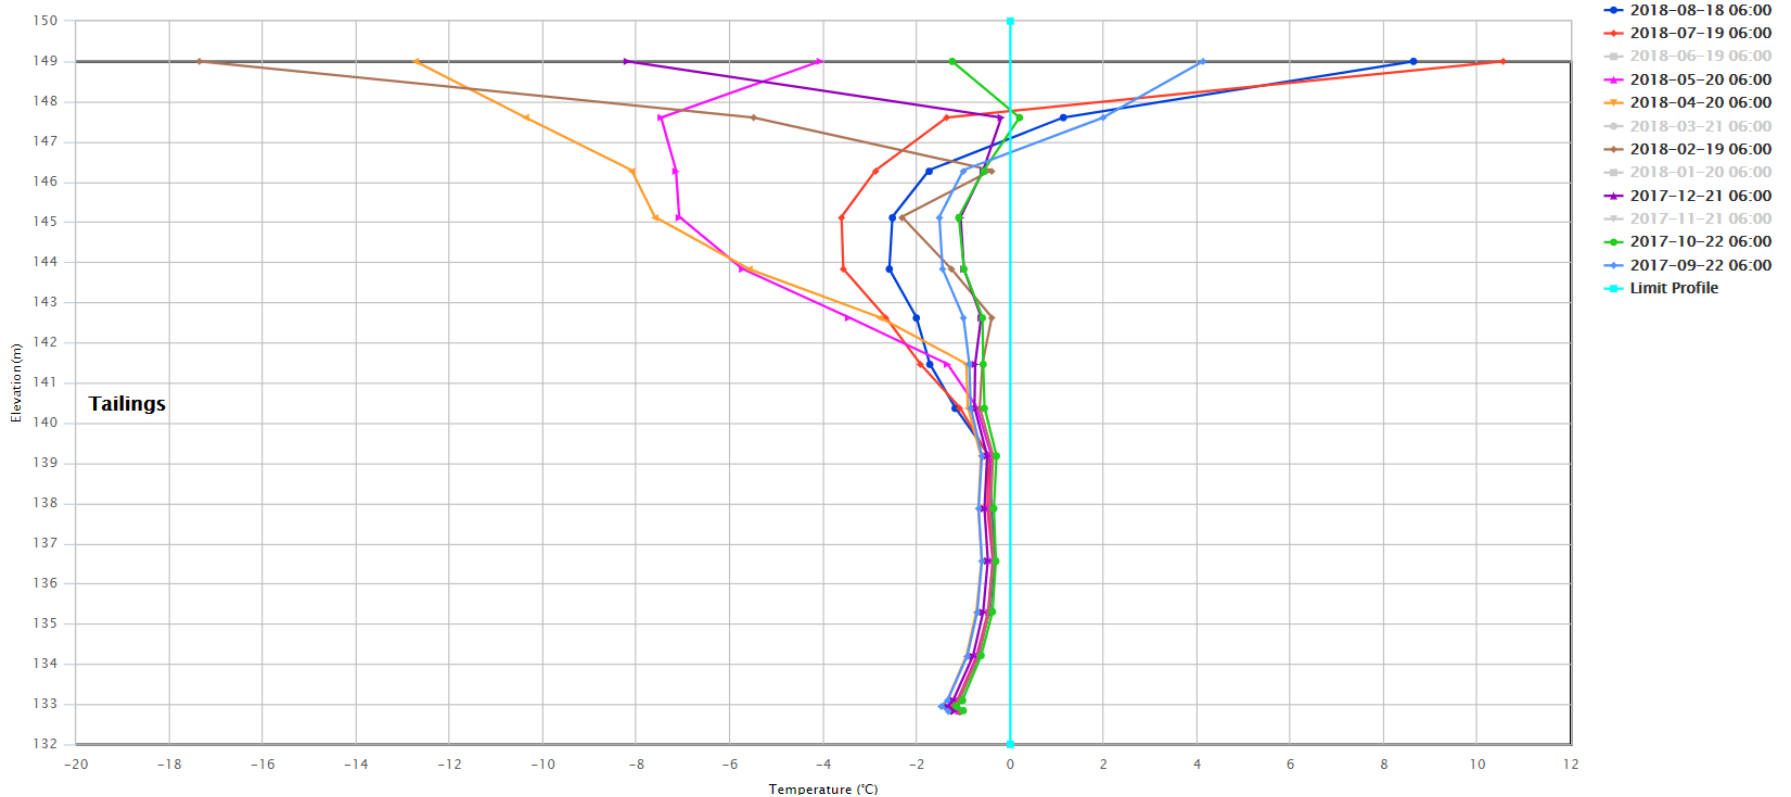
14 - SD1 - 01

- From Sept 22th, 2017 to Aug 18th, 2018
- Tailings frozen all year long below elevation 146.5 (masl)

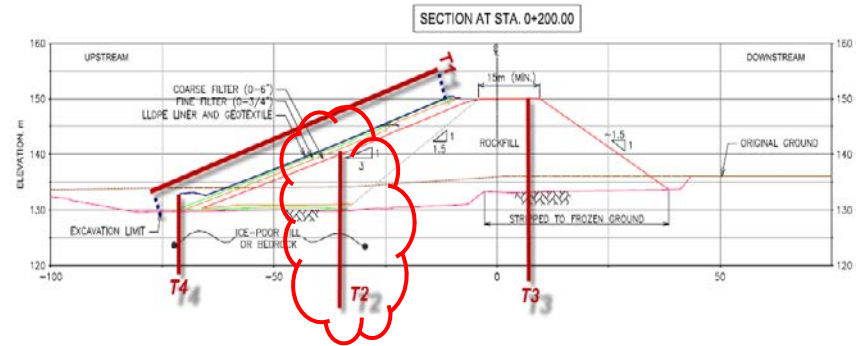
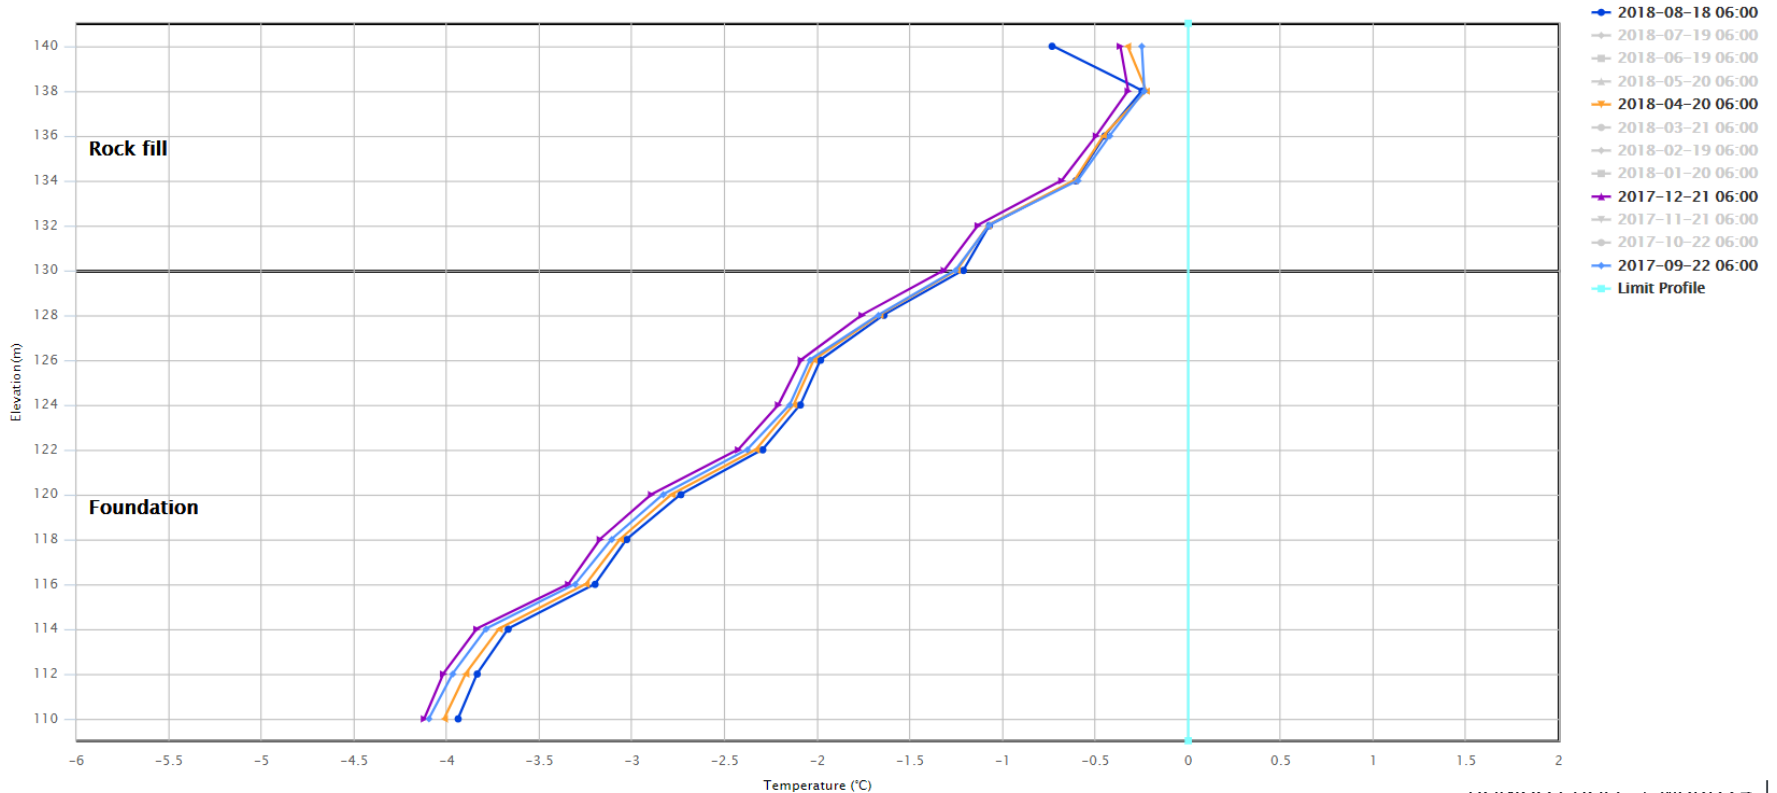
14 - SD1 - 02

- From Sept 22th, 2017 to Aug 18th, 2018
- Rock fill (slope) and foundation frozen all year long below elevation 140.0 (masl)

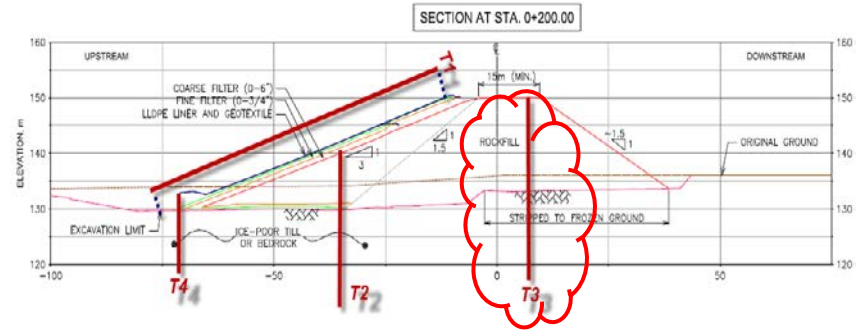
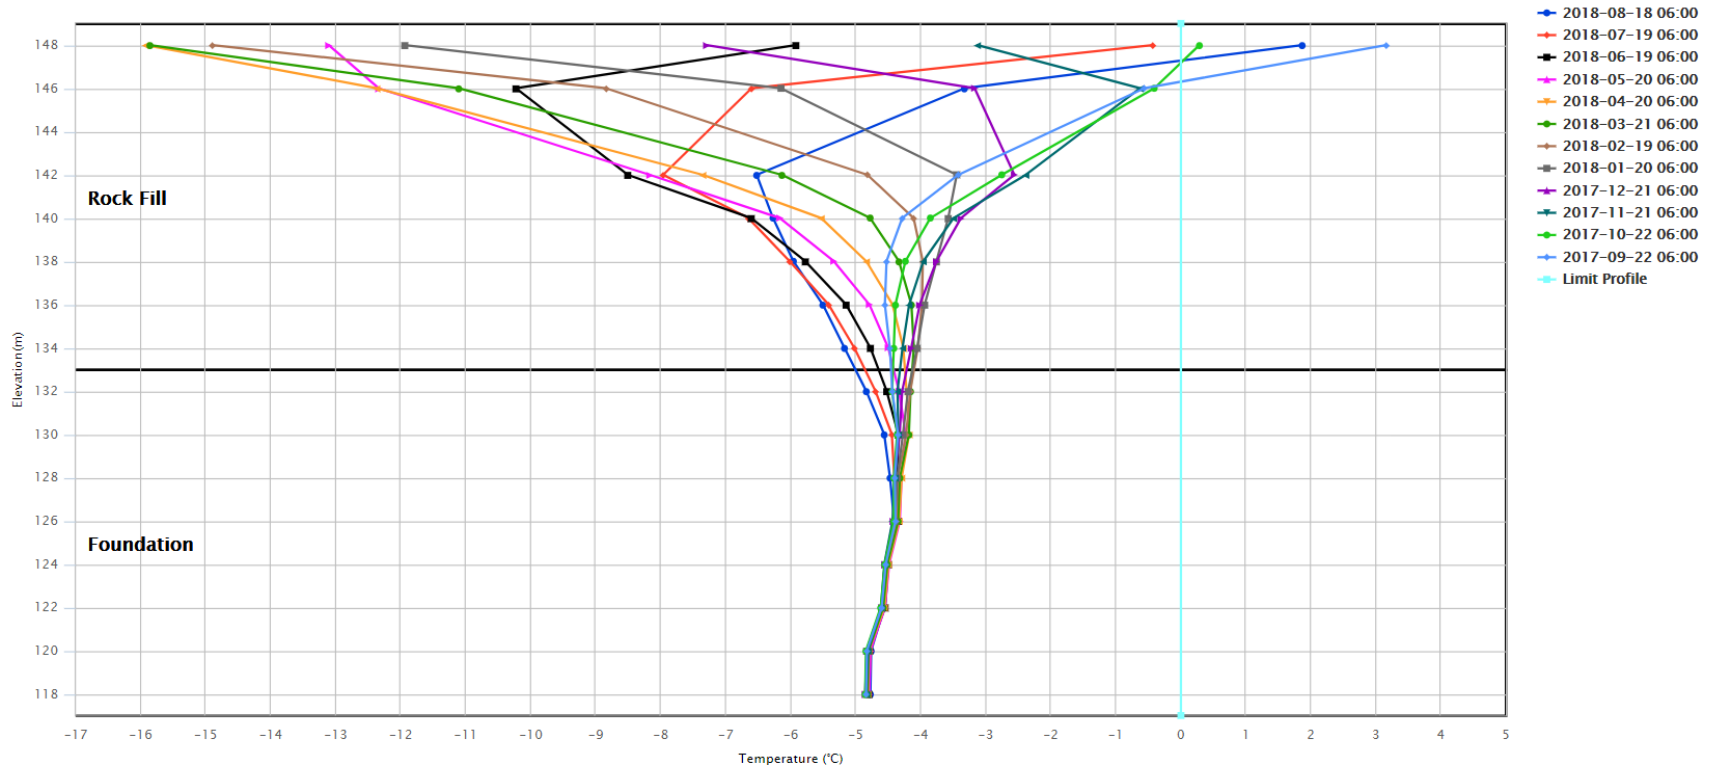
14 - SD1 - 03

- From Sept 22th, 2017 to Aug 18th, 2018
- Rock fill and foundation frozen all year long below elevation 146.0 (masl)

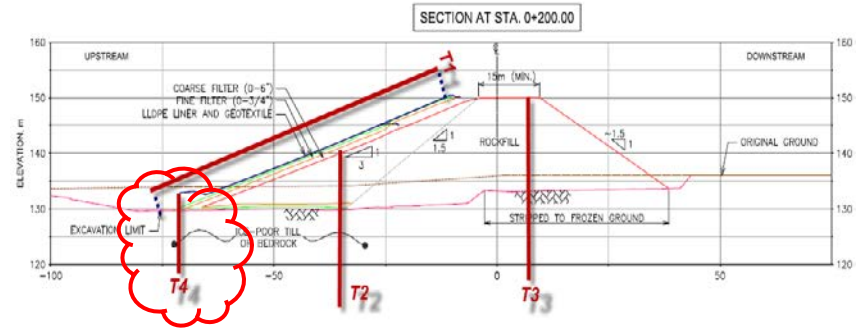
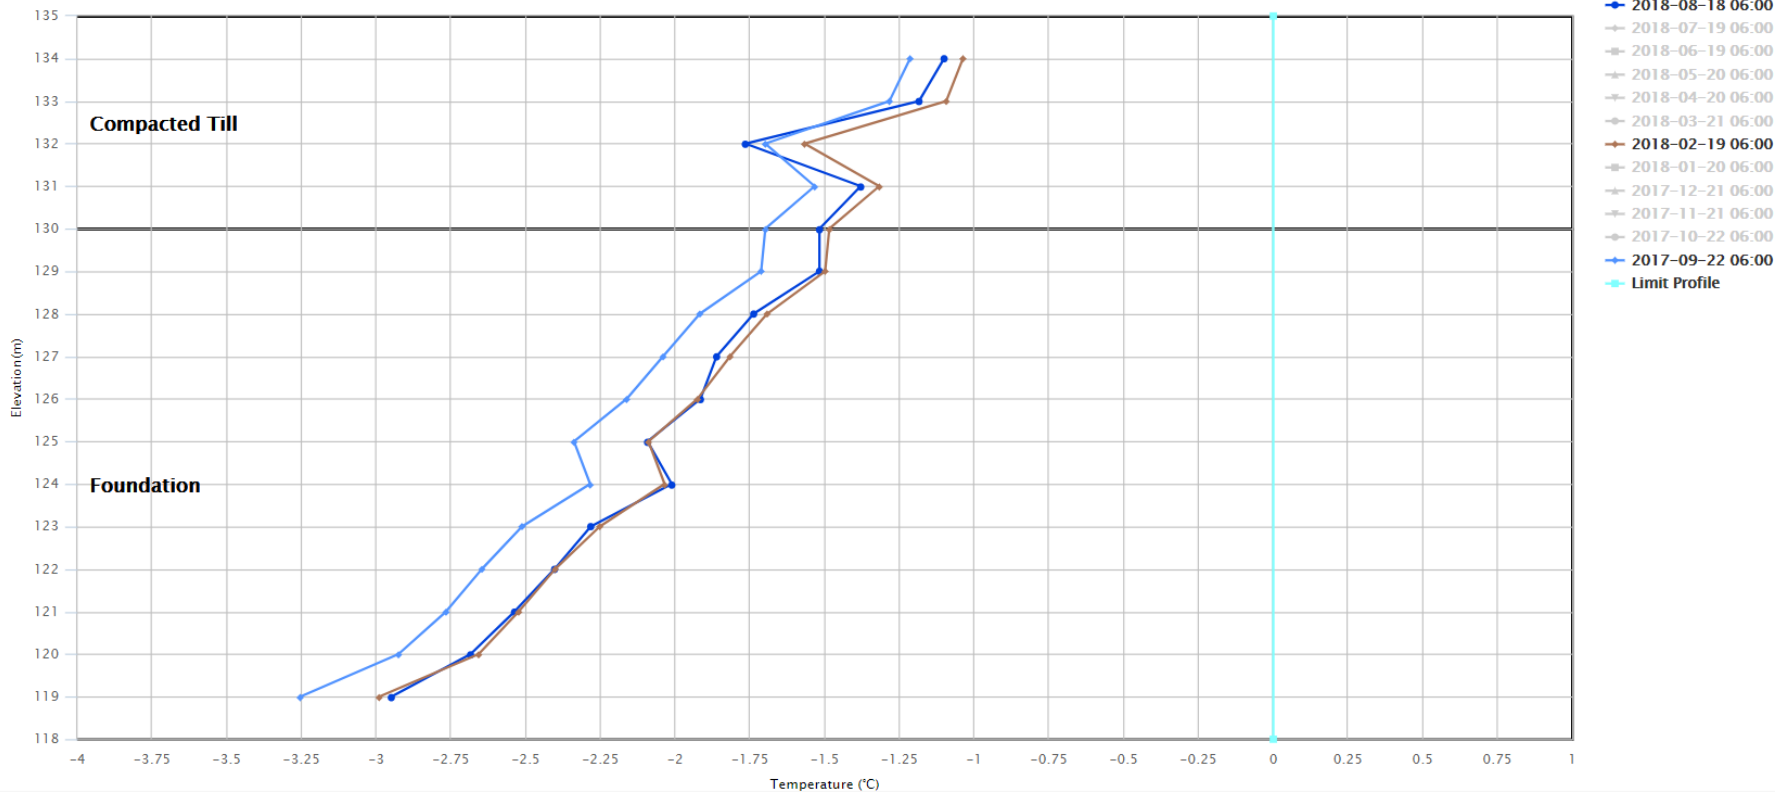
14 - SD1 - 04

- From Sept 22th, 2017 to Aug 18th, 2018
- Compacted till and foundation frozen all year long below elevation 134.0 (masl)

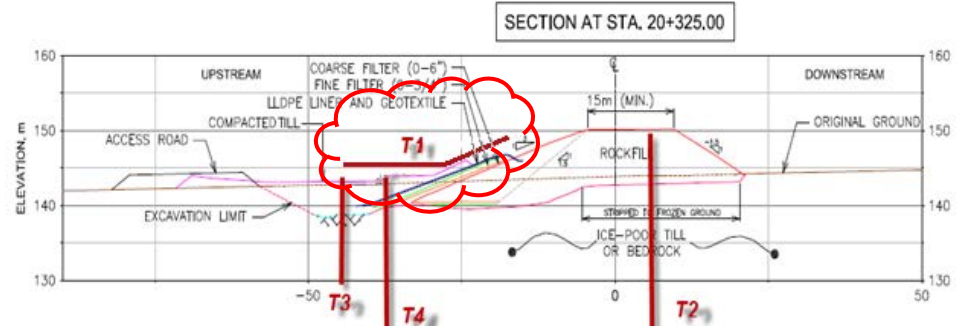
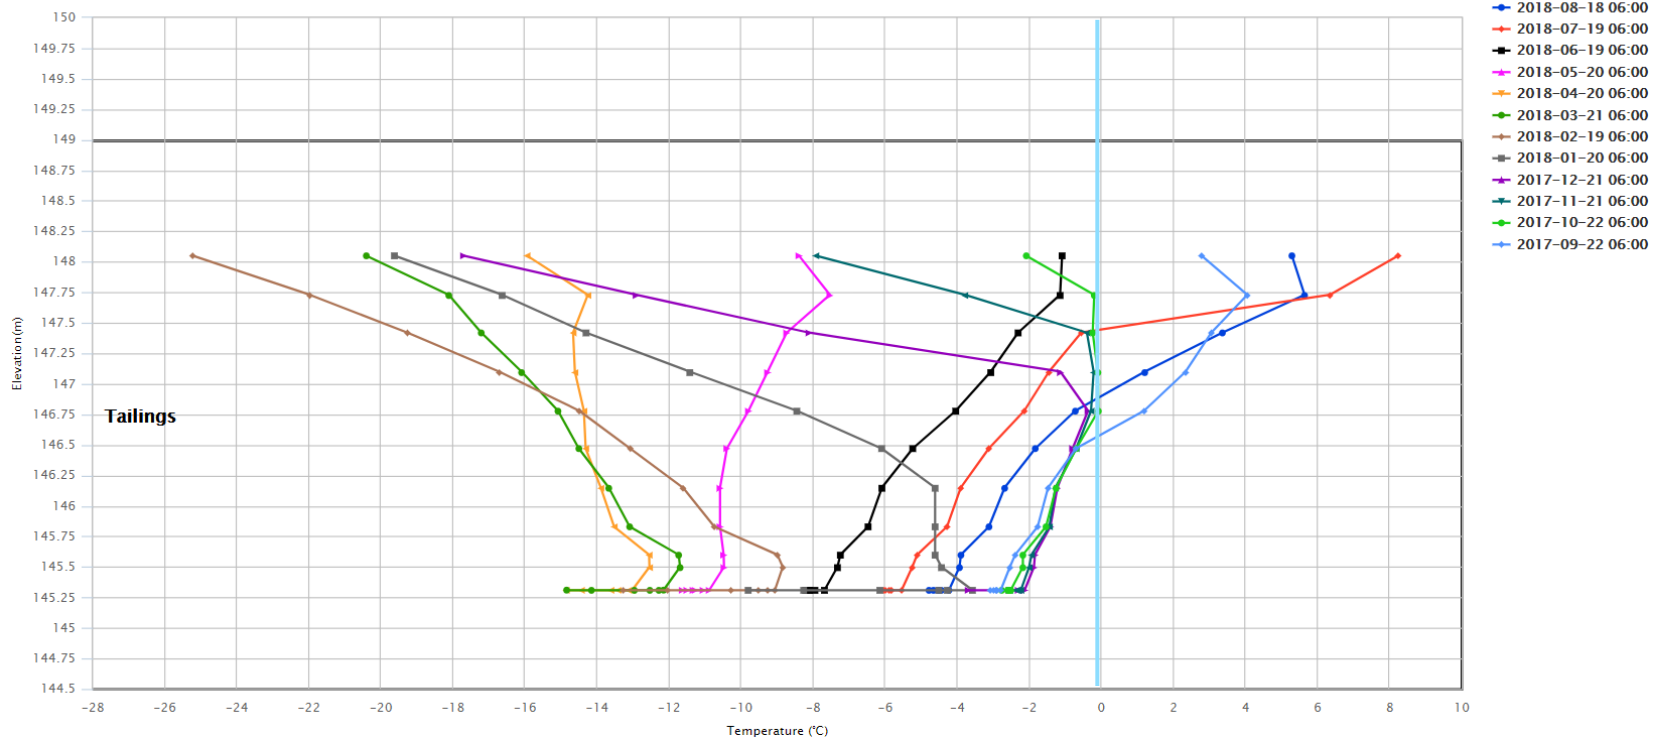
15 - SD2 - 01

- From Sept 22th, 2017 to Aug 18th, 2018
- Compacted till and foundation frozen all year long below elevation 146.5 (masl)

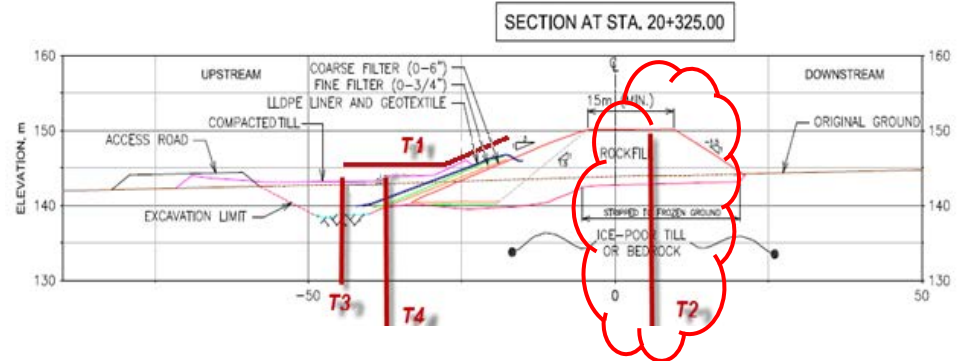
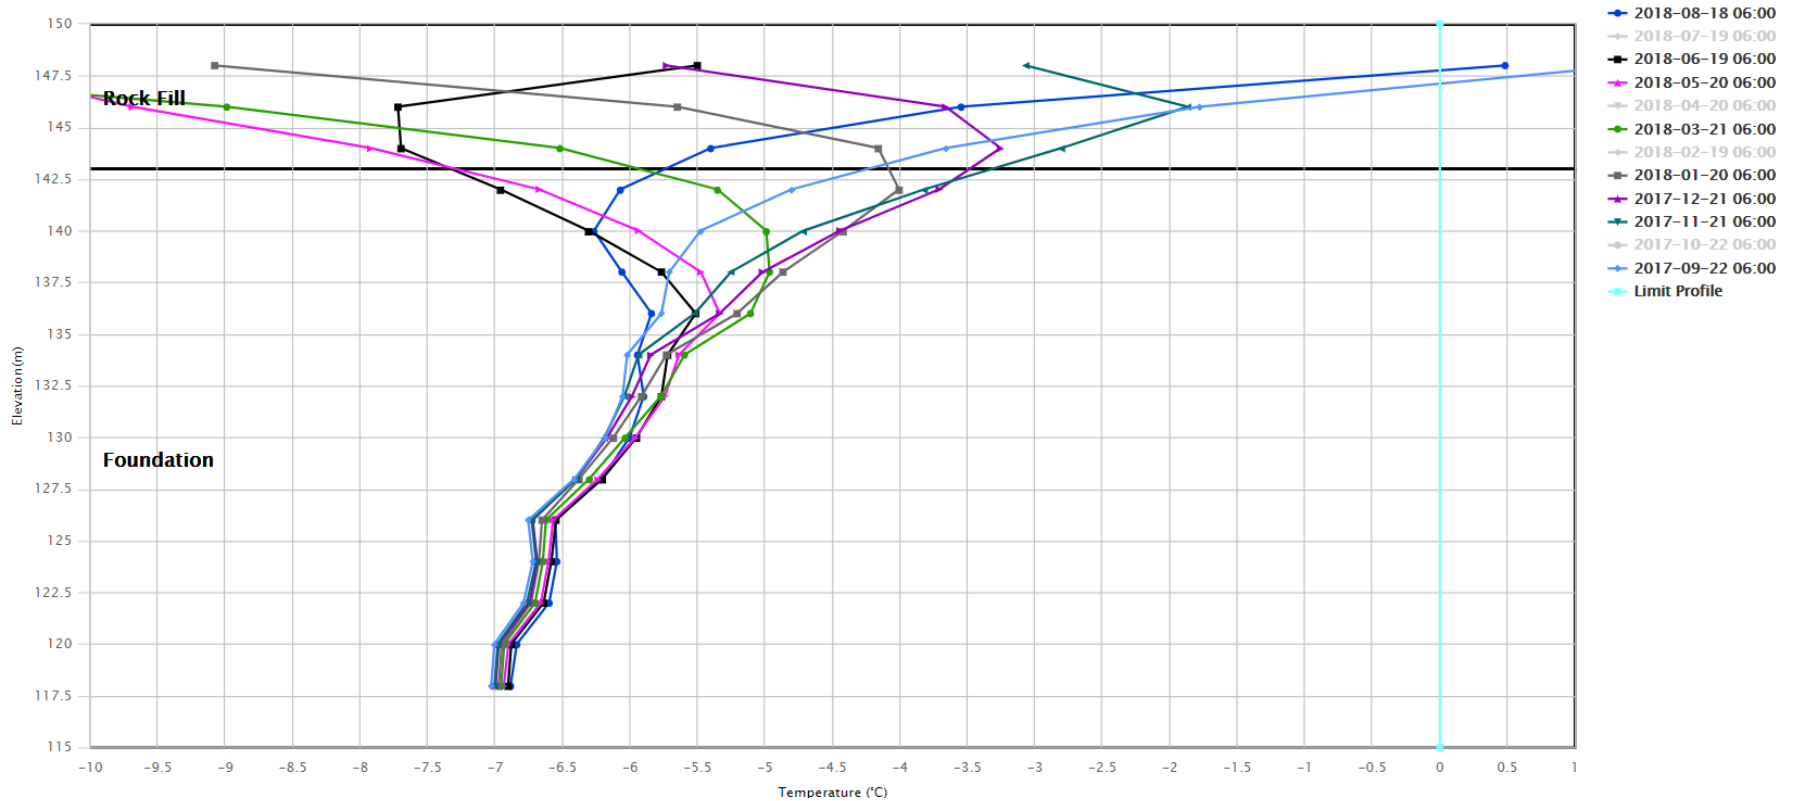
15 - SD2 - 02

- From Sept 22th, 2017 to Aug 18th, 2018
- Compacted till and foundation frozen all year long below elevation 146 (masl)

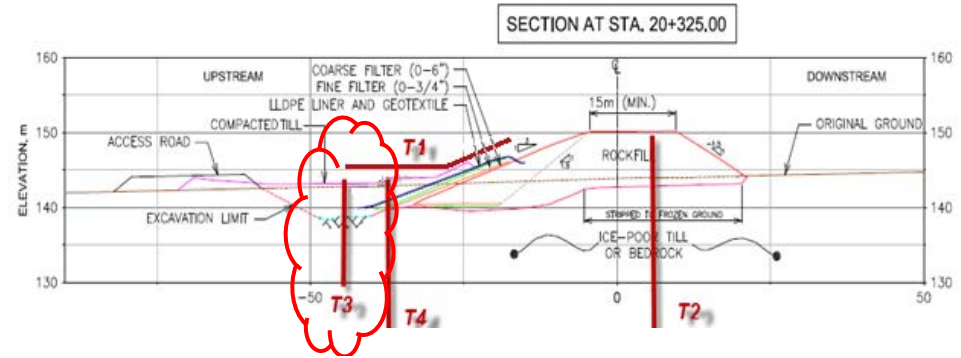
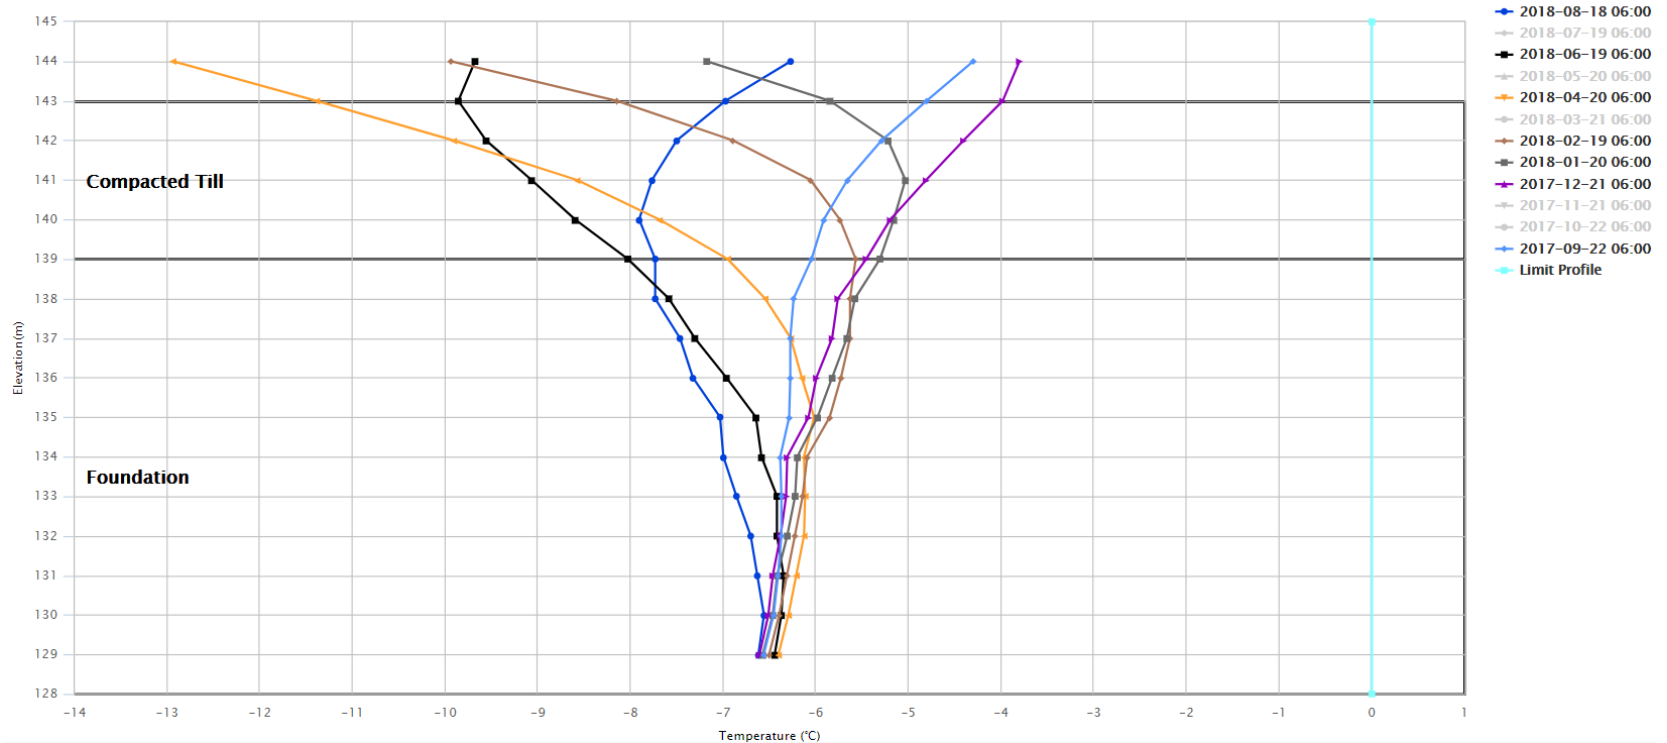
15 - SD2 - 03

- From Sept 22th, 2017 to Aug 18th, 2018
- Compacted till and foundation frozen all year long below elevation 144 (masl)

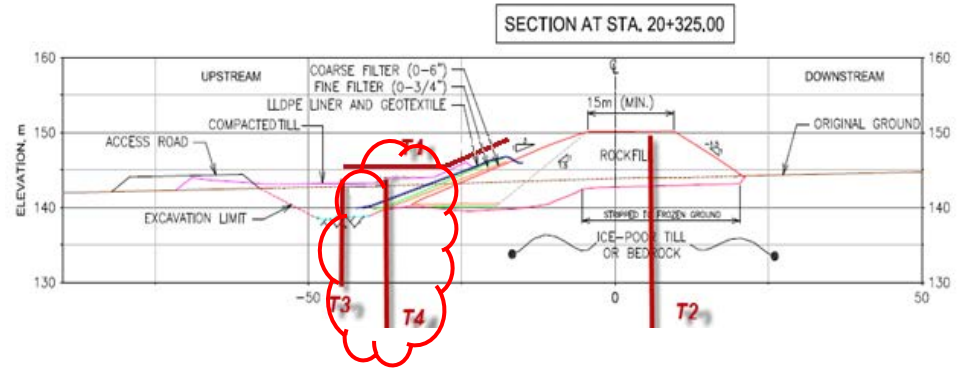
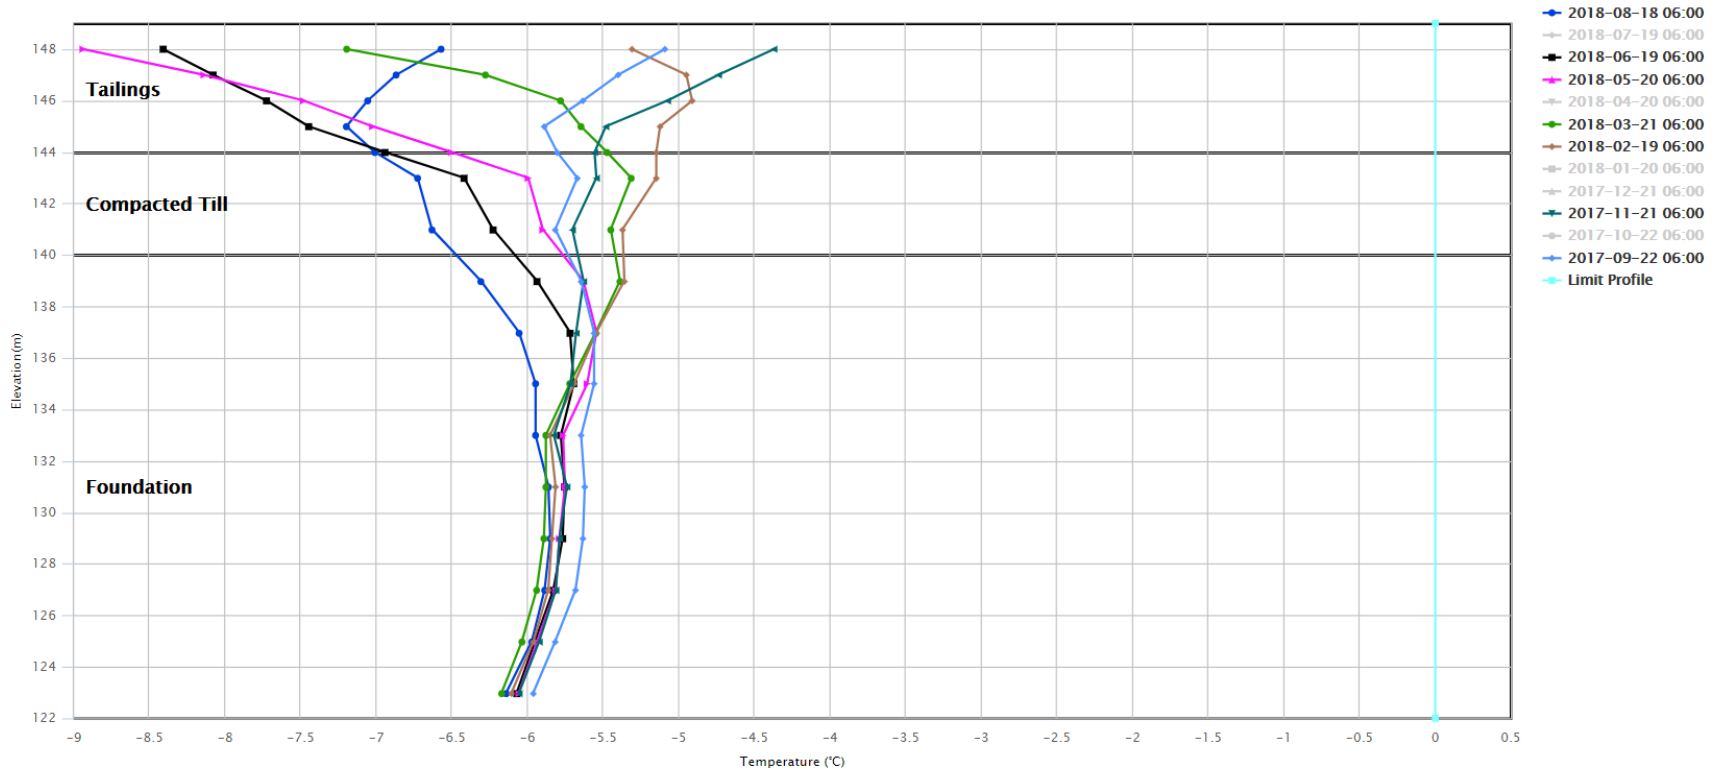
15 - SD2 - 04

- From Sept 22th, 2017 to Aug 18th, 2018
- Compacted till and foundation frozen all year long below elevation 148 (masl)
