# **Meadowbank and Whale Tail 2018 Annual Geotechnical Inspection**

# 2018 Annual Geotechnical Inspection

*Meadowbank Gold Mine, Nunavut*

18101627-1583-R-Rev0

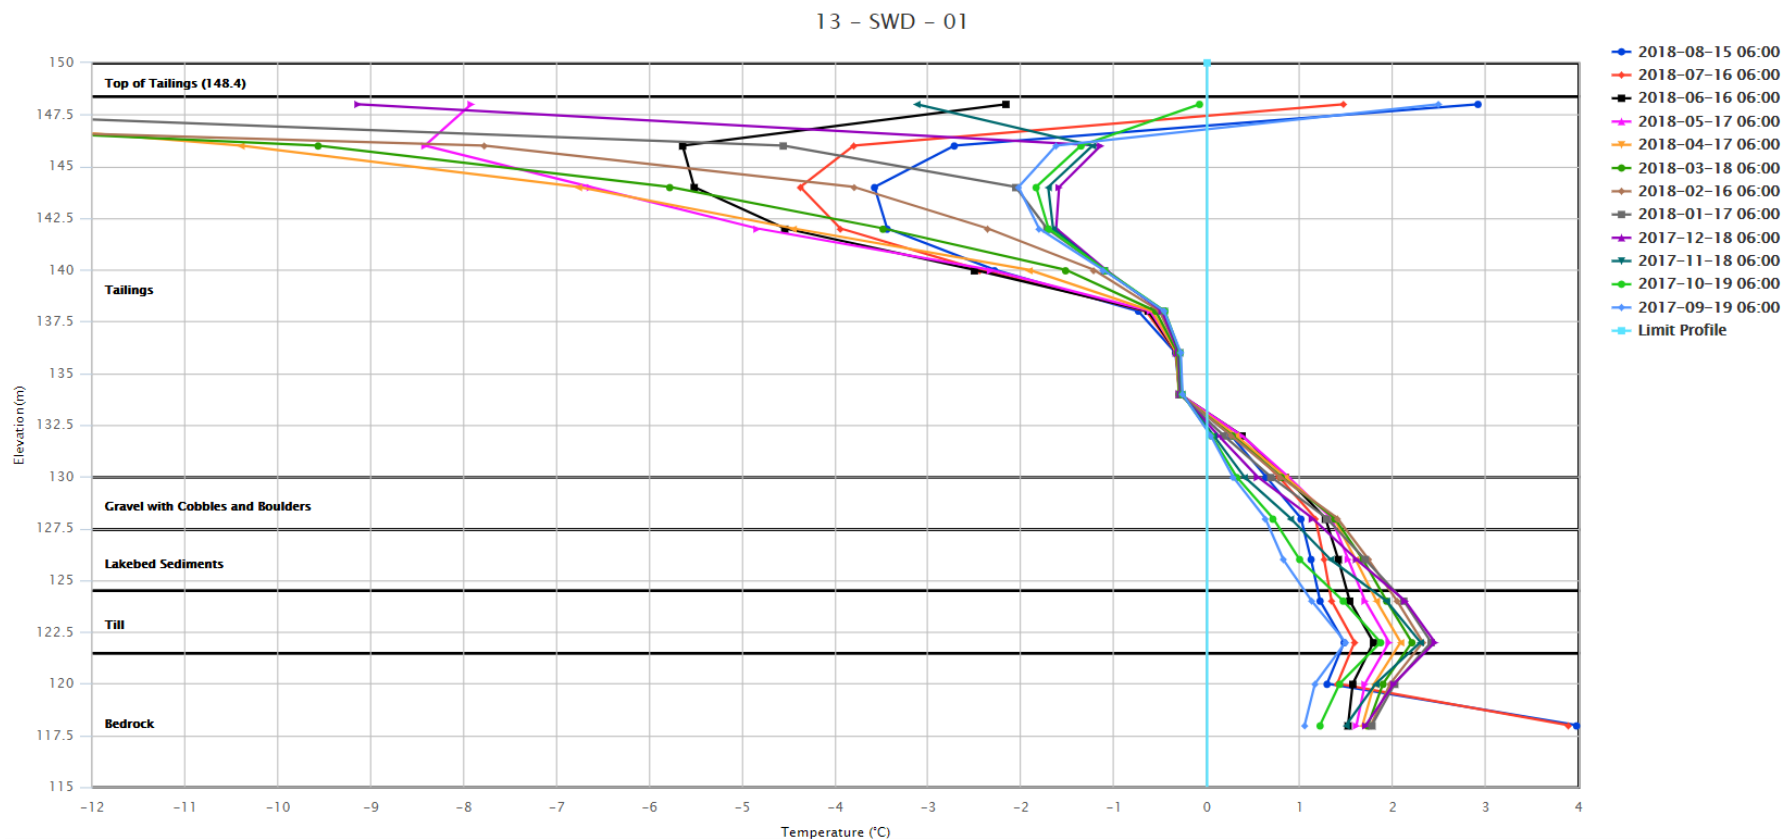
### Thermistor SWD 01

- From Sept 19th, 2017 to Aug 18th, 2018
- Unfrozen below 132.5 m (Due to South Cell pond water)

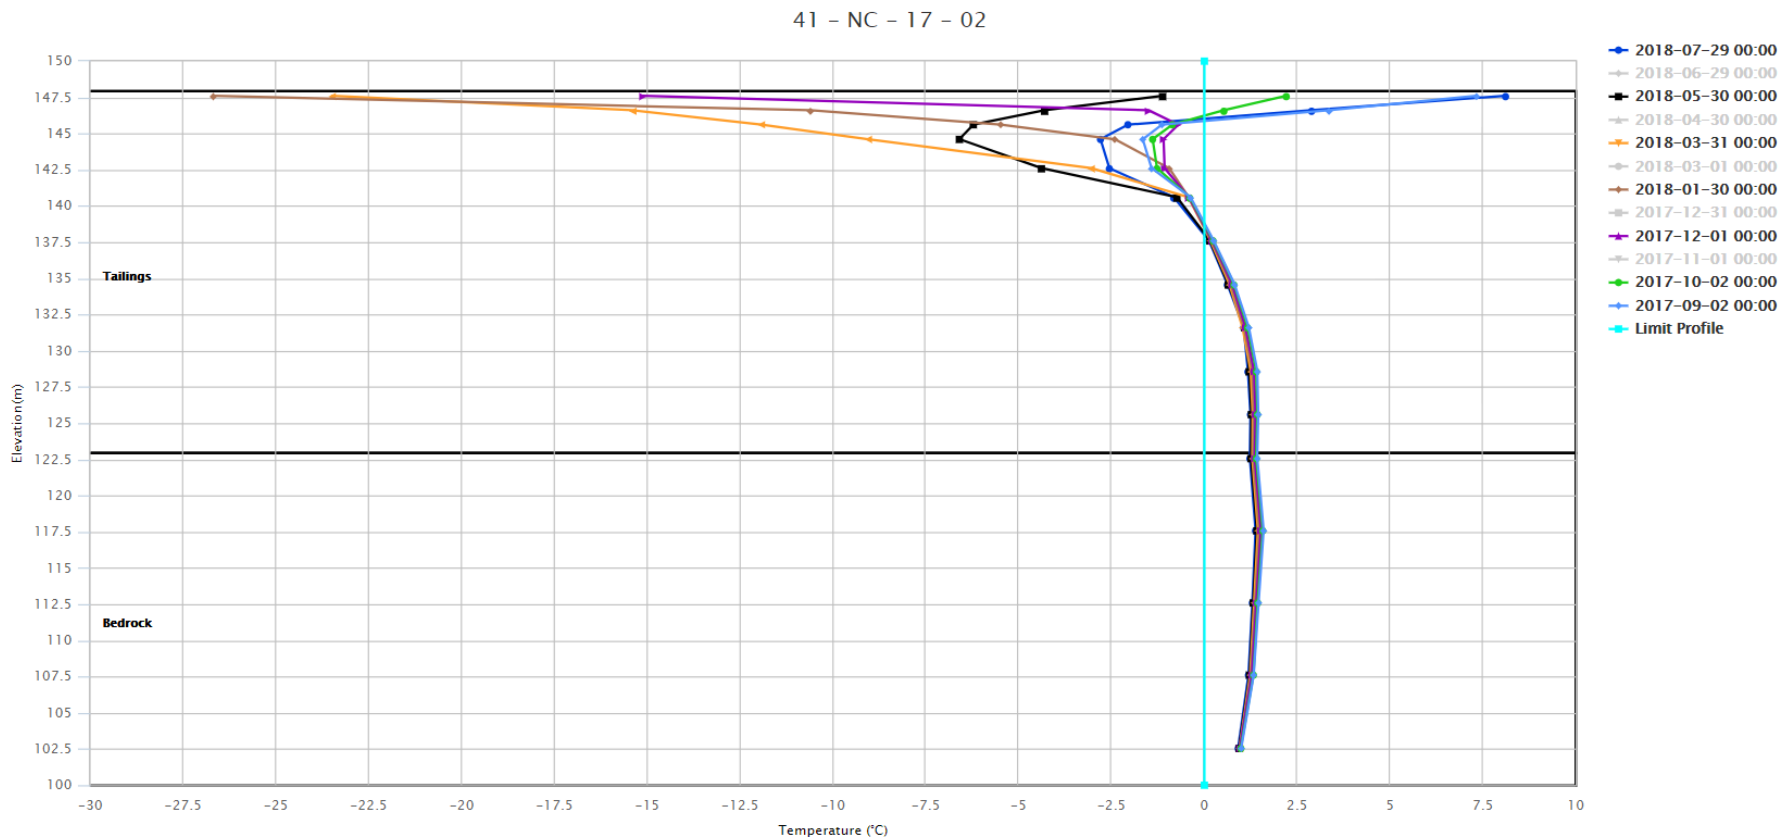
### Thermistor NC-17-02

- From Sept 2nd, 2017 to July 29th, 2018
- Unfrozen below 137.5 m (Due to North Cell pond water)

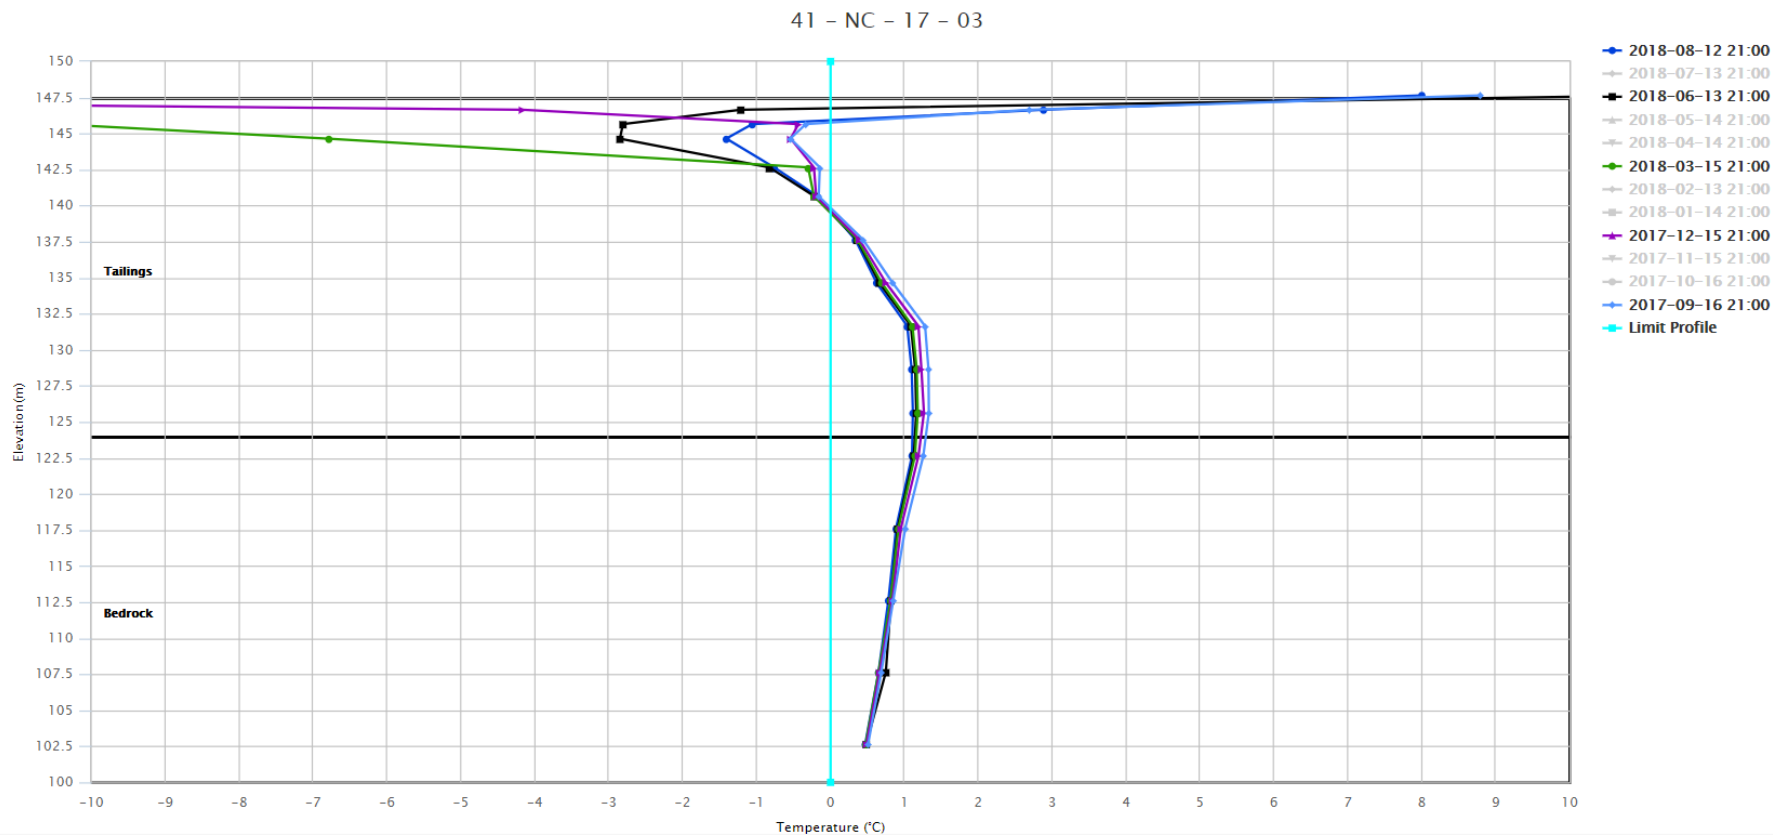
### Thermistor NC-17-03

- From Sept 16th, 2017 to Aug 12th, 2018
- Unfrozen below 140 m (Due to North Cell pond water)

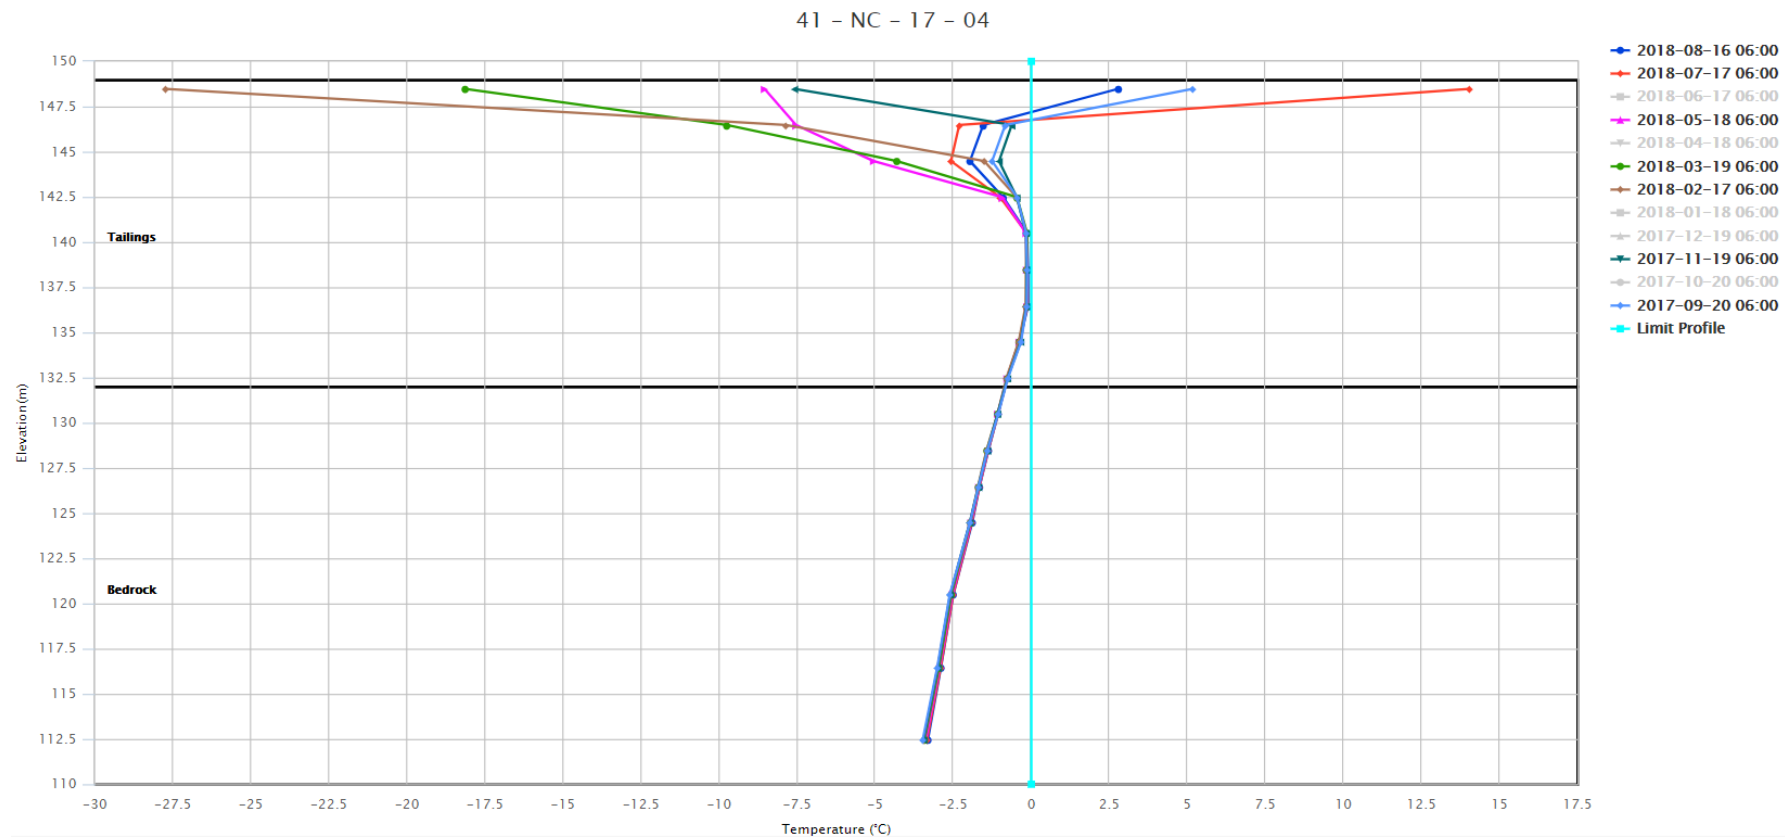
### Thermistor NC-17-04

- From Sept 20th, 2017 to Aug 16th, 2018
- Frozen below 147 m

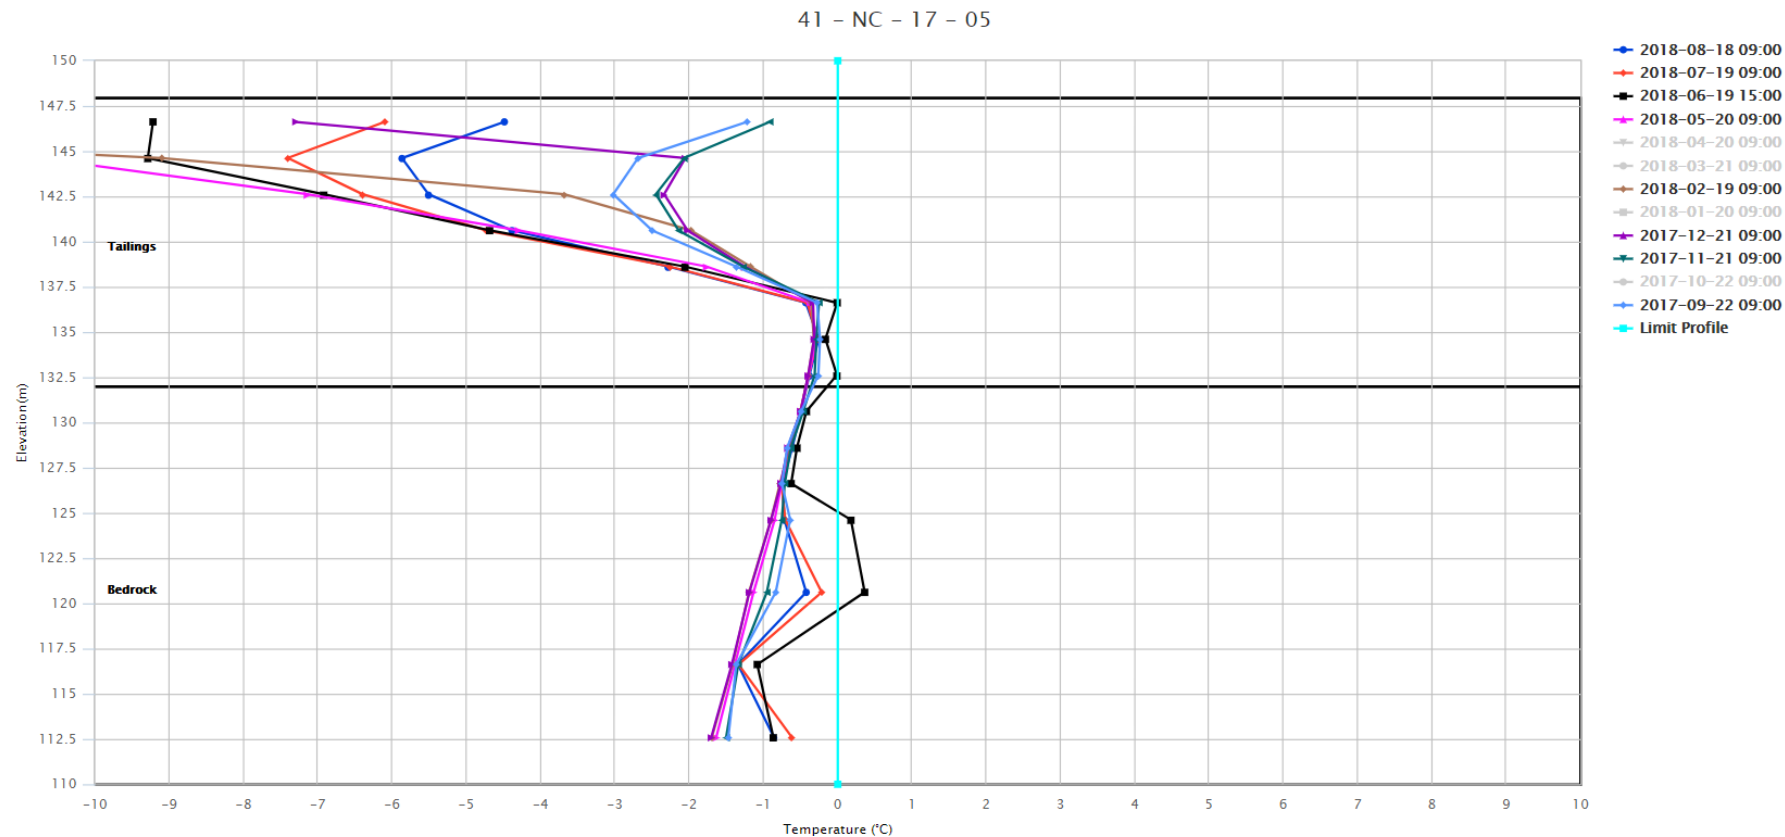
### Thermistor NC-17-05

- From Sept 22nd, 2017 to Aug 18th, 2018
- Frozen below 147 m

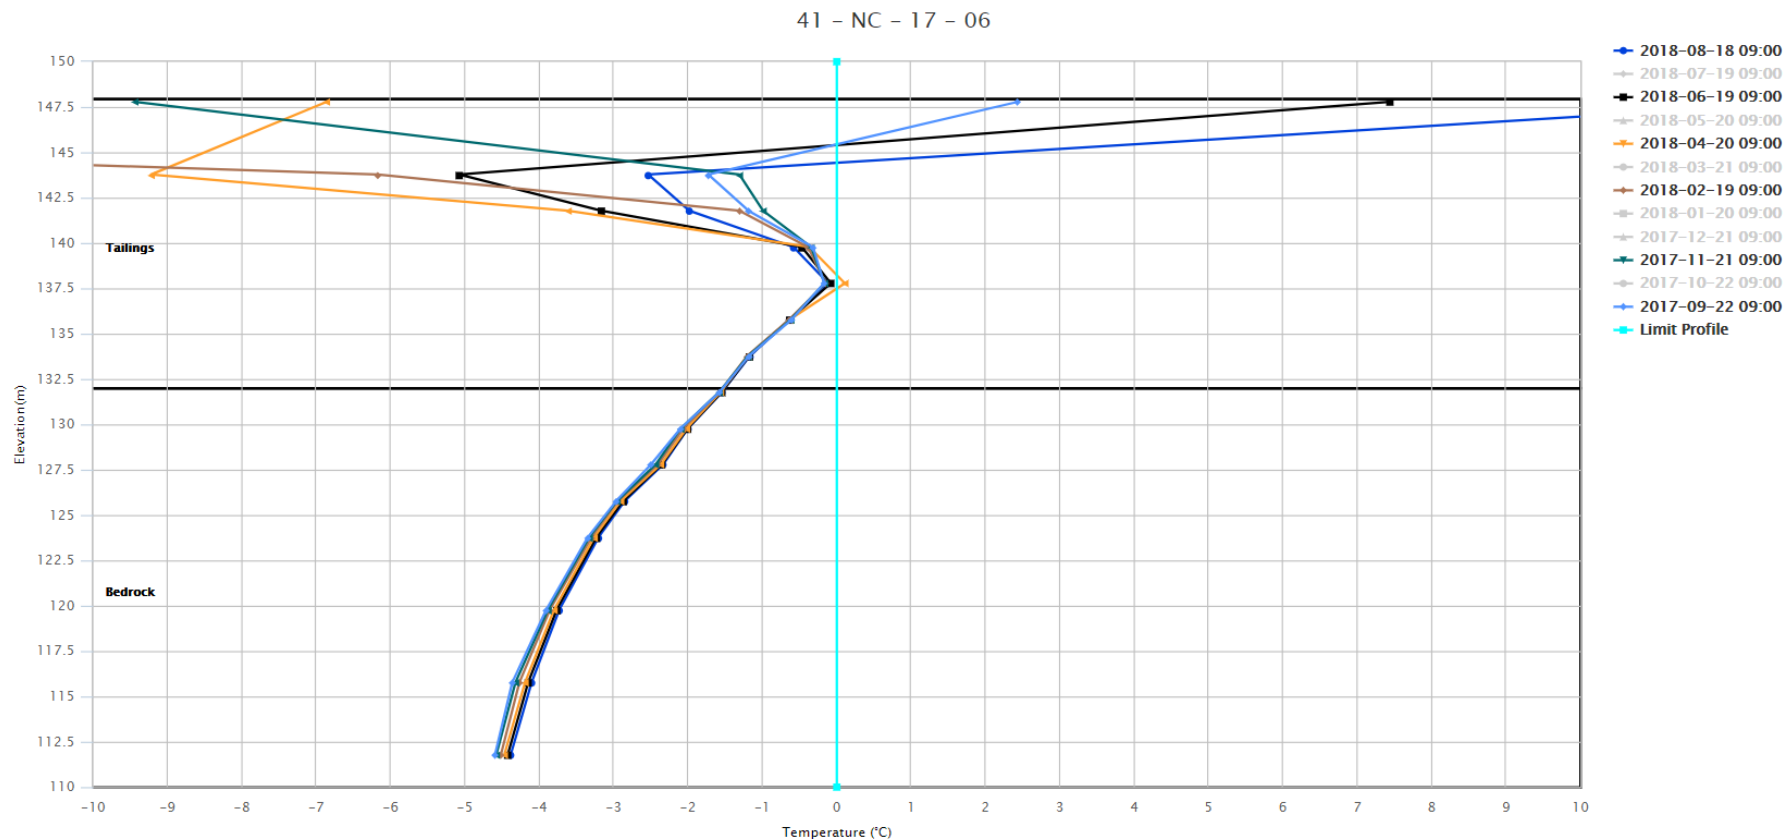
### Thermistor NC-17-06

- From Sept 22nd, 2017 to Aug 18th, 2018
- Frozen below 144 m

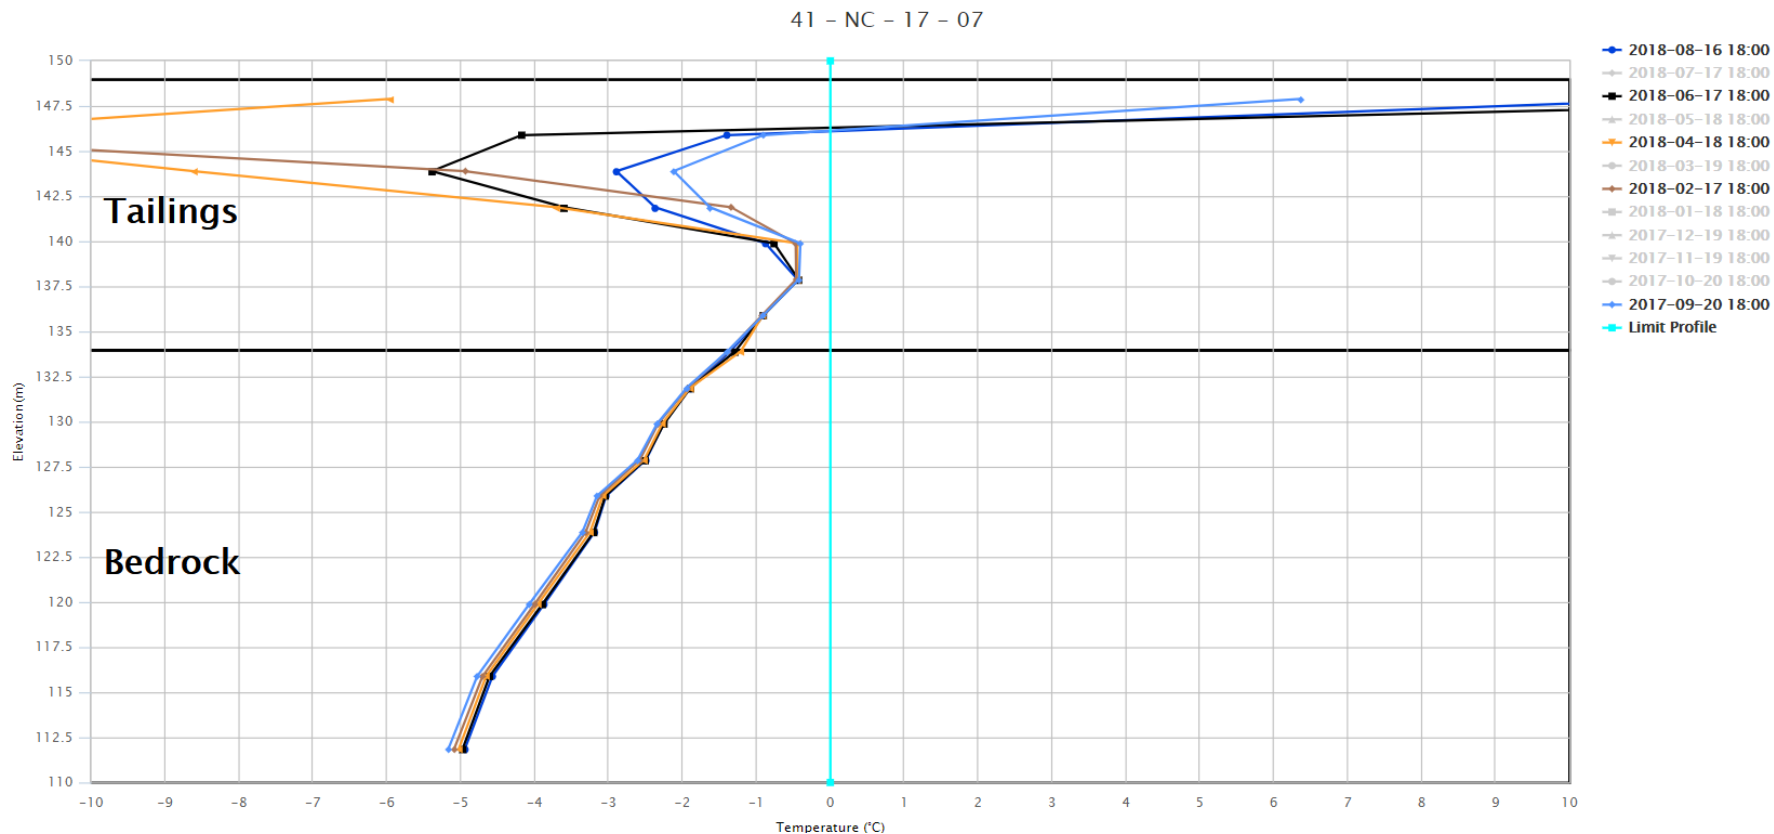
### Thermistor NC-17-07

- From Sept 20th, 2017 to Aug 16th, 2018
- Frozen below 146 m

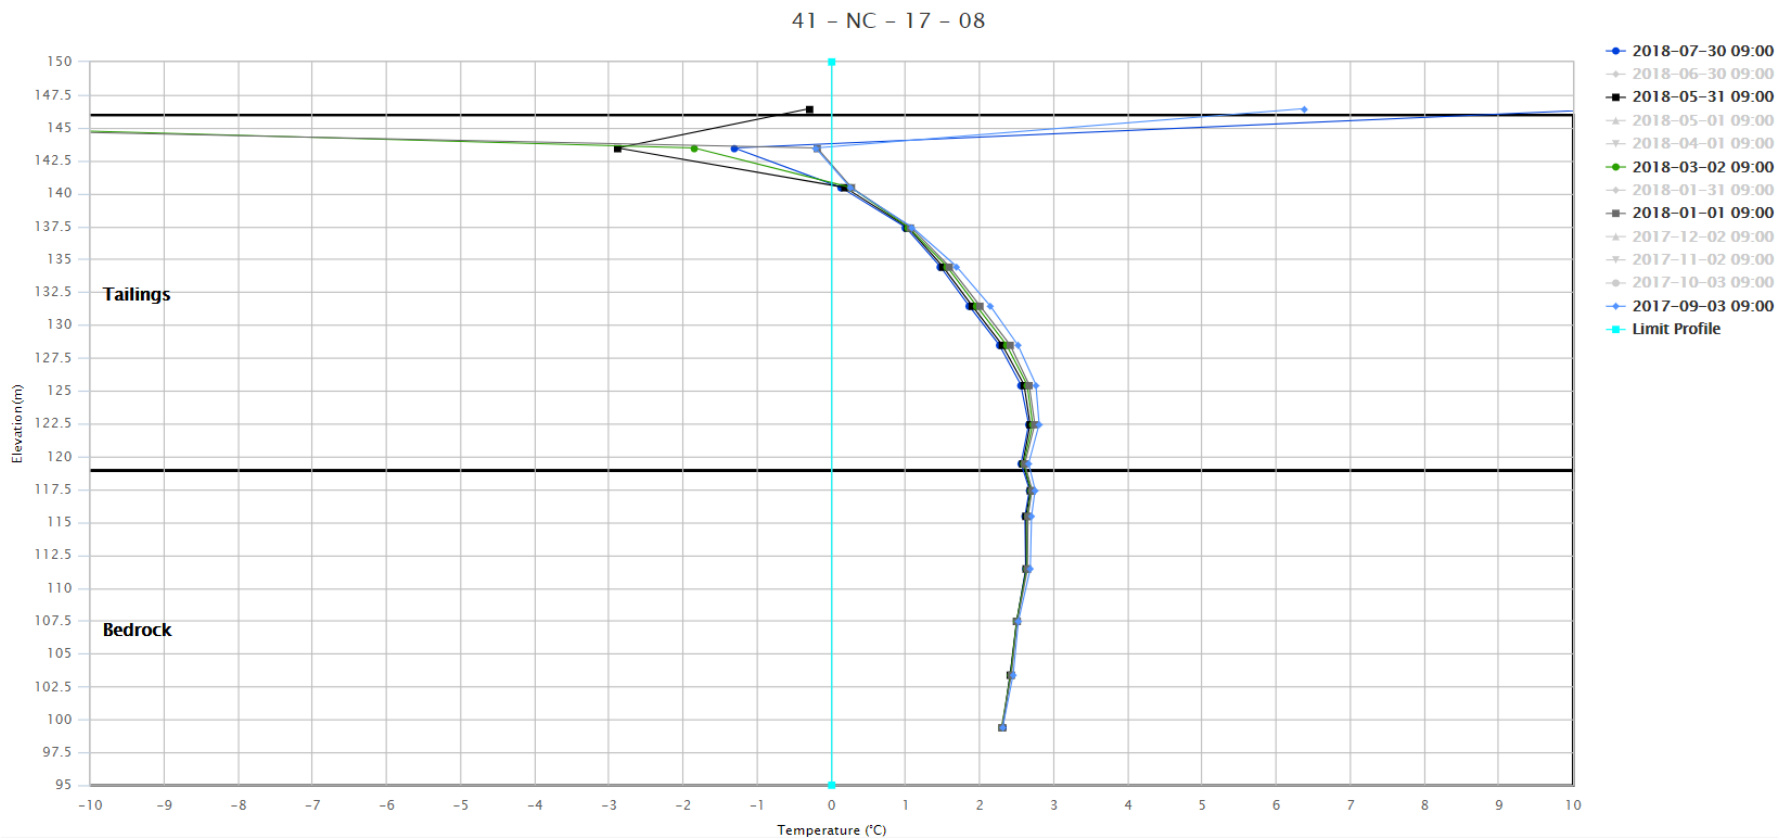
### Thermistor NC-17-08

- From Sept 3rd, 2017 to July 30th, 2018
- Unfrozen below 140 m (Due to North Cell pond water)

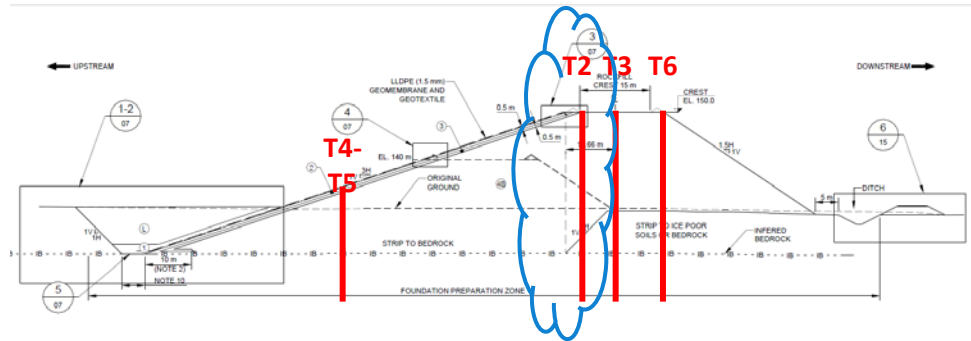
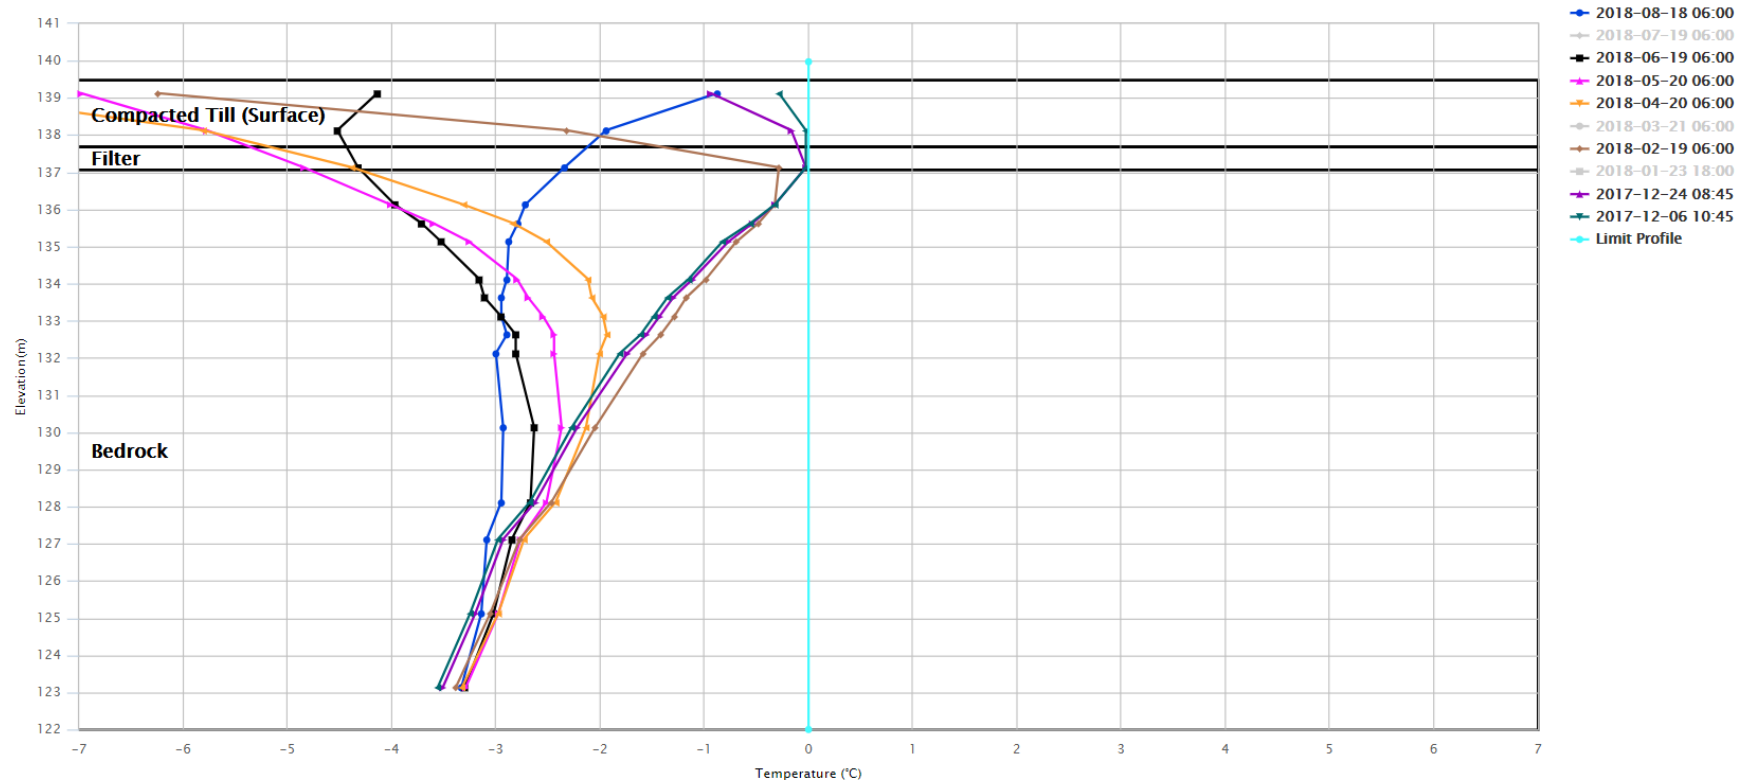
### SD3 Thermistors 2 (T2)

- From Dec 6th, 2017 to Aug 18th, 2018
- Compacted till, filters and bedrock frozen all year long below elevation 139 (masl)

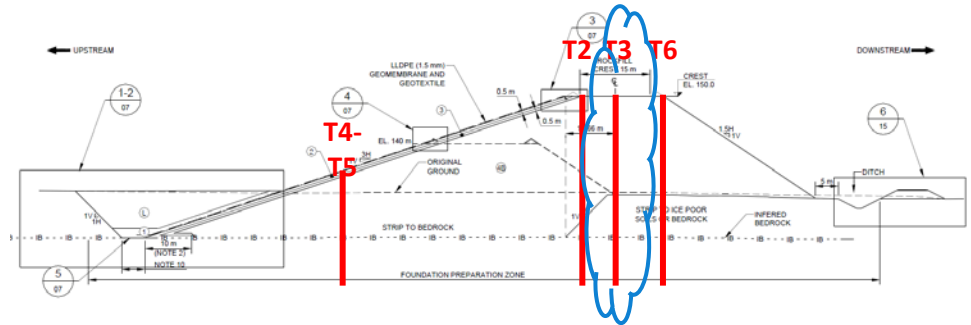
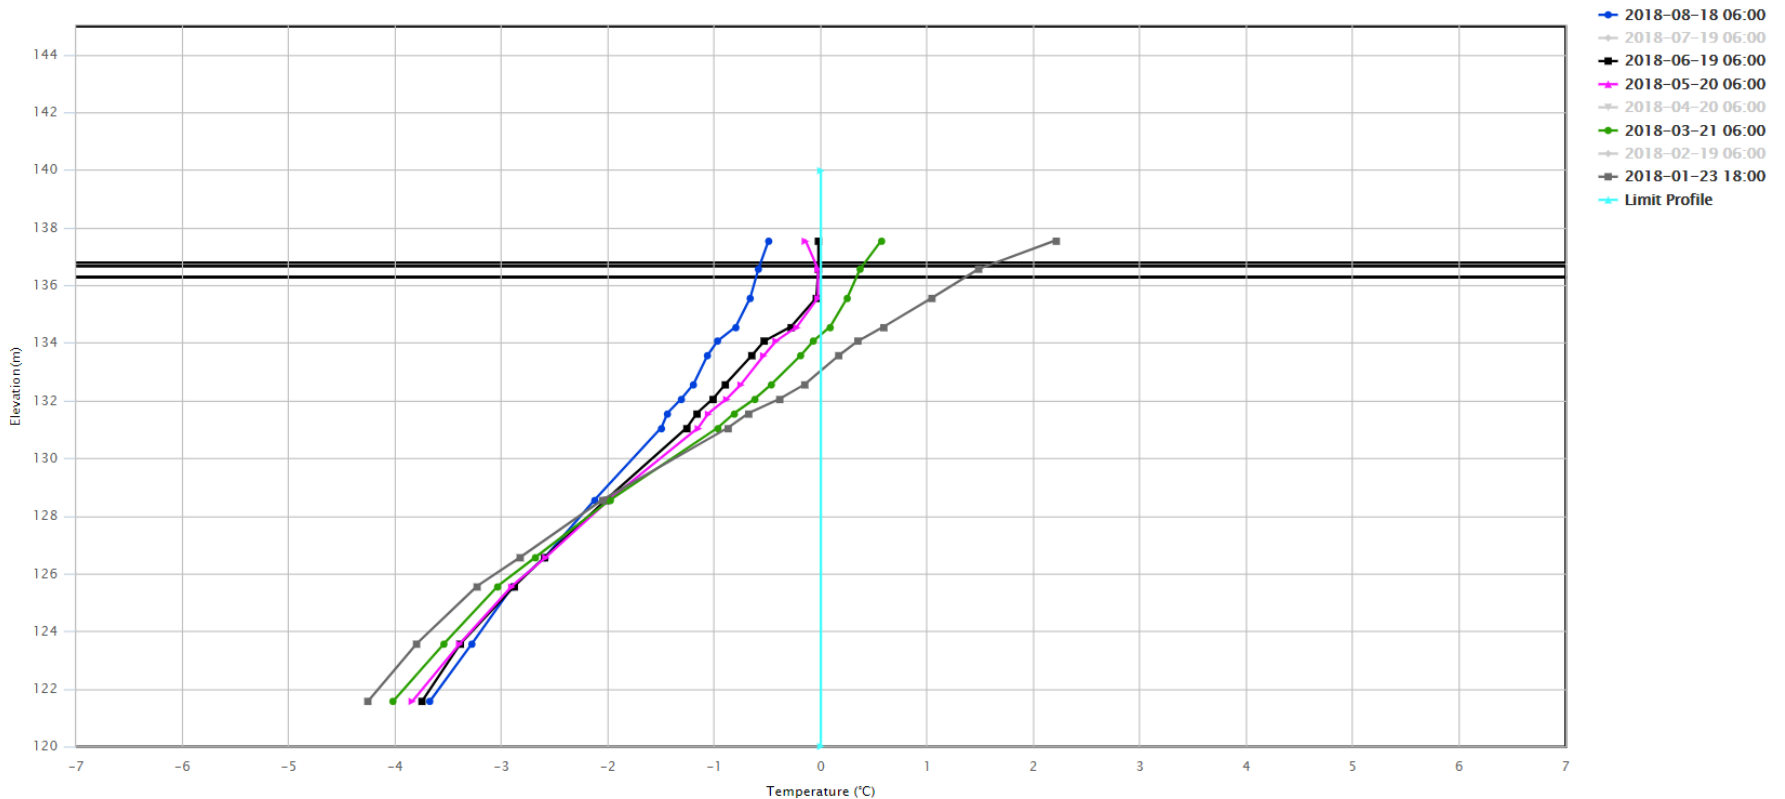
### SD3 Thermistors 3 (T3)

- From Jan 23rd, 2018 to Aug 18th, 2018
- Frozen all year long below elevation 132.5 (masl)

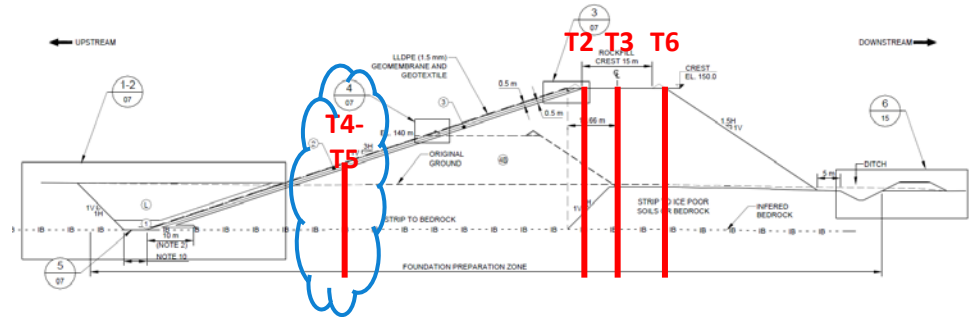
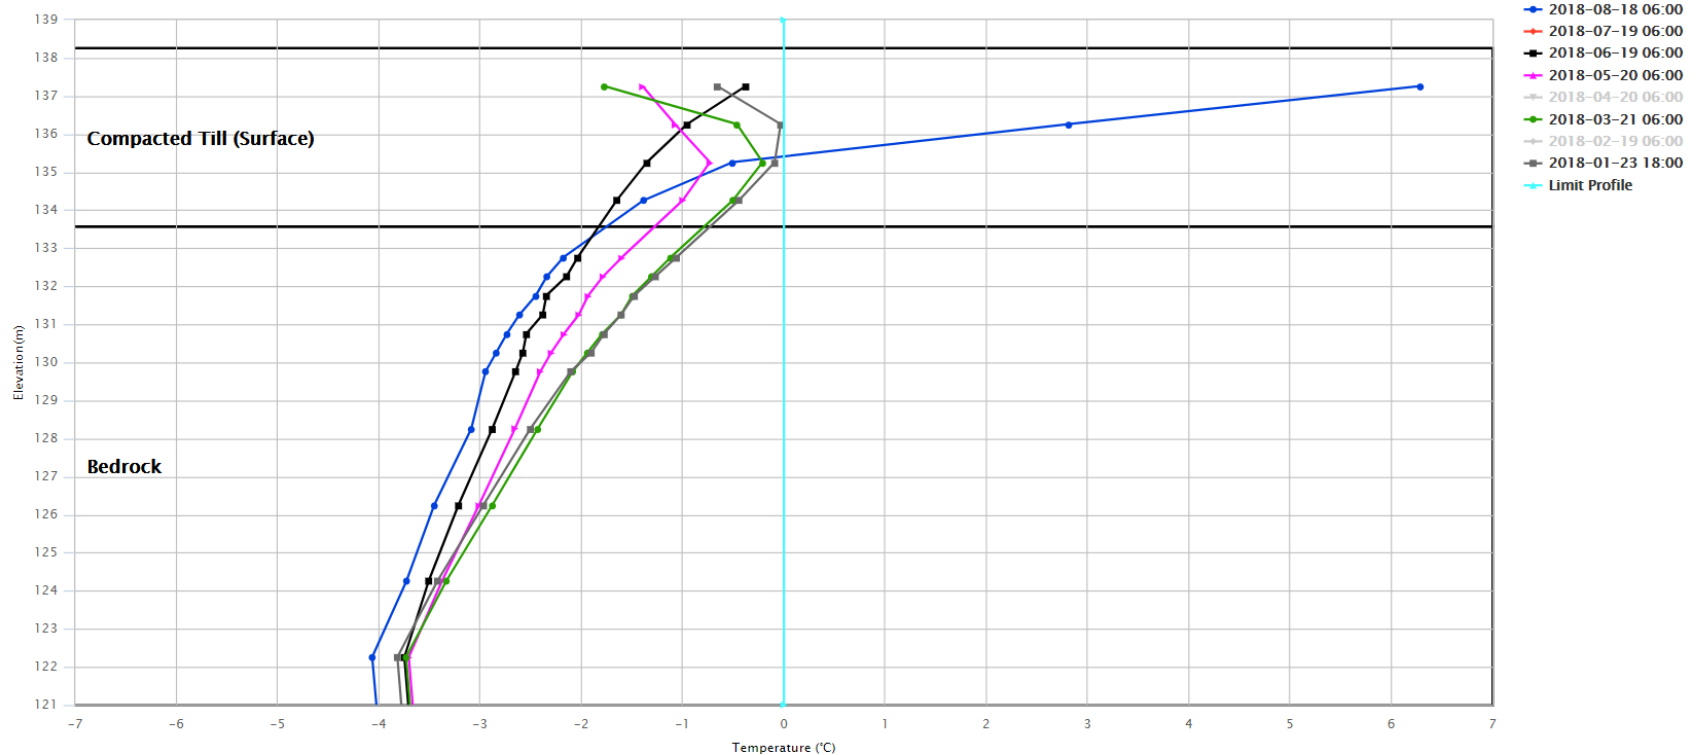
### SD3 Thermistors 4 (T4)

- From Jan 23rd, 2018 to Aug 18th, 2018
- Frozen all year long below elevation 135.5 (masl)

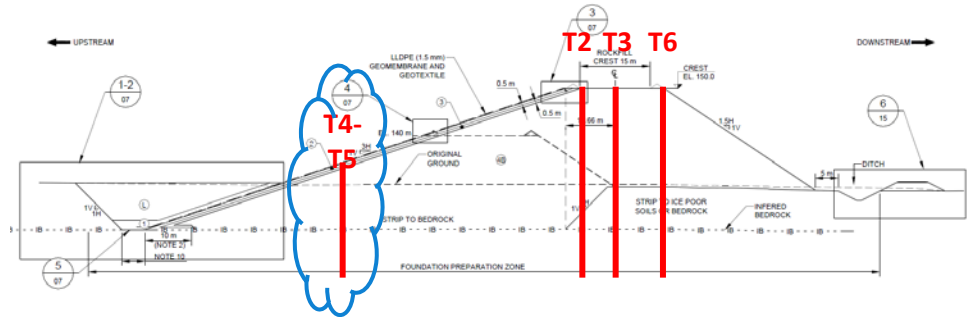
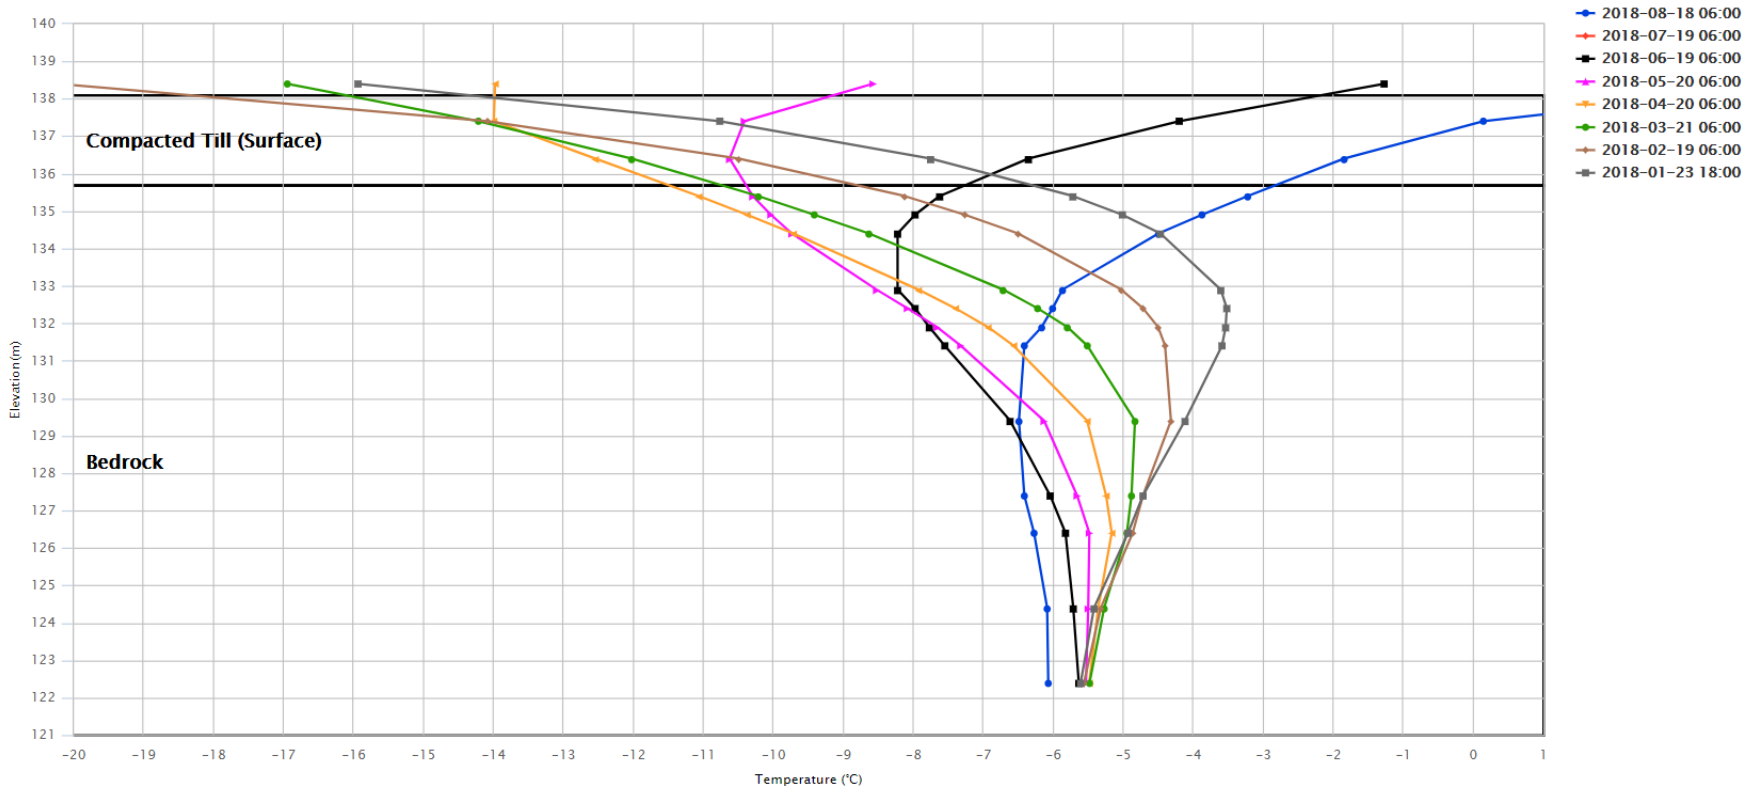
### SD3 Thermistors 5 (T5)

- From Jan 23rd, 2018 to Aug 18th, 2018
- Frozen all year long below elevation 137 (masl)

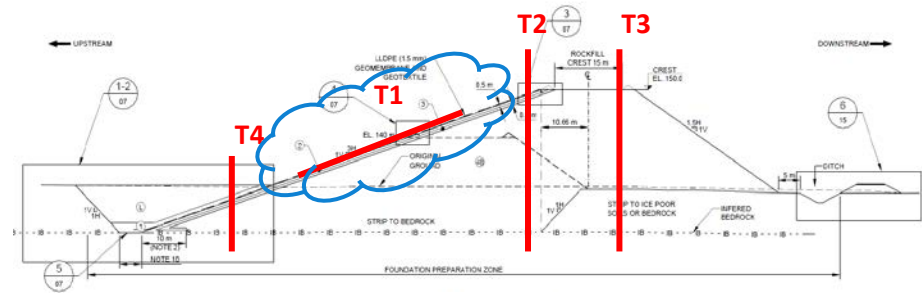
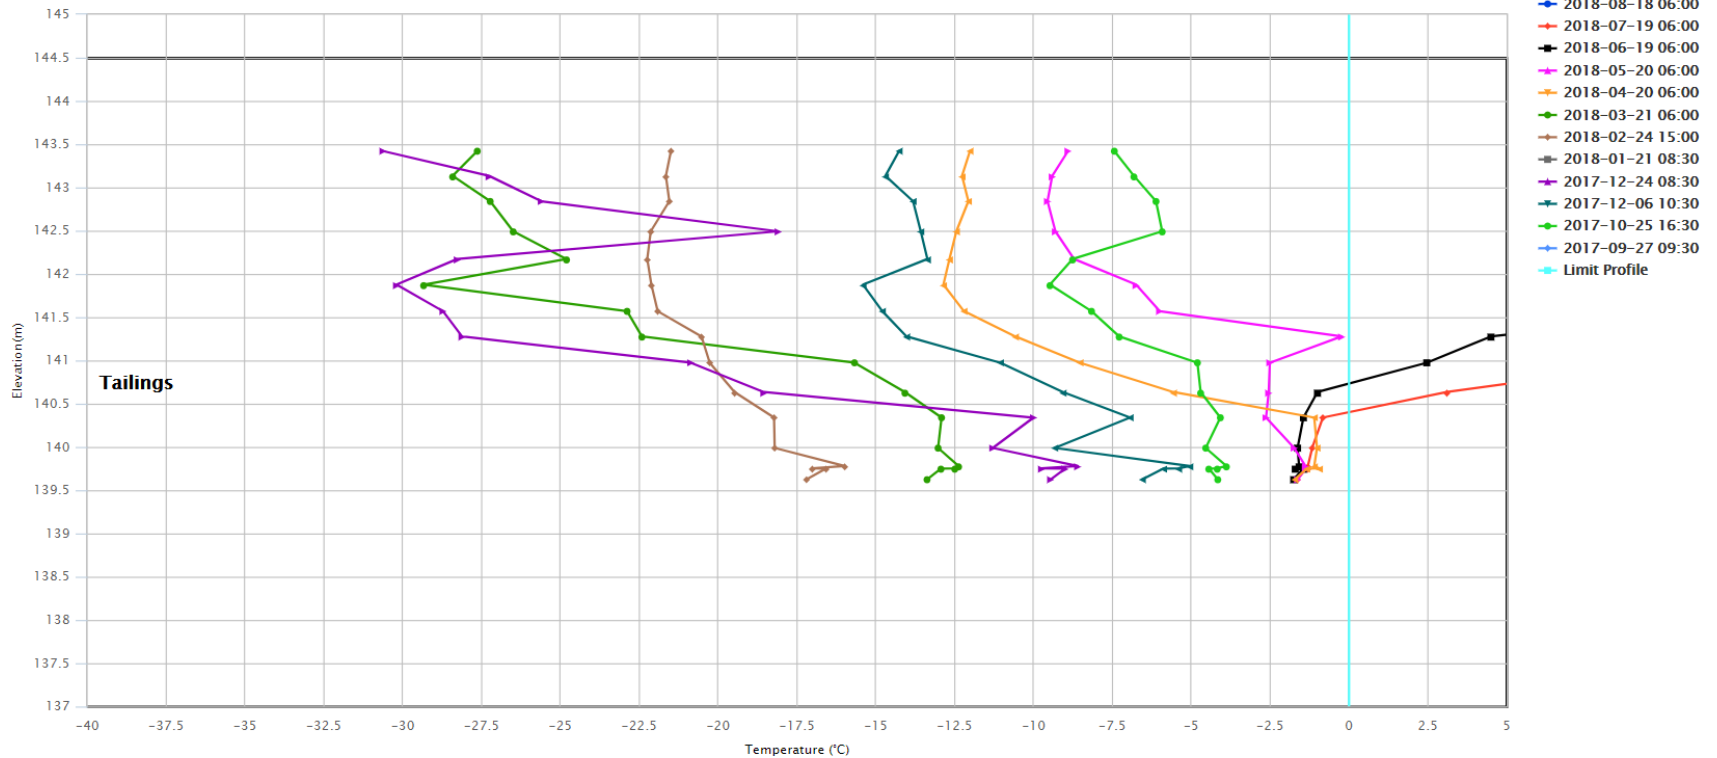
### SD4 Thermistors 1 (T1)

- From Sept 27th, 2017 to Aug 18th, 2018
- Tailings frozen all year long below elevation 140 (masl)

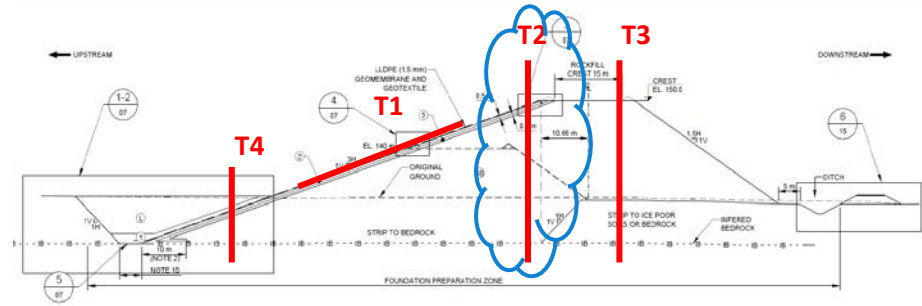
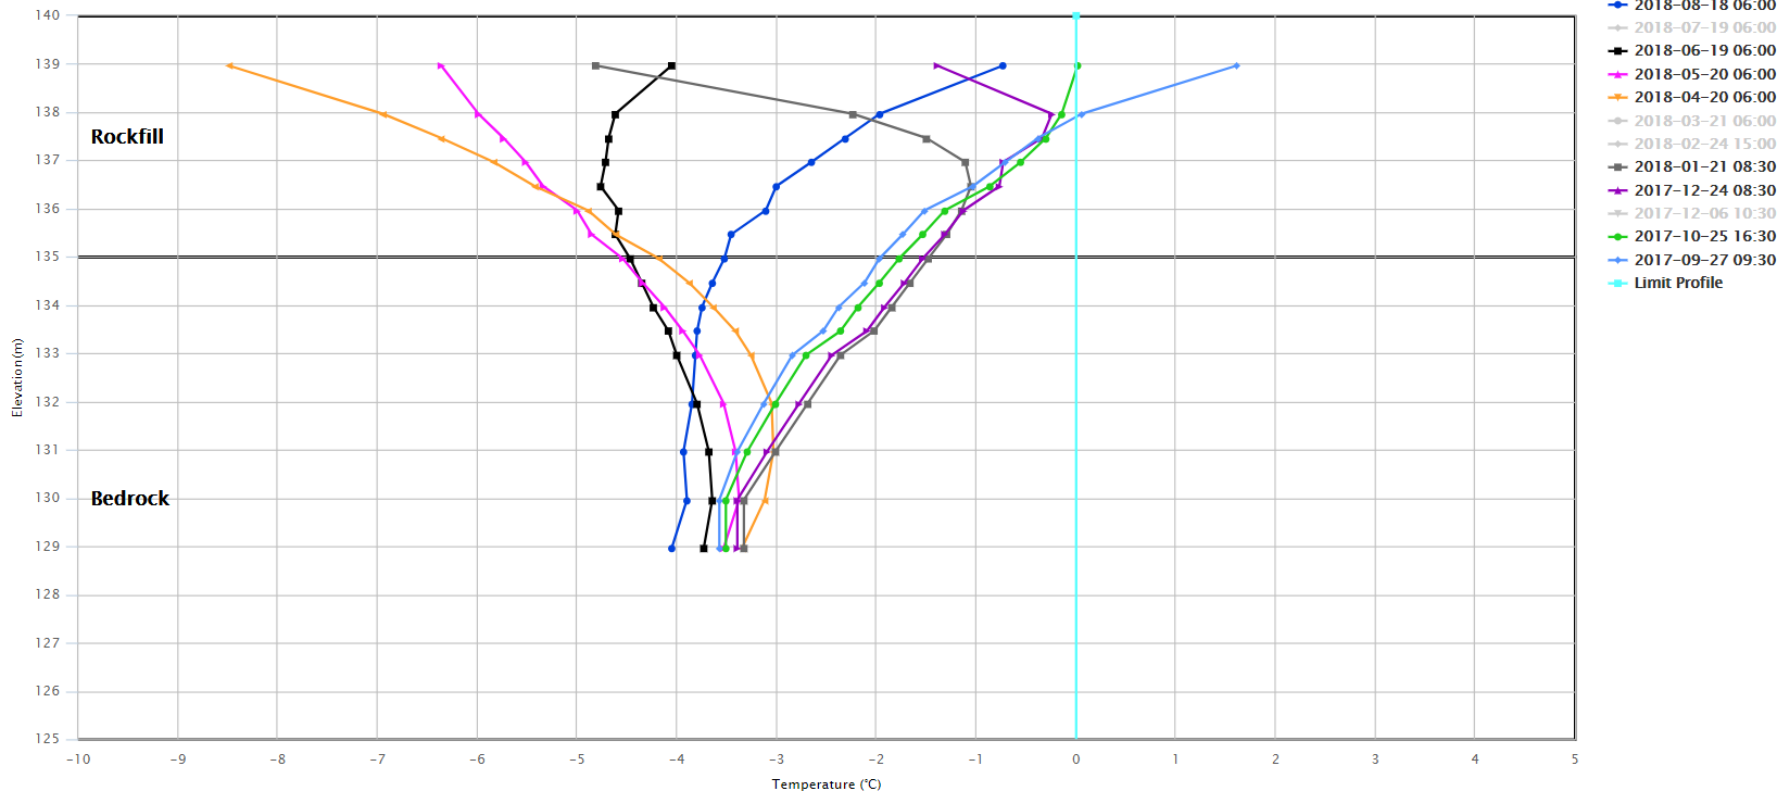
### SD4 Thermistors 2 (T2)

- From Sept 22th, 2017 to Aug 18th, 2018
- Rockfill and foundation frozen all year long below elevation 137.5 (masl)
