# **Meadowbank and Whale Tail 2018 Annual Geotechnical Inspection**

# 2018 Annual Geotechnical Inspection

*Meadowbank Gold Mine, Nunavut*

18101627-1583-R-Rev0

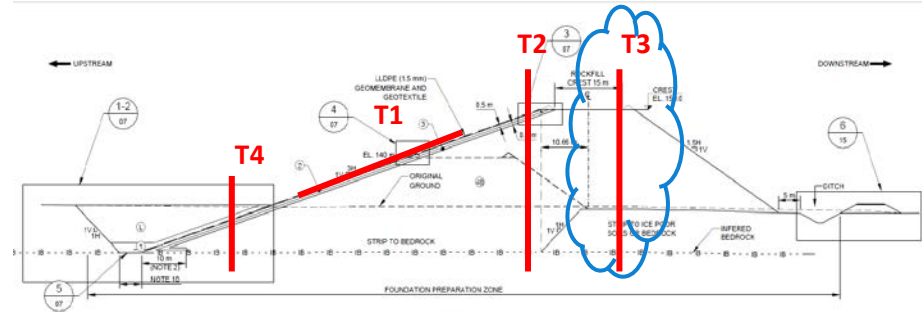
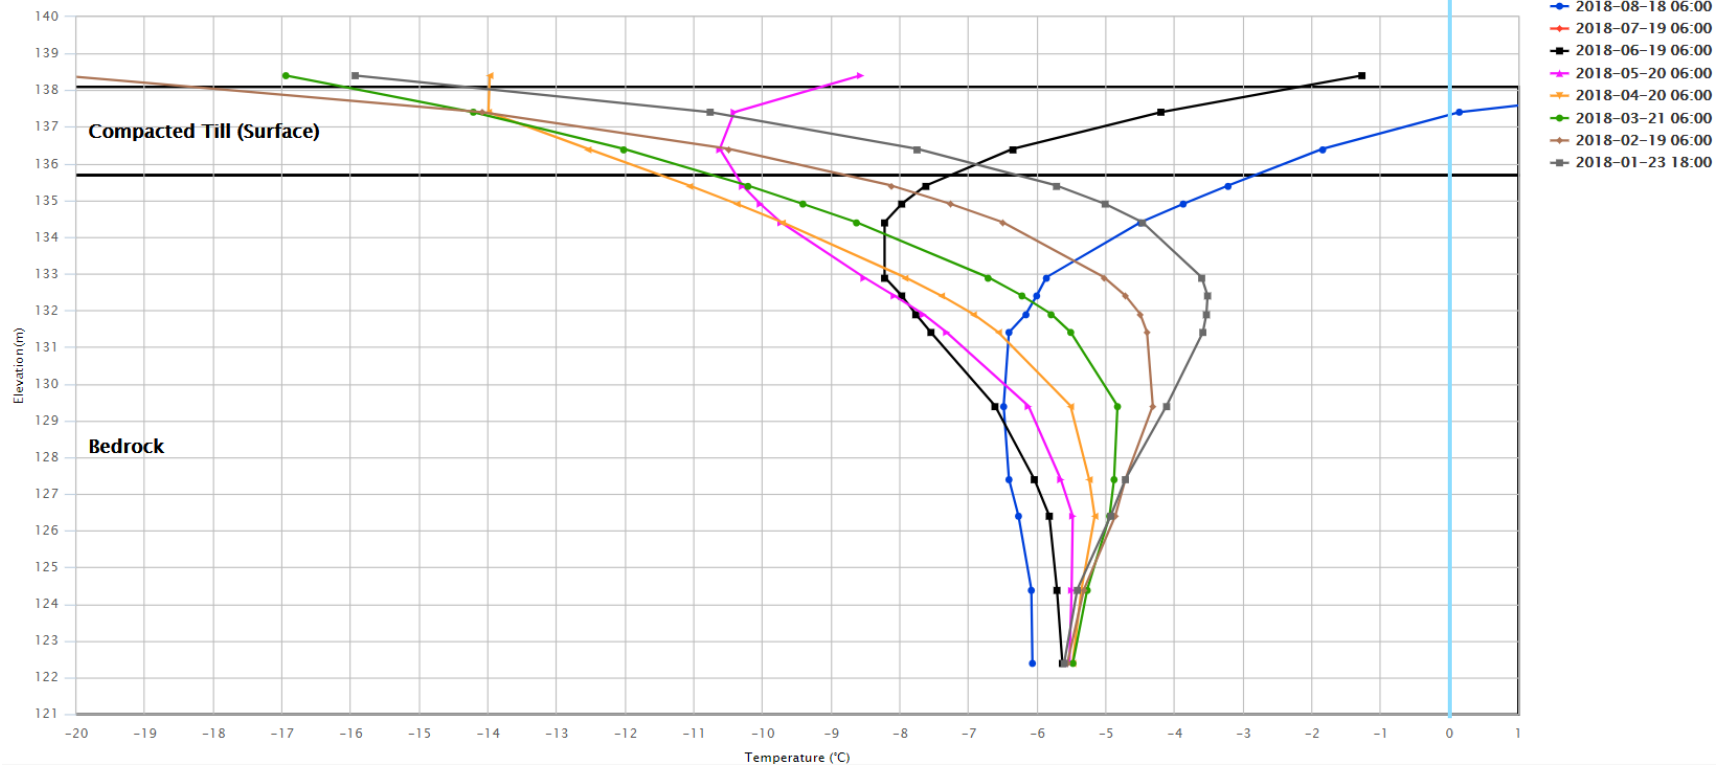
### SD4 Thermistors 3 (T3)

- From Jan 23rd, 2018 to Aug 18th, 2018
- Compacted till and bedrock frozen all year long below elevation 136.5 (masl)

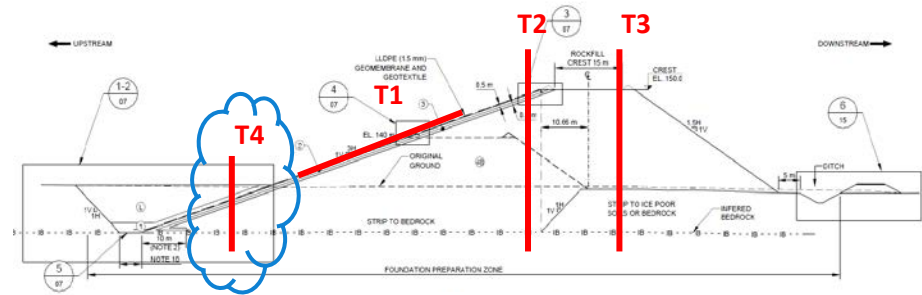
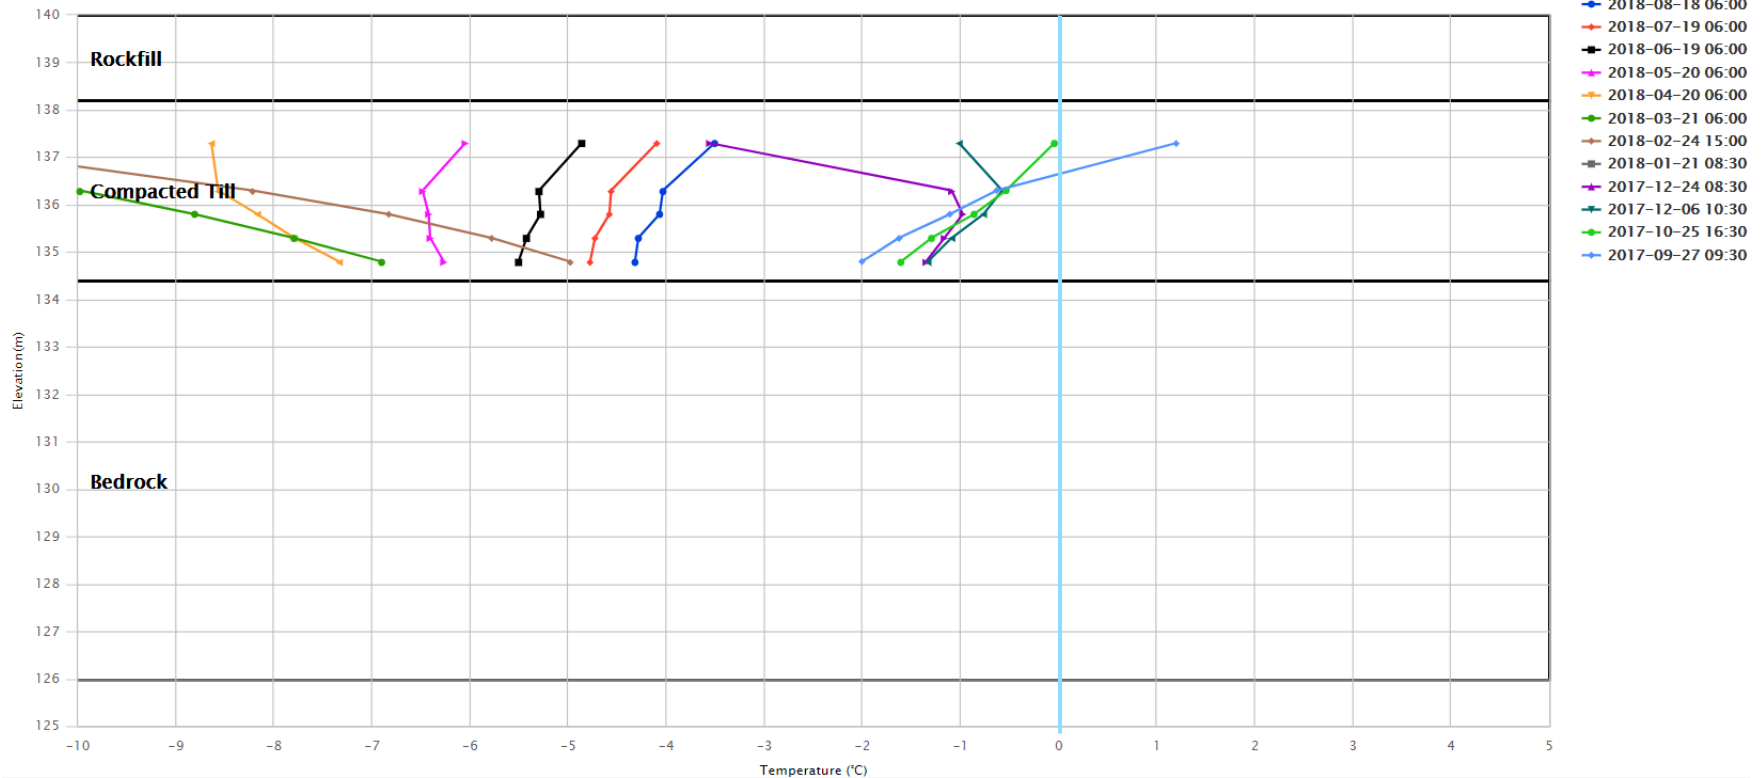
### SD4 Thermistors 4 (T4)

- From Sept 29th, 2017 to Aug 18th, 2018
- Compacted till frozen all year long below elevation 136.5 (masl)

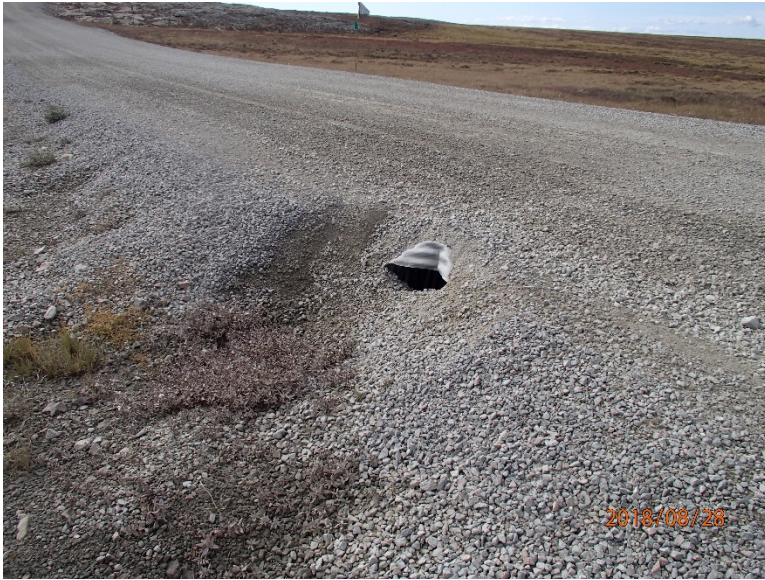
**Photograph D1-1: unnamed km 5+700**

**Description:** View of the culvert inlet. Good condition, inlet is short in length as the road rolling surface is at the edge of the inlet.

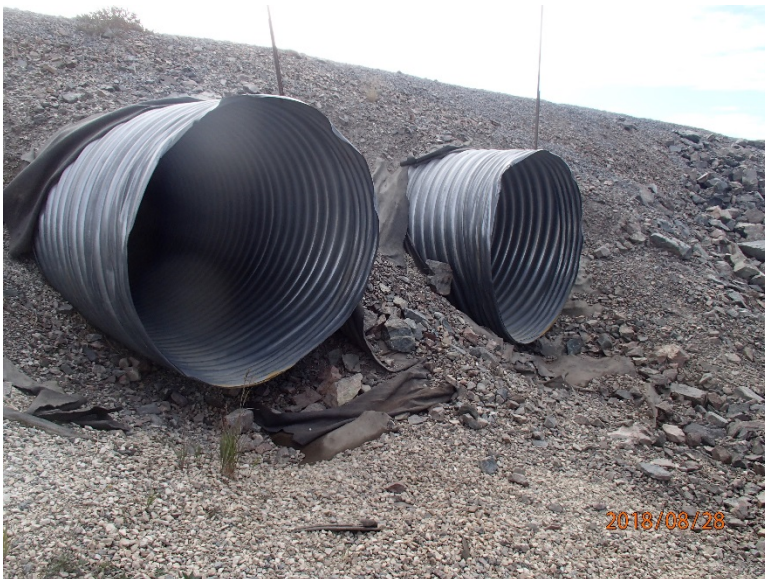
**Photograph D1-2: PC-17A km 8+830**

**Description:** View of the culverts inlet. No sign of degradation since last year.

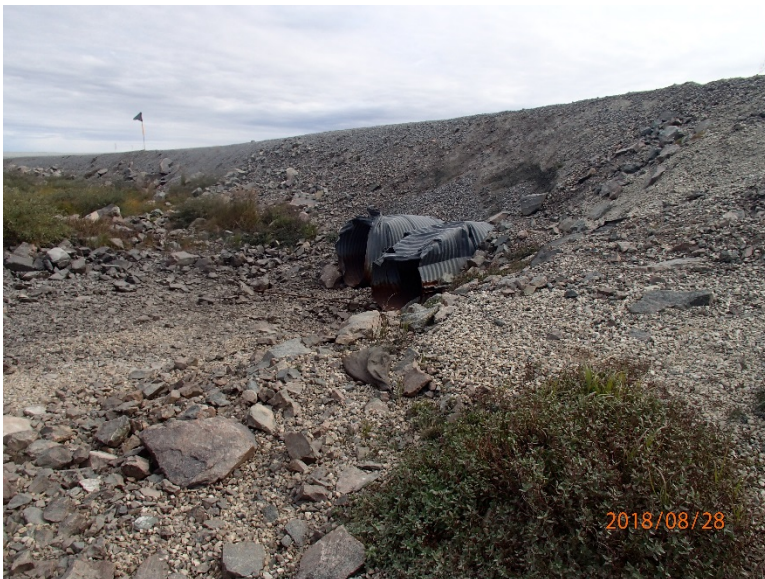
**Photograph D1-4: PC-17 km 8+850**

**Description:** View of the culverts inlet. Good condition.

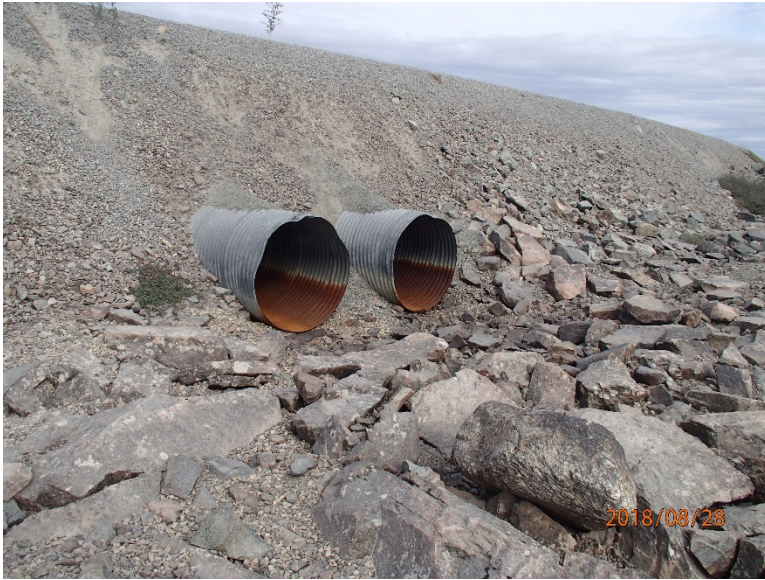
**Photograph D1-5: PC-17 km 8+850**

**Description:** View of the culverts outlet (right side of the picture). Good condition.

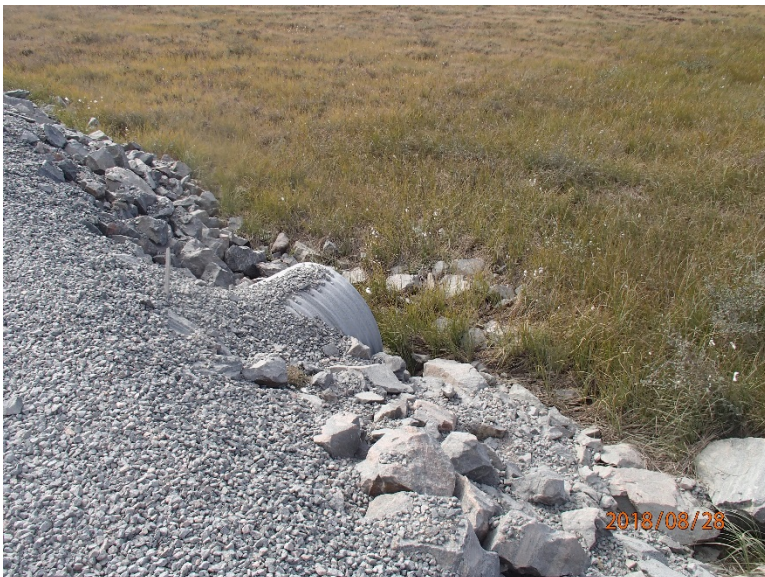
**Photograph D1-6: R-04 km 12+050**

**Description:** View of the culvert inlet. In good condition.

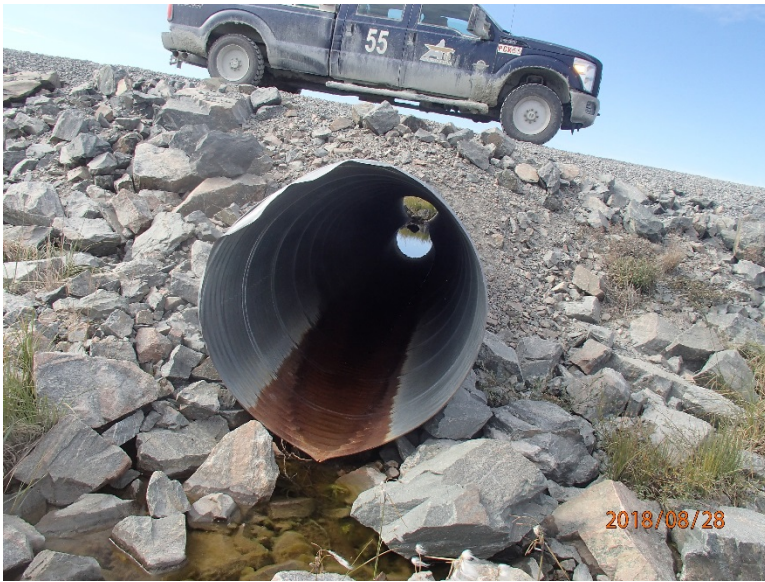
**Photograph D1-7: R-04 km 12+050**

**Description:** View of the culvert outlet. In good condition.

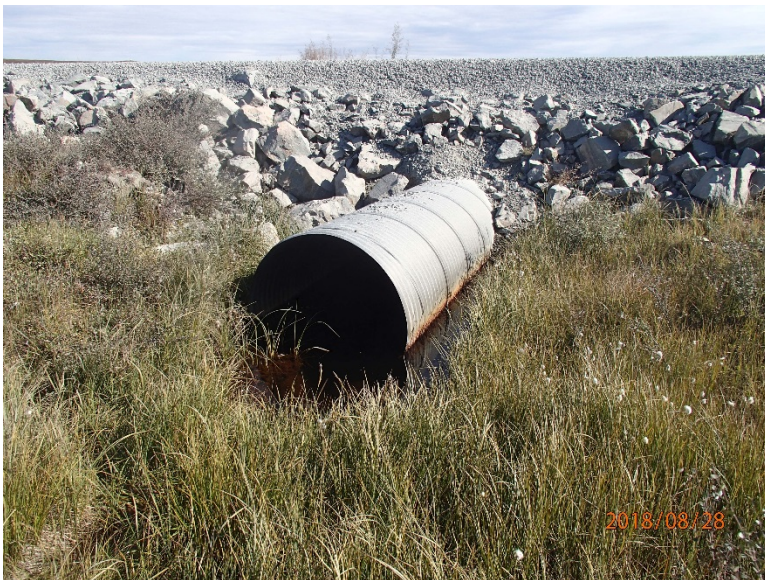
**Photograph D1-8: R-05A km 15+745**

**Description:** View of the culvert inlet. In good condition.

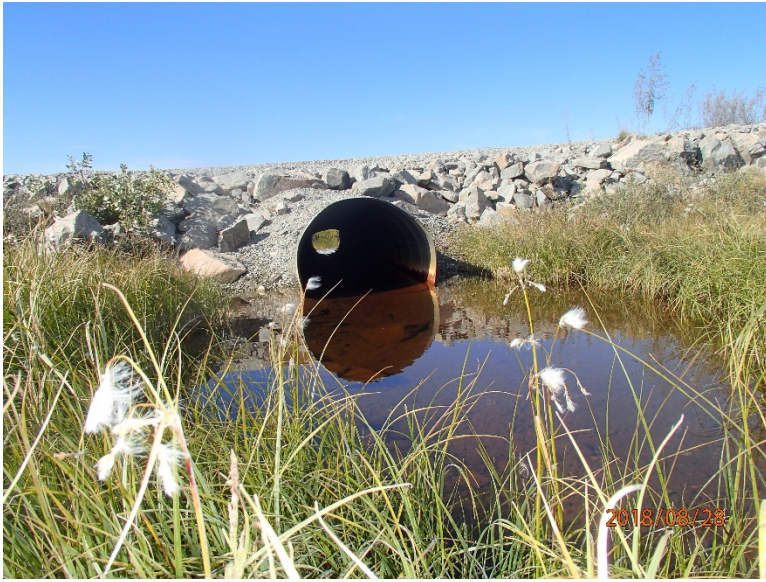
**Photograph D1-9: R-05A km 15+745**

**Description:** View of the culvert outlet. In good condition.

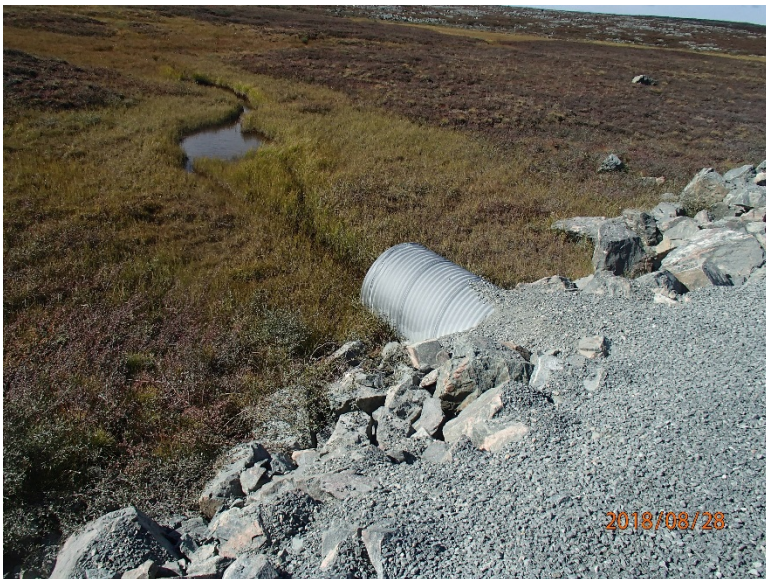
**Photograph D1-10: R-07 km 25+900**

**Description:** View of the culvert inlet. In good condition.

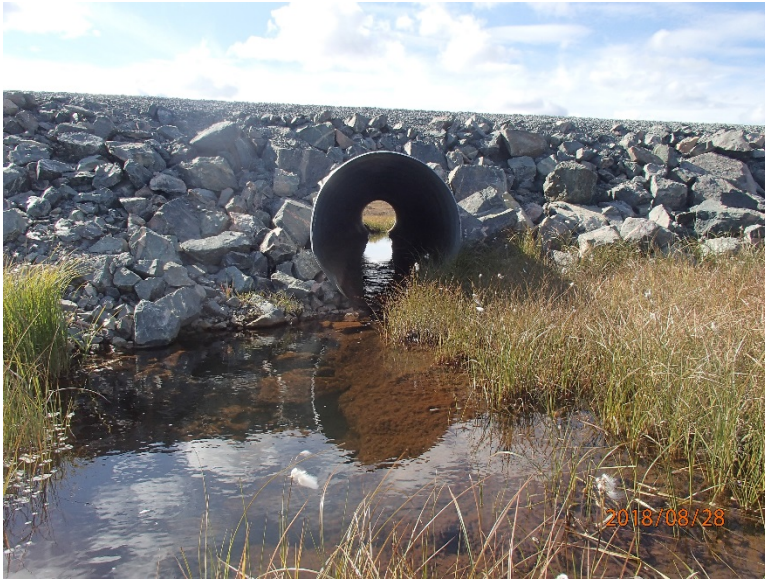
**Photograph D1-11: R-07 km 25+900**

**Description:** View of the culvert outlet. In good condition.

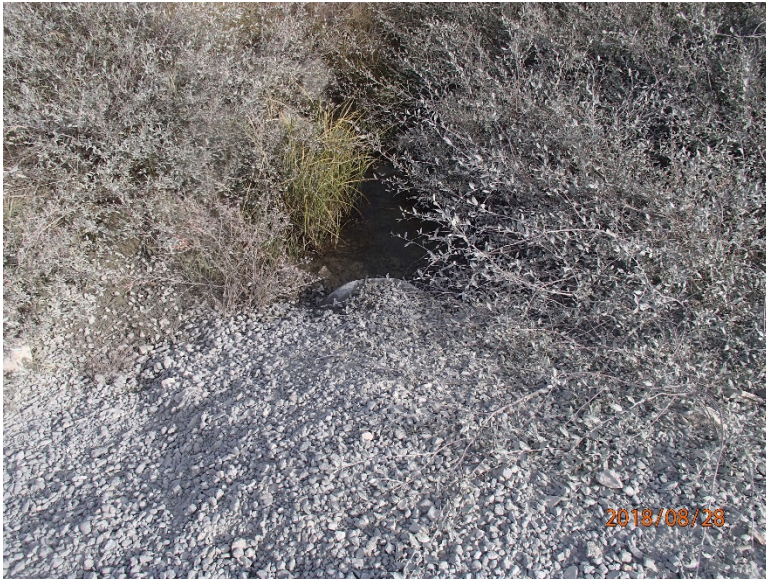
**Photograph D1-13: PC-11 km 39+552**

**Description:** View of the culvert outlet. In good condition, almost submerged.

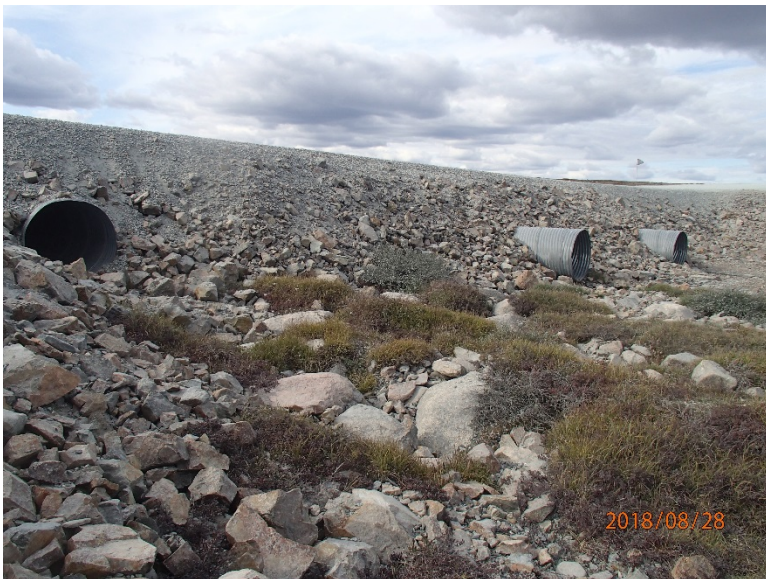
**Photograph D1-14: R-14 km 67+840**

**Description:** View of the outlet culverts. The middle and northern culverts show small signs of erosion at the outlet and these culverts are collapsed inside (hole in the middle). Expected to continue performing well.

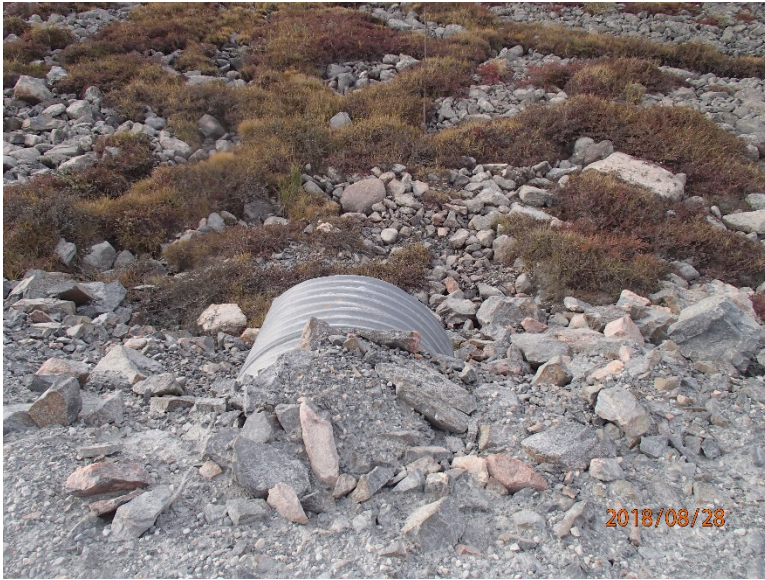
**Photograph D1-15: R-17 km 77+440**

**Description:** View of the culvert inlet. In good condition.

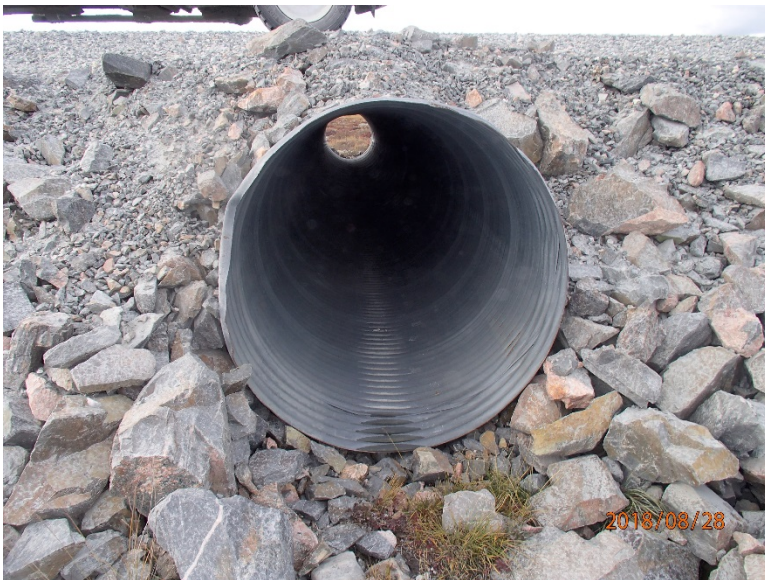
**Photograph D1-16: R-17 km 77+440**

**Description:** View of the culvert outlet. In good condition.

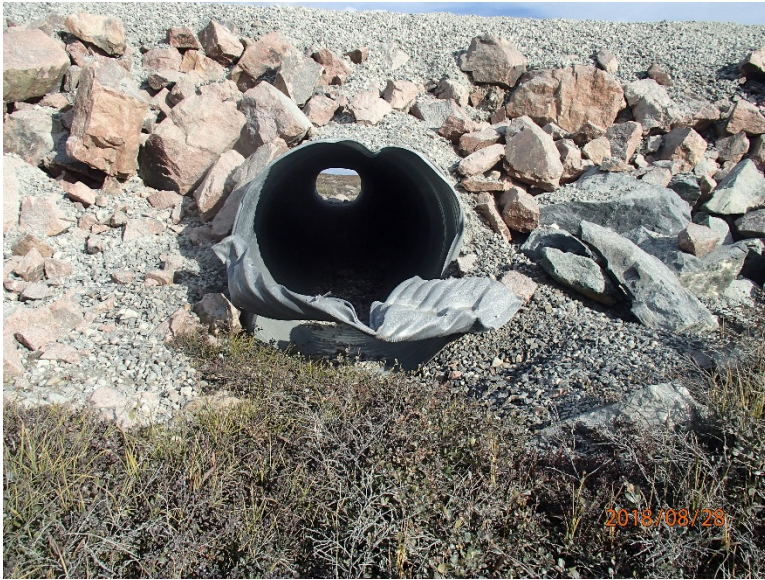
**Photograph D1-19: R-20 km 85+490**

**Description:** View of the culvert outlet. Outlet is a little bit twisted. The middle of the culvert is slightly collapsed. Water flows beneath the culvert. The culvert is in stable condition.

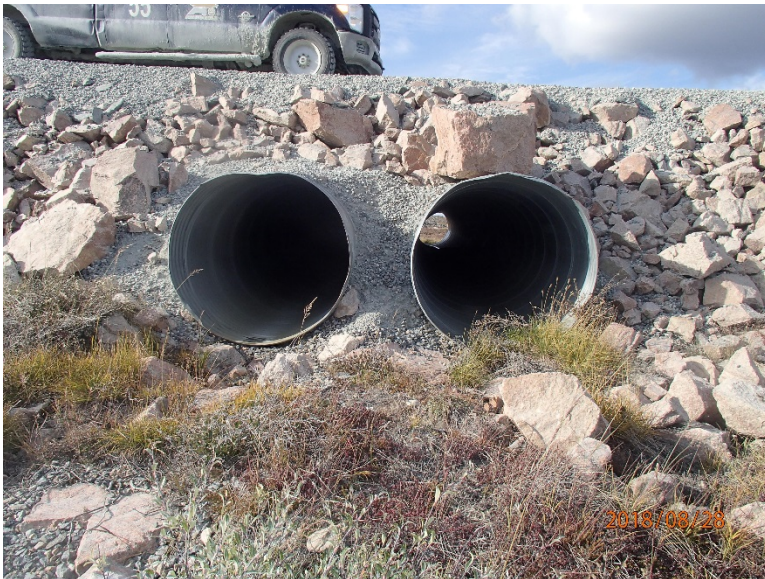
**Photograph D1-20: R-21 km 87+300**

**Description:** View of the culverts inlet. Both culverts are slightly collapsed in the middle. In stable condition, but should have been installed lower to avoid erosion issue.

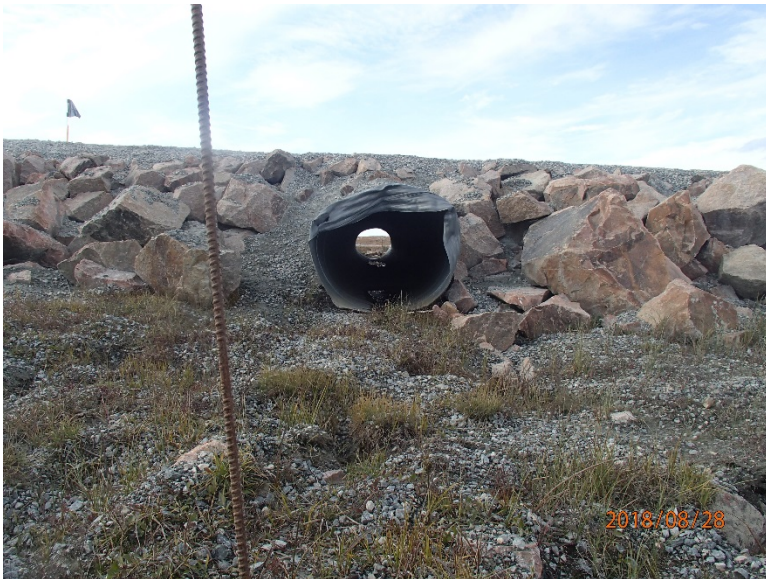
**Photograph D1-22: R-23 km 93+600**

**Description:** View of the culvert inlet. The culvert is installed too high and there is a low flow of water through the road rockfill. In good condition.

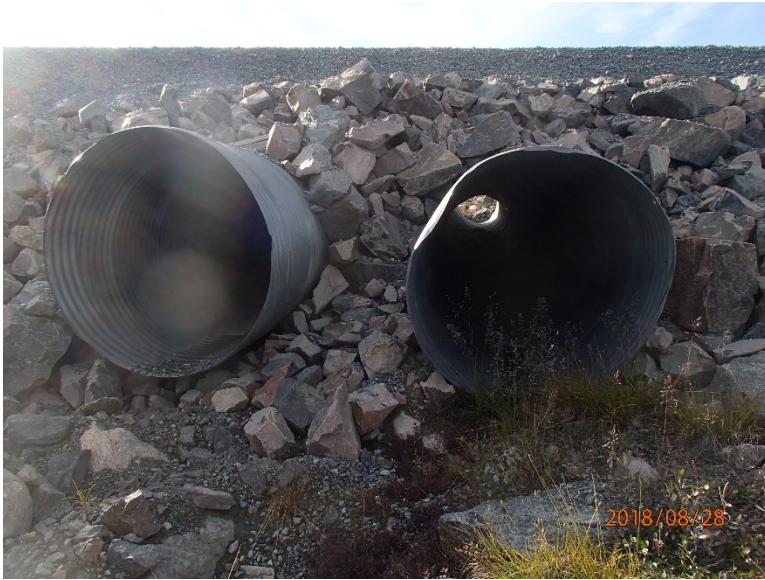
**Photograph D1-25: R-24 km 98+100**

**Description:** View of the culverts outlet. Both outlets are installed too high. The outlet of the southern culvert (left) shows signs of erosion. Both culverts show deformation in the upper part.

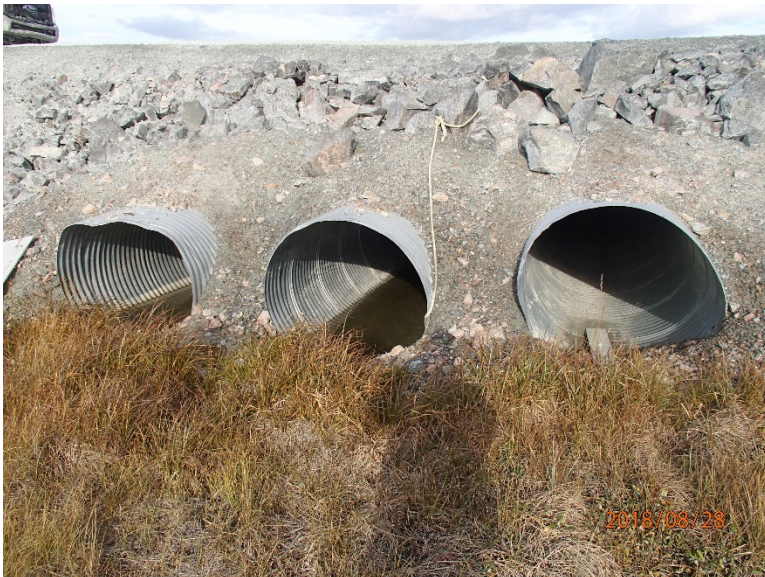
**Photograph D1-26: R-26 km 104+400**

**Description:** View of the culverts outlet. In good condition.

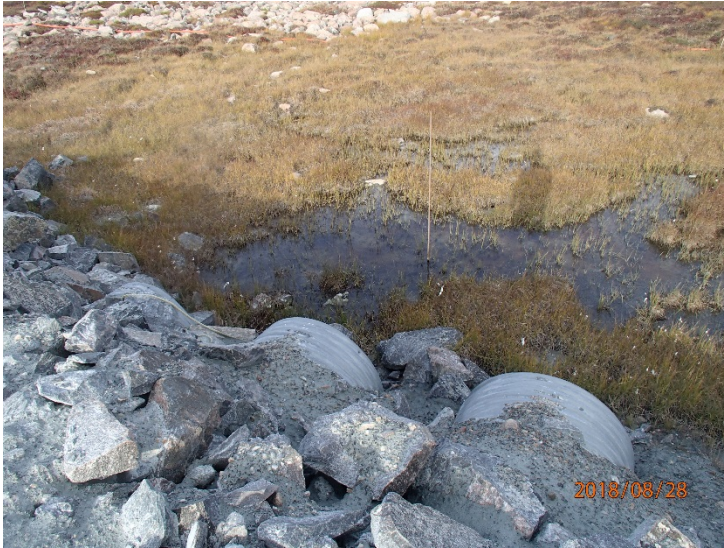
**Photograph D1-27: R-26 km 104+400**

**Description:** View of the culverts inlet. In good condition. In good condition.

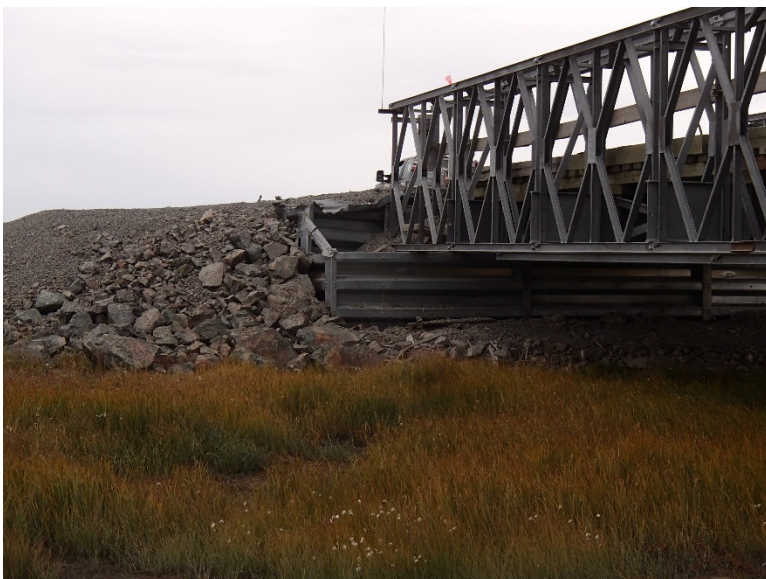
**Photograph D2-4 Bridges 2 – R05 km 17+600**

**Description:** Looking at the south abutment. Minor damage to the bin wall.

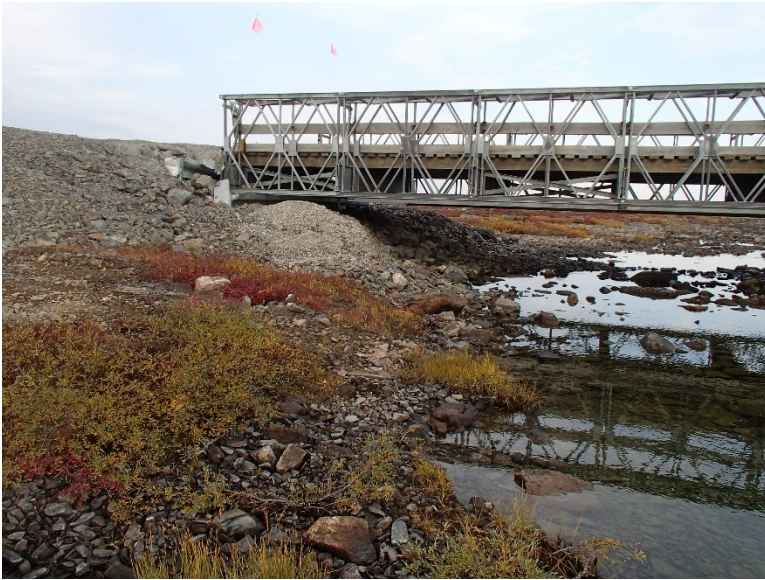
**Photograph D2-9 Bridges 6 – R15 km 69+200**

**Description:** Looking at the south abutment. Damage to the bin wall likely caused during snow removal activities. Bridge is tipping toward the west side on the abutment.

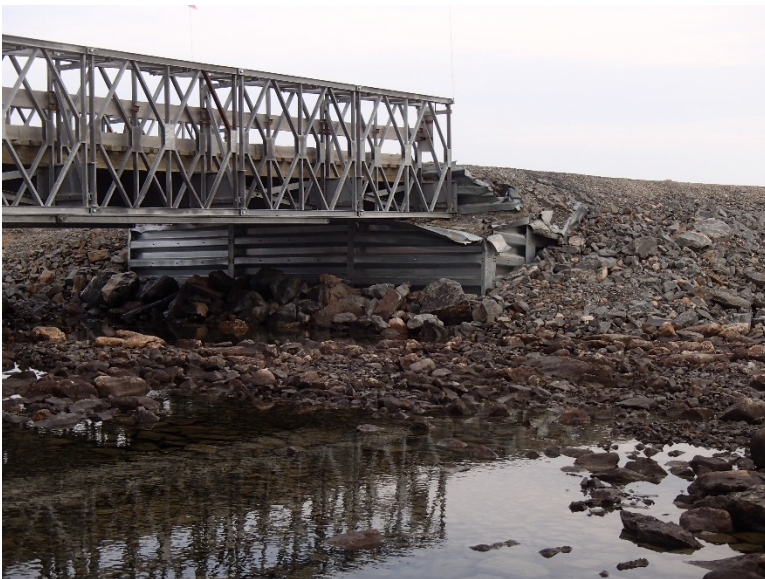
**Photograph D2-10 Bridges 6 – R15 km 69+200**

**Description:** Looking at the north abutment. Damage to the bin wall likely caused during snow removal activities. Bridge is tipping toward the west side on the abutment.

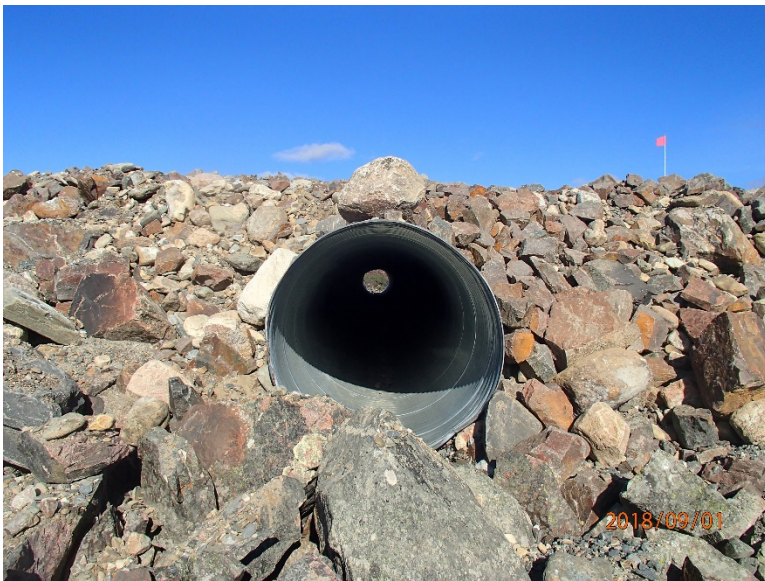
**Description:** View of culvert outlet, in good condition.

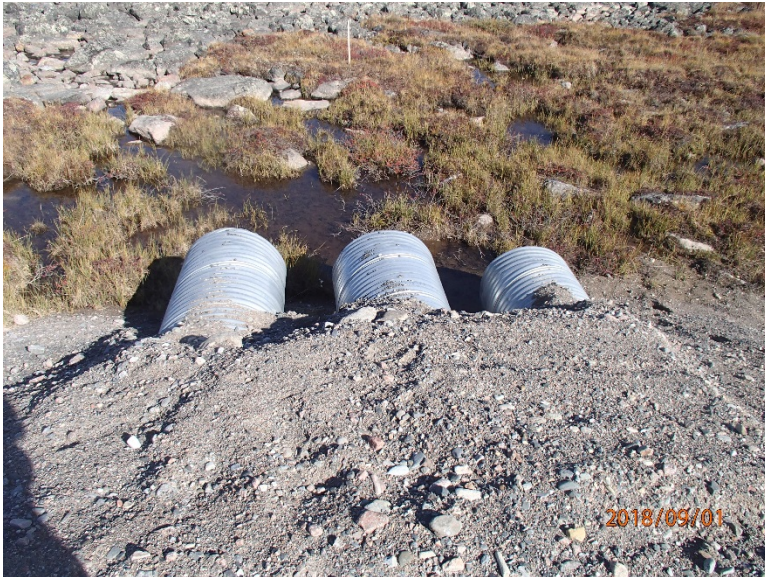
**Description:** View of culvert outlets, in good condition.

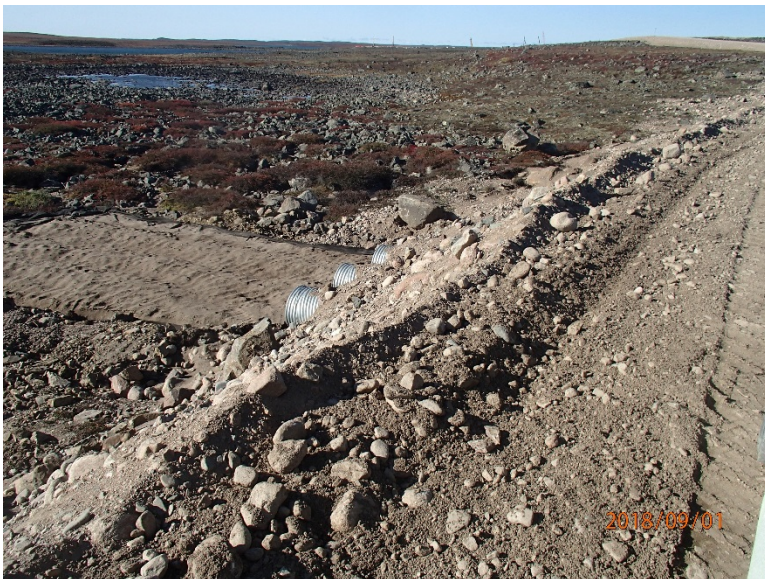
**Photograph E1-6: Culverts #284, #284-2 and #284-3, km 63+070 to 63+074**

**Description:** View of culvert outlets, in good condition.

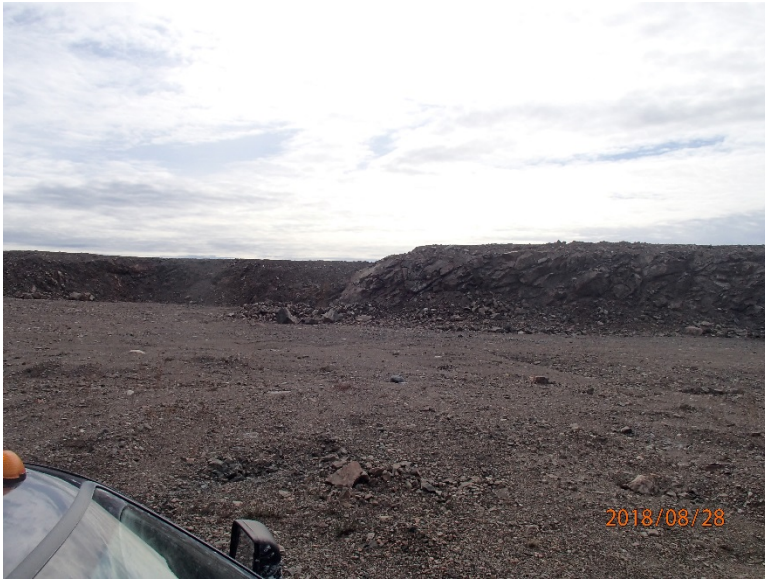
**Photograph F1-1: Quarry 1 – km 5+200**

**Description:** View of south and east walls.

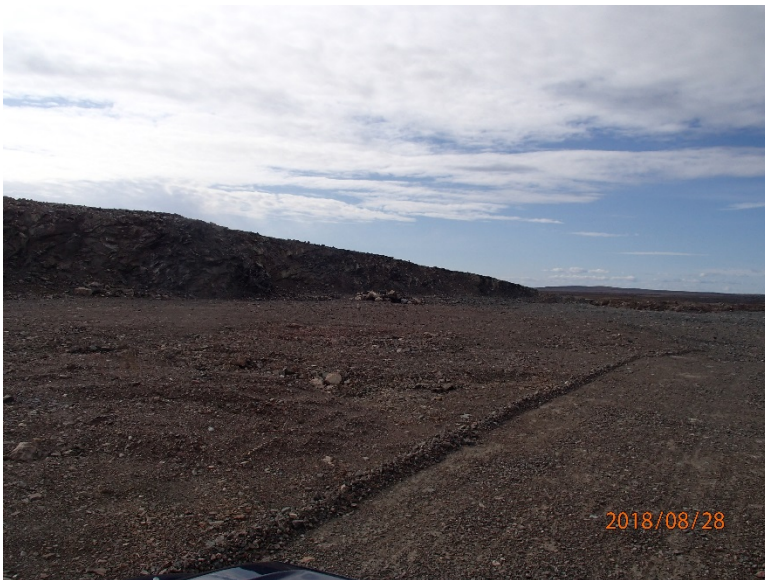
**Photograph F1-2: Quarry 1 – km 5+200**

**Description:** View of south wall.

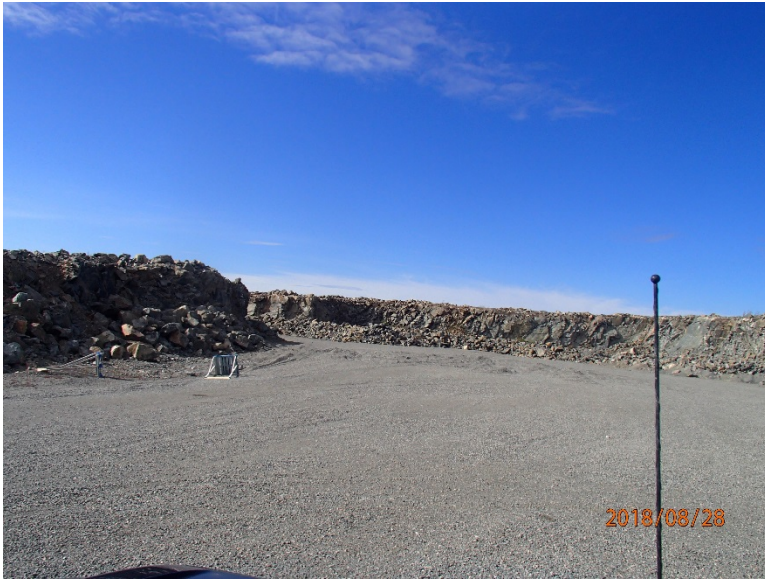
**Photograph F1-3: Quarry 2 – km 13+250**

**Description:** View of north and west walls.

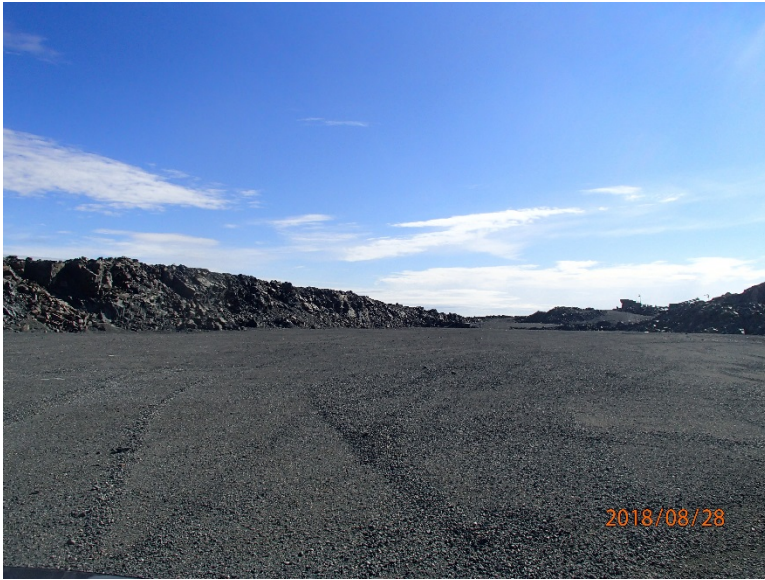
**Description:** View of north and east walls.

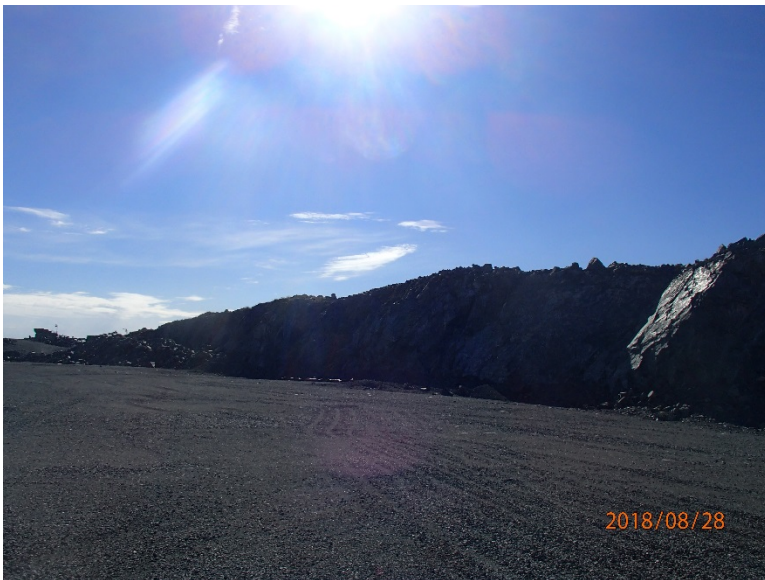
**Photograph F1-5: Quarry 3 – km 23+700**

**Description:** View of east wall.

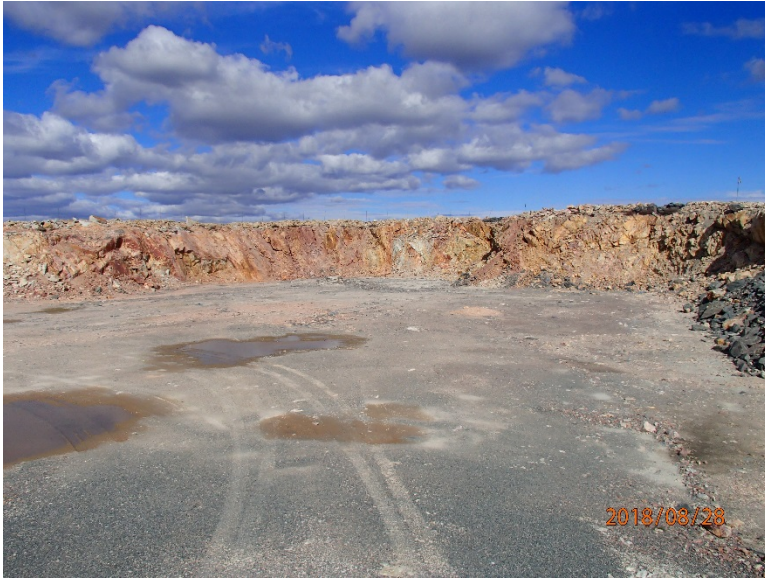
**Photograph F1-6: Quarry 3 – km 23+700**

**Description:** View of west wall. Presence of loose rock along steep wall.

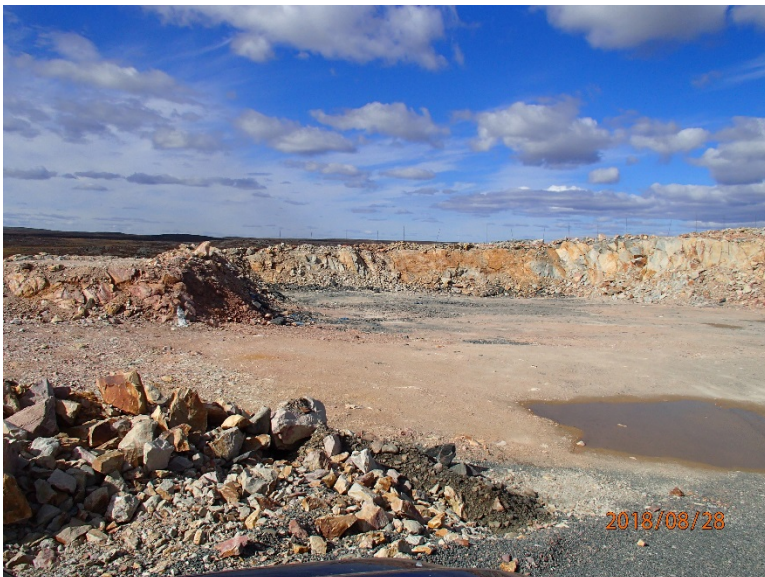
**Photograph F1-7: Quarry 5 – km 34+650**

**Description:** View of north and east walls.

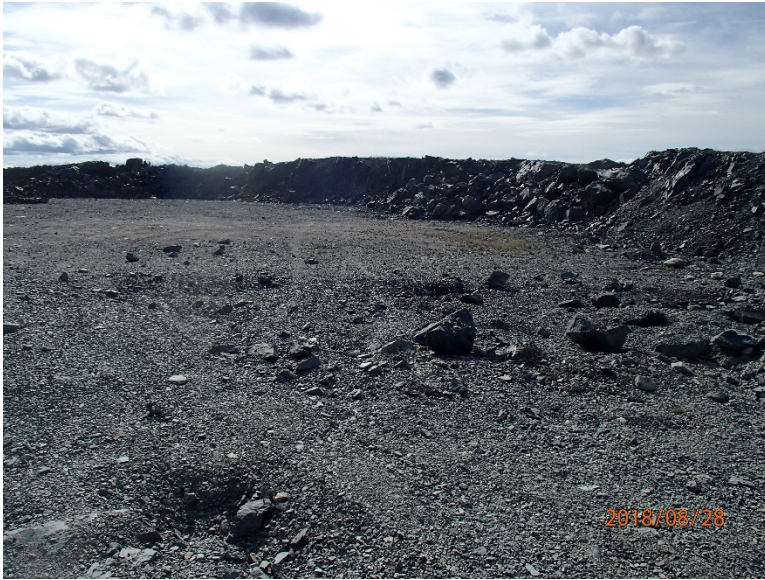
**Photograph F1-8: Quarry 5 – km 34+650**

**Description:** View of north and west walls.

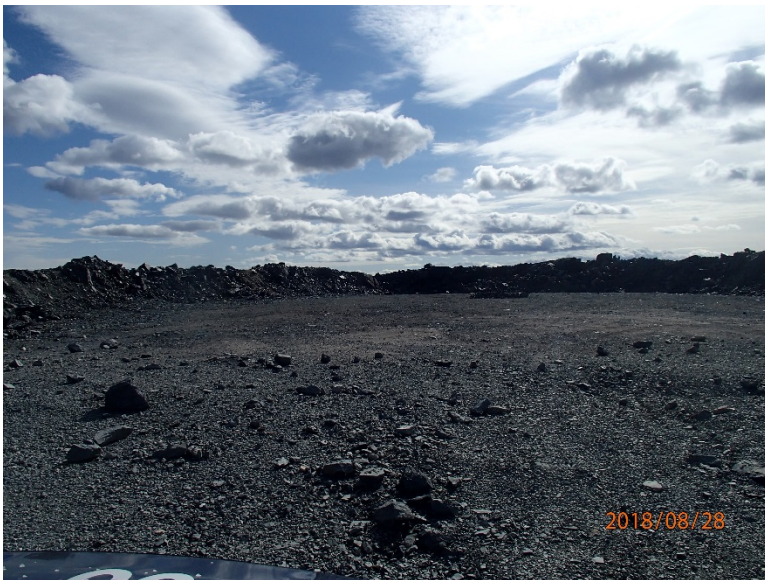
**Photograph F1-9: Quarry 6 – km 36+470**

**Description:** View of south and west walls.

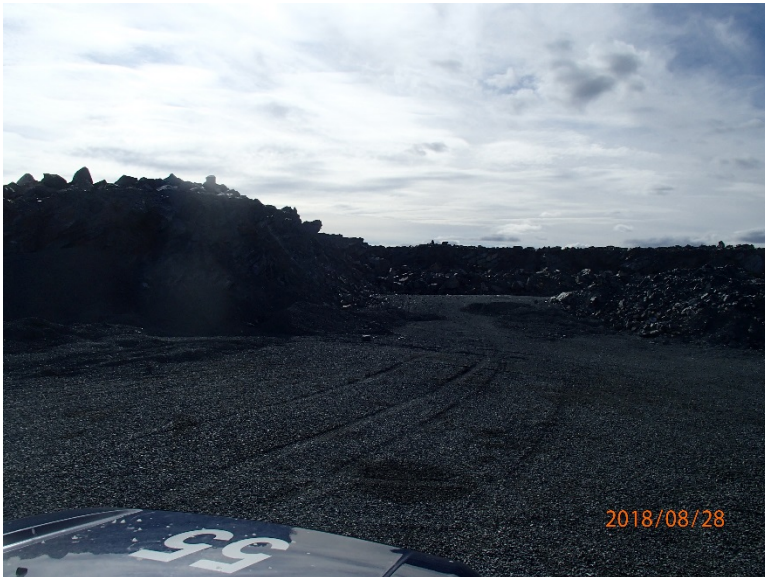
**Photograph F1-10: Quarry 6 – km 36+470**

**Description:** View of south and east walls.

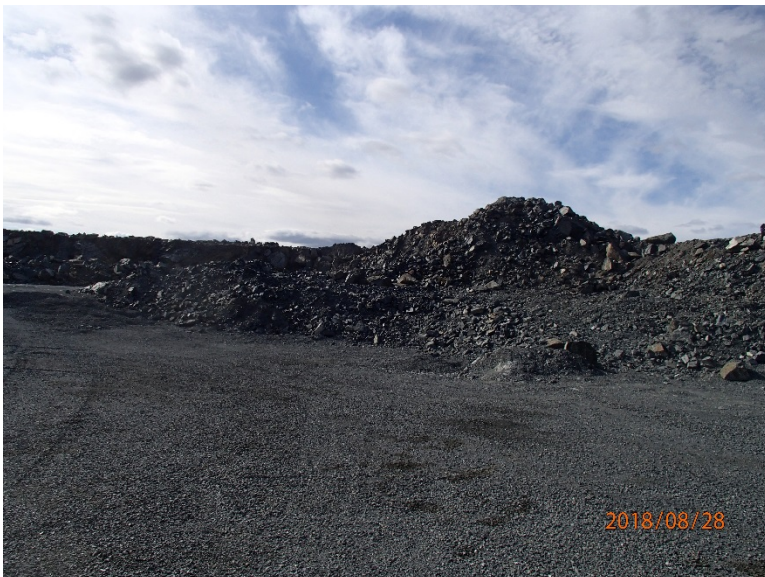
**Photograph F1-11: Quarry 8 – km 42+950**

**Description:** View of south wall. Presence of loose blocks.

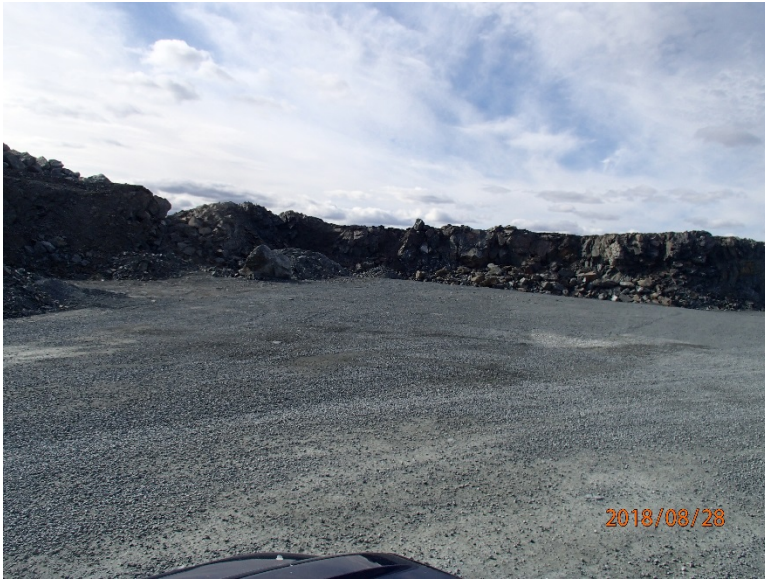
**Photograph F1-12: Quarry 8 – km 42+950**

**Description:** View of west wall.

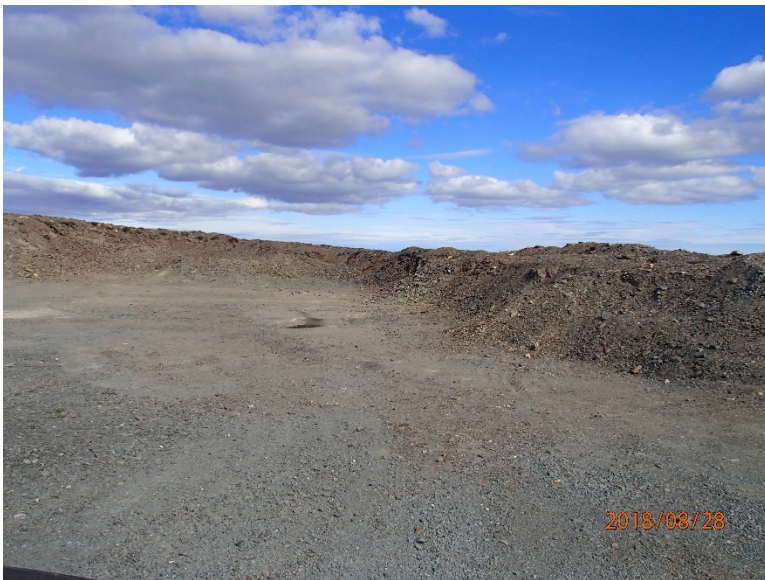
**Description:** View of the west wall. Presence of unstable blocks.

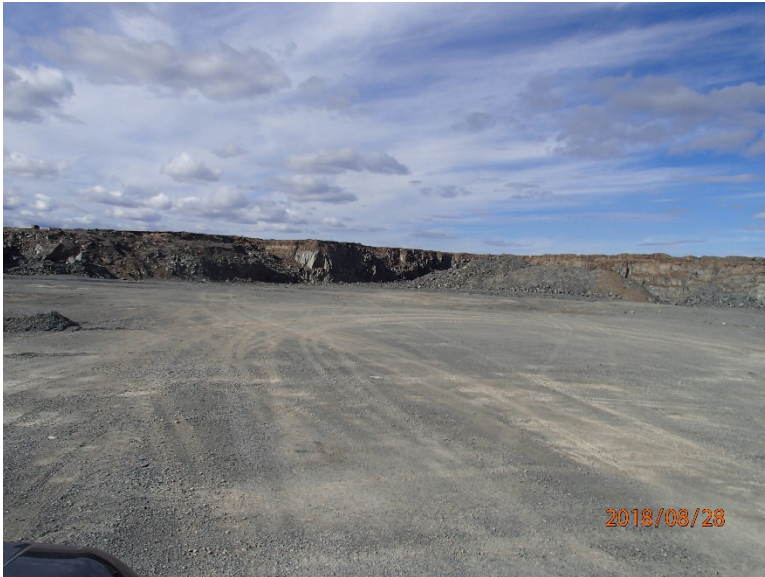
**Photograph F1-16: Quarry 10 – km 48+900**

**Description:** Overview of the quarry looking north at the east and north walls.

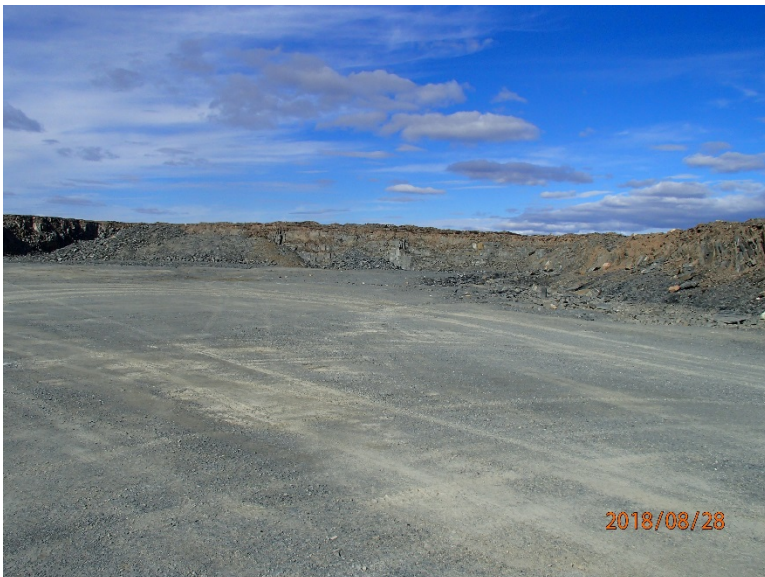
**Photograph F1-17: Quarry 11 – km 53+500**

**Description:** Overview of Quarry 11 looking at the west and north walls.
