# **Meadowbank and Whale Tail 2018 Annual Geotechnical Inspection**

# 2018 Annual Geotechnical Inspection

*Meadowbank Gold Mine, Nunavut*

18101627-1583-R-Rev0

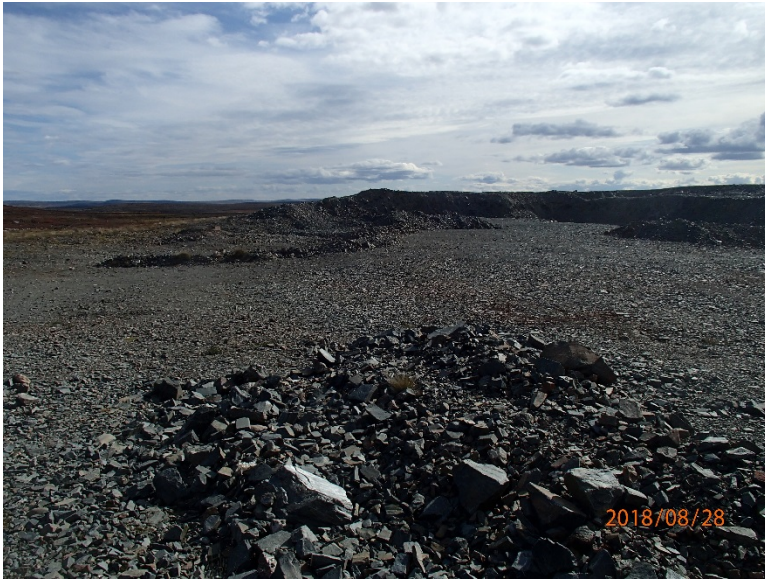
**Photograph F1-18: Quarry 11 – km 53+500**

**Description:** Overview of Quarry 11 looking at the north and east walls.

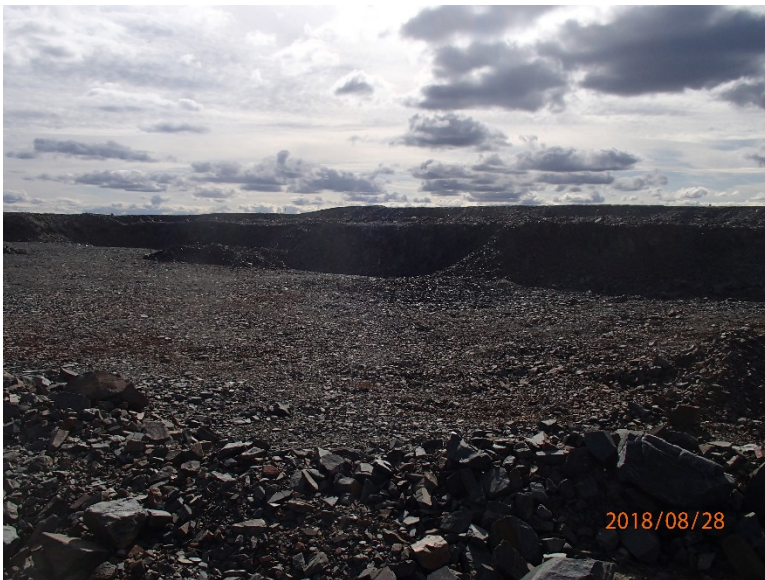
**Photograph F1-19: Quarry 12 – km 58+300**

**Description:** View of the south and east walls.

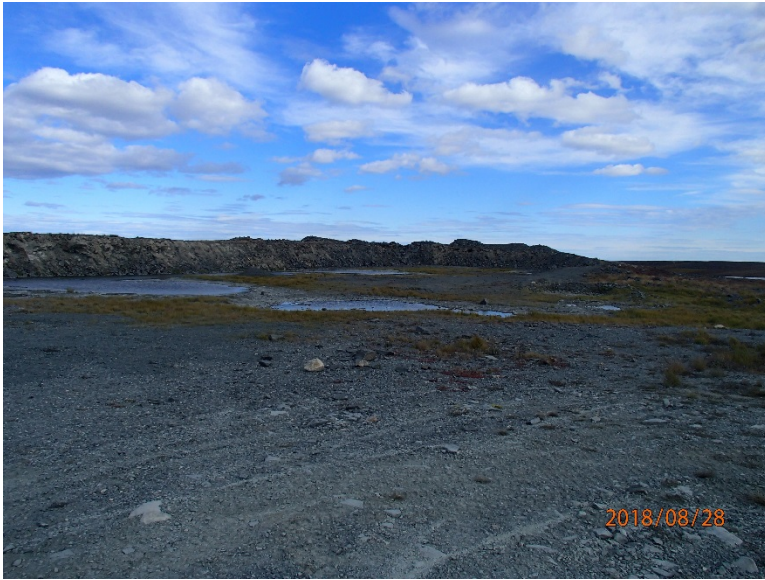
**Photograph F1-20: Quarry 12 – km 58+300**

**Description:** View of the west wall.

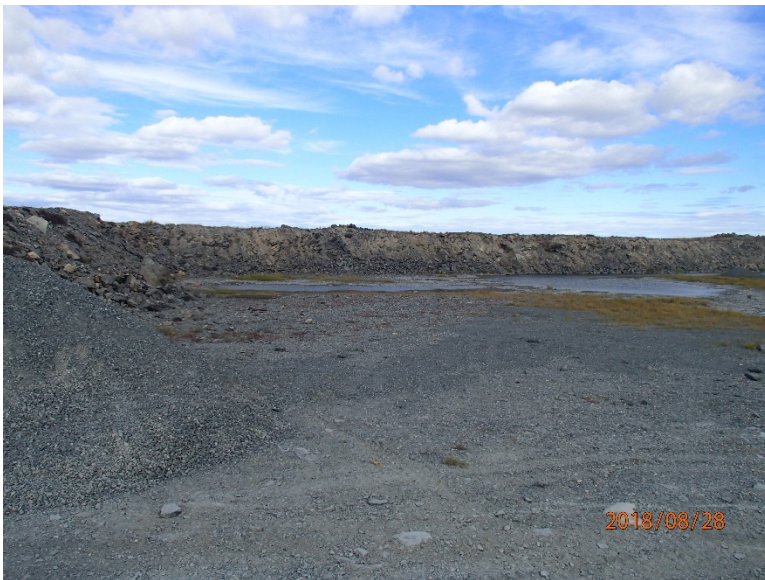
**Photograph F1-21: Quarry 13 – km 62+350**

**Description:** View of the west and north walls.

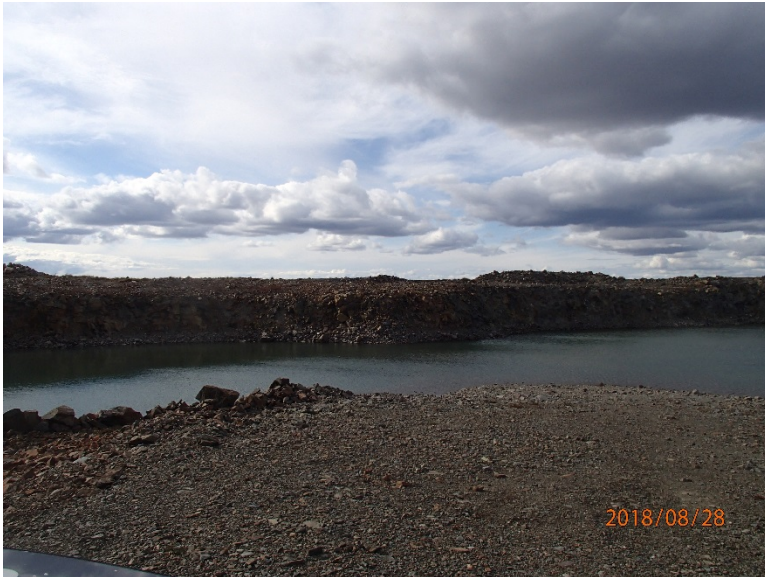
**Photograph F1-22: Quarry 13 – km 62+350**

**Description:** Looking at the south and east walls.

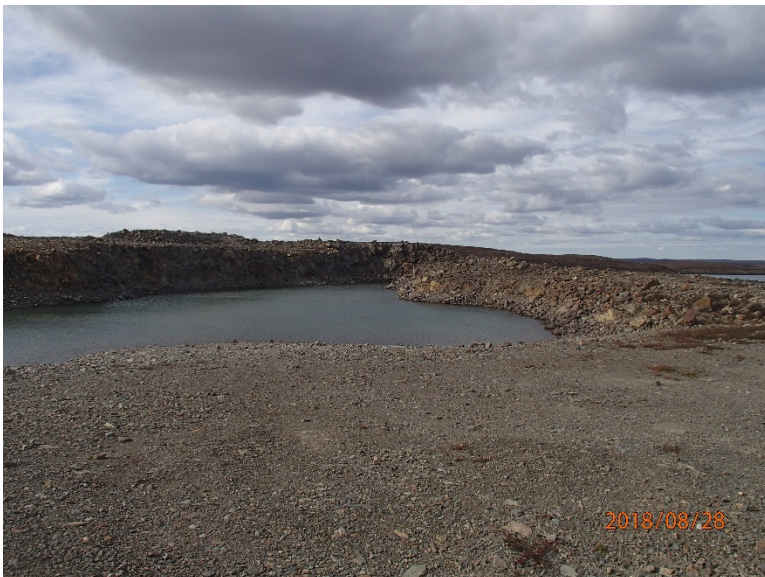
**Photograph F1-23: Quarry 14 – km 65+700**

**Description:** View of west and south walls. Quarry flooded.

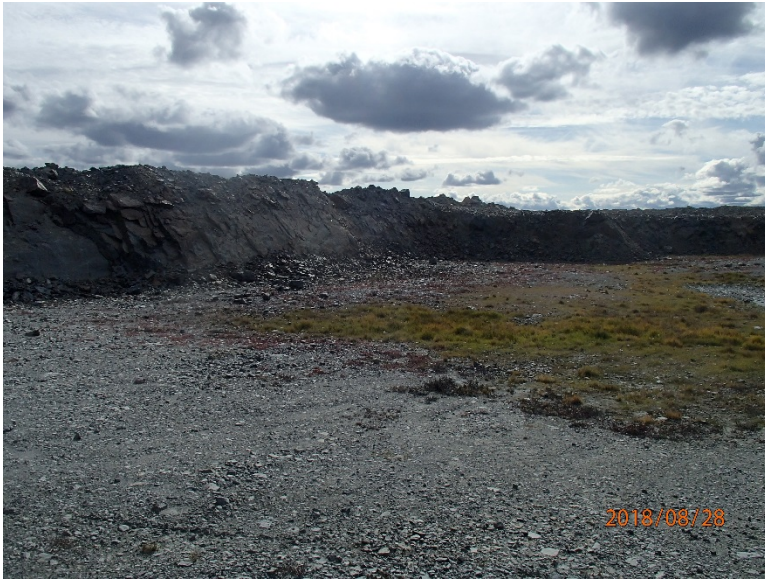
**Photograph F1-24: Quarry 14 – km 65+700**

**Description:** View of north and west walls. Quarry flooded.

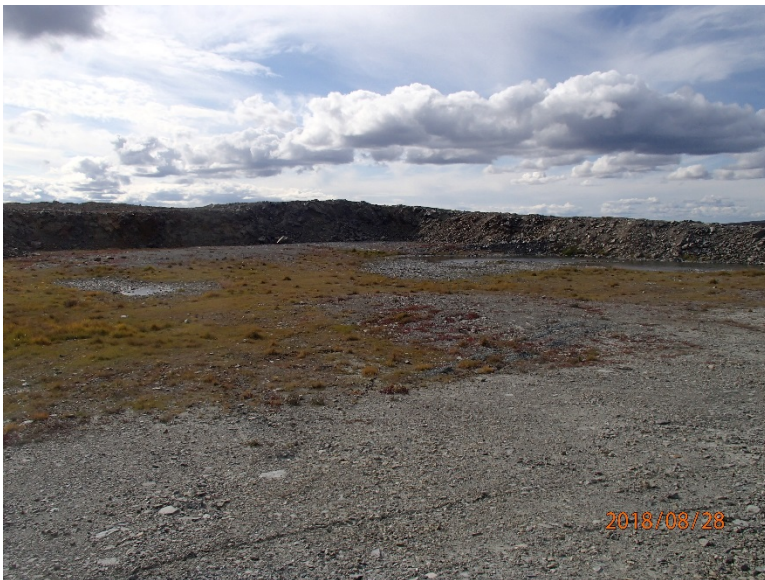
**Photograph F1-25: Quarry 15 – km 67+600**

**Description:** View of the south and west walls.

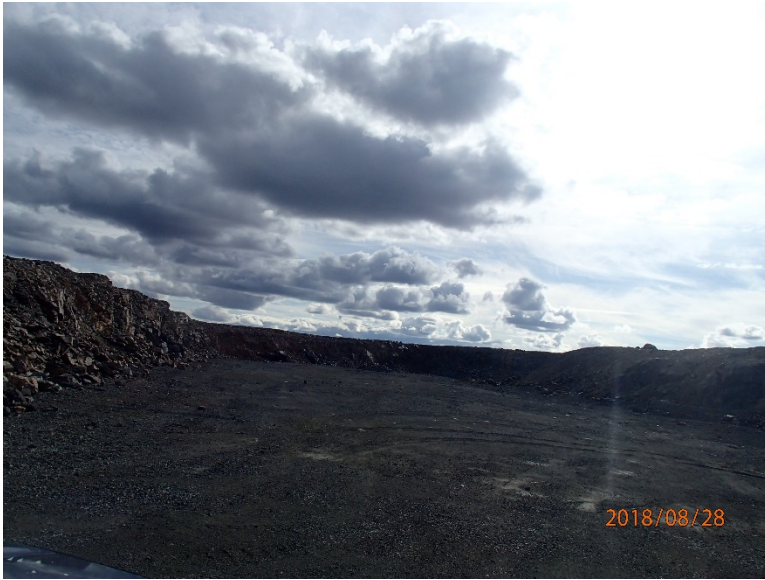
**Photograph F1-26: Quarry 15 – km 67+600**

**Description:** View of the north and west walls. Accumulation of water inside the quarry.

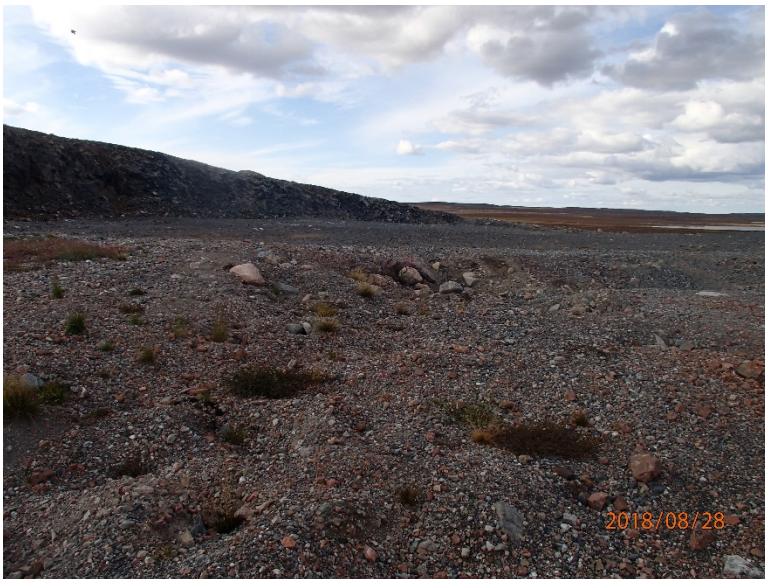
**Description:** View of the south wall.

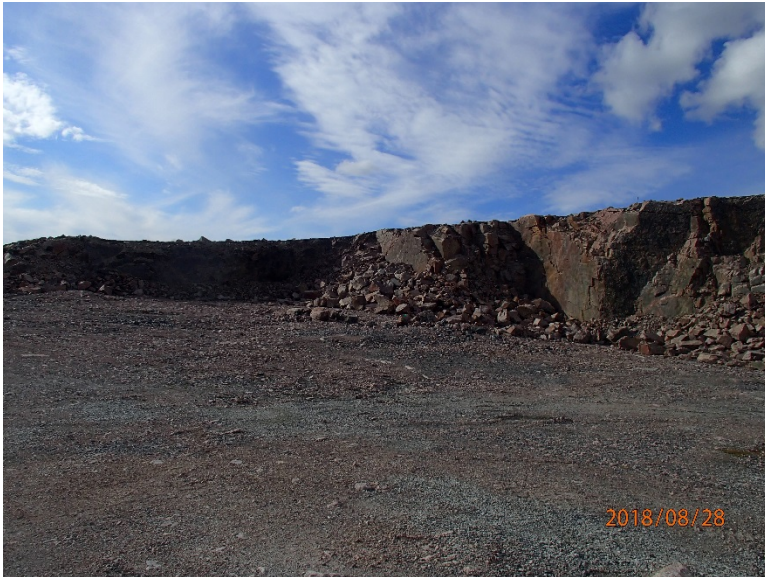
**Photograph F1-30: Quarry 18 – km 80+200**

**Description:** Looking at the north and west walls.

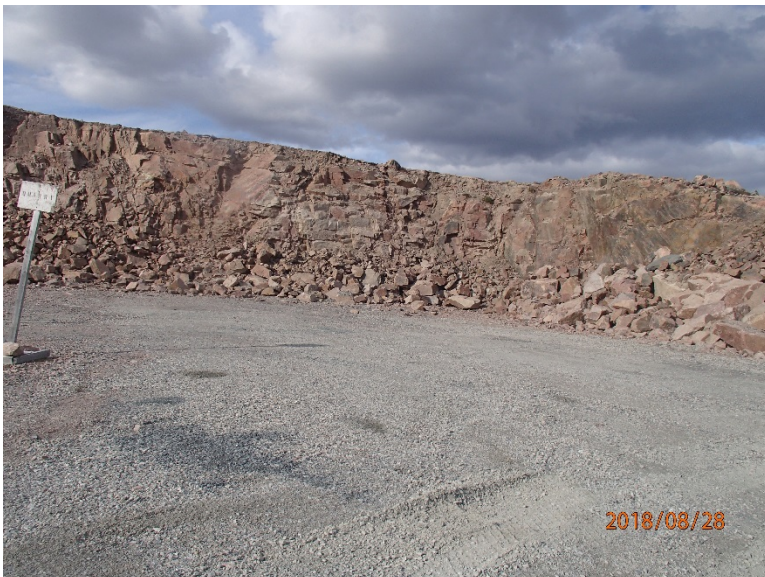
**Photograph F1-31: Quarry 19 – km 84+300**

**Description:** Looking at the north and west walls.

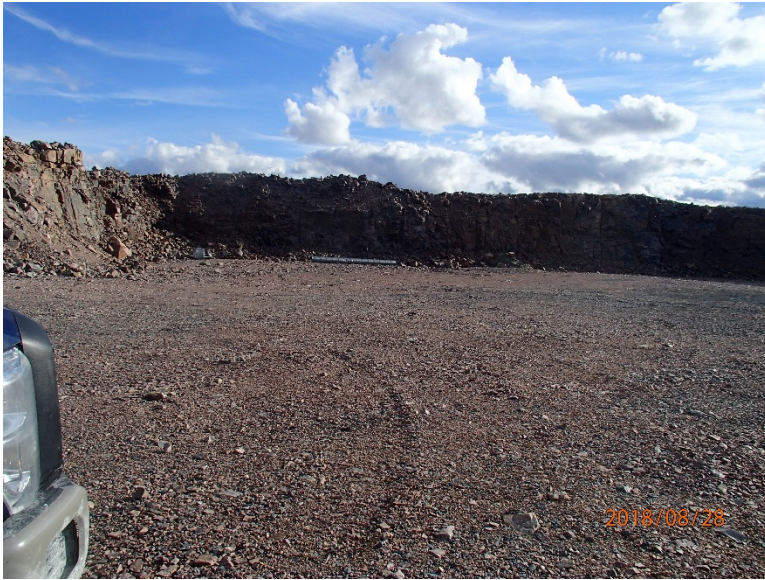
**Photograph F1-32: Quarry 19 – km 84+300**

**Description:** Looking at the north and east walls.

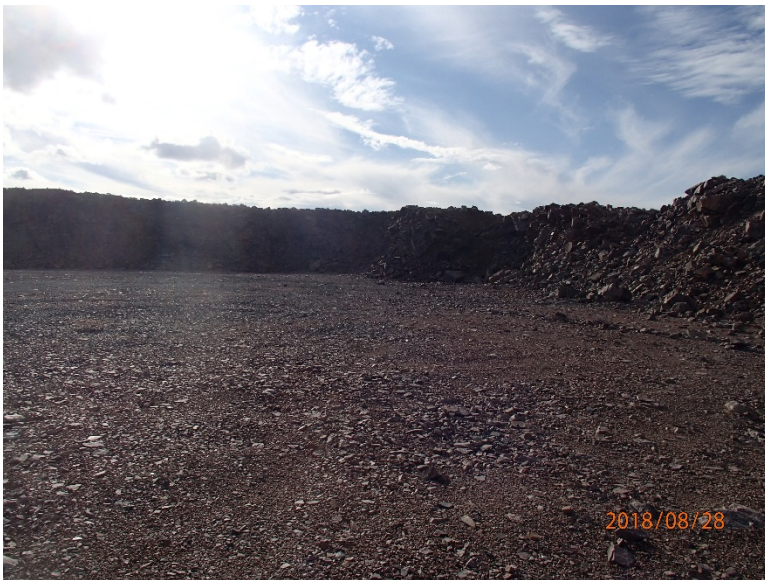
**Photograph F1-33: Quarry 21 – km 93+400**

**Description:** Looking at the south and east walls.

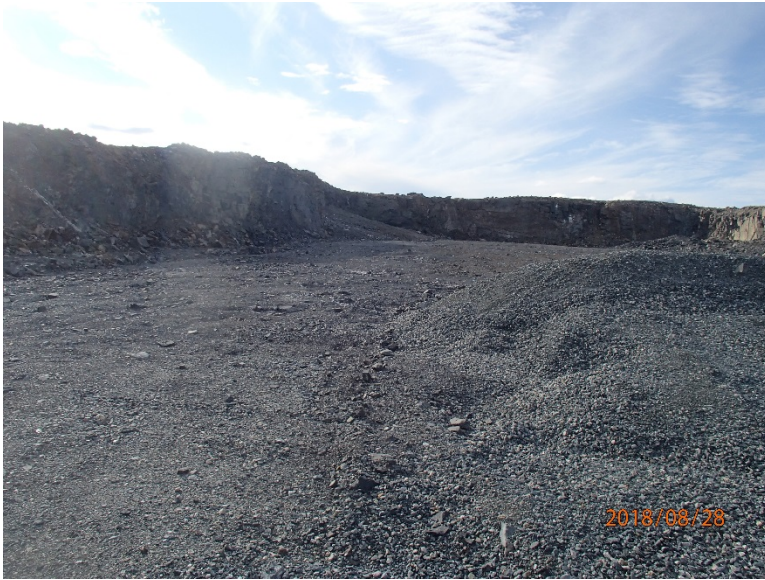
**Photograph F1-34: Quarry 21 – km 93+400**

**Description:** Looking at the north and the west walls.

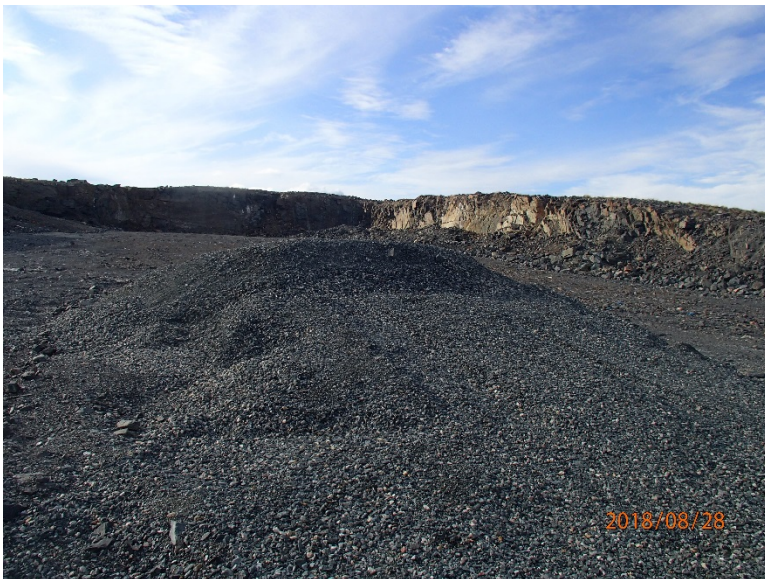
**Photograph F1-35: Quarry 22 – km 99+200**

**Description:** View of the south and west walls.

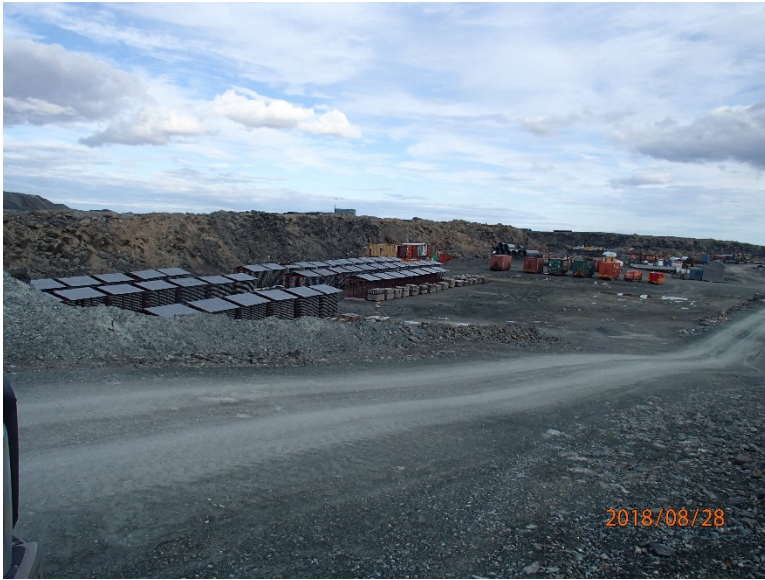
**Photograph F1-36: Quarry 22 – km 99+200**

**Description:** Looking at the north and west walls.

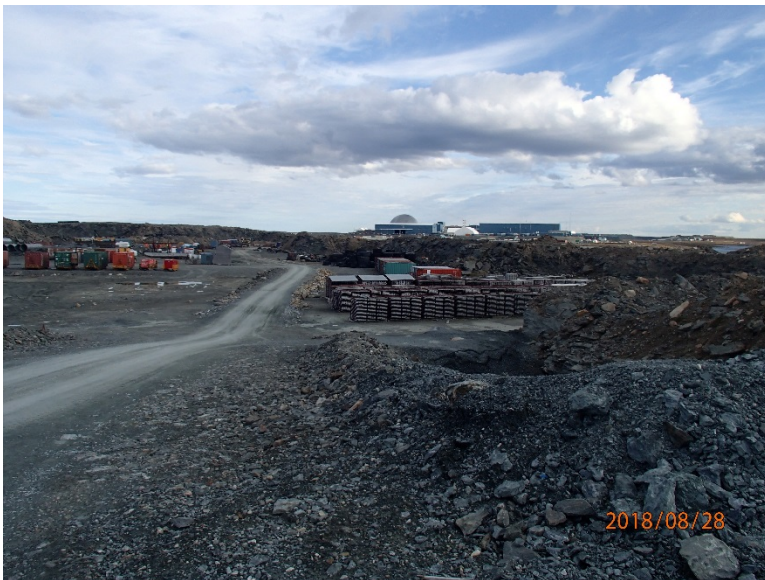
**Photograph F1-37: Quarry 23 (Airstrip Quarry)**

**Description:** Looking at the north wall.

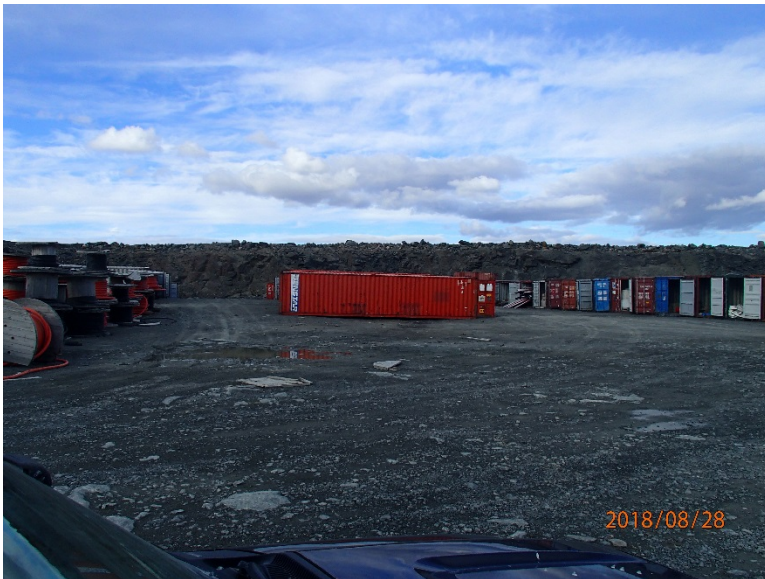
**Photograph F1-38: Quarry 23 (Airstrip Quarry)**

**Description:** Looking at the south wall.

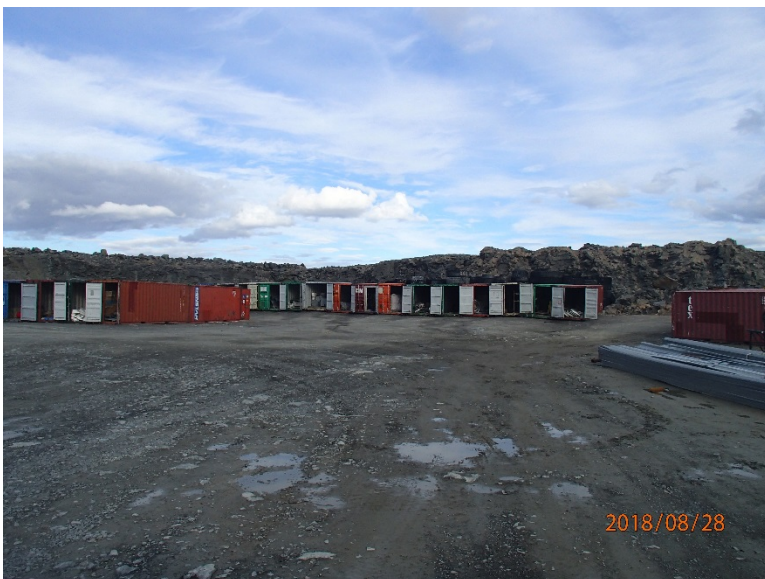
**Photograph F1-39: Quarry 23 (Airstrip Quarry)**

**Description:** Looking at the north wall. Presence of loose rocks along steep wall.

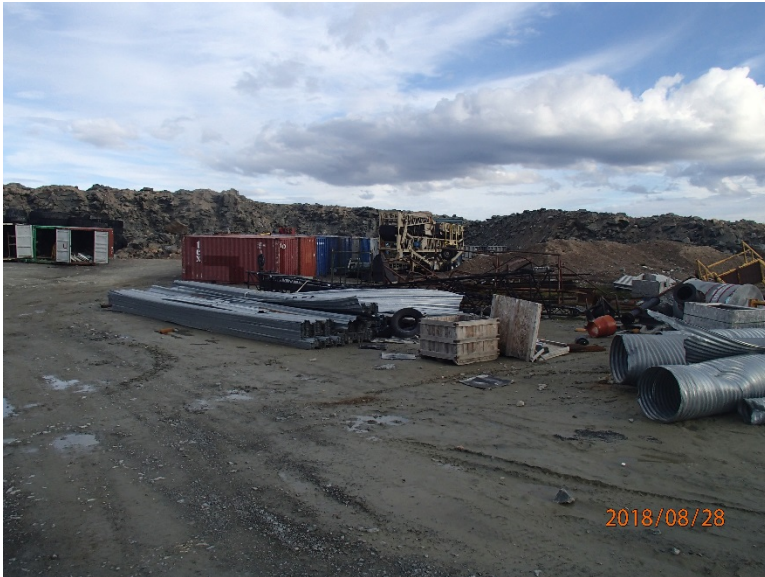
**Photograph F1-40: Quarry 23 (Airstrip Quarry)**

**Description:** Looking at the north and east walls.

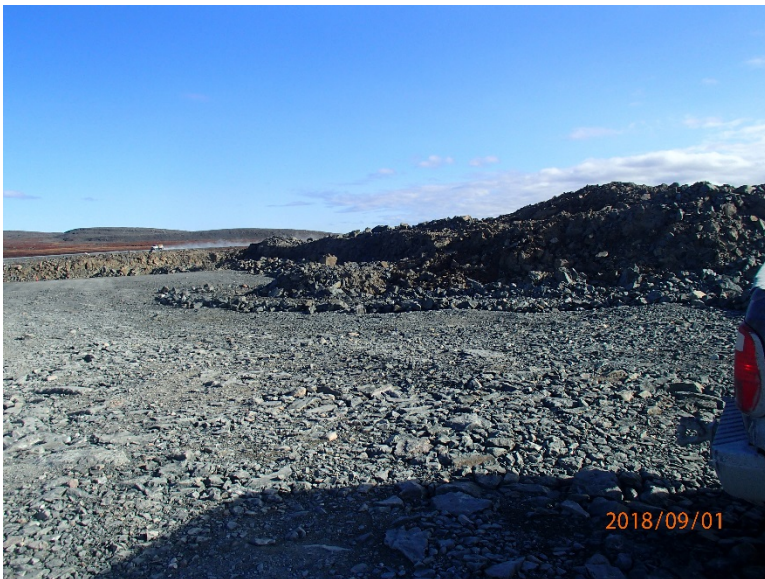
**Photograph F2-1 Eskers and Quarries 1 – km 10+500**

**Description:** View of Quarry 10.5. Loose rock is present on the steep wall.

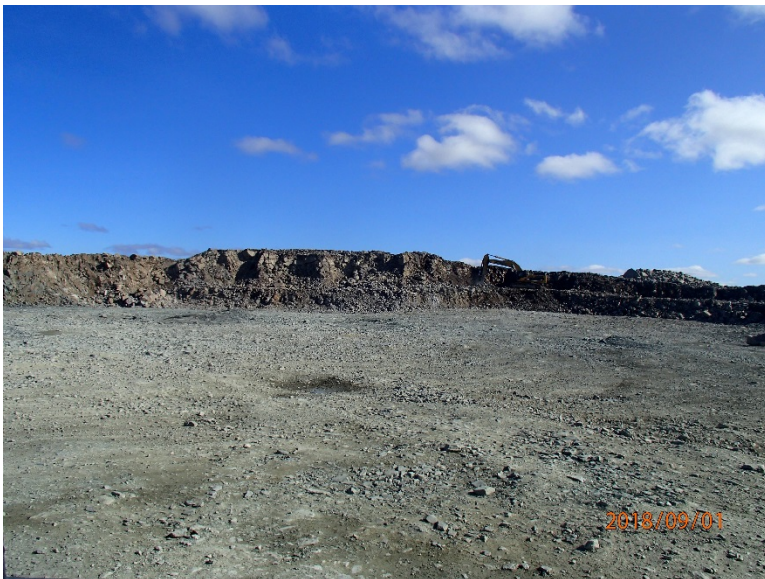
**Description:** View of esker #2. General good condition but some steep walls and loose rocks.

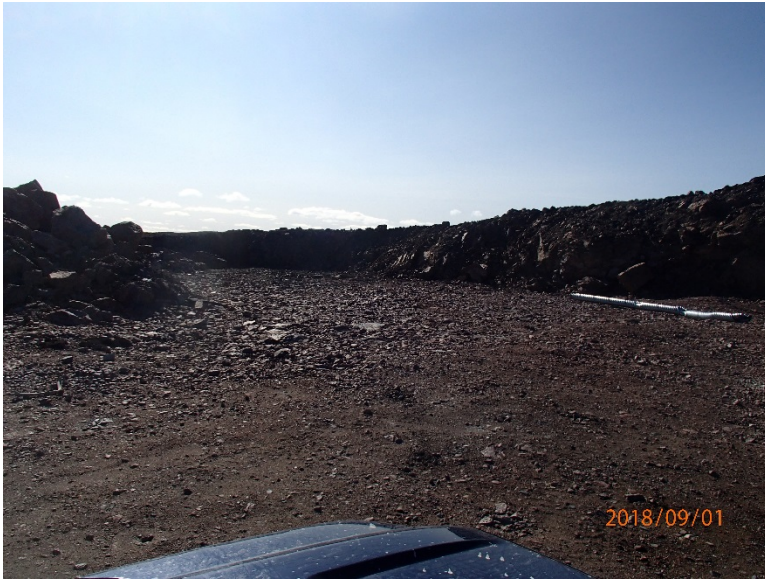
**Description:** View of esker #3. North access ramp along a steep slope that seems undercut at its toe.

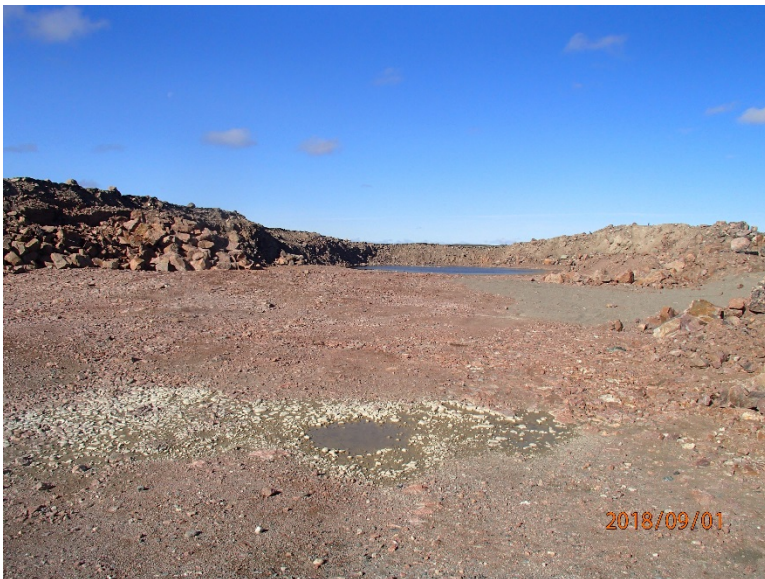
**Photograph F2-7 Eskers and Quarries 5 – km 52+000**

**Description:** View of the rock quarry at km 52. In good conditions with loose blocks and cobbles on the north wall.

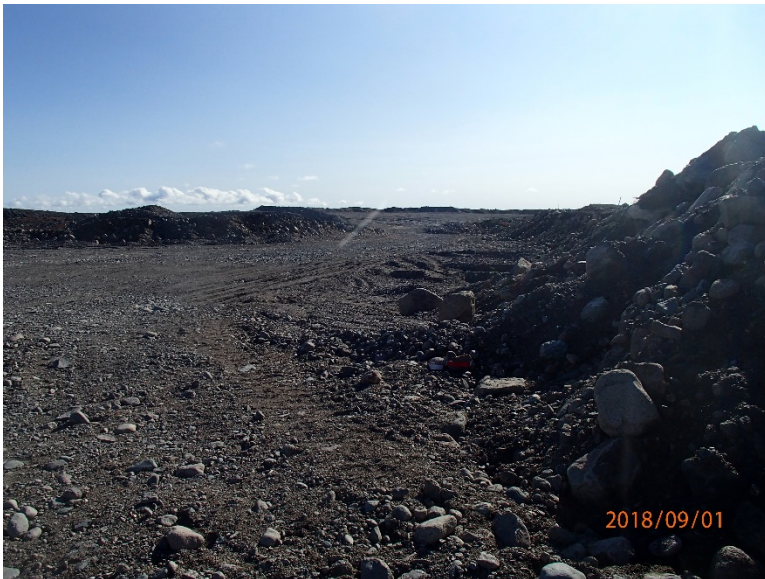
**Photograph F2-8 Eskers and Quarries 5 – km 52+000**

**Description:** View of the rock quarry at km 52. In good conditions with loose blocks and cobbles on the north wall.

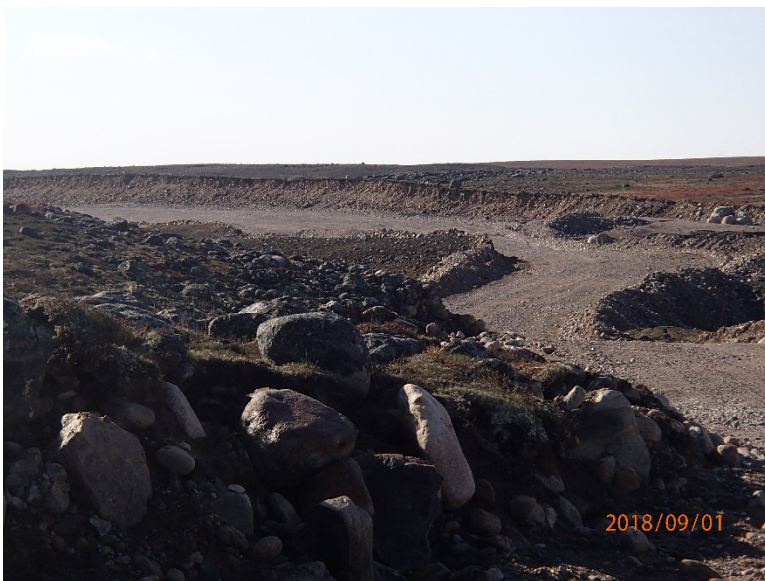
**Photograph F2-9 Eskers and Quarries 6 – km 62+500**

**Description:** View of esker #6. The 2-m high steep soil slopes are unstable.

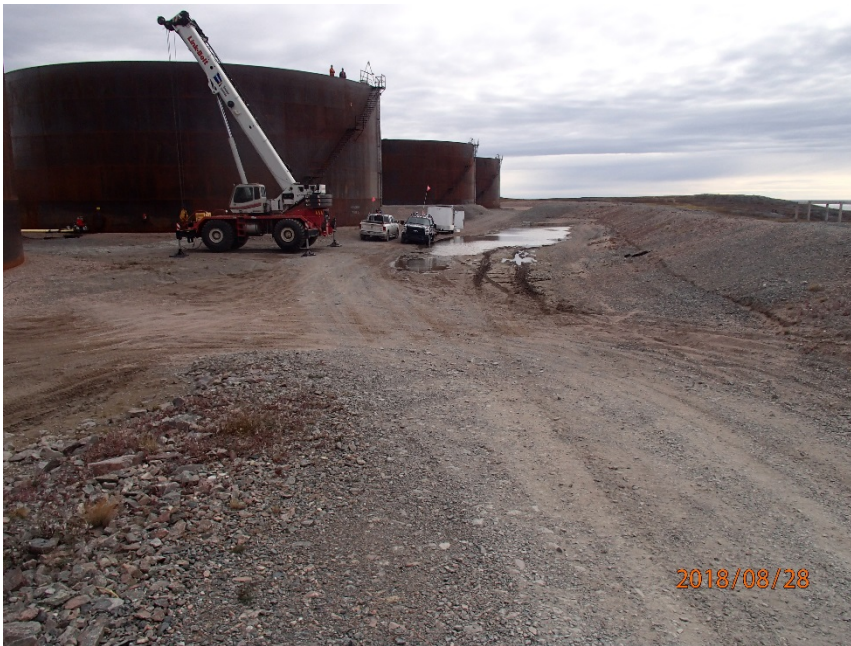
**Photograph G1-1 Baker Lake Tank Farm**

**Description:** From the south side of Tank 1, looking southeast at Tanks 1, 2, 3, and 4. Presence of water ponding.

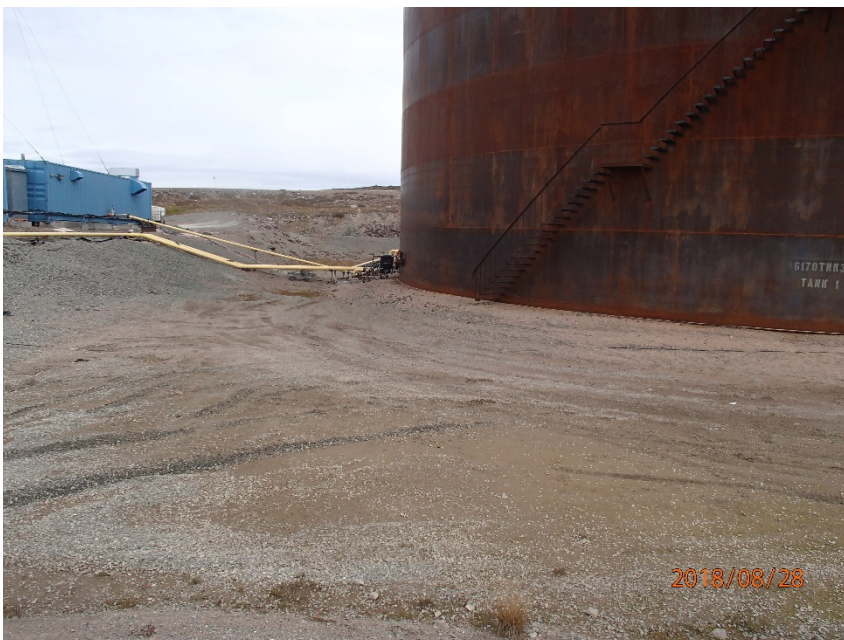
**Photograph G1-2 Baker Lake Tank Farm**

**Description:** Looking at the southwestern corner of Tank 1.

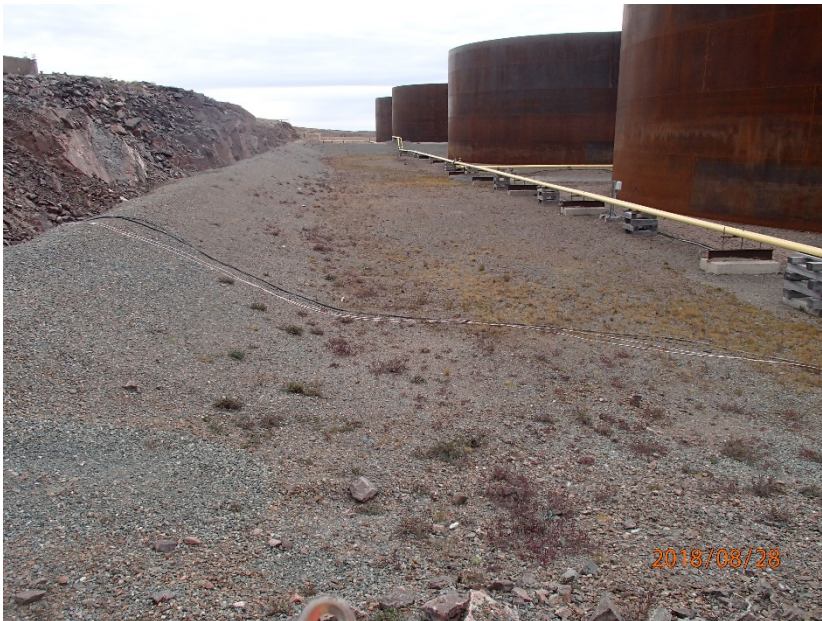
**Photograph G1-3 Baker Lake Tank Farm**

**Description:** From the north side of Tank 1, looking southeast at Tanks 1, 2, 3, and 4.

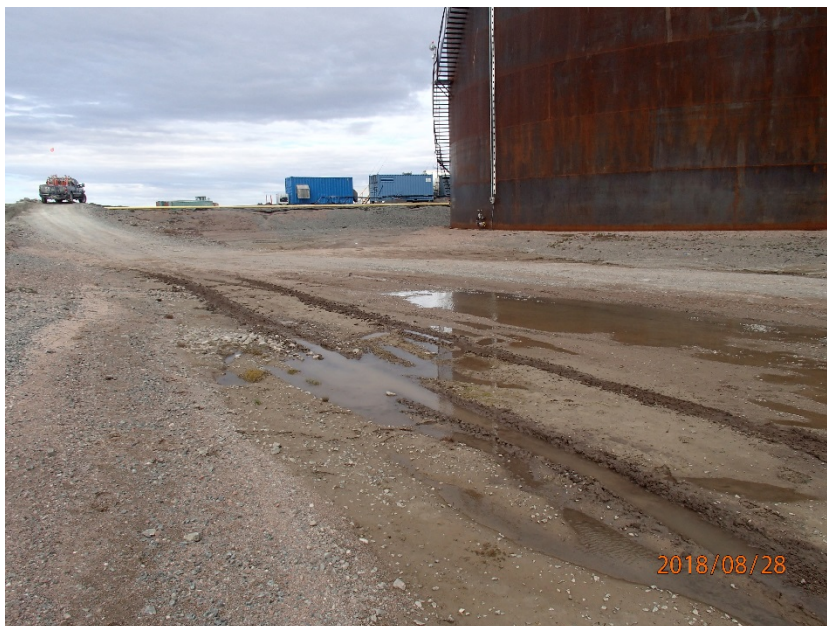
**Photograph G1-4 Baker Lake Tank Farm**

**Description:** Looking northwest toward the south side of Tank 1.

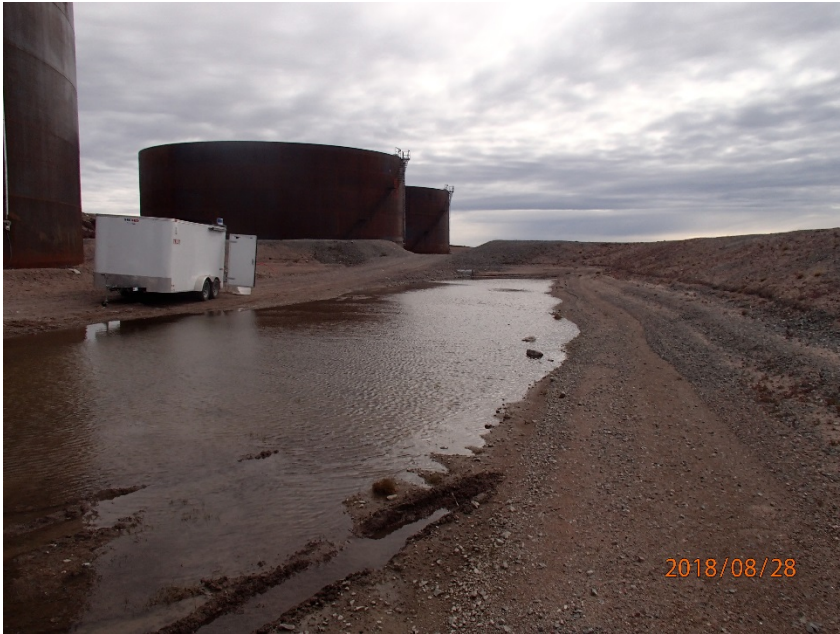
**Photograph G1-5 Baker Lake Tank Farm**

**Description:** Looking northeast toward the south side of Tanks 2 and 3.

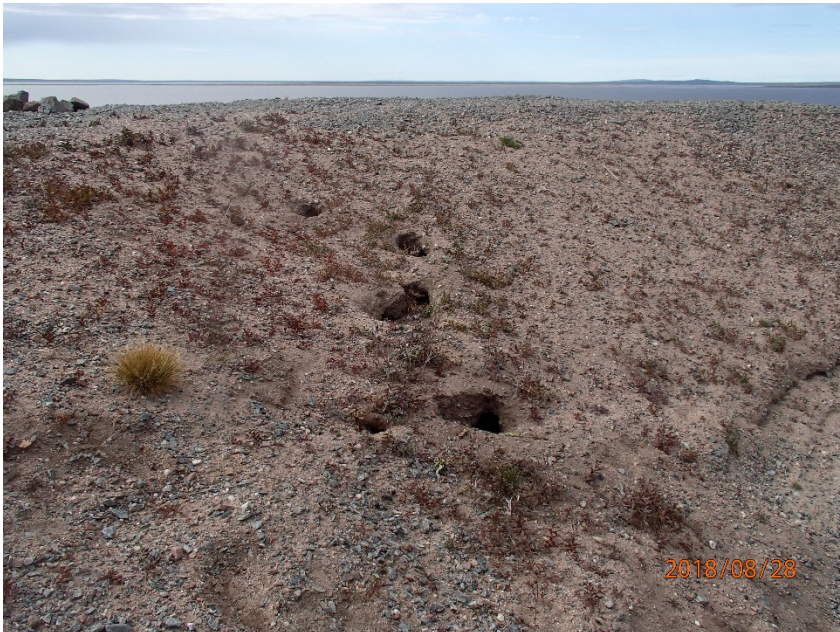
**Photograph G1-6 Baker Lake Tank Farm**

**Description:** Looking southwest toward the south wall of the tank farm. Presence of animal burrows.

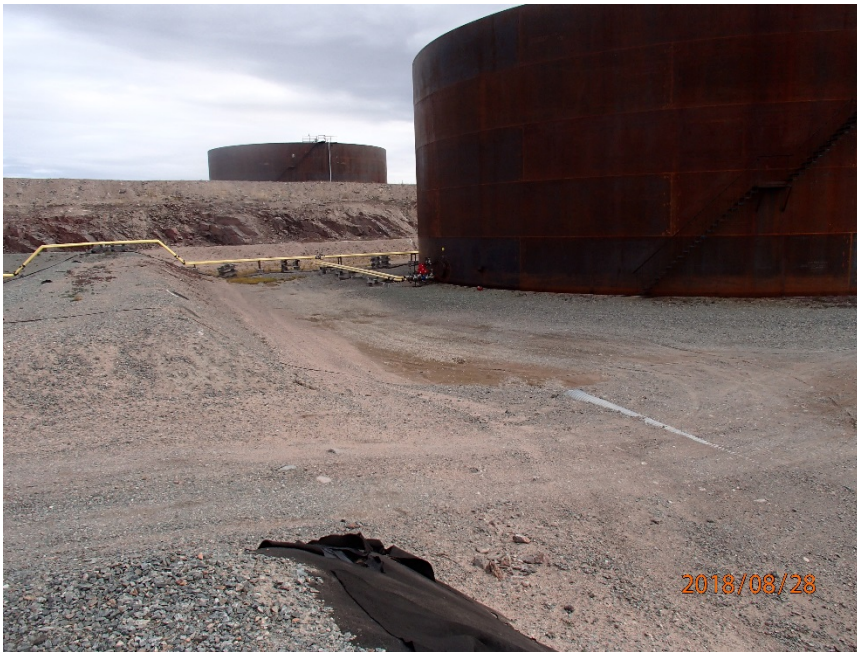
**Photograph G1-7 Baker Lake Tank Farm**

**Description:** Looking northeast. The geomembrane between the south side of tank 2 and 3 is damaged.

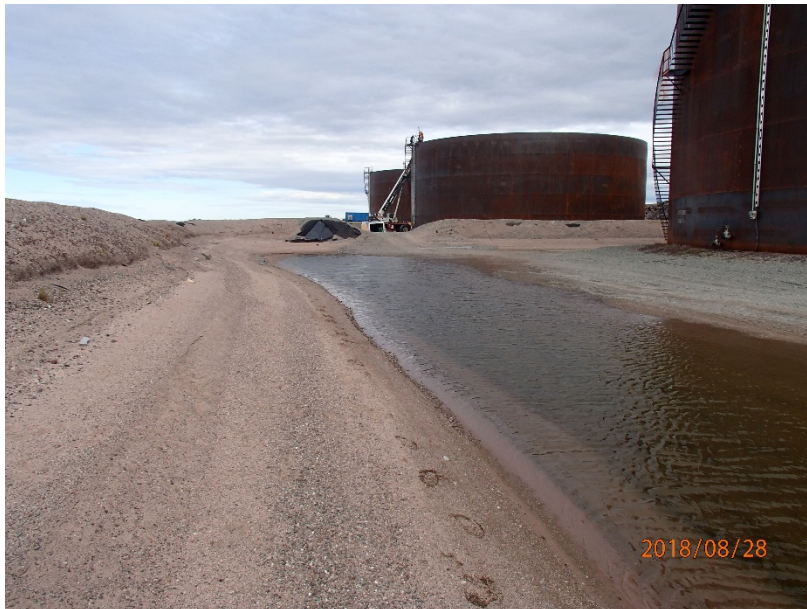
**Photograph G1-9 Baker Lake Tank Farm**

**Description:** From the southeastern corner of Tank 3, looking northwest at the south side of Tank 3, 2 and 1. View of exposed LLDPE.

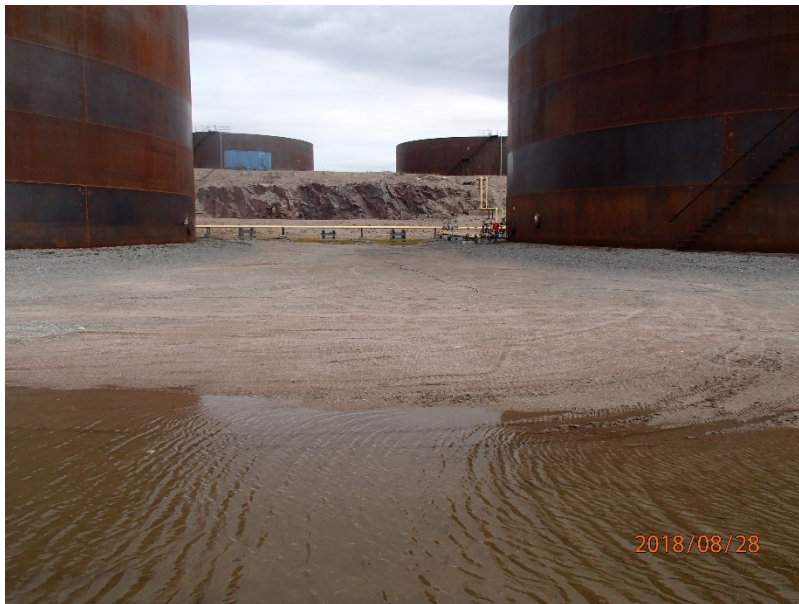
**Photograph G1-10 Baker Lake Tank Farm**

**Description:** From the south portion of the site looking north at the south side of Tank 3, 4 and 5.

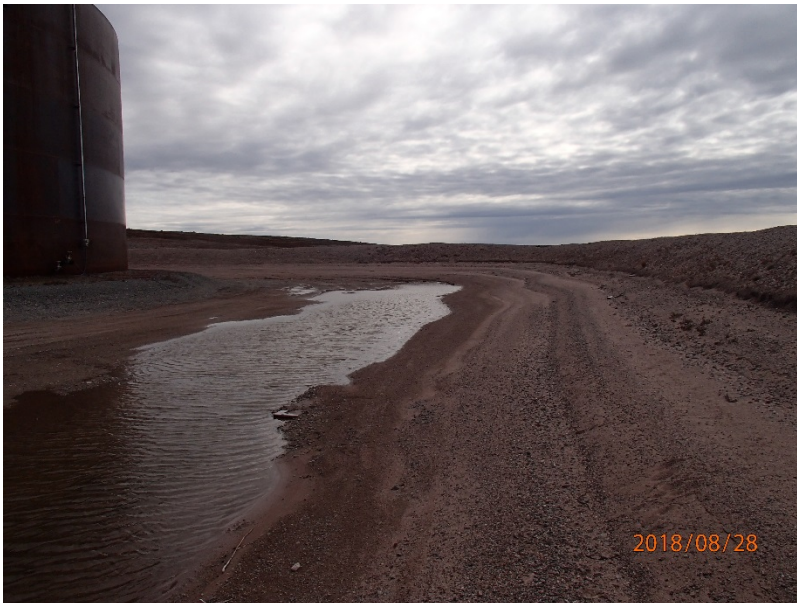
**Photograph G1-11 Baker Lake Tank Farm**

**Description:** From the south portion of the site looking southeast.

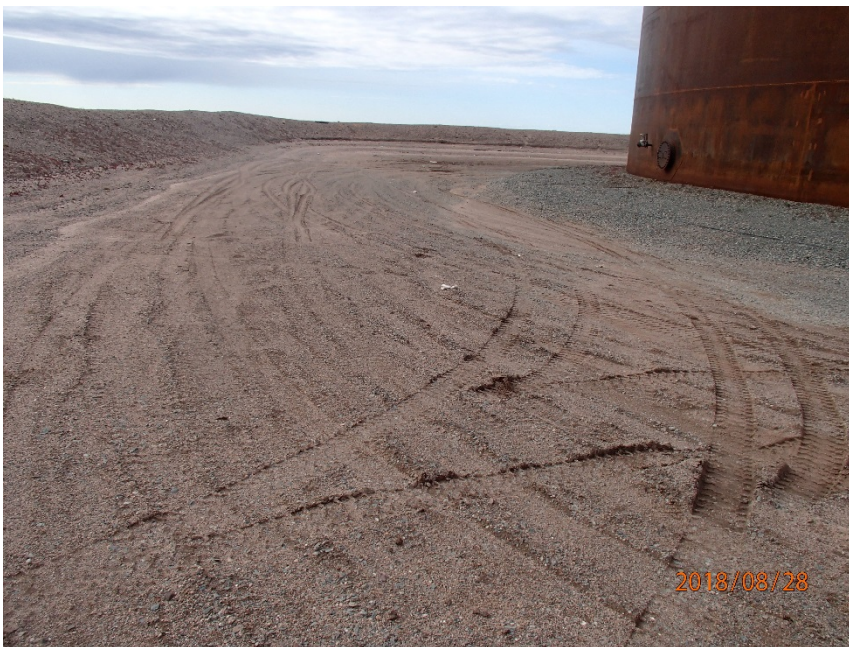
**Photograph G1-12 Baker Lake Tank Farm**

**Description:** From the northeastern corner of Tank 4 looking southwest toward Tank 4.

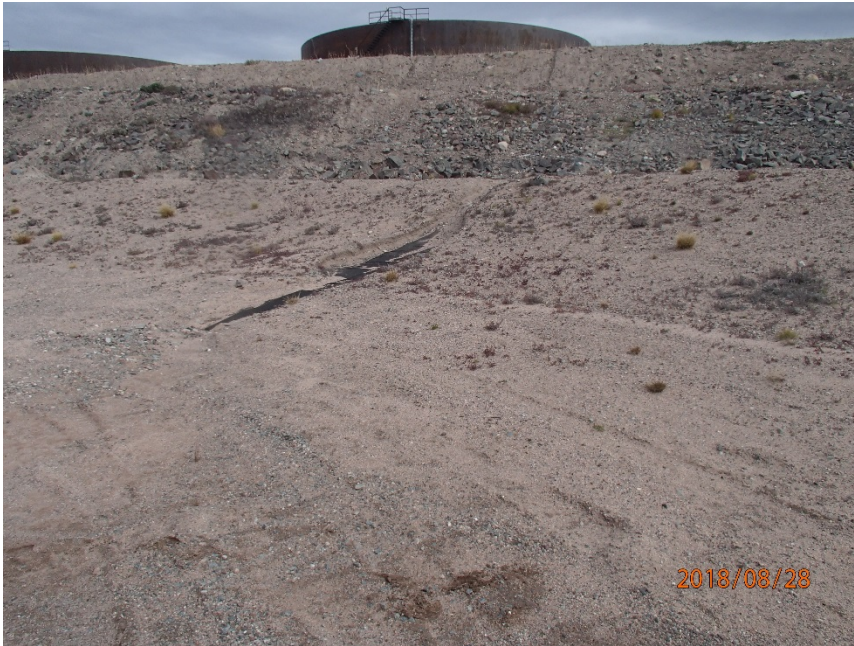
**Photograph G1-13 Baker Lake Tank Farm**

**Description:** From the northern side of Tank 4, looking northeast toward Tanks 4, 3, 2, and 1. Presence of exposed liner.

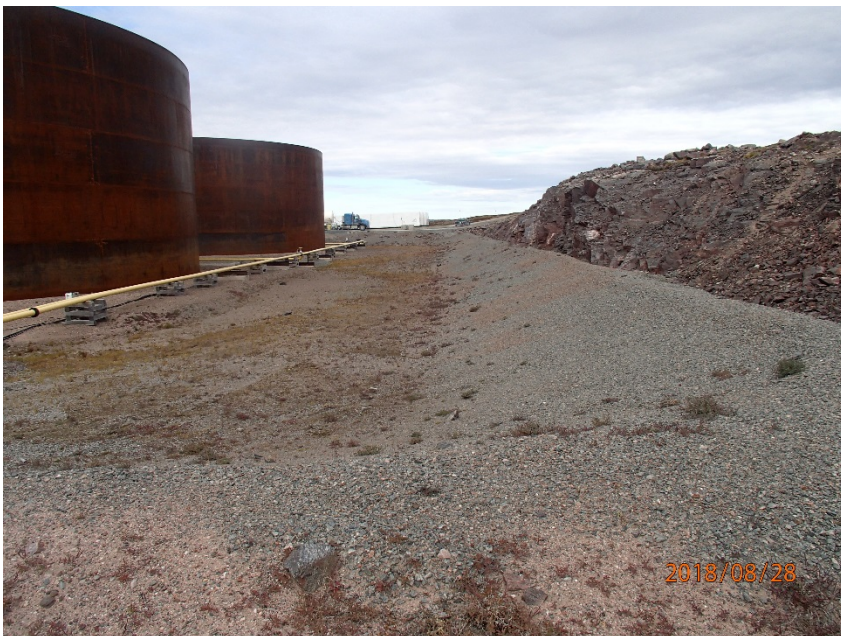
**Photograph G1-14 Baker Lake Tank Farm**

**Description:** From the northeastern corner of Tank 2 looking northwest towards the northeastern side of Tanks 1 and 2.

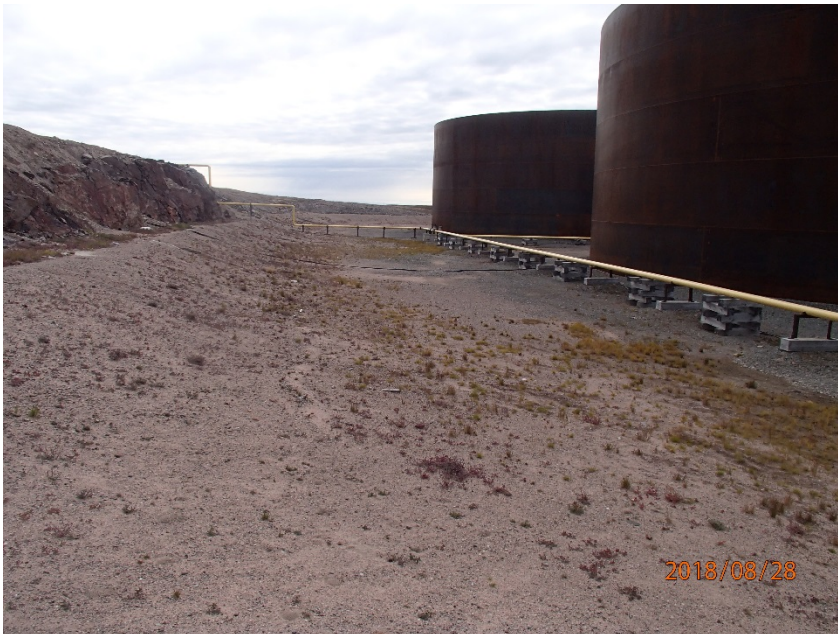
**Photograph G1-15 Baker Lake Tank Farm**

**Description:** From the northwestern corner of Tank 3 looking southeast towards the northeastern side of Tanks 3 and 4.

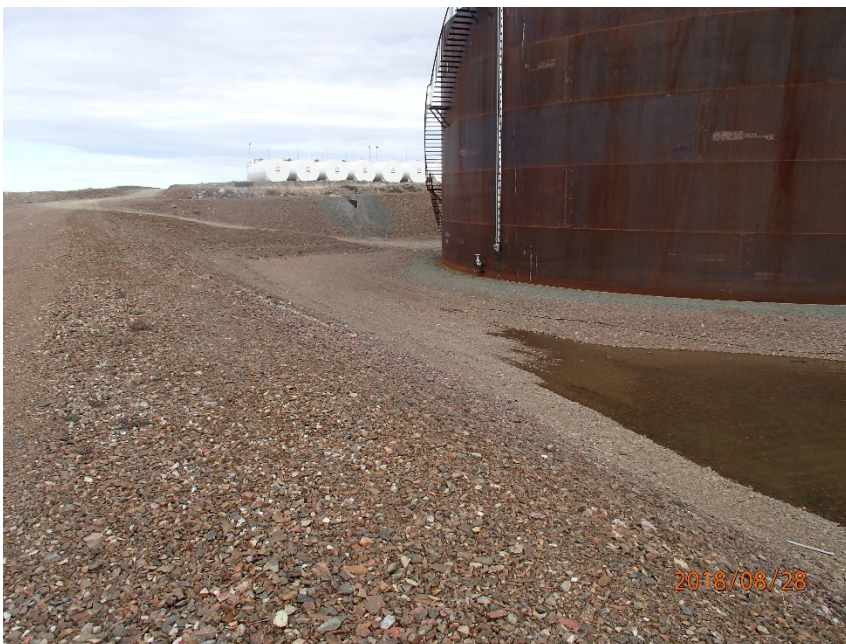
**Photograph G1-16 Baker Lake Tank Farm**

**Description:** Looking northwest at the southern and western sides of Tank 5.

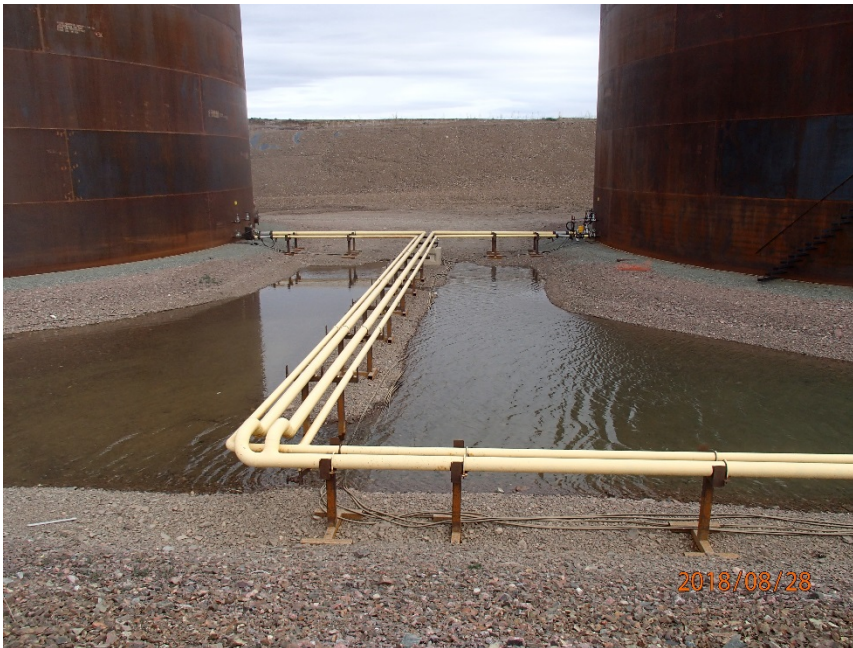
**Photograph G1-17 Baker Lake Tank Farm**

**Description:** Looking north between Tanks 5 and 6. Presence of water ponding.

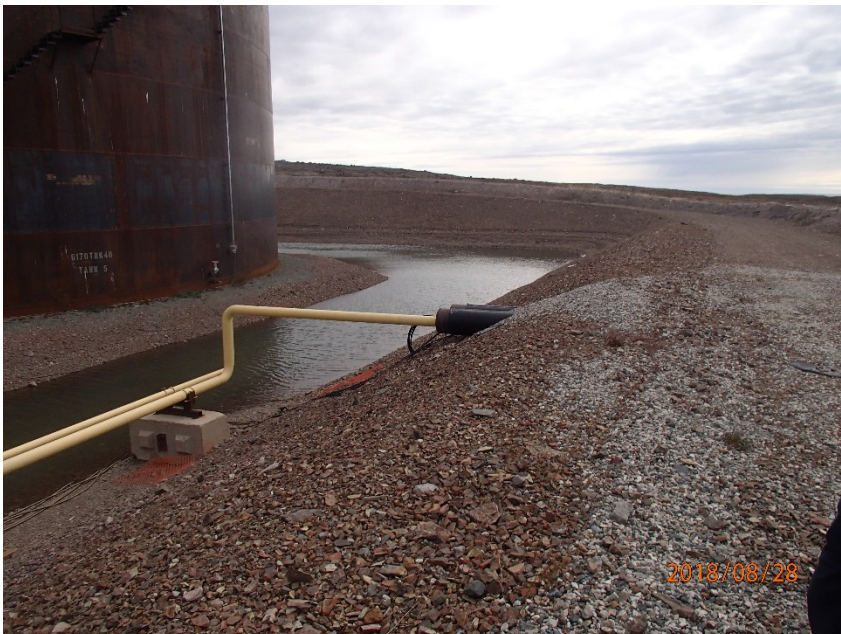
**Photograph G1-18 Baker Lake Tank Farm**

**Description:** Looking northeast at the southern side of Tank 6. Presence of water ponding.

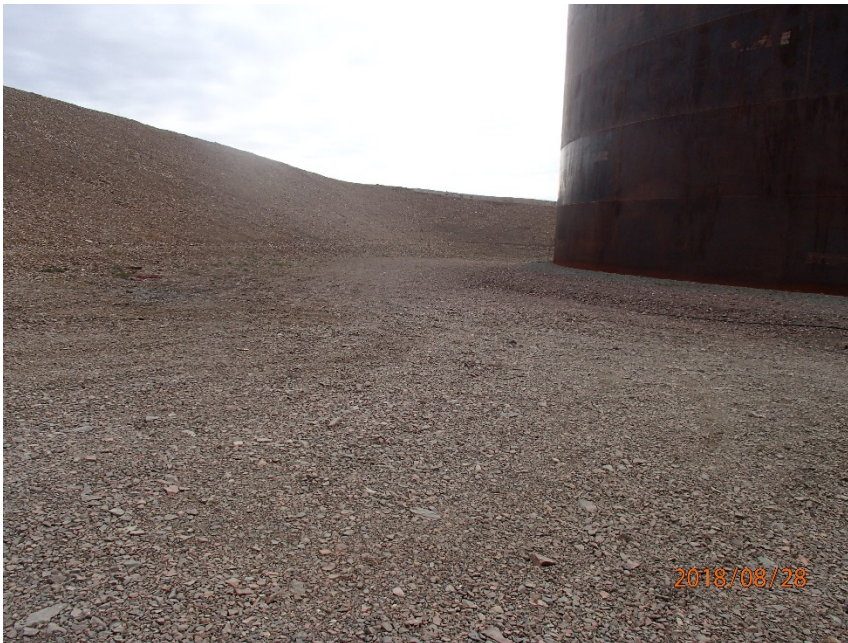
**Photograph G1-19 Baker Lake Tank Farm**

**Description:** Looking southeast at the northeastern side of Tank 6. Presence of water ponding.
