# **Meadowbank and Whale Tail 2018 Annual Geotechnical Inspection**

# 2018 Annual Geotechnical Inspection

*Meadowbank Gold Mine, Nunavut*

18101627-1583-R-Rev0

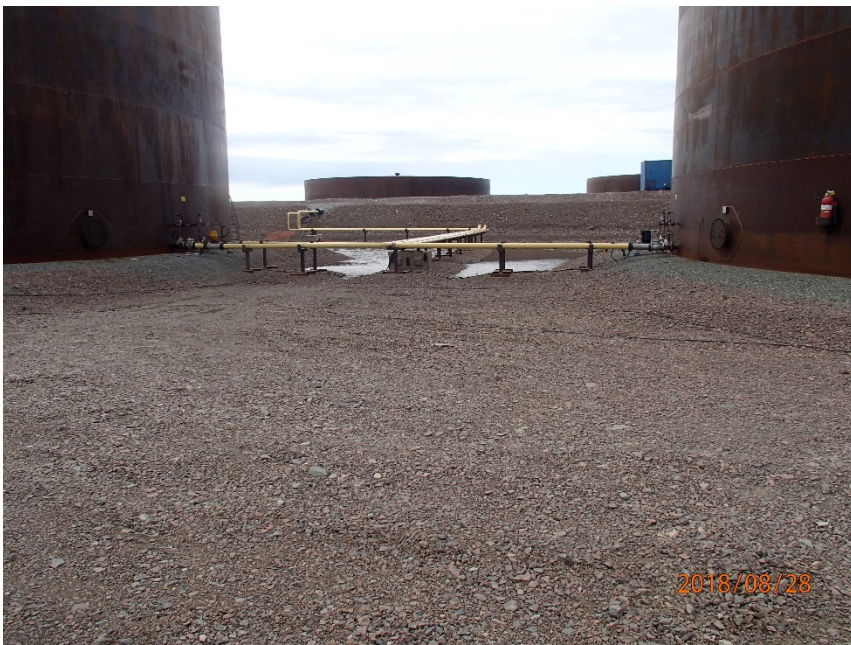
**Photograph G1-20 Baker Lake Tank Farm**

**Description:** Looking south between Tanks 5 and 6.

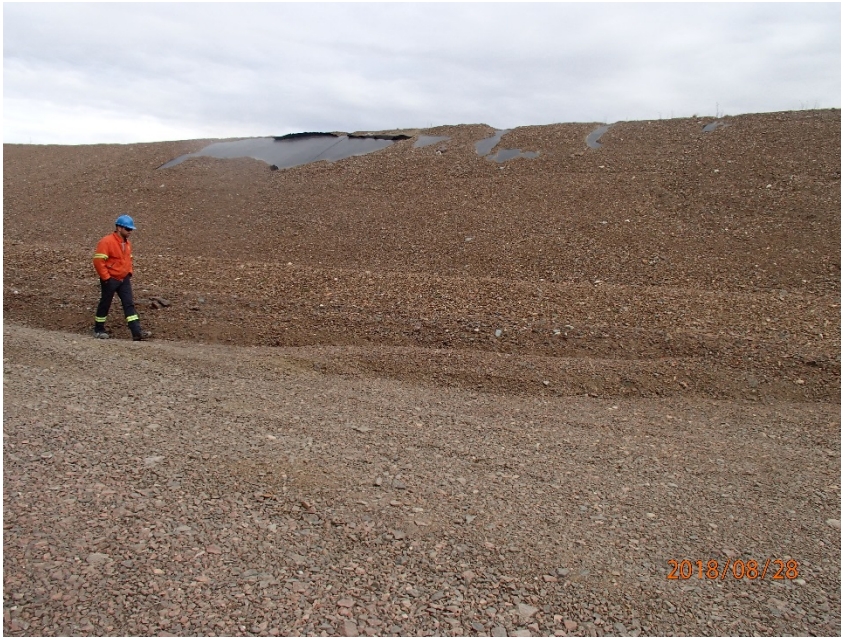
**Photograph G1-21 Baker Lake Tank Farm**

**Description:** Looking west at the northeastern side of Tank 5.

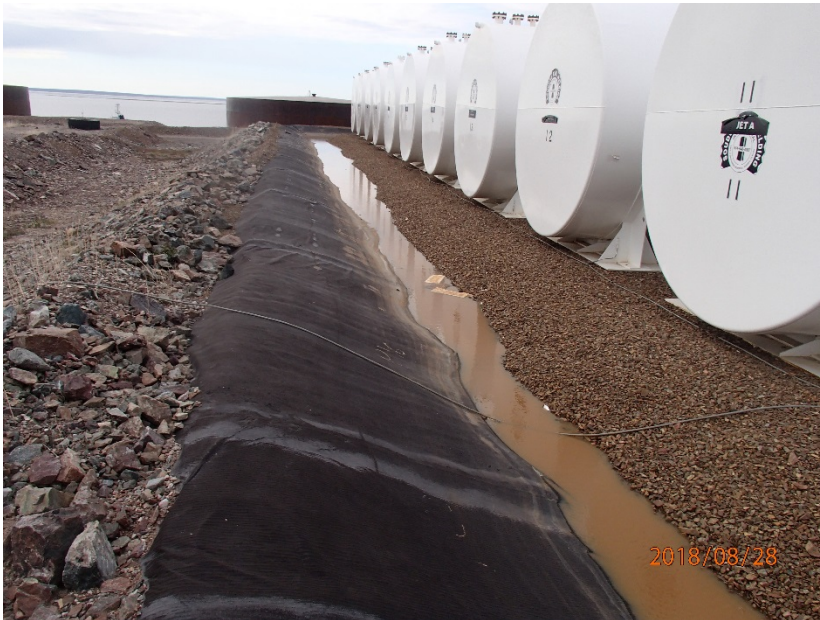
**Photograph G1-22 Baker Lake Tank Farm**

**Description:** From the northeastern corner of the Jet A fuel tanks looking south. Presence of exposed geomembrane.

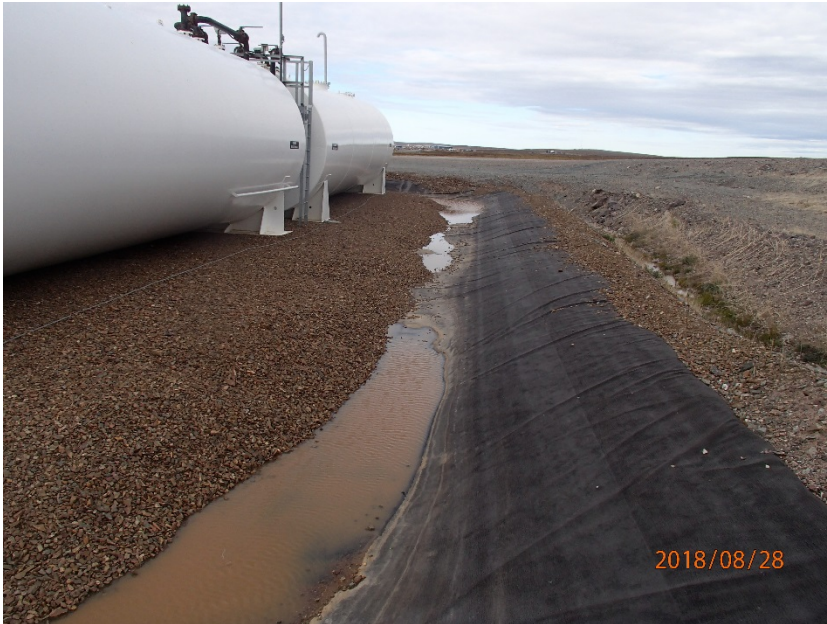
**Photograph G1-23 Baker Lake Tank Farm**

**Description:** From the northeastern corner of the Jet A fuel tanks looking west. Presence of exposed geomembrane.

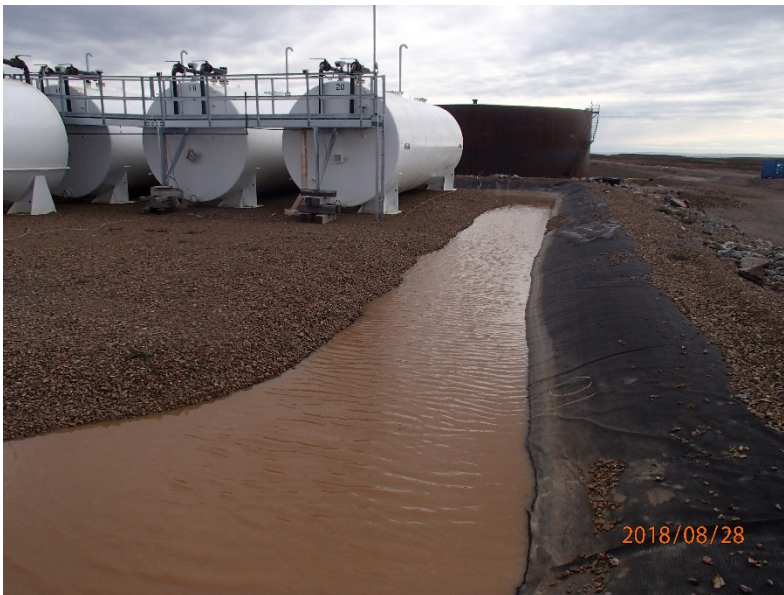
**Photograph G1-24 Baker Lake Tank Farm**

**Description:** From the southwestern corner of the Jet A fuel tanks looking east. Presence of exposed geomembrane and water ponding.

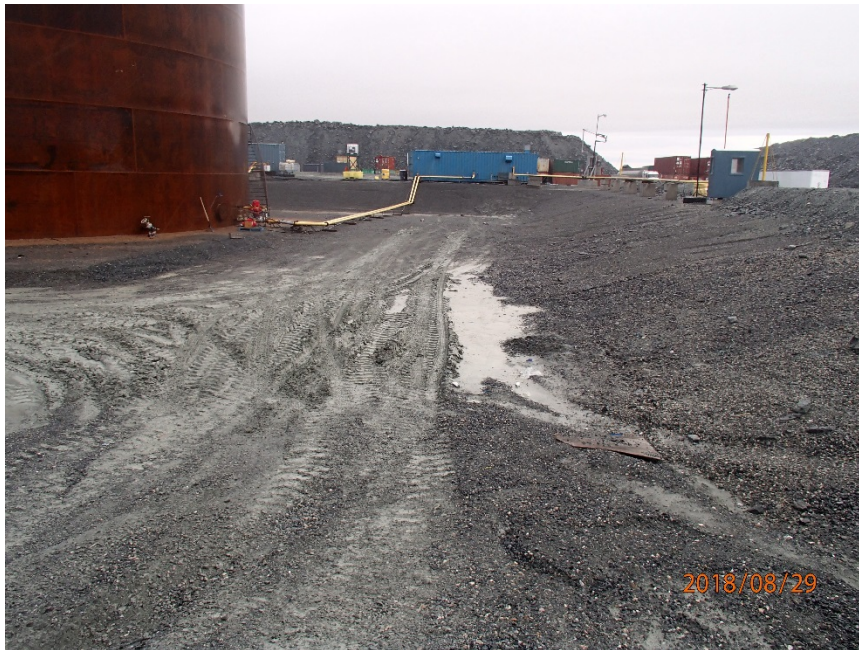
**Photograph G2-1 Meadowbank Tank Farm**

**Description:** From the western corner, looking east at the tank.

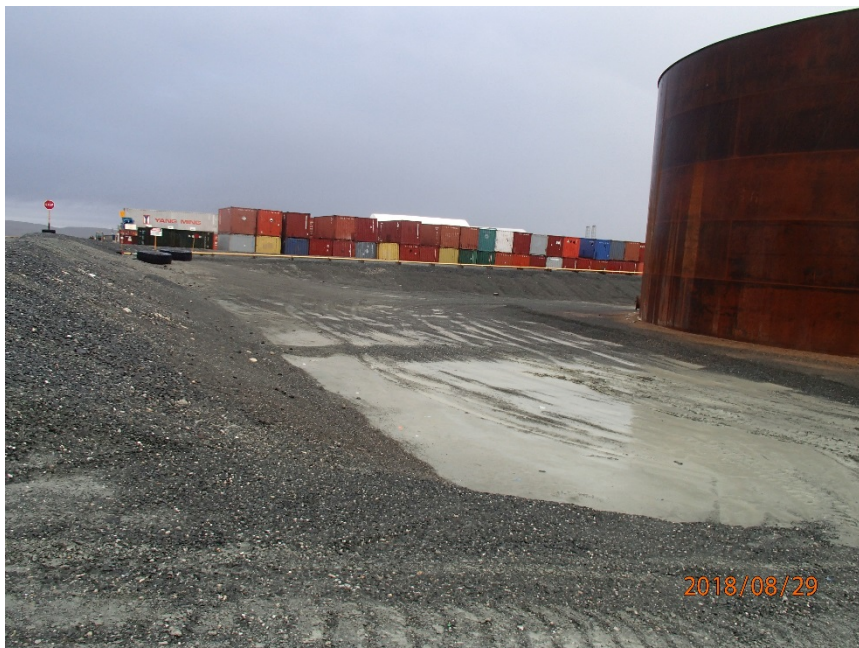
**Photograph G2-2 Meadowbank Tank Farm**

**Description:** From the western corner, looking northeast at the tank.

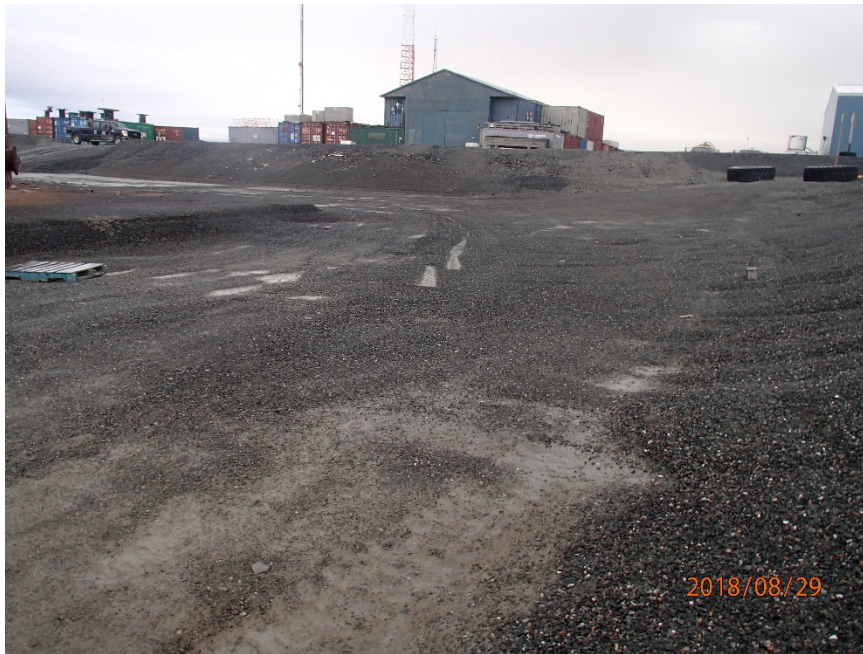
**Photograph G2-3 Meadowbank Tank Farm**

**Description:** From the eastern side, looking northwest.

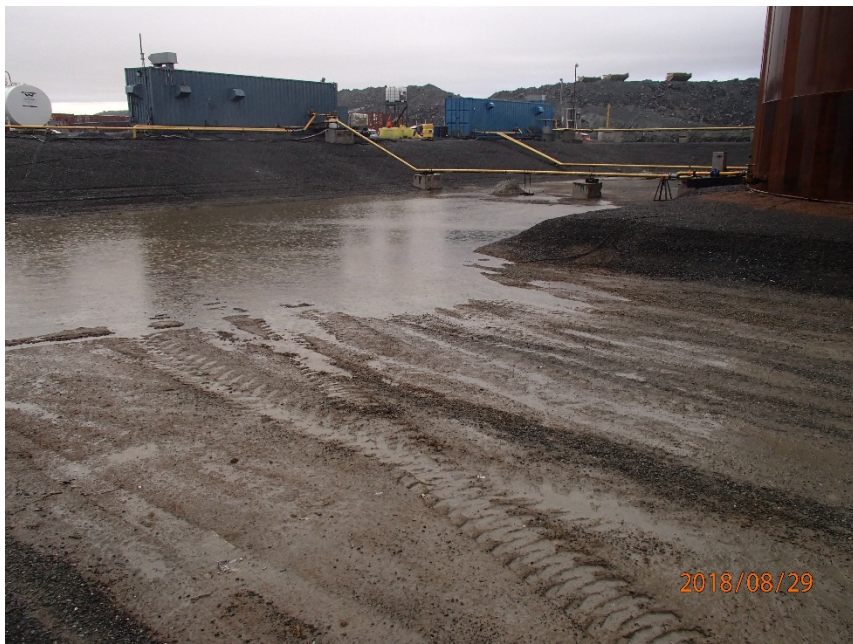
**Photograph G2-4 Meadowbank Tank Farm**

**Description:** From the eastern side looking southwest. Presence of water ponding. A pump is installed.

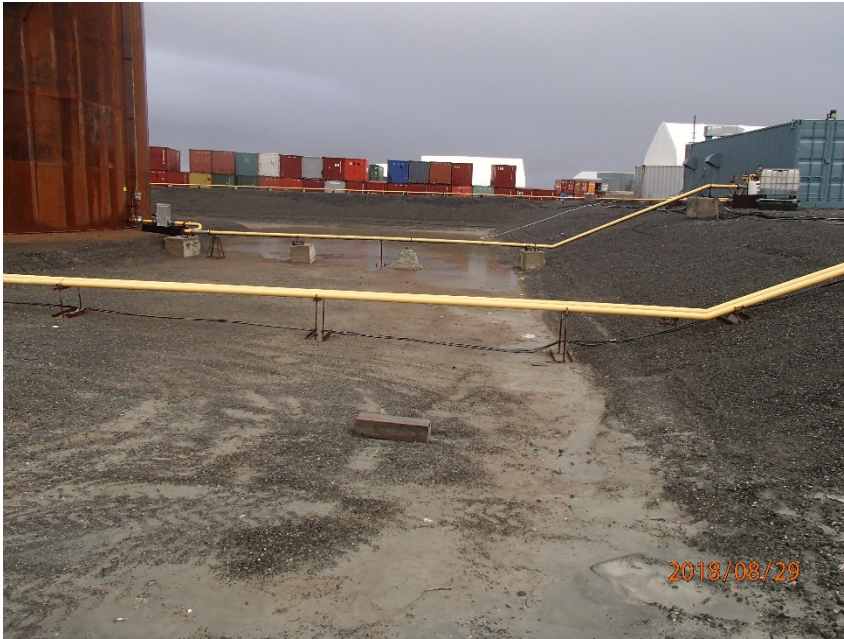
**Photograph G2-5 Meadowbank Tank Farm**

**Description:** Looking northeast from the southern corner. Accumulation of water in the eastern corner.

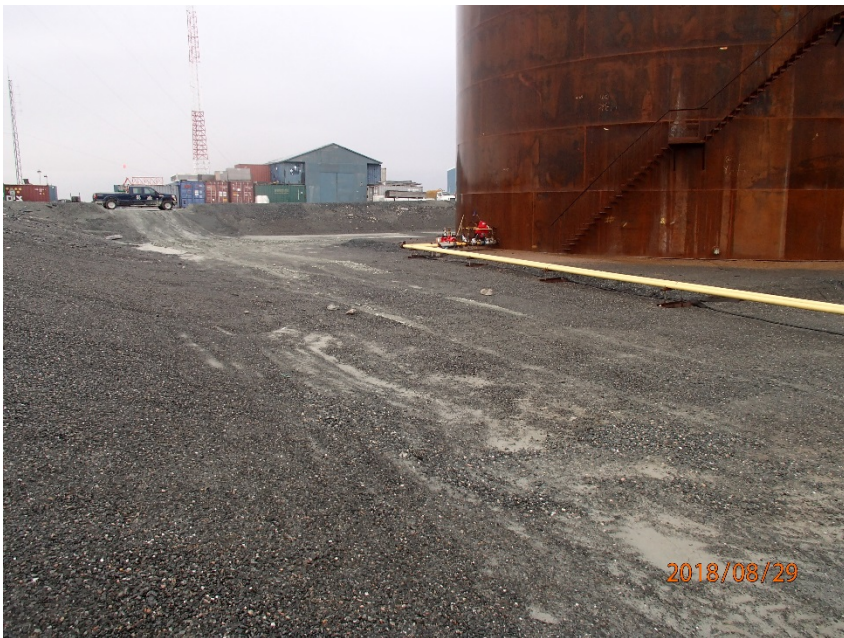
**Photograph G2-6 Meadowbank Tank Farm**

**Description:** Looking northwest from the southern corner.

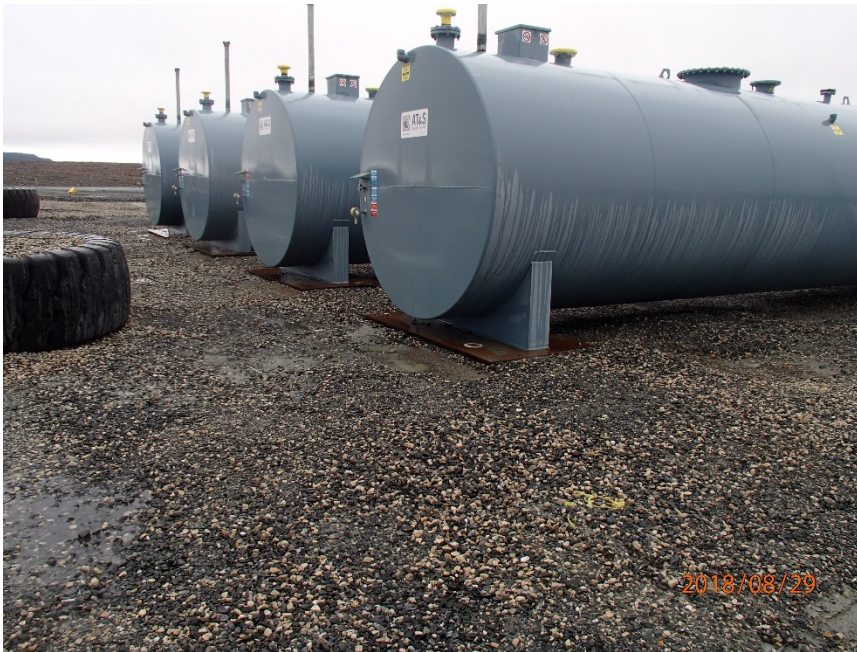
**Photograph G3-1 Vault Tank Farm**

**Description:** From the southeast corner of the Tanks looking northwest toward the Vault Tank Farm.

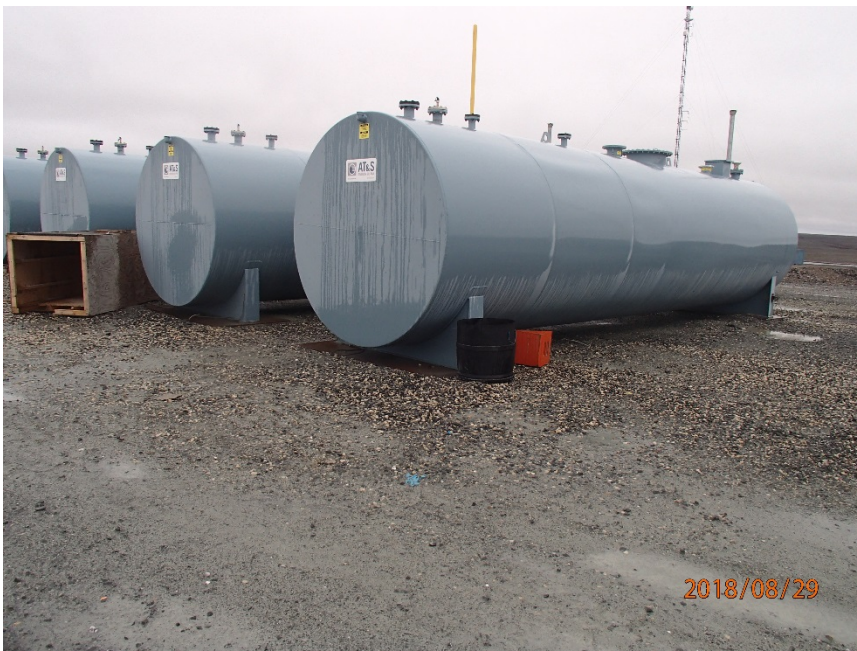
**Photograph G3-2 Vault Tank Farm**

**Description:** From the northwest corner of the Tanks Looking northeast toward the Vault Tank Farm.

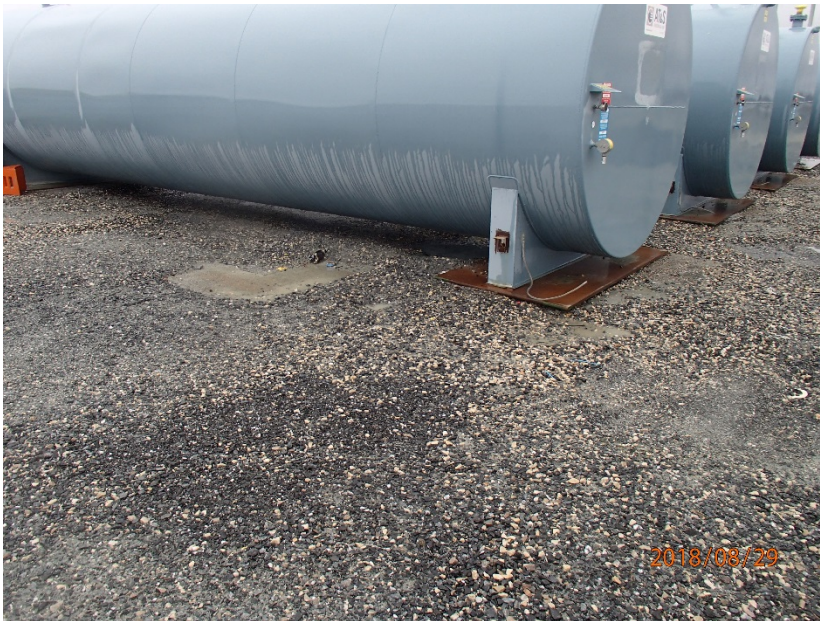
**Photograph G3-3 Vault Tank Farm**

**Description:** From the southwest corner of the Tanks Looking northeast toward the Vault Tank Farm.

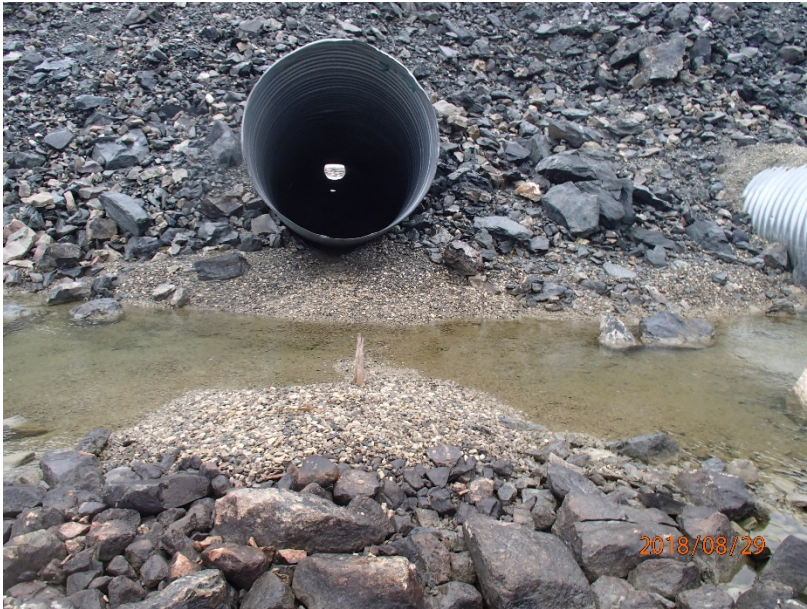
**Photograph H1-1 Vault Road Culverts**

**Description:** Looking at the outlet of the three culverts located on Vault Road at 640964E/7217466N. All of them are deformed in the middle.

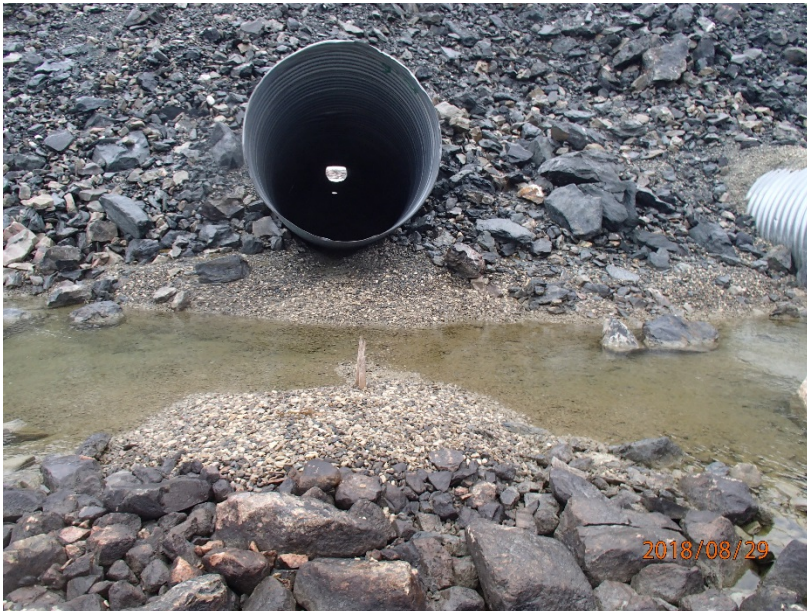
**Photograph H1-2 Vault Road Culverts**

**Description:** From the inlet side of the three culverts located on Vault Road at 640964E/7217466N. Looking inside the southern culvert. The culvert is slightly deformed on top in the middle.

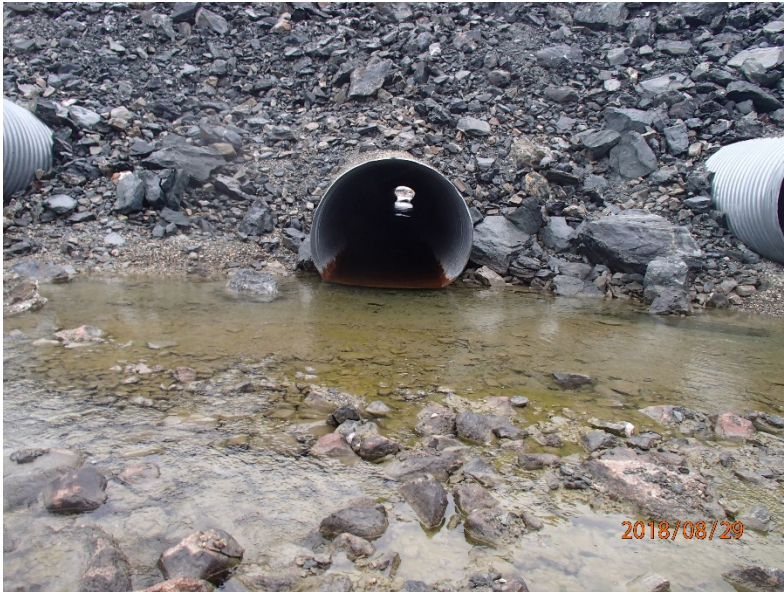
**Photograph H1-3 Vault Road Culverts**

**Description:** From the inlet side of the three culverts located on Vault Road at 640964E/7217466N. Looking inside the central culvert. The culvert is slightly deformed on top in the middle.

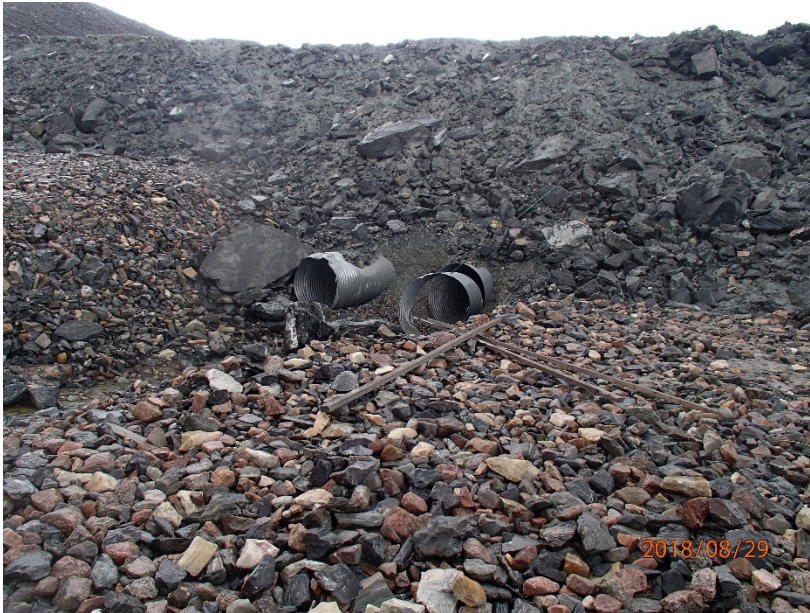
**Photograph H1-5 Vault Road Culverts**

**Description:** From the inlet side of the three culverts located on Vault Road at 640964E/7217466N. Looking inside the northern culvert. The culvert is slightly deformed on top in the middle.

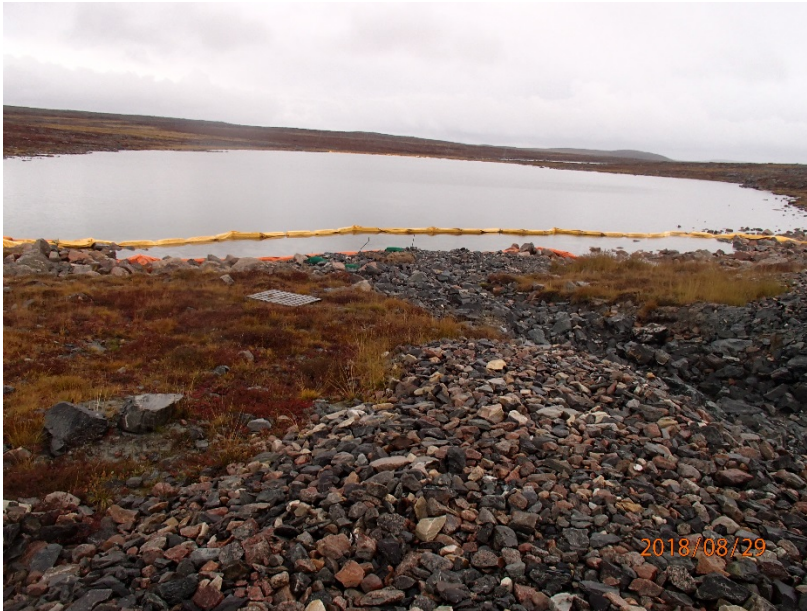
**Photograph H2-1 Diversion Ditch and its Sediment and Erosion Protection Structure**

**Description:** Looking south toward Lake NP1 at the sediment and erosion protection structure. Presence of 2 silt curtains and 3 wooden barrier.

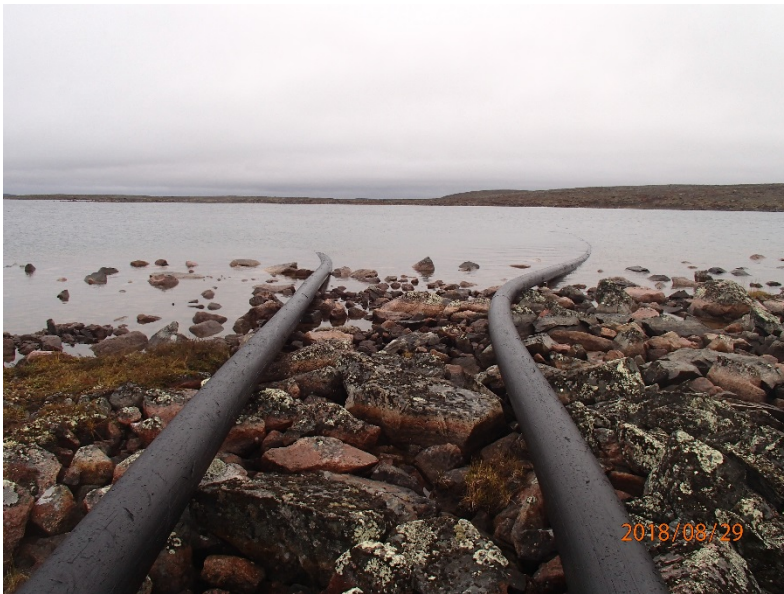
**Photograph H4-1 Diffusers – Vault Diffuser**

**Description:** Looking at the Diffuser at Vault. In good condition.

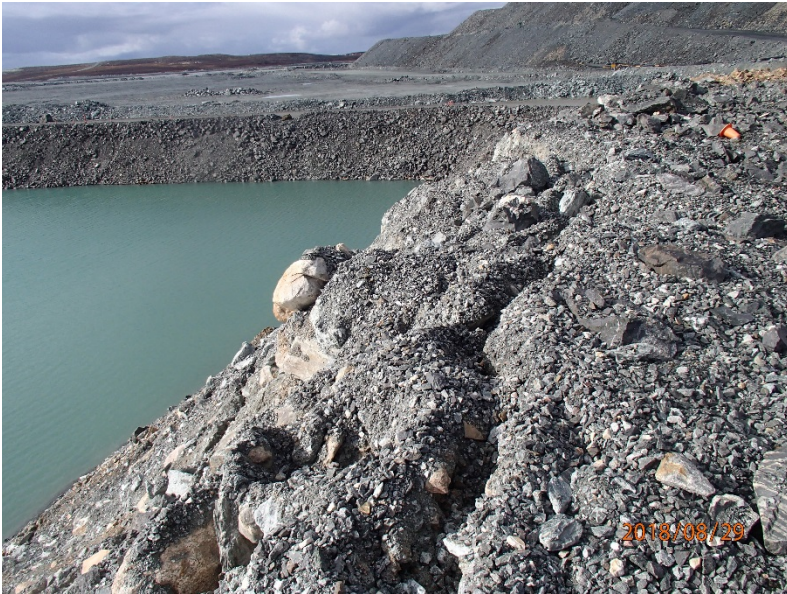
**Photograph H6-5 Contaminated Soil Storage and Bioremedial Landfarm Facility**

**Description:** From the northeast extremity of the South Cell, looking northwest at the Contaminated Soil Storage and Bioremedial Landfarm Facility. Sign of superficial slope failure.
