Appendix 70

Meadowbank and Regulators 2019 Regulators Inspection Reports

CIRNAC Inspection Report - Water License 2AM-WTP1826 April 2019

CIRNAC Inspection Report - Water Licence 2AM-MEA1526 April 2019

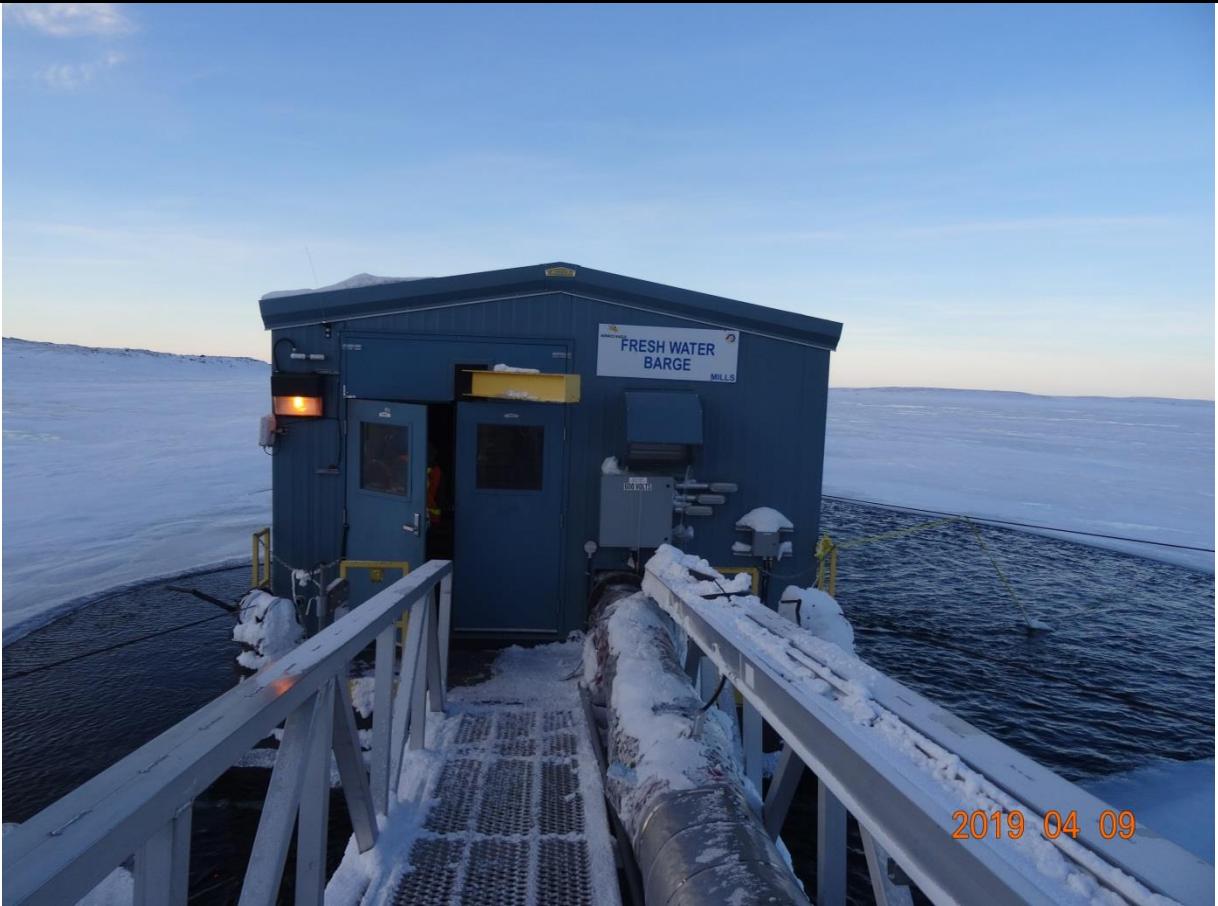
Date:	Camera	Inspector	Authorization
04/09/2019	Sony Cyber-shot	Jeremy FRASER	2AM-MEA1525
Photo Log # 1		Location (NAD 83 DD MM SS.SS)	
Photo #1		N	W

Description: Fresh Water Intake Facility on Third Portage Lake

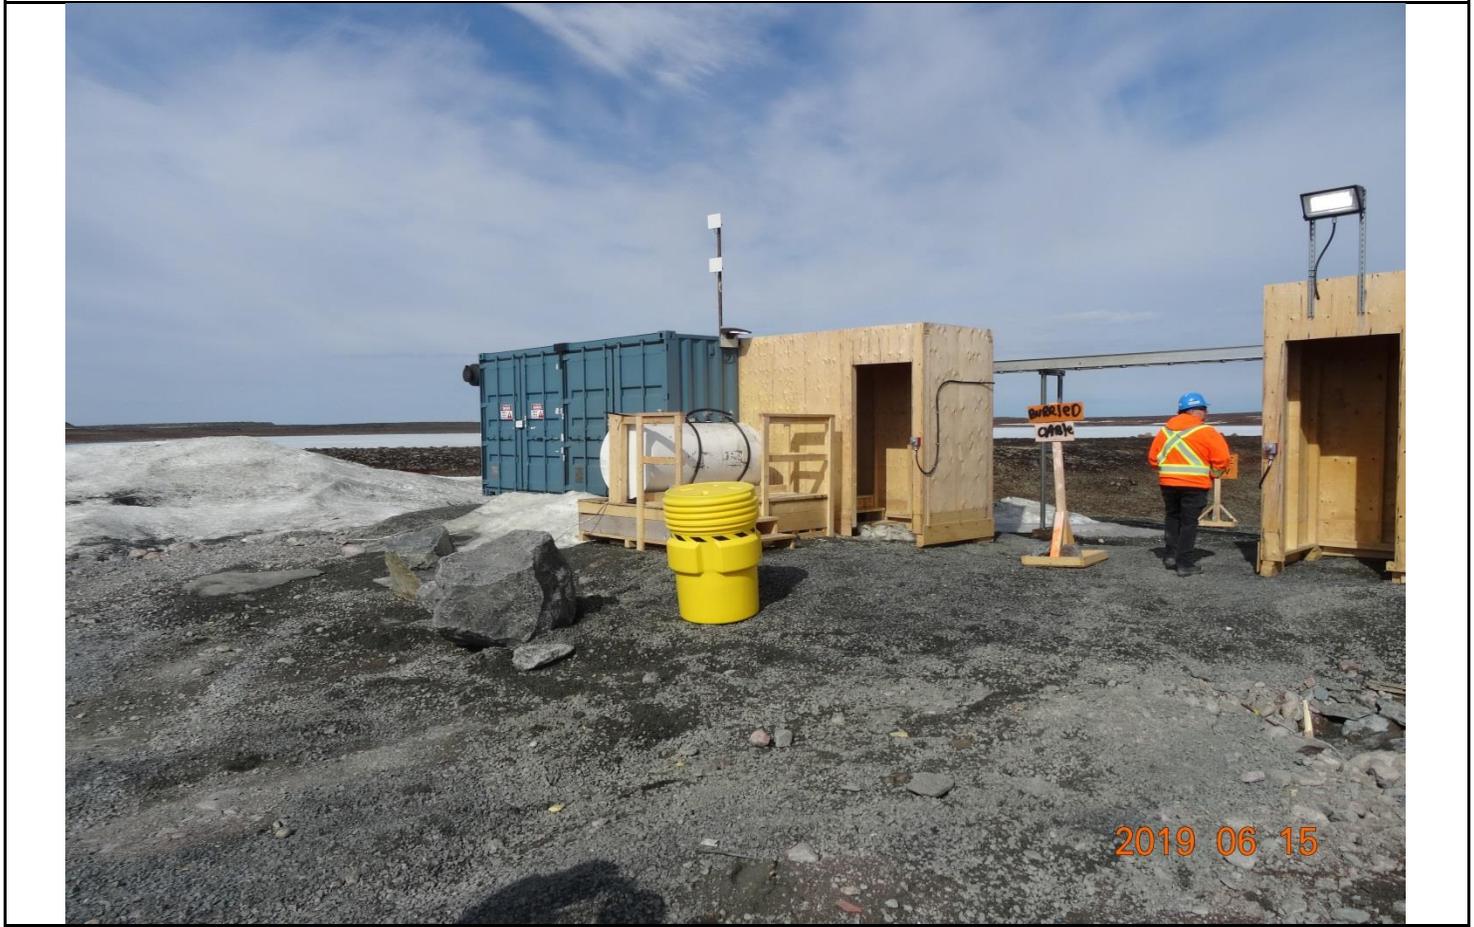
Photo Log # 1	Location (NAD 83 DD MM SS.SS)
Photo #1	N W

AEM is actively withdrawing water from Nemo Lake as approved by the Nunavut Water Board. It appears to be in good order and operating as intended however, it was noted that there was no signage indicating the location name. As per the Water License 2AM-WTP1826 "Part B Item 10 The Licensee shall post signs in the appropriate areas to inform the public of the location of the Water Supply Facilities and the Waste Disposal Facilities. All signs must be in English, Inuktitut and French and shall be located and maintained to the satisfaction of an Inspector". The fuel tank for the water intake facility backup generator is in secondary containment however the catchment is full of water with visible sheen and oils (see photo 1 & 2). The inspector notified AEM that they are to address this concern and dispose of the waste according to the provisions within the Water license.

Description: Nemo Lake Fresh Water Intake and backup generator building. White fuel tank in front of the backup gen set.

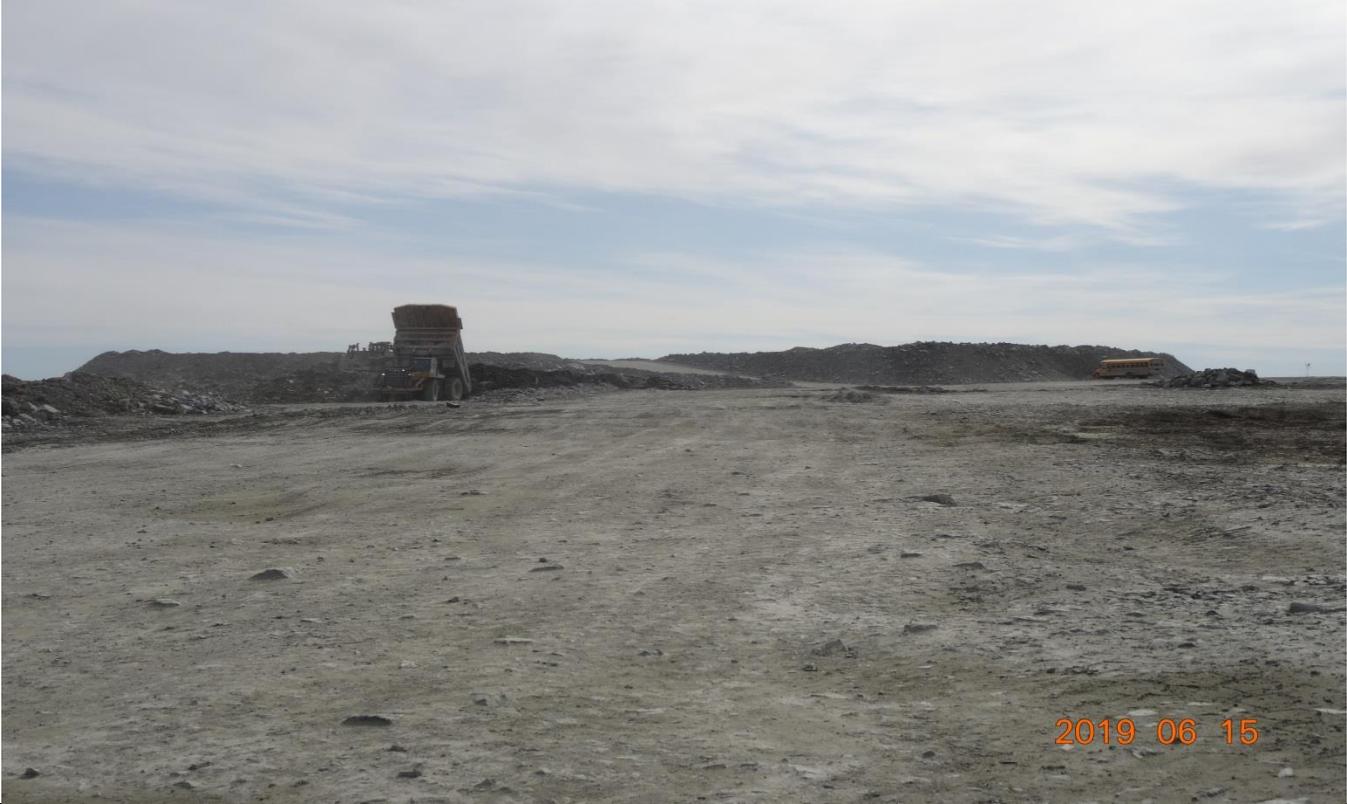
Photo #3

The Waste Rock Storage Facility (WRSF) is in operation. The waste rock within the facility appears to be segregated into Potentially Acid Generating (PAG) and Non-Potentially Acid Generating (Non PAG) material. Segregation of the waste rock is predetermined by AEM staff. No concerns related to this activity. (see photo 3)

Description: Waste Rock Storage Facility

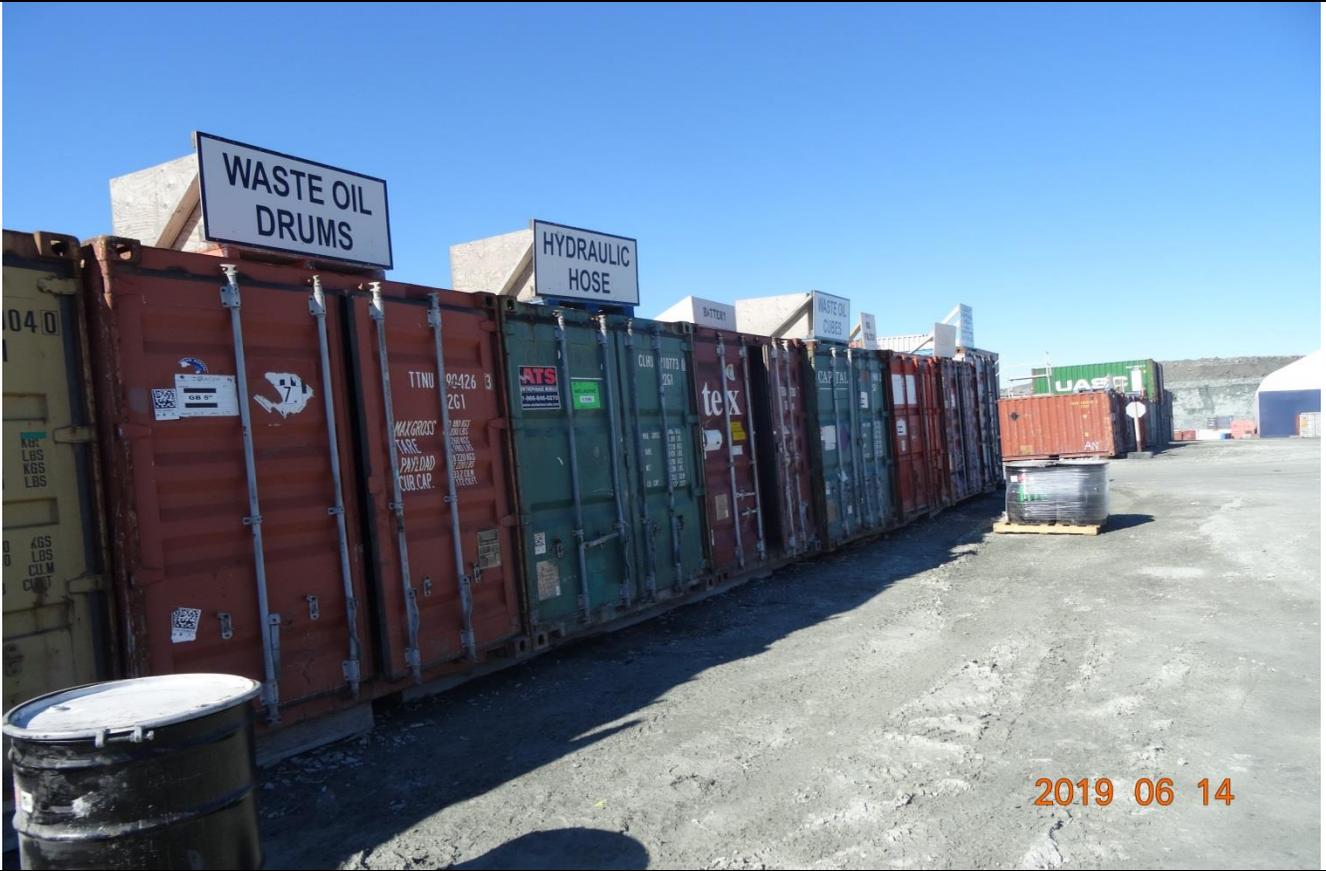
Date	Camera	Inspector	Authorization
June 14 2019	Sony Cyber-shot	Jeremy FRASER	2AM-MEA1526
Photo Log # 1		Location (NAD 83 DD MM SS.SS)	
Photo #1		N	W

AEM is currently segregating all Hazardous Waste into multiple sea cans separating items such as batteries, waste oils, used rags etc. and shipping generated waste off site as a requirement of the license *Part F Item 16 & 17*. (see photo 1,2 &3). AEM has addressed concerns regarding this area identified in the previous inspection dated April 8th 2019.

Description: hazardous waste storage area

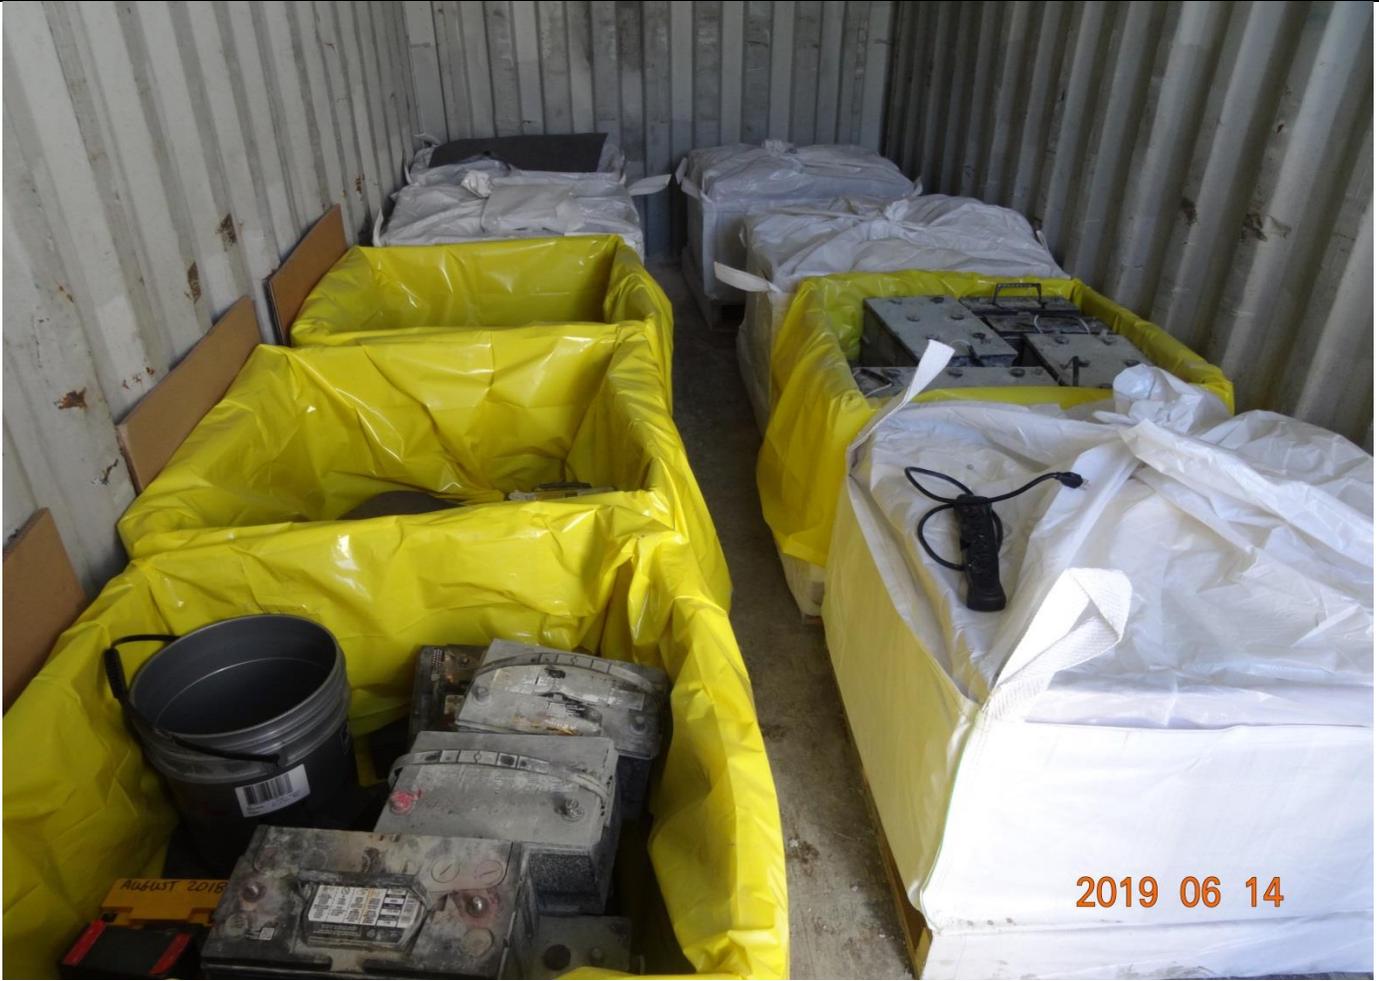
Photo #2

Description: battery bins within hazardous waste containers

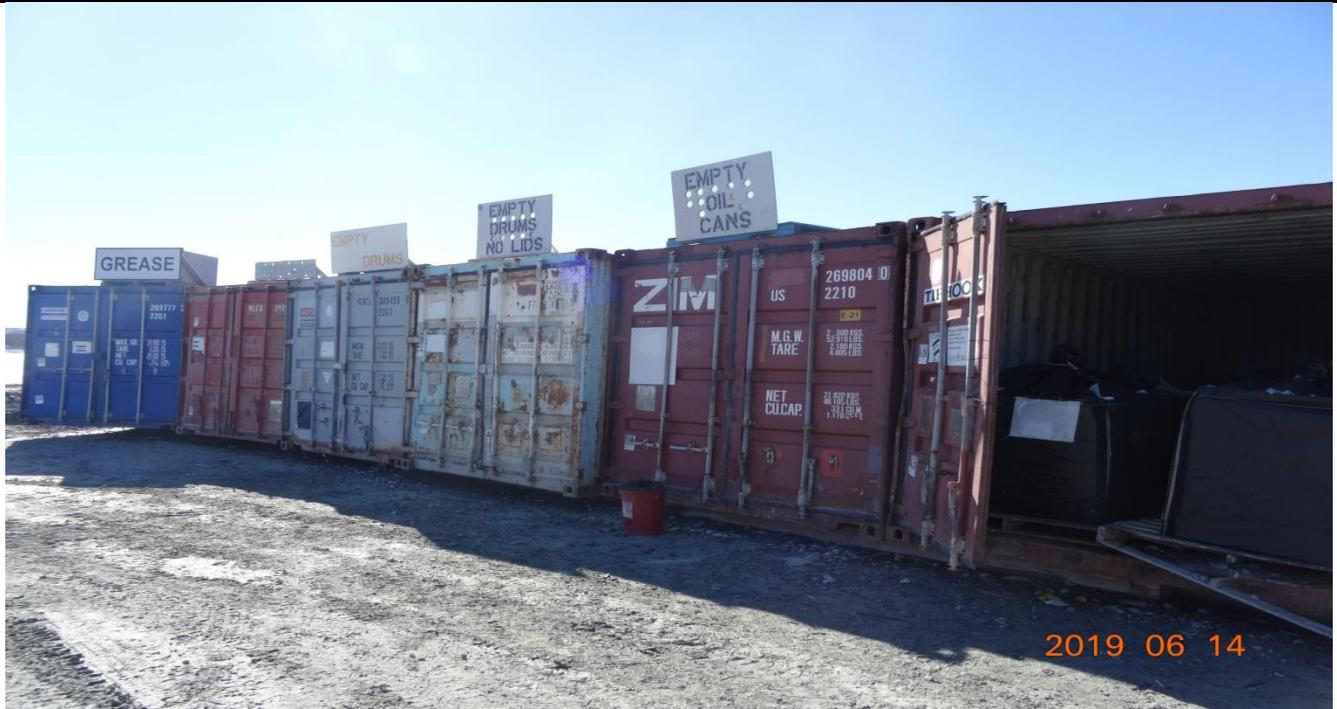
Photo #3

Description: hazardous waste material storage area

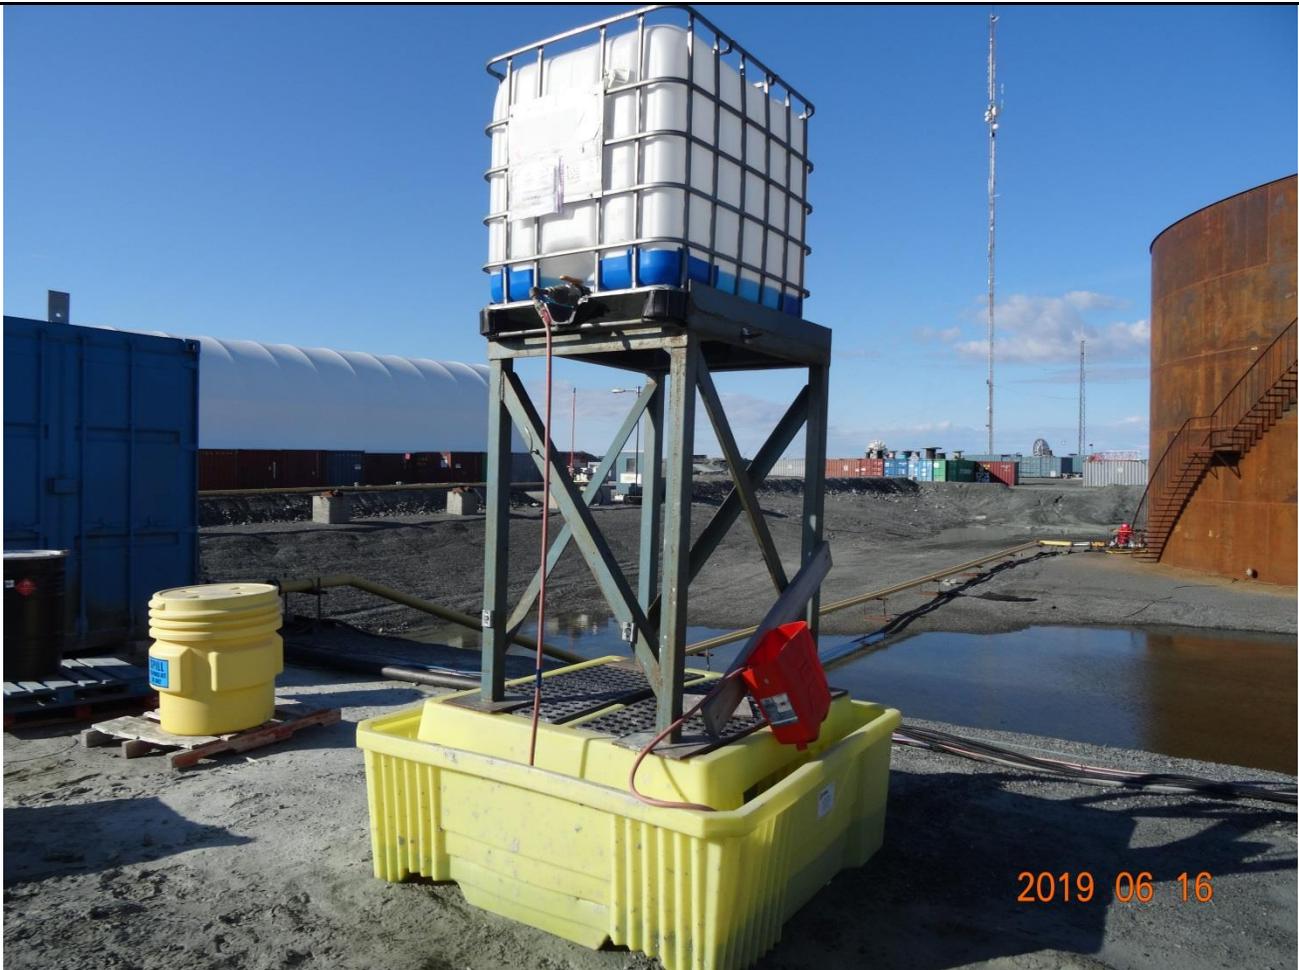
Photo #5

AEM has addressed concerns from the previous inspection in regards to this facility. Adequate secondary containment has been put in place to capture any residual liquids within this facility (see photo 5). The inspector noted some water within the single tank farm (see photo 6); AEM has sampled the water and results indicate the water meets discharge requirements set by the NWB regarding the Licence 2AM-MEA1526 *Part F Item 9*. No concerns regarding this facility.

Description: adequate secondary containment installed at fuelling station

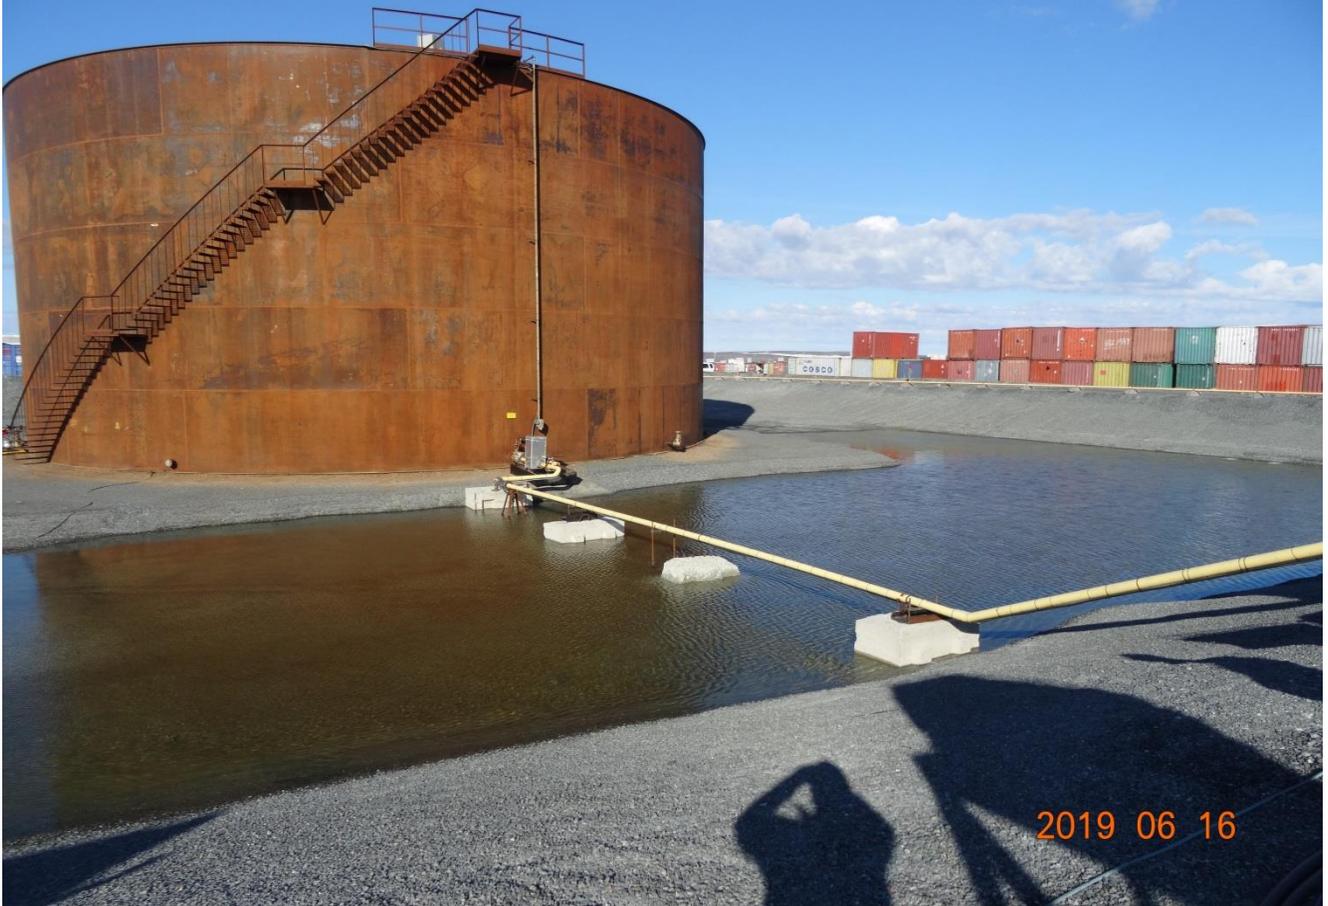
Photo #6

Description: single tank farm at Meadowbank site

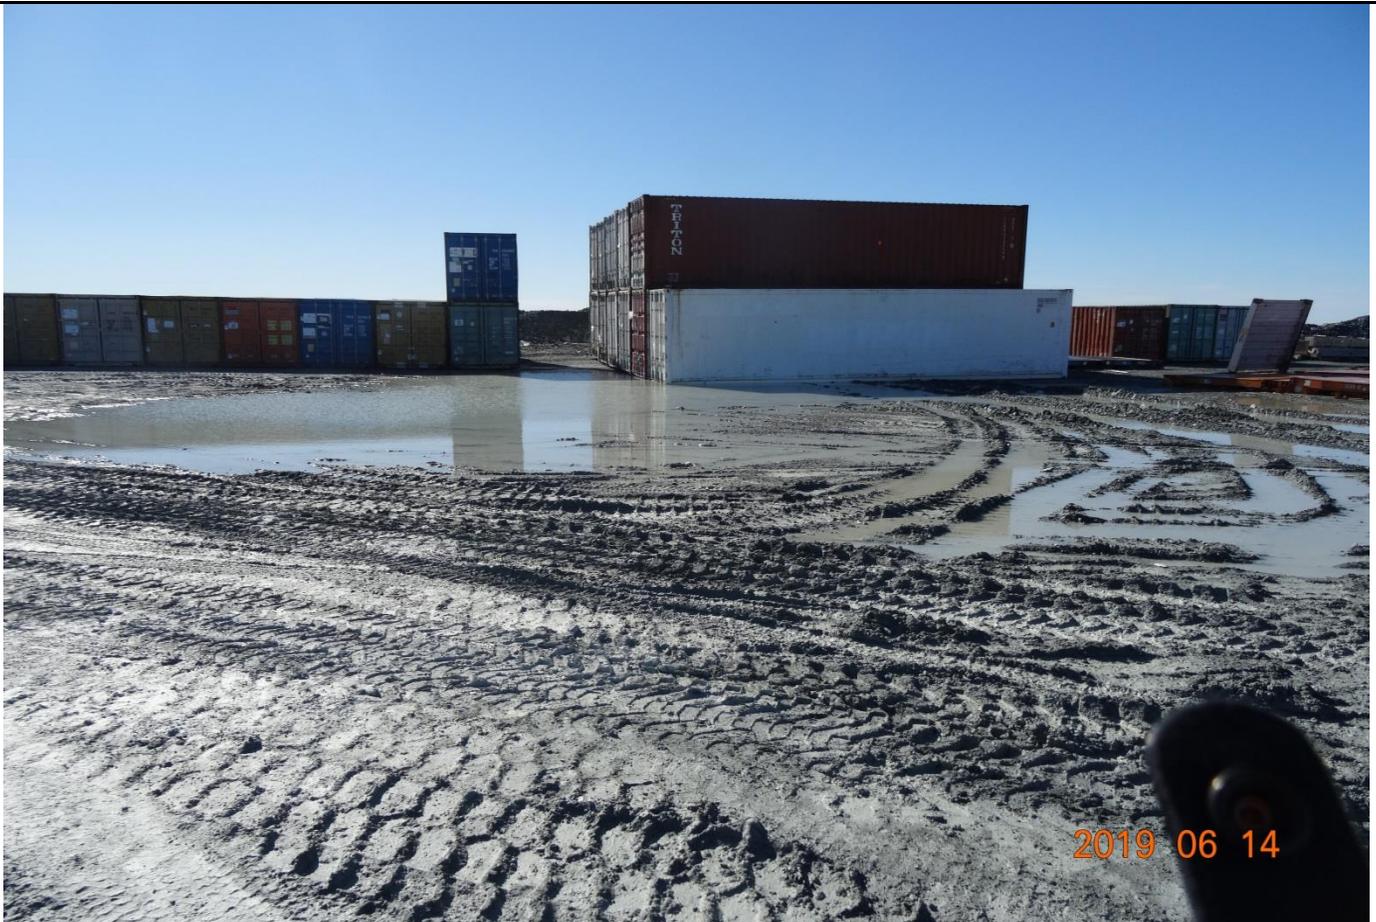
Photo #7

During the inspection of this facility it was noted that some pooling of water in what appears to be a low spot beneath a sea can on the pad. The sea can was labelled "super Heavy" and locked at this time; the inspector was unable to determine what is stored in the sea can (see photo 7). After further review of information provided by AEM it was determined that the container is housing dry goods only and no chemical products. No concerns were identified

Description: Sea cans in water AEM addressed concerns of contents

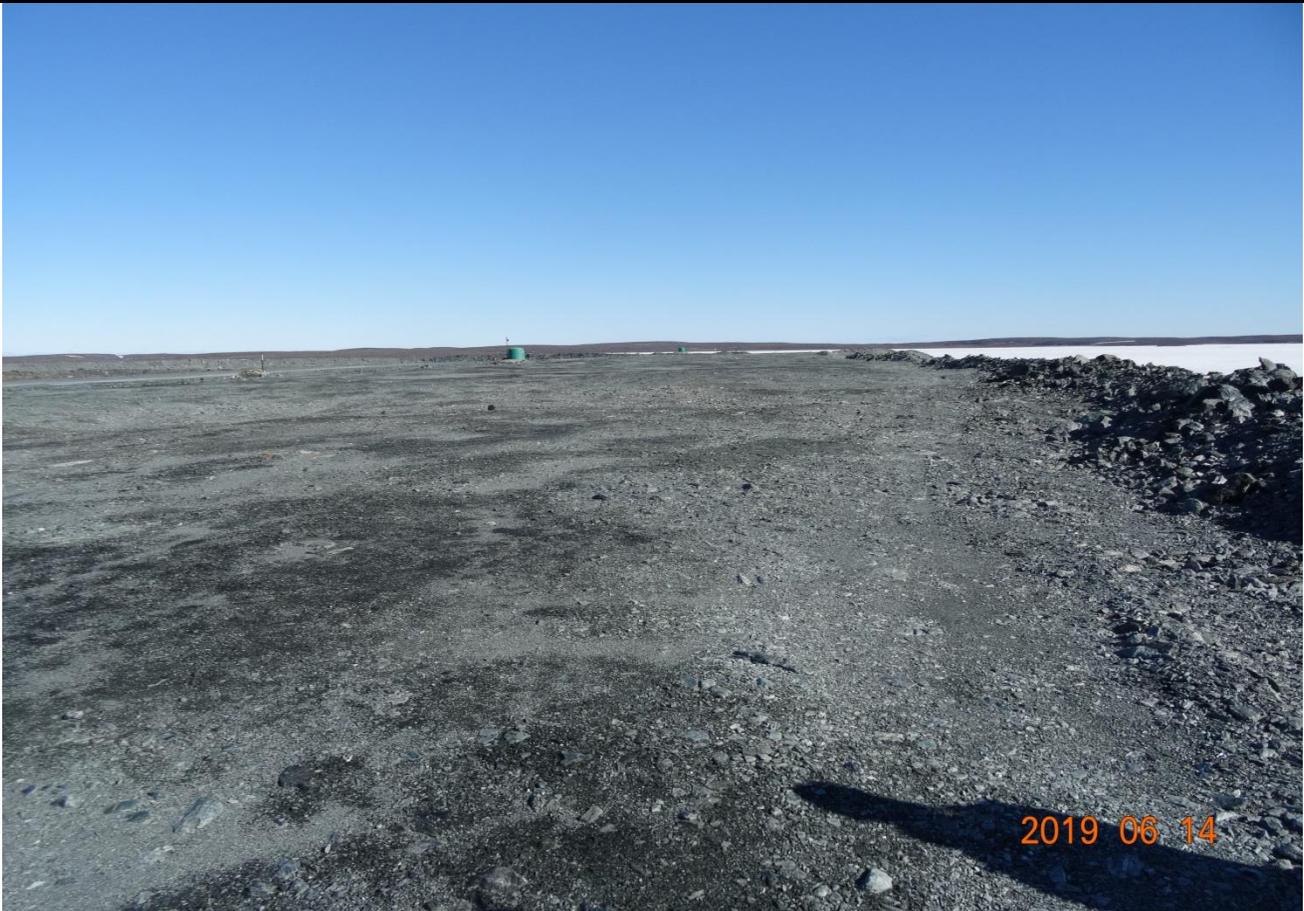
Photo #8

It was noted that the East Dyke appears to be operating as intended. AEM is continuing monitoring occurring with data collecting instrumentation including temperature sensors and piezometers installed within the dyke (see photo 8). There were no concerns identified regarding this structure.

Description: Meadowbank East Dyke; instrument housing in the background

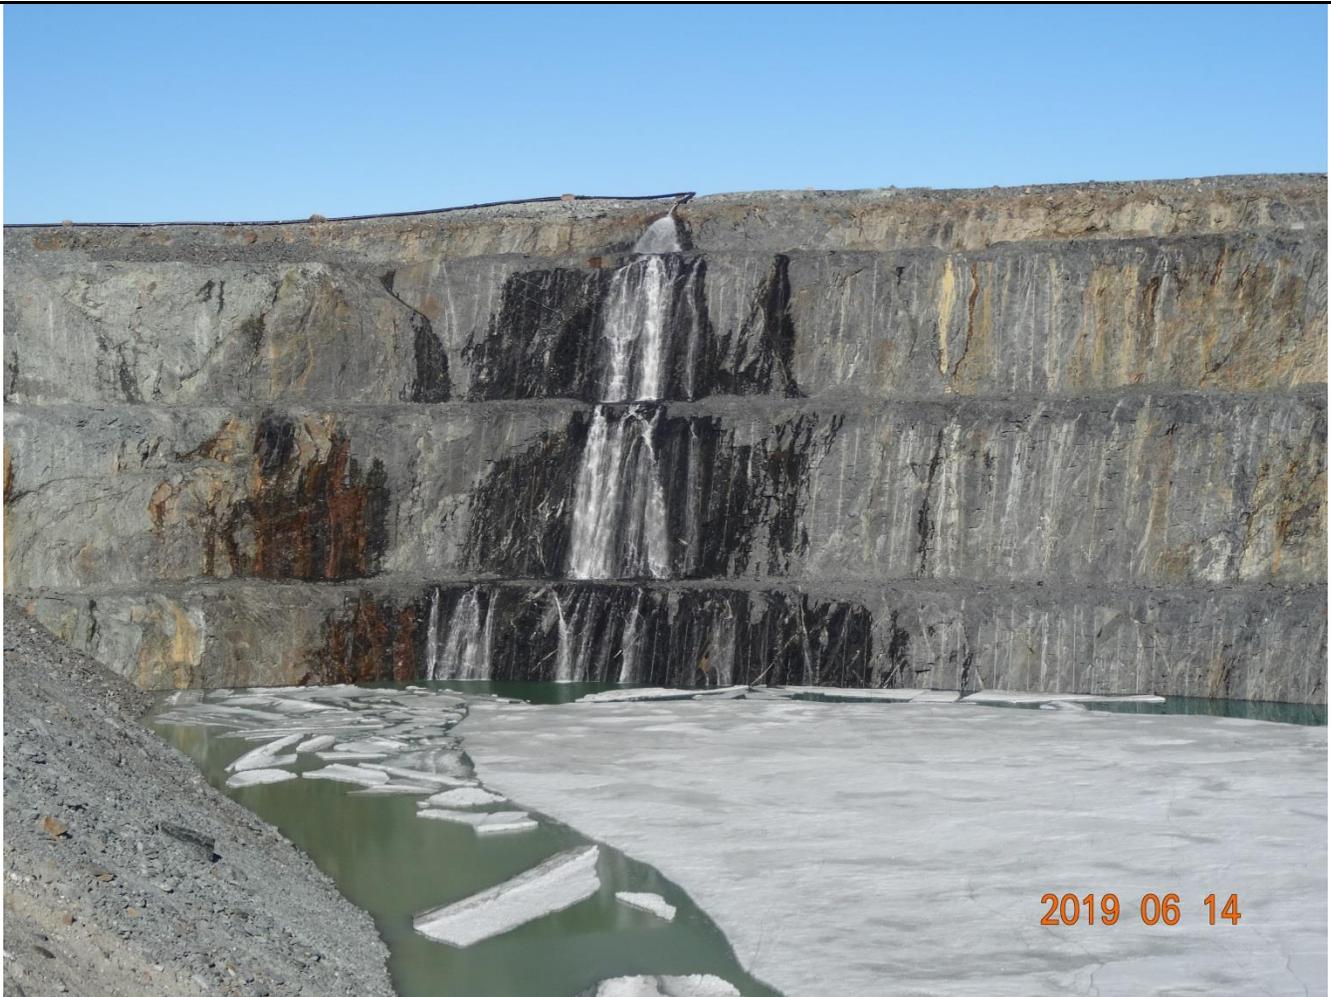
Photo #9

During this inspection AEM was in the progress of using the in-pit disposal authorization to deposit water that was seeping through the Central Dyke into a ditch and pumping it to the Goose Pit (see photos 9). There were no concerns regarding the deposition of waste at this time.

Description: In-Pit Deposition

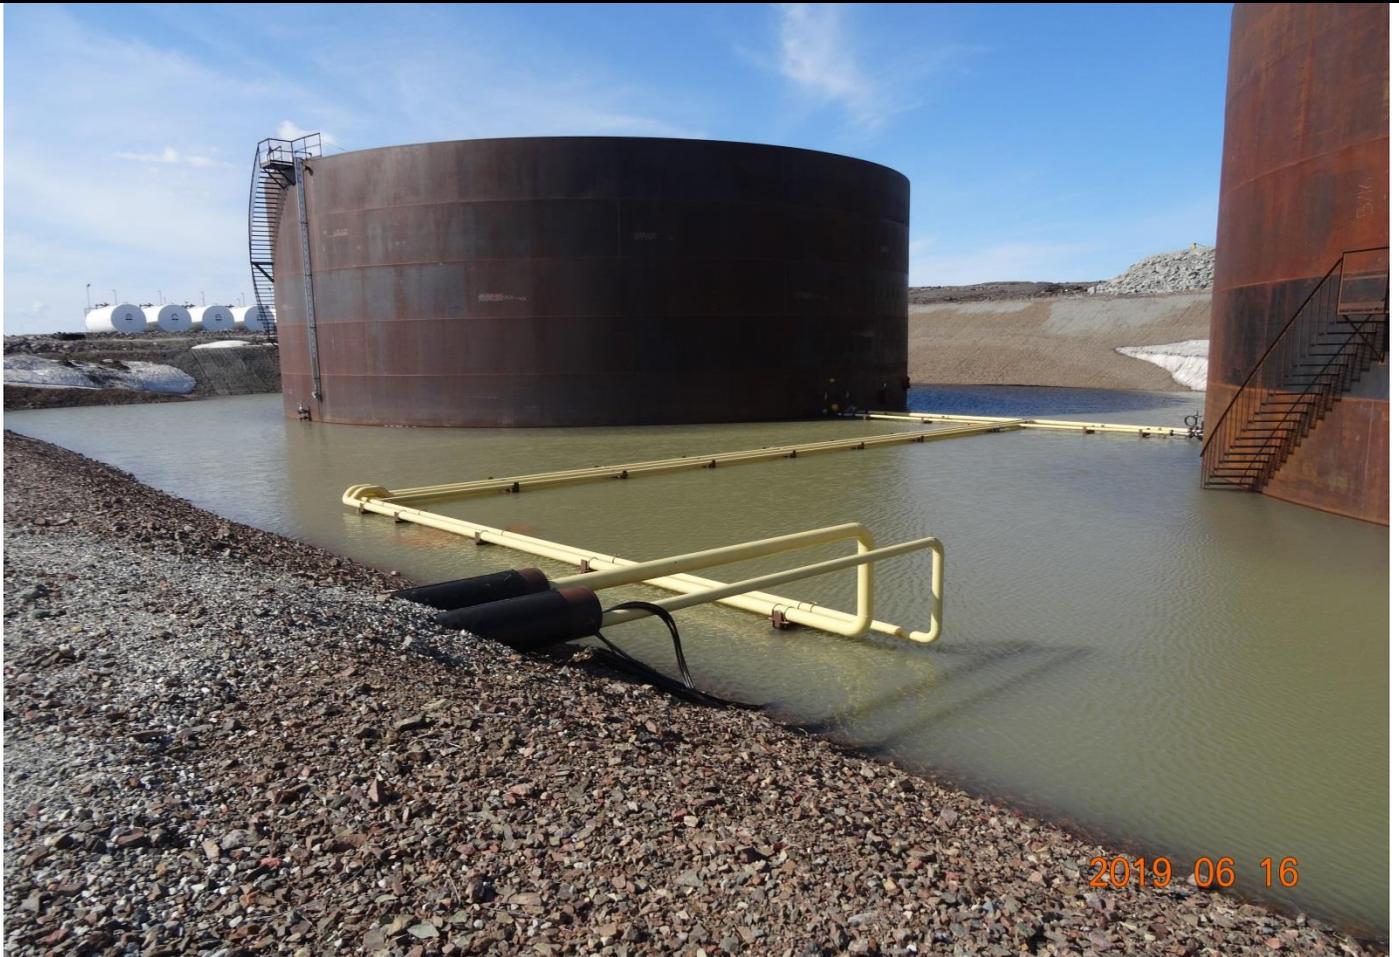
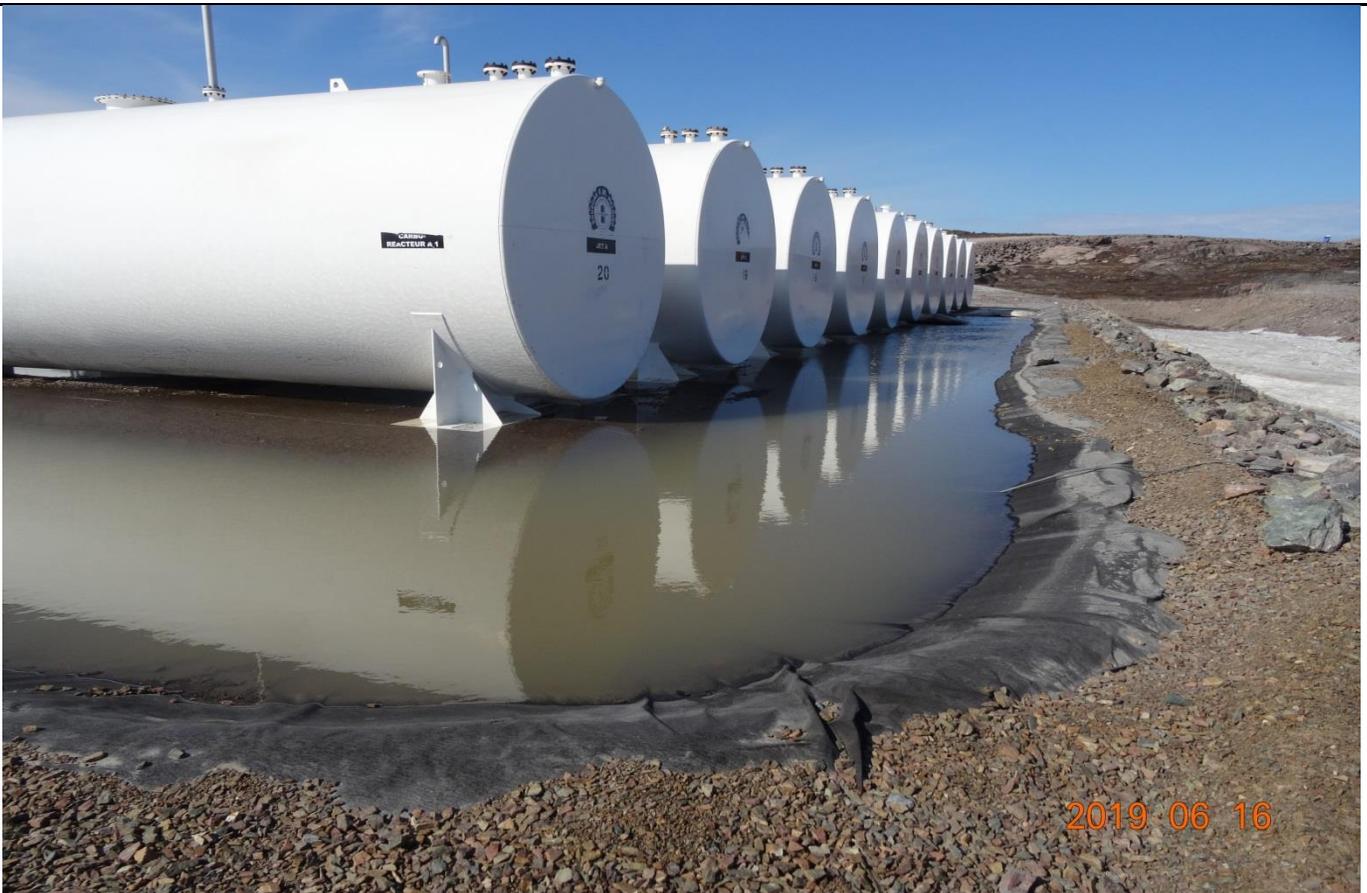
During the inspection the inspector noted approximately 300m³ of water within the berms. The tanks appeared to be mostly empty with one mostly full remaining tank of diesel (see photo 10 & 11), AEM has taken samples of the water and sent the collected samples to the laboratory in Winnipeg. Once Results return indicating the water meets the criteria of the licence and AEM is planning to discharge. There were no other concerns identified with this facility.

Description: AEM Baker Lake Fuel Tank Farm

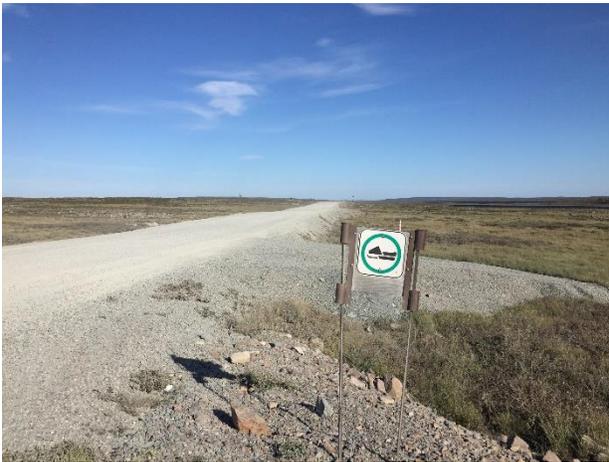
- a) Several species of wildlife were observed along the AWAR including geese, sand-hill cranes, Arctic hare, Peregrine Falcon, and siksik (ground squirrel). Agnico Eagle staff stated that caribou, muskox, and wolves were observed occasionally along the AWAR.
- b) At the snowmachine crossings, there were no signs of extreme slopes or rocks along the side of the AWAR (see [Photo 8](#)).
- c) While travelling along the AWAR towards Meadowbank on August 22, the road was not extensively used by Baker Lake community members but was extremely busy with haul trucks traveling from and to the Baker Lake facility (see [Photo 9](#)). On the way back to Baker Lake on August 24, the AWAR much of the traffic consisted of community members.

Photo 8: Snowmachine crossing near km 10

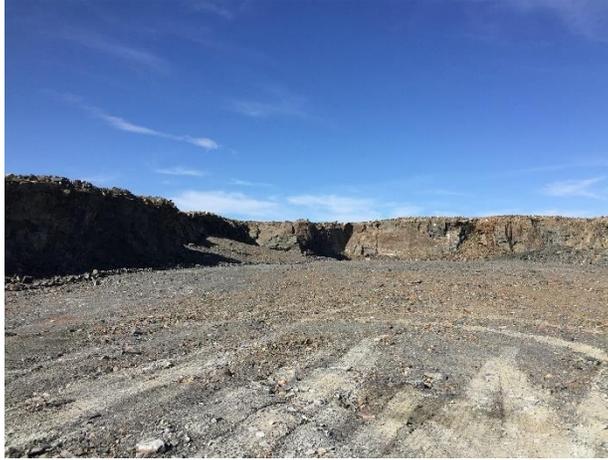
- d) As in previous years, remediation has been ongoing at Quarry 22 following storage of contaminated hydrocarbon soil in previous years with the soil/gravel still testing positive for hydrocarbons (see [Photo 10](#)). No remediation work was conducted in 2018 and 2019 due to active Peregrine Falcon nests at this quarry, but plans were in place to continue the remediation work in September 2019.

Photo 10: Quarry 22 along the AWAR

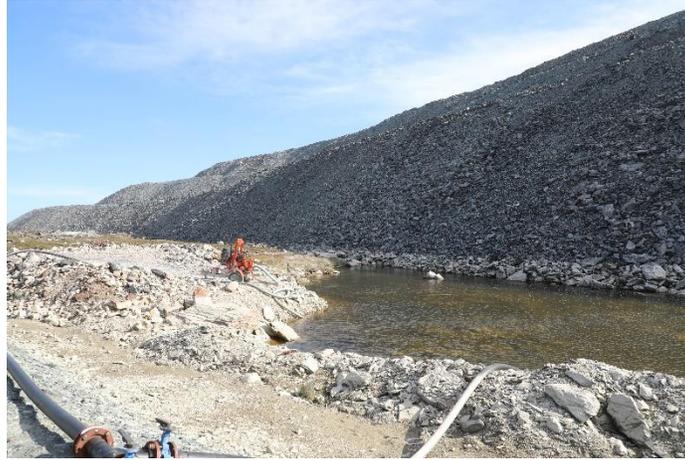
- d) In 2013, Agnico Eagle noted seepage from the Portage waste rock storage facility with potentially acid generating rock (which has a high sulphur content, heavy metals, and other contaminants) at a location near the south shore of a fish bearing lake (referred to as North Pole 2 or NP-2 lake) (see [Photo 19](#)). Agnico Eagle staff stated during the site visit that monitoring of the seepage is still ongoing during the open water season and that

accumulated water continues to be pumped directly back to the North Cell tailings storage facility. No seepage was observed since the North Cell was raised during the summer of 2016 as the assumption is that the tailings storage facility was built on an old riverbed system and may have seeped through this system.

Photo 19: Portage Waste Rock Facility Runoff

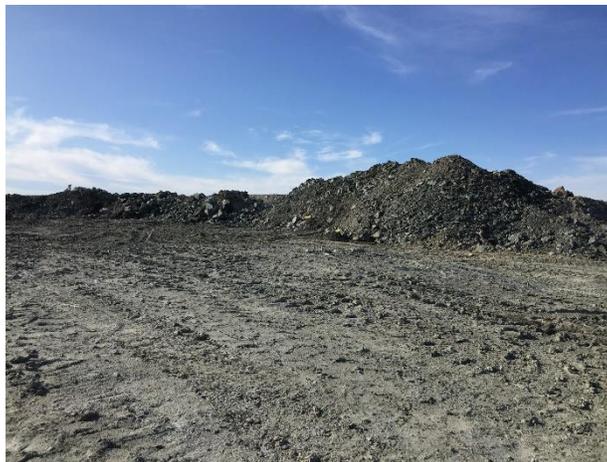
- e) During the site visit, it was observed that the second landfarm constructed in 2017 continues to operate with the addition of on-site nutrients (sewage sludge) to assist in the biodegradation of contaminated hydrocarbon soils (see [Photo 20](#)). The original landfarm, developed in 2013 and located next to the South Cell Tailings Facility was flooded with tailings deposition in 2017.

Photo 20: Landfarm at Meadowbank Mine Site

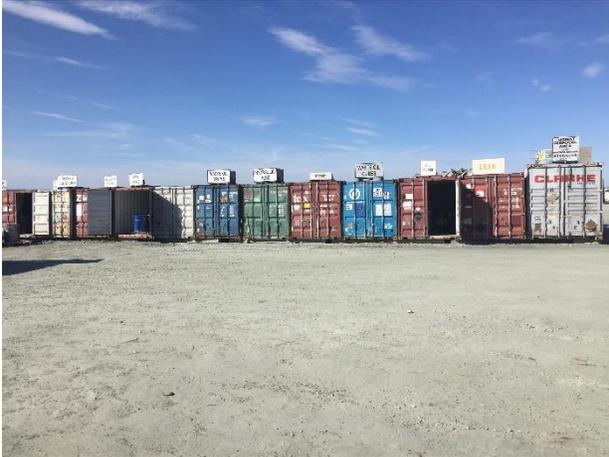
- f) As per previous NIRB site visits, and during the 2019 site visit that Agnico Eagle continues to segregate and store all domestic, hazardous, and combustible wastes in marked seacans prior to these materials being incinerated or shipped to the appropriate and approved off-site disposal facilities (see [Photo 21](#)).
- g) Agnico Eagle stated that the landfill is frequently inspected by employees to ward off any wildlife that may be present, to ensure wastes are segregated appropriately, and that wastes designated to the incinerator or metal dump do not end up in the landfill (see [Photo 22](#)).

Photo 21: Seacans used for waste segregation and storage area at Meadowbank Mine Site

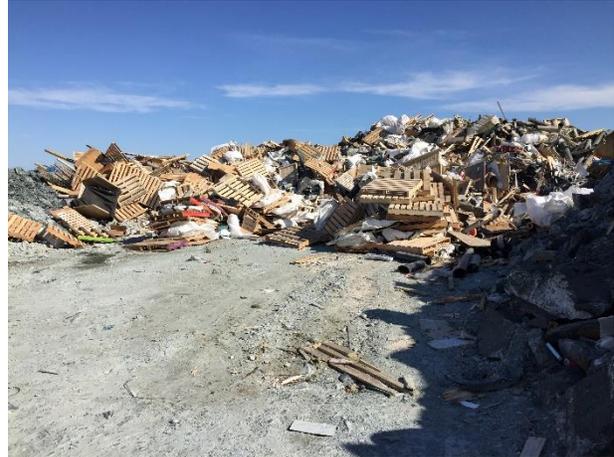
Photo 22: Landfill at Meadowbank mine site

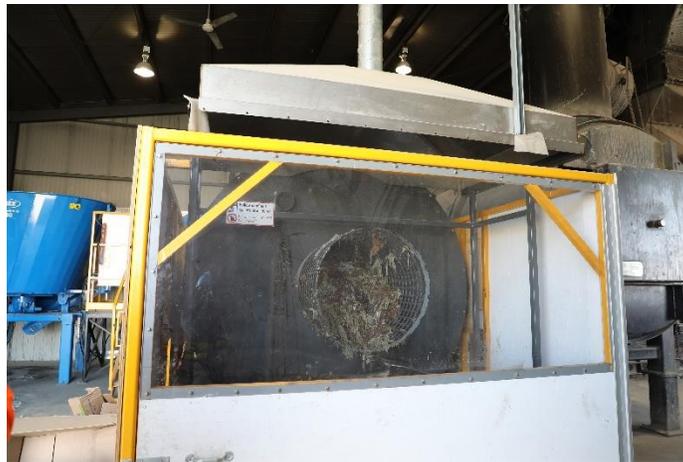
- h) In 2019 Agnico Eagle started a composting program located at the incinerator building with the compost materials being disposed of at the landfill (see [Photo 23](#)). The composter was installed to reduce the quantity of waste burned by the incinerator.

Photo 23: Compost program at the incinerator building

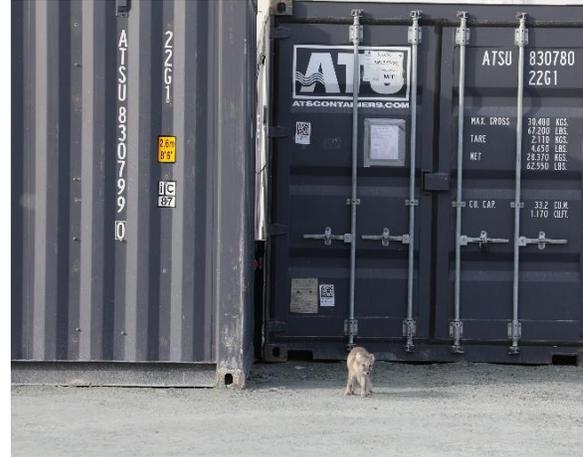
- i) During the site visit, a caribou was observed near the Vault Pit area (see [Photo 24](#)), while a young Arctic fox was observed at the Meadowbank site (see [Photo 25](#)).

Photo 25: Young arctic fox at the mine site

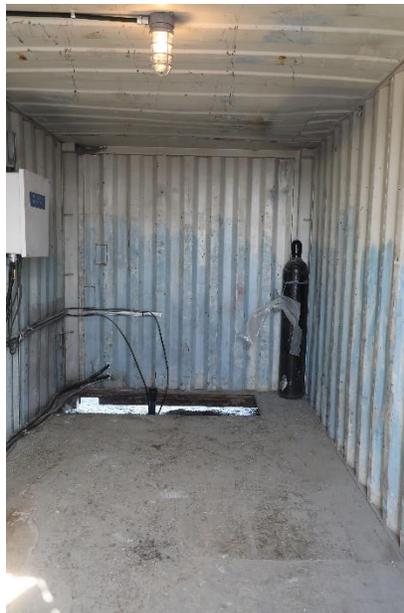
During the site visit, five (5) groundwater monitoring wells were operational and were the same wells in operation since 2018: MW-08-02, MW-16-01, MW-IPD-01, MW-IPD-07 (see [Photo 26](#)), and MW-IPD-09. The modifications to the wells appear to be working as the wells have been functional for two (2) years.

Photo 26: Groundwater monitoring well MW-IPD-07

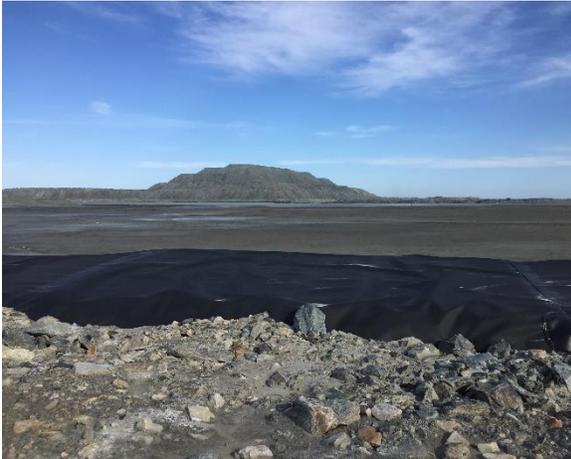
During the site visit, NIRB staff observed that reclamation was ongoing at the North Cell of the tailings storage facility and it was noted that reclamation has not commenced at the South Cell. Agnico Eagle staff stated that tailings will continue to be deposited into South Cell until the cell is full (see [Photo 27](#) and [Photo 28](#)).

Photo 27: Tailings Storage Facility – North Cell

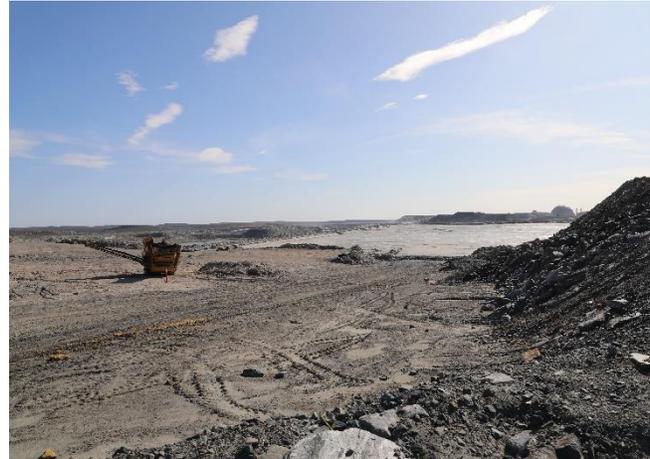
Photo 28: Tailings Storage Facility – South Cell

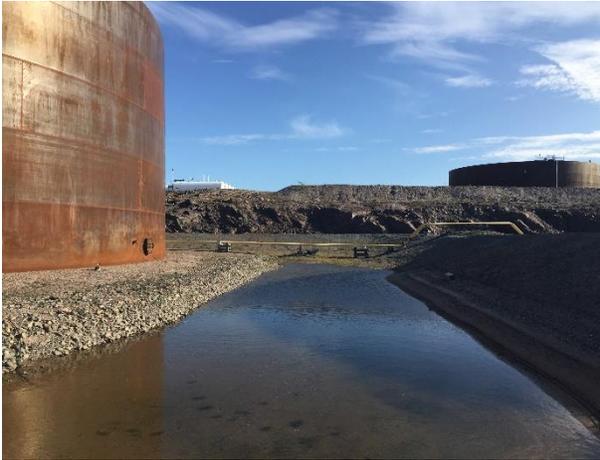
Water was observed within the secondary storage containment facilities for the fuel tank farms but there was no visible sheen on the water or discernable hydrocarbon odours at either the Baker Lake or the Meadowbank site fuel facilities (see [Photo 29](#) to [Photo 32](#)). The liner at the Baker Lake Fuel Storage facility was exposed and it was noted by Agnico Eagle staff that this may be due to the amount of rainfall over the summer that washed away the gravel that usually covers the liner. No indication was provided on whether or not the liner would be fixed or covered with gravel.

Photo 29: Baker Lake Fuel Tank Farm Facility

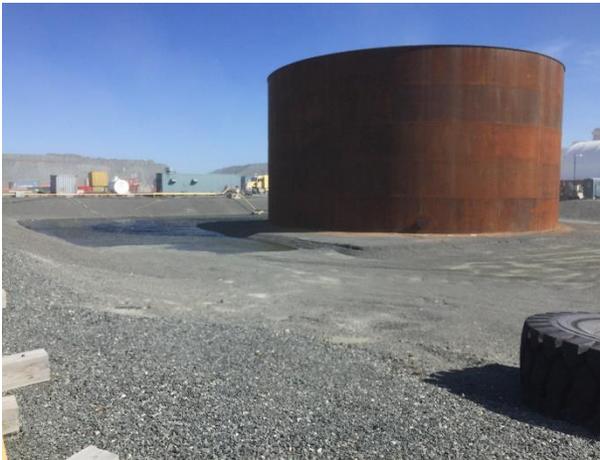
Photo 31: Meadowbank Fuel Tank Farm Facility

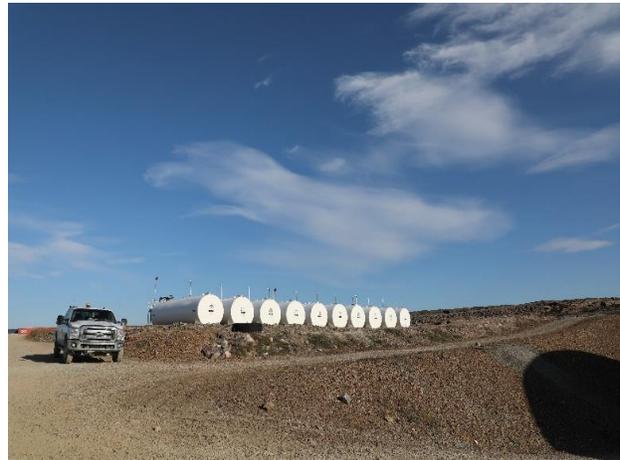
Photo 32: Aviation Fuel Tank Farm
