Appendix 70

Meadowbank and Regulators 2019 Regulators Inspection Reports

CIRNAC Inspection Report - Water License 2AM-WTP1826 April 2019

CIRNAC Inspection Report - Water Licence 2AM-MEA1526 April 2019

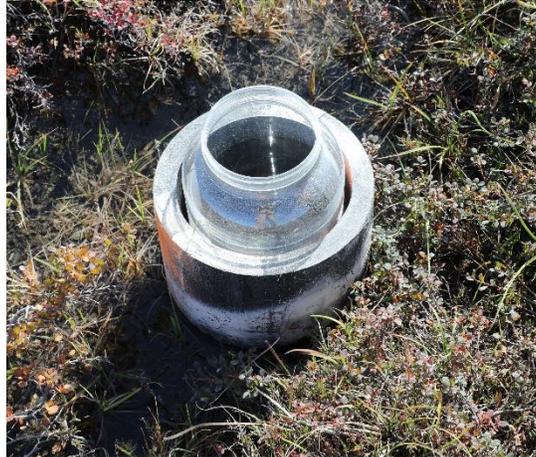
Agnico Eagle staff noted that it continues to apply TETRA flakes (calcium chloride) along three (3) critical areas on a two (2) km section of the AWAR as agreed upon with the local Hunters and Trappers Organization as well as two (2) additional sites. Along each of the five (5) sites, Agnico Eagle also continues to conduct dust sampling to assess dustfall rates in the dust suppression locations, as well as long two (2) reference sites without dust suppression (km 18 and 78). No other dust suppressants are applied along the rest of the AWAR. In addition, dust monitoring continues to be conducted along multiple stations along the AWAR (see [Photo 33](#)).

Agnico Eagle staff also stated that calcium chloride flakes are applied to the areas around the Meadowbank camp site and from the Baker Lake dock facility to the gatehouse. In addition, water is used as the dust suppressant on the mine access roads around the Meadowbank site and within the pits. However, during the site visit NIRB staff noted that the use of water as a dust suppressant did not appear to be effective.

Photo 33: Dust Sampling Station along the AWAR

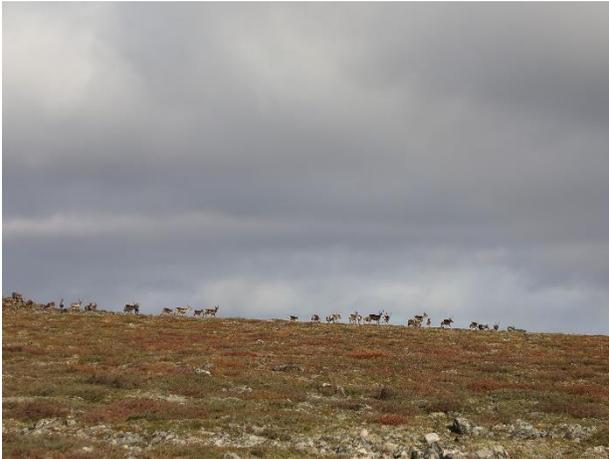
the Environmental Supervisor to conduct the site visit along the Haul-road and at Whale Tail Pit as the Environmental Supervisor needed to conduct monitoring of the caribou along the road (see [Photo 34](#) and [Photo 35](#)).

Photo 34: Caribou herd along the Haul-road

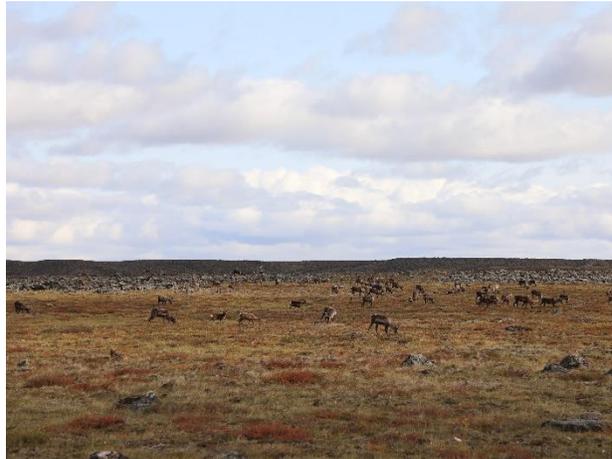
Photo 35: Caribou along the Haul-road

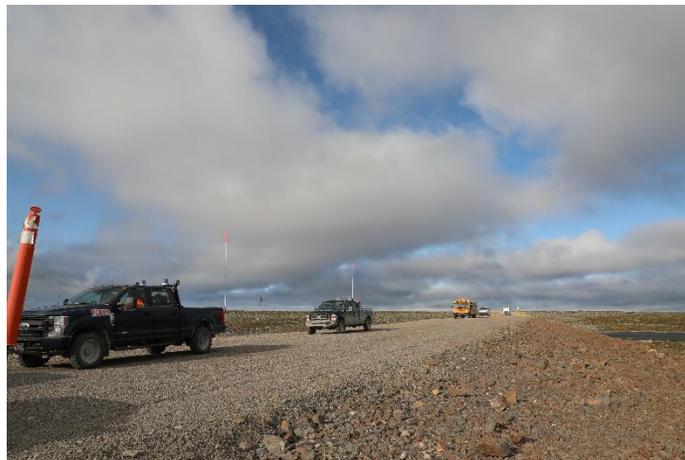
- b) While travelling along the road, a convoy of essential vehicles was travelling from the Whale Tail site to the Meadowbank Mine site. The convoy is always escorted by the Environment Department and it was observed that the convoy consisted of three (3) trucks (Environment Department truck, and two (2) trucks that were being returned to Meadowbank), one (1) bus (containing employees going home for the shift change), and a food truck (see [Photo 36](#)).

Photo 36: View of convoy travelling along the Amaruq Haul-road

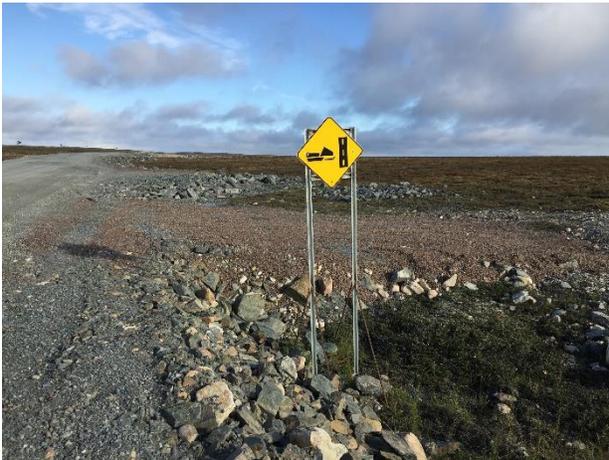
- e) The one (1) snowmachine crossing is located along the Haul-road near km 127 and there were no signs of extreme slopes or rocks at the crossing (see [Photo 38](#) and [Photo 39](#)).

Photo 38: Snowmachine crossing near km 12

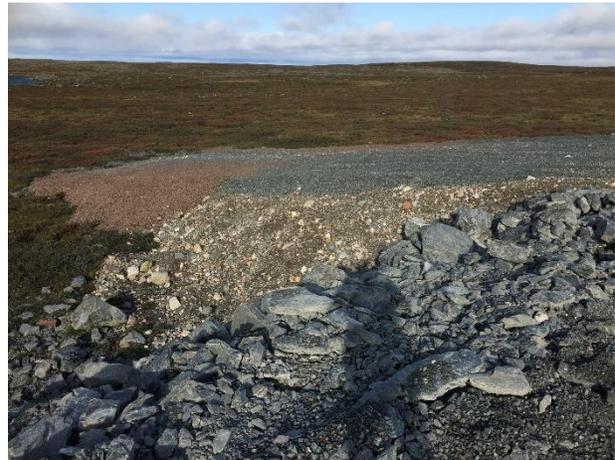
Photo 39: Slope on the other side of the snowmachine crossing near km 12

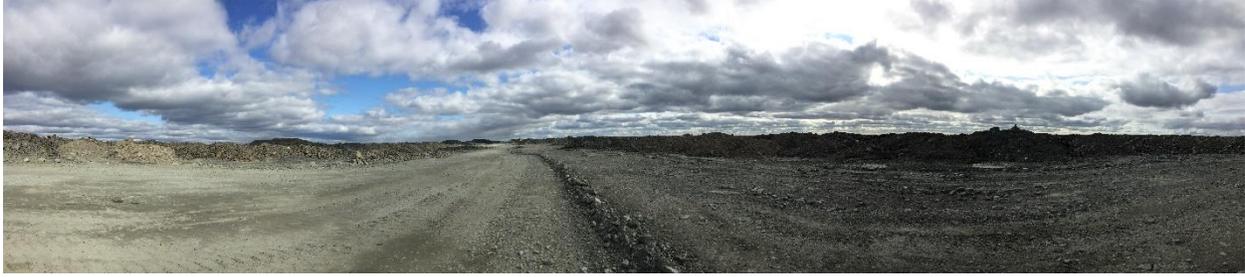
- a) The Whale Tail site was extremely active with drilling occurring at the North Basin and the site moving into full operations (see [Photo 40](#) through [Photo 44](#)).
- b) Exploration activities were also ongoing with haul trucks moving rock and ore from the underground via the portal (see [Photo 45](#) and [Photo 46](#)).

Photo 40: Overview of the Whale Tail Pit Site

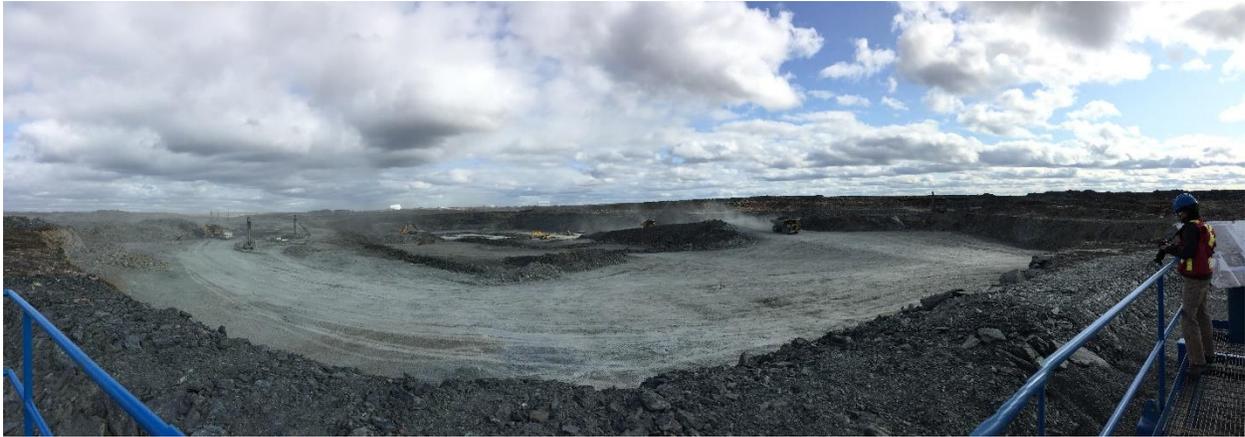
Photo 41: View of Whale Tail Pit – North Basin

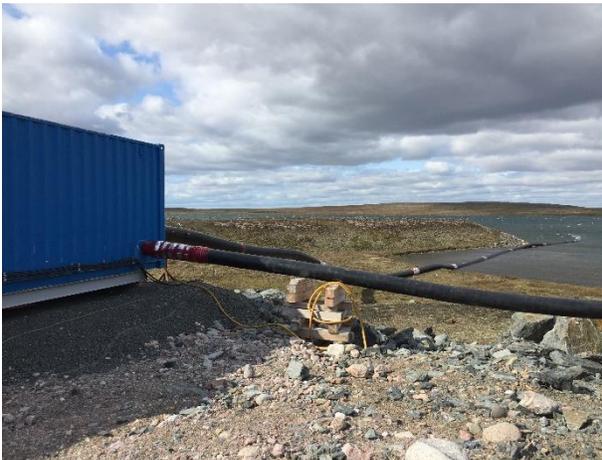
Photo 42: Nemo Lake Freshwater Intake

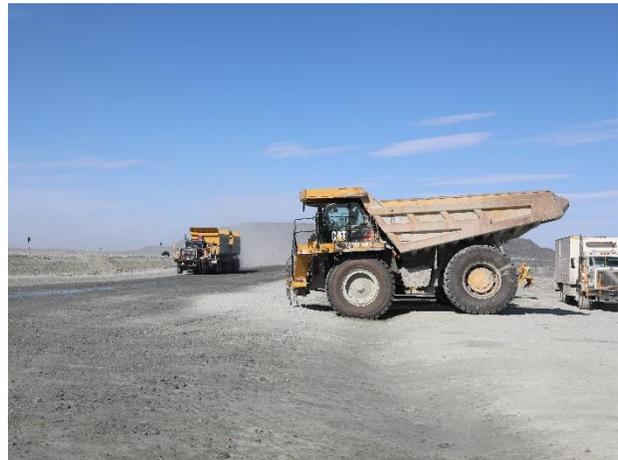
Photo 43: Long Haul Truck at Meadowbank Mine Site

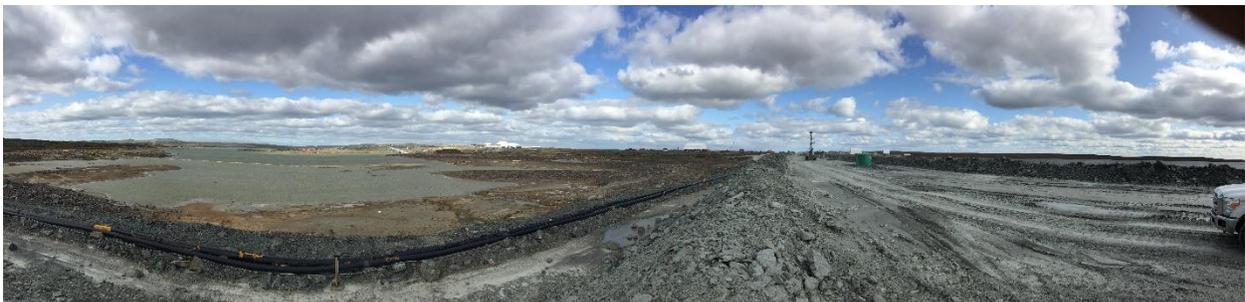
Photo 44: View of the North Basin from the Dike Across Whale Tail Lake

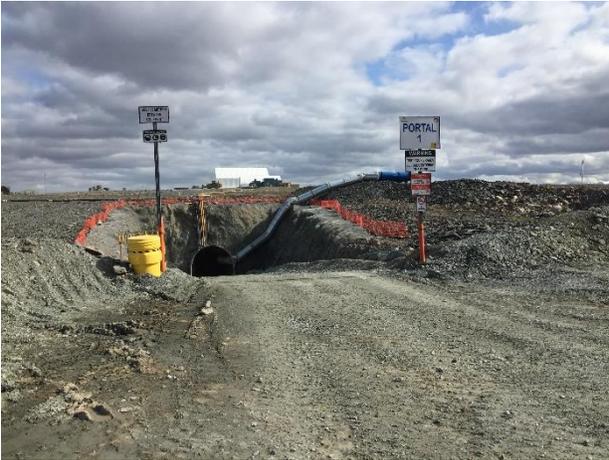
Photo 45: Entrance to the underground portal

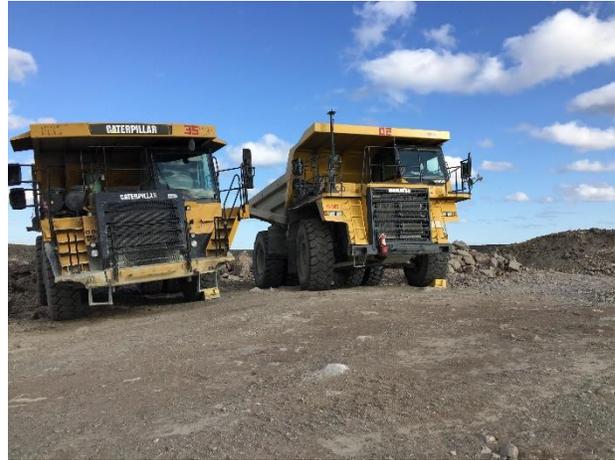
Photo 46: Haul Trucks

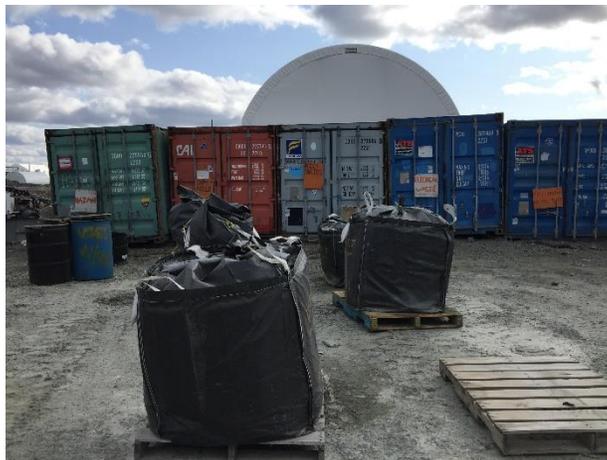
- c) It was noted during the 2019 site visit that Agnico Eagle had started to segregate and store all domestic, hazardous, and combustible wastes in marked seacans prior to these materials being incinerated at the Meadowbank site or shipped to the appropriate and approved off-site disposal facilities (see [Photo 47](#)).

Photo 47: Seacans used for waste segregation and storage area at Whale Tail Site

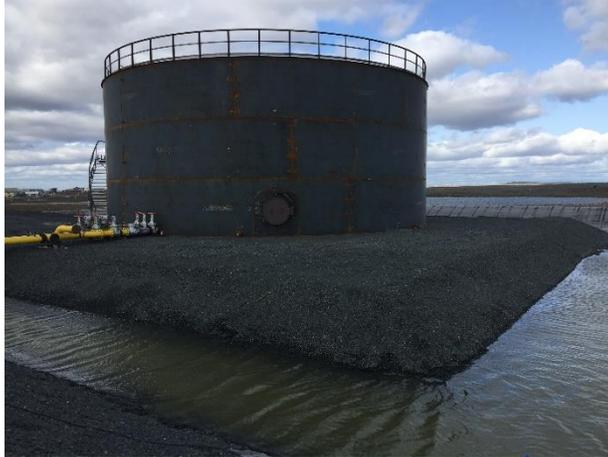
- d) Water was observed within the secondary storage containment facility for the fuel tank farm at the Whale Tail Pit site but there was no visible sheen on the water or discernable hydrocarbon odours (see [Photo 48](#)).

Photo 48: Whale Tail Pit Fuel Tank Farm Facility

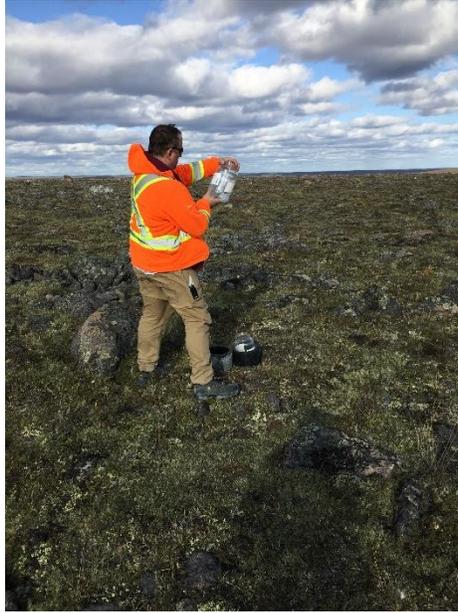
During the site visit, it was noted that dust suppressants were not being applied to the whole AWAR (see [Section 3.2.3.2](#) for further discussion), along the haul-road to the Whale Tail site nor at the Whale Tail site. Agnico Eagle noted that water is the only dust suppressant being used along the Haul-road; however, none was applied due to the heavy rains received. Further, it was observed during the site visit that no dust suppressants were applied at the Whale Tail site including at the North Basin Pit which was later confirmed by the Agnico Eagle staff (see [Photo 41](#), [Photo 49](#) and [Photo 50](#)). The reason for not applying suppressants at the time was due to the heavy rains received in August. Dust monitoring continues to be conducted along multiple stations along the Haul-road which was observed during the site visit (see [Photo 51](#)).

Photo 51: Dust Monitoring Station along the Haul-road
