# **Meadowbank 2019 Annual Geotechnical Inspection**

# 2019 Annual Geotechnical Inspection

*Meadowbank Gold Mine, Nunavut*

19123067-1588-R-Rev0

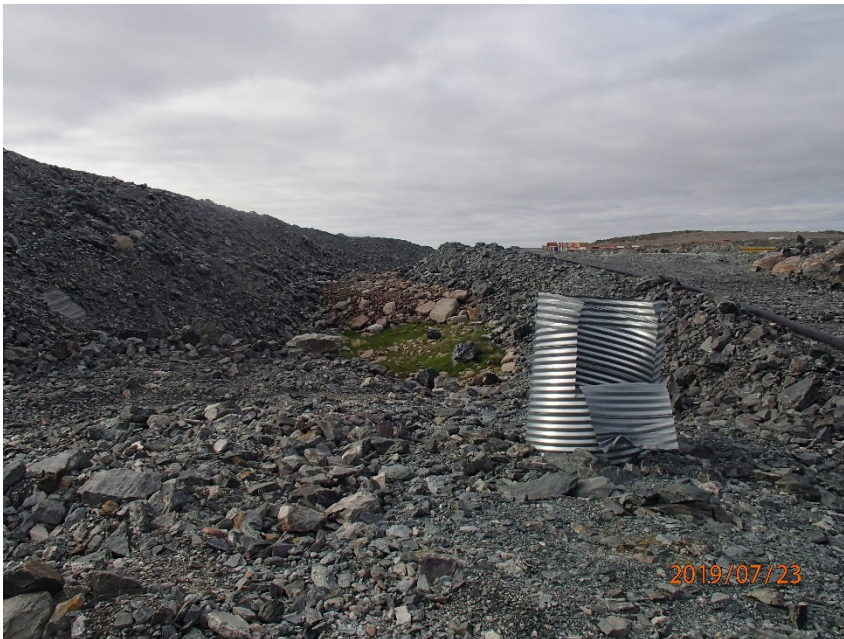
**Photograph A1-10 East Dike**

At the time of the 2019 inspection, no signs of sloughing or settlement were observed on the structure (including the vicinity of the 2009 sinkhole near Sta. 60+472). A tension crack, observed in 2018, of approximately 3 m in length, perpendicular to the dike alignment, was still observed around Sta. 60+480 m and seems inactive.

**Description:** From approximately Sta. 60+475, looking south at the downstream toe.

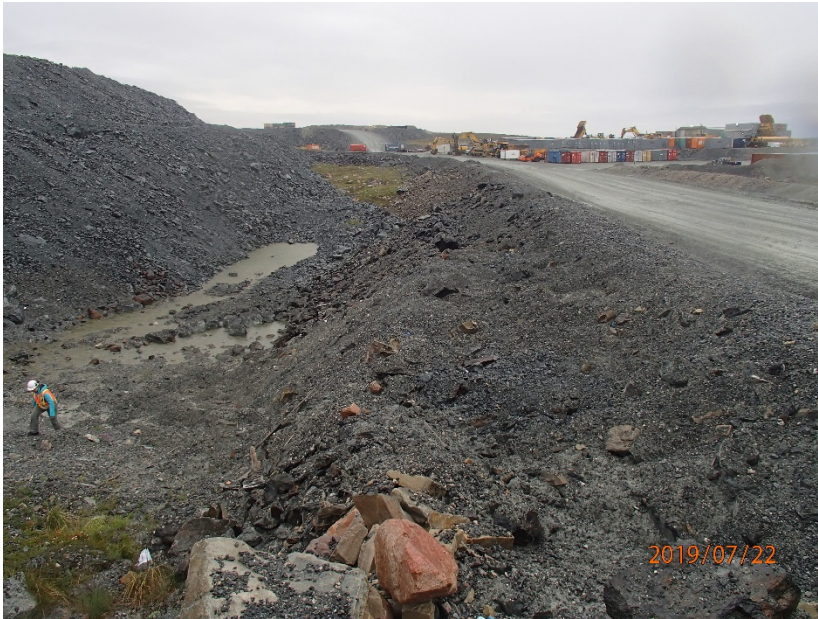
**Photograph A2-5 South Camp Dike**

Some water was ponding on the downstream side of South Camp Dike. No flow was observed. This is likely due to run-off water as there were unusually high precipitations in 2019. The water accumulation should still be monitored to confirm this.

**Description:** From the north abutment, looking south at the downstream slope. There is an accumulation of water, probably from run-off.

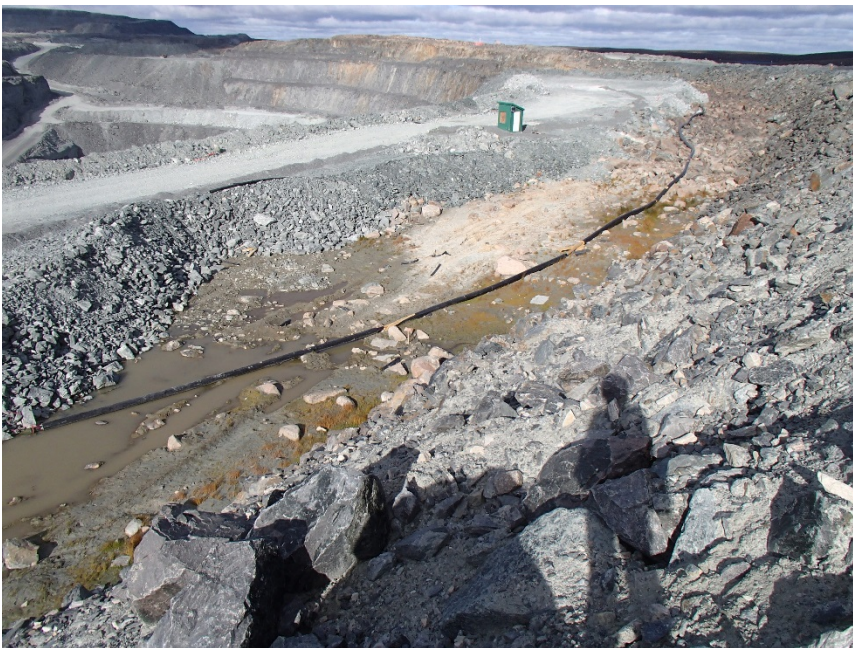
**Photograph A3-4 Bay Goose Dike**

Water was observed flowing in the North Channel during the inspection at Sta. 30+420 m. The flow was low and decreased since 2016. According to AEM, water was observed ponding at the toe during the year. Due to the topography, it is possible that water is ponding in this area from a nearby seepage channel (i.e., near the northern abutment). The piezometers of the North Channel have shown response to the unloading conditions that is part of the push back planned for extension of Pit E3 and Pit E4 (see Section 5.3.1 for more details). The North Channel is closely monitored to ensure that blast vibrations from Pit E do not exceed the design limit of 50 mm/s. It is recommended to regularly inspect this area, monitor the flow of water, and be on the lookout for signs of seepage from the toe of the dike and in Pit E4.

**Description:** From approximately Sta. 30+340, looking northwest at the north seepage channel.

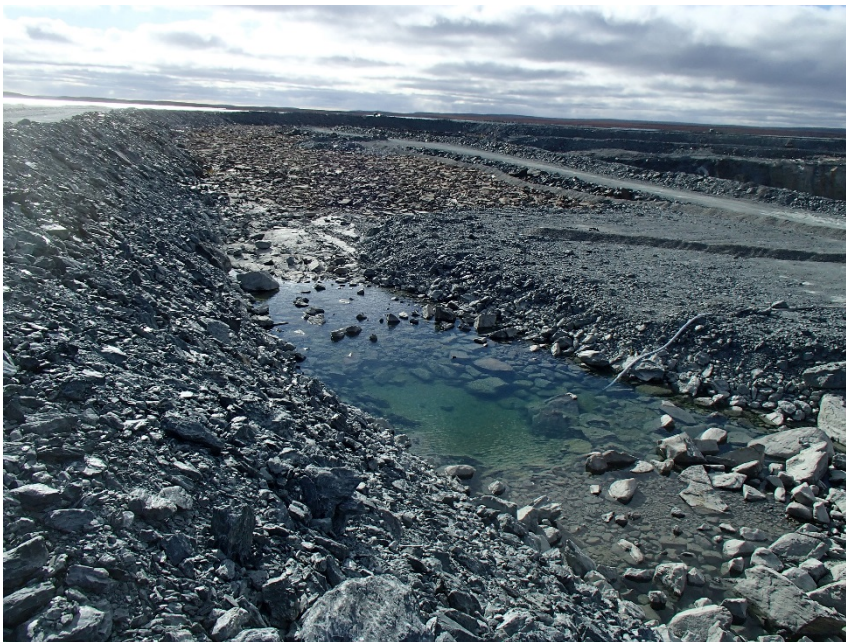
**Photograph A3-12 Bay Goose Dike**

**Description:** From approximately Sta. 31+080 on the crest, looking southwest at the pond of water at Central Channel seepage at Sta. 31+165.

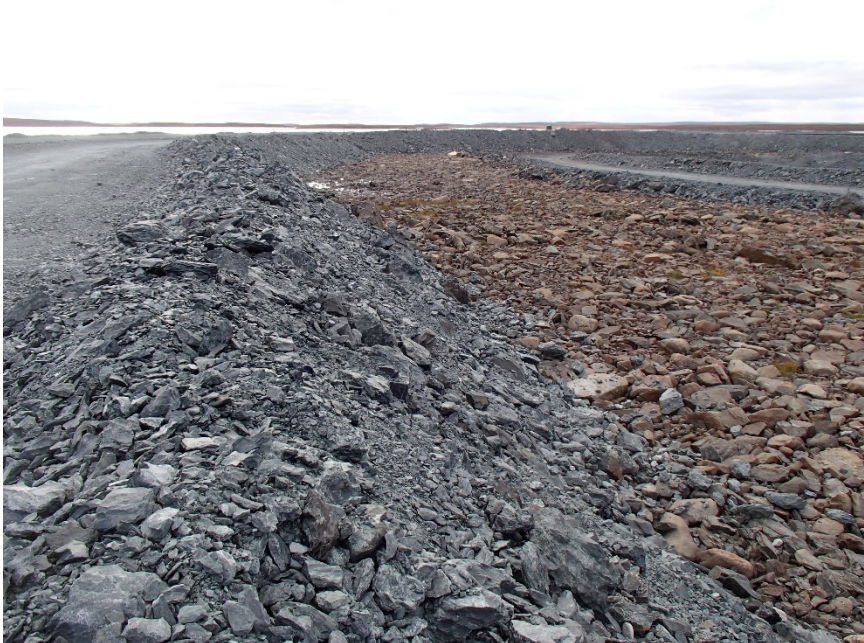
**Photograph A3-16 Bay Goose Dike**

**Description:** From approximately Sta. 31+280 on the crest, looking southwest at the downstream slope and the water pond at the downstream toe at Sta. 31+350.

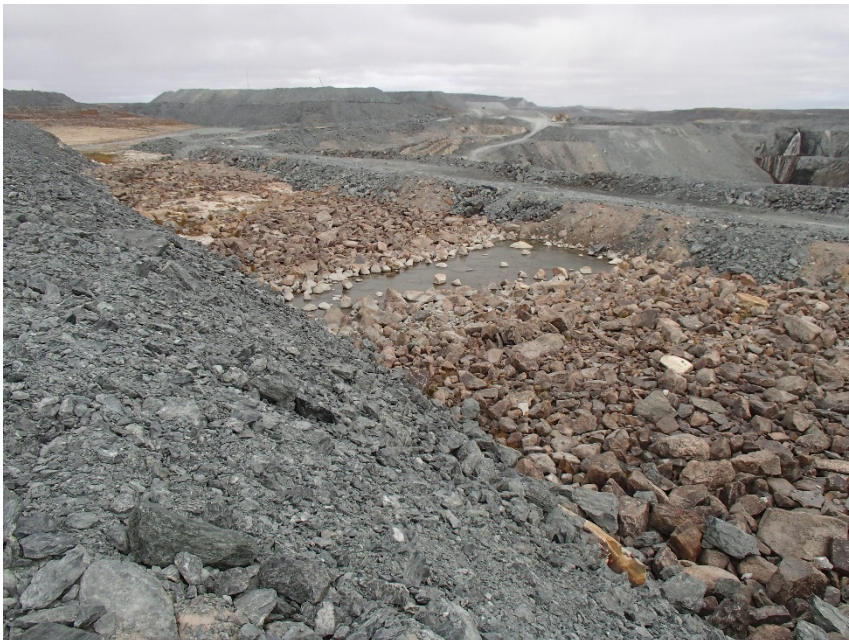
**Photograph A3-30 Bay Goose Dike**

**Description:** From the crest at approximately Sta. 31+740, looking north downstream at the water pond at Sta. 31+750.

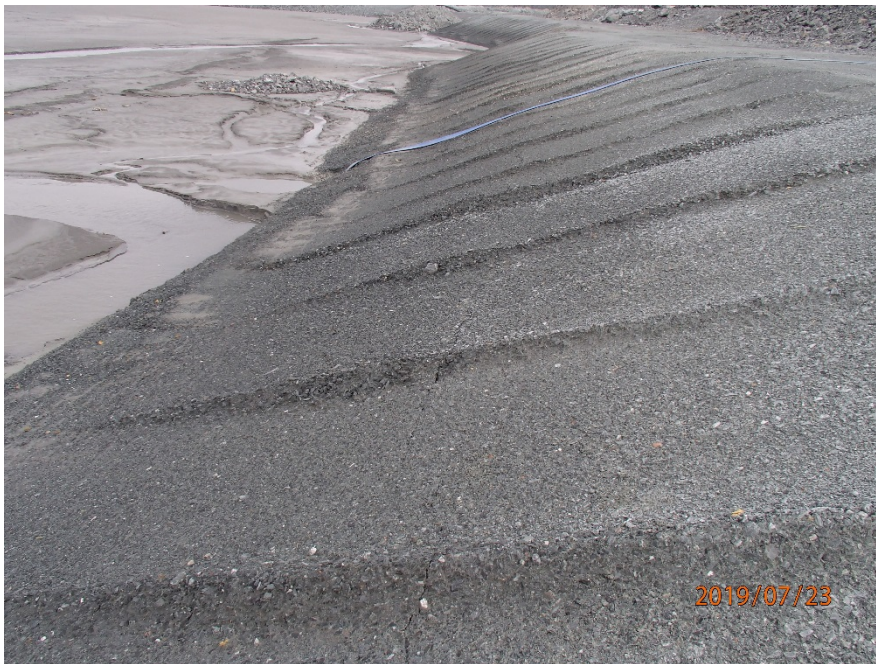
**Photograph B1-8 Tailings Storage Facility**

**Description:** From the North Cell Internal Structure at approx. Sta. 2+800. The toe of the slope is eroded by water.

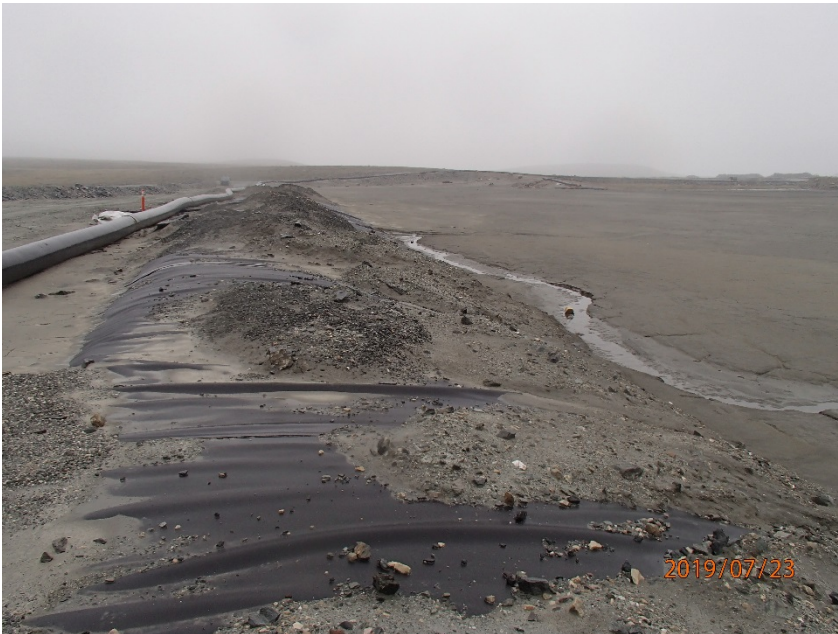
**Photograph B2-7 Saddle Dam 1**

**Description:** From approximately Sta. 0+195 upstream, looking south at the upstream slope. Adequate tailings beach against SD1. A small pond of water is present at the surface of the tailings and is not a concern.

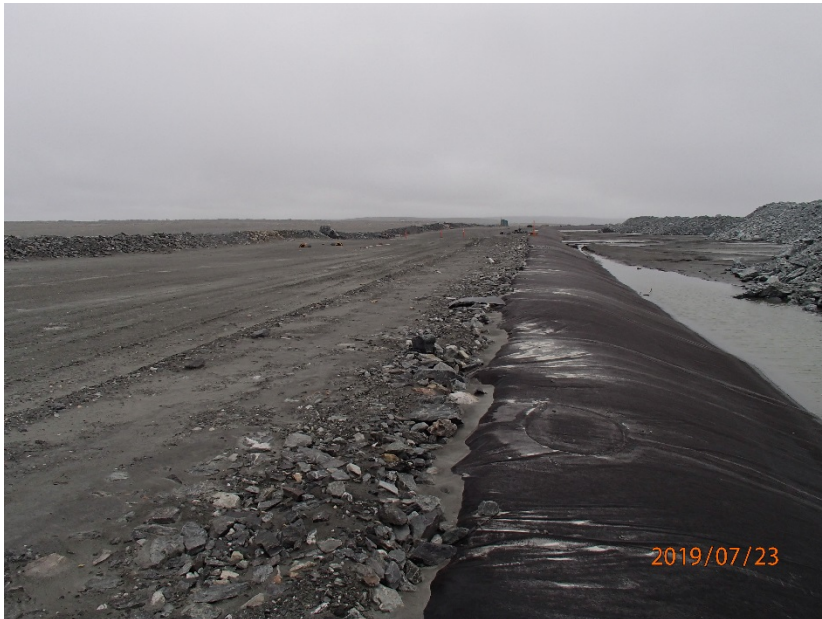
**Photograph B4-1 Stormwater Dike**

**Description:** From the east abutment (11+100 approximately), looking west at the upstream face and the rockfill cover of the North Cell. Shallow water ponding against portion of the dike (less than 30 cm deep). Large rocks are present near the liner.

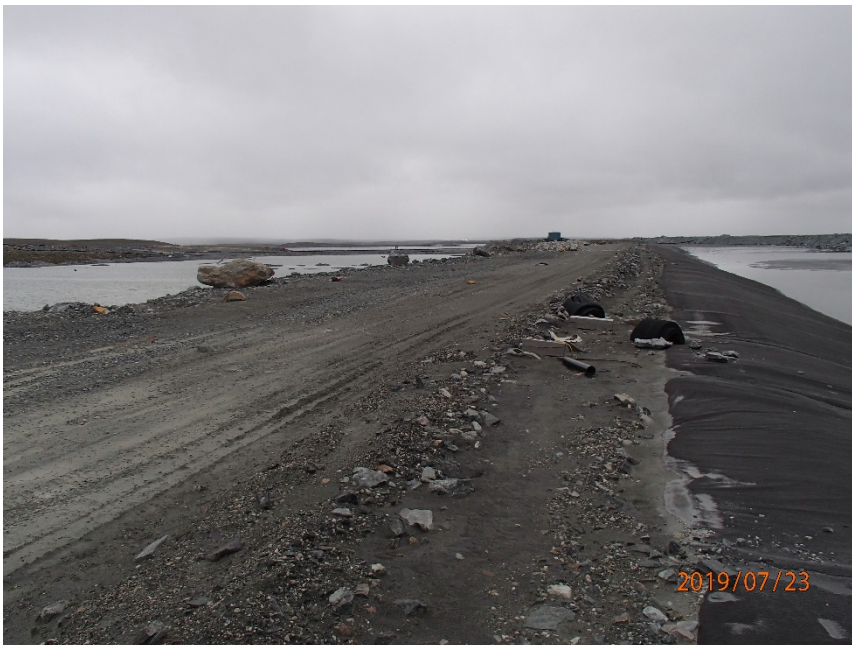
**Photograph B4-4 Stormwater Dike**

**Description:** From Sta. 10+650 looking west at the crest. Shallow water against portion of Stormwater Dike.

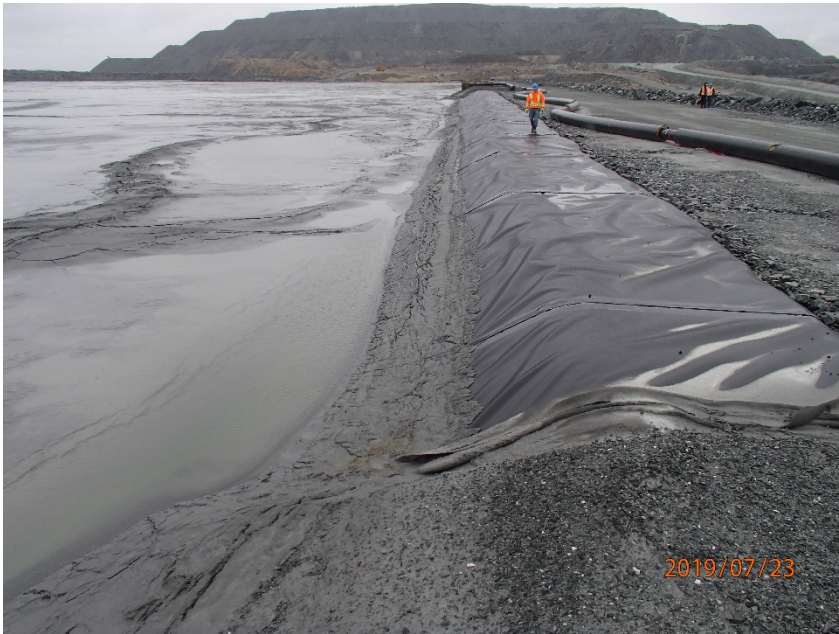
**Photograph B7-1 Central Dike and Saddle Dam 5**

**Description:** From approximately Sta. 0+525 looking northwest at the upstream slope. Adequate tailings beach against the south section of the structure.

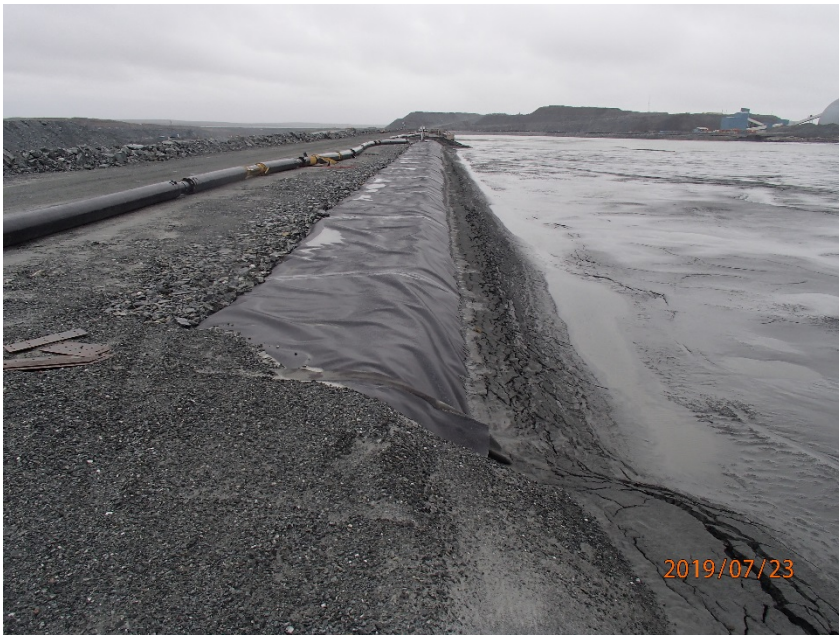
**Photograph B7-2 Central Dike and Saddle Dam 5**

**Description:** From approximately Sta. 0+525 looking southwest at the upstream slope. Adequate tailings beach against the south section of the structure.

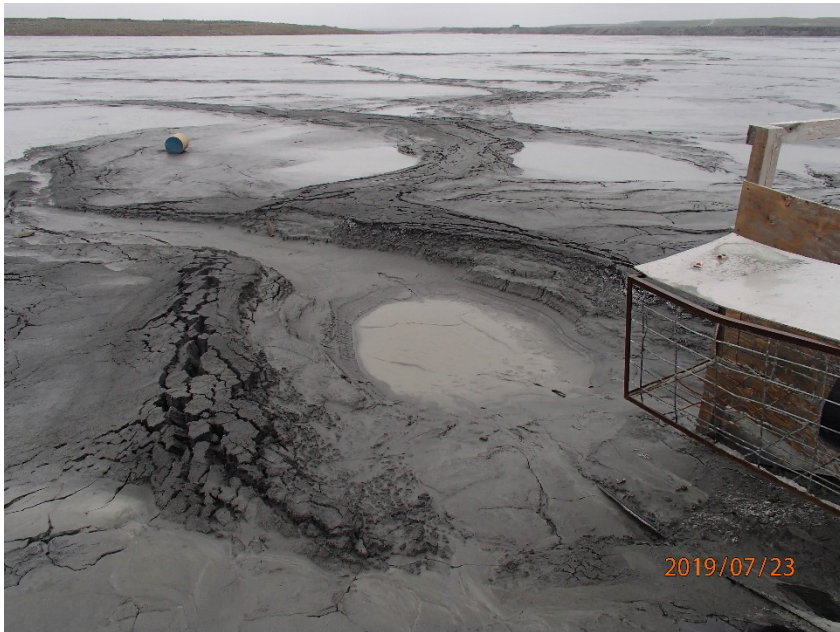
**Photograph B7-3 Central Dike and Saddle Dam 5**

**Description:** From approximately Sta. 0+525 looking at the deposition finger. The LLDPE liner is well protected and the tailing beach against the structure is adequate.

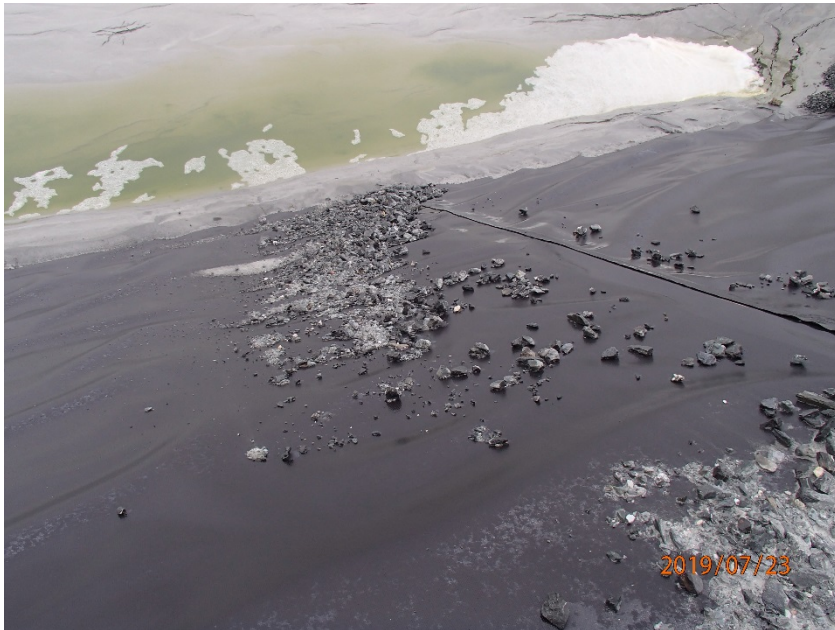
**Photograph B7-8 Central Dike and Saddle Dam 5**

**Description:** From approximately Sta. 0+800 on the crest, looking at the upstream slope. Granular material is present on the LLDPE liner.

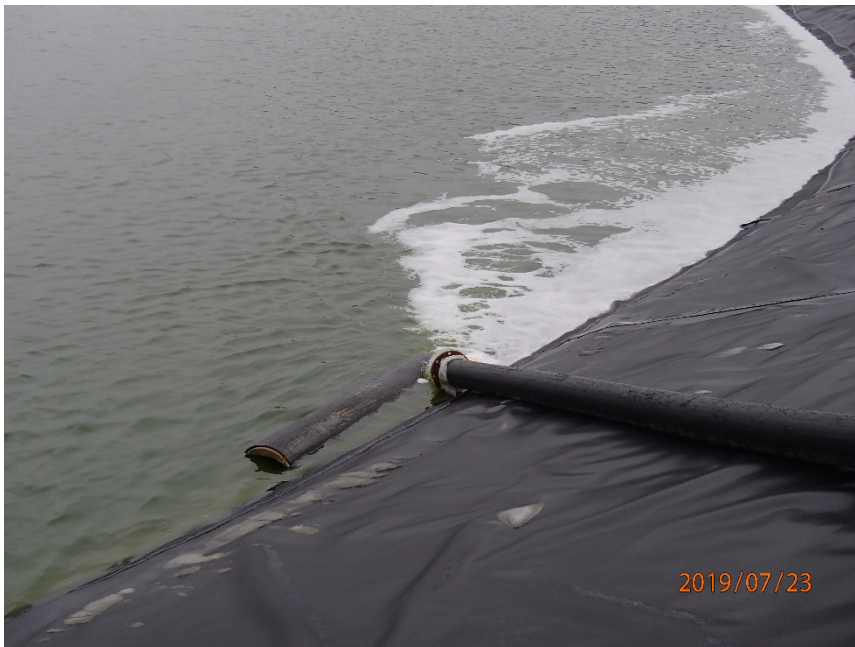
**Photograph B7-10 Central Dike and Saddle Dam 5**

**Description:** From approximately Sta. 1+000 looking north at the upstream slope of Central Dike and SD5. A metallic pipe is present on the LLDPE liner.

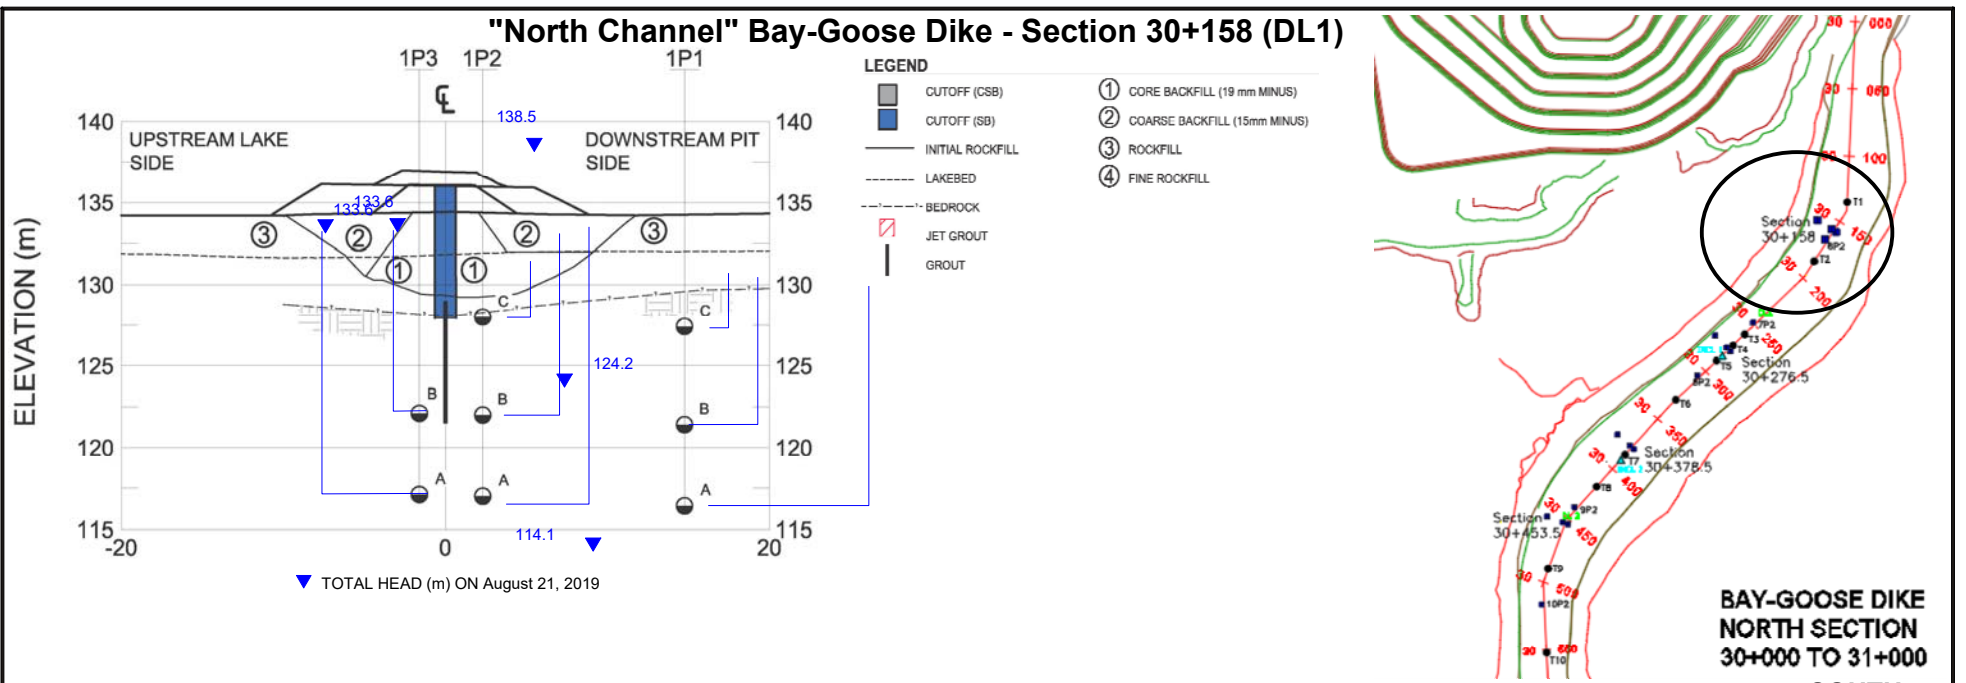
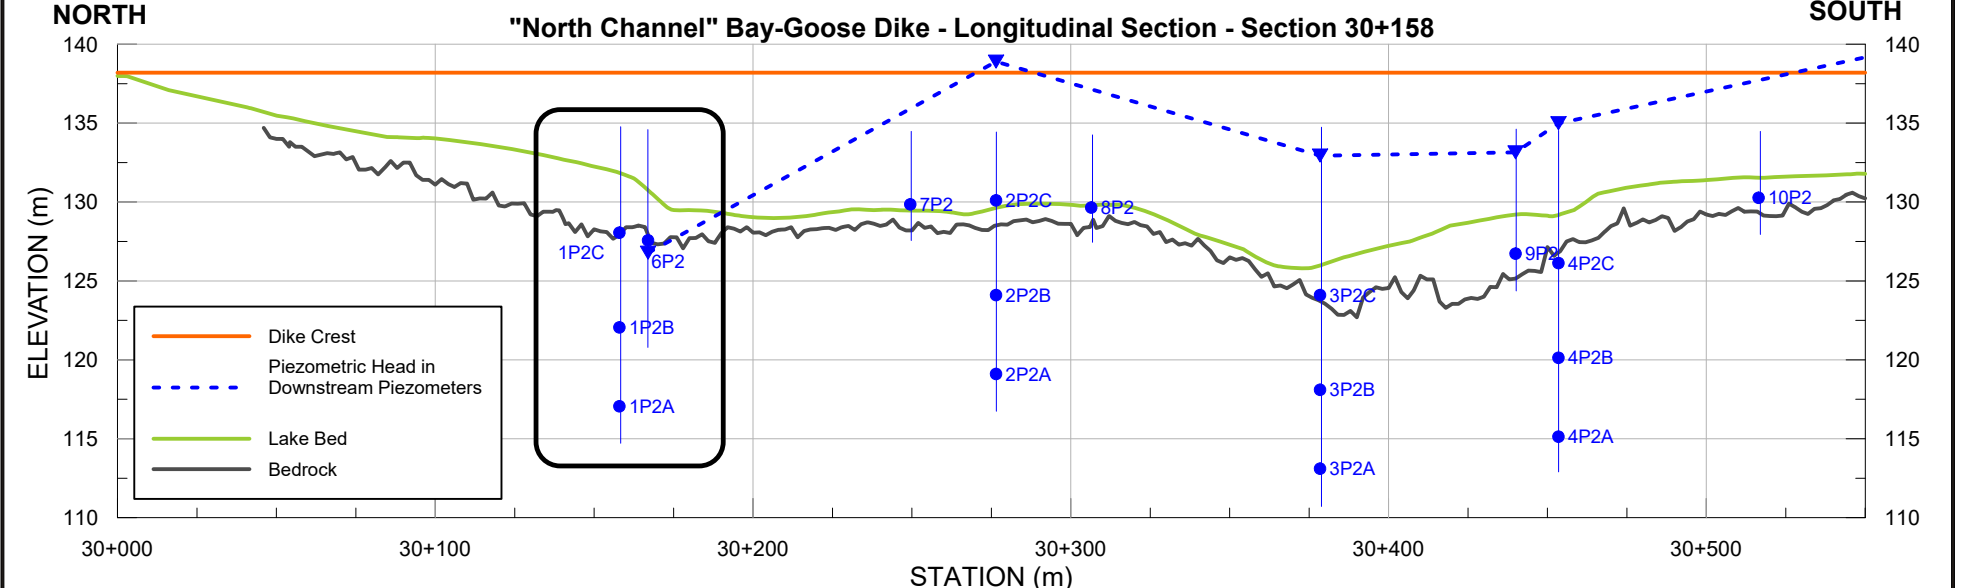
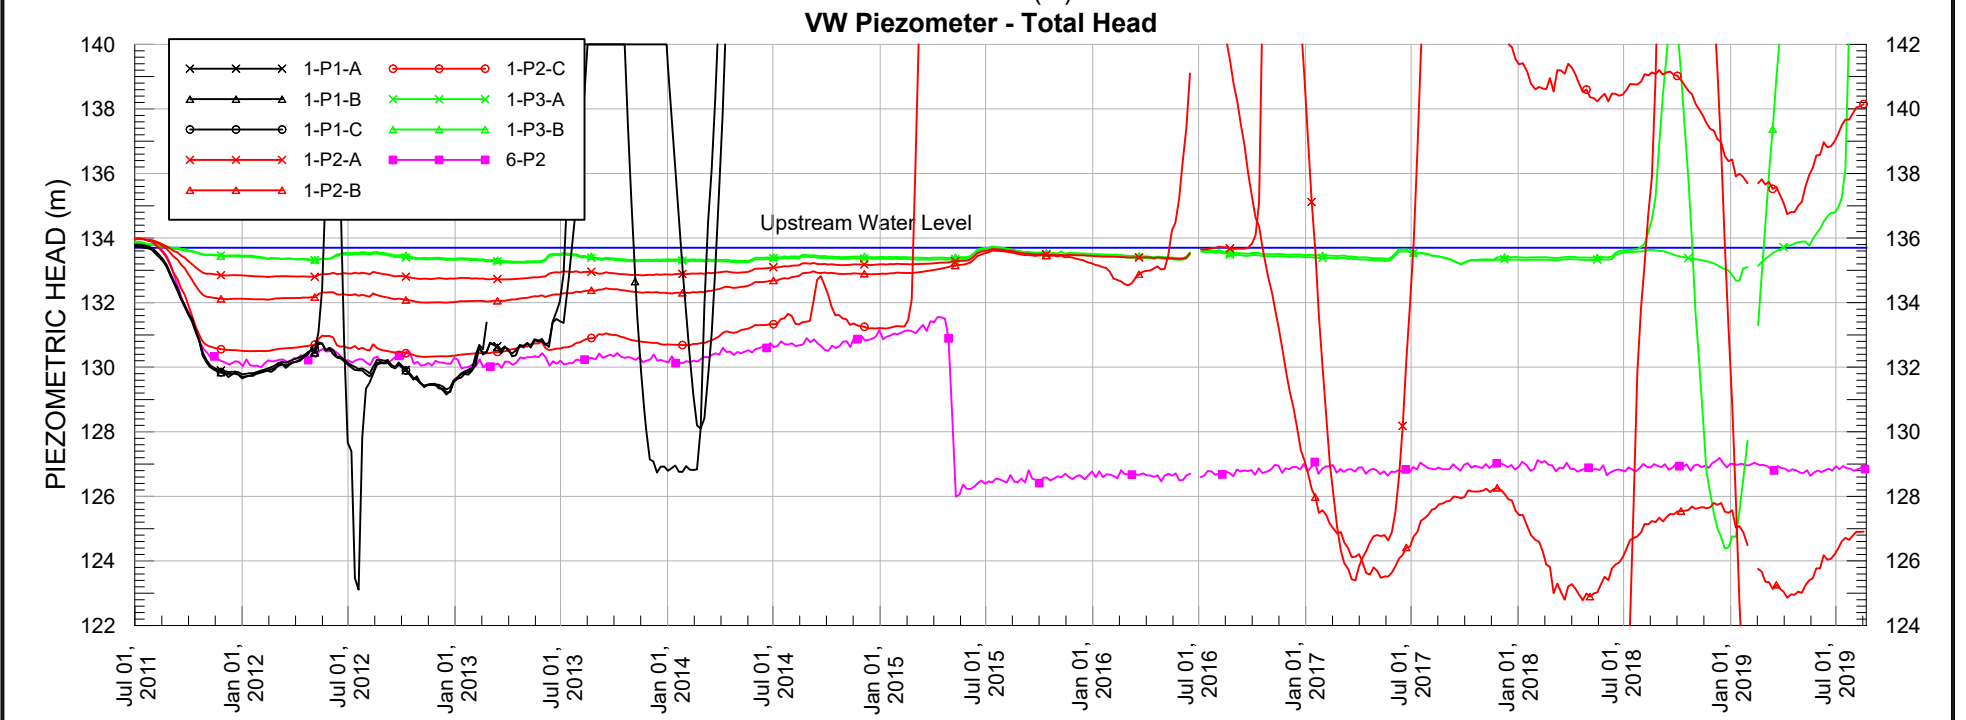
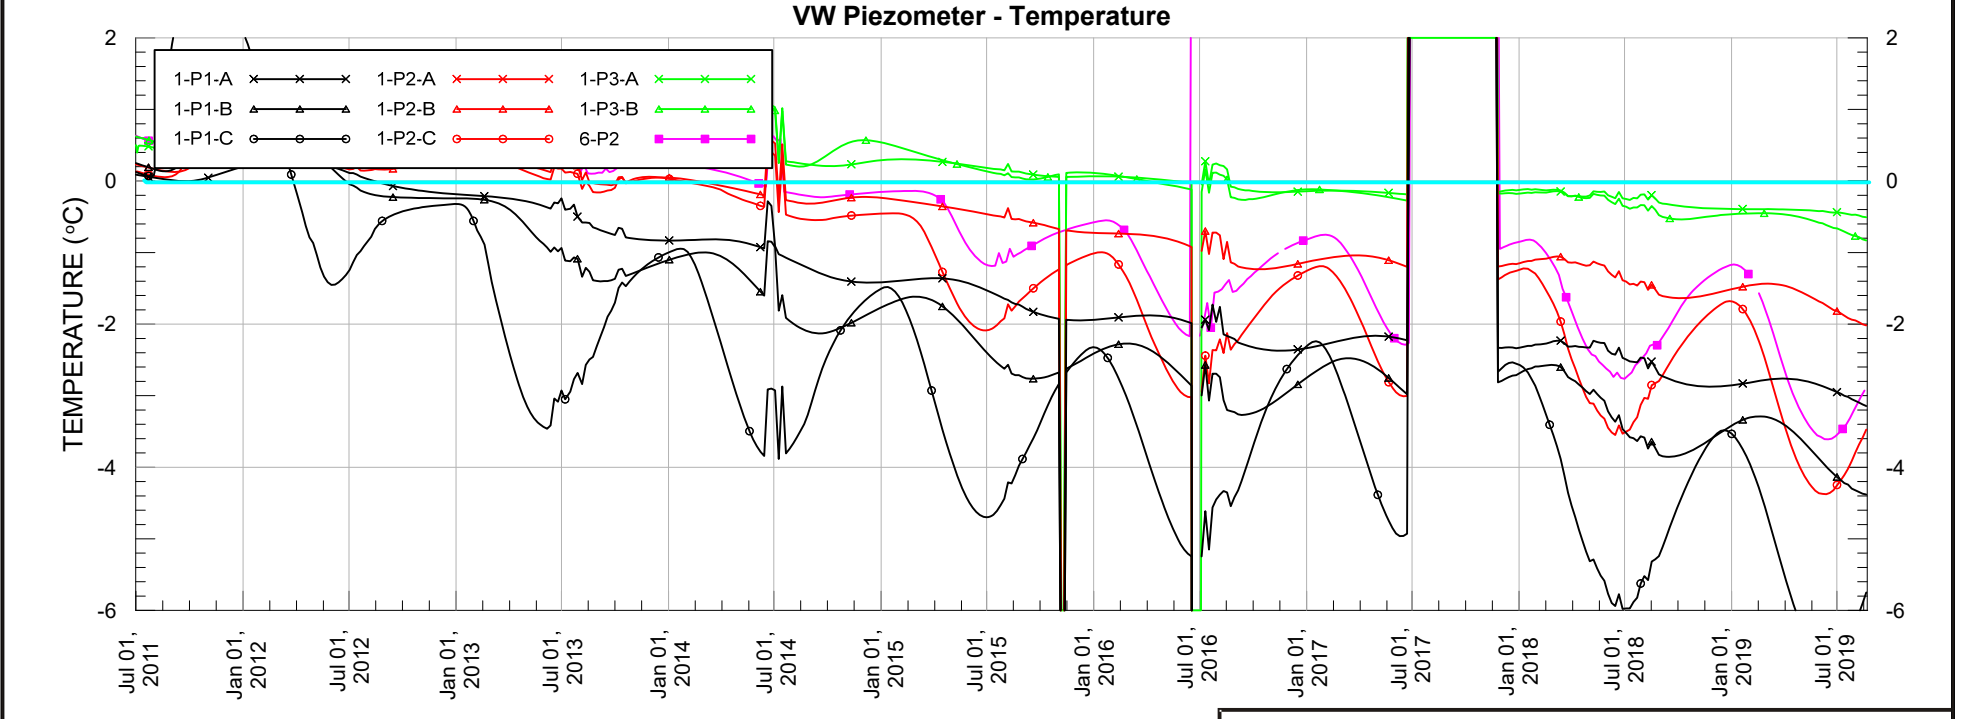
**NOTES:**  
 1. 1-P1-A, 1-P2-B, 1-P1-C, 1-P2-C and 6P2 are assumed to be frozen and not giving good data. The PWP not considered reliable.

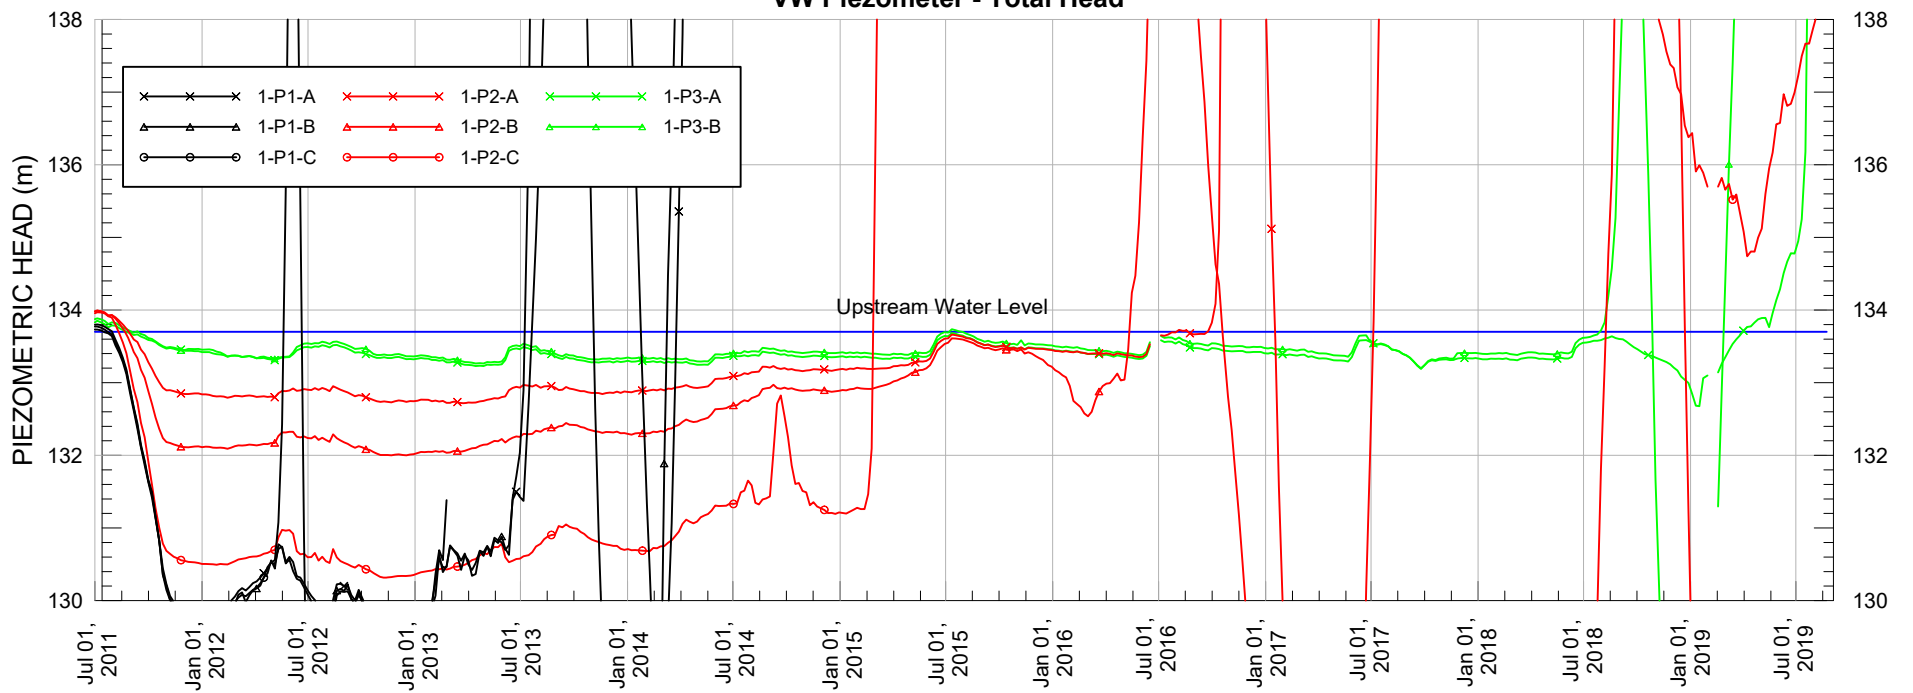
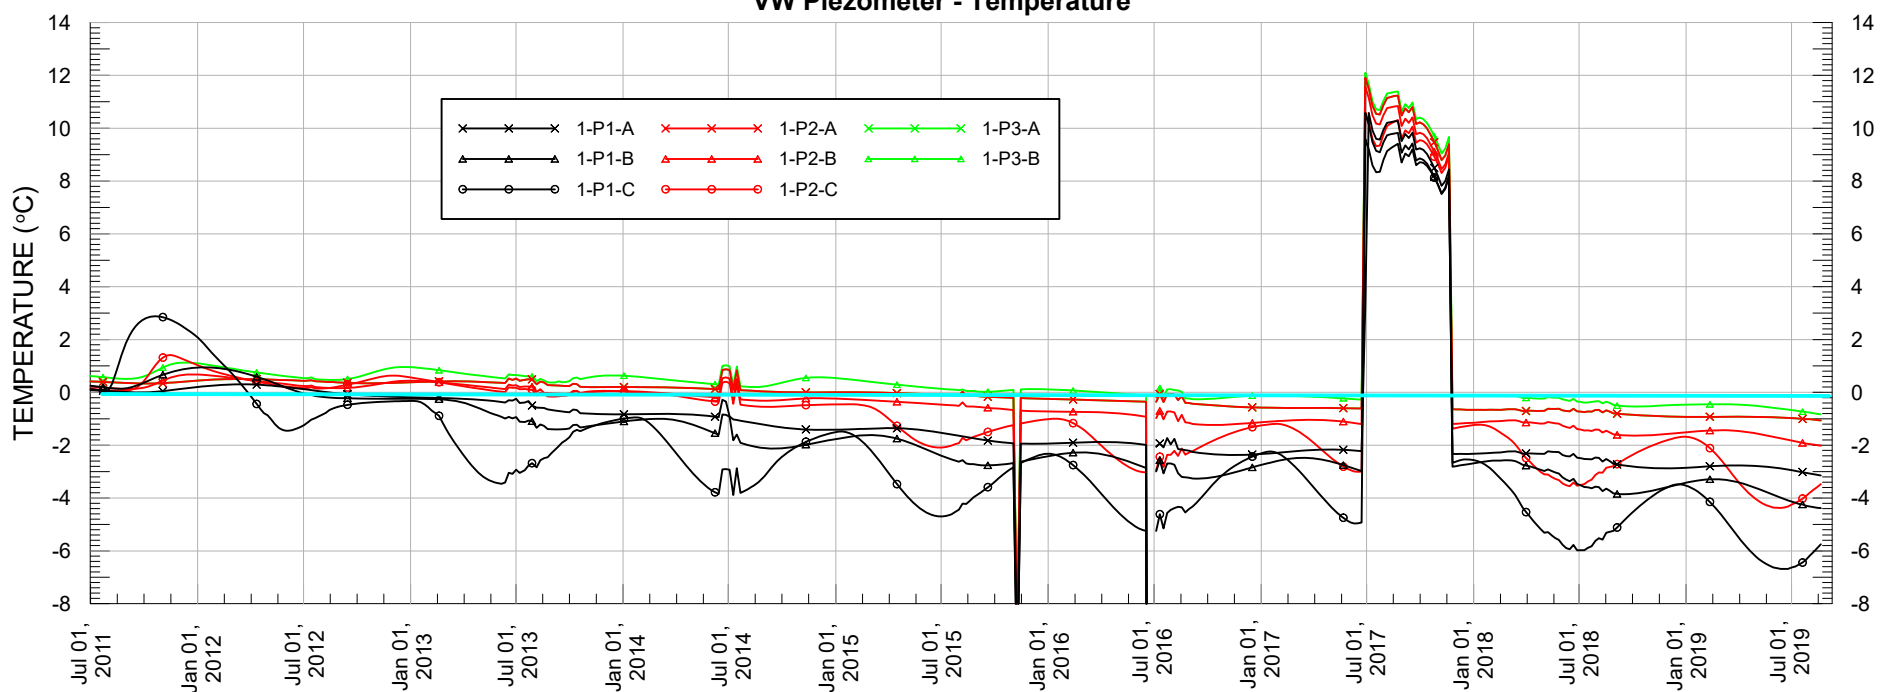
PROJECT		AGNICO EAGLE MINES LIMITED MEADOWBANK GOLD PROJECT NUNAVUT	
TITLE		BAYGOOSE DIKE - SECTION 30+158 PIEZOMETRIC DATA (July 1/11 to Aug 21/19)	
	PROJECT No.	PHASE No.	
	DESIGN TD	31AUG14	SCALE AS SHOWN REV.
	CADD TD	31AUG14	
	CHECK PG	28AUG14	<b>FIGURE 2</b>
REVIEW

- 1-P1-A, 1-P2-B, 1-P1-C, 1-P2-A and 6P2 are assumed to be frozen and not giving good data. The PWP not considered to be reliable data.

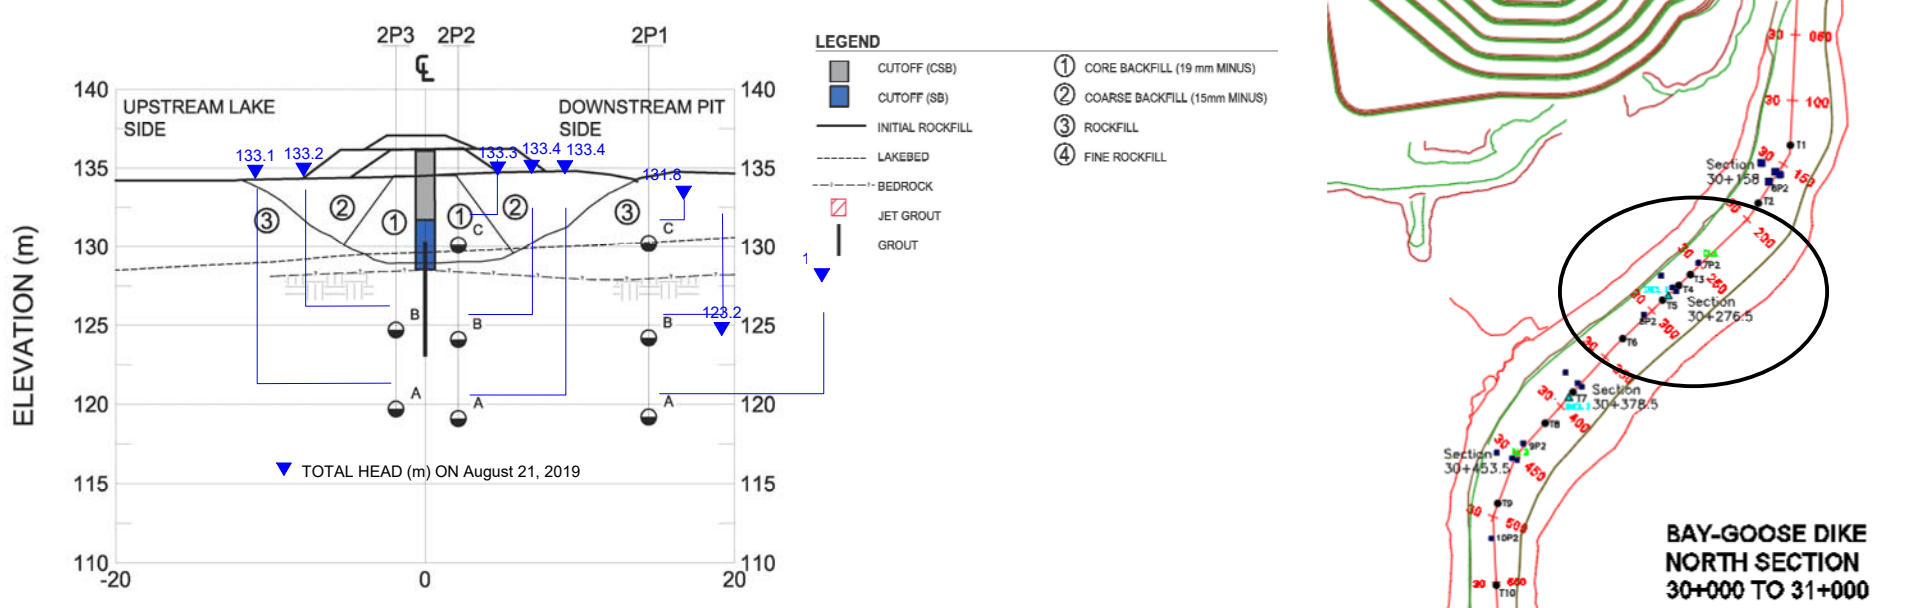
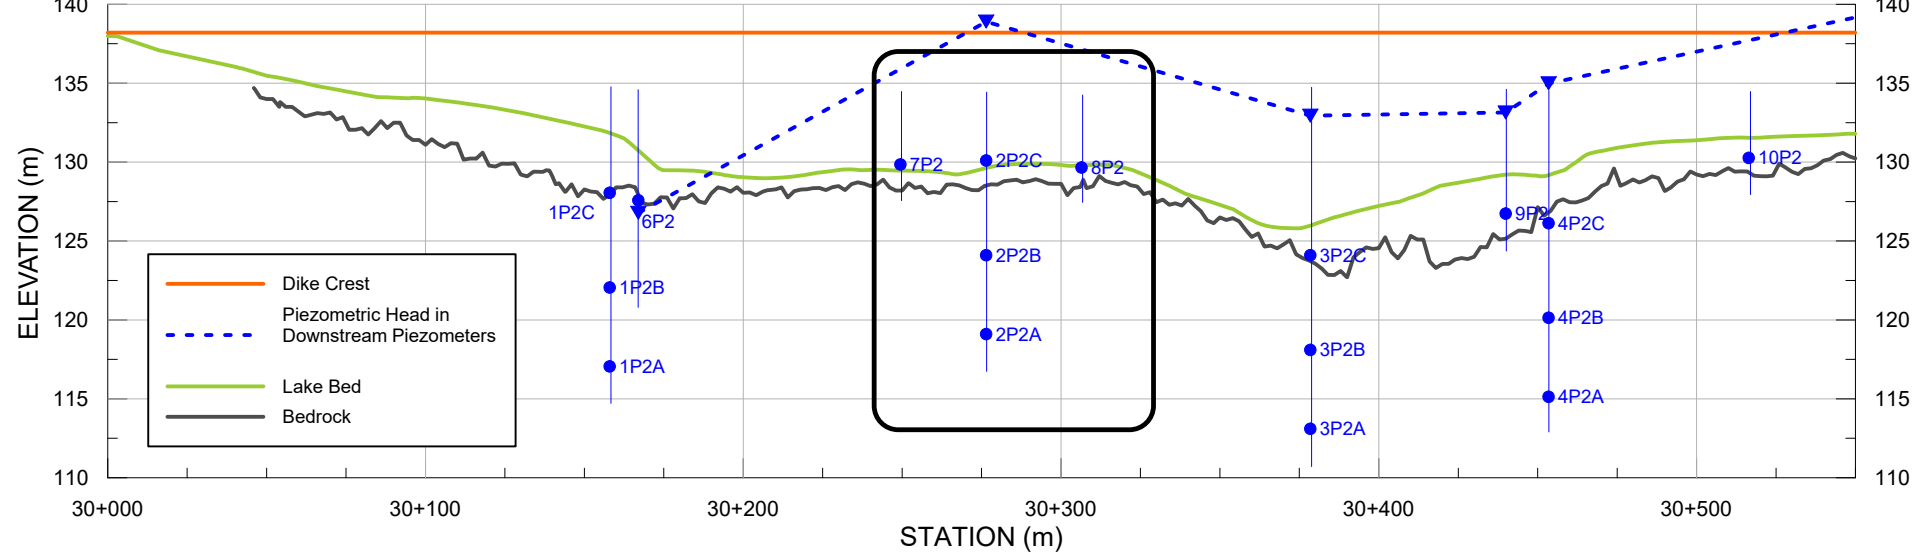
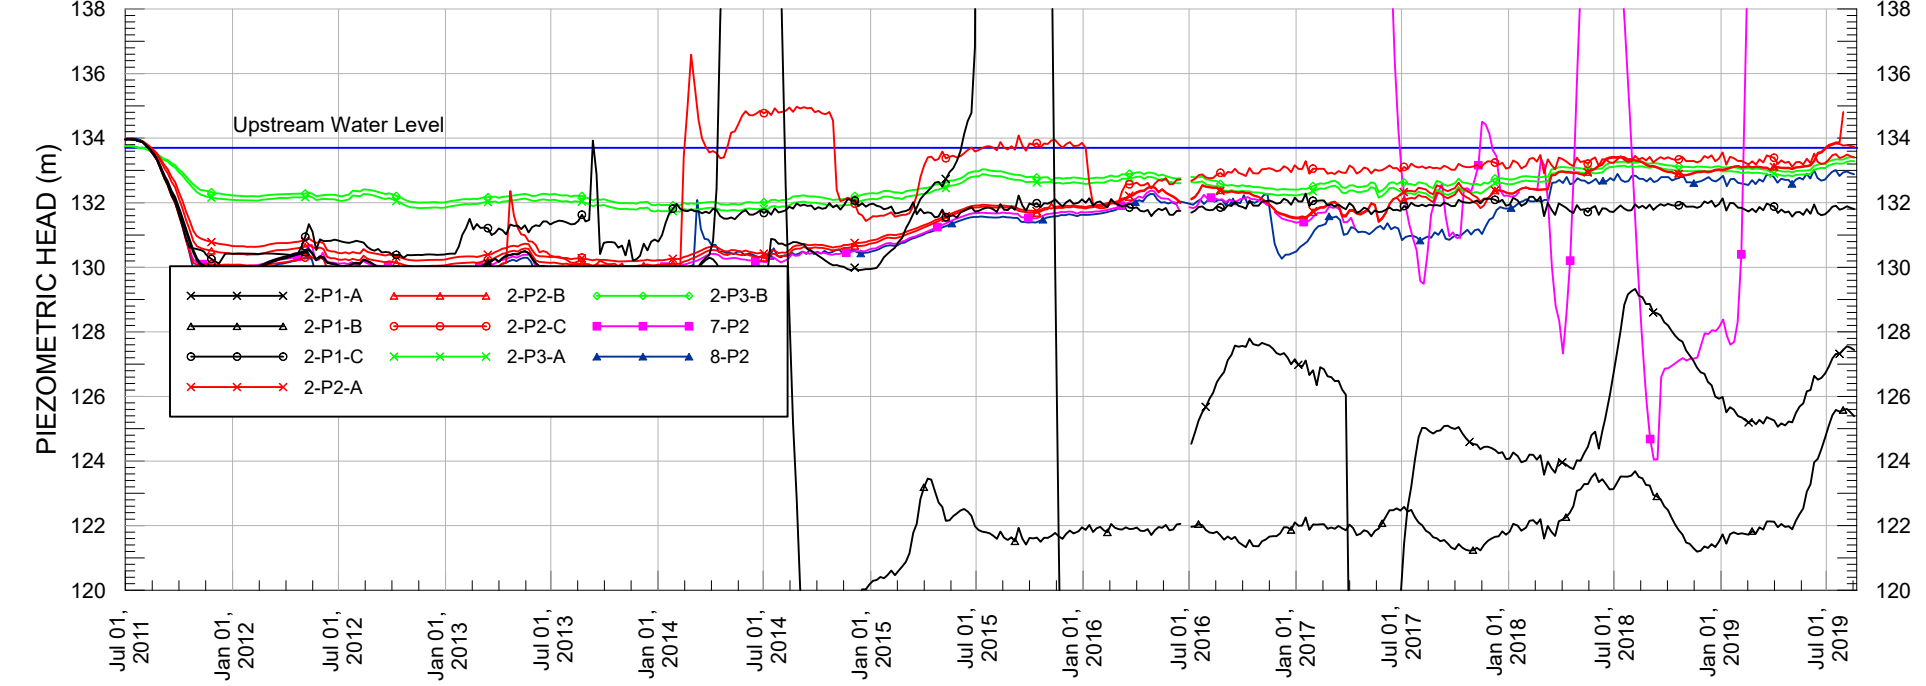
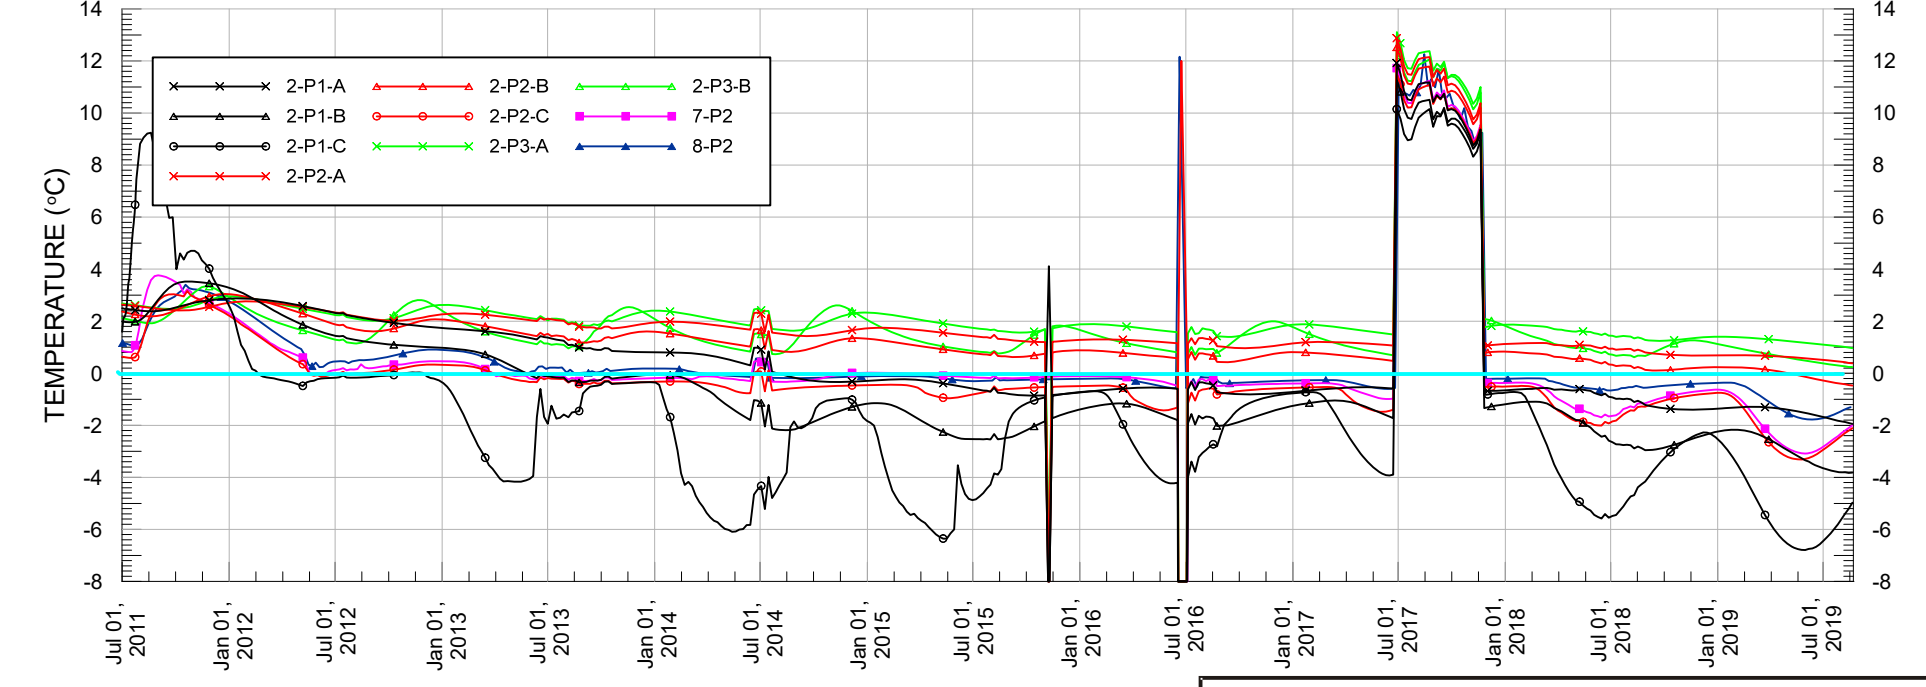
PROJECT		<b>AGNICO EAGLE MINES LIMITED MEADOWBANK GOLD PROJECT NUNAVUT</b>	
TITLE		<b>BAYGOOSE DIKE Section 30+276.5 - PIEZOMETRIC DATA (July 1/11 to Aug 21/19)</b>	
	PROJECT No.	PHASE No.	
	DESIGN TD 28AUG14	SCALE AS SHOWN	REV.
	CADD TD 28AUG14	<b>FIGURE 3</b>	
	CHECK PG 28AUG14		
REVIEW

**NOTES:**  
 1: 2P1A, 2P1B and 2P2C are assumed to be frozen. 7P2 and 8P2 are also considered frozen therefore the data is considered not reliable as the previous trend shows.
