# **Meadowbank 2019 Annual Geotechnical Inspection**

# 2019 Annual Geotechnical Inspection

*Meadowbank Gold Mine, Nunavut*

19123067-1588-R-Rev0

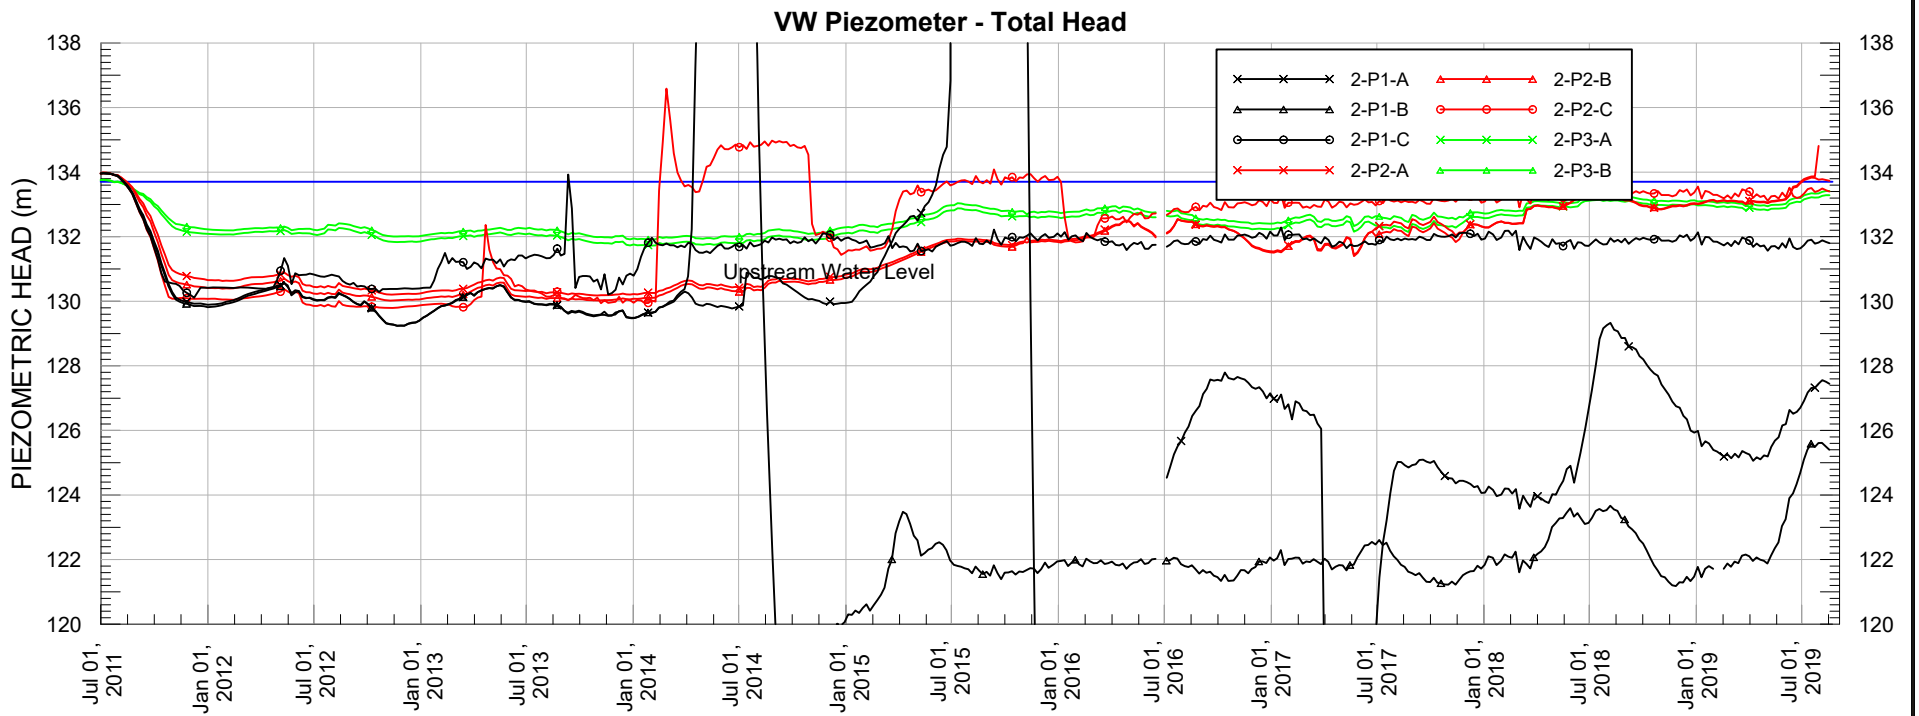
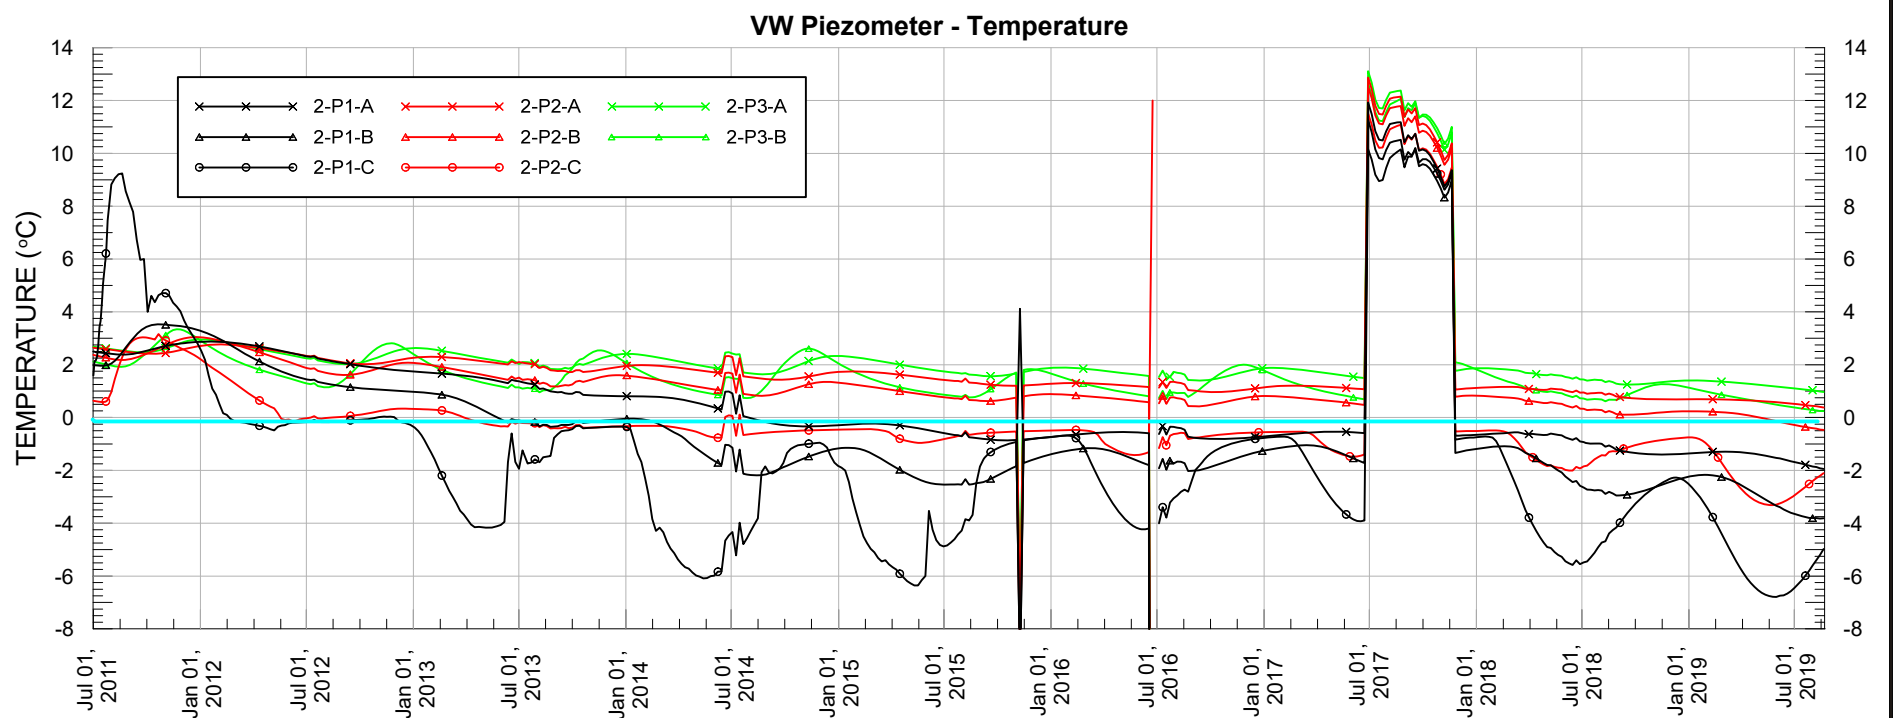
PROJECT		<b>AGNICO EAGLE MINES LIMITED MEADOWBANK GOLD PROJECT NUNAVUT</b>		
TITLE		<b>BAY GOOSE DIKE - SECTION 30+276.5 PIEZOMETRIC DATA (July 1/11 to Aug 21/19)</b>		
	PROJECT No.	PHASE No.		
	DESIGN TD 28AUG14	SCALE AS SHOWN	REV.	
	CADD TD 28AUG14	<b>Figure 4</b>		
	CHECK PG 28AUG14			
REVIEW

1. 2P1A, 2P1B and 2P2C are assumed to be frozen. 7P2 is also frozen therefore the instrument is not giving reliable data.

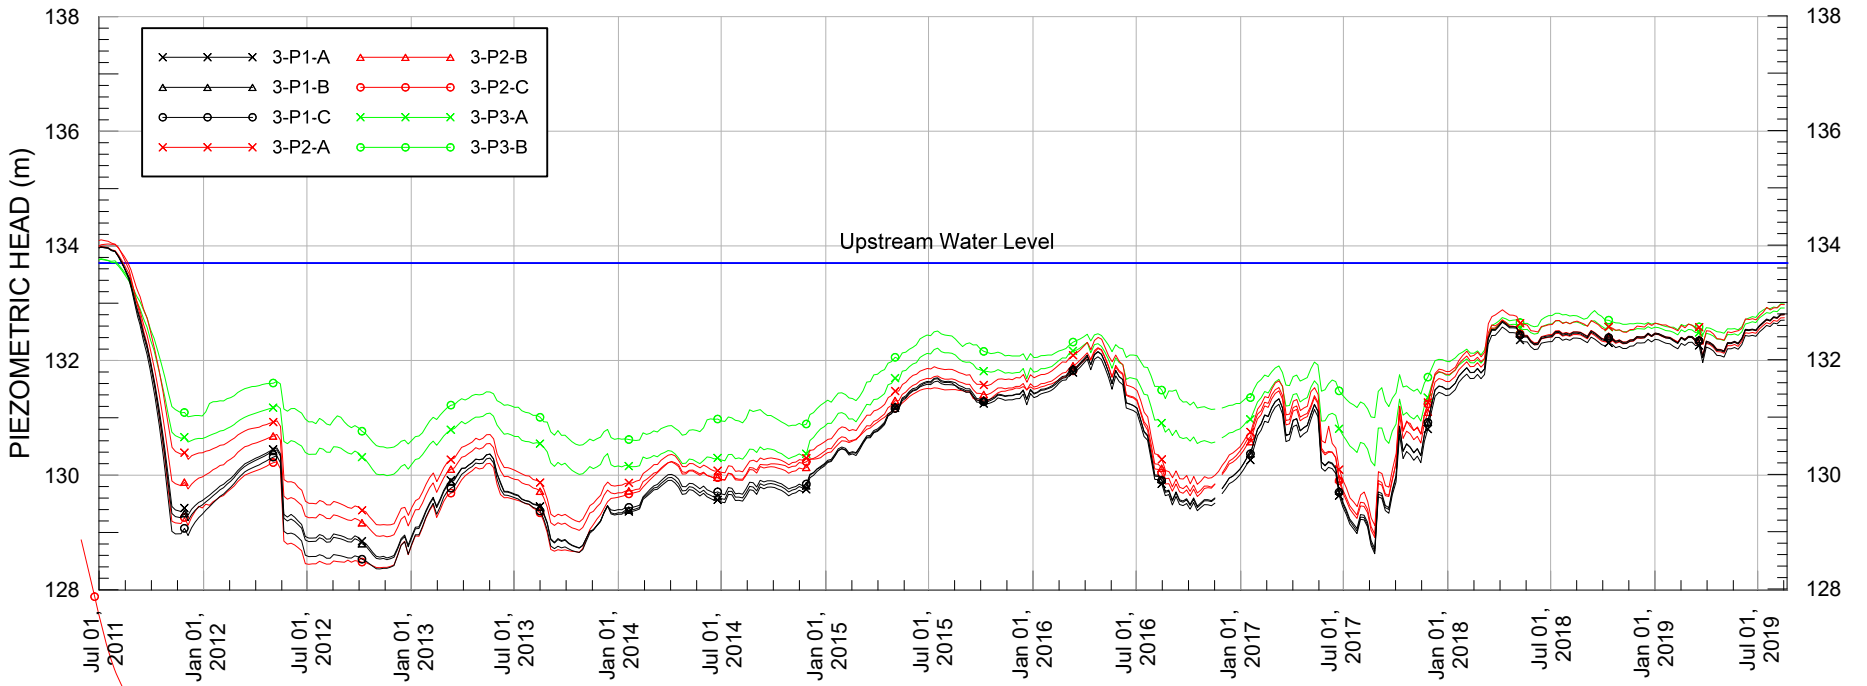
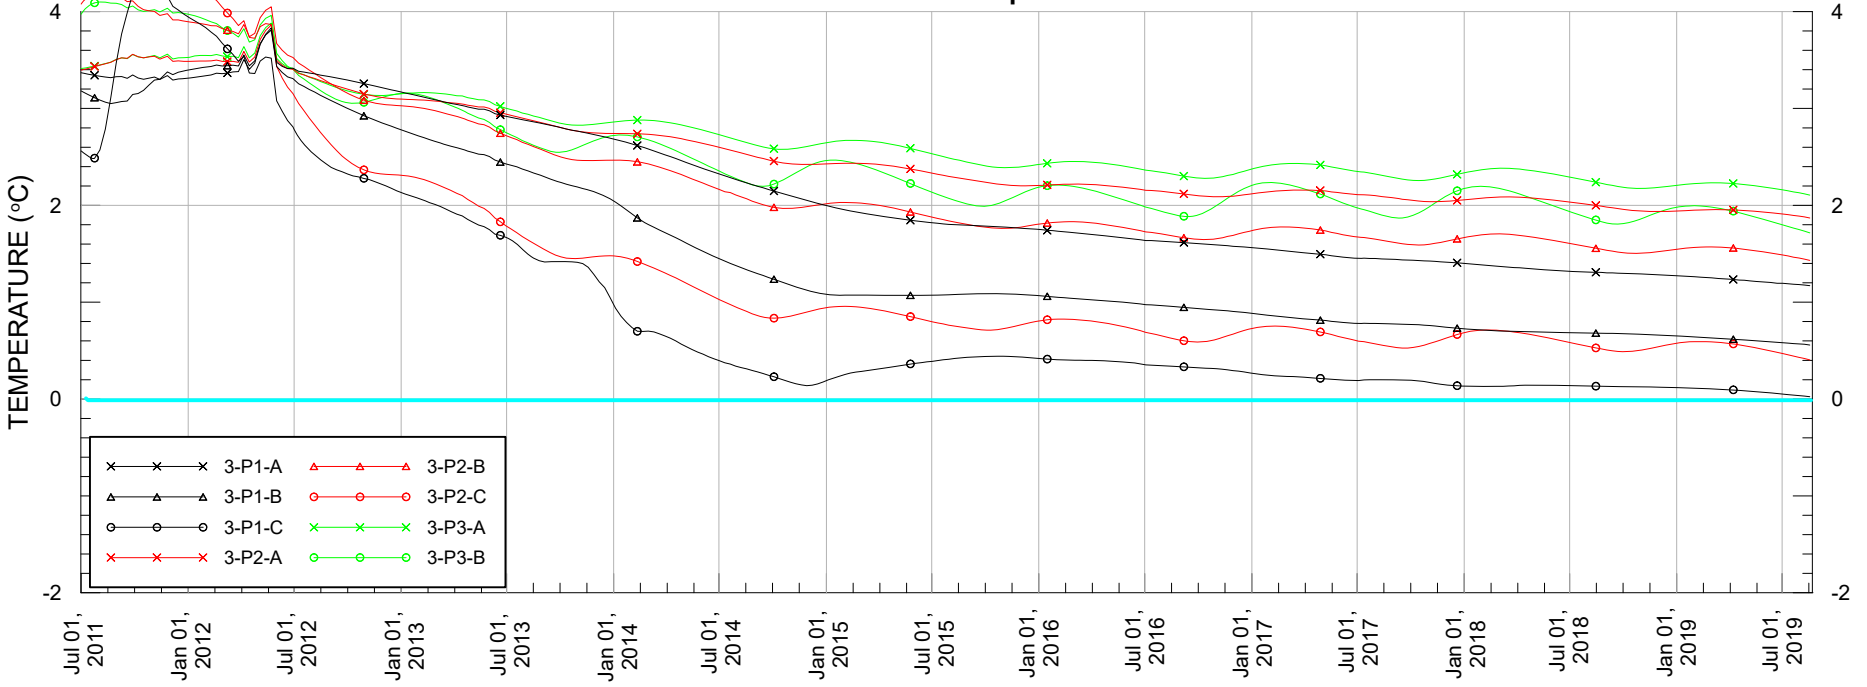
PROJECT		<b>AGNICO EAGLE MINES LIMITED MEADOWBANK GOLD PROJECT NUNAVUT</b>		
TITLE		<b>BAYGOOSE DIKE - SECTION 30+378.5 PIEZOMETRIC DATA (July 1/11 to Aug 21/19)</b>		
	PROJECT No.	PHASE No.		
	DESIGN	TD	28AUG19	
	CADD	TD	28AUG19	
	CHECK	TD	28AUG19	
REVIEW	PG	28AUG19	SCALE	AS SHOWN
		<b>FIGURE 6</b>

1. Changes in PWP pressure are directly related to the drill and blasting that is currently ongoing in Portage Pit E5. Ice buildup is also a factor.

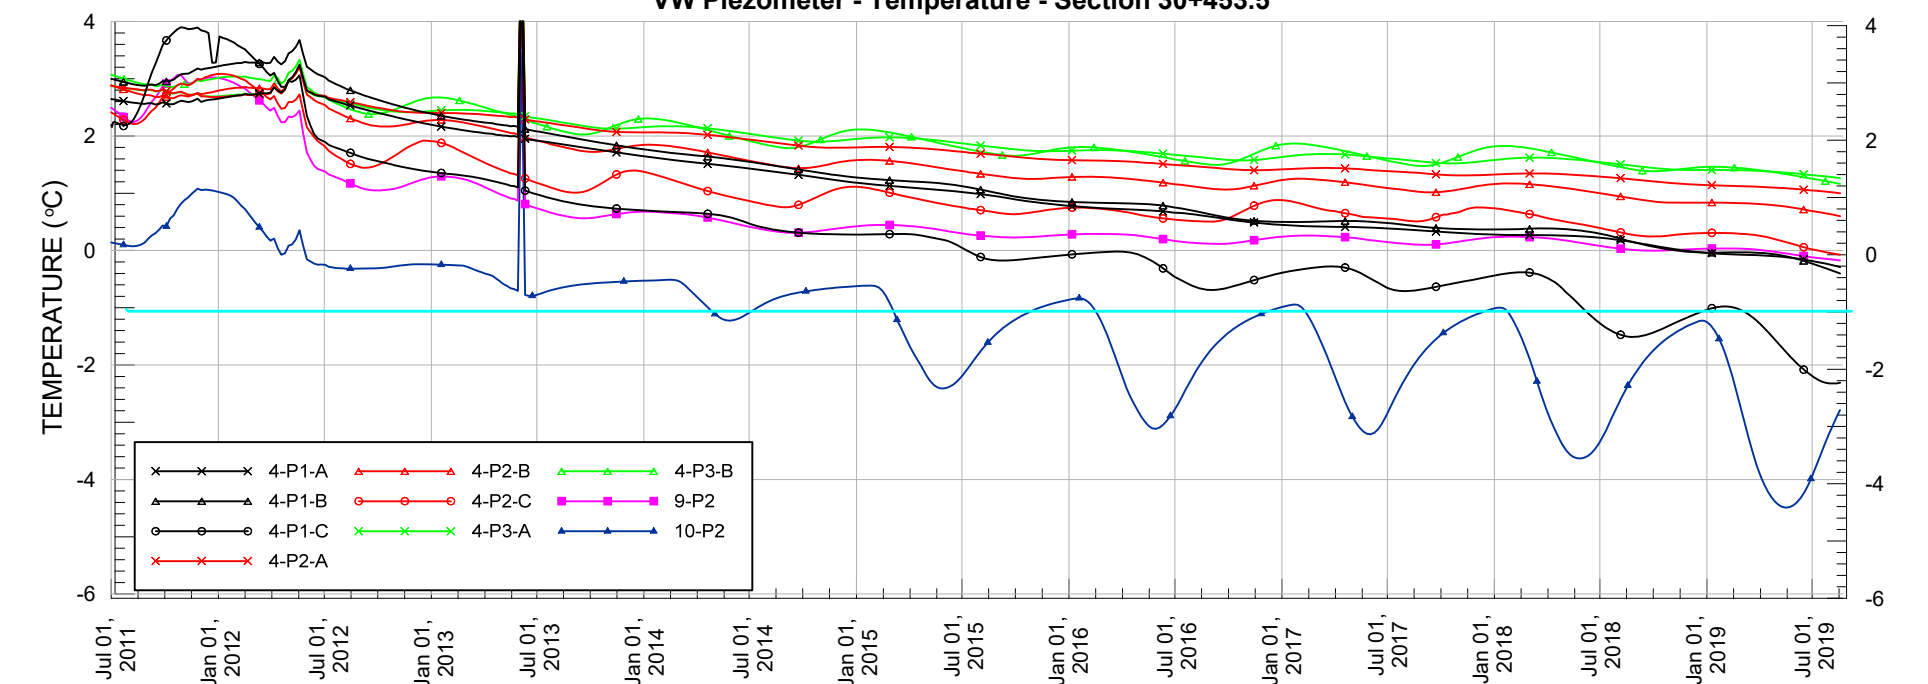
PROJECT	AGNICO EAGLE MINES LIMITED MEADOWBANK GOLD PROJECT NUNAVUT			
TITLE	BAYGOOSE DIKE Section 30+453.5 - PIEZOMETRIC DATA (July 1/11 to Aug 21/19)			
	PROJECT No.	PHASE No.		
	DESIGN TD 28AUG14	SCALE AS SHOWN	REV.	
	CADD TD 28AUG14			
	CHECK PG 28AUG14			
REVIEW	FIGURE 7

- All 4P1, 4P2C and 10P2 is given unstable readings and since the temperature either shows a negative reading or is close to a negative reading it is assumed to be frozen.
- Pressure changes are attributed to the drill and blast in Portage Pit E5 along with ice buildup that occurs.
- Some of the PWP that are over the Upstream Water Level can be attributed to having a negative temperature and assumed frozen.

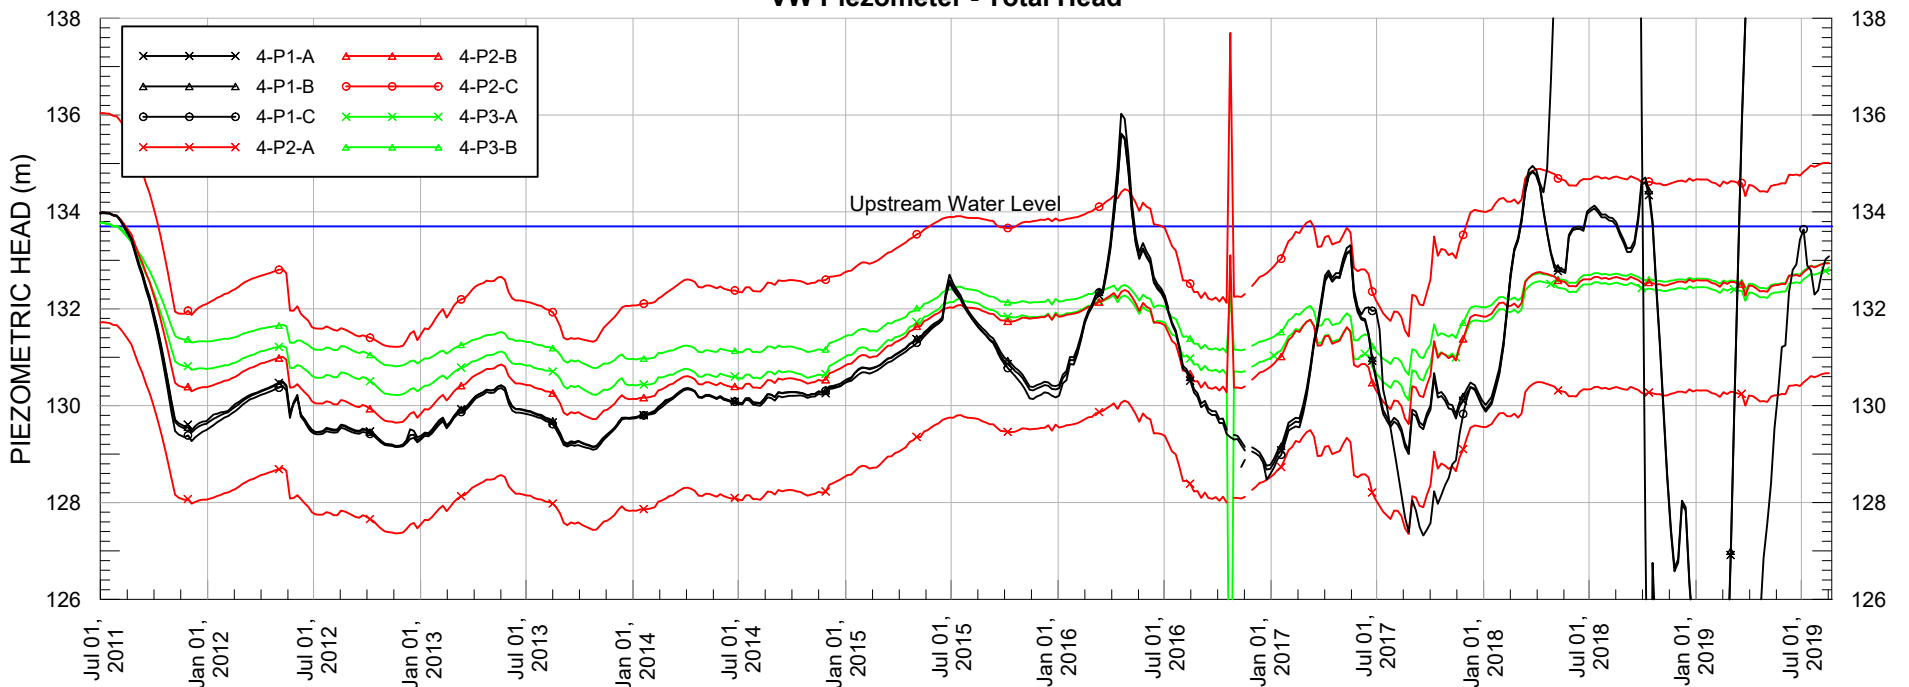
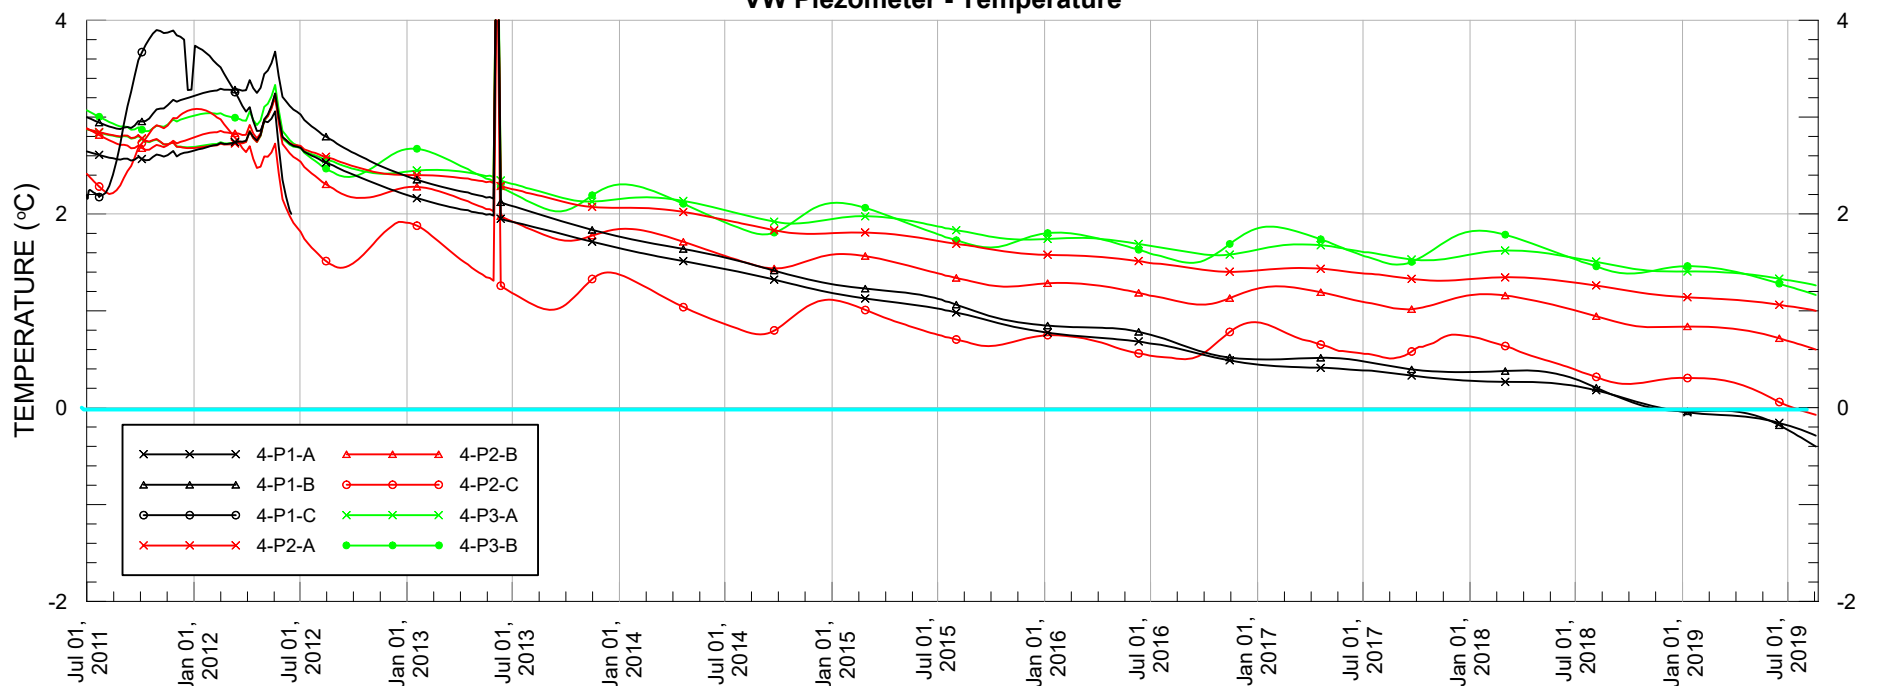
1. 4P1 and 4P2CPWP is given unstable readings and since the temperature is close to a freezing temperature it is assumed to be frozen.
2. Pressure changes are attributed to the drill and blast in Portage Pit E5 along with ice buildup that occurs.
3. Some of the PWP that are over the Upstream Water Level can be attributed to having a negative temperature and assumed frozen and data considered to not be reliable.

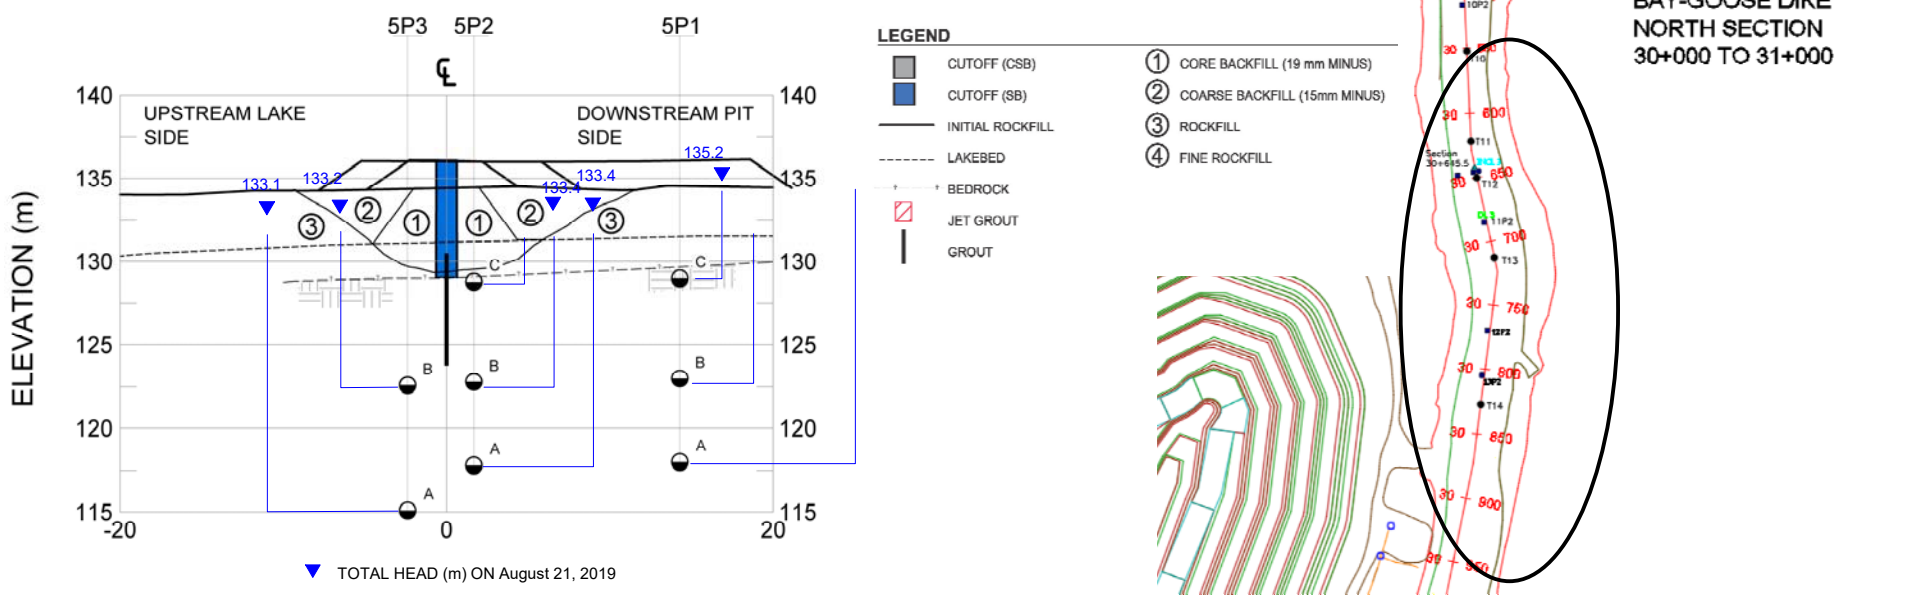
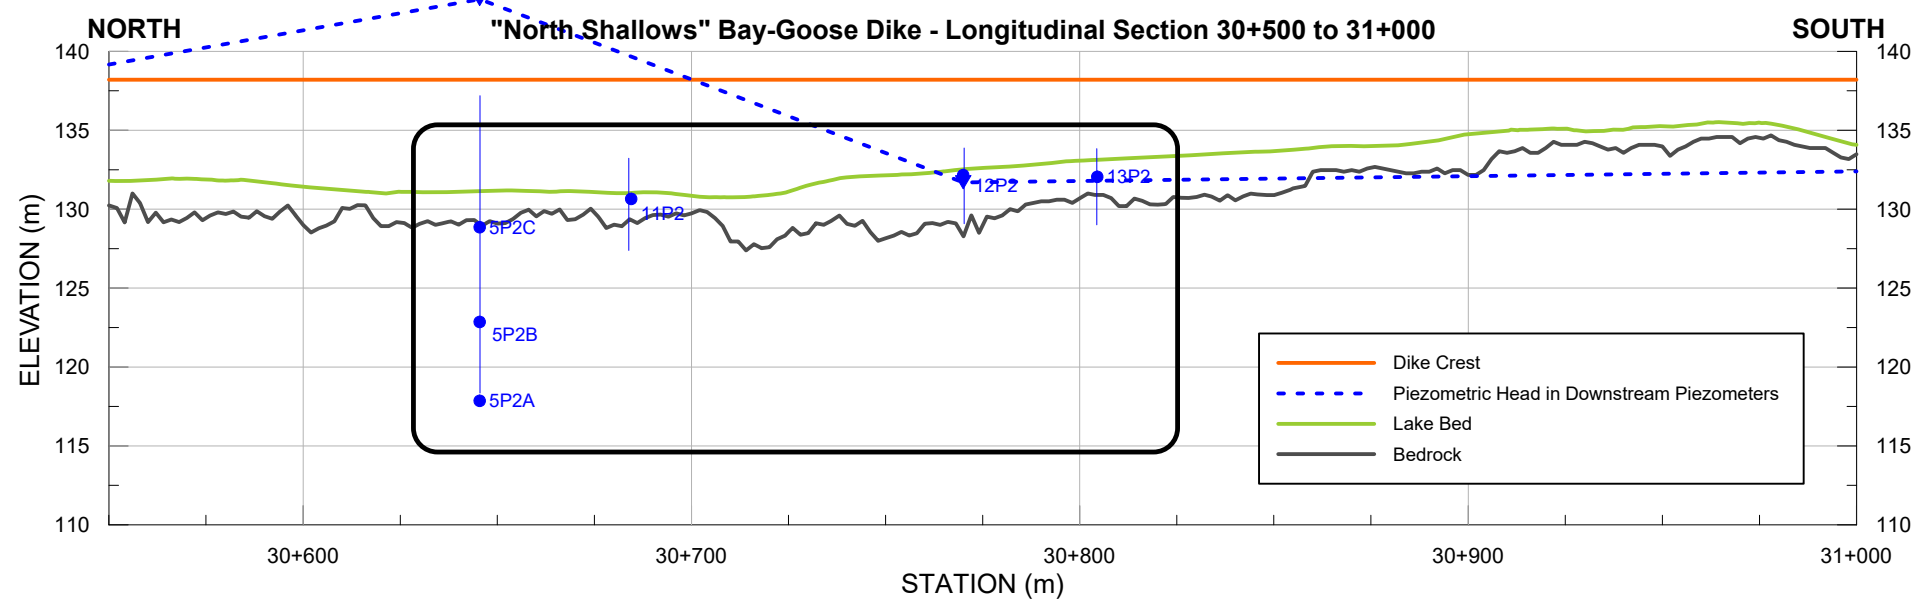
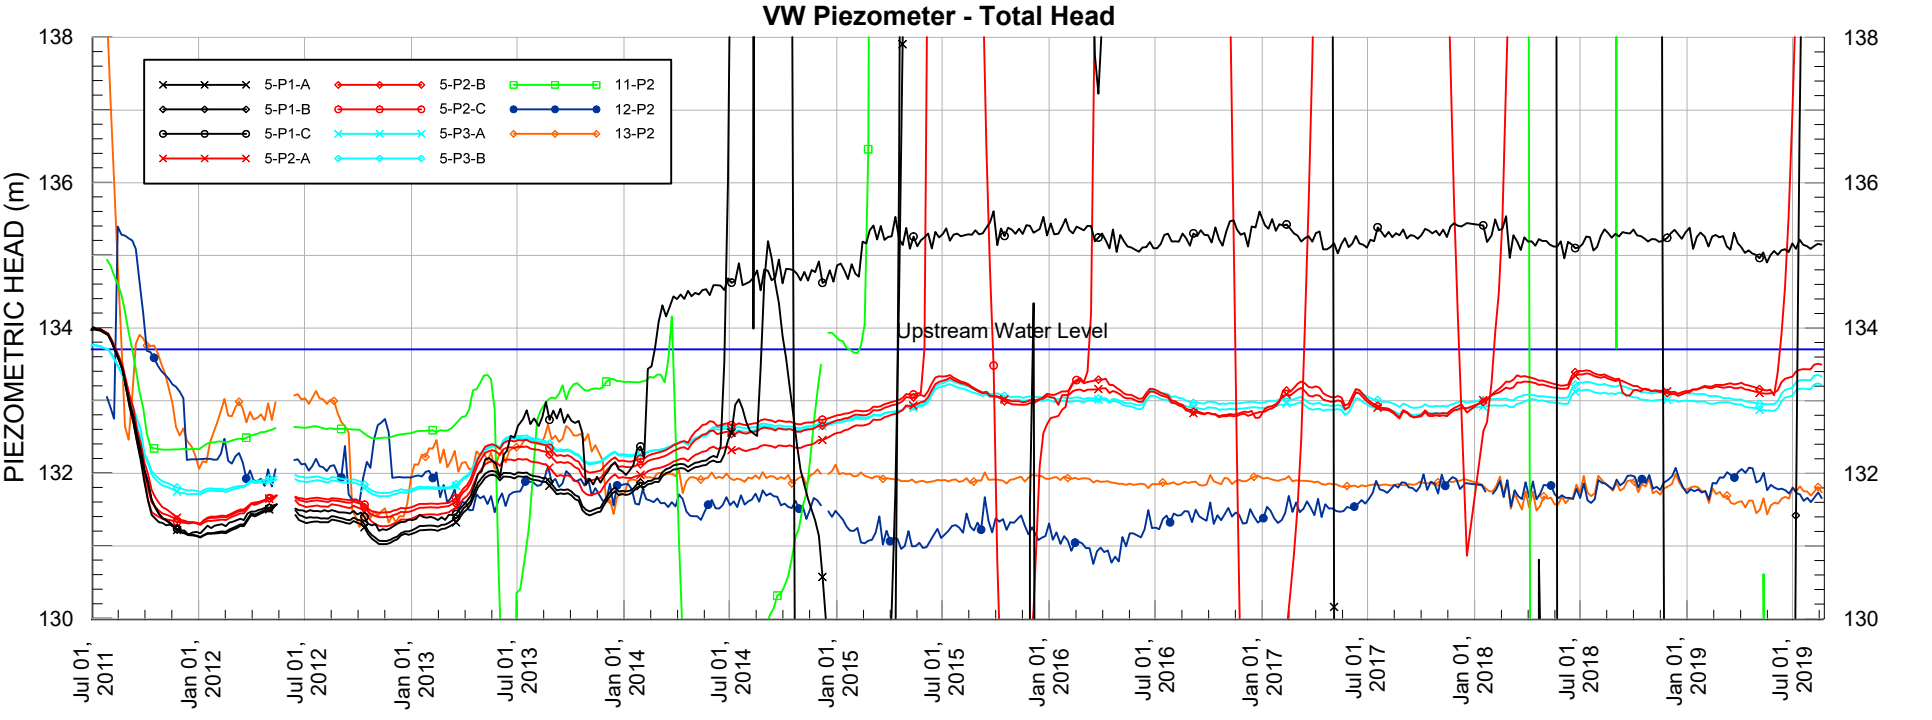
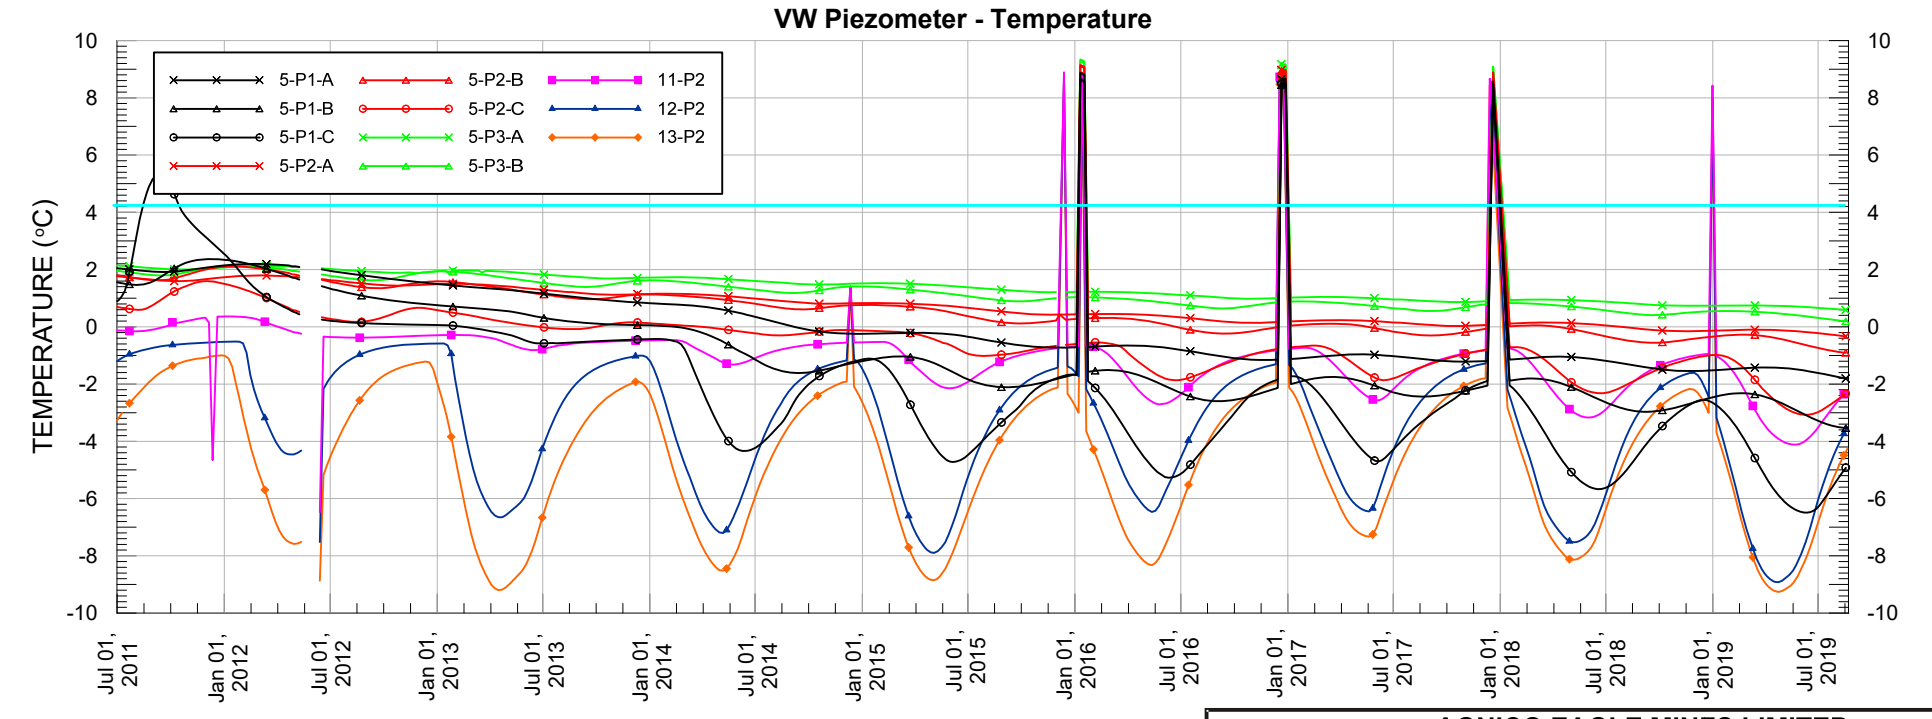
**NOTES:**  
1. 5P1A, 5P1B, 5P1C, 5P2C and 11P2 are giving unstable readings and since the temperature shows a negative reading it is assumed to be frozen.

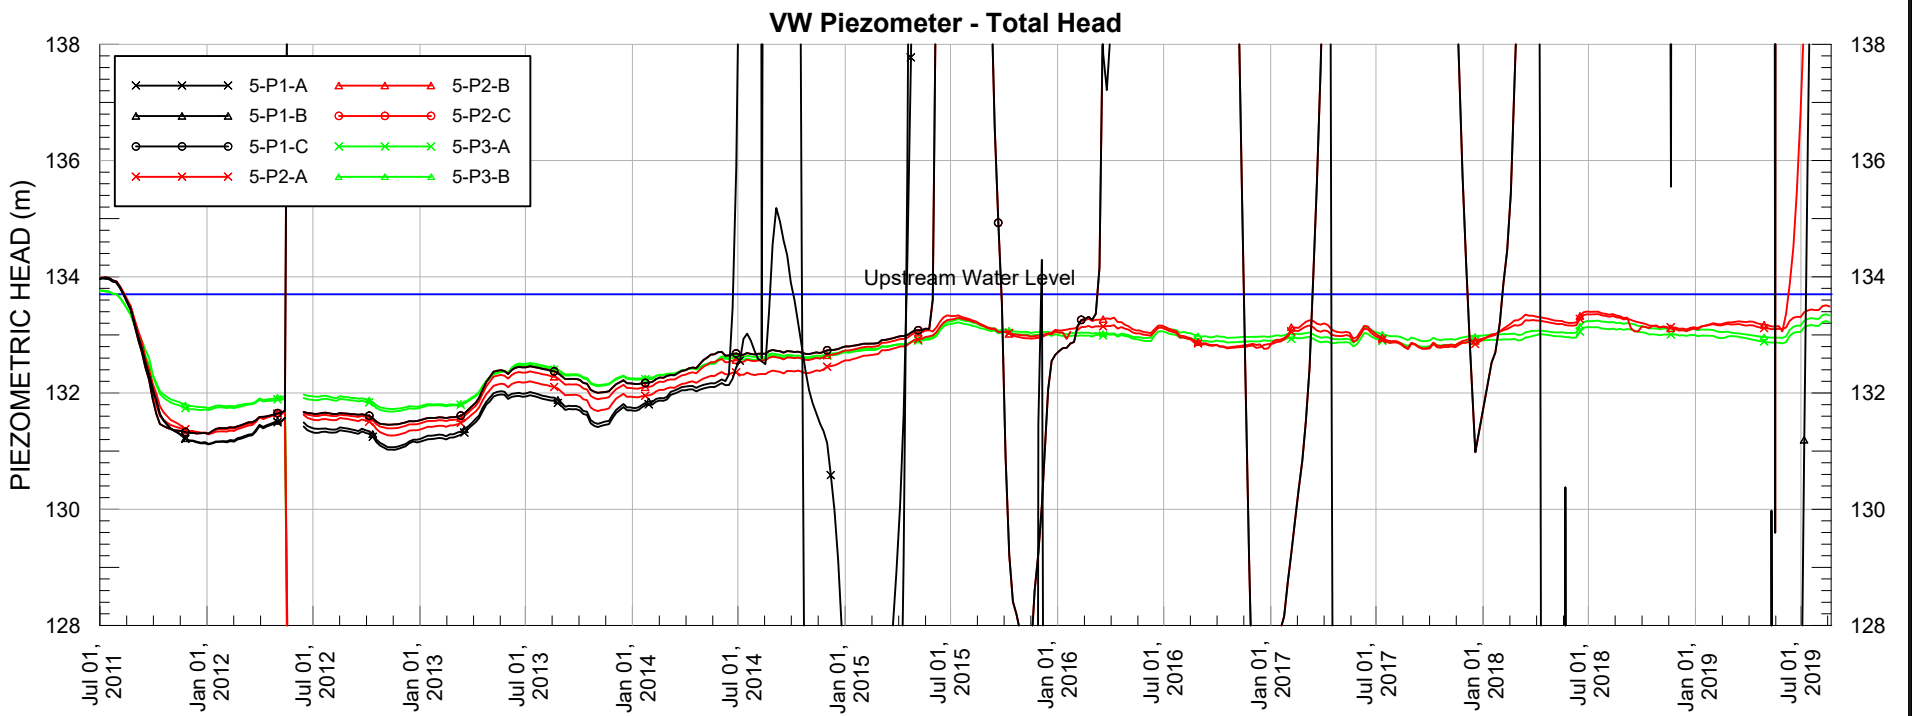
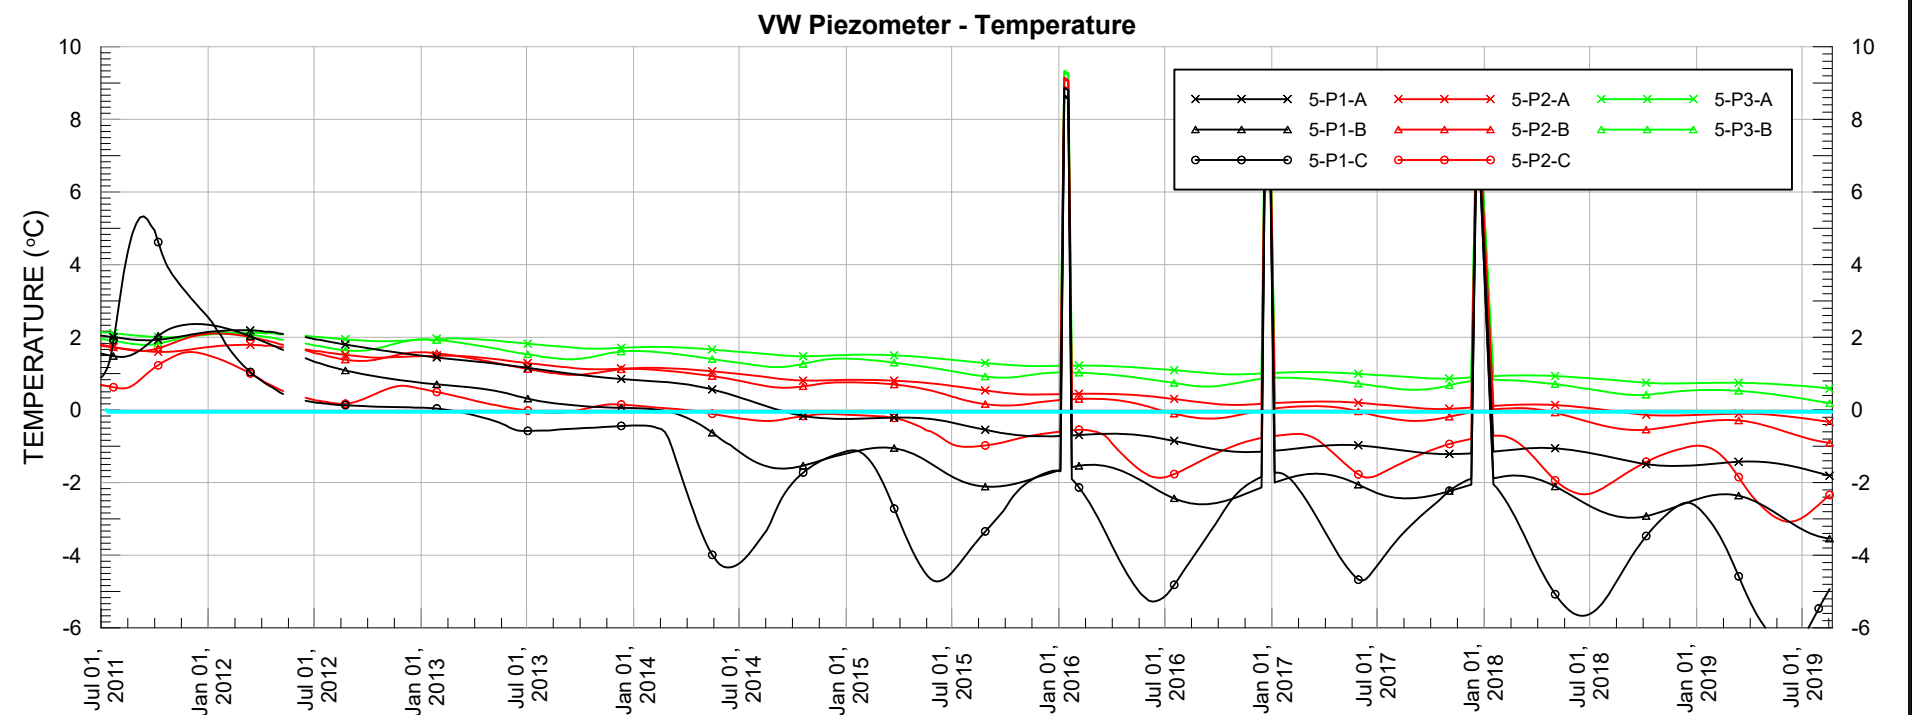
PROJECT		<b>AGNICO EAGLE MINES LIMITED MEADOWBANK GOLD PROJECT NUNAVUT</b>	
TITLE		<b>BAYGOOSE DIKE - SECTION 30+645.5 PIEZOMETRIC DATA (July 1/11 to Aug 21/19)</b>	
	PROJECT No.	PHASE No.	
	DESIGN TD 17JAN14	SCALE AS SHOWN	REV.
	CADD TD 17JAN14		
	CHECK		
REVIEW			
			<b>FIGURE 10</b>

**NOTES:**  
1. 5P1A, 5P1B, 5P1C, 5P2C are giving unstable readings and since the temperature shows a negative reading it is assumed to be frozen and PWP data is not considered reliable.

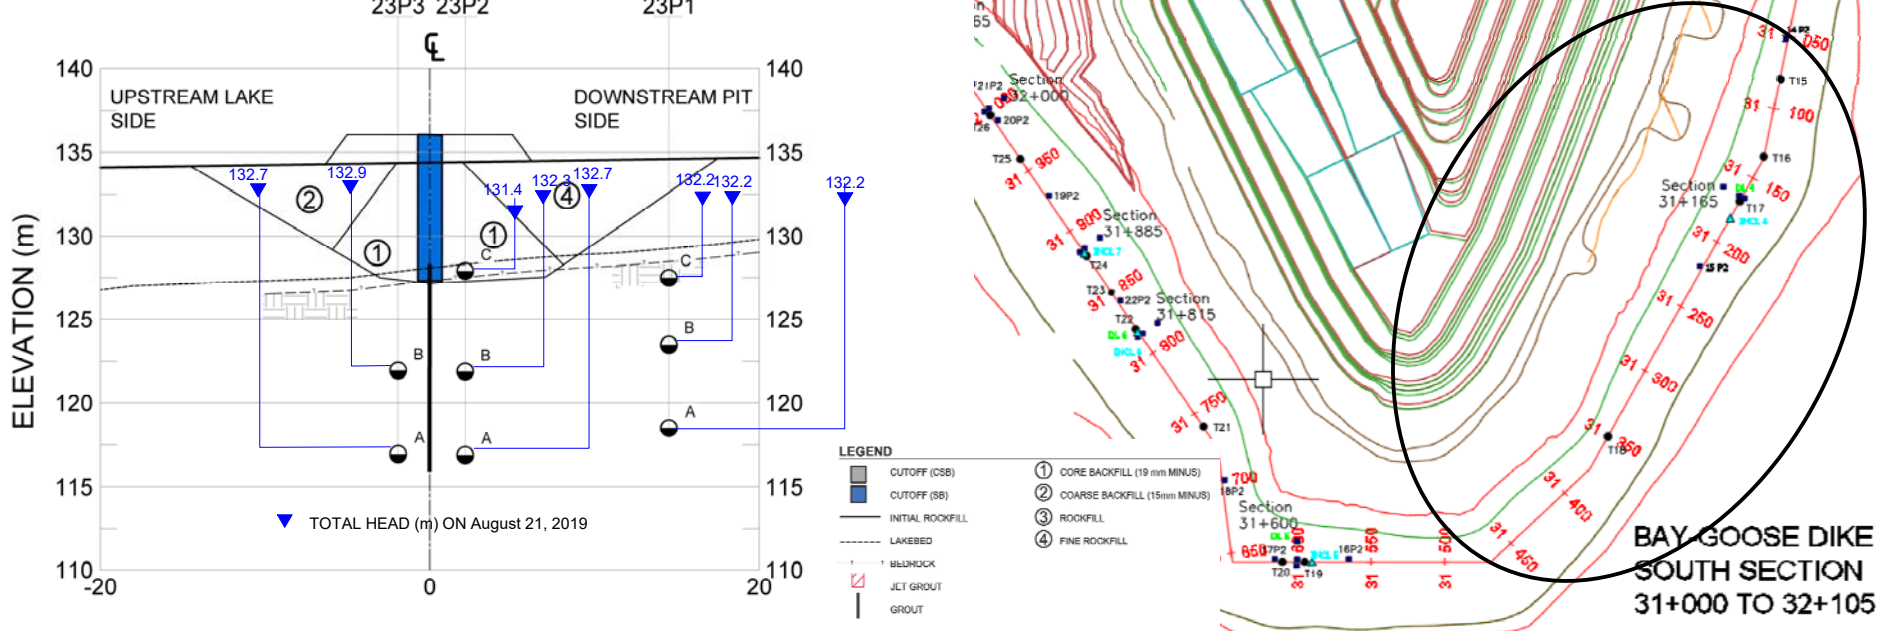
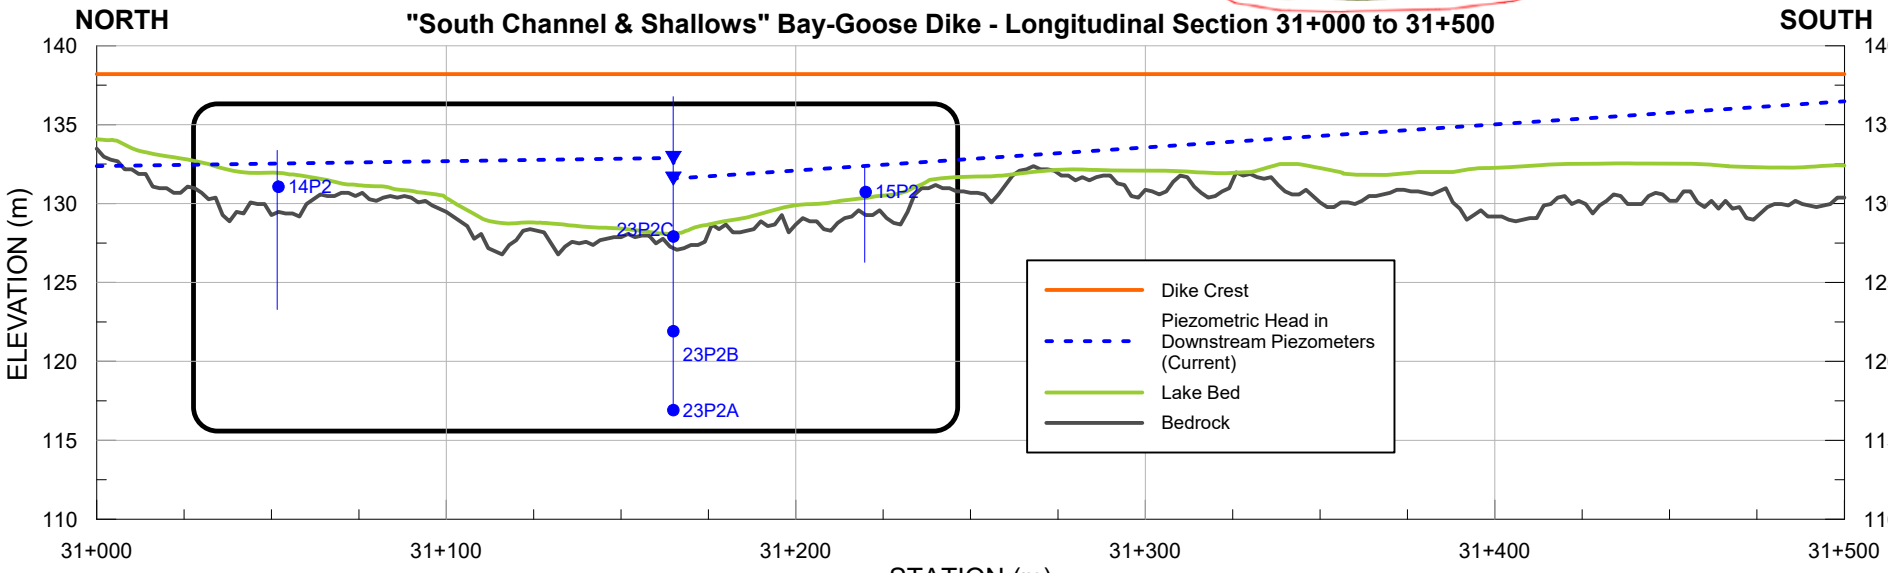
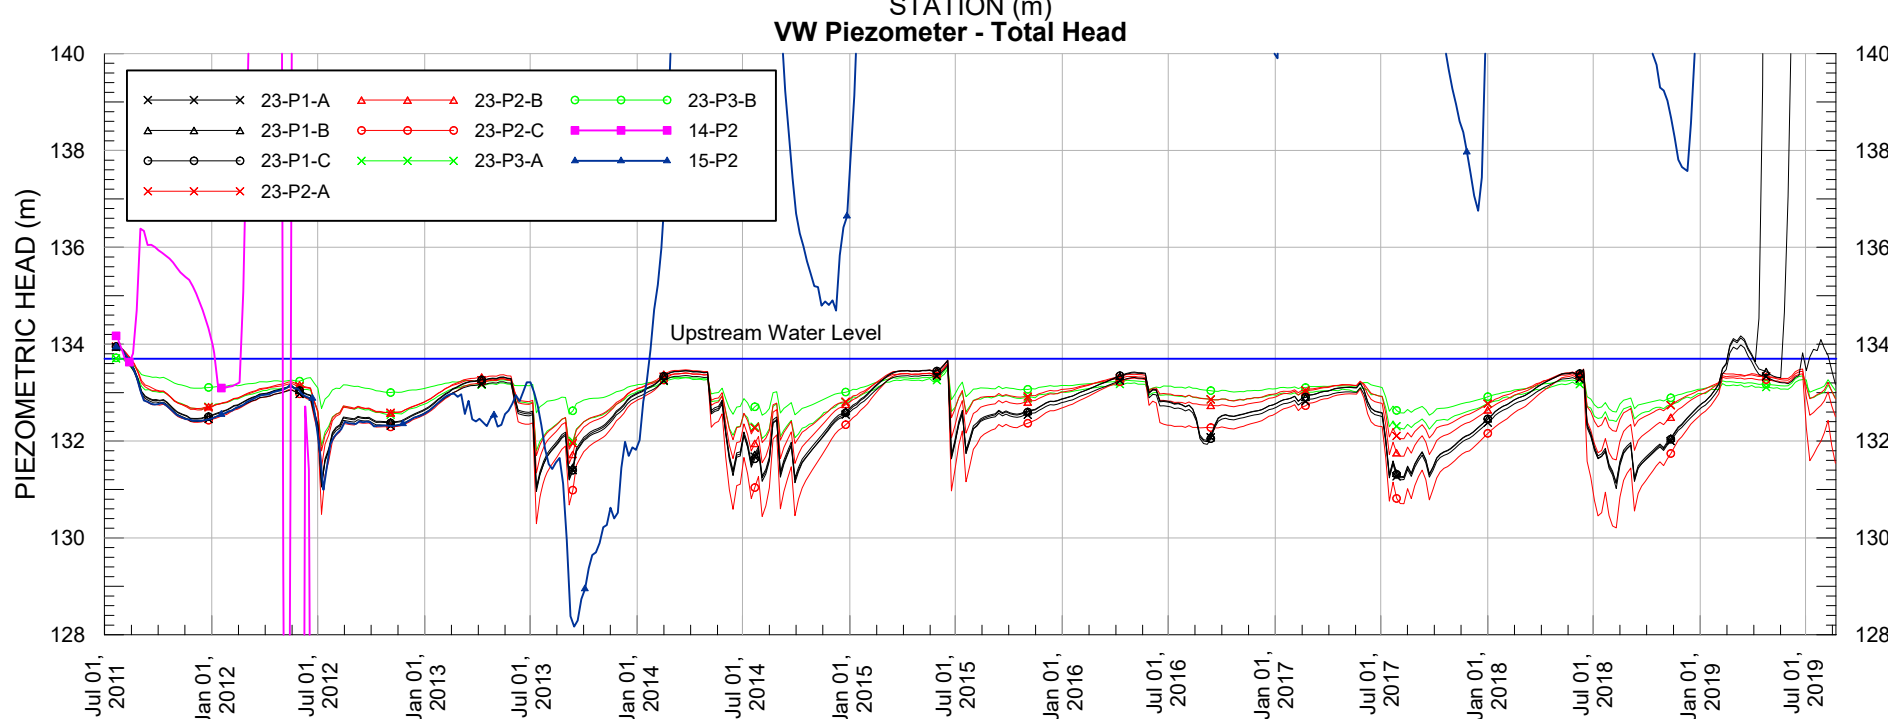
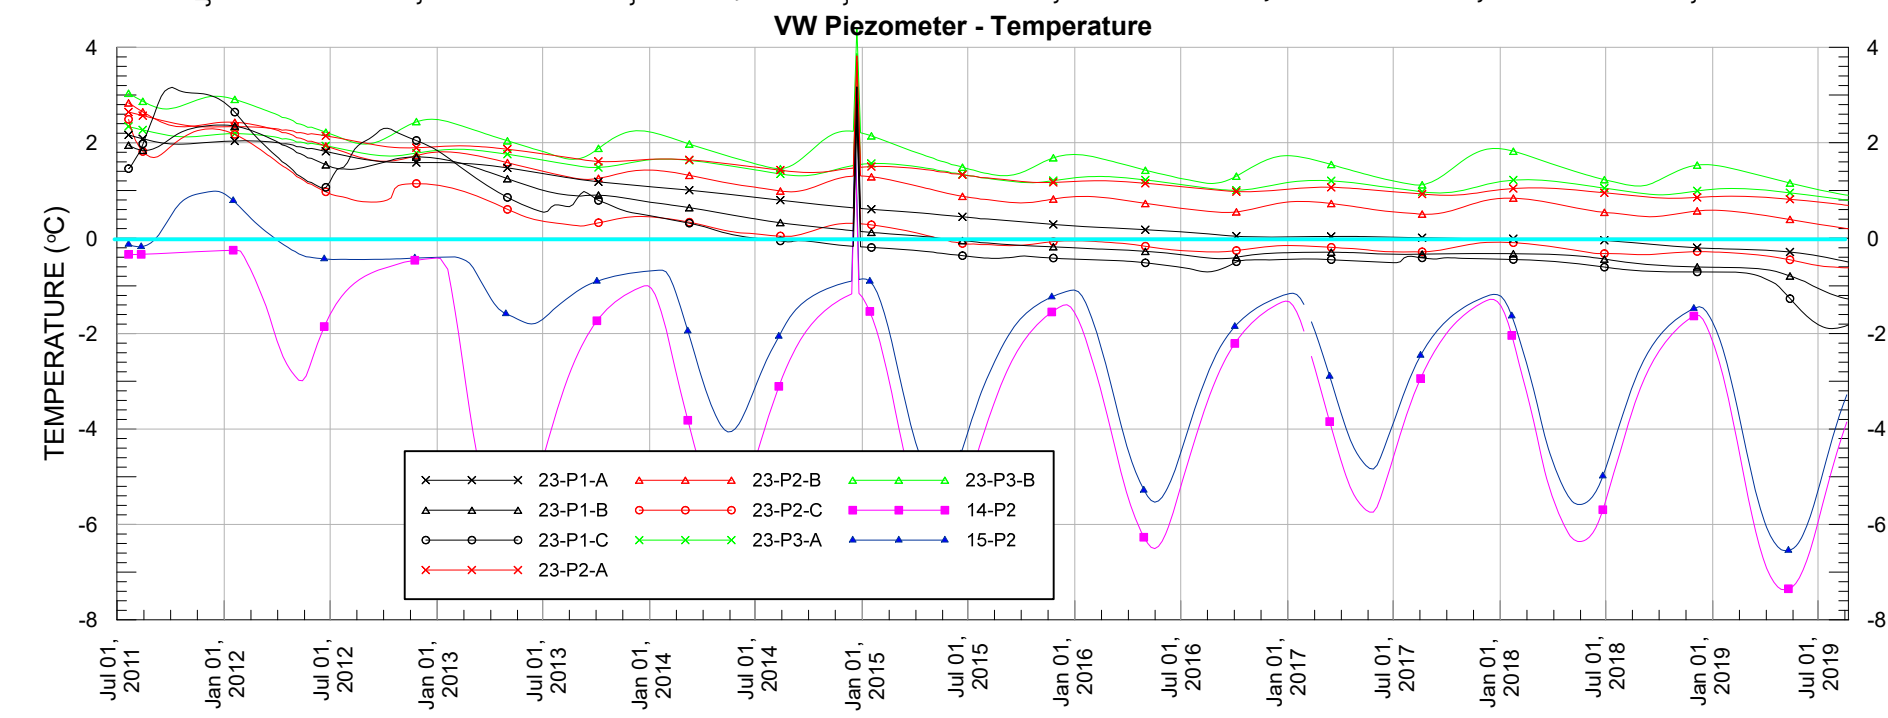
PROJECT		<b>AGNICO EAGLE MINES LIMITED MEADOWBANK GOLD PROJECT NUNAVUT</b>	
TITLE		<b>BAYGOOSE DIKE 31+000 to 31+500 - PIEZOMETRIC DATA (July 1/11 to Aug 21/19)</b>	
	PROJECT No.	PHASE No.	
	DESIGN TD	28AUG14	SCALE AS SHOWN REV.
	CADD TD	28AUG14	
	CHECK PG	28AUG14	<b>FIGURE 11</b>
REVIEW

- Pz23P1B, Pz23P1C, 14P2 and 15P2 are given unstable readings and since the temperature shows a negative reading it is assumed to be frozen.
- PWP rises and falls due to ponding in the area and continuous pumping, and allowing the ponding to raise. The steady increase is when the ponding area freezes, and no pumping is done till the thawing of the area.
