# **Meadowbank 2019 Annual Geotechnical Inspection**

# 2019 Annual Geotechnical Inspection

*Meadowbank Gold Mine, Nunavut*

19123067-1588-R-Rev0

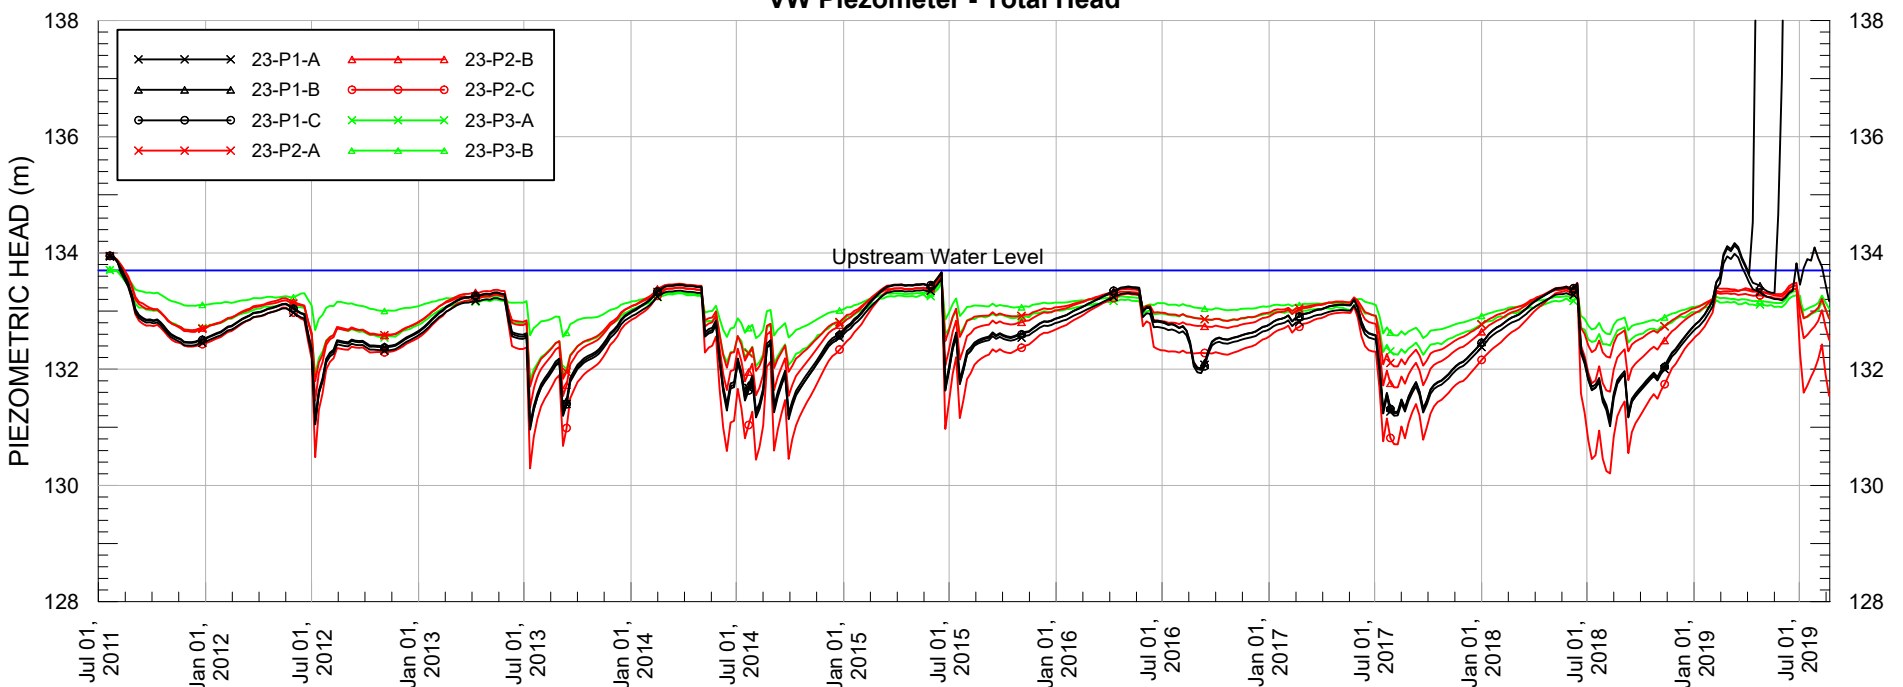
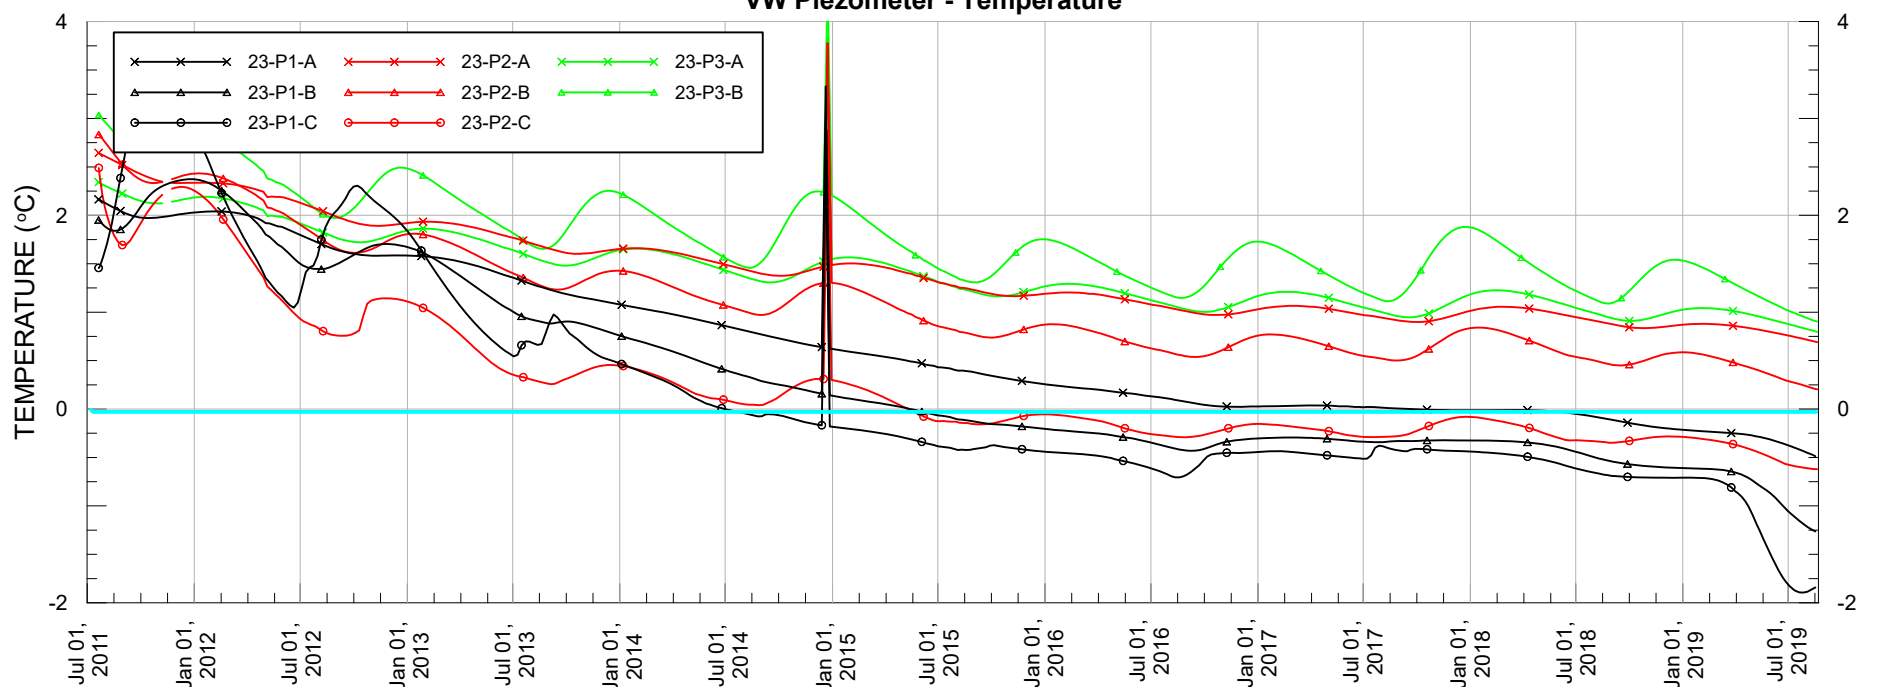
PROJECT	<b>AGNICO EAGLE MINES LIMITED MEADOWBANK GOLD PROJECT NUNAVUT</b>			
TITLE	<b>BAYGOOSE DIKE - SECTION 31+165 PIEZOMETRIC DATA (July 1/11 to Aug 21/19)</b>			
	PROJECT No.	PHASE No.		
	DESIGN TD 28AUG14	SCALE AS SHOWN	REV.	
	CADD TD 28AUG14	<b>FIGURE 12</b>		
	CHECK PG 28AUG14			
REVIEW

- PWP rises and falls due to ponding in the area and continuous pumping, and allowing the ponding to raise. The steady increase is when the ponding area freezes, and no pumping is done till the thawing of the area.
- 23-P1-B and 23-P1-C have a negative temperature and appear to be frozen and not giving good data.

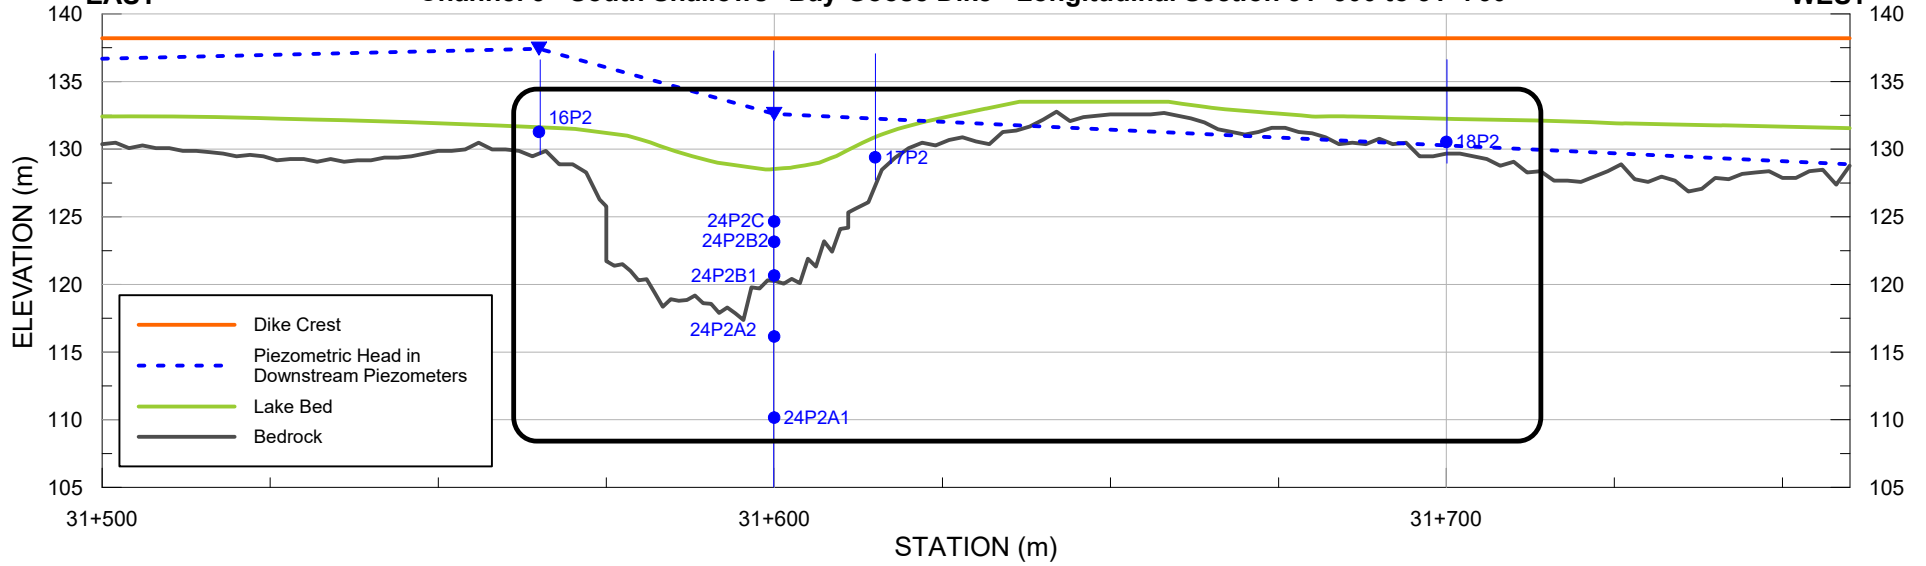
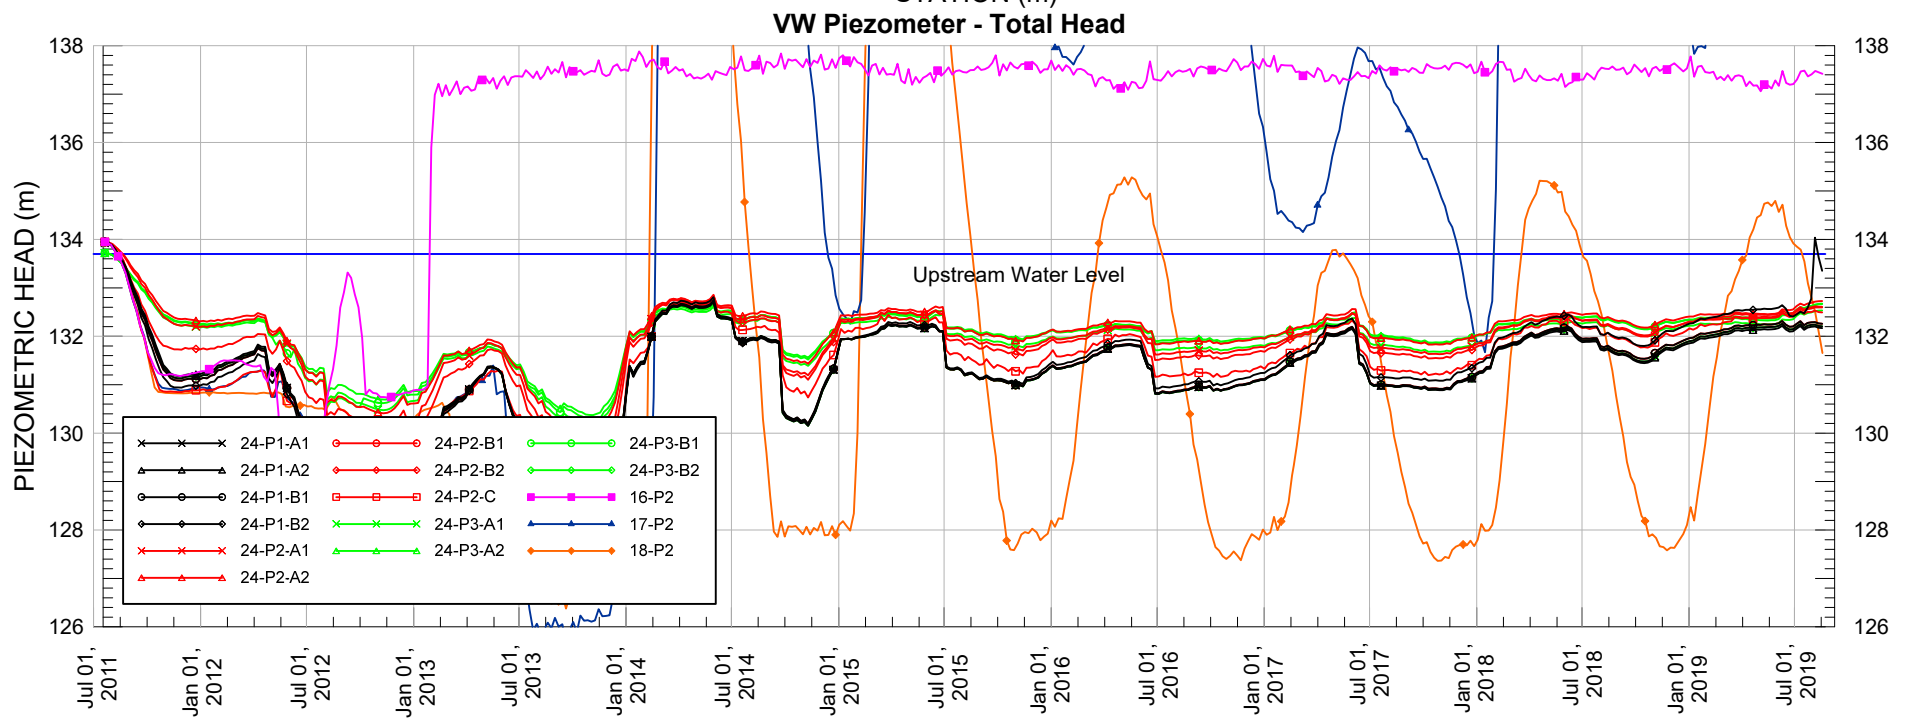
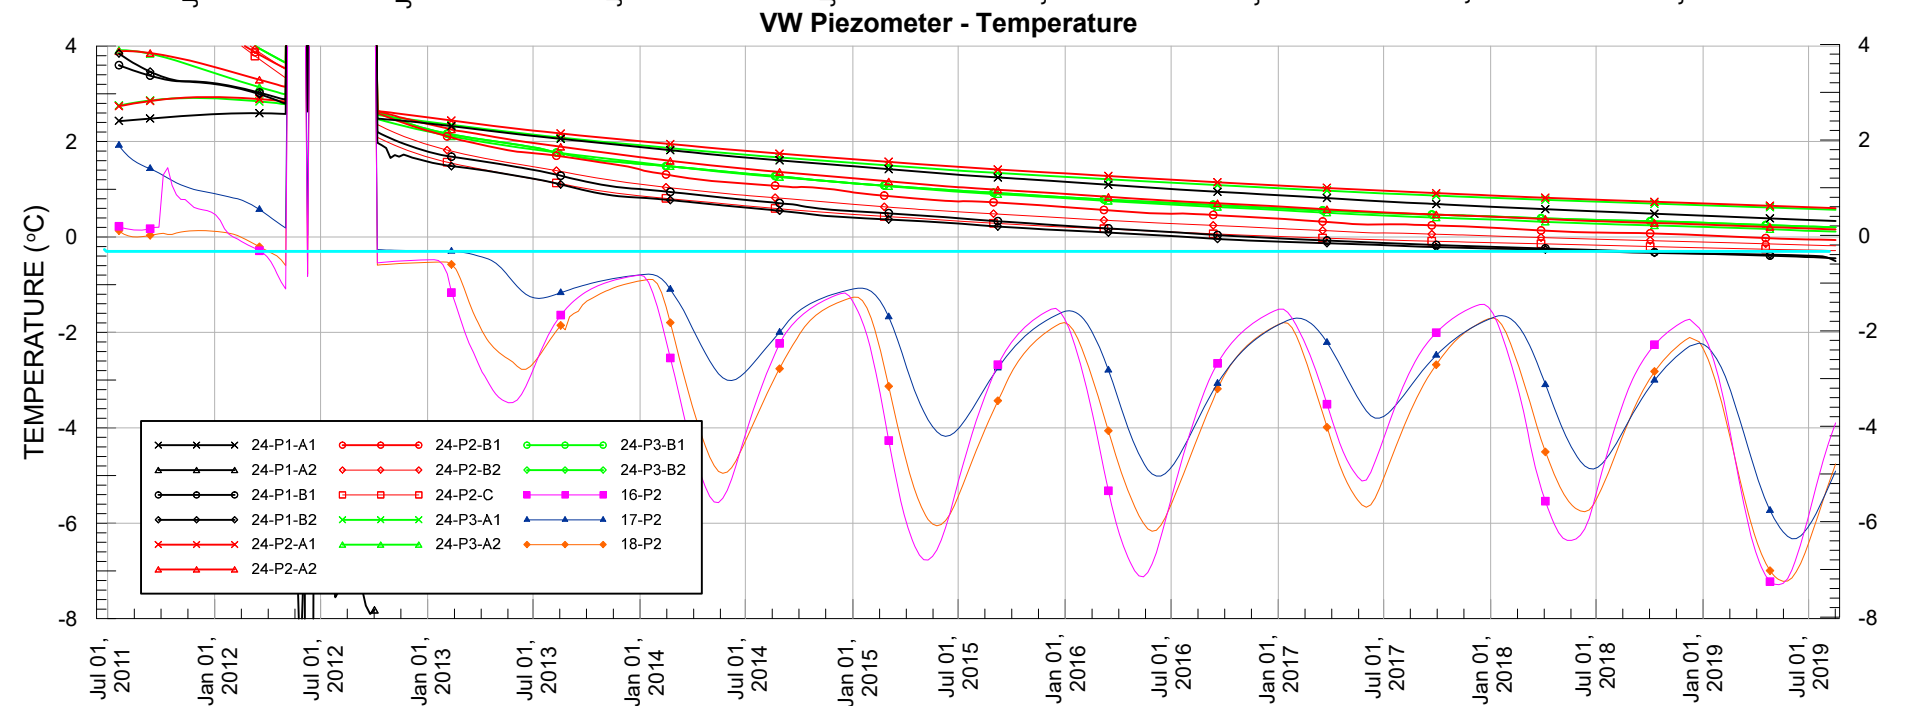
PROJECT		<b>AGNICO EAGLE MINES LIMITED MEADOWBANK GOLD PROJECT NUNAVUT</b>	
TITLE		<b>BAYGOOSE DIKE 31+500 to 31+760 - PIEZOMETRIC DATA (July 1/11 to Aug 21/19)</b>	
	PROJECT No.	PHASE No.	
	DESIGN TD 28AUG14	SCALE AS SHOWN	REV.
	CADD TD 28AUG14	<b>FIGURE 13</b>	
	CHECK PG 28AUG14		
REVIEW

- 16P2, 17P2 and 18P2 are given unstable readings and since the temperature shows a negative reading it is assumed to be frozen.
- PWP is following same trend as previous years. When ice builds the pressure increases and when it melts in summer the pressure decreases

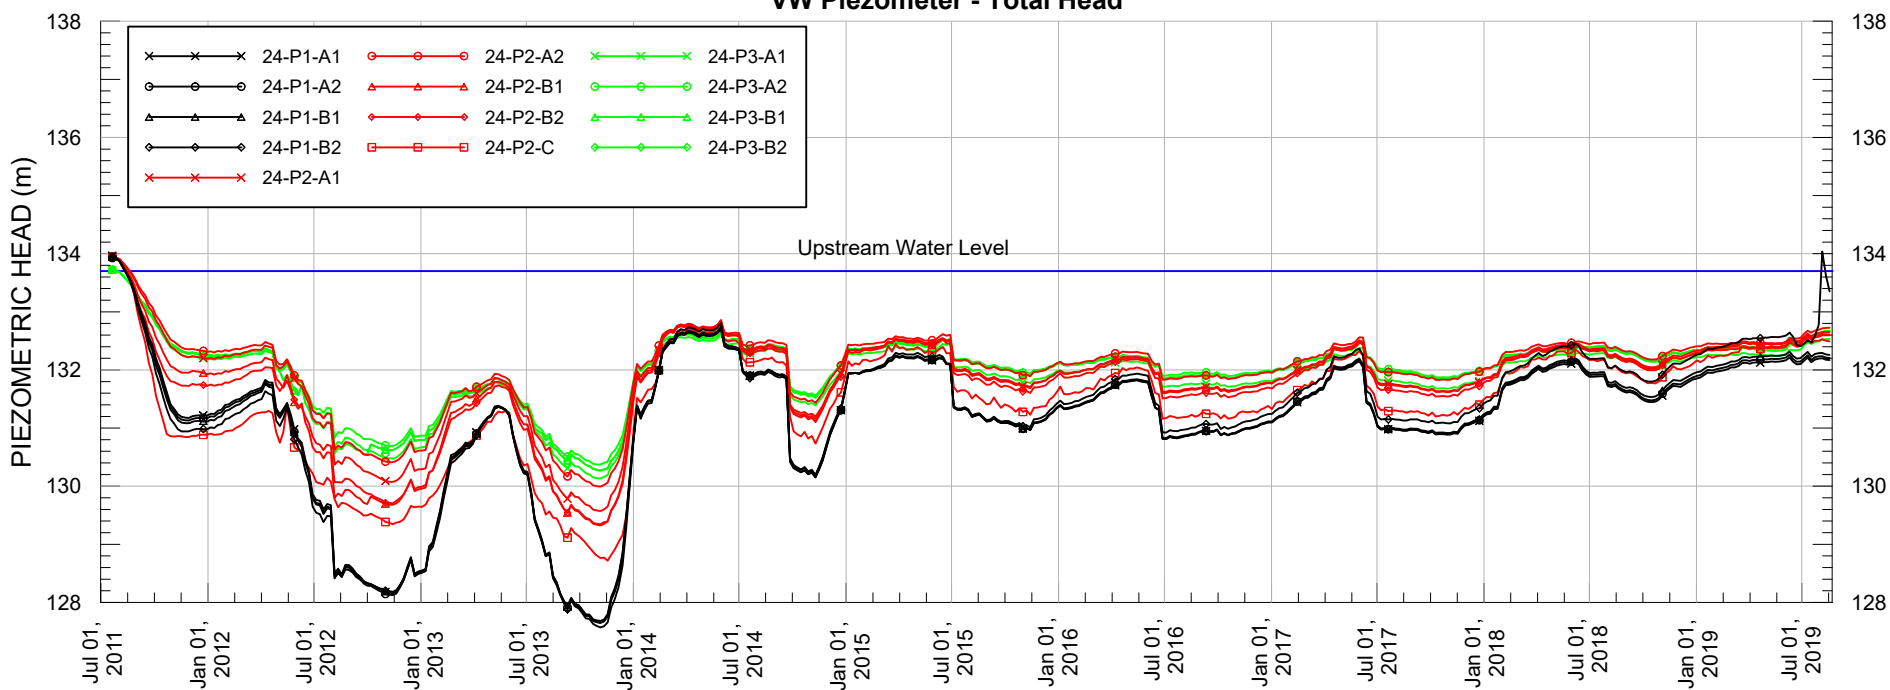
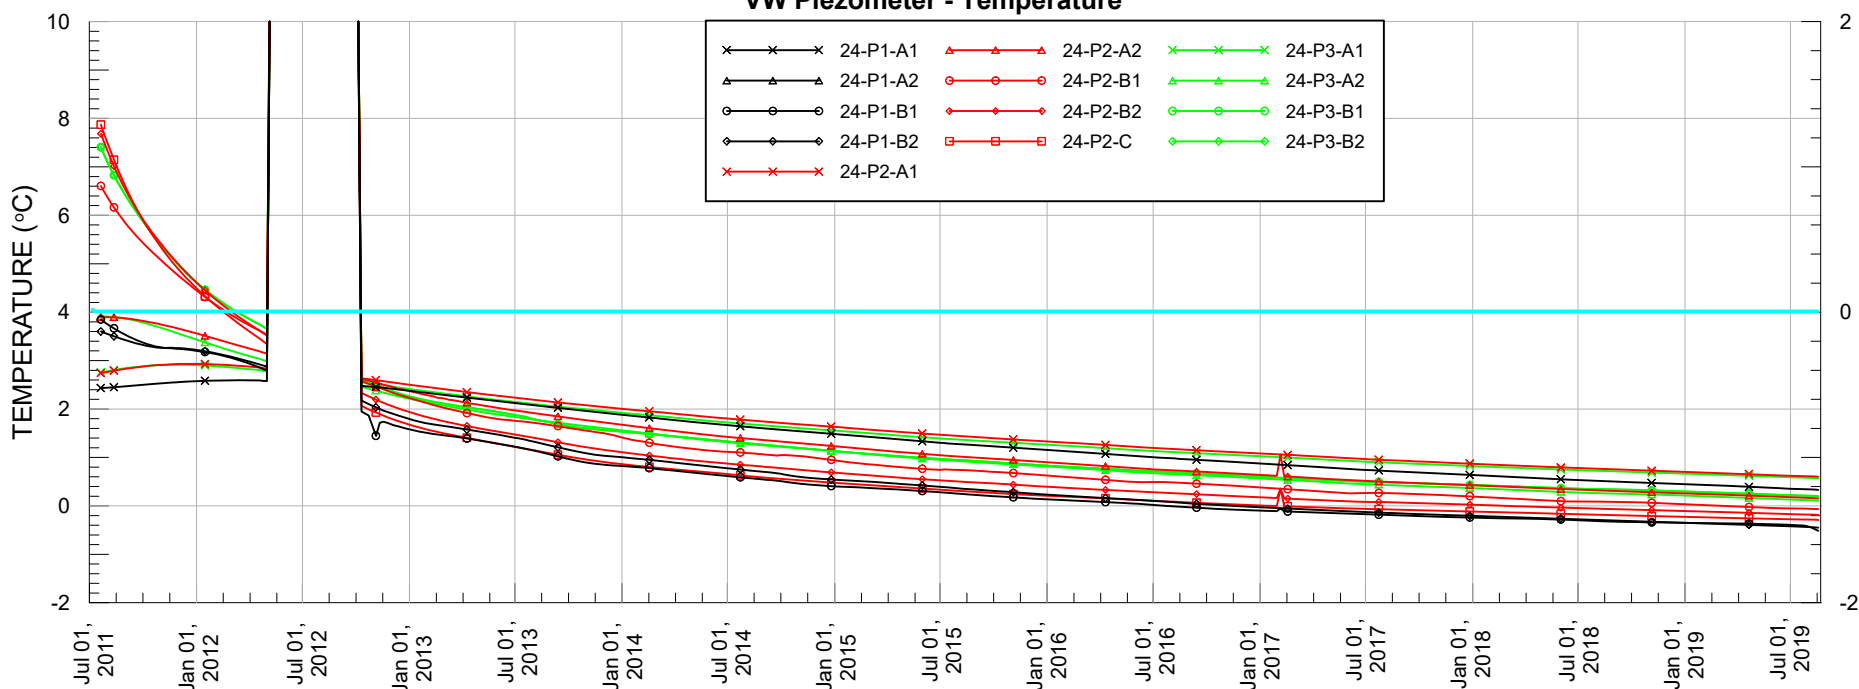
1. PWP is following same trend as previous years. When ice builds the pressure increases and when it melts in summer the pressure decreases
- 2.

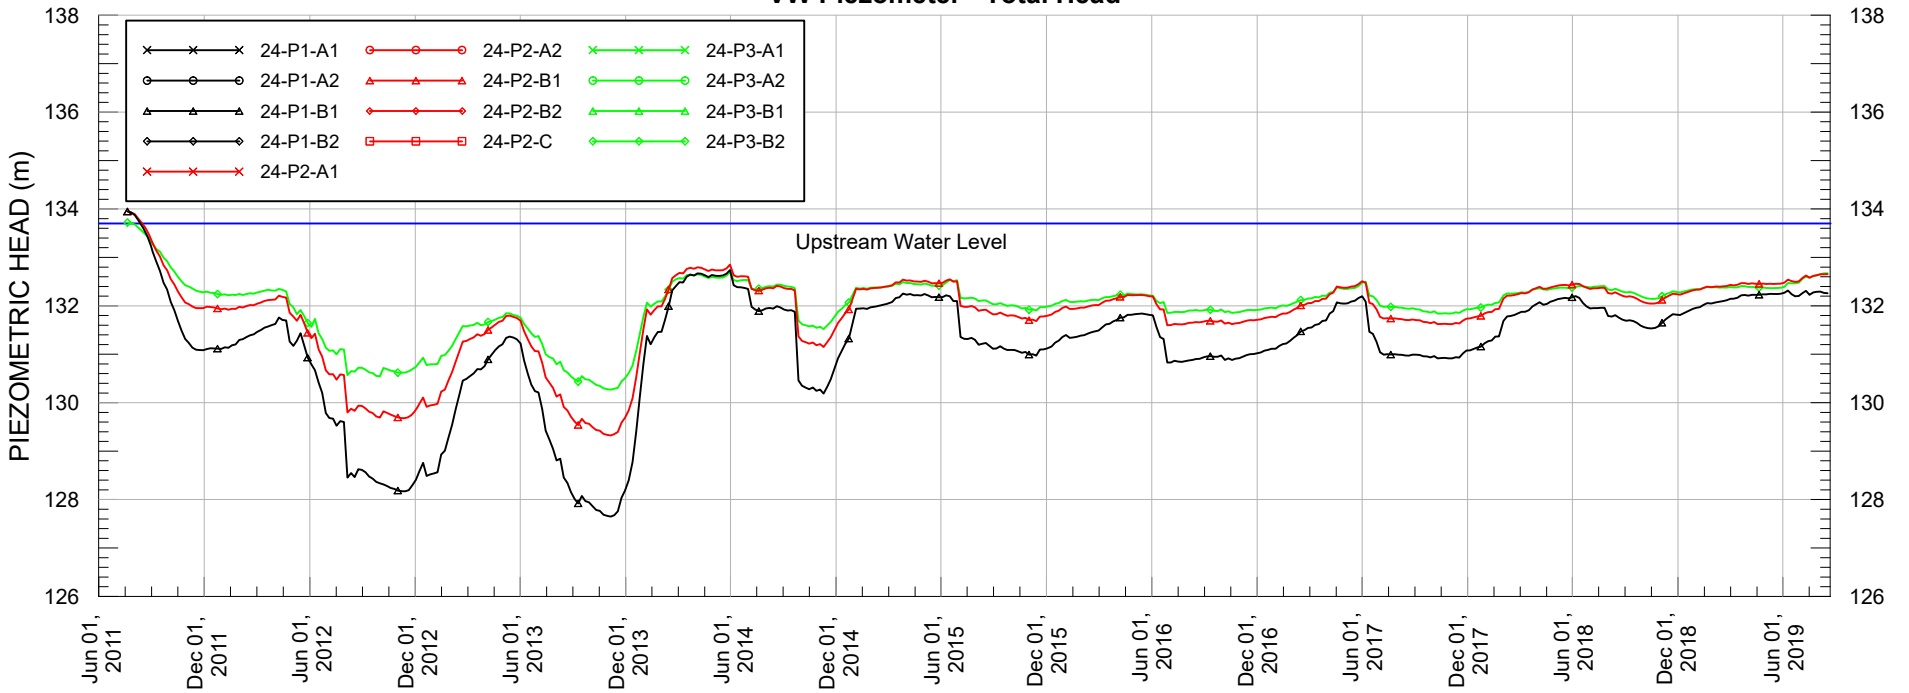
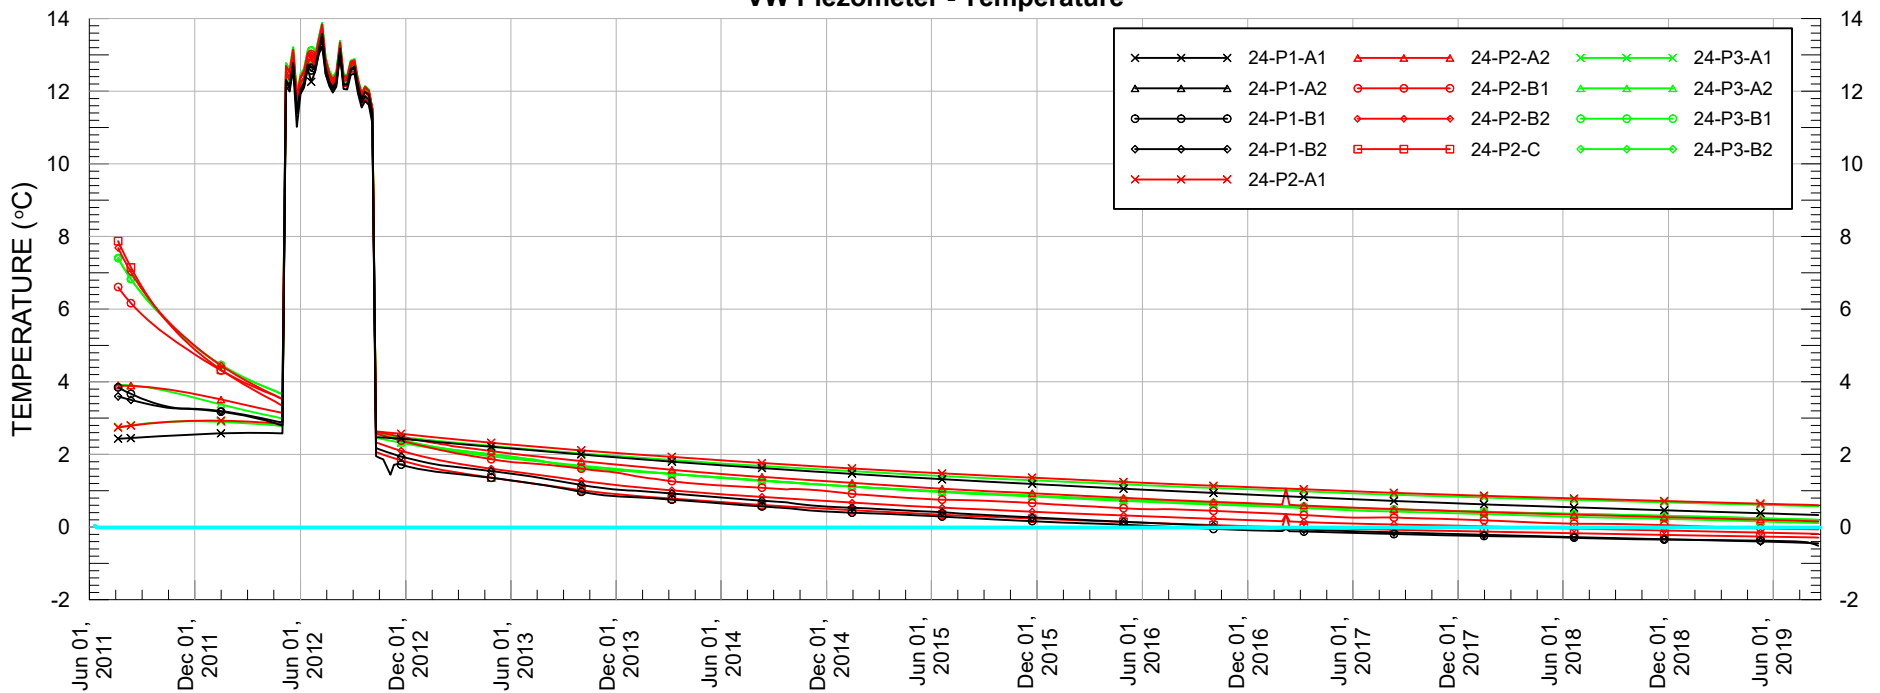
1. PWP is following same trend as previous years. When ice builds the pressure increases and when it melts in summer the pressure decreases
2. Small gaps in data are due to a low battery. Battery was changed the following day.
3. The large temperature fluctuation was due to a faulty MUX board which was changed when the new one arrived on site.

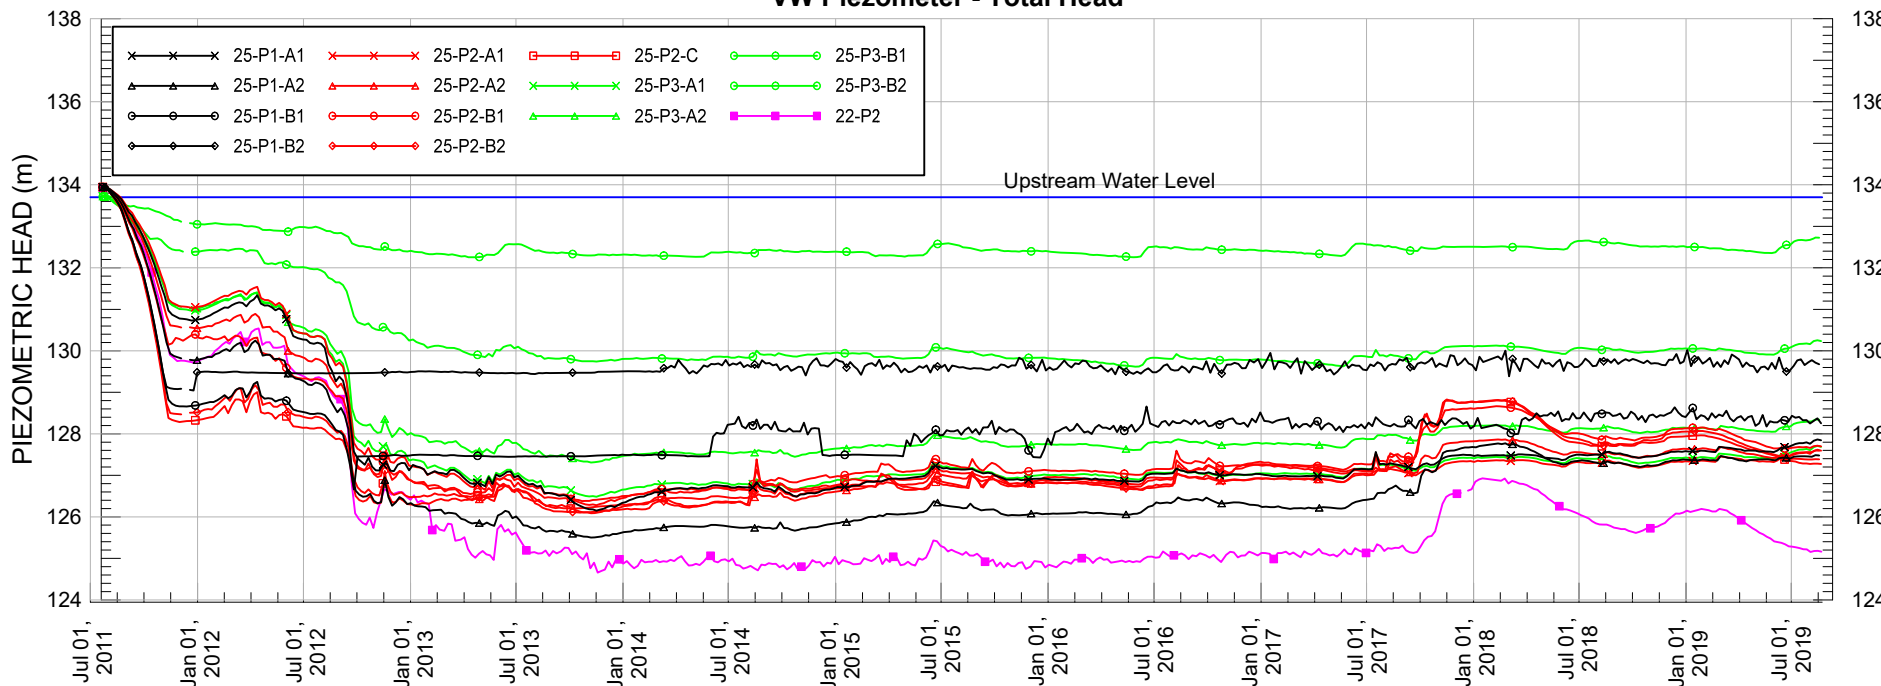
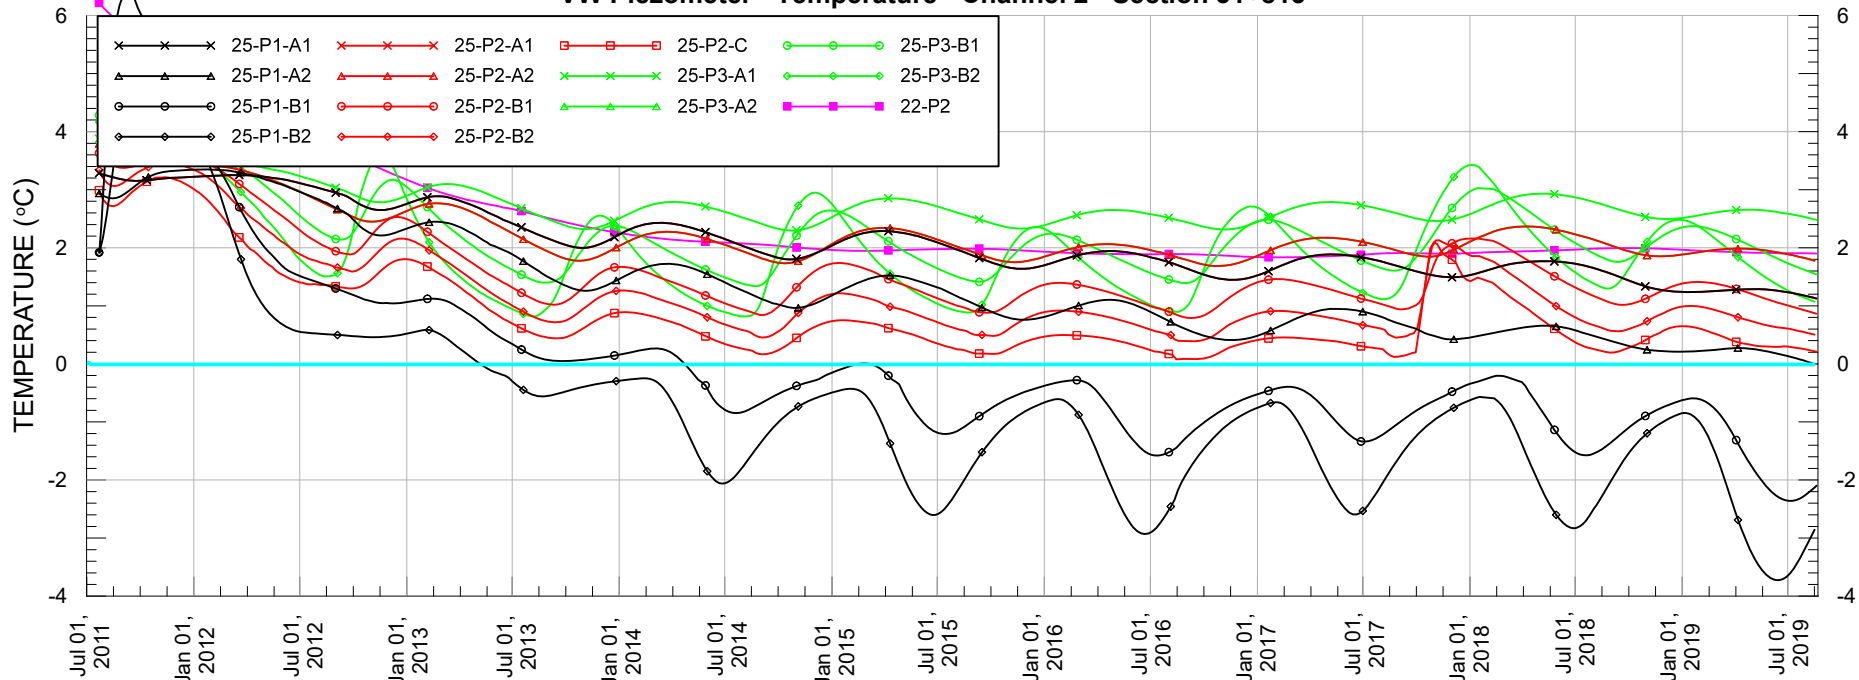
PROJECT	<b>AGNICO EAGLE MINES LIMITED MEADOWBANK GOLD PROJECT NUNAVUT</b>		
TITLE	<b>BAYGOOSE DIKE Section 31+815 - CHANNEL 2, PIEZOMETRIC DATA (July 1/11 to Aug 21/19)</b>		
	PROJECT No.	PHASE No.	
	DESIGN TD 28AUG14	SCALE AS SHOWN	REV.
	CADD TD 28AUG14	<b>FIGURE 15</b>	
	CHECK PG 28AUG14		
REVIEW

1. The rise in temperature and PWP was interpreted as the permafrost at the toe of the dike blocking the seepage path which led to this events. Will continue to monitor in the field and the instruments. Since the snow melt the blockage is not longer there and the PWP is on a downtrend.
2. 25P1B1 and 25P1B2 are showing a negative temperature reading and are assumed to be frozen.

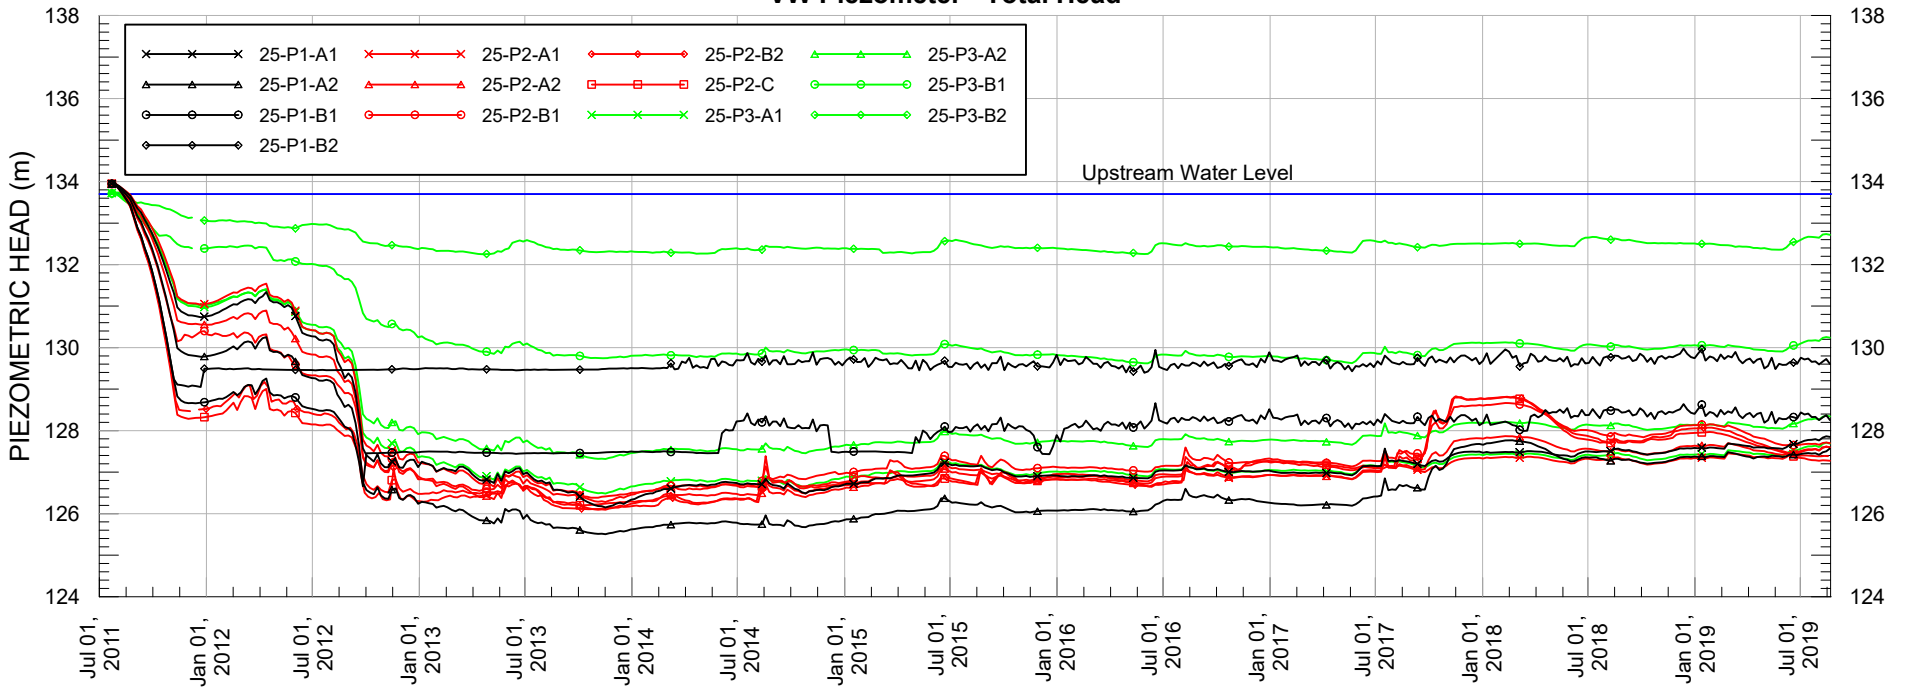
1. The rise in temperature and PWP was interpreted as the permafrost at the toe of the dike blocking the seepage path which led to this events. Will continue to monitor in the field and the instruments. Since the snow melt the blockage is no longer there and the PWP is on a downtrend.

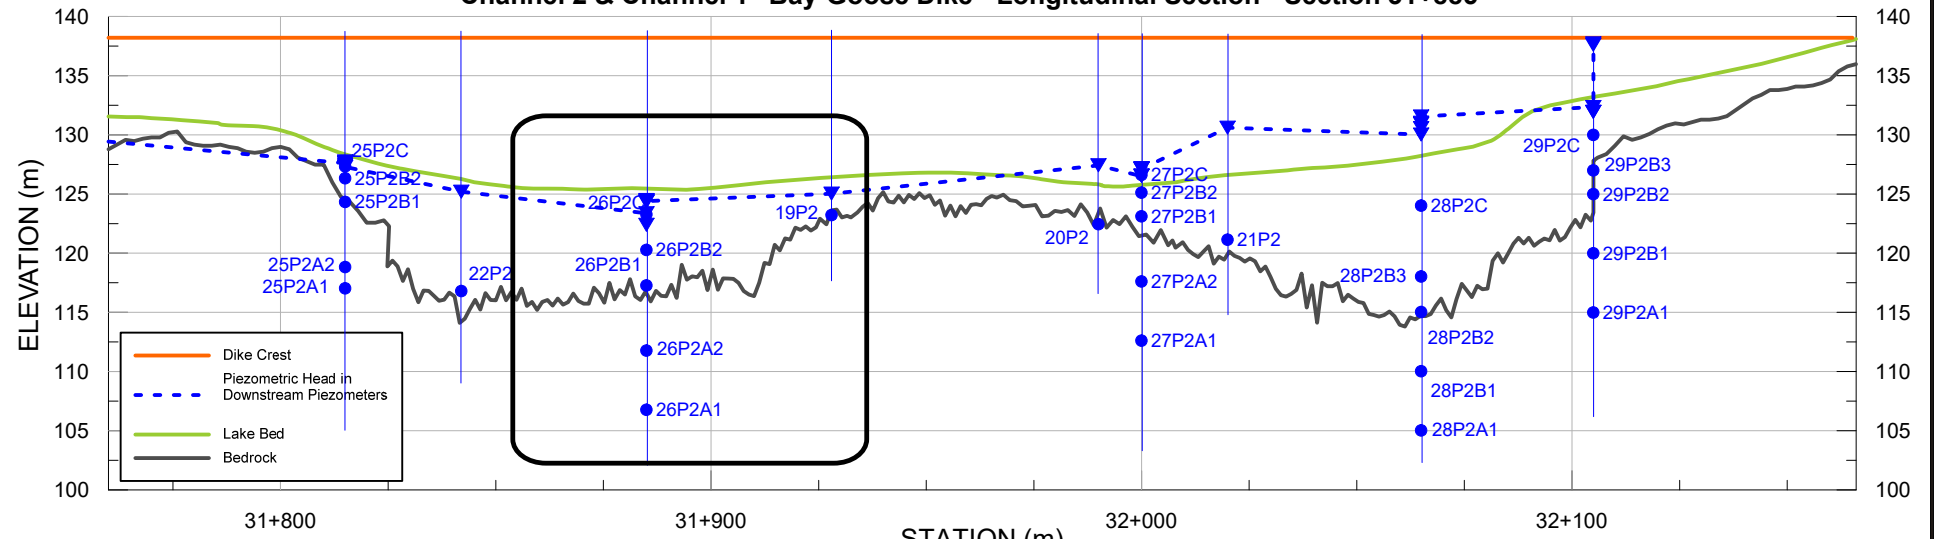
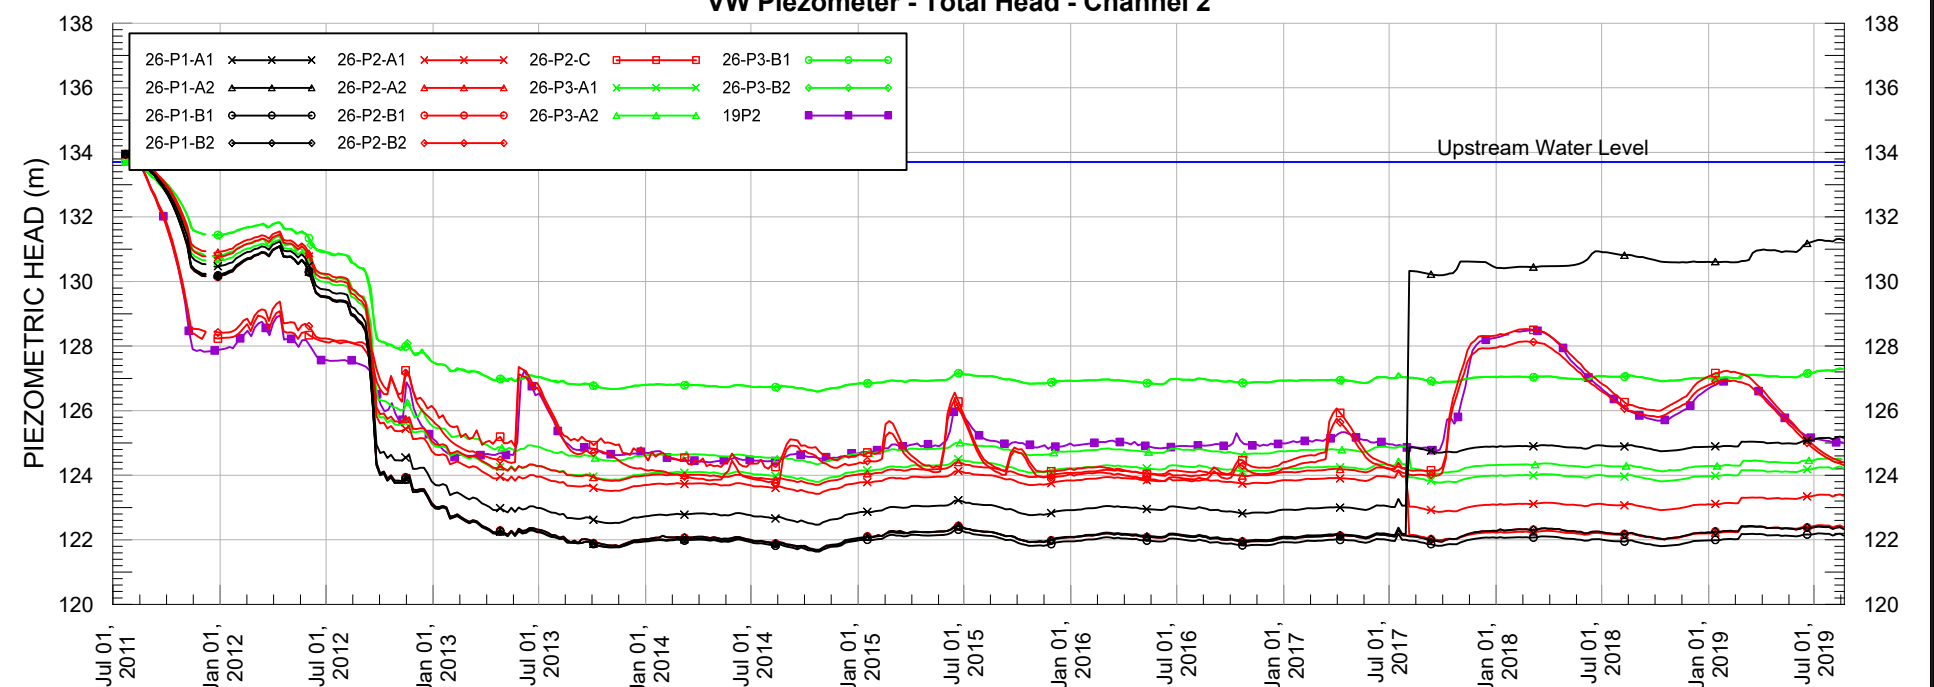
PROJECT	<b>AGNICO EAGLE MINES LIMITED MEADOWBANK GOLD PROJECT NUNAVUT</b>		
TITLE	<b>BAYGOOSE DIKE Section 31+885 - CHANNEL 2, PIEZOMETRIC DATA (July 1/11 to Aug 21/19)</b>		
	PROJECT No.	PHASE No.	
	DESIGN TD 28AUG14	SCALE AS SHOWN	REV.
	CADD PG 28AUG14	<b>FIGURE 17</b>	
	CHECK PD 28AUG14		
REVIEW

**NOTES:**  
 1. The rise in temperature and PWP was interpreted as the permafrost at the toe of the dike blocking the seepage path which led to this events. Will continue to monitor in the field and the instruments. Now that ice has melted the PWP has decreased as the seepage path is no longer blocked.

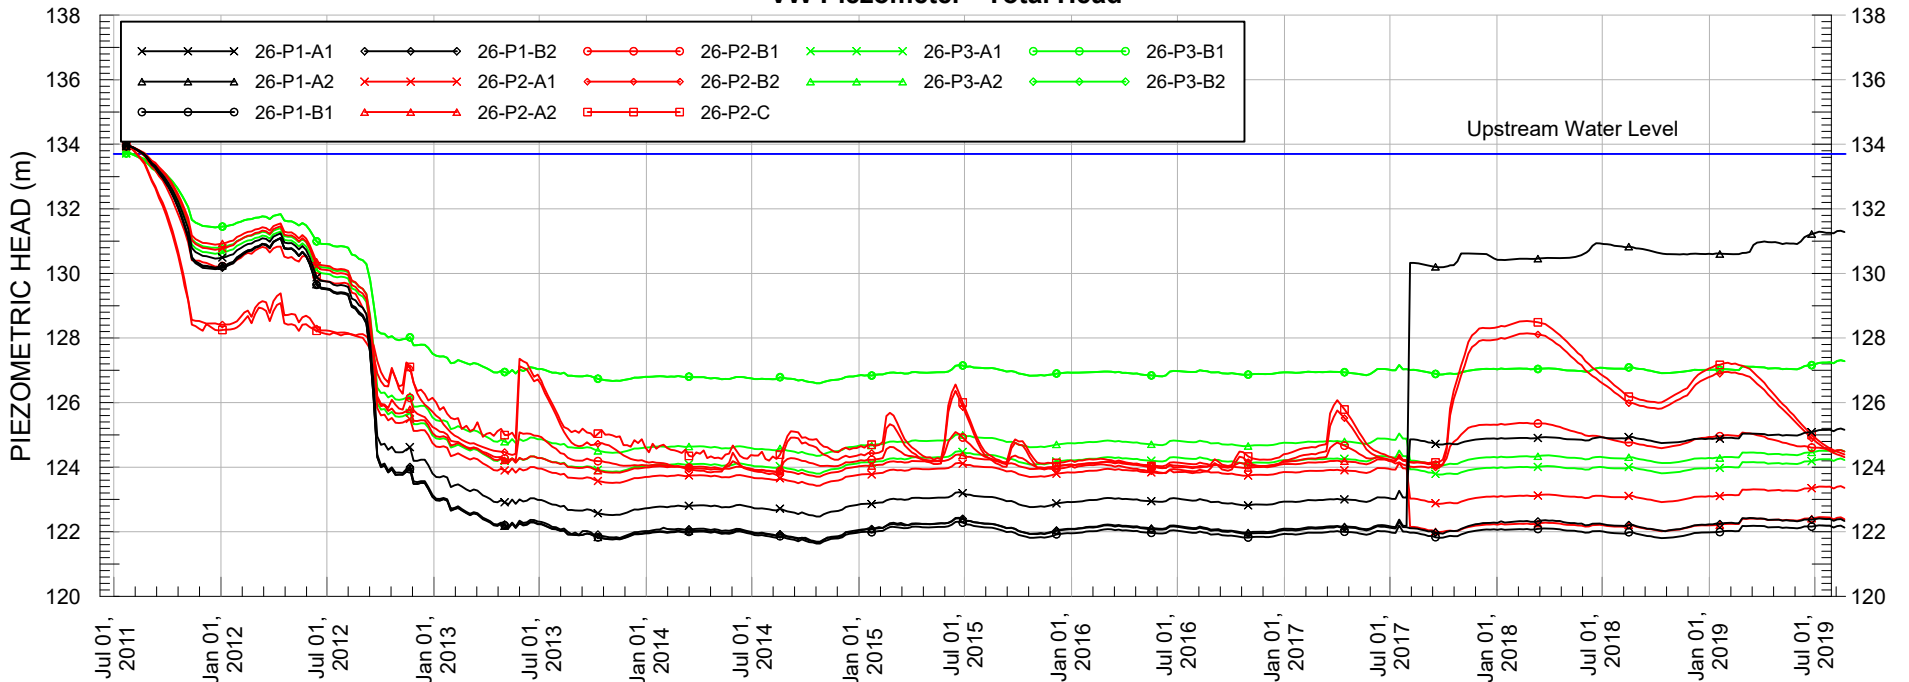
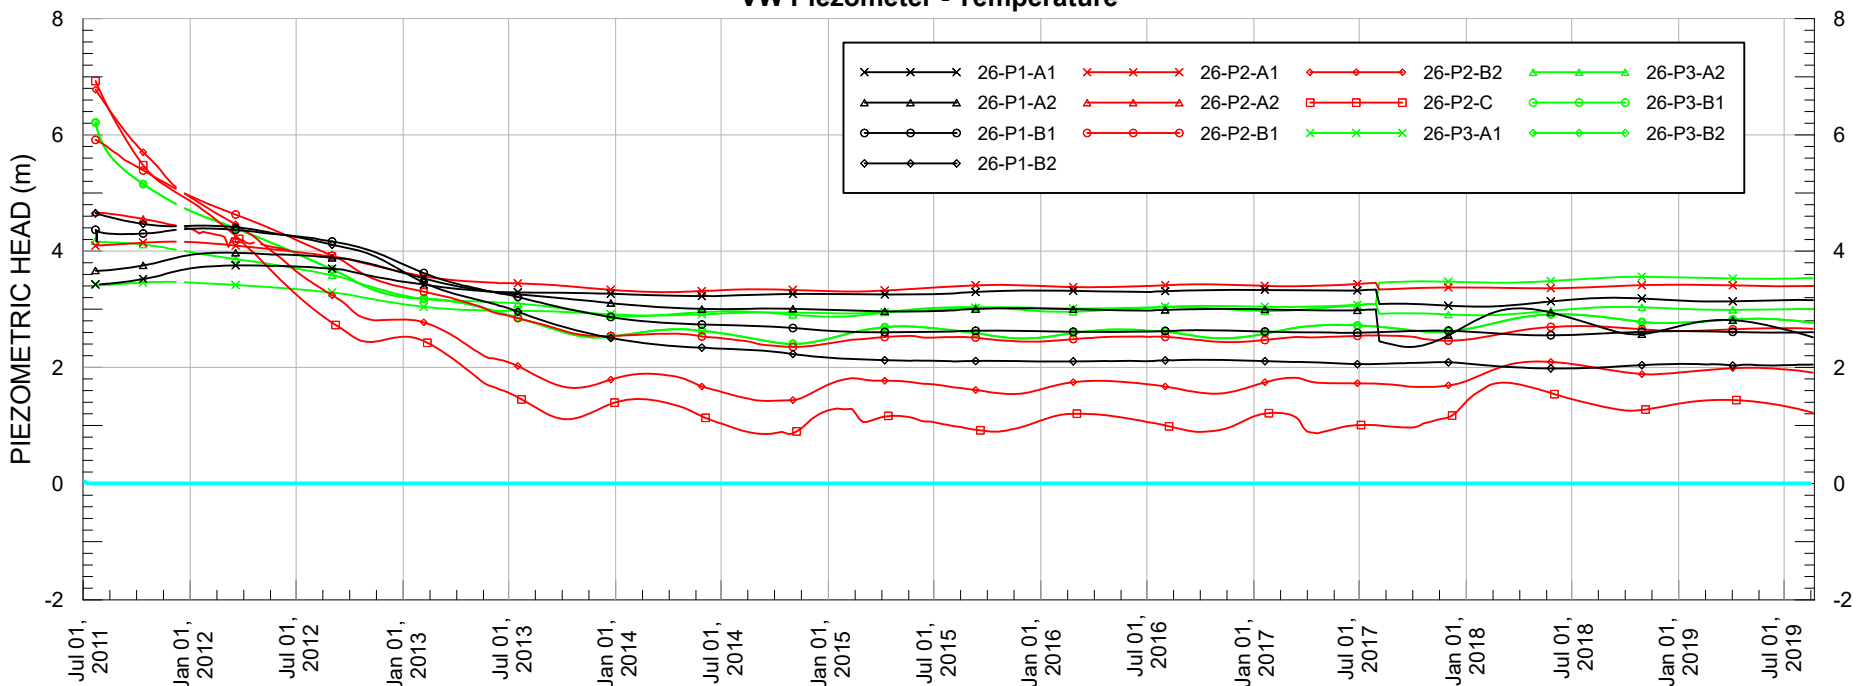
PROJECT	<b>AGNICO EAGLE MINES LIMITED MEADOWBANK GOLD PROJECT NUNAVUT</b>			
TITLE	<b>BAYGOOSE DIKE - SECTION 31+885 PIEZOMETRIC DATA (July 1/11 to Aug 21/19)</b>			
	PROJECT No.	PHASE No.		
	DESIGN TD 28AUG14	SCALE AS SHOWN	REV.	
	CADD TD 28AUG14	<b>FIGURE 18</b>		
	CHECK PG 28AUG14			
REVIEW

1. The rise in temperature and PWP was interpreted as the permafrost at the toe of the dike blocking the seepage path which led to this events. Will continue to monitor in the field and the instruments. Now that ice has melted the PWP has decreased as the seepage path is no longer blocked.
