# **Meadowbank 2019 Annual Geotechnical Inspection**

# 2019 Annual Geotechnical Inspection

*Meadowbank Gold Mine, Nunavut*

19123067-1588-R-Rev0

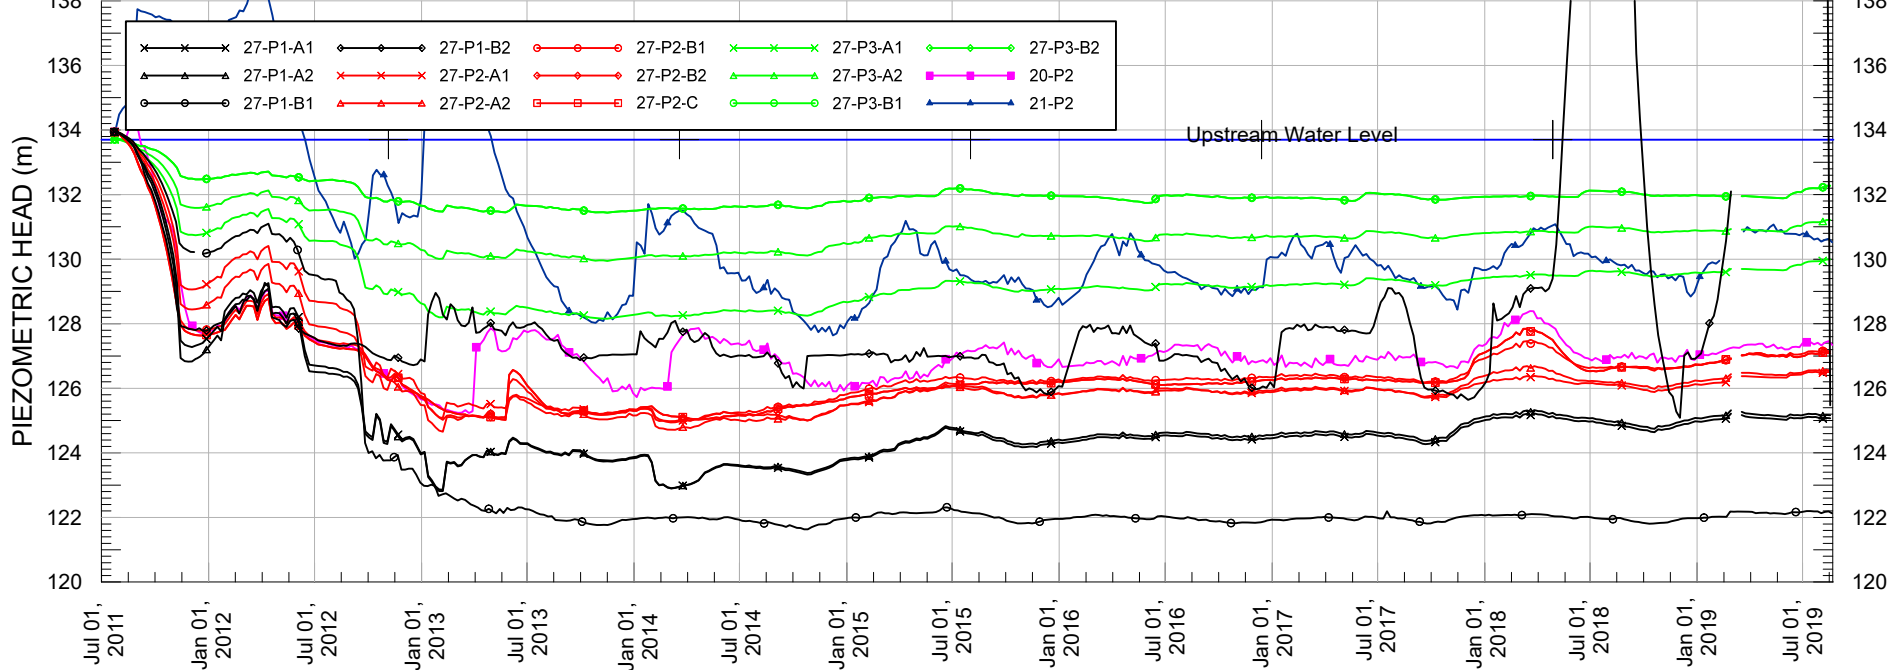
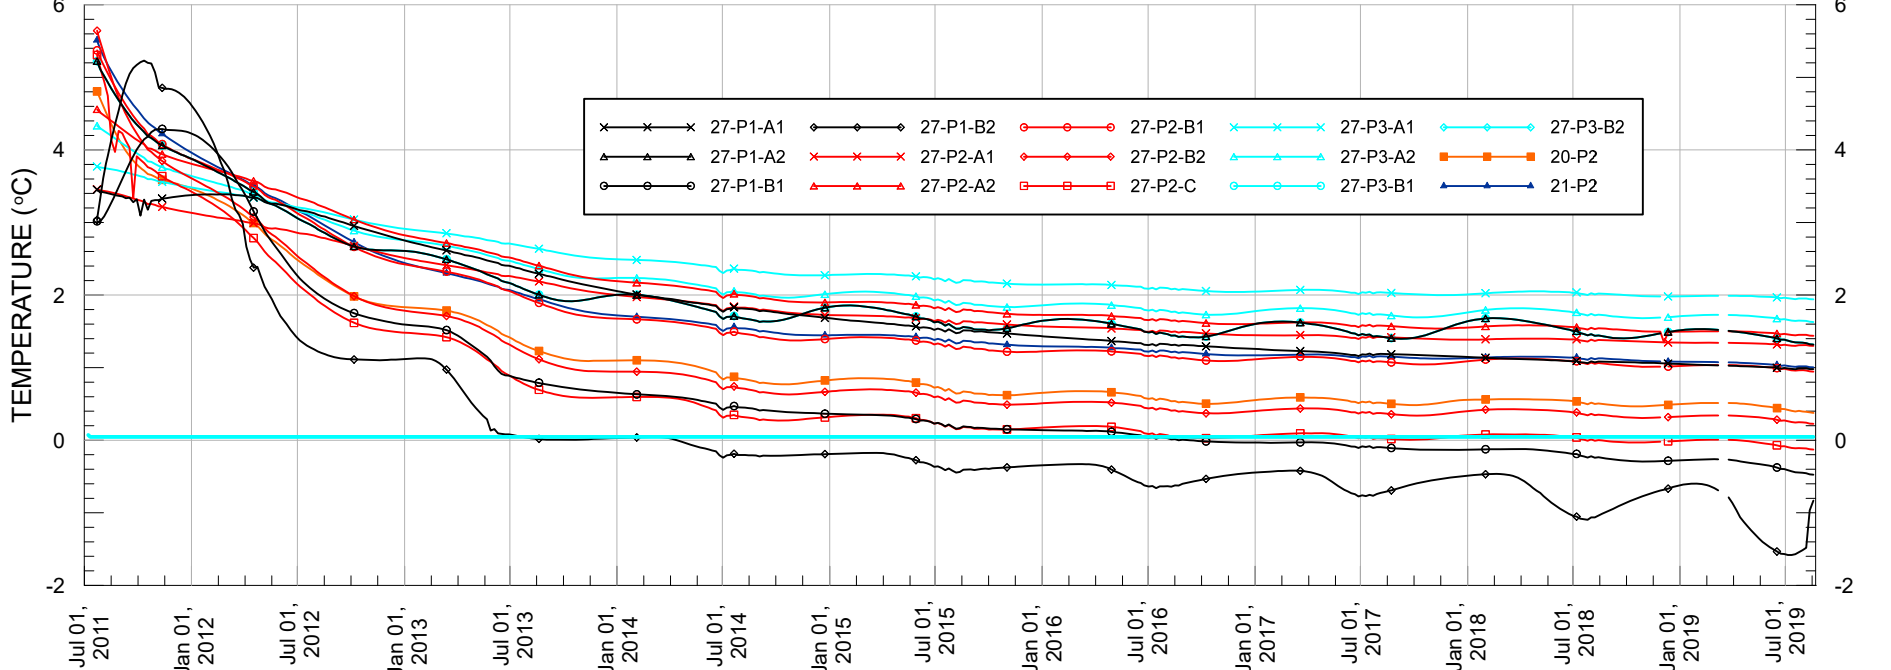
PROJECT		<b>AGNICO EAGLE MINES LIMITED MEADOWBANK GOLD PROJECT NUNAVUT</b>		
TITLE		<b>BAYGOOSE DIKE CHANNEL 1, PIEZOMETRIC DATA SECTION 32+000 (July 1/11 to Aug 21/19)</b>		
	PROJECT No.	PHASE No.		
	DESIGN TD	28AUG14	SCALE	AS SHOWN
	CADD PG	28AUG14	REV.	
	CHECK PG	28AUG14	<b>FIGURE 19</b>	
REVIEW

**NOTES:**  
 1. With the spike PWP pressure in 27-P1-B2 it is assumed that this instrument is not functioning anymore as the PWP pressure is higher than the lake elevation.

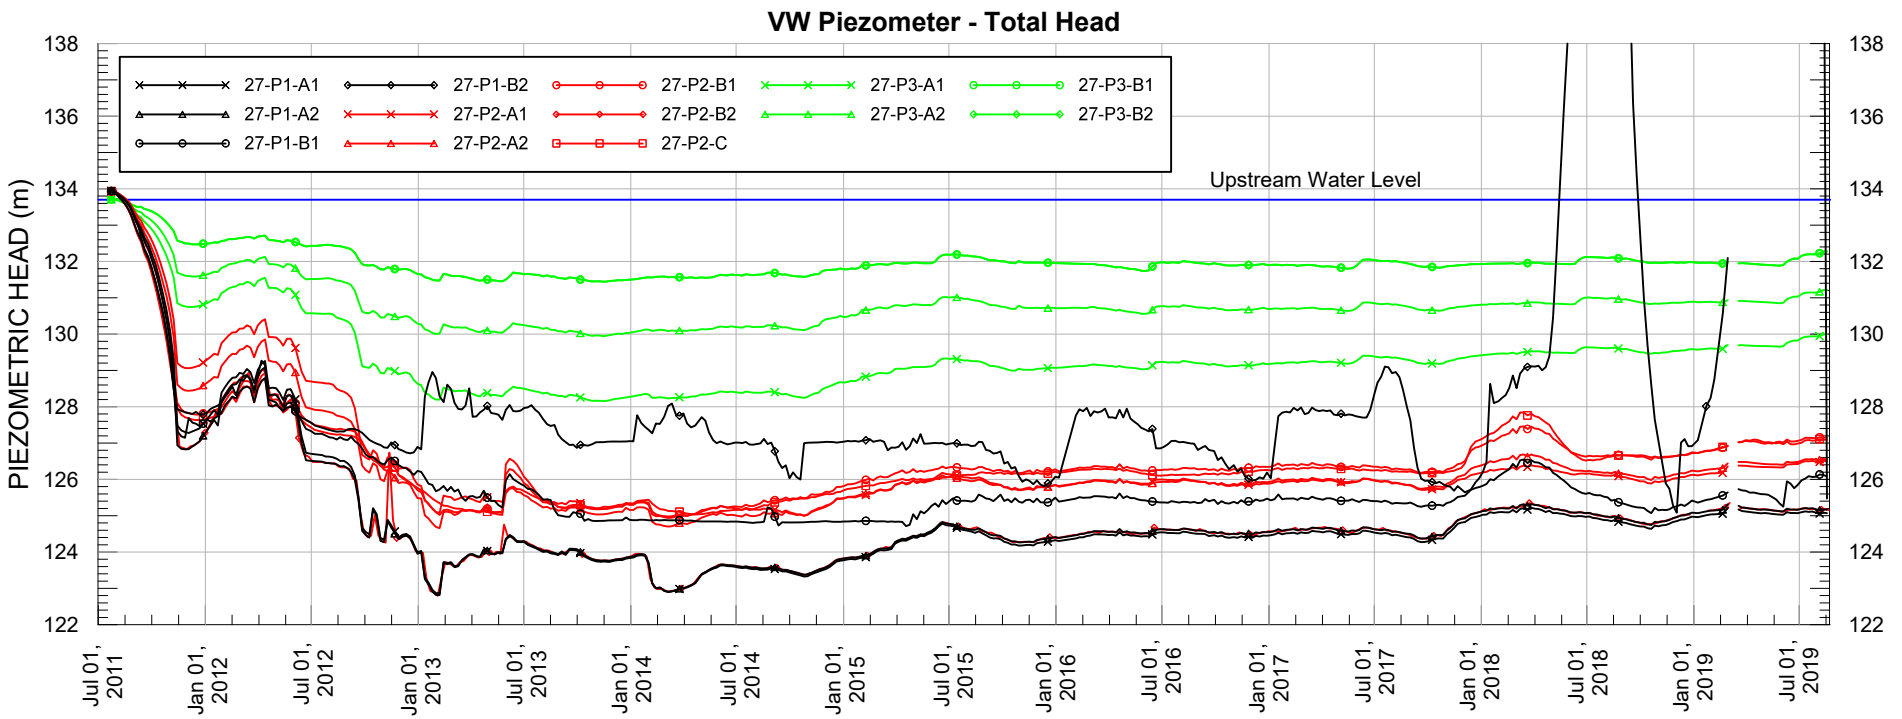
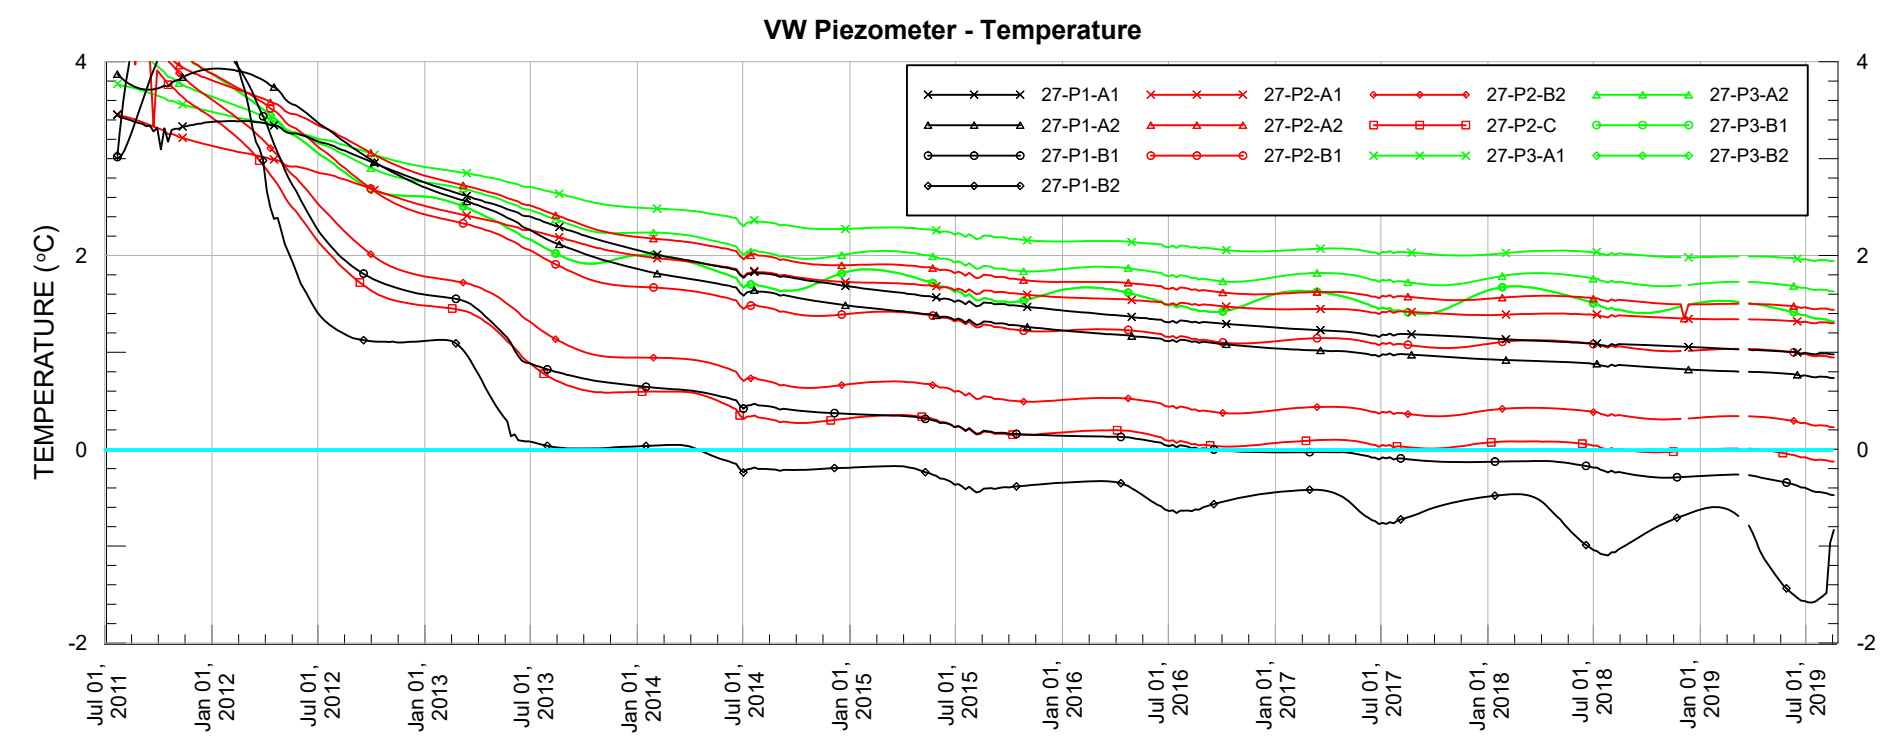
PROJECT		<b>AGNICO EAGLE MINES LIMITED MEADOWBANK GOLD PROJECT NUNAVUT</b>	
TITLE		<b>BAY OOSE DIKE - SECTION 32+000 PIEZOMETRIC DATA (July 1/11 to Aug 21/19)</b>	
	PROJECT No.	PHASE No.	
	DESIGN TD	28AUG14	SCALE AS SHOWN REV.
	CADD TD	28AUG14	
	CHECK PG	28AUG14	
REVIEW			
			<b>FIGURE 20</b>

**NOTES:**  
 1. With the spike PWP pressure in 27-P1-B2 it is assumed that this instrument is not functioning anymore as the PWP pressure is higher than the lake elevation.

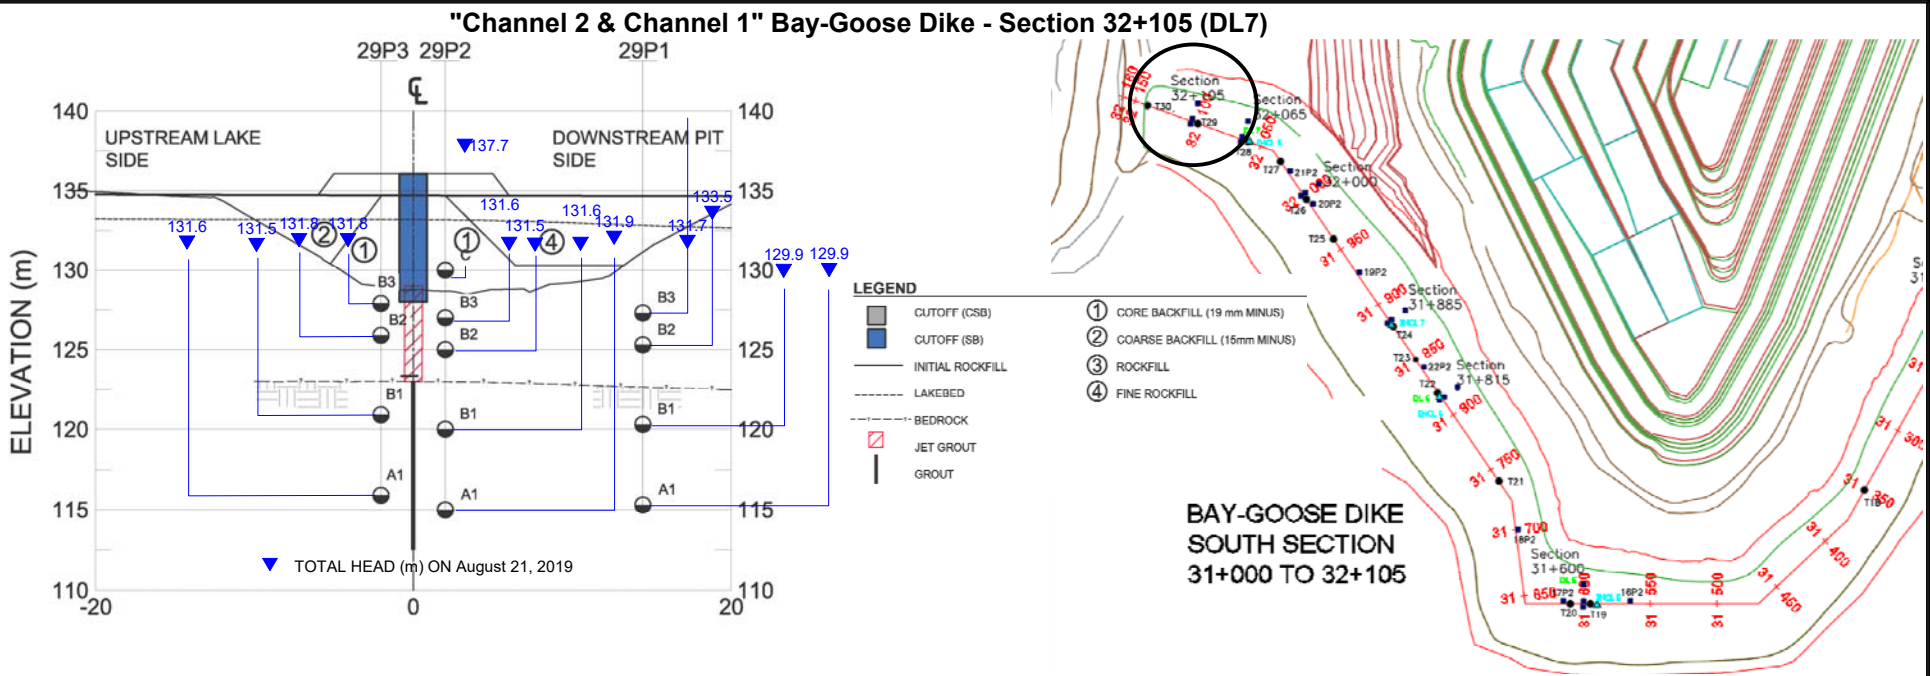
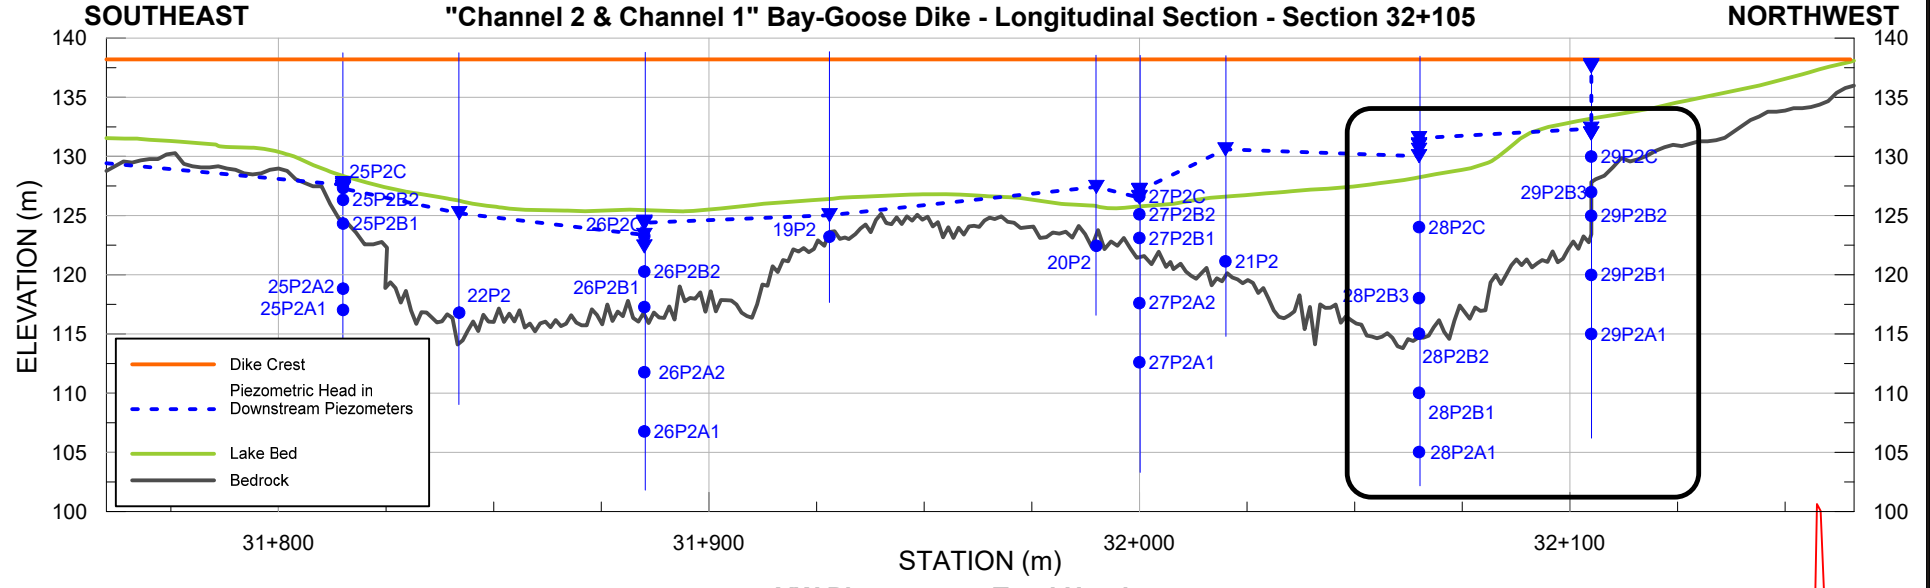
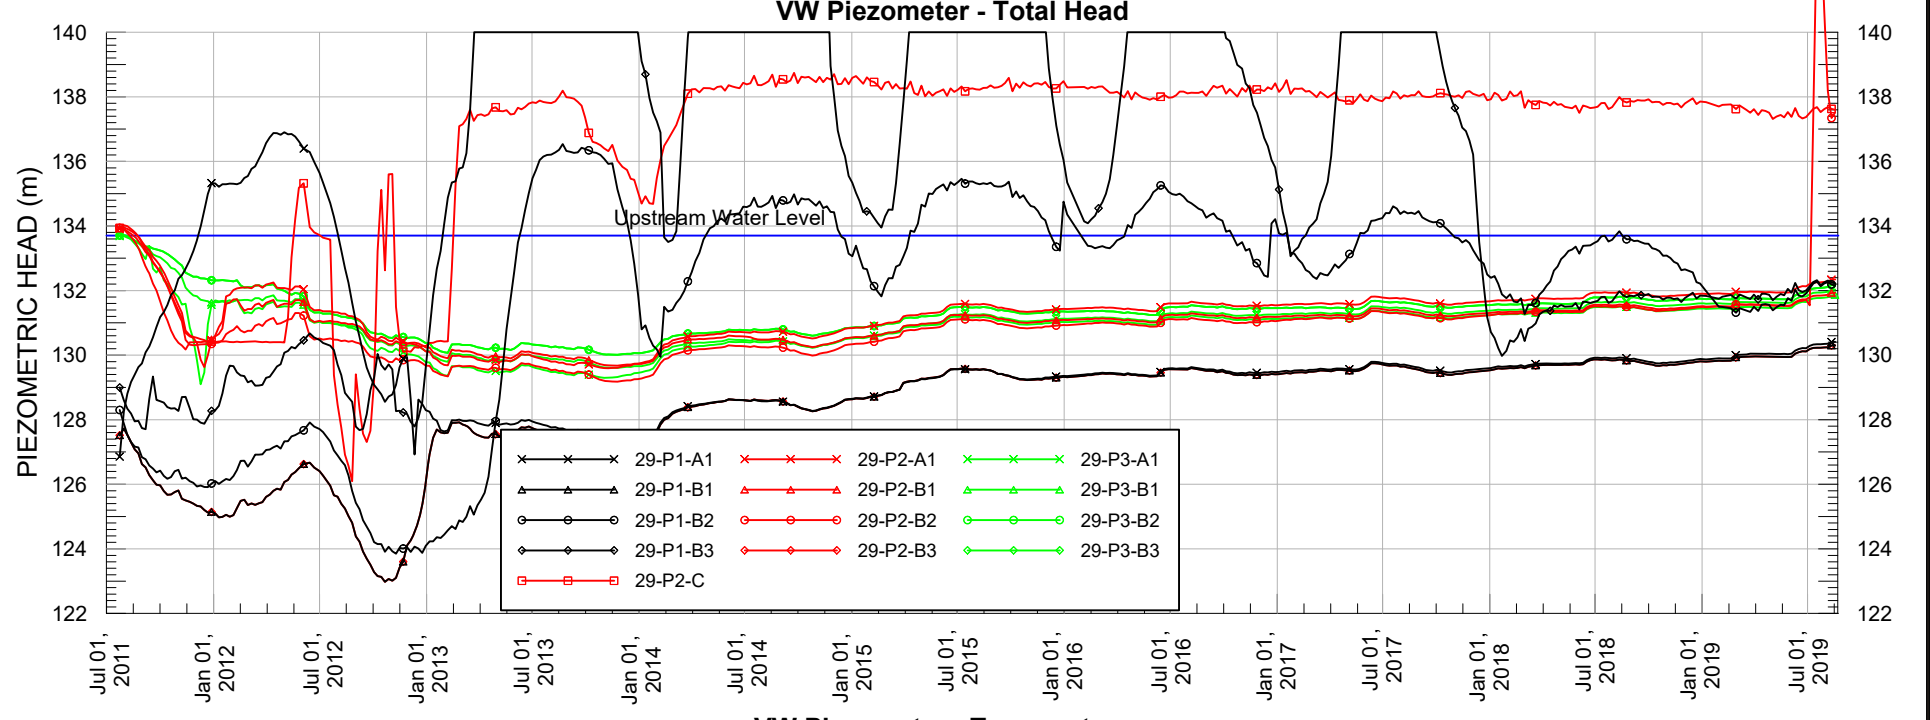
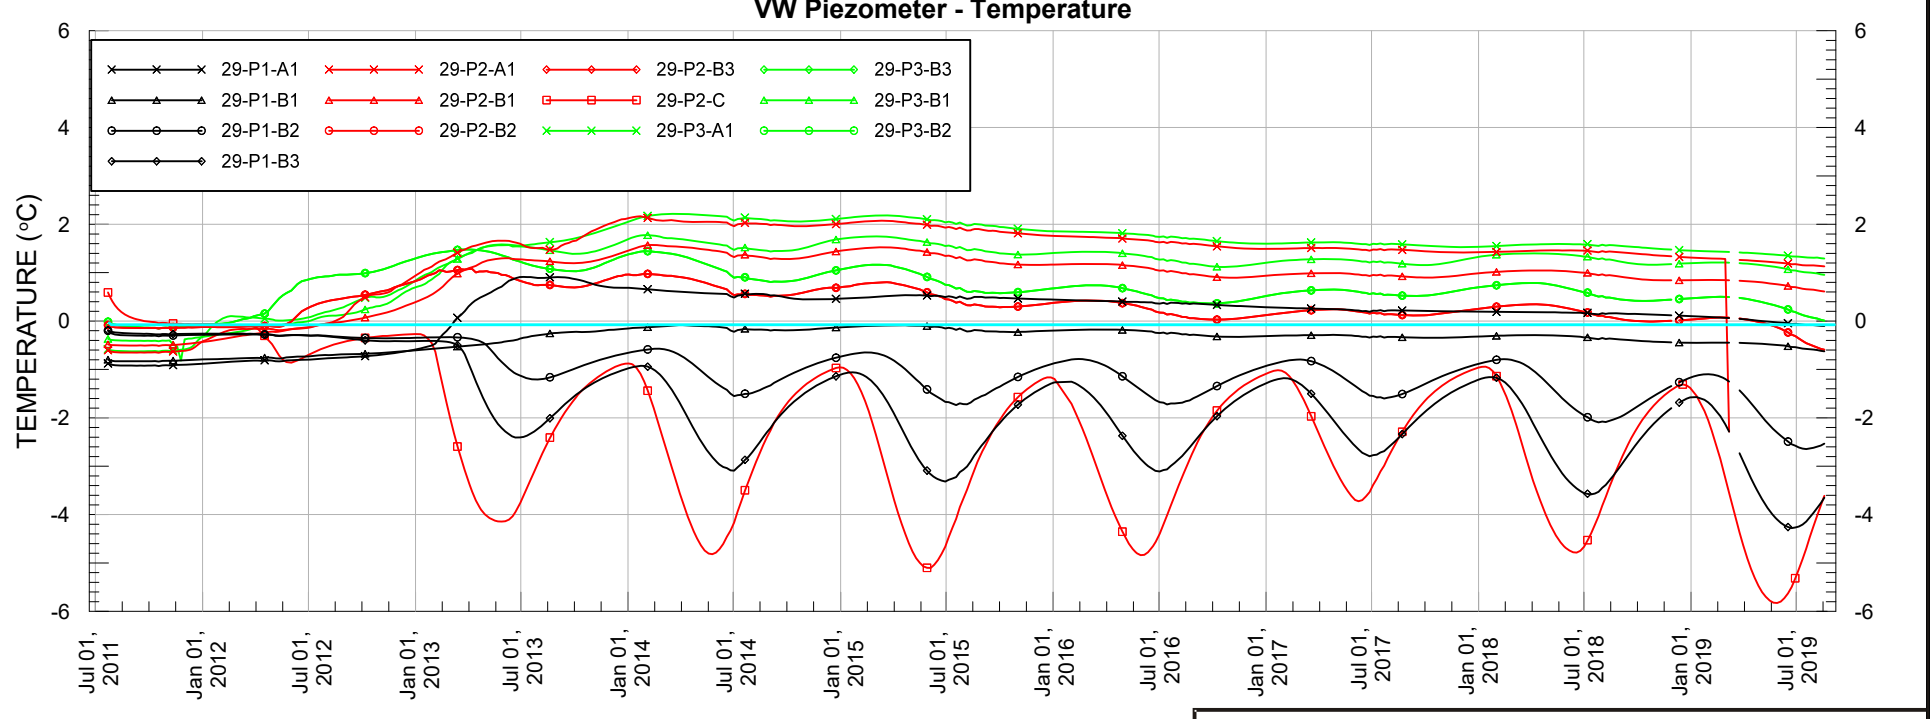
**NOTES:**  
 1. 29P1B2, 29P1B3, 29P2B3, 29P3B3 and 29P2C are given unstable readings and since the temperature shows a negative reading it is assumed to be frozen.

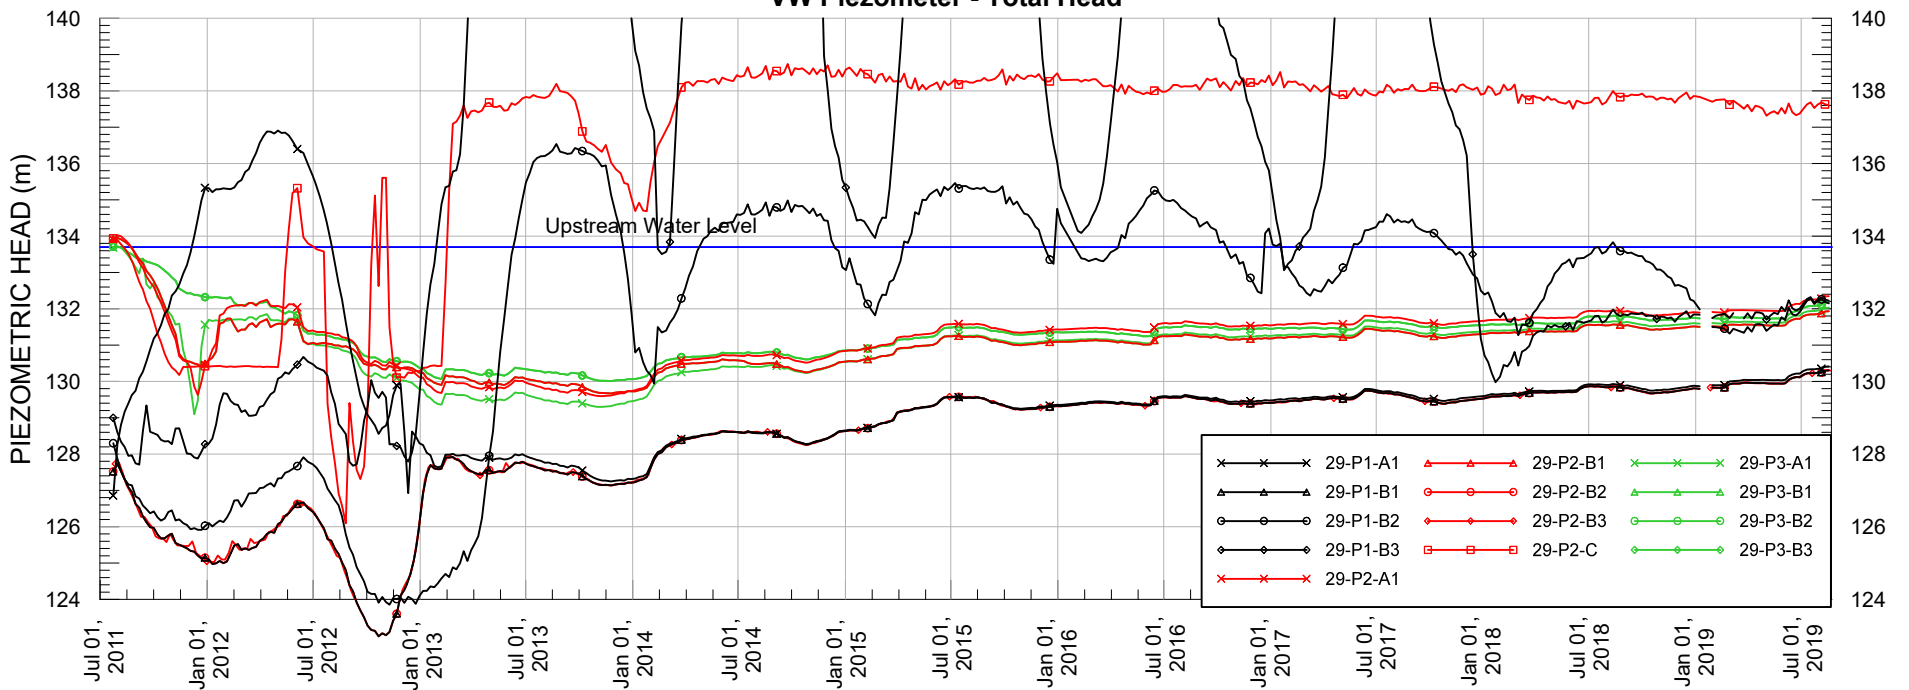
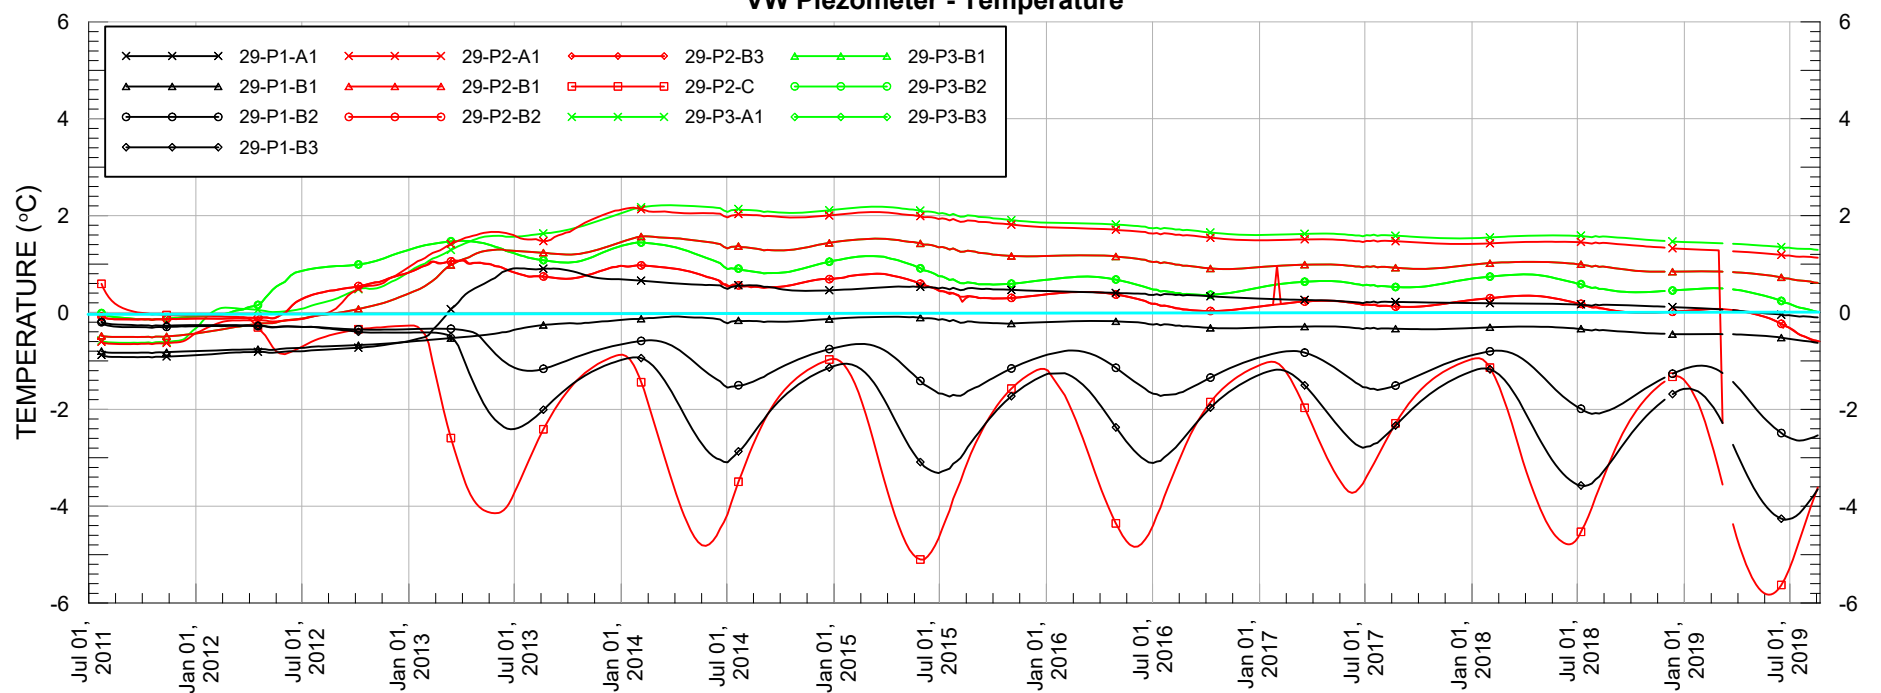
PROJECT		AGNICO EAGLE MINES LIMITED MEADOWBANK GOLD PROJECT NUNAVUT		
TITLE		BAYGOOSE DIKE - SECTION 32+105 PIEZOMETRIC DATA (July 1/11 to Aug 21/19)		
	PROJECT No.	PHASE No.		
	DESIGN TD	28AUG14	SCALE AS SHOWN	REV.
	CADD TD	28AUG14	<b>FIGURE 24</b>	
	CHECK PG	28AUG14		
REVIEW

1. 29P1B2, 29P1B3, 29P2B3, 29P3B3 and 29P2C are given unstable readings and since the temperature shows a negative reading it is assumed to be frozen.

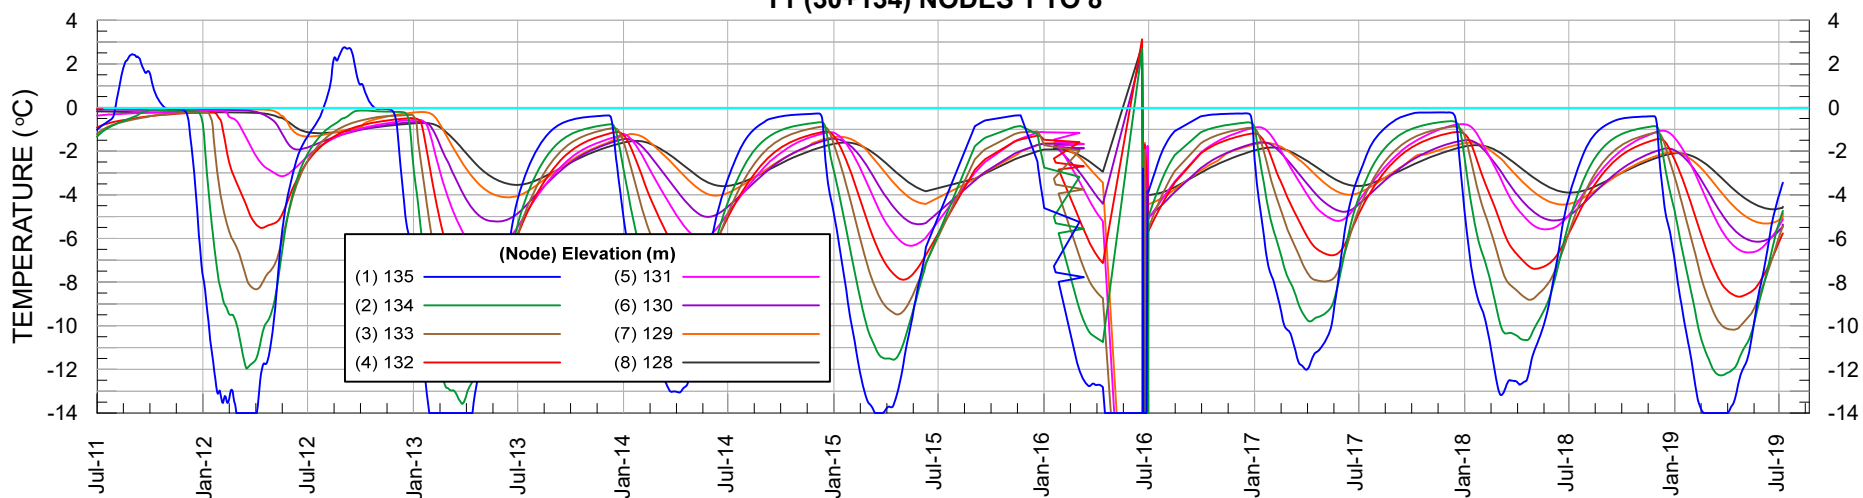
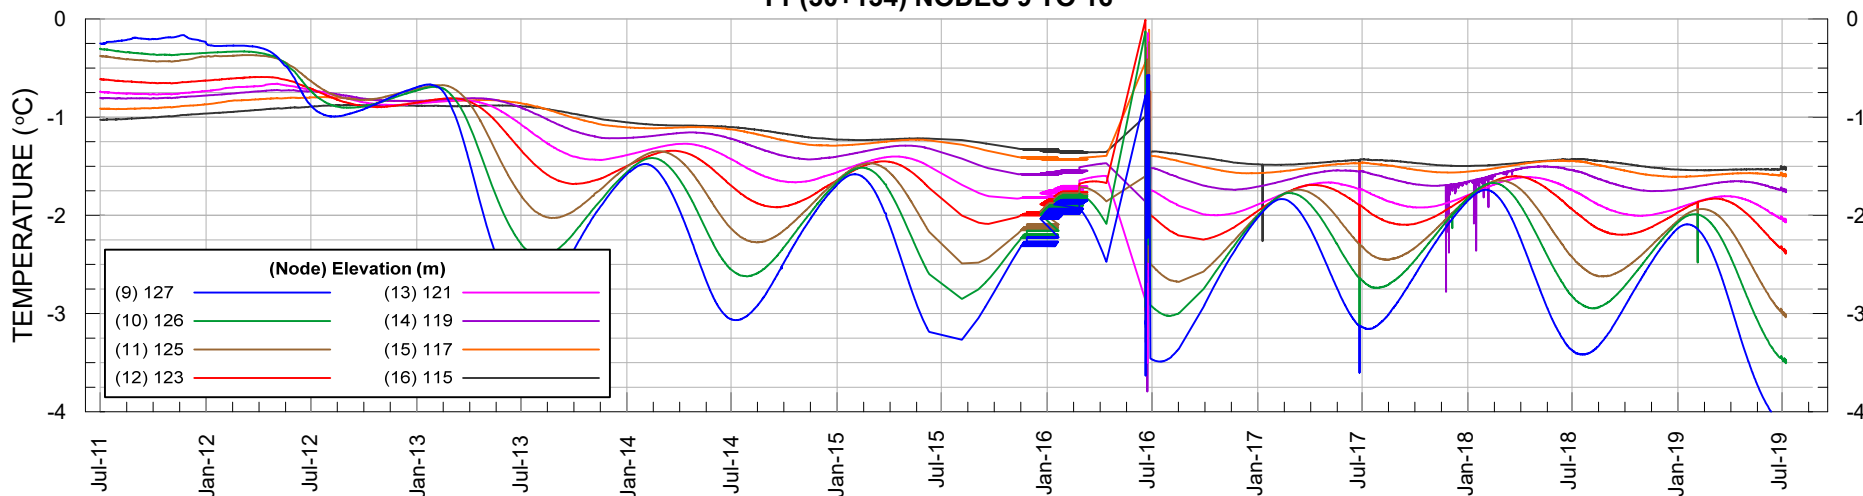
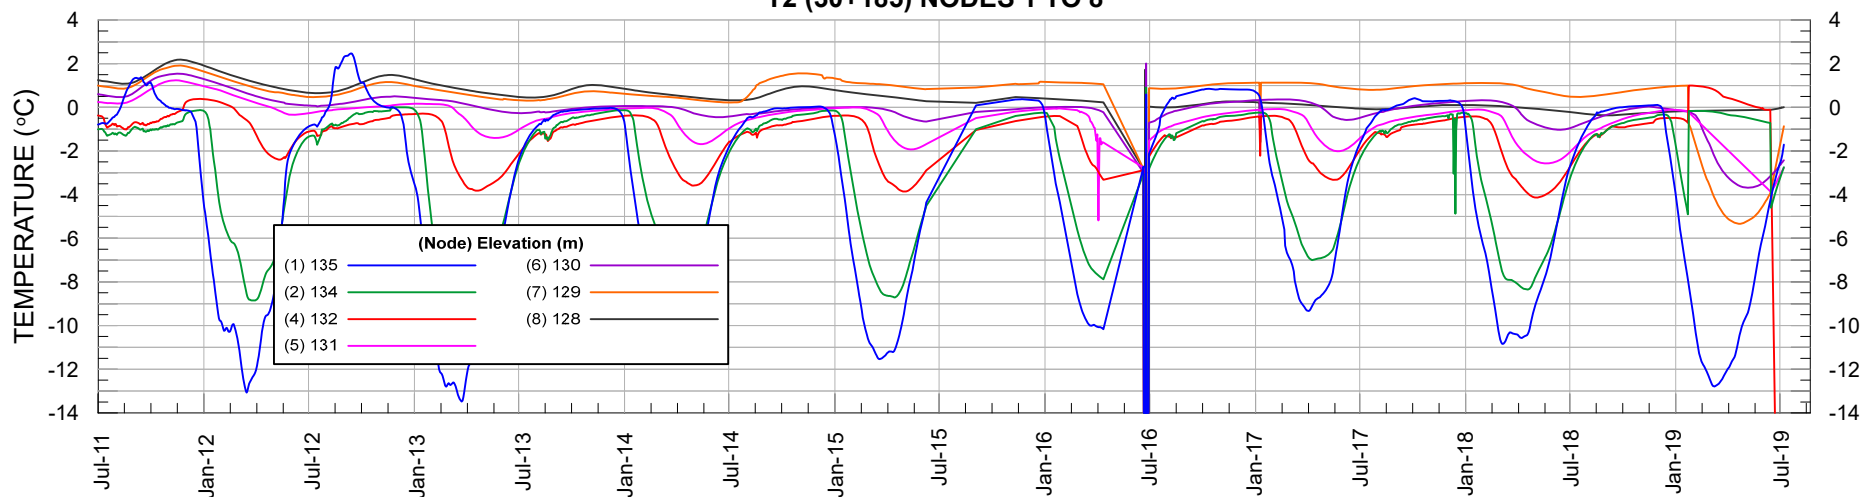
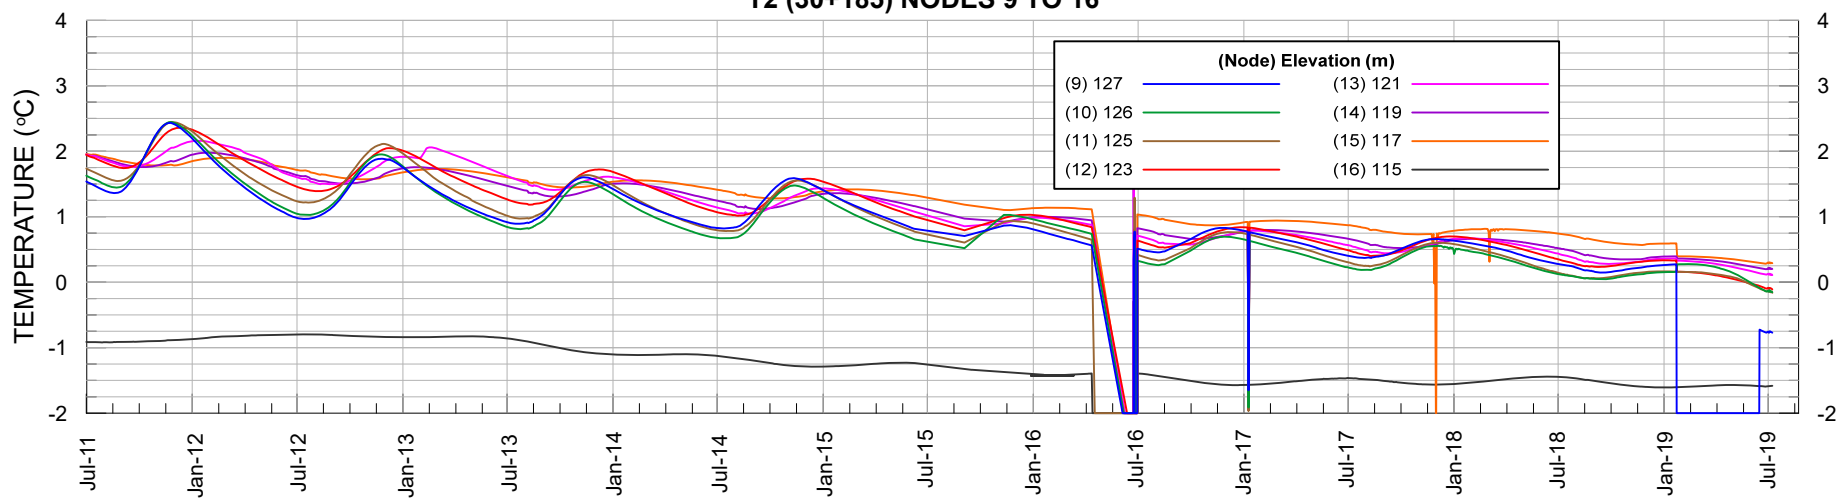
PROJECT No.	PHASE No.		
	DESIGN TD 20JAN14	SCALE	AS SHOWN	
	CADD TD 20JAN14	REV.		
	CHECK	FIGURE 30		
REVIEW

NOTE: On July 11th, 2019 there appears to be an issue with the receiving reliable data. This is under investigation.

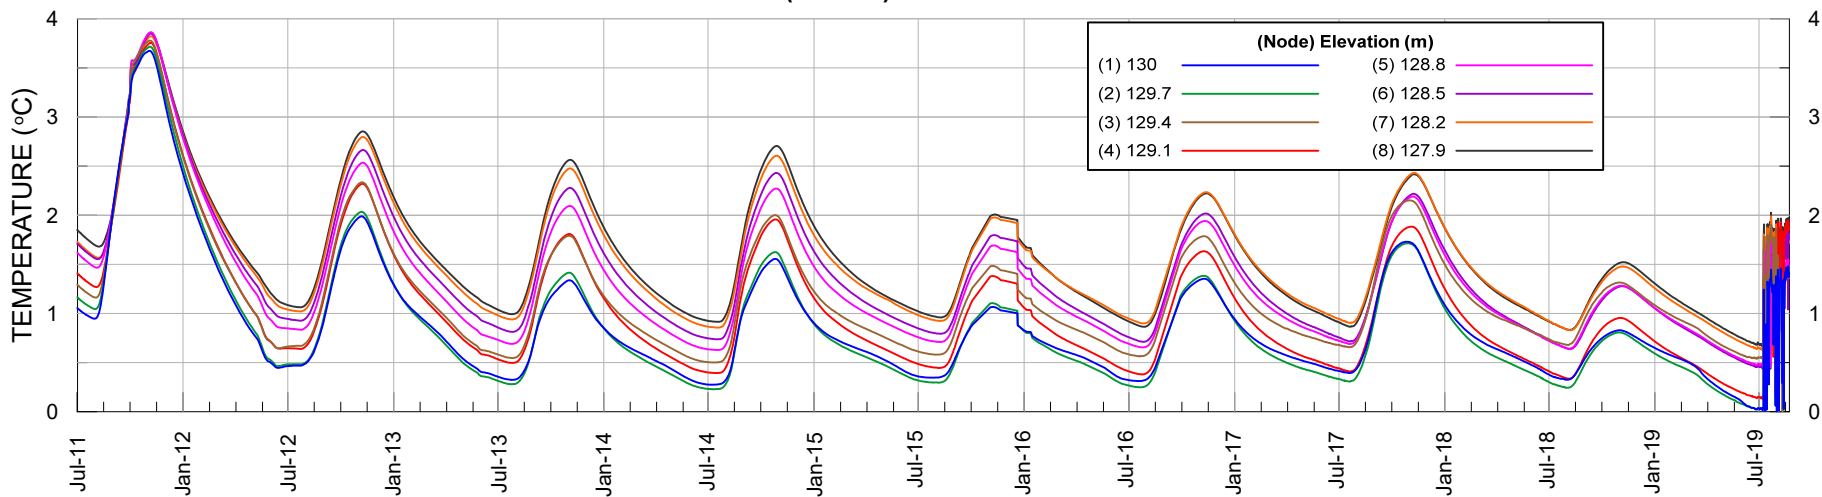
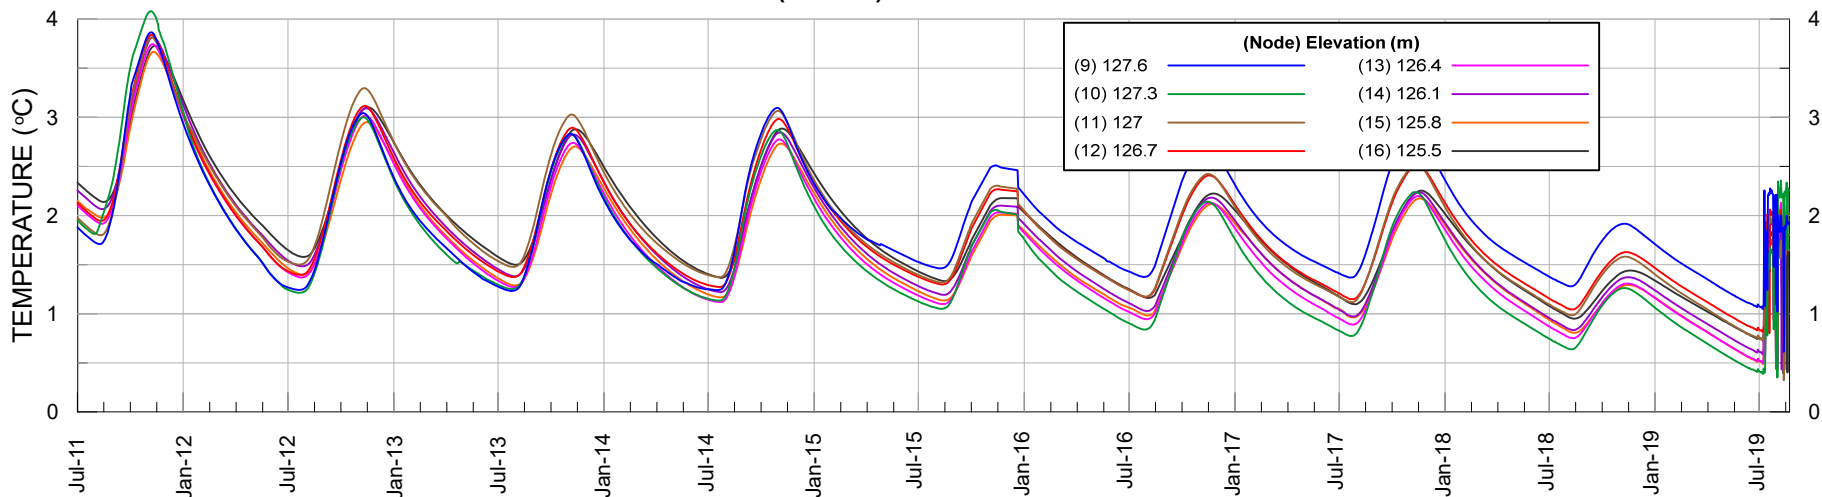
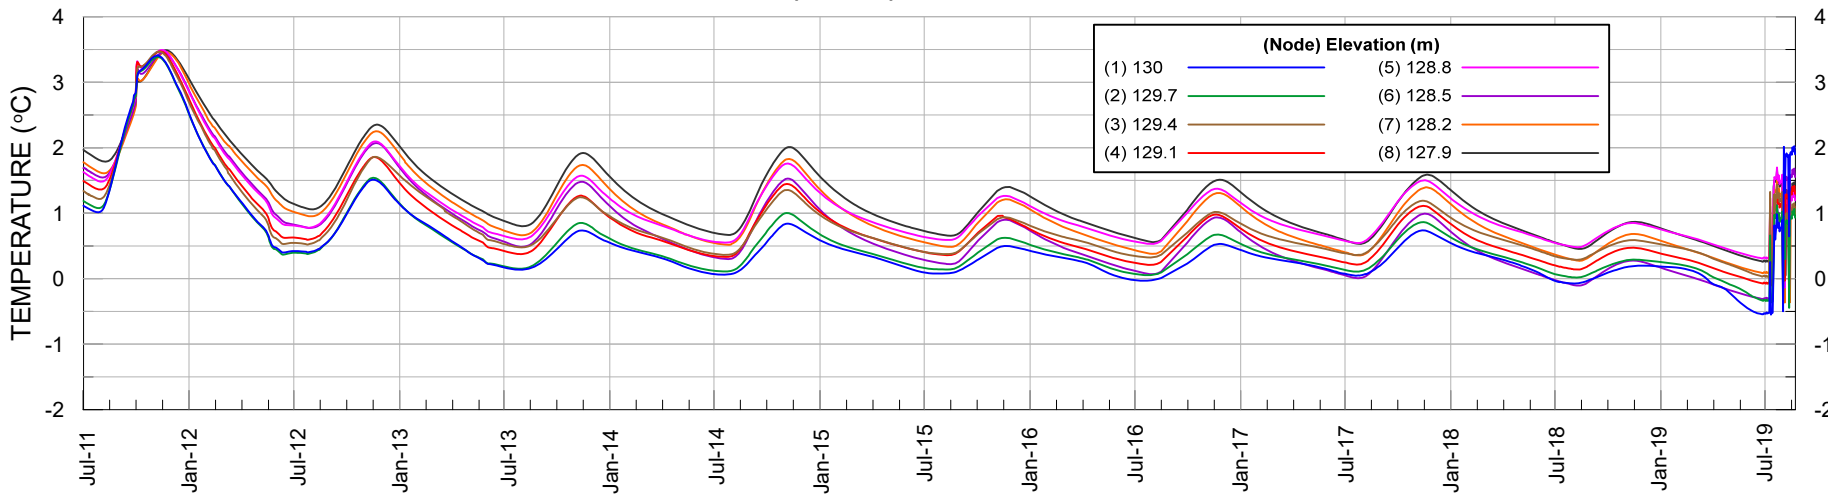
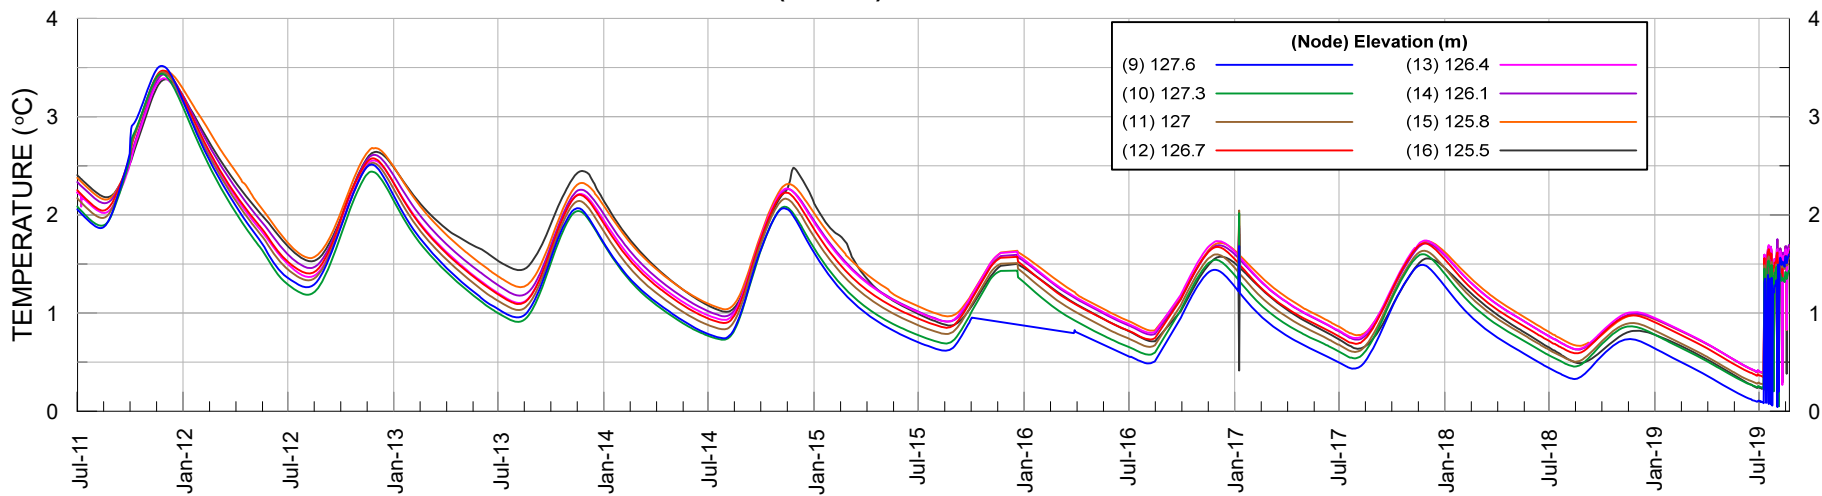
PROJECT No.		PHASE No.	
	DESIGN	TD	20JAN14	SCALE AS SHOWN
	CADD	TD	20JAN14	REV.
	CHECK			
REVIEW				<b>FIGURE 31</b>

NOTE: On July 11th, 2019 there appears to be an issue with the receiving reliable data. This is under investigation.
