# **Meadowbank 2019 Annual Geotechnical Inspection**

# 2019 Annual Geotechnical Inspection

*Meadowbank Gold Mine, Nunavut*

19123067-1588-R-Rev0

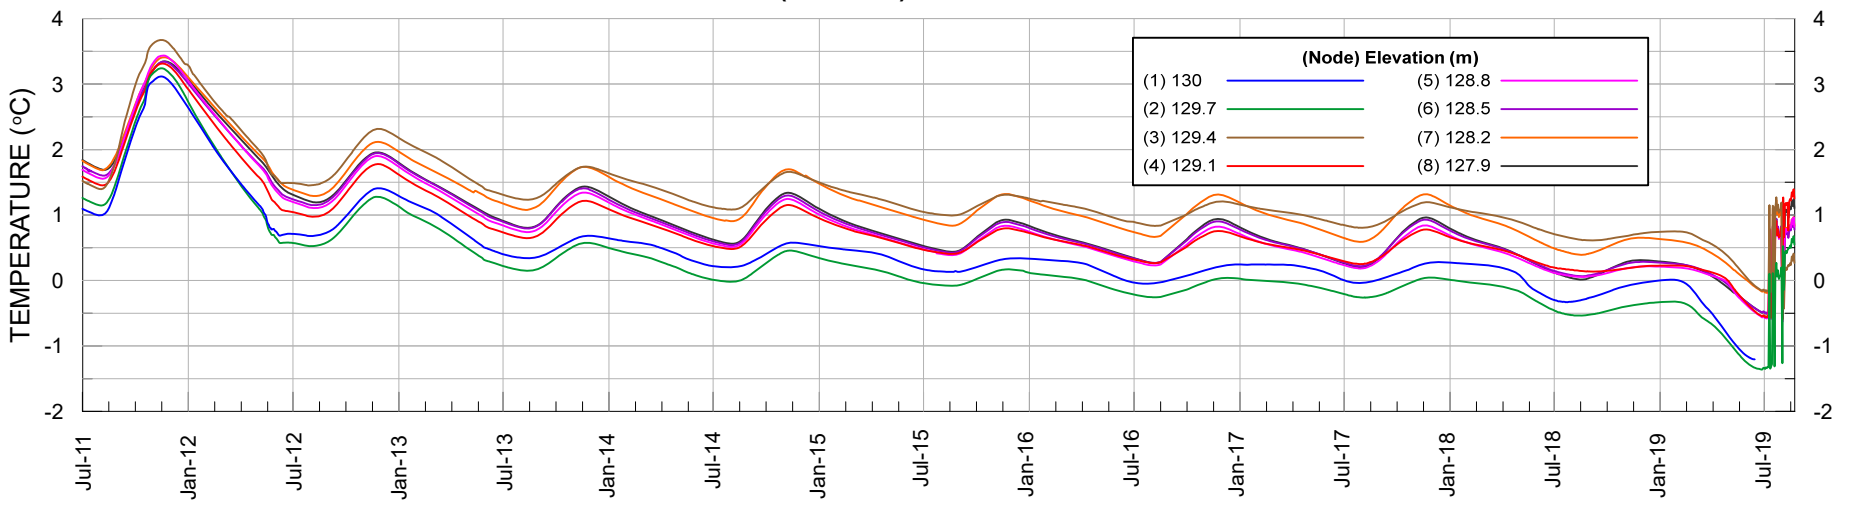
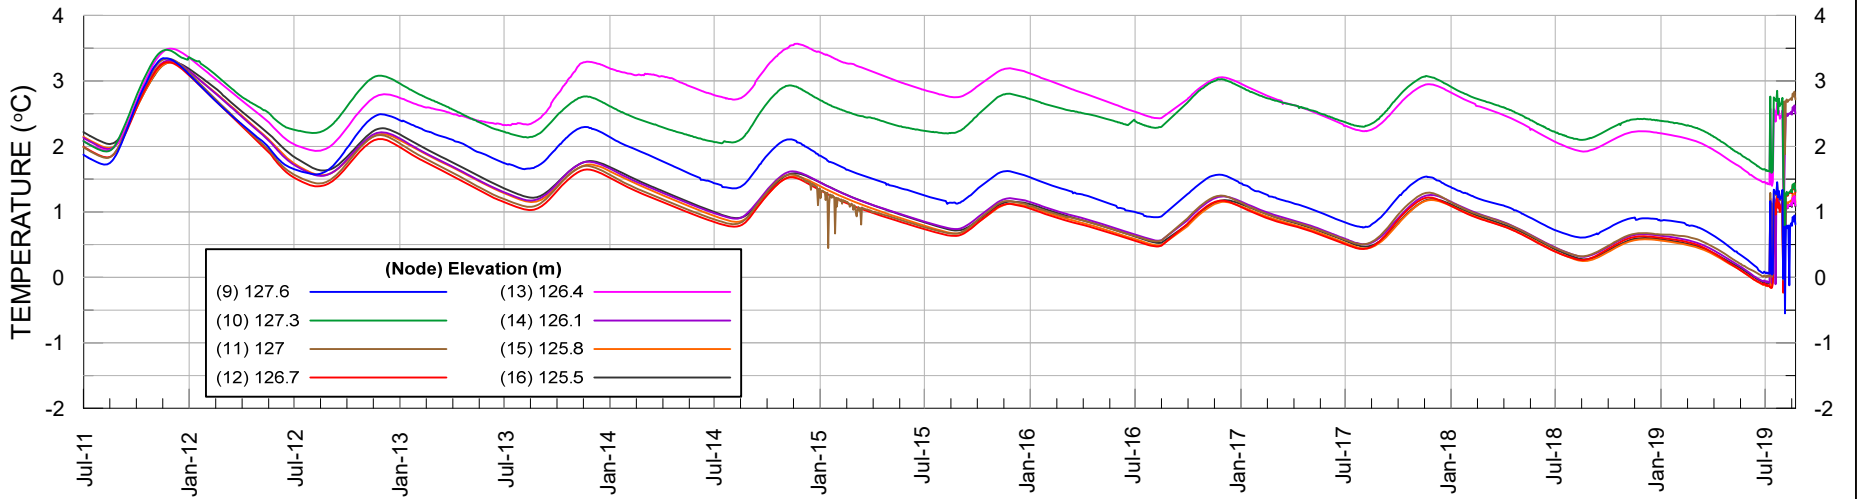
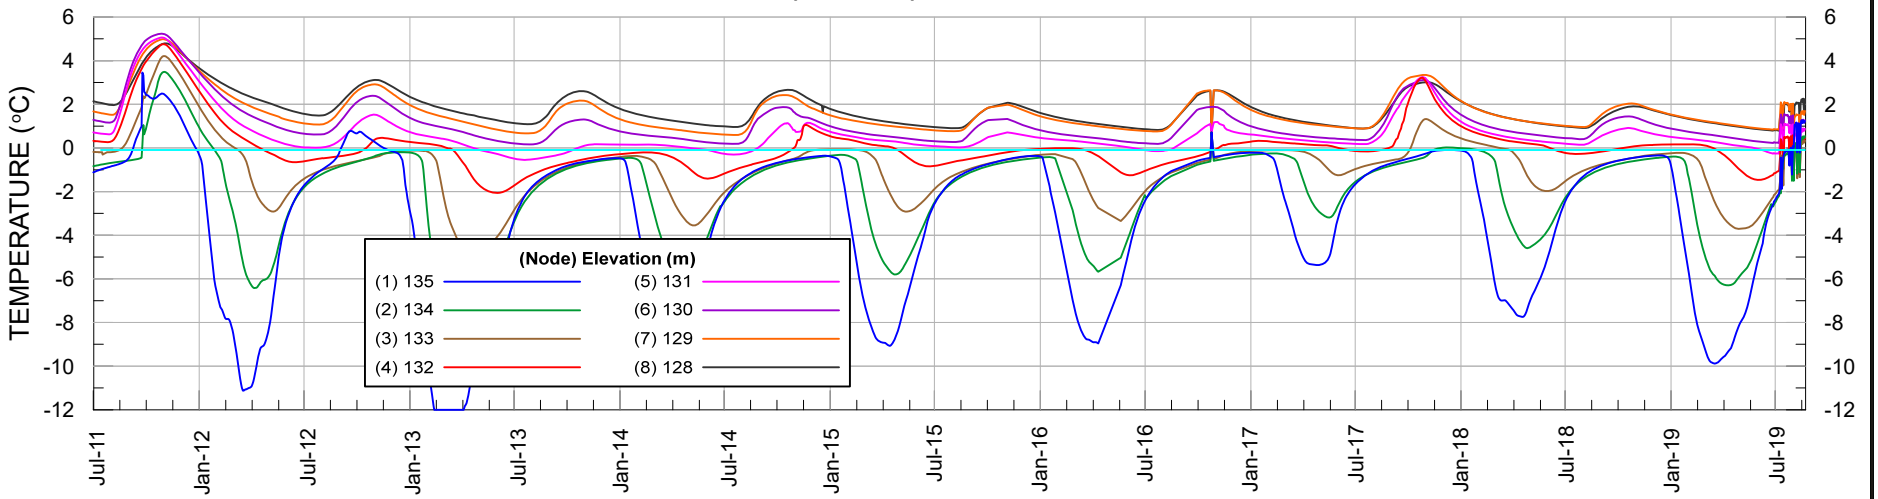
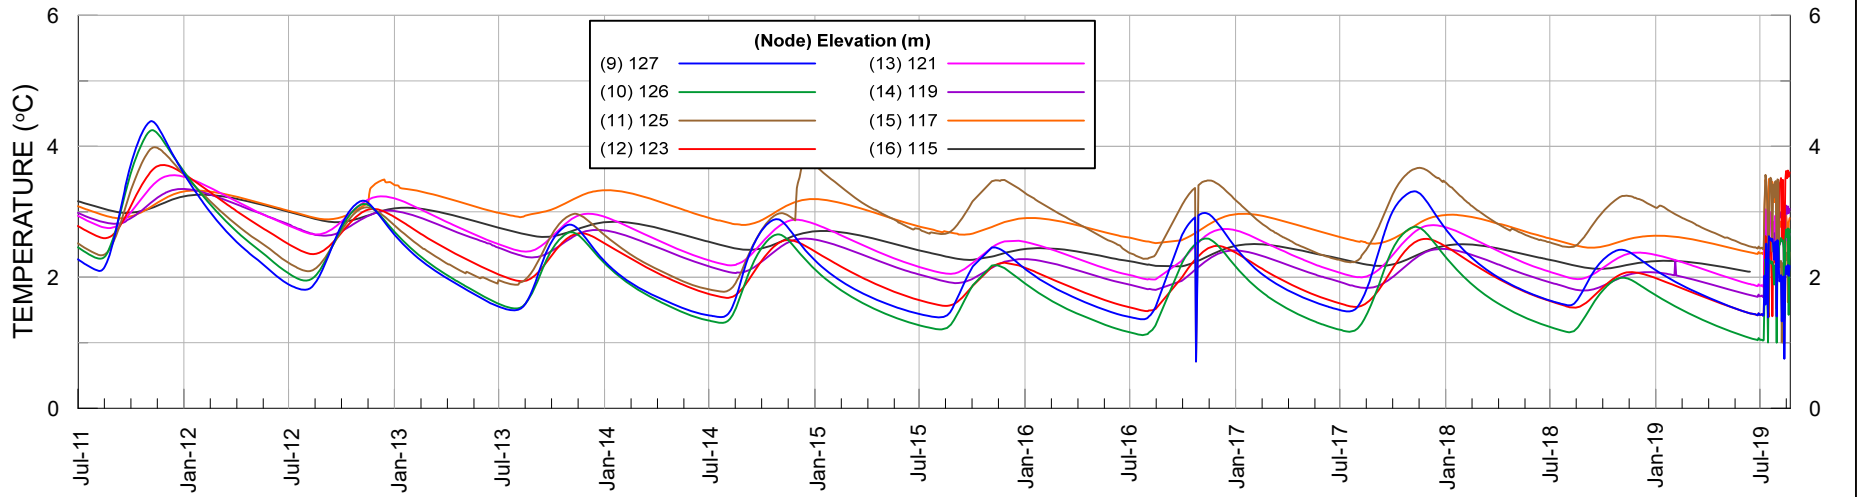
PROJECT No.		PHASE No.	
	DESIGN	TD	20JAN14	SCALE AS SHOWN
	CADD	TD	20JAN14	REV.
	CHECK			<b>FIGURE 32</b>
REVIEW

**NOTE:** On July 11th, 2019 there appears to be an issue with the receiving reliable data. This is under investigation.

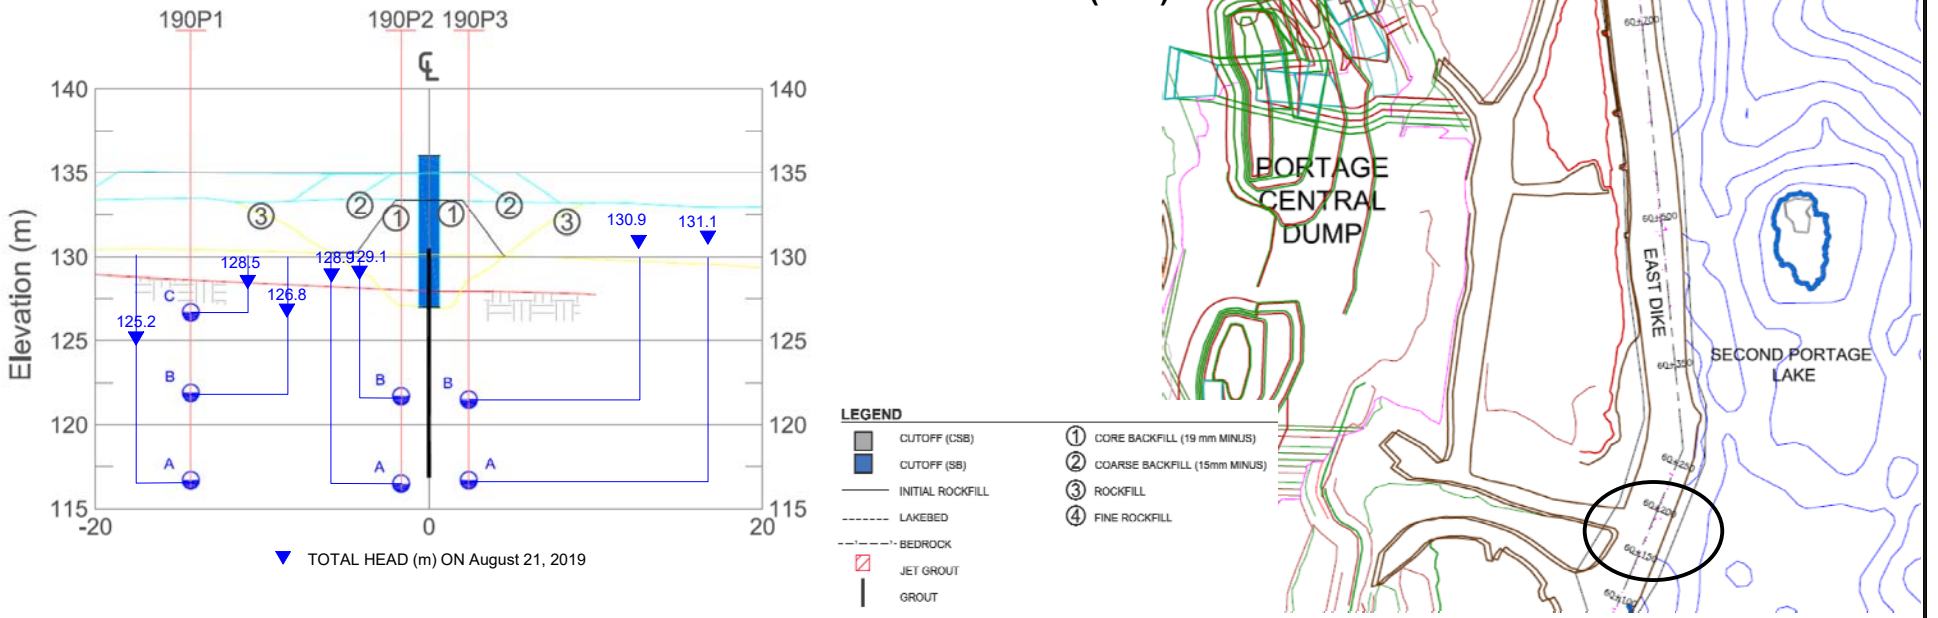
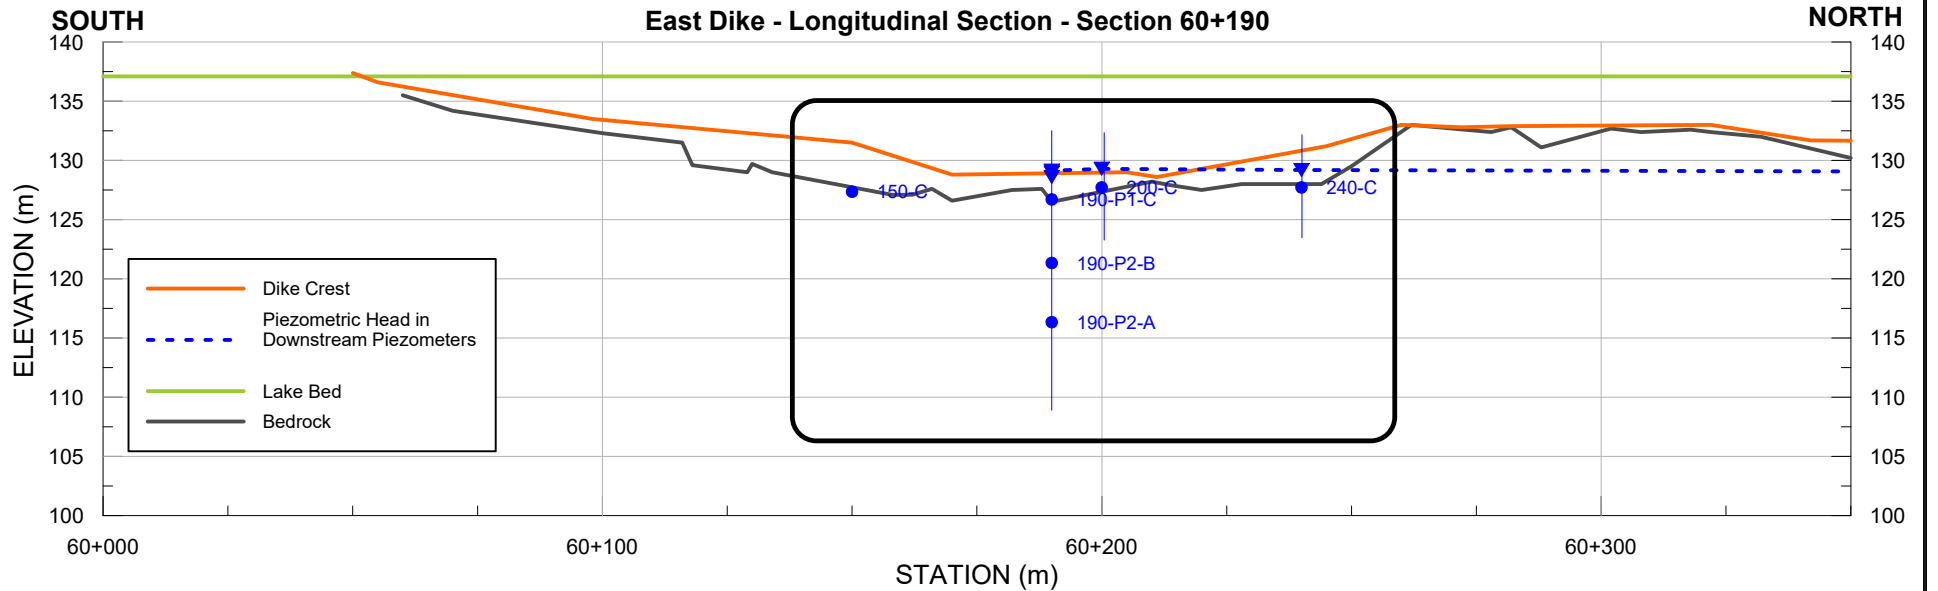
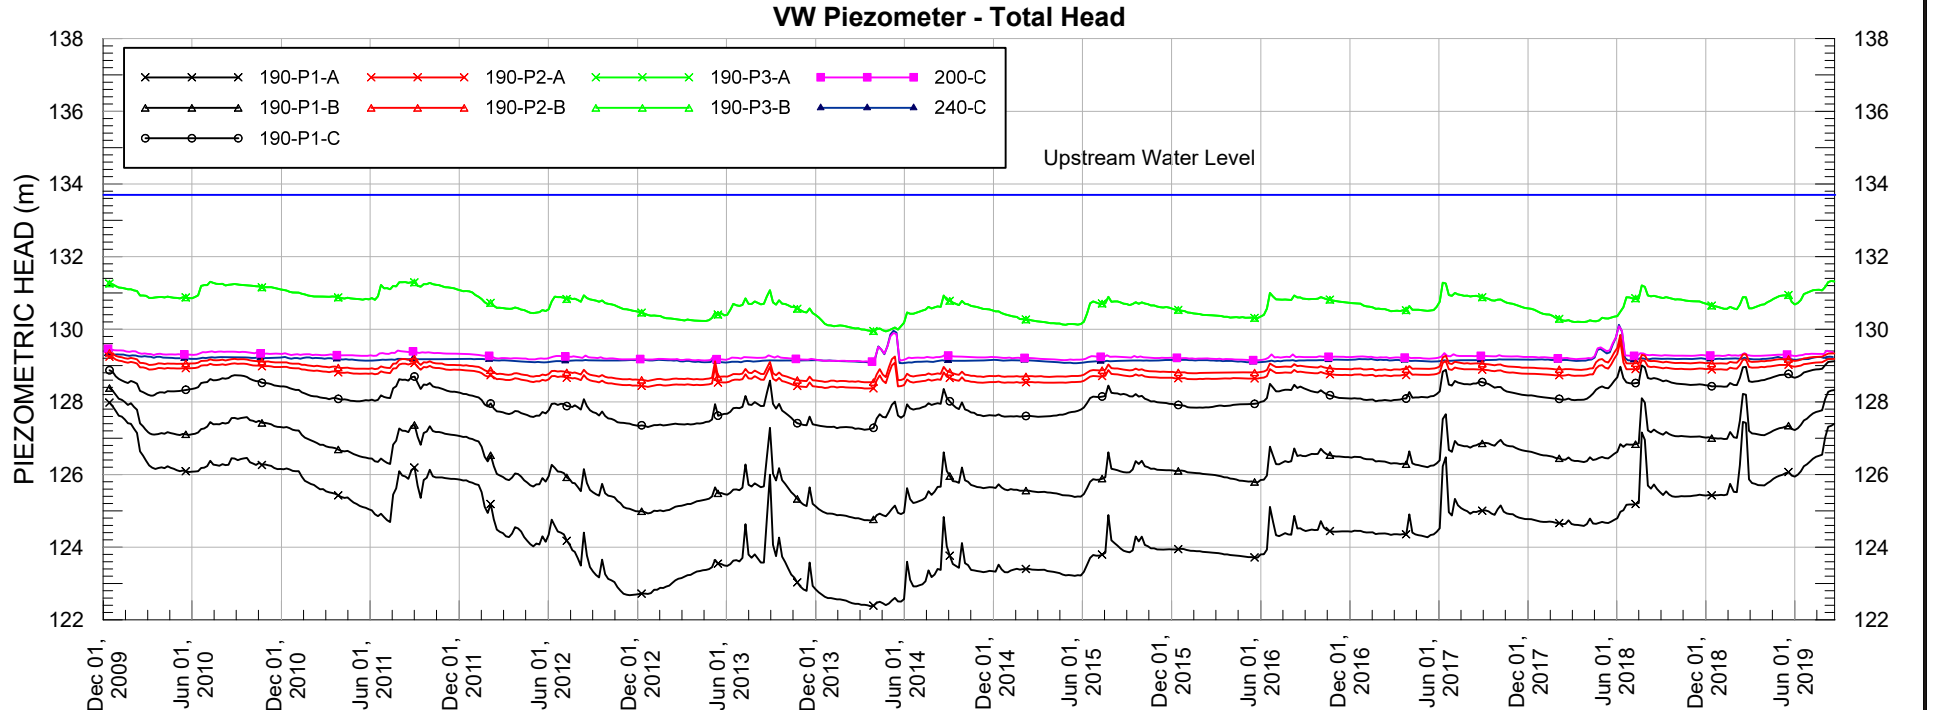
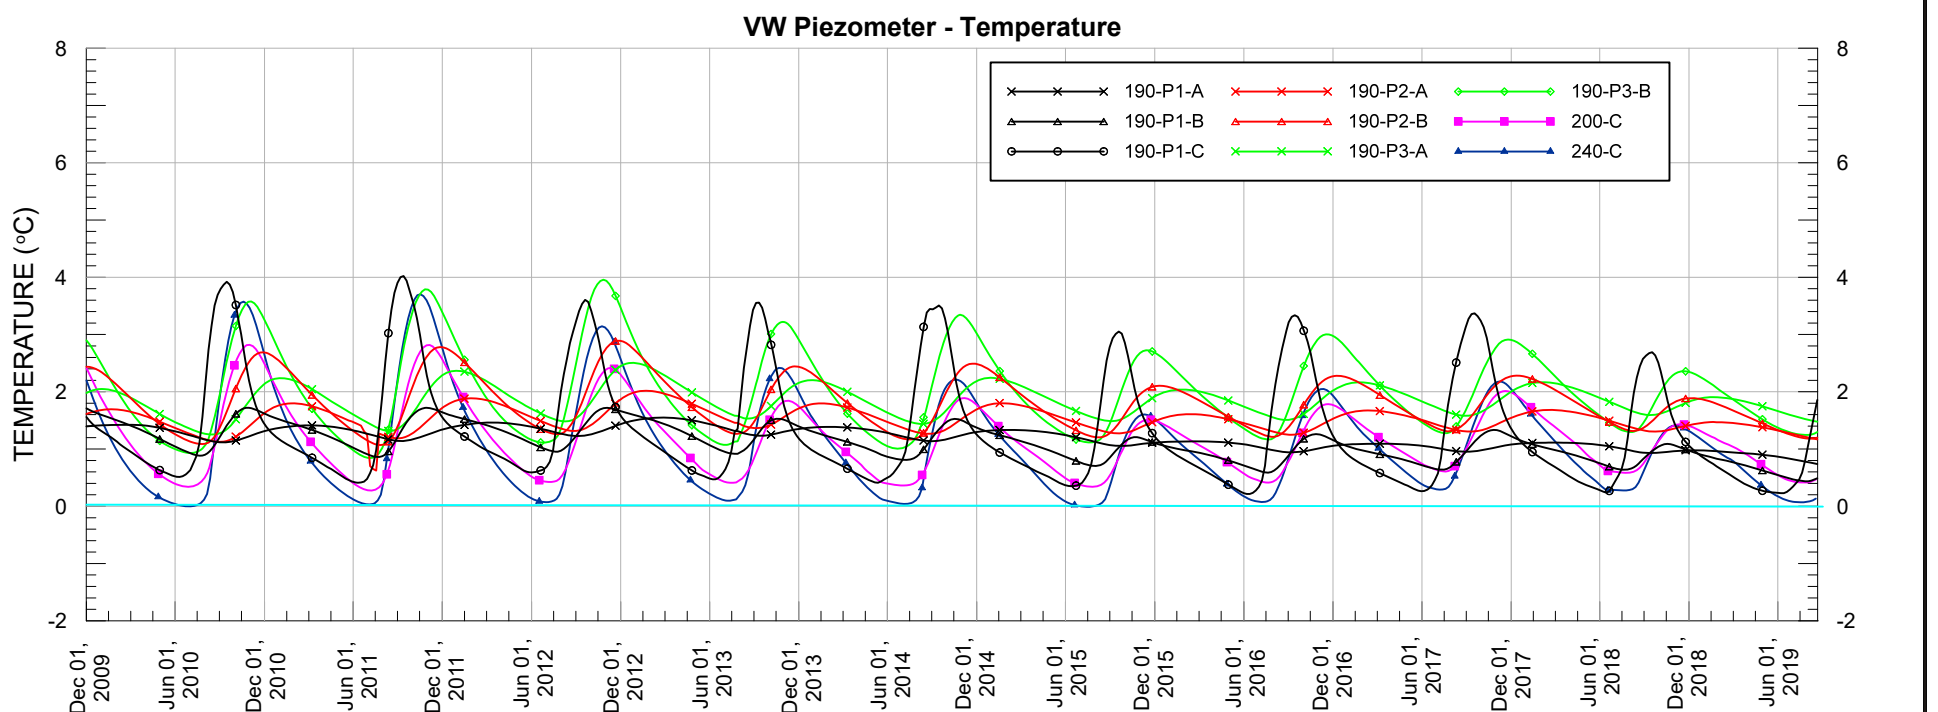
PROJECT		<b>AGNICO EAGLE MINES LIMITED MEADOWBANK GOLD PROJECT NUNAVUT</b>		
TITLE		<b>EAST DIKE Section 60+190 - PIEZOMETRIC DATA (Dec 1/09 to Aug 21/19)</b>		
	PROJECT No.	PHASE No.		
	DESIGN TD	28AUG14	SCALE	AS SHOWN
	CADD TD	28AUG14	REV.	
	CHECK PG	28AUG14	<b>FIGURE 45</b>	
REVIEW

- 1: 150-C stopped working in Nov 2012
- 2: Change in PWP and temperature are related to the discharge pipe changed from pit to lake.
- 3: Bumps in data are from discharge pipes freezing and water being discharged close to the area.

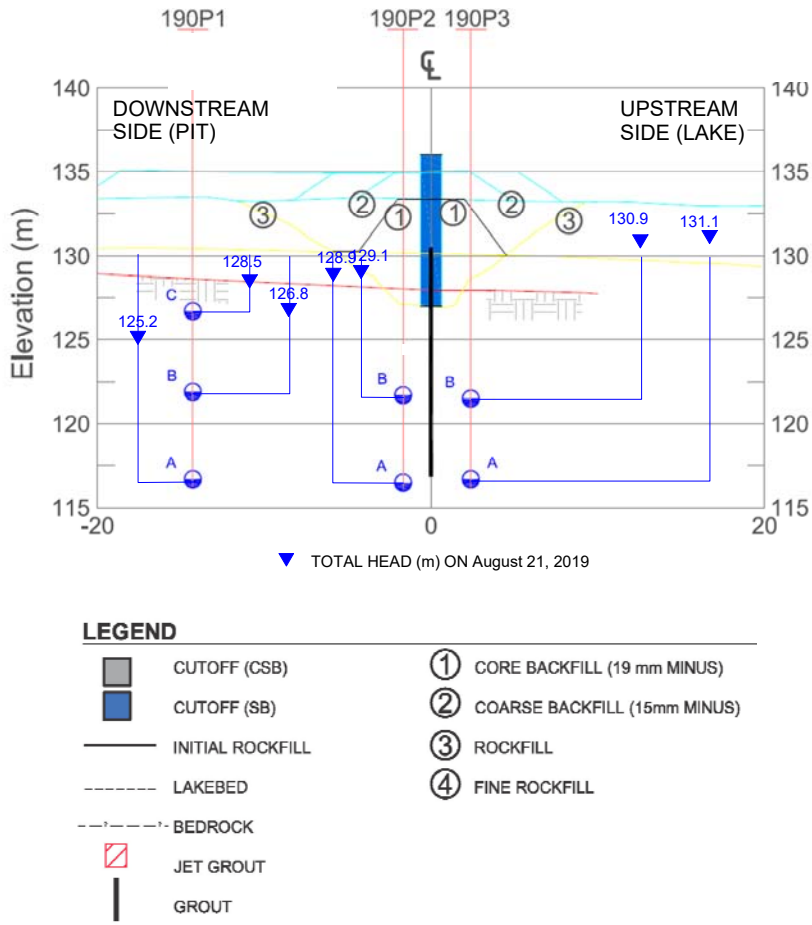
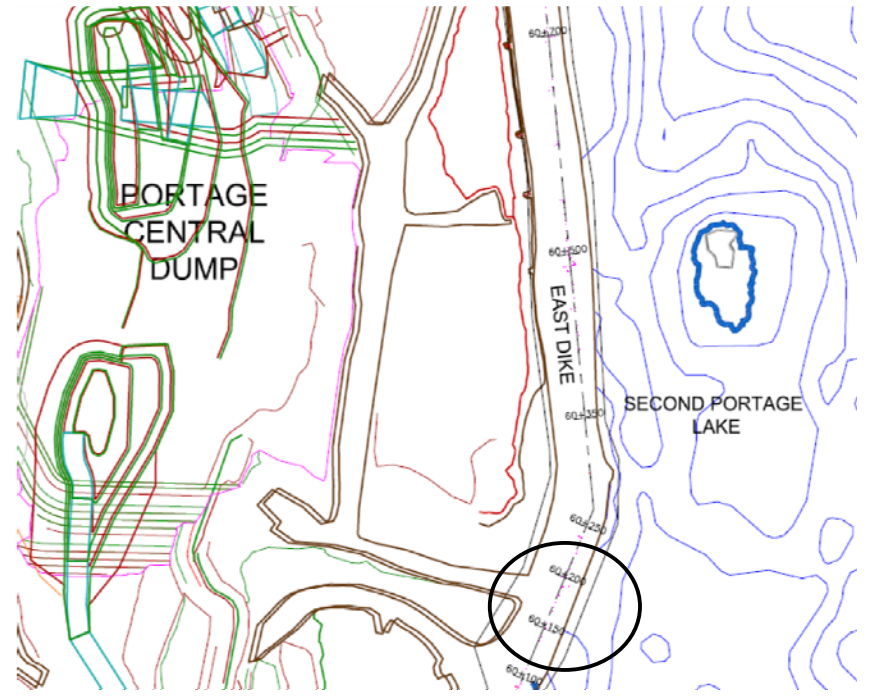
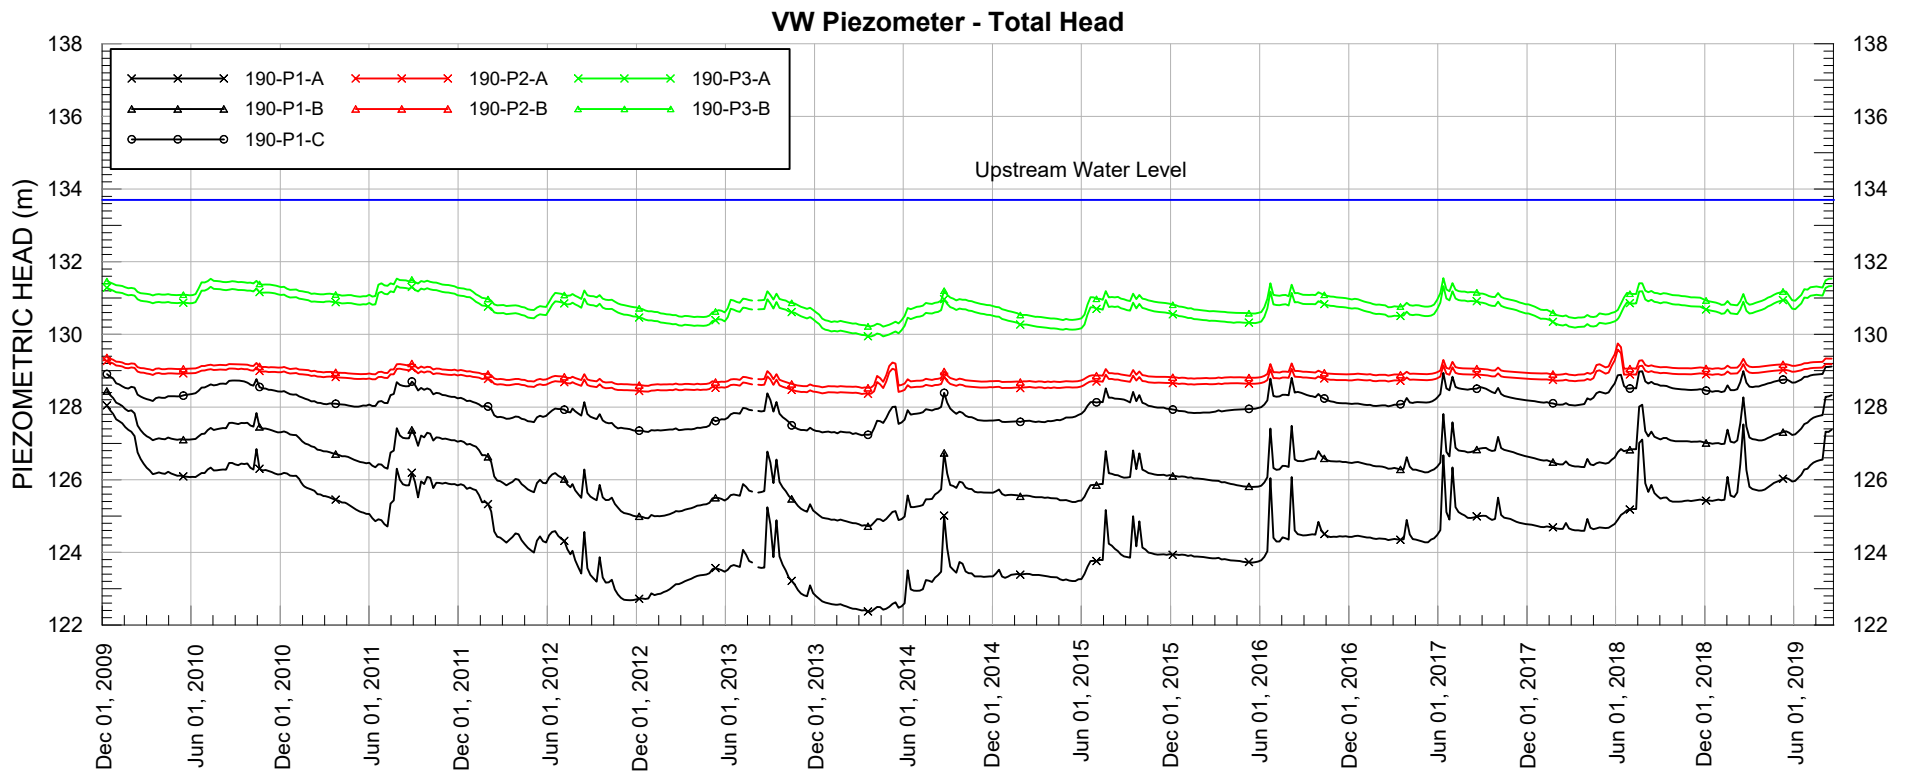
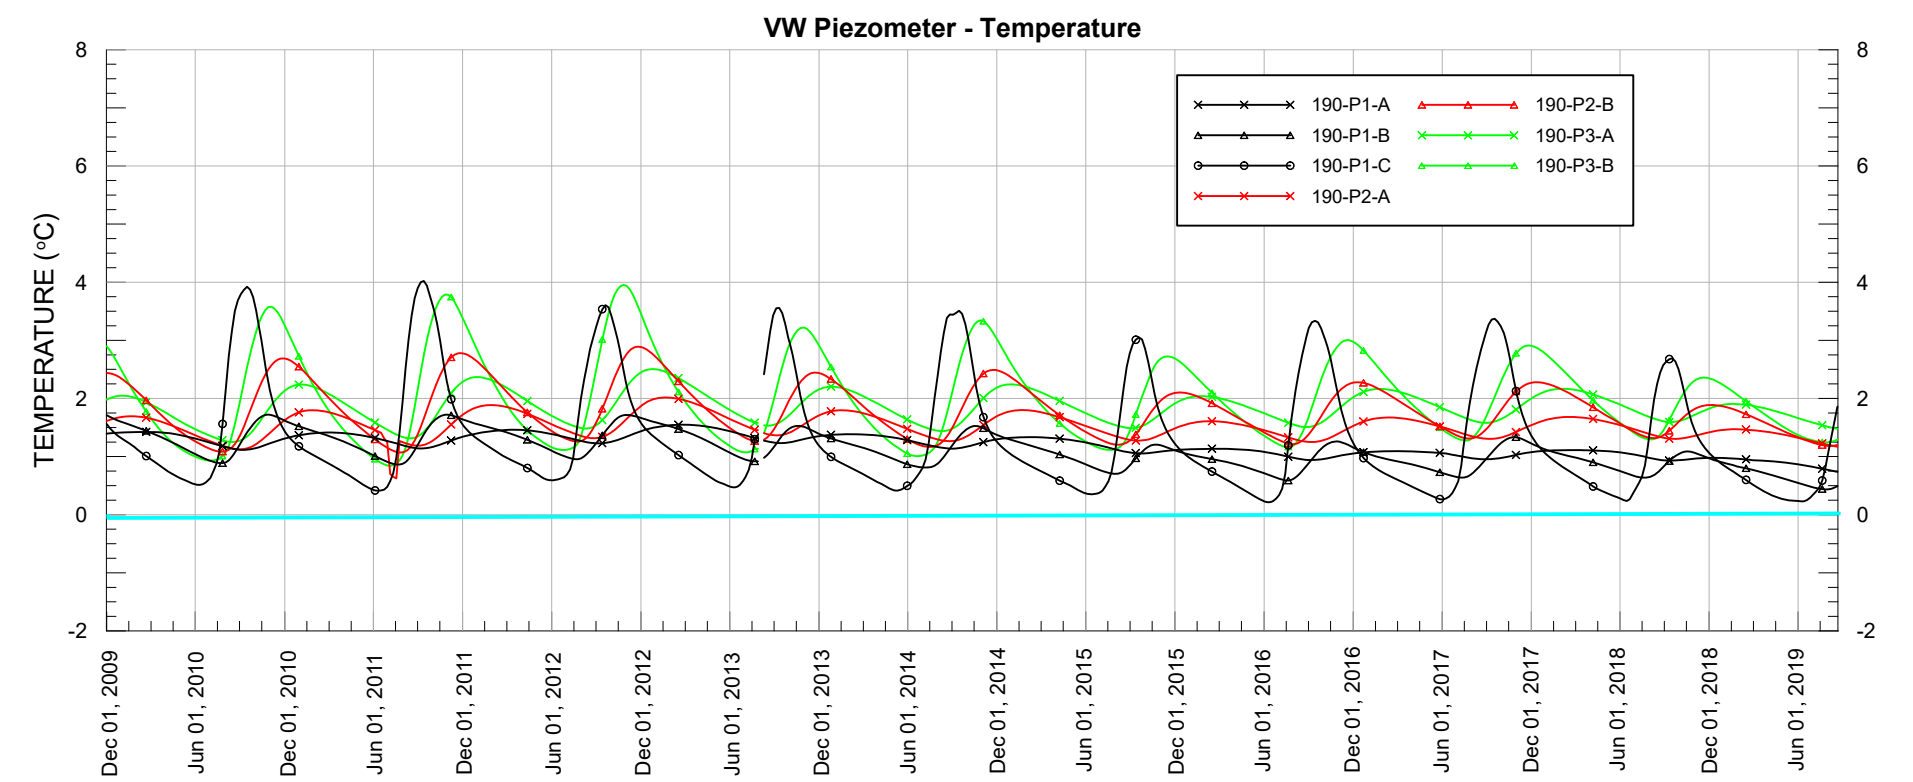
PROJECT	<b>AGNICO EAGLE MINES LIMITED MEADOWBANK GOLD PROJECT NUNAVUT</b>			
TITLE	<b>EAST DIKE - SECTION 60+190 PIEZOMETRIC DATA (Dec 1/09 to Aug 21/19)</b>			
	PROJECT No.	PHASE No.		
	DESIGN TD 28AUG14	SCALE	AS SHOWN	
	CADD TD 28AUG14	REVIEW		
	CHECK PG 28AUG14	<b>FIGURE 46</b>		
REVIEW

1. Change in PWP and temperature are related to the discharge pipe changed from pit to lake and lake to pit.
2. Bumps in data were caused when the pipes froze and water was discharge close by until the pipes were fixed.

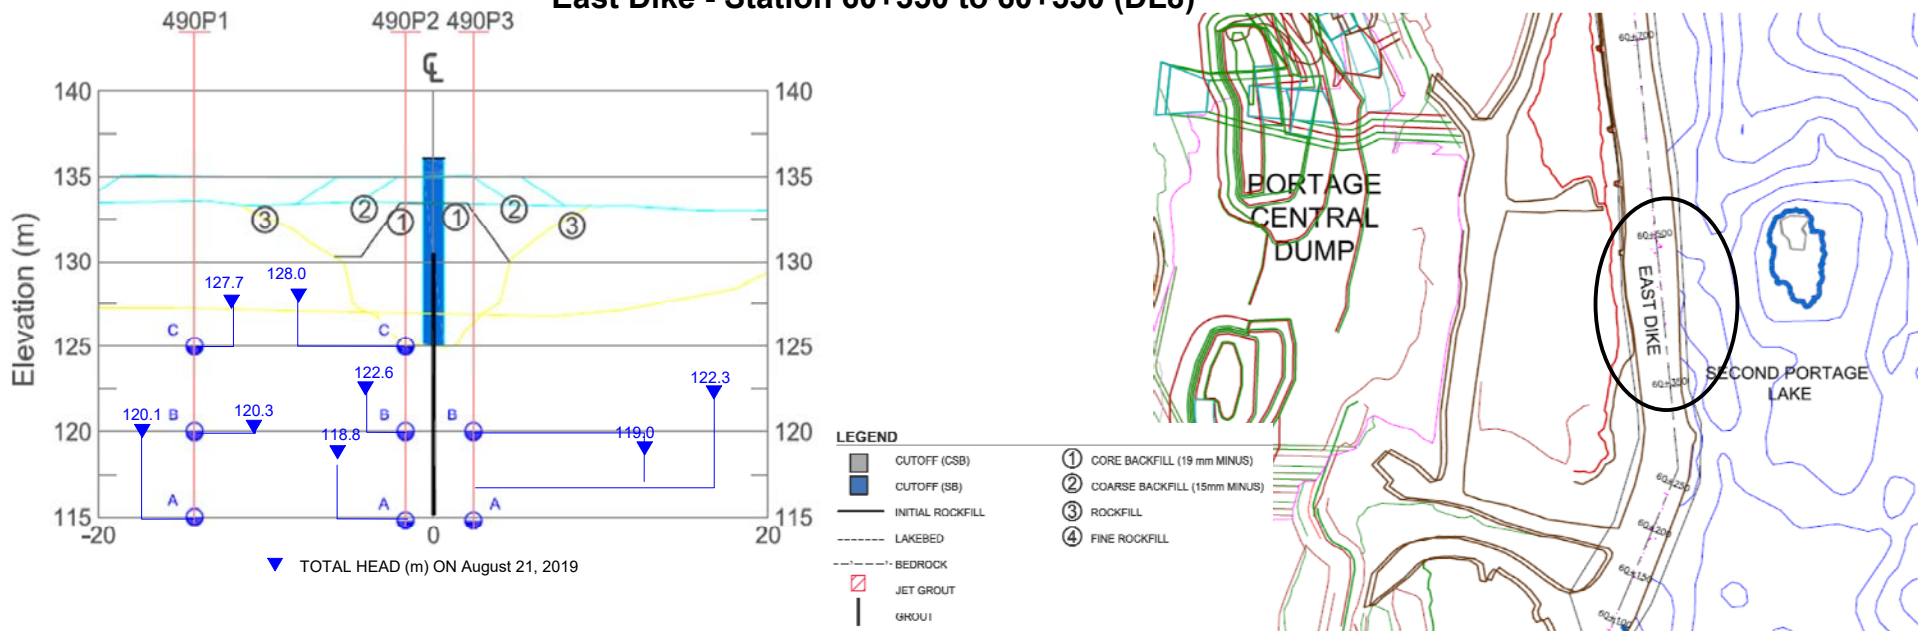
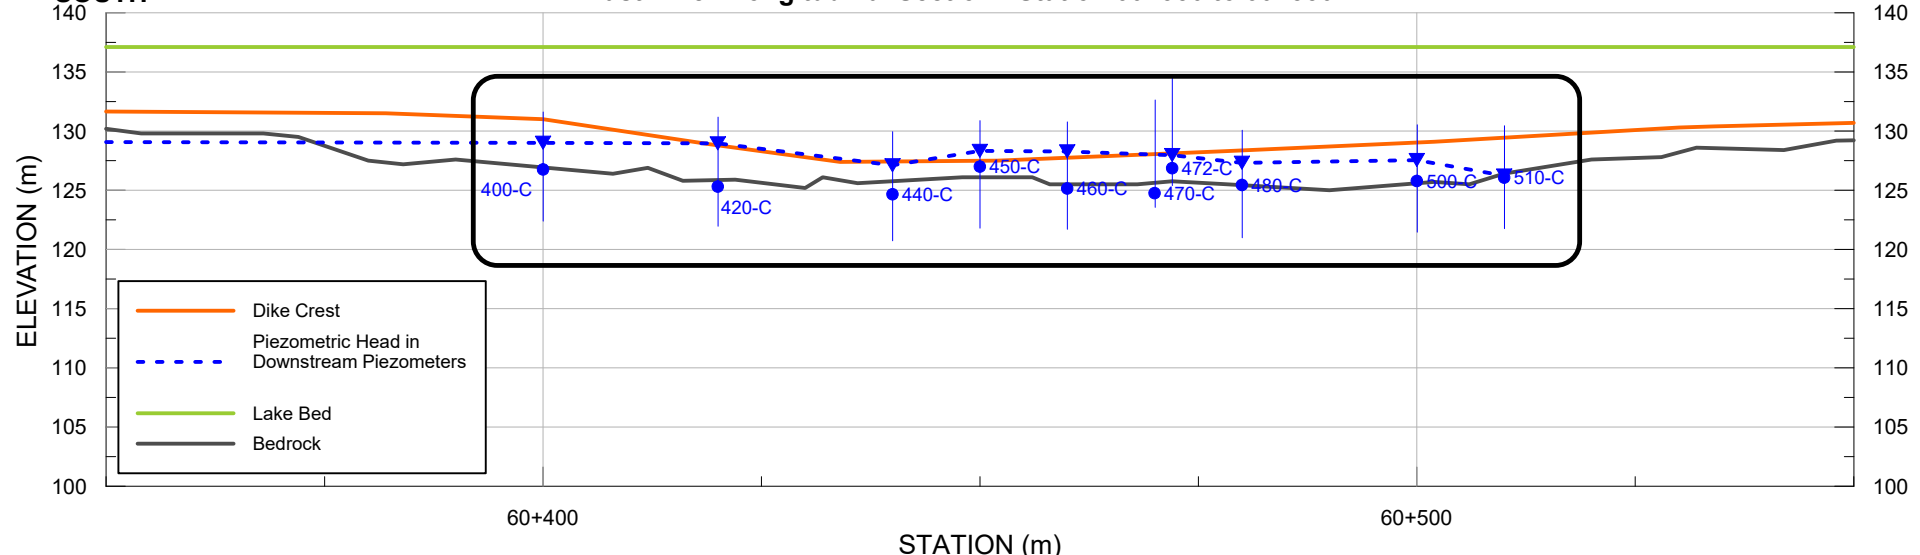
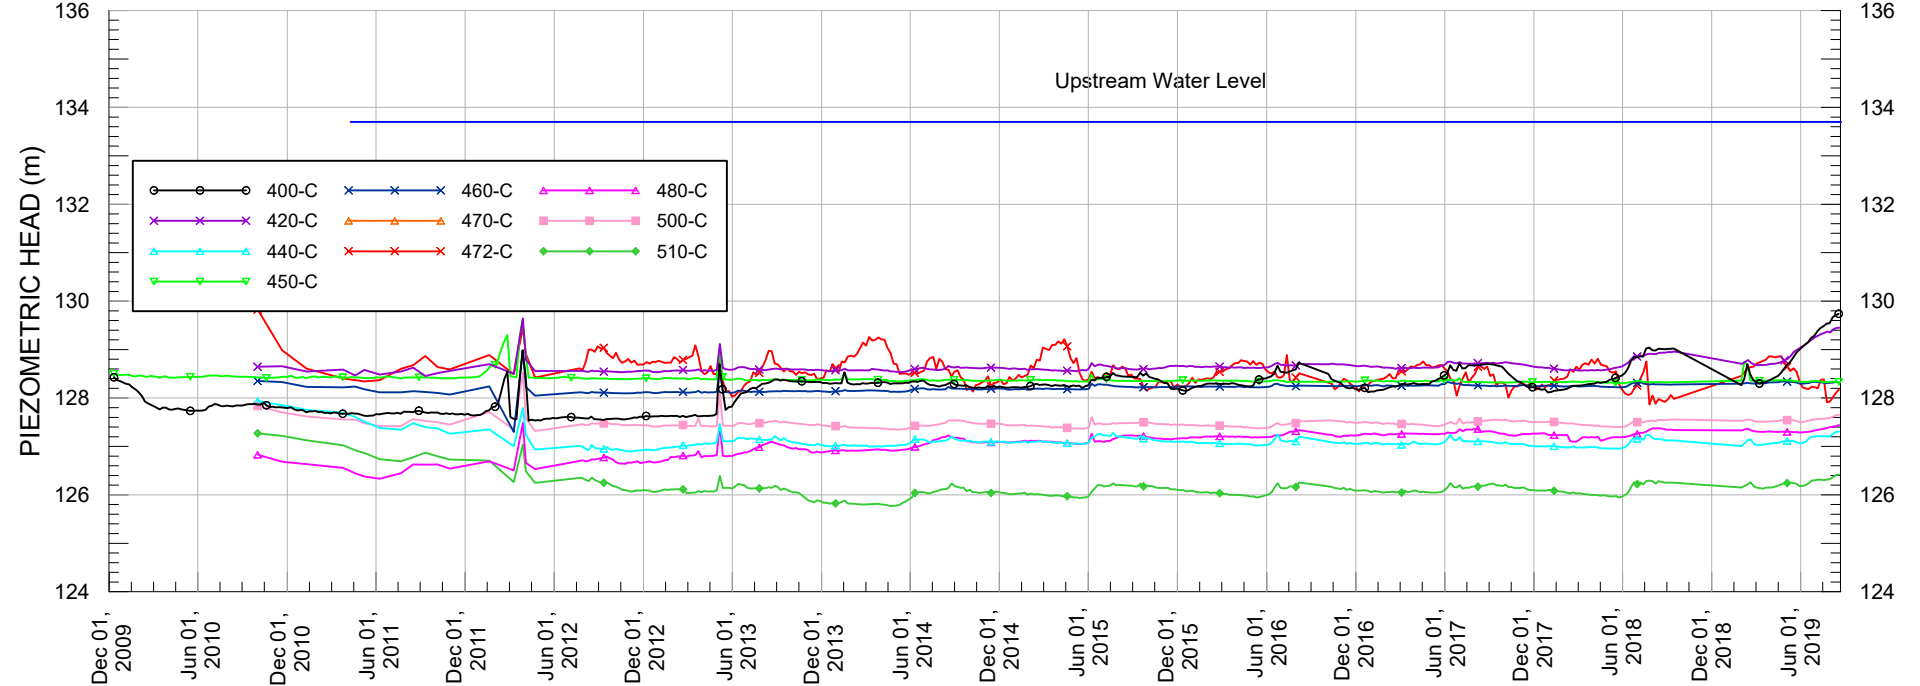
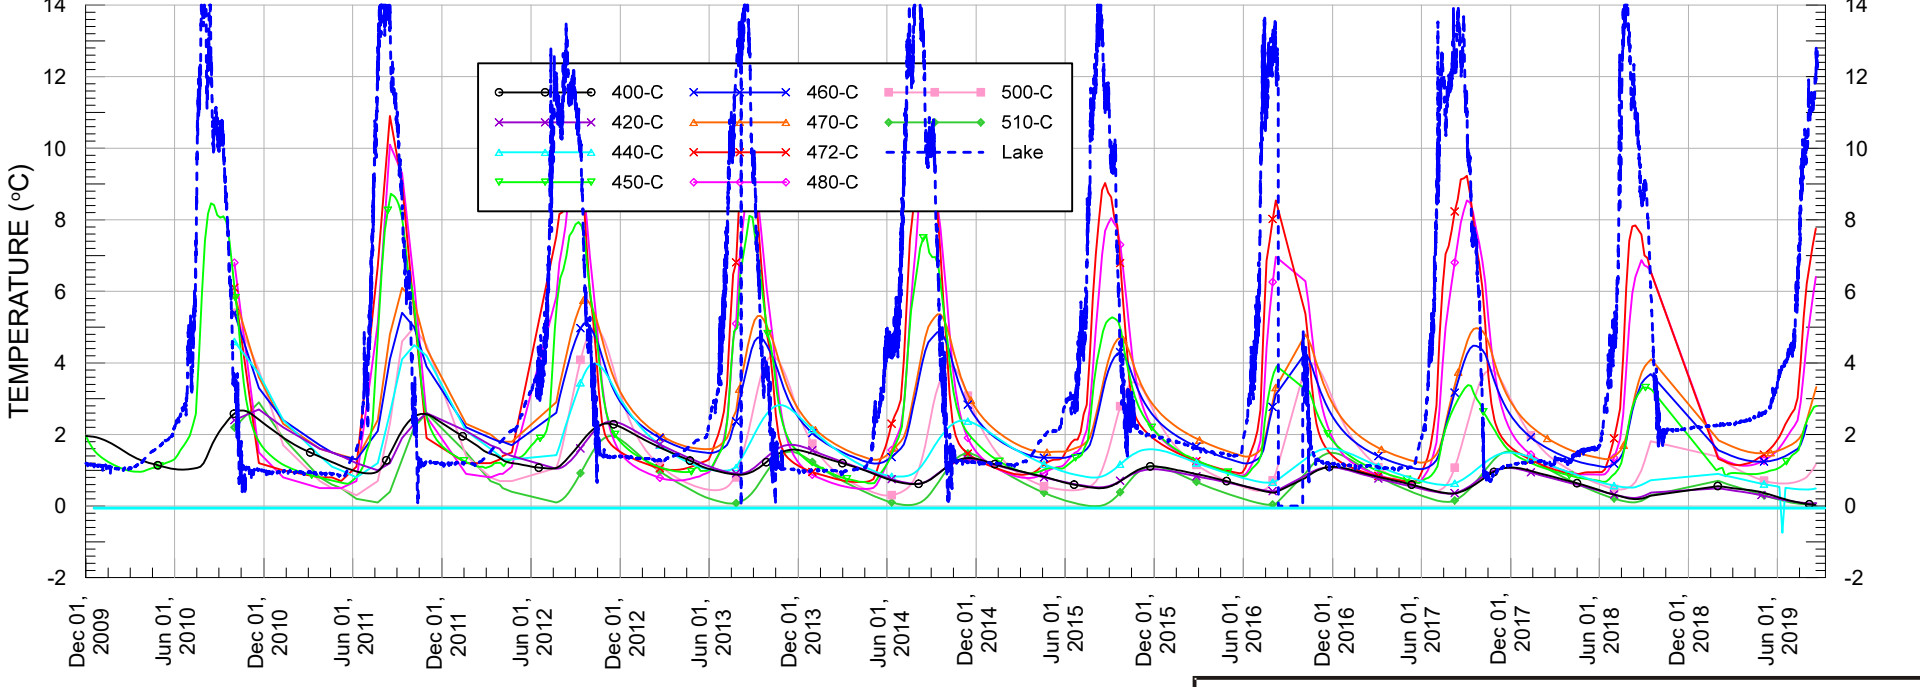
PROJECT		<b>AGNICO EAGLE MINES LIMITED MEADOWBANK GOLD PROJECT NUNAVUT</b>	
TITLE		<b>EAST DIKE Section 60+350 to 60+550 - PIEZOMETRIC DATA (Dec 1/09 to Aug 21/19)</b>	
	PROJECT No.	PHASE No.	
	DESIGN TD 28AUG14	SCALE AS SHOWN	REV.
	CADD TD 28AUG14		
	CHECK PG 28AUG14		
REVIEW		<b>FIGURE 47</b>

- As seen in the graph on the side, the progression of the temperature in the Pz follows the lake temperature closely. Usually it takes approximately one to two weeks to see the trend following the lake temperature.
- Bumps in data are from discharge pipes freezing and water being discharged close to the area.
