# **Meadowbank 2019 Annual Geotechnical Inspection**

# 2019 Annual Geotechnical Inspection

*Meadowbank Gold Mine, Nunavut*

19123067-1588-R-Rev0

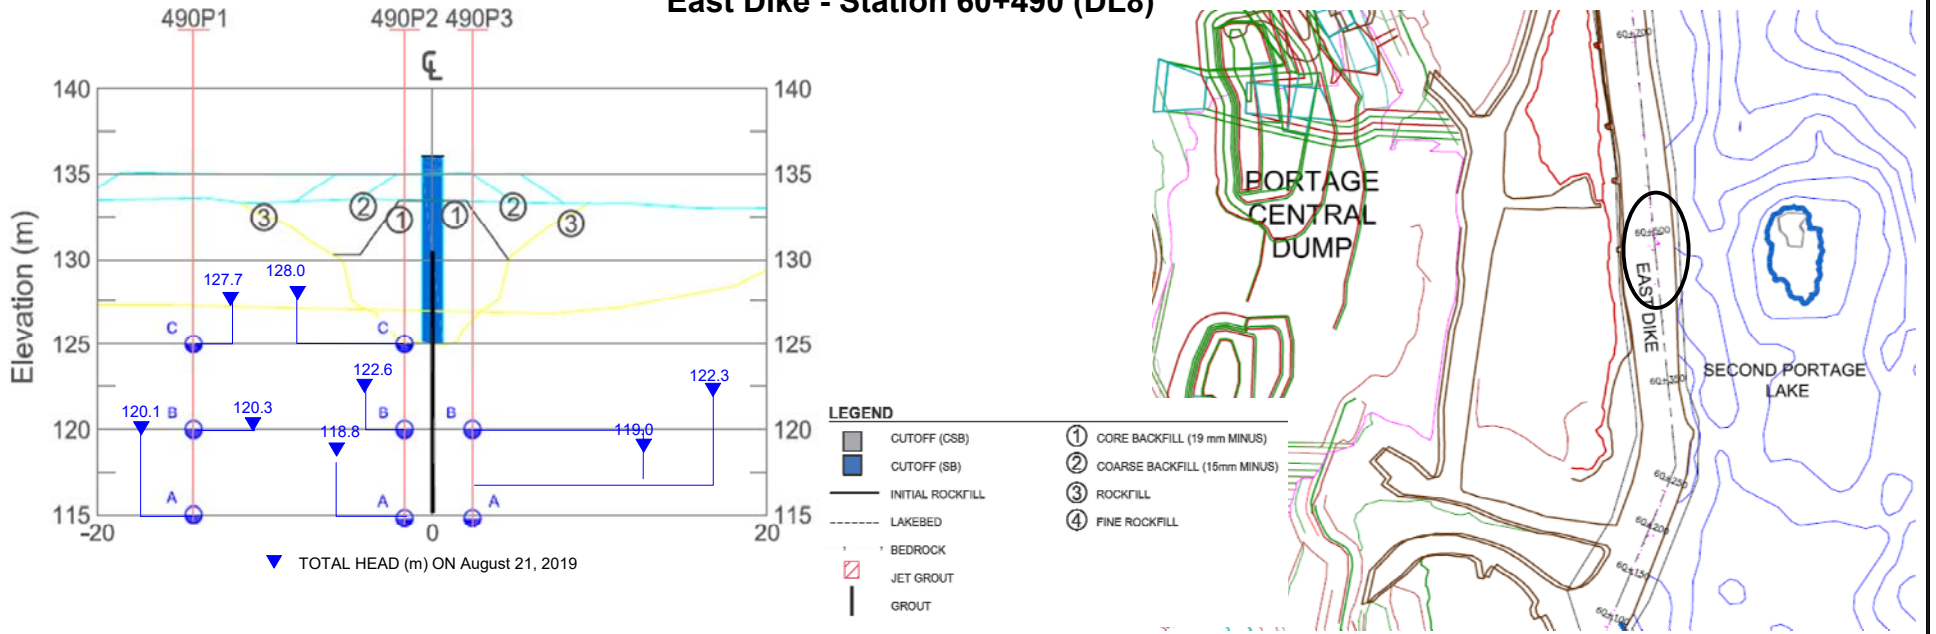
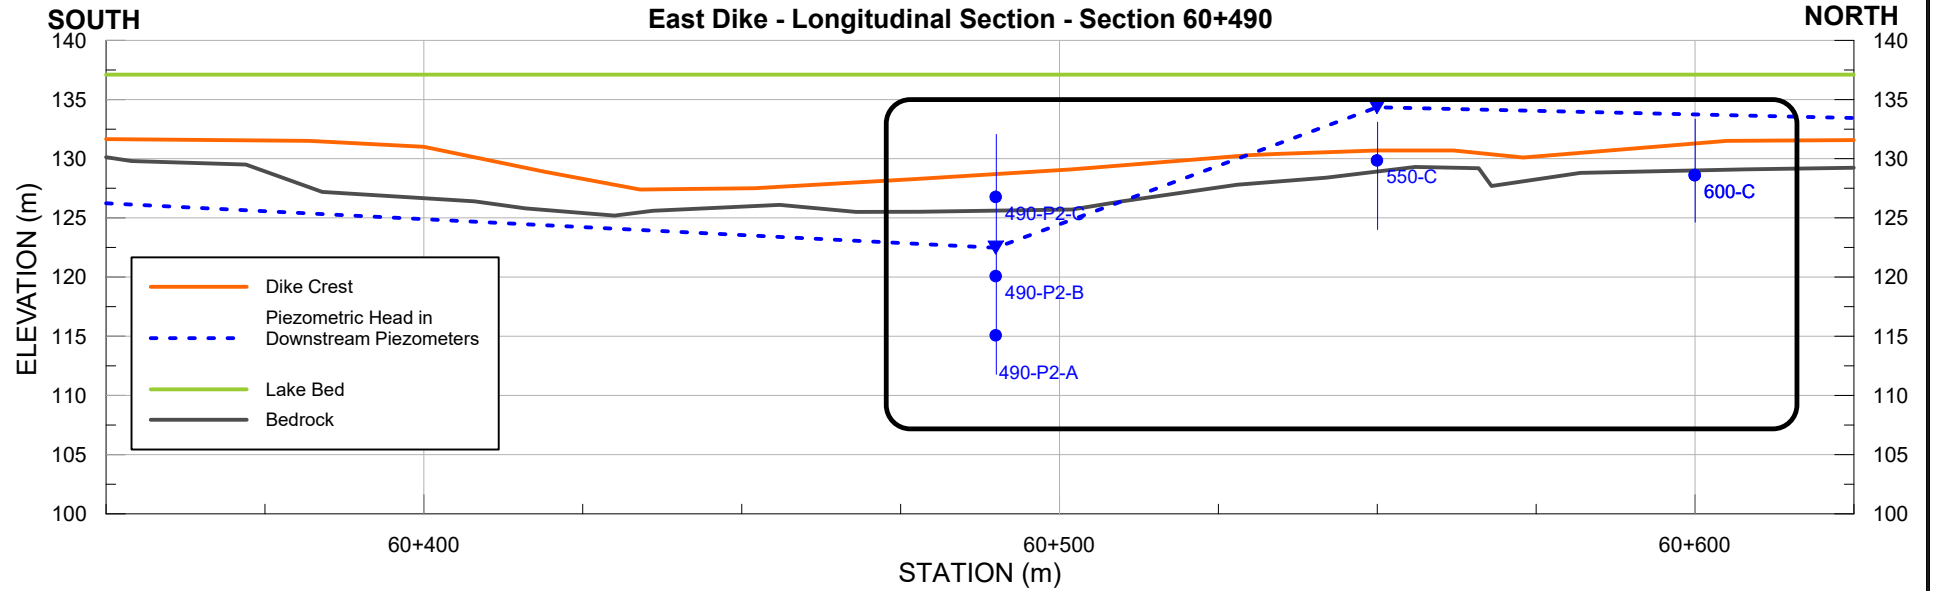
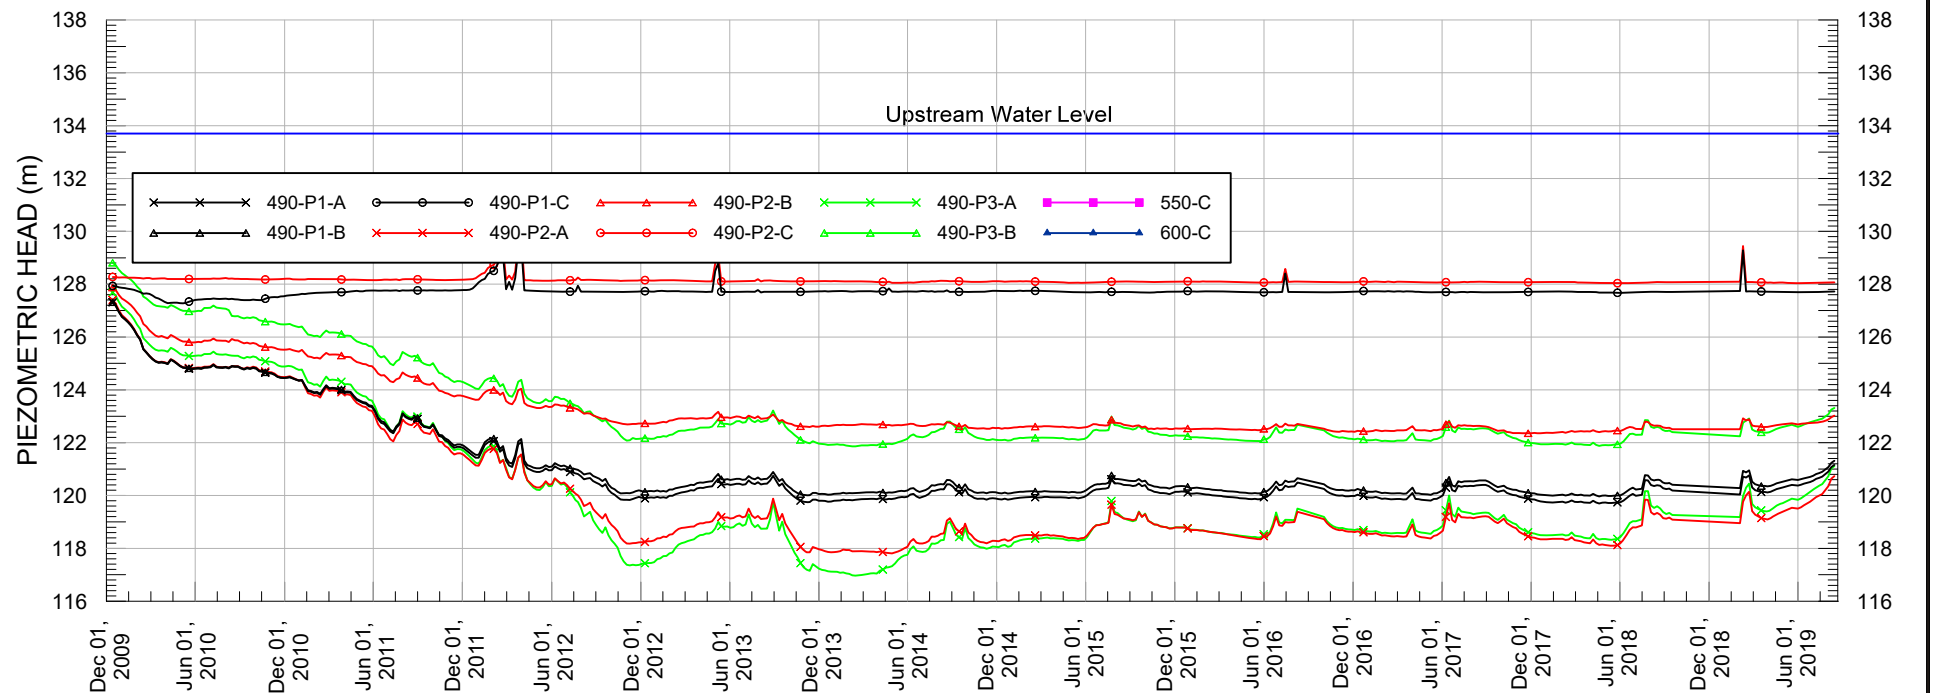
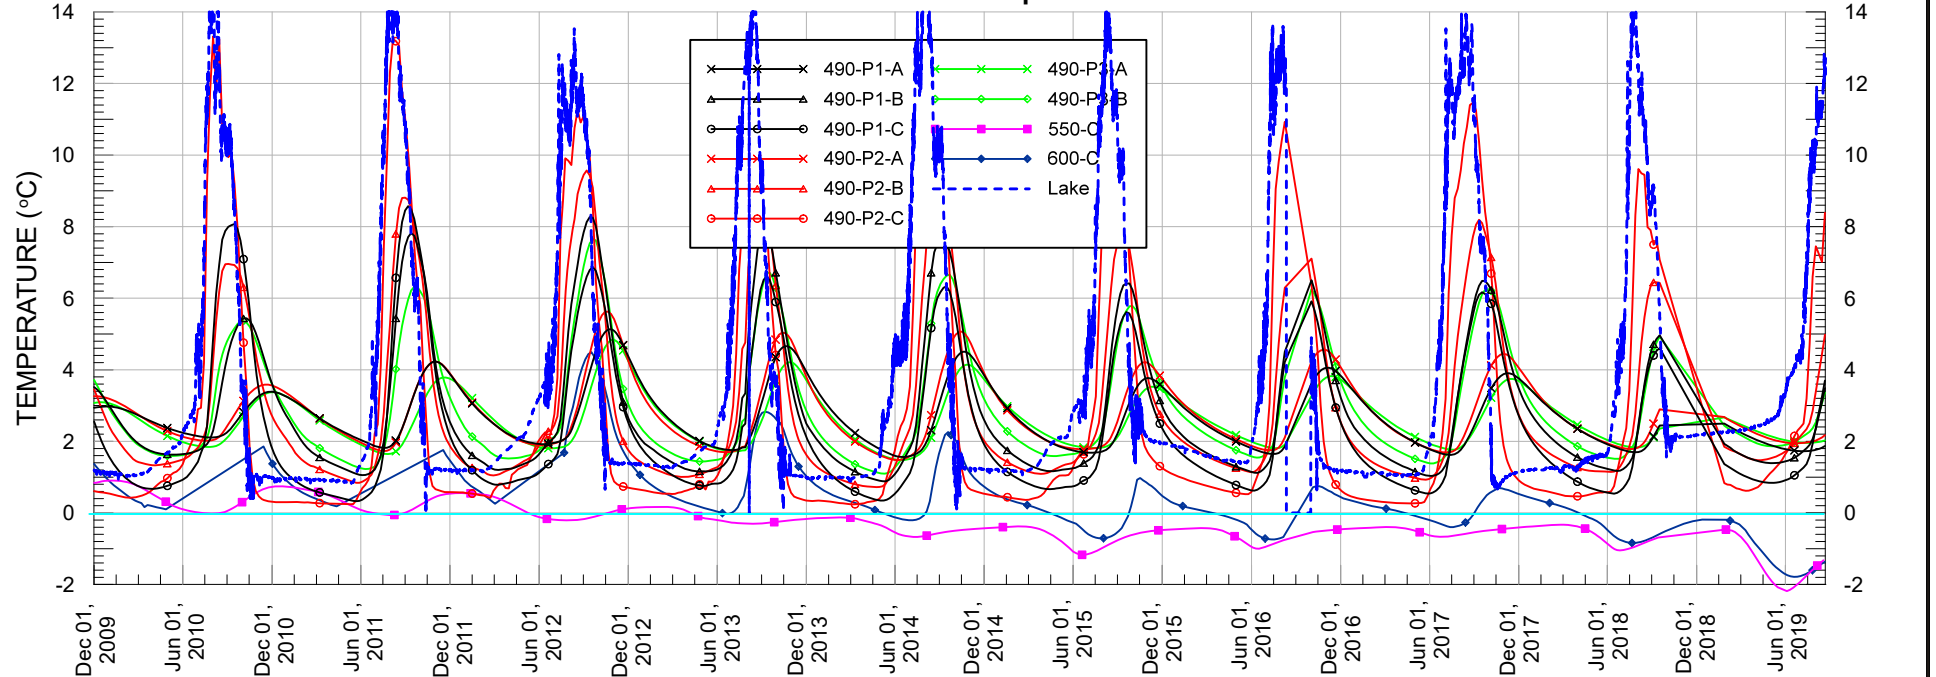
PROJECT	<b>AGNICO EAGLE MINES LIMITED MEADOWBANK GOLD PROJECT NUNAVUT</b>		
TITLE	<b>EAST DIKE Section 60+490 - PIEZOMETRIC DATA (Dec 1/09 to Aug 21/19)</b>		
	PROJECT No.	PHASE No.	
	DESIGN TD 28AUG14	SCALE AS SHOWN	REV.
	CADD TD 28AUG14		
	CHECK PG 28AUG14	<b>FIGURE 48</b>	
REVIEW

- 1: 550-C and 600-C are giving unreliable readings and with a negative temperature are assumed to be frozen.
2. As seen in the graph on the side, the progression of the temperature in the Pz follows the lake temperature closely. Usually it takes approximately one to two weeks to see the trend following the lake temperature.
3. Bumps in data are from discharge pipes being frozen and water being discharged in the area.

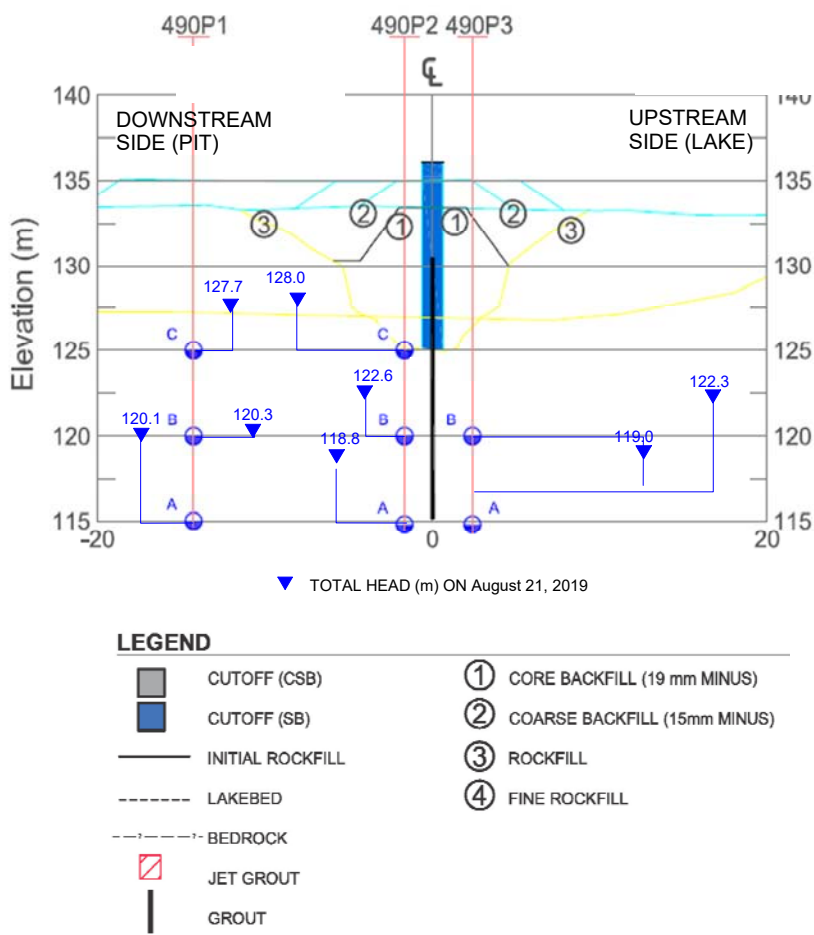
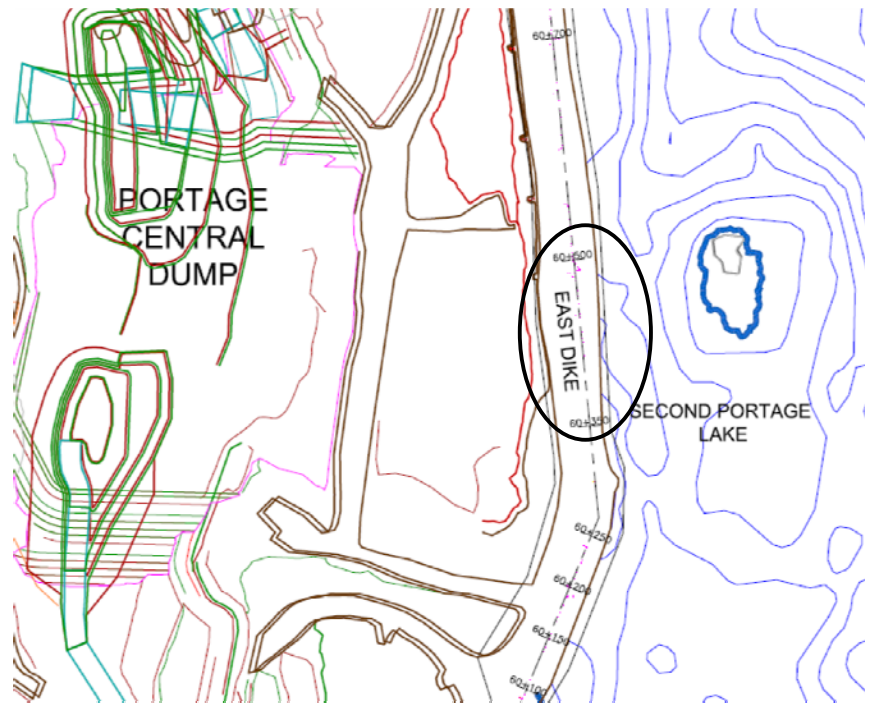
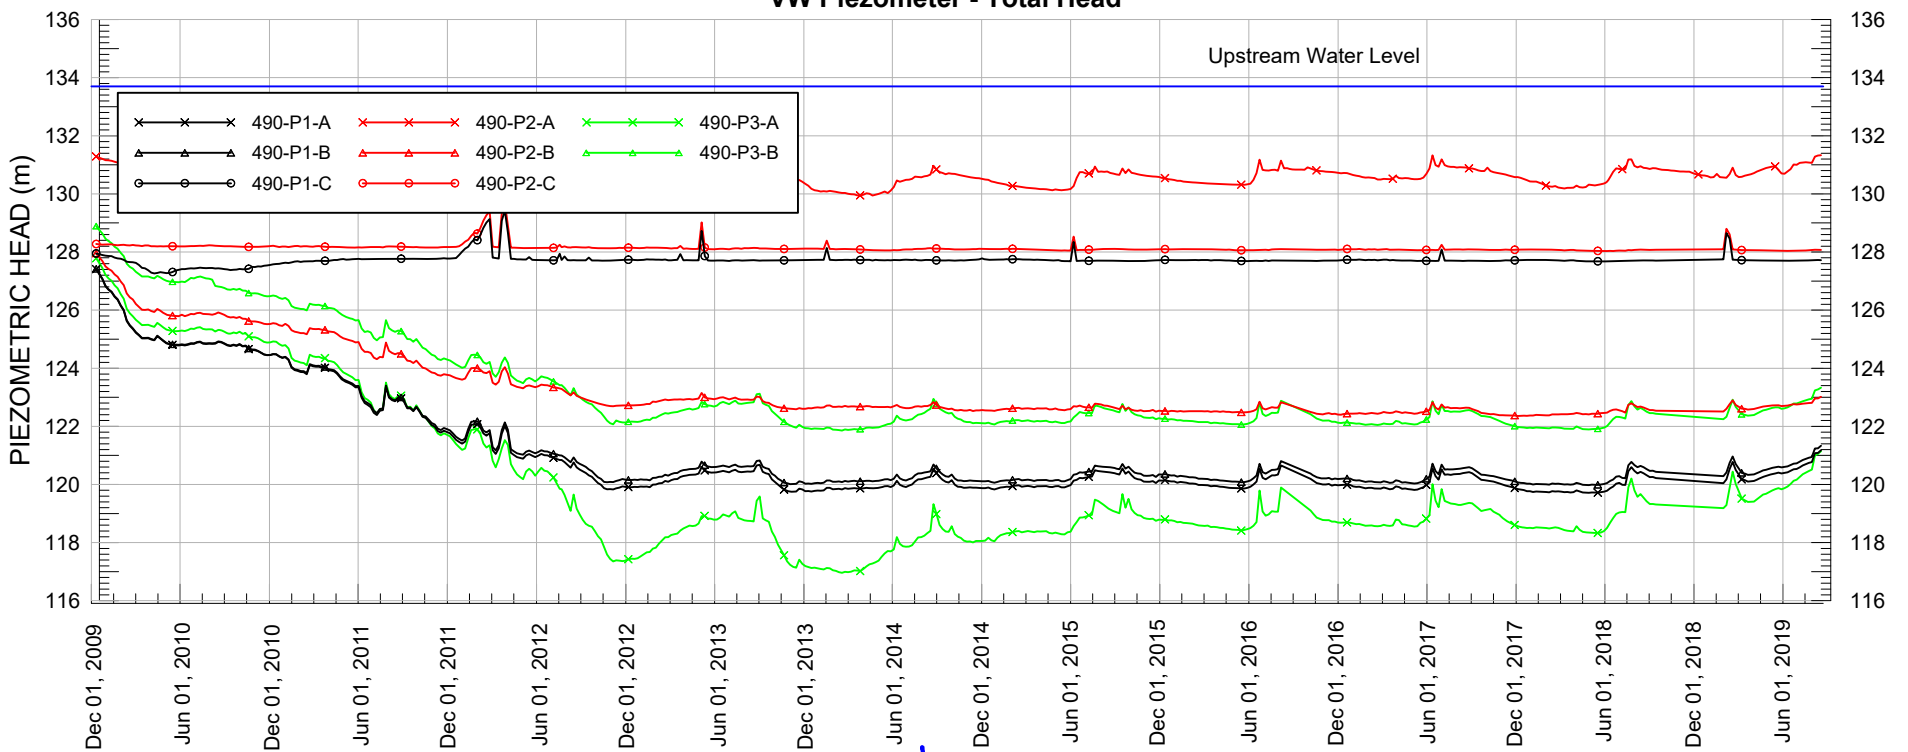
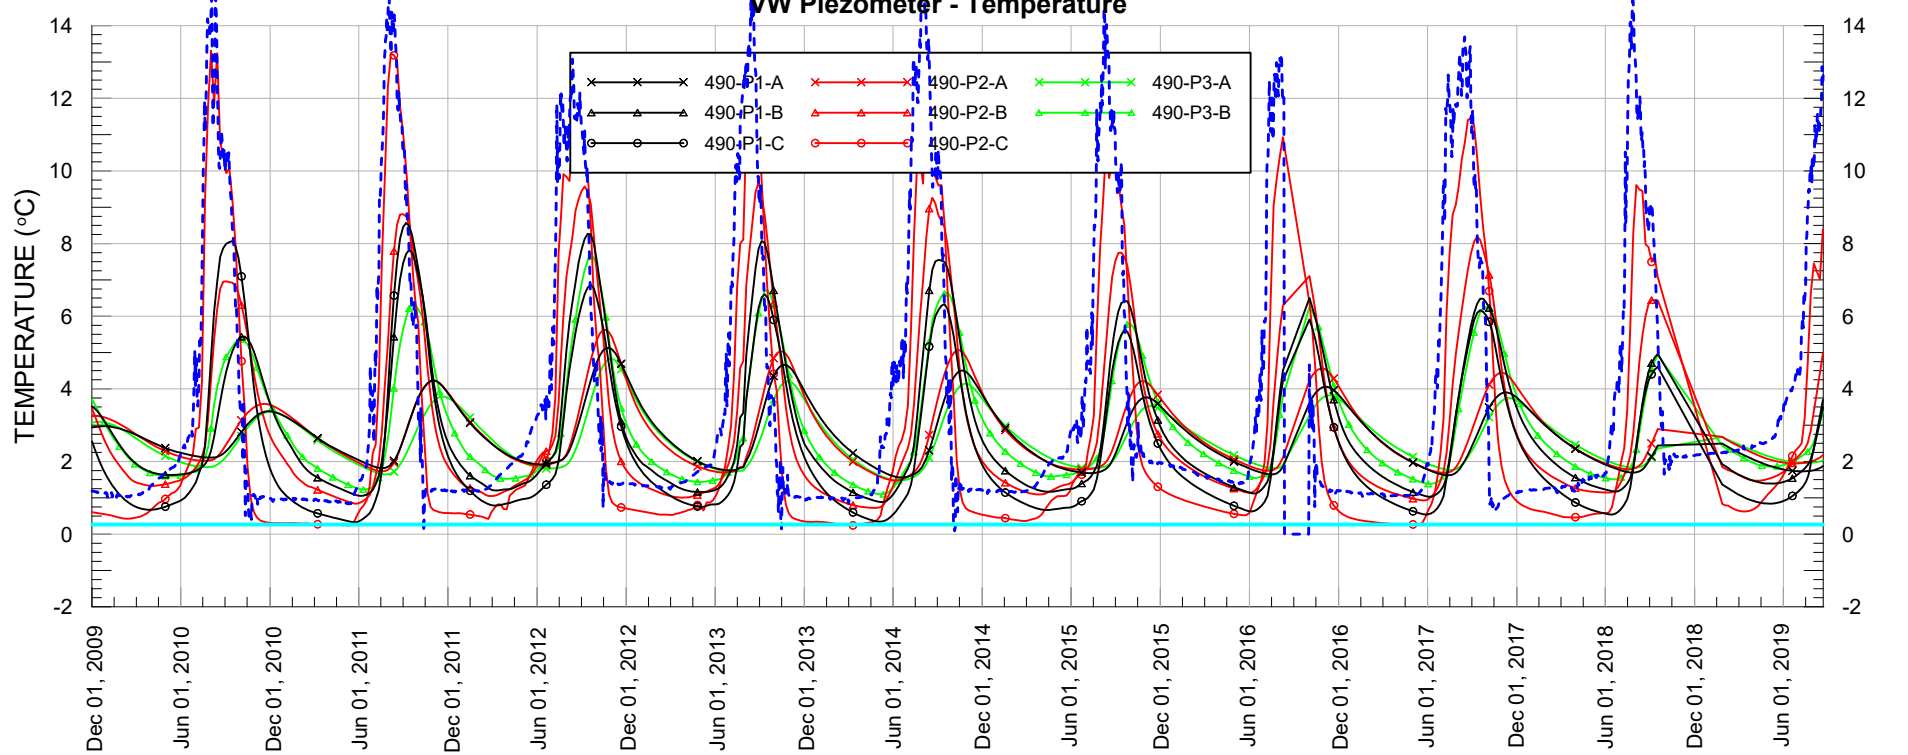
- As seen in the graph on the side, the progression of the temperature in the Pz follows the lake temperature closely. Usually it takes approximately one to two weeks to see the trend following the lake temperature.
- Bumps in data were caused when the pipes froze and water was discharge close by until the pipes were fixed.

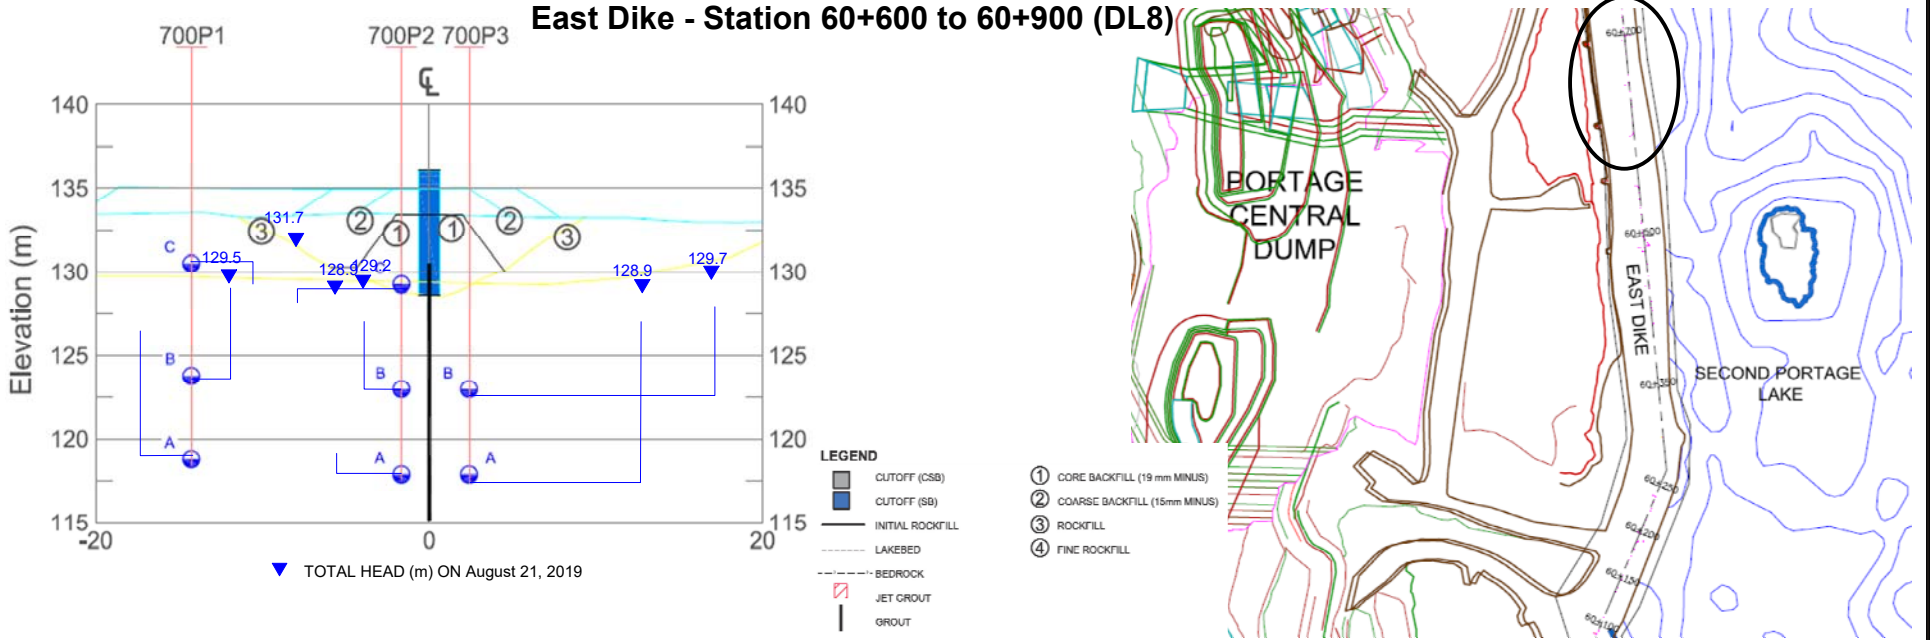
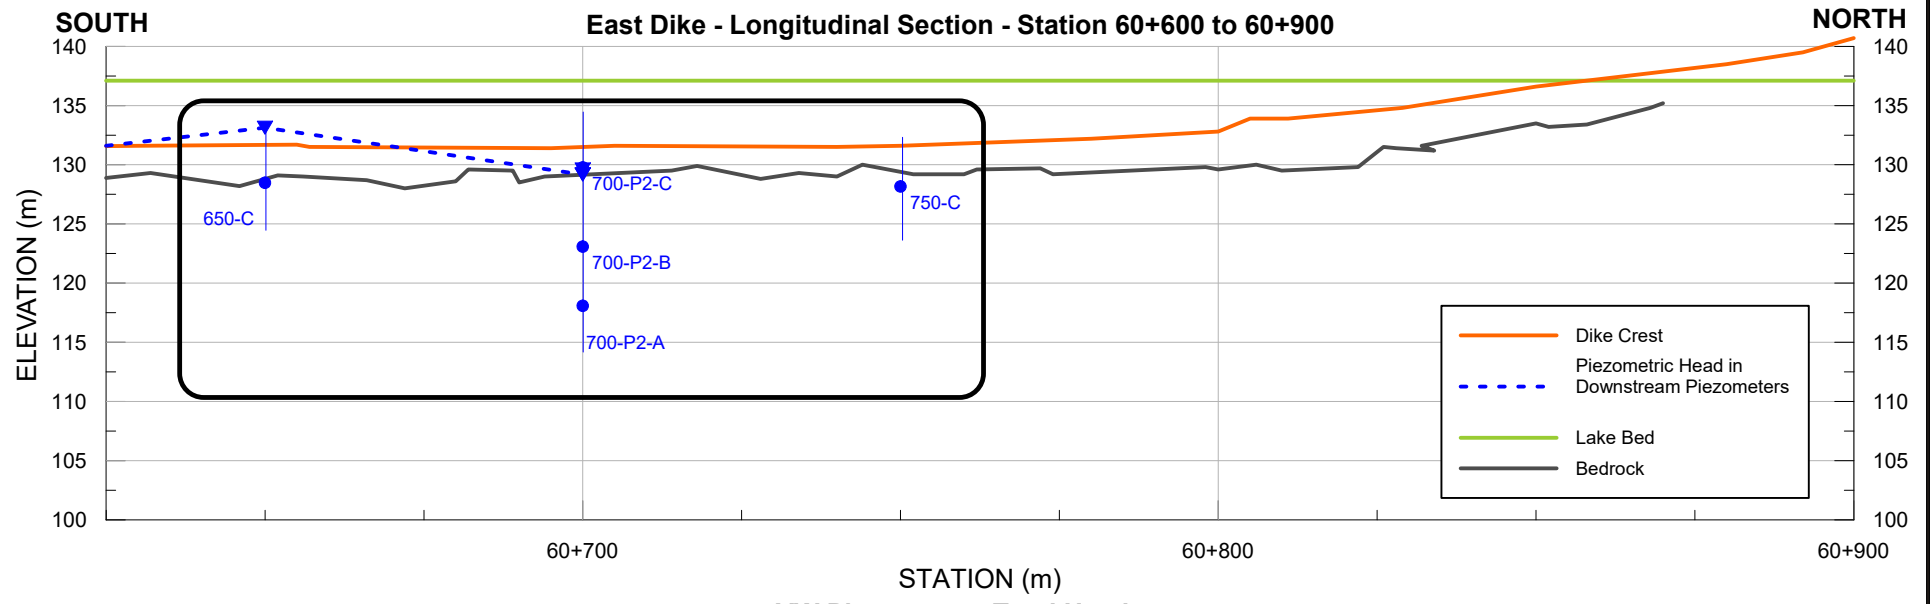
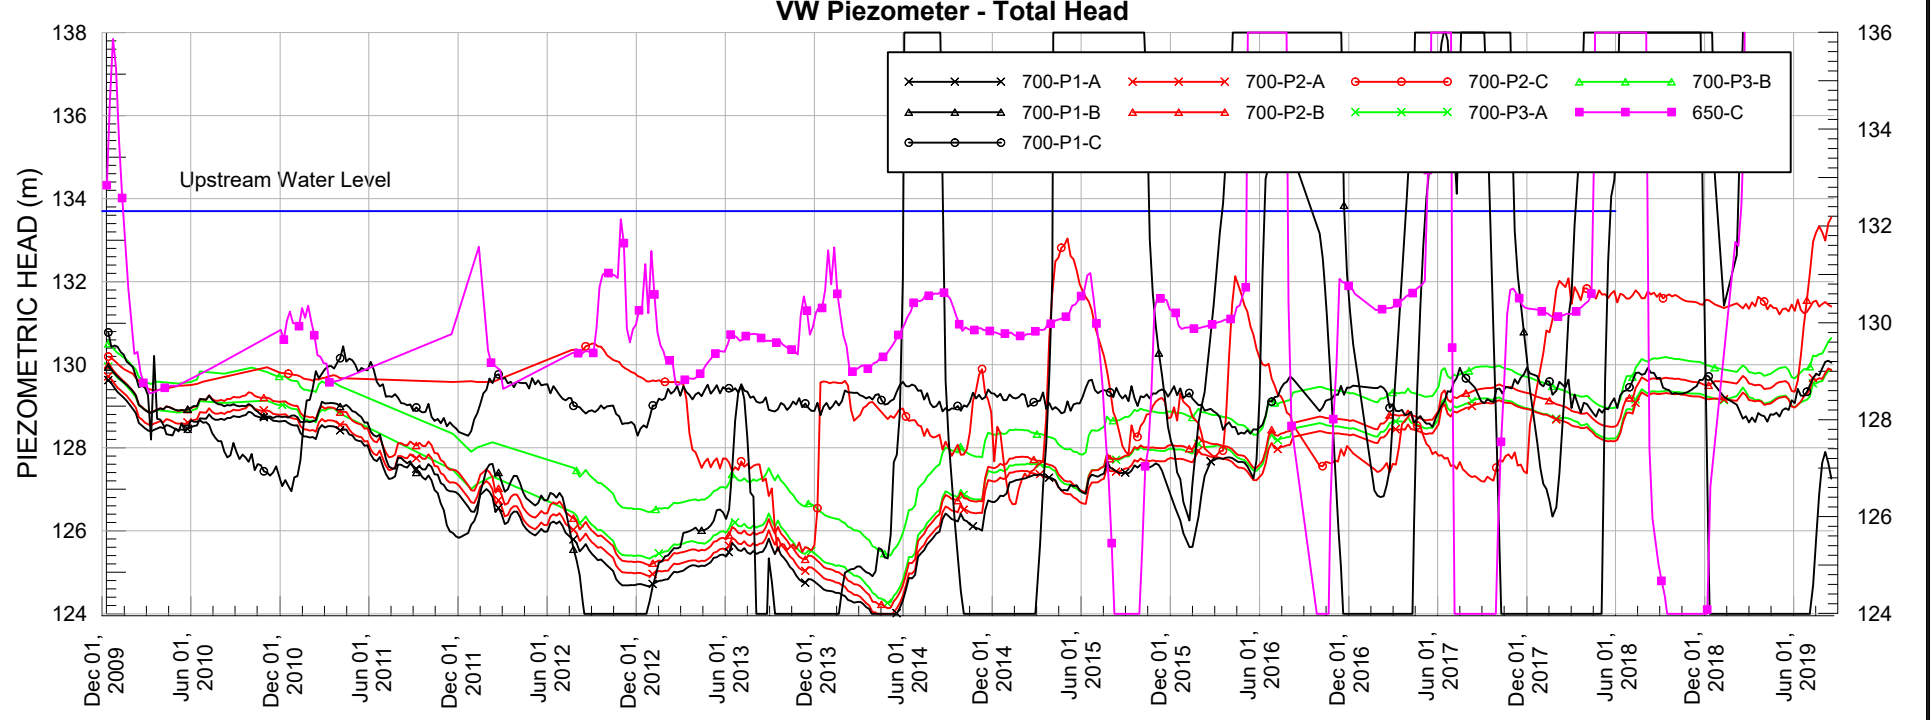
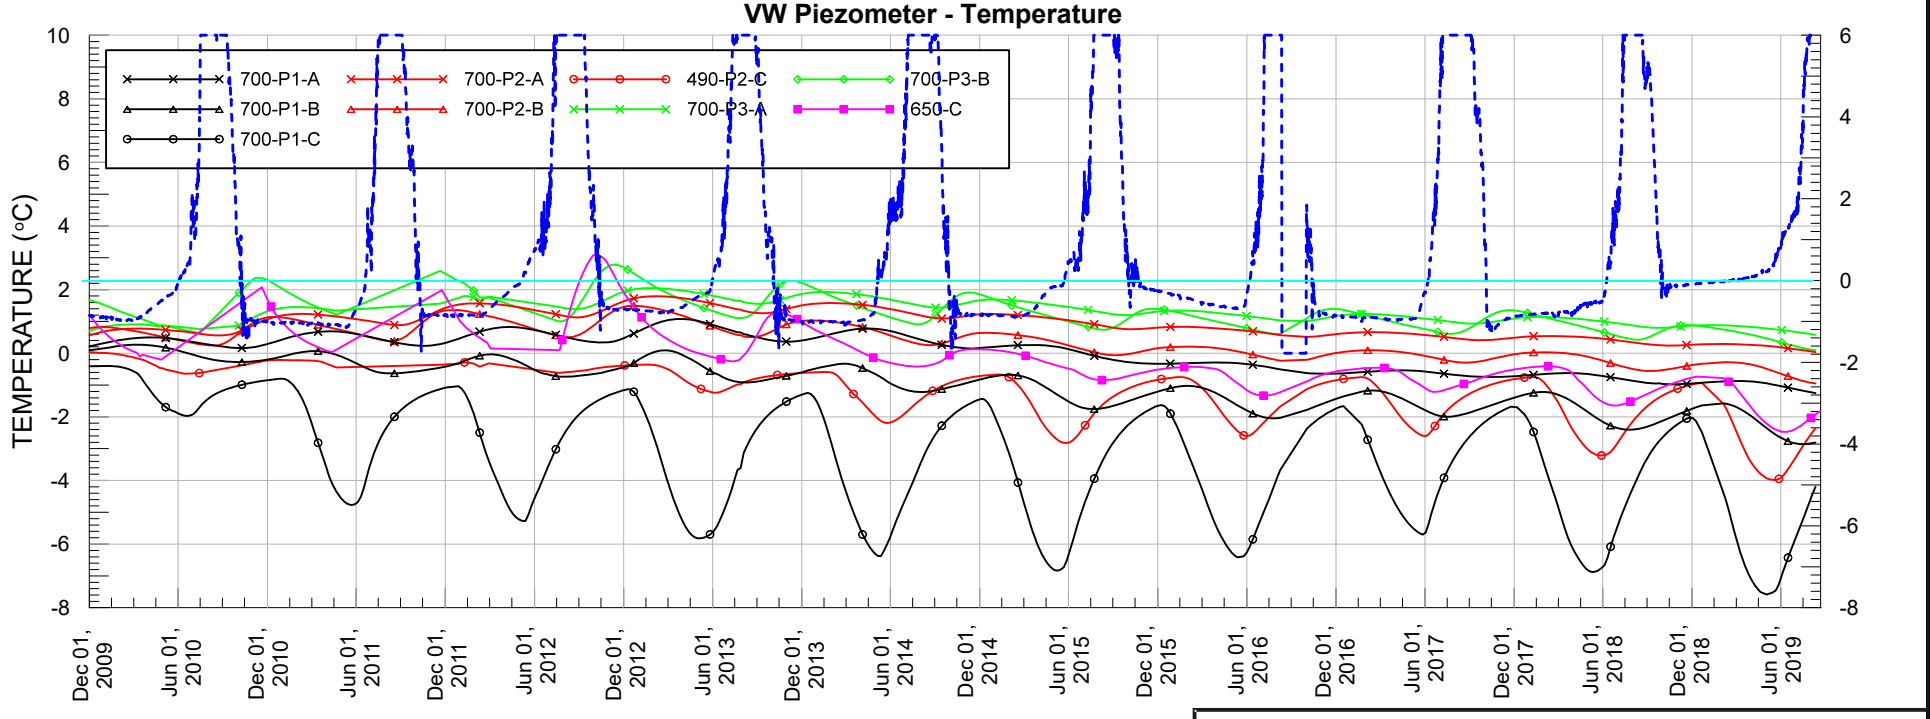
- 700-P1-B and 750-C are giving unreliable readings and with a negative temperature are assumed to be frozen.
- PWP follows same trends as previous years.

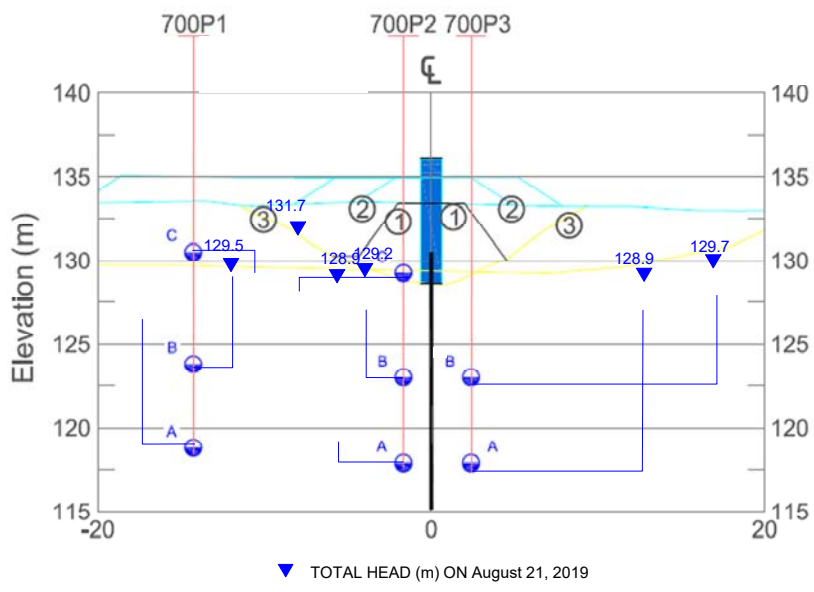
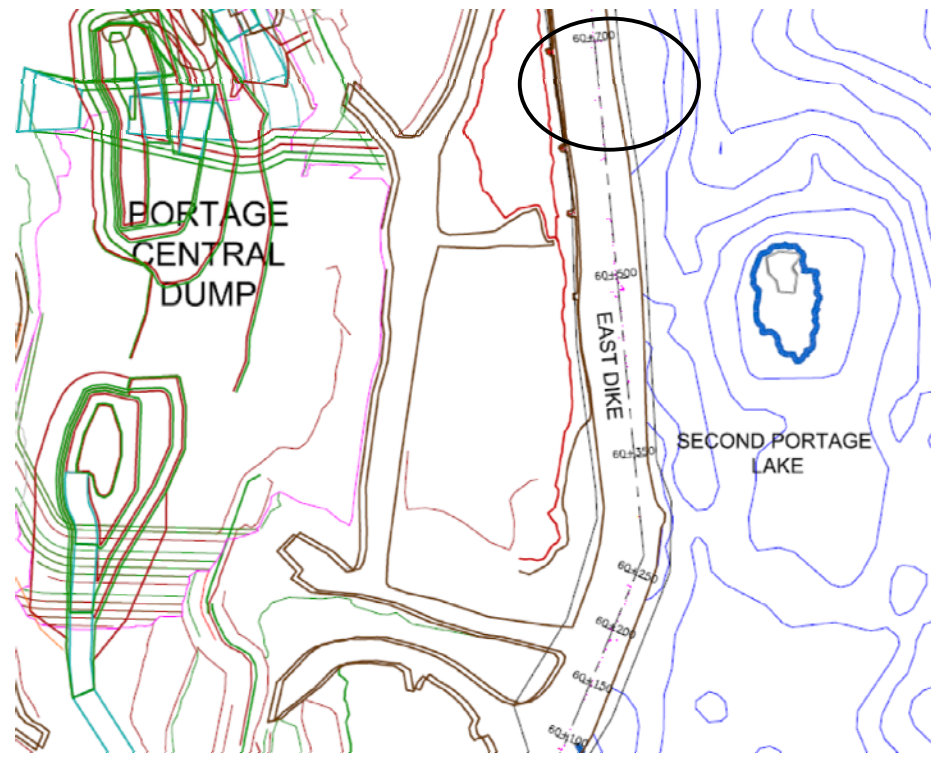
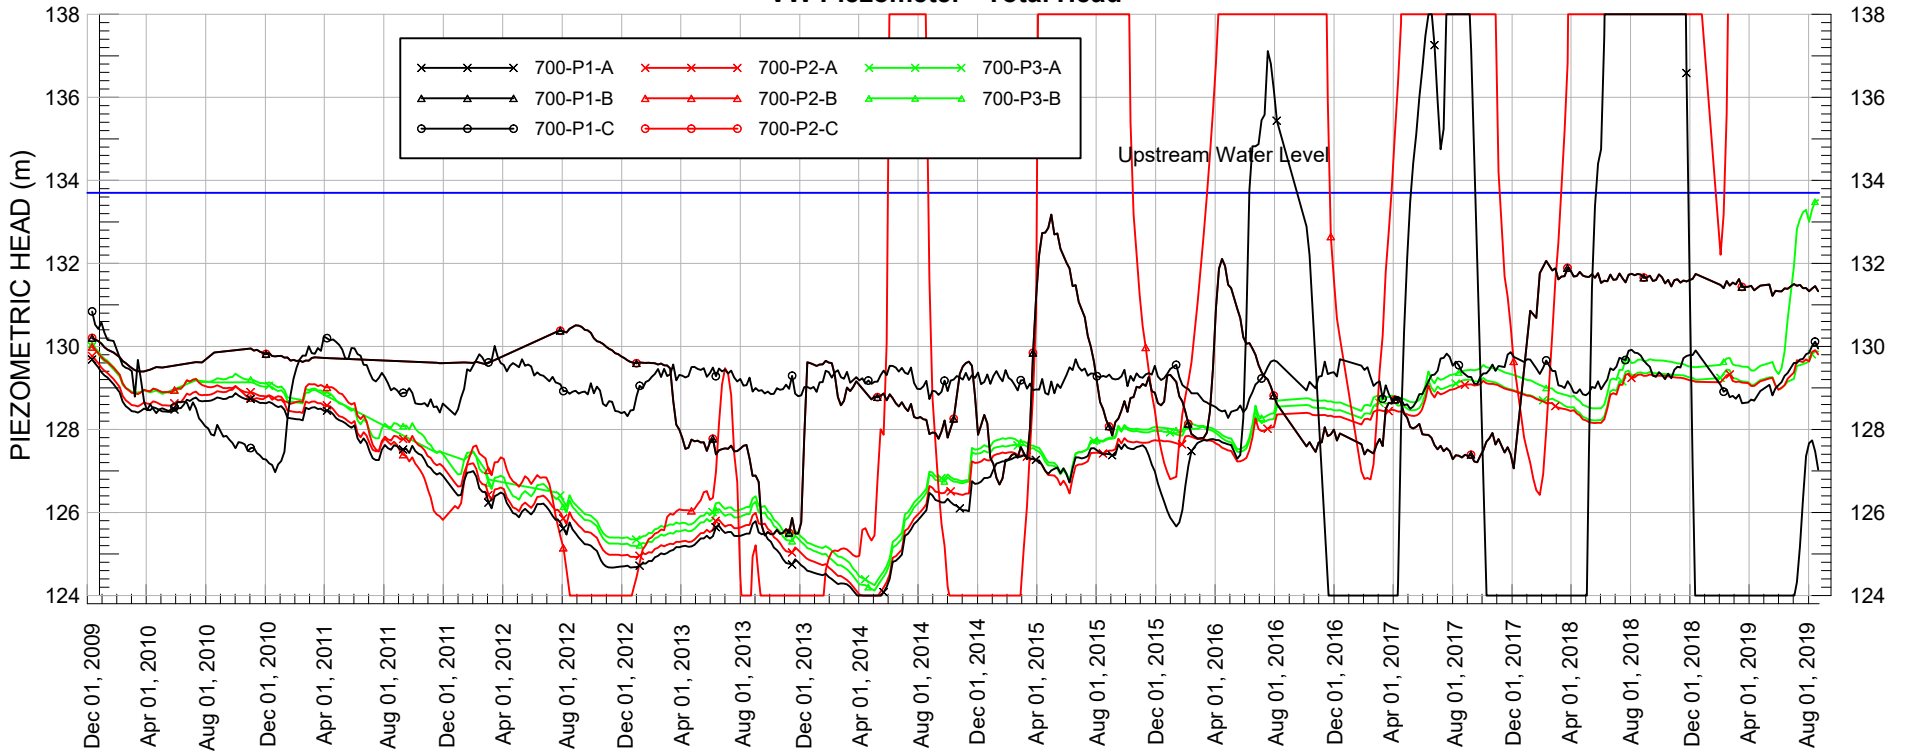
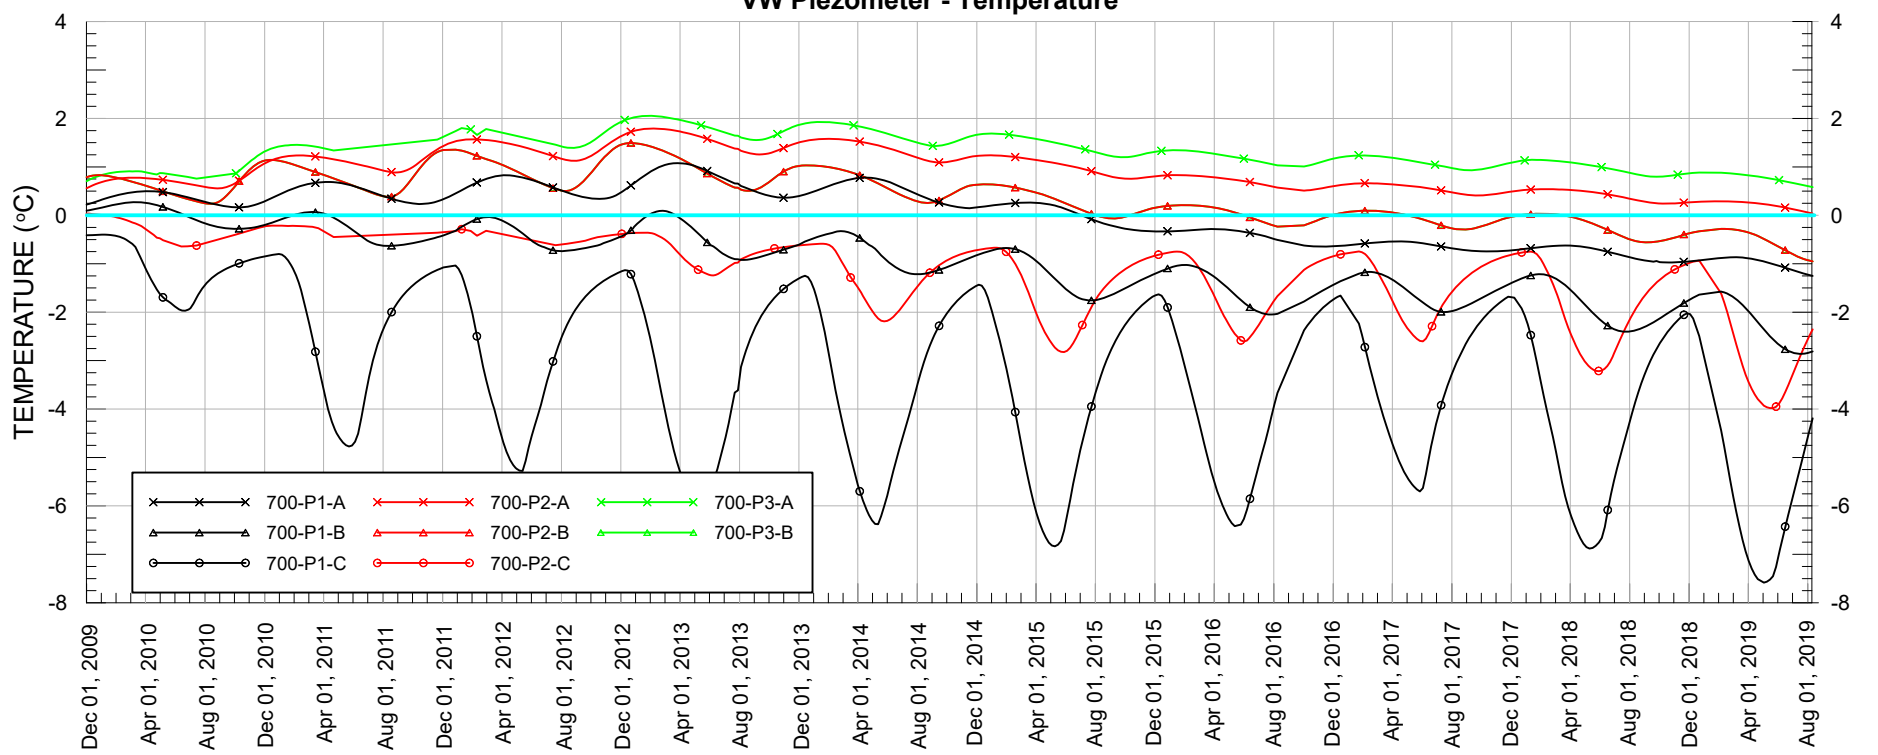
PROJECT		<b>AGNICO EAGLE MINES LIMITED MEADOWBANK GOLD PROJECT NUNAVUT</b>		
TITLE		<b>EAST DIKE - SECTION 60+700 PIEZOMETRIC DATA (Dec 1/09 to Aug 21/19)</b>		
	PROJECT No.	PHASE No.		
	DESIGN TD 28AUG14	SCALE	AS SHOWN	REV.
	CADD TD 28AUG14			
	CHECK PG 28AUG14			
REVIEW	<b>FIGURE 51</b>

1: 700-P1-B and 750-C are giving anomaly readings and with a negative temperature are assumed to be frozen and data is not considered reliable.

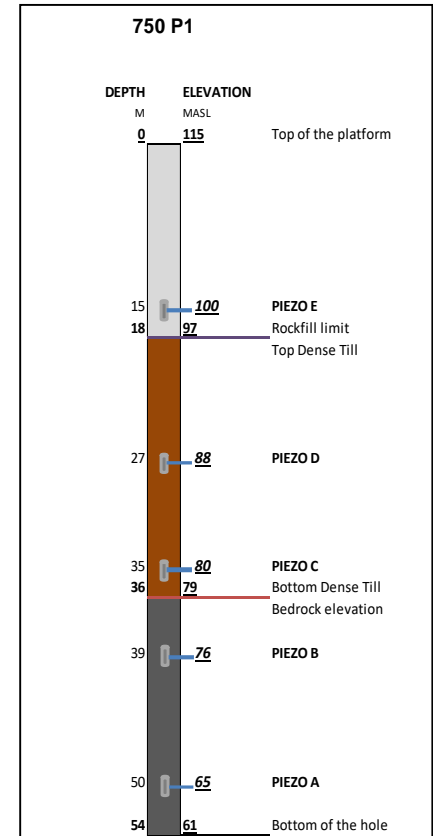
# Thermistor 750-P1

**Comments:** Bead #8 at elevation 90MASL is below the freezing point. Temperature tends to decrease from top to bottom at elevation 63 MASL. The data taken on the field indicates that the reading on that bead is stable despite the apparent capacitance effect.

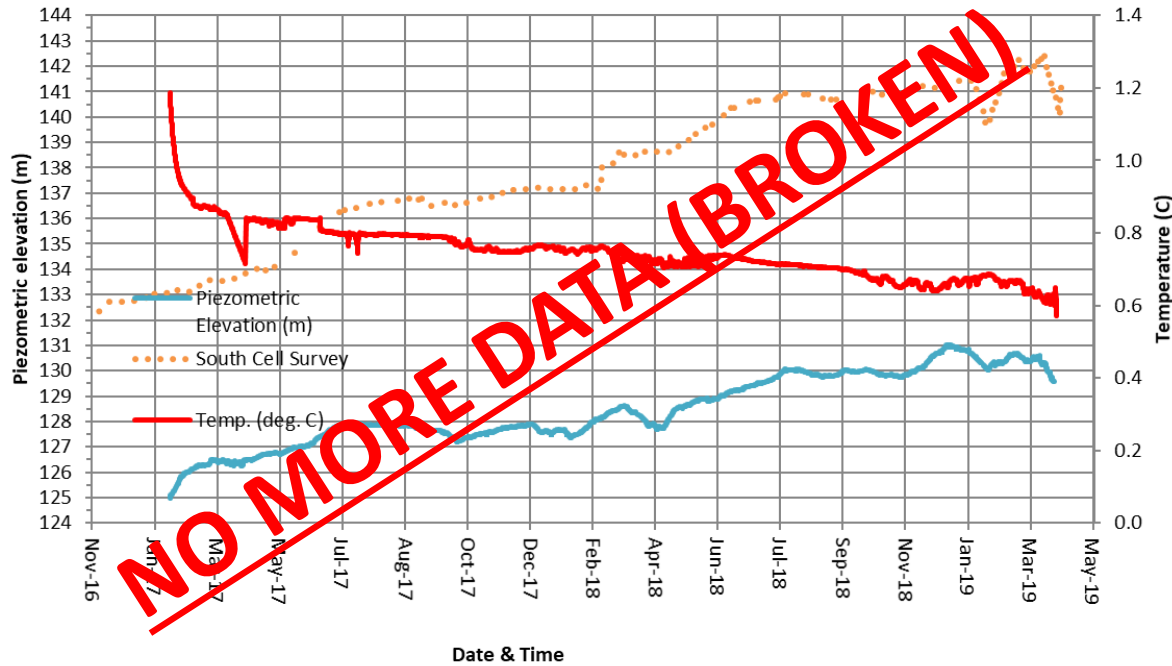
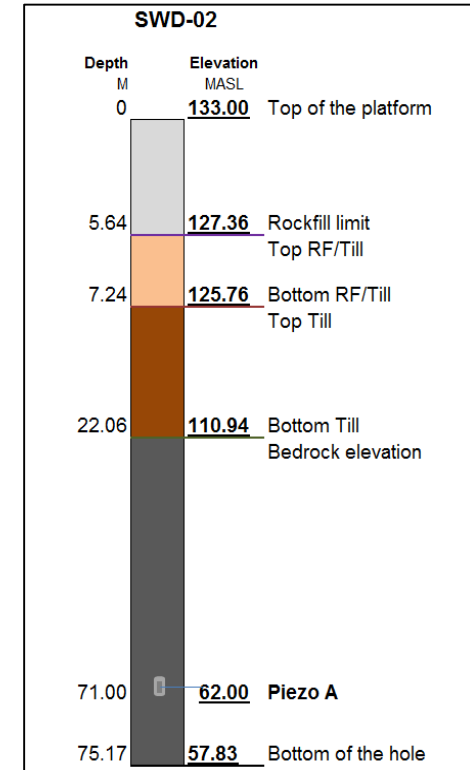
# Piezometer SWD-02-16

The piezometer stopped sending data on March 30, 2019.

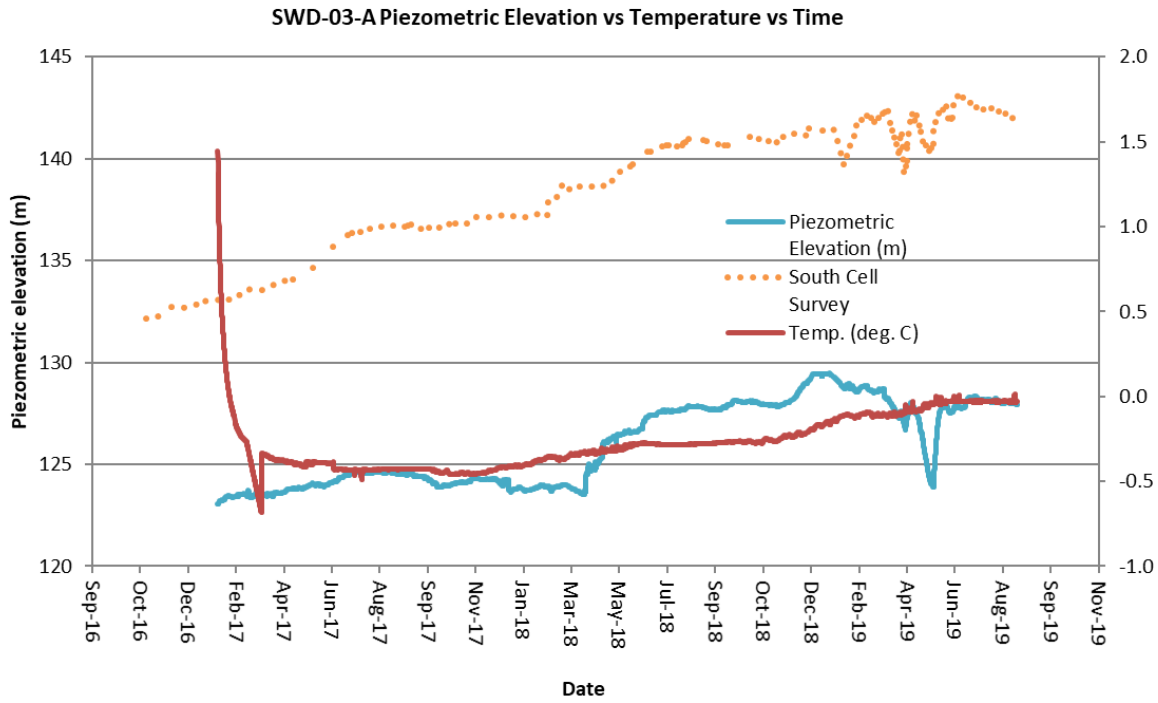
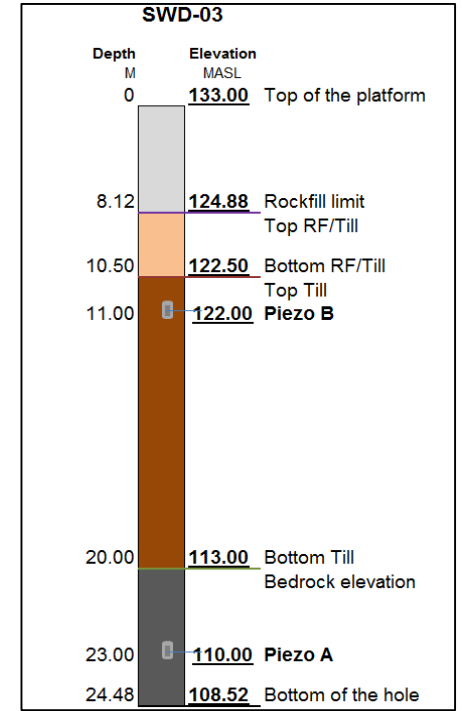
# Piezometer SWD-03-16-A

The instrument temperature is below the freezing point and therefore won't be interpreted.

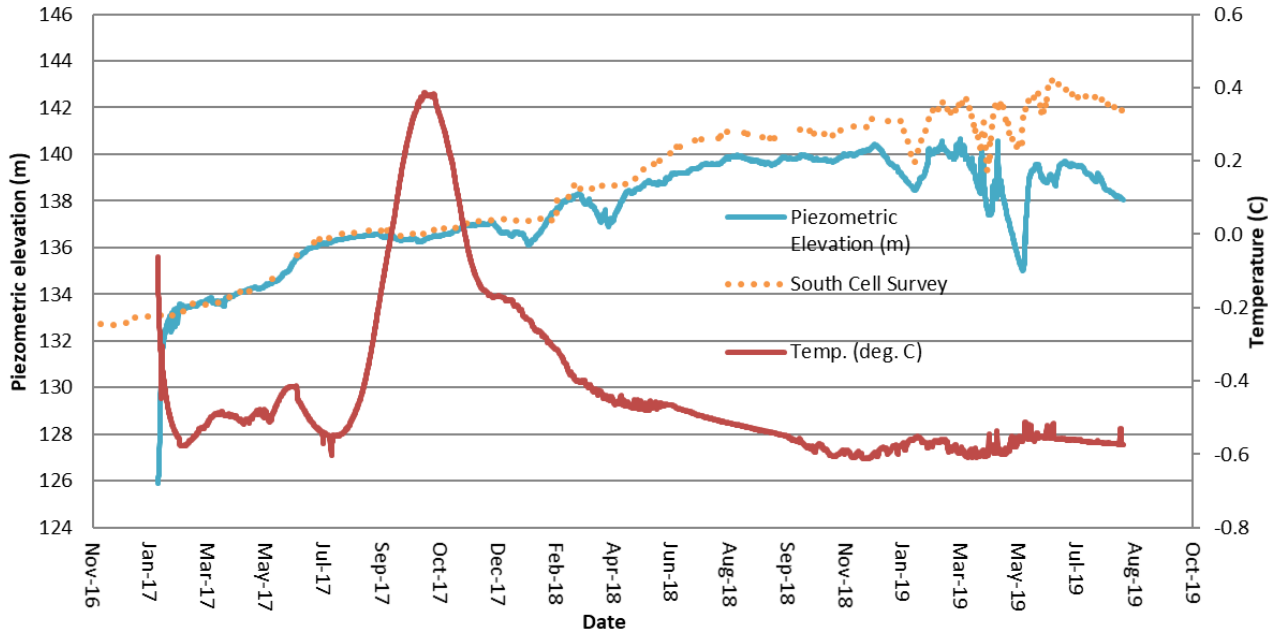
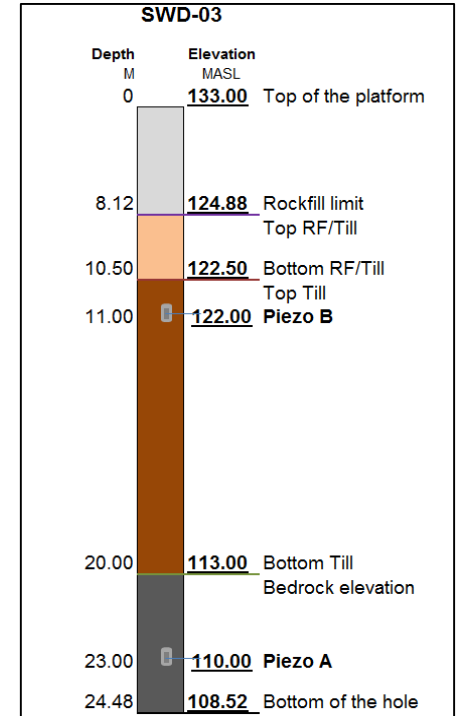
# Piezometer SWD-03-16-B

The instrument is below the freezing point. Therefore, it won't be interpreted.
