# **Meadowbank 2019 Annual Geotechnical Inspection**

# 2019 Annual Geotechnical Inspection

*Meadowbank Gold Mine, Nunavut*

19123067-1588-R-Rev0

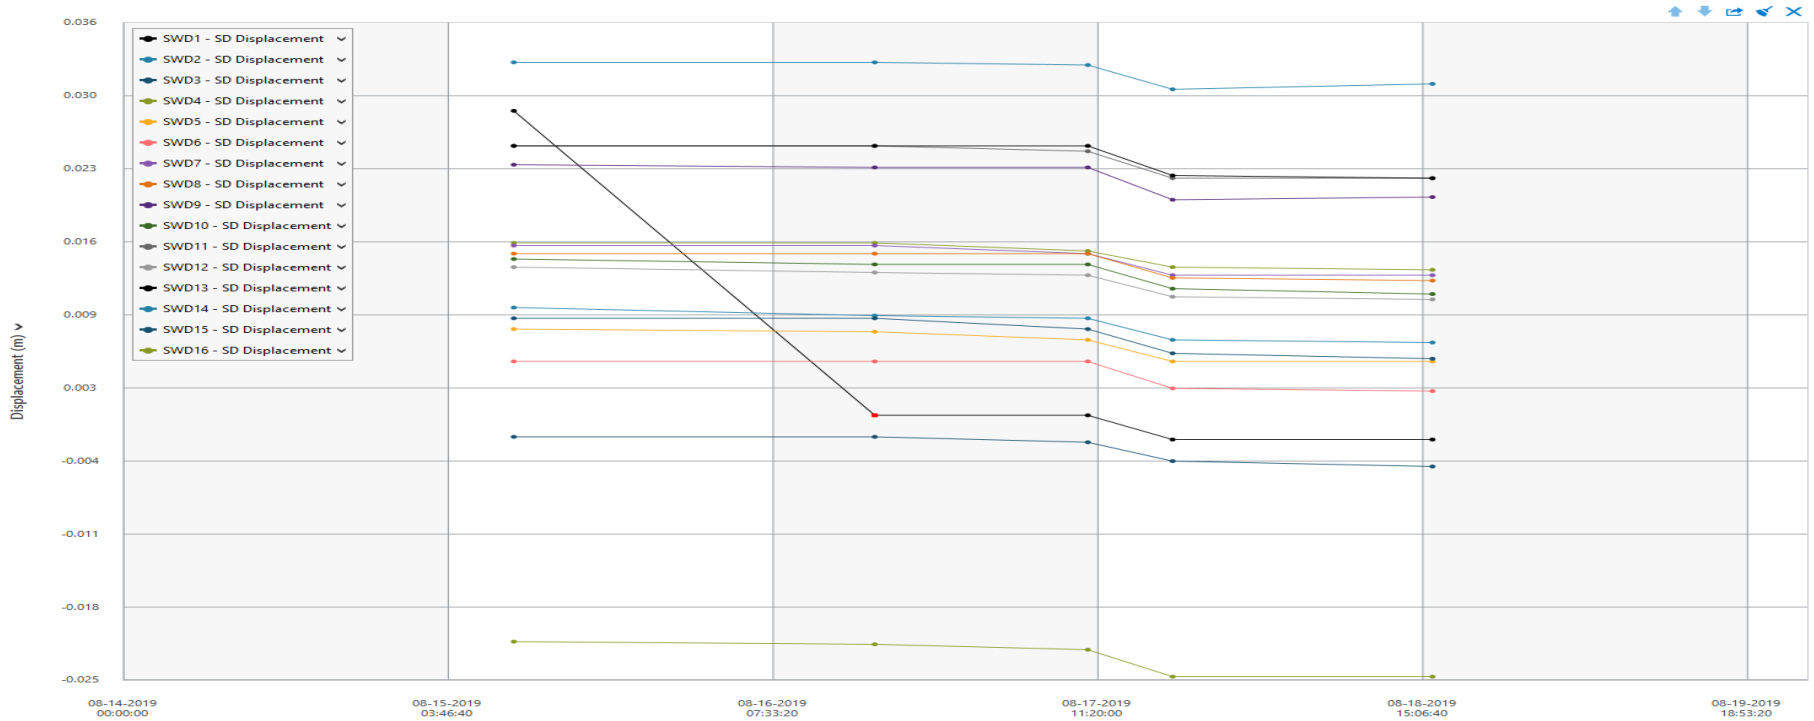
## Prisms slope distance displacement (base line October 2018)

The Total Station is back from repair and a new base line was created last year to be able to monitored the internal structure as well. Adjustments needs to be implement into the GeoExplorer software. However, from last year base line there is very few displacement associated with the structure, ranging from +3cm to -2 cm. That confirm our visual inspections and other instrumentation.

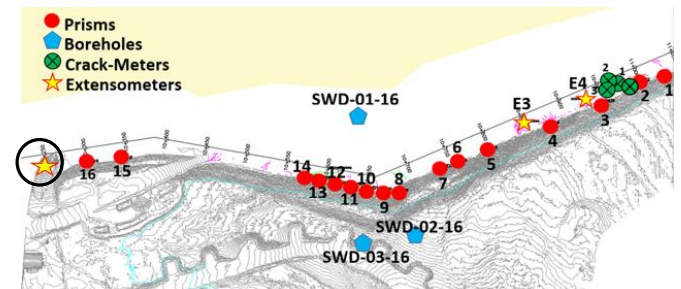
### Extensometer 6 (Booster Pump)

An additional extensometer was installed close to the booster pump after the apparition of small tension cracks. Original cracks are not showing any progression and the extensometer is confirming the visual observations.

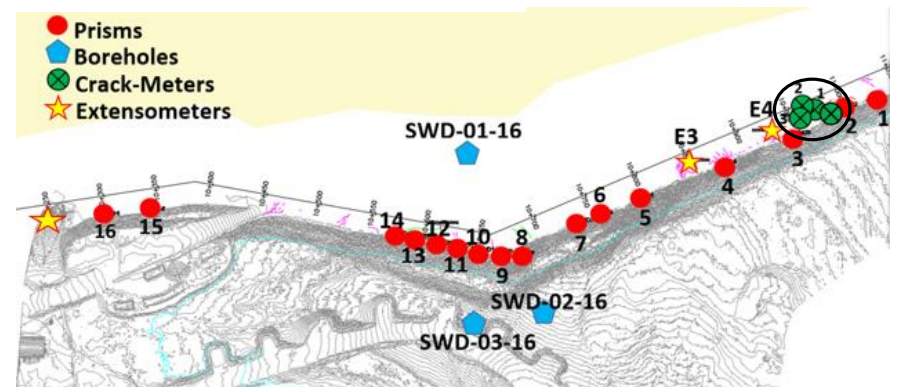
## Crackmeter 1-2-3 (10+ 975)

All of the crackmeter are showing stable result without significant trend during the past month. All of them have been disable by wildlife during the period and were repaired. However, crackmeter # 1 is still not functioning. We will repair it again.

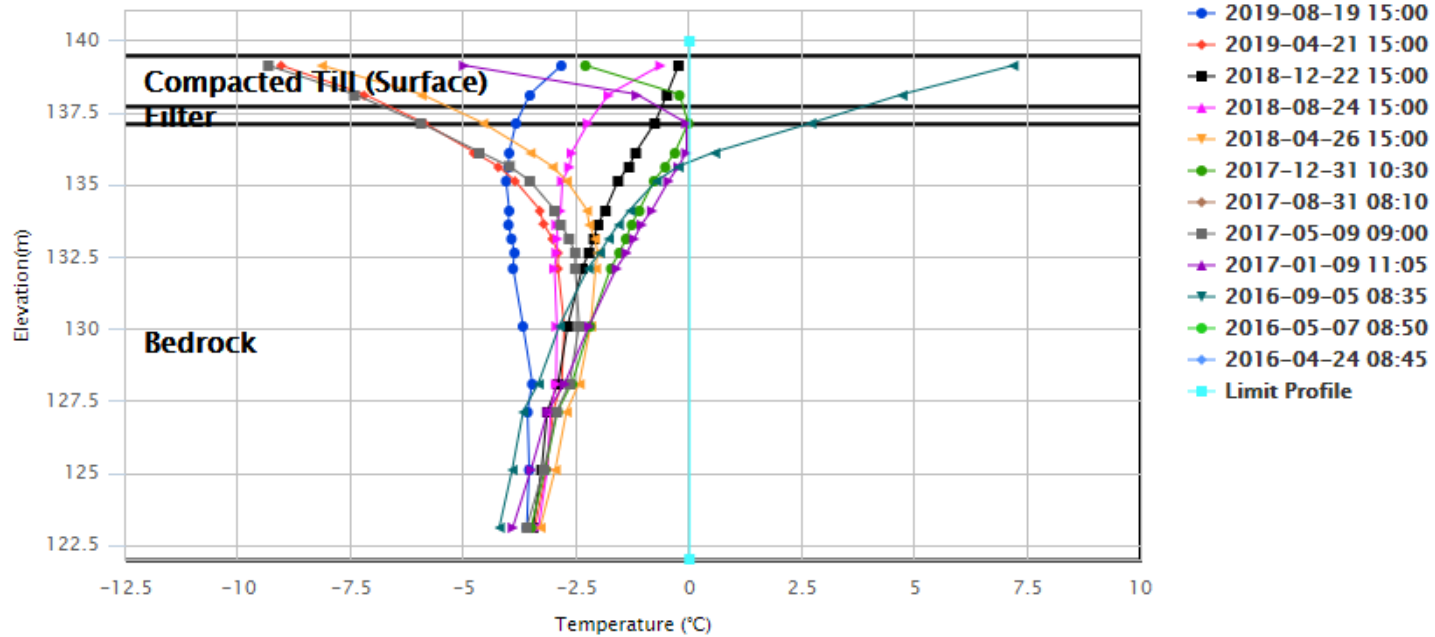
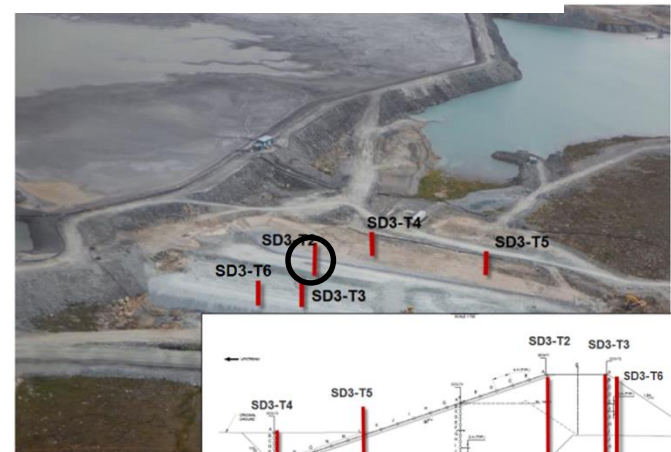
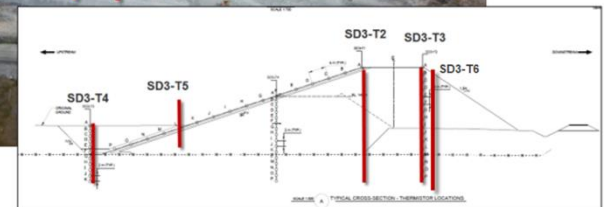
**Thermistor SD3-T2**

All temperatures were below the freezing point during Q2, 2019. From the bedrock layer to the bottom of the hole, temperature dropped significantly.

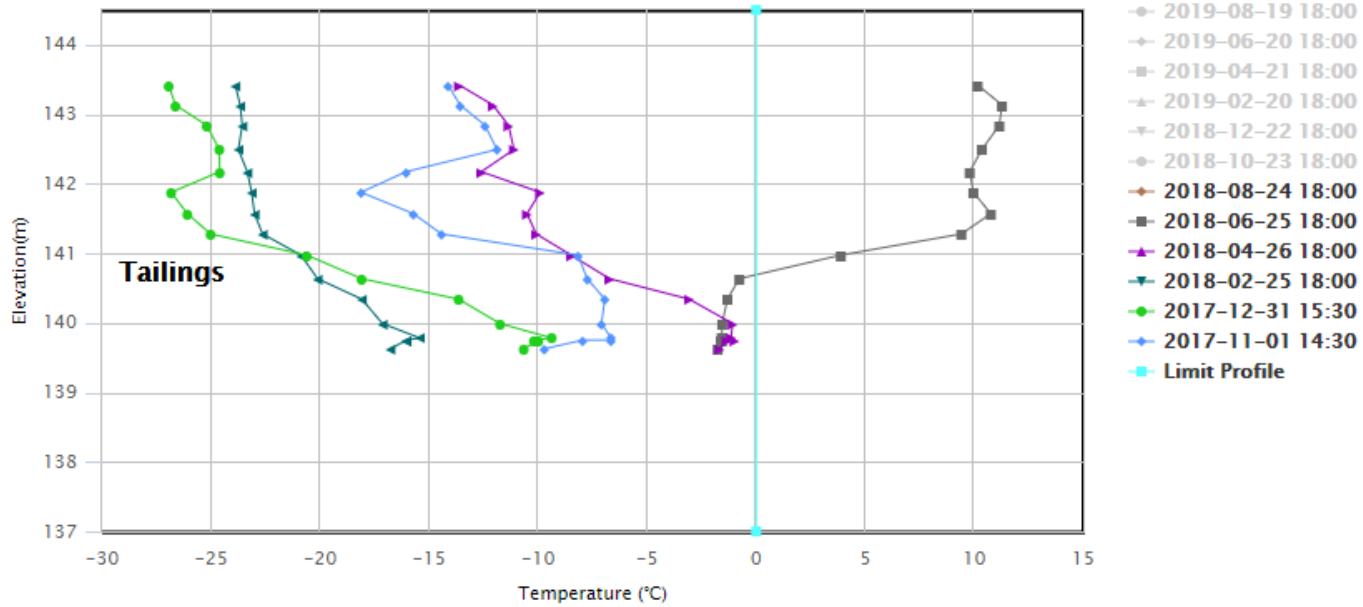
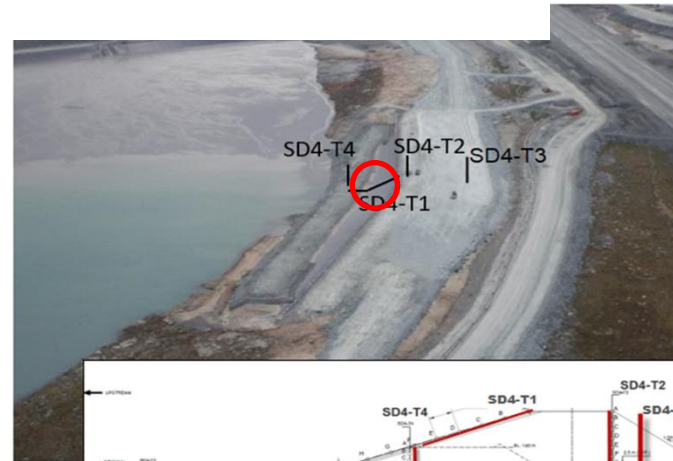
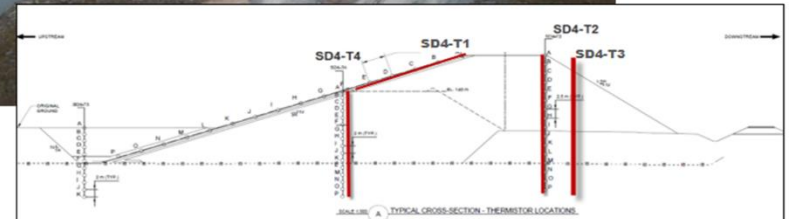
**Thermistor SD4-T1**

The thermistor has not given data since August 2018.

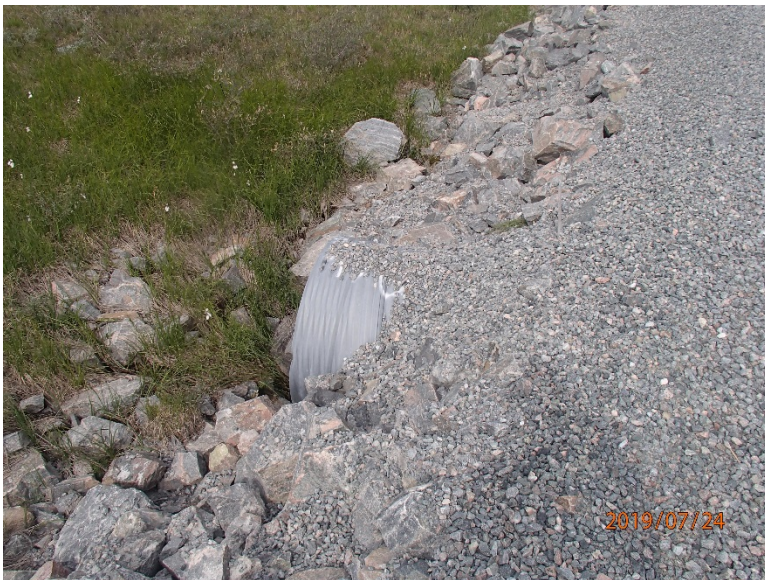
**Photograph D2-4: R-04 km 12+050**

**Description:** View of the culvert outlet. In good condition.

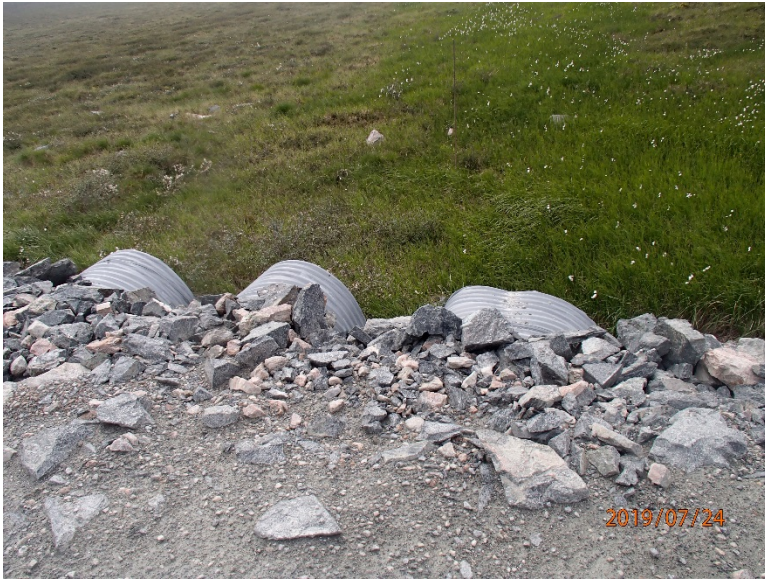
**Photograph D2-5: R-18A km 80+950**

**Description:** View of the culverts outlet. In good condition.

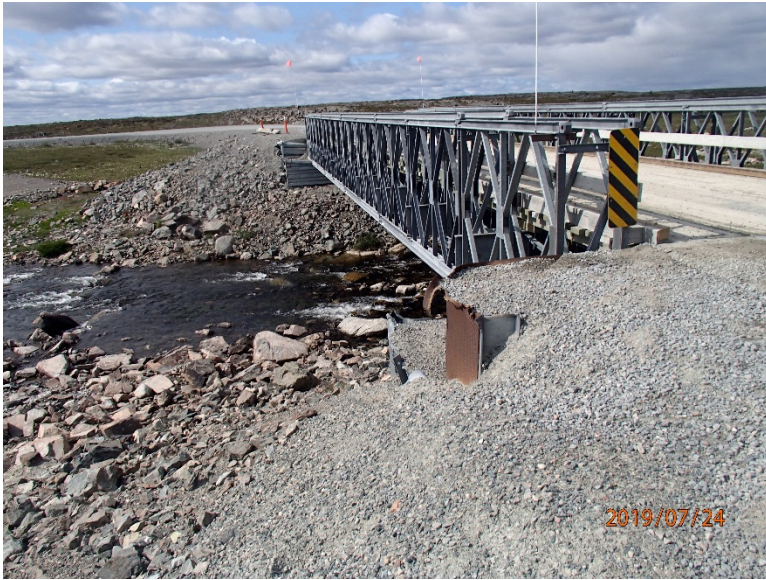
**Photograph D3-1 Bridges 1 – R02 km 8+750**

~5+700	unnamed	1x600 mm CSP	The inlet is buried in gravel. The outlet is in good condition.	14w 644762 /7140728	
8+750	R02 Centre Bridge	30m Acrow Panel Bridge	In general good condition. The two corrugated steel bins at both abutments show deformation under the weight of the bridge.		194: north 195: south

**Description:** Looking at the north abutment. The corrugated steel bin shows deformation under the weight of the bridge.

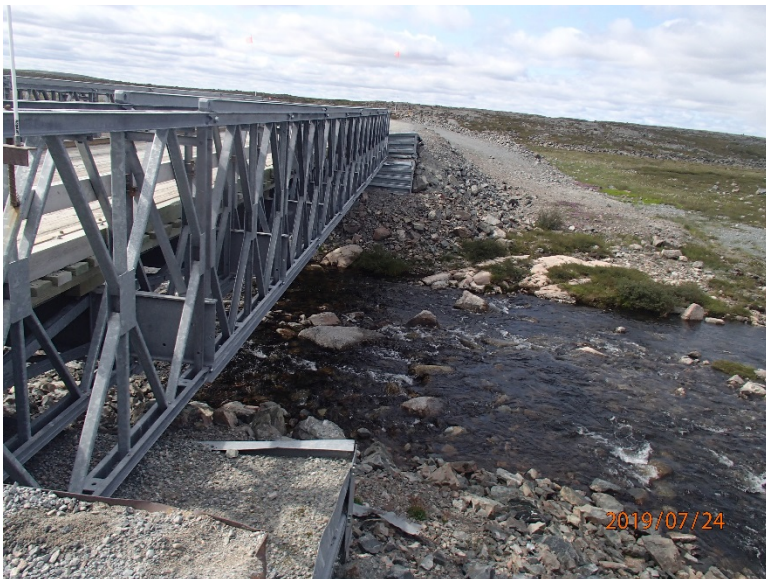
**Photograph D3-2 Bridges 1 – R02 km 8+750**

**Description:** Looking at the south abutment. The corrugated steel bin shows deformation under the weight of the bridge.

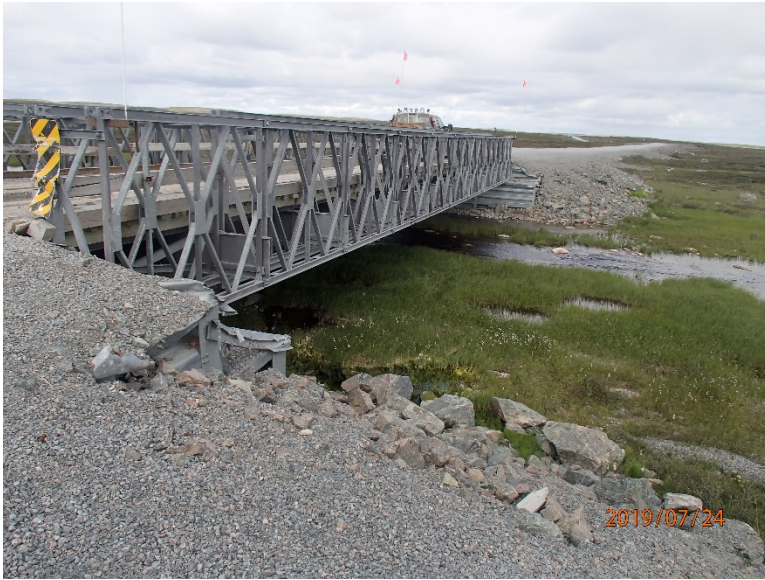
**Photograph D3-3 Bridges 2 – R05 km 17+600**

**Description:** Looking at the north abutment.

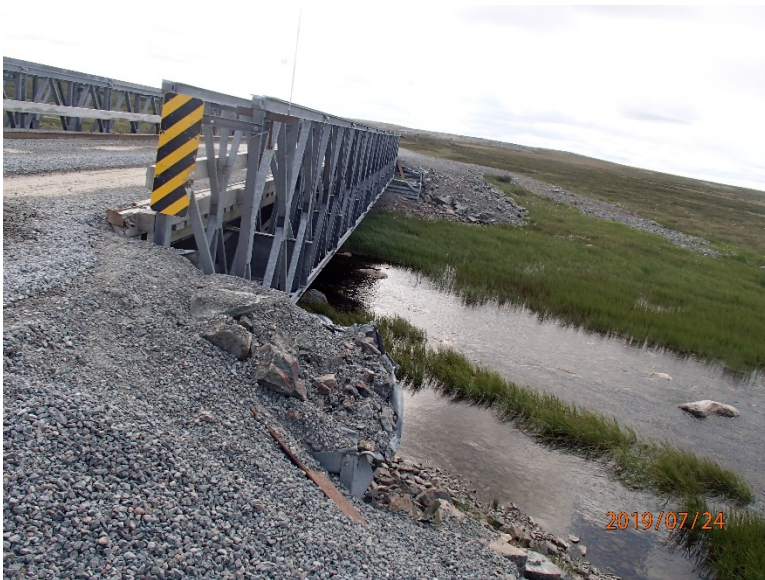
**Photograph D3-4 Bridges 2 – R05 km 17+600**

**Description:** Looking at the south abutment. Minor damage to the bin wall.

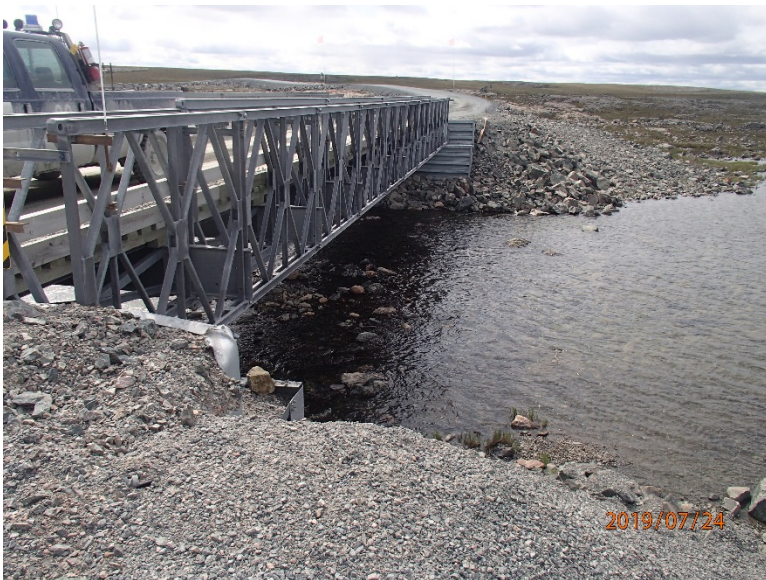
**Photograph D3-6 Bridges 3 – R06 km 23+100**

**Description:** Looking at the south abutment.

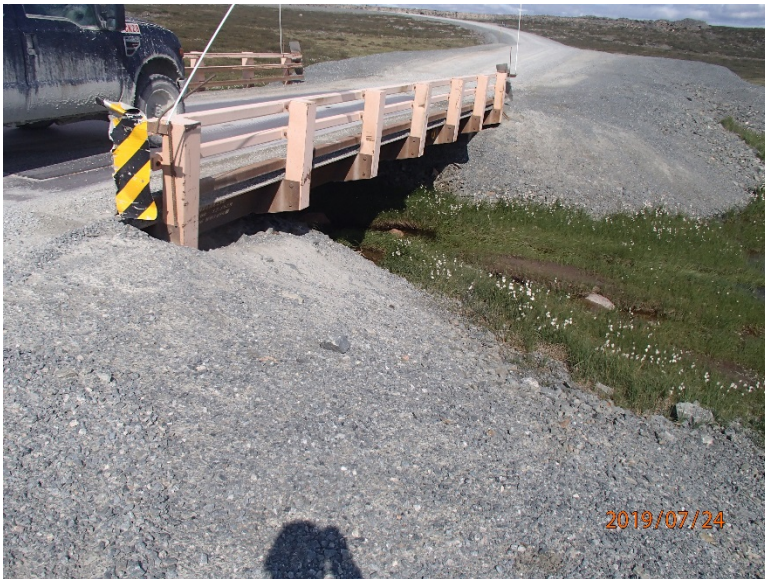
**Photograph D3-7 Bridges 4 – R13 km 62+060**

**Description:** Looking at the north abutment.

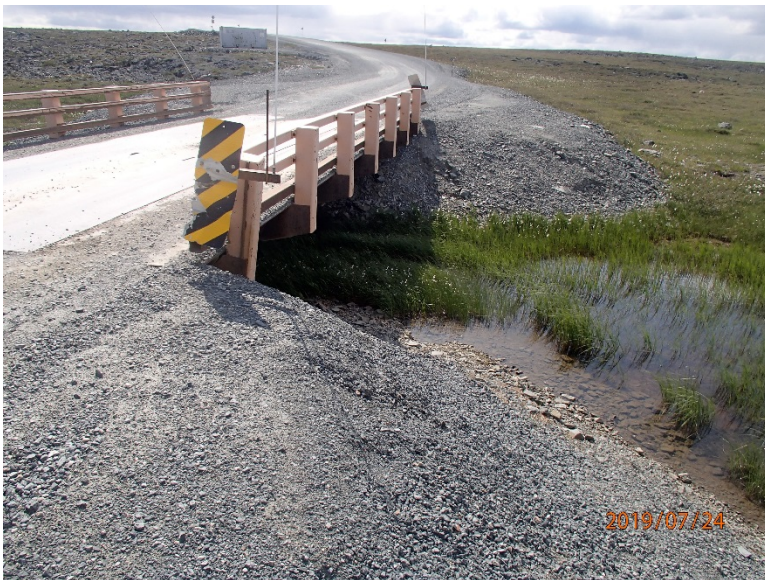
**Photograph D3-8 Bridges 4 – R13 km 62+060**

**Description:** Looking at the south abutment.

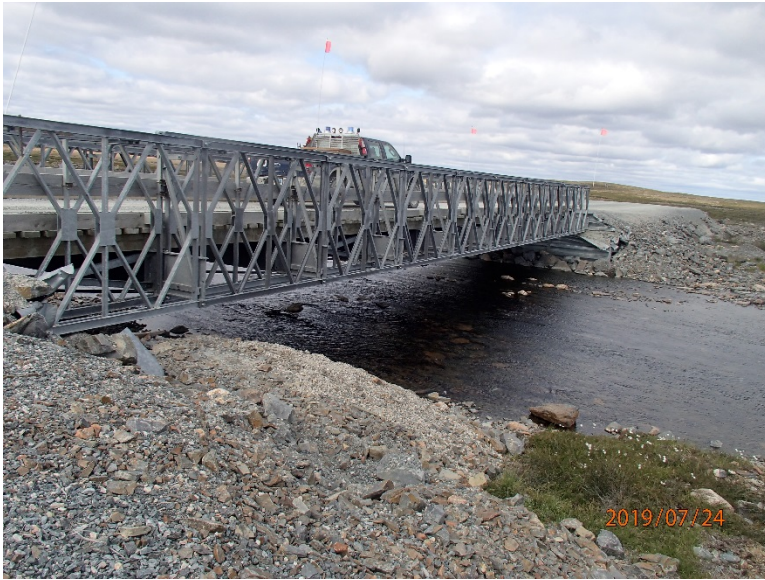
**Photograph D3-9 Bridges 5 – R15 km 69+200**

STATION	NAME	STRUCTURE DESCRIPTION	COMMENTS	GPS COORDINATES	PHOTO
69+200	R15 Centre Bridge	30 m Acrow Panel Bridge	Bin wall of both abutments were observed to be damaged but they are still holding well. The bridge is dipping toward the west side on both north and south abutments. The foundation does not show signs of failure but is slowly settling. Its condition should be monitored.	14w 627469 /7192035	232 : north 233 : south
70+400	Quarry 16		Presence of unstable loose rocks and boulders but in general good condition.	14w 627216 /7193129	234
72+800	Quarry 17		Steep rock wall in stable conditions.	14w 626884 /7195600	
73+800	R16 Centre Bridge	12m Rapid Span Bridge	In good condition	14w 626701 /7196535	235 : north 236 : south
77+440	R-17	1x1200 mm CSP	In good condition	14w 626127 /7199708	
79+500	R18 Centre Bridge	12 m Rapid Span Bridge	In good condition	14w 627270 /7201462	237 : north 238 : south

**Description:** Looking at the north abutment. Damage to the bin wall likely caused during snow removal activities. Bridge is tipping toward the west side on the abutment.

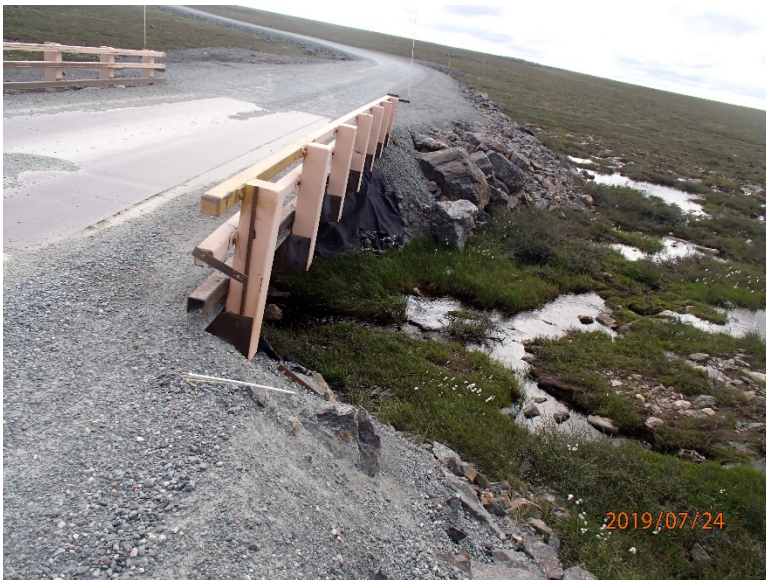
**Photograph D3-12 Bridges 6 – R16 km 73+800**

**Description:** Looking at the south abutment. In good condition.

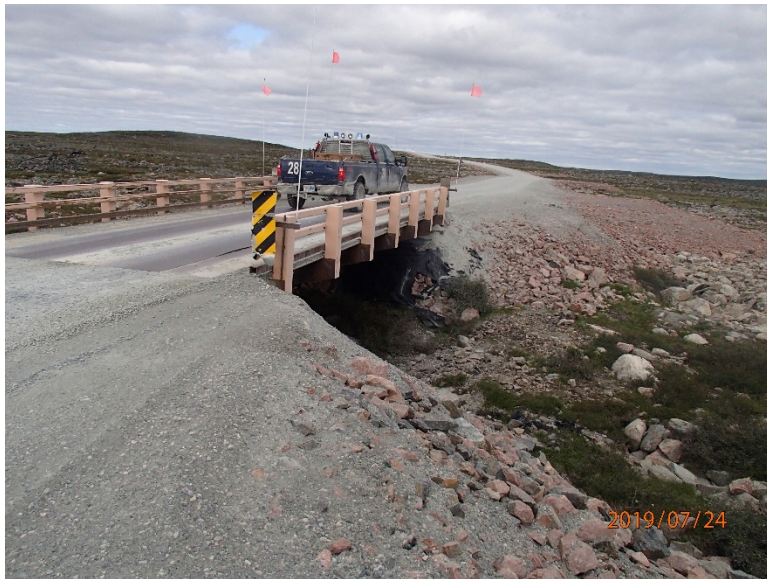
**Photograph D3-13 Bridges 7 – R18 km 79+500**

**Description:** Looking at the north abutment. In good condition.

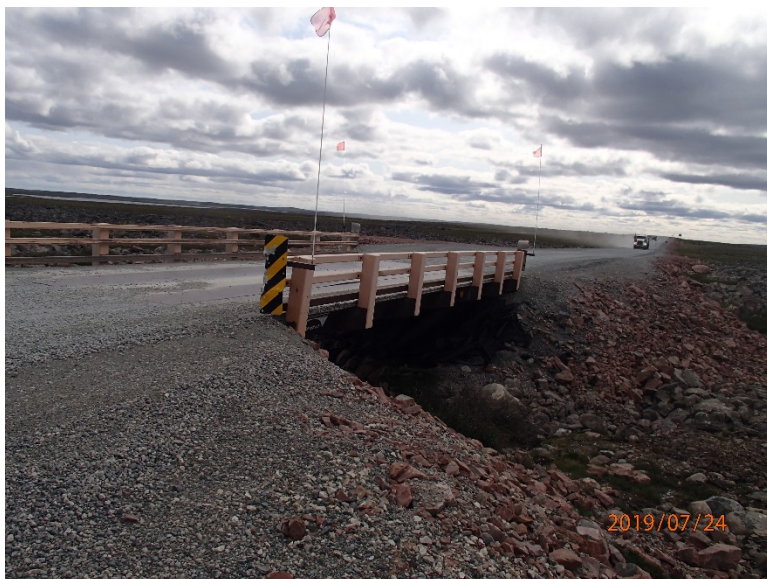
**Photograph D3-14 Bridges 7 – R18 km 79+500**

**Description:** Looking at the south abutment. In good condition.

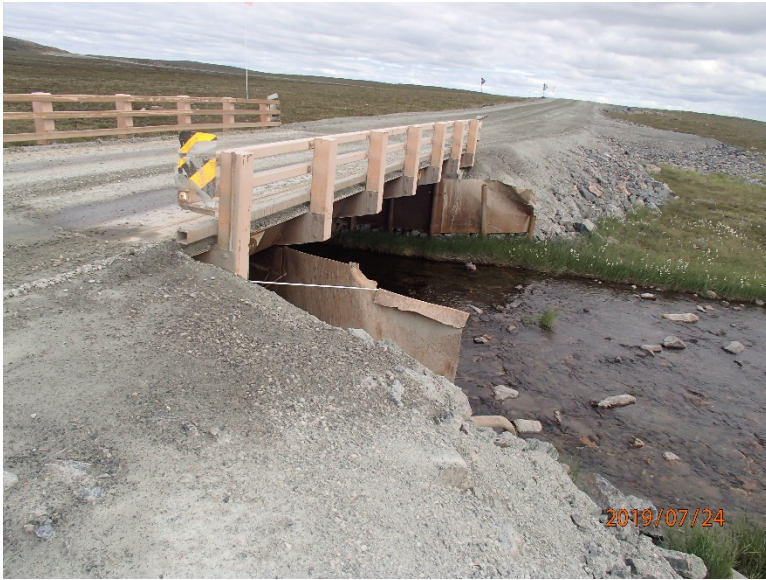
**Photograph D3-15 Bridges 8 – R19 km 83+150**

STATION	NAME	STRUCTURE DESCRIPTION	COMMENTS	GPS COORDINATES	PHOTO
83+150	R19 Centre	12m Rapid Span Bridge	Some damage to the steel containment plates and to one pile was observed, which may be associated with snow removal activity. The damage is minor and does not affect the geotechnical integrity of the bridge.	14w 627680 /7203918	241 : north 242 : south
84+300	Quarry 19		Rock walls are in good condition.		
85+490	R-20	1x1200 mm CSP	Outlet of the culvert is slightly twisted. The middle of the culvert is slightly collapsed. The inlet is installed above the ground surface and water is able to flow beneath the culvert. No follow-up required, in stable conditions.	14w 629596 /7204573	
87+300	R-21	2x1200 mm CSP	Both culverts are slightly collapsed in the middle. Should have been installed lower to avoid erosion issue. In stable condition.	14w 630593 /7206335	
89+550	Quarry 20		Quarry walls are in good condition	14w 631254 /7208023	243, 244

**Description:** Looking at the north abutment. Minor damage to steel plate due to snow removal activity.

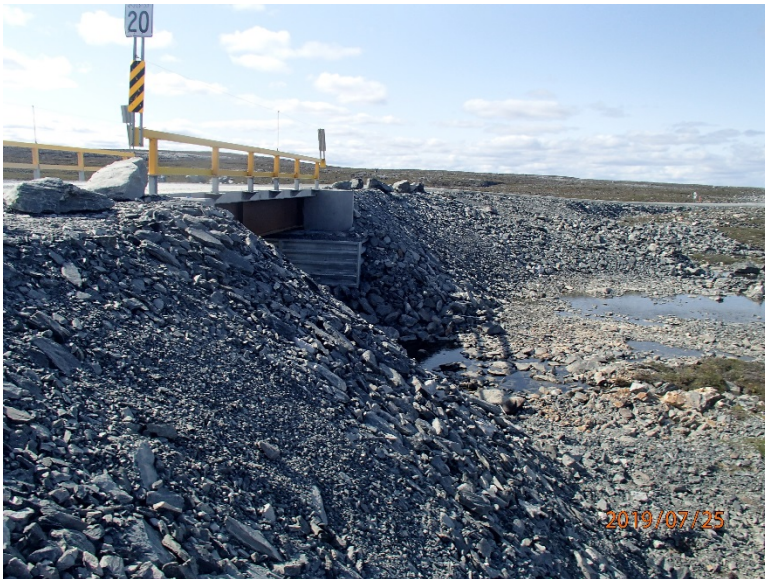
**Photograph E3-1 Bridges 1 – km 3+400**

**Description:** Looking at the north abutment.

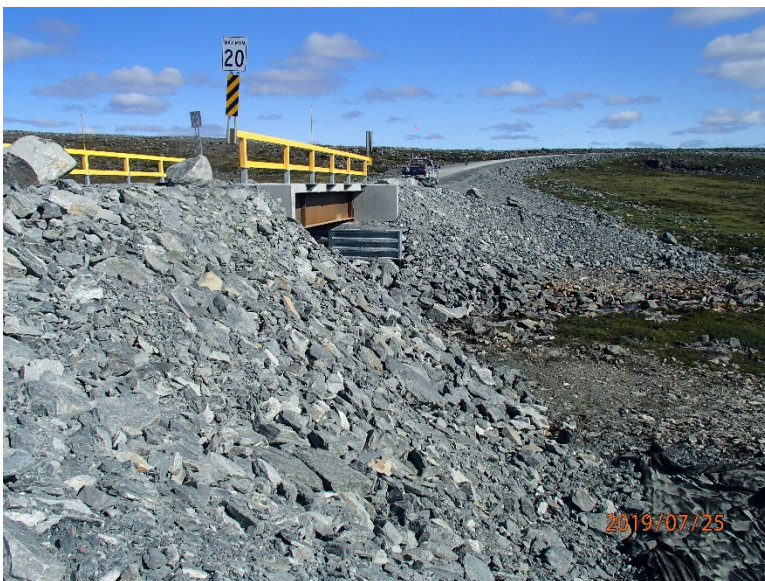
**Photograph E3-2 Bridges 1 – km 3+400**

**Description:** Looking at the south abutment.

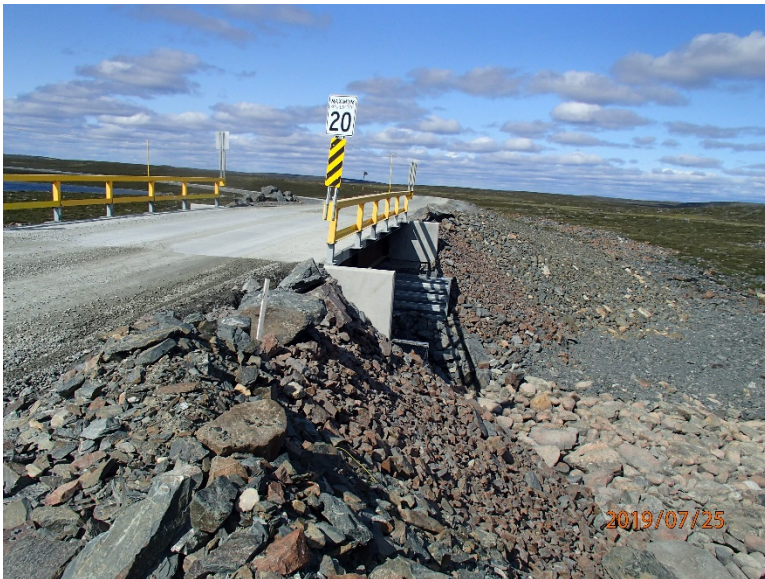
**Photograph E3-3 Bridges 2 – km 10+700**

**Description:** Looking at the north abutment.

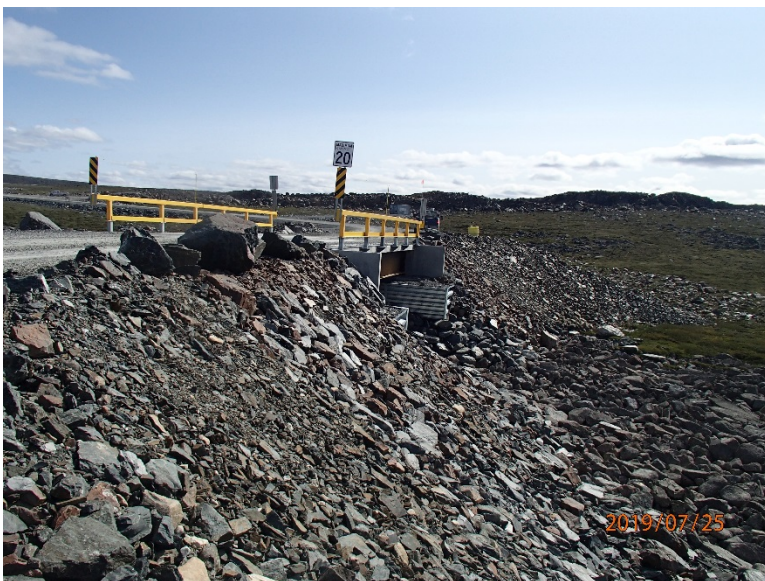
**Photograph E3-4 Bridges 2 – km 10+700**

**Description:** Looking at the south abutment.

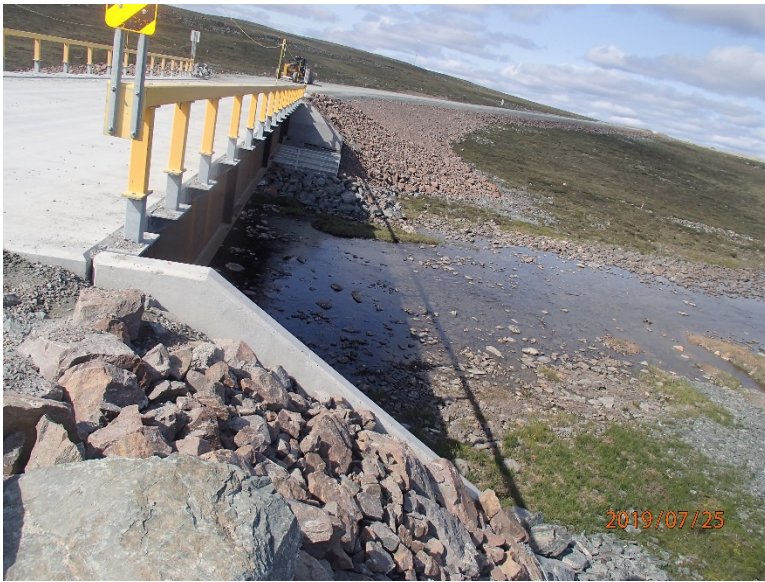
**Photograph E3-5 Bridges 3 – km 16+000**

**Description:** Looking at the north abutment.

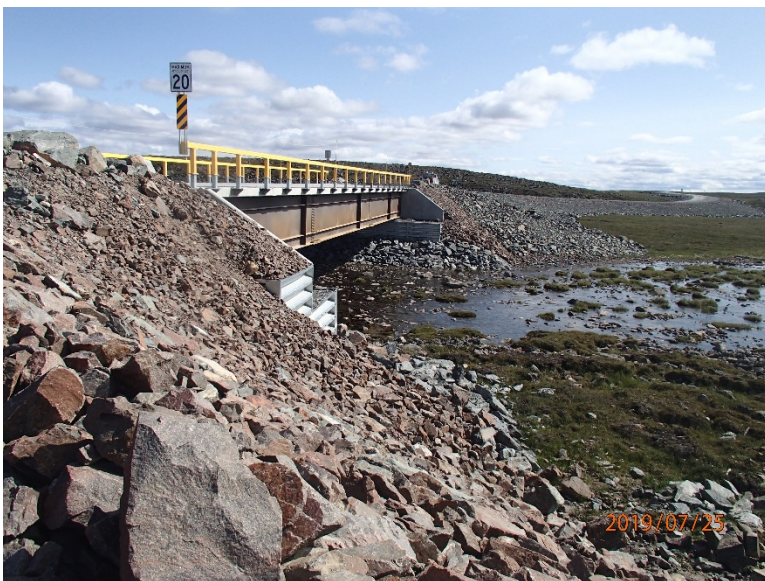
**Photograph E3-6 Bridges 3 – km 16+000**

**Description:** Looking at the south abutment.

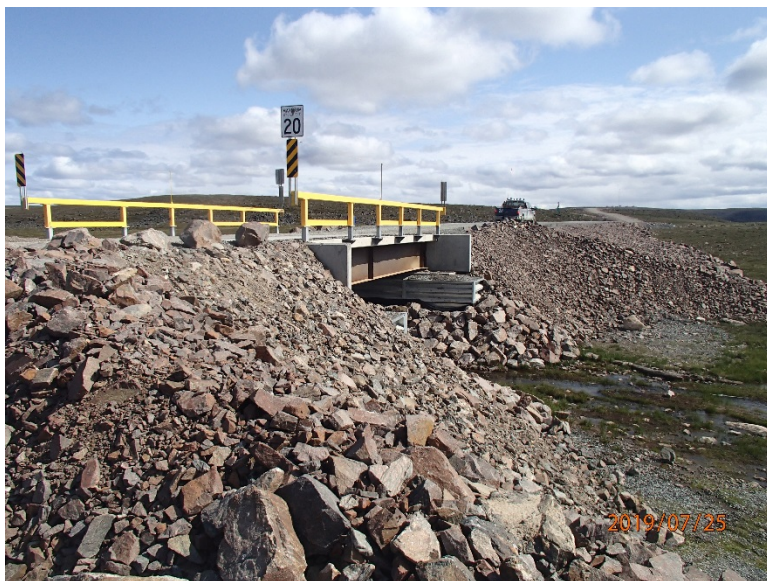
**Photograph E3-8 Bridges 4 – km 20+000**

**Description:** Looking at the south abutment.

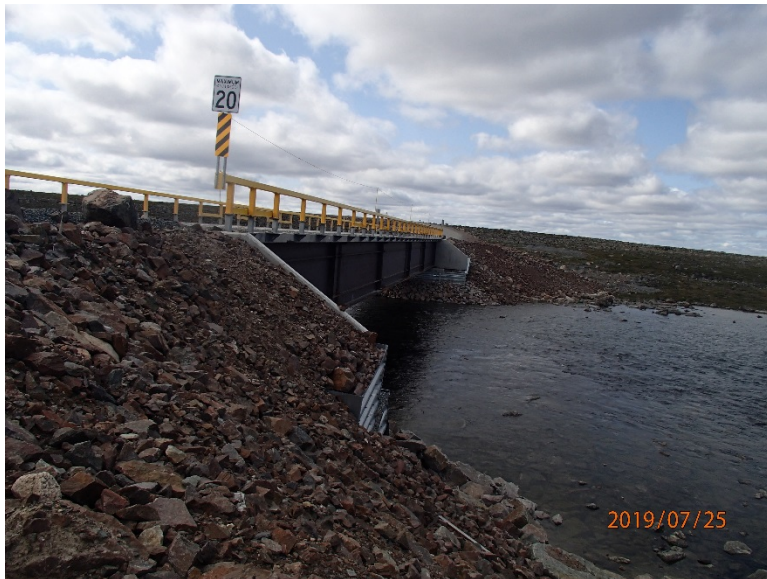
**Photograph E3-9 Bridges 5 – km 23+900**

**Description:** Looking at the north abutment.

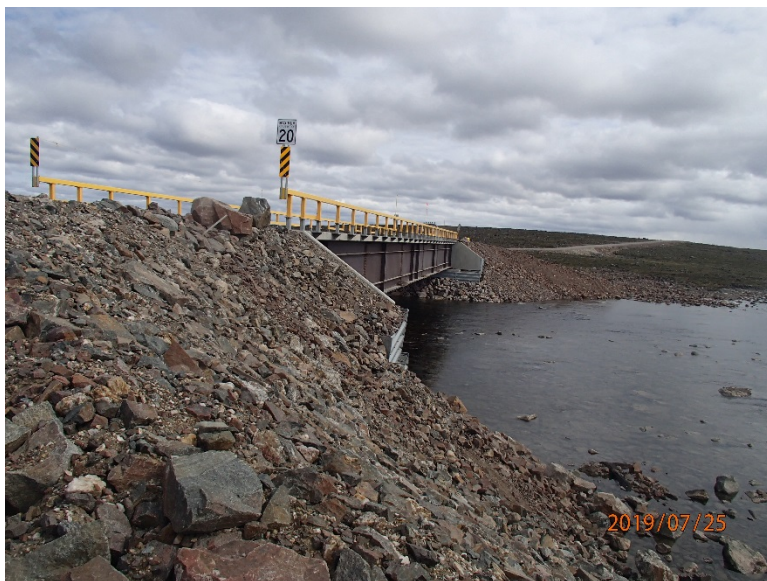
**Photograph E3-10 Bridges 5 – km 23+900**

**Description:** Looking at the south abutment.

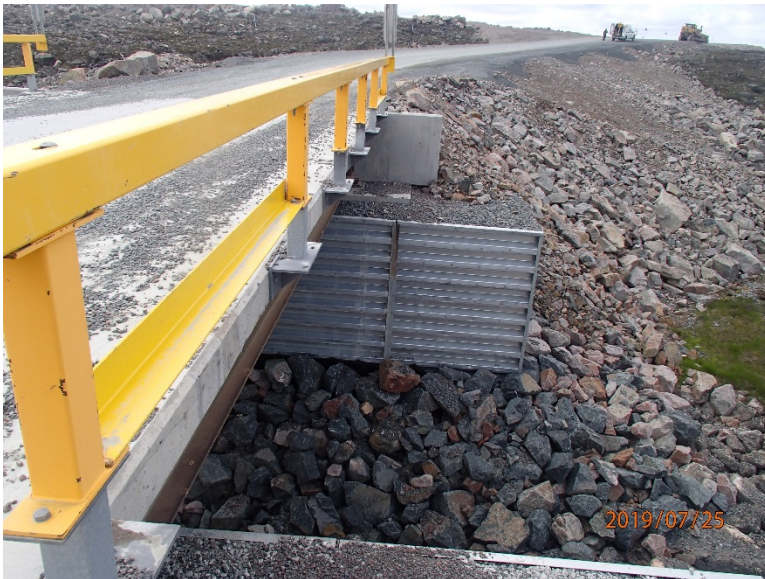
**Photograph E3-11 Bridges 6 – km 26+100**

**Description:** Looking at the north.

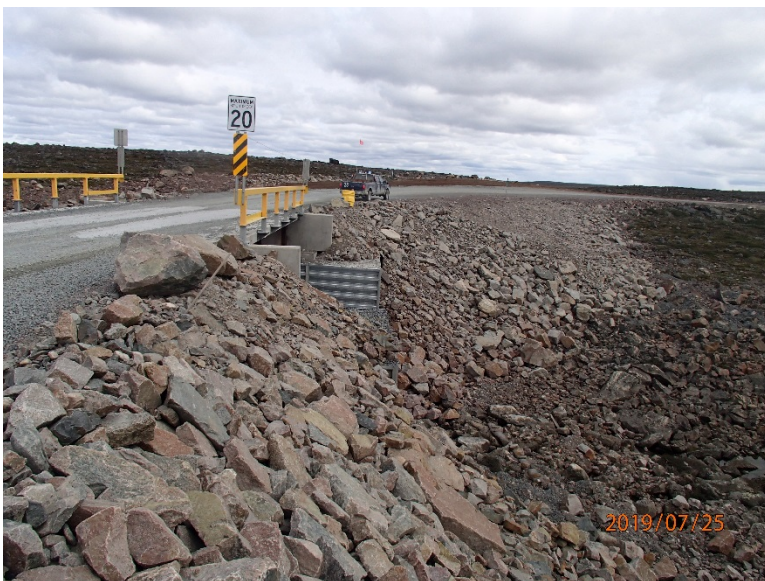
**Photograph E3-12 Bridges 6 – km 26+100**

**Description:** Looking at the south abutment.

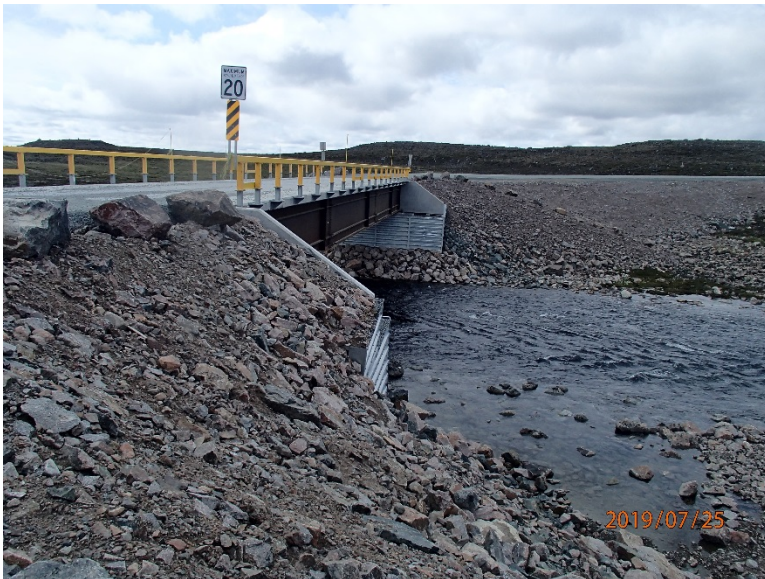
**Photograph E3-13 Bridges 7 – km 32+300**

**Description:** Looking at the north abutment.

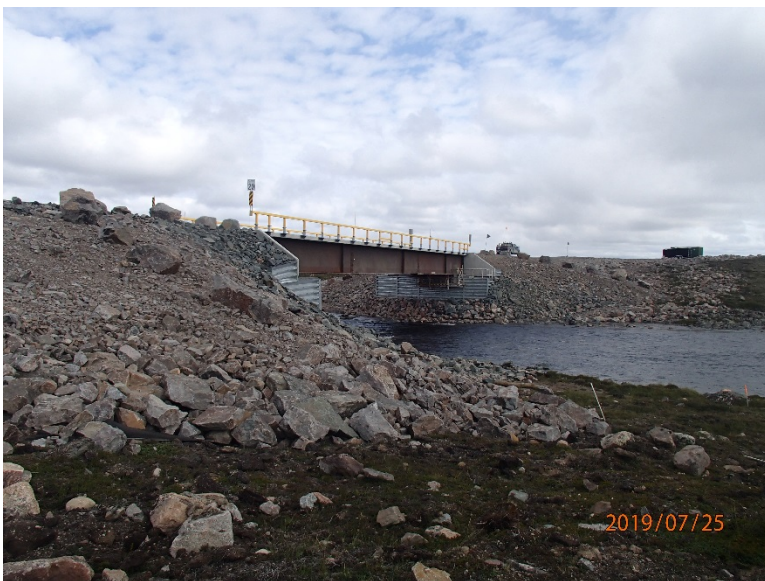
**Photograph E3-14 Bridges 7 – km 32+300**

**Description:** Looking at the south abutment.

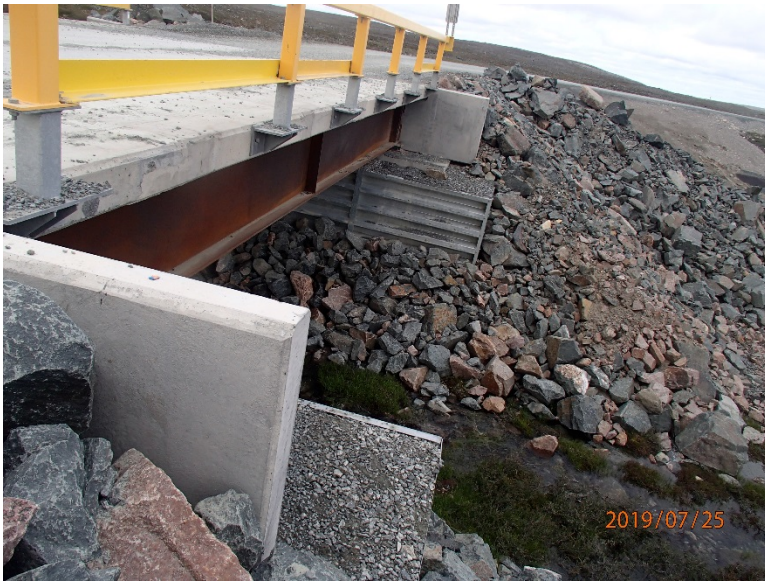
**Photograph E3-15 Bridges 8 – km 43+500**

**Description:** Looking at the north abutment.

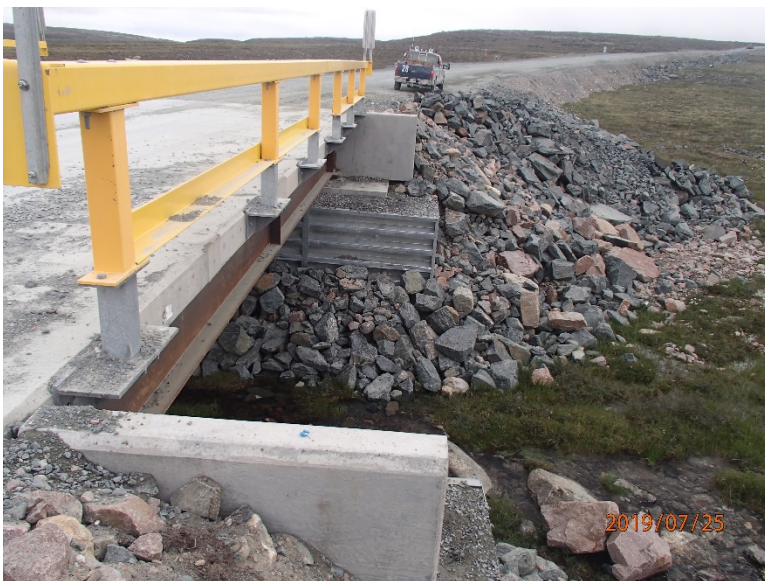
**Photograph E3-16 Bridges 8 – km 43+500**

**Description:** Looking at the south abutment.

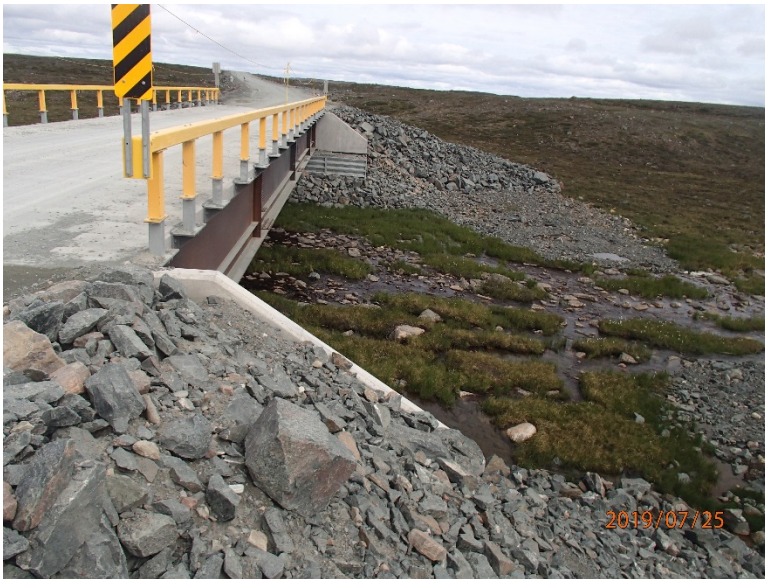
**Photograph E3-17 Bridges 9 – km 44+800**

**Description:** Looking at the north abutment. A crack is present in the concrete on the western side.

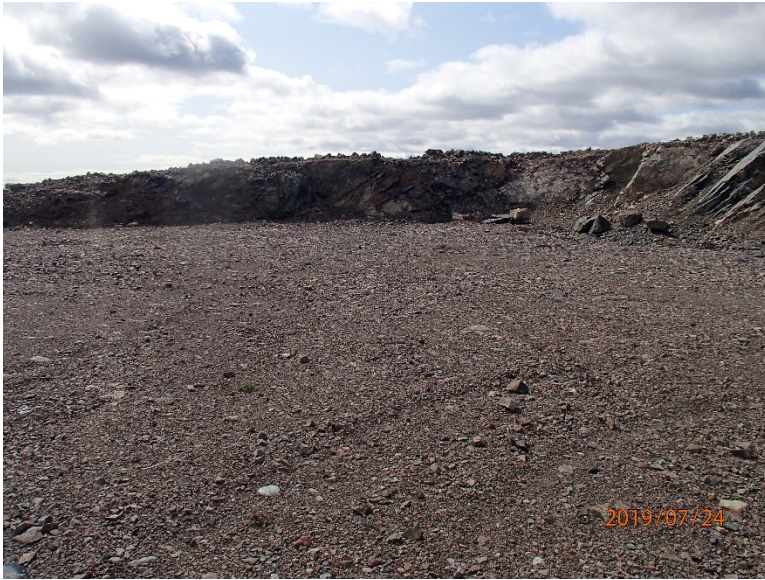
**Photograph F-1: Quarry 1 – km 5+200**

**Description:** Rocks walls are generally clean and stable.

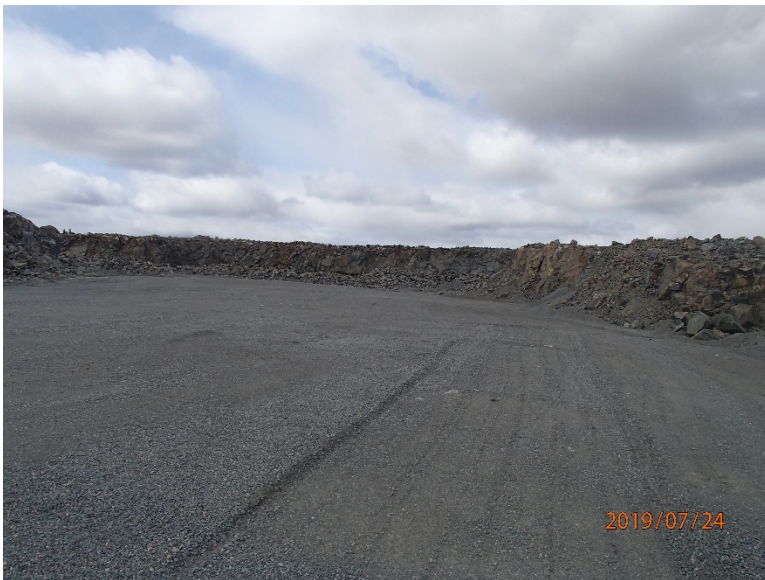
**Photograph F-2: Quarry 2 – km 13+250**

**Description:** The wall is mostly clean. One steep area is unstable and would require cleaning if operations resume.

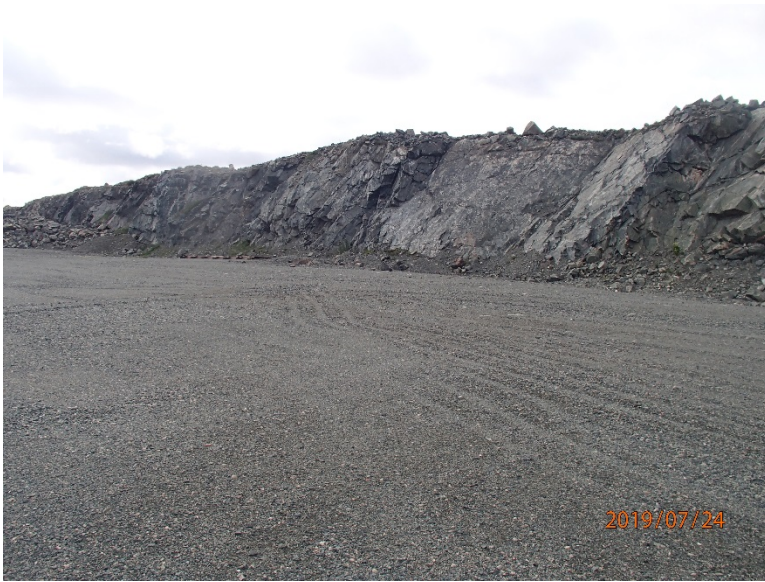
**Photograph F-3: Quarry 3 – km 23+700**

**Description:** View of west wall. In good and stable condition but would need additional cleaning locally.

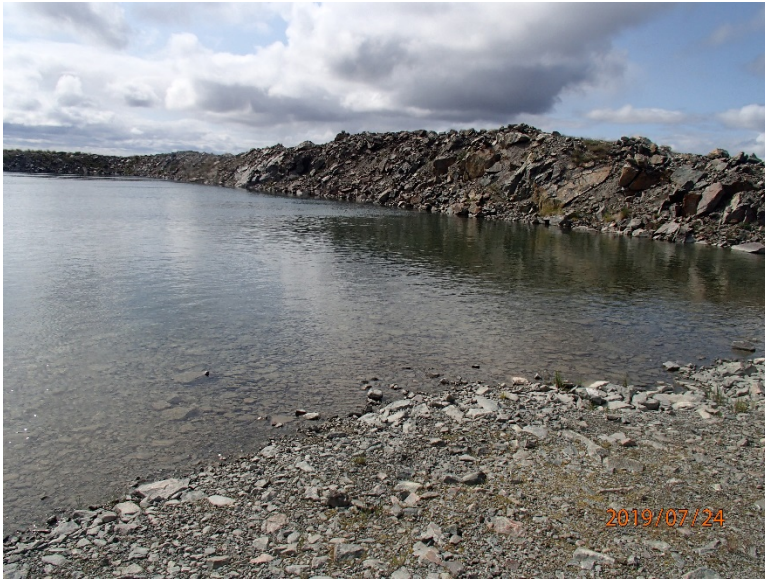
**Photograph F-5: Quarry 4 – km 31+300**

**Description:** Quarry flooded. In good condition.

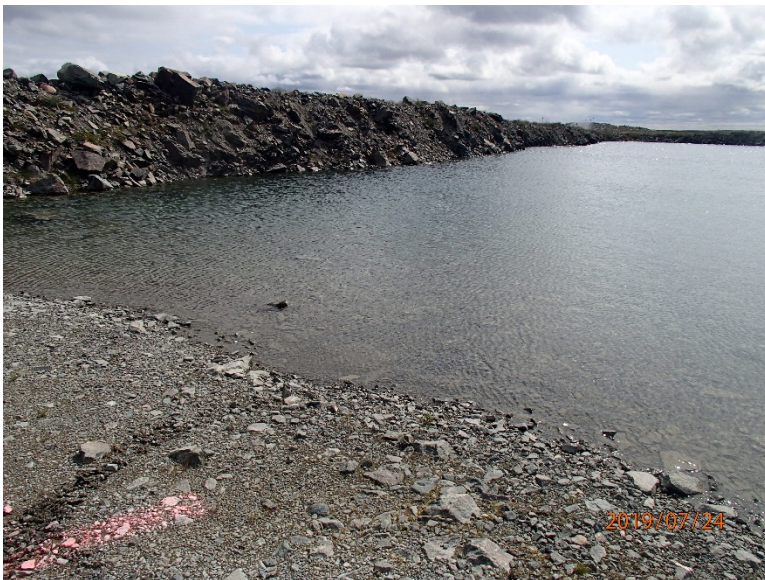
**Photograph F-6: Quarry 4 – km 31+300**

**Description:** Quarry flooded. In good condition.

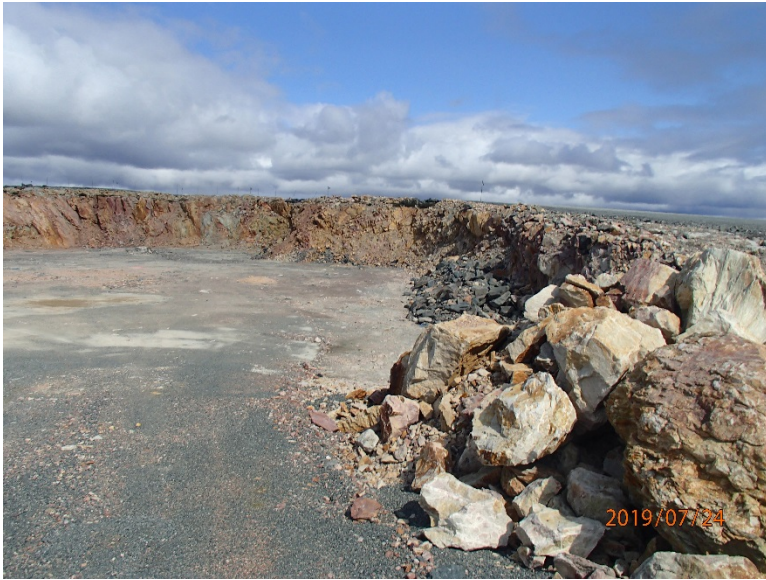
**Photograph F-7: Quarry 5 – km 34+650**

**Description:** View of north and east walls. Rock walls are in good and stable condition, except for a small portion on the east side.

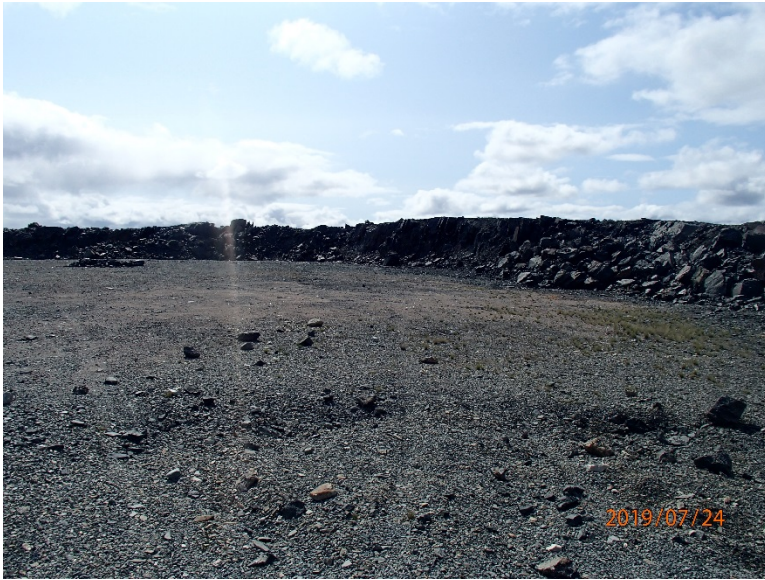
**Photograph F-9: Quarry 6 – km 36+470**

**Description:** View of south and west walls. In good condition.
