# **Meadowbank 2019 Annual Geotechnical Inspection**

# 2019 Annual Geotechnical Inspection

*Meadowbank Gold Mine, Nunavut*

19123067-1588-R-Rev0

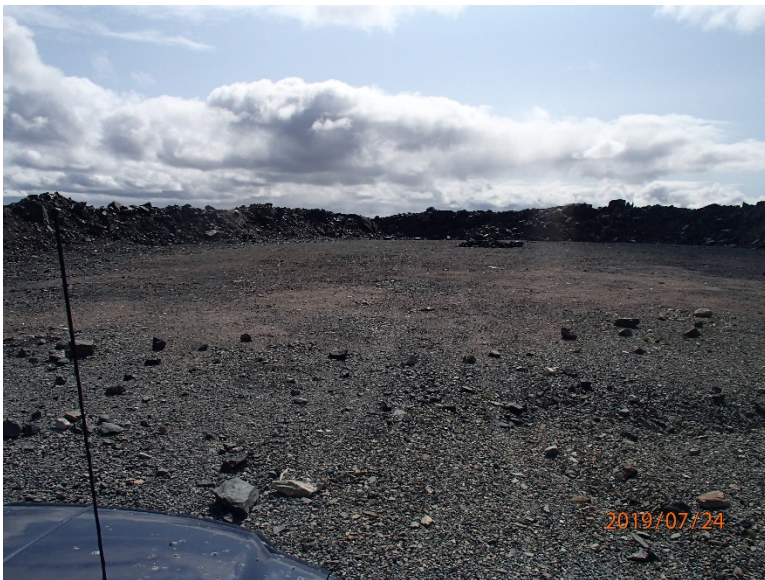
**Photograph F-10: Quarry 6 – km 36+470**

**Description:** View of south and east walls. In good condition.

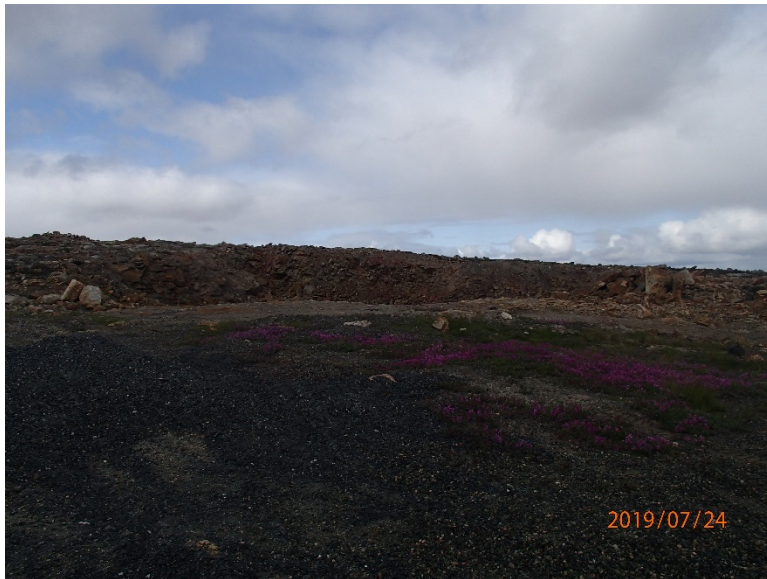
**Photograph F-11: Quarry 7 – km 39+800**

**Description:** The quarry walls are in unstable condition. Scaling is recommended before resuming activities..

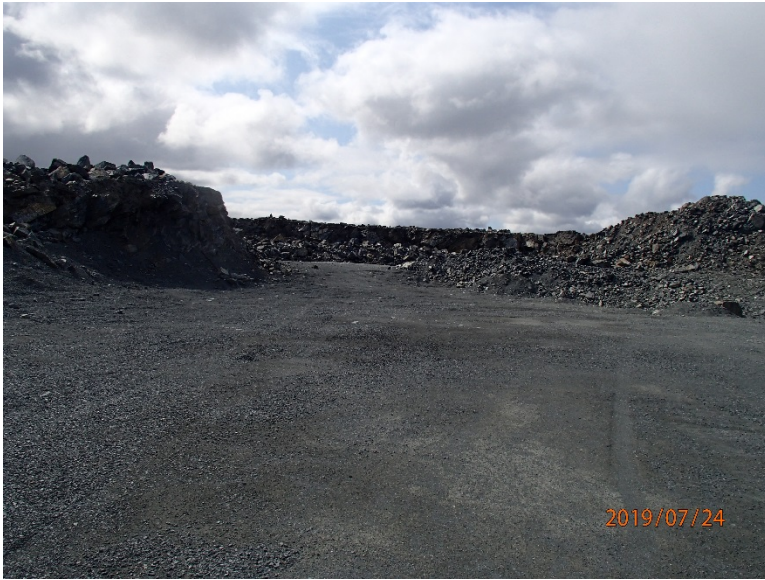
**Photograph F-13: Quarry 8 – km 42+950**

**Description:** View of south wall. Presence of loose blocks.

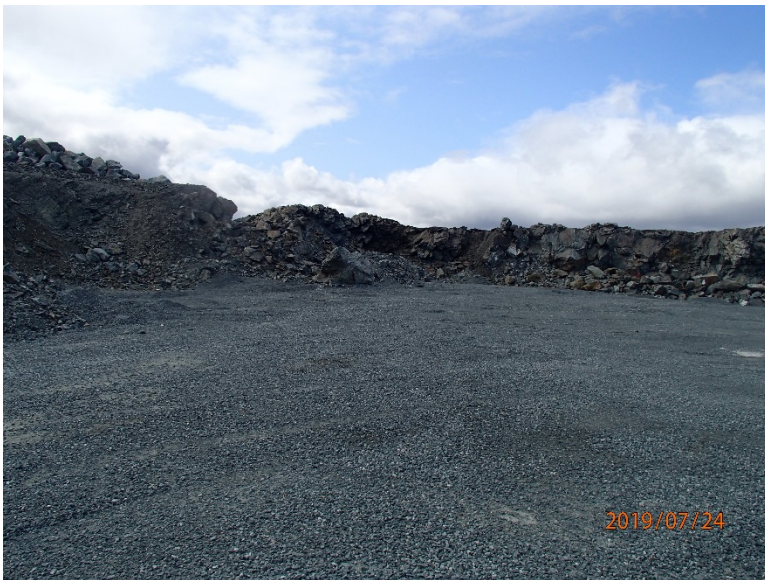
**Photograph F-14: Quarry 9 – km 44+600**

**Description:** View of west and south walls. Presence of loose blocks at the base of the wall.

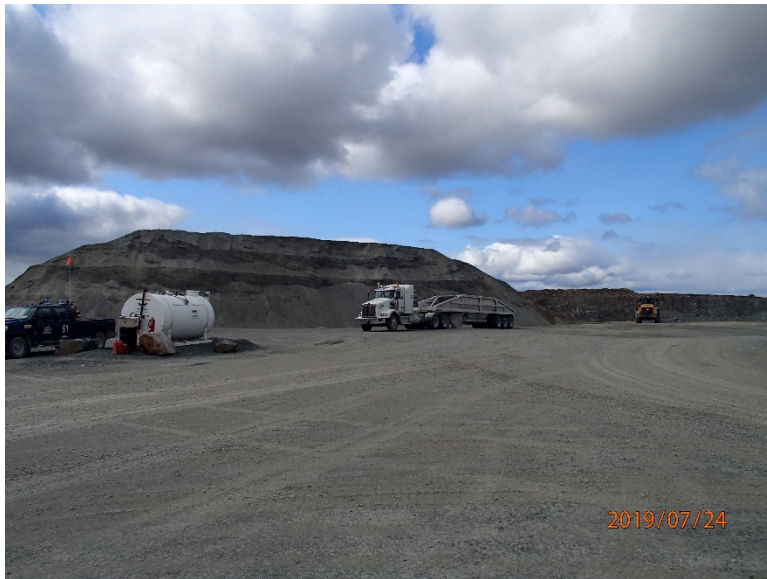
**Photograph F-17: Quarry 11 – km 53+500**

**Description:** View of west and north walls. In good condition.

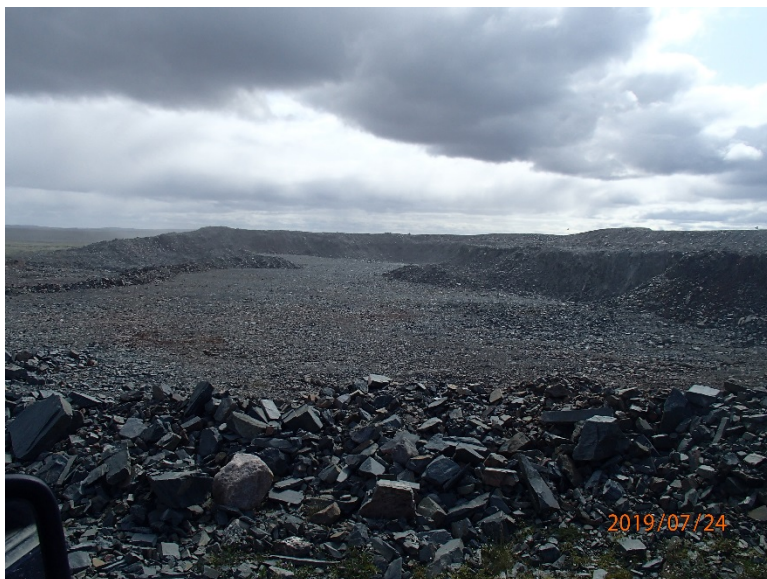
**Photograph F-18: Quarry 12 – km 58+300**

**Description:** In good condition.

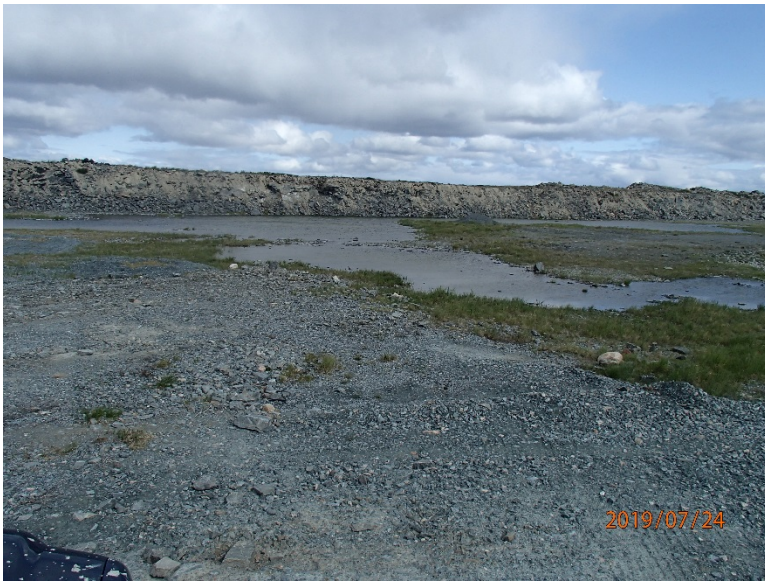
**Photograph F-19: Quarry 13 – km 62+350**

**Description:** View of the south and east walls. In general good condition.

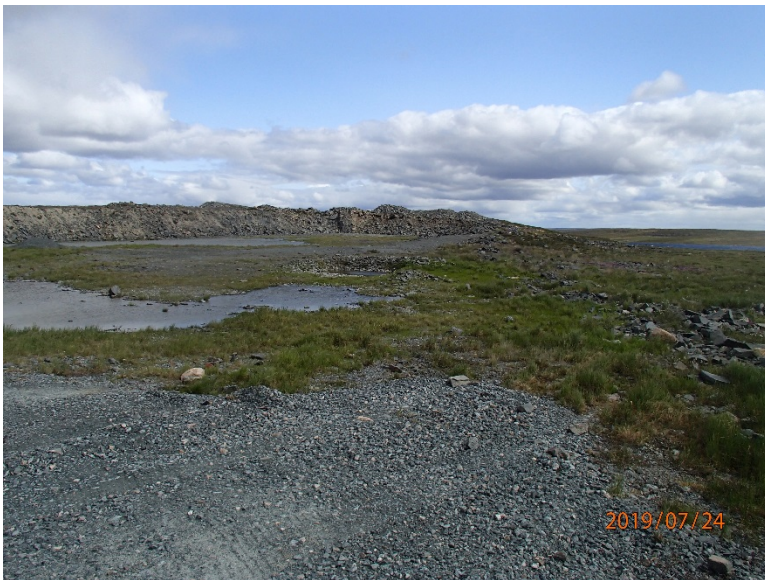
**Photograph F-20: Quarry 13 – km 62+350**

**Description:** View of the west and north walls. In general good condition.

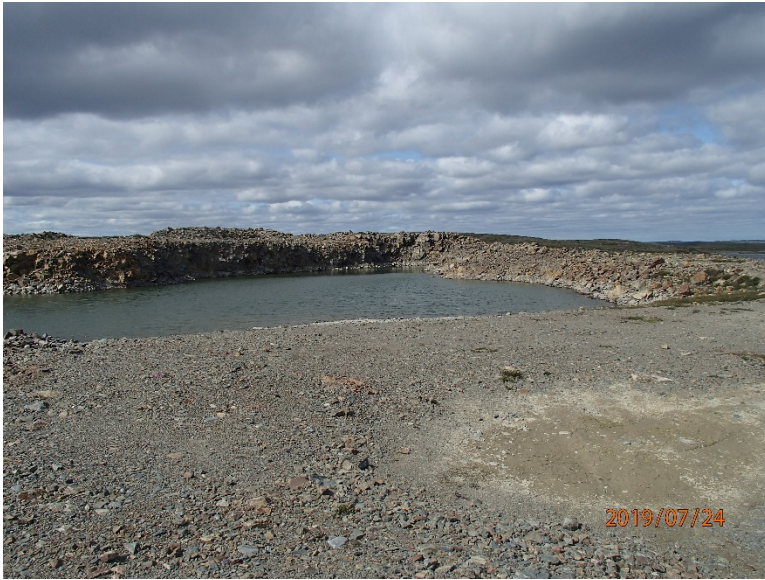
**Photograph F-21: Quarry 14 – km 65+700**

**Description:** View of north and west walls. Quarry flooded.

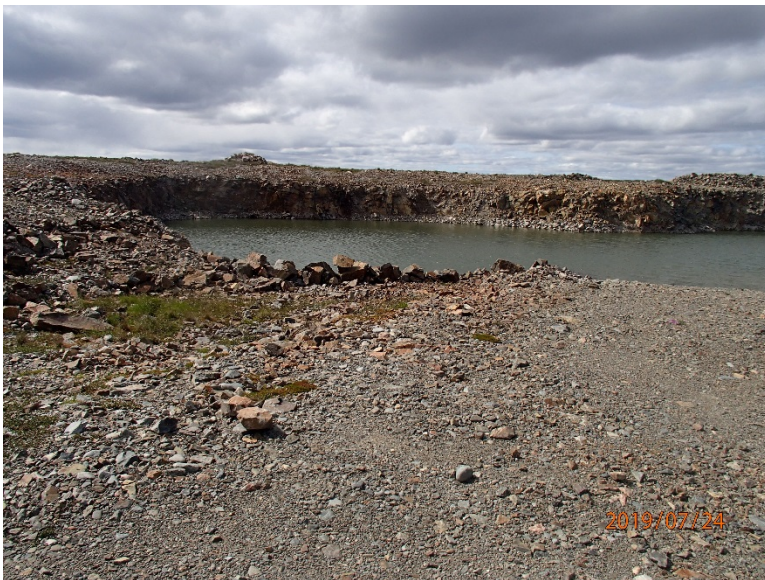
**Photograph F-22: Quarry 14 – km 65+700**

**Description:** View of west and south walls. Quarry flooded.

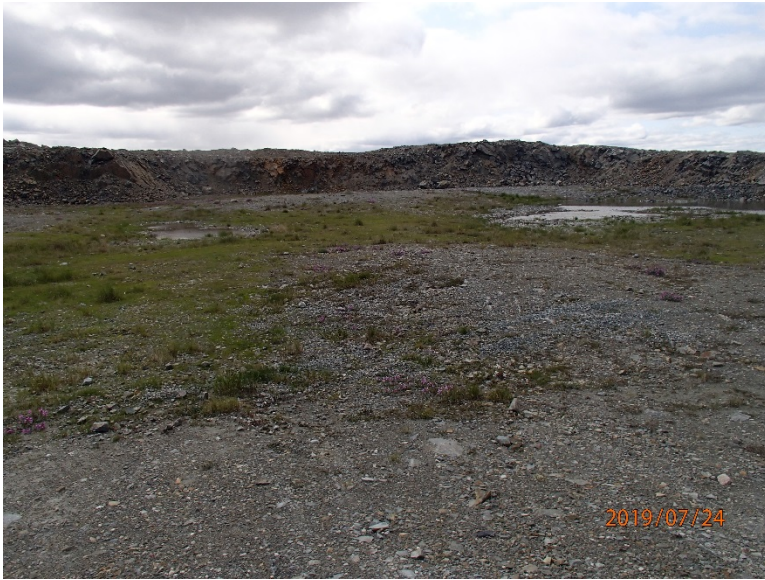
**Photograph F-23: Quarry 15 – km 67+600**

**Description:** Steep rock wall in generally stable condition.

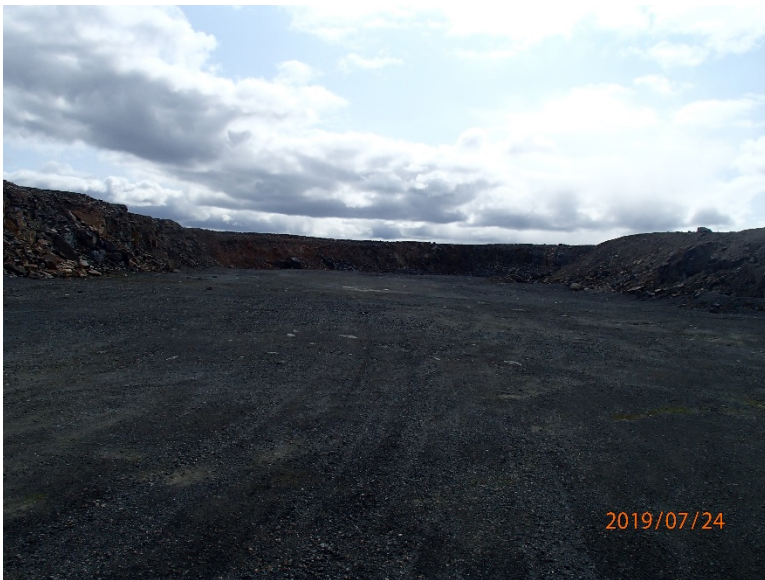
**Photograph F-24: Quarry 16 – km 70+400**

**Description:** View of the south and west walls. Presence of loose rocks on steep wall but in general good condition.

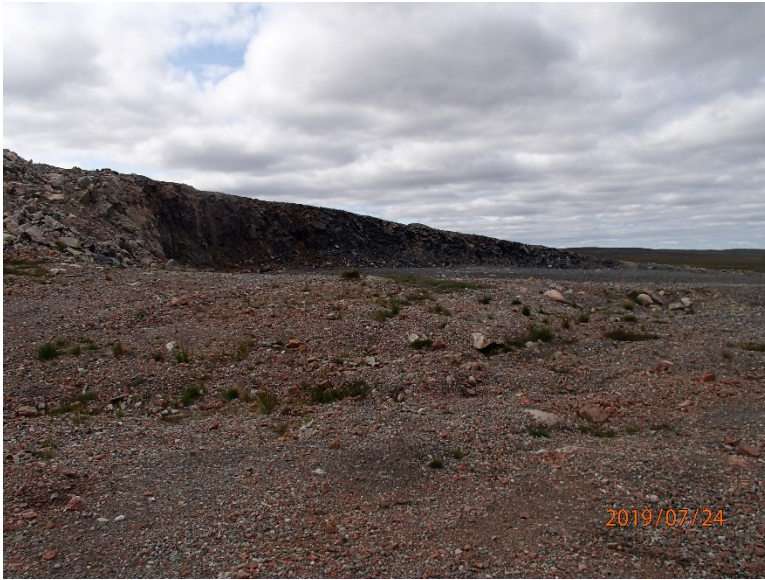
**Photograph F-25: Quarry 18 – km 80+200**

**Description:** View of the south wall. In general good condition, south wall is high (about 8 m) with some loose blocks

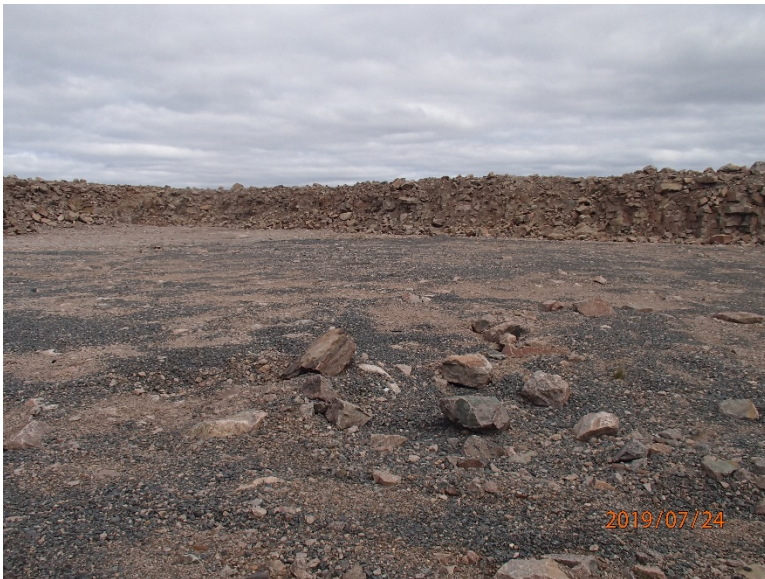
**Photograph F-26: Quarry 20 – km 89+550**

**Description:** In good condition.

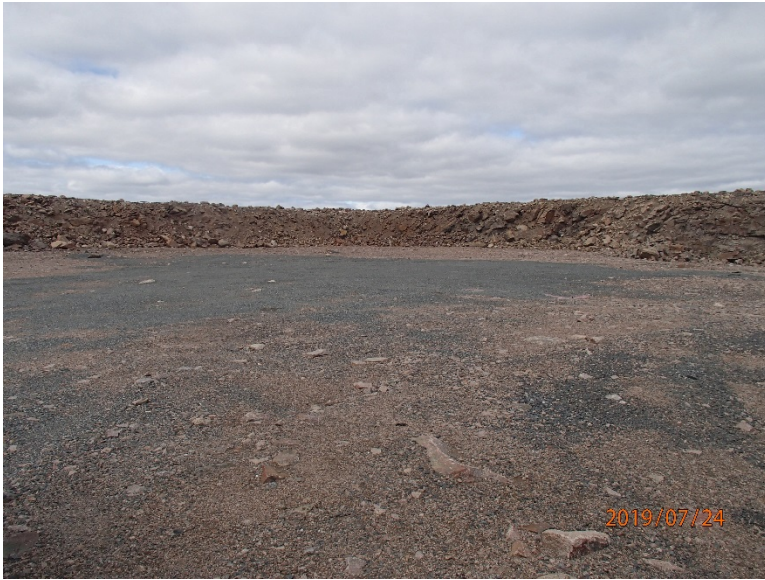
**Photograph F-27: Quarry 20 – km 89+550**

**Description:** In good condition.

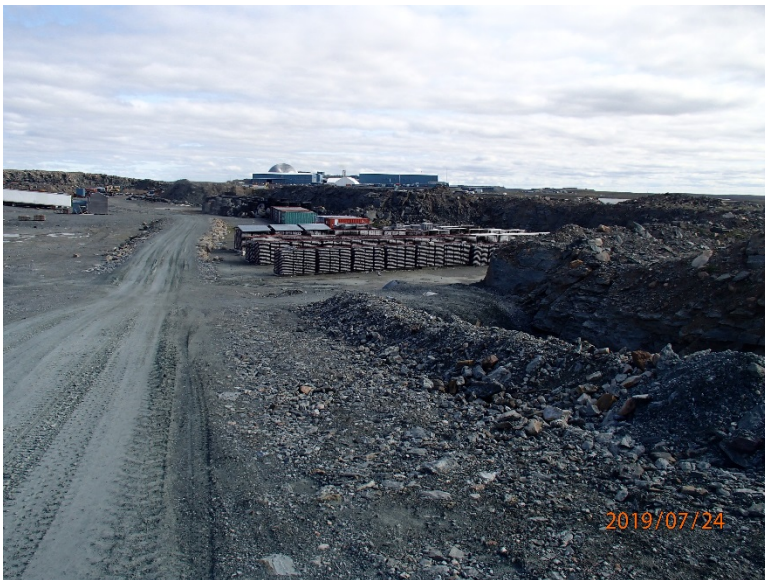
**Photograph F-28: Quarry 23 (Airstrip Quarry)**

**Description:** Loose rocks on top of steep wall (bermed). The quarry is used to store equipment.

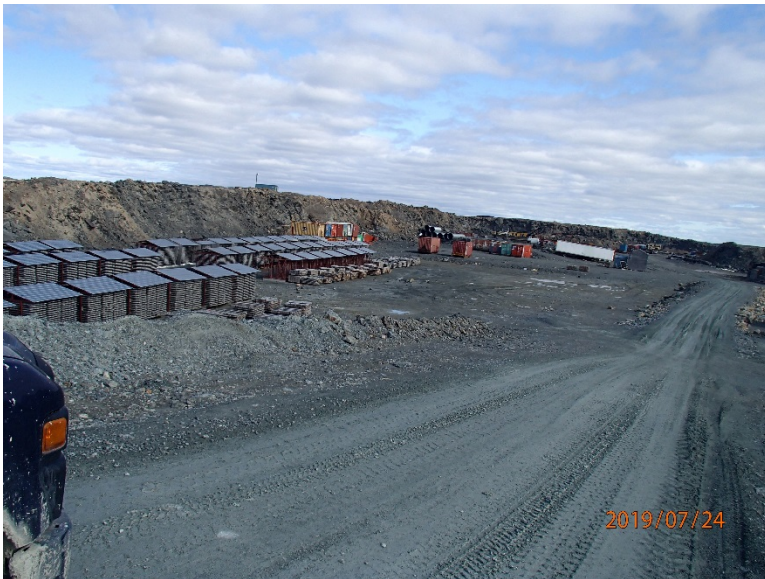
**Photograph F-29: Quarry 23 (Airstrip Quarry)**

**Description:** Loose rocks on top of steep wall (bermed). The quarry is used to store equipment.

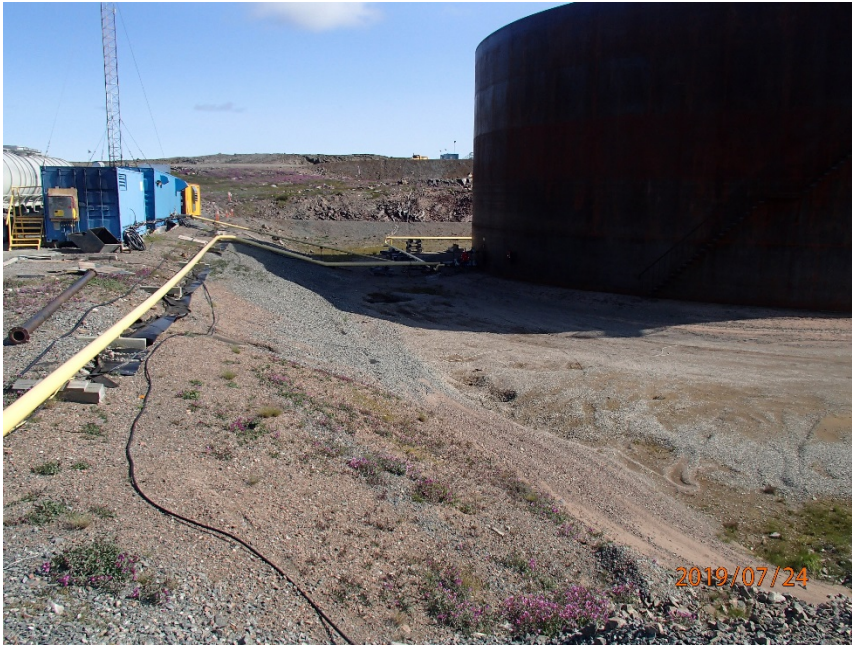
**Photograph G1-1 Baker Lake Tank Farm**

**Description:** From the south side of Tank 1, looking southeast at Tanks 1, 2, 3, and 4. Presence of water ponding.

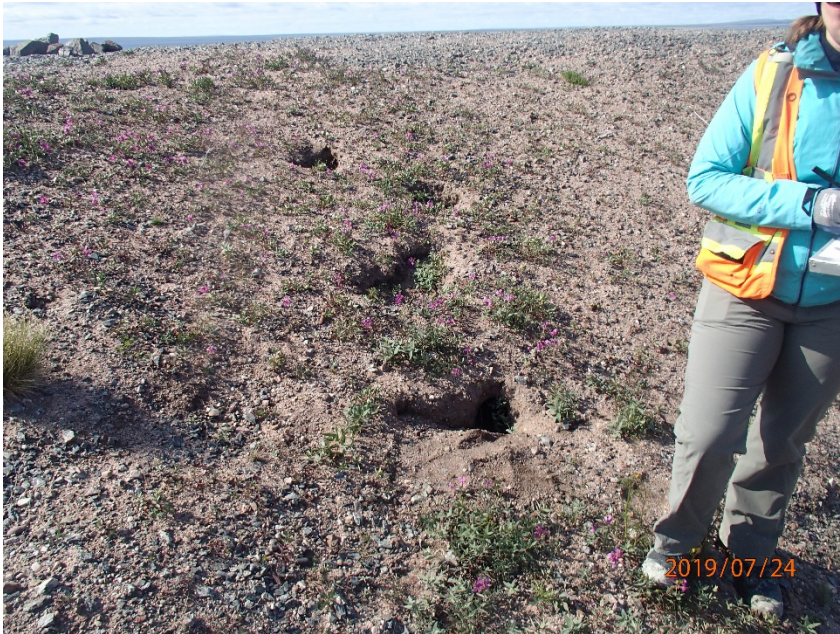
**Photograph G15 Baker Lake Tank Farm**

**Description:** Looking southwest toward the south wall of the tank farm. Presence of animal burrows.

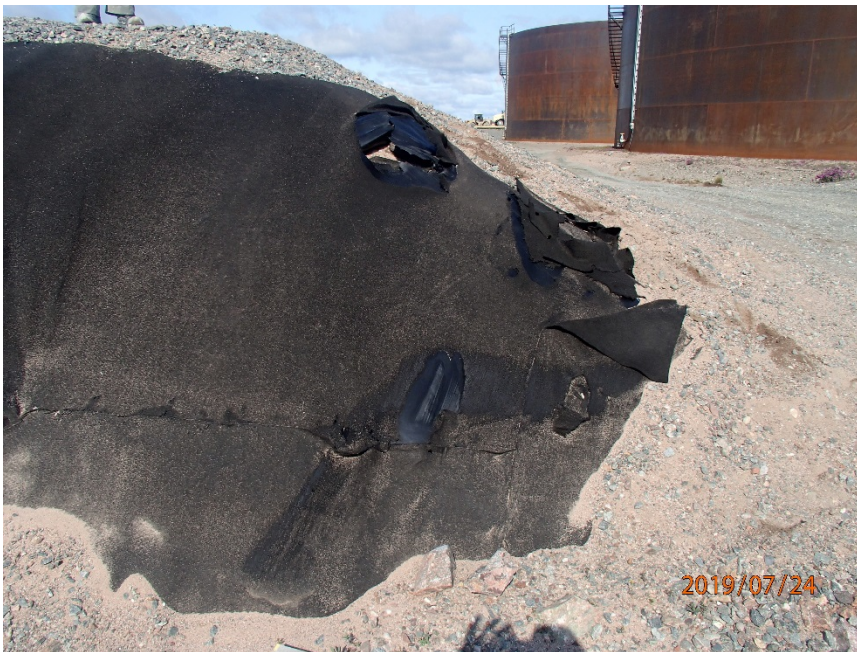
**Photograph G1-6 Baker Lake Tank Farm**

**Description:** Looking southwest. The geomembrane between the south side of tank 2 and 3 is damaged.

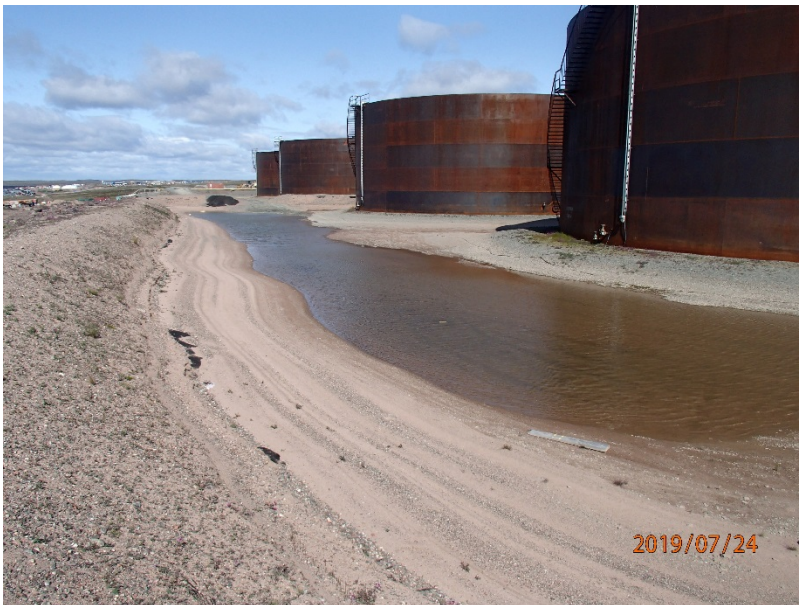
**Photograph G1-8 Baker Lake Tank Farm**

**Description:** From the southwestern corner of Tank 3 looking southeast. View of exposed LLDPE and water ponding.

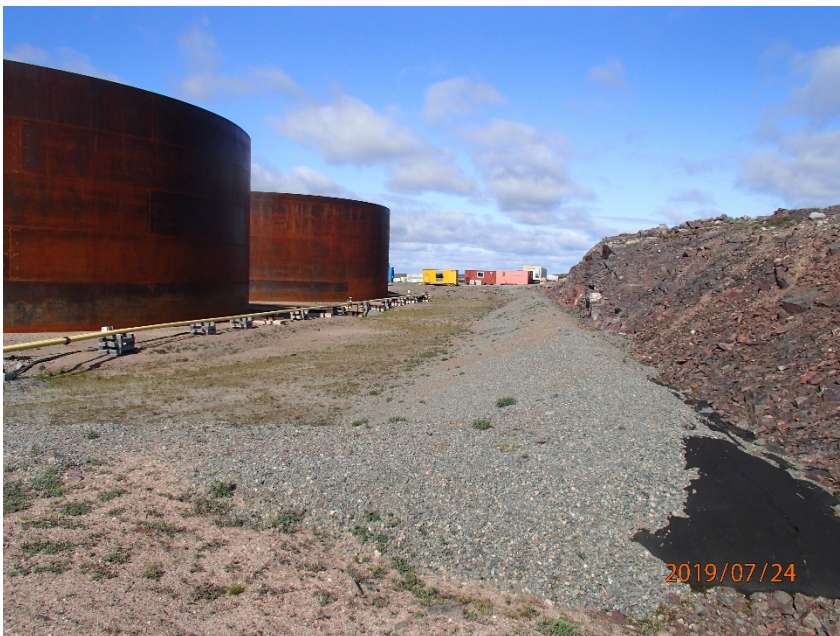
**Photograph G1-12 Baker Lake Tank Farm**

**Description:** From the northern side of Tank 4, looking northwest toward Tanks 4, 3, 2, and 1. Presence of exposed liner.

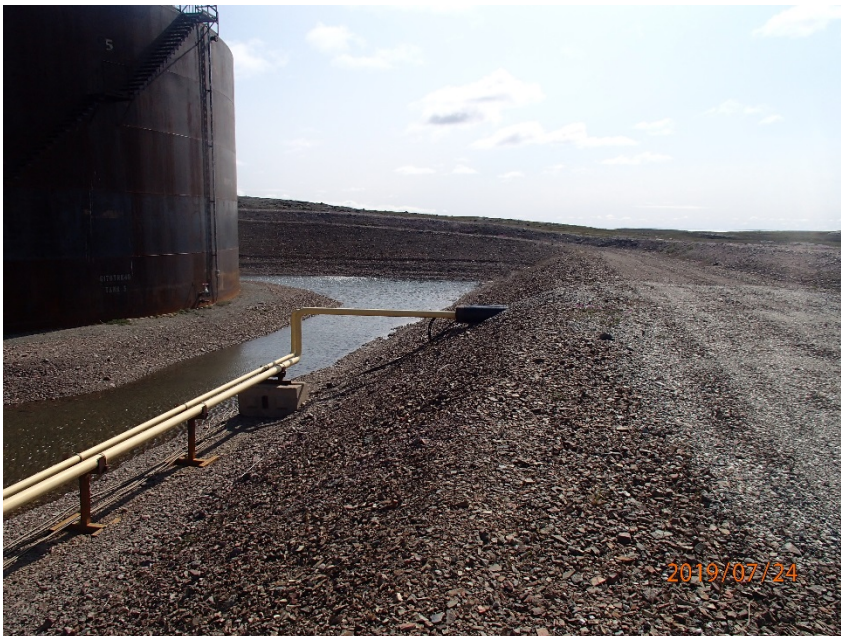
**Photograph G1-16 Baker Lake Tank Farm**

**Description:** Looking north between Tanks 5 and 6. Presence of water ponding.

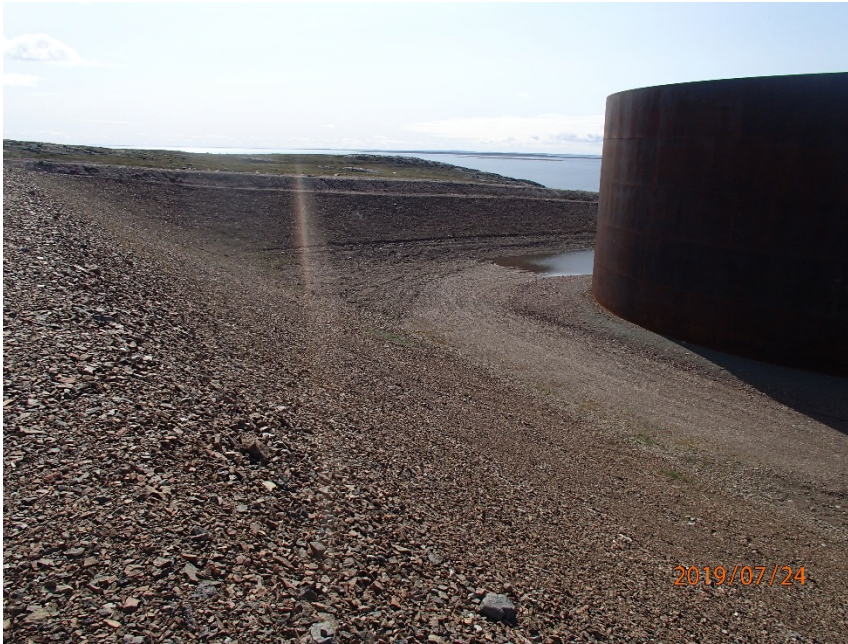
**Photograph G1-17 Baker Lake Tank Farm**

**Description:** Looking northeast at the southern side of Tank 6. Presence of water ponding.

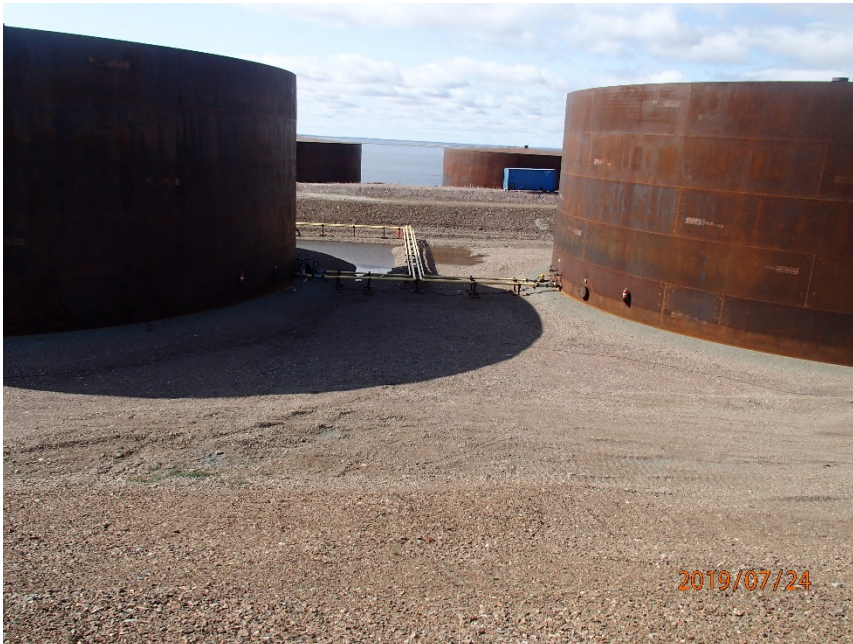
**Photograph G1-18 Baker Lake Tank Farm**

**Description:** Looking southeast at the northeastern side of Tank 6. Presence of water ponding.

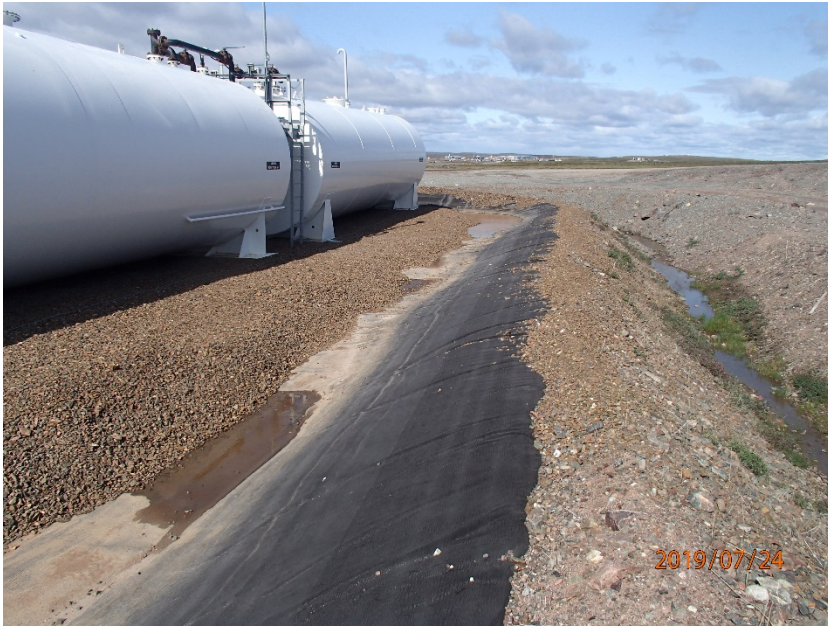
**Photograph G1-21 Baker Lake Tank Farm**

**Description:** From the northeastern corner of the Jet A fuel tanks looking south. Presence of exposed geomembrane.

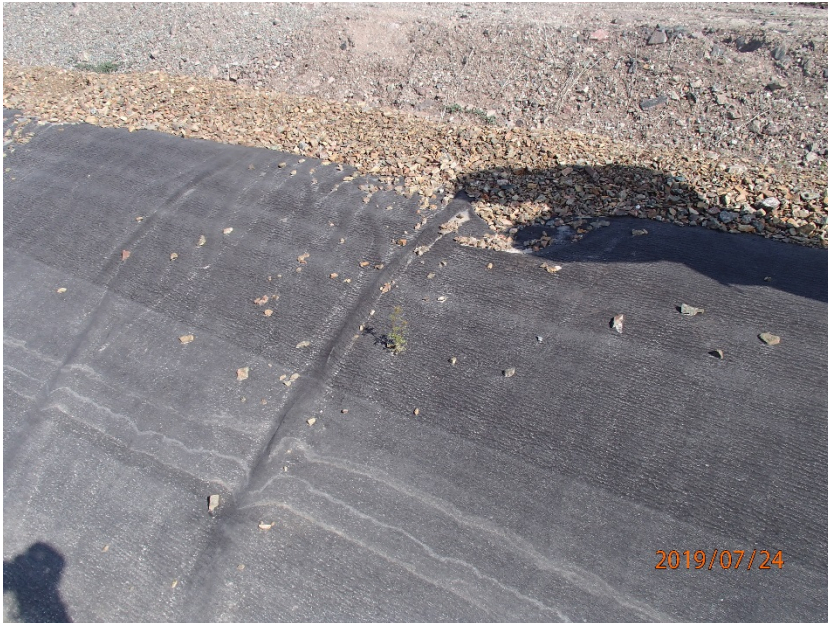
**Photograph G1-22 Baker Lake Tank Farm**

**Description:** From the northeastern corner of the Jet A fuel tanks looking west. Presence of exposed geomembrane.

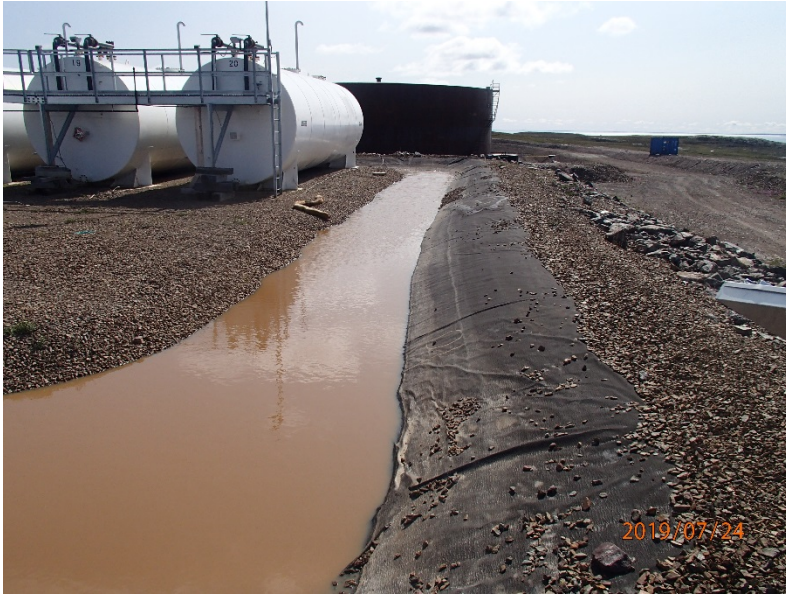
**Photograph G1-23 Baker Lake Tank Farm**

**Description:** From the northern side the Jet A fuel tanks looking southwest. Presence of a hole in the geomembrane.

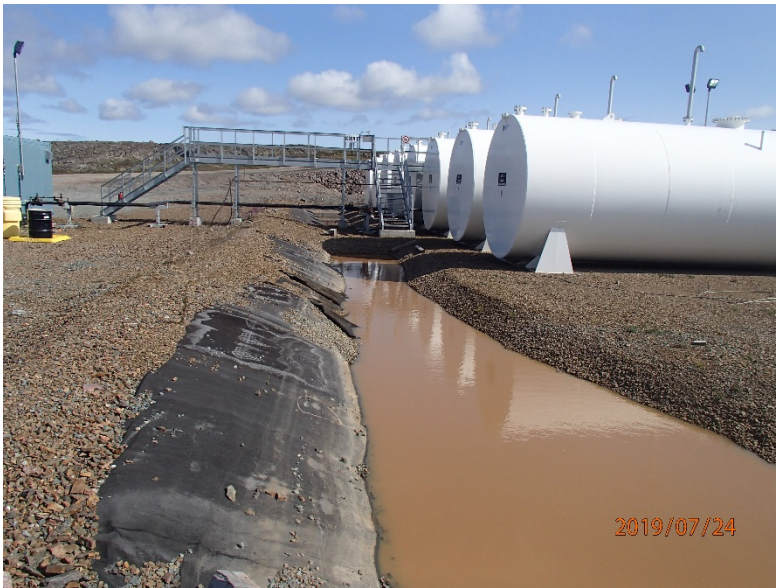
**Photograph G1-24 Baker Lake Tank Farm**

**Description:** From the southwestern corner of the Jet A fuel tanks looking east. Presence of exposed geomembrane and water ponding.

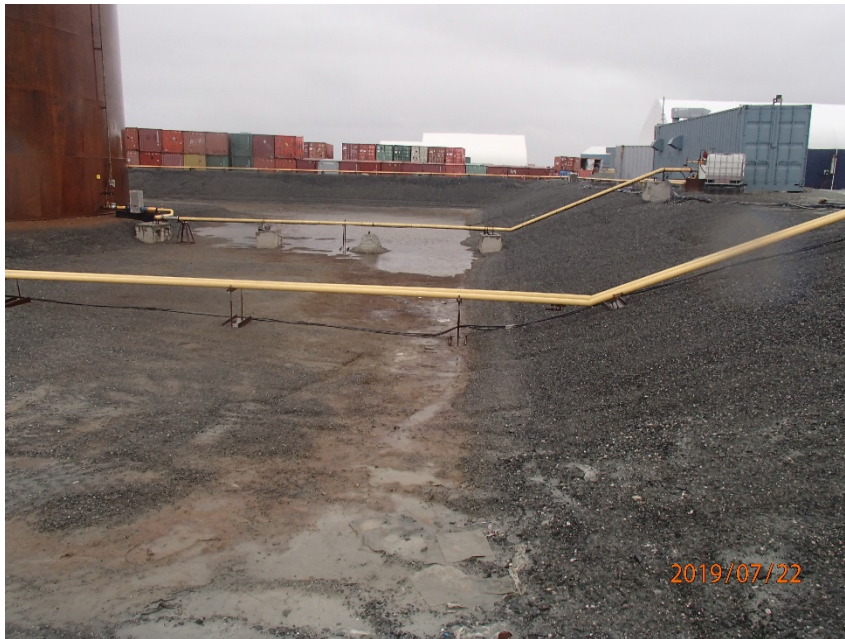
**Photograph G2-5 Meadowbank Tank Farm**

**Description:** From the eastern side looking southwest. Presence of water ponding. A pump is installed.

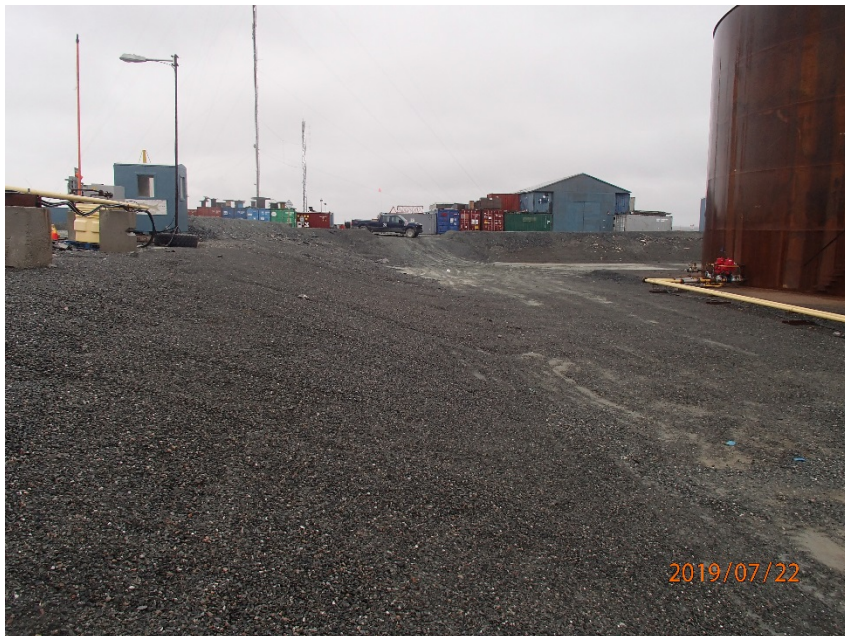
**Photograph G2-6 Meadowbank Tank Farm**

**Description:** Looking northeast from the southern corner. Accumulation of water in the eastern corner.

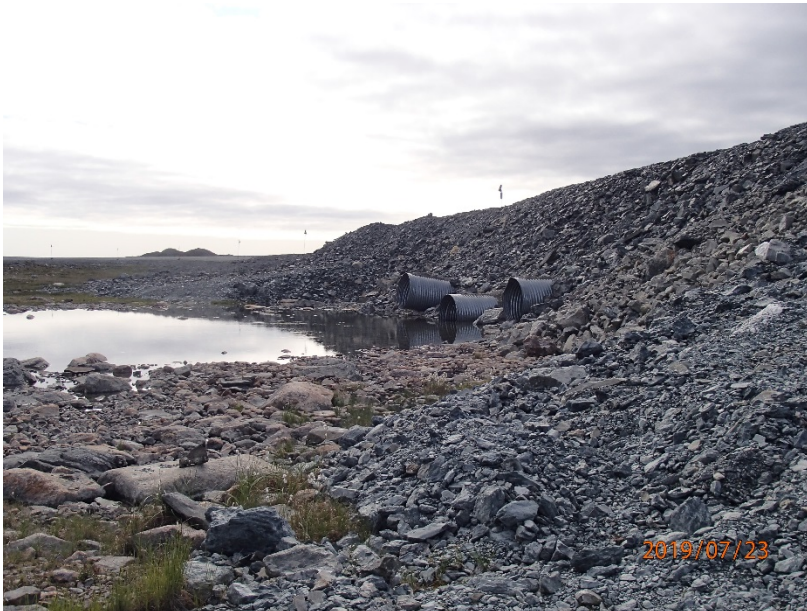
**Photograph H1-2 Vault Road Culverts**

**Description:** Looking at the outlet of the three culverts located on Vault Road at 640964E/7217466N. All of them are deformed in the middle.

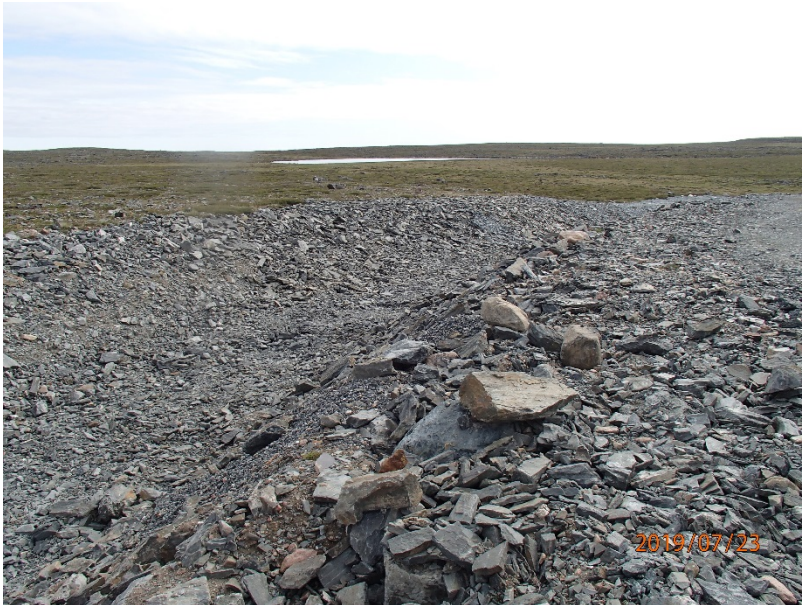
**Photograph H2-7 Diversion Ditch and its Sediment and Erosion Protection Structure**

**Description:** From the northern diversion ditch looking southeast.

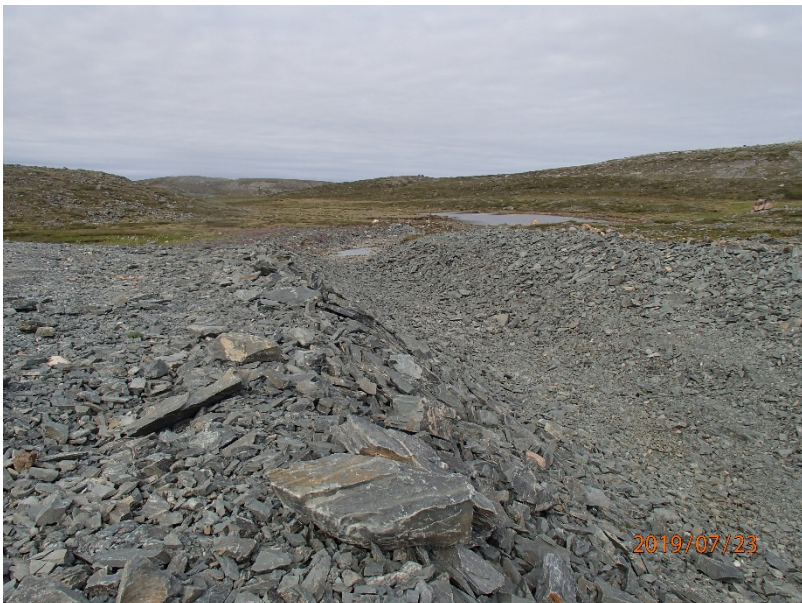
**Photograph H2-8 Diversion Ditch and its Sediment and Erosion Protection Structure**

**Description:** From the northern diversion ditch looking west.

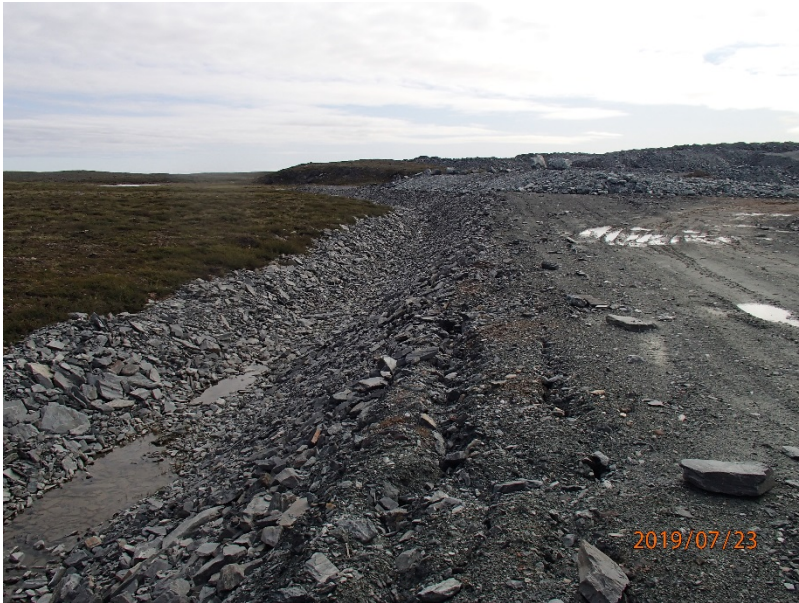
**Photograph H2-9 Diversion Ditch and its Sediment and Erosion Protection Structure**

From the northern diversion ditch looking east.

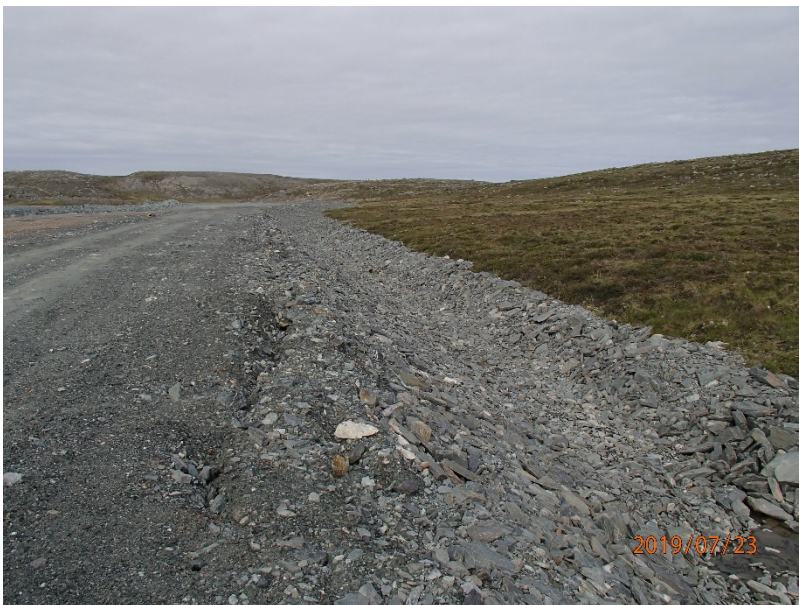
**Photograph H2-10 Diversion Ditch and its Sediment and Erosion Protection Structure**

From the northern diversion ditch looking west.

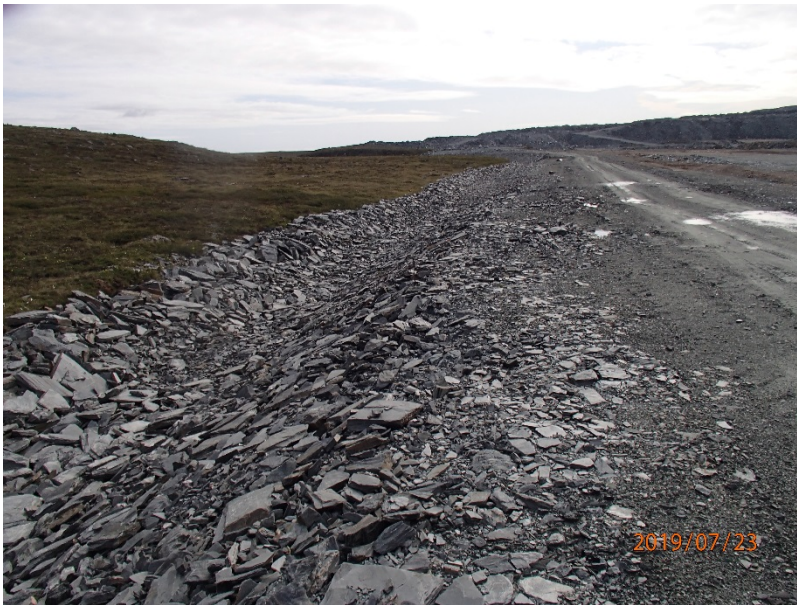
**Photograph H2-11** Diversion Ditch and its Sediment and Erosion Protection Structure

**Description:** From the northern diversion ditch looking east.

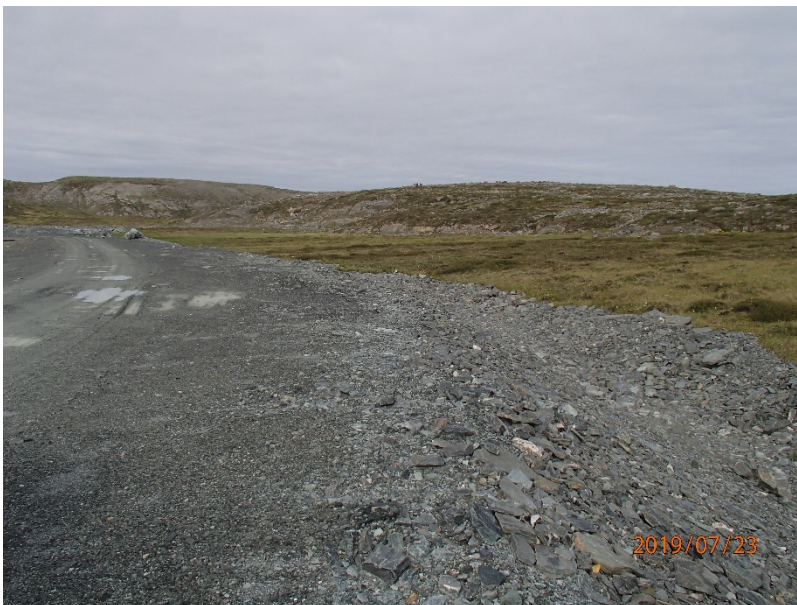
**Photograph H2-12** Diversion Ditch and its Sediment and Erosion Protection Structure

**Description:** From the northern diversion ditch looking west.

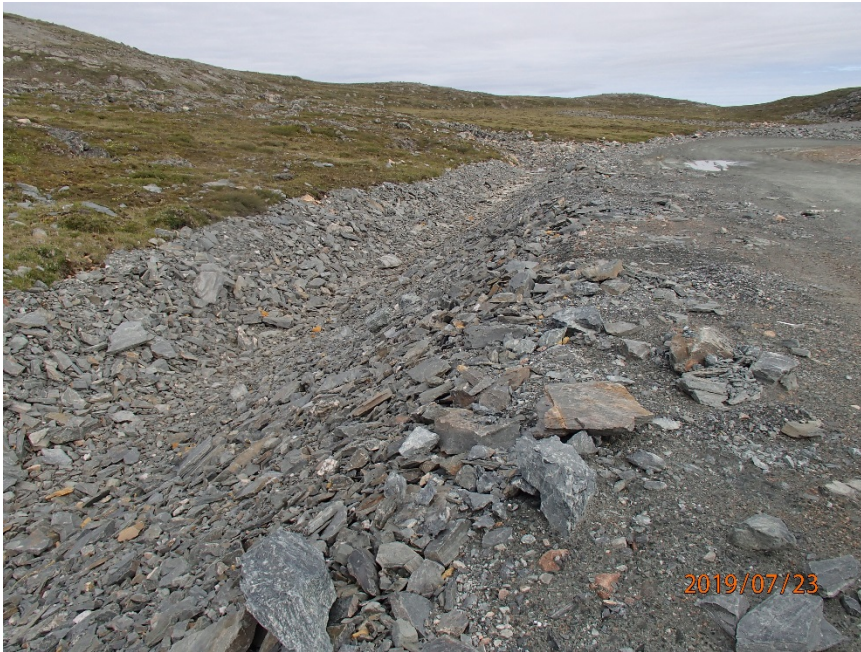
**Photograph H2-13 Diversion Ditch and its Sediment and Erosion Protection Structure**

**Description:** From 637281E/7216790N, looking north. View of the western diversion ditch.

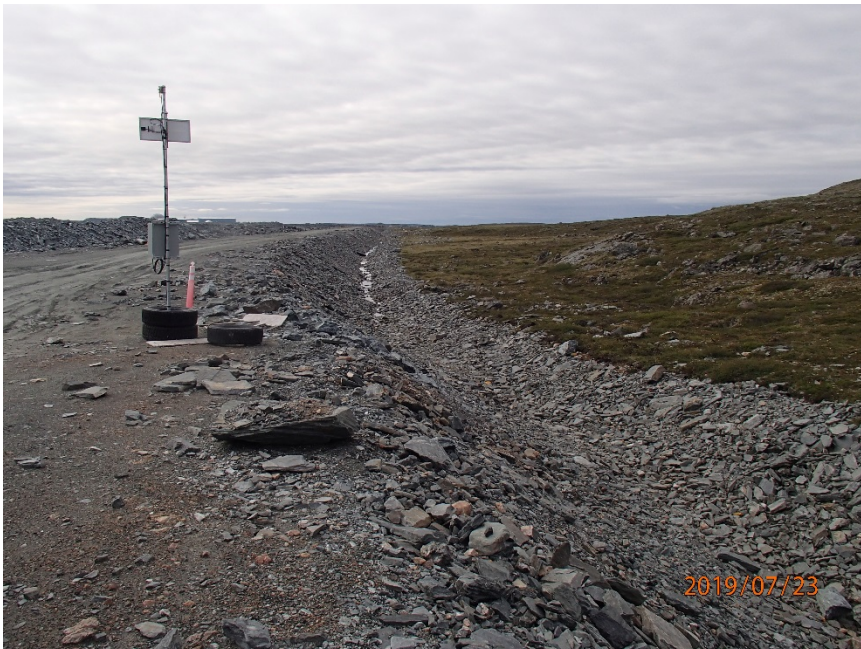
**Photograph H2-14 Diversion Ditch and its Sediment and Erosion Protection Structure**

**Description:** From 637281E/7216790N, looking south at the western diversion ditch.

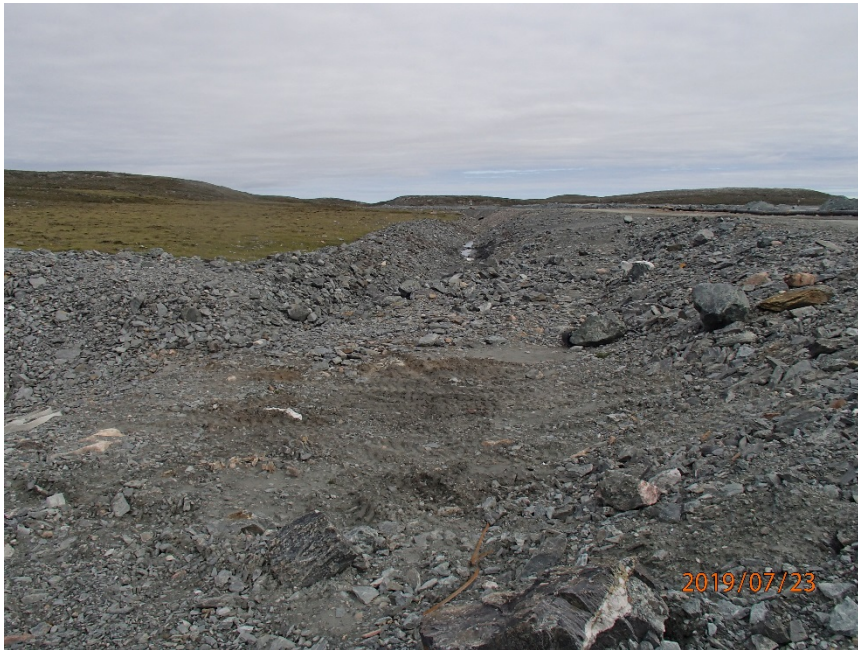
**Photograph H2-15 Diversion Ditch and its Sediment and Erosion Protection Structure**

**Description:** From 637251E/7216171N, looking north at the western diversion ditch.

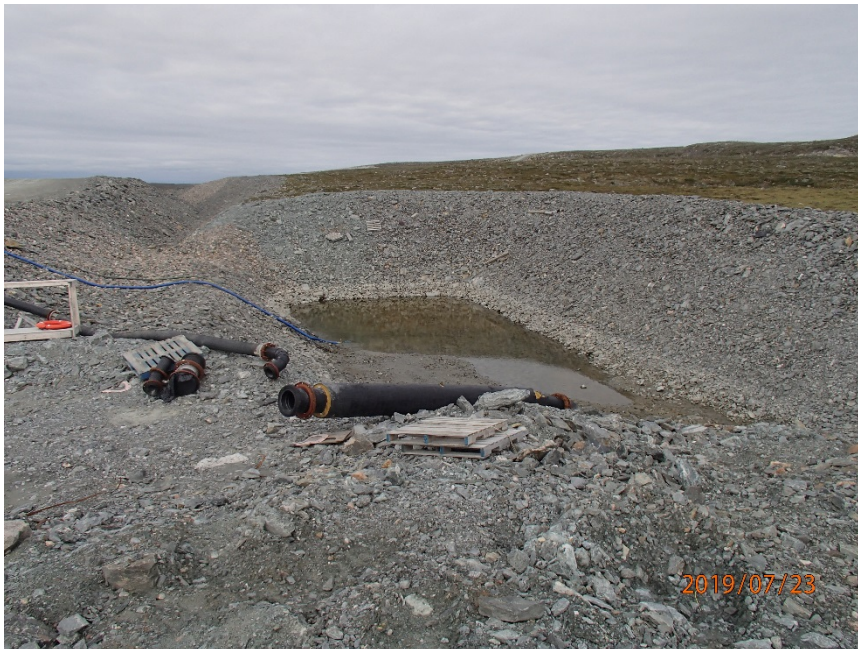
**Photograph H2-16 Diversion Ditch and its Sediment and Erosion Protection Structure**

**Description:** From 637251E/7216171N, looking west at the western diversion ditch and its retention basin.

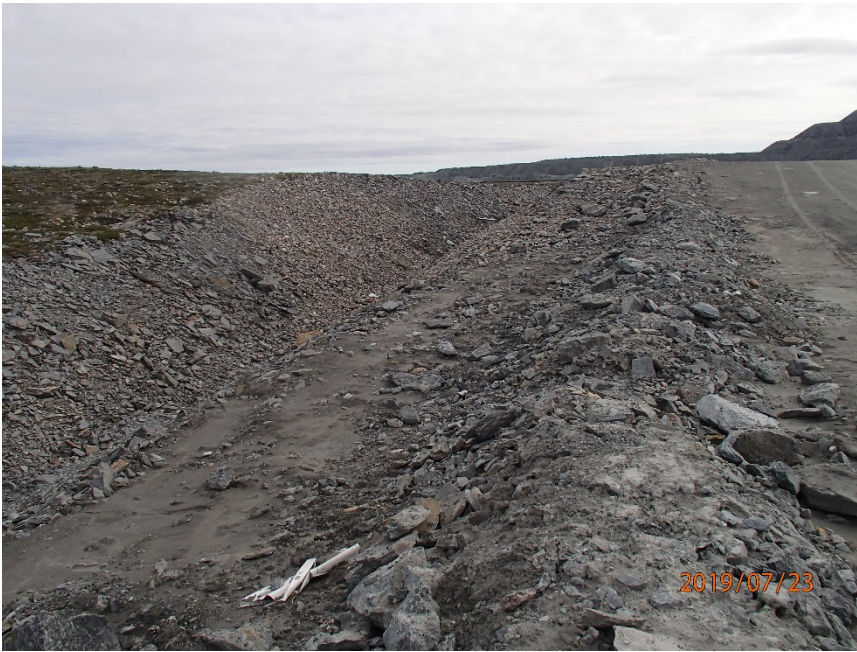
**Photograph H2-17** Diversion Ditch and its Sediment and Erosion Protection Structure

**Description:** From 637074E/7216157N, looking east at the western diversion ditch.
