# **Meadowbank 2019 Annual Geotechnical Inspection**

# 2019 Annual Geotechnical Inspection

*Meadowbank Gold Mine, Nunavut*

19123067-1588-R-Rev0

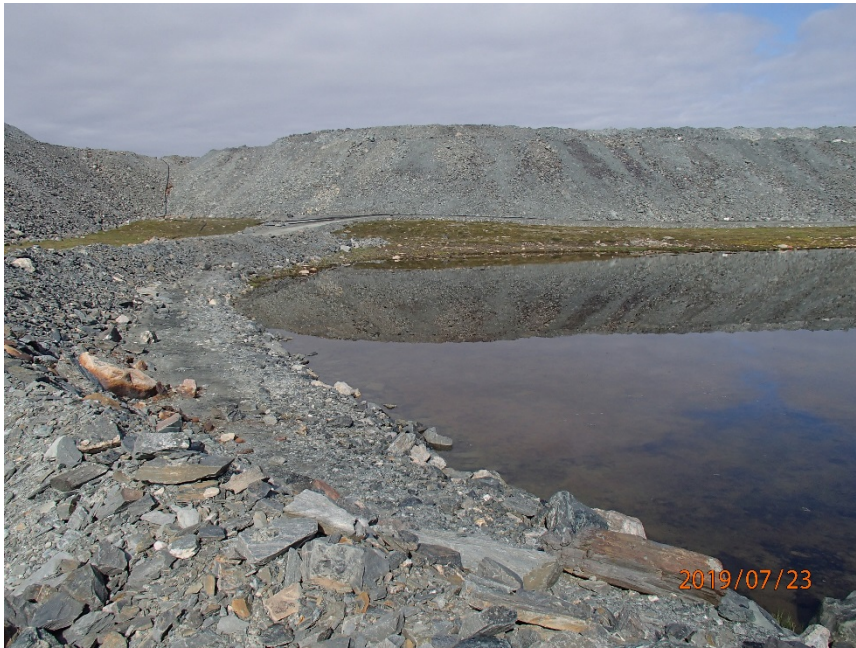
**Photograph H3-1 RSF Till Plug**

**Description:** From the south side of NP2 Lake (north of the diversion ditch) looking west at the RSF till plug.

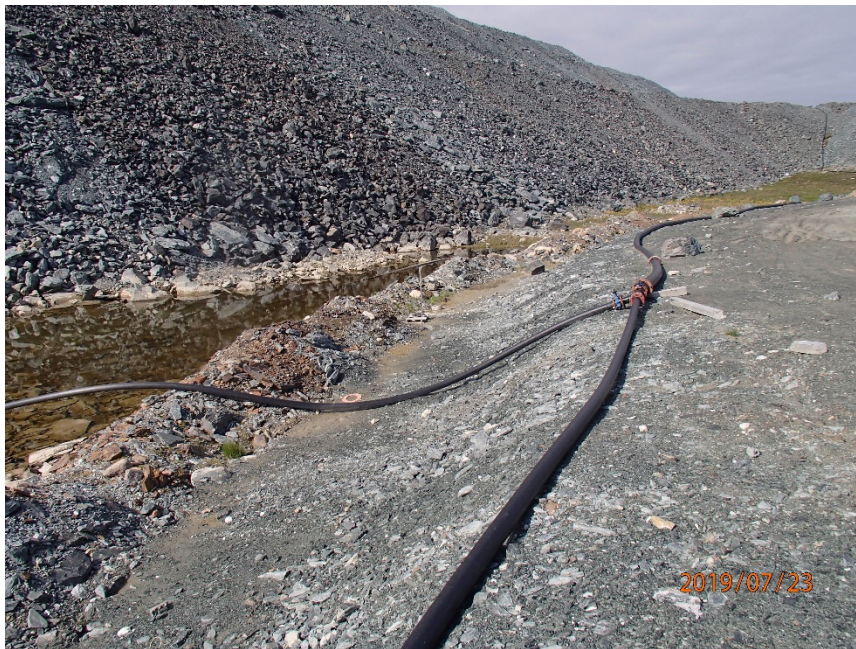
**Photograph H3-2 RSF Till Plug**

**Description:** From the south side of NP2 Lake (south of the diversion ditch) looking west at the RSF till plug.

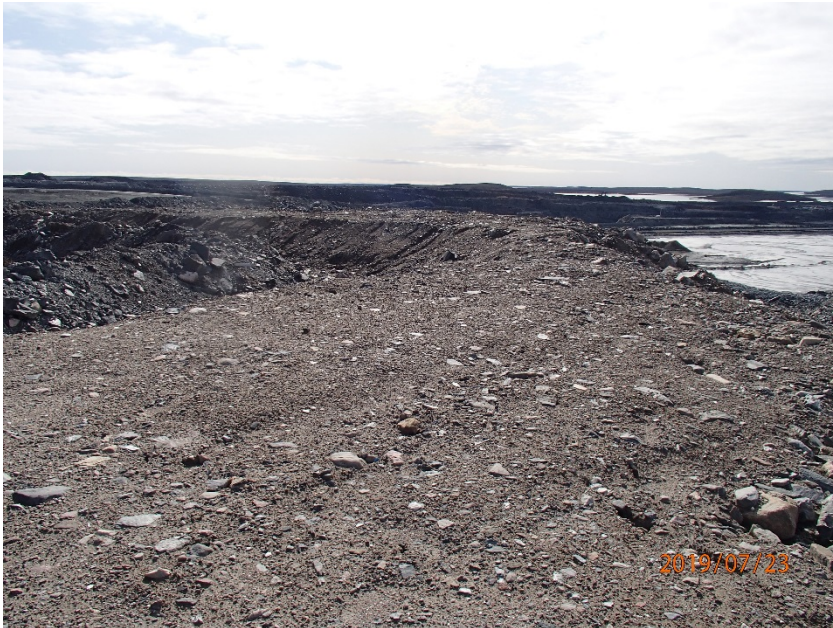
**Photograph H5-1 Contaminated Soil Storage and Bioremedial Landfarm Facility**

**Description:** From the northeast extremity of the South Cell, looking southeast at the Contaminated Soil Storage and Bioremedial Landfarm Facility. Signs of superficial slope failure are disappearing.

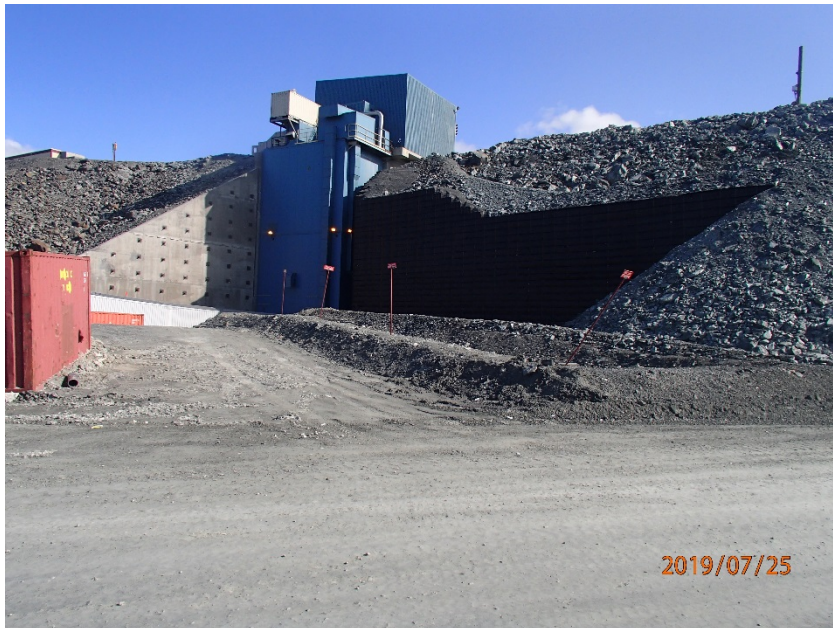
**Photograph H6-1 Crusher Retaining Wall**

**Description:** From the access road, looking southeast at the retaining wall.

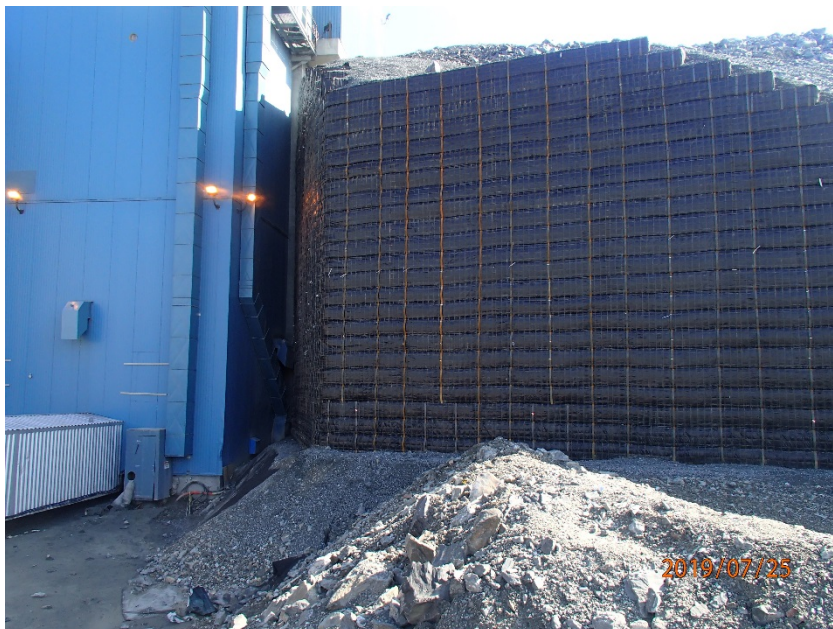
**Photograph H6-2 Crusher Retaining Wall**

**Description:** From the base of the retaining wall, looking south.

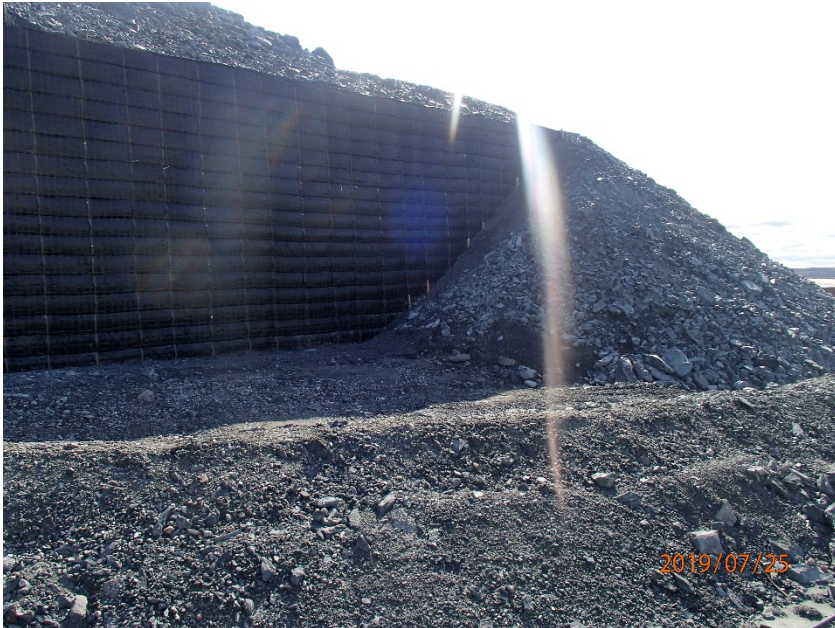
**Photograph H6-3 Crusher Retaining Wall**

**Description:** From the base of the retaining wall, looking southwest.

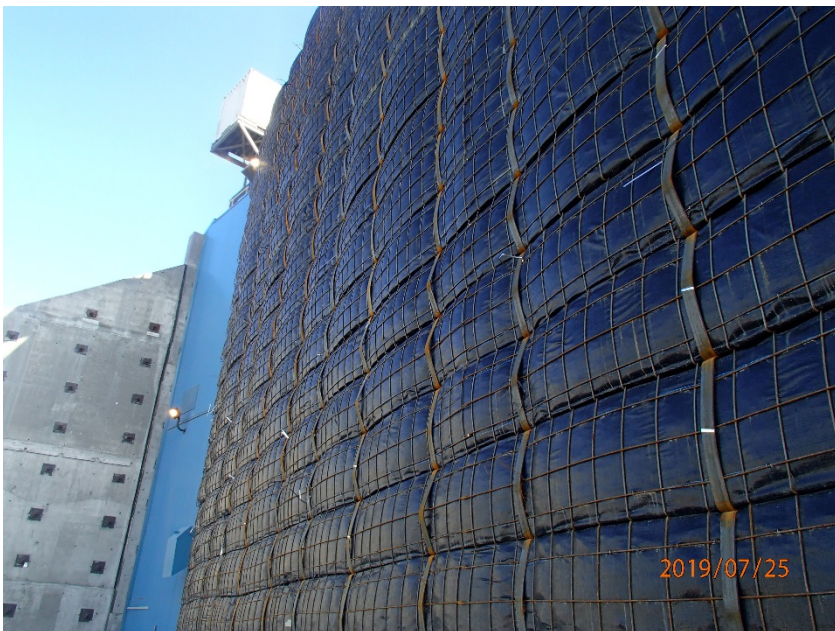
**Photograph H6-4 Crusher Retaining Wall**

**Description:** From the base of the retaining wall, looking southeast.
