**Report: 2017 Annual Geotechnical Inspection**

February 2018

# 2017 Annual Geotechnical Inspection Meadowbank Gold Mine, Nunavut

**Report Number:** 1784282-1574-RPT-Rev0

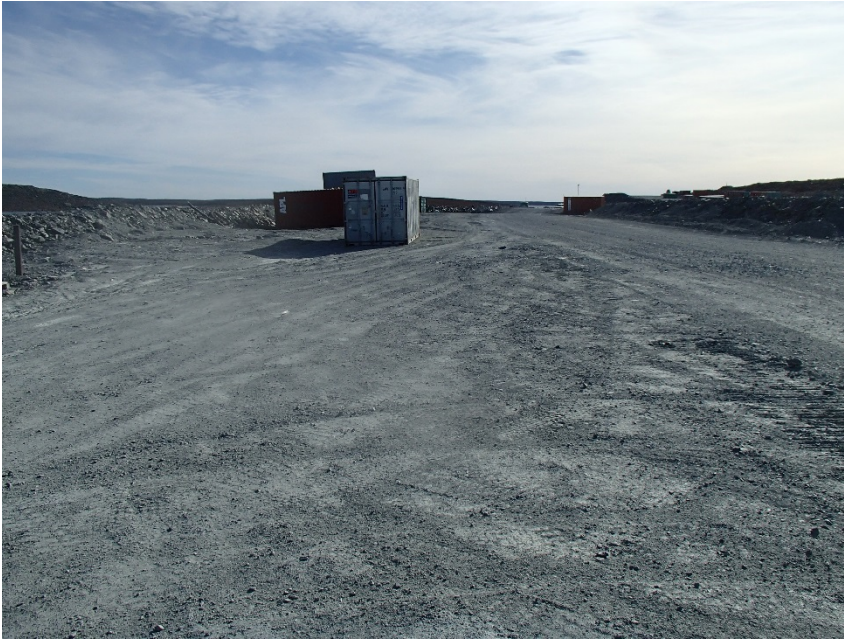
*Photograph A1-1 East Dike*

**Description:** From approximately Sta. 60+375, looking south at the crest.

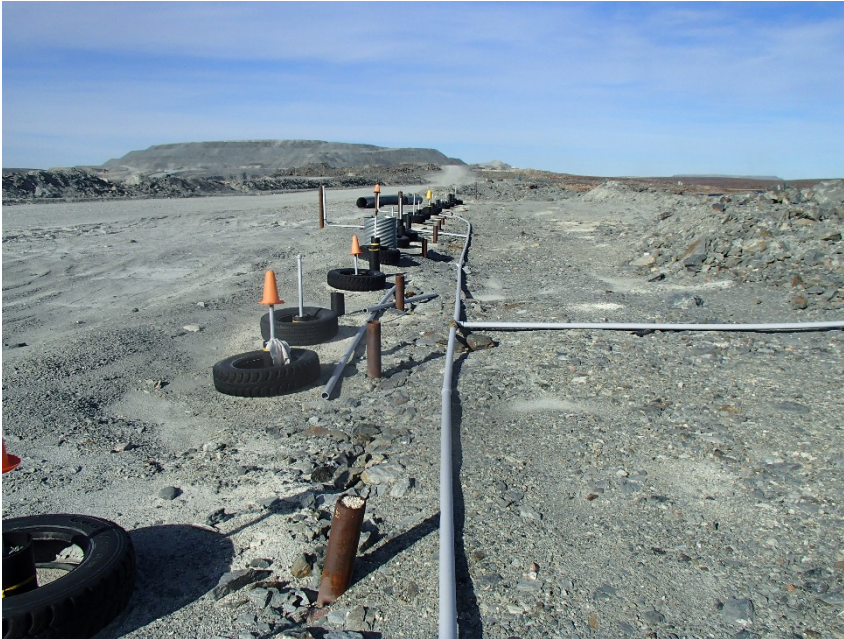
*Photograph A1-3 East Dike*

**Description:** From approximately Sta. 60+560, looking north at the crest.

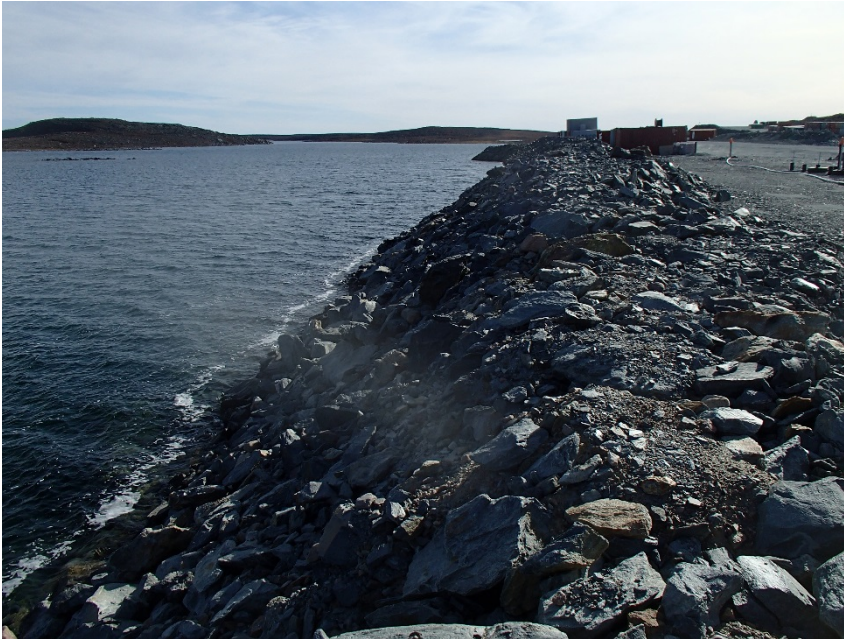
*Photograph A1-5 East Dike*

**Description:** From approximately Sta. 60+540 upstream, looking south at the crest and the upstream slope.

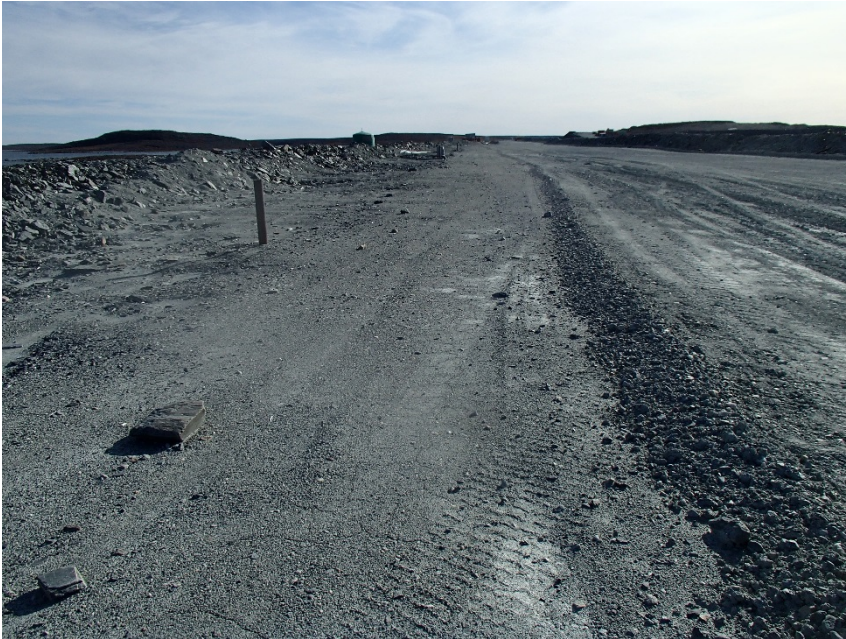
*Photograph A1-7 East Dike*

**Description:** From approximately Sta. 60+810, looking south at the crest.

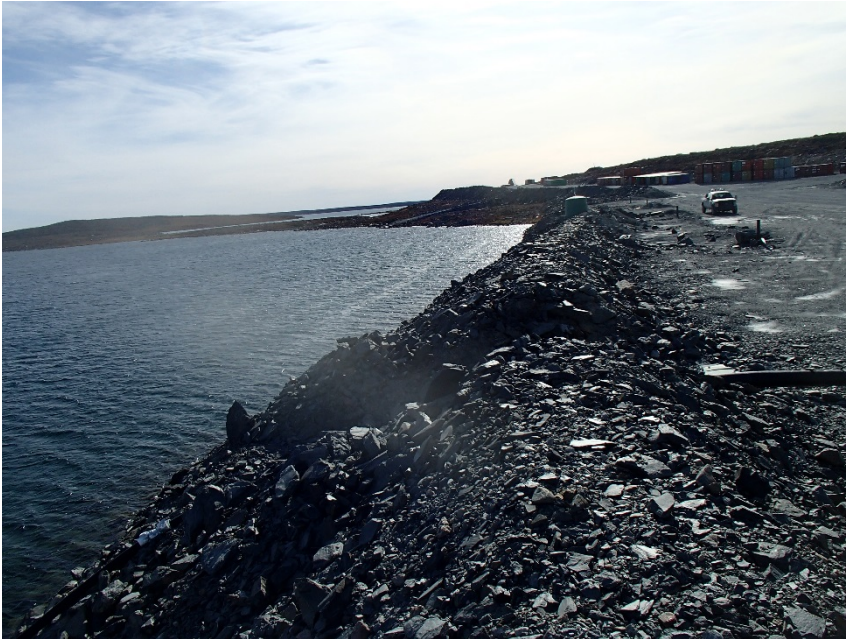
*Photograph A1-9 East Dike*

**Description:** From approximately Sta. 60+250 upstream, looking south at the crest and the upstream slope.

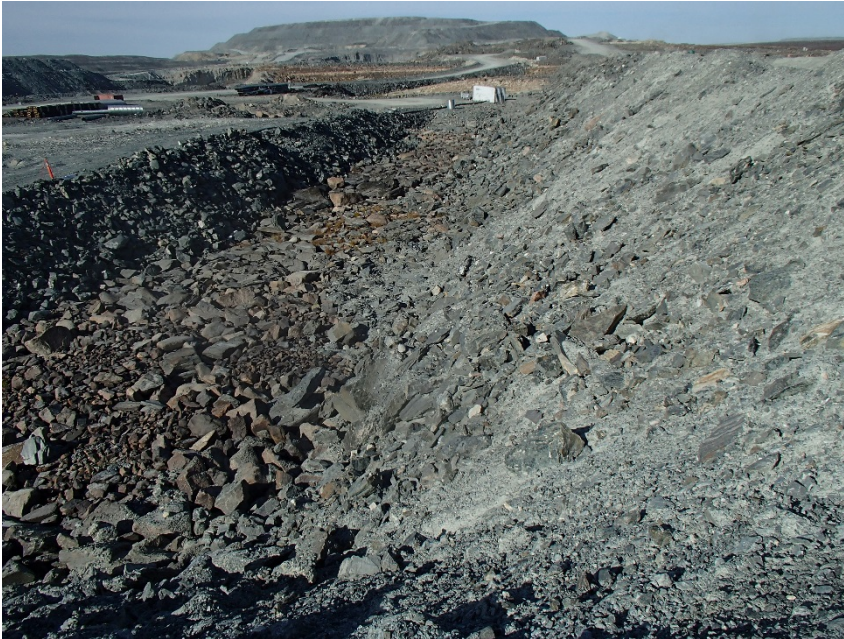
*Photograph A1-11 East Dike*

**Description:** From approximately Sta. 60+380, looking north at the downstream side.

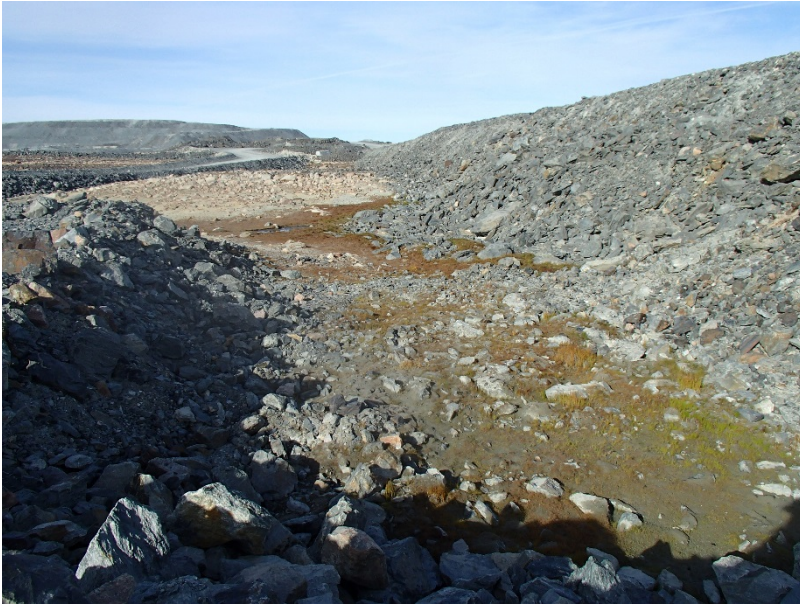
*Photograph A1-13 East Dike*

3.7 Other unusual conditions	None		
<b>4. DOWNSTREAM TOE AREA</b>		520, 523, 531, 532, 533	
4.1 Seepage from dam	Yes, presence of 3 zones		Zone of seepage downstream near Sta. 60+247. A sump is installed (pumping system located in container on the photo). No additional seepage observed at the surface of the ground. Pumping collection system started on April 4, 2012. Flow is being monitored since July 2013.
			Zone of seepage downstream near Sta. 60+498. A sump is installed (pumping system located in container on the photo). Pondered water nearby. No additional seepage observed at the surface of the ground during the inspection. Pumping collection system started on April 4, 2012. Flow is being monitored since July 2013.
			Seepage zone near Sta. 60+575. According to AEM, this zone was practically dry all year. Water ponding was observed during inspection but no flow was noticed.

**Description:** From approximately Sta. 60+570 downstream, looking north at the downstream toe.

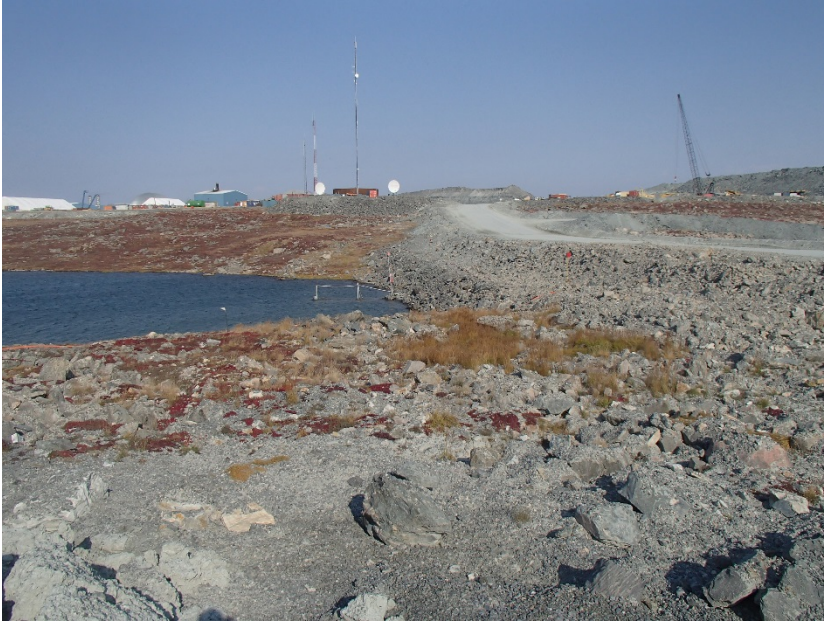
*Photograph A2-1 South Camp Dike*

**Description:** From the south abutment, looking north at the upstream slope and the thermistors instrumentation set-up.

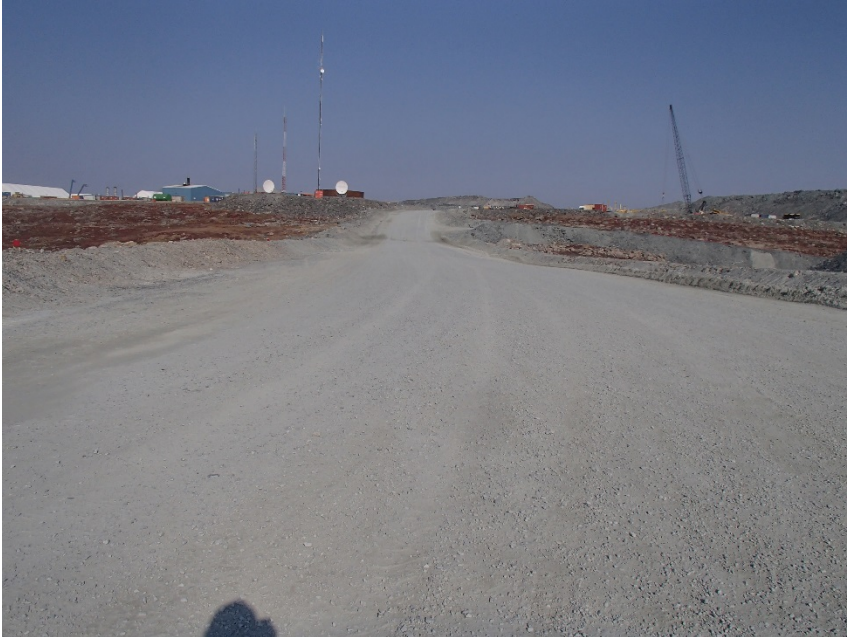
*Photograph A2-3 South Camp Dike*

**Description:** From the south abutment, looking north at the crest.

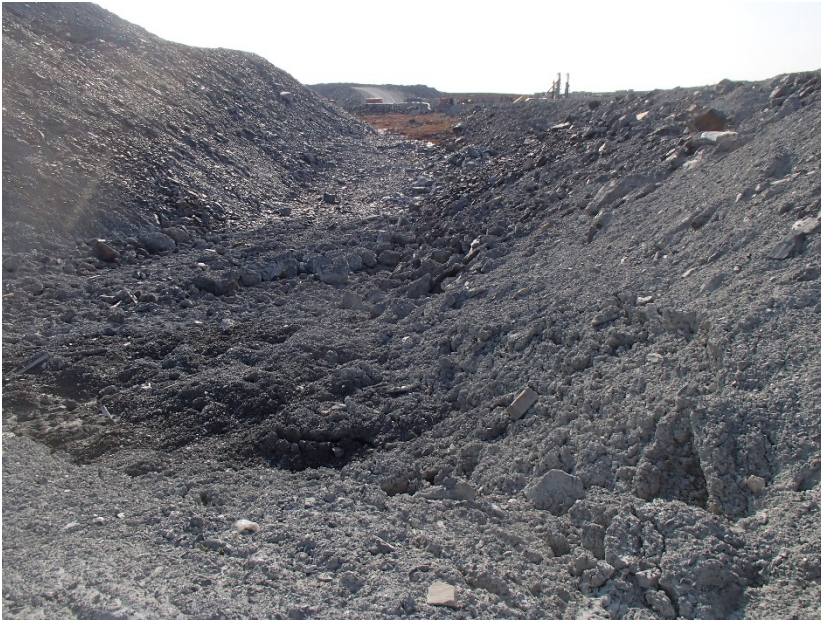
*Photograph A2-5 South Camp Dike*

**Description:** From the north abutment, looking south at the downstream slope.

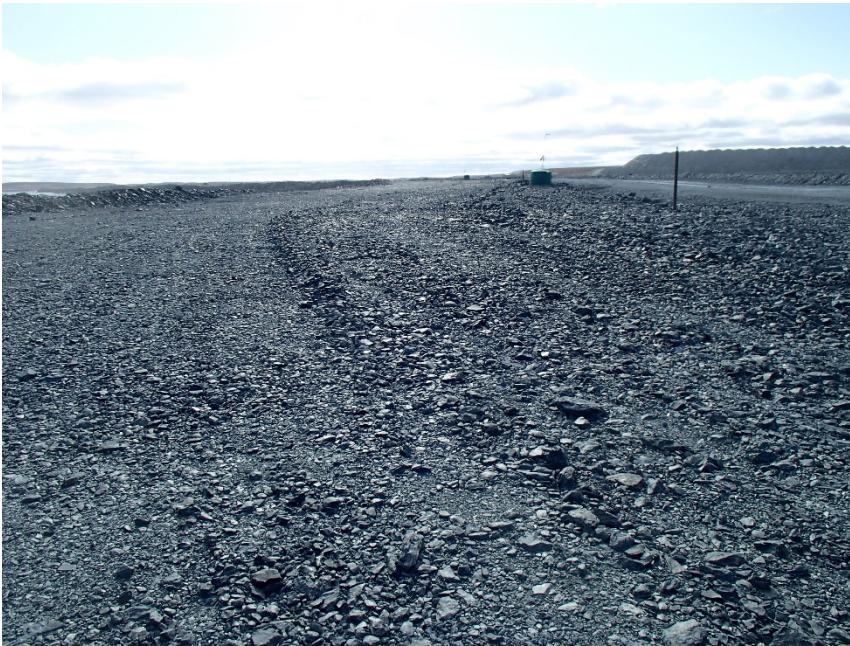
*Photograph A3-1 Bay Goose Dike*

**Description:** From approximately Sta. 30+142 (north abutment) looking southwest at the crest.

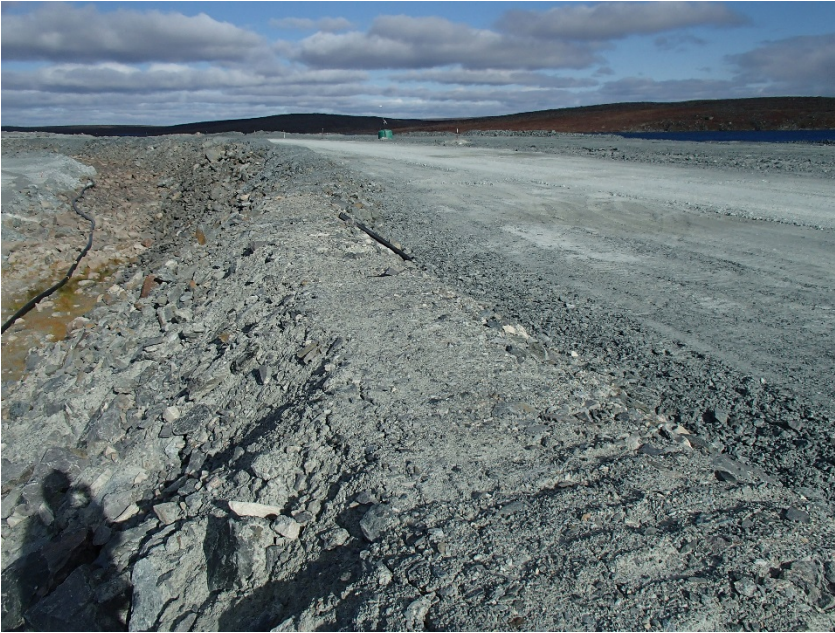
*Photograph A3-3 Bay Goose Dike*

**Description:** From approximately Sta. 30+340 on the crest, looking northeast at the dam crest and downstream slope

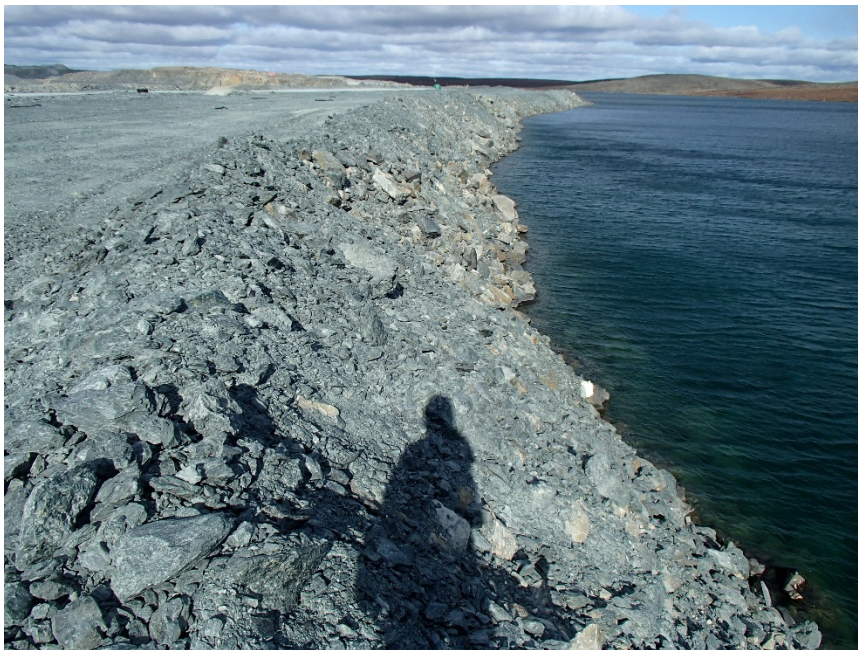
*Photograph A3-7 Bay Goose Dike*

**Description:** From Sta. 30+500, looking northeast at the crest and the upstream slope.

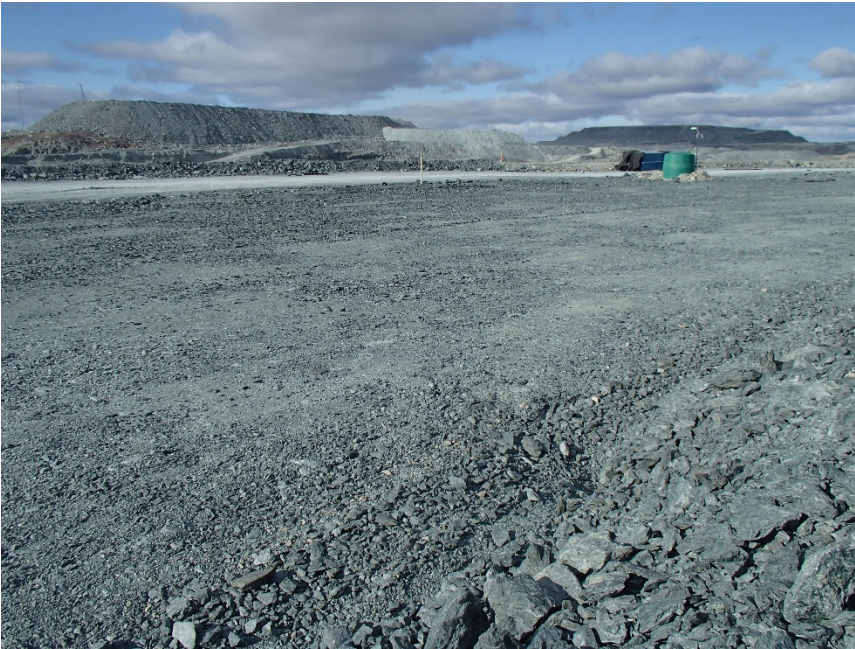
*Photograph A3-9 Bay Goose Dike*

**Description:** From Sta. 30+500, looking west at the downstream slope.

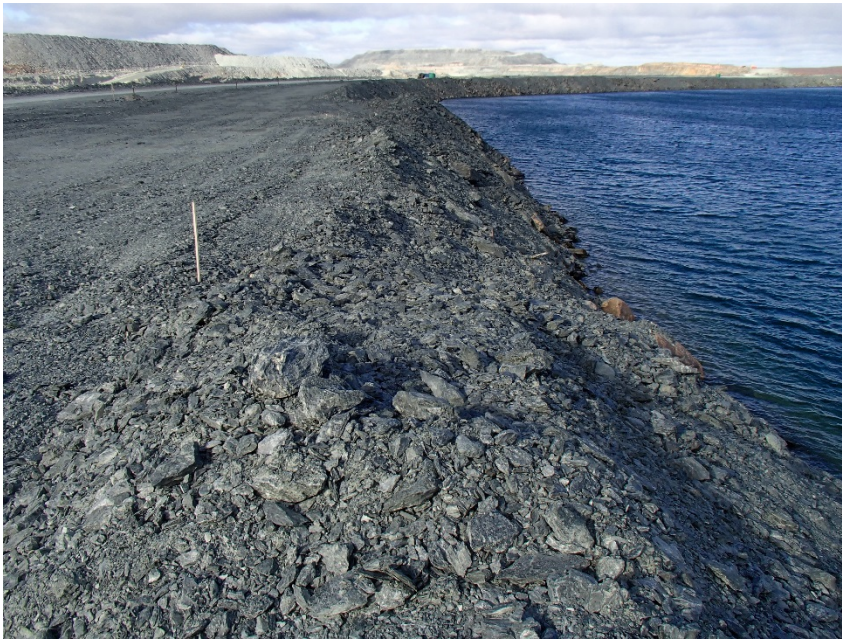
*Photograph A3-11 Bay Goose Dike*

**Description:** From approximately Sta. 30+680, looking north at the crest and the upstream slope.

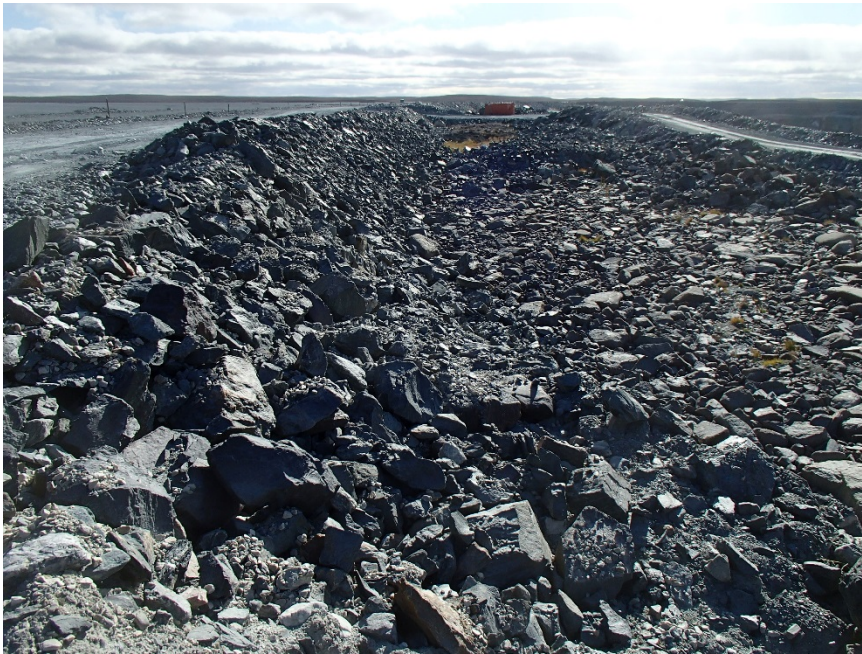
*Photograph A3-13 Bay Goose Dike*

**Description:** From approximately Sta. 30+680 on the crest, looking south at the downstream slope and toe.

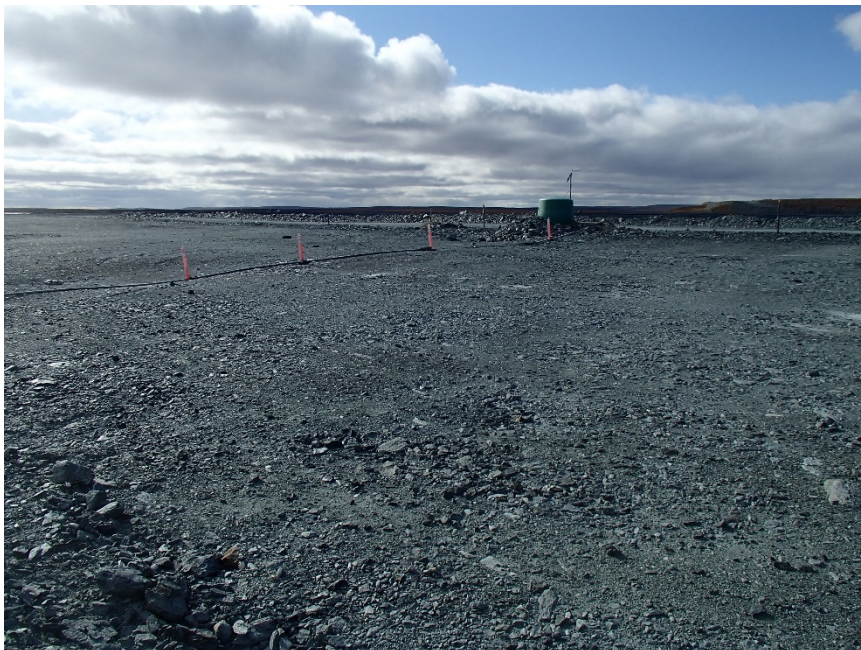
**Photo Number:** 316

INSPECTION ITEM	OBSERVATIONS DATA	PHOTO	COMMENTS & OTHER DATA
	Central Channel	316	Presence of a seepage channel at Sta. 31+165. Water ponding was observed at the time of the inspection. It was pumped once after freshet only.
	Channel 3	297, 302, 305	Light flow observed during inspection. Monitored by station 6.
	Channel 1	289, 290	This seepage channel was not flowing at the time of the inspection.
	Water Ponds	298	Presence of water pond with no sign of seepage. Located at 31+750. Water was observed downstream of Channel 1 ponding against the ring rod of Goose Pit.

**Description:** From approximately Sta. 31+080 on the crest, looking southwest at the pond of water at Central Channel seepage at Sta. 31+165.

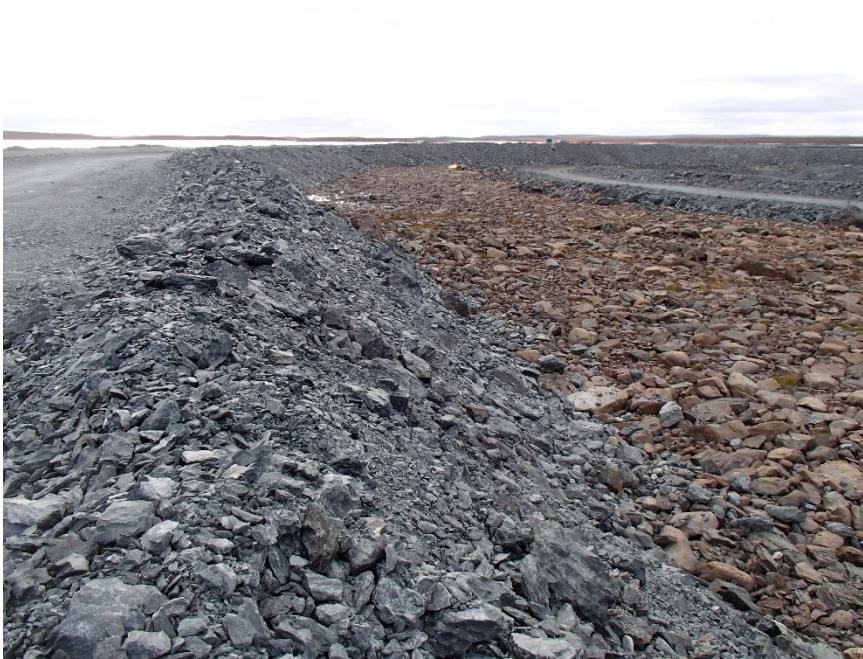
**Photo Number:** 310

**Description:** From approximately Sta. 31+280 on the crest, looking southwest at the downstream slope and the water pond at the downstream toe at Sta. 31+350.

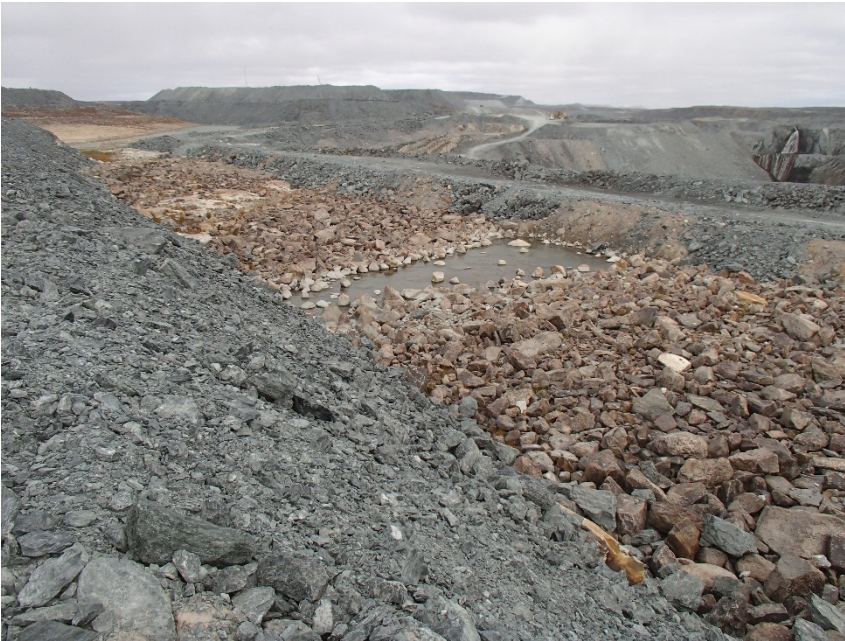
**Photo Number:** 298

**Description:** From the crest at approximately Sta. 31+740, looking north downstream at the water pond at Sta. 31+750.

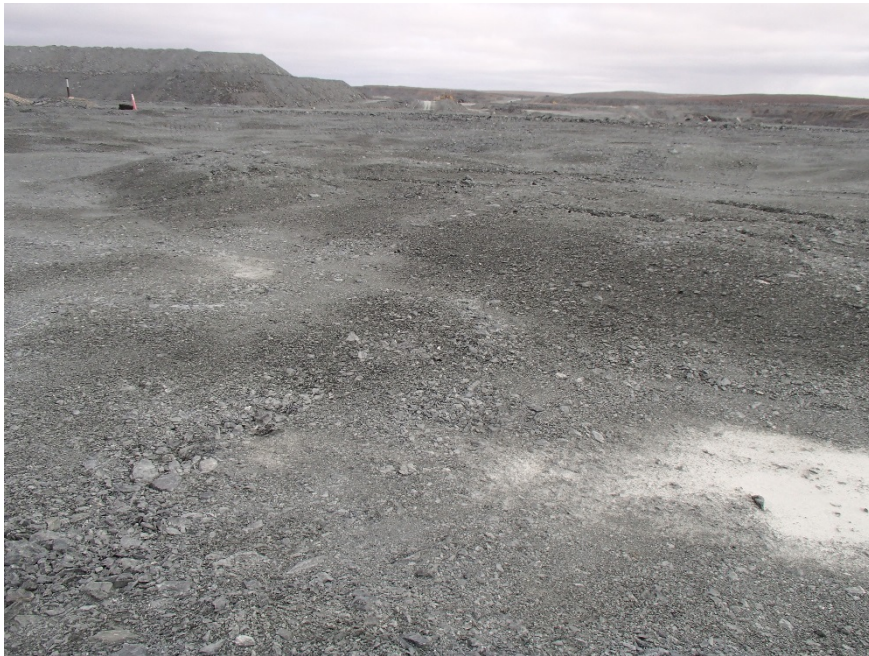
**Photo Number:** 286

**Description:** From approximately Sta. 32+015 (south abutment) looking east at the crest. Presence of high magnitude settlements in the ultramafic cap placed in the winter of 2013.

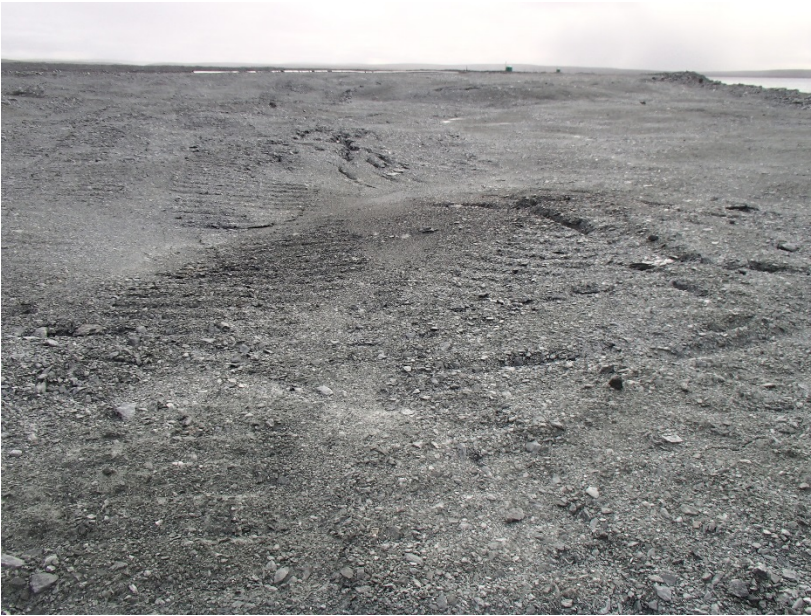
*Photograph A3-45 Bay Goose Dike*

**Description:** From approximately Sta. 32+025 (south abutment) looking east at the crest. Zone of high magnitude settlement in the ultramafic cap. The tension cracks seem no longer active.

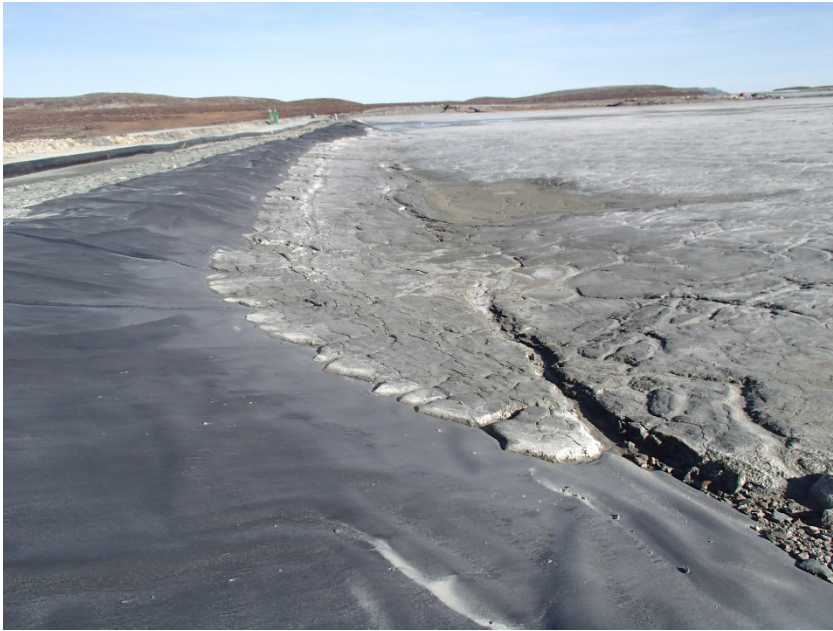
**Photo Number:** 565

**Description:** From Saddle Dam 1 (approximately Sta. 0+410) looking northeast at the North Cell tailings pond. Adequate tailings beach against SD1.

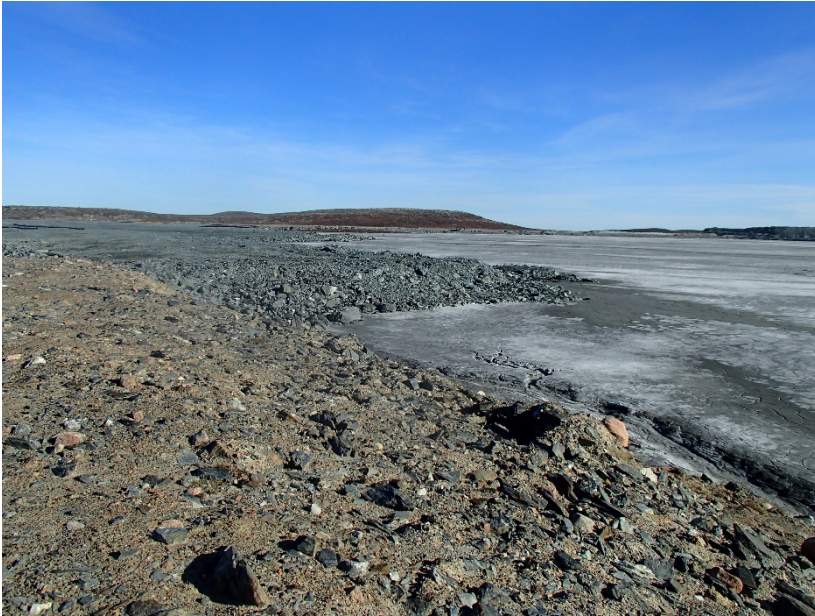
*Photograph B1-5 Tailings Storage Facility*

**Description:** From the western diversion ditch, looking northeast toward the North Cell.

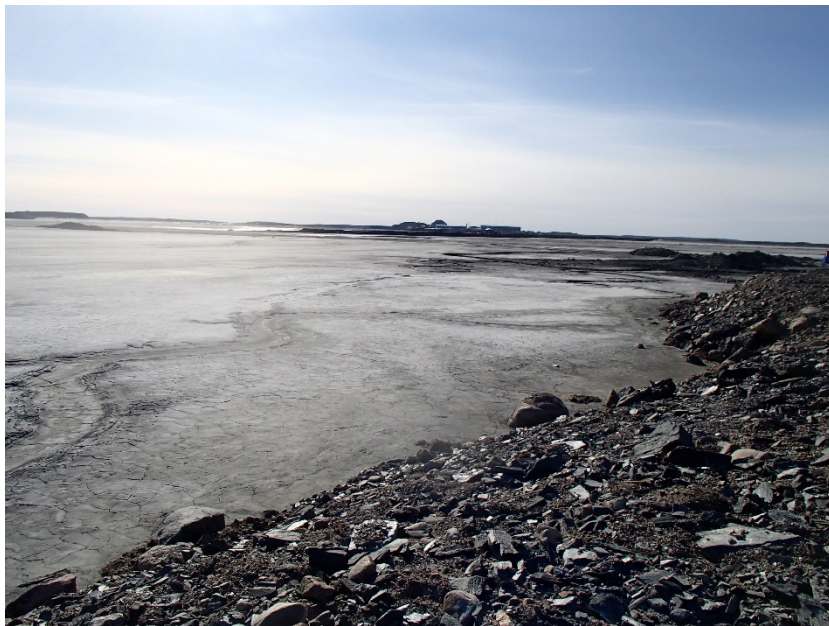
*Photograph B1-7 Tailings Storage Facility*

**Description:** From the western diversion ditch, looking southeast toward the North Cell.

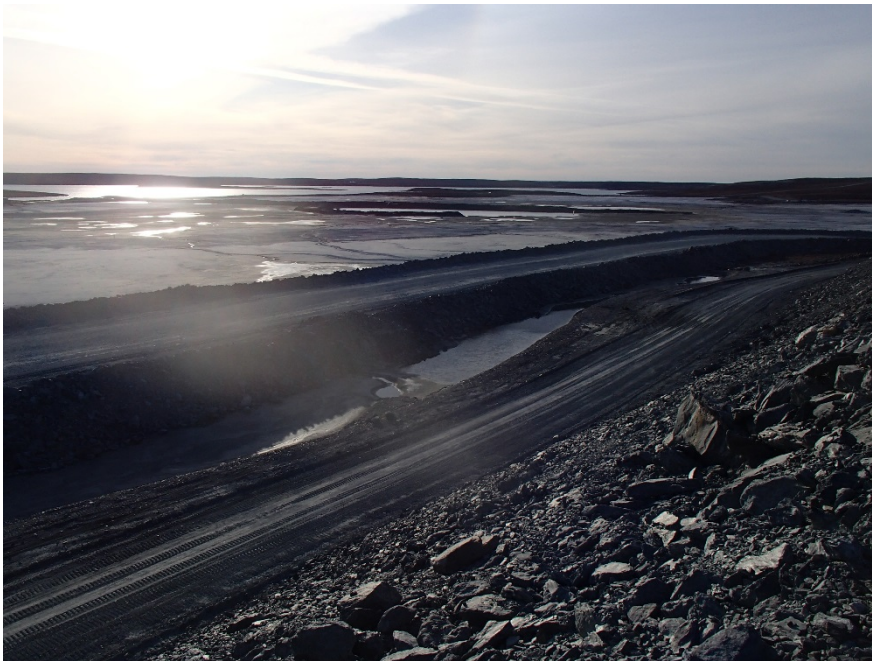
*Photograph B1-9 Tailings Storage Facility*

**Description:** From the RSF looking west at RF1 and the North Cell toward Saddle Dam 2. View of the 2016 North Cell capping.

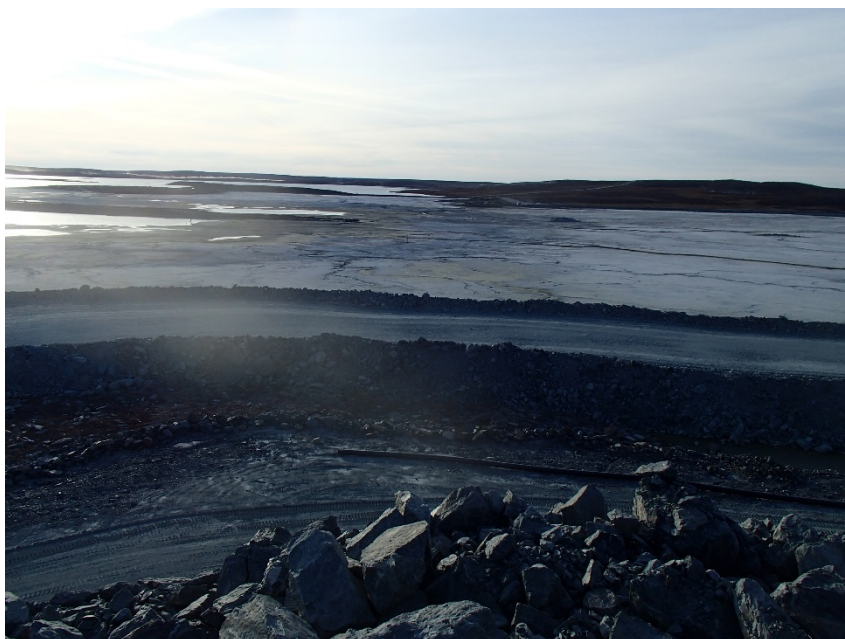
*Photograph B1-11 Tailings Storage Facility*

**Description:** From the RSF looking southwest at RF1 and the North Cell.

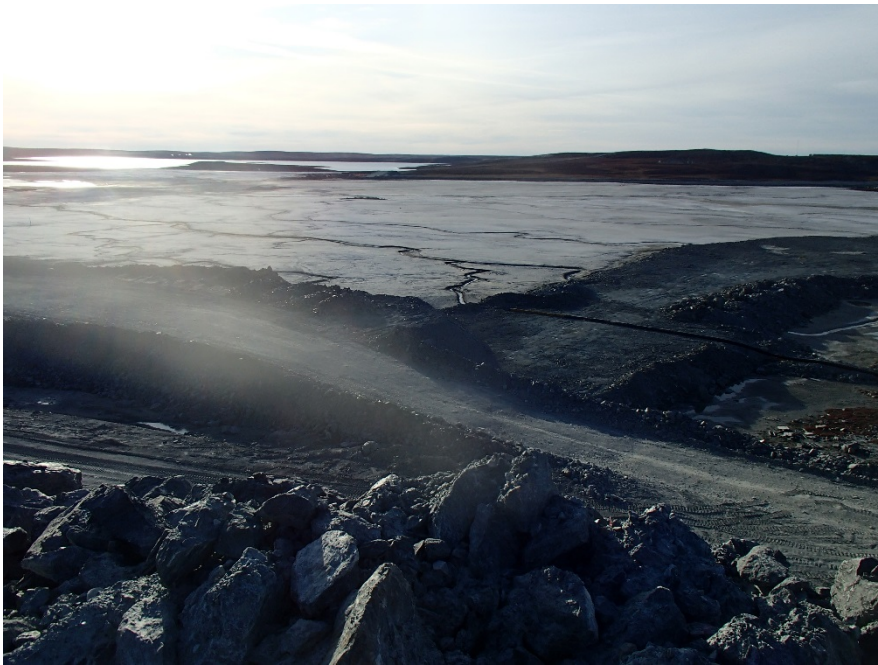
*Photograph B1-13 Tailings Storage Facility*

**Description:** From the RSF looking southwest at RF2 and the North Cell. View of the 2016 capping.

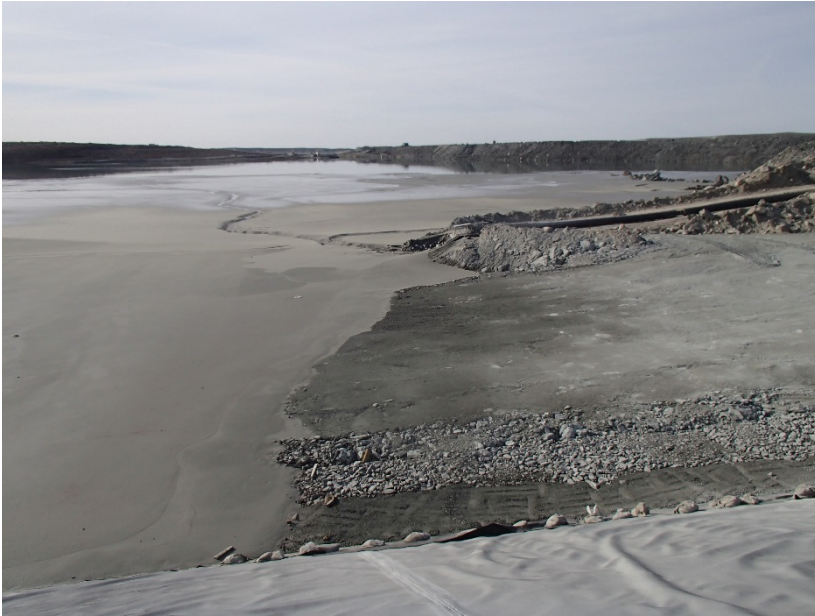
*Photograph B1-15 Tailings Storage Facility*

**Description:** From the northern abutment of Central Dike, looking west at the South Cell.

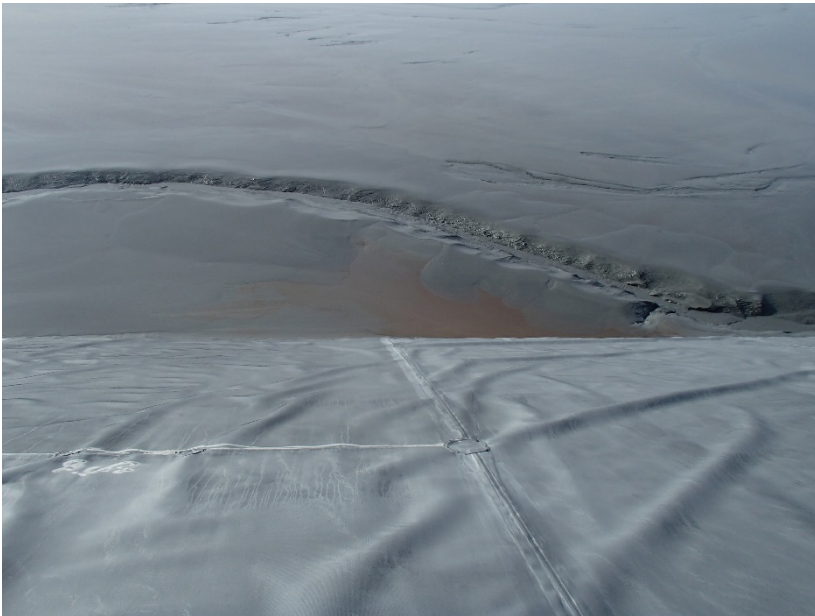
*Photograph B1-17 Tailings Storage Facility*

**Description:** From Central Dike looking west at the South Cell. A small pond with an orange colour is present in the tailings.

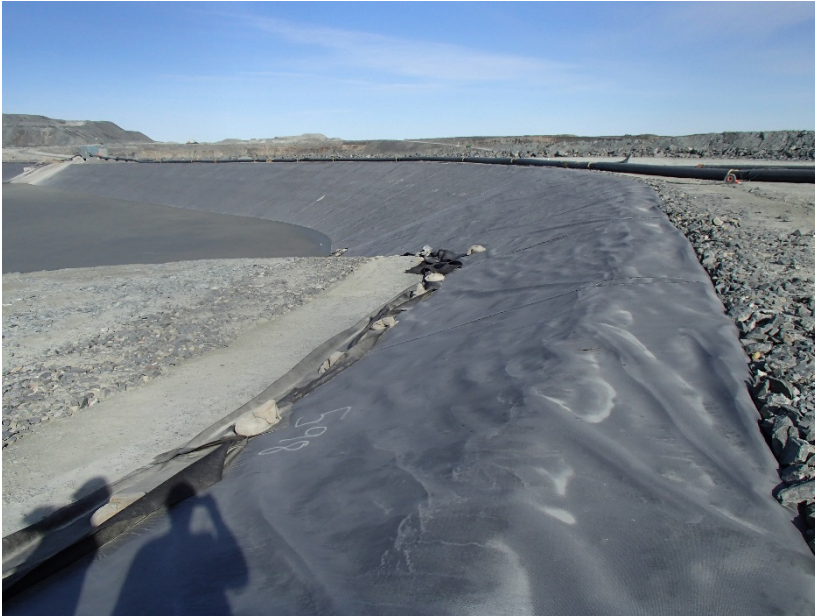
*Photograph B1-19 Tailings Storage Facility*

**Description:** From Central Dike looking north at Central Dike and the South Cell.

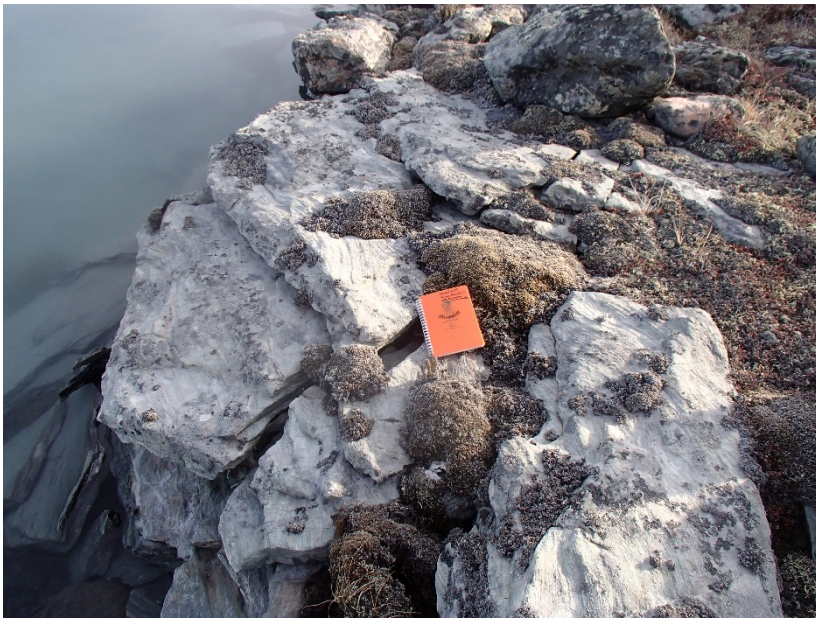
*Photograph B1-21 Tailings Storage Facility*

**Description:** View of the bedrock on the northwestern extremity Saddle Dam 4. Important surface cracks are visible.

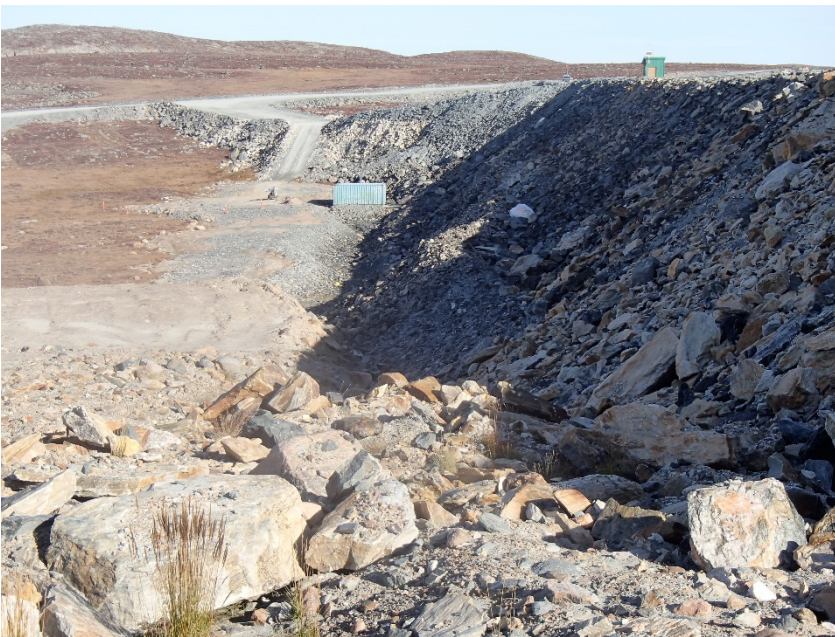
*Photograph B2-1 Saddle Dam 1*

3.6 Vegetation growth	None observed		
3.7 Other unusual conditions	None		
<b>4. DOWNSTREAM TOE AREA</b>		566, 567	
4.1 Seepage from dam	Uncertain		A dewatering sump is installed downstream. Water was observed ponding in that area.

**Description:** From the south abutment (Sta. 0+350) looking north at the downstream face. Notice the sea-can container where a sump is installed.

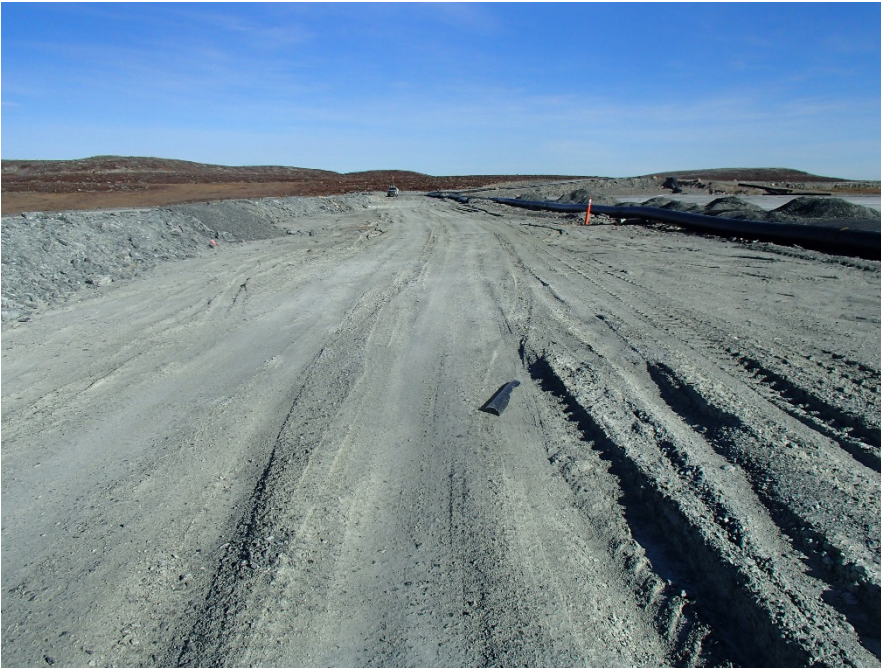
*Photograph B2-3 Saddle Dam 1*

**Description:** From approximately Sta. 0+225, looking north at the crest.

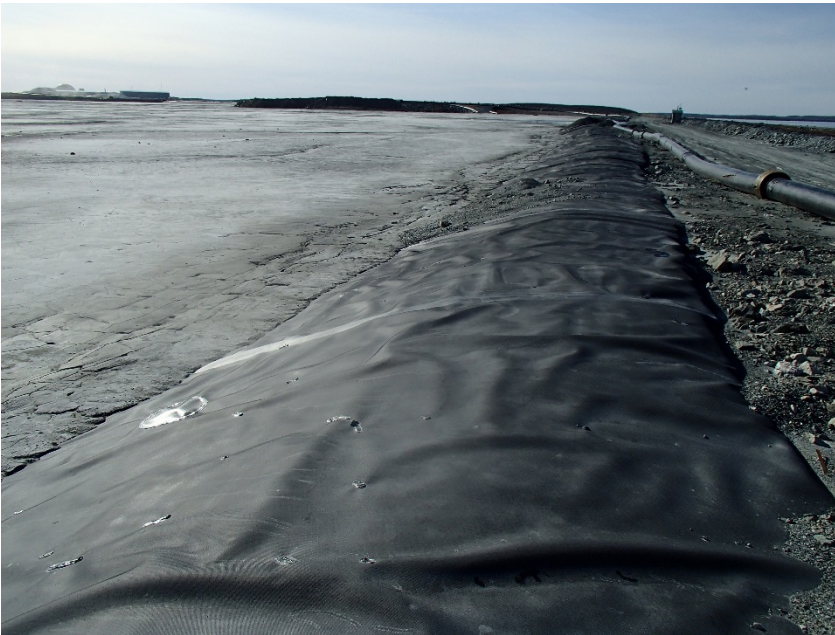
*Photograph B2-5 Saddle Dam 1*

**Description:** From approximately Sta. 0+055, looking south at the crest and upstream slope.

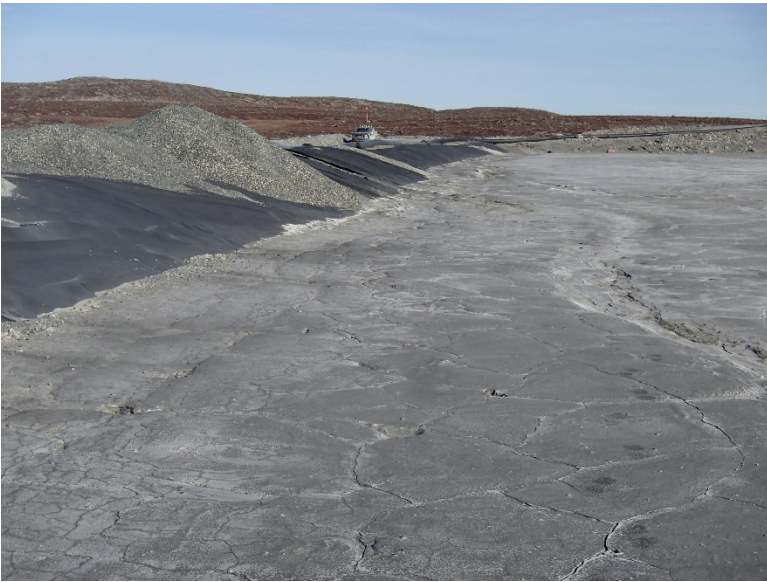
*Photograph B2-7 Saddle Dam 1*

**Description:** From approximately Sta. 0+195 upstream, looking north at the upstream slope. Adequate tailings beach against SD1.

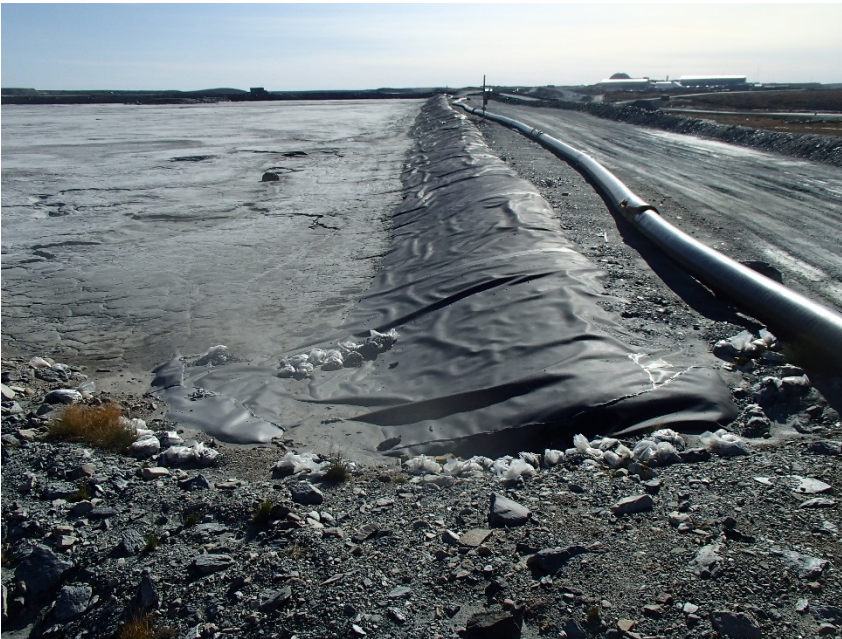
*Photograph B3-1 Saddle Dam 2*

**Description:** From Saddle Dam 2 (approximately Sta. 20+110) looking southeast at the crest and upstream slope of Saddle Dam 2. The tailings beach against SD2 is adequate.

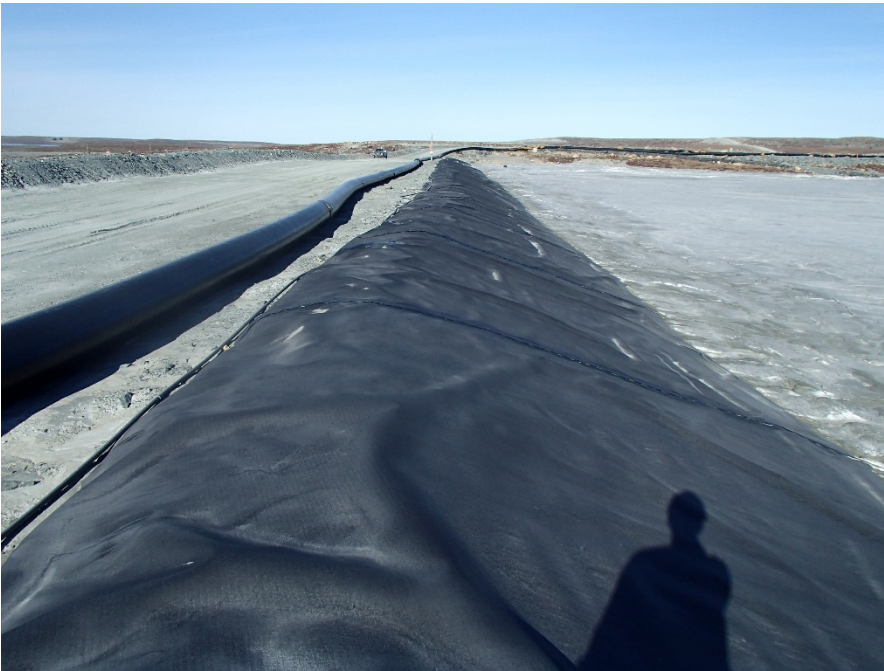
*Photograph B3-3 Saddle Dam 2*

**Description:** From approximately Sta. 20+370 looking northwest at the crest and upstream slope.

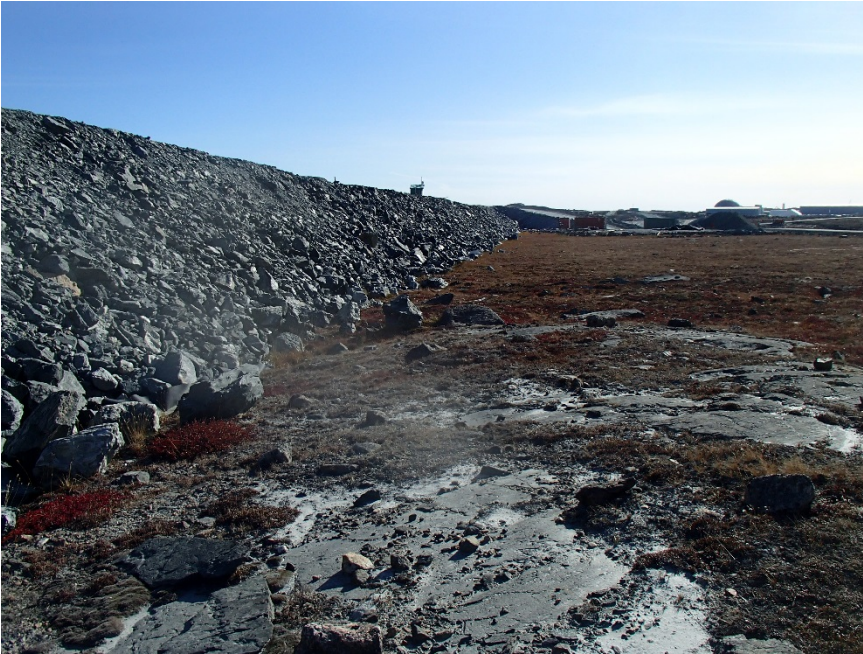
*Photograph B3-5 Saddle Dam 2*

4.6 Other unusual conditions	Yes		Water is still ponding within the rockfill embankment between 20+275 to 20+475 approximately.
<b>5. ABUTMENTS</b>			
5.1 Seepage at contact zone (abutment/embankment)	None observed

**Description:** From approximately Sta. 20+210 downstream, looking southeast at the downstream toe.

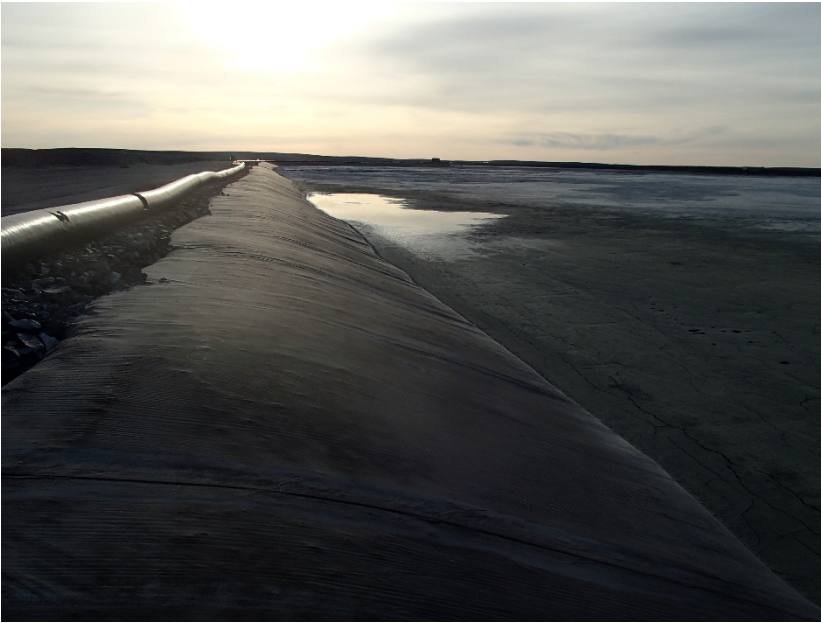
*Photograph B4-1 Stormwater Dike*

**Description:** From the east abutment (11+100 approximately), looking west at the upstream face. Shallow water ponding against portion of the dike (less than 30 cm deep). The tailings beach is considered adequate.
