**Report: 2017 Annual Geotechnical Inspection**

February 2018

# 2017 Annual Geotechnical Inspection Meadowbank Gold Mine, Nunavut

**Report Number:** 1784282-1574-RPT-Rev0

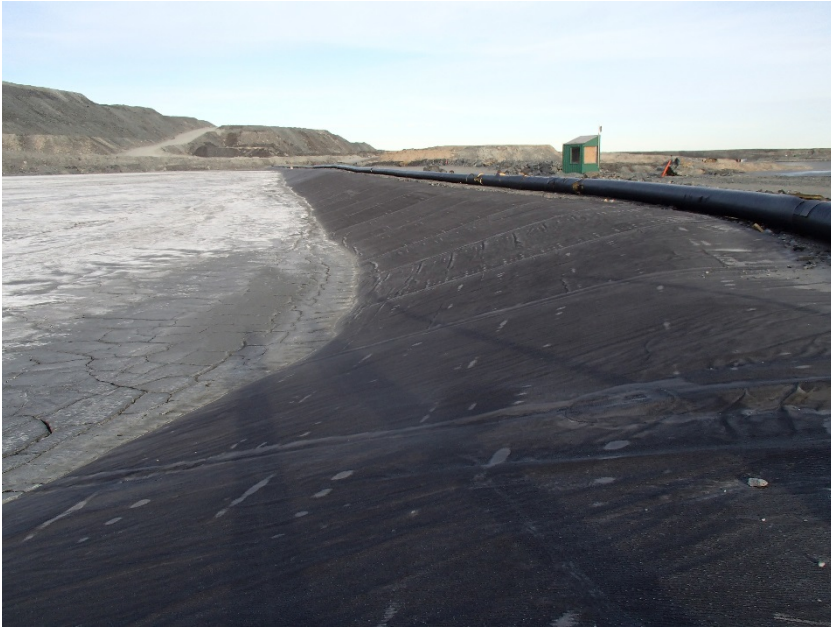
*Photograph B4-3 Stormwater Dike*

**Description:** From Sta. 10+650 looking east at the upstream slope. Adequate tailings beach.

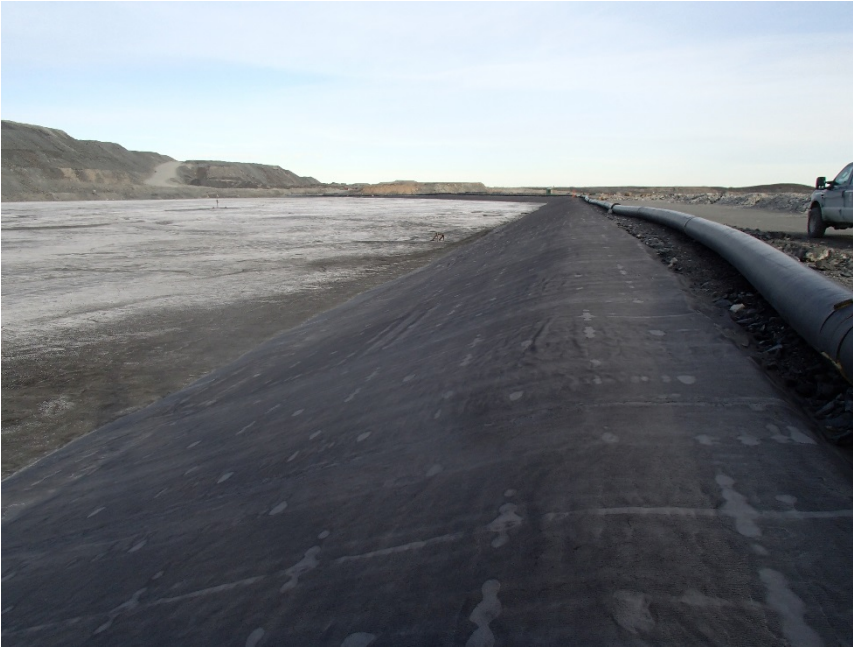
*Photograph B7-5 Stormwater Dike*

**Description:** From approximately Sta. 10+450 looking east at the upstream slope. Adequate tailings beach.

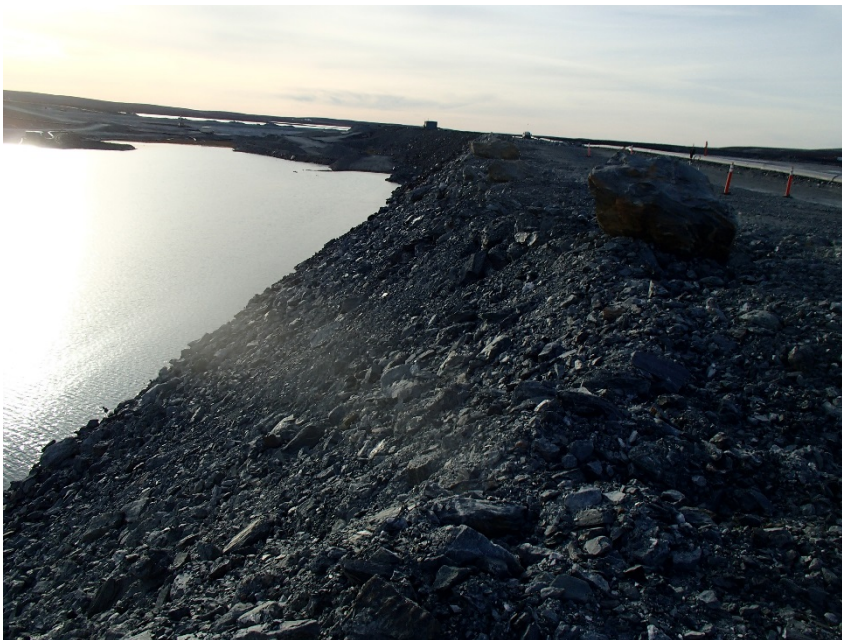
*Photograph B7-10 Stormwater Dike*

**Description:** From Sta.10+650, looking east at the crest and the downstream slope.

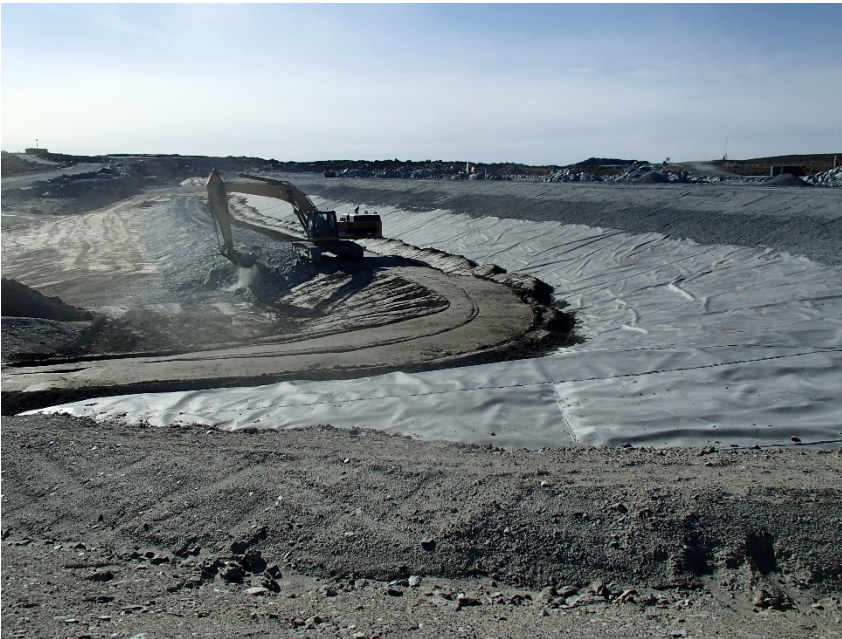
*Photograph B5-1 Saddle Dam 3*

**Description:** From approximately Sta. 20+610 looking south at the upstream slope.

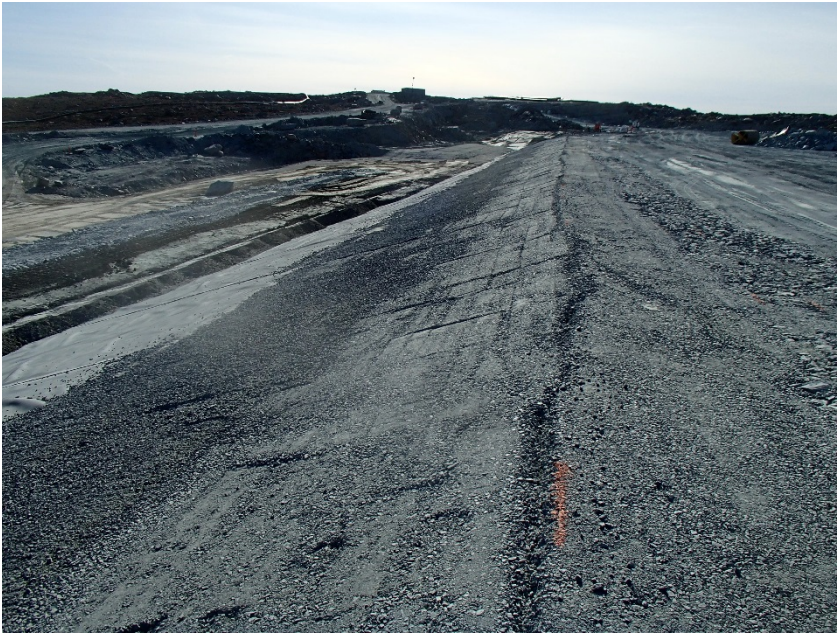
*Photograph B5-3 Saddle Dam 3*

**Description:** From Sta. 20+700, looking southeast at the crest and the upstream slope.

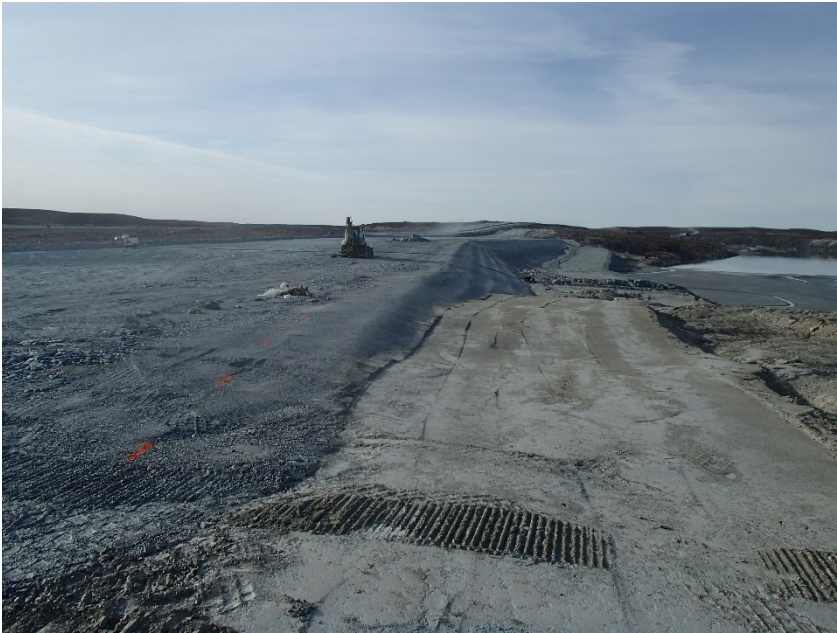
*Photograph B6-1 Saddle Dam 4*

**Description:** From 40+200 approximately, looking northwest at the upstream slope.

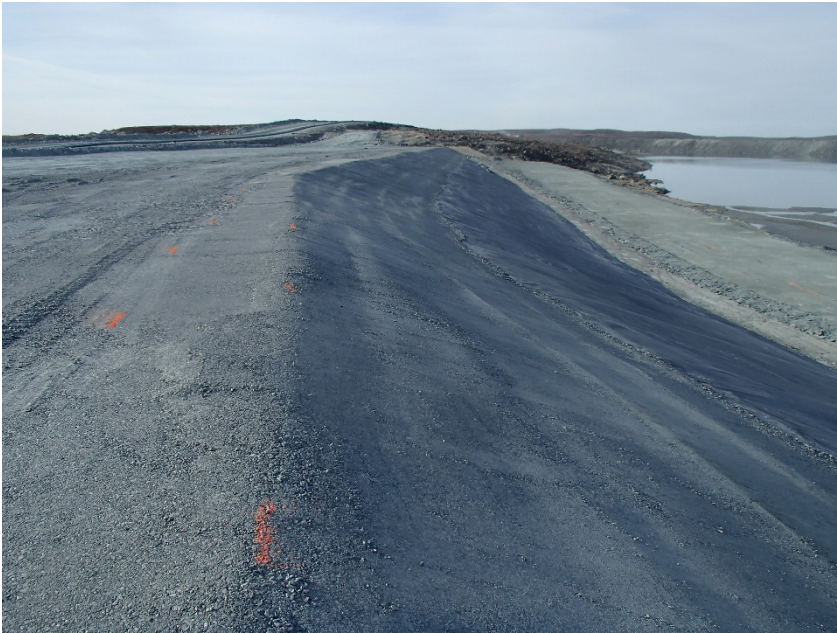
*Photograph B6-3 Saddle Dam 4*

**Description:** From 40+250 approximately, looking northwest at the crest and the upstream slope.

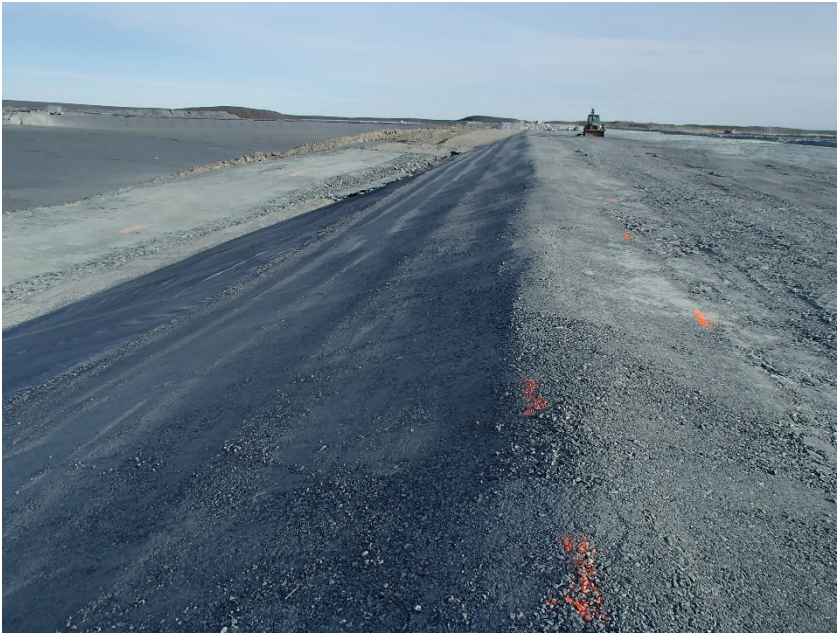
*Photograph B6-5 Saddle Dam 4*

**Description:** From 40+250 approximately, looking southeast at the crest and the upstream slope.

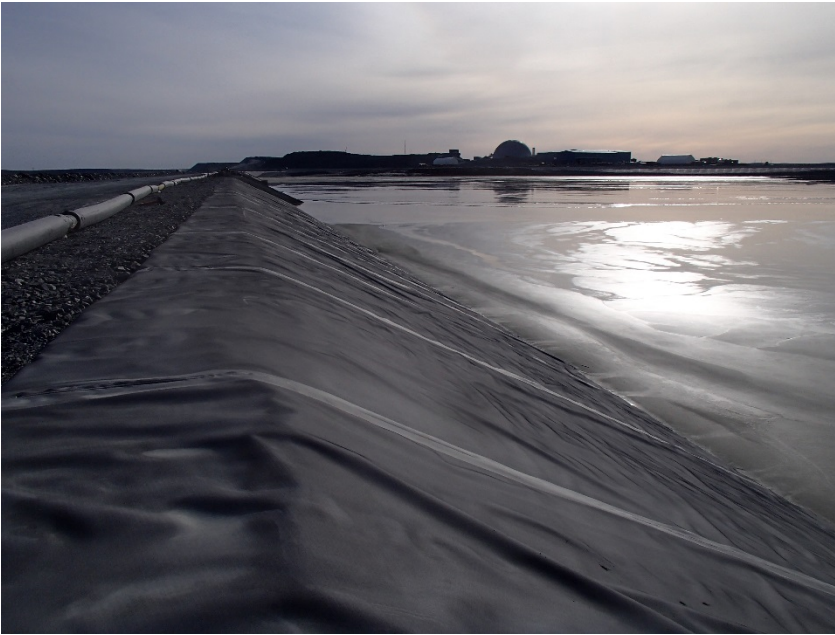
*Photograph B7-1 Central Dike and Saddle Dam 5*

**Description:** From approximately Sta. 0+325 looking southwest. View of the upstream slope of Central Dike.

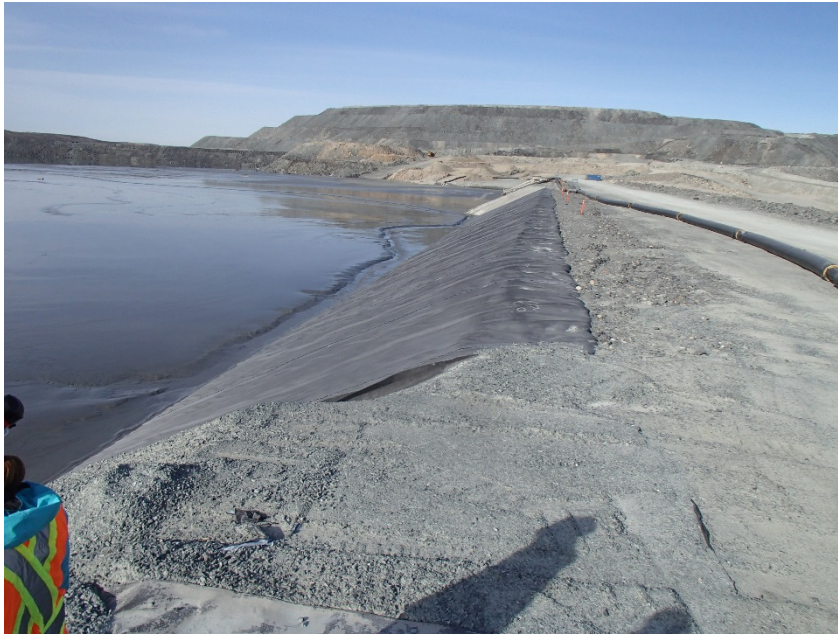
*Photograph B7-5 Central Dike and Saddle Dam 5*

**Description:** From approximately Sta. 0+525 looking northwest at the upstream slope. Adequate tailings beach against the south section of the structure.

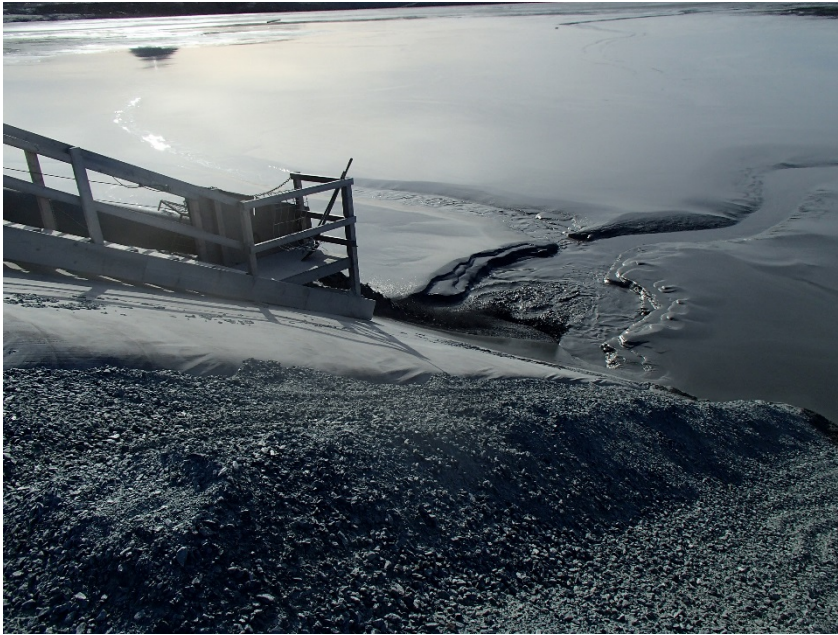
*Photograph B7-7 Central Dike and Saddle Dam 5*

**Description:** From approximately Sta. 0+525 looking at the deposition finger. The LLDPE liner is well protected and the tailing beach against the structure is adequate.

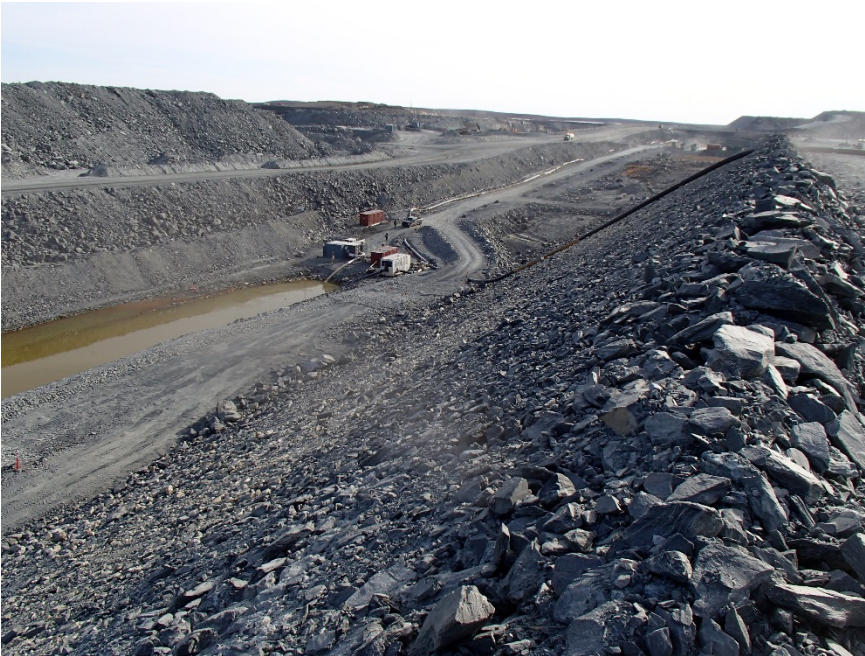
*Photograph B7-9 Central Dike and Saddle Dam 5*

**Description:** From approximately Sta. 0+720 looking southeast at the downstream slope and toe. View of the downstream pond and pumping system.

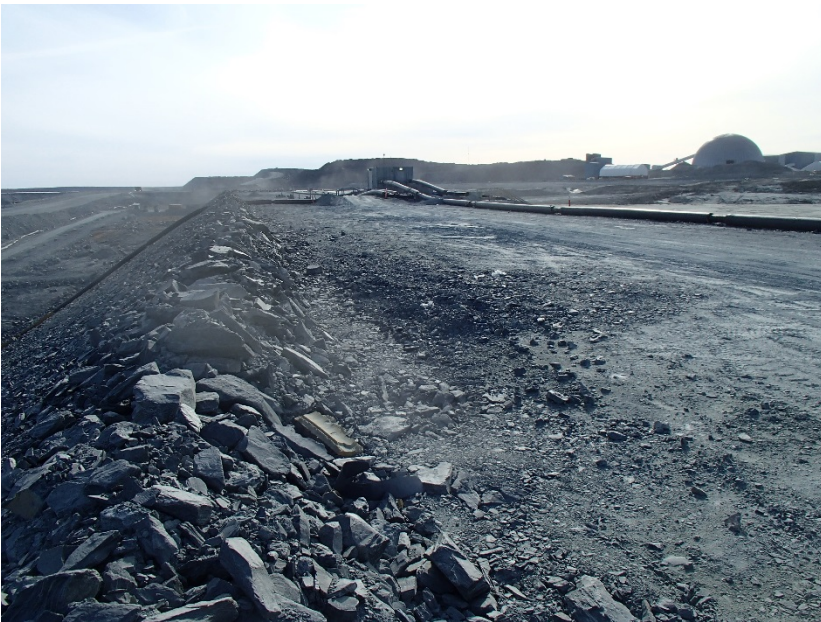
*Photograph B7-11 Central Dike and Saddle Dam 5*

**Description:** From approximately Sta. 0+720 looking south at the crest.

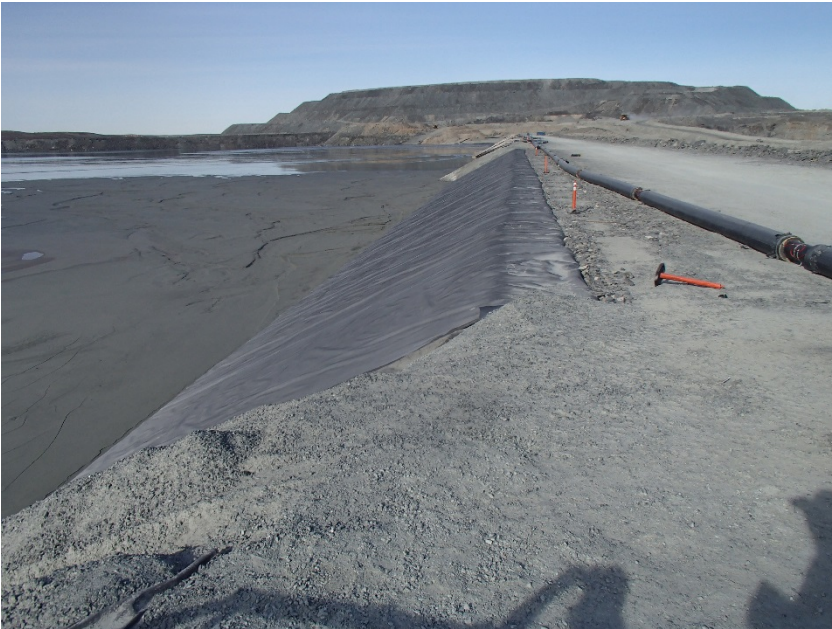
*Photograph B7-13 Central Dike and Saddle Dam 5*

**Description:** From approximately Sta. 0+800 on the crest, looking northwest at the upstream slope.

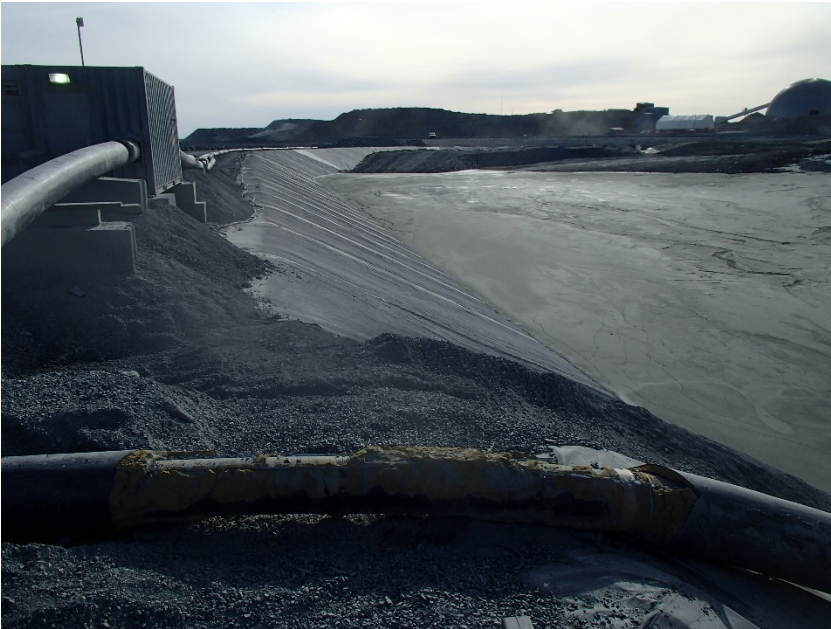
*Photograph B7-15 Central Dike and Saddle Dam 5*

**Description:** From approximately Sta. 0+800 on the crest, looking south at the upstream slope and a tailings deposition finger

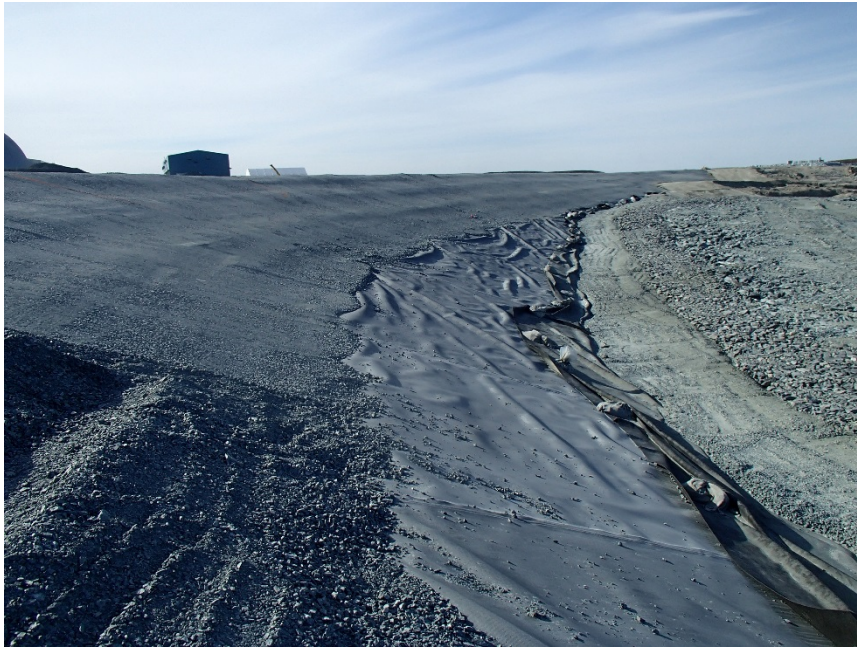
*Photograph B7-17 Central Dike and Saddle Dam 5*

**Description:** From approximately Sta. 1+000 looking southwest at the upstream slope of SD5.

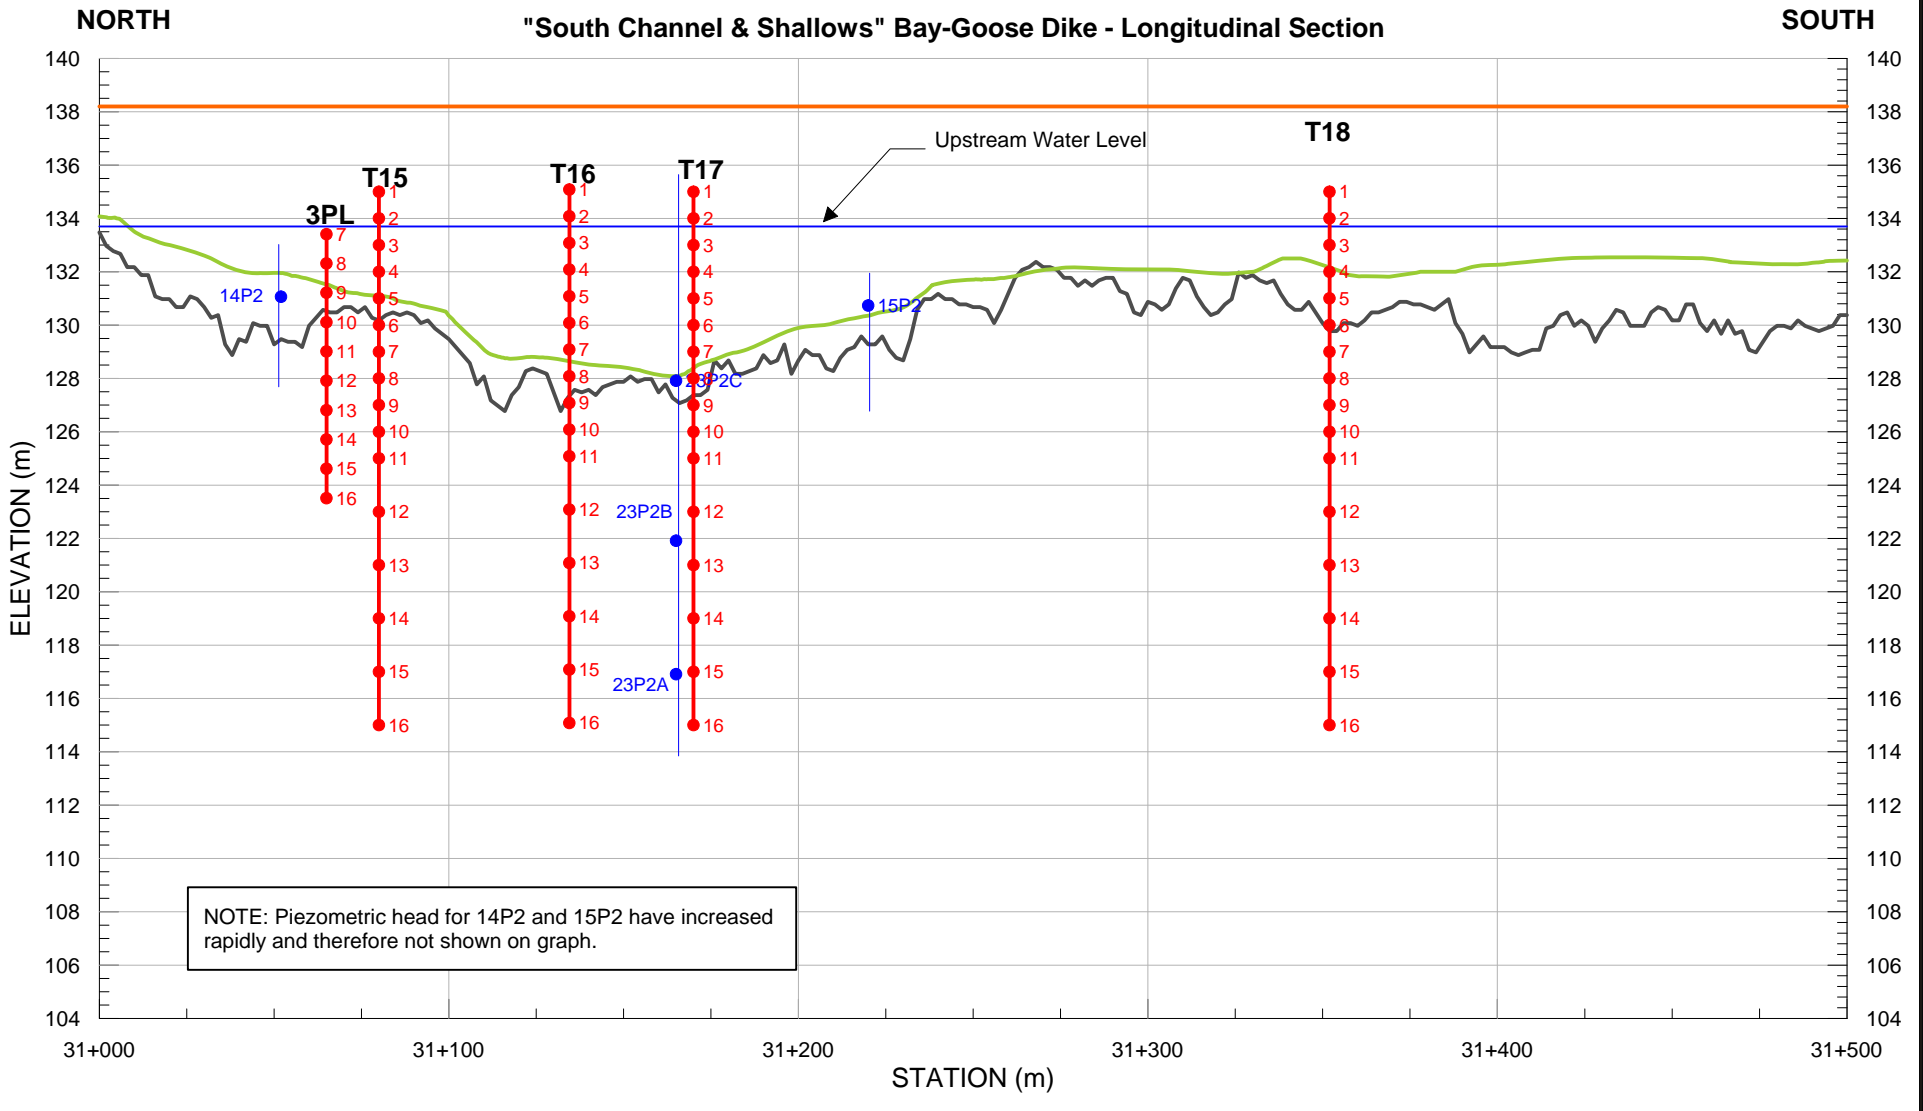
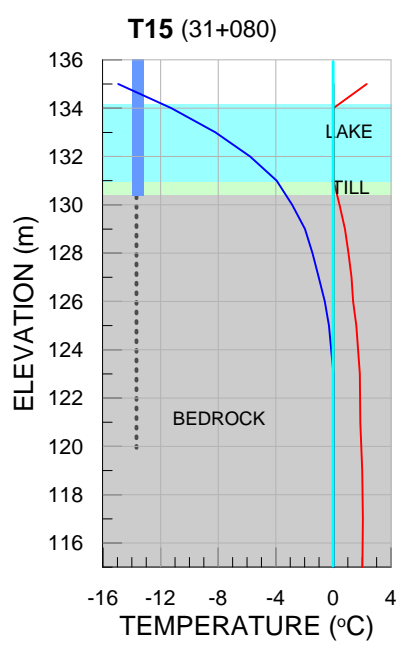
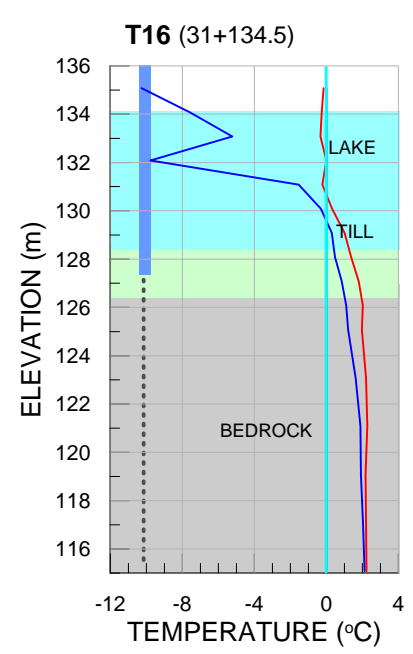
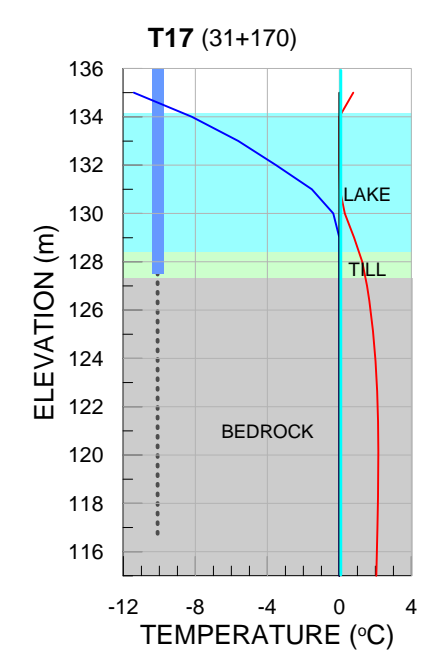
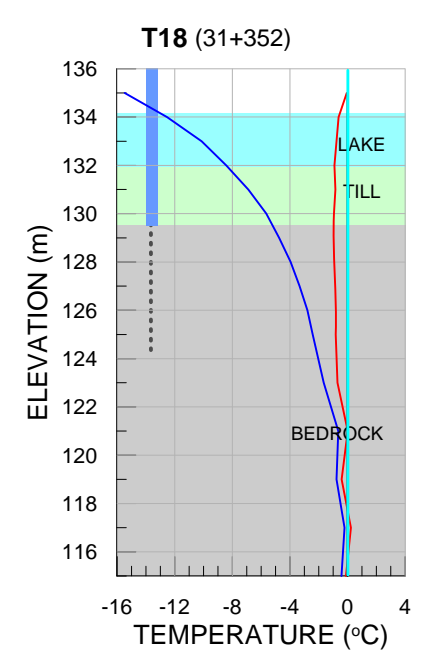
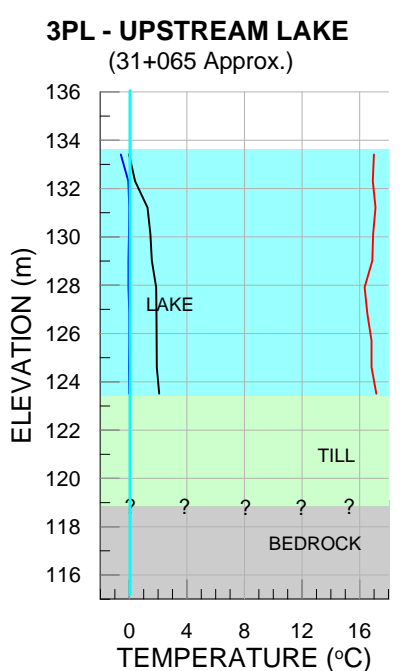
**NOTES:**  
1. Thermistor 3PL is installed upstream of the dike within Third Portage Lake.

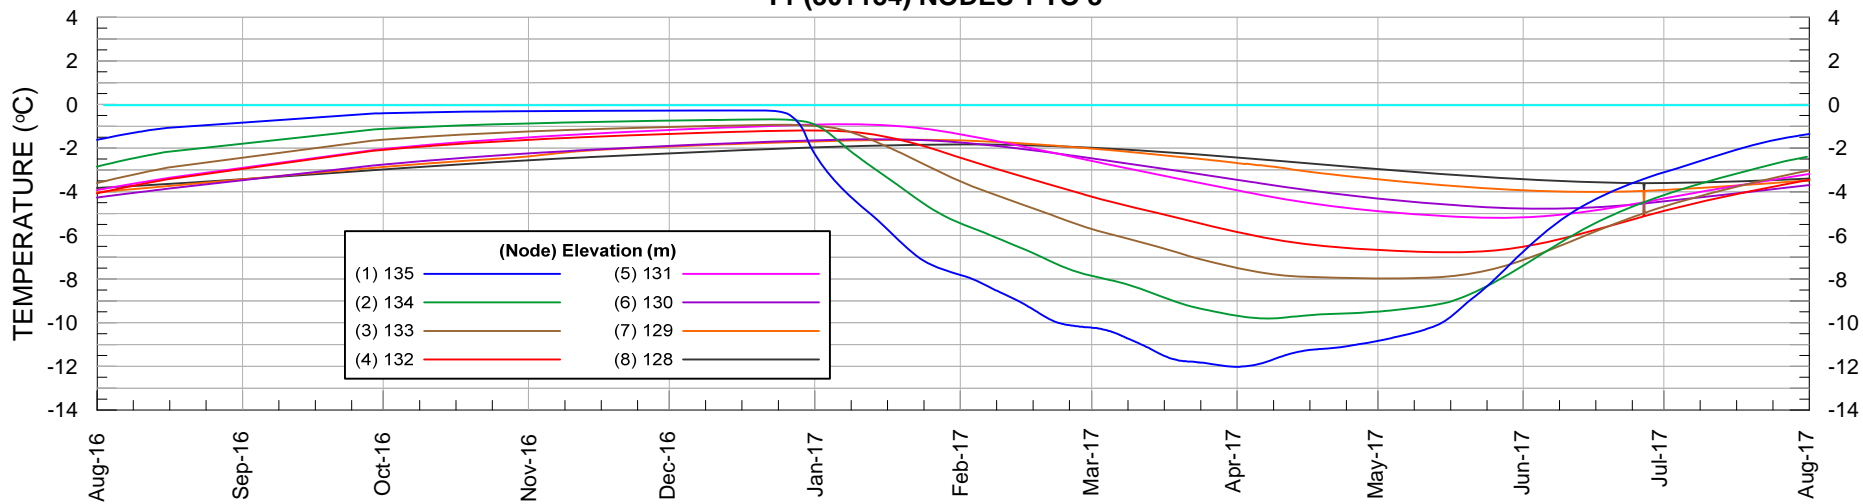
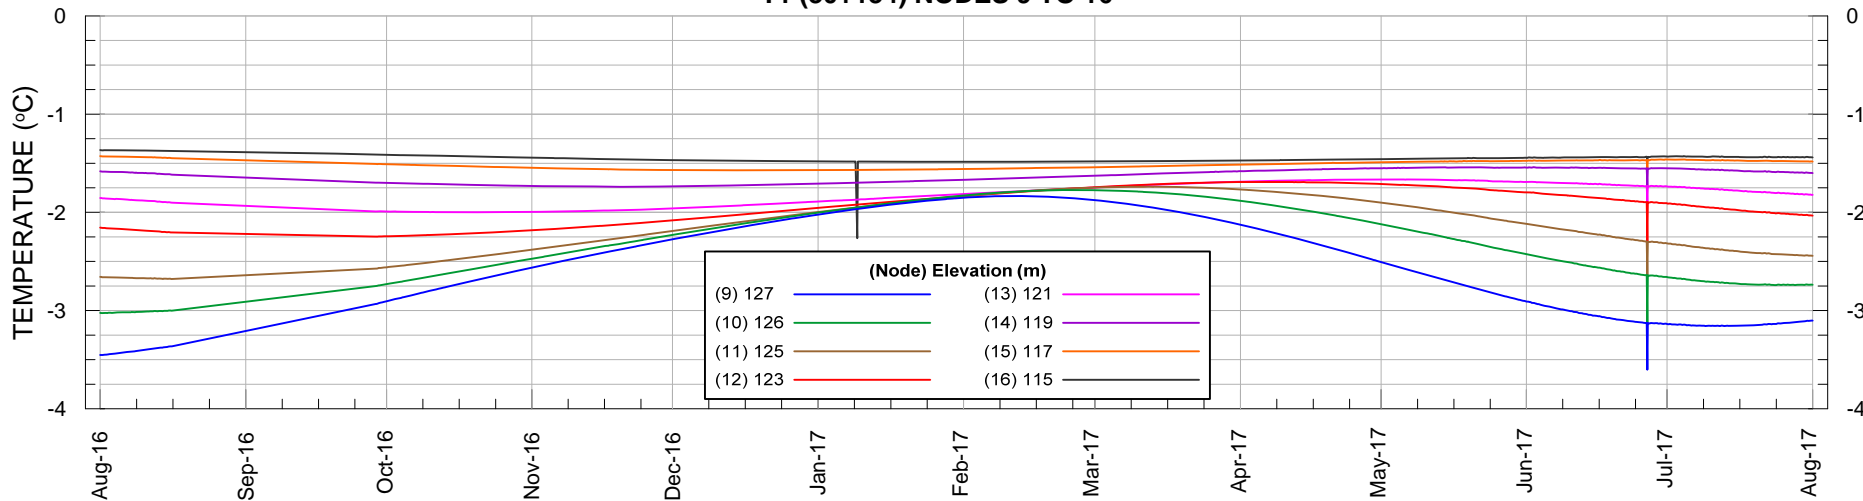
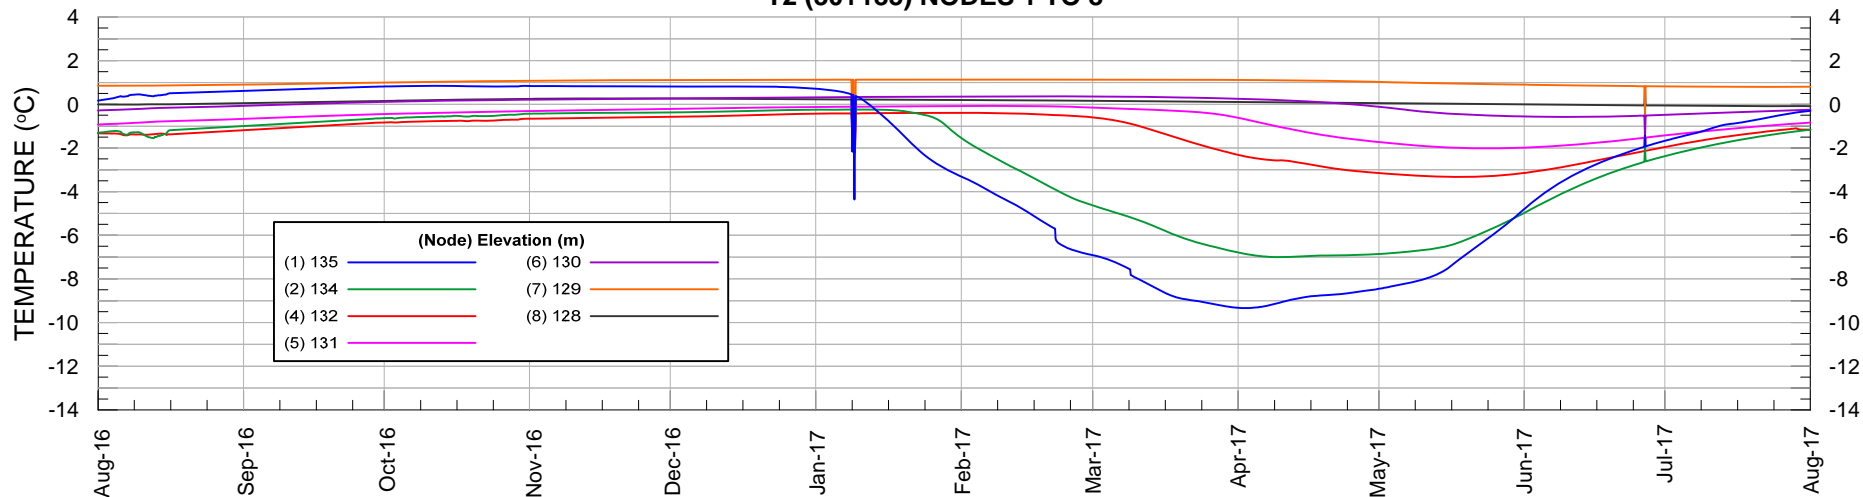
T1 (30+134) NODES 1 TO 8

1. T1 (30+134) - values less than -0.5°C are not shown for Node 8 at elevation 128 m from June 24, 2011 to June 30, 2011 as these values are believed to be inaccurate.
2. Third node of thermistor T2 (elevation 135 m) is not functional.
3. T1 and T2 thermistors stopped transmitting data on June 10, 2015. Inspecting areas to determine a cause.

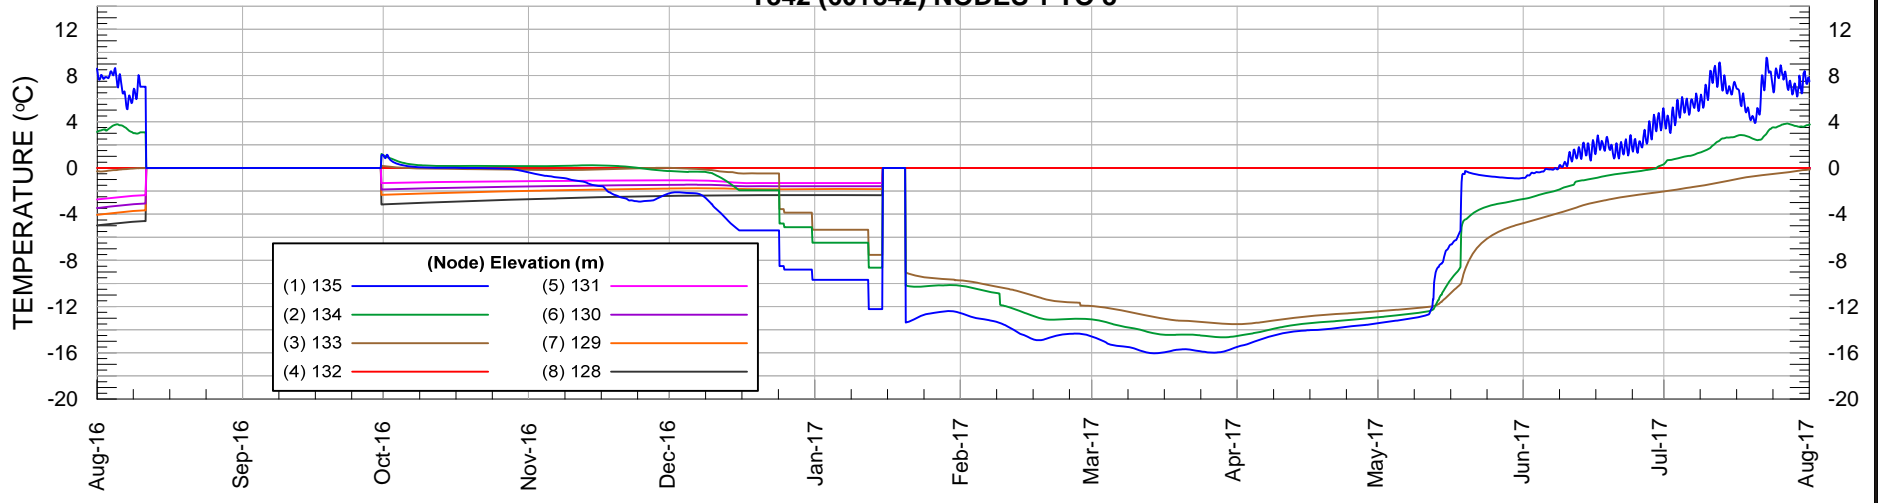
T842 (60+842) NODES 1 TO 8

**NOTES:**  
 1. Beads 2 and 4 on T60+842 do not seem to be working properly.

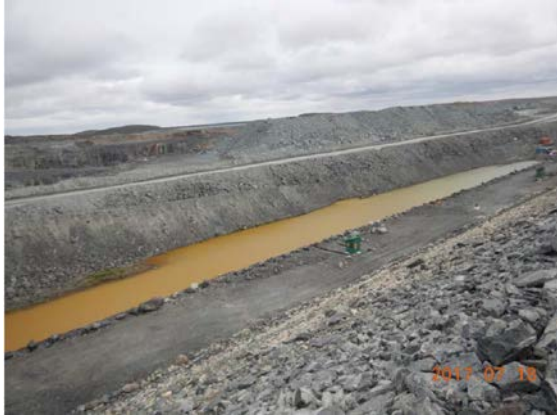
July 18 2017

**July 18** - Change in D/S Pond Coloration Observed

# CHANGE IN COLORATION OF D/S POND

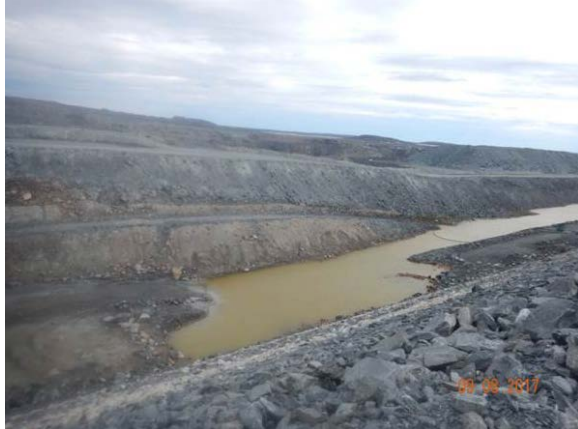
August 9 2017

# CHANGE IN COLORATION OF D/S POND

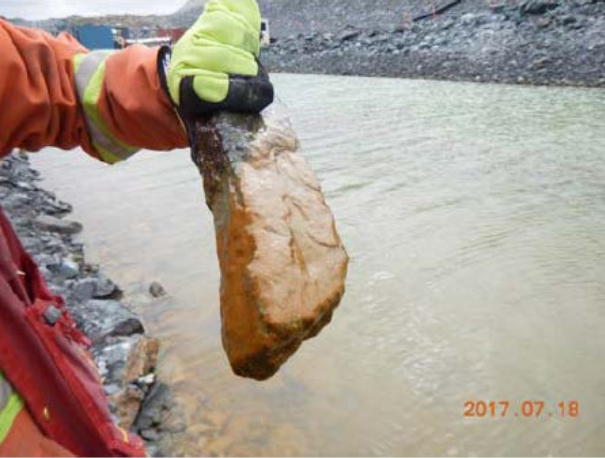
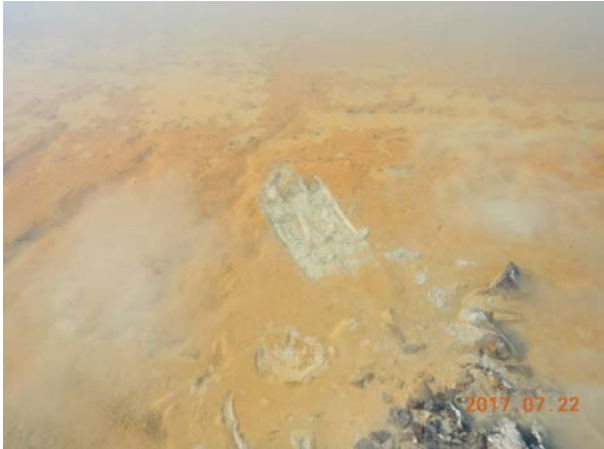
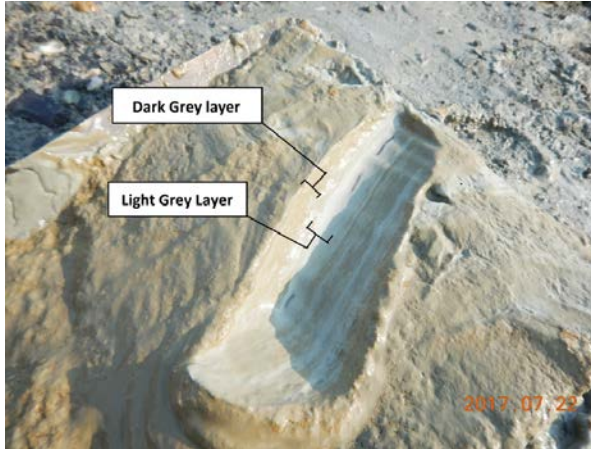
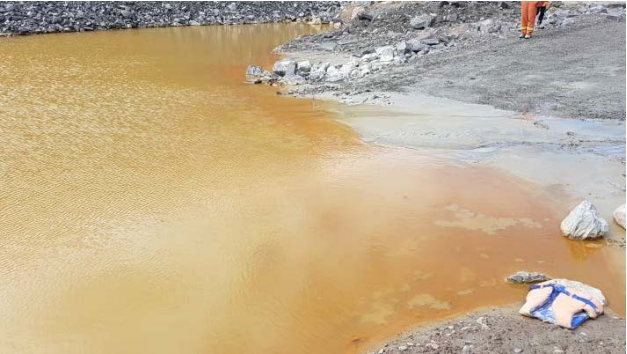
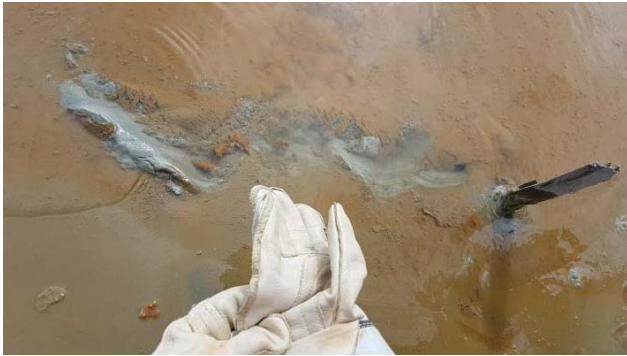
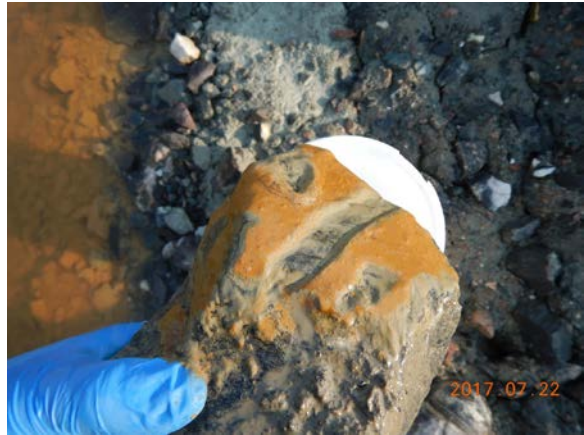
## Orange Sludge Observed in the Pond Following Change In Coloration

- The tailings (2) and pond samples (1 & 3) have a similar chemical profile, though at different concentrations. This means that the material is not a simple precipitate of iron. It seems like the material is either tailings or some other rock that is found on site.

Second solid sampling will be required to confirmed the nature of the sediment found in the D/S pond and the coloration change mechanism.

- ➔ Recollect solid samples at the same location as last time, with some slight revisions to the analyses
  - Geochem - total sulphur (Leco), sulphate sulphur, carbonate content (colometry, not total carbon), ICP-MS multi-element scan on aqua regia digest with low detection limits
  - Mineralogy - submit for QEMSCAN modal mineralogy by SGS Burnaby. It will provide better quantification of minerals in this case, or at least remove some of the uncertainty in XRD only results, especially since the iron precipitate is likely poorly ordered and not really detectable by XRD.
- ➔ Collect a fresh mill tailings sample

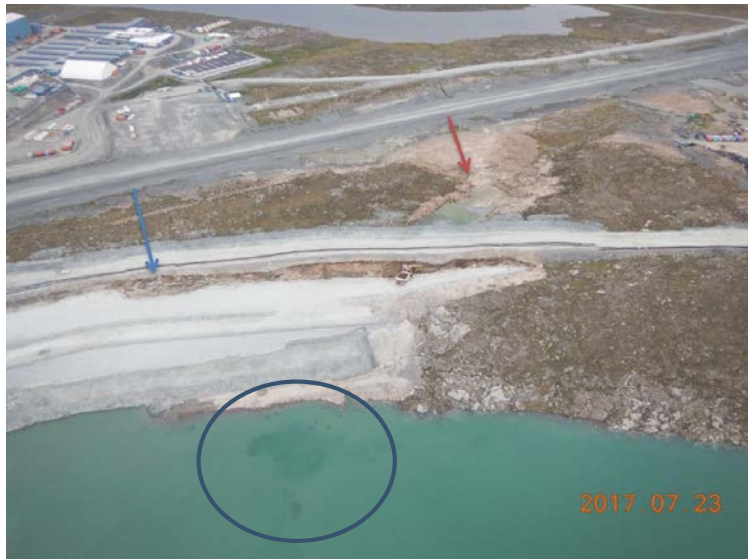
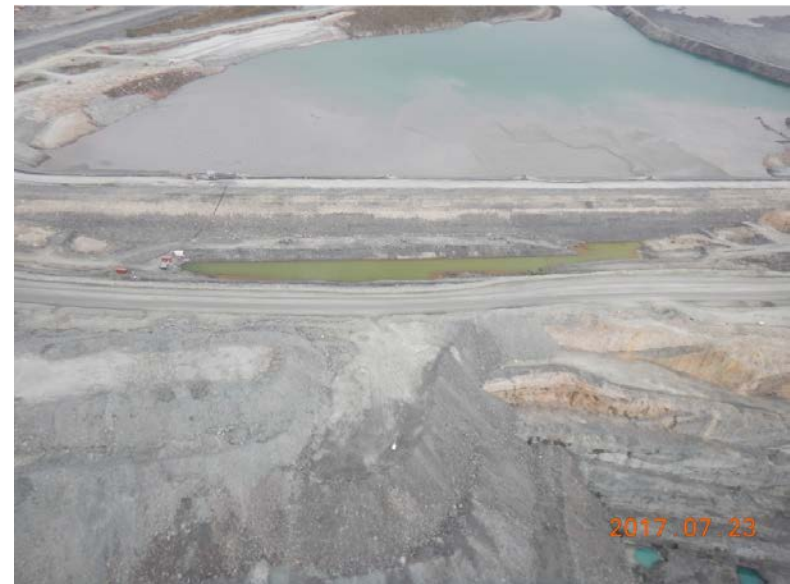
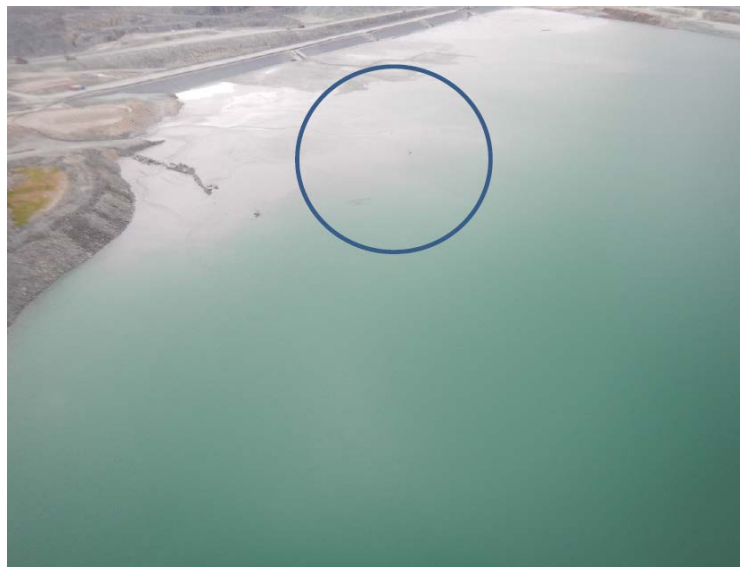
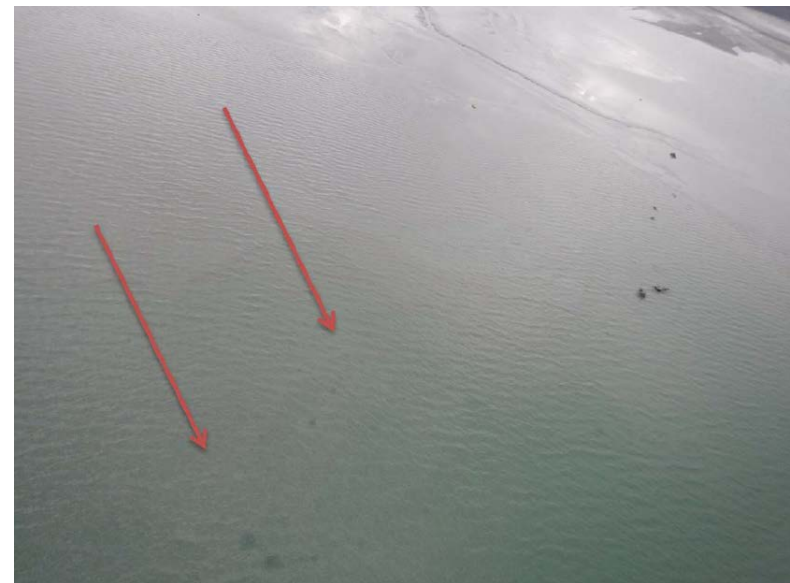
# DEPRESSIONS IN TAILINGS POND

First Observed On July 23 2017 During an Helicopter Inspection

- ➔ Daily visual inspection of Central Dike;
- ➔ Increased frequency of instrumentation review;
- ➔ Tailings deposition strategy modified to promote beach along SD4 and cover the depression observed;
- ➔ Sampling and analysis of water and solid to understand cause of coloration change;
- ➔ Evaluation of strategy to diminish water level in South Cell.

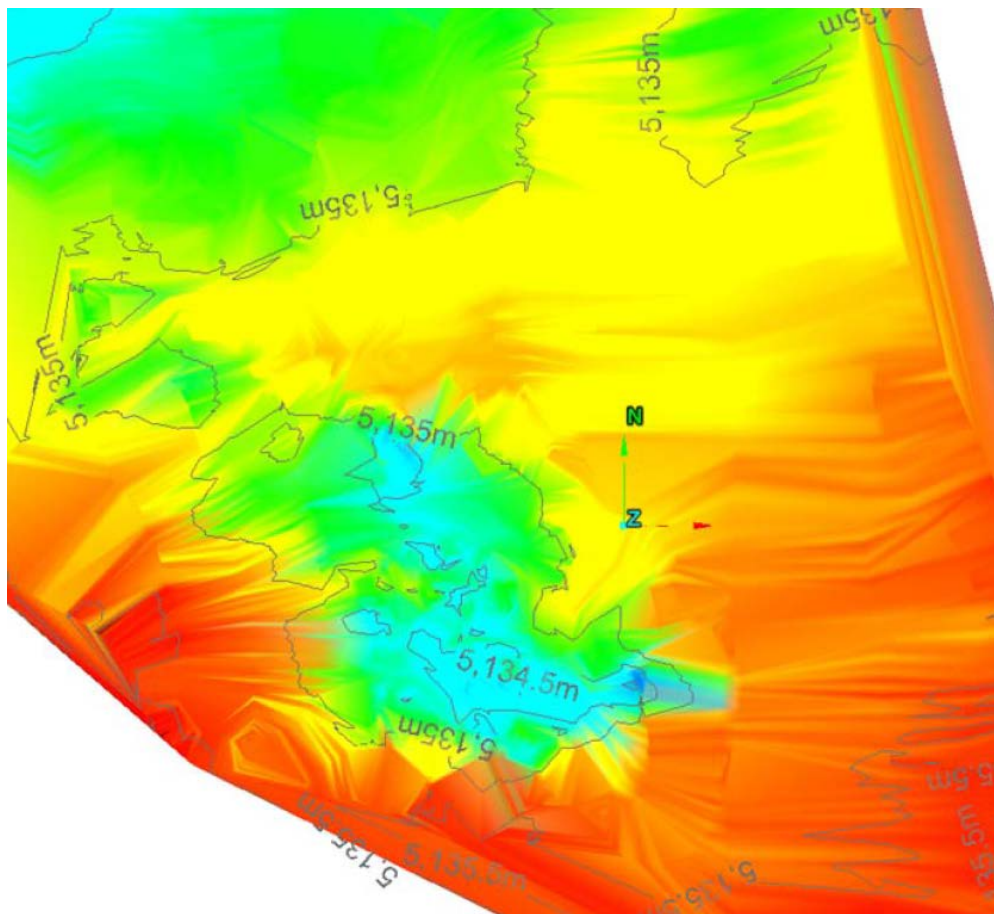
## July 28<sup>th</sup> Bathymetry by SD4

Depression dimension of 30 x  
36 x 1 m

Volume of 1 080 m<sup>3</sup>

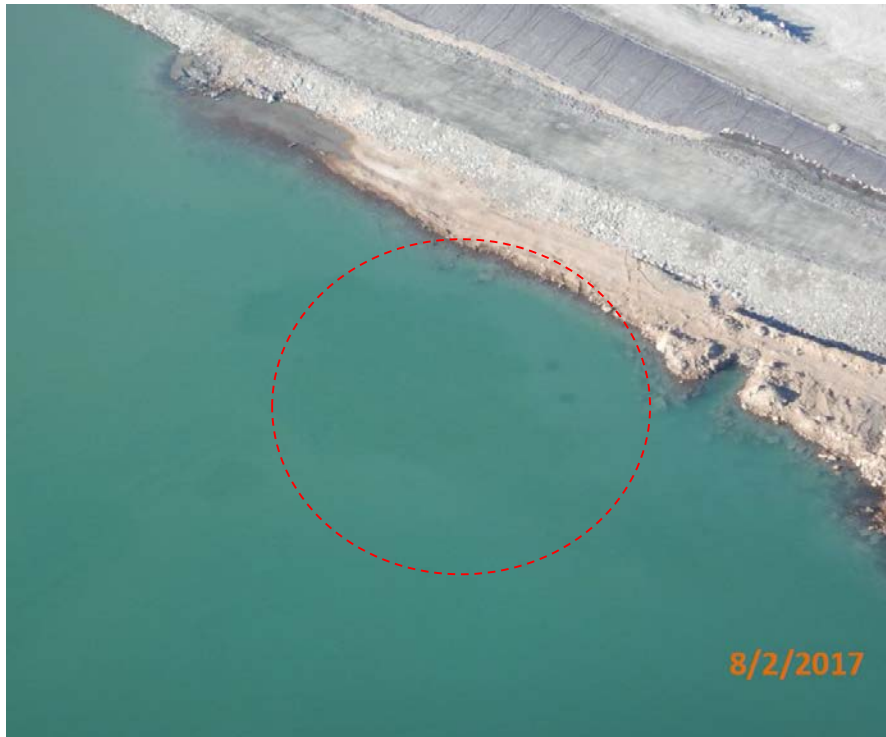
August 2

Deposition Point Switched on August 5 to promote beach against SD4
