**Report: 2017 Annual Geotechnical Inspection**

February 2018

# 2017 Annual Geotechnical Inspection Meadowbank Gold Mine, Nunavut

**Report Number:** 1784282-1574-RPT-Rev0

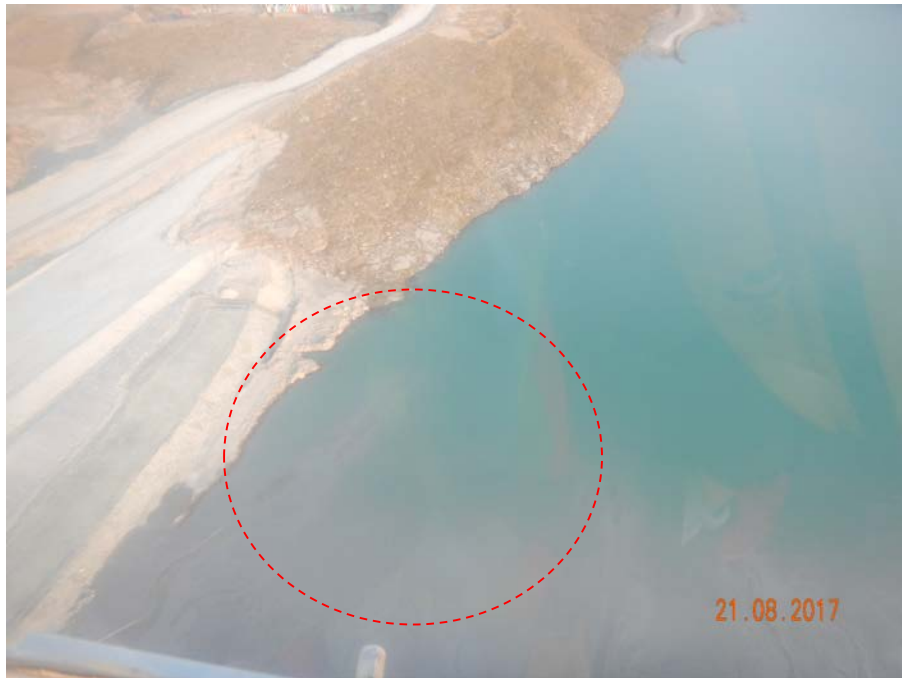
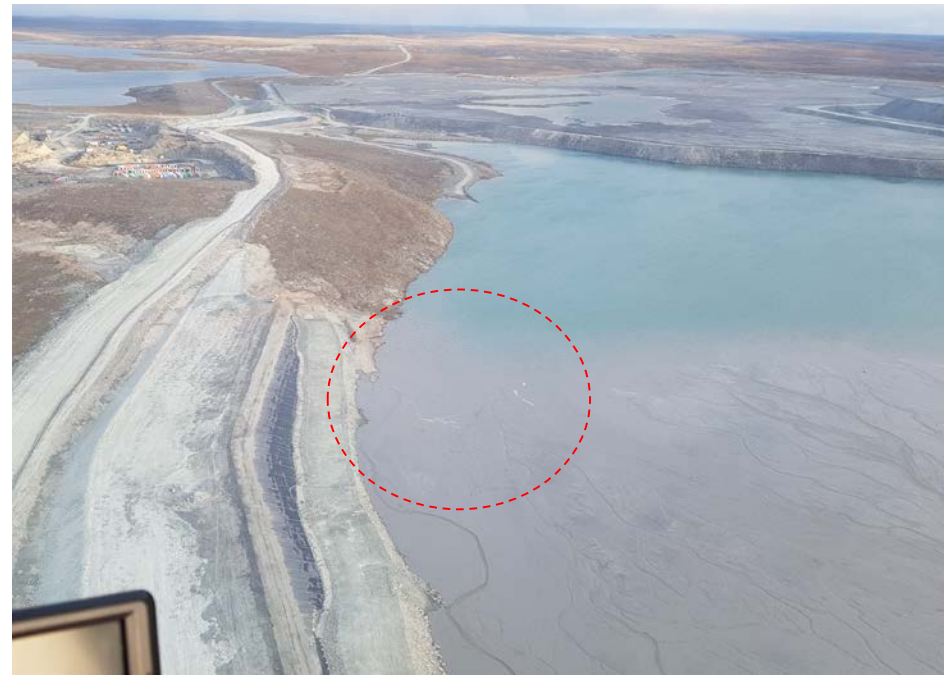
# DEPRESSIONS IN TAILINGS POND

Deposition Point Switched on August 5 to promote beach against SD4

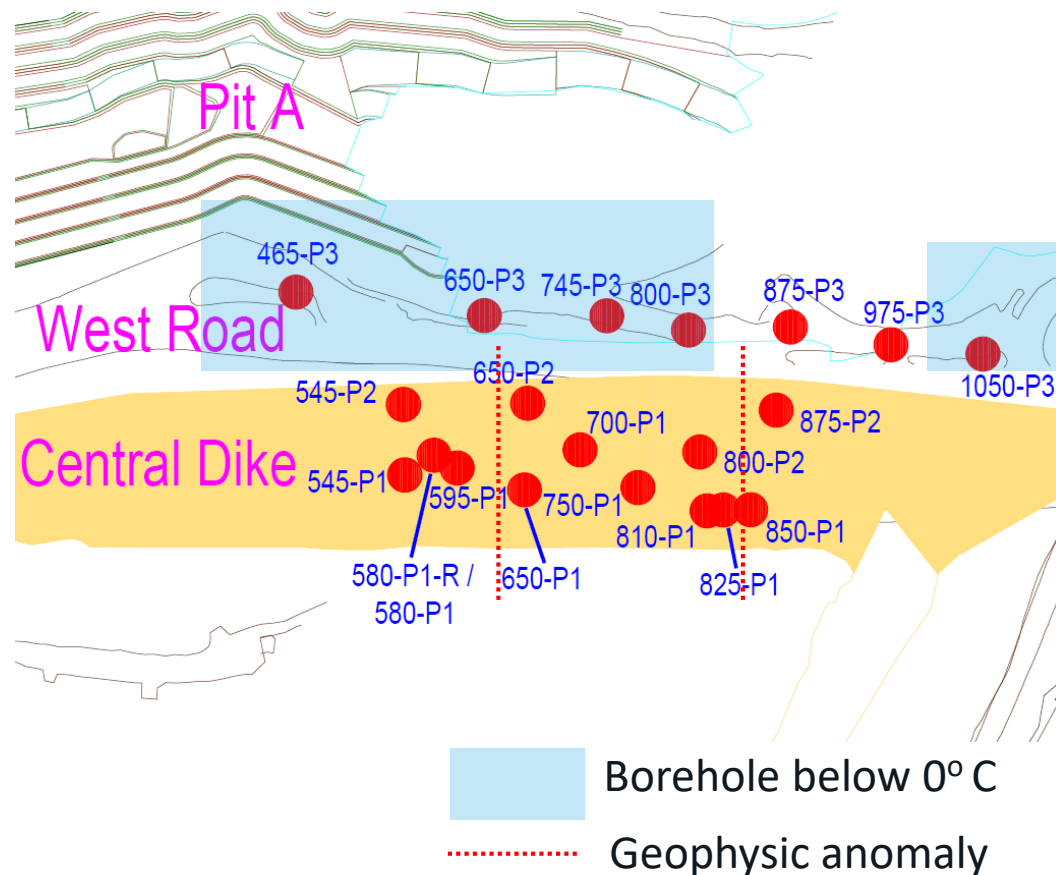
- Most instruments are correlated with D/S pond elevation
- Some instruments follow South Cell trend (generally the one deeper in bedrock)
- General piezometric trend is stable

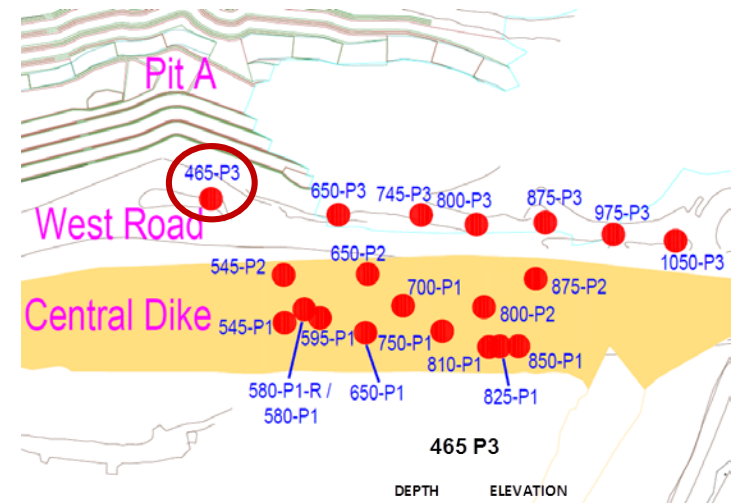
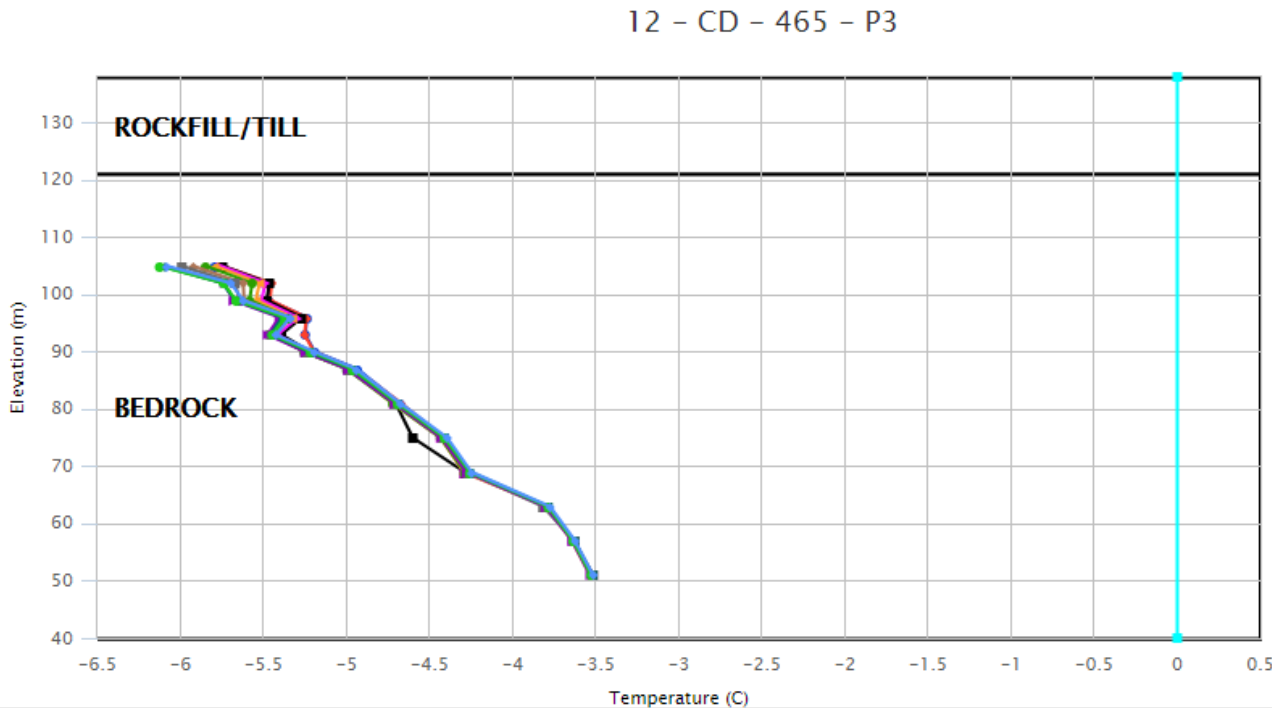
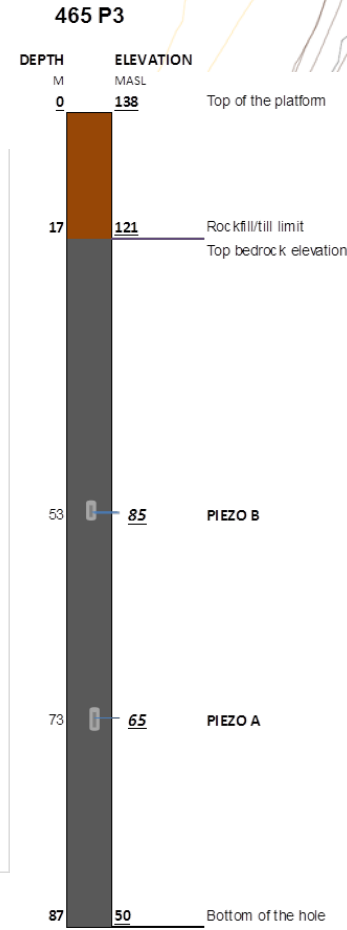
Bedrock Below 0° C at 465-P3 [-6 to -3.5° C]

Bead below El. 69 m stopped working in June 2017

At the time of the inspection, and based on the instrumentation data, the condition of the dewatering dikes appears stable. It is recommended to flag the piezometers that recorded data below 0°C in the past at East Dike and Bay-Goose Dike and be very careful when interpreting their data, as they might be broken. Once a piezometer has frozen, it cannot be relied upon even if it thaws.

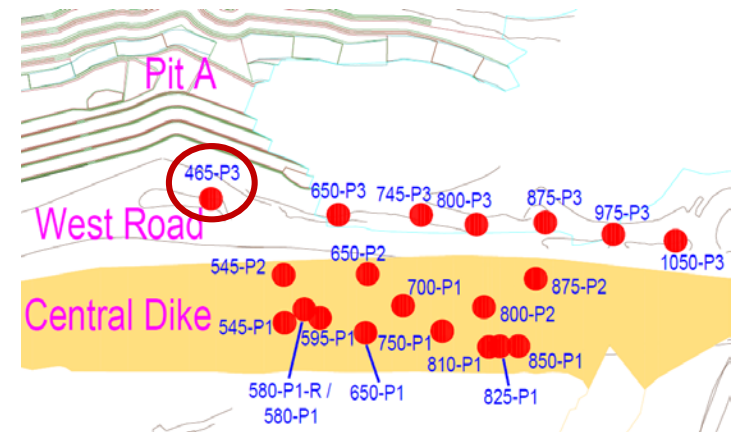
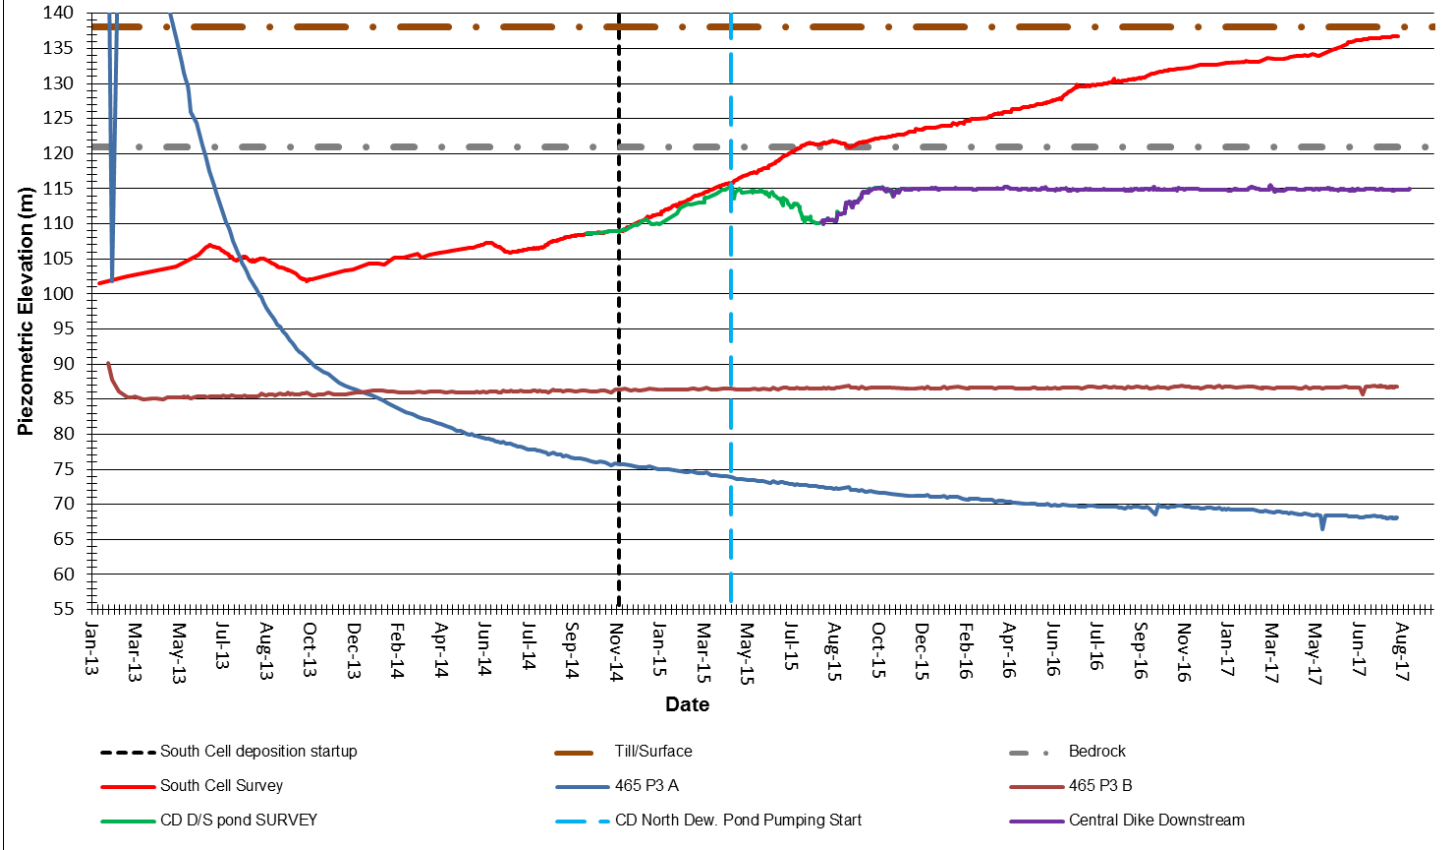
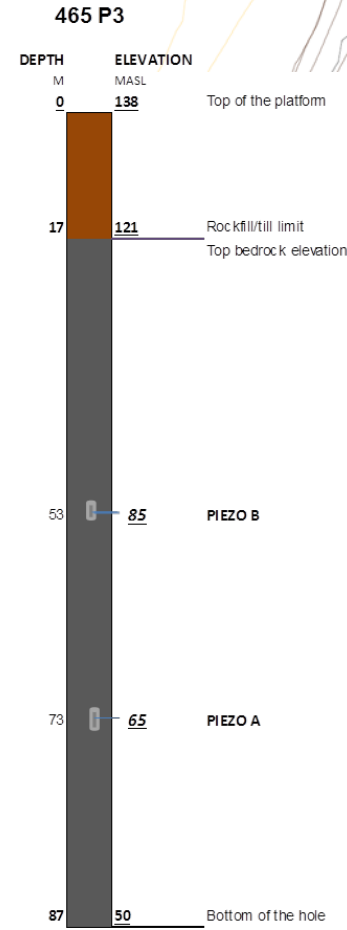
# PIEZOMETERS 465-P3

## Frozen Piezometers

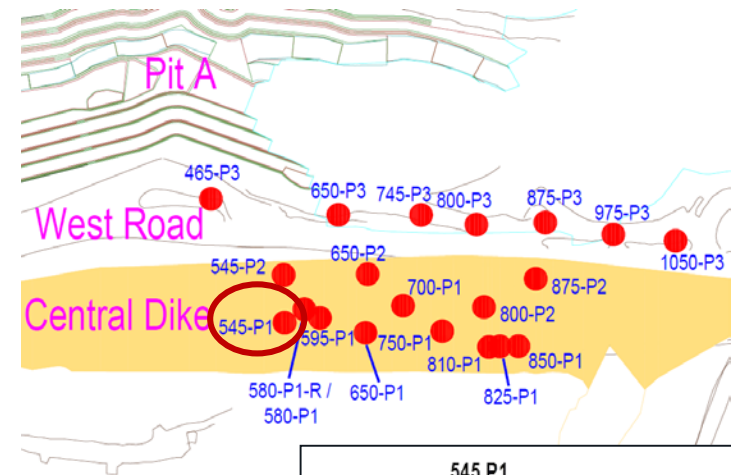
# THERMISTOR 545-P1

- 545-P1 thermistor is showing the same temperature profile than last year. Warmer peak observed at elevation 70m since the installation.
- Temperature in the bedrock/till unit is in between 1.1 and 1.75° C.

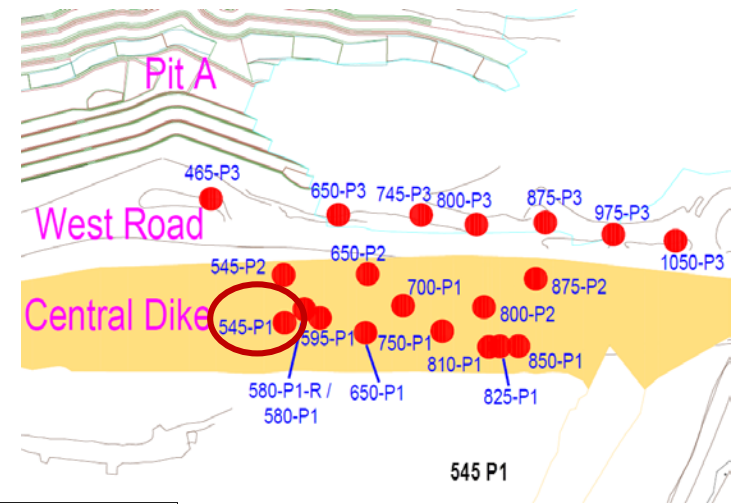
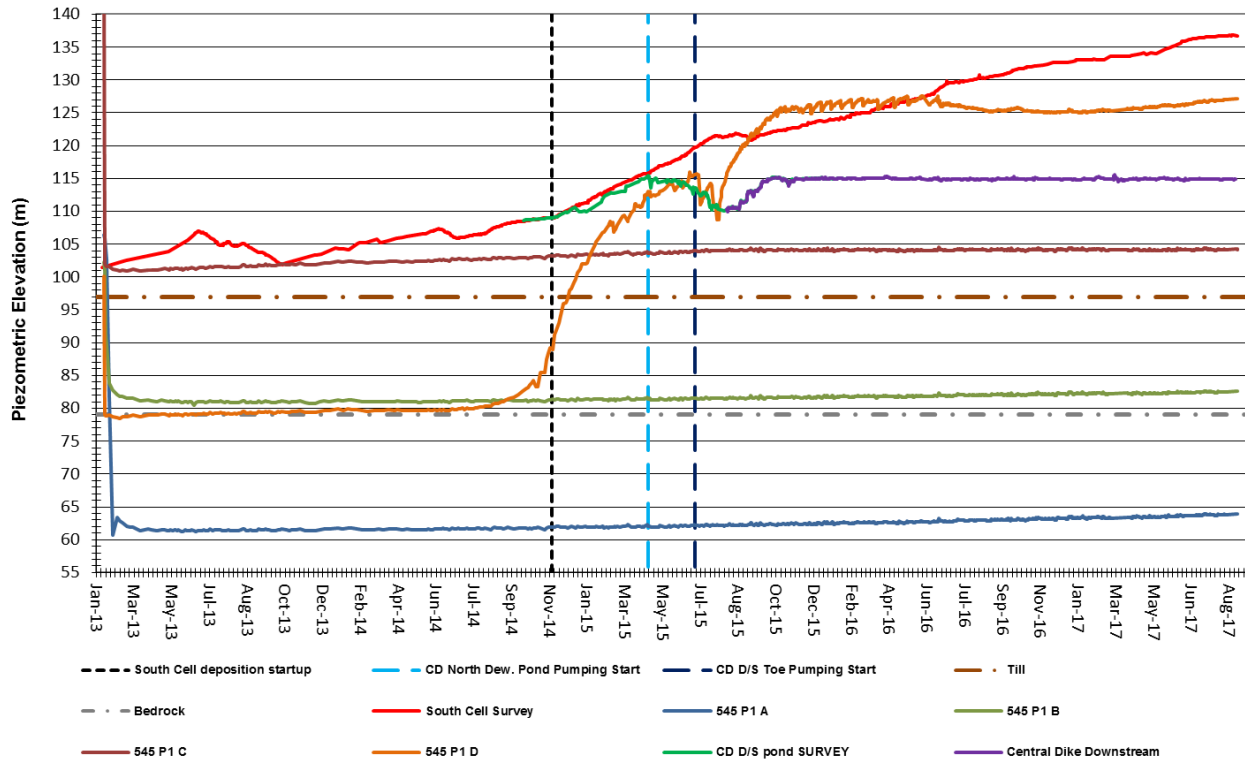
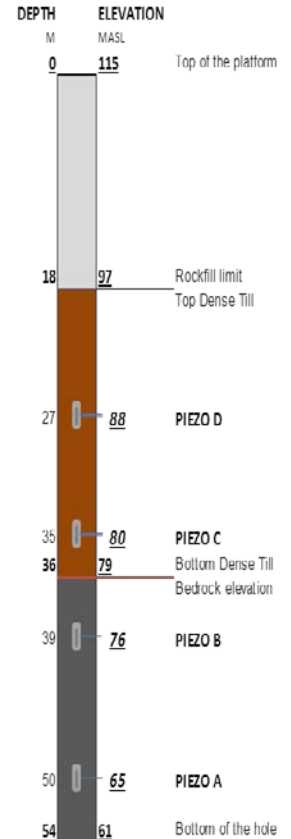
# PIEZOMETER 545-P1

- Piezometer D still constant, no change since August 2015
- Piezometer A is recording suction since its installation
- Identification of the piezo on the field is confusing. Interpretation of the readings must be done with precaution.

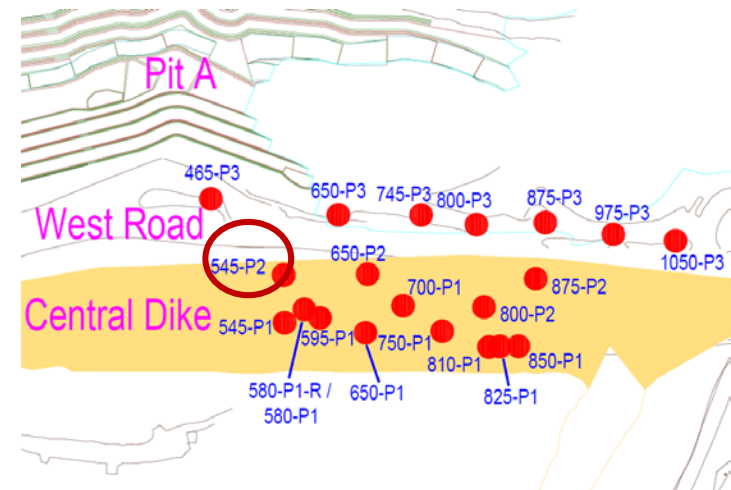
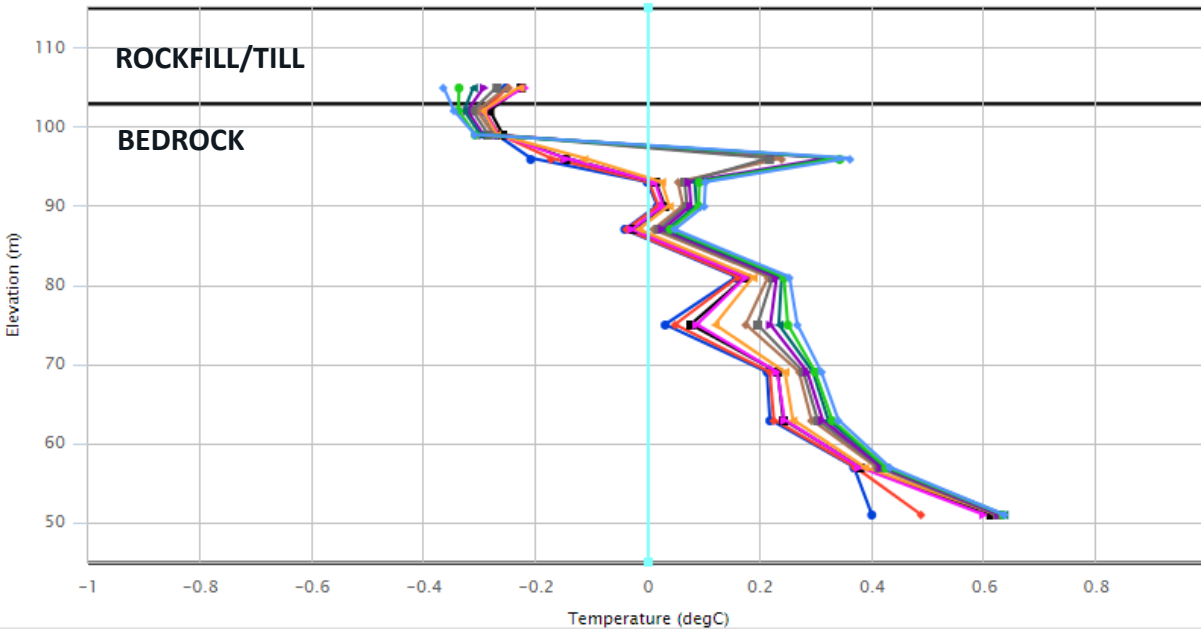
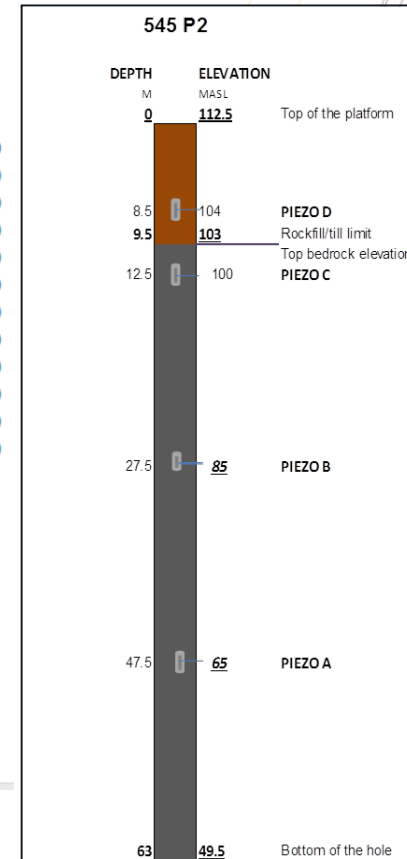
# THERMISTOR 545-P2

- Temperature peak observed on the bead located at El. 96m from January 2015 to March 2017;
- In January 2015 readings was switched from manual to automatic;
- In March 2017, AVW multiplexer was changed and temperature profile was back to its original profile;
- Investigation still on going – interpretation of data must be done with precaution.

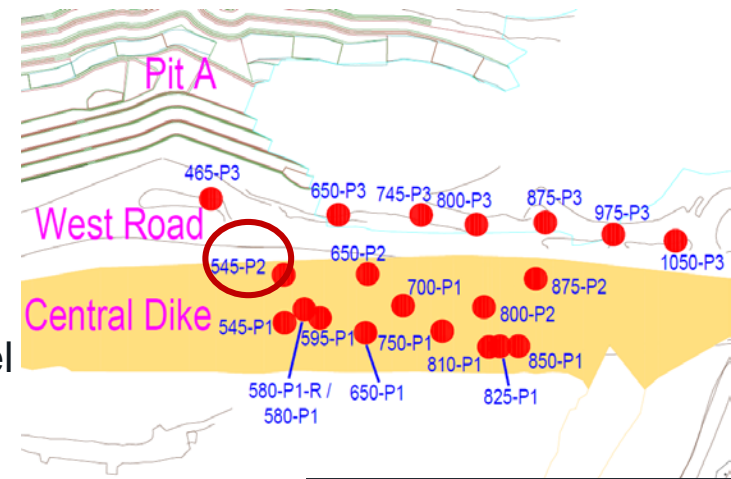
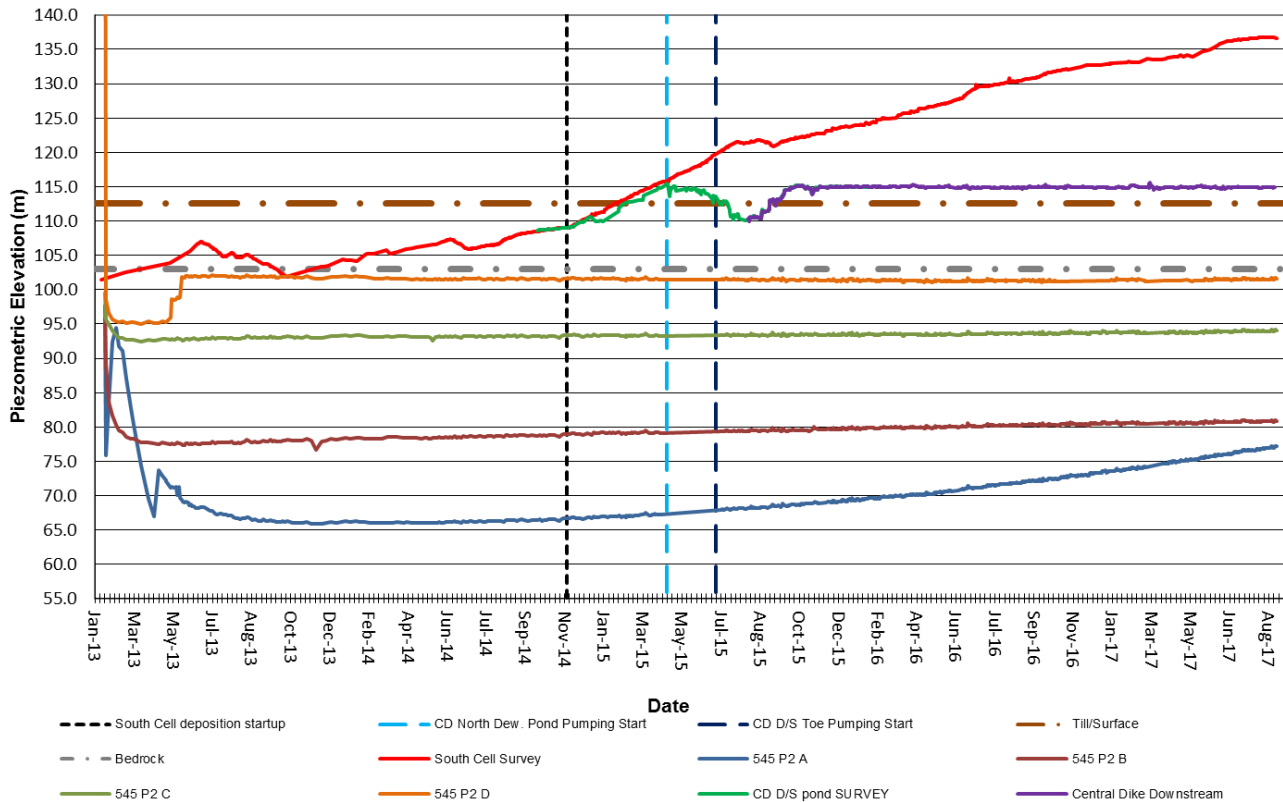
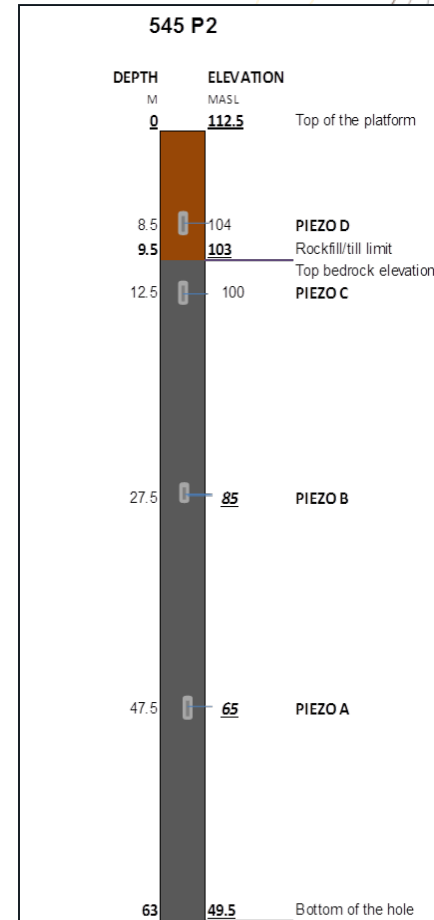
# PIEZOMETER 545-P2

- ➔ Piezometer A reading is increasing with South Cell level
- ➔ Other piezometers are recording suction

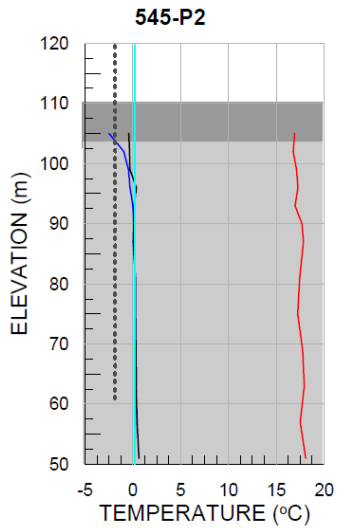
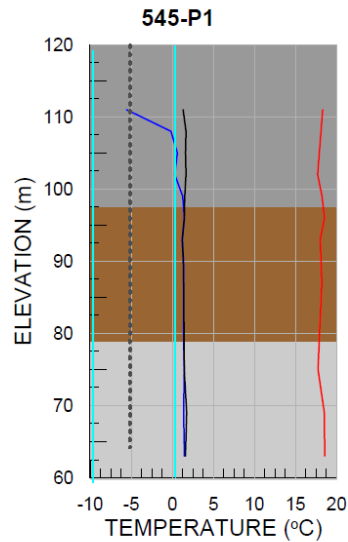
## THERMISTOR READINGS FROM AUGUST 2015 - 2016

Max temperature in 2015-2016 was more around 2°C

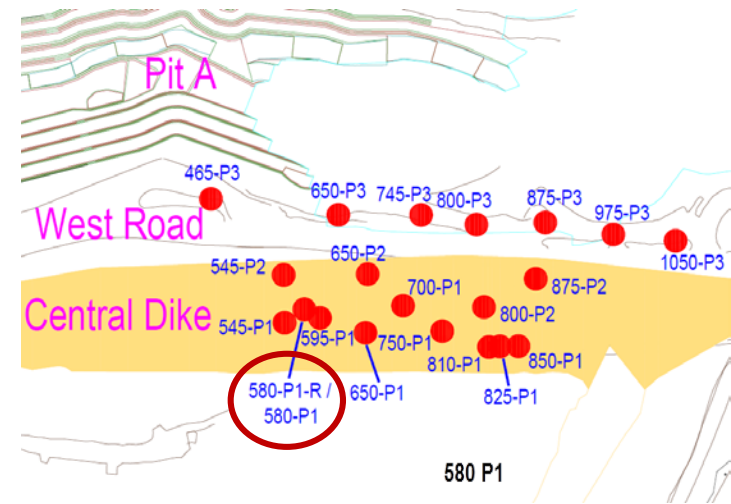
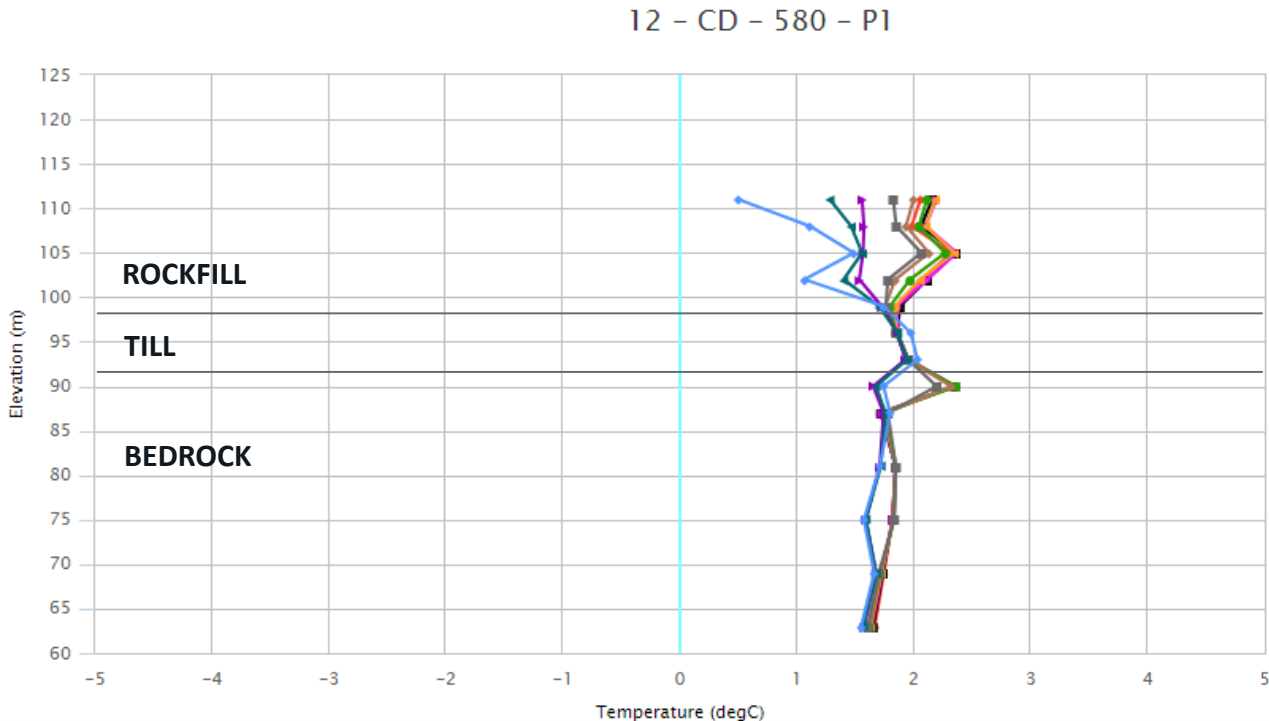
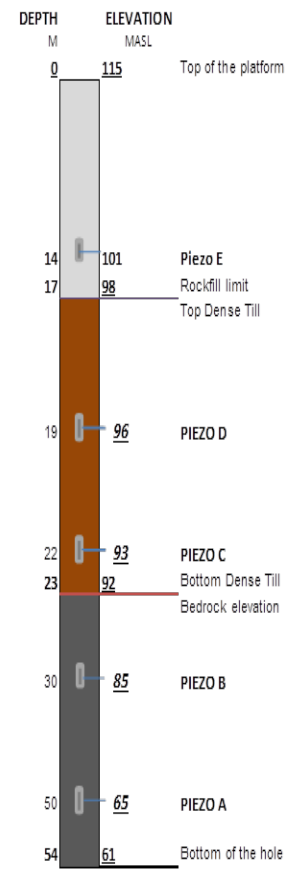
# 580-P1

- Piezometer and thermistance readings are not functional since July 2016
- Replacement hole 580-P1R drilled during 2017 campaign

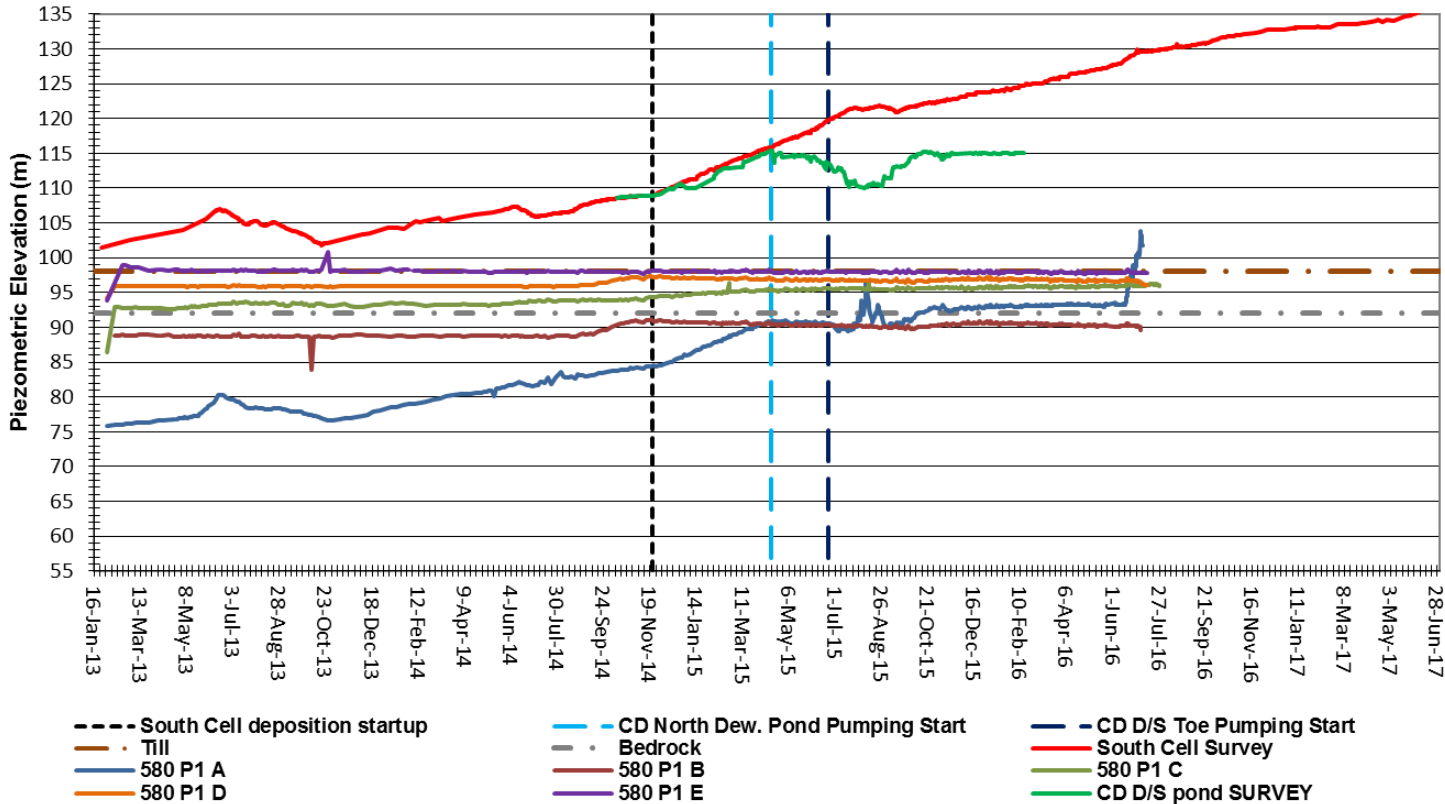
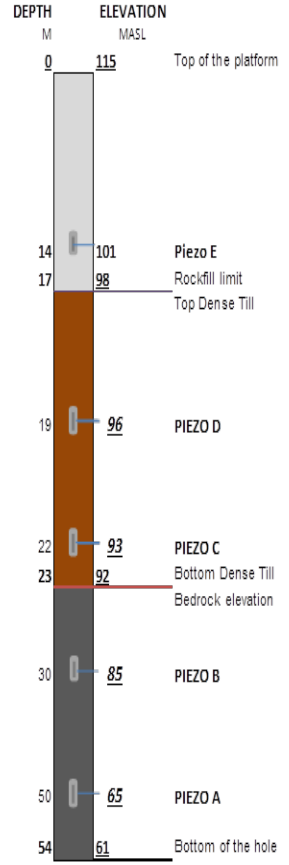
**580-P1 Hole - Piezometrics Elevation and Attenuation Pond Elevation vs Time**

- Piezometer and thermistor readings are not functional since July 2016
- Replacement hole 580-P1R drilled during 2017 campaign

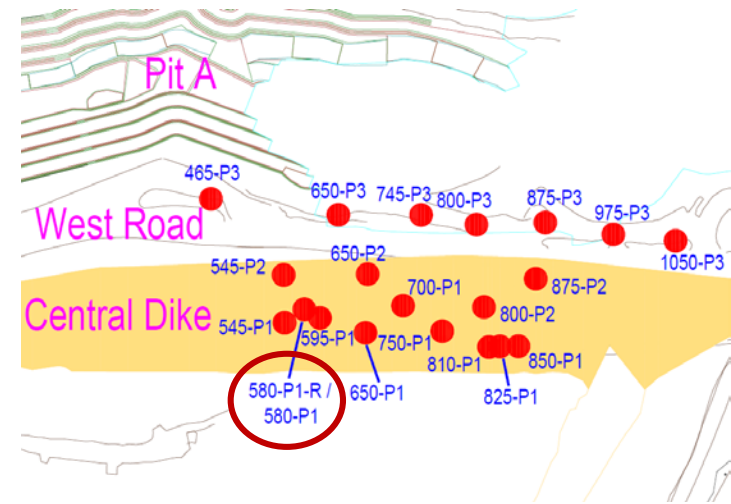
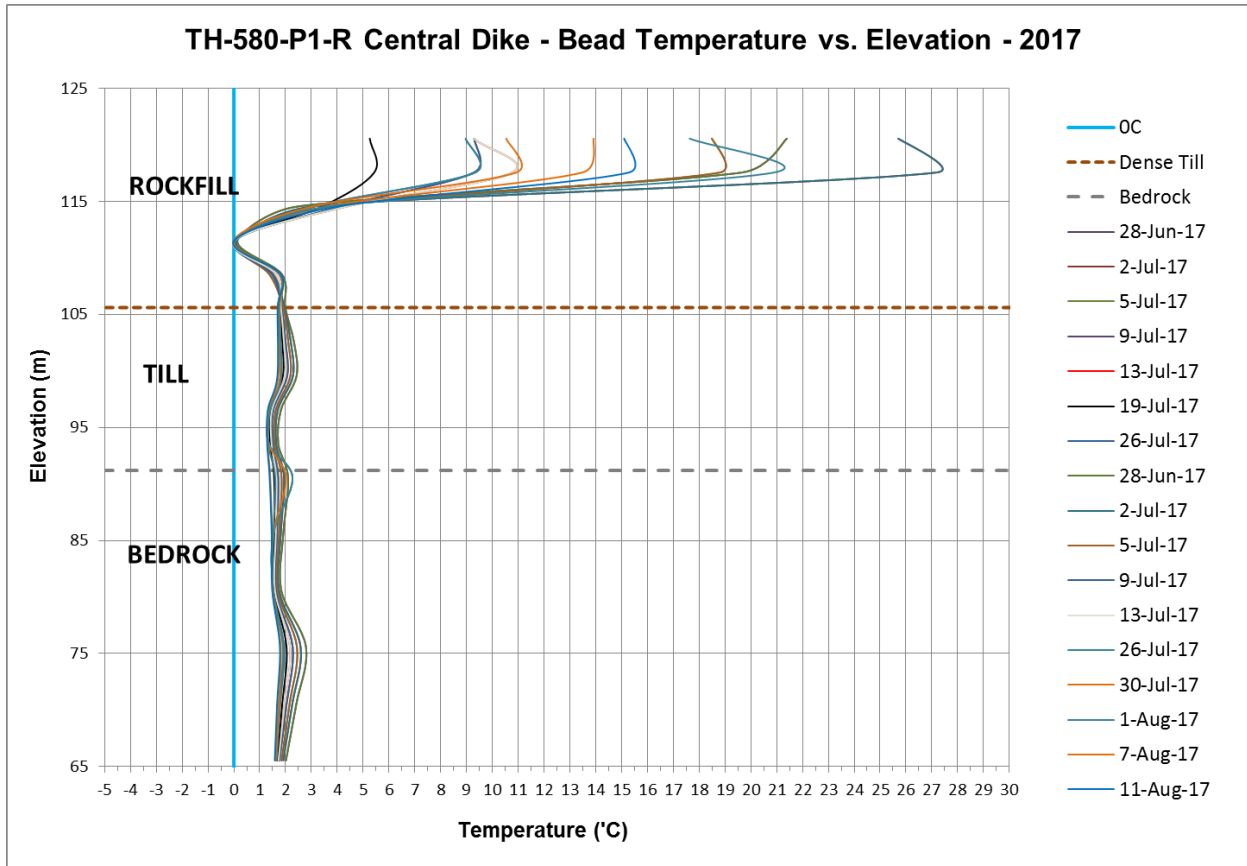
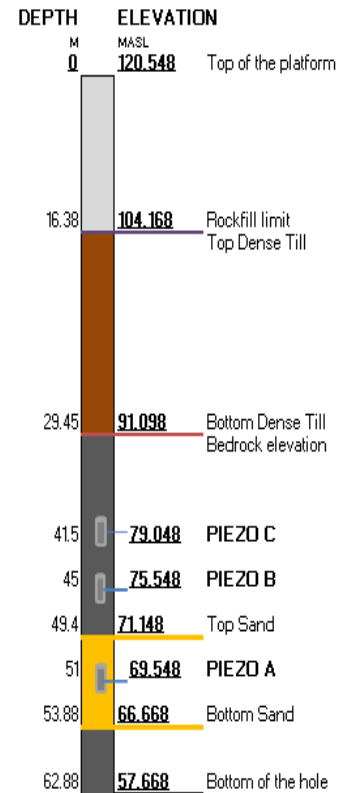
# THERMISTOR 580-P1R

- Stabilisation in progress
- Temperature readings above 0°C
- Similar temperature readings range than 580-P1

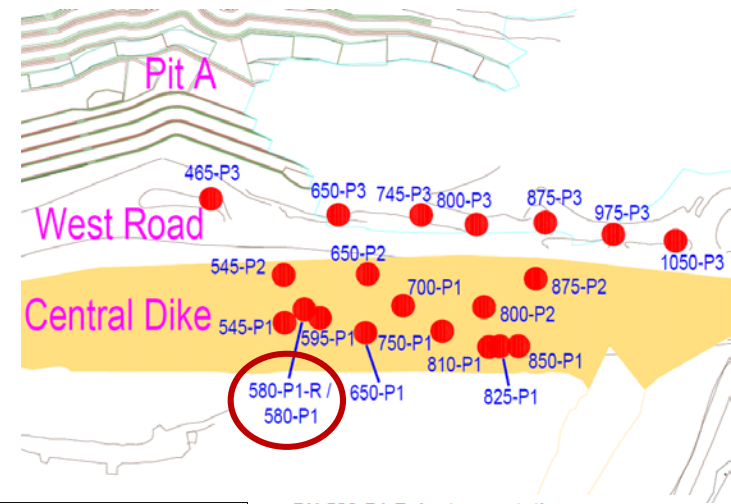
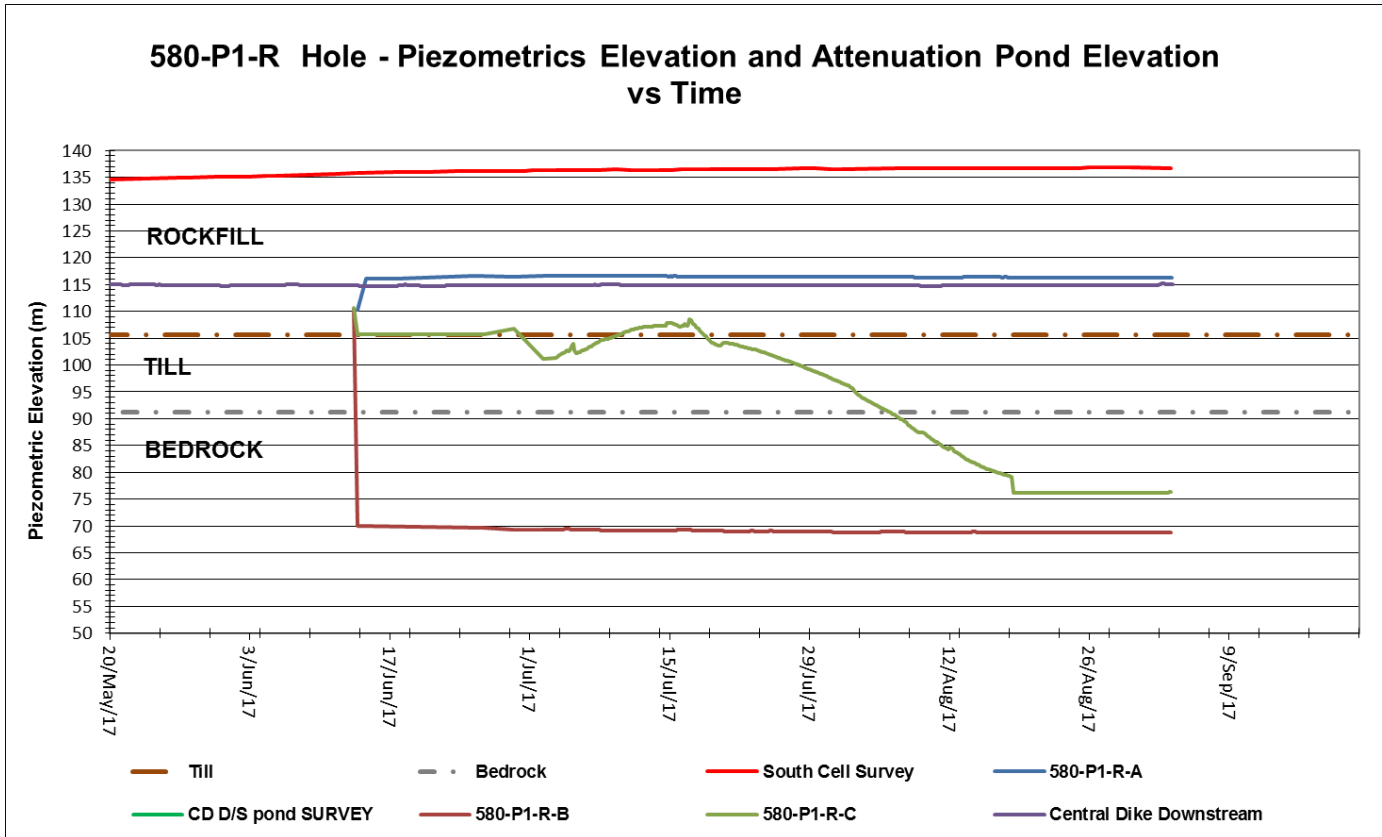
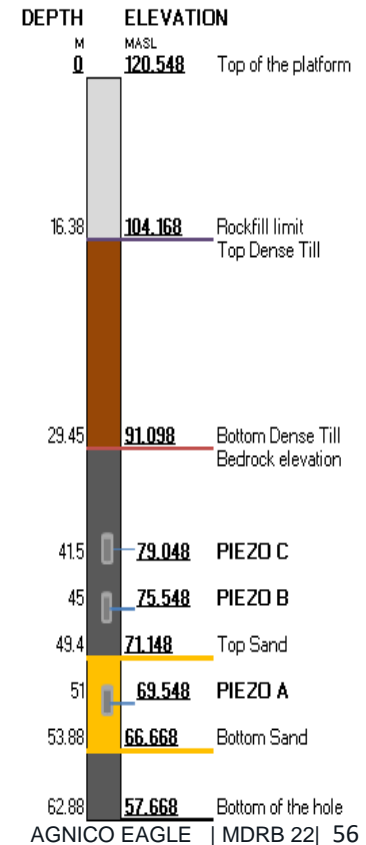
# PIEZOMETER 580-P1R

- Piezo A is located in a sand layer and pressure readings are following the D/S pond regime
- Decrease in piezometric elevation ongoing for Piezo B
- Small data GAP

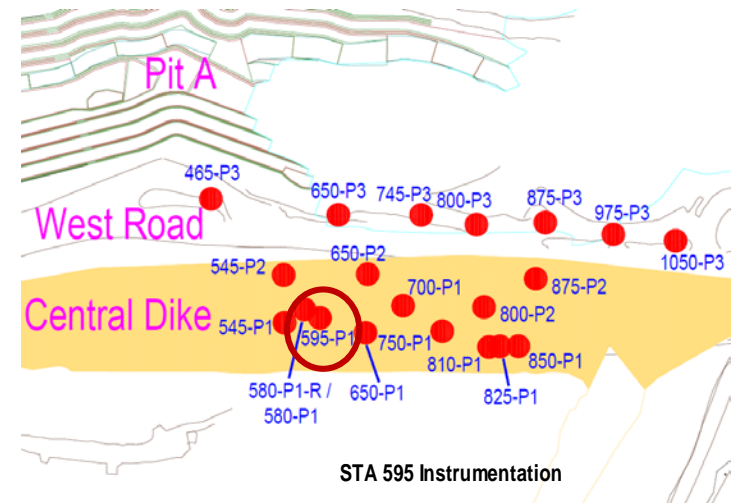
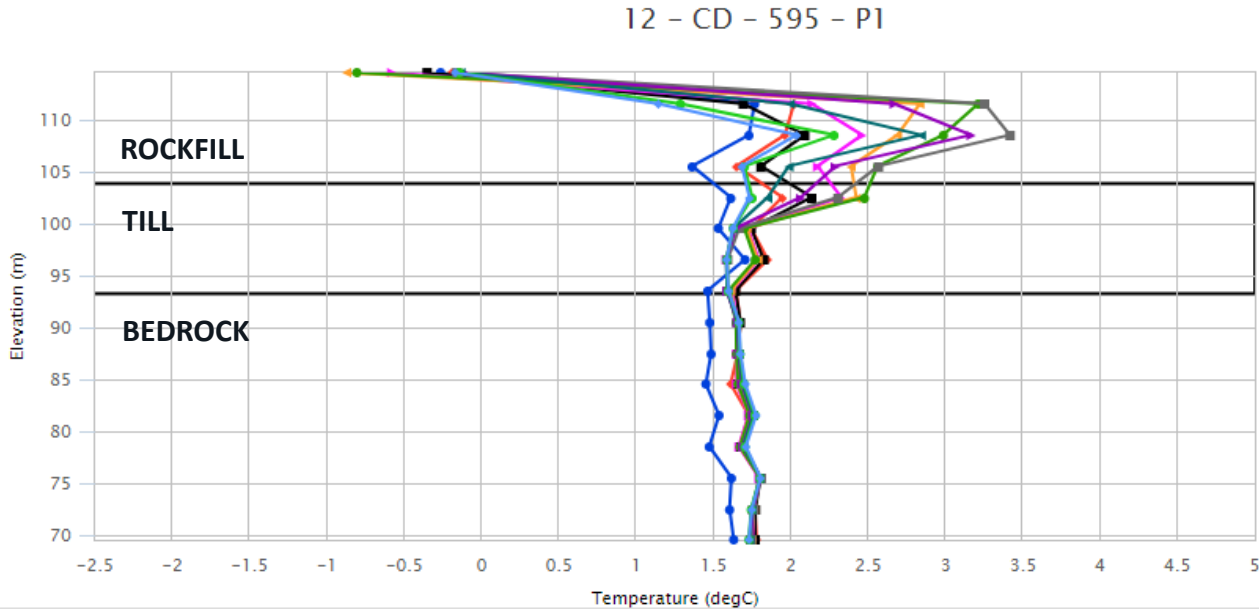
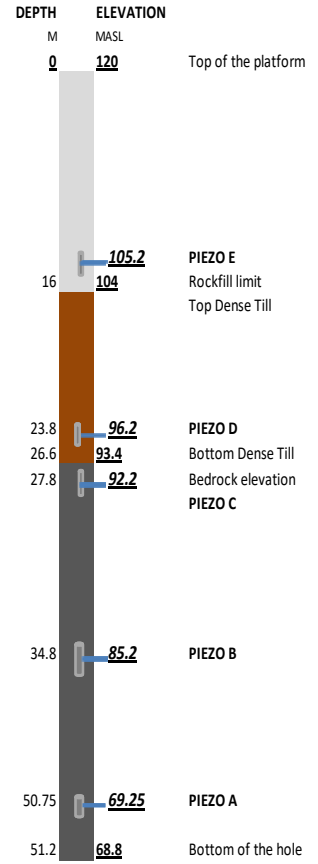
# THERMISTOR 595-P1

- Temperature in the bedrock/till unit is in between 1.5 and 1.75° C.
- Glitch of 0.25° C could be caused by the automatization works done in August 2017.

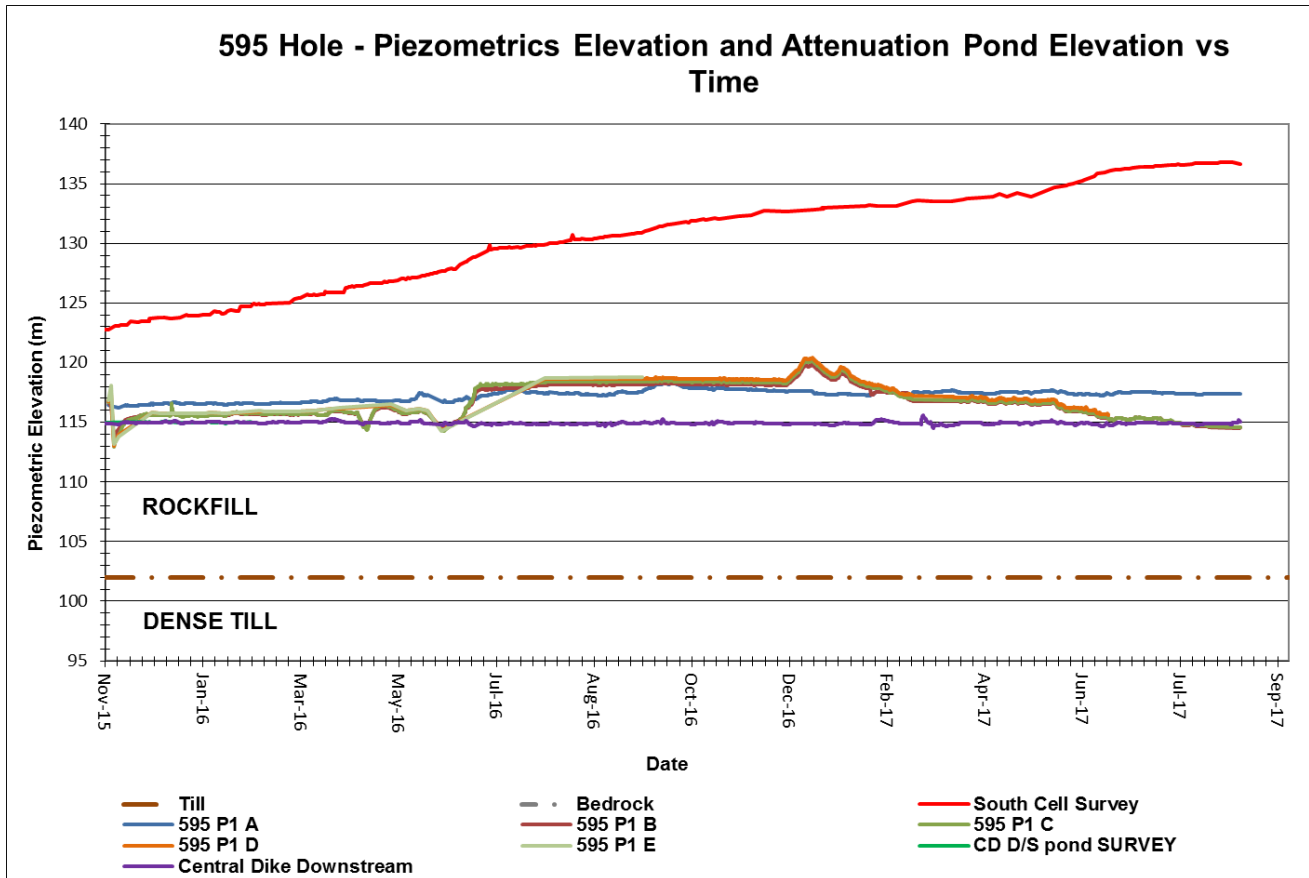
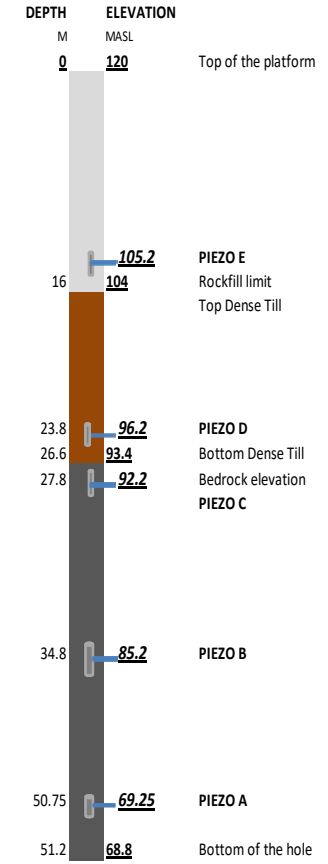
# PIEZOMETER 595-P1

- ➔ Piezometric readings are fluctuating around D/S pond elevation since the installation.
- ➔ **Piezo C to E was installed in casing**

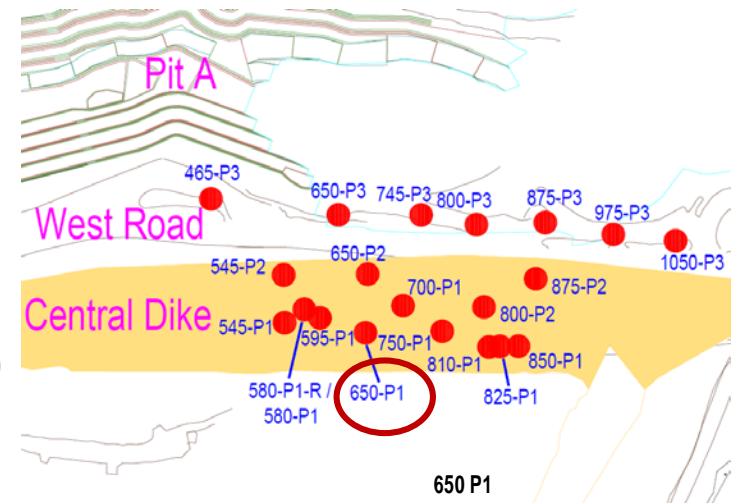
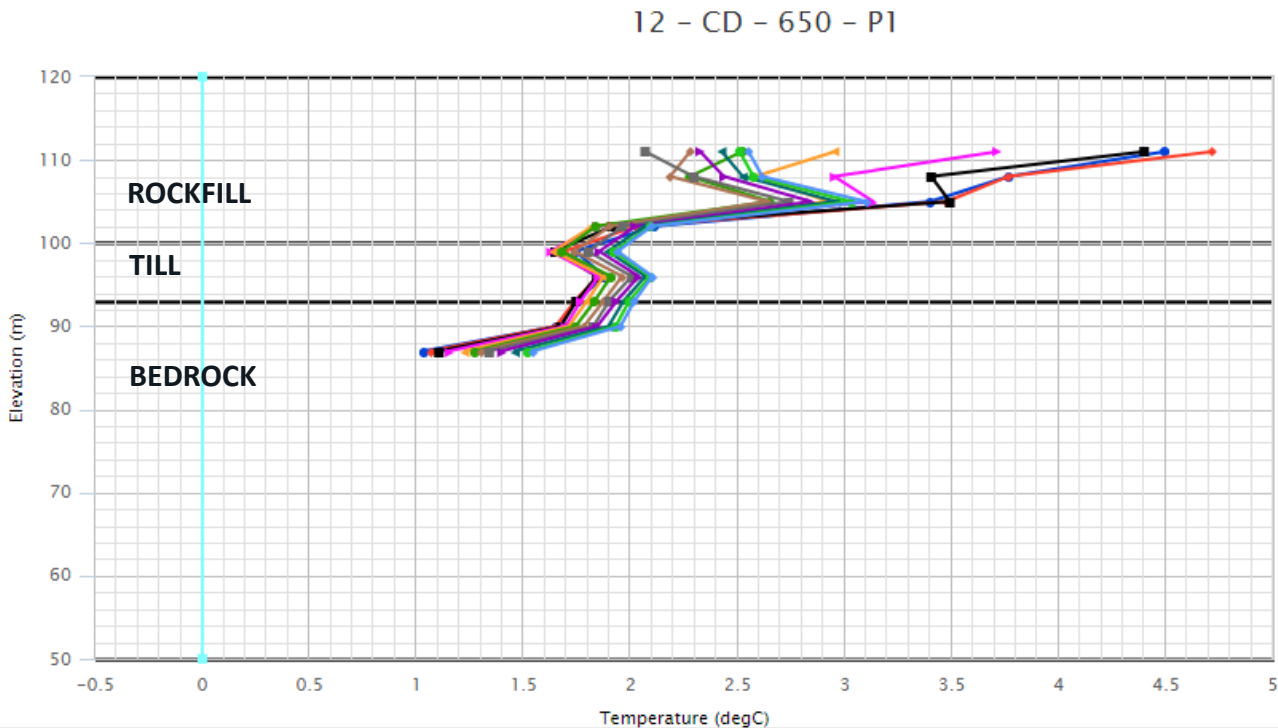
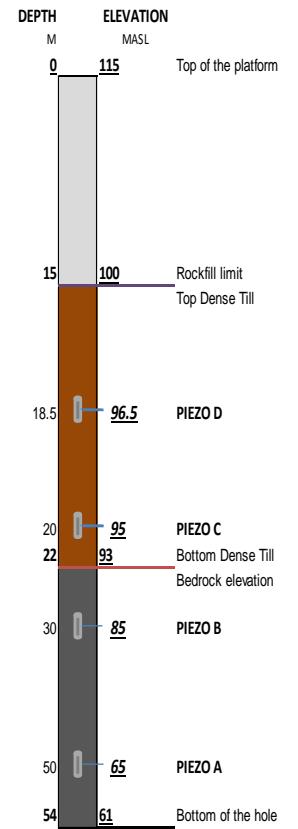
# THERMISTOR 650-P1

- Thermistance reading not functional since January 2017
- Beads 10 to 12 are not functioning since August 2016
- Temperature of the bedrock/till units were in between 1.0 and 2.1°C.
